P-05-199

Forsmark site investigation

Investigations of superficial fracturing and block displacements at drill site 5

Bengt Leijon (ed)
Svensk Kärnbränslehantering AB

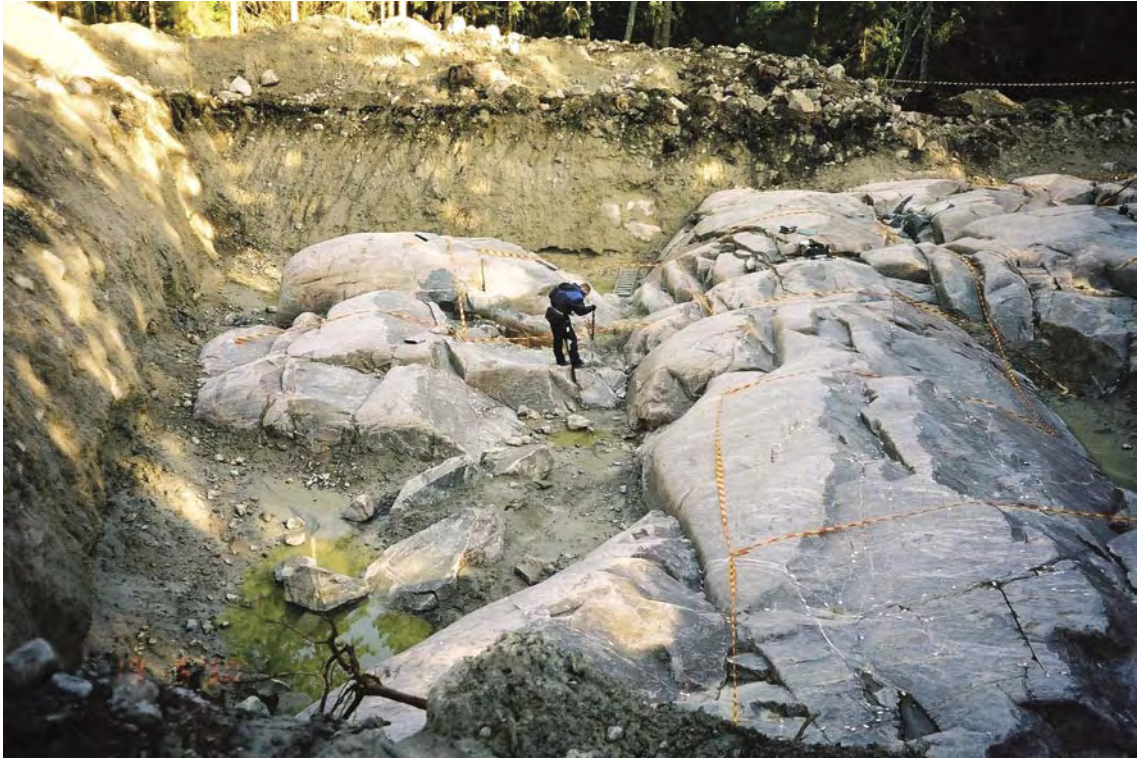
Figure 1-2. Appearance of the bedrock surface at drill site 5 after removal of the overburden. View from the southwest.

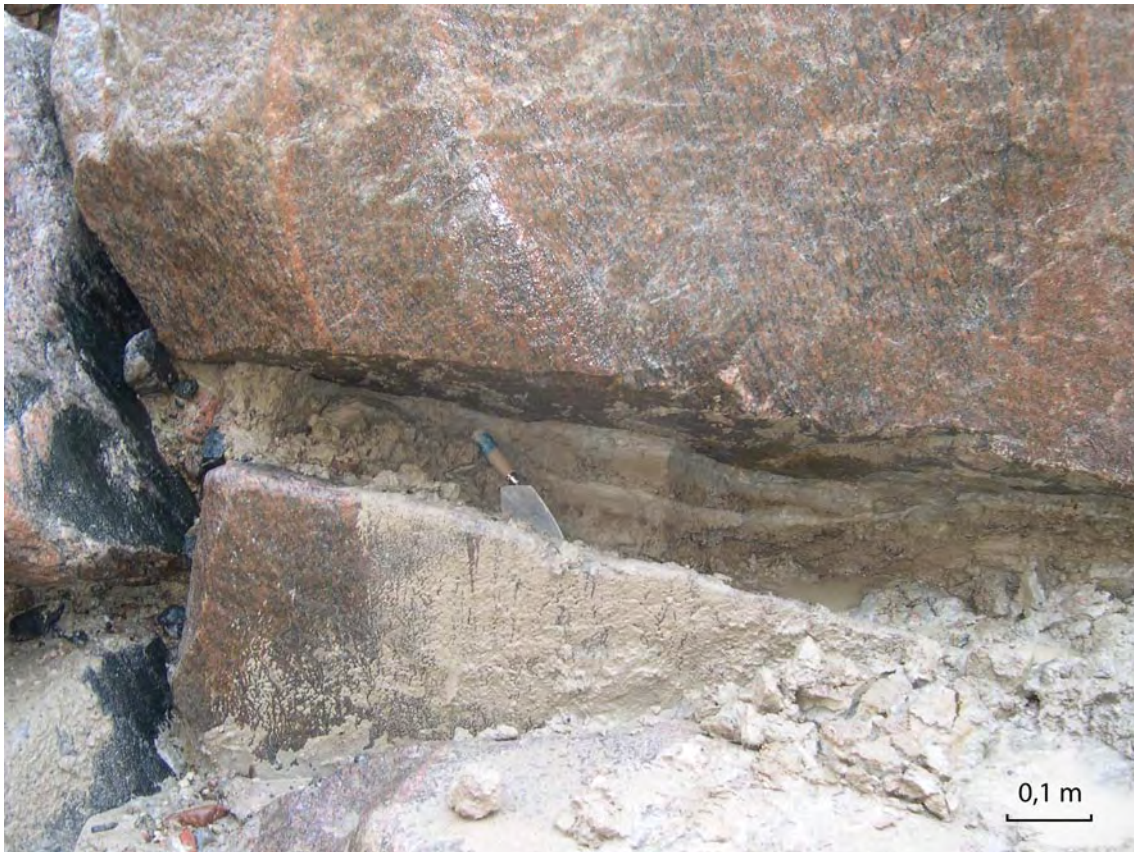
Another observation was that a number of large, gently dipping fractures were filled with soil material, similar in appearance to the excavated till overburden. Thicknesses of these fracture fillings varied up to about 2 dm. Overlying blocks were uplifted correspondingly, and in some cases slightly rotated relative to the underlying rock. Figure 1-4 shows one of these fractures.

Figure 1-4. Example of a gently dipping fracture, more than 10 cm wide and filled with sedimented soil material.

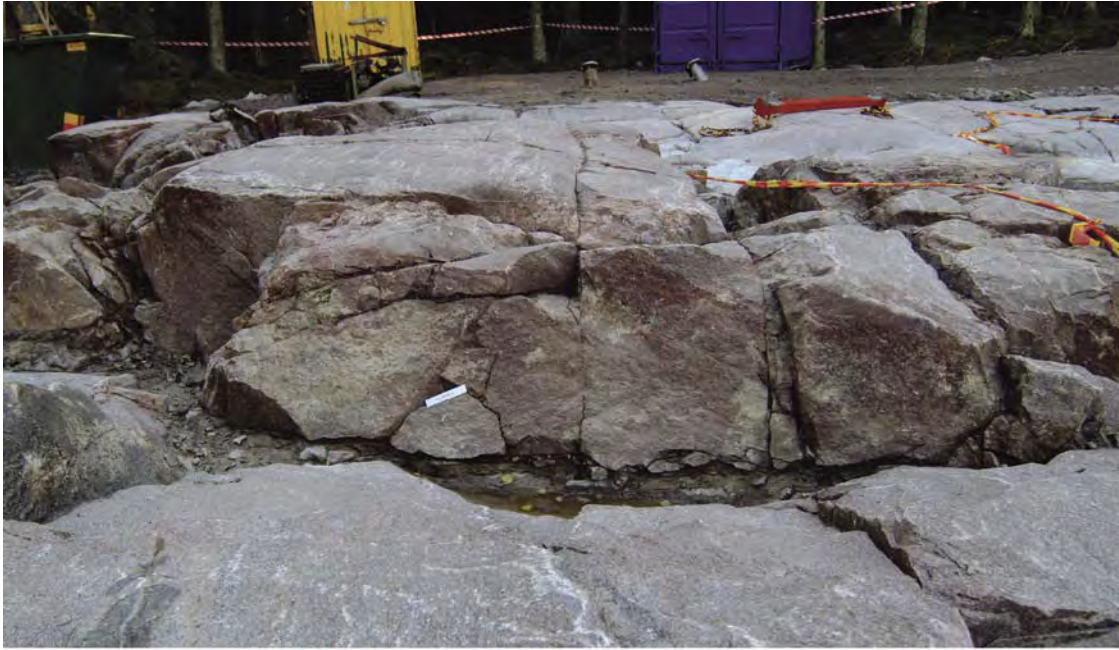
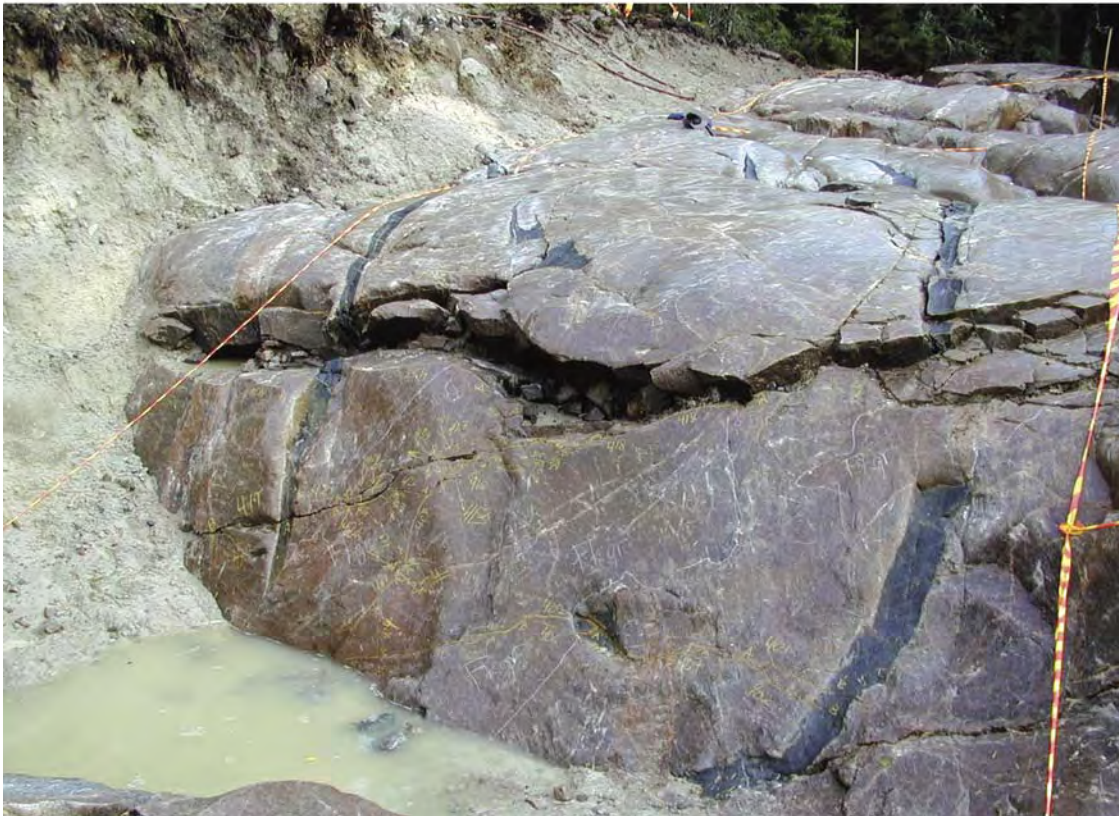
Figure 4-4. Two of the predominant, gently dipping fractures containing sediments, both viewed from northwest. The lower photo also illustrates the uplift of the superficial rock overlying these fractures.

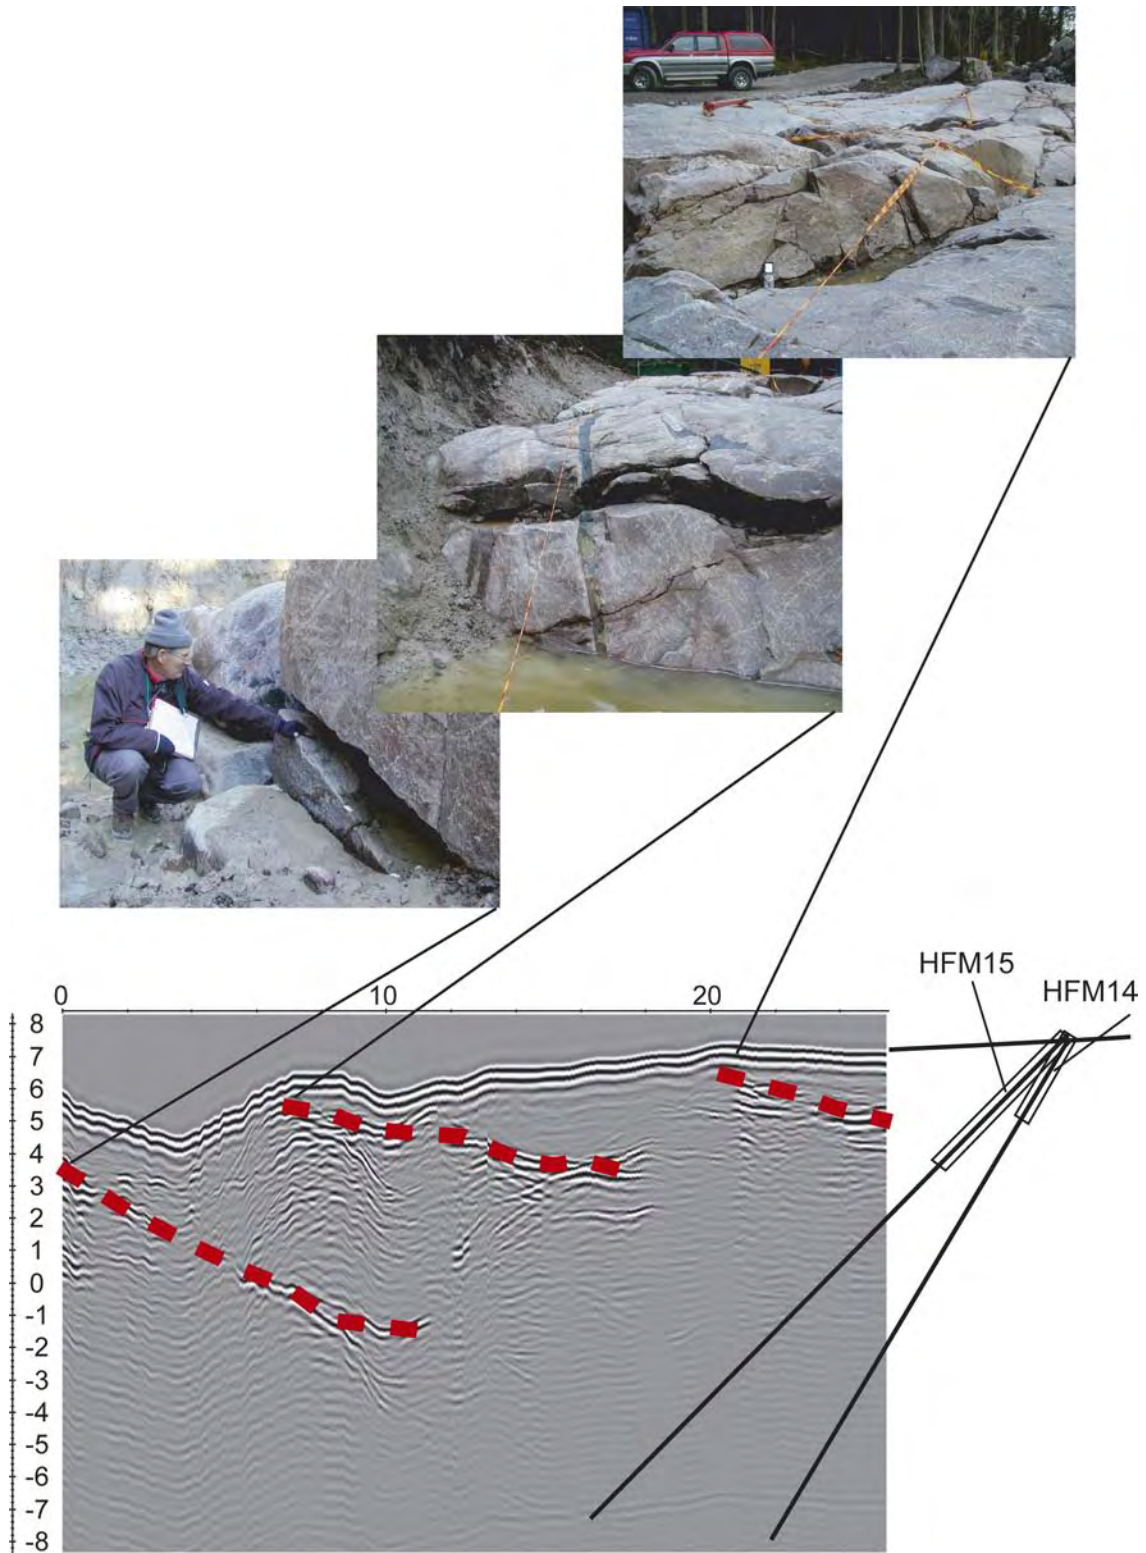
Figure 4-5. Three major fractures at drill site 5, as documented at surface and interpreted from GPR measurements along a NW-SE section.

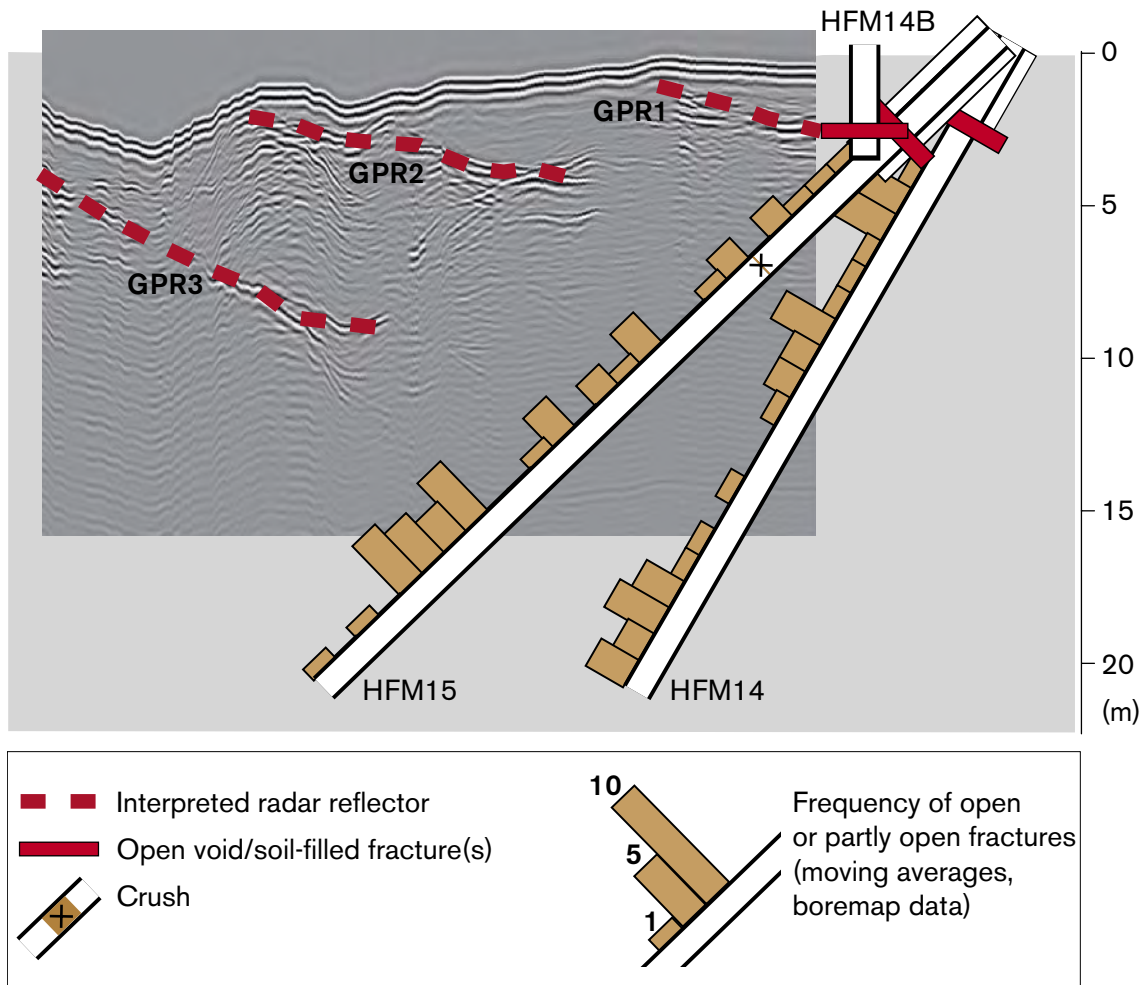
For the remainder of the depth interval shown in Figure 4-7, i.e. below the large fracture at c 3 m and down to 20 m, data show low fracture frequencies. Orientations are not indicated in the figure, but examination of data shows that a majority of the fractures are subhorizontal, although steeply dipping sets are also present. More importantly, there are no indications of unusually large fracture apertures or presence of soil material in any of the fractures. GPR-records allowed the fractures GPR2 and GPR3 to be traced from surface and some 10 m into the bedrock. Extrapolating positions and orientations from the GPR-results yields that these two fractures would intersect HFM14 and HFM15 at c 6 m and c 15 m vertical depth respectively. Whether some of the open fractures observed at these depths in the holes do in fact represent the continuation of GPR2 and GPR3 can not be determined. (A 10 cm wide, crushed zone observed at about 7 m in HFM15 is a possible candidate.) What can be stated, however, is that neither fracture apertures comparable to those seen at surface,

Figure 4-7. NW-SE section of the uppermost 20 m at drill site 5, showing main results from the borehole investigations, together with main fractures inferred from GPR-surveying.

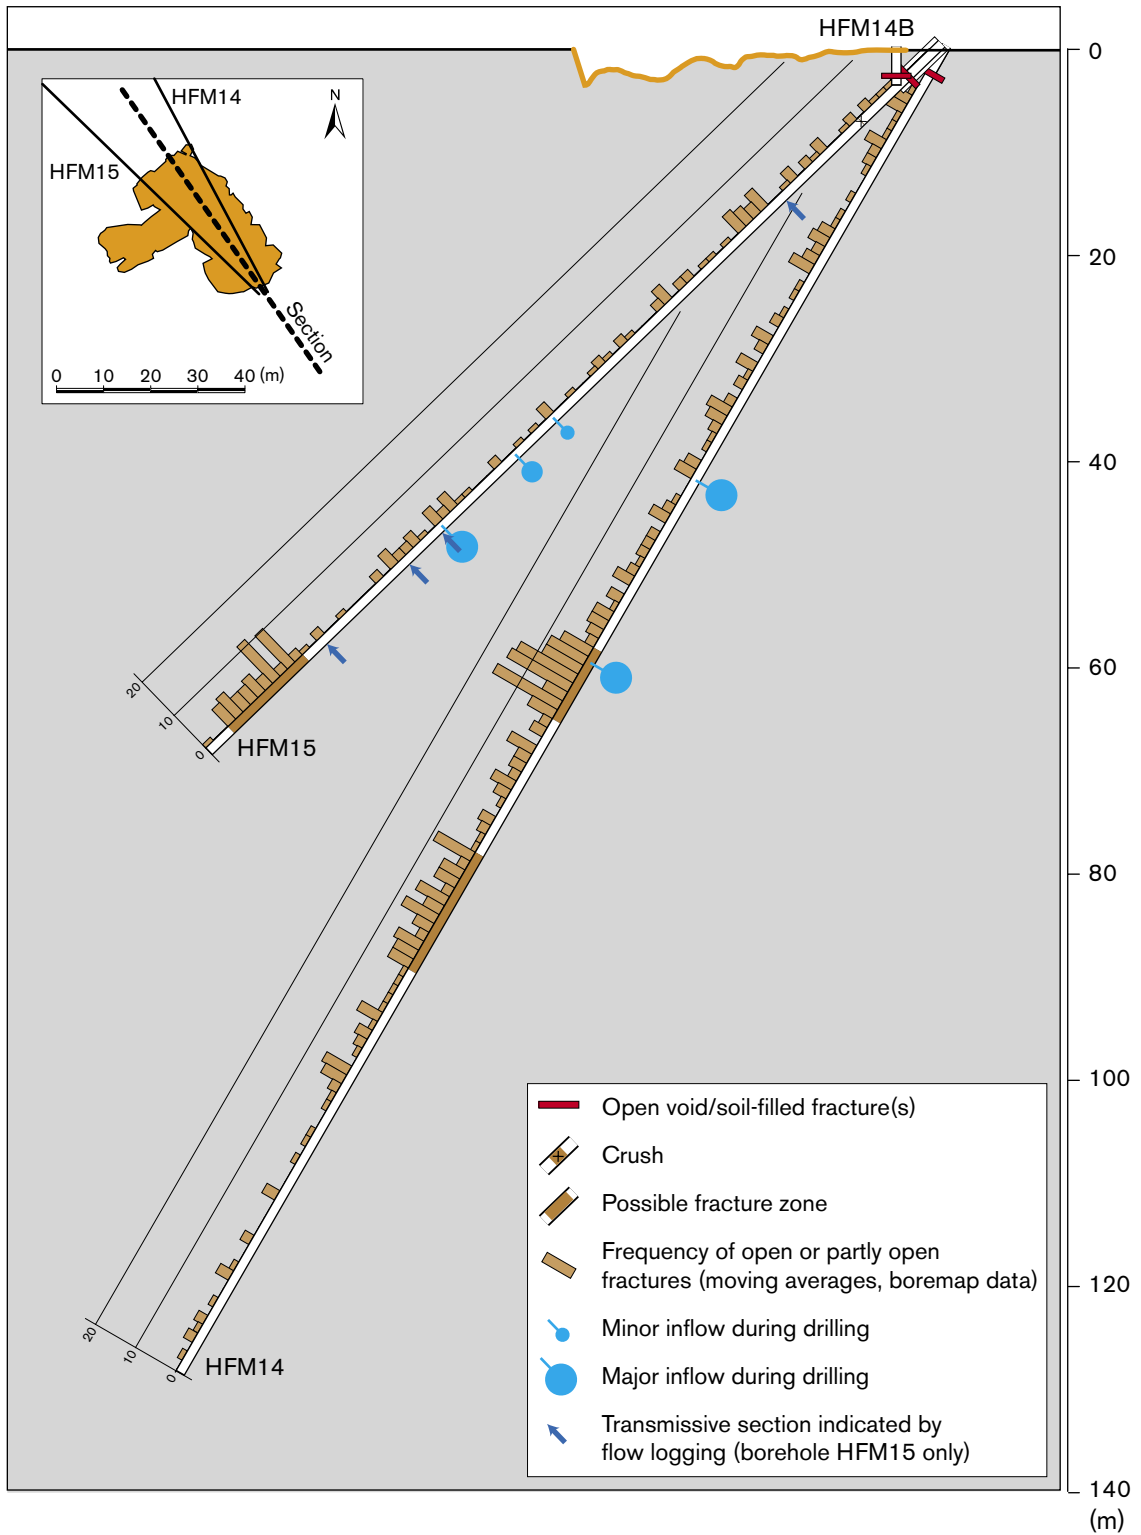
Figure 4-8 shows the same section as Figure 4-7, but in a scale such that the boreholes are displayed to their full lengths (neglecting borehole deviations). As far as fracturing is concerned, data towards depth offer few surprises. Overall fracture frequencies are low. In both HFM14 and HFM15, increased fracturing indicates a possible fracture zone within the approximate depth interval 60–67 m. In HFM14, another similar zone is indicated at 79–90 m. The fractures constituting the inferred zones are largely subhorizontal. The lithological conditions (not indicated in the figures) along the boreholes are comparable to those at surface and do not show any significant changes with depth.

Figure 4-8. NW-SE section of the uppermost 130 m at drill site 5, showing main results from the borehole investigations.

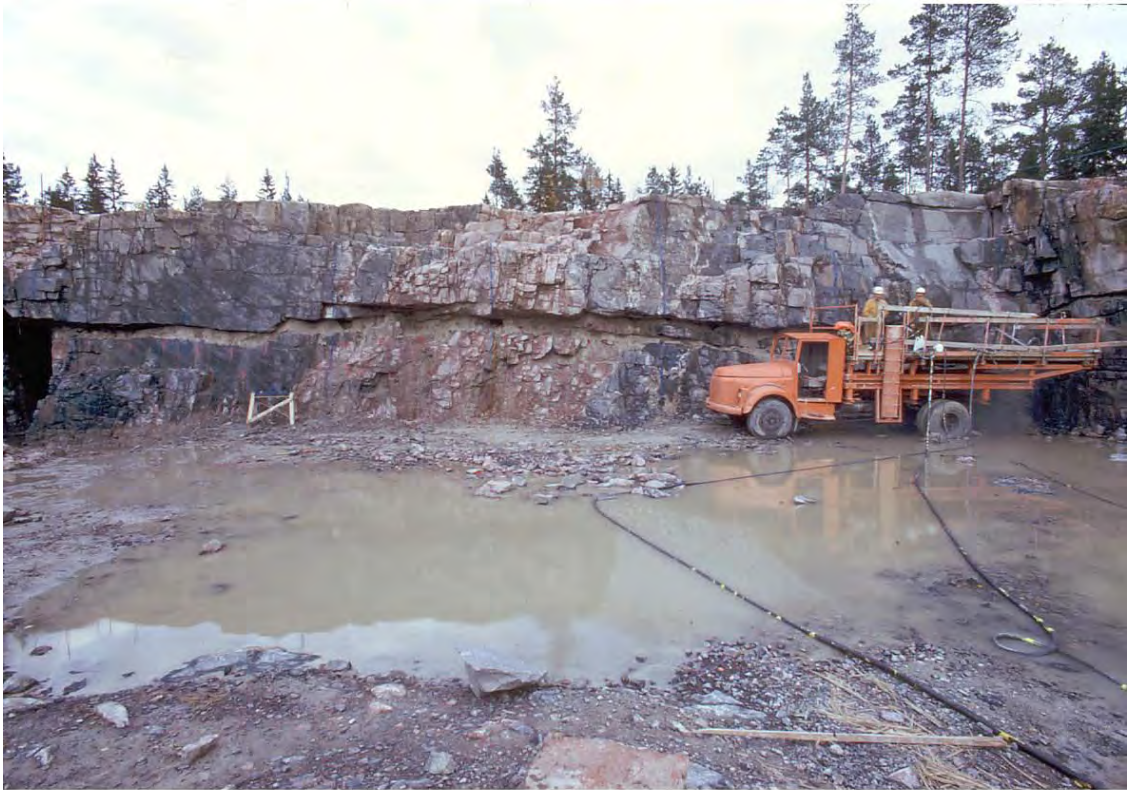
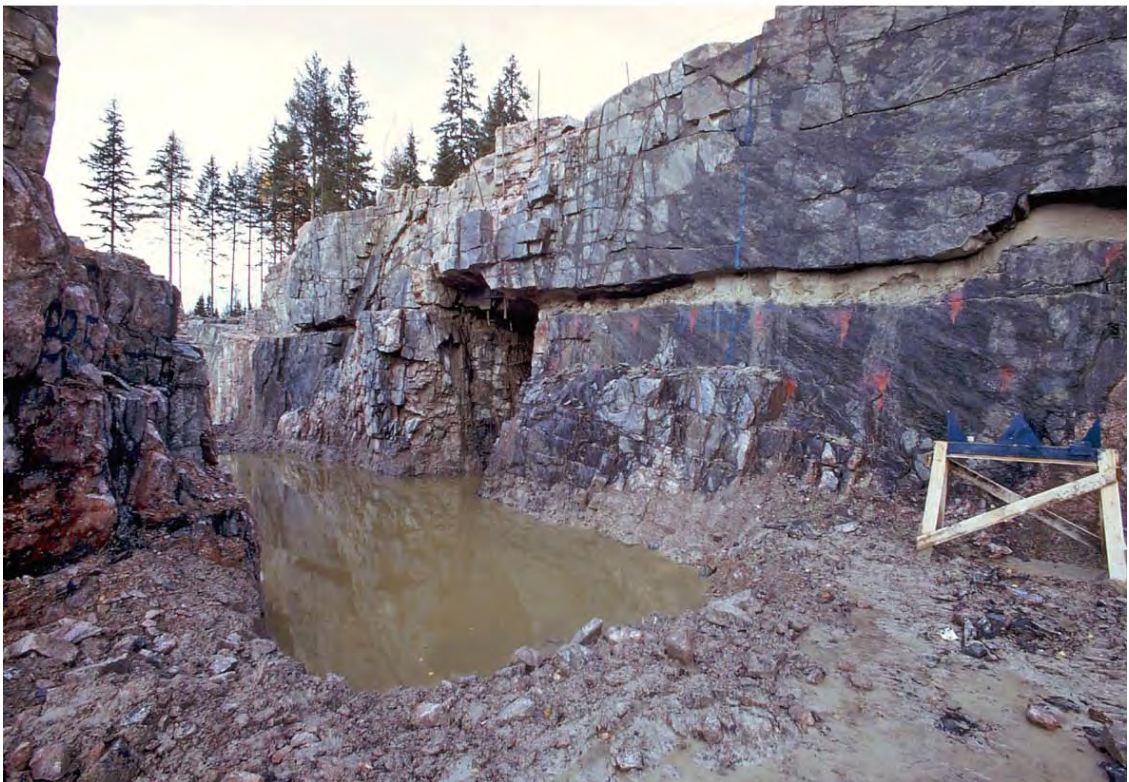
Figure 5-1. A shaft wall of a storage basin for industrial water under construction at Forsmark. This was one of several excavations investigated by /Carlsson 1979/ during the period when the nuclear power plants and auxiliary facilities were constructed. The system of extensive, horizontal and subhorizontal fractures can be seen, as well as steeply dipping fractures. The outstanding, horizontal fracture is c 0.5 m wide and filled with sediment. Photo Göran Hansson/N.

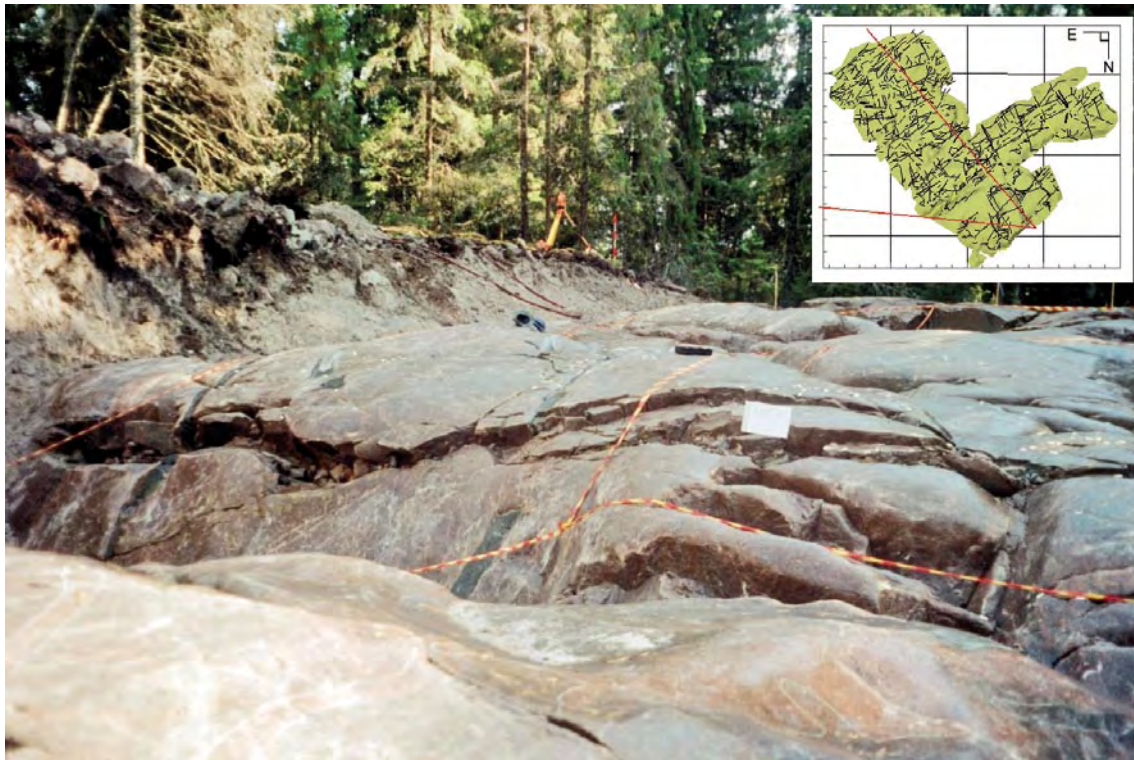
Figure A-5. Overview of location Pl 1. The block above the long fracture system stretching from left to right is uplifted and limited by a system of fractures, some subhorizontal dipping southeast, and some subvertical striking northeast. Vertical displacement varies from insignificant to the right (outside the picture), to 20 cm to the left. The centre of rotation for the block is assessed to be just outside the centre of the right edge of the print. Two components contribute to the block movement: upwards translation (uplift) and upwards-clockwise rotation.

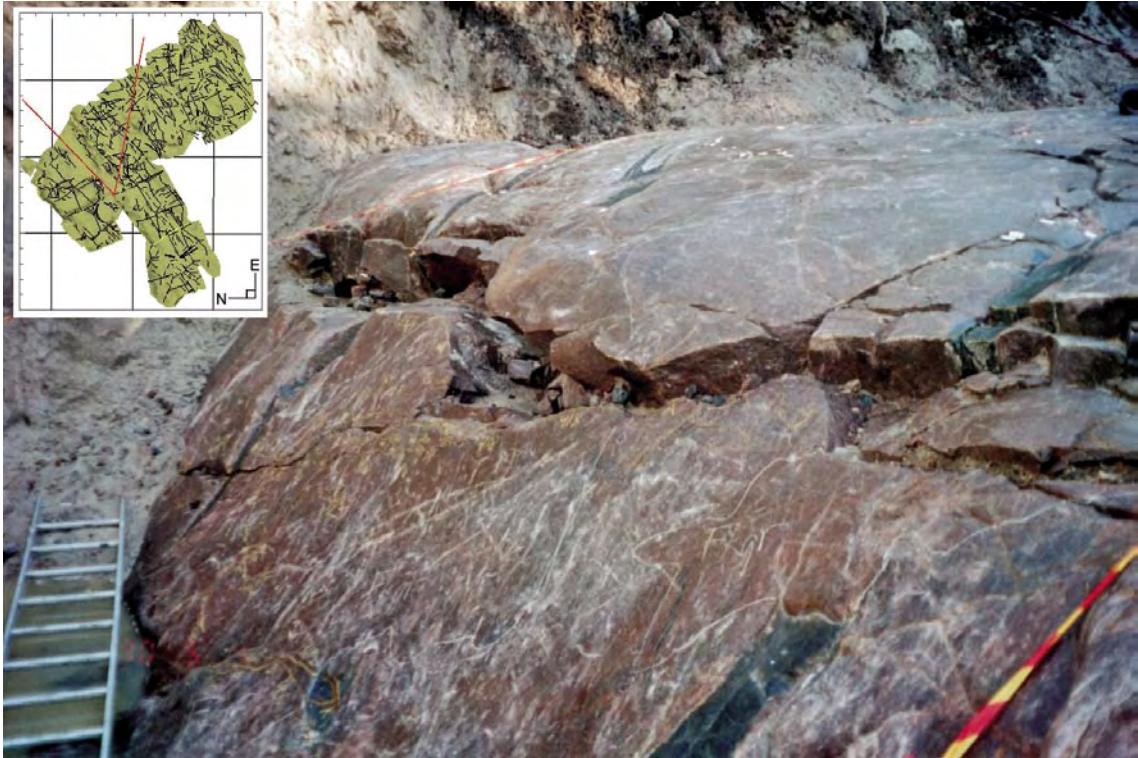
Figure A-6. View of the longest fracture at Pl 1.

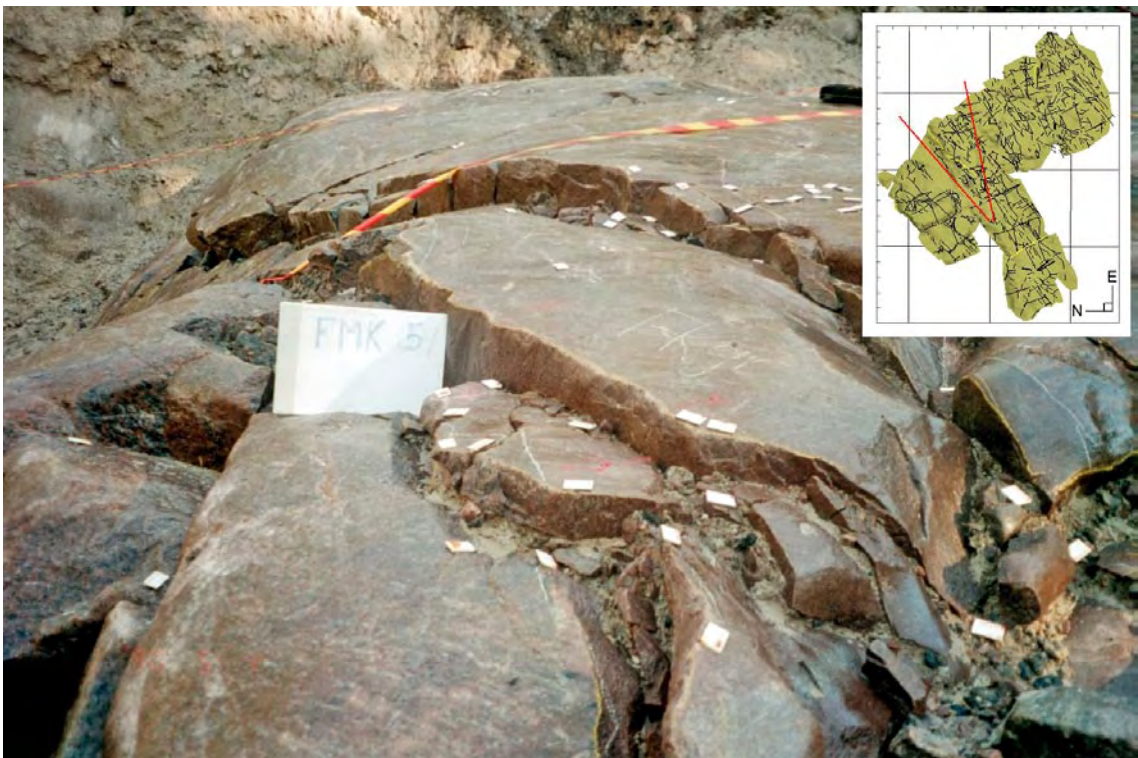
Figure A-7. View of fracture system at Pl 1. Vertical displacements vary from zero (front right) over 10–15 cm in several steps (front) to c 20 cm in one step (distant left).

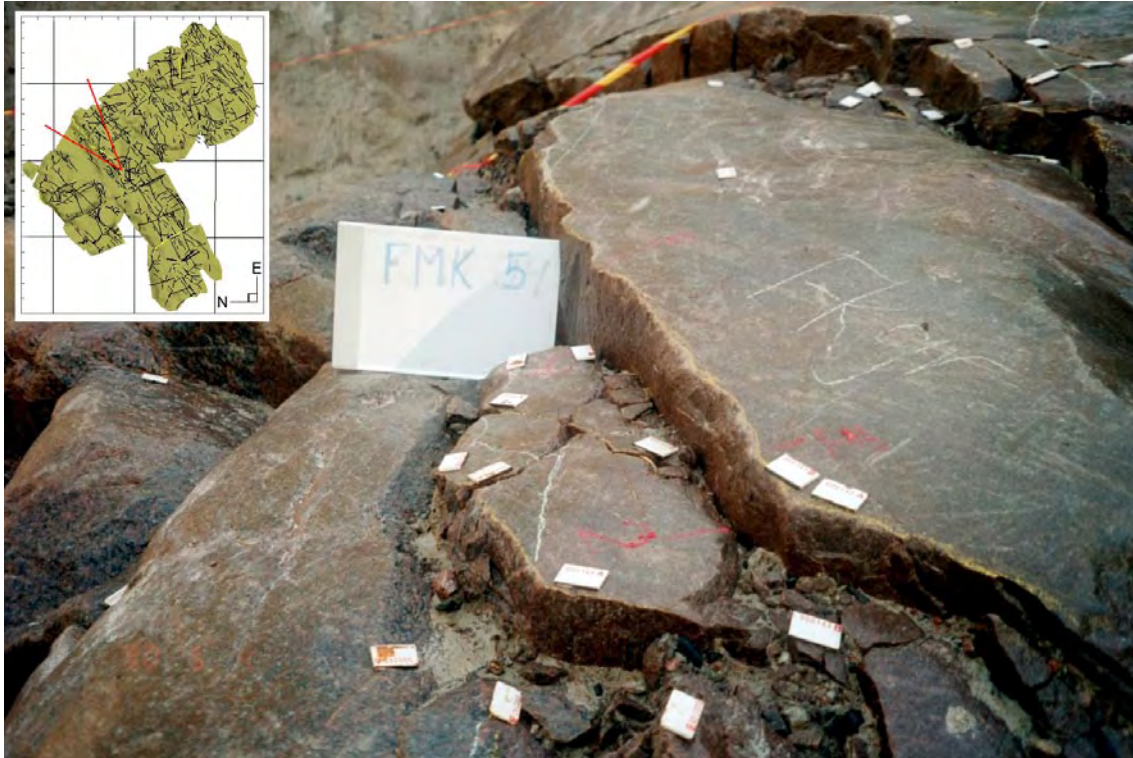
Figure A-8. Detail of fracture system at Pl 1. The glacially polished surface has been displaced with up to c 15 cm in several steps.

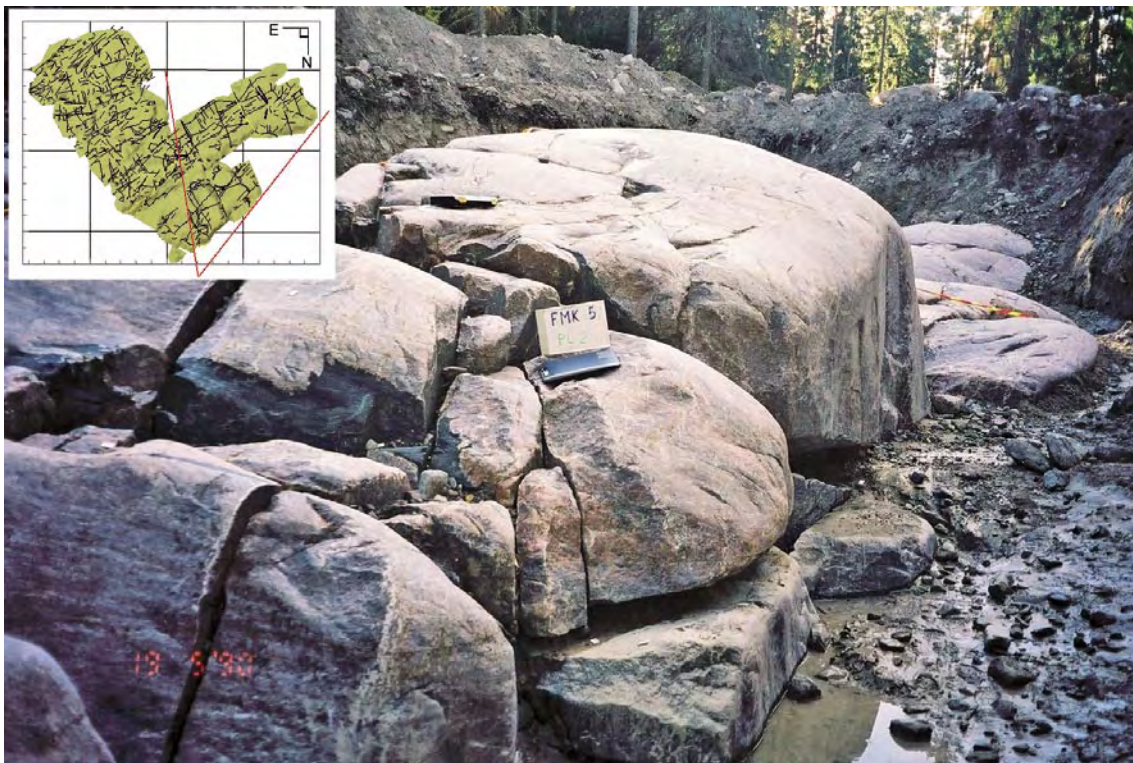
Figure A-9. Loose blocks at Pl 2. Notice the subhorizontal fractures near the bottom of the pit.

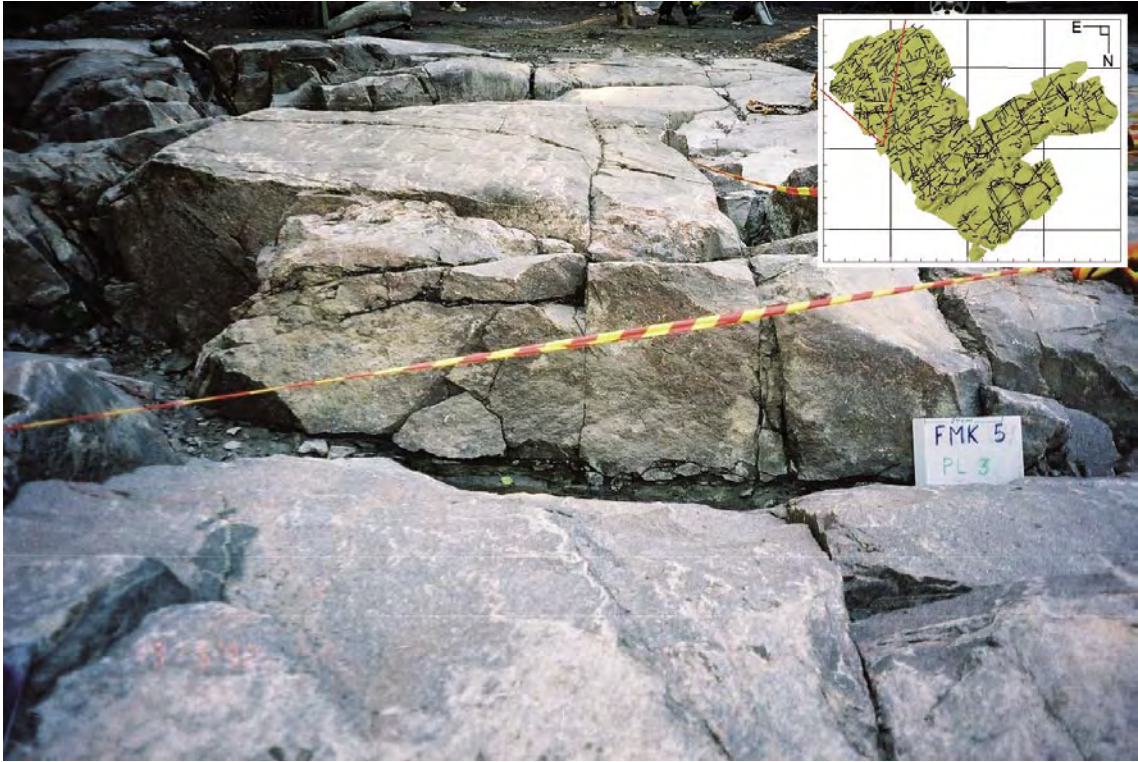
Figure A-10. Pl 3. Subhorizontal fracture with sediment fill. Label at right end of fracture.

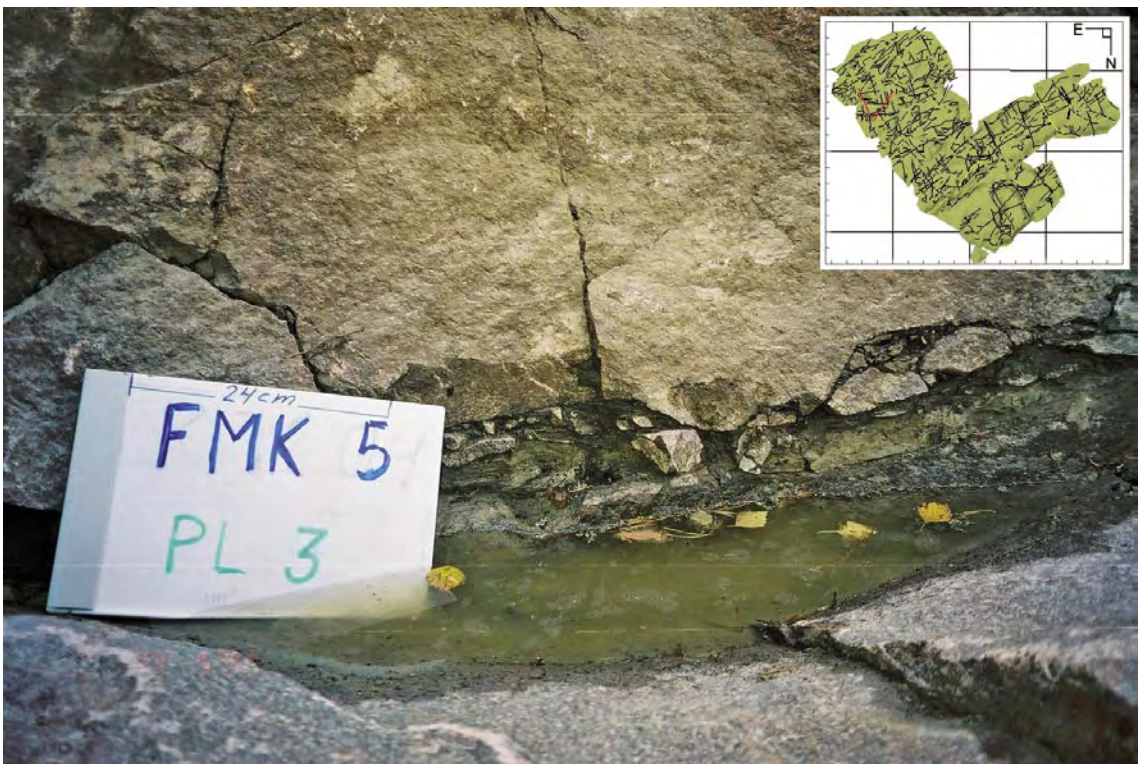
Figure A-11. Detail of subhorizontal fracture with sediment fill at Pl 3. The sediment infilling is also shown in Appendix G, Figure G-1.

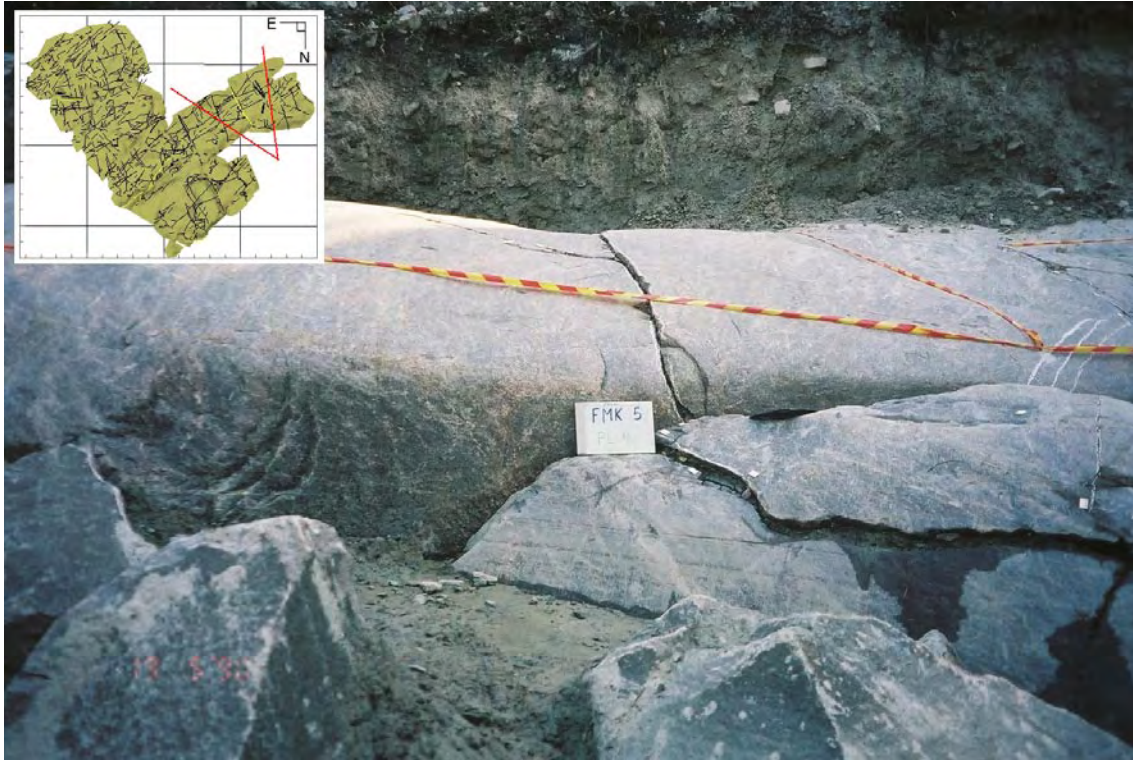
Figure A-12. Pl 4, the right block features an uplift of 2–3 cm relative to the left block.

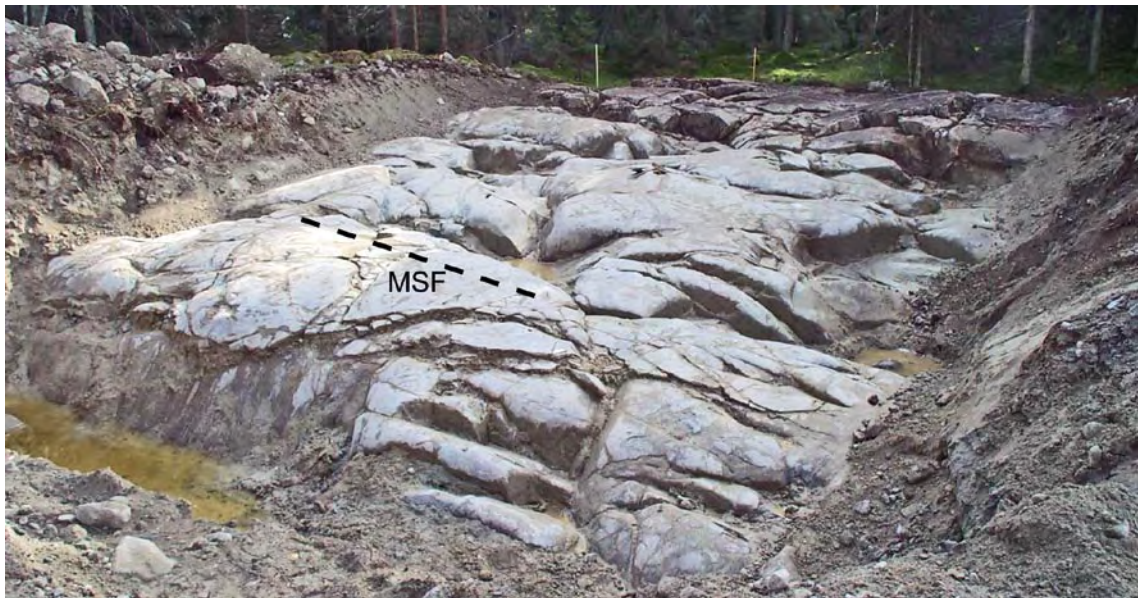
Figure B-2. Overview of the SE outcrop. The hatched line points out the orientation of the main fracture system. View towards SE.

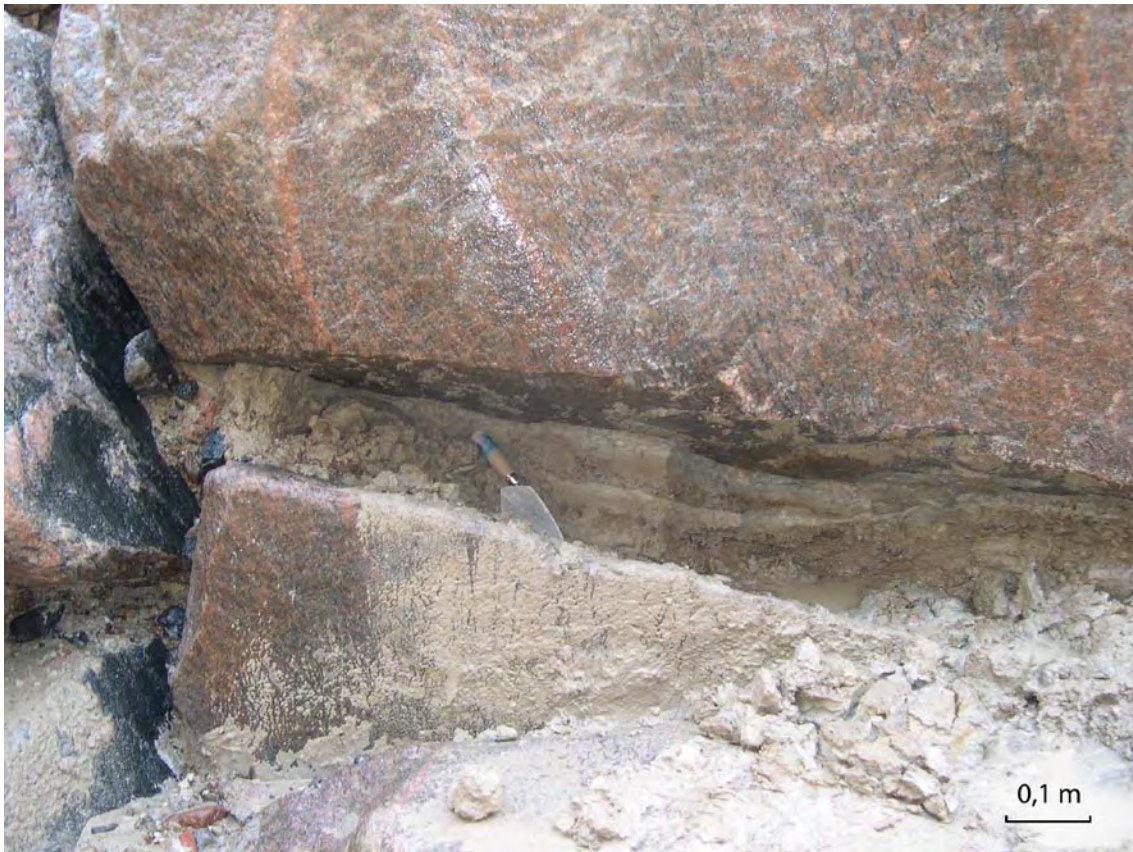
Figure B-4. Laminated silt in a fracture in the NW part of the whole outcrop. The outer part of the sediment fill, which consisted of till, has been removed (cf Figure B-2b).

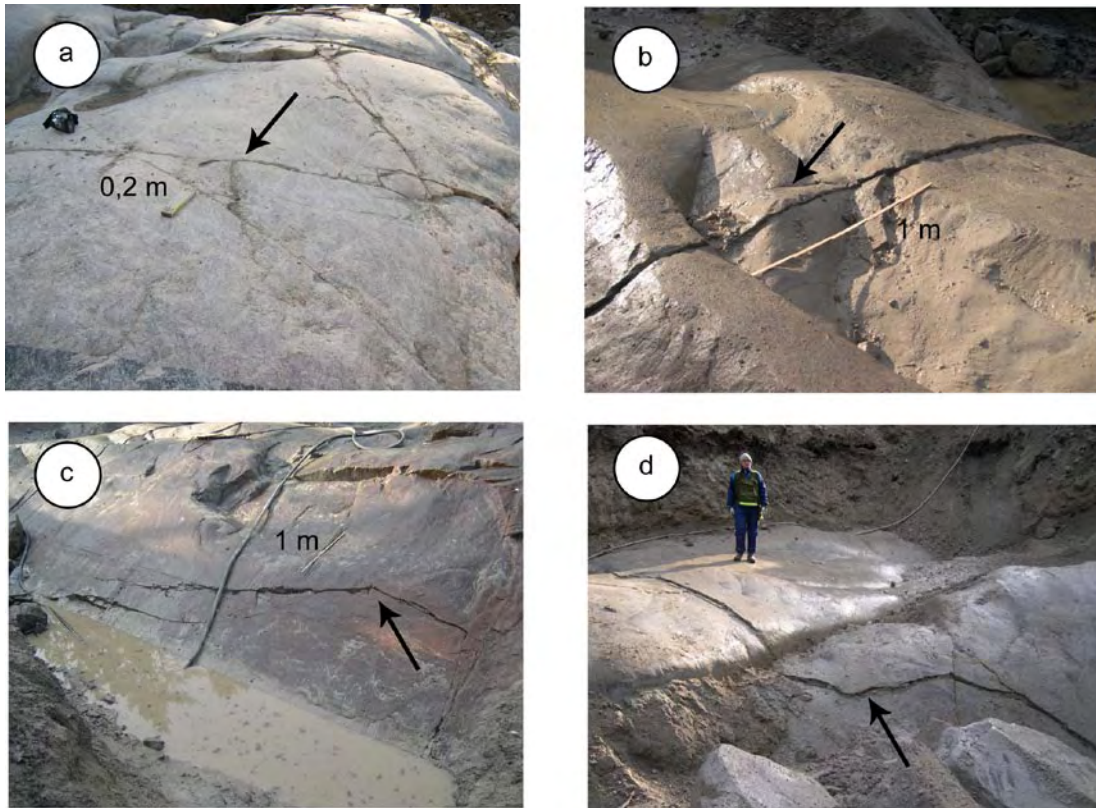
Figure B-5. Fractures that appear to be fresh without signs of glacial abrasion. a) and b) fractures orientated perpendicular to the main fracture system (cf Figure B-1). Both views towards WSW. c) fracture without any particular orientation. View towards NW. d) the same fracture as in Figure b, but it has taken a new course. View towards SSW.

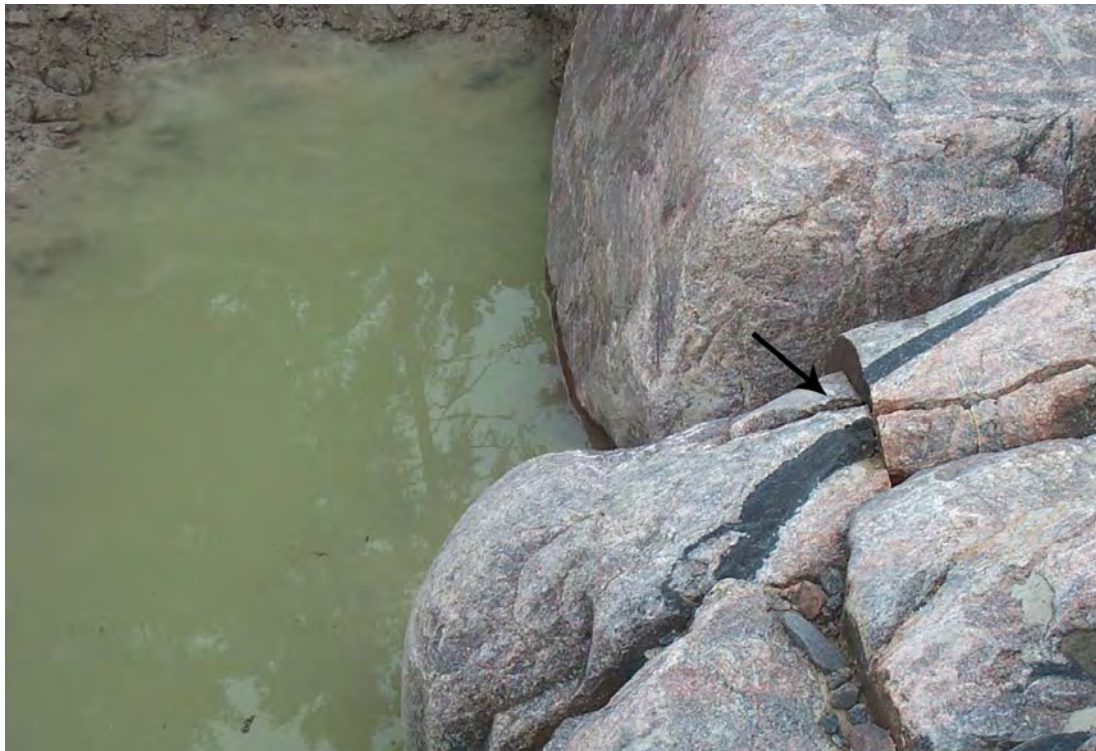
Figure B-6. Fracture showing a strike-slip movement. View towards NE.
