P-05-199

Forsmark site investigation

Investigations of superficial fracturing and block displacements at drill site 5

Bengt Leijon (ed)
Svensk Kärnbränslehantering AB

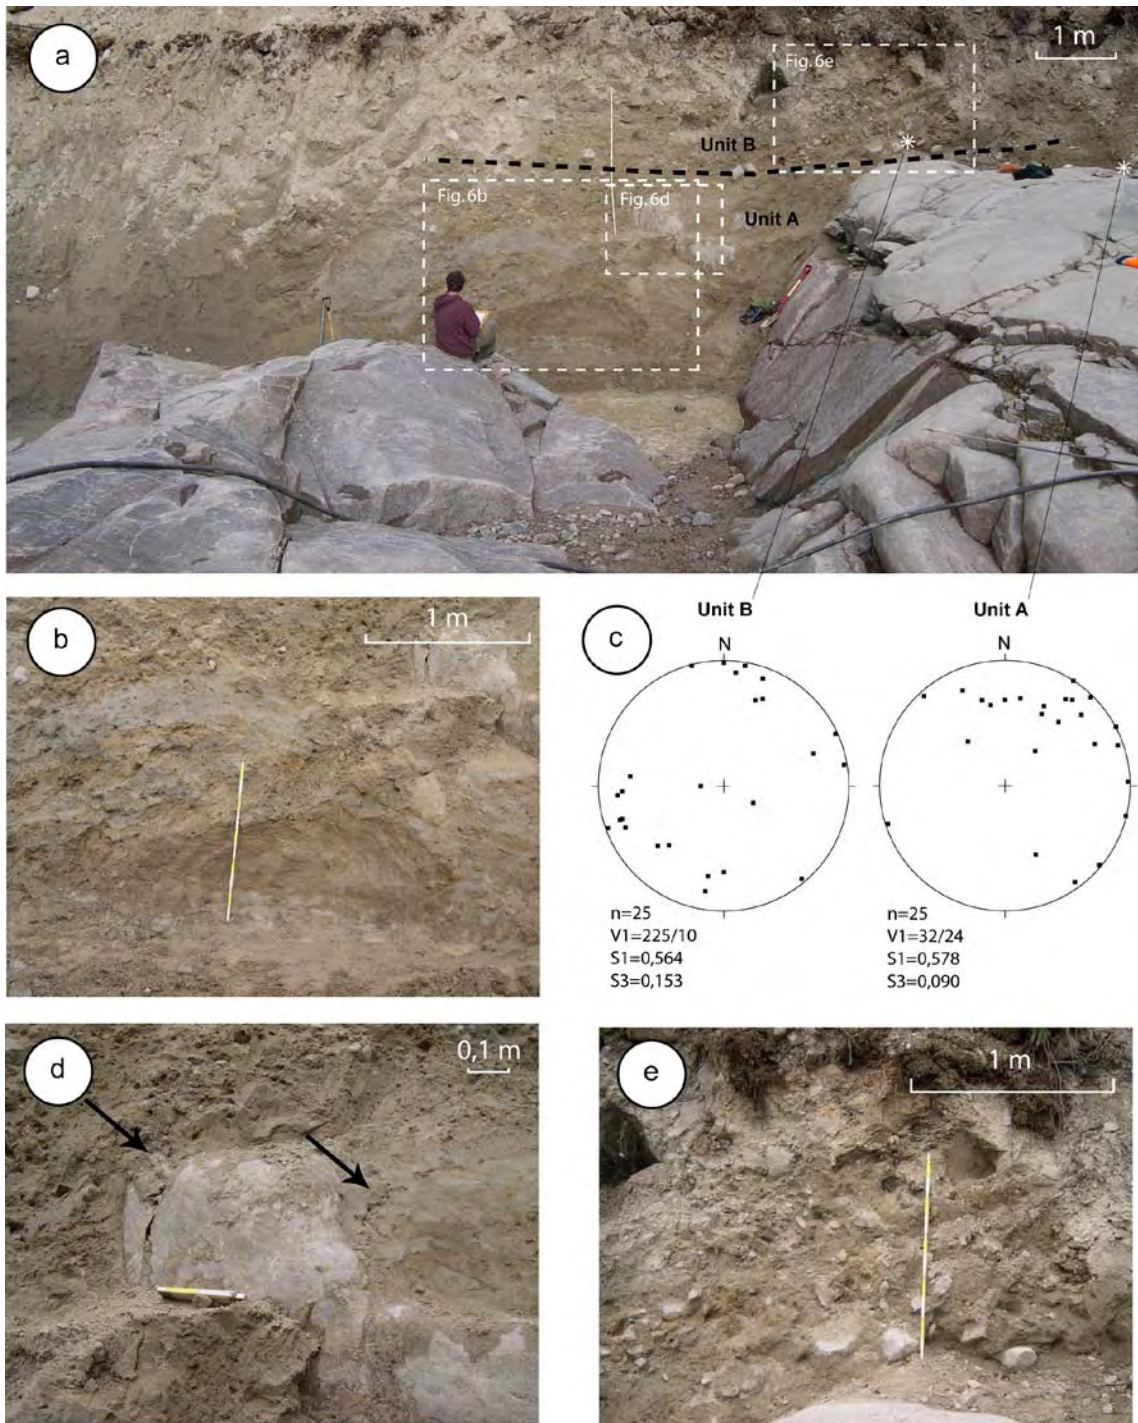
Figure B-7. Till in the western wall. a) overview, sites for till fabric measurements are marked with *. b) sandy diamicton with inclusions of silt and sand, unit A. c) Schmitt stereographic plot (lower hemisphere) of till fabric measurements from unit A and B. V1=eigenvector orientation, S1/S3=eigenvalues. d) stringers of sand in connection to fractures in the bedrock. e) sandy till with stones, unit B.

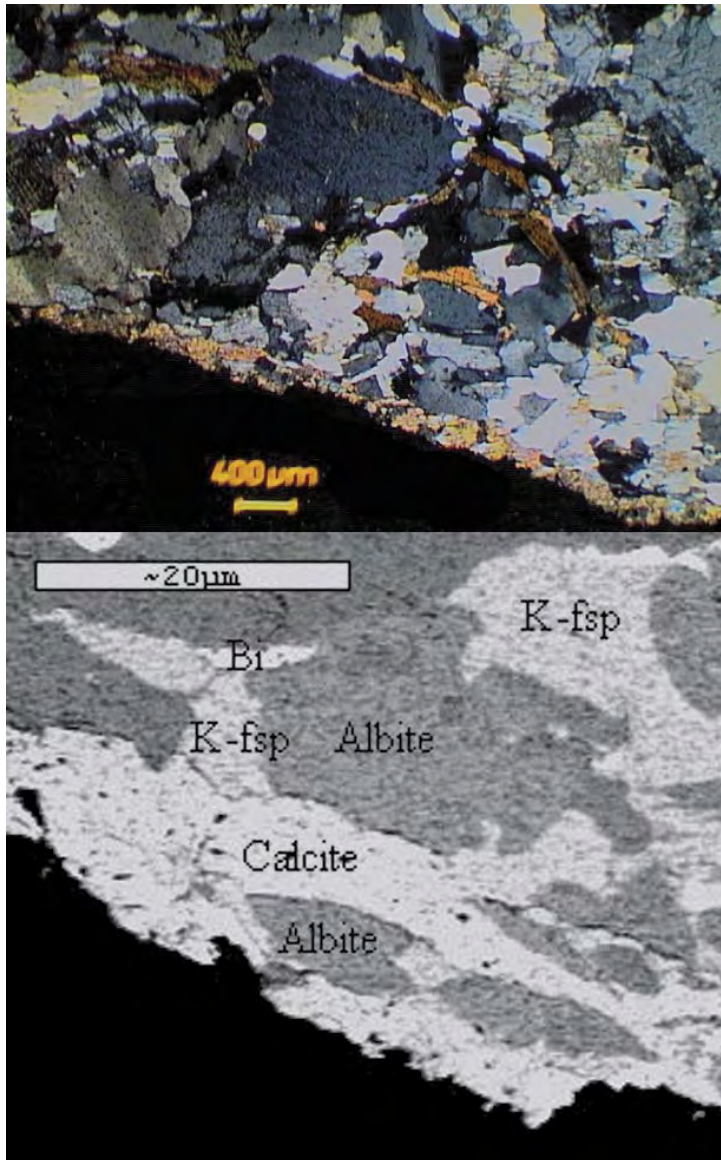
Figure D-2. Fracture with thin calcite coating from drill core 4, photomicrograph with crossed polars (upper) and backscattered electron image (lower).

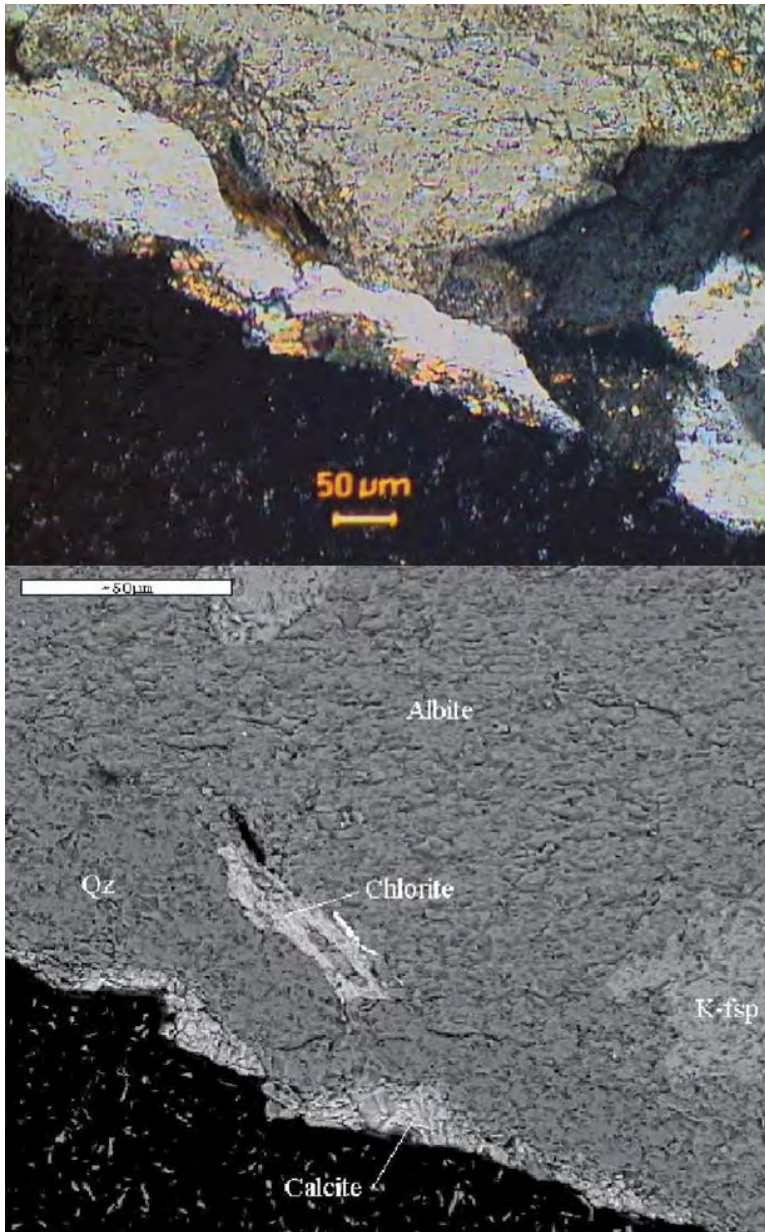
Figure D-4. Fracture surface with a thin calcite coating from drill core 6, photomicrograph with crossed polars (upper) and backscattered electron image (lower).

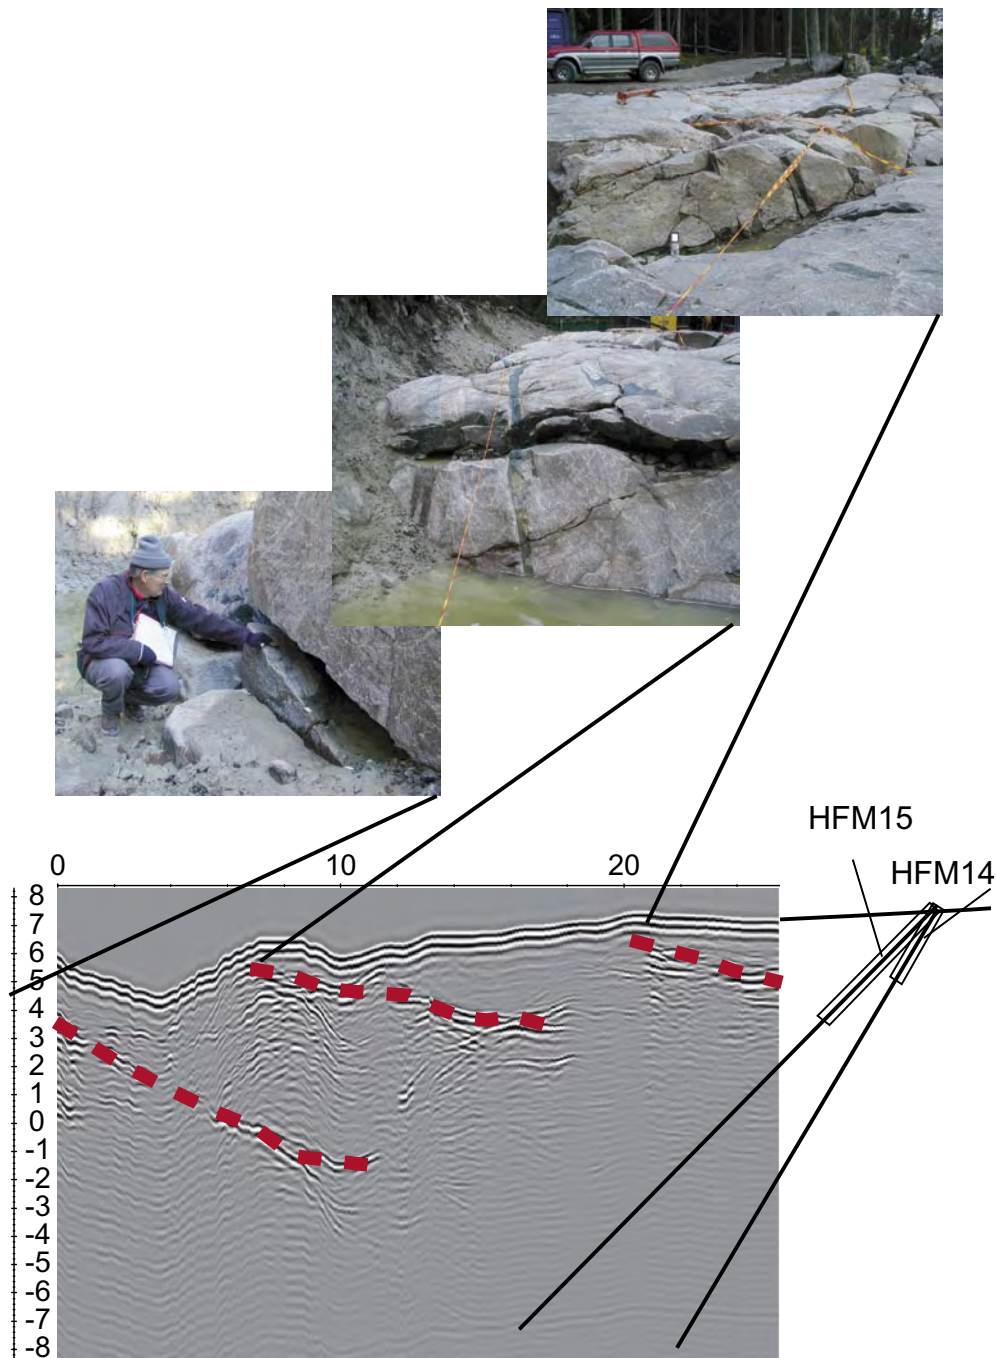
Figure E-6. Three major fractures at drill site 5, as documented at surface and interpreted from the GPR measurements.

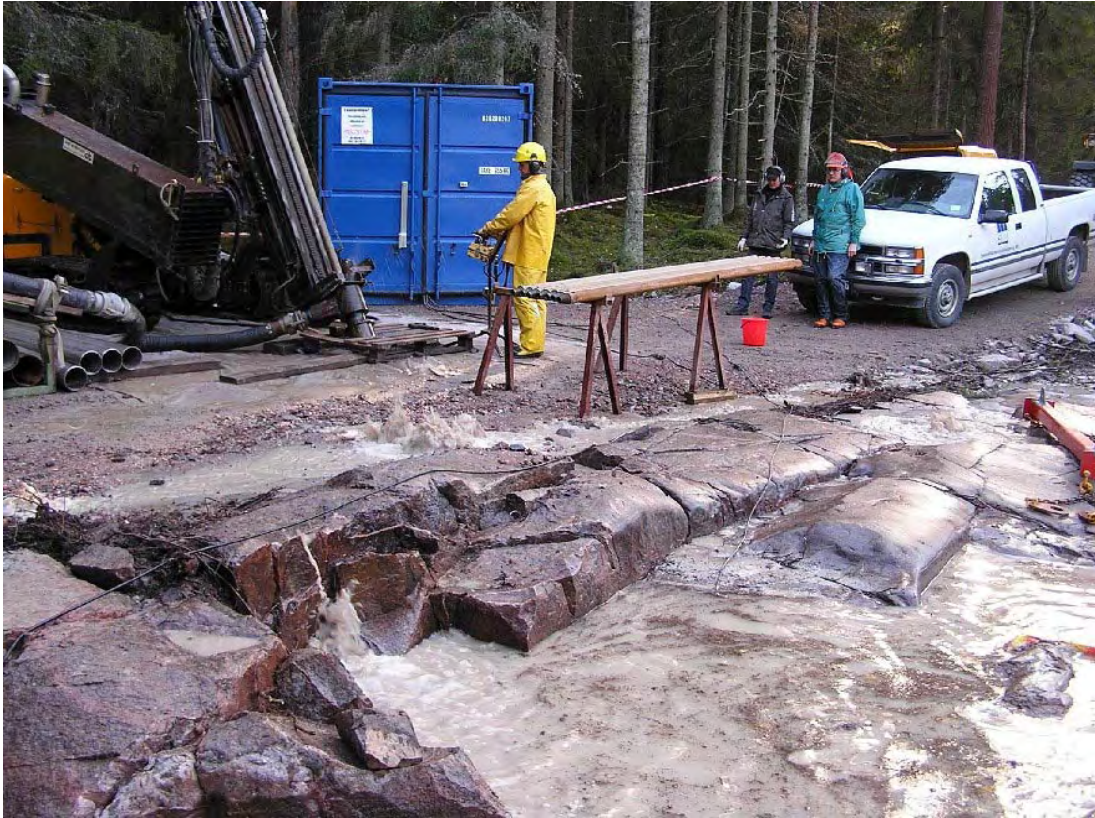
Figure F-6. When drilling HFM14, flushing water was flowing in open fractures, from the borehole to surface.

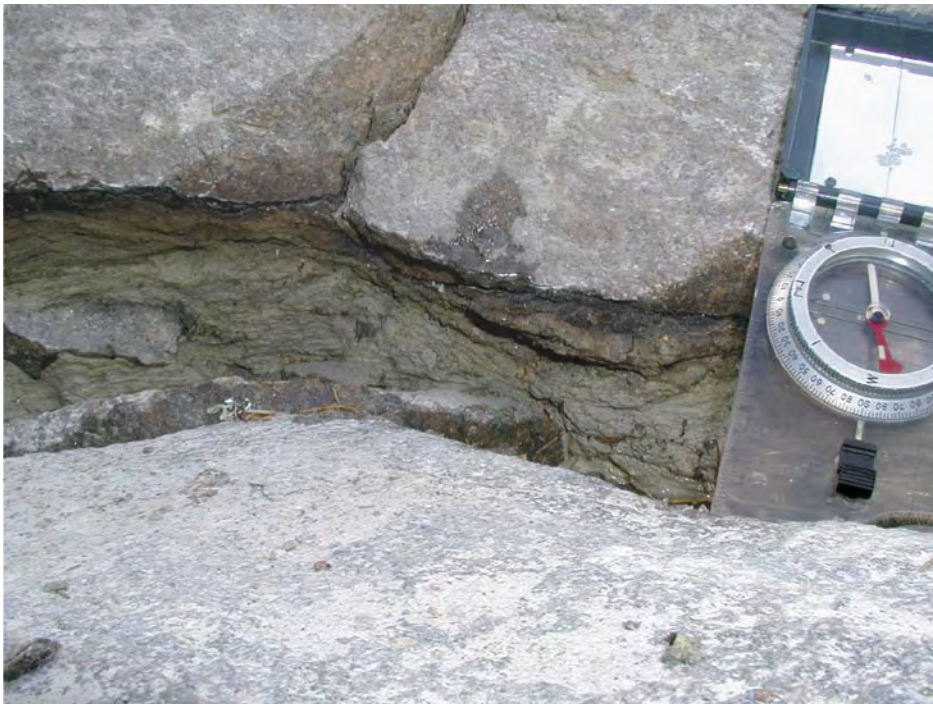
Figure G-1. Silt layer with rock fragment in horizontal fracture (photo: Kaj Ahlbom). The material is very firmly consolidated but has been slightly loosened up at the surface in this case.
