IPR-03-28

TBM assembly hall

Geological mapping of the assembly
hall and deposition hole

SwedPower AB

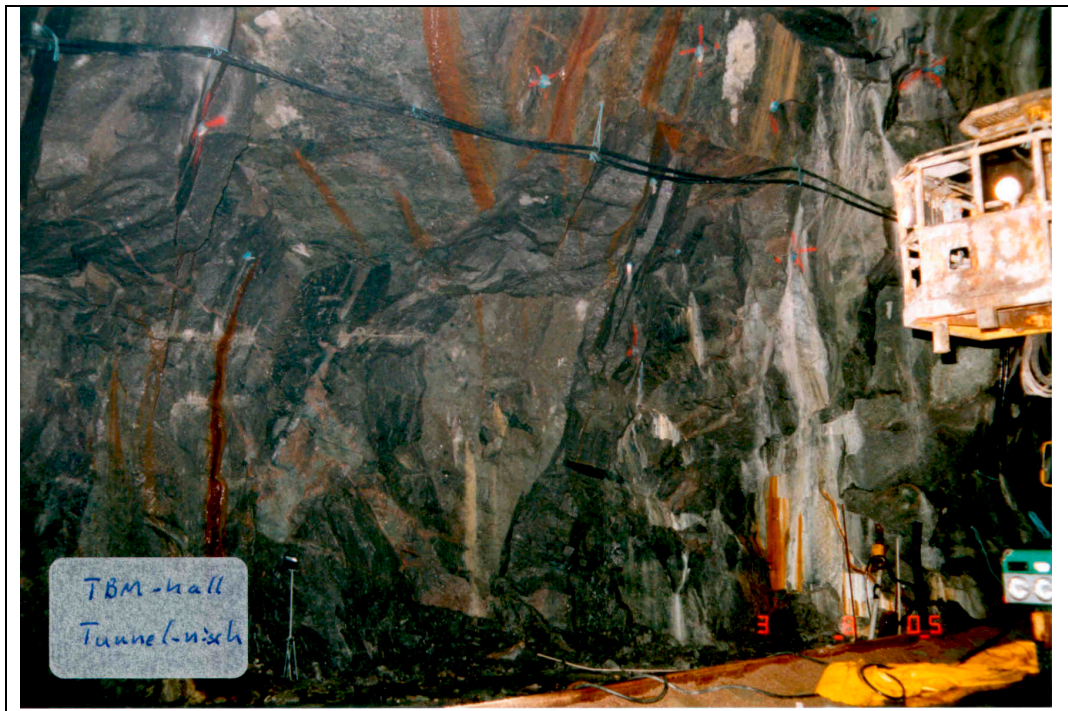
Appendix 3A. Photos showing the interior of the TBM assembly hall (photos: Geologist team at the time, SKB). Small niche, left side wall. Mainly Åspö diorite (grey).

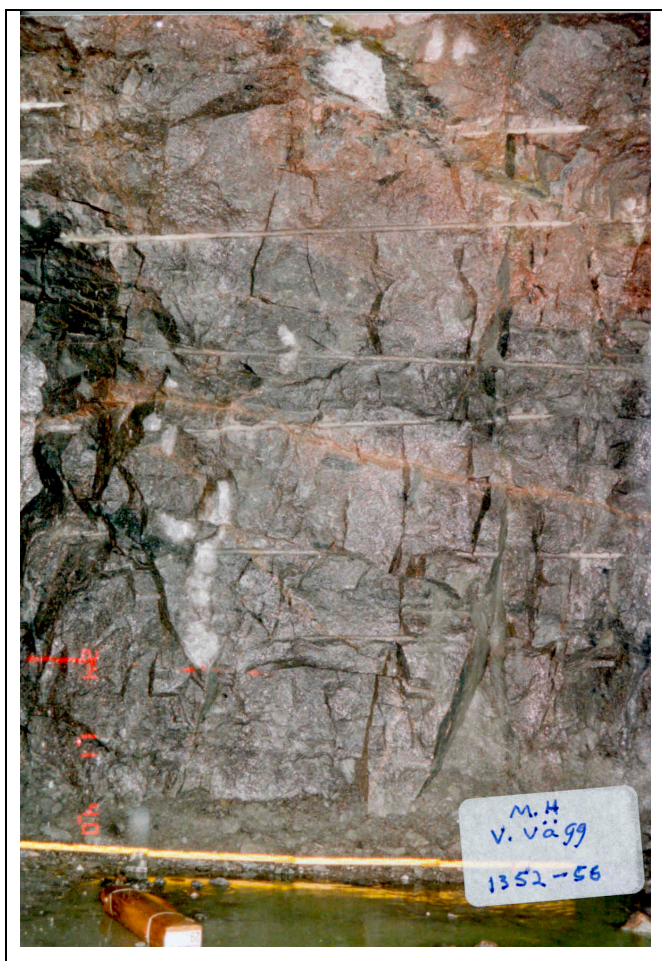
Appendix 3B. Photos showing the interior of the TBM assembly hall (photos: Geologist team at the time, SKB). Left side wall, section 3/152-3/156. Mainly Åspö diorite (grey) and fracture with some oxidation (reddish brown)

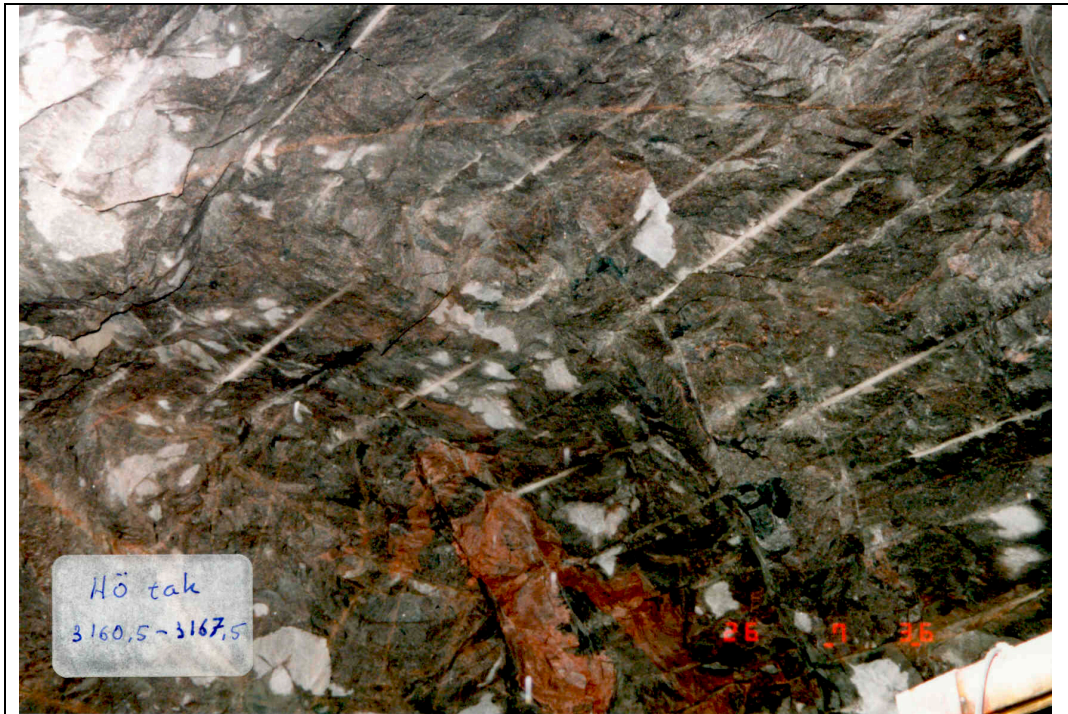
Appendix 3C. Photos showing the interior of the TBM assembly hall (photos: Geologist team at the time, SKB). Roof, right side, section 3/160.5-3/167.5. Mainly Äspö diorite (grey) with some fine-grained granite (brownish red).

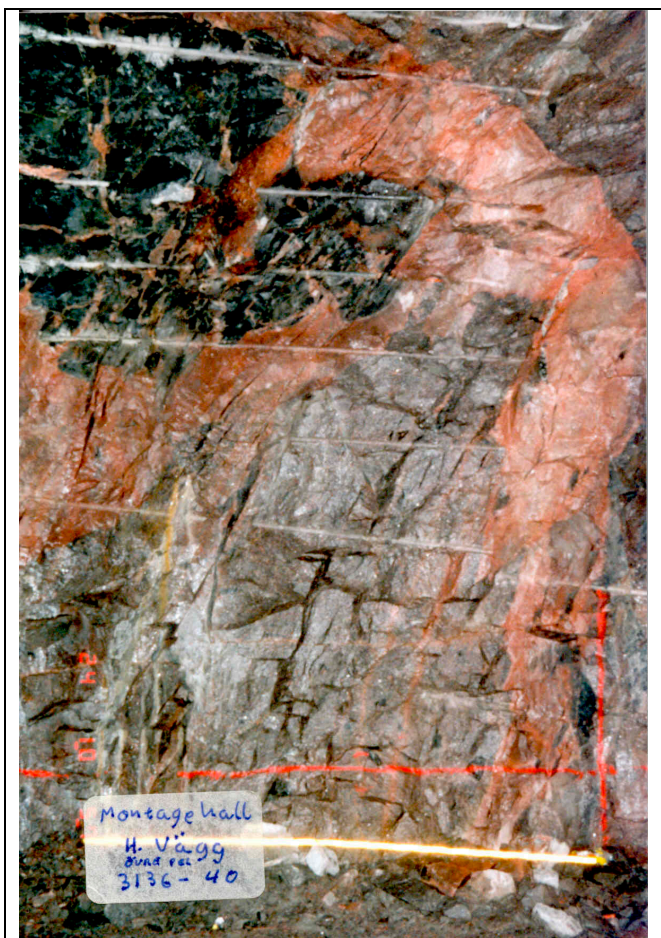
Appendix 3D. Photos showing the interior of the TBM assembly hall (photos: Geologist team at the time, SKB). Right side wall, section 3/136-3/140. Mainly Äspö diorite (grey) with fine-grained granite (brownish red). A greenstone xenolith (black) is seen in the left upper corner of the picture

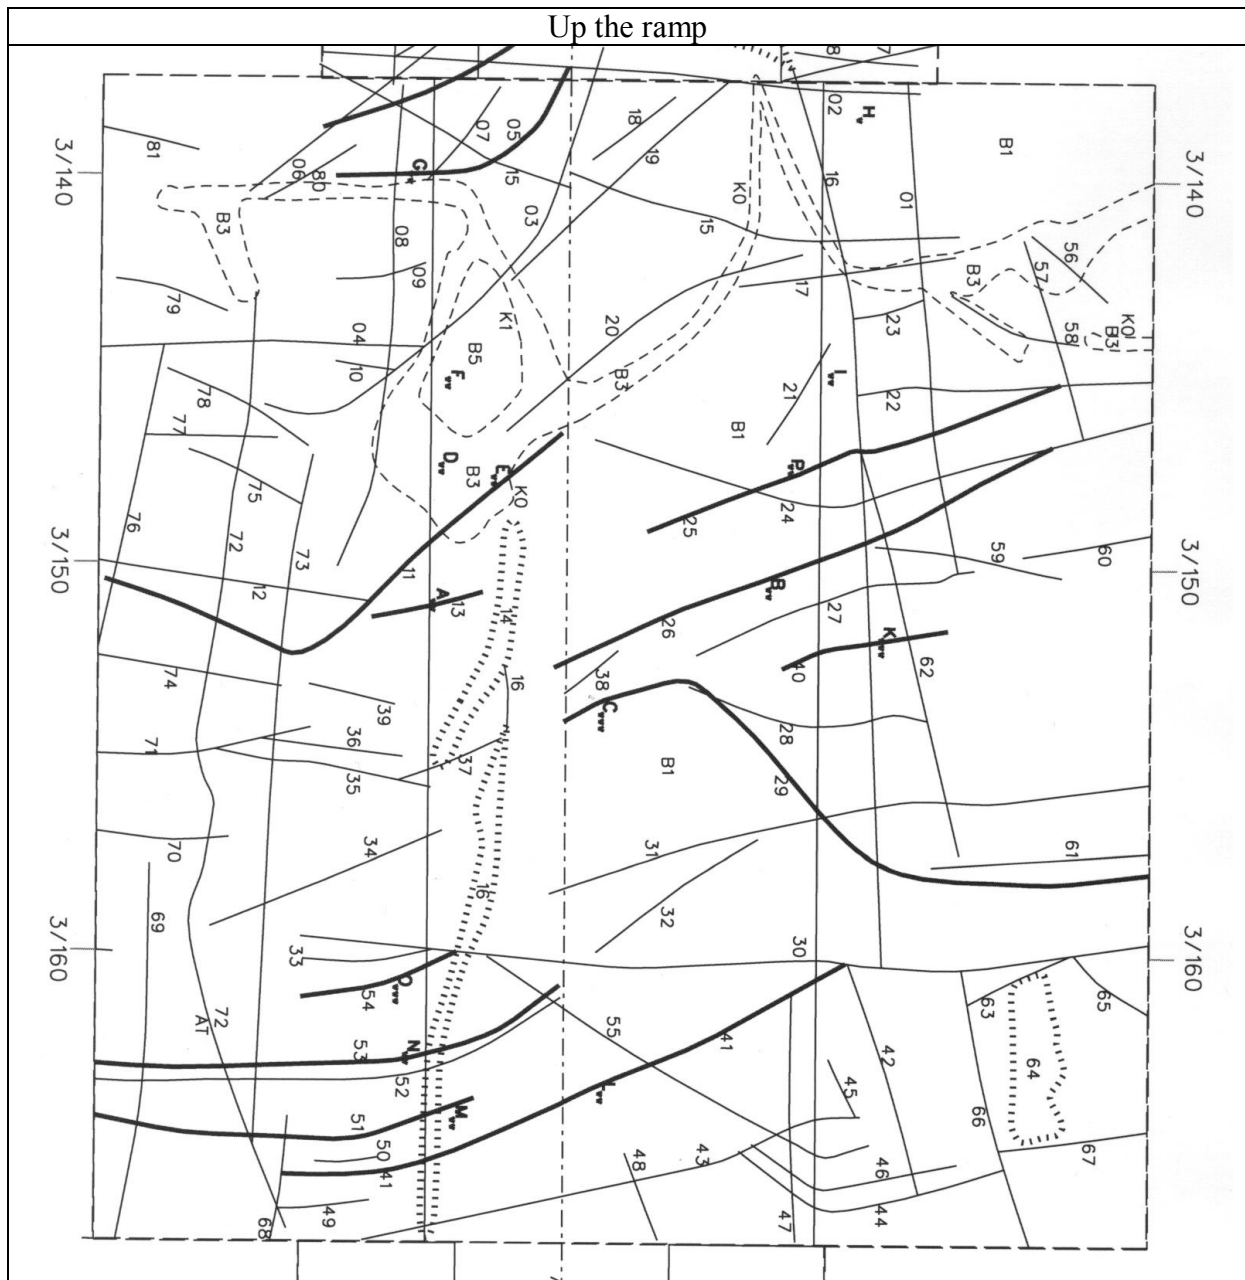
Appendix 4. Geological mapping of the TBM assembly hall, roof and side walls

The distribution of the fractures can be seen in appendix 4 (mapping of walls and roof). Fracture orientations presented in Schmidt net and joint rosette diagrams are found in appendices 5-7. No adjustments for the orientation of the mapped surfaces have been made in the diagrams. Nor has the compass readings been corrected for magnetic declination.

Seventeen (17) fractures (or 13% of the fractures) are shown to be water bearing. They are all steeply dipping (80-90°) and strike 290-305° alternatively 105-130°, except the one which is the most water bearing (4litres/minute) that strike 205°. The orientations of fractures that carry water are shown in stereo net and joint rosette diagrams (appendix 7). Four records of patches of water that probably originate from minor cracks in the rock mass have been observed too.

Mostly only small quantities of water have been recorded (<0.3litre/minute). Three of the fractures, however, deliver as much as 2-4 litre of water/minute (see table 3.1-5).

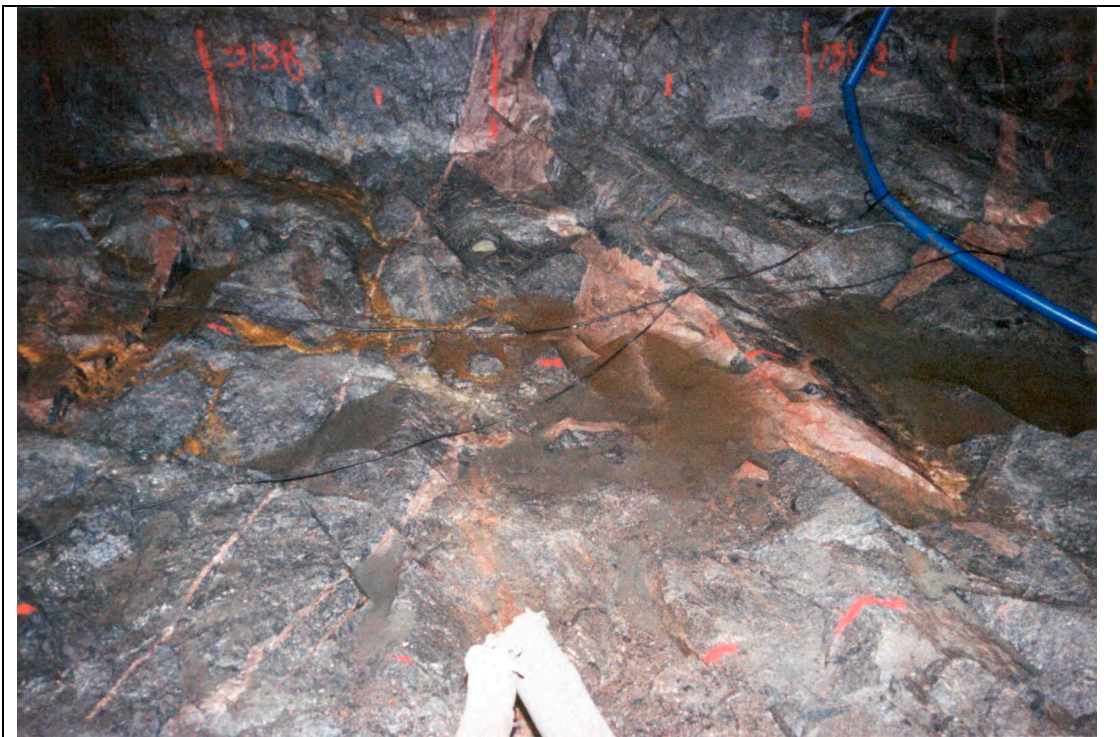
Appendix 8B. Photos showing the pit-floor in the TBM assembly hall (photos: Lars Andersson, SKB). Section 3/138-3/142, Äspö diorite (grey) with some fine-grained granite (pinkish red)

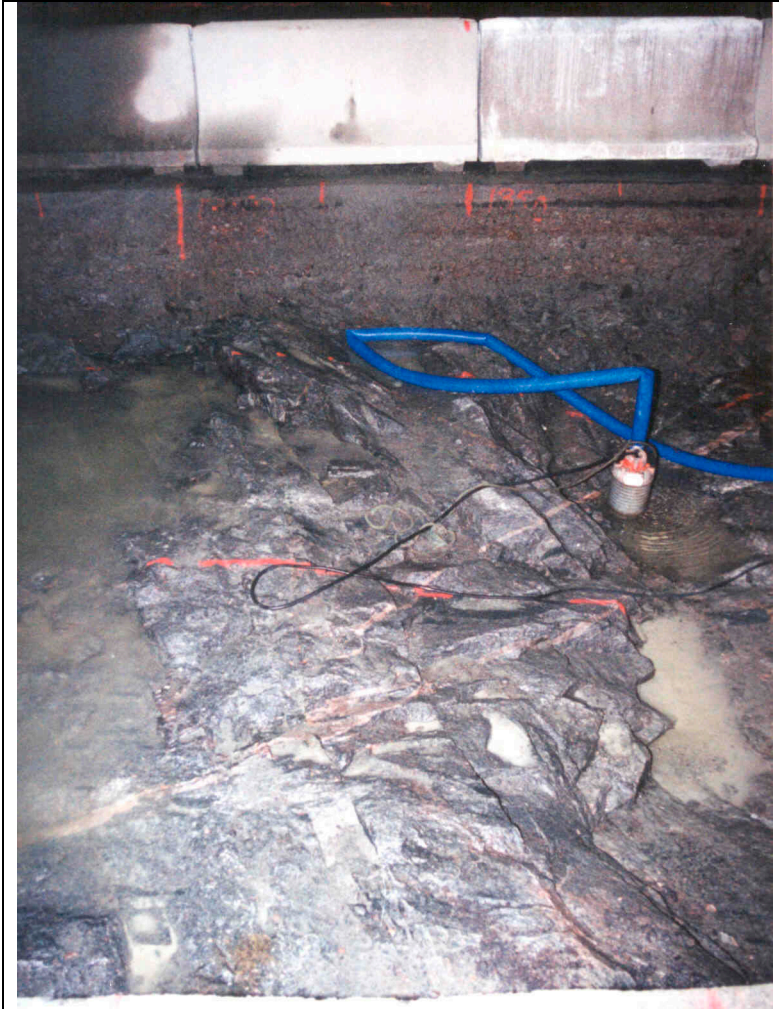
Appendix 8C. Photos showing the pit-floor in the TBM assembly hall (photos: Lars Andersson, SKB). Section 3/148-3/153, Äspö diorite (grey) with fine-grained granite veins (pinkish red)

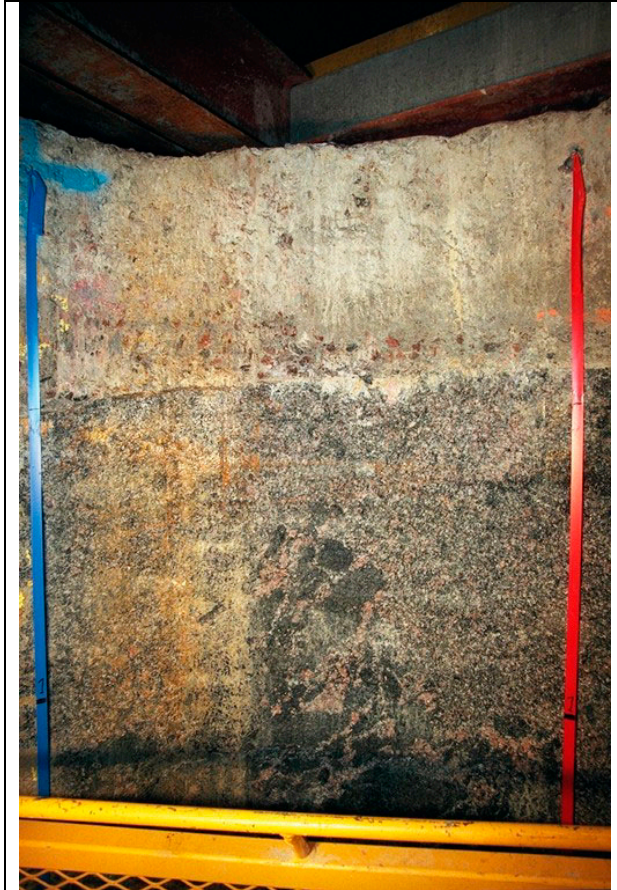
Appendix 11C. Photos from deposition hole DA3147G01 (photos: Lars Andersson, SKB). Upper part of the hole. Boundary between concrete (top) and bedrock below. Rock types: Äspö diorite (greyish) and impure greenstone xenolith (dark grey – black). The blue and red ribbons were used during the mapping procedure not only for orientation but were also a part of a grid system

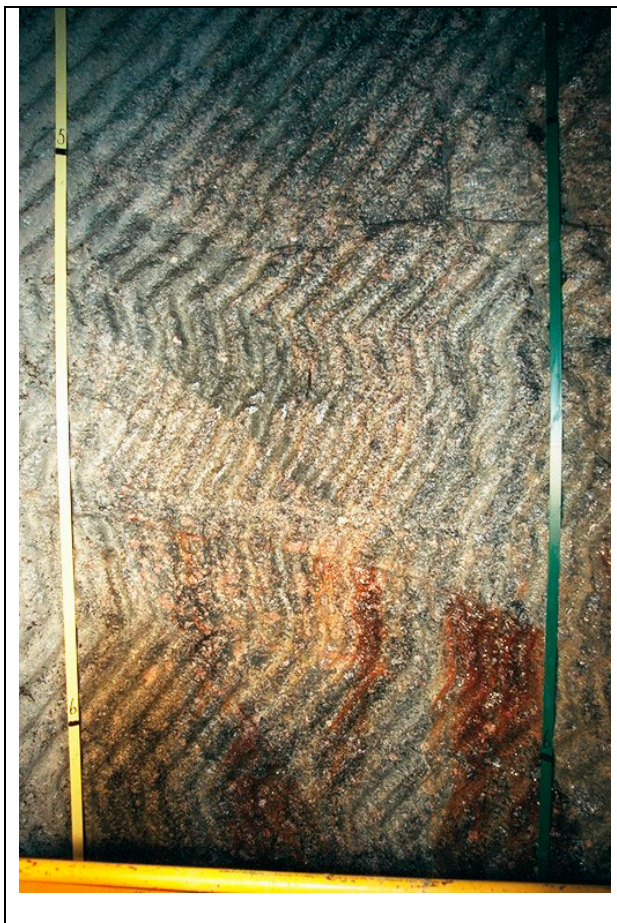
Appendix 11D. Photos from deposition hole DA3147G01 (photos: Lars Andersson, SKB). Section 5-6m. Rock types: Äspö diorite (greyish) and greenstone xenolith (dark grey – black). Water bearing fracture with rust staining below. The grooves are a result from the drilling. The yellow and green ribbons were used during the mapping procedure not only for orientation but were also a part of a grid system.

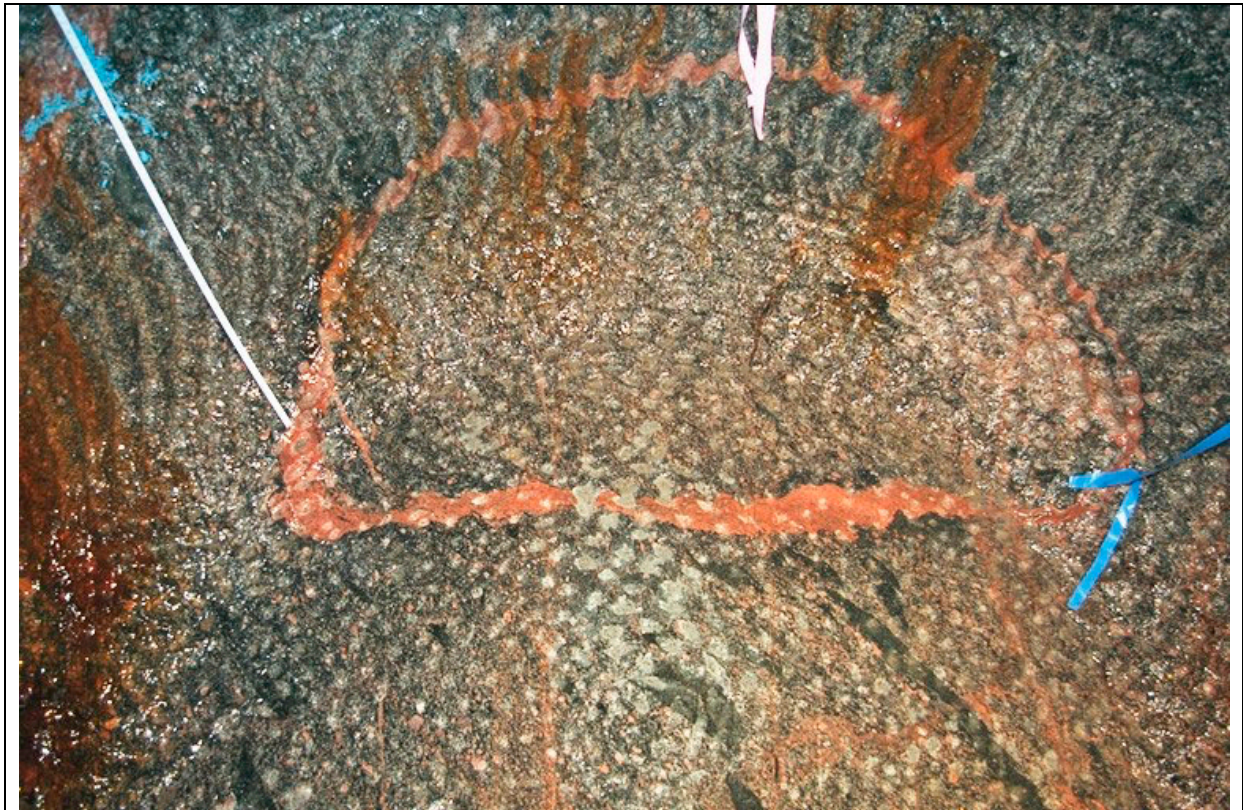
Appendix 11E. Photos from deposition hole DA3147G01 (photos: Lars Andersson, SKB). Bottom part of the hole. Rock types: Äspö diorite (greyish) with minor greenstone xenoliths (dark grey – black) and fine-grained granite (pinkish red). Water bearing fracture with rust staining below. The grooves are a result from the drilling. The white, pink and blue ribbons were used during the mapping procedure not only for orientation but were also a part of a grid system
