Äspö Hard Rock Laboratory

Long-Term Diffusion Experiment

Structural model of the LTDE site and detailed description of the characteristics of the experimental volume including target structure and intact rock section

Report no.	No.
IPR-03-51	F79K
Author	Date
Anders Winberg	Nov 2003
Jan Hermanson	
Eva-Lena Tullborg	
Isabelle Staub	
Checked by	Date
Mats Skålberg	
Approved	Date
Christer Svemar	2004-10-17

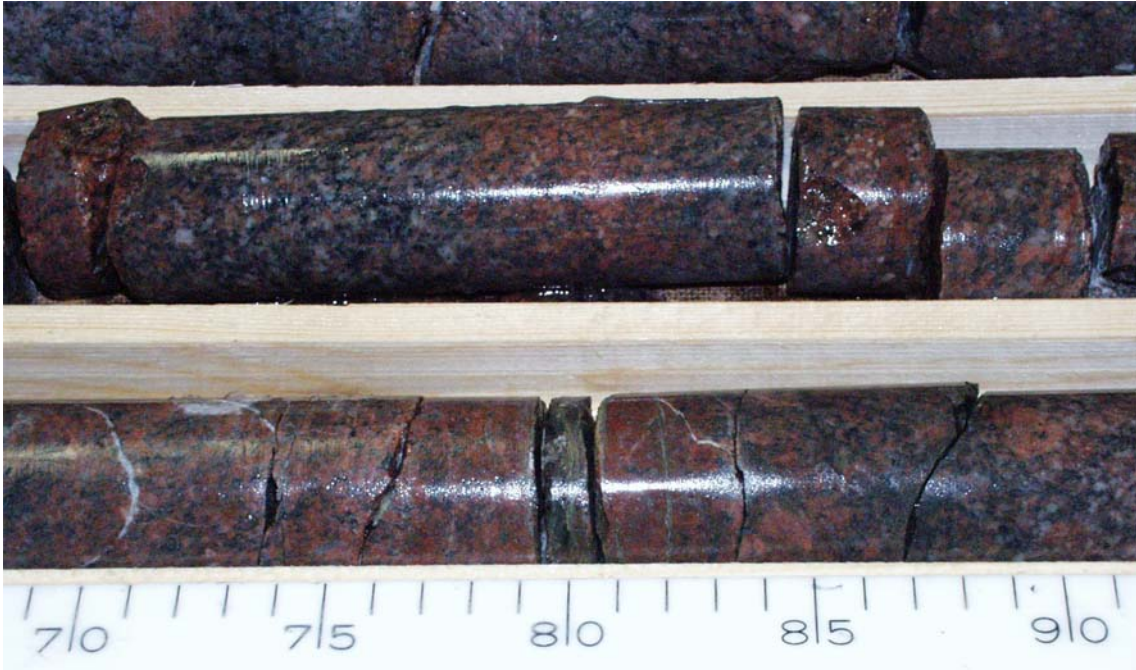
The selected target structures are the fractures associated with the main fault at 9.81 m in KA3065A02, c.f. Figure 2-2. The selection is made mainly on the basis of;

Figure 2-2. The main fault in KA3065A02 at L=9.81 m. The two fractures below the “main fault” (cf. slab in lower box at coordinate 80 cm) are interpreted to be splay fractures to the fault of which the lowermost is the proposed target fracture.

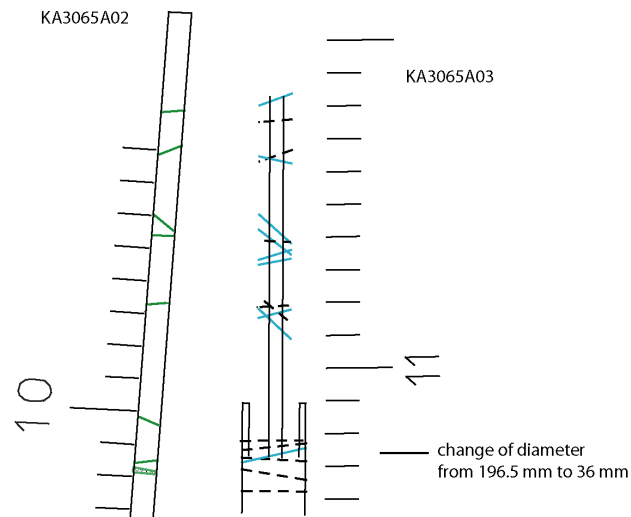
The actual fracturing in the 36-mm extension shows a quite poor correlation with the projected intersections (hatched) from fractures in KA3065A02, see Figure 3-5. Eight fractures were observed on the 36-mm core while five had been predicted from the BIPS measurements in KA3065A02.

Figure 3-5 Predicted intersections in KA3065A03 (black hatched traces) based on the BIPS 4 logging of KA3065A02 (green), and the outcome of core mapping in the 36-mm hole (light blue).

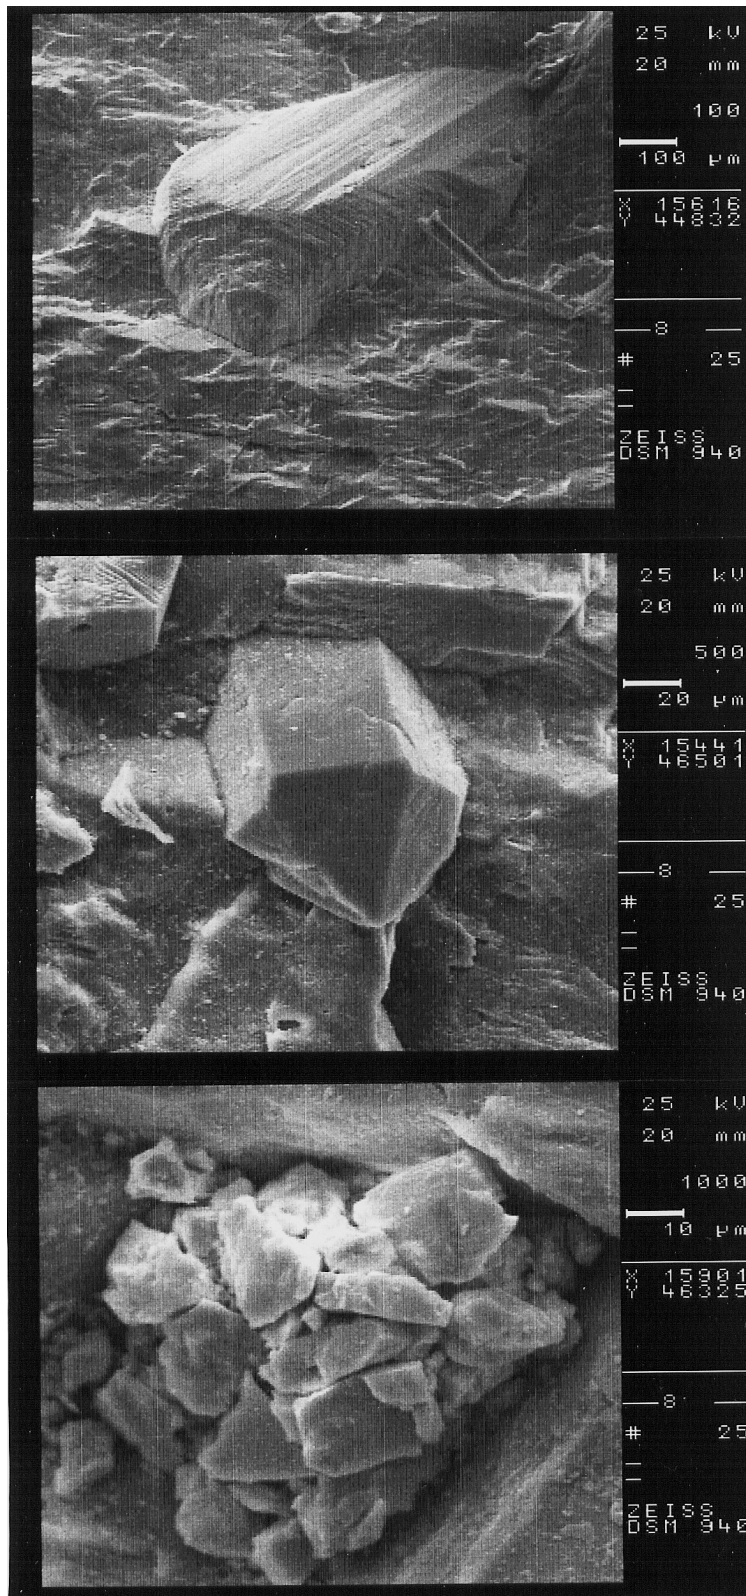
Figure 4-2. SEM photo of chalcopyrite, CuFeS_2 (upper) , barite, BaSO_4 (middle) and quartz crystals (lower) grown on the #10a fracture surface in borehole KA3065A03 i.e. the surface corresponding to the stub surface in the borehole. Note the different scale bars (upper=100 μm , middle = 20 μm , lower=10 μm , cf. Table 4-2).

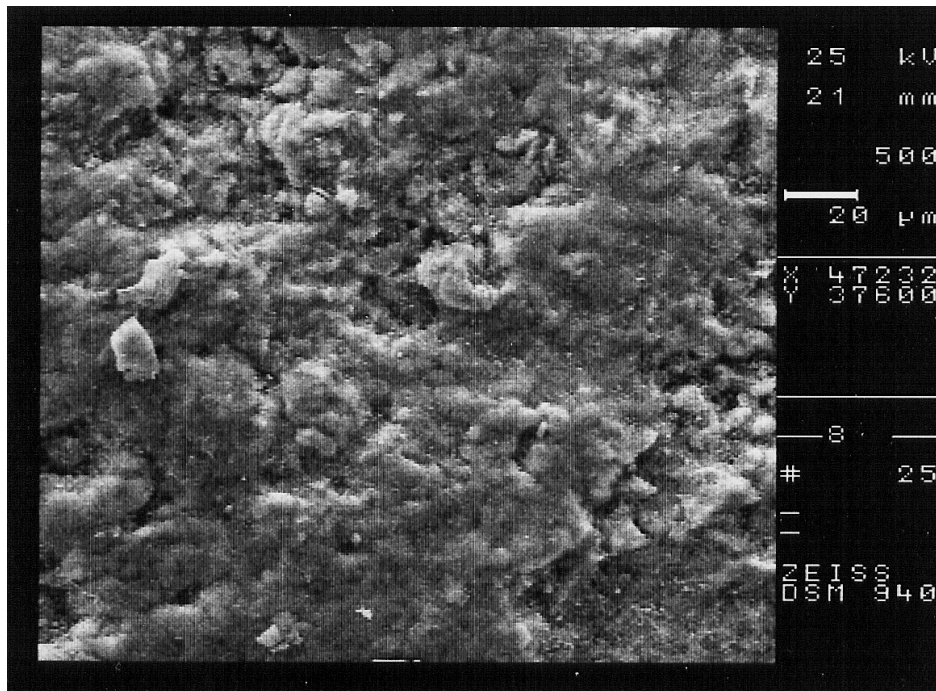
Figure 4-3. SEM photo of the surface of #10b in KA3065A03 with calcite and chlorite grown on the fracture surface. The scale bar is 20 µm, cf. Table 4-2.

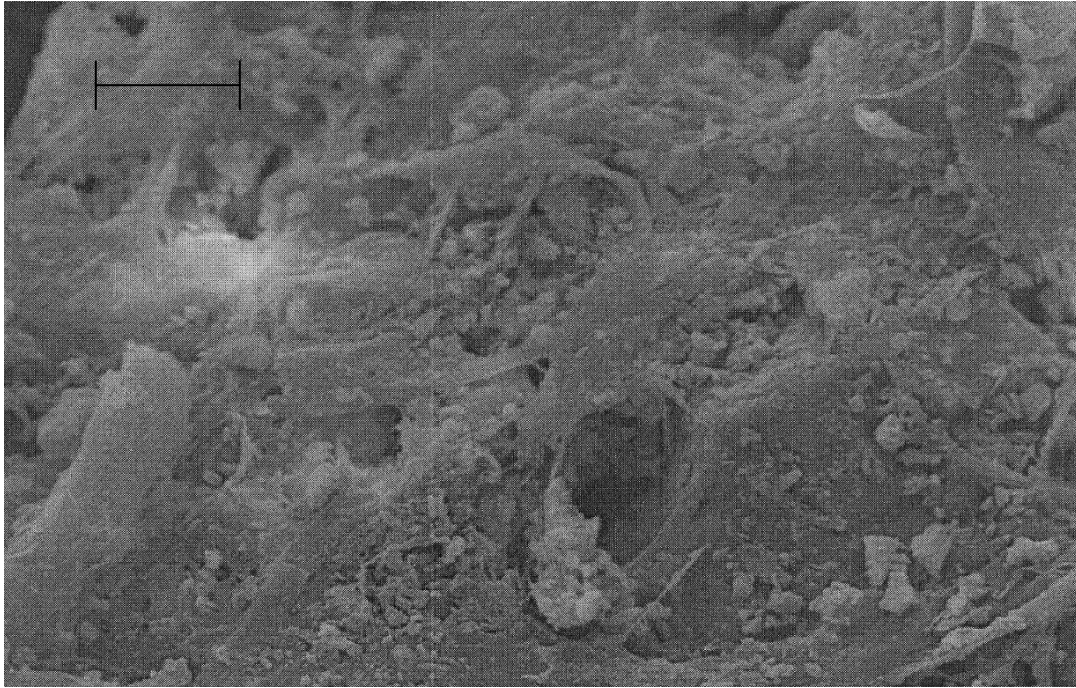
Figure 4-5. SEM photo of #11 in borehole KA3065A03; small flakes of clay minerals on the rough fracture surface. The scale bar is 20 μm , cf. Table 4-2.

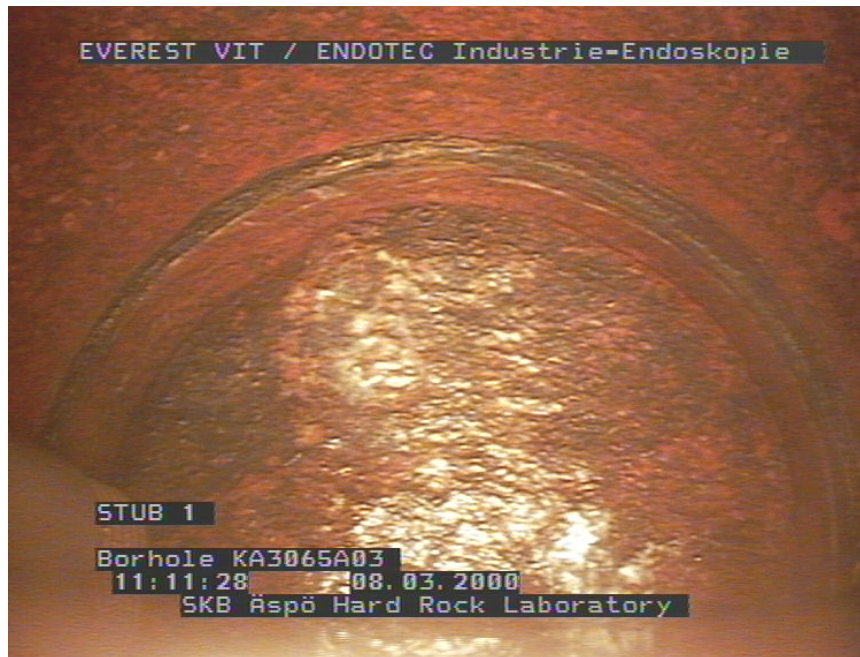
Figure 4-8. Image of the target fracture surface. Still from the ENDOTEC video. The greenish band that surrounds the circumference is the main fault that was penetrated before the target fracture. The white area on the surface is calcite and the green is mainly chlorite. There is an intersecting fracture that has cut a part of the fracture surface in the top left corner.

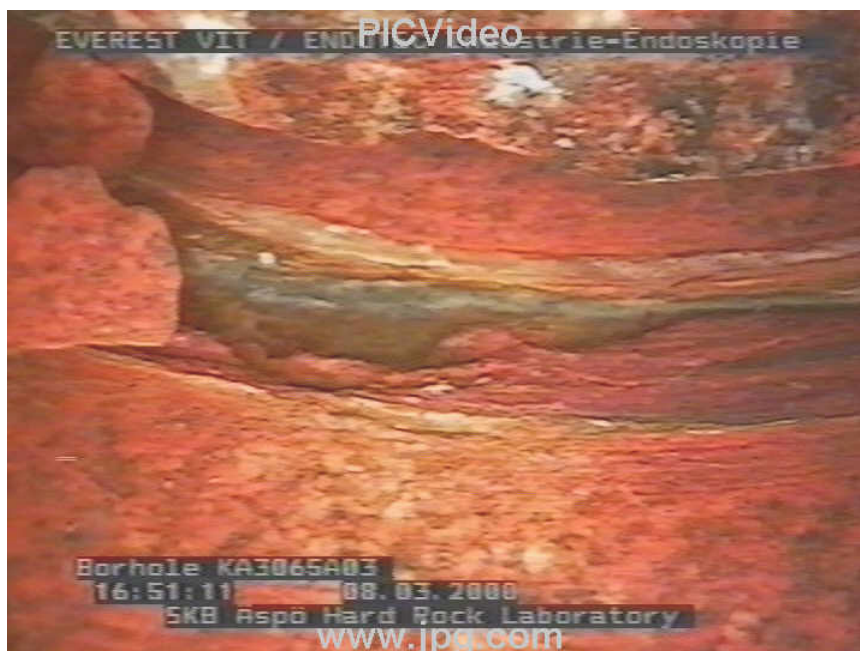
Figure 4-9. Detailed image of the lower circumference of the borehole and the lower part of the stub. The coloured band in the main fault consists of epidote, chlorite and calcite. The entry to the slot is readily visible in the upper part of the image as a dark curved band. In the left side of the photograph, loose cm sized fragments are readily identified on the bottom of the borehole and partly covering the entry to the slot.

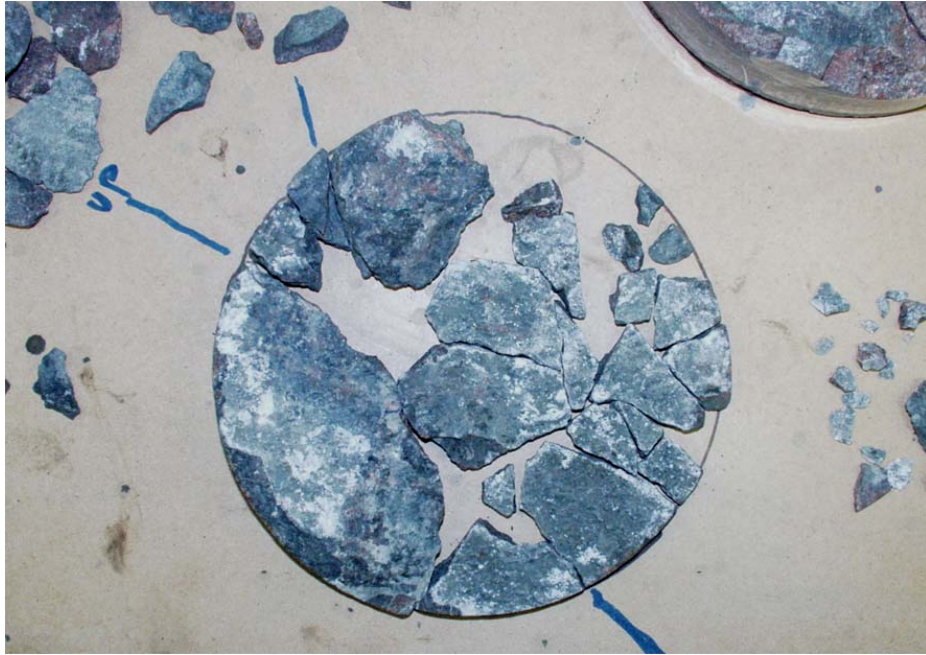
Figure 4-13. The matching surface to the target fracture. The major part of the surface is covered by a mm thick layer of calcite as can be inferred from the borehole wall next to the stub. The main fault is extensively deformed and shows strike slip behaviour.

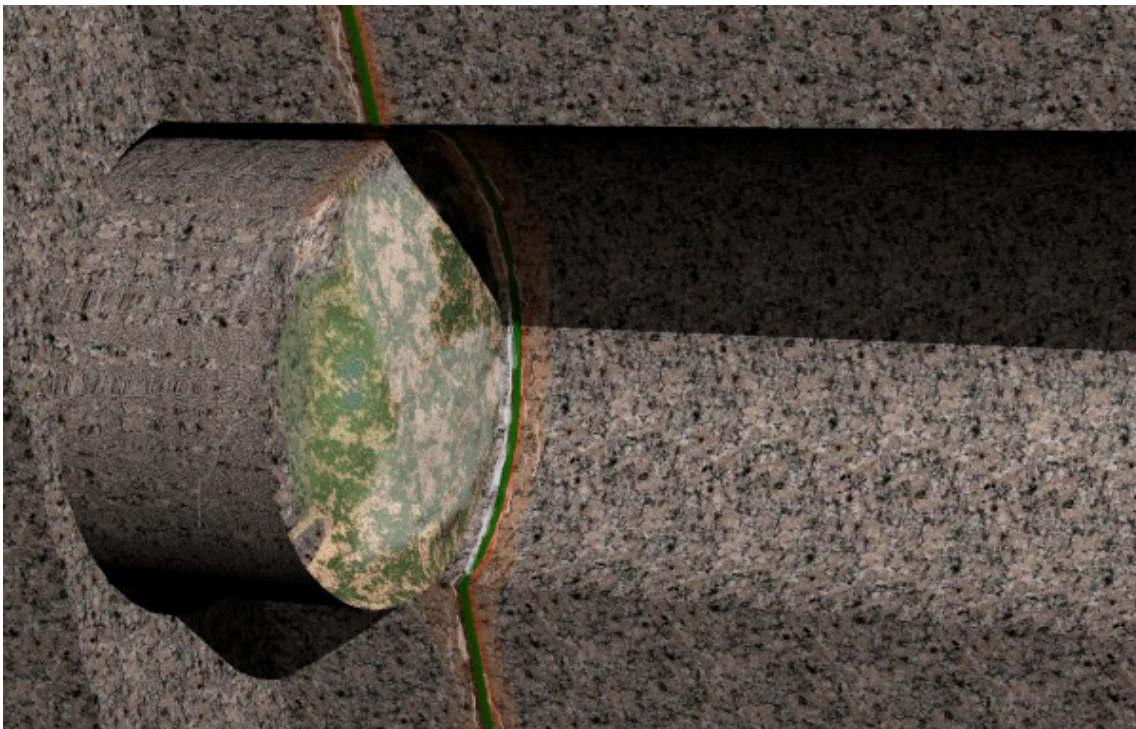
Figure 4-14. Illustration of the stub and the location of the fault on the borehole wall. The surface is covered by calcite (white) and chlorite (green). The upper left part shows the surface of the chlorite-covered splay fracture intersecting the main surface. The main fault is shown as the red-green-white altered epidote and calcite filled section of the rock.
