SKB TR-25-06

August 2025

Analysis of copper samples from the canister in deposition hole 4 in the Prototype repository

Abdelkader Meroufel, Xuying Wang, Dan Persson, Alice Moya Nunez,
Kristina Lindgren, David Malmström, Rikard Norling
RISE AB

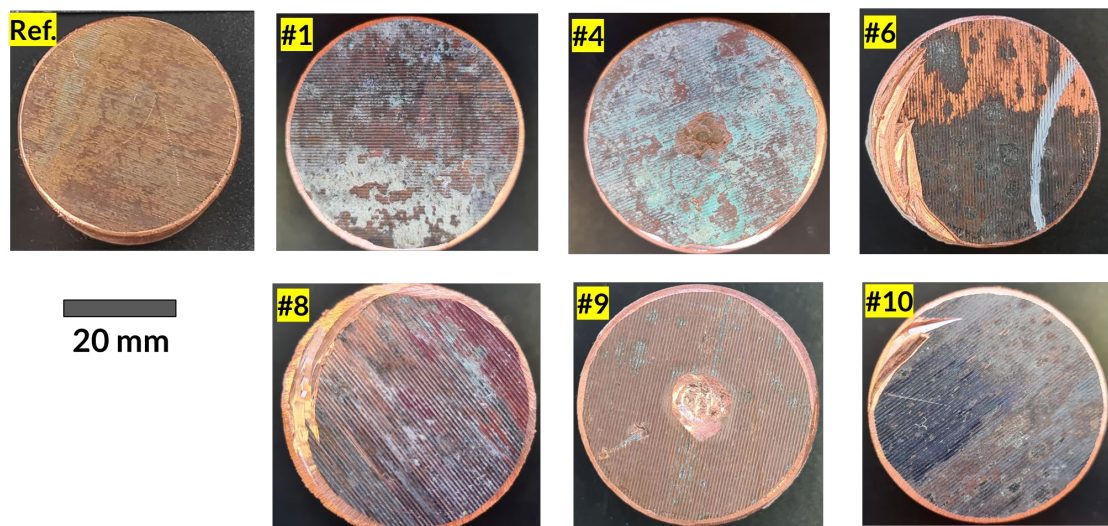
The surface displayed considerable variation, largely consisting of a combination of dark black, white, green and red surfaces. In some regions, metallic shiny surface with typical copper colour was observed. Surface machining striations were observed and are expected to be related to the canister manufacturing stage

Evidence of mechanical damage was observed for certain samples (either in the core or the edge) which can be due to sampling and/or handling procedures as for samples #4, #6, #8, #9 and #10.

Solid corrosion products and probably bentonite residues are visible with variable appearance on the surface, compared with the reference sample. Samples #1 and #4 surfaces distinguish from the others by their colour, texture and flaking which may indicate thicker surface layer. Unexpected surface redness was detected on samples #1 and #8. The presence of white line on sample #6 is caused by marking during sampling as confirmed by SKB engineer. In general, all surfaces exhibited a non-uniform appearance when it comes to surface products coverage. Also, it is not obvious to correlate the visual appearance to the sample's locations in the absence of surrounding environment information.

Figure 7. Visual appearance of samples surfaces including the non-exposed reference sample (Ref.) and six exposed samples (noted #1, #4, #6, #8, #9, #10).

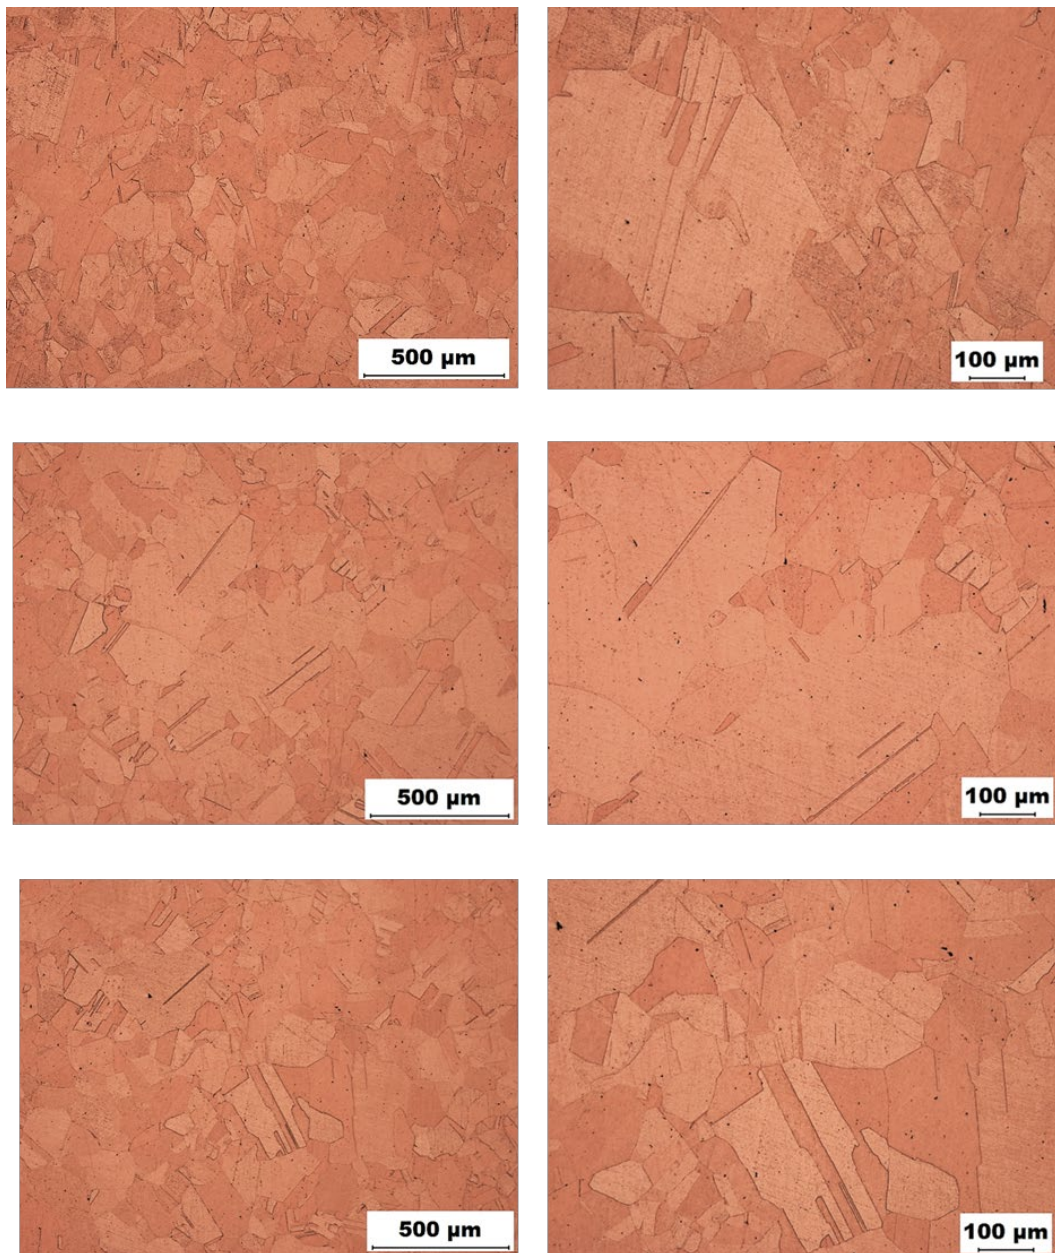
Reference copper sample was subject to microstructure examination where its surface was finely polished and lightly etched according to procedure described in section 2.2. The images were taken from three different sites under a microscope with 50x and 200x magnification, as shown in Figure 8. It can be seen in that copper sample is composed of grains with sizes ranging from 30 μm to 300 μm , with irregular polygon structures. This structure also includes a high fraction of twinned grains as observed in previous assessment (Taxén et al. 2012)

Dark spots are observed at grains and grain boundaries which may be related to the surface preparation and/or to some microporosity. Diamond suspension particles can be embedded easily on the soft copper surface depending on polishing force, diamond particles size, and other factors. Also, microporosity of pure copper is believed to originate from the manufacturing stage because of trapped hydrogen in the melt (Sunny group 2023, Bodington 2024). Hydrogen trapping in copper is preferentially in grain boundaries but can also be in the bulk lattice (in case of defects such as dislocations or vacancies) (Nagumo et al. 2023). Deeper investigation of this aspect is out of the scope of the present analysis.

Figure 8. Metallographic microstructure of the reference copper sample.

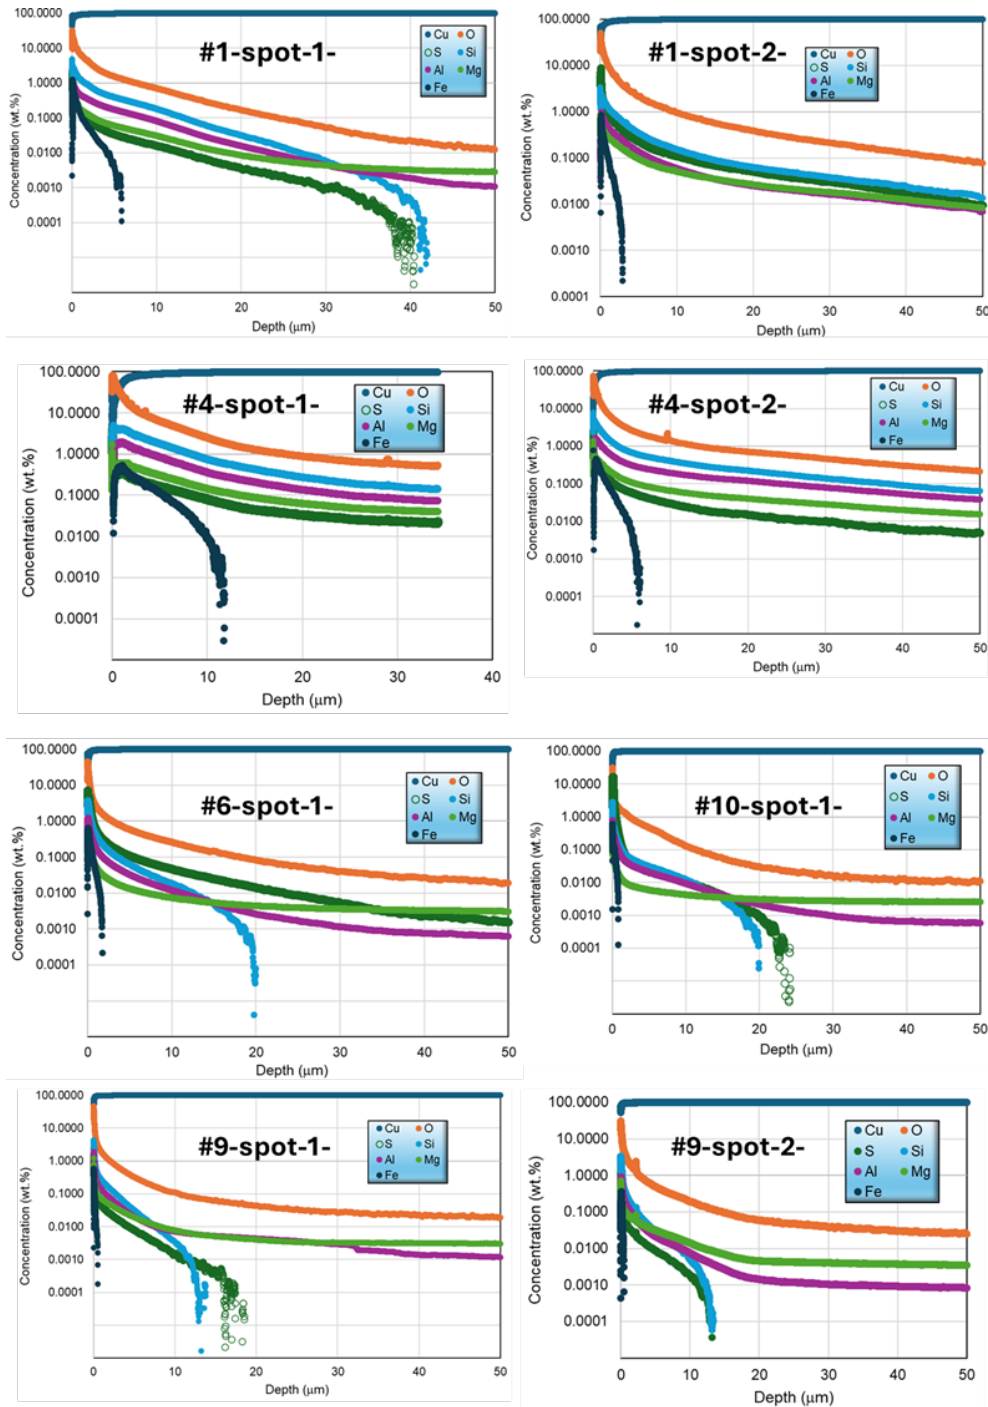
Elemental depth profile was characterized by GDOES where the obtained spectra are shown in Figure 15 with one or two spots for each sample. Sample 8 is not included since the available part was dedicated for an additional hydrogen analysis. It can be noticed from the penetration depth variation for each sample that there is an inhomogeneity of the sample. The detected elements remain like what was found by EDS analysis. Due to the non-availability of reference samples for calibration, both chlorides and hydrogen element are excluded from the results shown in Figure 15. The dominant elements are oxygen, silicon, aluminium and magnesium which decreased with depth increase in the same sample. The concentration of elements (except copper and oxygen) falls below 1 wt.% beyond 5 to 10 μm depths. The sulphur amount varies across and between samples which indicates its discontinuity. Relative to the sample position versus the canister base, both oxygen and sulphur amounts did not follow clear trends. Further discussion is given in section 4 (Discussion).

Figure 15. Elemental depth profile obtained by GDOES on the surface of the exposed copper samples from canister.

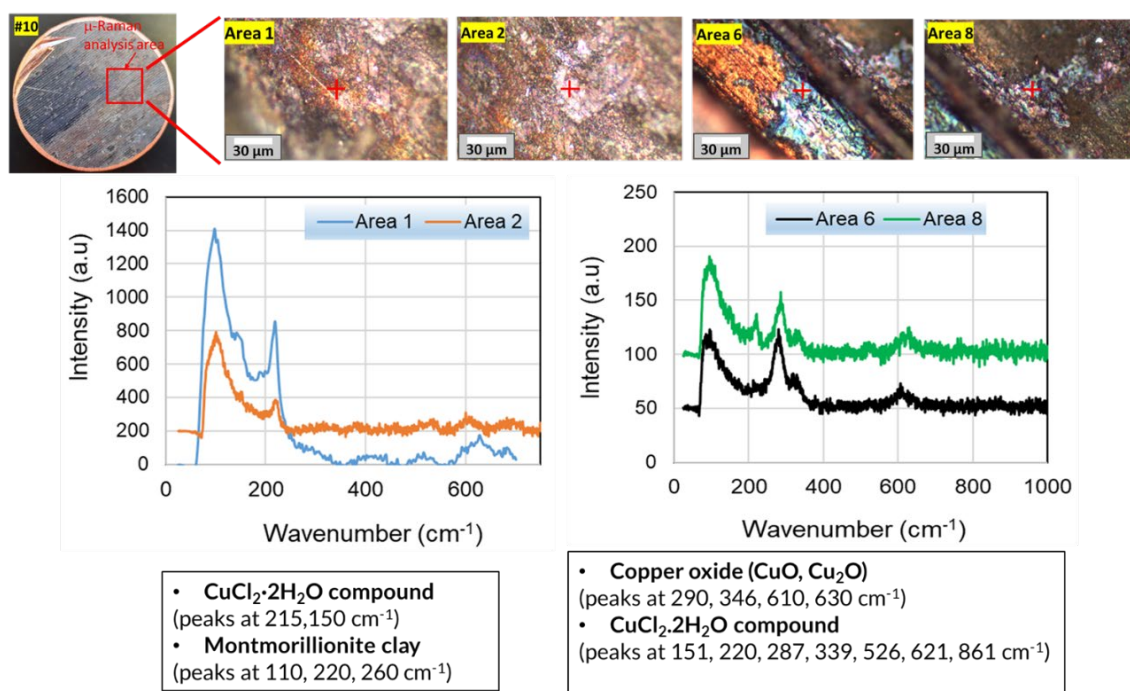
μ -Raman spectroscopy was also conducted on sample #10 since it showed a high amount of sulphur element through EDS analysis (Table 5), to explore further the possibility of sulphur-based corrosion products (CuS or Cu_2S) that could not be detected by XRD and FTIR. Typical Raman characteristic peaks of CuS or Cu_2S are expected to appear at 474 cm^{-1} (Chaki et al. 2014, Patil et al. 2018).

Eight different sites from the surface of sample #10 were analysed. Raman spectra of four representative different areas, along with the identified compounds are shown in Figure 29. The remaining area results can be found in Appendix B (Figure B-1). Most areas showed the presence of dehydrated copper chloride ($\text{CuCl}_2 \cdot 2\text{H}_2\text{O}$) (Medeiros et al. 2018) and montmorillonite clay (one of the bentonite constituents) characteristic Raman bands. The spectrum range beyond 1000 cm^{-1} (where further Raman bands of $\text{CuCl}_2 \cdot 2\text{H}_2\text{O}$ exist) was not explored due to the purpose of this characterization (detection of sulfur-based corrosion products). In two other areas (6 and 8), with greenish appearance, the surfaces were detected with copper oxides (CuO , Cu_2O) and with dehydrated copper compound (Guha 1991, Debbichi 2012). Thus, Raman results confirmed previous XRD and FTIR findings.

Figure 29. μ -Raman measurement on different areas of the sample #10, and corresponding spectra and identified compound of four representative areas. The Raman spectra of other areas can be found in Appendix B.

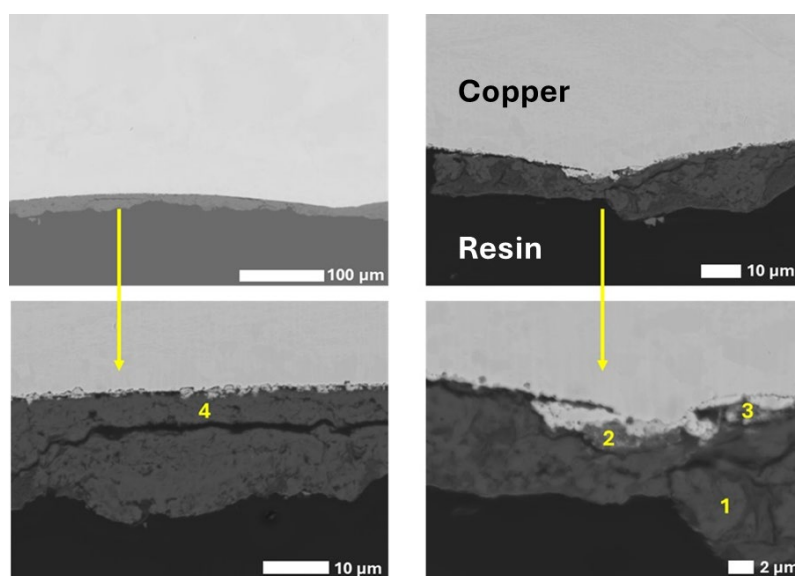
Figure 30 shows cross-section SEM images on sample 1 with a quite continuous layer with different thickness and with some cracks. That layer was identified to be bentonite based on its typical major chemical elements such as Ca, Mg, Si, and Al (Table 7). No significant underneath corrosion attack could be observed. Some sulphur was detected on both location 1 (bentonite) and between the pure copper and bentonite layer. It is not obvious to attribute it to a local corrosion process when considering that sulfur can be attributed to the present gypsum identified on this sample surface by XRD (Figure 16). Such compound can be related to the groundwater and/or bentonite as discussed in previous studies (King et al. 2010, Johannsson et al. 2020).

Figure 30. SEM images of cross-section on sample 1.

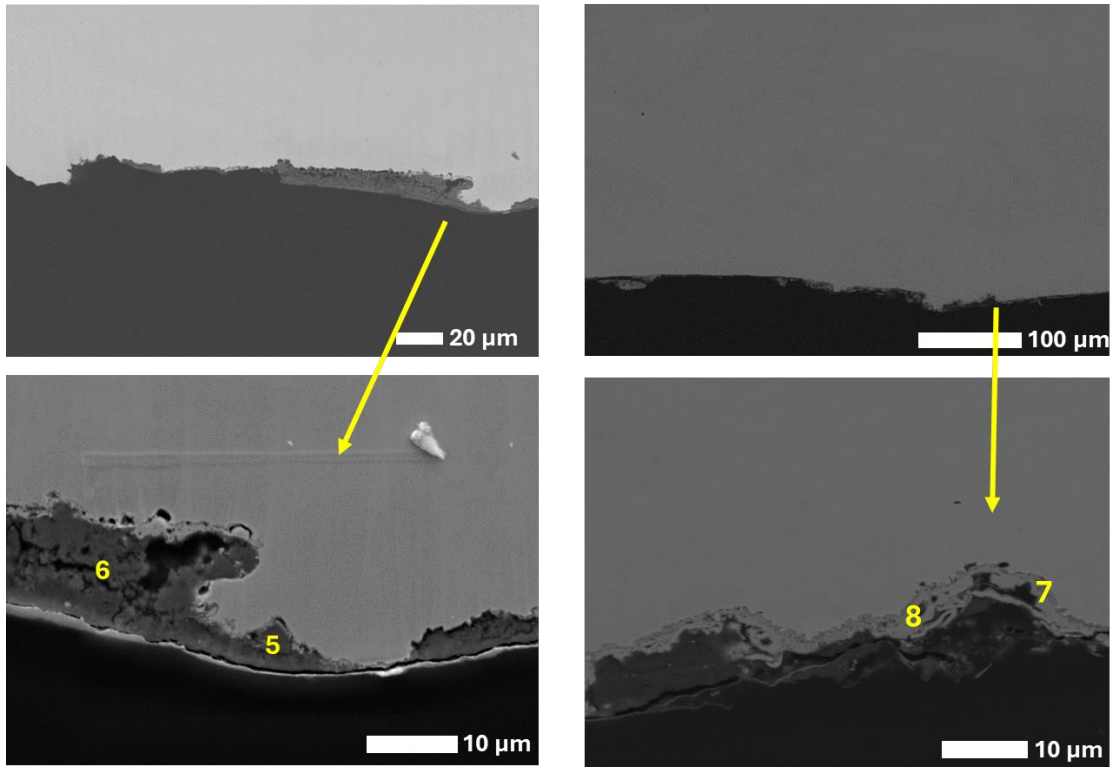
The detection of some chlorides on sample 4 cross-section is consistent with both XRD and FTIR findings with paratacamite compound. Sample 6 showed a porous and thin ($\sim 3 \mu\text{m}$) corrosion layer that contains significant amount of sulphur and little oxygen. This very thin layer is challenging to determine its specific compound by the conventional characterization techniques that were used in the present assessment. The presence of chloride and oxygen on cross-section of sample 8 may indicate the possibility of oxychloride copper product which was not detected by XRD or FTIR. The presence of local sulphur combined with oxygen on cross-section of sample 10 would support more the presence of sulphates as highlighted in FTIR result (Figure 28) despite the presence of porous corrosion layer with limited extent. Additional SEM images at lower magnification are gathered in Appendix D.

Figure 31. SEM images of cross-section on samples 4 (left) and 6 (right).

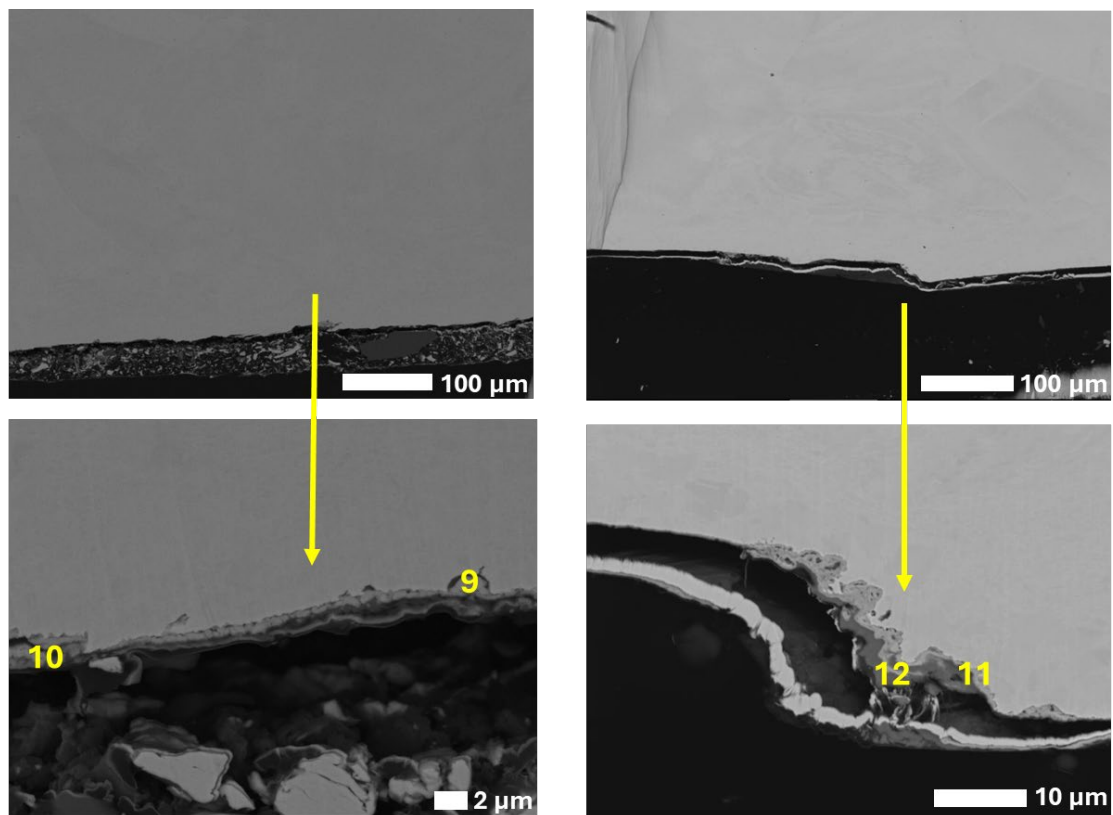
Figure 32. SEM images of cross-section on samples 8 (left) and 10 (right).

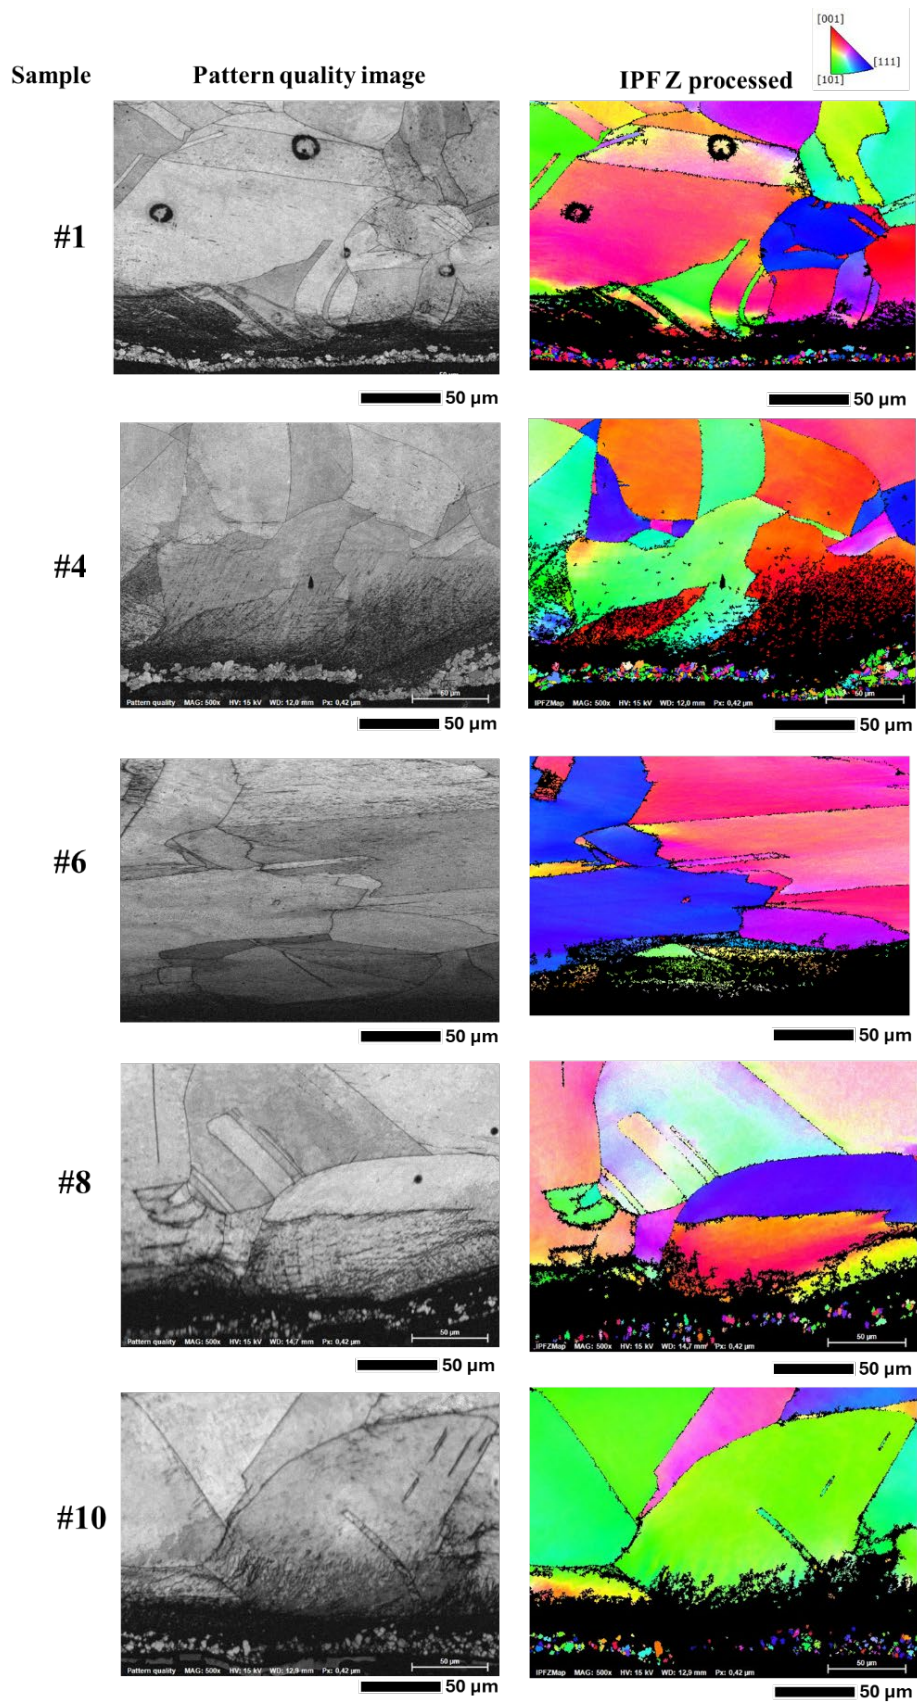
EBSD allows to determine the local crystal structure and crystal orientation at the surface of a metal. Figure 33 shows the EBSD analysis for five samples and sample 9 was excluded due to the absence of corrosion or surface product layer. Crystalline orientation for the different samples seems variable. However, it is not possible to draw any conclusion on the statistics of grain size or orientation due to the small, analysed surface area and big and variable grain size. Also, some plastic deformation within grains could be noticed at the grain boundaries. For some samples such as samples 1 and 10, this is seen in the IPFZ (Inverse Pole Figure in Z direction) in Figure 33. For all samples, this can be seen in the average misorientation maps, in Appendix E -Figure E-1.

Further, indication of plastic deformation zone (appearing as black zone) was noticed for all samples associated with grain refinement at the surface in contact with bentonite clay. The grain refined zone may include corrosion product which could not be distinguished by EBSD. This can be due to the corrosion layer which is thinner (than grain refined zone) and not continuous as revealed by SEM-EDS on cross-section samples. The plastic deformation associated with grain refinement may have two possible explanations i.e. the surface machining process that the copper canister surface has been subjected to or samples preparation prior to EBSD analysis. The last possibility was excluded for two reasons i.e. the absence of this plastic deformation when moving to the bulk material and considering that the BIB treatment can remove up to 60 μm in depth which may exclude a great part of cutting artefacts.

On the other hand, literature survey shows that surface machining was found to induce grain deformation, recrystallization and refinement due to the temperature increase associated with stress (Pan et al. 2017). The recrystallization temperature of oxygen free pure copper reported in literature is ranged between 379.05 $^{\circ}\text{C}$ to 433.2 $^{\circ}\text{C}$ (Su et al. 2021). The consequence of this microstructure alteration consists in the improvement of the corrosion resistance with less tendency for pitting corrosion (Lapeire et al. 2017). Also, the mechanical yield strength was found to improve with grain refinement without losing fracture elongation (Zhang et al. 2020). In this case, the very low corrosion extent can be related to this microstructural aspect. Further investigation on this hypothesis should be undertaken.

Figure 33. EBSD analysis on cross-section samples. Pattern quality map (left), processed IPF⁹ Z (right).

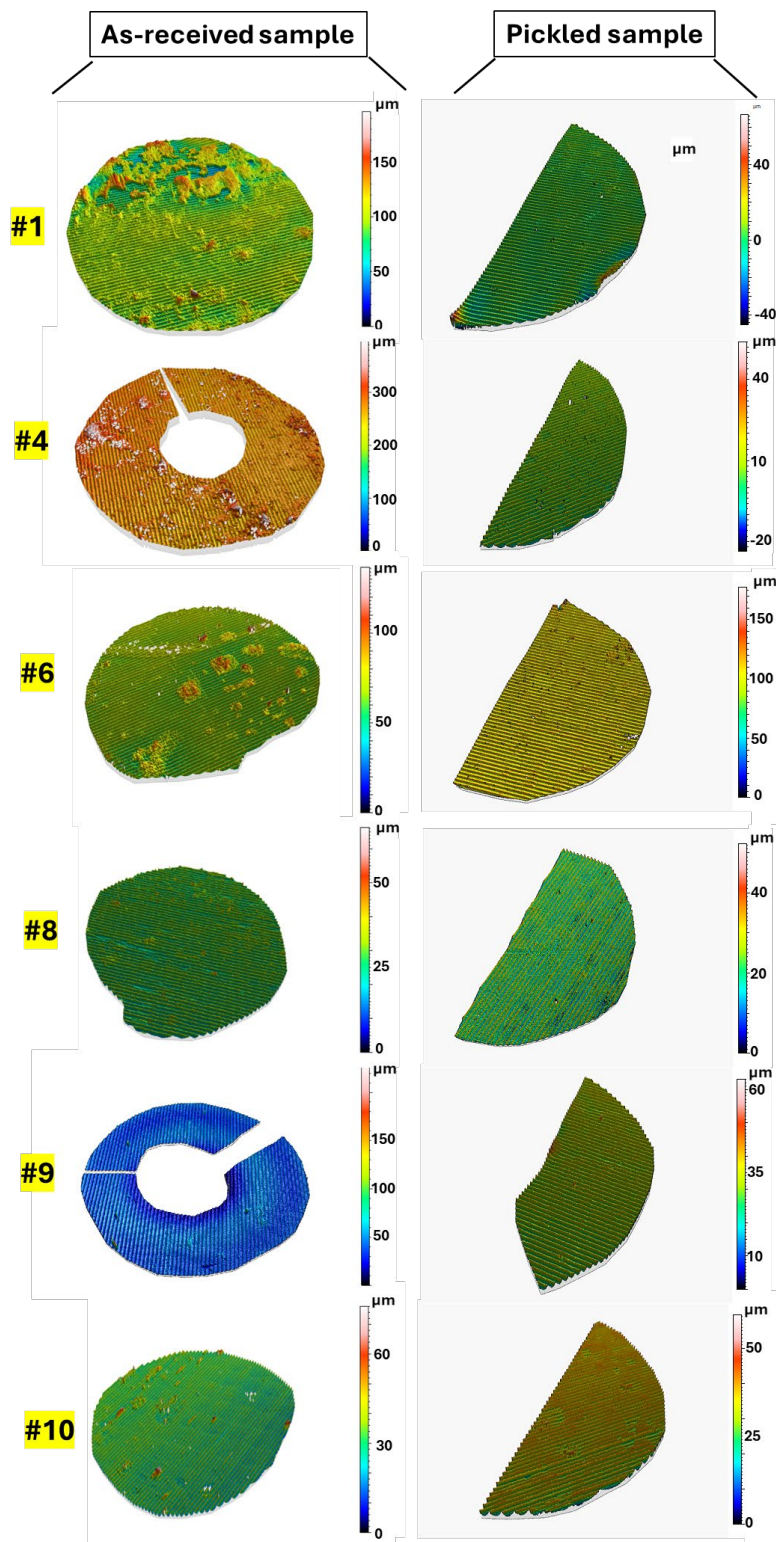
The surface topography before and after chemical pickling is shown in Figure F-1 (Appendix F). The surface topography of the samples was examined using optical profilometer both before and after the removal of corrosion products by pickling, as shown in Figures 34. Mechanically damaged zones are excluded when applicable. Surface profile measurements showed clearly that the surface striations are attributed to the machining of the canister. Their measured height is equal to 10 μm and is relatively sharp, see the line profiles of each sample in the Appendix F, Figure F-2. The height of striations determined by the optical profilometer on non-pickled samples was found between 12 and 17 μm in previous characterization (Taxén et al. 2012). Through these line profiles, corresponding to the topographic analysis before pickling, it can be found that the maximum surface product height reaches 50 μm . This height includes the contribution of existing surface products such as bentonite, gypsum, and corrosion oxide products.

Figure 34. 3D surface topography of exposed samples before (left) and after (right) removal of corrosion products.

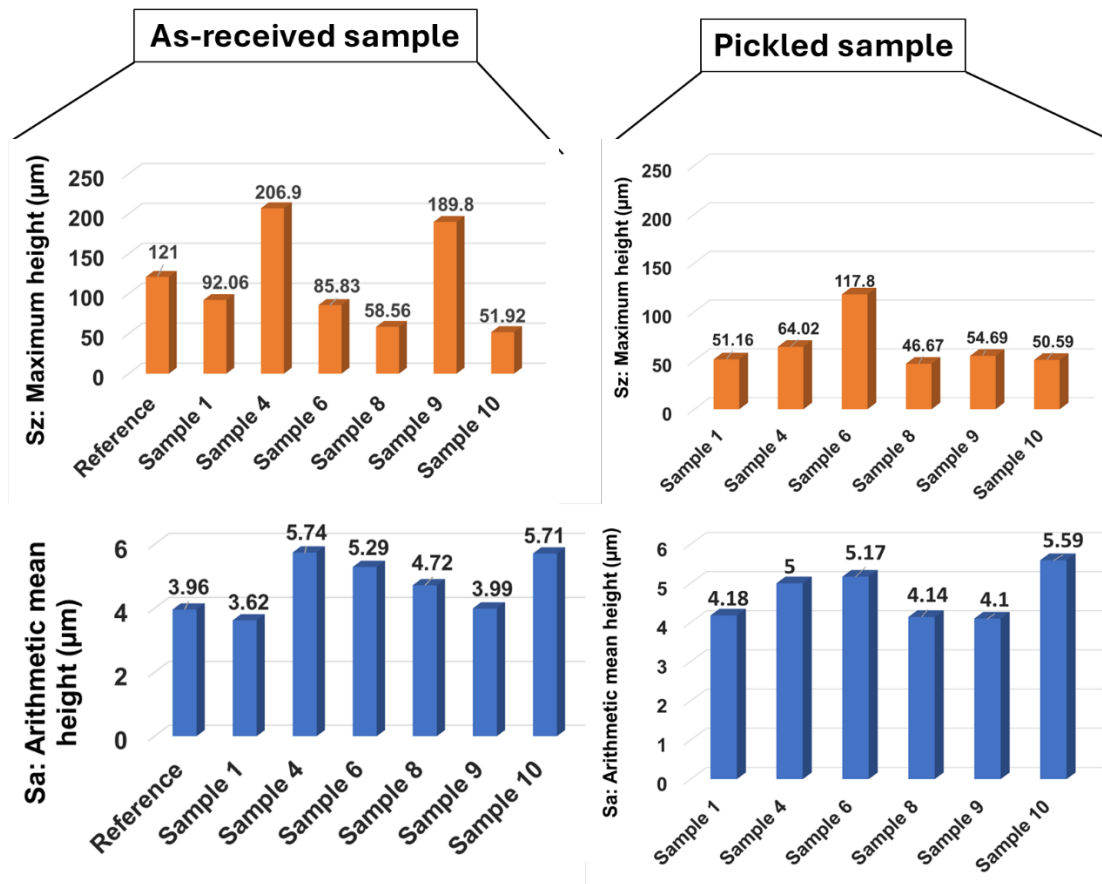
The sample surface roughness (estimated using ISO 25187 procedure) comparison of the maximum height (S_z) and the average height (S_a) before and after pickling can be found in Figure 35. Notice that each pickled sample surface area represents 50 % of the total original sample area approximately. It is observed that the maximum height on the surface relative to the mean plane is lower for the pickled samples, which confirms the removal of corrosion/surface products for all samples. However, the average surface roughness before and after pickling is nearly the same, indicating that the surface features from machining dominates the surface roughness calculation thus makes the distinction of surface roughness due to corrosion and any possible metal substrate localized attack due to pickling quite uncertain. This was observed in previous studies (Högberg et al. 2017).

Figure 35. Surface maximum height (μm) and mean height (μm) of samples before (left) and after (right) removal of corrosion products.

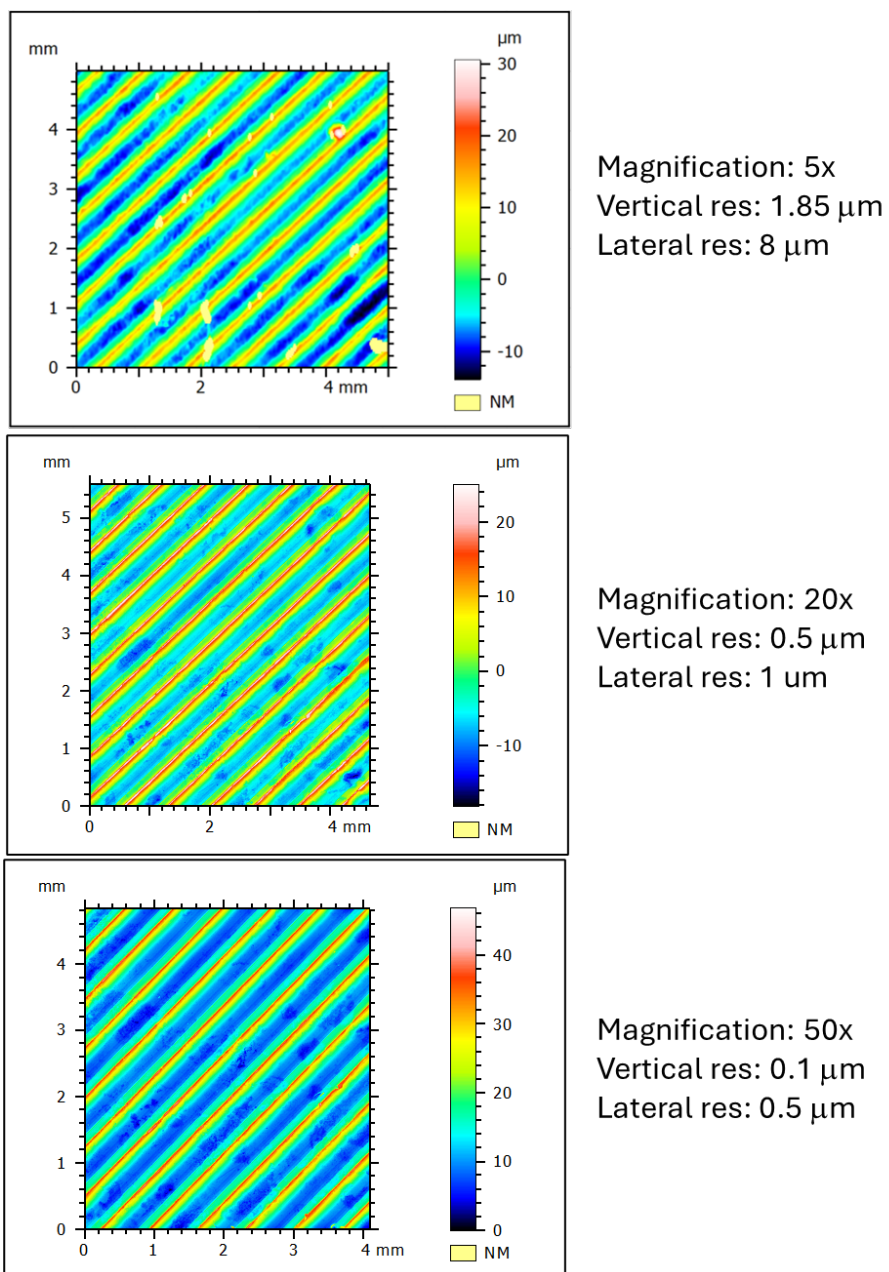
Sample 4 was selected to carry out a trial on one representative area of 25 mm^2 with analysis of surface defects and/or measurements of pit depths utilising different magnifications. The reason behind is related to the significant chloride amount detected on the surface of this sample, which could lead to possible pitting corrosion prior to the anoxic stage of the process where still some oxygen exists. Three different magnification objective lenses (5x, 20x, and 50x) with different resolutions (vertical and lateral) were considered to map the samples, as shown in Figure 36. Pitting analysis was performed using an advanced surface analysis software Mountains Map® wherein specific features that distinguish pits from general surface roughness (based on characteristics - such as depth, diameter, and shape) can be automatically detected and measured. The pitting analysis of a larger area (at 5x) did not yield good results as the pit depth determined was smaller than the resolution of the measurement. Higher magnifications (20x and 50x) gave more reliable results, but only smaller areas can be scanned. The pits under the surface products were quite small, between 2 and 6 μm deep (Table 8). This agrees with previous assessment (Taxén et al. 2012, Johansson et al. 2020) and cross-section samples examination (next section).

Figure 36. Pit depth determination at different magnification of the sample #4 after removal of corrosion products.

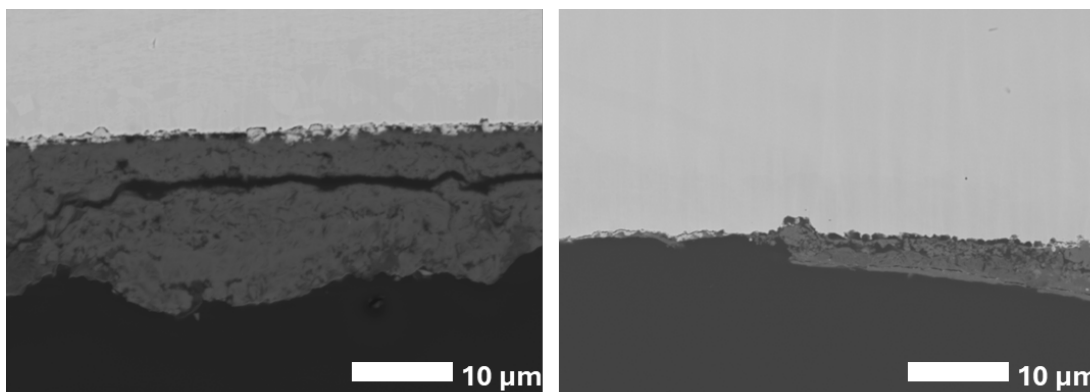
The determination of pit depth through cross-section analysis under SEM showed some challenges. It was quite difficult to find typical pit forms since the copper corrosion attack was very limited and appearing more as surface roughness. Figure 37 shows example on samples 1 and 4 where attack depth did not exceed 3 to 5 μm . Moreover, in some cases the surface attack is close to certain observed porosity as seen for sample 4 in Figure 38.

Figure 37. SEM images showing surface corrosion attack on sample 1(left) and sample 4(right).

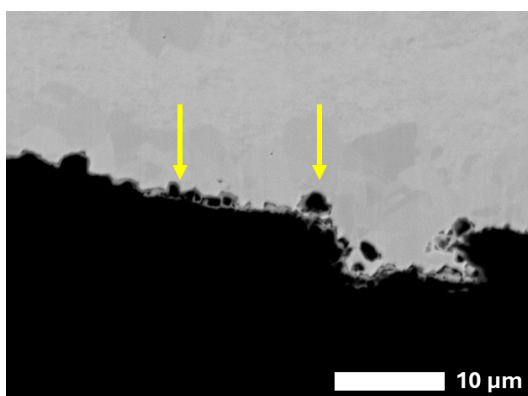
Figure 38. SEM image of corrosion attack on sample 4.

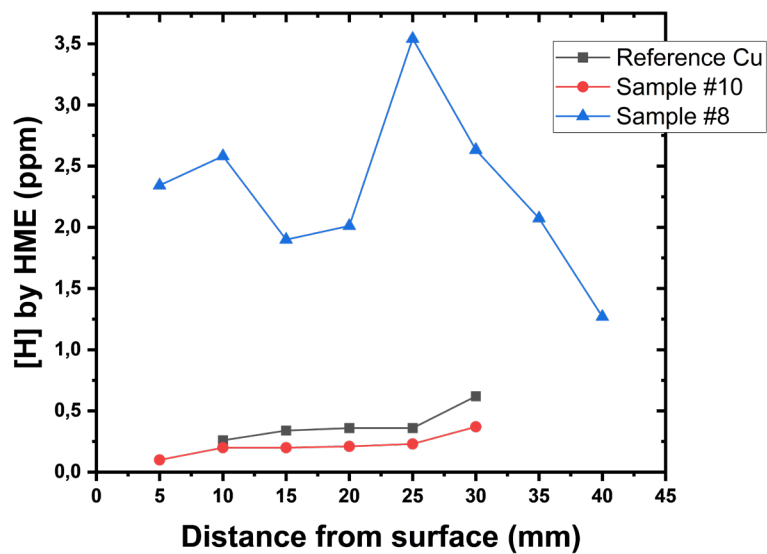
Figure 39 shows the hydrogen content profile obtained by HME from the corroded surface to the bulk material for the different tested samples where the first 5 mm samples include the corroded layer. As discussed above comparison of sample 10 with the reference gives that it is unlikely to have absorbed hydrogen because of corrosion. On the other hand, if it is assumed that for sample 8, the hydrogen source is a corrosion process, it can be expected that its hydrogen amount should decrease when moving from the corroded surface to the bulk material. However, this is not the case in the obtained result. Therefore, in such a case other factor may have affected the profile such as microstructure defects through which hydrogen could have diffused or progressed.

Figure 39. Hydrogen content profile of reference and exposed copper samples as measured by HME technique.
