## TR-12-09

### Analysis of SKB MiniCan Experiment 3

Nick Smart, Andy Rance, Bharti Reddy, Paul Fennell, AMEC

November 2012

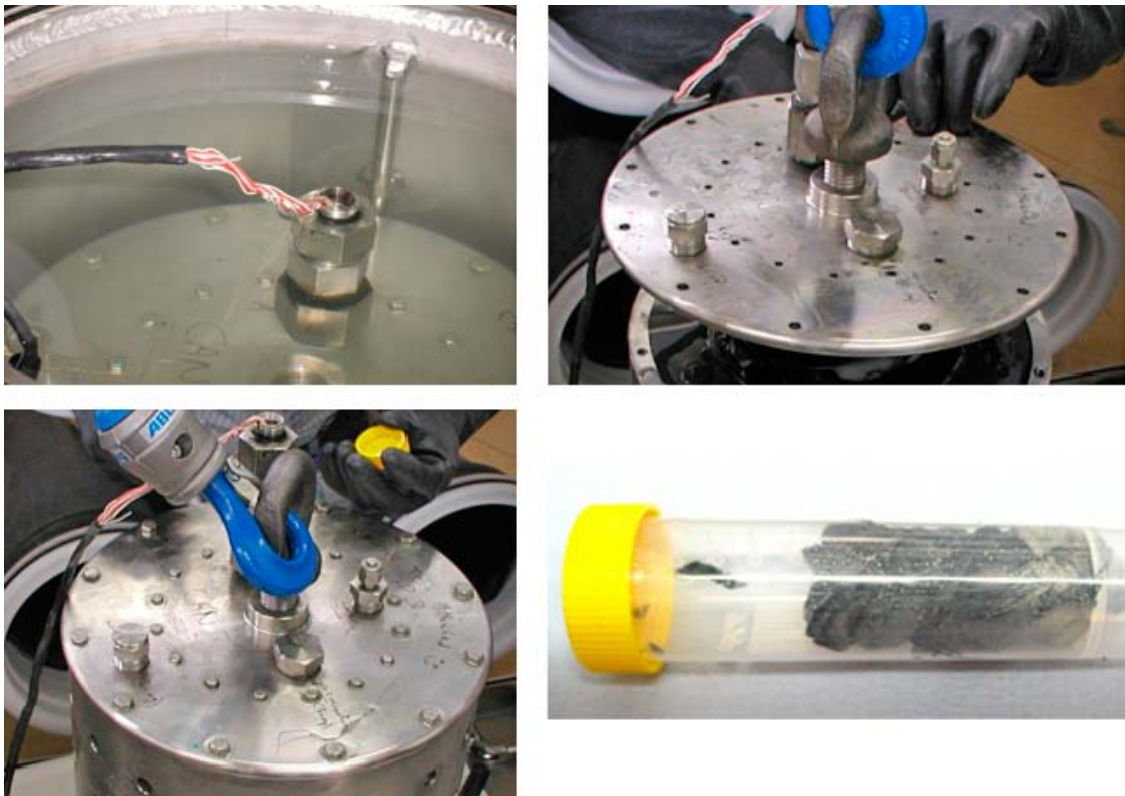
**Figure 6-3.** Photographs of lid of support cage when it was removed from the transfer flask showing: presence of thin patchy film on surface, black deposit around the stainless steel fitting where it enters the lid (top left hand photo) and swabs taken from surface.

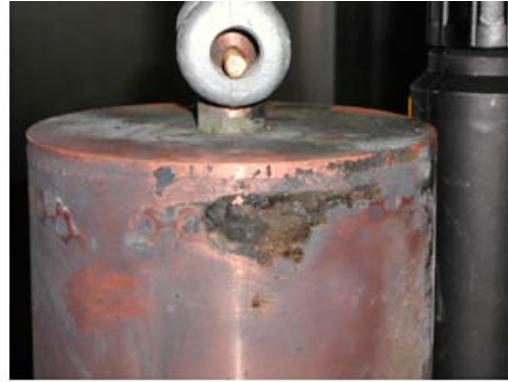
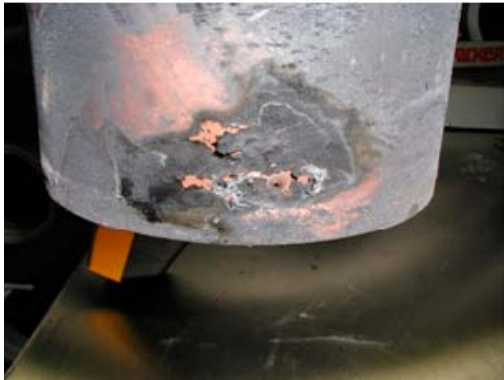
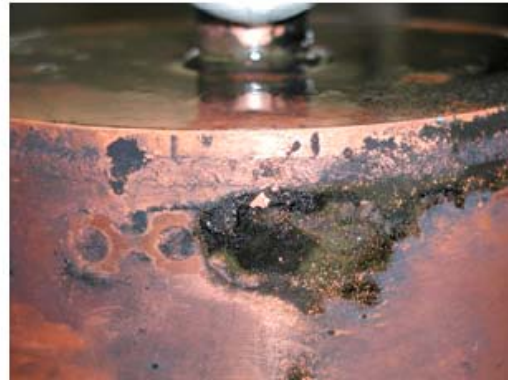
- The top 1 mm defect which was located near to the top weld appeared to have a black volcano-shaped extruberance emerging from it. The thickest layer of black deposit on the canister surface was around the hole, suggesting that it was due to material that had extruded out of the defect.

- The bottom 1 mm defect showed signs of a black layer around it, which was flaking off as the can dried, leaving a comparatively clean area (Figure 6-11). There was a ring around the bottom hole, which was probably an artefact caused when the defect was drilled before the canister was placed in the support cage (see also Section 7.3.12).

*Figure 6-11. Appearance of copper canister after removal from support cage, showing condition of holes at top and bottom of the copper canister. Note that the surface had dried in the glovebox due to the very low humidity.*

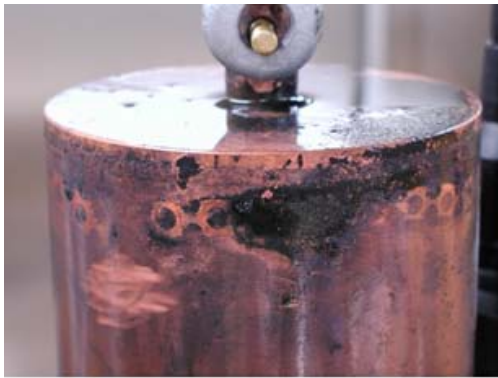
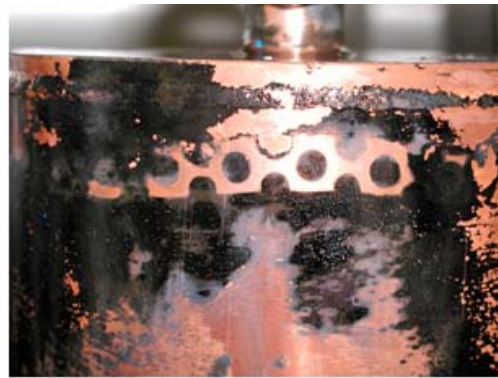
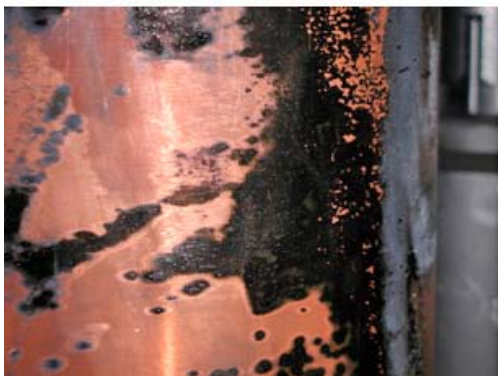
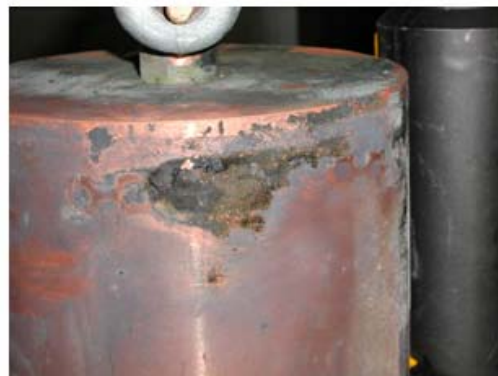
- There were areas with a green tinge around the black areas on the surface of the copper canister.
- There was a clear 'chain-like' pattern on the surface, which corresponded with the plastic insulator that was placed around the copper canister to prevent electrical contact between the copper canister and the support cage. This would suggest that the insulator material had screened the surface for material deposited from the groundwater, or that it had prevented access of the substances that caused development of the black layer.

*Figure 6-12. Appearance of the surface of the copper canister. The chain-like pattern on the surface at the top of the canister corresponds to the contact area with the strip of plastic insulator that was placed between the copper canister and the inner surface of the support cage.*

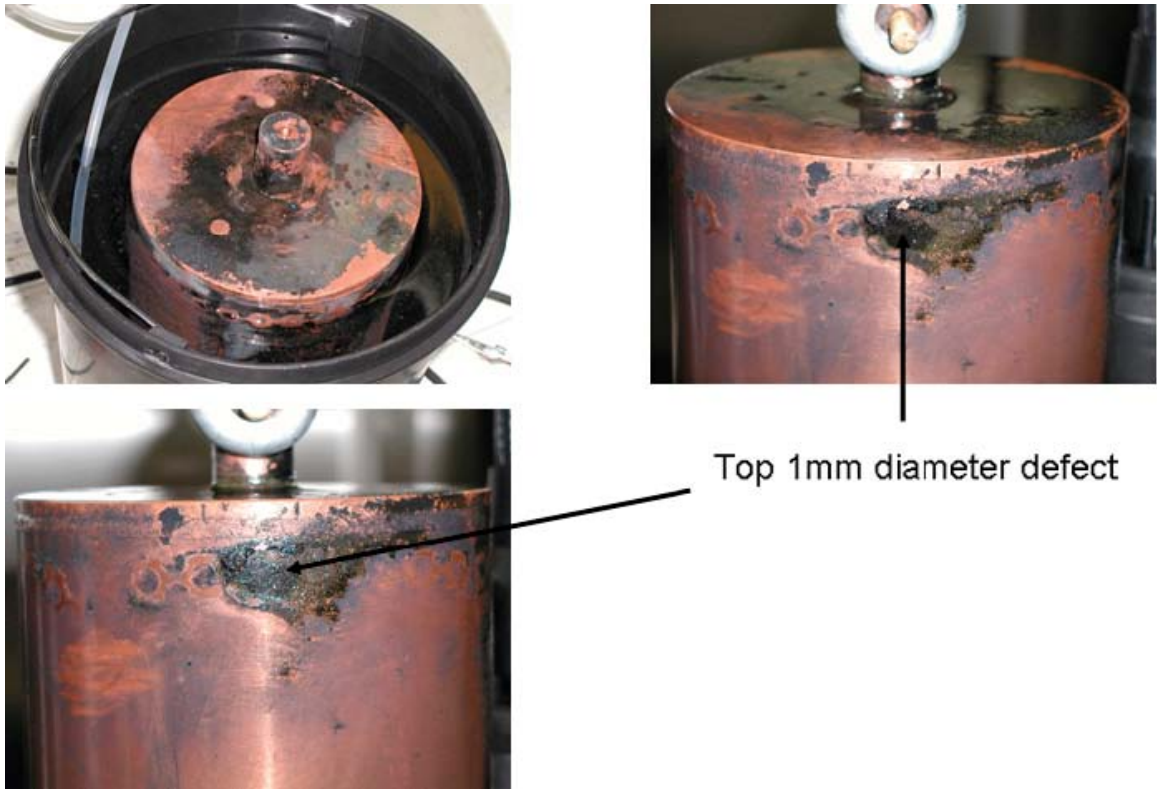
*Figure 6-13. Appearance of the surface of the copper canister; showing location of defects at top of canister.*

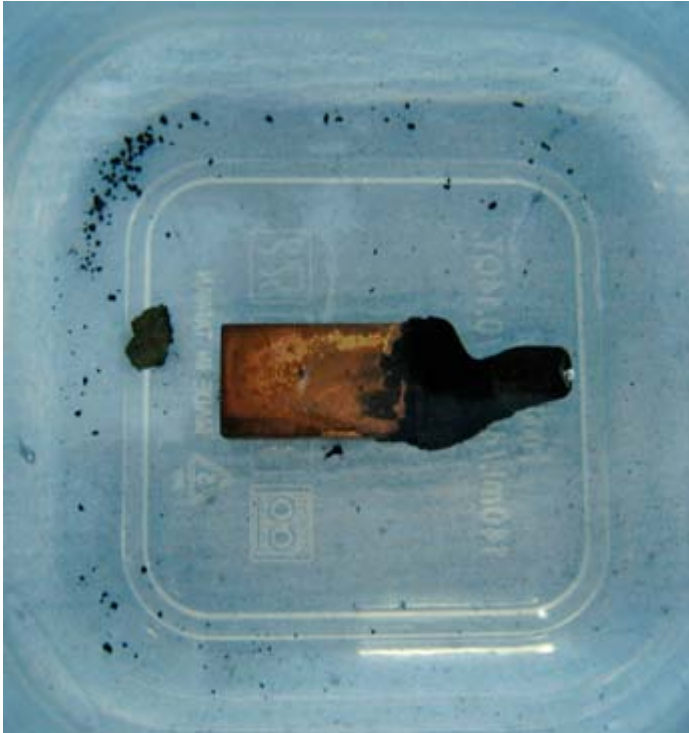
The appearance of the copper electrode 1 is shown in Figure 7-1 and 7-2 and that of copper electrode 2 is shown in Figure 7-3. It can be seen that the electrodes were covered with a blotchy, non-uniform black deposit and that some loose black non-adherent material flaked off the electrodes when they were stored in water (see Figure 7-1). When the electrically insulating PTFE heat shrink was removed from copper electrode 2 a shiny metallic surface was visible indicating that crevice corrosion had not occurred beneath the sheathing (see right hand side images in Figure 7-2). The surface of copper electrode 1 was analysed by Raman spectroscopy and the results from the analysis are shown in Figure 7-4. These results indicate that the material was predominantly non-crystalline, with possible indications of graphitic carbon and mixed oxide/sulphide species. The SEM/EDX (Appendix 2) analysis for copper electrode 1 identified the following main features (note that all results refer to the elements detected and that EDX does not provide any information about the chemical state of the material analysed):

*Figure 7-1. Copper electrode 1 in water, showing loose deposit that washed off electrode.*

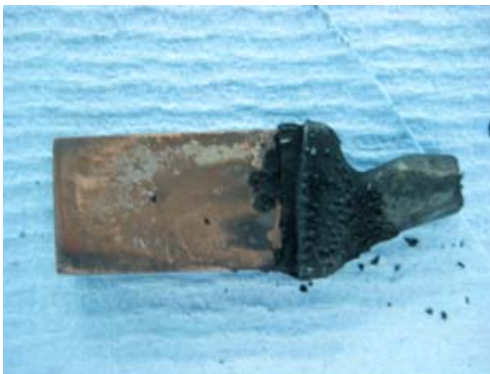
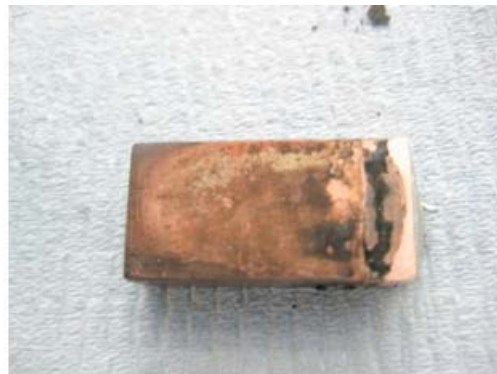
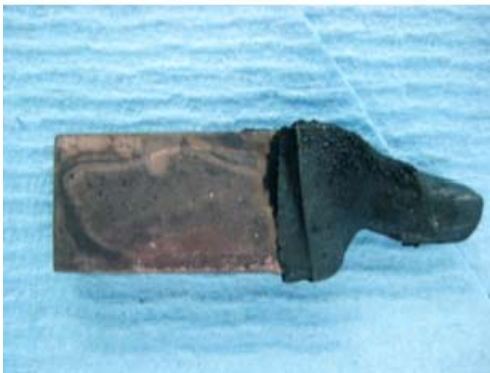
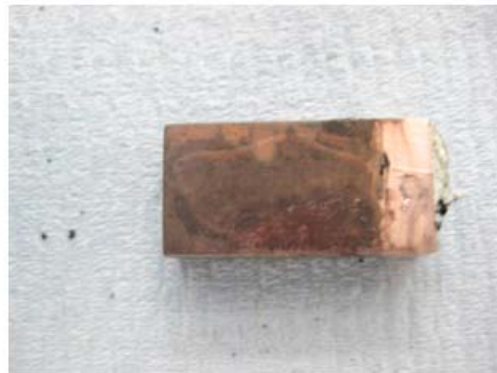
These features are consistent with the copper surfaces being covered with a thin film of copper sulphur/oxygen superimposed in some areas with a layer rich in iron, sulphur and silicon. The chlorine and calcium are probably residues from the groundwater, since the specimens were not washed in pure water before analysis.

*Figure 7-2. Copper electrode 1 showing both sides, before and after removal of sheathing. Note that the surface had dried out in the glovebox when these photographs were taken. The specimens were 10 mm wide.*

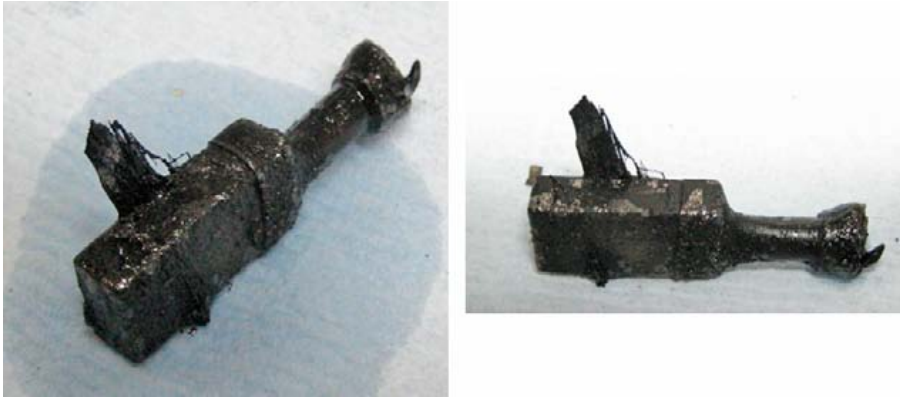
Figure 7-9. Iron electrode 2 from MiniCan Experiment 3, showing presence of whiskers of iron sulphide.

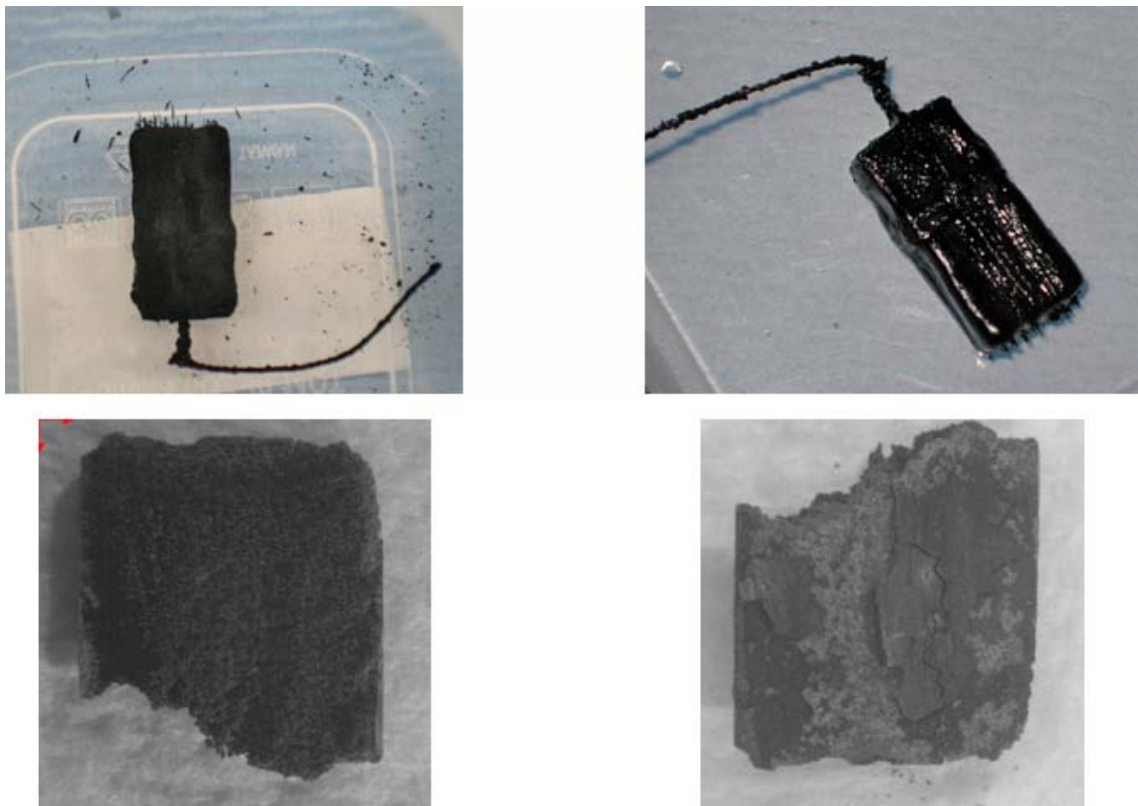
3. The cast iron weight loss coupon in MiniCan Experiment 3 had completely corroded, due to a graphitisation process induced by the presence of sulphate reducing bacteria. Severe corrosion was also observed on the cast iron electrodes, although some residual iron was present at the core of the specimen.

The iron weight loss sample was removed from the Perspex holder used for the Raman analysis and a fragment of the black surface removed and placed in a sealed capillary tube for analysis by XRD. When the sample was ground up for analysis it was found that it was easily broken up using a mortar and pestle, indicating a low mechanical strength. The XRD pattern (Figure 7-15) showed that the only crystalline phase present was graphite, showing that all the metallic iron phase had completely corroded away.

*Figure 7-13. Iron weight loss specimen after removal from Experiment 3.*

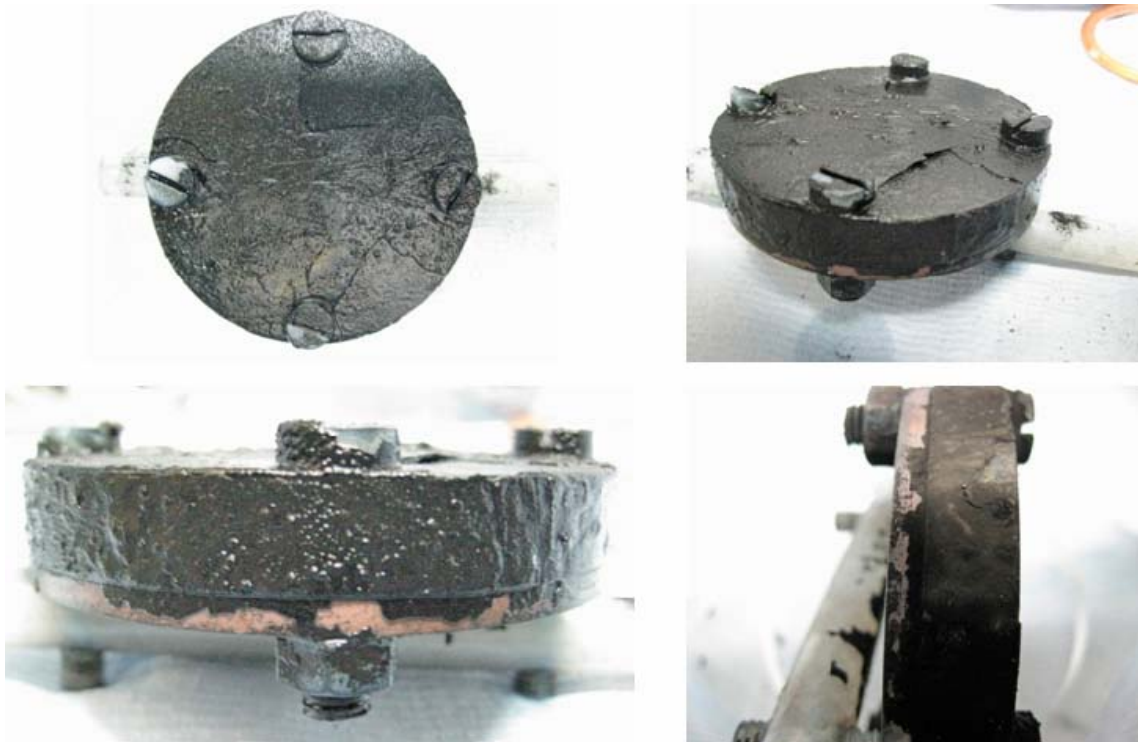
- The cast iron outer surface of the cast iron component of the sandwich specimen was predominantly graphitic.
- The inner surface of the cast iron component was composed of a mixture of spinel type materials, such as magnetite,  $\text{Fe}_3\text{O}_4$ , as well as iron sulphide, including  $\text{FeS}_2$ , graphite and amorphous carbon. There were variations between different areas on the surface.
- The outer surface of the copper component had a composition that varied at different locations, but showed signs of sulphides, including copper sulphide,  $\text{Cu}_2\text{S}$ .
- The inner surface of the copper component showed variations in composition at different locations, with indications of crystalline copper sulphide  $\text{Cu}_2\text{S}$  and an unidentified amorphous phase.

*Figure 7-20. Appearance of sandwich specimen when removed from MiniCan Experiment 3.*

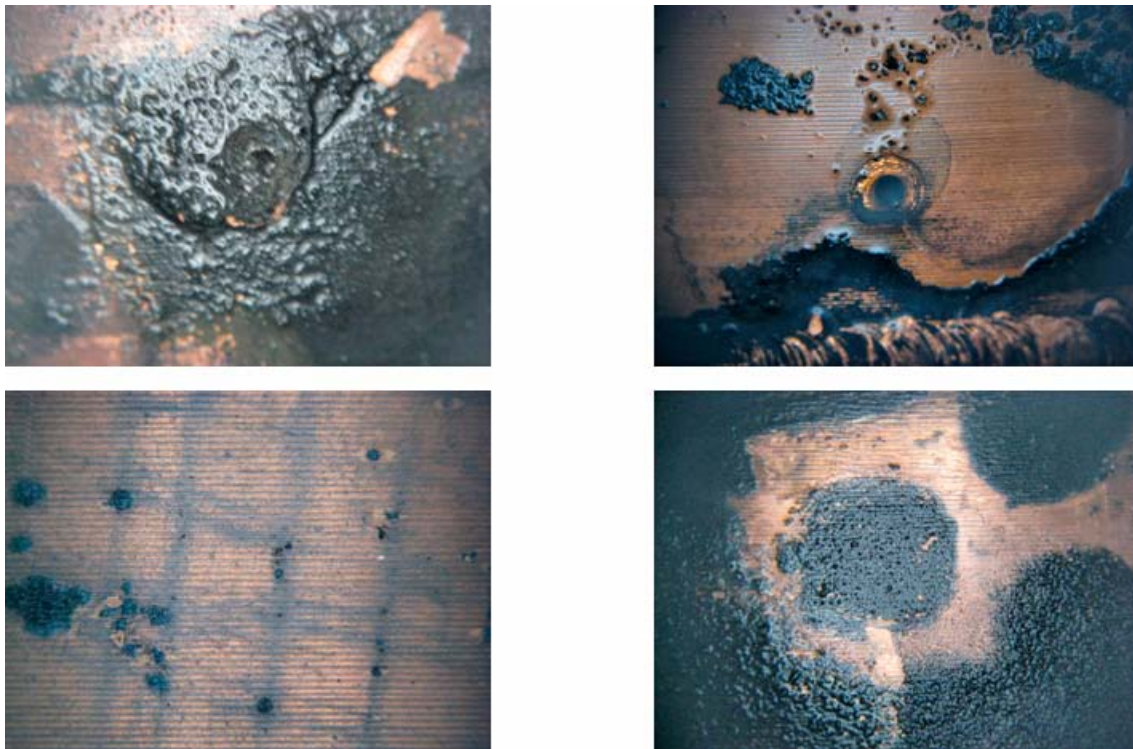
**Figure 7-38.** Appearance of features on surface of copper canister from Experiment 3: top left – top defect in copper canister; top right – bottom defect in copper canister; bottom left – machining marks in copper and areas of dark deposit; bottom right – details of ‘chain’ pattern from under plastic insulator.

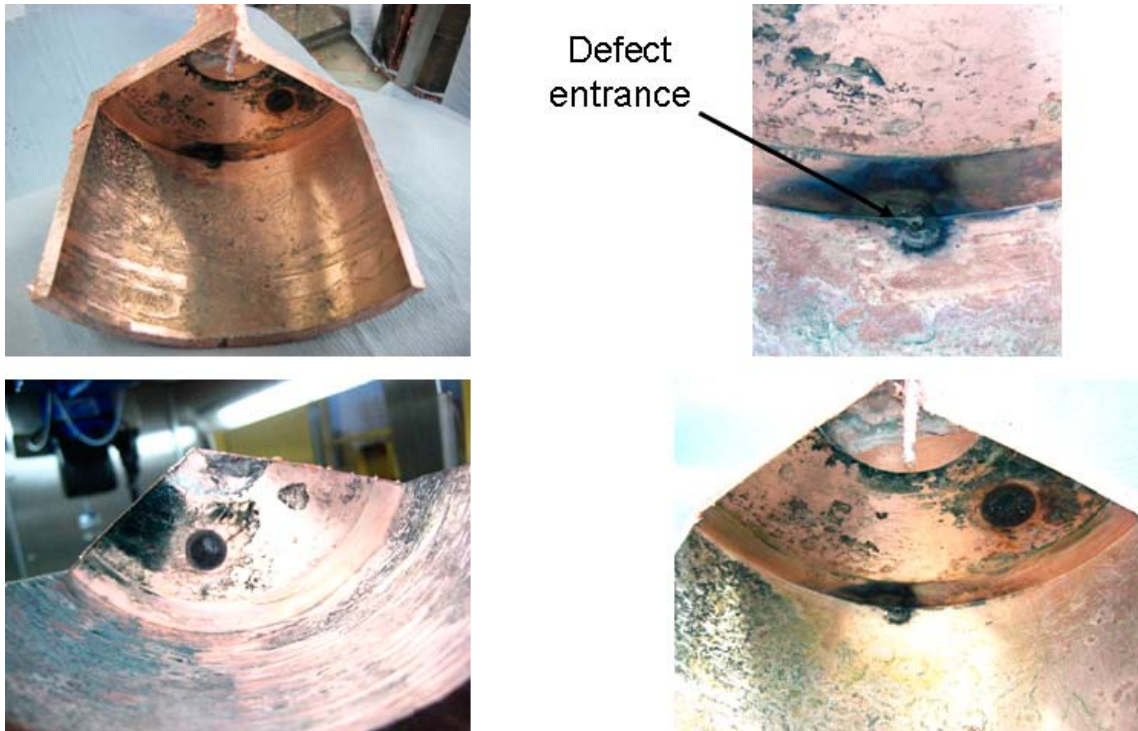
**Figure 7-39.** Appearance of inner surface of copper canister – top section. The entrance of the defect can be seen.

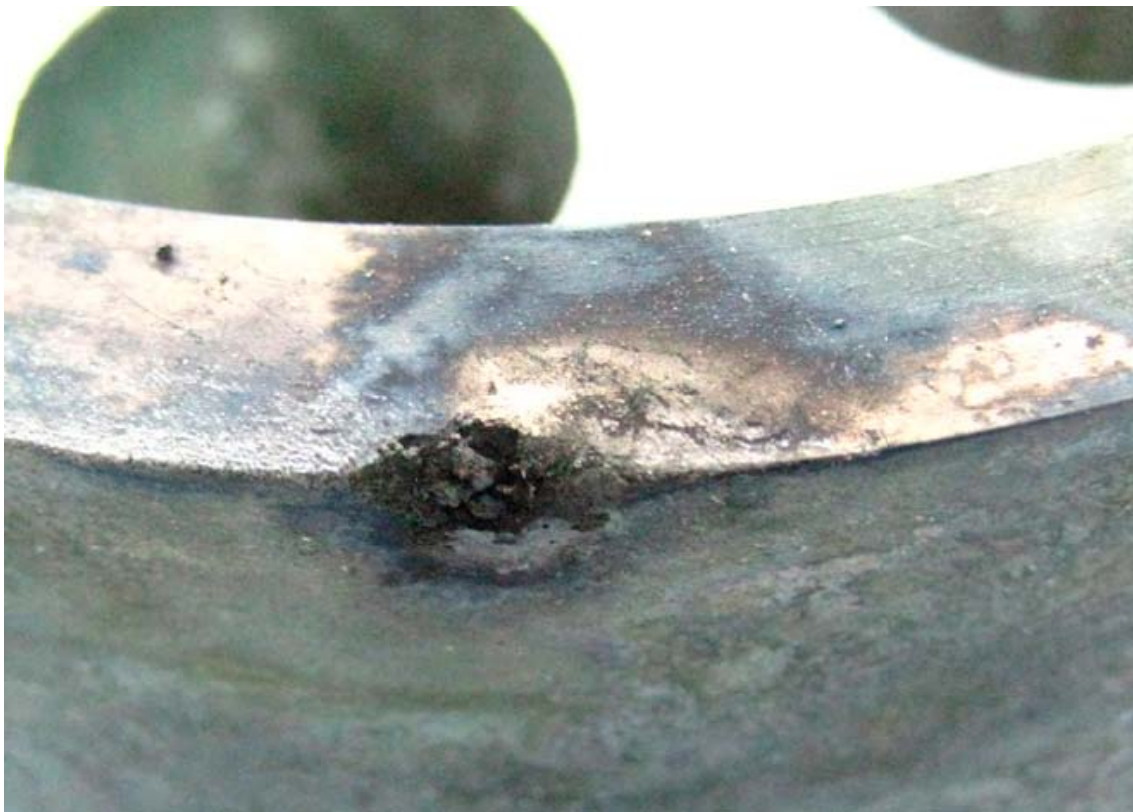
*Figure 7-42. Top of cast iron insert showing attack of iron opposite defect in copper.*

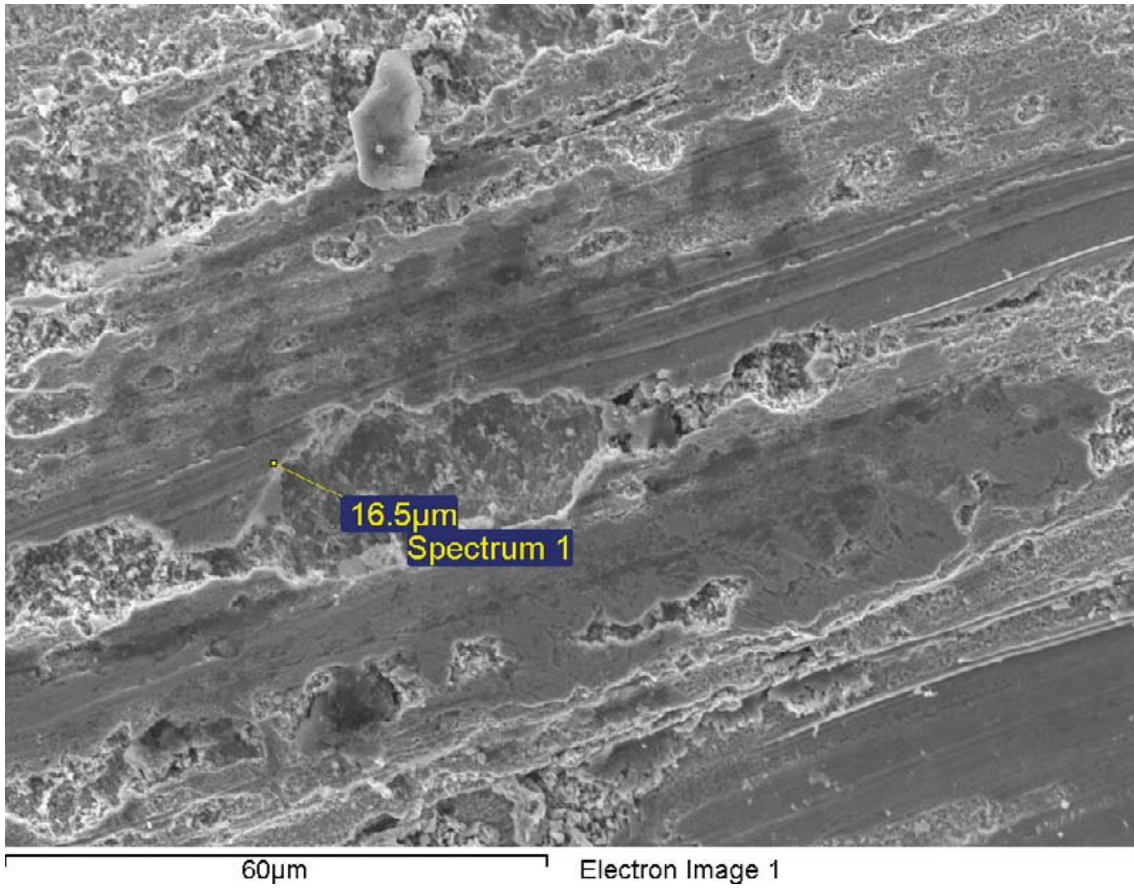
*Figure 7-51. Area on outer surface of copper canister at approximately half height, showing machine marks and areas of surface damage.*

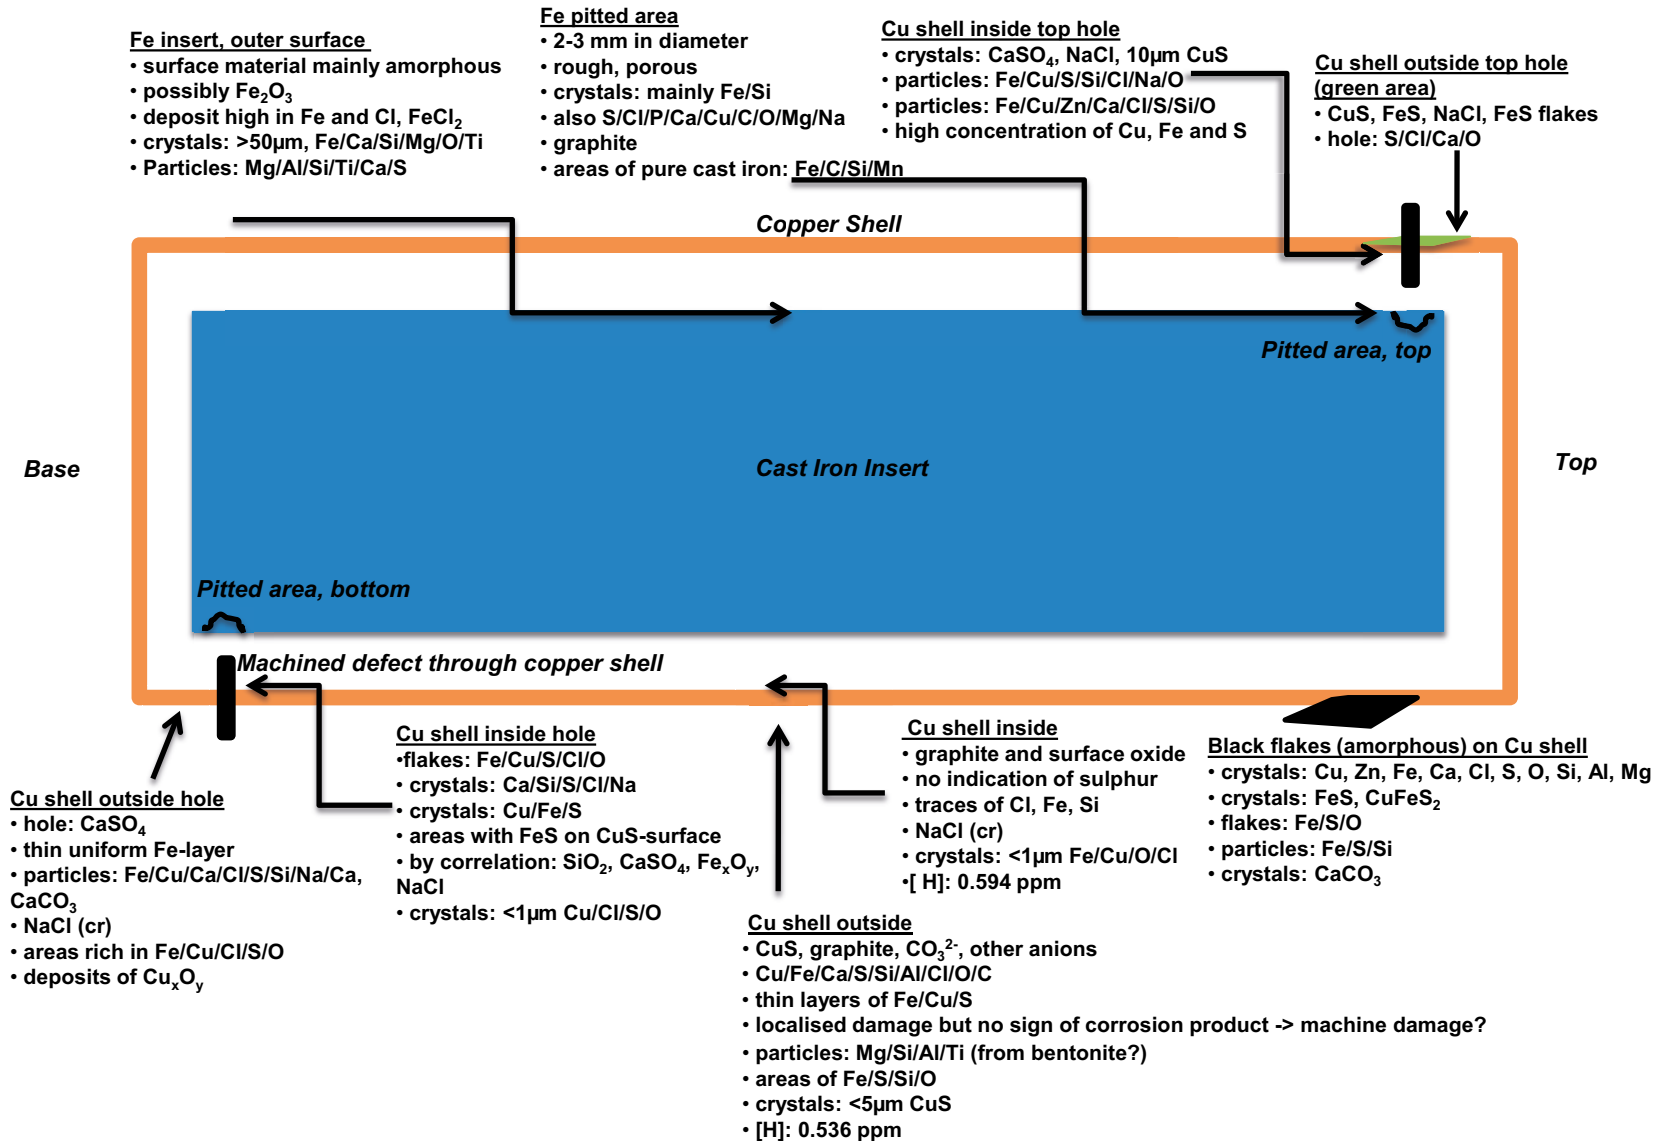
Figure 8-1. Summary of observations of corrosion product on surfaces of miniature canister.
