## **Oskarshamn site investigation**

# **Structural investigations of deformation zones (ductile shear zones and faults) around Oskarshamn – a pilot study**

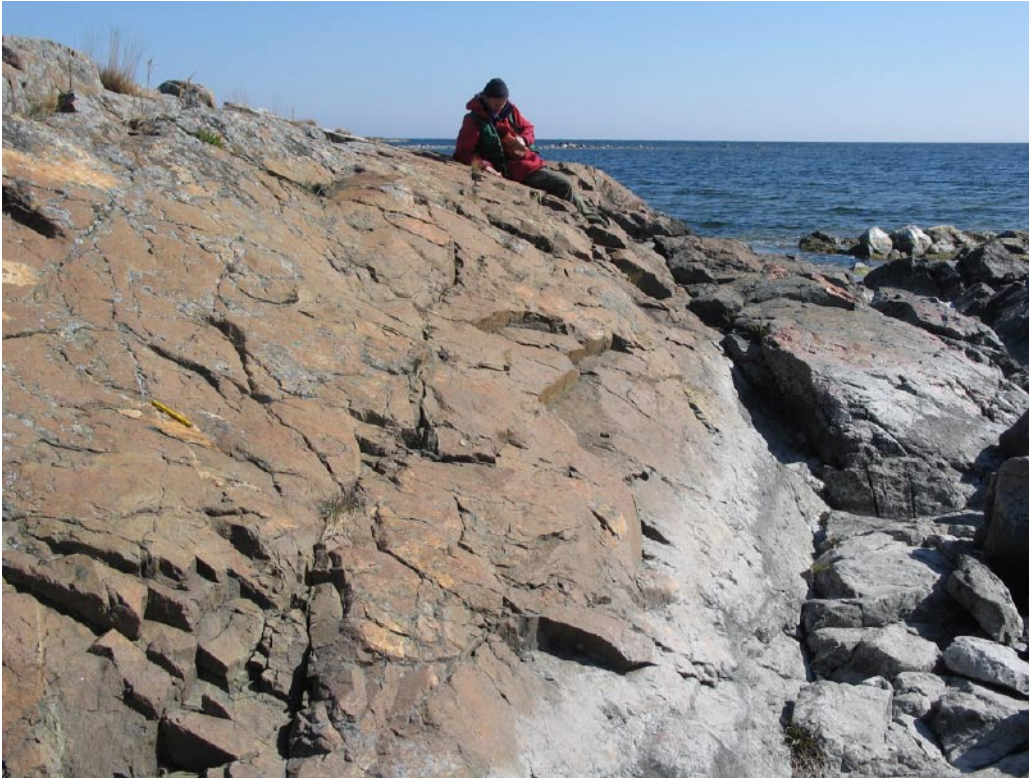
**Figure 5-1.** Green cataclasite in fault in coastal outcrop (locality PSM 007066). Two fault rocks are seen; the yellow-green, epidote rich cataclasite on the photograph, and a thin layer of ultracataclasite(?) that also appears as clast in the green cataclasite.

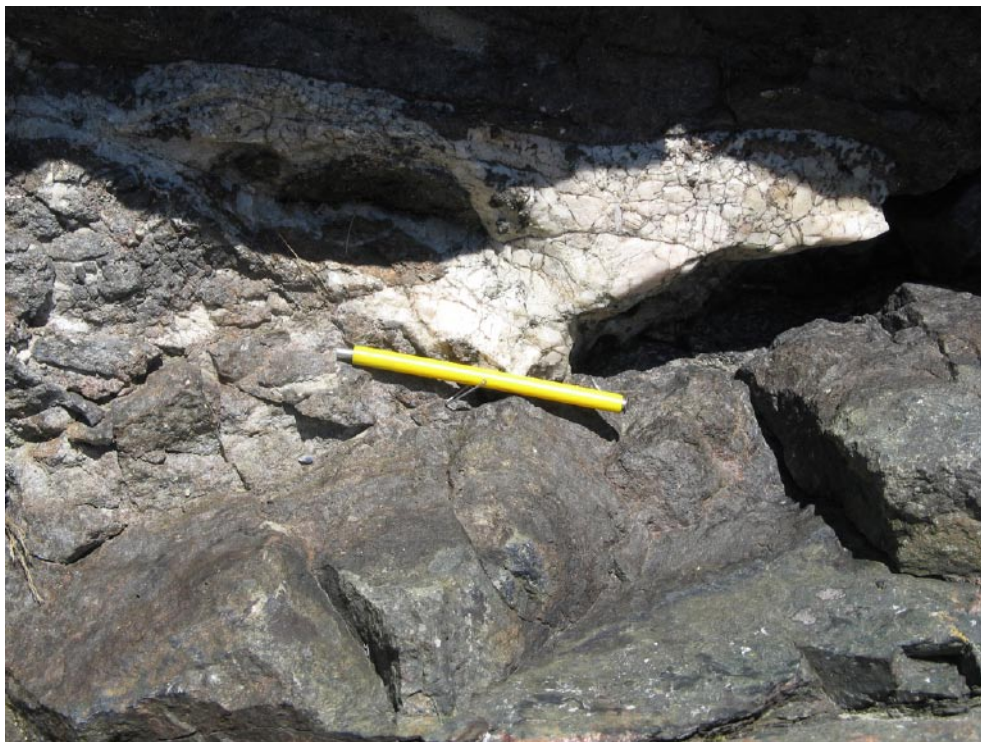
**Figure 5-4.** Photograph of WSW-ENE striking and steeply dipping fault with a green cataclasite. This fault has been reactivated, as documented by a carbonate-cemented breccia (not visible on the photograph).

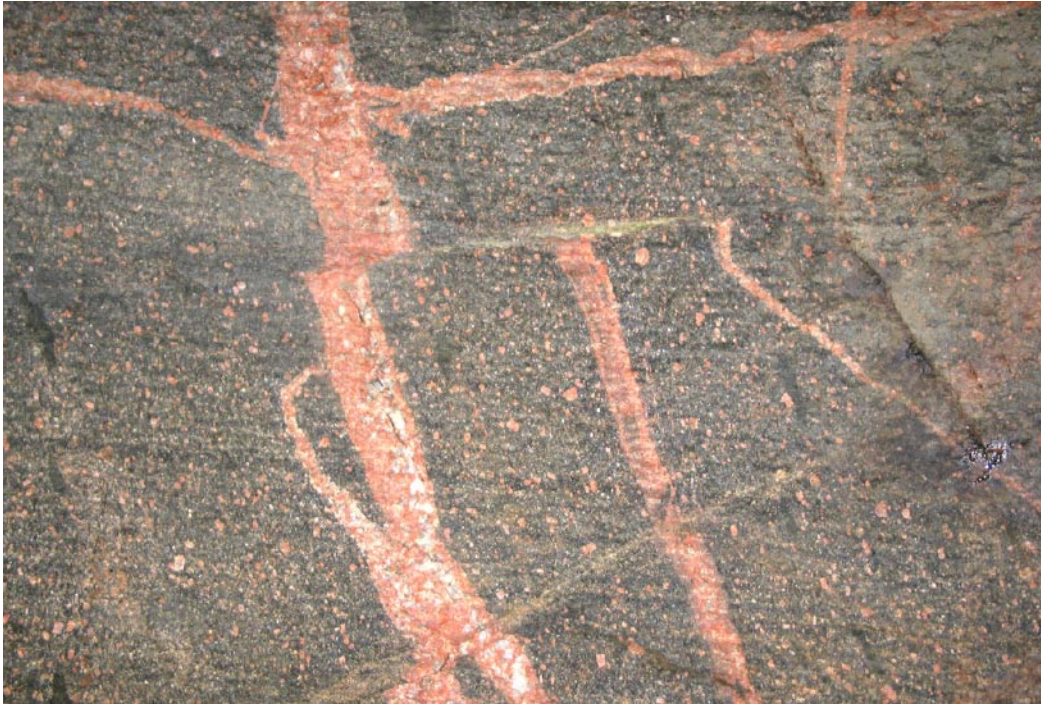
**Figure 5-5b.** Simpevarp field data. Slip-linear plot of mesoscopic faults ( $N = 38$ ) along roadcuts close to power plant (localities PSM007075 and PSM007078). The slip-linear plot shows the pole to the fault plane decorated by a line/arrow that indicates the direction (line orientation) and sense of slip (arrow) of the hanging wall. Lower hemisphere, equal area projection (Schmidt net). The plot shows that there are two main populations among the observed faults; one oriented approximately NNW-SSE with steep dips, and another with steep to intermediate dips towards the south to southeast. Slickenlines and striations on the NE-SW oriented faults are consistent with mainly strike-slip motion. In contrast, dip slip and oblique slip dominate the other fault set, with both normal and reverse motion.

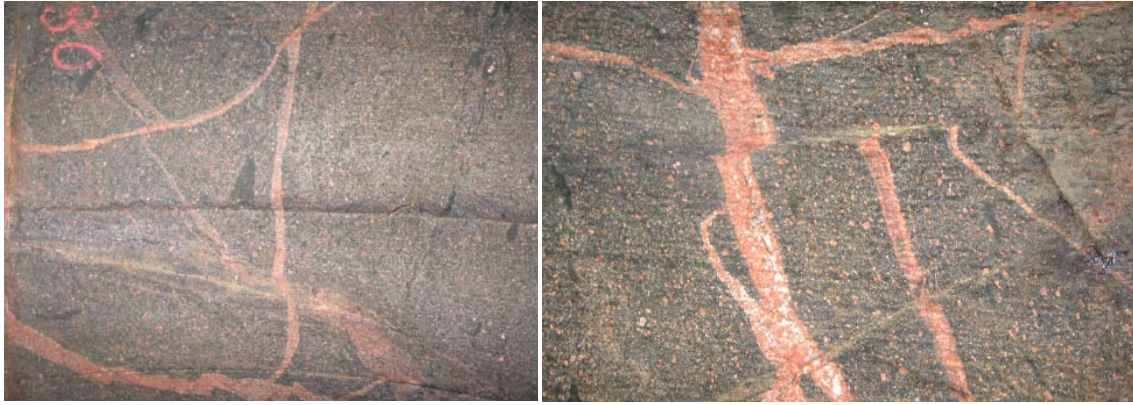
**Figure 5-6a and b.** Photographs from the full profiled tunnel, exemplifying deformation encountered in the lower part of the Äspö tunnel. Small faults are well displayed in the clean-cut tunnel walls. The faults host green cataclasites with abundant epidote. Deformation is seen as protocataclasite along faults with associated red staining of feldspar (intercrystalline fractures) in the fault damage zones. Locally, there are zones of ultracataclasite with cm-size feldspar clasts in a very fine grained epidote(?) matrix. Cross-cutting relationships between various faults can easily be studied in this part of the tunnel.

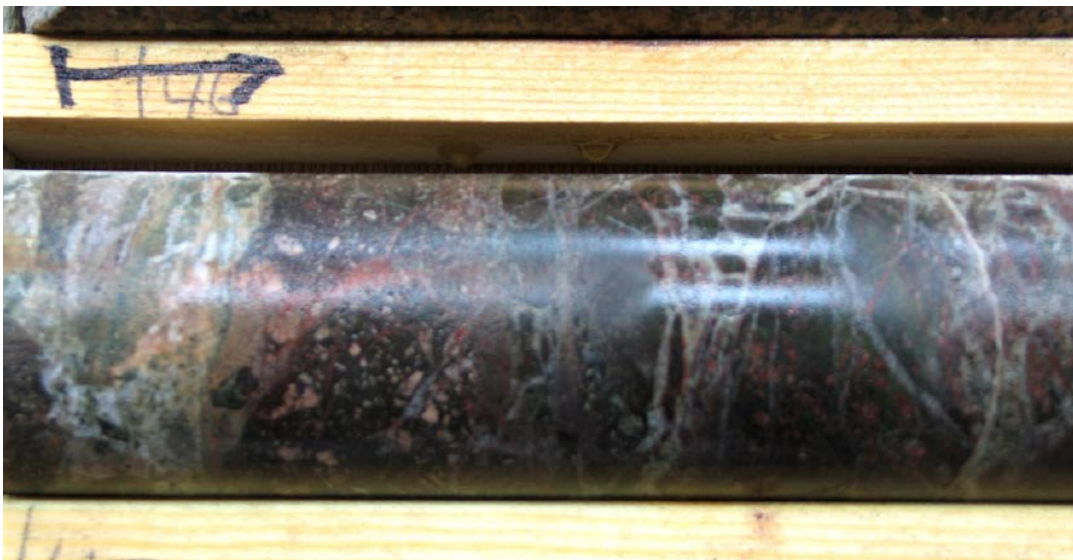
**Figure 5-8.** Photograph from drill core KSH03A, at 213 m. There, a 5 cm wide fault shows several faulting events. An 3–4 cm thick zone of epidote-quartz(?) bearing cataclasite locally stained pink, is cut by a narrow zone of dark red carbonate-cemented breccia, in which the former fault rock appears as mm-size clasts. The cataclasite is also cut by a calcite filled veining network.

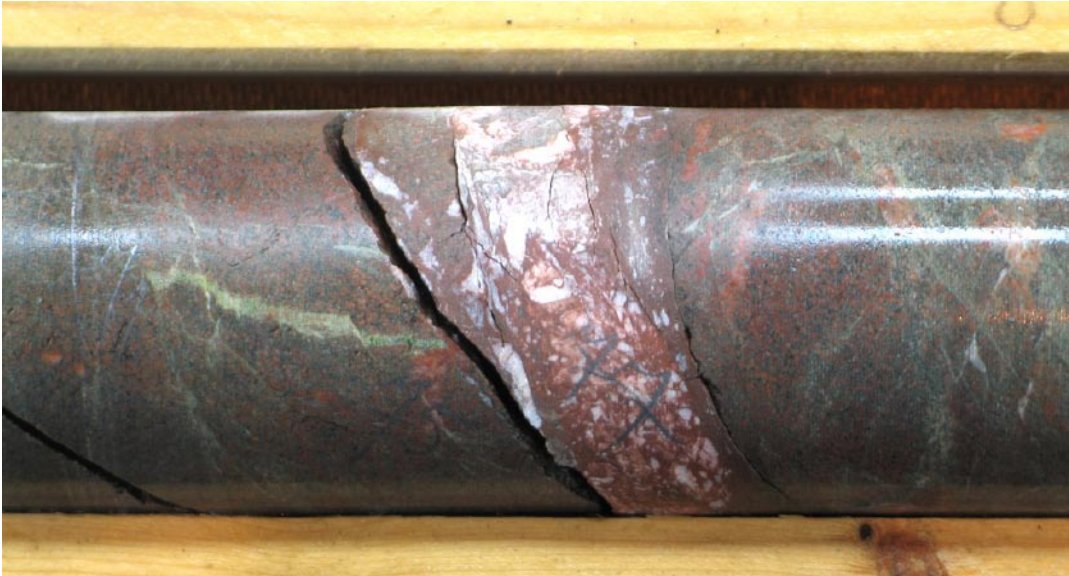
*Figure 5-9. Photograph from drill core KAV 04, at 863 m, showing an iron-stained calcite-cemented breccia that truncates a green zone consisting of epidote-bearing cataclasite.*

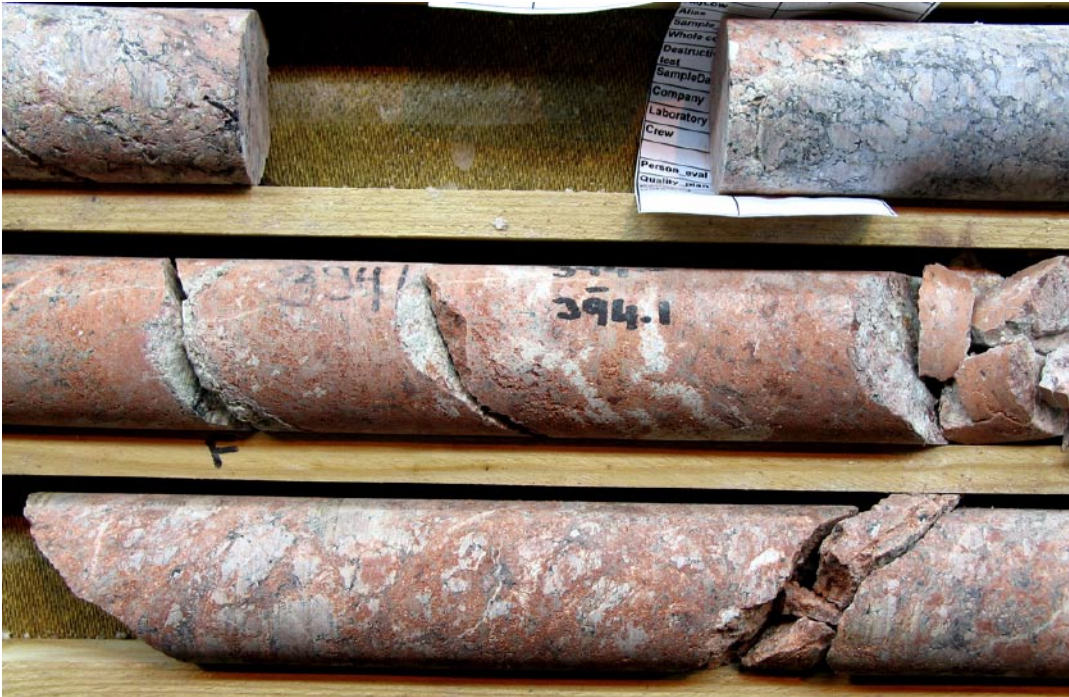
*Figure 5-10. Photograph from drill core KLX06, at 395 m, showing a protobreccia to breccia that is cemented by laumontite zeolite.*

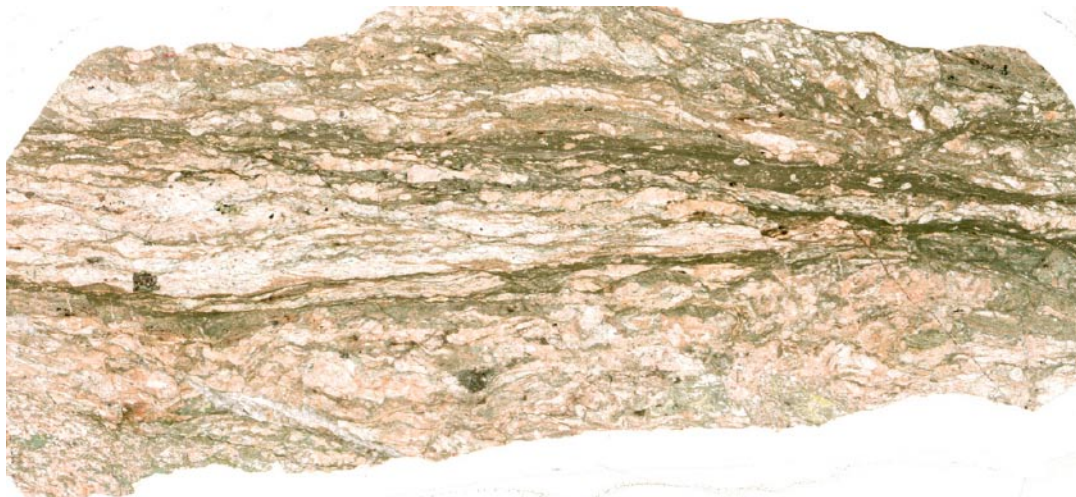
**Figure 5-11.** Scanned thin section (A3370A) of mylonites encountered in thin section the Äspö tunnel (–450 m). The fault rock has a well-developed planar fabric of pink feldspar and white quartz, which appear in lenses surrounded by a very fine grained, dark green matrix of chlorite, epidote, white mica and opaque. Quartz mosaics are seen in stringed out as lenses and in pressure shadows around feldspars. Feldspar appears to be broken down by fracturing into trails of angular sub-grains. Other places, feldspar seems to be basically entirely replaced by the matrix minerals. The long axis of the thin section is approximately 50 mm.

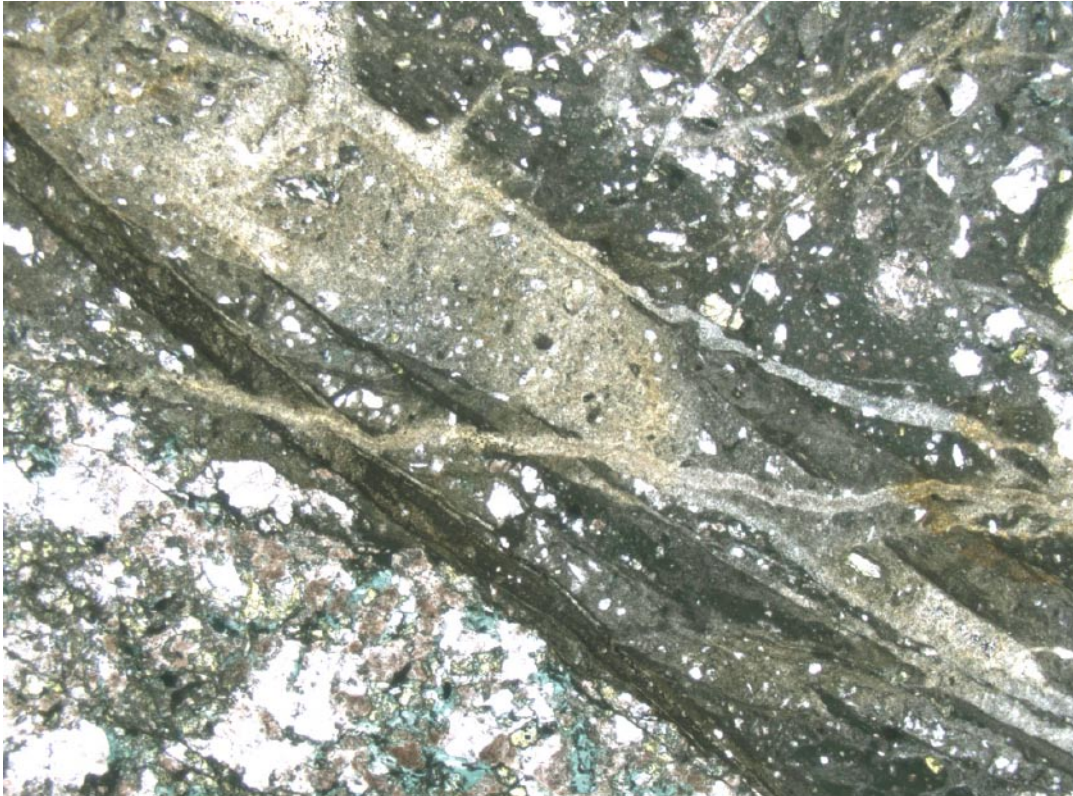
**Figure 5-13.** *Photomicrograph (PSM007074) of light greyish-green ultracataclasite(?) that cut the darker, surrounding cataclasite. The ultracataclasite hosts some 100–10 μm clasts of quartz, K-feldspar and subordinate zircon. These clasts are sub-rounded to rounded. SEM studies indicate the matrix of this fault rock to consist of zeolite or clinzoisite with a grain size around 3 μm. The picture is 4.36×5.4 mm in the thin section.*

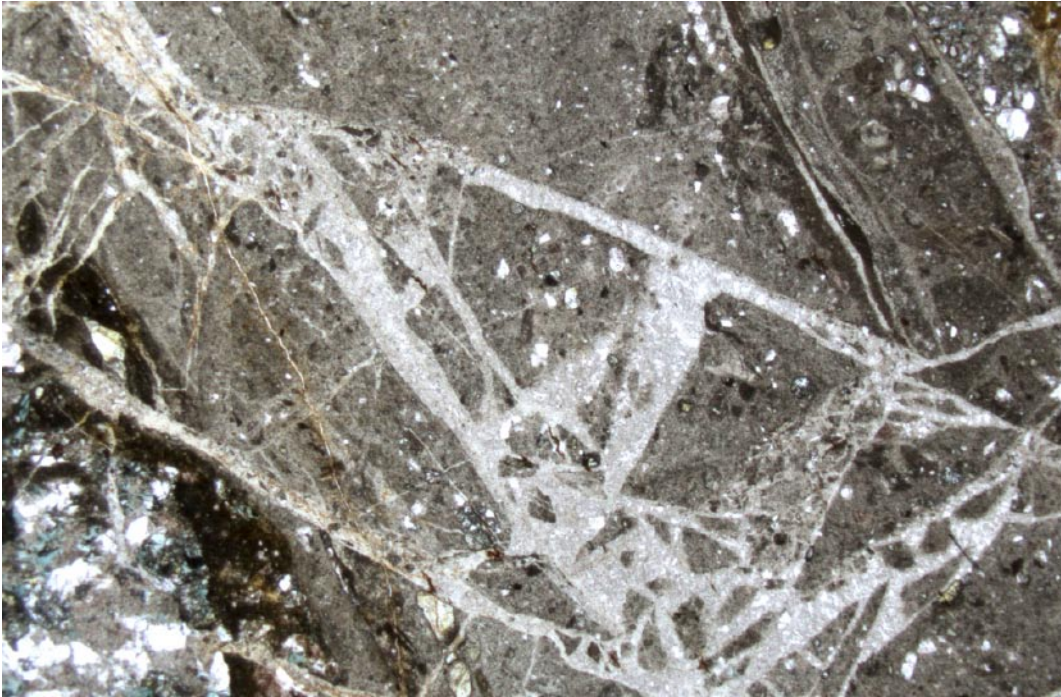
**Figure 5-14.** Photomicrograph (PSM007074) of a fracture network, as shown in Figure 5-12. The fractures are filled with clasts of K-feldspar, and a fine matrix of chlorite and K-feldspar(?). The chaotic appearance and dilation represented by the fracture network represent the fundamental observations for classifying the rock as hydraulic breccias. The picture is 4.36×5.4 mm in the thin section.

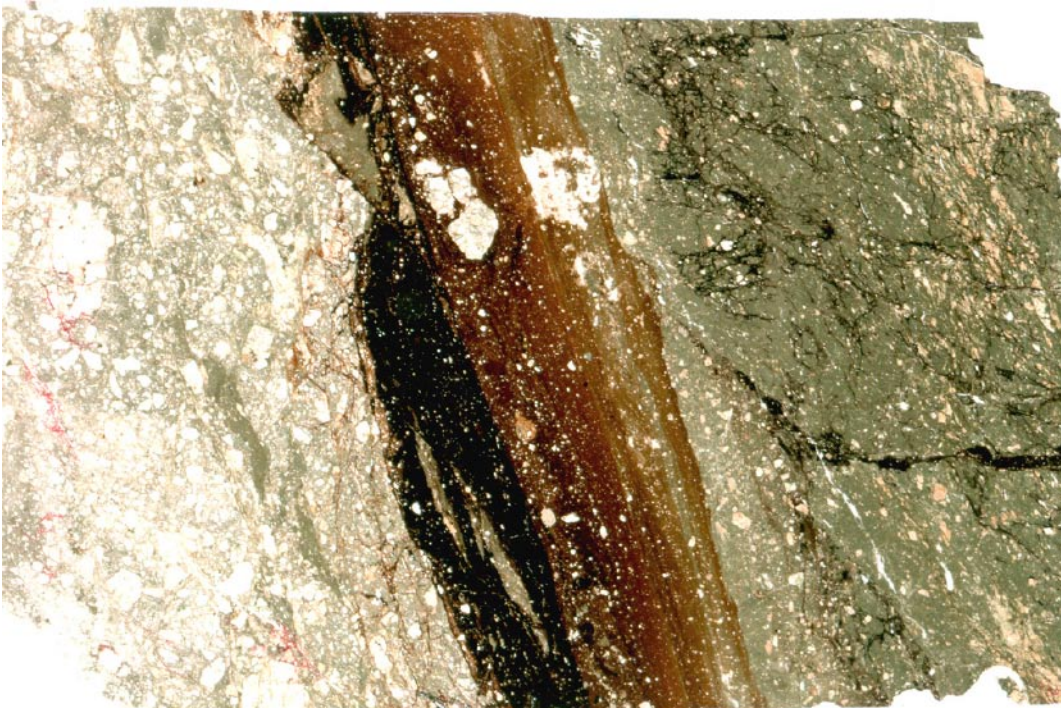
**Figure 5-15.** Scan of thin section KAV04-863, showing a cataclasite similar to the one described in other photographs. In addition, there is an ultra-fine grained, black to brown-red fault rock with laminae defined by colour variations. The rock is likely a pseudotachylyte, since it injects into the wall rocks, and has a minimum grain size that exceeds the resolution of the SEM. This matrix could therefore be glass. The long axis of the thin section is approximately 50 mm.

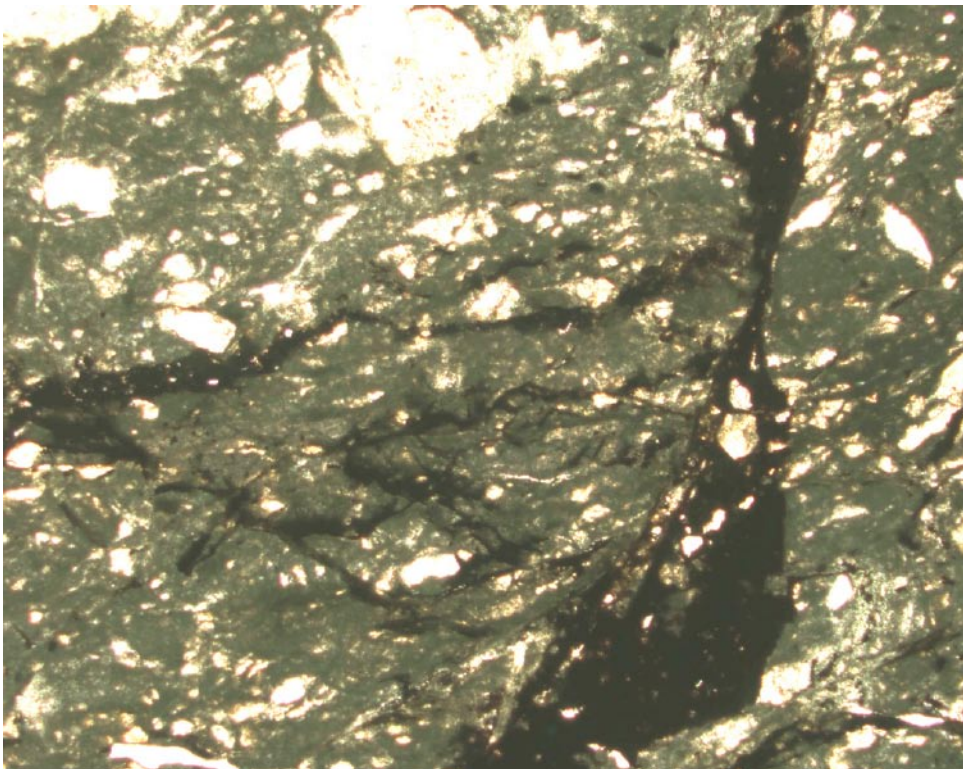
**Figure 5-17.** Photomicrograph showing the black fault rock in fracture networks of the host cataclasite (see Figure 5-15). The material seems to have injected into small fractures and voids. The picture is 4.36×5.4 mm in the thin section.

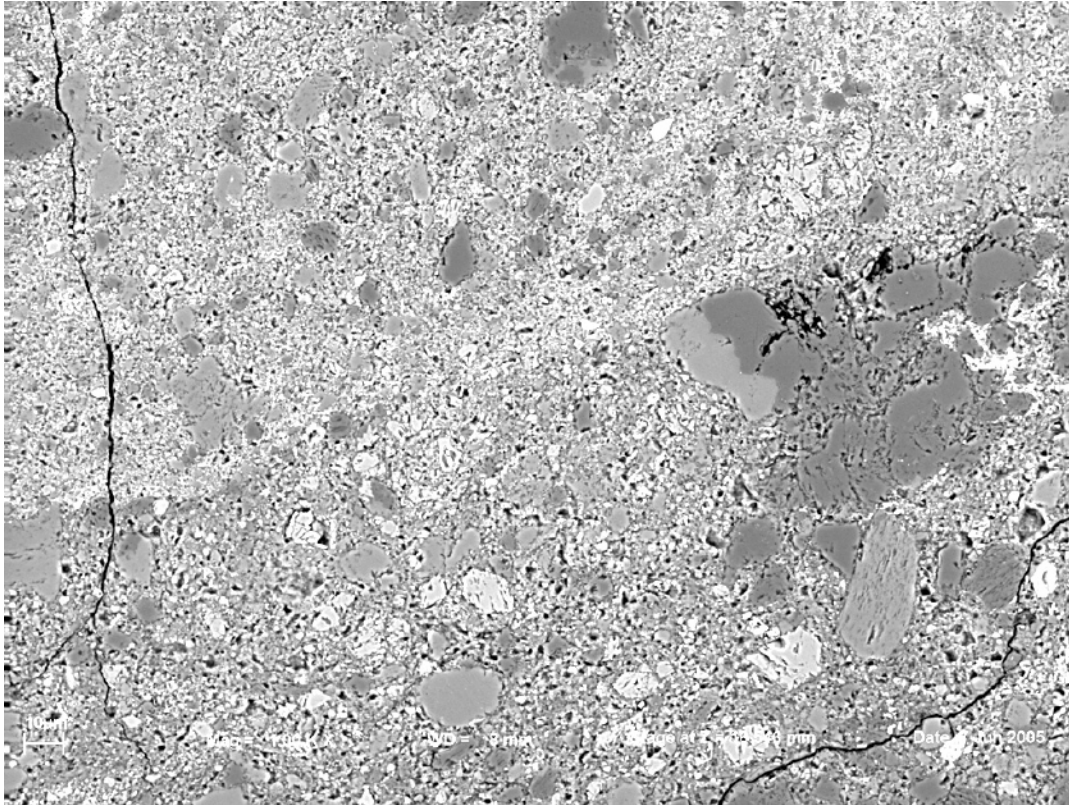
**Figure 5-18.** Scan of psedotachylyte from SEM, showing grain fragments down to 2–3  $\mu\text{m}$ . The bulk of the matrix has a grain size below the resolution of 1,000 $\times$ . Note scale bar in the lower left corner.
