**International
Progress Report**

IPR-04-10

TRUE-1 Continuation project

**Overcoring (300mm) of impregnated
fault rock zones at chainages 2/430,
2/545, 2/163 and 1/600m**

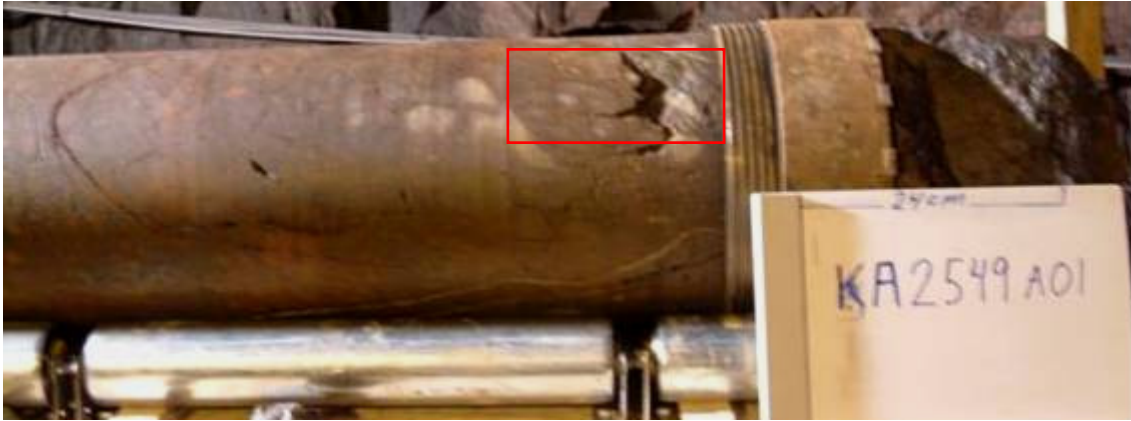
Overcoring (Figure 4-1): At the target zone at ca 200 cm of depth, two epoxy filled fractures were observed with an orientation of 268/62. The dip was measured in situ by aiming with the clinometer at the core stub in the hole, before overcoring, and the angle was subsequently used for core orientation. The two fractures diverge into four, with an orientation of 292/50 (one such divergence can be seen in Figure 4-2). A few fractures at 150-170 cm, with an orientation of 136/85° are also filled with epoxy, and also minor randomly oriented fractures were filled up well with epoxy (Figure 4-3).

Figure 4-1. KA2549A01. Core recovery with target zone, and outline of Figure 4-2.

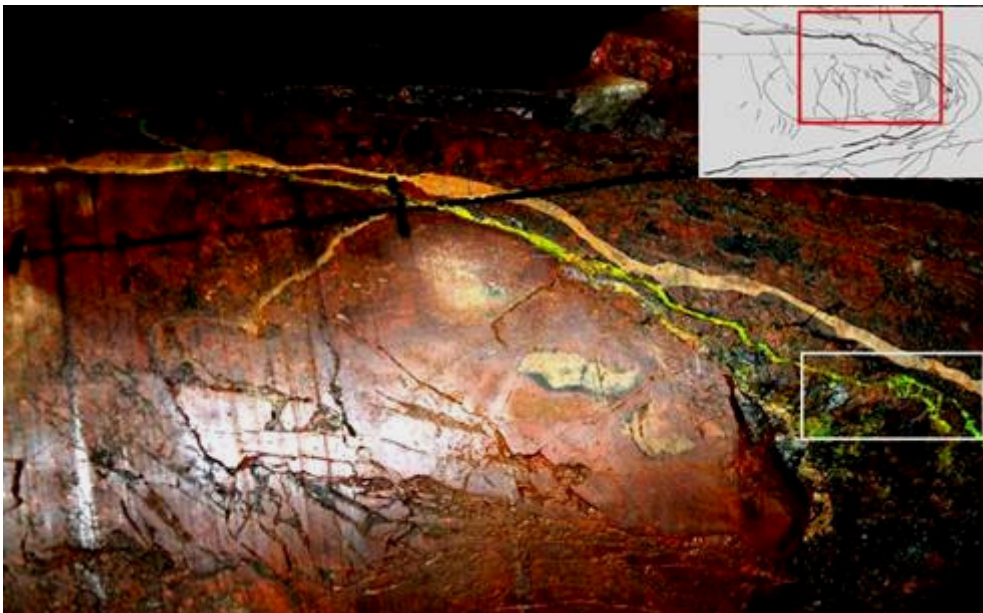
Figure 4-2. KA2549A01. Target zone with diverging fracture zone with epoxy fill, and approximate outline white box of Figure 4-3. Miniature in upper right-hand corner shows approximate coverage of figure in relation to the corresponding envelope drawing in Appendix 1.

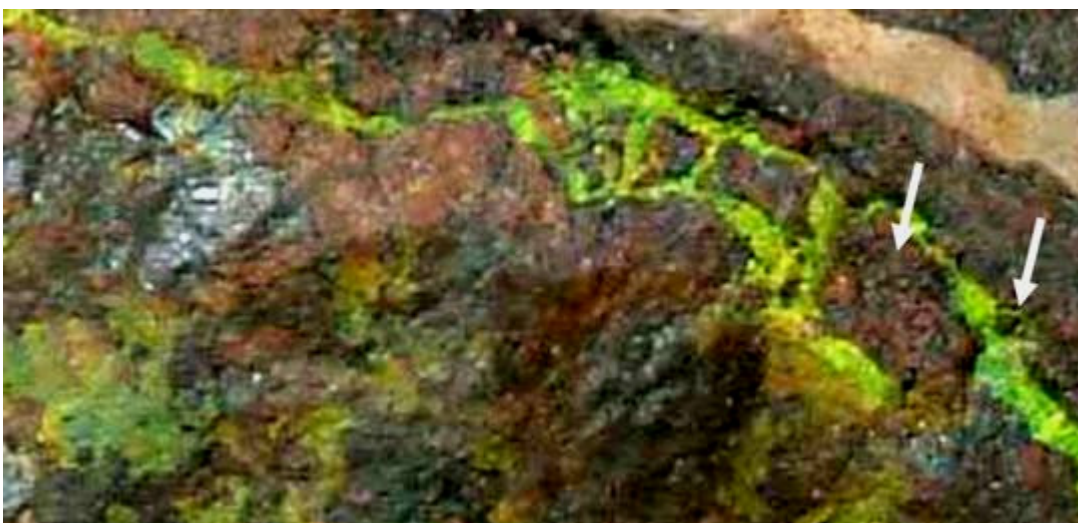
Figure 4-3. KA2549A01. Epoxy fill detail, c.f. Figure 4-2 for relative position.

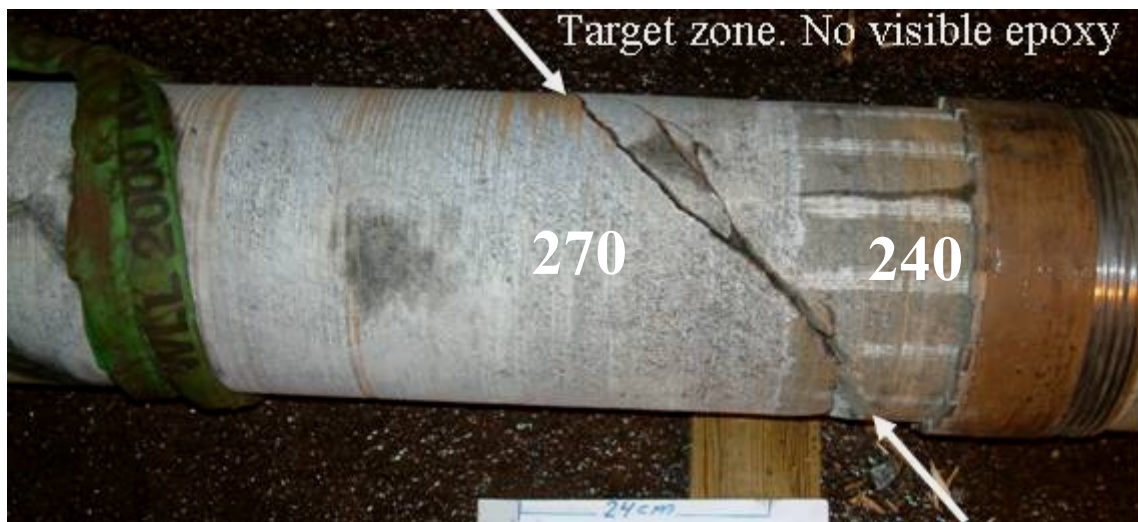
Overcoring: Overcoring showed that the target fracture is connected with adjacent subparallel fractures (Figure 4-4). There is no visible epoxy in the zone. But three fractures at 210-235 cm are epoxy filled, two oriented 340/70 and one 130/78 with a sub system of splays (Figure 4-5). No connection with the target zone is visible in the core, but fracture orientations indicate that they will intersect or merge.

Figure 4-4. KA2169A01. Core recovery with target zone at 250 cm, with no visible epoxy grout. Hidden under the drill bit (far right) are epoxy filled fractures at 210-235 (Figure 4-5).

Conclusions: The target structure consists of a few sub-parallel converging master fractures. It is regarded as containing clay minerals which has obstructed epoxy intrusion. Instead three fractures striking NW-SE, two 340/70 and one 130/78, were filled well with epoxy as well as adjacent minor splay fractures (Figure 4-6). This is in accordance with the noted epoxy take (cf Table 1-1)

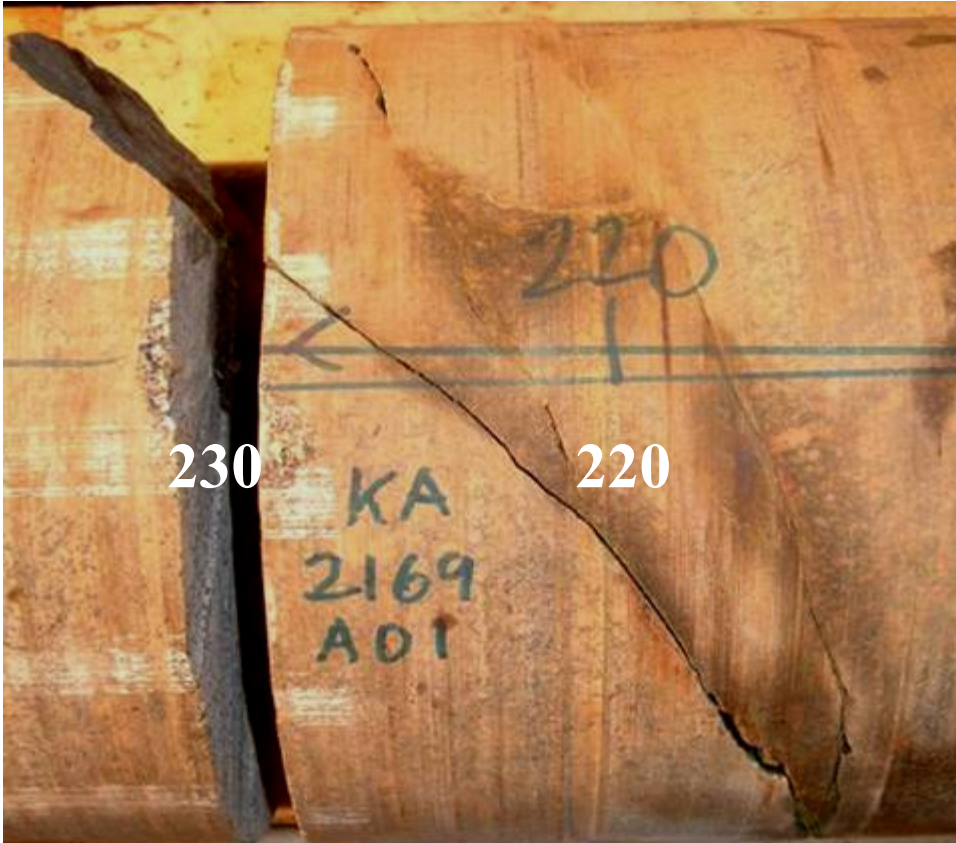
Figure 4-5. KA2169A01. Core recovery with epoxy filled fractures at 215-235 cm.

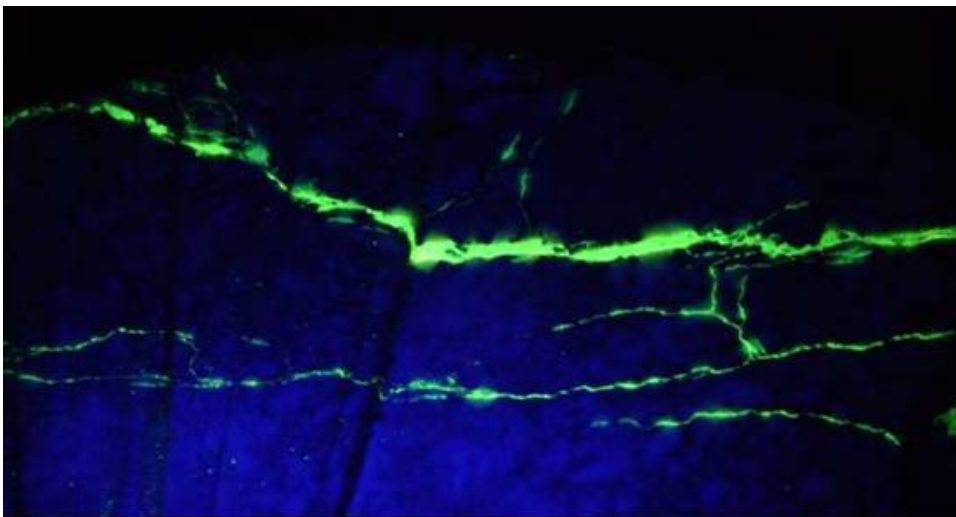
Figure 4-6. KA2169A01. Epoxy filled fractures on a surface cut across the core at 220 cm in UV light. Approximate 1:1 scale.

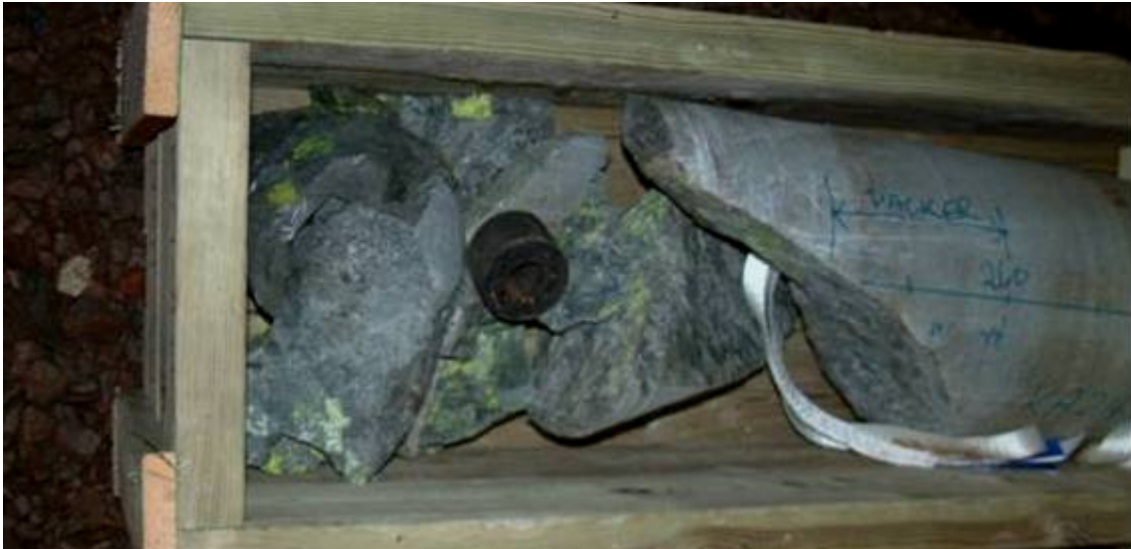
Overcoring: The core was damaged during drilling. Only debris with patches of epoxy was recovered from the target zone, and no direction data could be measured (Figure 4-7).

Conclusions: Clayey infilling has obstructed epoxy intrusion and also resulted in bad cohesion of the fault gouge and breccia material.

Figure 4-7. KA2169A02. Epoxy patches on fracture surfaces.

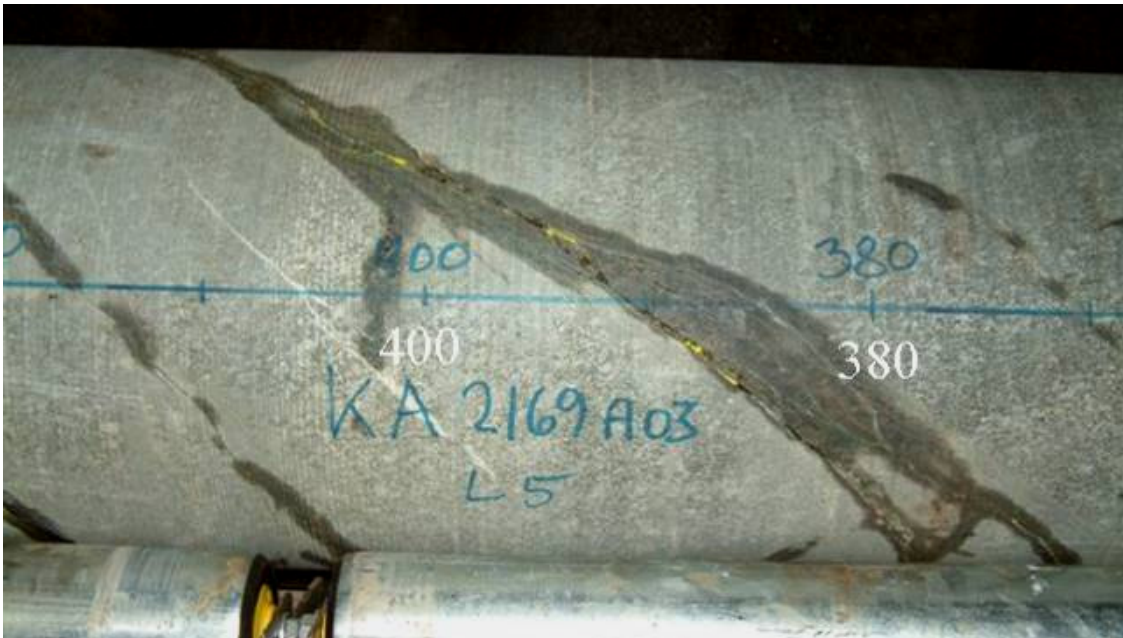
Figure 4-8. KA2169A03. Core recovery with target zone at 390 cm, with plenty of epoxy grout (yellow along the diagonal fracture). The area above the 400 mark is shown in Figure 4-9.

Overcoring: The target structure appeared as an up to 5 cm wide zone with mylonitic foliation, (foliation caused by shearing, common in fault zones) with an orientation of 300-315/80°, and with sub-parallel, converging and diverging epoxy filled master faults, with orientations of 300-315/80°, and also epoxy filled cavities and minor splay fractures (Figure 4-8 and Figure 4-9).

Conclusions: The structure appeared as projected and has a structure similar to that observed in the pilot borehole. The overcore is filled well with epoxy (cf epoxy take in Table 1-1) both in NW-SE striking master faults and in splays (Figure 4-9), preserving the rock material, and resulting in excellent core recovery.

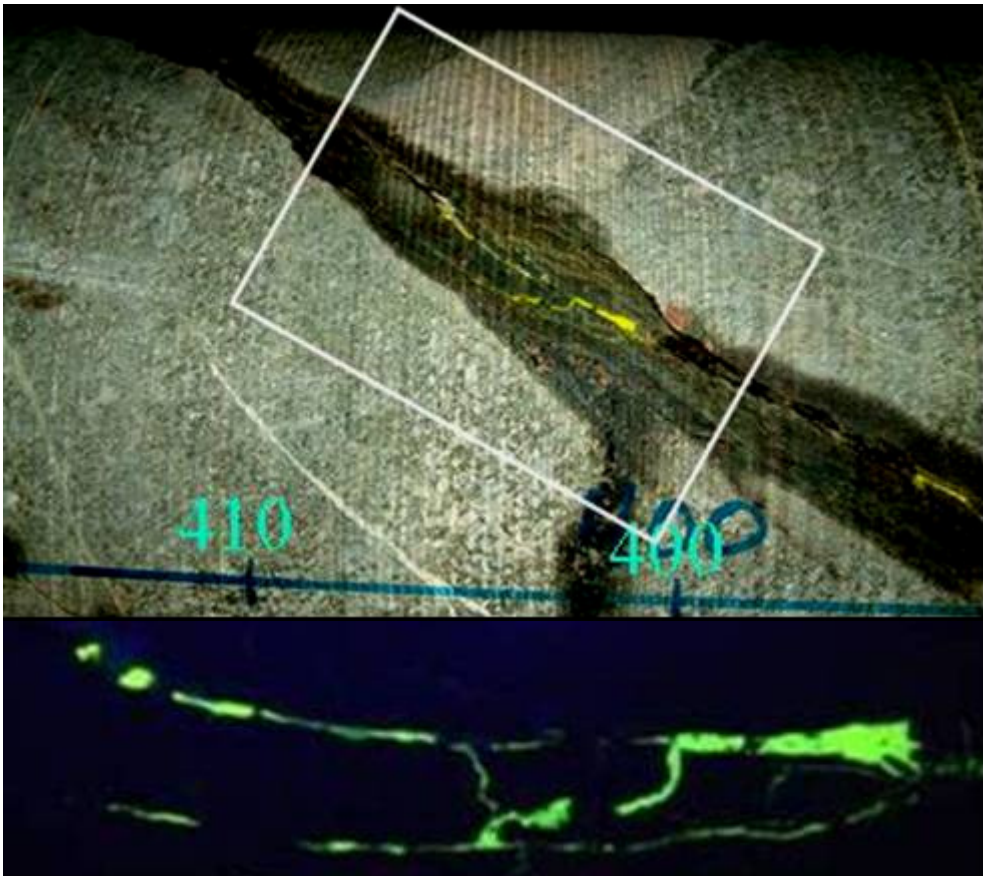
Figure 4-9. KA2169A03, 390 cm. Above: Epoxy grouted structure flanked by mylonitic foliation. Below: detail in ultraviolet light (Approximate magnification = 3.5).

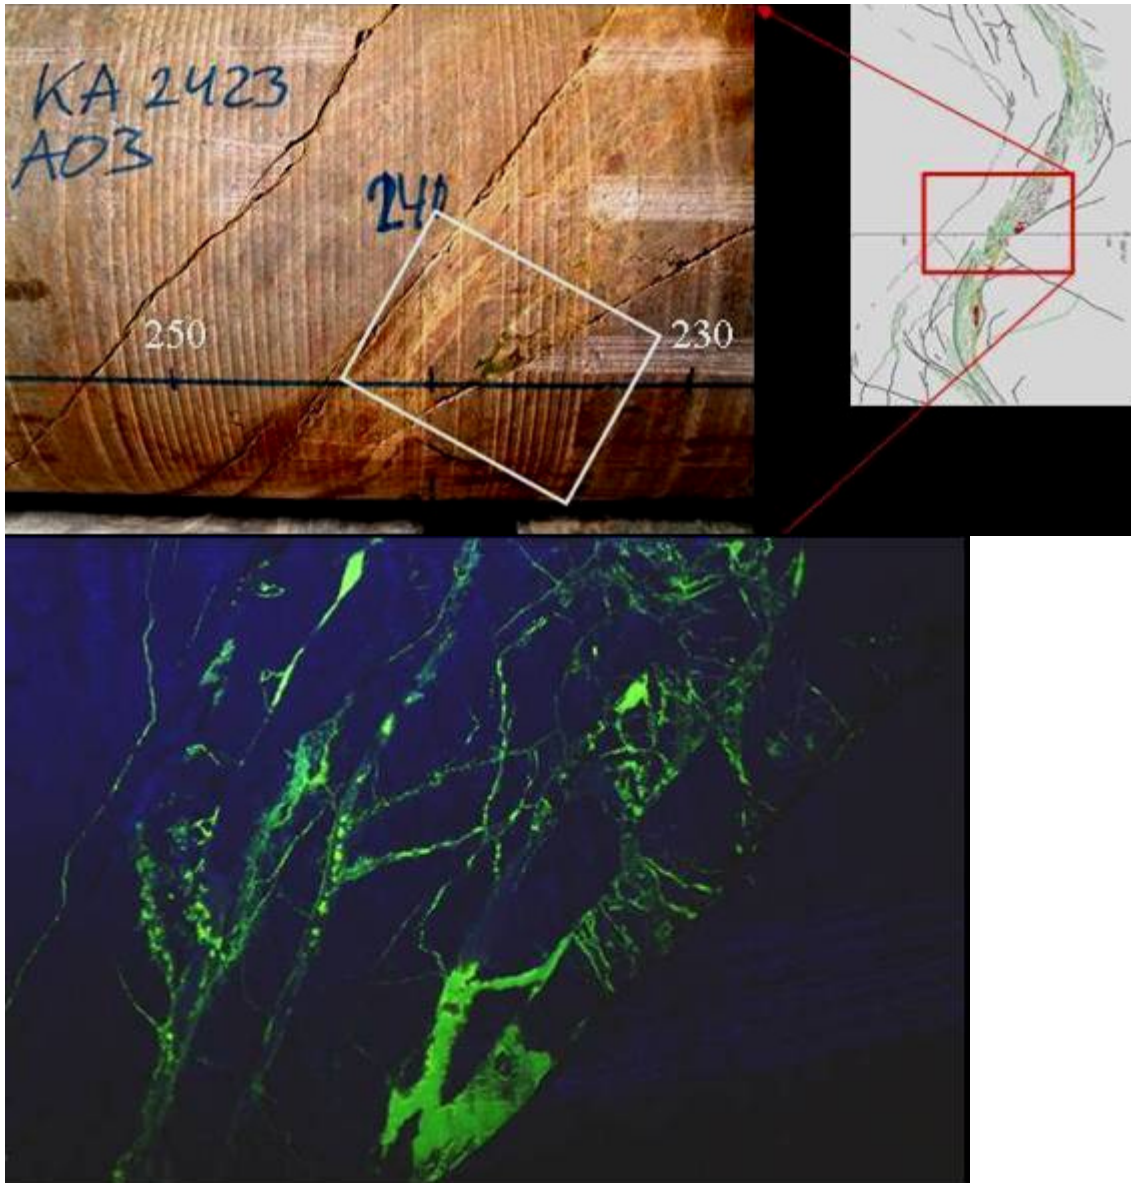
Overcoring: An up to 10 cm wide zone with mylonitic foliation has an orientation of 150-160/80-85, approximately 50° to the core axis. This zone contains converging and diverging epoxy filled master faults with orientations of 150-160/80-85 but also abundant epoxy filled cavities and splay fractures. Also tight fractures can be observed (Figure 4-10).

Conclusions: The structure appeared as projected and has a structure similar to that observed in the pilot borehole (Hansen et al, 2003). It is filled well with epoxy, both in master fractures and splays, preserving the rock material and resulting in excellent core recovery.

Figure 4-10. KA2423A03, Core recovery with target zone at 240 cm, 50° to core axis, and with mylonitic foliation along the zone, and with epoxy grout (dark green in middle of rectangle indicating outline of UV picture) The pore spaces vary up to 1x2 cm (lower mid centre) and seem to be well connected. NB the cm-wide spaces in the lower part of the blow-up are assumed to be a result of the angle of the cutting plane to the pore, i.e. a likely geometrical effect to be substantiated by further analysis. NB Pore size mapped on core mantel surface is a function of the cutting surface relative to the geometry of the pore.

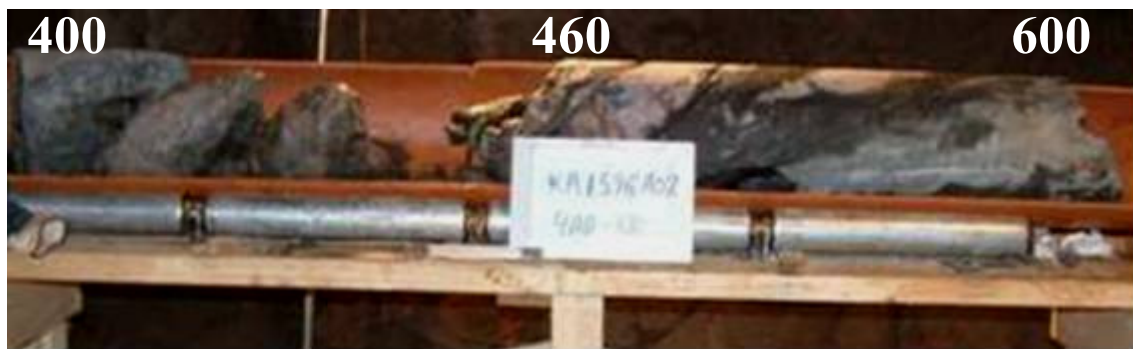
Overcoring: The core at the position of the target zone was severely damaged by drilling and only loose debris, presumably from the zone, was recovered. Some epoxy had intruded into the fault gouge, but only up to a few cm from pilot hole perimeter, and only sporadic epoxy was observed on the core surface. However epoxy was abundant in fractures at 370-390 cm with an orientation of 145/80°, approximately perpendicular to the zone (Figure 4-11), and parallel with the horizontal stress.

Conclusions: The structure appeared as expected and has a structure similar to that observed in the pilot borehole. Clayey infilling has obstructed epoxy impregnation of the fault gouge, but, as for KA2169A01 and KA2169A03, epoxy is abundant in steep fractures in the NW quadrant.

Figure 4-11. KA1596A02. Core recovery with target zone at ca 460 cm.

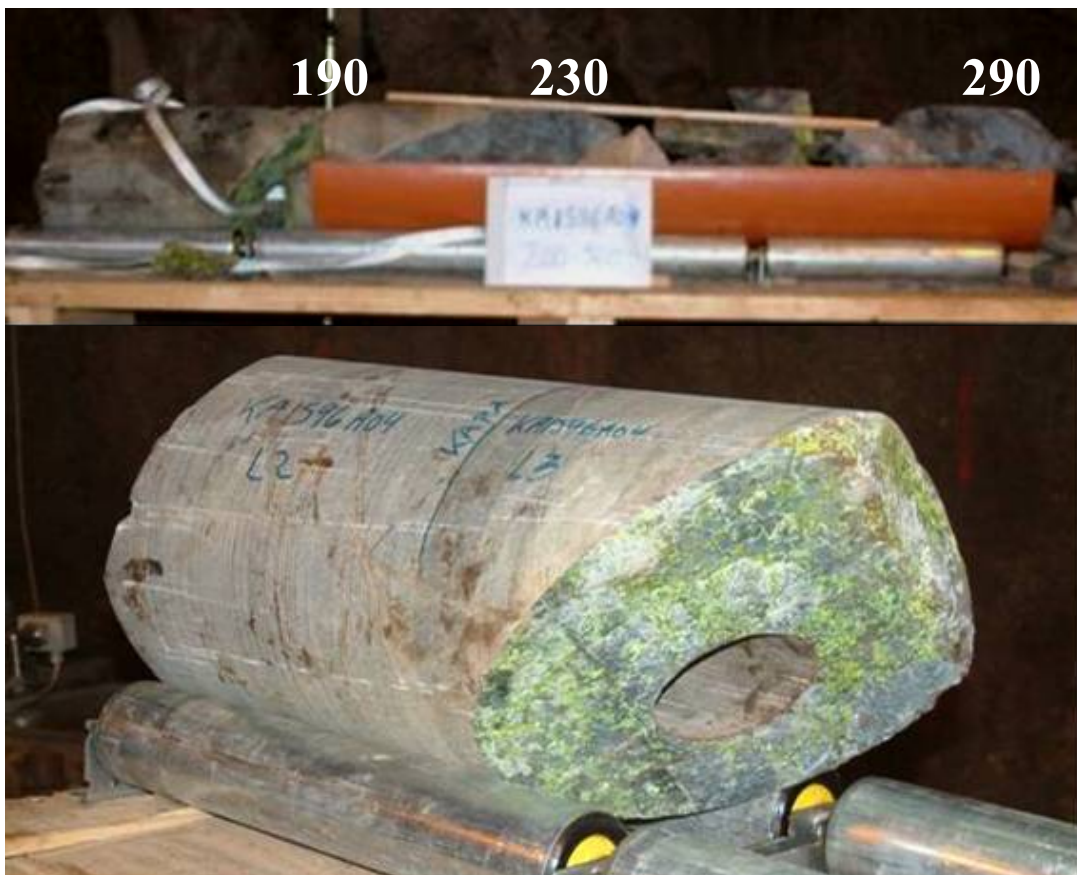
Conclusions: The structure appeared as projected and has a structure similar to that observed in the pilot drill hole. Clay fill has obstructed epoxy impregnation of the fault gouge but, as for KA2169A01, KA2169A02, and KA2169A03, epoxy is abundant in steep fractures in the NW quadrant, but also in one fracture oriented 0/63°.

Figure 4-12. KA1596A04. Above: core recovery with epoxy at 190 cm and target zones at 230-320cm. Below: 0°/63° fracture with epoxy at 190 cm.

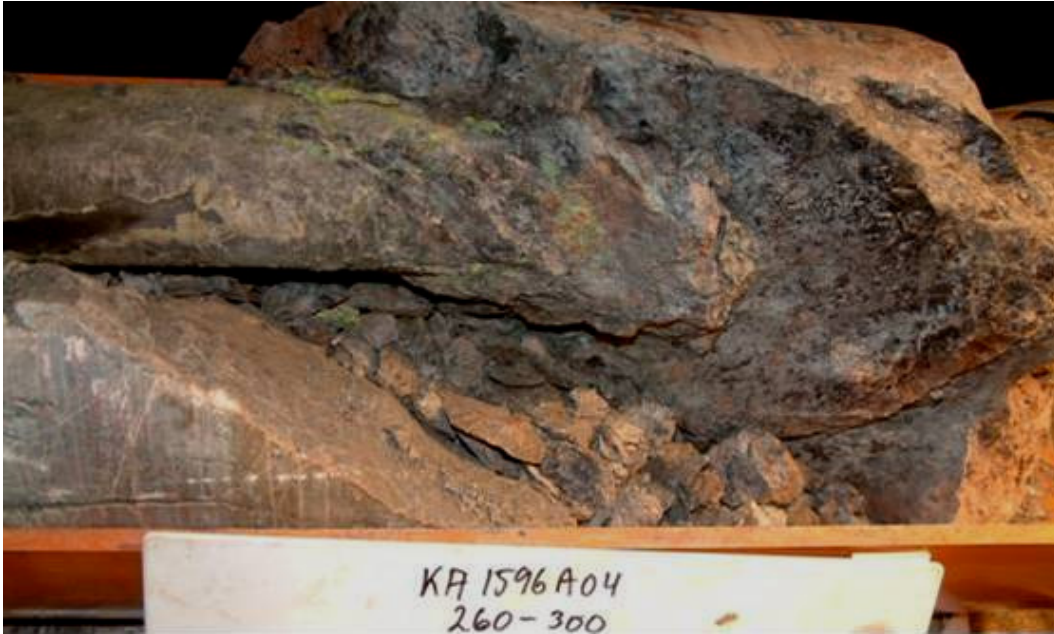
Figure 4-13. KA1596A04. Zone with epoxy at 190-300cm.

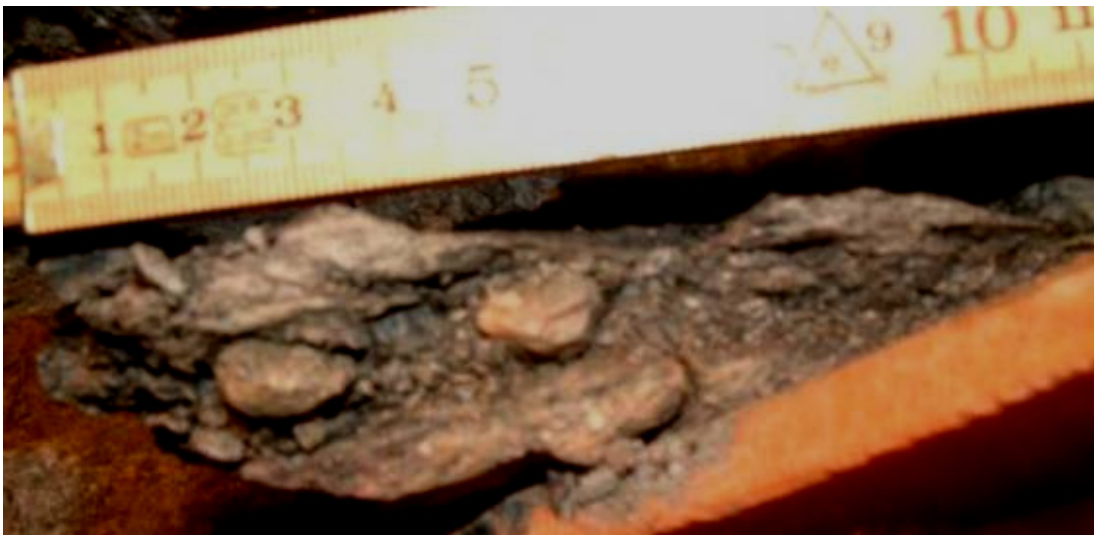
Overcoring: The core at the position of the target zone was heavily damaged by the removal from the core barrel, but loose debris could to some extent be identified with respect to position in core. Epoxy was abundant in 130/80-85° fractures at 210 cm and 270 cm and in one 0/63° fracture at 190 cm (Figure 4-12), and some epoxy had intruded into the fault gouge, but only up to a few cm from pilot, and no epoxy was observed on the core surface (Figure 4-13). Some pieces of intact fault gouge were also recovered and secured in sealed plastic bags and sent to the laboratory for further testing of porosity and other petrophysical parameters (Figure 4-14).

Figure 4-14. KA1596A04. Zone with fault gouge at 290 cm.
