## **Forsmark site investigation**

# **The character and kinematics of deformation zones (ductile shear zones, fault zones and fracture zones) at Forsmark – report from phase 1**

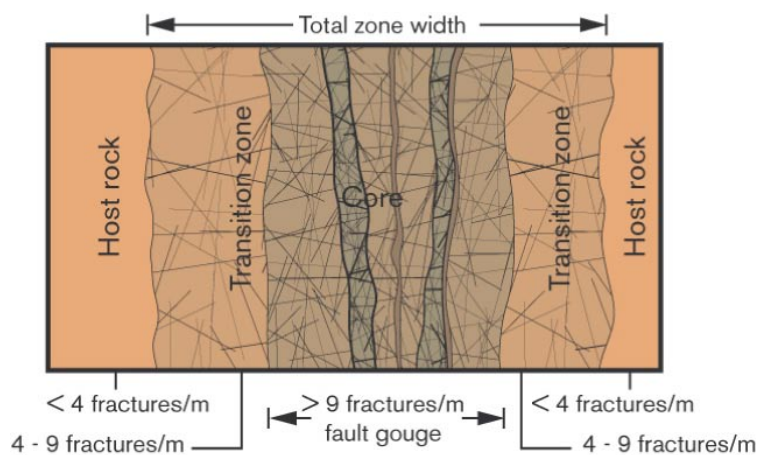
**Figure 4-1.** Schematic illustration of a brittle deformation zone according to SKB definition /after Munier et al. 2003/

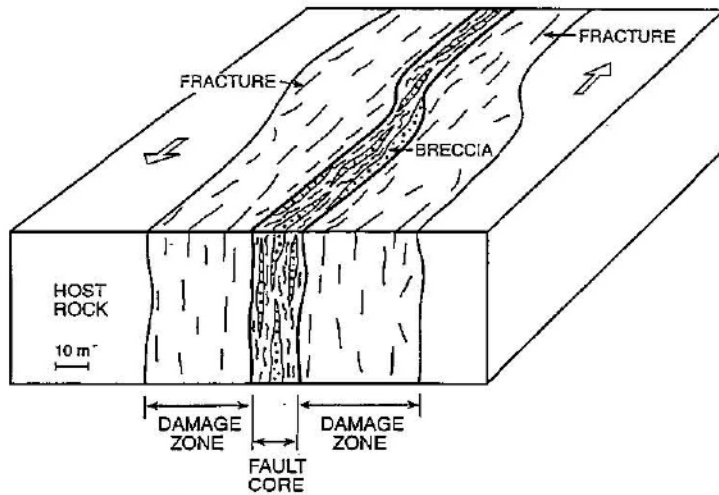
**Figure 4-2.** Schematic illustration of the architecture of an idealized fault zone /Gudmundsson et al. 2001/. Note that the term “damage zone” corresponds conceptually to the term “transition zone” of Figure 4-1.

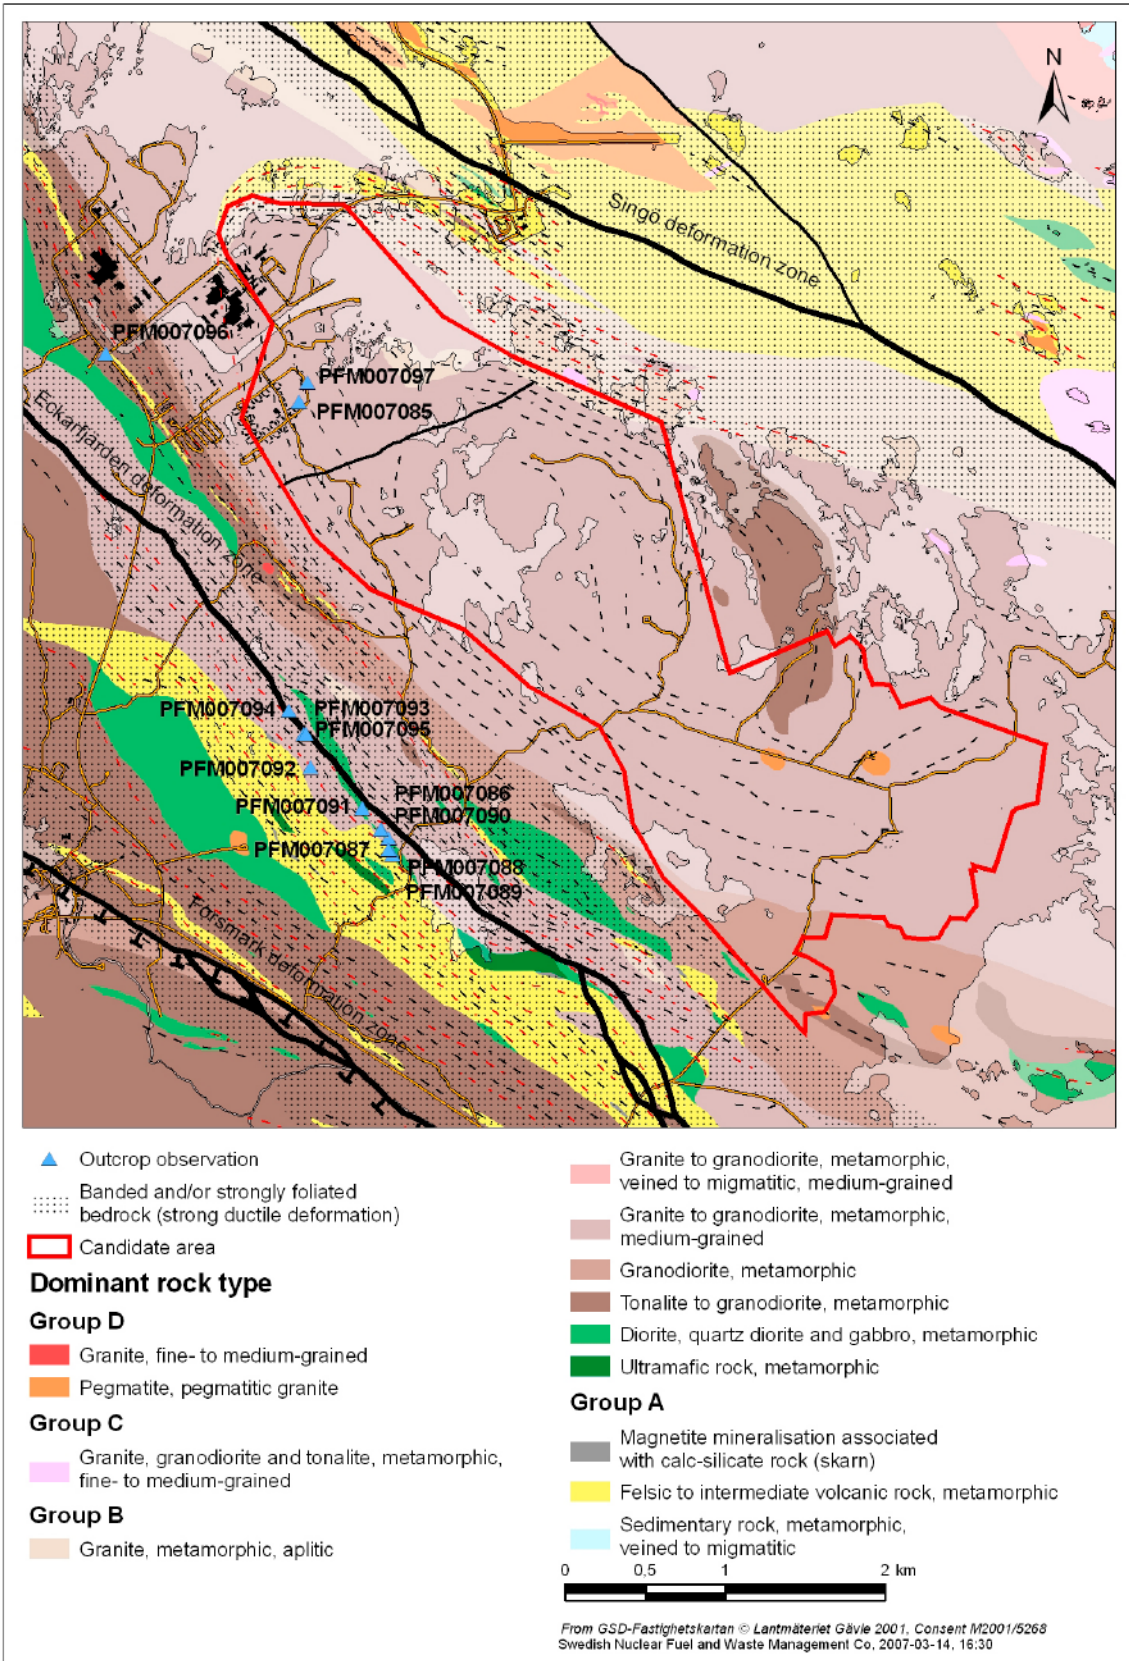
Figure 5-1. Overview of the Forsmark area showing the locations where fieldwork was conducted in October 2005.

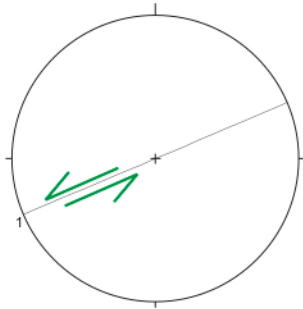
**Figure 5-3.** Sinistral component of displacement (shown by arrows) along a N067 trending fracture as determined by the offset of pre-existing ductile fabric (site PFM007086).

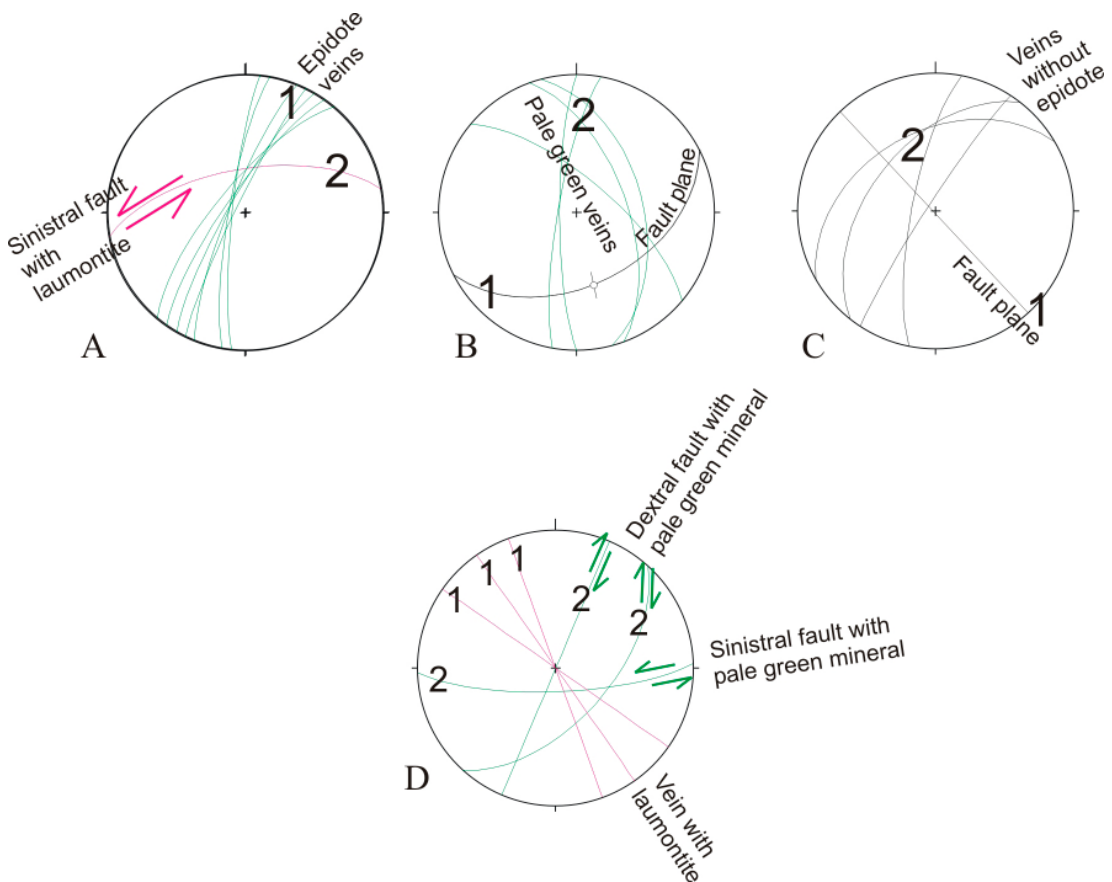
**Figure 5-4a.** Examples of relative chronologies between different sets of fractures observed at site PFM007086. (In each case, 1 is the oldest fracture).

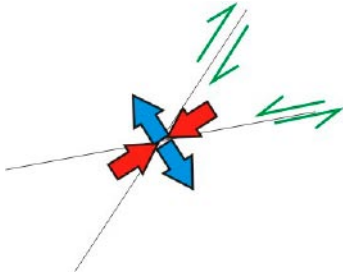
**Figure 5-4b.** Young sets of NNE-SSW to NE-SW dextral faults and ENE-WSW sinistral faults as a conjugate system of late strike-slip faults (PFM007086). Couple of blue arrows as inferred extensional trend and couple of red arrows as inferred compressional trend in a strike-slip stress regime.

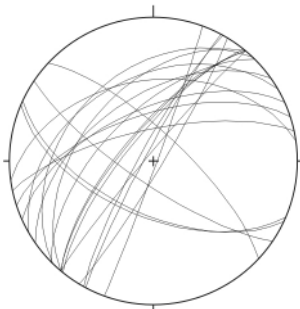
**Figure 5-5.** Stereoplot of the 21 fractures observed at site PFM007087.

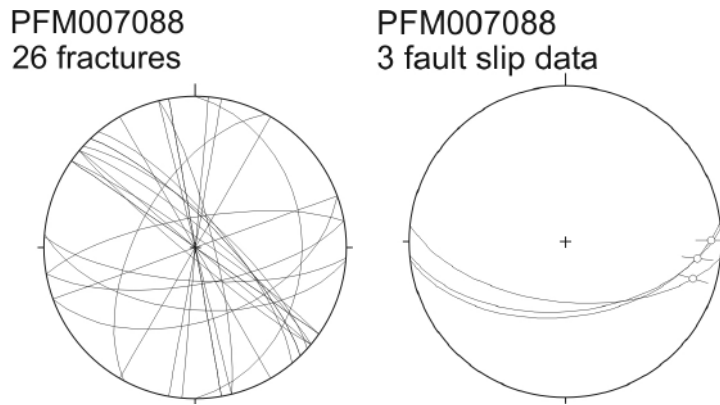
**Figure 5-6.** Stereoplots of the 26 fractures (A), and 3 fault slip data (B) obtained at site PFM007088.

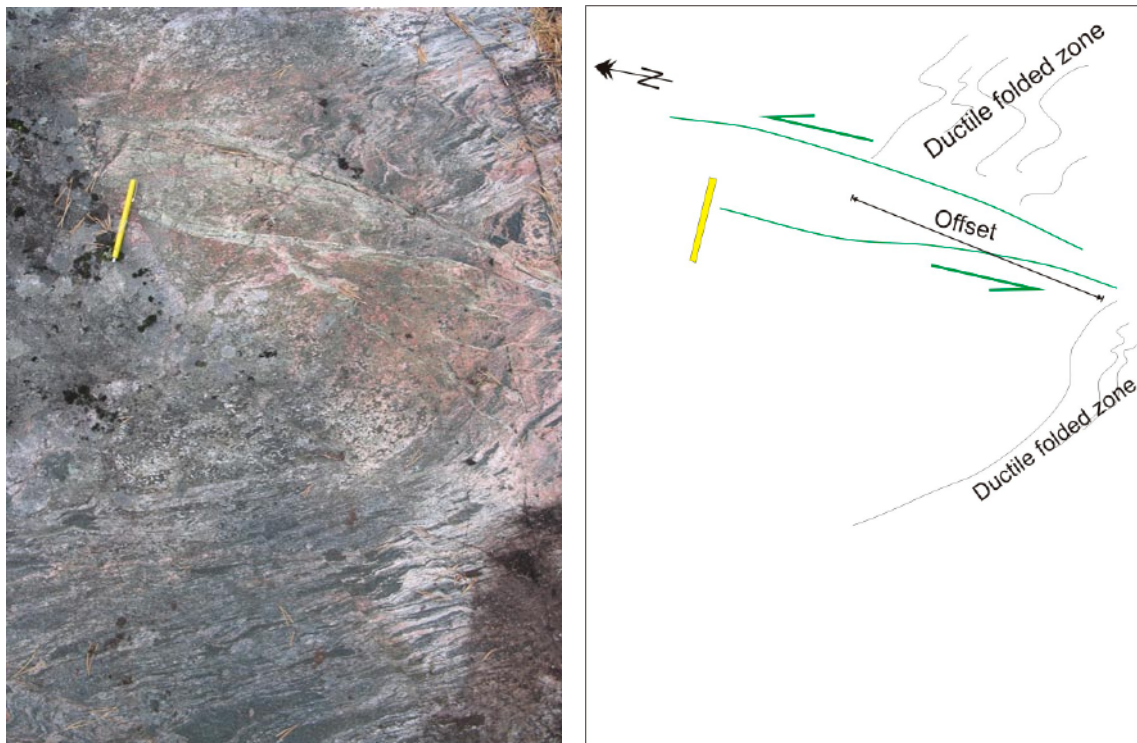
**Figure 5-7.** Coarse-grained hornblende-bearing meta-igneous rock with pale lenses of metagranite. The ductile fabric in the rock is folded and subsequently cut by a N-S to NNW-SSE sinistral fault with pale green epidote. Reddish stain of the host rock is indicative of oxidation along the zone affected by brittle deformation. Site PFM007088.

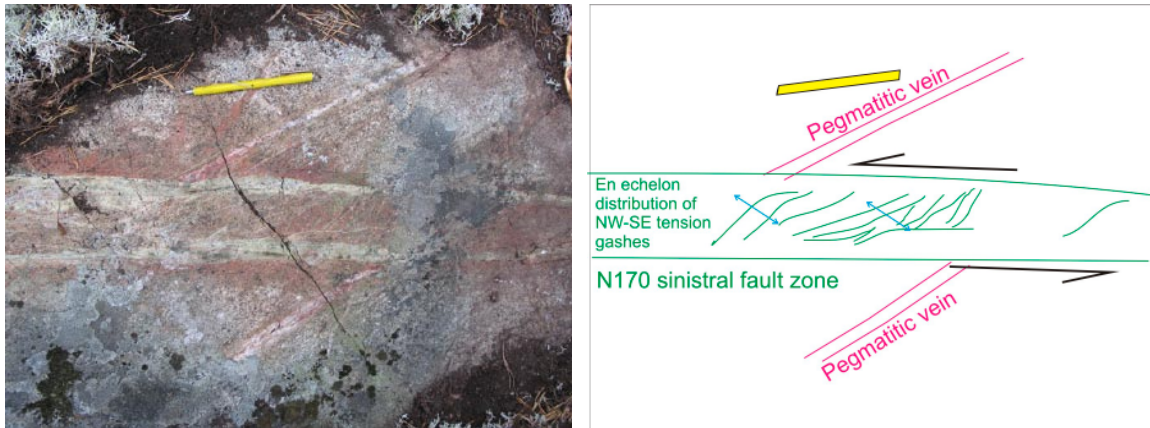
**Figure 5-8.** Photograph from outcrop and line-drawing (right) showing epidote-filled faults in reddish metagranite. Sinistral movement along the NNW-SSE fault zone is indicated by (1) sinistral offset of a feldspar-rich pegmatitic vein and (2) en echelon distribution of NW-SE tension gashes within the fault zone (extension direction indicated by the blue arrows). PFM007088.

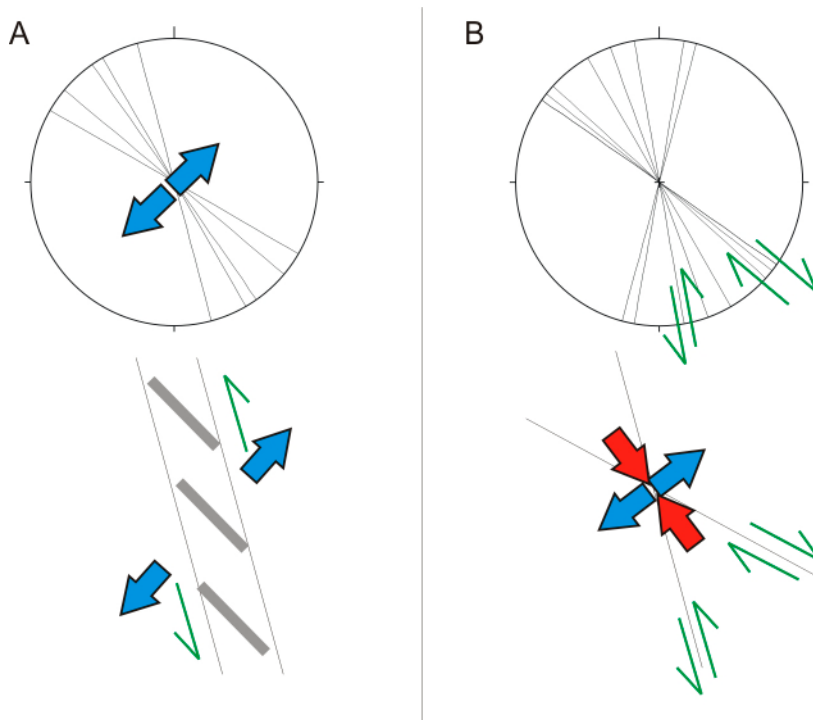
**Figure 5-9.** A) Stereoplot of five en echelon tension gashes into a NNW-SSE sinistral fault zone. B) Stereoplot of N-S to NW-SE fractures showing dextral or sinistral components of displacement that are consistent with a conjugate system of strike-slip faults (couple of blue arrows: extension; couple of red arrows: compression). PFM007088.

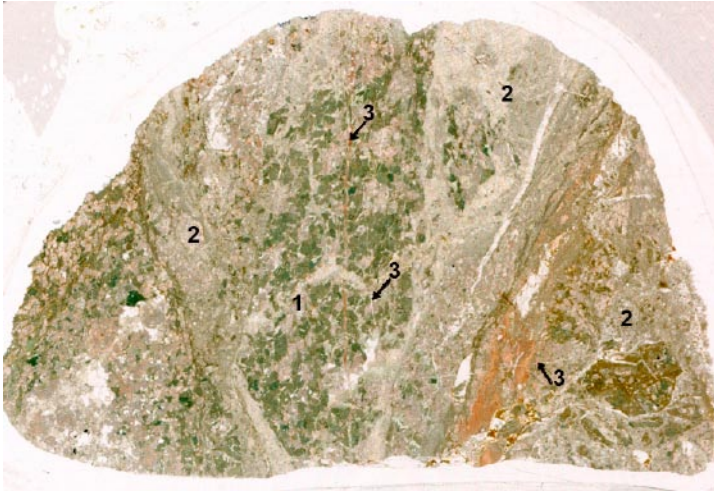
**Figure 5-10.** Scanned thin section (sample PFM007088) showing a multi-generation cataclasite developed in amphibolite (1). A variety of fine-grained cataclasites containing plagioclase, amphibole, epidote and clinozoisite (2) are shown. An angular clast of an older generation of cataclasite is present as a dark fragment to the right. The fault rocks are cut by thin veinlets of quartz and brownish epidote+laumontite (3). The field of view is 35 mm wide.

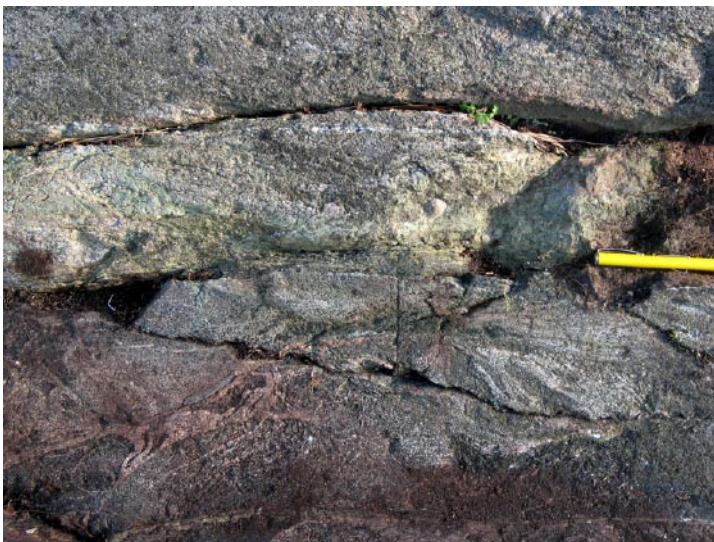
**Figure 5-11.** Epidote-rich cataclasite along steep fault (325/80) in granitoid gneiss. PFM007089.

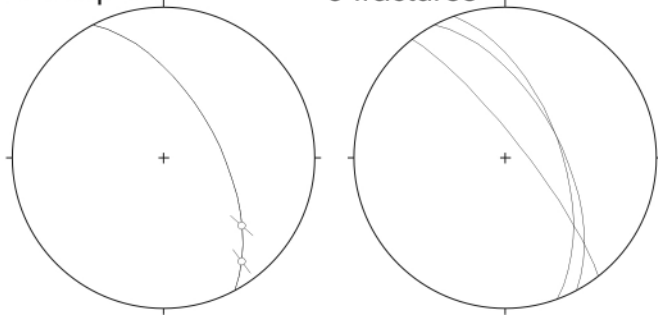
*Figure 5-12. Stereoplots showing data from site PFM007089.*

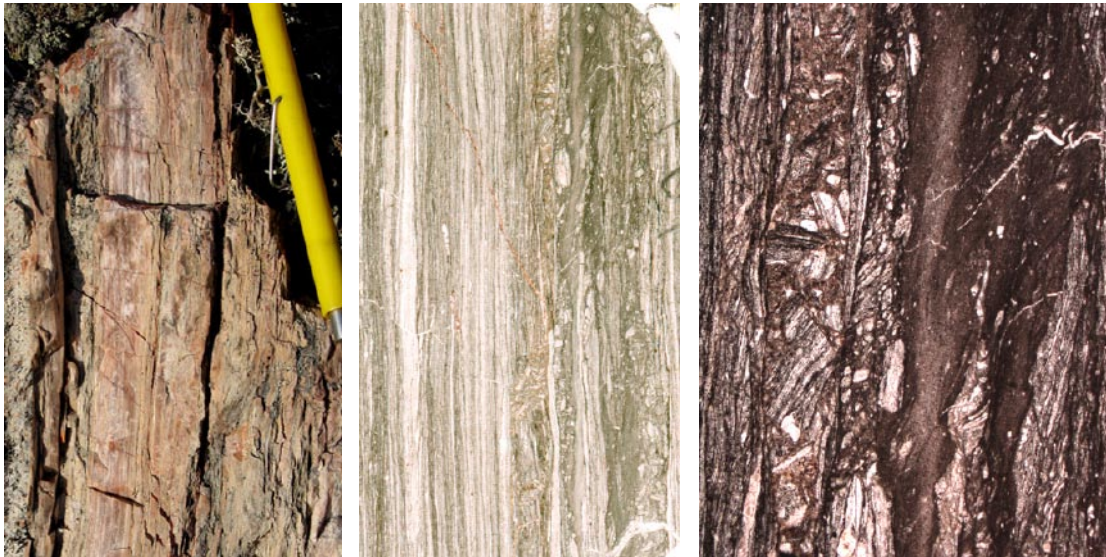
*Figure 5-13. From left to right the figure shows: 1) Outcrop of mylonite to ultramylonite along the EDZ; 2) part of scanned thin section showing the high-strain planar ductile fabric in ultramylonite. At the right-hand side of the figure, the ductile fabric has been broken apart forming a fine-grained cataclastic texture. The field of view is ca. 20 mm wide. 3) Photomicrograph showing details from the upper right-hand part of the scanned thin section. The ductile fabric is completely disrupted in the cataclasite. A layering due to variation in average clast size is apparent in the cataclasite. The fine-grained, dark grey material cut by thin veins (upper right) is an ultra-cataclasite devoid of microscopically visible mineral grains. The field of view is ca. 8 mm wide. Sample from PFM007090.*

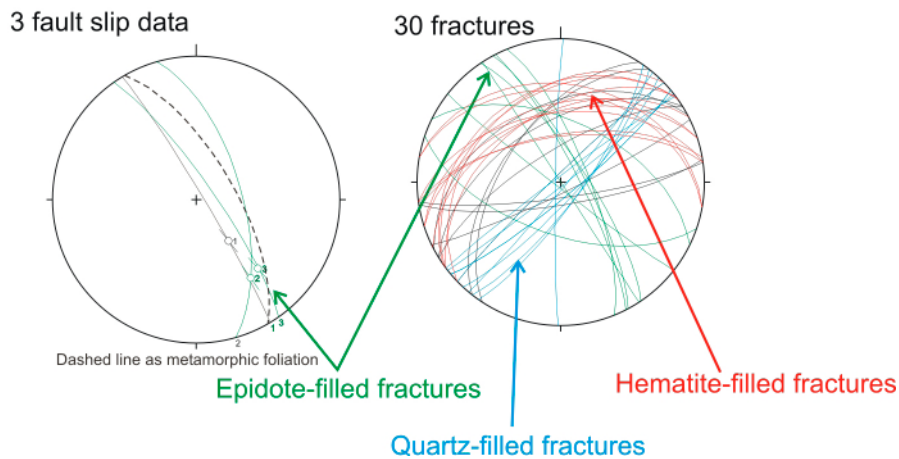
**Figure 5-14.** Stereoplots of the brittle structures measured at site PFM007090. NW-SE strike-slip oblique displacements along the NW-SE steep fractures (parallel to foliation and to the EDZ) and the sorting of fractures by plane attitudes and by mineral infill.

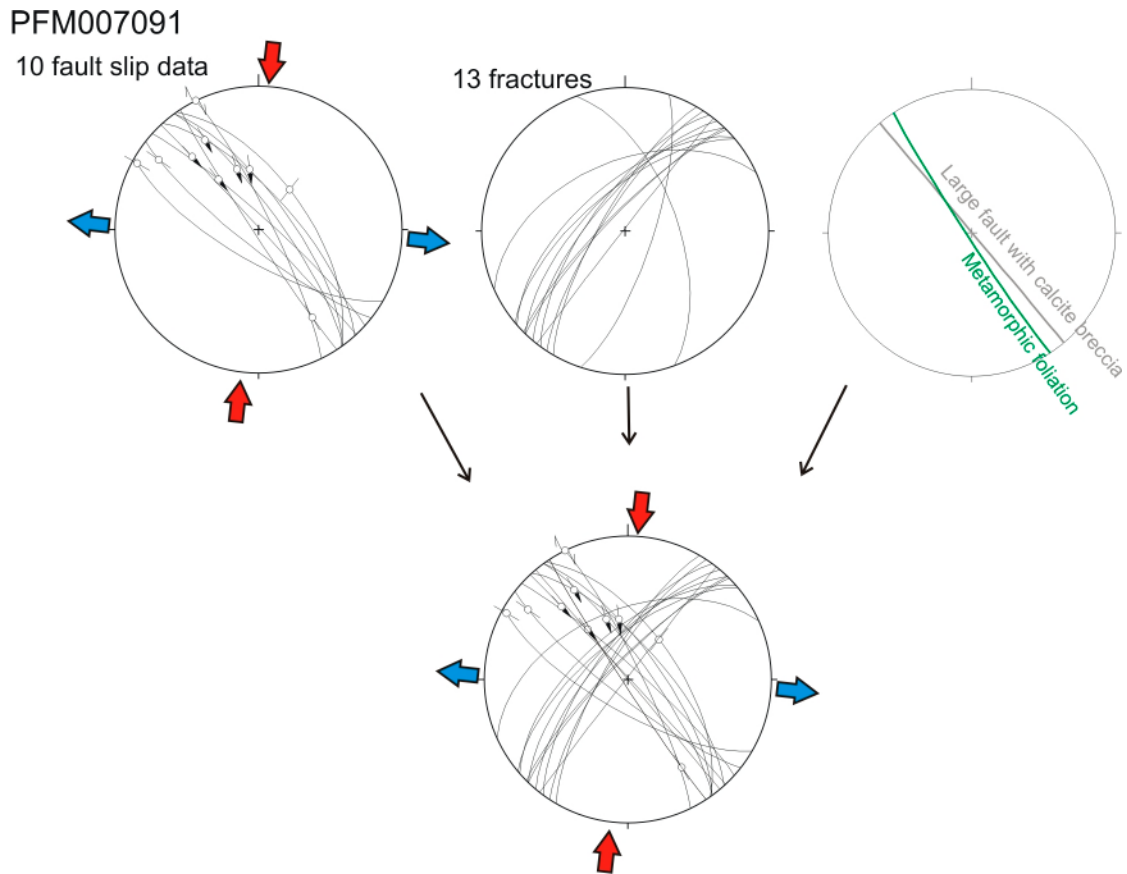
**Figure 5-15.** Stereoplots showing all data measured at site PFM007091. The brittle structures are consistent with a strike-slip regime with N-S compression (red arrows) and E-W extension (blue arrows).

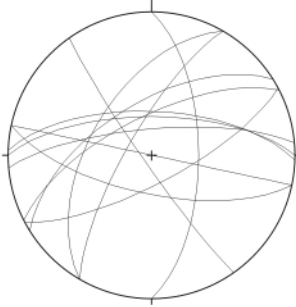
**Figure 5-17.** Stereonet of fractures showing the main E-W to NE-SW trending and steep to 50–60 degrees S- or N-dipping fracture set. PFM007092.

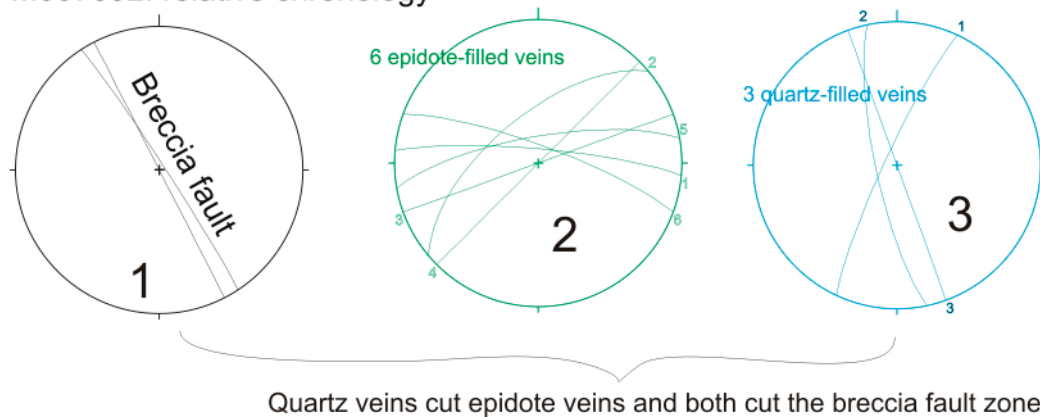
**Figure 5-18.** From left to right, and from older to younger structures: 1) trend of the fault breccia parallel to the EDZ; 2) E-W- to NE-SW-trending tension gashes dipping 60 degrees to the north; and 3) approximately N-S-oriented, steep, quartz-filled tension gashes. From left to right: from the older structures to the younger structures. PFM007092.

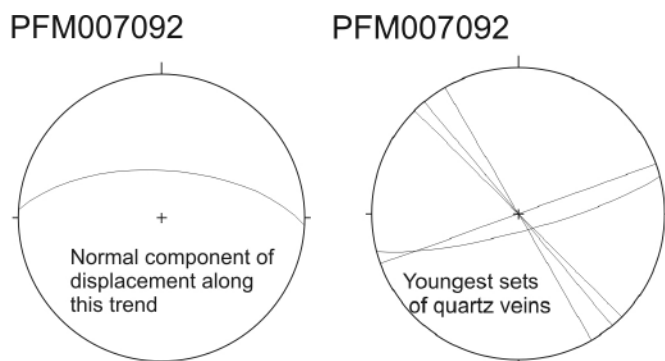
**Figure 5-19.** To the left: Sets of vertical quartz veins, one of the trends is parallel to the EDZ. These veins cut many other types of structures. To the right: Normal component of movement along E-W-trending fault. PFM007092.

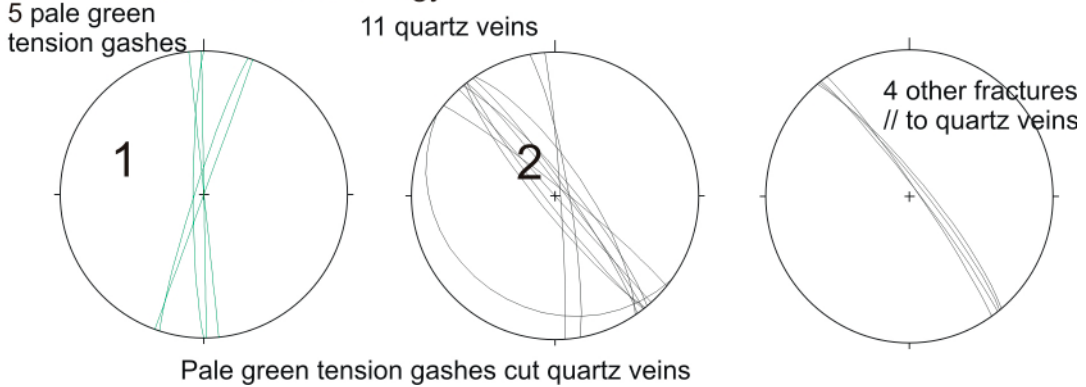
**Figure 5-21.** Epidote-filled fractures (1) are cut by quartz-filled veins forming a network of predominantly steep NW-SE-oriented fractures. Non-mineralized fractures (to the right) are parallel to the quartz-filled fractures. PFM007093.

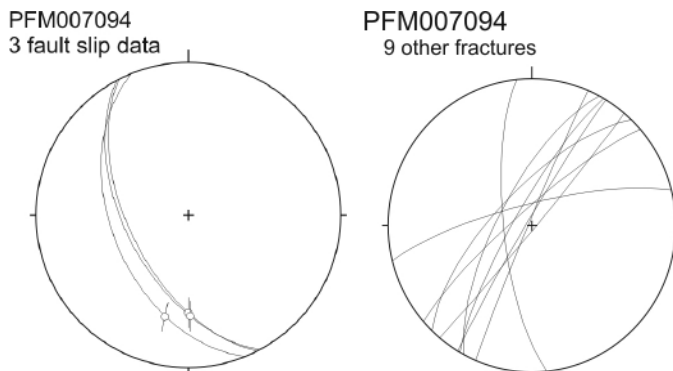
**Figure 5-22.** Fault slip data set (left) and steeply dipping, non-mineralized NE-SW-oriented fractures (right). PFM007094.

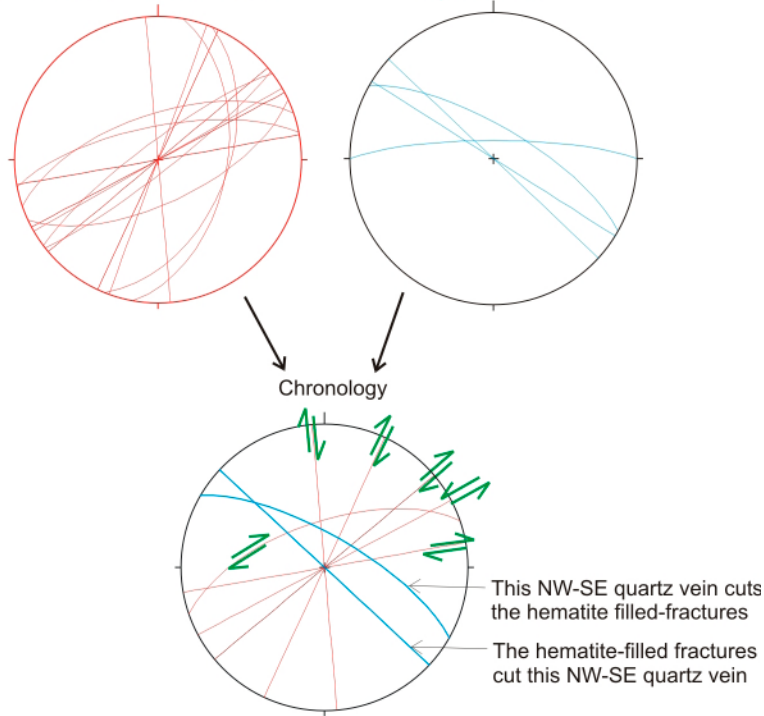
**Figure 5-23.** Red stereoplot (upper left) showing the hematite-filled NE-SW vertical fractures; blue stereoplot (upper right) shows the NW-SE vertical quartz veins. The complex cross-cutting relationships between structures at this site indicate a complex fracture evolution (bottom; see text for explanation). PFM007094.

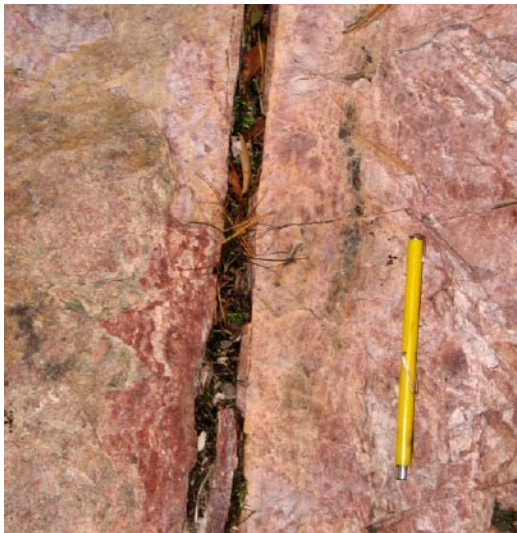
**Figure 5-24.** Reddish pink (oxidized) proto-cataclasite is cut by a number of thin micro-fractures and by a 2 cm wide (ultra-)cataclasite (eroded) oriented ca. 320/88, i.e. sub-parallel to the EDZ. Sub-horizontal outcrop, up is to the southeast. PFM007095.

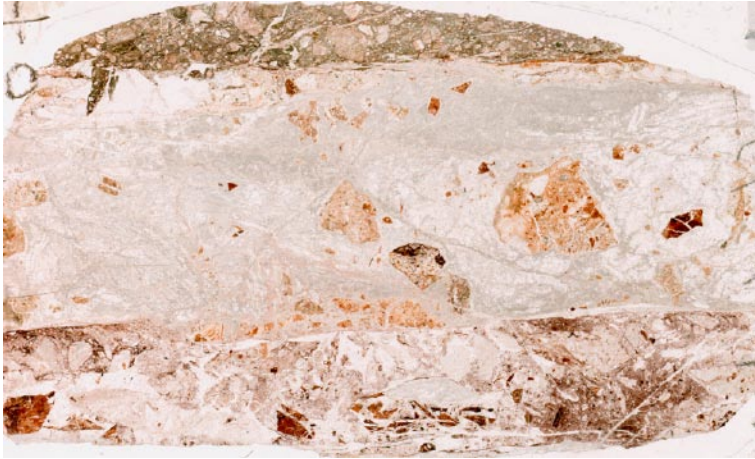
**Figure 5-25.** Scanned thin section from site PFM007095. Along the margins of the sections there is greenish to reddish cataclasite with variably sized angular fragments of cataclasite in 2<sup>nd</sup> generation fault rock. Hence, this part of the section is preserving two events of brittle deformation. The central part of the section consists of a fine-grained fault rock with clasts of reddish cataclasite embedded in a matrix of mainly quartz and calcite. See Figure 5-26 for details. The field of view is 35 mm wide.

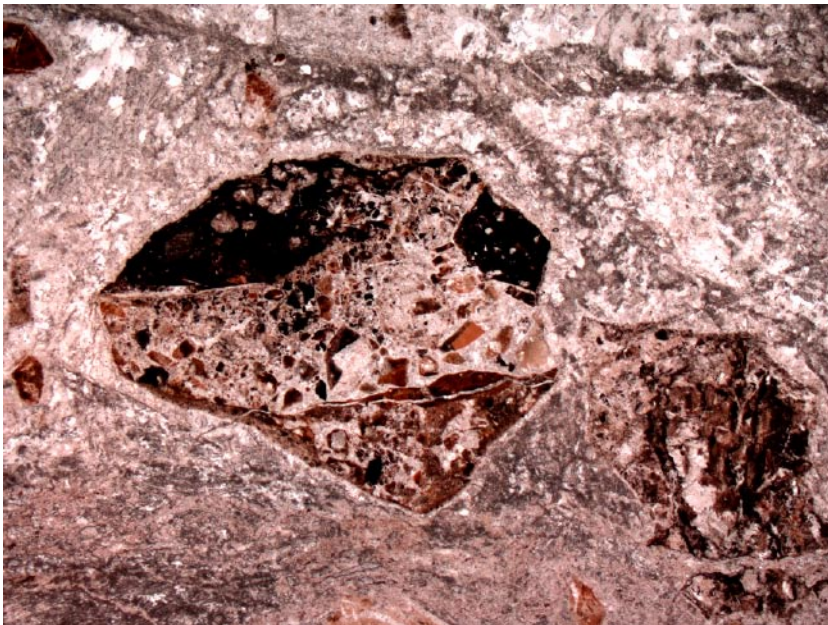
**Figure 5-26.** Photomicrograph showing a detail from the central part of thin section of Figure 5-25. Composite, angular clasts that consist of different types of earlier formed cataclasite sit in a fine-grained groundmass and are cut by very thin quartz veins. The field of view is ca. 4.5 mm wide.

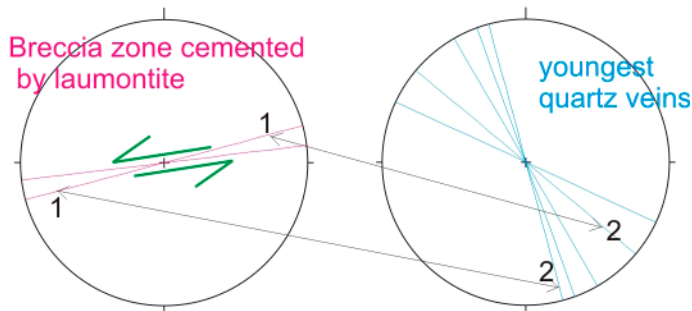
**Figure 5-27.** Stereoplot to the left: ENE-WSW vertical and brecciated left-lateral strike-slip fault zone. These structures are post-dated by NW-SE vertical quartz veins developed parallel to the trend of the EDZ (stereoplot to the right). (1, 2 and arrows between them, refer to the cross-cutting relationships, or the relative chronology, between fractures: '1' being cut by, or older than, '2'). PFM007095.

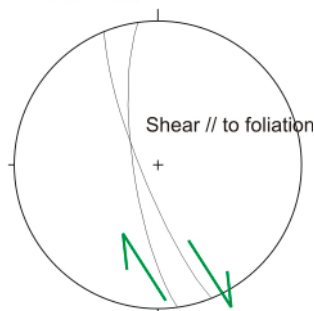
**Figure 5-28.** Dextral ductile shear along the metamorphic foliation at site PFM007085.

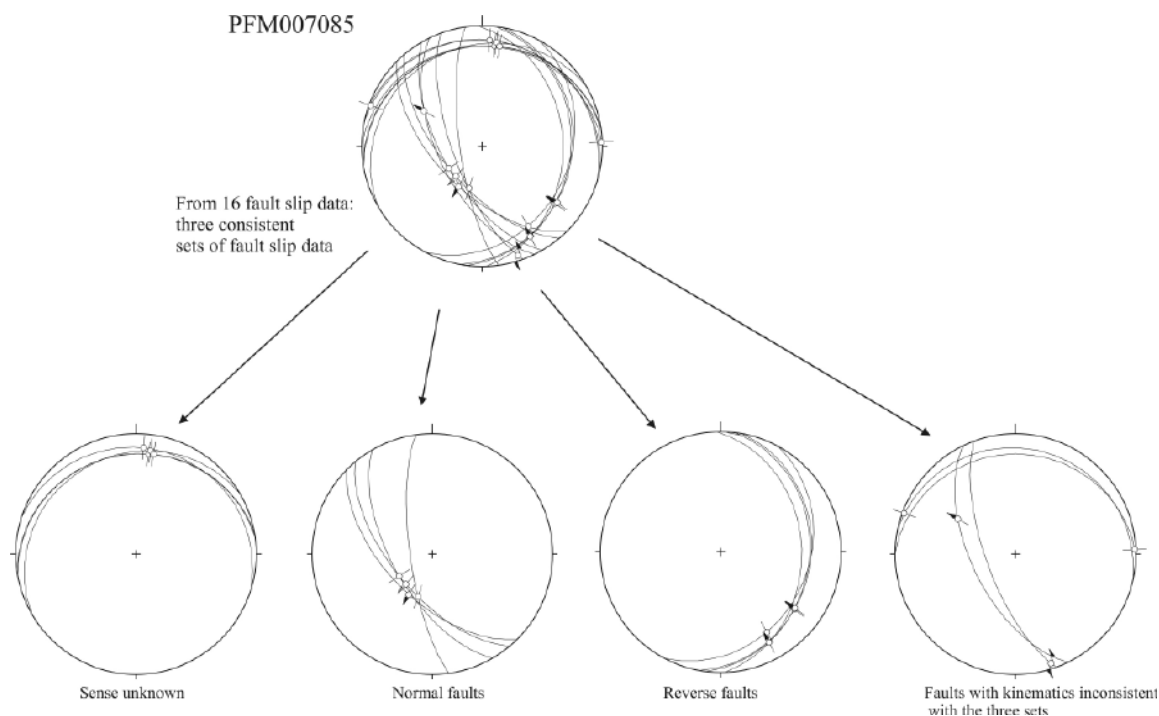
**Figure 5-29.** Sorting of the 16 fault slip data into consistent sets based on the kinematics observed on variably oriented faults. See text for details. PFM007085.

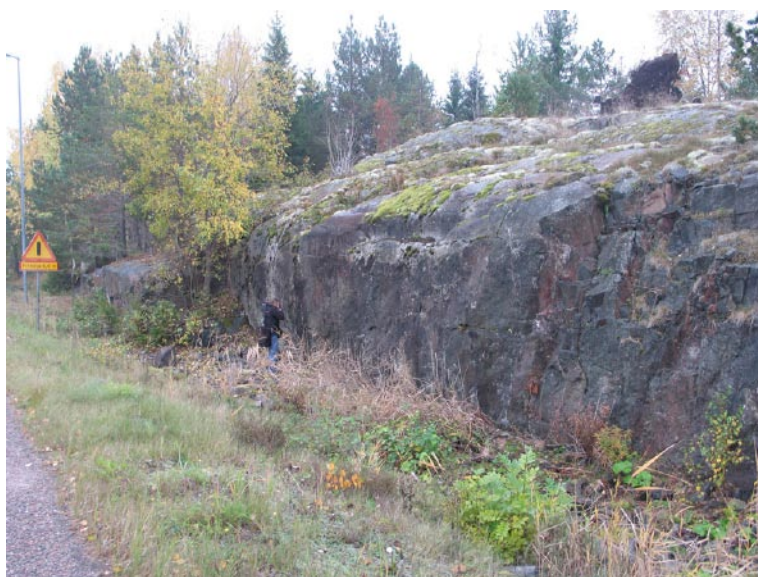
**Figure 5-30.** The NW-SE large fault plane that crops out at site PFM007096, viewed towards the south.

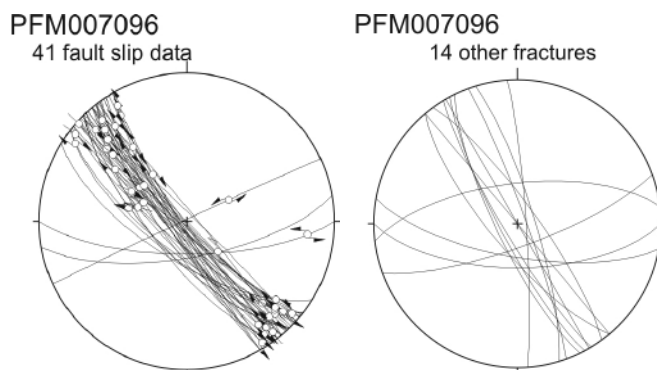
**Figure 5-31.** A) The complete set of 41 fault slip data collected at site PFM007096. The kinematic indicators were obtained from the NW-SE-trending fault surfaces representing individual strands in the steep and large main fault zone (see Figure 5-29). B) Other fractures measured at site PFM007096. These do not exhibit kinematic indicators, but their attitude is consistent with those of the striated faults.

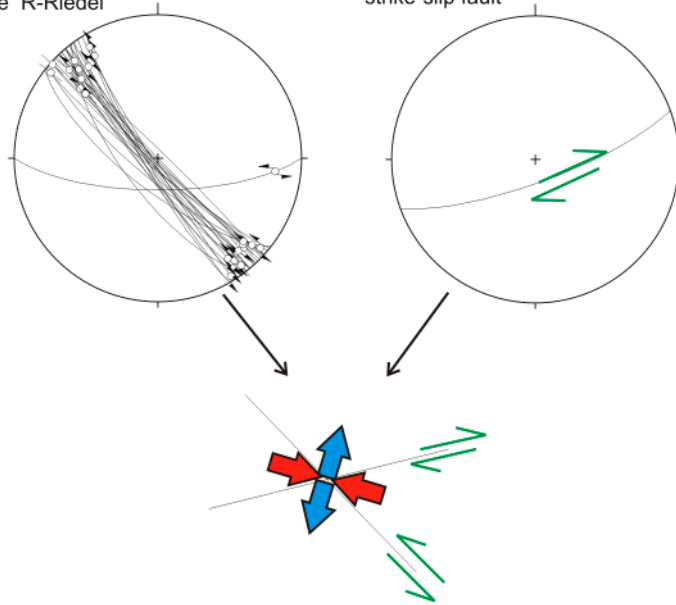
Strike-slip conjugate system of faults

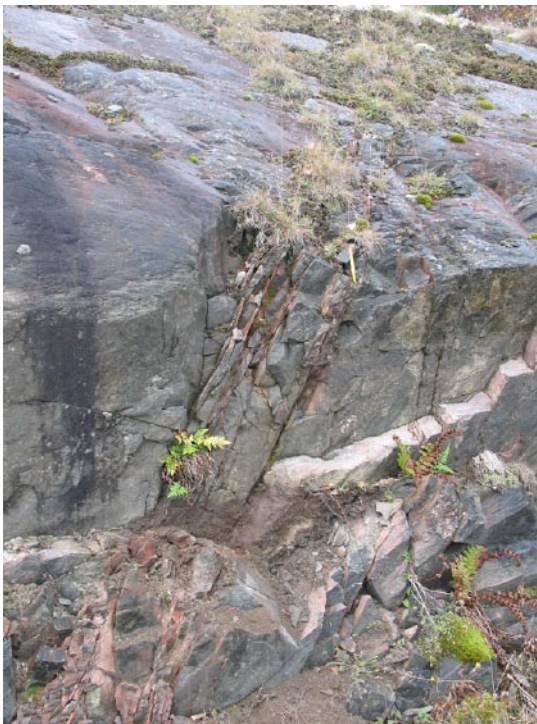
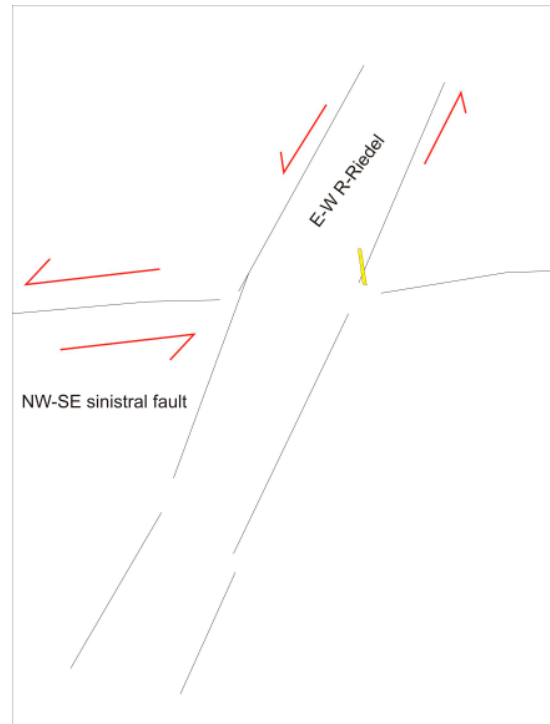
**Figure 5-33.** Outcrop (left) and line-drawing (right) showing the major NW-SE sinistral fault and its E-W R-Riedel structure.

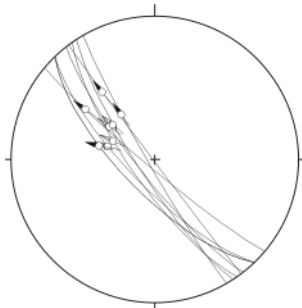
**Figure 5-35.** Normal dextral slips along the NW-SE large fault zone.

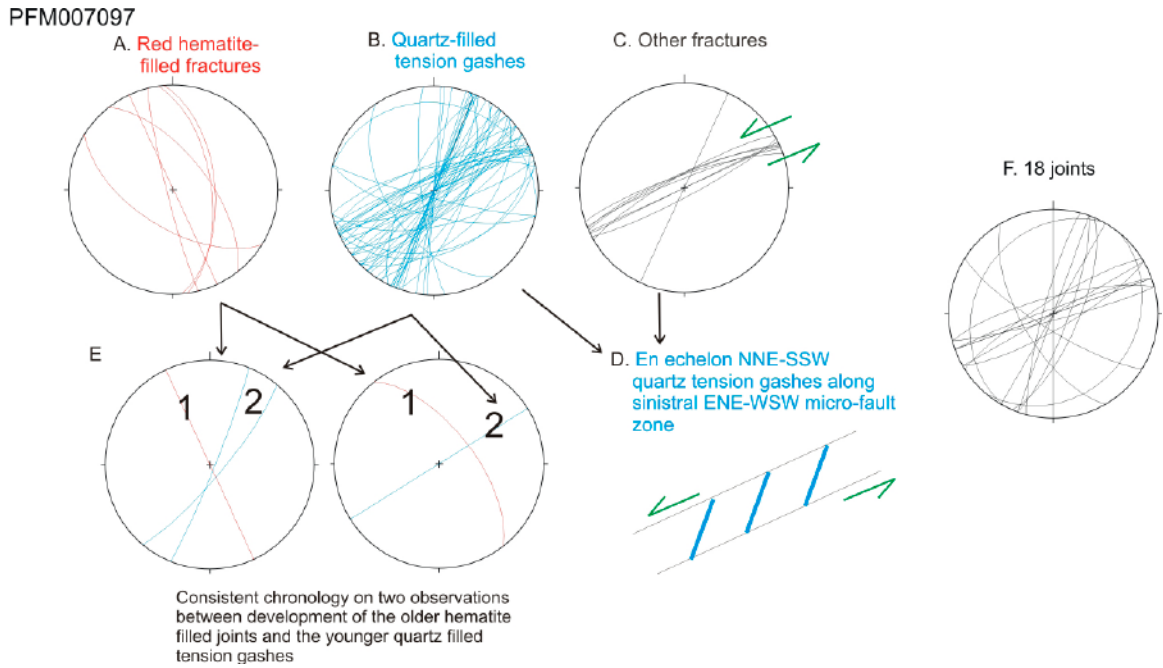
**Figure 5-36.** Stereoplots of fracture data collected at site PFM007097. A) Hematite-coated fractures. B) Quartz tension gashes developed en echelon along sinistral faults. C) ENE-WSW sinistral faults. D) Drawing illustrating the strike-slip opening of quartz-filled tension gashes along ENE-WSW sinistral trends. E) Relative chronology between tensional fractures. F) Joints with similar trends.

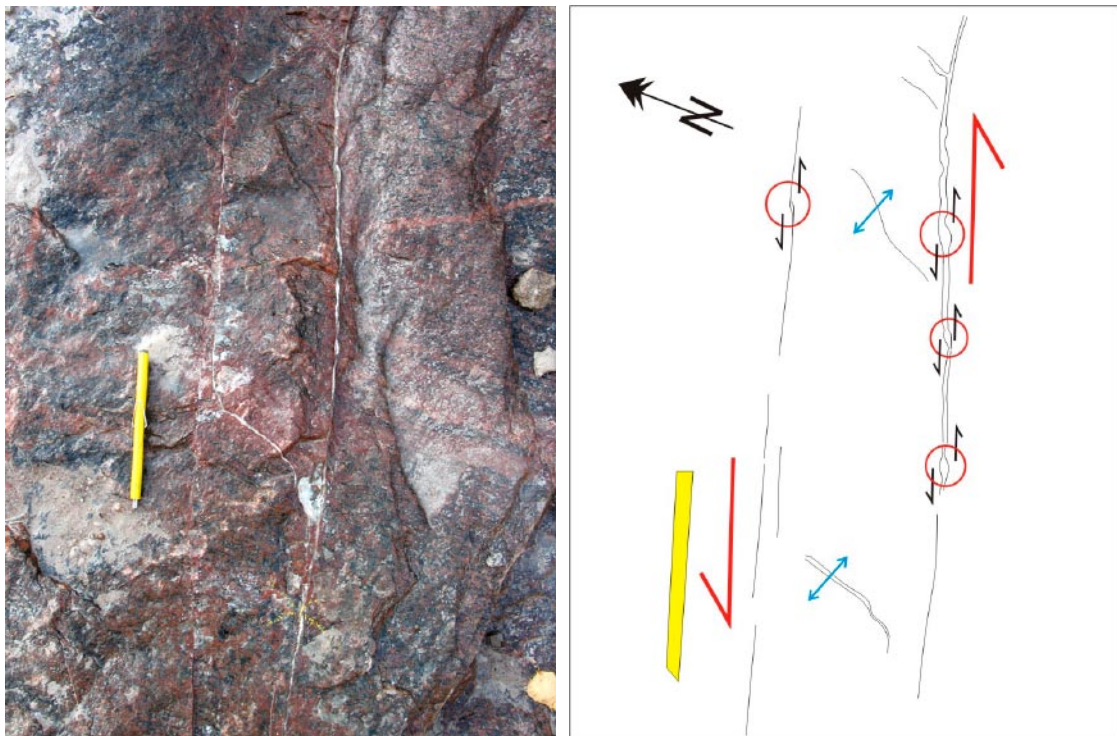
**Figure 5-37.** En echelon distribution of NNE-SSW tension gashes along an ENE-WSW sinistral zone. Some sinistral steps of quartz are also observed along the ENE-WSW sinistral faults (into red circles). (Note that the line drawing is enlarged compared to the picture).

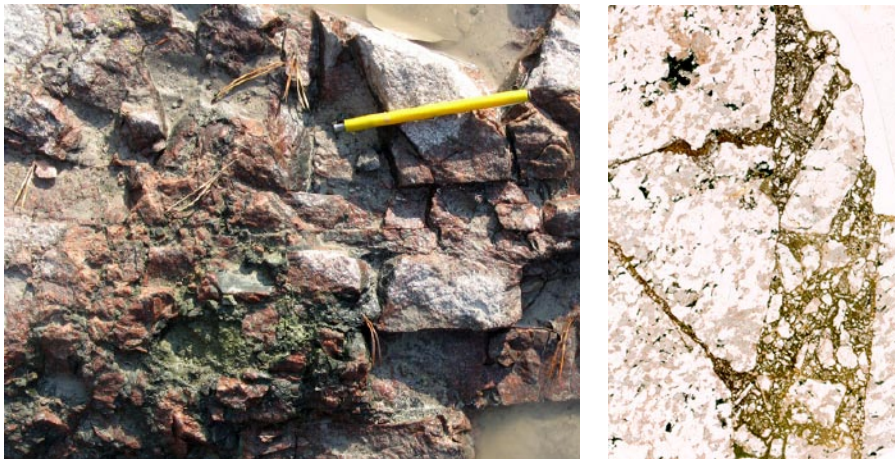
*Figure 5-39. Left: Detail from horizontal outcrop in the trench at site PFM007097. Steep NNW-oriented fractures (vertical on the photograph) intersect with NE- and ENE-fractures. Note green chlorite infill, strong oxidation and local brecciation of the metagranite host rock. Right: Scanned thin section from a sample collected at the outcrop. The metagranite is strongly crushed and brecciated along fractures. Dark, hematite-dusted chlorite-rich material with minor epidote fills the voids between angular clasts in the breccia. Note that the breccia developed preferably, but not exclusively, along NE- and ENE-trends. The field of view is ca. 20 mm wide.*

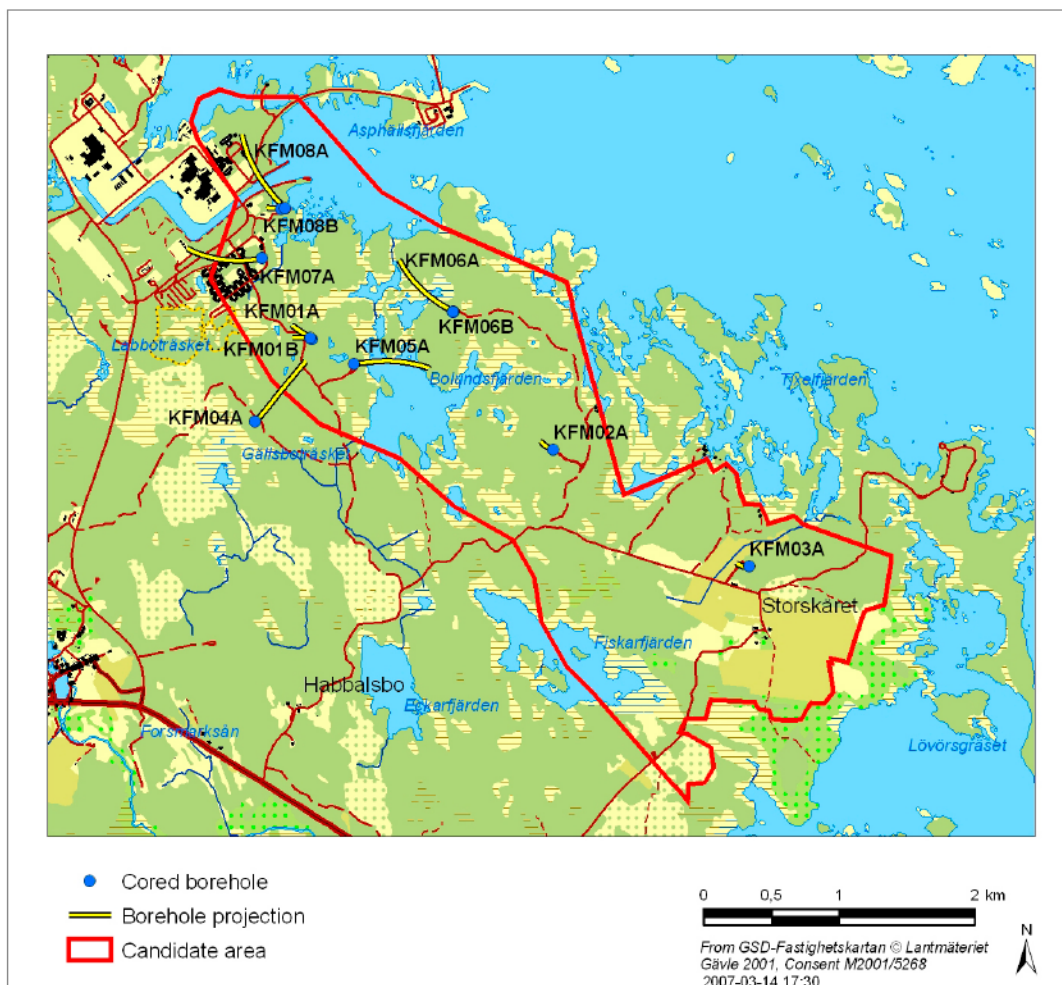
**Figure 5-40.** Map of the Forsmark area showing candidate investigation area (red line) and the geographic location of the boreholes.

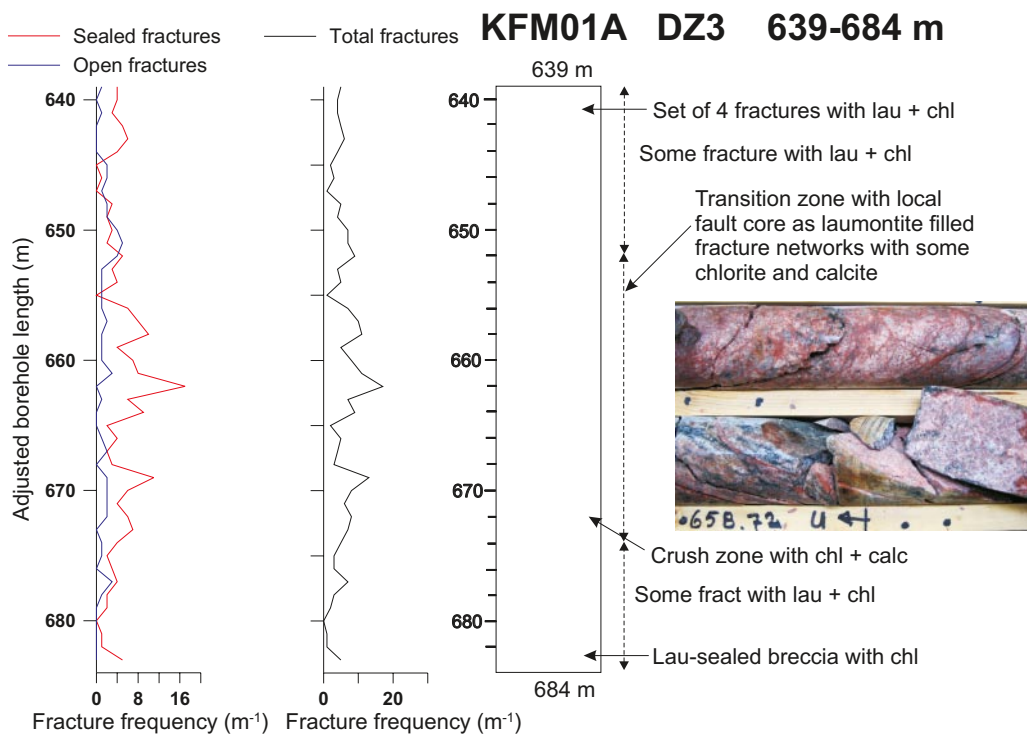
**Figure 5-41.** Simplified drawing of DZ1 showing the most prominent brittle structures. The photo (inset) shows sections in the central part of the zone with a relatively high abundance of laumontite-sealed fractures. Abbreviations used throughout the report: Ep=epidote, Chl=chlorite, Qtz=quartz, Lau=laumontite, Corr=corrensite, Py=pyrite, Fract=fracture(s), w/=with.

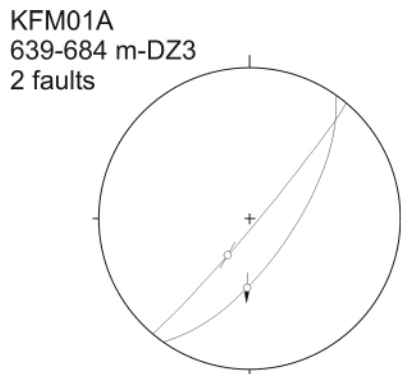
*Figure 5-42. Stereoplot of fault slip data in DZ3 (KFM01A).*

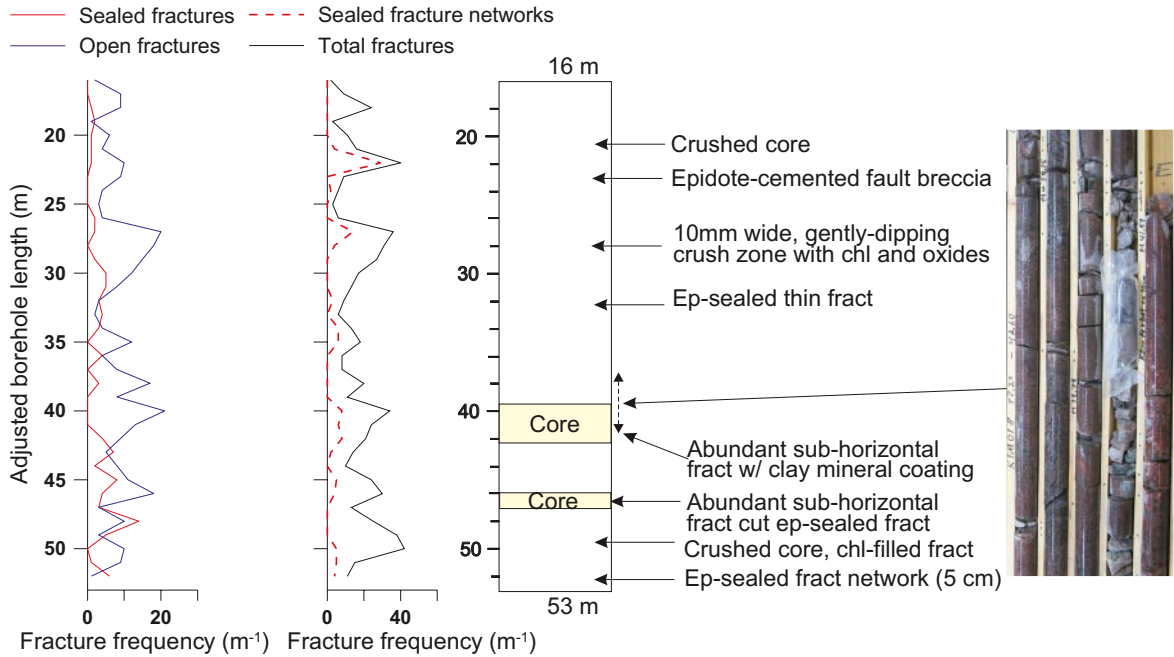
**Figure 5-43.** Simplified drawing of DZ1 showing the most prominent brittle structures. At approximately 28 m the zone exhibits high fracture frequency and a ca. 10 mm wide crushed fault rock with chlorite and iron oxides (?). The photo (inset) shows the section between 37.2 and 41.6 m. Relatively strong deformation with abundant open, sub-horizontal fractures commonly with clay mineral coating continues down to ca. 42.5 m. The interval between ca. 46 – 48 m has abundant sub-horizontal fractures that cut steeper epidote-sealed fractures. Abbreviations used throughout the report: Ep=epidote, Chl=chlorite, Qtz=quartz, Lau=laumontite, Corr=corrensite, Py=pyrite, Fract=fracture(s), w/=with.
