## **Forsmark site investigation**

# **The character and kinematics of deformation zones (ductile shear zones, fault zones and fracture zones) at Forsmark – report from phase 1**

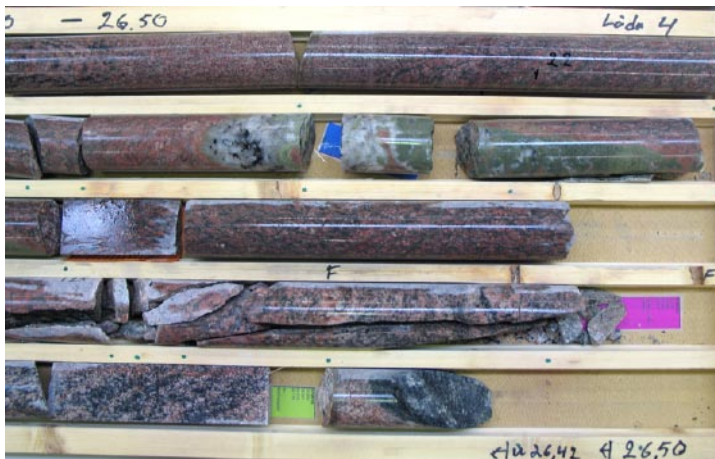
**Figure 5-44.** Overview showing the upper part of DZ1. At approximately 23 m there is a marked fault with epidote-cemented fault breccia that contains small, angular fragments of pink, altered metagranite and quartz. This is post-dated by white vein quartz.

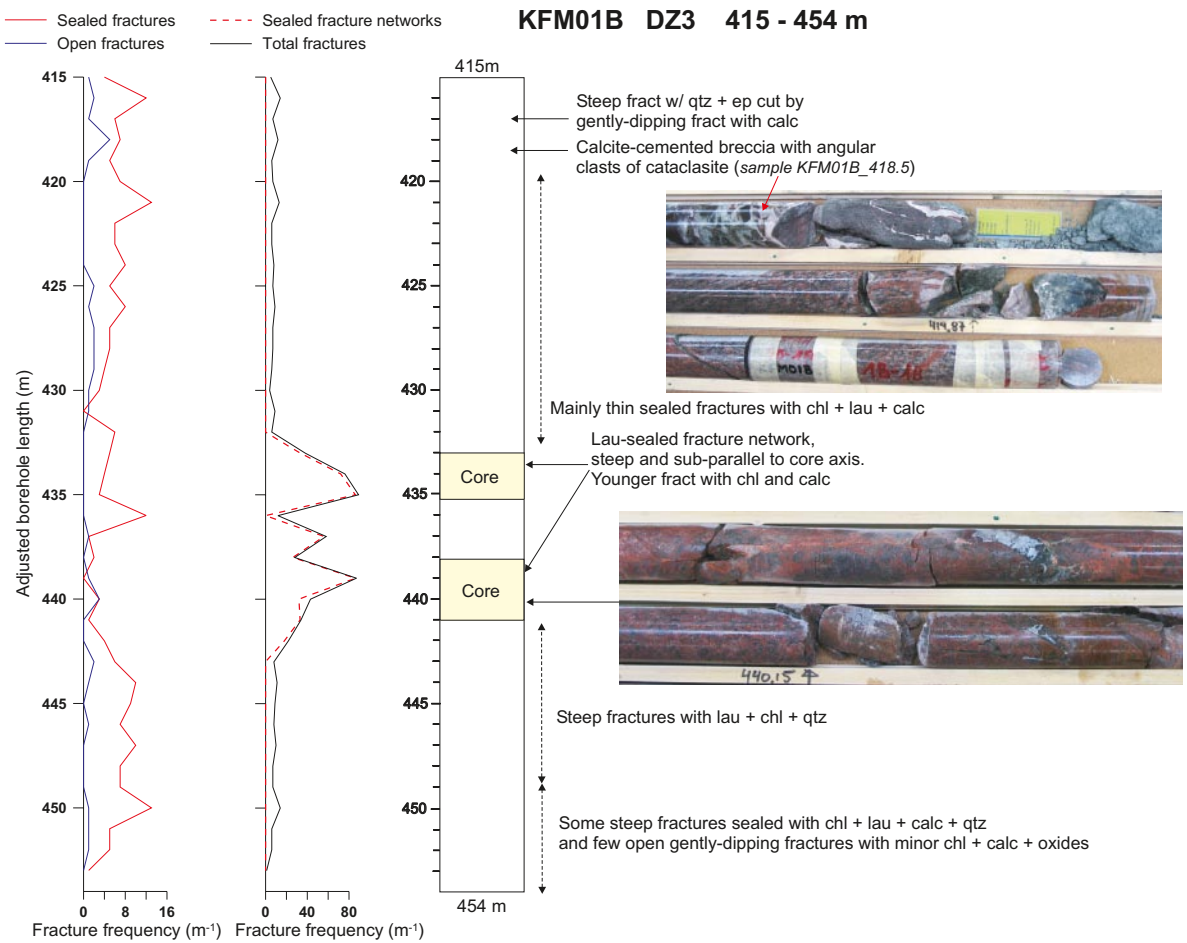
**Figure 5-47.** Simplified drawing of DZ3 with photo insets showing the most prominent brittle structures. Fragments of reddish, fine-grained cataclasite in calcite-cemented breccia occurs at 418.5 m (see upper photo). Note strong crushing of the core below the calcite-cemented breccia. Abundant laumontite-sealed fractures and fracture networks (433–434 m) are similar to those present in KFM01A (Figure 5-40). Some fractures contain chlorite and/or calcite. From about 438 m there are abundant fractures sealed with laumontite. In several places, there are thin zones with cemented breccias containing small fragments of quartz and host rock. Younger fractures contain chlorite and calcite. Note reddish staining in the host rock.

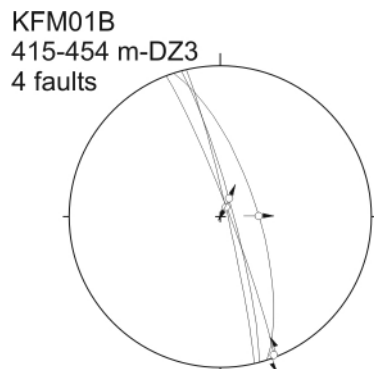
**Figure 5-48.** Stereoplots of fault slip data in DZ3 (KFM01B).

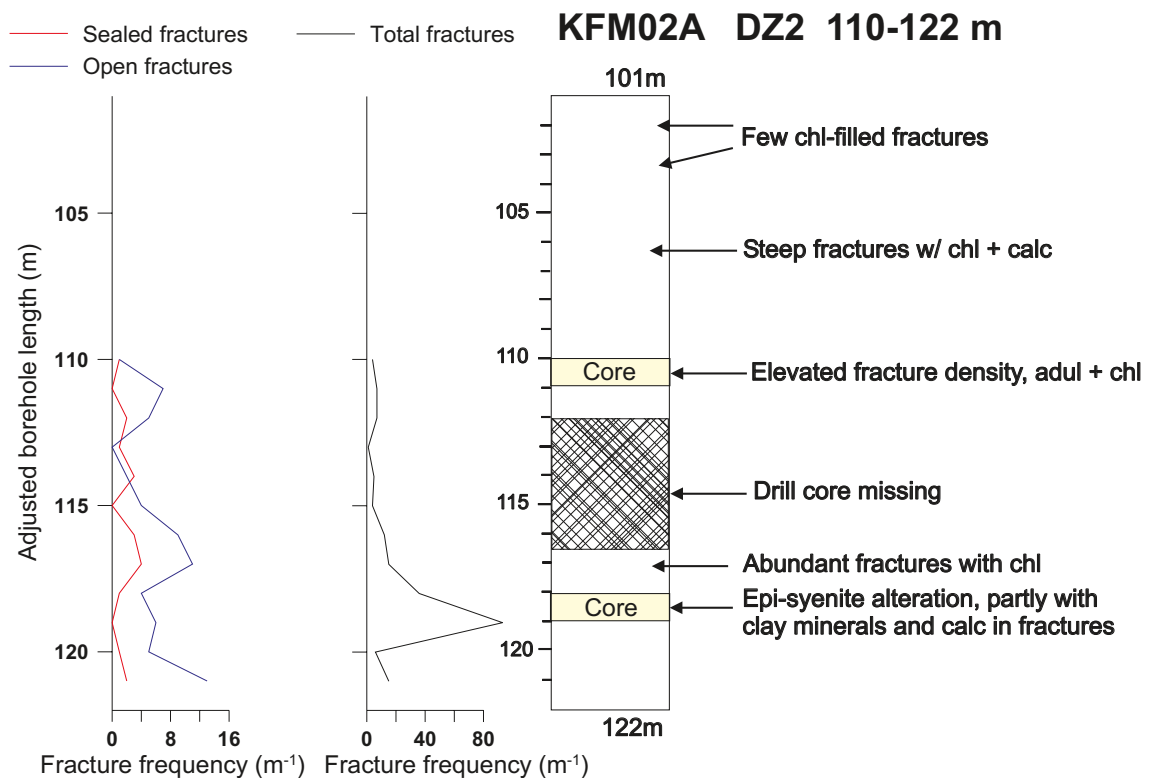
**Figure 5-50.** Simplified drawing of DZ2 showing the most prominent occurrences of brittle structures. Note that the core is missing over several metres from 112 metres. Elevated fracture frequency occurs at ca. 110 to 111 m and locally abundant fractures with chlorite are present at 117.3 m. Fractures filled with calcite occurs in somewhat altered metagranite with clay minerals (118–119 m).

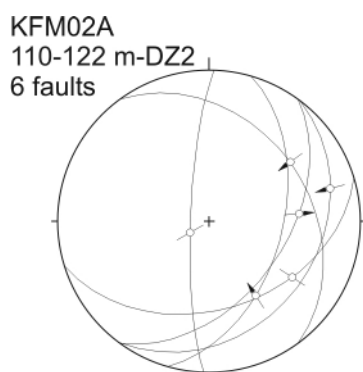
**Figure 5-51.** Stereoplot of fault slip data in DZ2 (KFM02A).

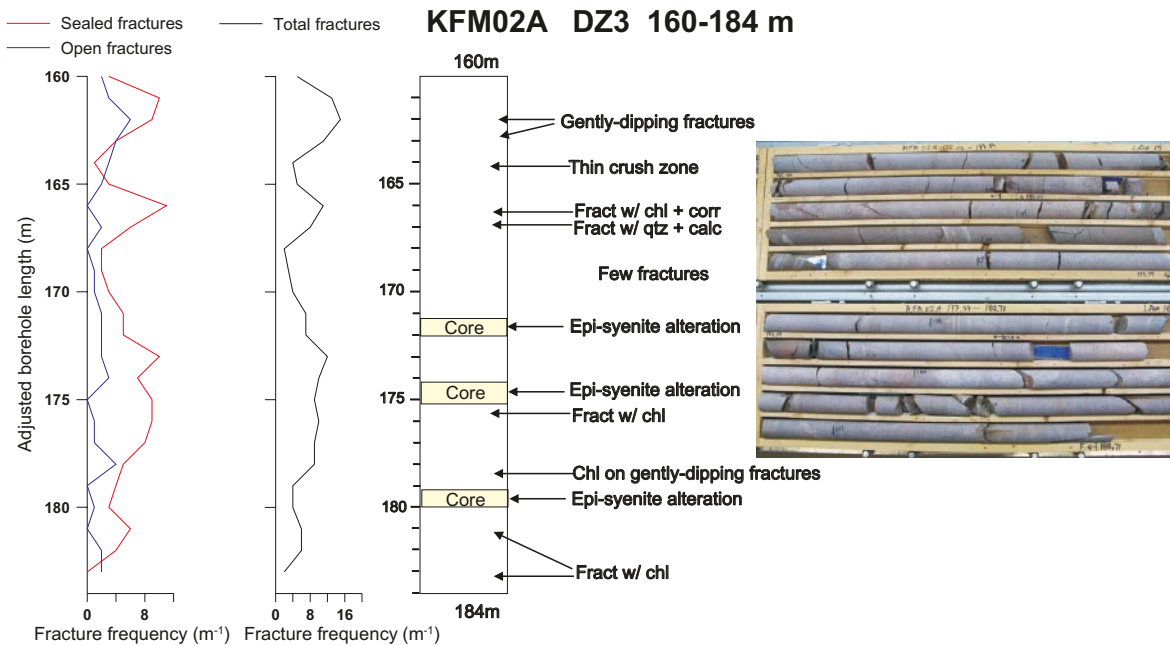
**Figure 5-52.** Simplified drawing of DZ3 showing the most prominent brittle structures. The photo shows the lower section of the zone. Note the generally moderate fracture frequency and variable reddish staining of the core.

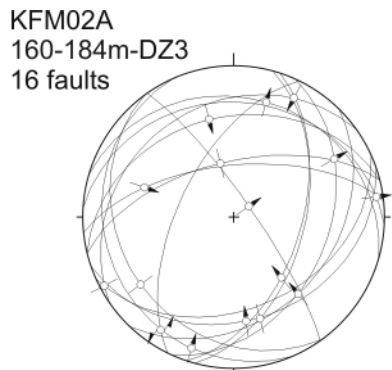
**Figure 5-53.** Stereoplot of fault slip data in DZ3 (KFM02A).

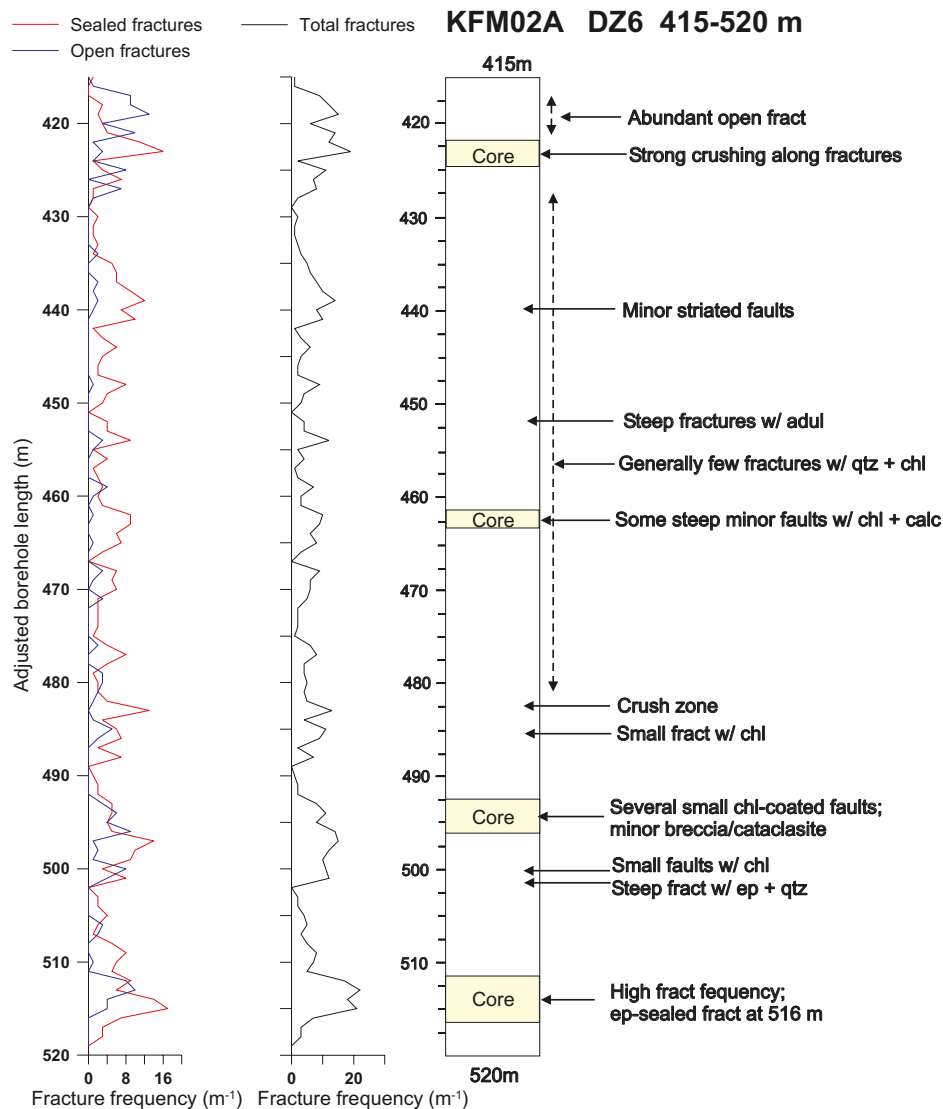
**Figure 5-54.** Simplified drawing of DZ6. Note that the interval between 430 and 480 m has low fracture frequency; higher fracture frequencies occur towards the upper and lower end of the deformation zone.

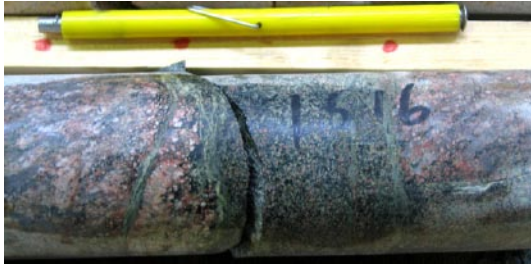
**Figure 5-55.** Dense array of epidote-sealed fractures cut mesocratic diorite and altered metagranite. DZ6 (KFM02A, 516 m).

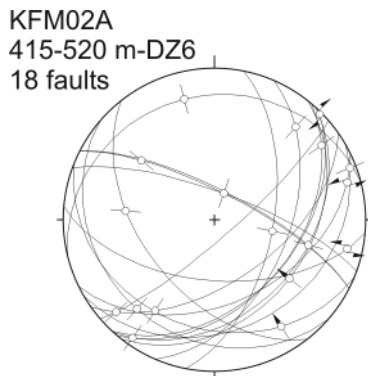
**Figure 5-56.** Stereoplot of fault slip data for different sections of DZ6 (KFM02A).

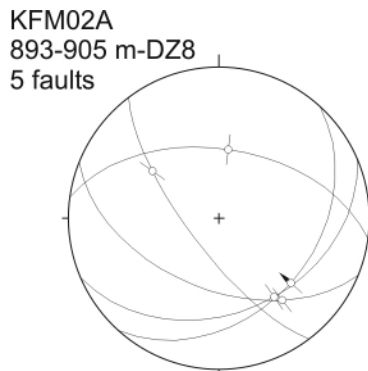
**Figure 5-57.** Stereoplot of fault slip data in DZ8 (KFM02A)

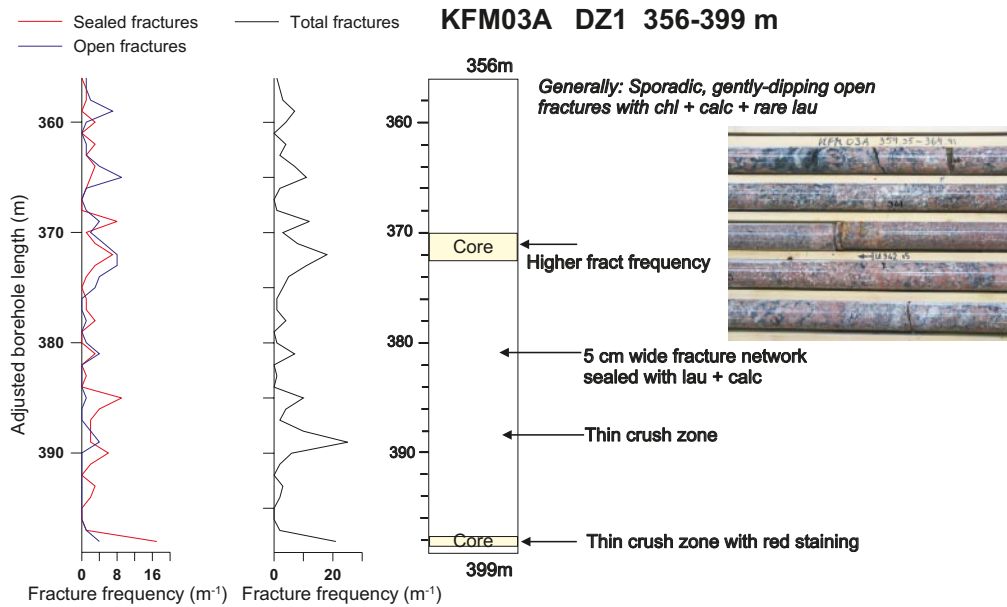
**Figure 5-59.** Simplified drawing of DZ1. The photo inset illustrates the pegmatitic granite in the upper part of the deformation zone. Note that this interval has a low fracture frequency. Higher frequencies of gently dipping fractures occur in narrow zones that are clearly identified using geophysical methods.

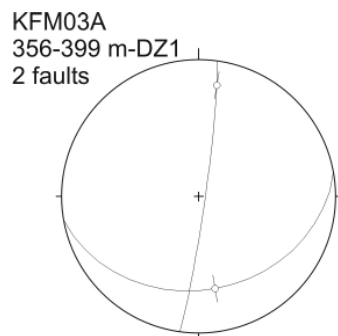
**Figure 5-60.** Stereoplot of fault slip data in DZ1 (KFM03A).

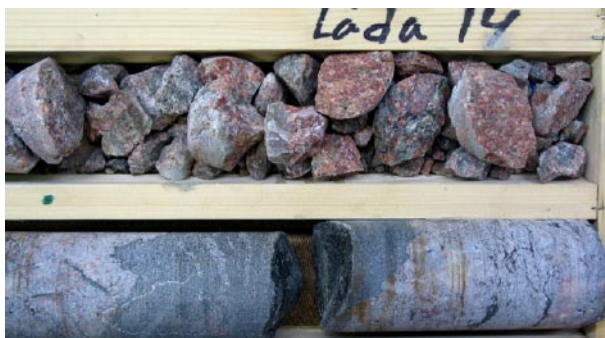
**Figure 5-62.** The drill core is highly fractured and broken into variably sized pieces. The rock is oxidised with quartz and epidote on broken fragments DZ2, ca. 65 m (KFM03B).

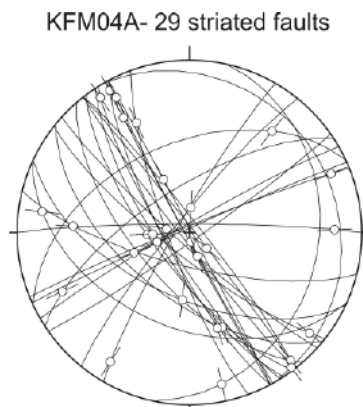
Figure 5-63. Stereonet showing all the fault slip data collected along all the studied DZ of drill core KFM04A.

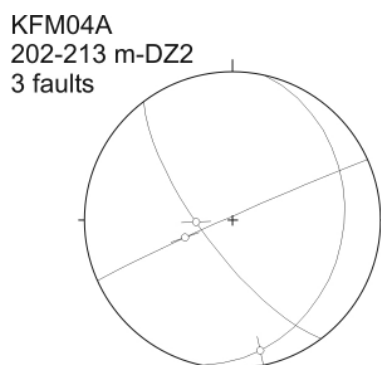
**Figure 5-66.** Stereoplot of fault slip data in DZ2 (KFM04A).

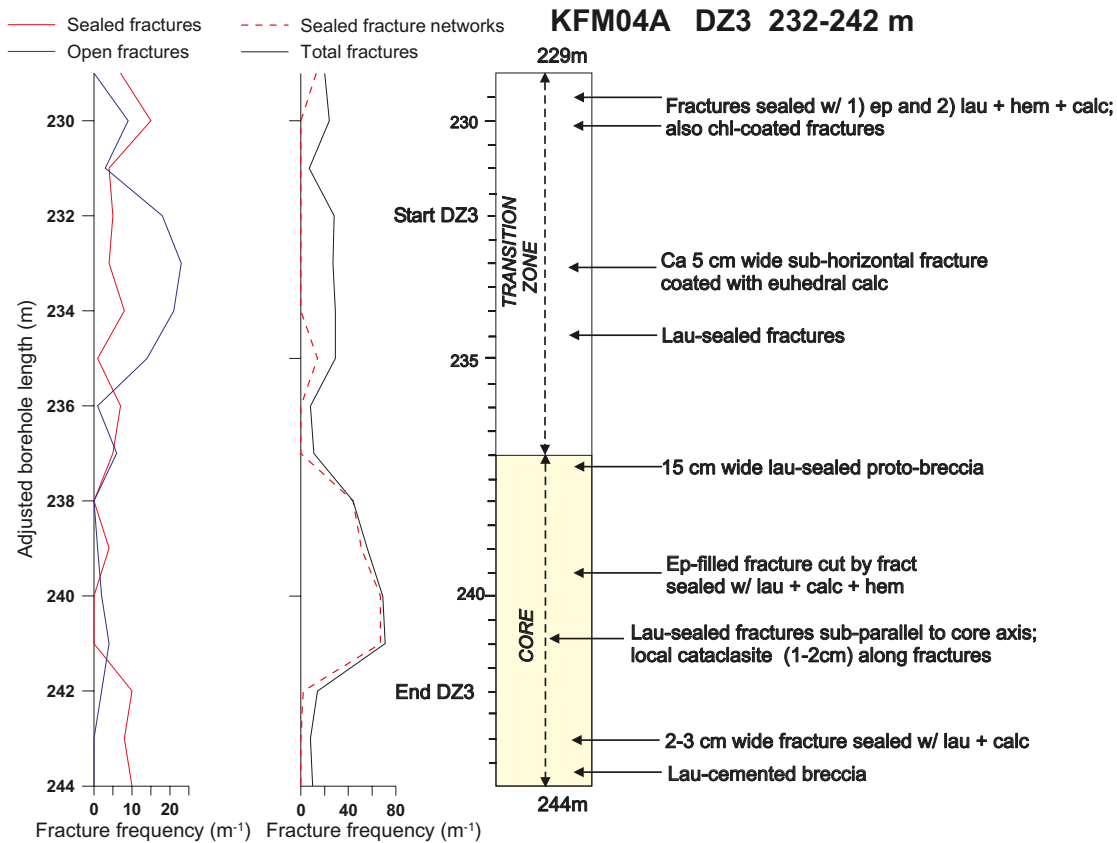
**Figure 5-67.** Simplified drawing of DZ3. The upper part of the investigated interval (229–237 m) is considered a transition zone with local fault core (Munier et al. 2003). The lower part (237–244 m) is a fault core with relatively abundant sealed fractures and small faults. Specific features include: At 229.4 m: Fractures sealed with 1) epidote; 2) laumontite+hematite+calcite. Also chlorite-covered fractures with calcite and prehnite (?). At 237.3 m: Laumontite-cemented proto-breccia (ca. 15 cm wide); little rotation of the clasts. From 237 m and below (see Figure 5-68): Faults and network of sealed fractures sub-parallel to the core axis. Very fine-grained zones of cataclasite (laumontite+hematite+calcite), 1–2 cm wide, are developed along the faults. Note that strong fracturing continues below the defined base of the zone at 242 m.

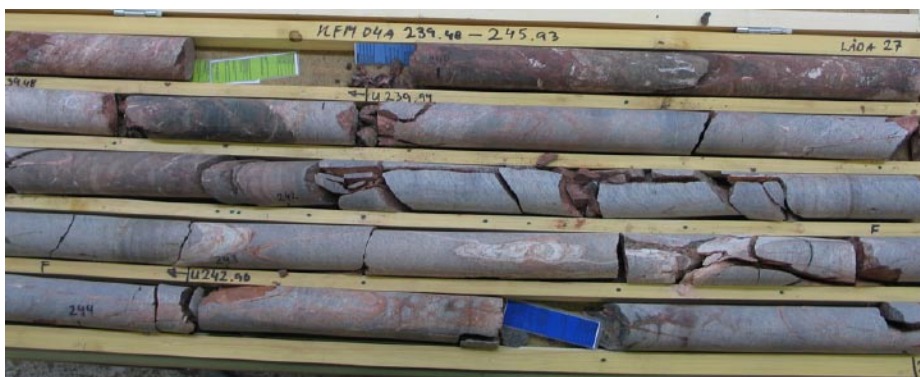
**Figure 5-68.** Overview showing the lower part of DZ3. Note the abundant fractures and faults that are sub-parallel to the core and filled with laumontite and calcite.

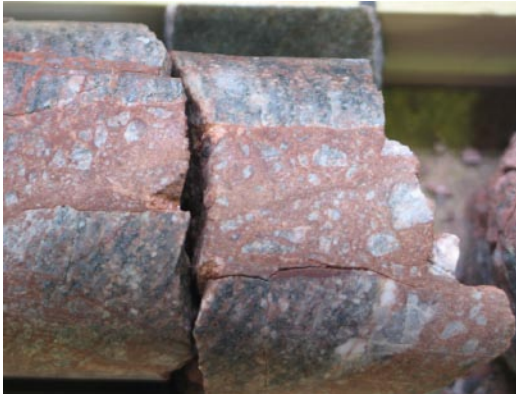
**Figure 5-69.** Section of core showing laumontite-cemented breccia and cataclasite. KFM04A, DZ3; 244.10 m.

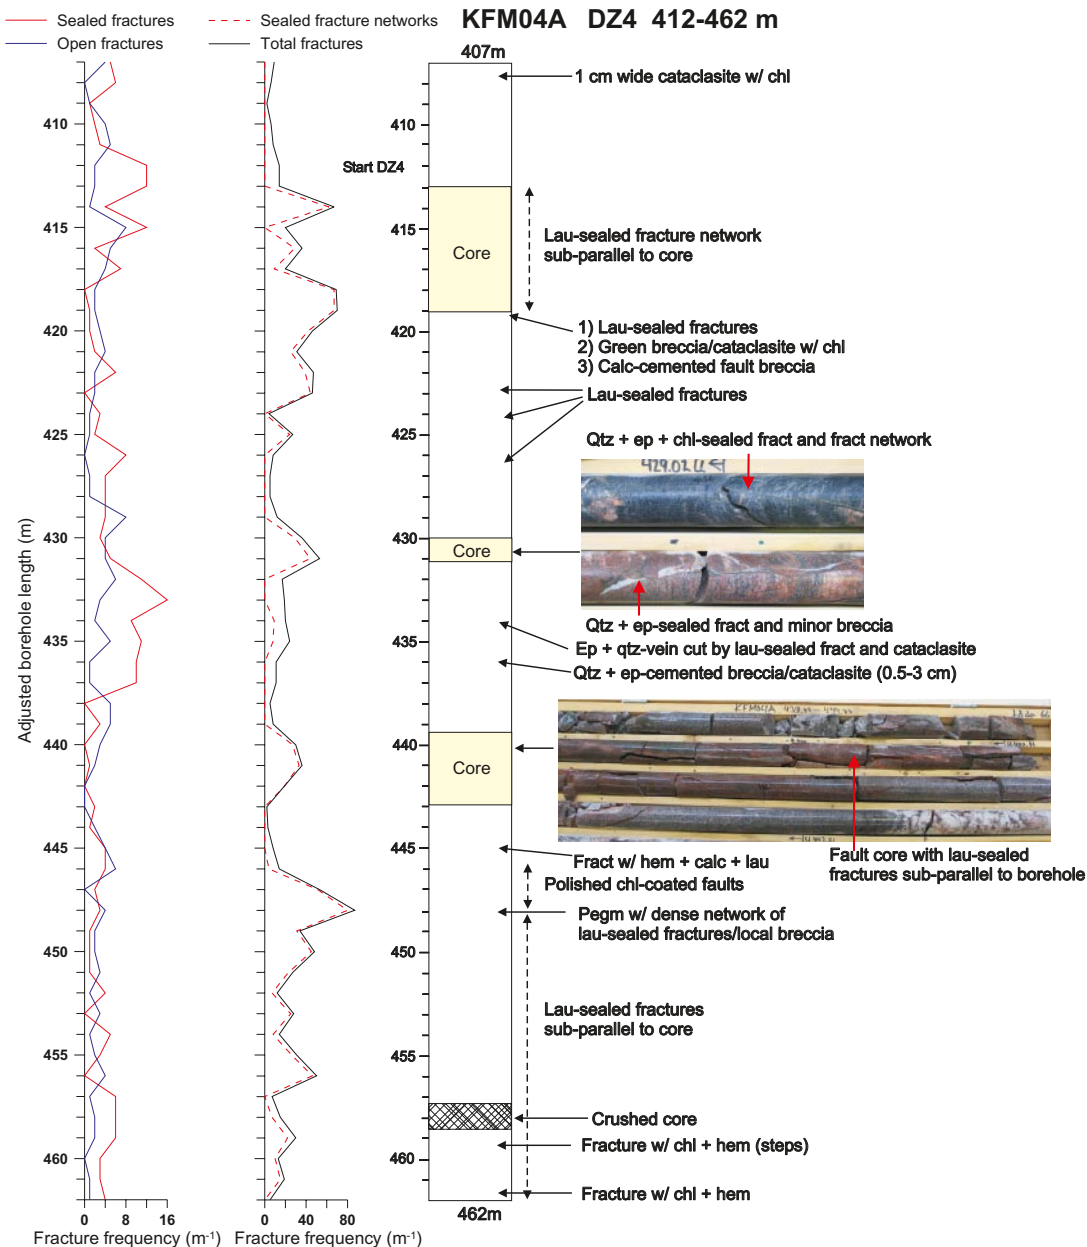
**Figure 5-72.** Simplified drawing of DZ4. A number of sections along this interval are characterized by abundant laumontite-sealed fractures and fracture networks. The photo of the core at ca. 431 m shows a reddish, oxidized host rock cut by a sharply defined fault and fracture network sealed mainly with epidote and quartz. The amphibolite (ca. 430 m, upper part) is cut by a quartz+epidote+chlorite-sealed minor fault and fractures. These fractures predate the laumontite-sealed fractures. Calcite-cemented fractures and fault breccias are younger than the laumontite-sealed fractures.

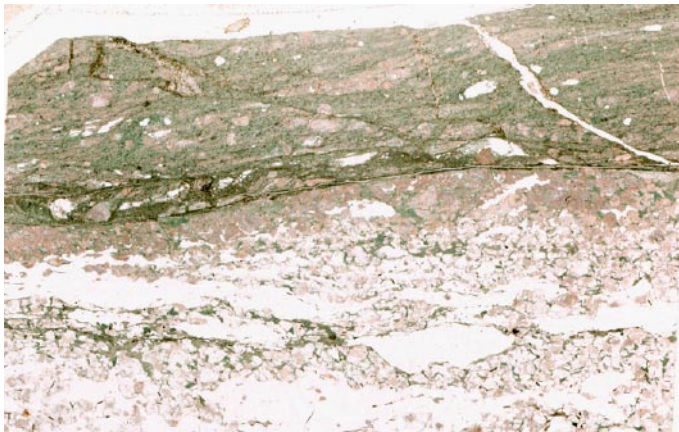
**Figure 5-73.** Scanned thin section from DZ4 of KFM04A\_407.4. A ca. 1 cm wide greenish, chlorite-rich semi-ductile shear zone (upper half) predates a thin cataclasite occurring along a planar zone along the shear zone. The vein-like feature in the upper left has no mineral fill. Field of view is 35 mm wide.

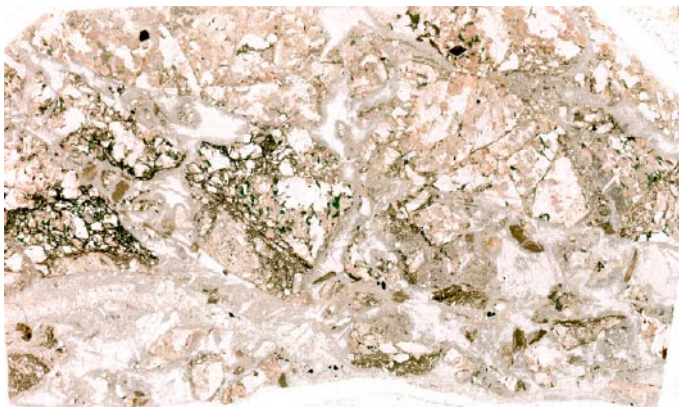
**Figure 5-74.** Scanned thin section from DZ4 of KFM04A\_419.2. The sample shows 1) early alteration (chlorite, epidote) associated with cataclasis/brecciation of the host rock, 2) reactivation and growth of laumontite and feldspar(?), 3) growth of euhedral quartz followed by calcite on the walls of open voids and fractures (see Figure 5-75 below). The field of view is 35 mm wide.

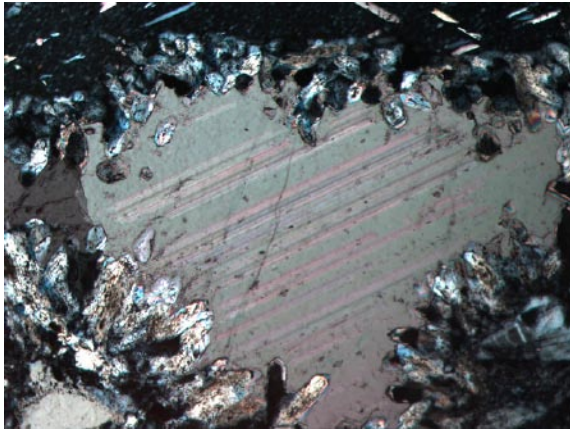
**Figure 5-75.** Details from thin section KFM04A\_419.2 shown in Figure 5-74. Growth of euhedral quartz followed by calcite has taken place on the walls of open voids and fractures in the fault rock. The field of view is ca. 1.3 mm wide.

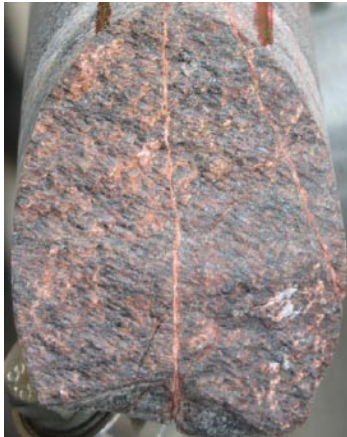
**Figure 5-76.** Planar fractures with chlorite, hematite and laumontite. Note steps on the surface. Later laumontite-filled fractures intersect the fault surface. KFM04A, 459.3 m.

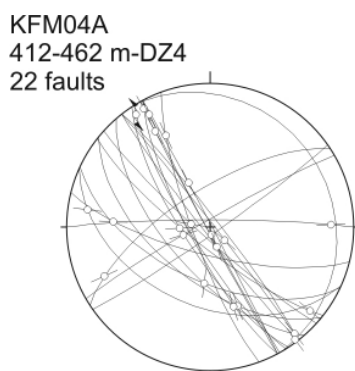
**Figure 5-77.** Stereoplot of fault slip data in DZ4 (KFM04A).

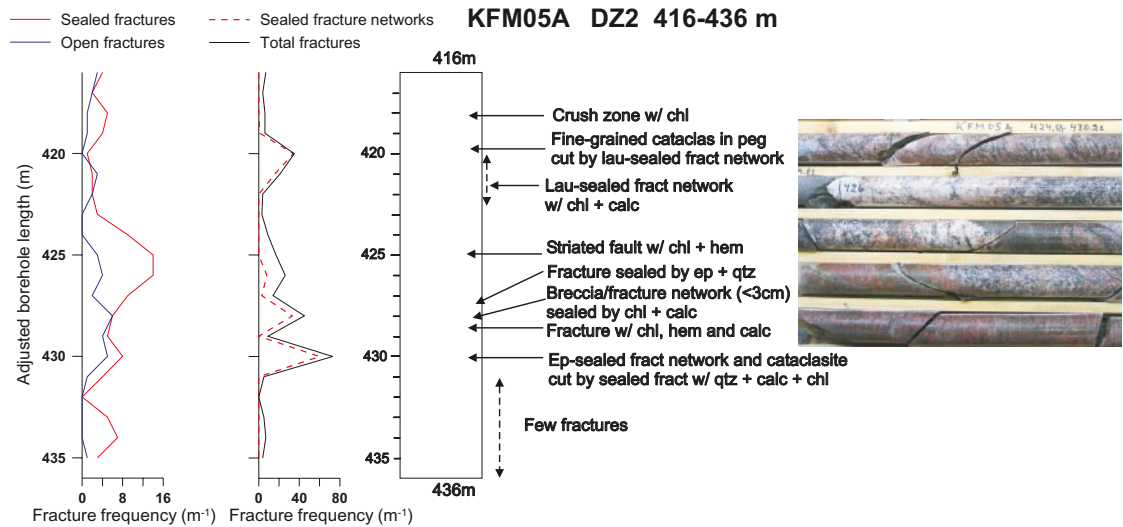
**Figure 5-78.** Simplified drawing of KFM05A, DZ2. A number of different deformation products are present throughout the zone, however, relatively few fractures are present in the upper and lower part of the investigated section. A crush zone with chlorite is present near the top of the zone. The photo of the core shows the interval between ca. 425 and 430 m. Note moderate fracture frequency and weak reddish to pink alteration of the metagranite. Fractures are filled/coated with quartz + epidote, and chlorite + calcite ± laumontite ± hematite. Laumontite and calcite generally postdate quartz and epidote as fracture fill.

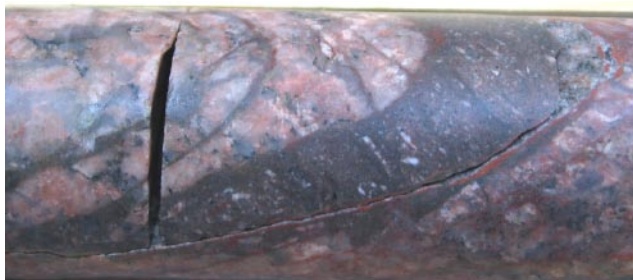
**Figure 5-79.** KFM05A, DZ2, ca. 419.8 m, up is to the left. Fine-grained cataclasite with fragments of the host metagranite. Note thin fractures in the hanging wall that relate to the cataclasite and a younger, reddish fracture filled with laumontite(?) close to the footwall of the cataclasite.

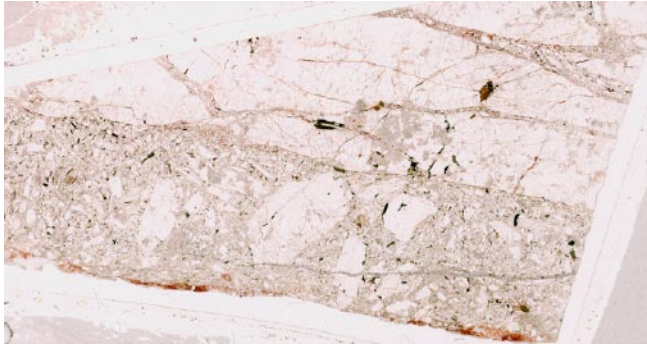
**Figure 5-80.** Scanned thin section of sample KFM05A, DZ2, ca. 419.8 m. Note angular fragments of variable size in the cataclasite occupying the lower half of the section. Strong crushing has also occurred along variably oriented, discrete fractures in the hanging wall of the main cataclasite. The field of view is ca. 35 mm wide.

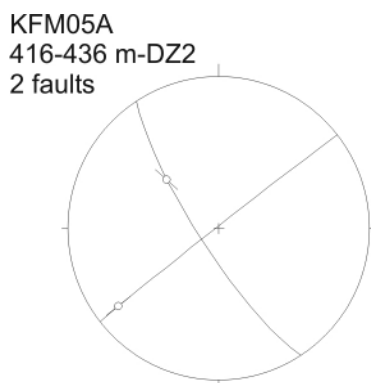
**Figure 5-81.** Stereoplot of fault slip data in DZ2 (KFM05A).

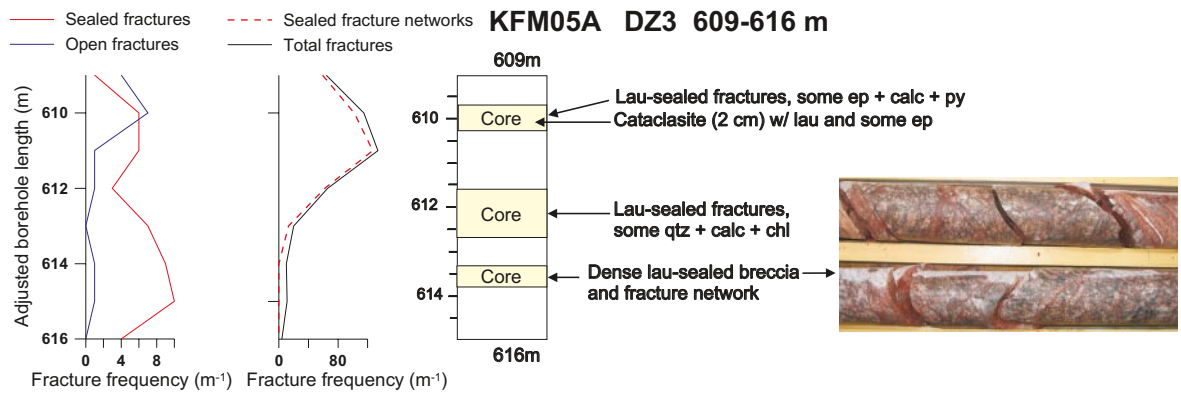
**Figure 5-82.** Simplified drawing of the upper part of KFM05A, DZ3. In some intervals, the rocks are cut by dense arrays of mainly laumontite-sealed fractures. A thin cataclasite is also present at ca. 610 m. The photo shows an interval from the fault core with abundant fractures sealed with laumontite and some calcite.

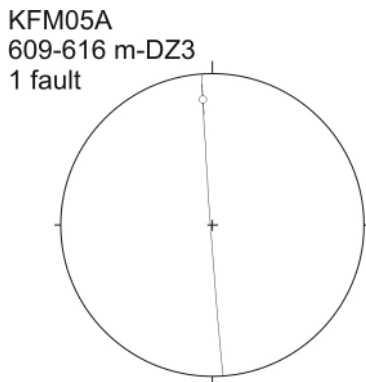
**Figure 5-83.** Stereoplot of fault slip data in the upper part of DZ3 (KFM05A).

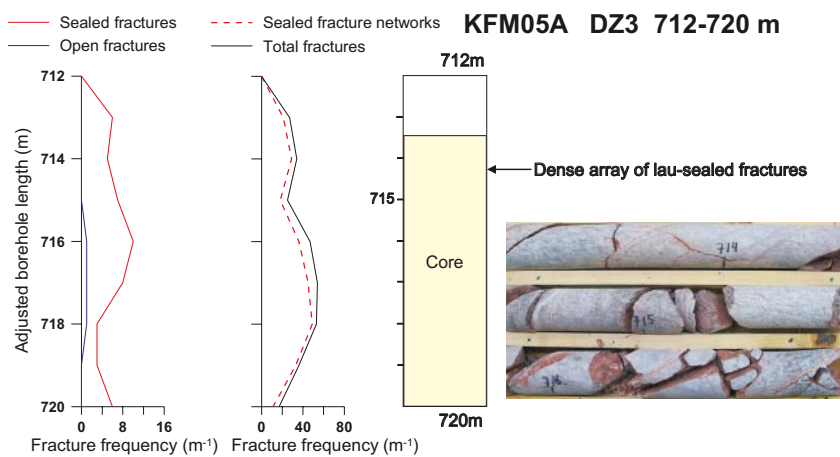
**Figure 5-84.** Simplified drawing of the lower part of KFM05A, DZ3. From ca. 713.5 down to 720.5 m, the rocks are cut by dense arrays of mainly laumontite-sealed fractures with local fault breccias containing small clasts in a laumontite-sealed matrix. The photo shows an interval from the fault core with abundant laumontite-filled fractures.

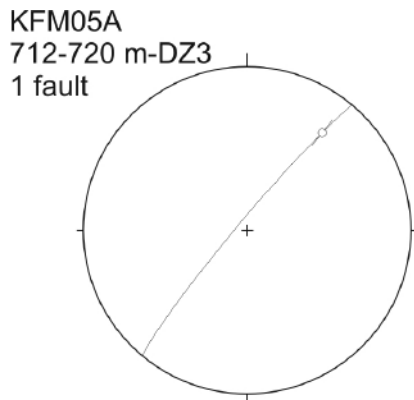
*Figure 5-85. Stereoplot of fault slip data in the lower part of DZ3 (KFM05A).*

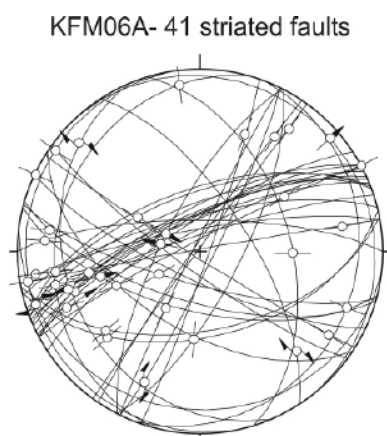
*Figure 5-86. Stereoplot showing all the fault slip data collected along all the studied DZ of drill core KFM06A.*

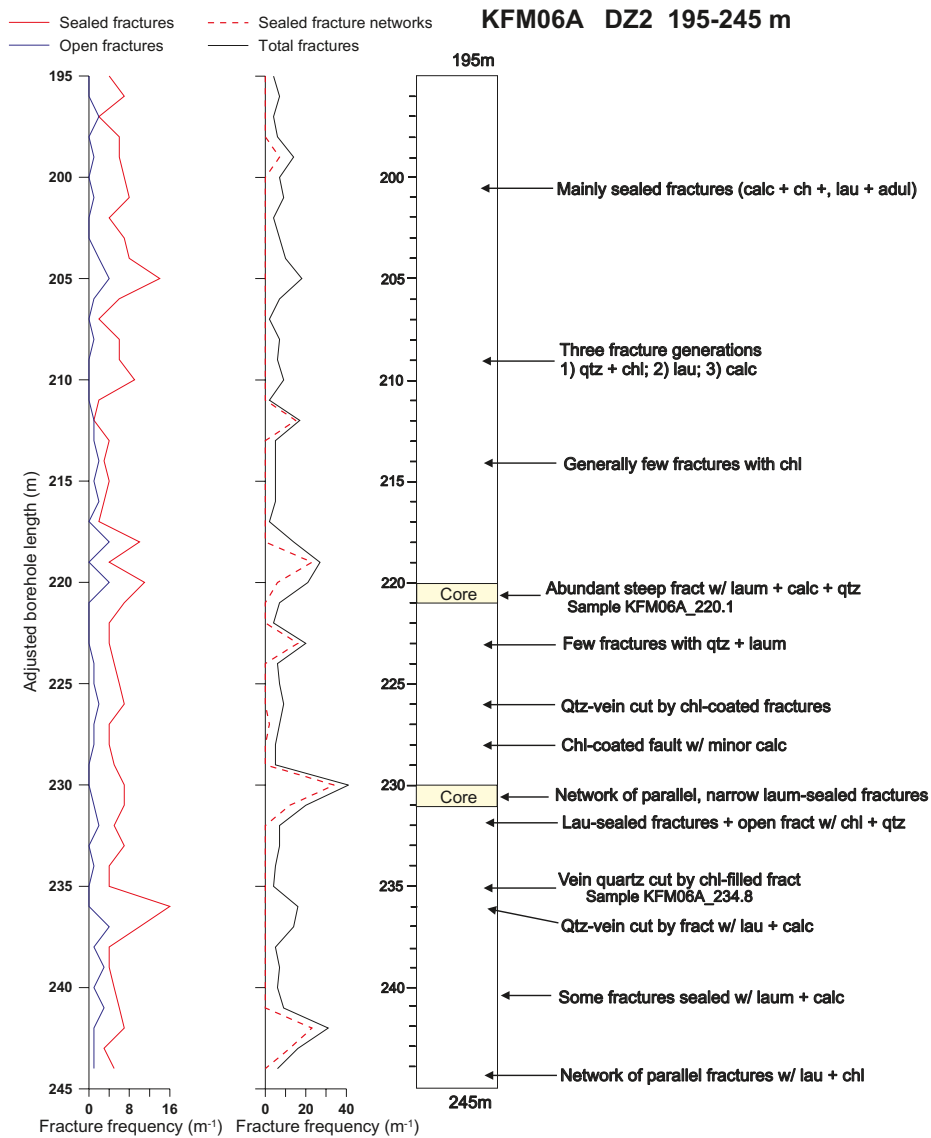
**Figure 5-89.** Simplified drawing of KFM06A, DZ2, showing the occurrences of the most significant brittle deformation features. At ca. 220–221 m, there are abundant steep fractures filled with laumontite, quartz and some calcite (Figure 5-89, 5-90 and 5-91). Networks consisting of narrow laumontite-sealed fractures occur at 230–231 m. These intervals are defined as fault core; otherwise DZ2 is a transition zone /Munier et al.2003/.

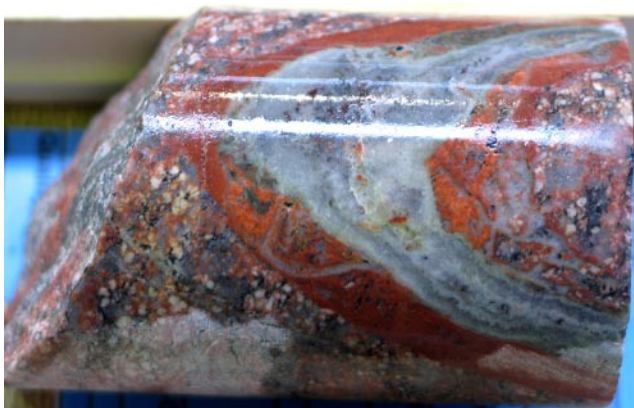
**Figure 5-90.** KFM06A, DZ2, ca. 220.1 m, up is to the left. Medium-grained metagranite with pink staining is cut by a sealed fault with laumontite and quartz, and minor fractures with laumontite, calcite and quartz (for textural details, see Figure 5-91, below).

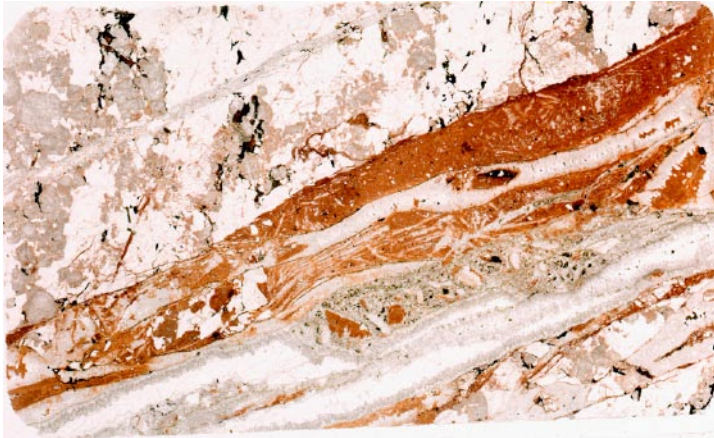
**Figure 5-91.** Scanned thin section of sample KFM06A\_220.1, DZ2. The metagranite (up to the left) is traversed by a fracture zone containing quartz and calcite. The lower part of the section exhibits a brownish laumontite fracture fill followed by quartz that has grown as euhedral crystals perpendicular to the walls of the fractures. The textures suggest that the quartz has grown in dilational open voids rather than during incremental opening of fractures in the laumontite (see detail from thin section in Figure 5-92, below). This reflects a change in the fluid composition through time. The field of view is 35 mm wide.

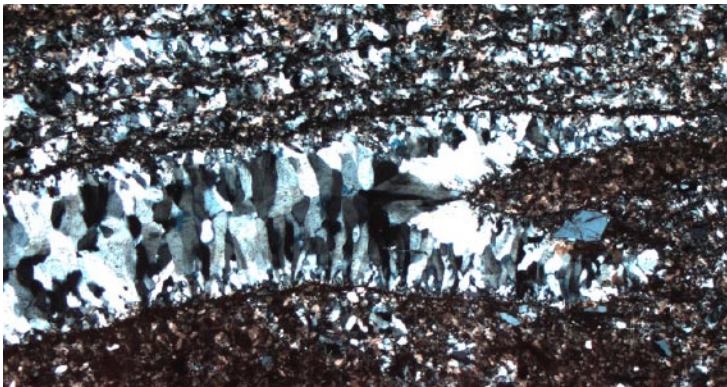
**Figure 5-92.** Photomicrograph from thin section of sample KFM06A\_220.1, DZ2, showing quartz that has grown as euhedral crystals perpendicular to the walls of open voids. The field of view is ca. 3 mm wide.

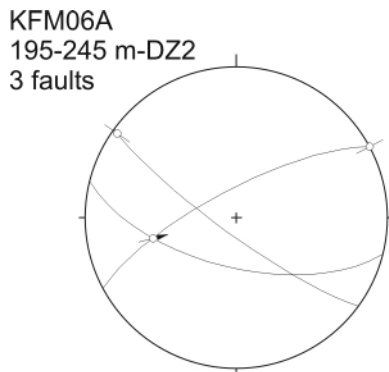
**Figure 5-95.** Stereoplot of fault slip data in DZ2 (KFM06A).

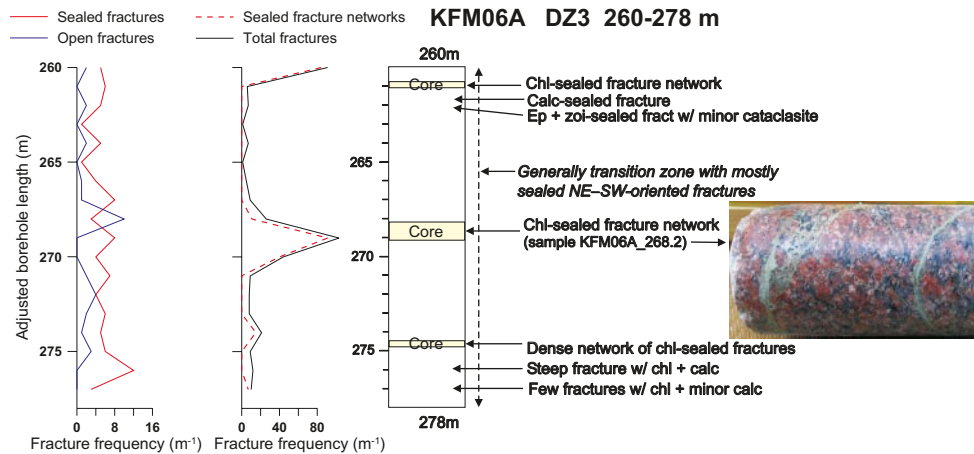
**Figure 5-96.** Simplified drawing of KFM06A, DZ3, showing the occurrences of significant brittle deformation features. Chlorite-sealed fracture networks with local crushing of the host rock are present at ca 260.5 m, at 268.2–269.2 m, and at 274.5 m. The photo shows the core section that was sampled at 268.2 m, up is to the left. Medium-grained, pink and partly chloritised metagranite is cut by epidote+zoisite-filled thin veins containing small fragments of the host rock (see Figure 5-97 for textural details).

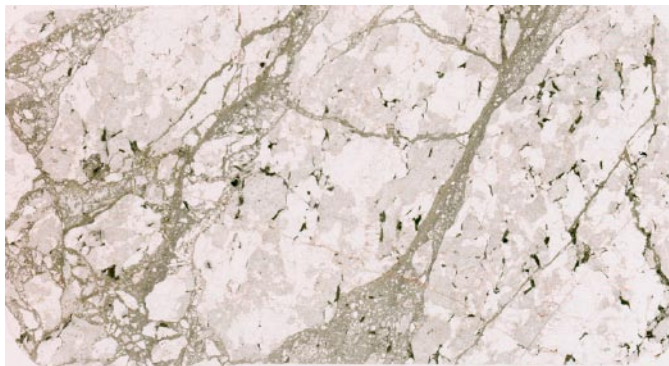
**Figure 5-97.** Scanned thin section of sample KFM06A\_268.2, DZ3. Variably oriented fractures with crushed and finely crushed metagranite host rock. Chlorite, epidote and clinozoisite fill the space between the angular fragments. The field of view is ca. 35 mm wide.

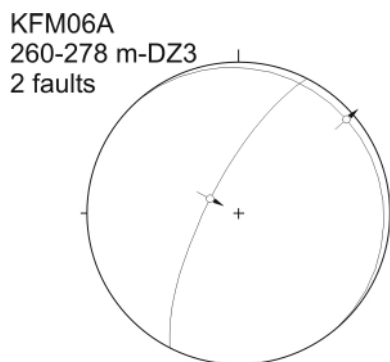
**Figure 5-98.** Stereoplot of fault slip data in DZ3 (KFM06A).

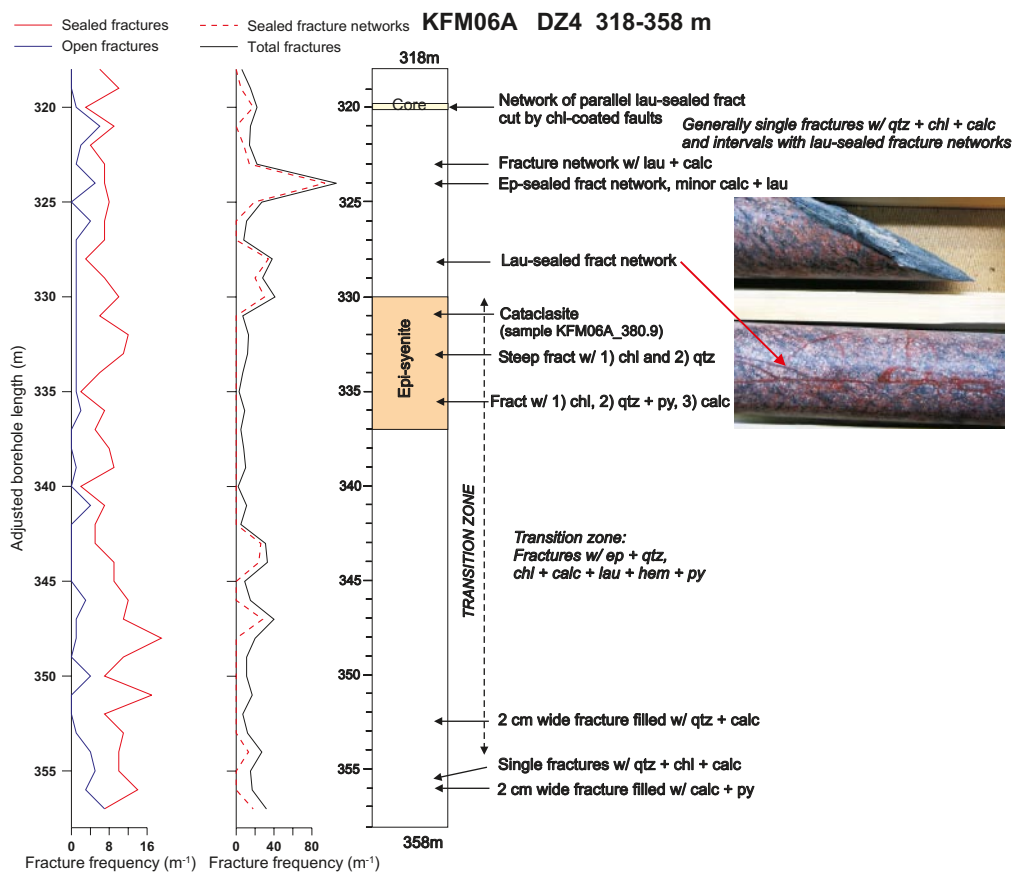
**Figure 5-99.** Simplified drawing of KFM06A, DZ4, showing the occurrences of significant brittle deformation features. The interval from 330 to 342 m is considered a transition zone /Munier et al. 2003/. The upper and lowermost parts of DZ4 have sporadic intervals of fault core defined by sealed fracture networks; apart from these intervals this part of DZ4 is a transition zone. The photo shows laumontite-sealed fractures in metagranite from ca. 328 m (lower part) and a chlorite-sealed broken fracture (upper part). Generally, epidote, quartz and chlorite predate laumontite and calcite. However, chlorite-coated fractures post-date laumontite, and late quartz growth has also been recorded followed by calcite (Figure 5-101).

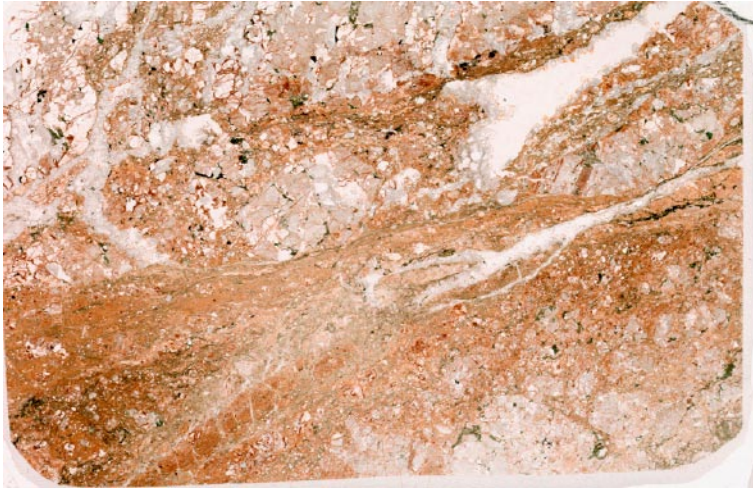
**Figure 5-100.** Scanned thin section of sample KFM06A\_330.9, DZ3. Cataclasite and ultracataclasite showing a sequence of increasing degradation of the host metagranite. The colour of the fine-grained fault rocks is due to fine dusting of laumontite. Note that quartz and calcite fill what appear to have been open voids in the cataclasite. The field of view is ca. 35 mm wide. See Figure 5-101 below for details.

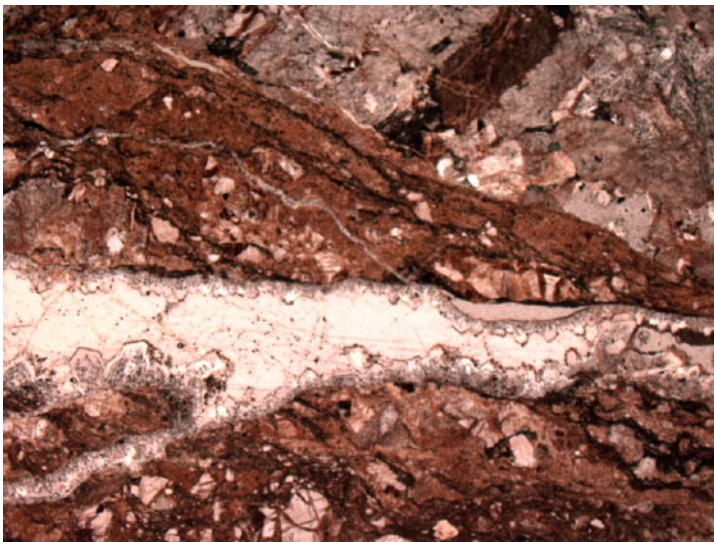
**Figure 5-101.** Photomicrograph showing details from the thin section of sample KFM06A\_330.9, DZ4 (see Figure 5-100 above). A finely layered or laminated, brownish, fine-grained cataclasite containing small angular fragments transects earlier brittle structures (upper right) also showing cataclastic textures. The brown cataclasite is in turn post-dated by a pale vein with quartz and calcite. The textures of the vein suggest that euhedral quartz has grown normal to the walls of dilational open voids in the cataclasite, later followed by calcite closing the voids. The field of view is ca. 5 mm wide.

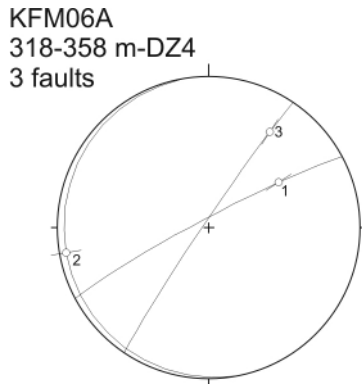
Figure 5-102. Stereoplot of fault slip data in DZ4 (KFM06A).

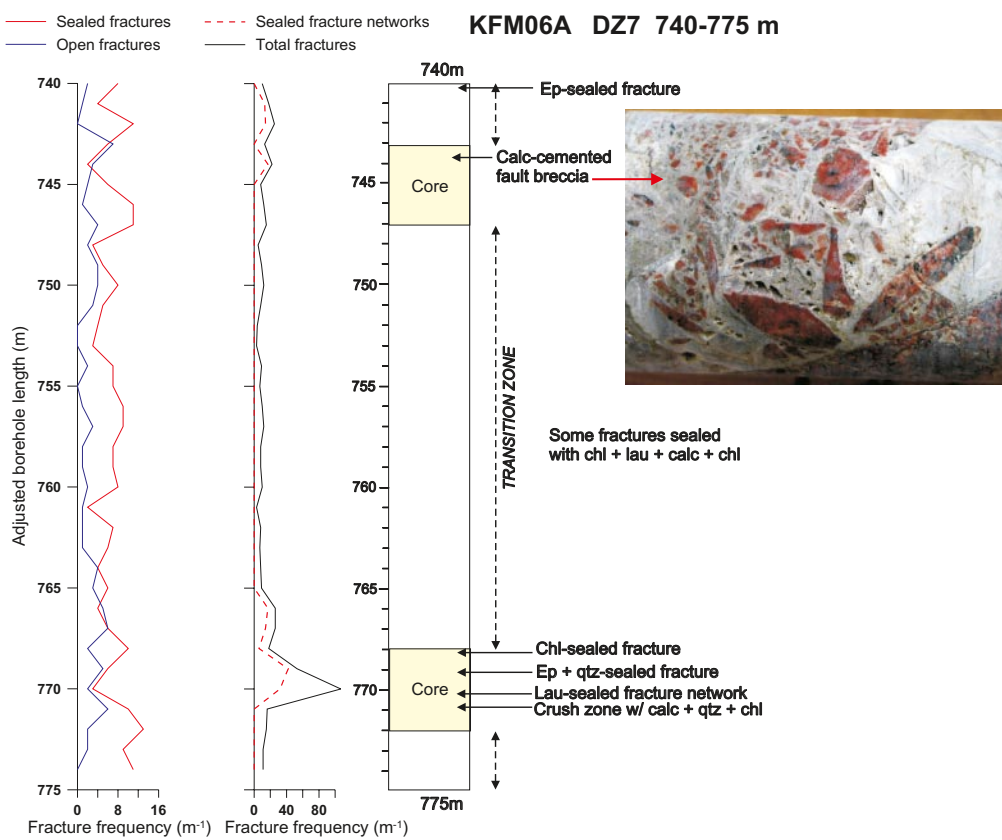
Figure 5-103. Simplified drawing of KFM06A, DZ7, showing the occurrences of significant brittle deformation features. Two intervals are considered to be fault core, whereas the remaining part of the DZ7 is considered a transition zone /Munier et al. 2003/. The photo shows a section of core from 743.5 m; up is to the left. A ca. 5 cm wide fault consists of angular, rotated fragments of the host metagranite embedded in euhedral calcite that has cemented the fault. Note the sharply defined wall of the fault at lower right. The central damage zone of this small fault may have formed by hydraulic fracturing creating the angular rock fragments.

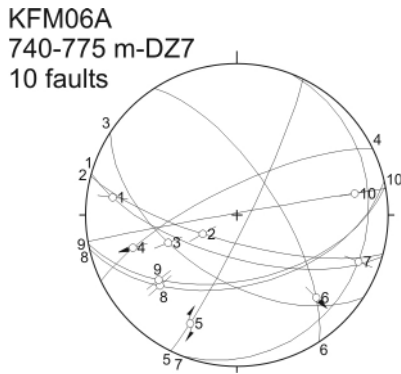
**Figure 5-104.** Stereoplot of fault slip data in DZ7 (KFM06A).

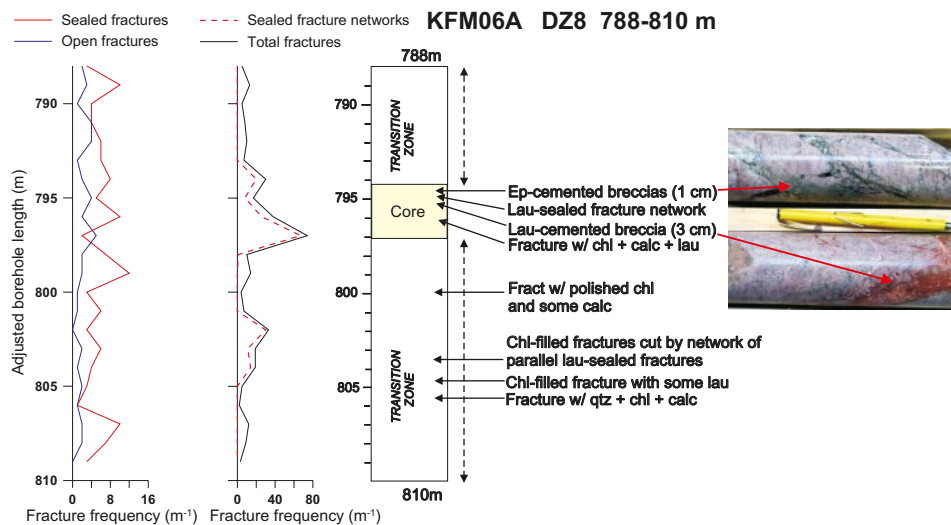
**Figure 5-105.** Simplified drawing of KFM06A, DZ8, showing the occurrences of selected brittle deformation features. One interval is considered to be fault core, whereas the remaining part of the DZ7 is considered a transition zone /Munier et al. 2003/. The photo shows two sections of core from KFM06A. The upper part illustrates networks of epidote-cemented breccias and fractures at ca. 794.4 m. The lower part shows a ca. 3 cm wide laumontite-sealed breccia/cataclasite that occurs at ca. 795.2 m.

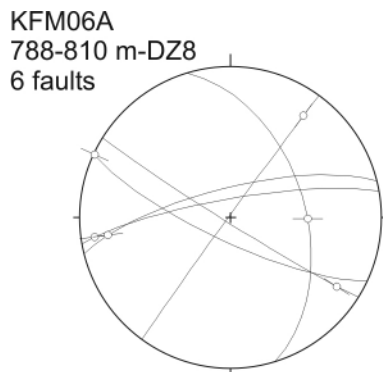
Figure 5-106. Stereoplot of fault slip data in DZ8 (KFM06A).
