## **Forsmark site investigation**

# **The character and kinematics of deformation zones (ductile shear zones, fault zones and fracture zones) at Forsmark – report from phase 1**

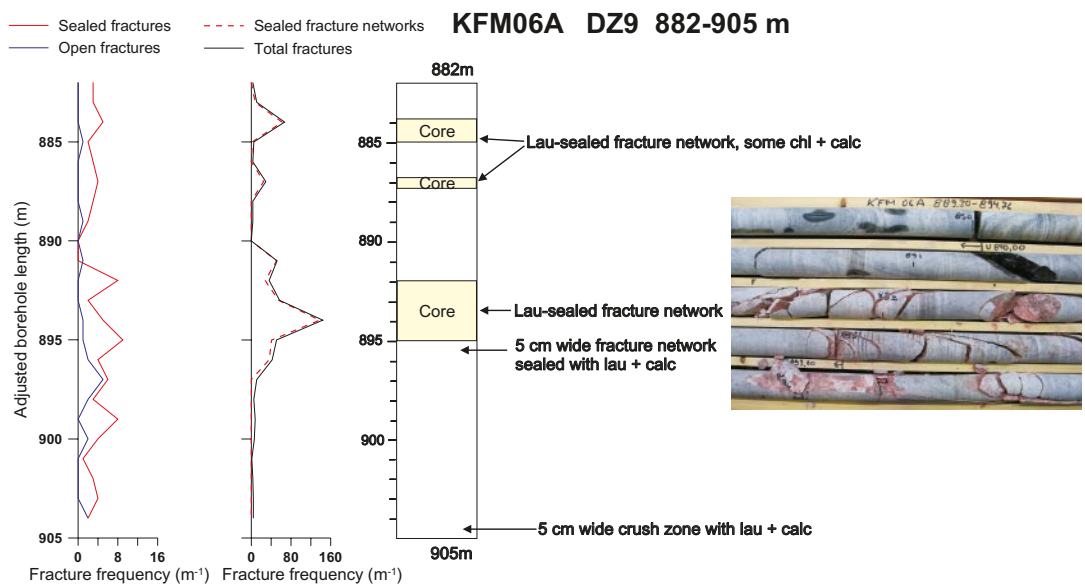
Figure 5-107. Simplified drawing of KFM06A, DZ9, showing the occurrences of selected brittle deformation features. Three intervals with a high frequency of laumontite-sealed fractures are defined as fault cores. The remaining part of DZ9 is considered a transition zone /Munier et al. 2003/. The photo shows a core section from 890–895 m (core box no. 150). Note few chlorite-coated fractures in the upper part down to 892 m, in contrast to the fairly dense set of laumontite-sealed fractures in the lower part. Some of the laumontite-sealed fractures were probably opened during drilling.

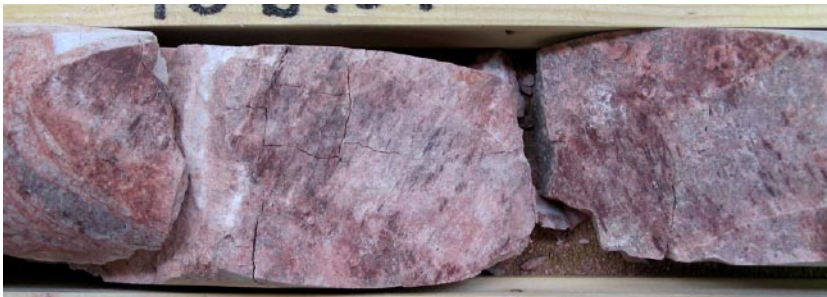
**Figure 5-108.** KFM06A\_895.4 m. Close-up of fault sealed with laumontite + calcite + minor chlorite. Striation documenting oblique relative movement occurs on a steeply NNW-dipping fault. Absolute movement cannot be determined from this observation.

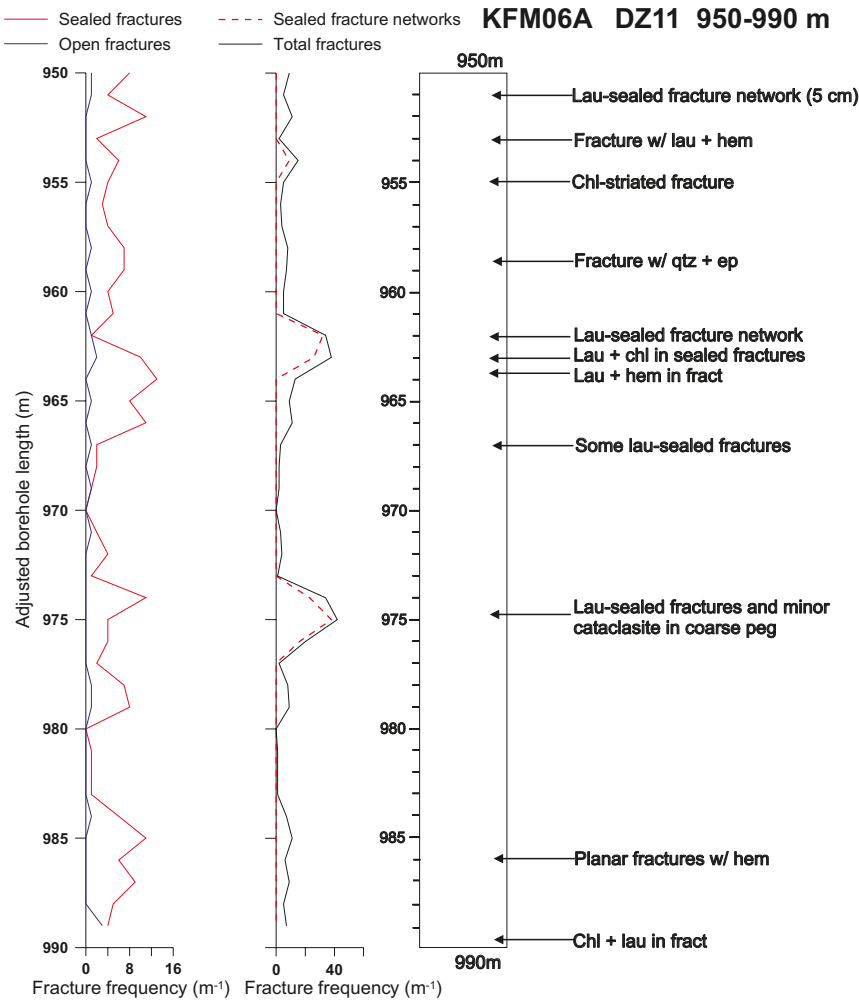
**Figure 5-111.** Simplified drawing of KFM06A, DZ11, showing the occurrences of brittle deformation features. The interval 967–973 m and 980–985 m generally contain fewer fractures that in parts is similar to the background level. The highest fracture frequencies occur in the upper and lower parts of DZ11, and some short sections may classify as fault core within a transition zone /Munier et al. 2003/.

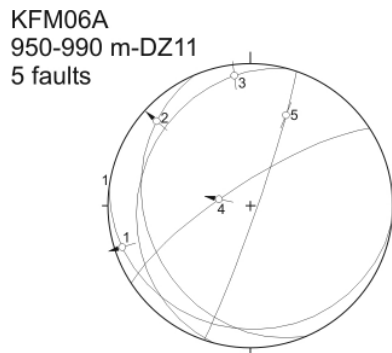
*Figure 5-112. Stereoplot of fault slip data in DZ11 (KFM06A).*

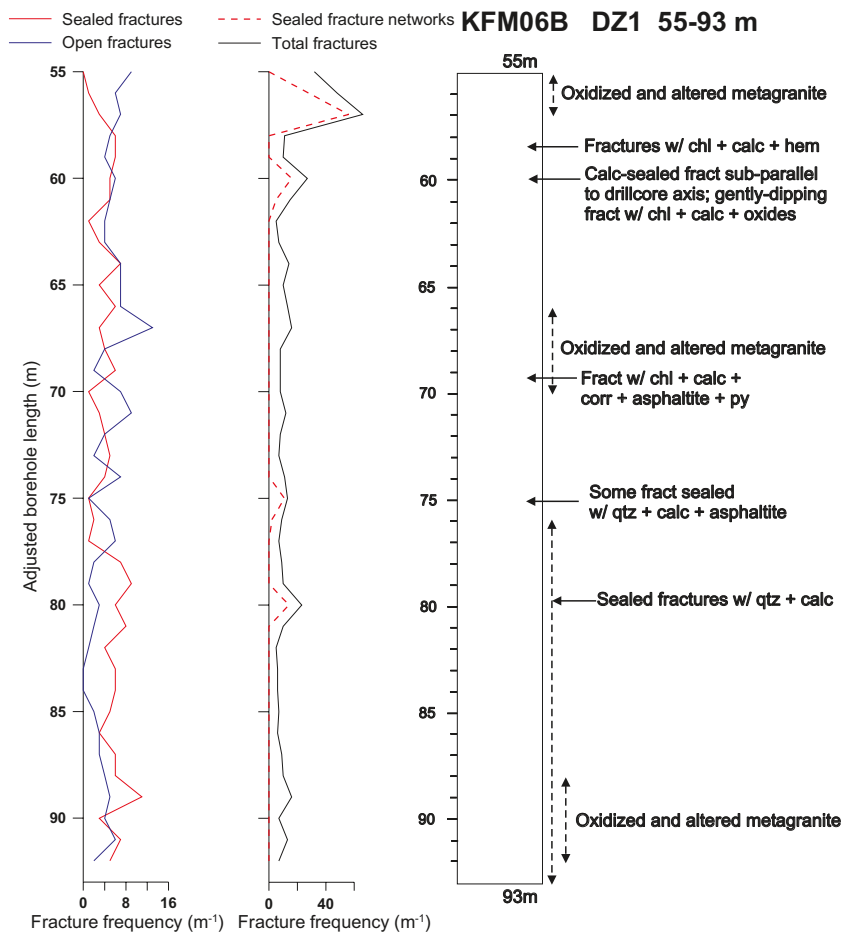
**Figure 5-113.** Simplified drawing of KFM06B, DZ1, showing the occurrences of brittle deformation features and alteration of the metagranite. Based on the recorded brittle deformation features, the observed fracture frequencies /Carlsten et al. 2005a/ and the definitions of /Munier et al. 2003/, the interval straddles the boundary between a fault core and a transition zone.

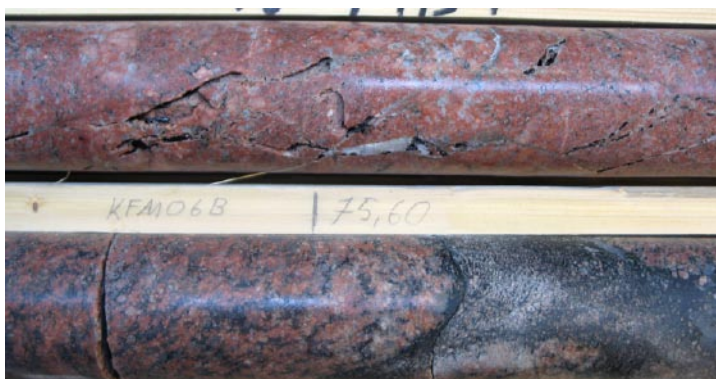
**Figure 5-114.** KFM06B\_75 m. Strong reddish alteration and abundant small fractures filled with quartz and calcite that has been partly dissolved.

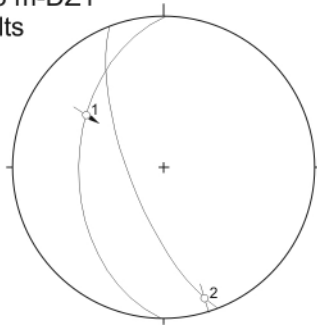
*Figure 5-115. Stereoplot of fault slip data in DZ1 (KFM06B).*

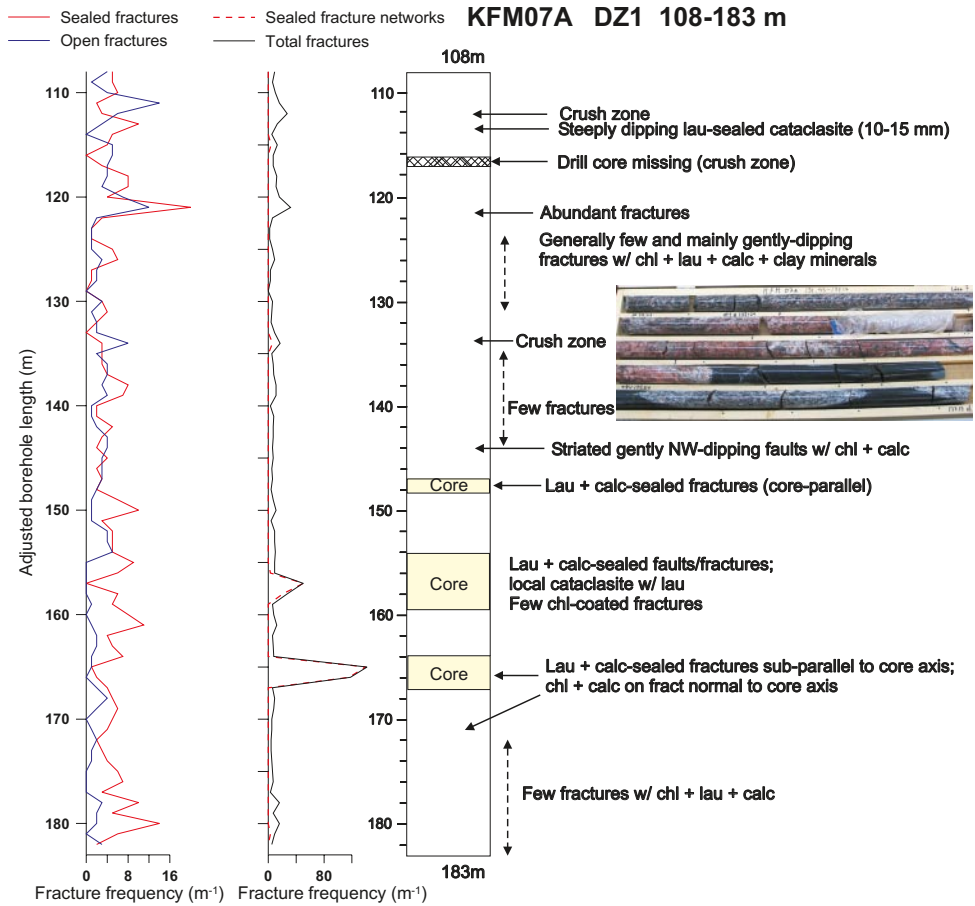
**Figure 5-117.** Simplified drawing of KFM07B, DZ1, showing the occurrences of important brittle deformation features. The deformation zone is for the most part a transition zone /Munier et al. 2003/, with some sections that are classified as fault core due to the presence of crush zones or core-parallel sealed fault sets.

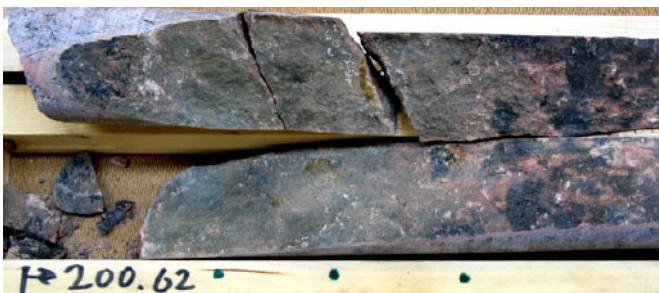
**Figure 5-121.** Photograph of core section at ca. 200.5 m. The fracture is sub-parallel to the core axis and sealed with laumontite + some calcite and chlorite. Note oxidation.

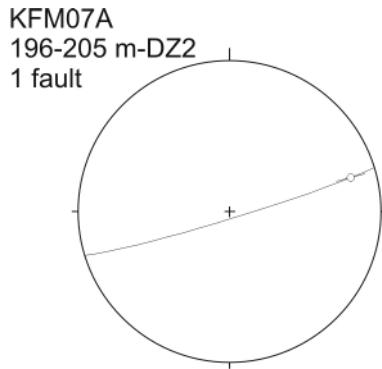
*Figure 5-122. Stereoplot of fault slip data in DZ2 (KFM07A).*

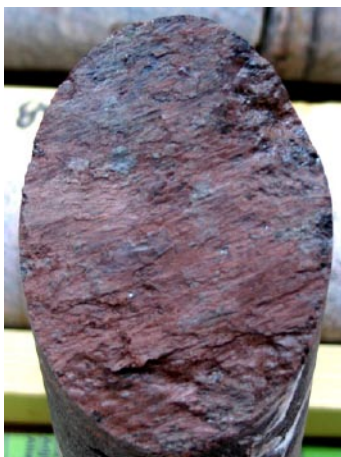
*Figure 5-123. KFM07A DZ3, 419.5 m. Striated fault surface with chlorite and dark red hematite.*

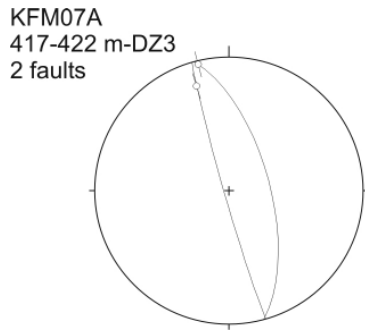
**Figure 5-124.** Stereoplot of fault slip data in DZ3 (KFM07A).

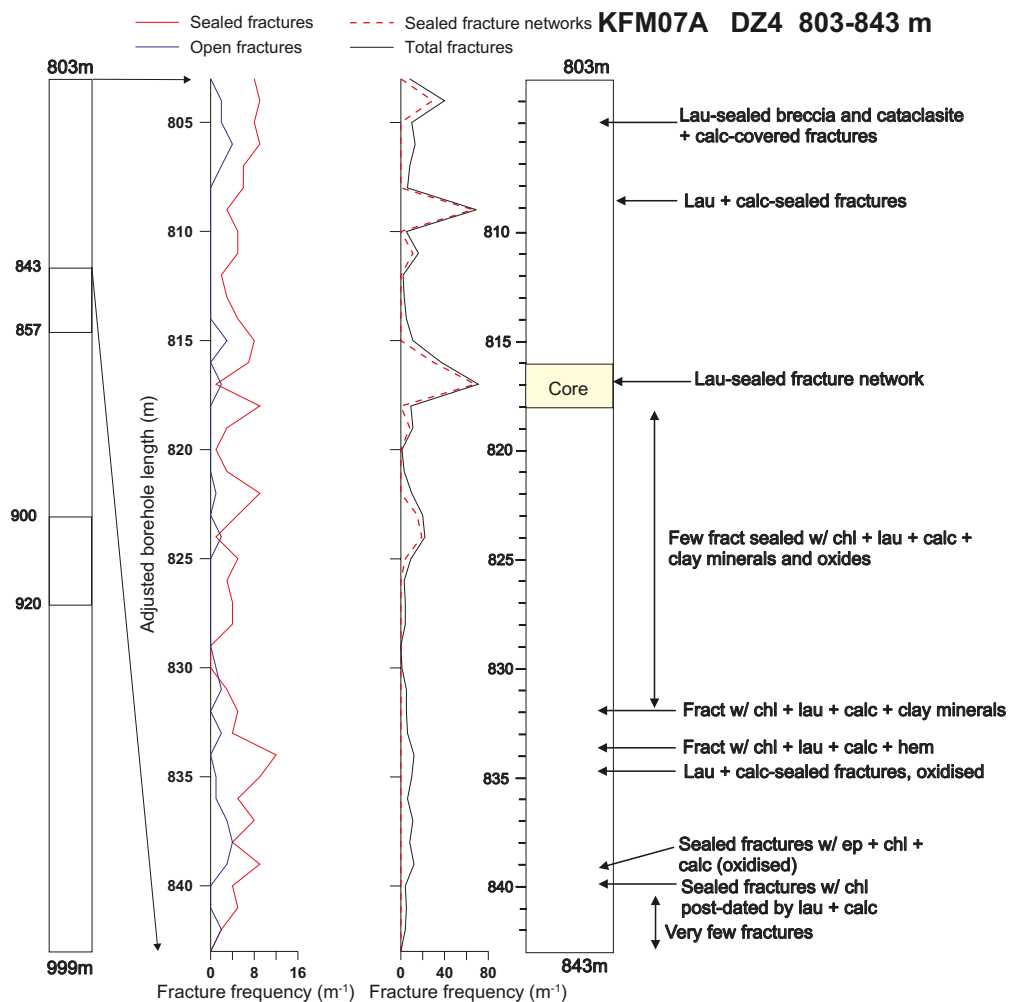
**Figure 5-125.** Simplified drawing of KFM07A, DZ4, showing the occurrences of brittle deformation features in the upper part of the zone (803–843 m). At 816–818 m, there are sub-parallel arrays of fractures and dense fracture networks that form up to ca. 10 mm wide zones cutting the foliation in the metagranite to metagranodiorite at a high angle (Figure 5-128). There is marked grain size reduction due to local crushing along the fractures (Figure 5-129).

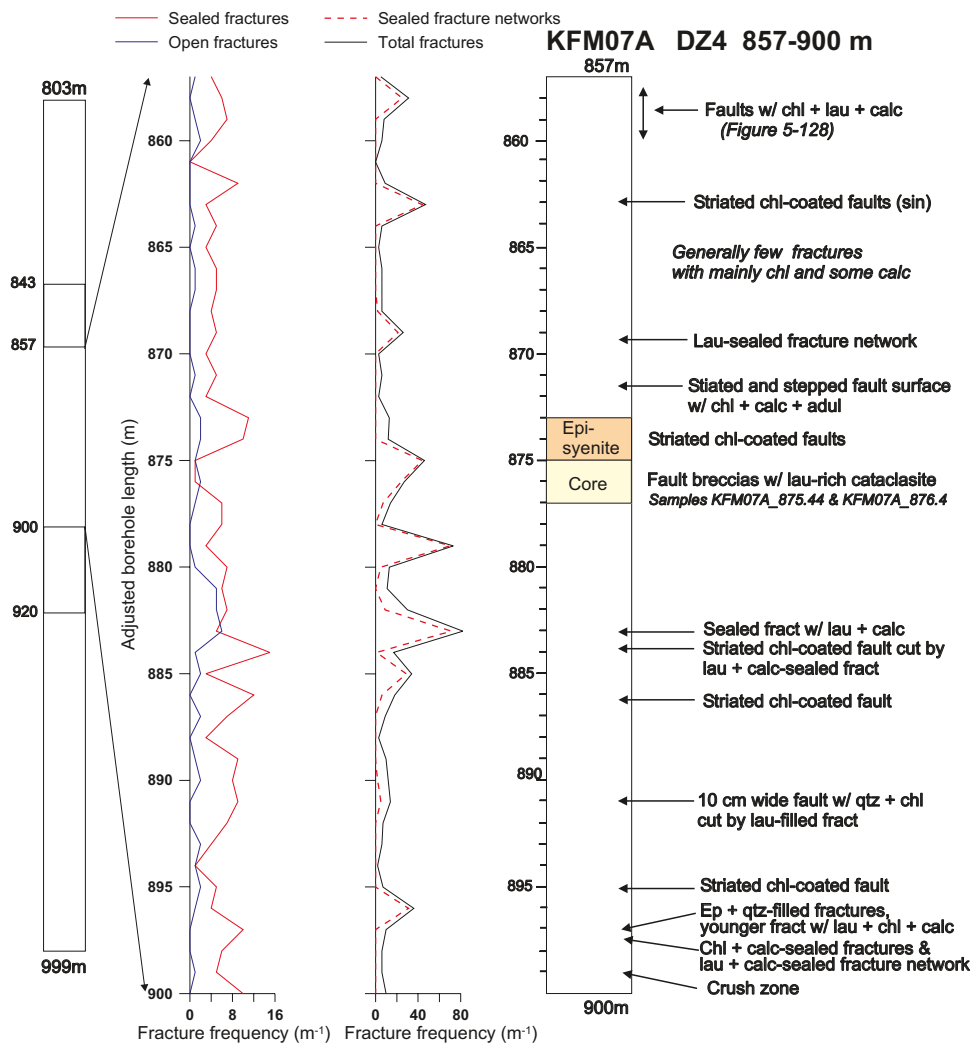
**Figure 5-126.** Simplified drawing of KFM07A, DZ4, showing the occurrences of brittle deformation features in the central part of the zone (857–900 m). See text for a more detailed description.

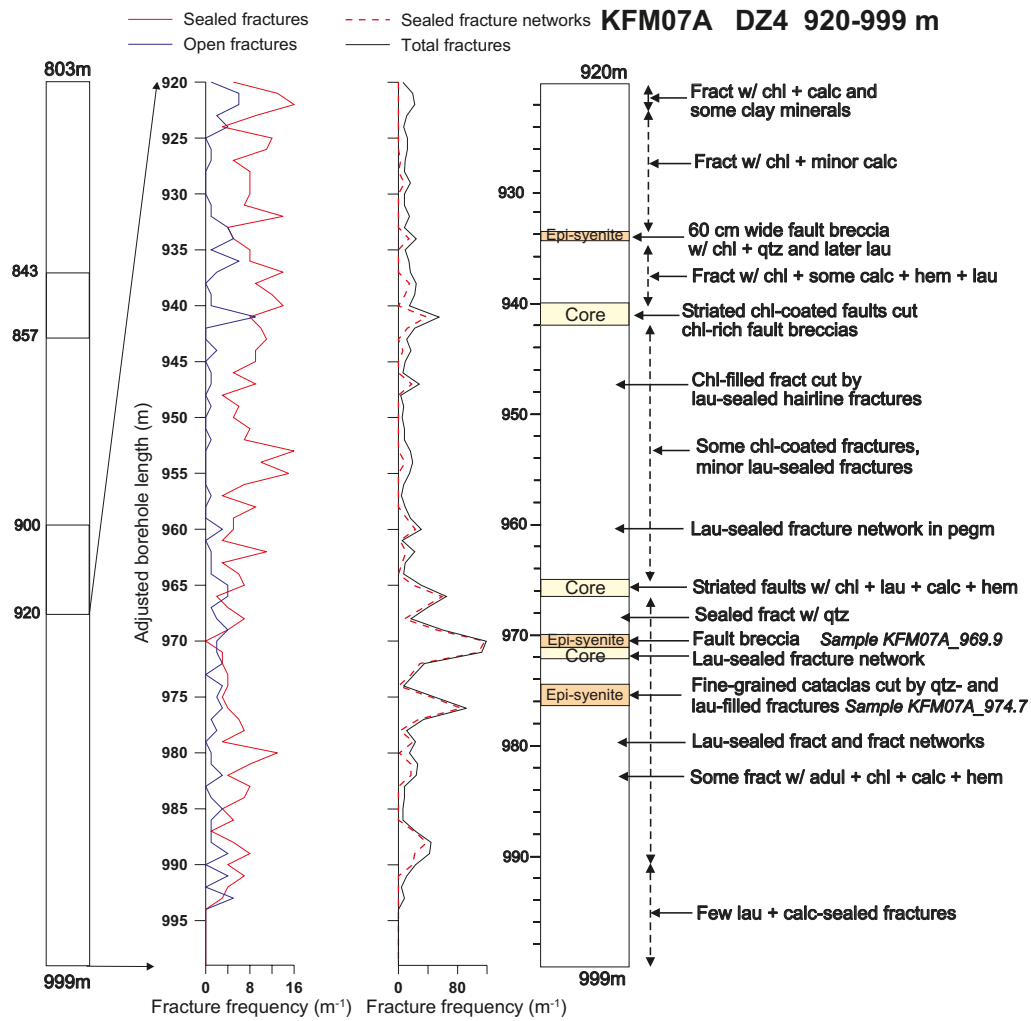
**Figure 5-127.** Simplified drawing of KFM07A, DZ4, showing the occurrences of brittle deformation features in the lower part of zone (920–999 m). See text (below) for a more detailed description.

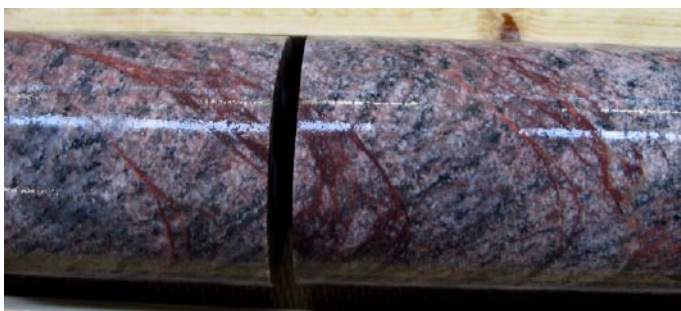
**Figure 5-128.** Core from KFM07A, 817.7 m, DZ4, up is to the left. Granodioritic gneiss is cut by laumontite-sealed fractures and fracture networks consisting of sub-parallel fractures and narrow zones with crushing of the host rock (see Figure 5-129 for details).

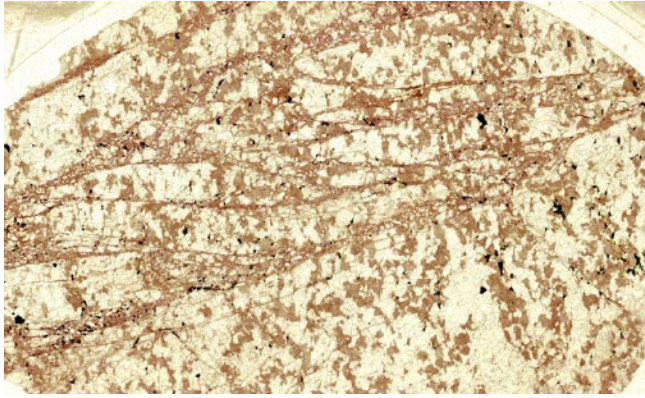
**Figure 5-129.** Scanned thin section of sample KFM07A\_817.7 m, DZ4. Metagranodiorite with faint foliation is cut by a ca. 1 cm wide zone showing strong fracturing with marked grain size reduction producing angular clasts in a fine-grained groundmass that contain epidote and chlorite. The zone is delimited by two parallel bounding fractures, and between these there are numerous slightly curved fractures intersecting each other at small angles. Reddish dusting (oxides and/or laumontite) along the fractures is prominent. The field of view is ca. 35 mm wide.

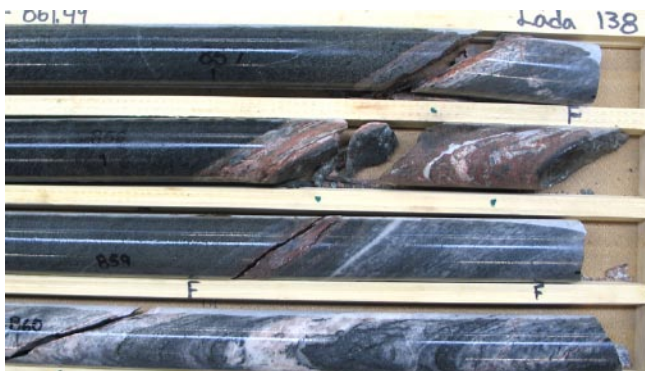
**Figure 5-130.** Core from KFM07A in the interval 857–860 m, DZ4. At ca. 858.3 m there is a 30 cm wide zone of fault rocks with chlorite, laumontite and calcite in addition to altered amphibolite. Minor faults are present at ca. 857.2 m and at 859.1 m. These structures are approximately parallel to the strong foliation in the amphibolitic to granitic host rocks. A minor laumontite-sealed fracture can be seen crossing the foliation at ca. 860 m.

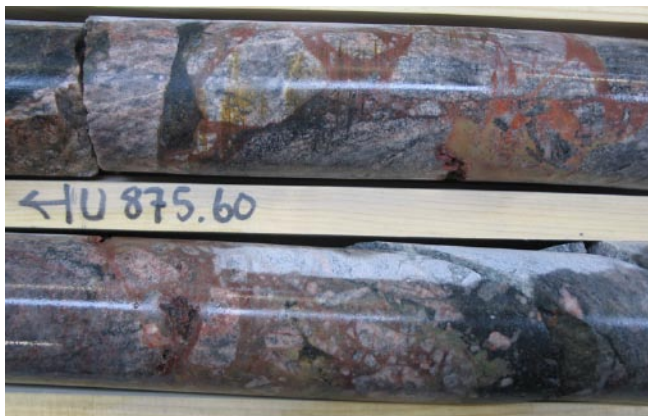
**Figure 5-131.** Core from KFM07A in the interval 874–876 m, DZ4. Fault breccias consisting of small and larger fragments of the host rock embedded in fine-grained brownish-red, laumontite-rich cataclasite. Details from the core in the upper part of the figure are shown in Figure 5-132 (below).

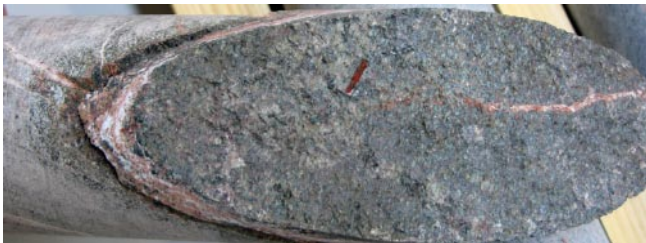
**Figure 5-133.** Core from KFM07A at 883.78 m, DZ4. A fault surface exhibits chlorite striation (shown by red mark) and small steps showing sense of shear. A late fracture sealed with laumontite cuts the fault.

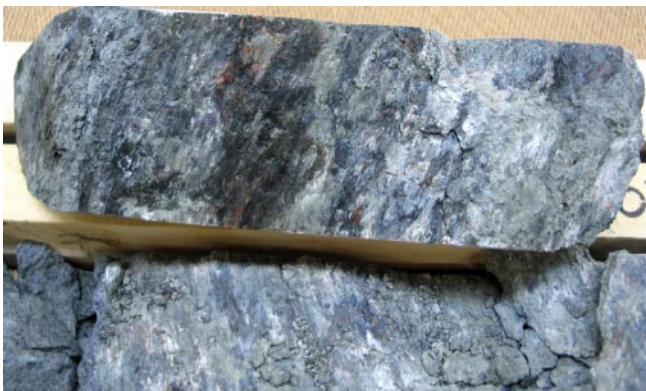
**Figure 5-134.** Core from KFM07A at 941.8 m, DZ4. Fault surface with excellent chlorite striation.

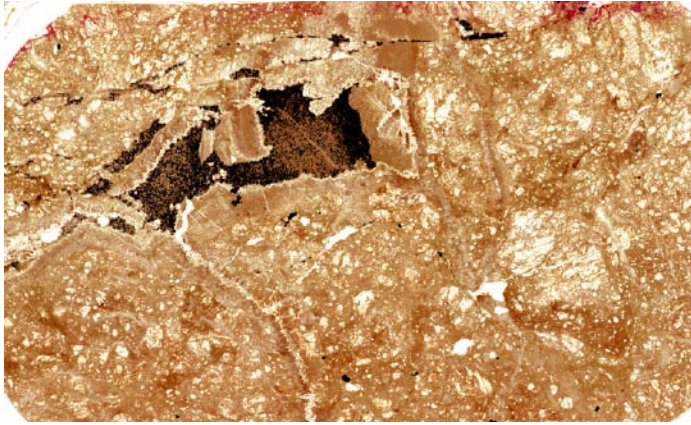
**Figure 5-135.** Scanned thin section from core KFM07A\_969.9 m. Fragments of host rock metagranite are present as angular small clasts in fine-grained, reddish-brown cataclasite. Pale vein-like features that traverse the cataclasite consist of euhedral quartz that grew epitaxially into open fractures and voids. The dark irregular area is also rimmed by euhedral quartz, and the same is the case for the irregular fracture going across the upper part of the section. The dark fill consists of unidentified sub-microscopic material that has filled open voids following the growth of quartz. The field of view is ca. 35 mm wide.

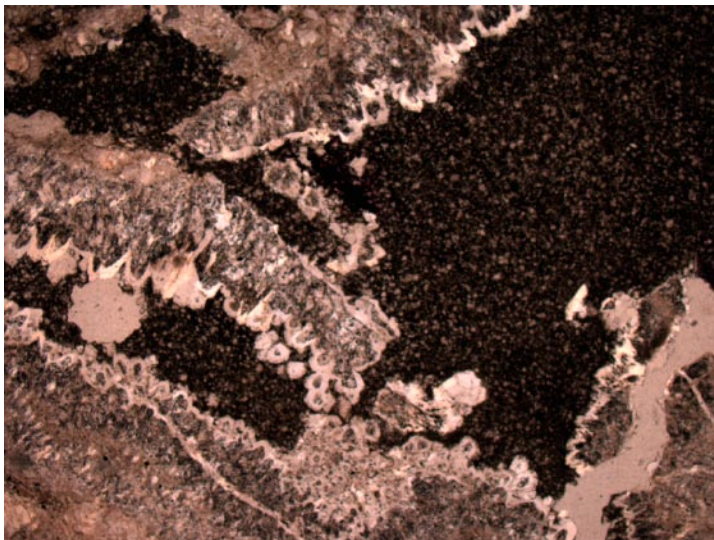
**Figure 5-136.** Photomicrograph showing details from Figure 5-135. (KFM07A\_969.9 m). The field of view is ca. 1.4 mm wide.

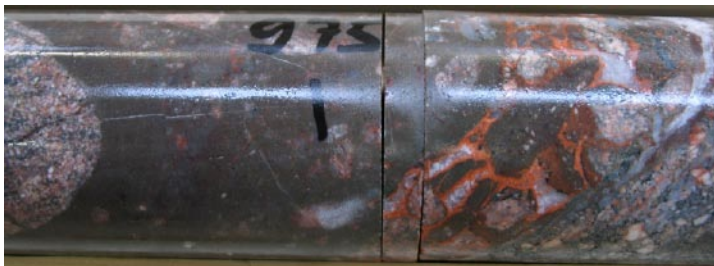
**Figure 5-137.** Core from KFM07A at 975 m, DZ4. Fine-grained cataclasite which in the footwall (right) is post-dated by quartz- and laumontite-filled fractures, in places with some calcite. The section cut from the core was used for thin section study (Figure 5-138).

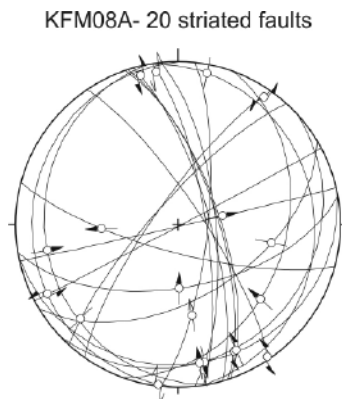
**Figure 5-140.** Stereoplot showing all the fault slip data collected along all the studied DZ of drill core KFM08A.

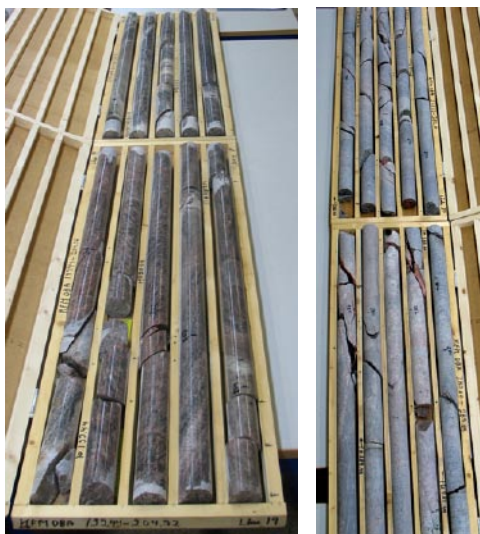
**Figure 5-142.** Overview of core sections from KFM08A, DZ1. To the left, the section 200–210.5 m illustrates a part of the zone with few spaced, open fractures. To the right, the section 274–287 m is characterized by a relatively high frequency of laumontite-sealed closed and broken fractures, including a 3 cm wide cataclasite sealed with laumontite and euhedral calcite at 281.7 m.

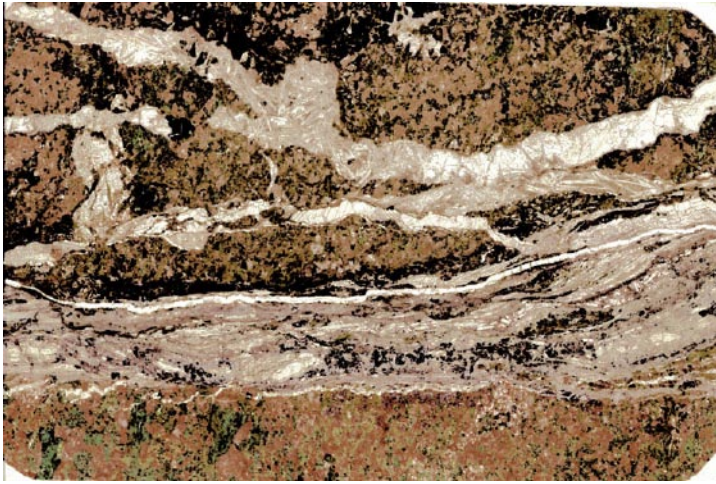
**Figure 5-143.** Scanned thin section from core KFM08A\_258.2 m. The host rock is a chloritized amphibolite with altered plagioclase, amphibole, chlorite, opaques and titanite. The amphibolite is transected by a fault and irregular fractures cemented by chlorite, laumontite and euhedral calcite. Early formed euhedral quartz has locally precipitated on fracture walls and along the edges of calcite that fill the fractures. Late thin fracture going across the thin section is partly filled with calcite. The field of view is ca. 35 mm wide.

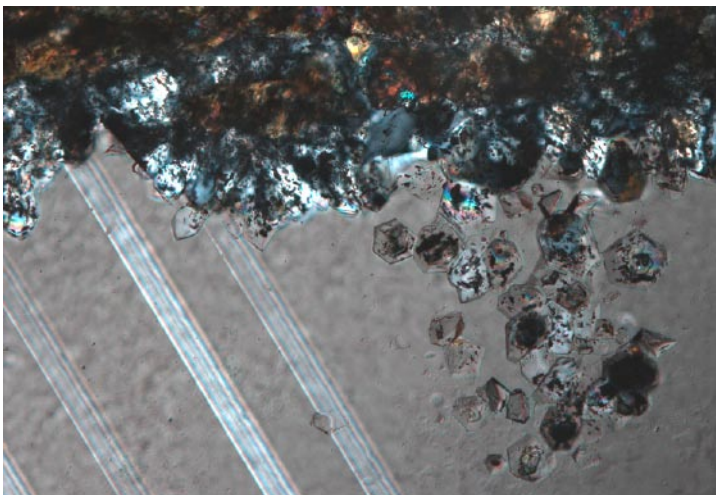
**Figure 5-144.** Photomicrograph from thin section from core KFM08A\_258.2 m. Small crystals of euhedral quartz have grown along fracture walls and in calcite that fills the fractures. The field of view is ca. 0.5 mm wide.

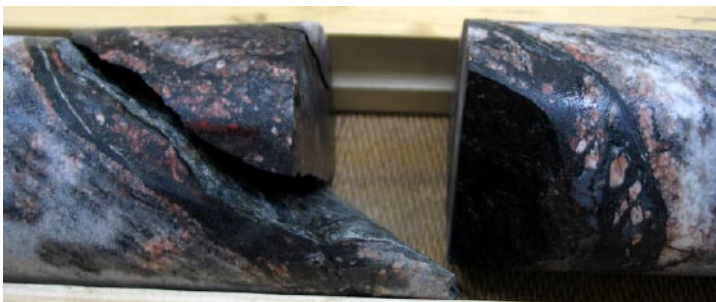
**Figure 5-145.** Core section from KFM08A, DZ1, 335.5 m. The meta-granite is cut by a 3–4 cm wide fault rock with small, angular fragments of red-stained feldspar embedded in a chlorite-rich matrix. A broken fault surface is coated with quartz + pyrite + hematite.

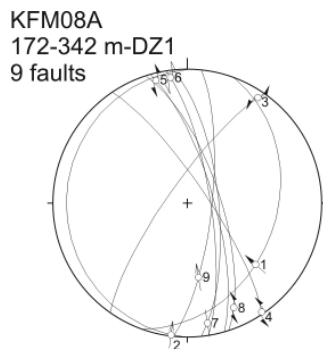
Figure 5-146. Stereoplot of fault slip data in DZ1 (KFM08A).

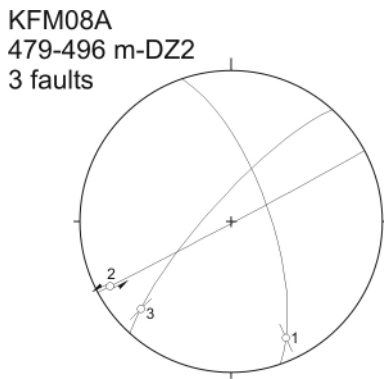
Figure 5-148. Stereoplot of fault slip data in DZ2 (KFM08A).

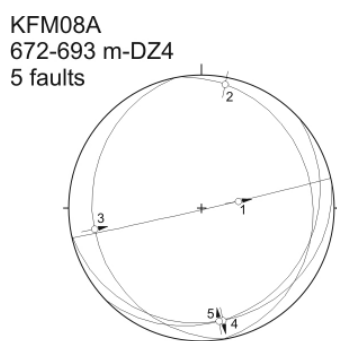
**Figure 5-150.** Stereoplot of fault slip data in DZ4 (KFM08A).

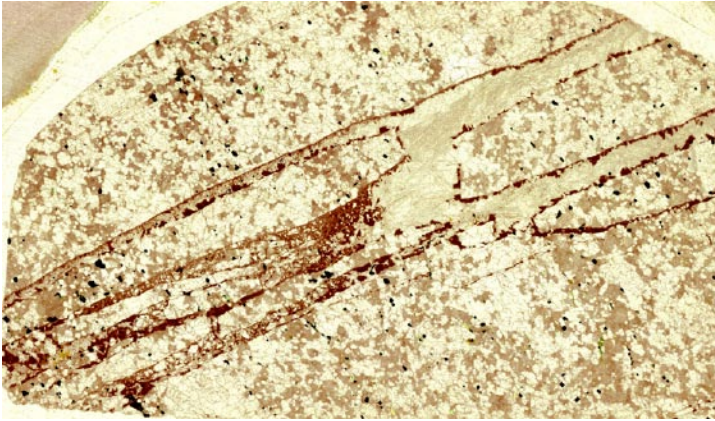
**Figure 5-153.** Scanned thin section from core KFM08A\_940.38 m. The fractures cut a pink-grey, biotite-bearing metagranite to metagranodiorite. Strong crushing of the host rock has taken place along the fractures, and some epidote/clinozoisite and laumontite have sealed the fine-grained deformation products. Laumontite (brown) and minor quartz have also grown on fracture walls, whereas coarse-grained calcite is a late mineral filling remaining space along the central part of the fractures. The field of view is ca. 35 mm wide.

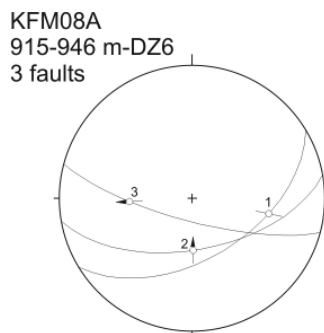
**Figure 5-154.** Stereoplot of fault slip data in DZ6 (KFM08A).

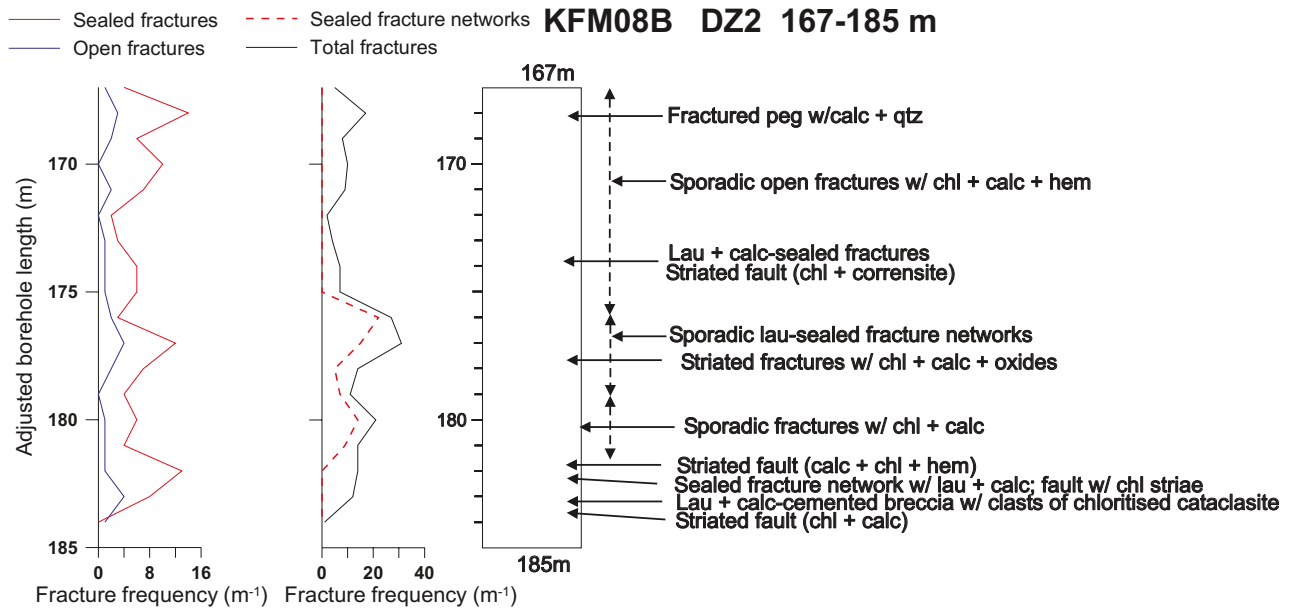
**Figure 5-155.** Simplified drawing of KFM08B, DZ2, showing the recorded brittle deformation features. The intervals marked at ca. 920 m and 940 m are considered fault core. The remaining part of the DZ is a transition zone according to /Munier et al. 2003/.

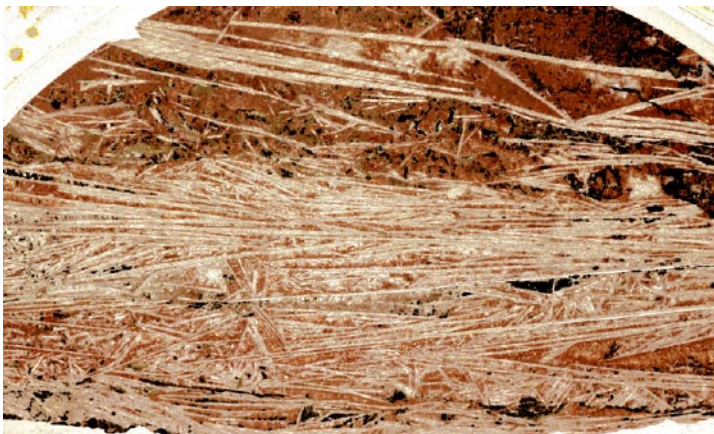
**Figure 5-157.** Scanned thin section from core KFM08B\_183.5 m. Platy calcite is prominent and post-dates laumontite. Other minerals include mainly chlorite, epidote/clinoziosite and opaques representing the altered amphibolitic host rock. The field of view is ca. 35 mm wide.
