**Assessment of copper resistance
to stress-corrosion cracking in nitrite
solutions by means of joint analysis
of acoustic emission measurements,
deformation diagrams, qualitative
and quantitative fractography, and
non-linear fracture mechanics**

V G Khanzhin, S A Nikulin
Moscow State Institute of Steel and Alloys

June 2005

Svensk Kärnbränslehantering AB

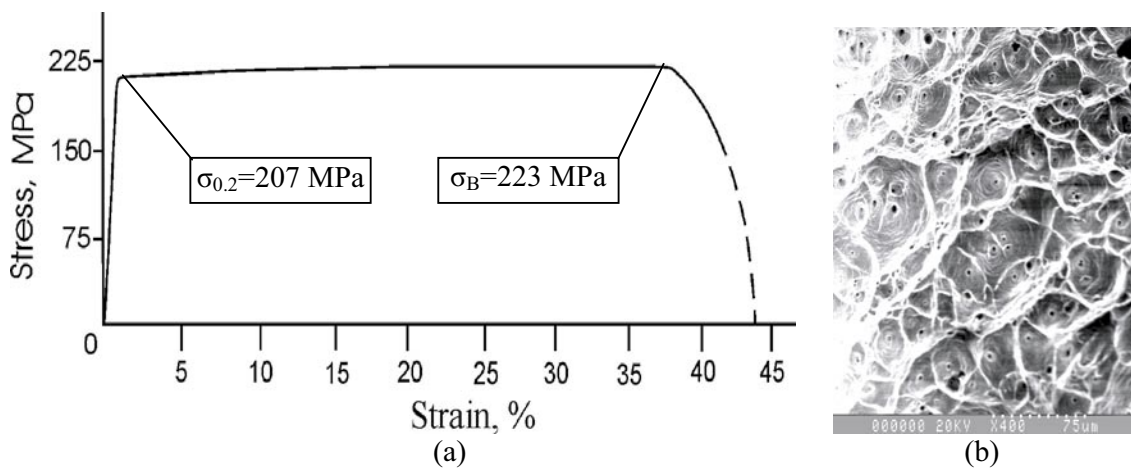
Figure 3. Tensile test on cylindrical copper specimens.
a – schematic deformation diagram of a tensile tested copper specimen;
b – fracture surface of a copper specimen tested in air.

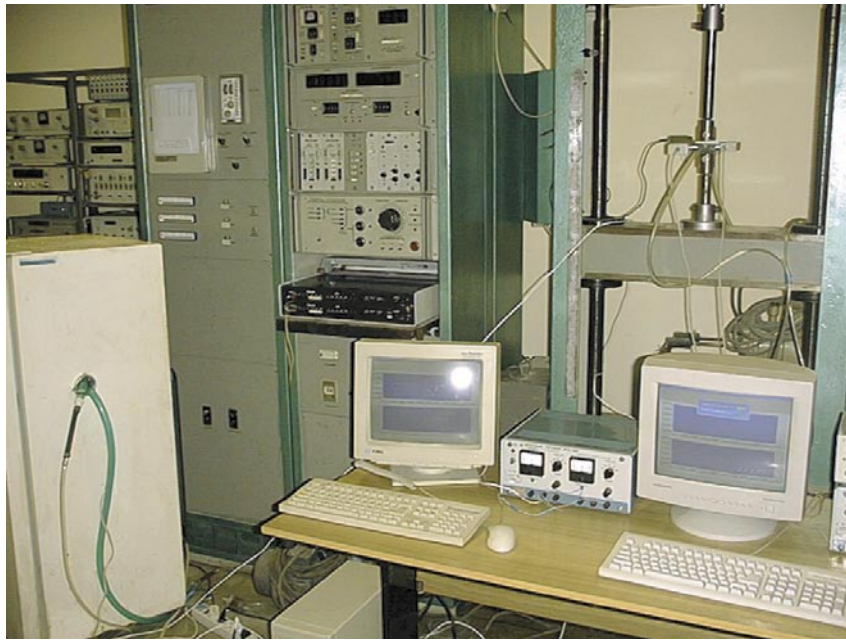
Figure 15. Acoustic emission (AE) monitoring during SCC tests on CT specimens at a fixed crack opening.

a, b – mounting of an AE sensor and of an analog pre-processing module on the cylindrical pedestal of a CT specimen;

c – CT specimen with the installed electronic module and with the attached system for continuous circulation of corrosive solution through the crack.

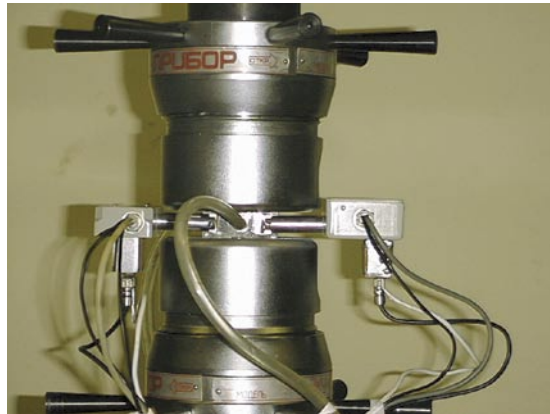
Figure 14. Acoustic emission (AE) monitoring during SCC tests on MT panel specimens.
a – installation for SCC tests combined with AE monitoring;
b – MT panel specimen with the attached AE sensor that is made physically integral with a small-size electronic module for analog pre-processing;
c – placement of the AE sensors on a specimen during tests.

Figure 14 shows: (a) installation for SCC tests combined with AE monitoring, (b) panel specimen with the attached AE sensor that is made physically integral with small-size electronic module for analog pre-processing, and (c) placement of the AE sensors on a specimen during tests. Figure 15 shows mounting of an AE sensor and of an analog pre-processing module on the cylindrical pedestal of a CT specimen (a, b), as well as a photo of a CT specimen with the installed electronic module and with the attached system for continuous circulation of corrosive solution through the crack (c).

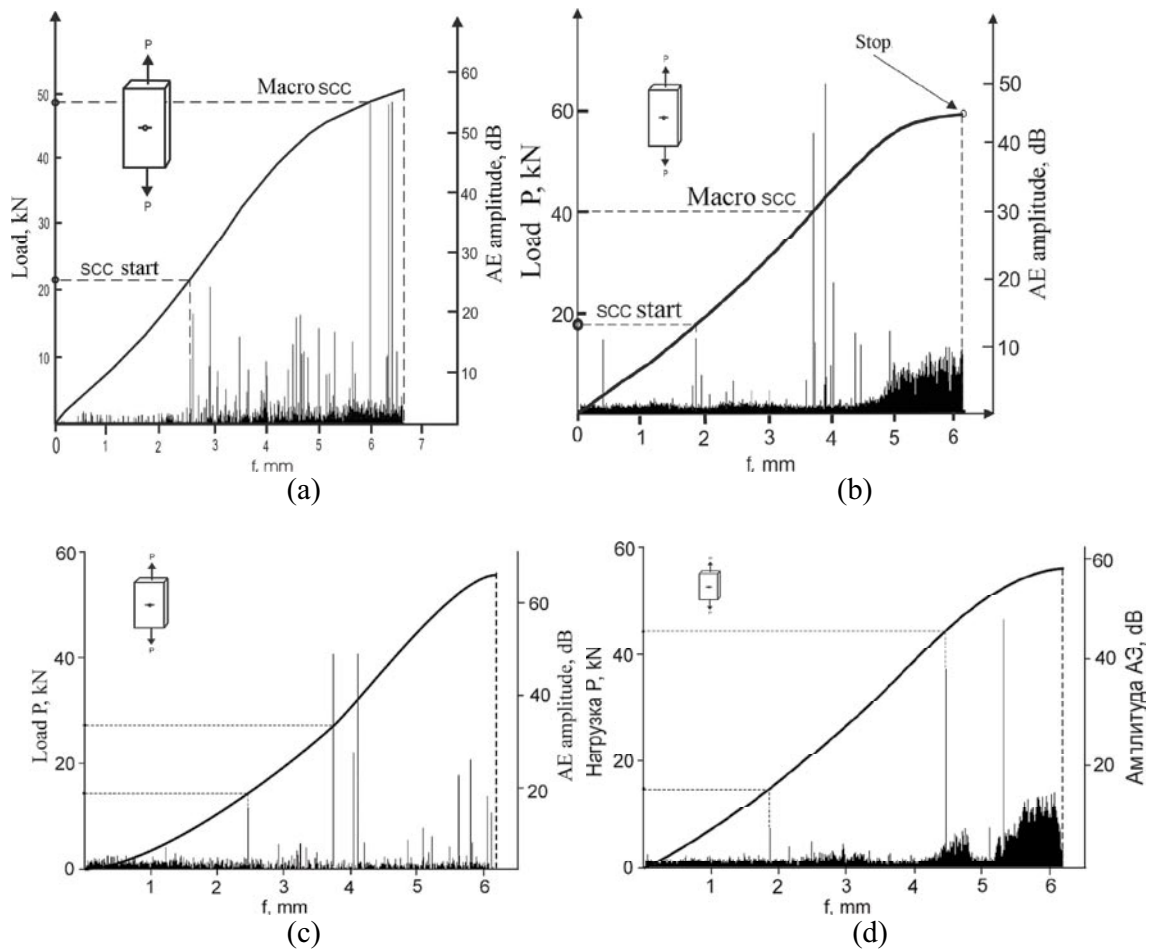
Figure 20. Examples of the joint deformation diagrams and AE diagrams for MT panel specimens during SCC CERT experiments, for obtaining estimates of copper resistance to corrosion-assisted fracture at two characteristic stages of SCC kinetics.

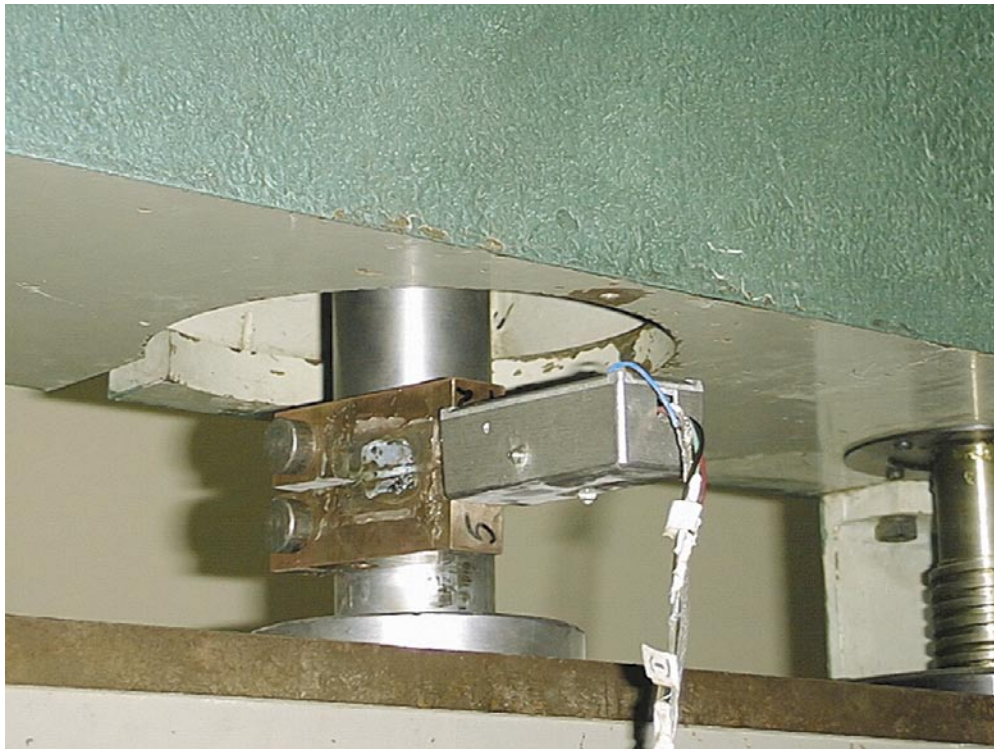
Figure 21. Tensile test on a compact tension (CT) specimen after completion of the SCC test.
a – CT-specimen mounted in the grips of a testing machine;
b – AE-signals during extension of a CT-specimen;
c – the joint deformation diagrams and AE diagrams for compact tension (CT) specimen (using extension rate 0.02 mm/sec). This experiment was performed after completion of the SCC test, for obtaining estimates of the copper fracture resistance, and it also shows two characteristic stages of the fracture kinetics.

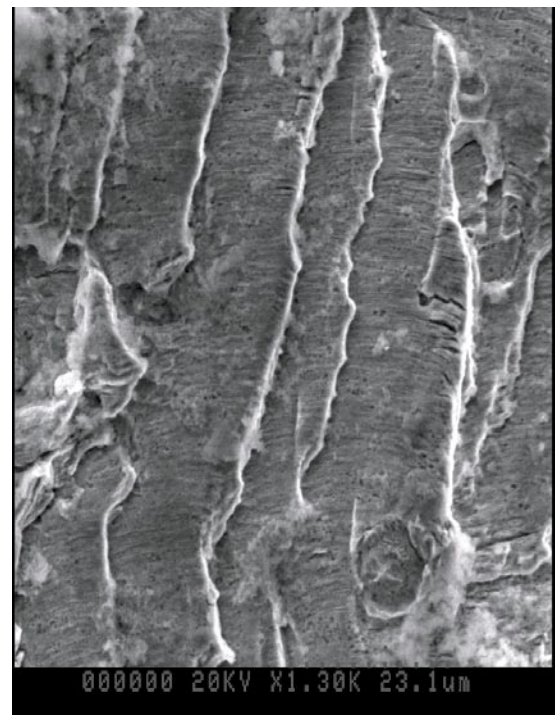
Figure 39. Fracture surface in the SCC zone of a CT specimen (continued on the next page).
e – transgranular crack propagation (bottom left to top right) through a twin (center);
f, g, h – regions within in the SCC fracture zone.
