## **Forsmark site investigation**

### **Some corrosion observations and electrical measurements at drill sites DS4, DS7 and DS8**

December 2005

**Svensk Kärnbränslehantering AB**

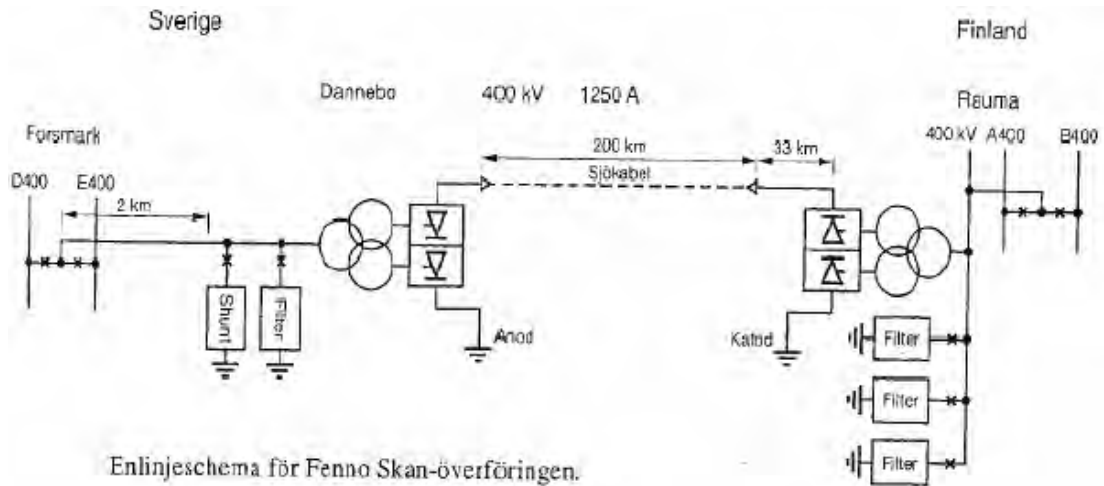
A connection for transferring High Voltage Direct Current exists between Finland and Sweden. The power rating for this system is 500 MW and the power can be transferred in both directions. The connection is designed according to the chart diagram in Figure 1-2. The location of the sea cable in the vicinity of Forsmark is shown in Figure 1-3. The Swedish electrode (anode) is placed at the vicinity of lighthouse Björn, approximately 30 km north of the site investigation area in Forsmark, see Figure 1-4. The Finnish electrode (cathode) is placed in Rauma. The anode consists of a titanium net and the cathode of a copper net.

**Figure 1-2.** Wiring chart showing the High Voltage DC cable between Sweden and Finland with anode and cathode.

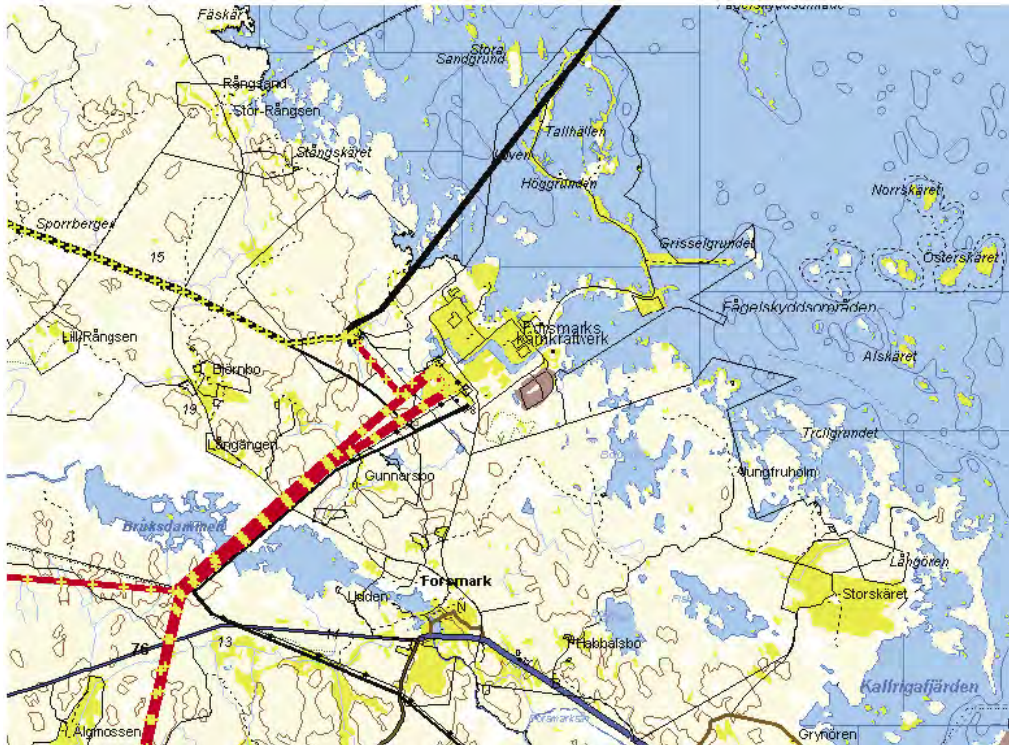
**Figure 1-3.** General overview of Forsmark Power station, showing the location of Fennoskan (the High Voltage DC cable to Finland, black line on the map).

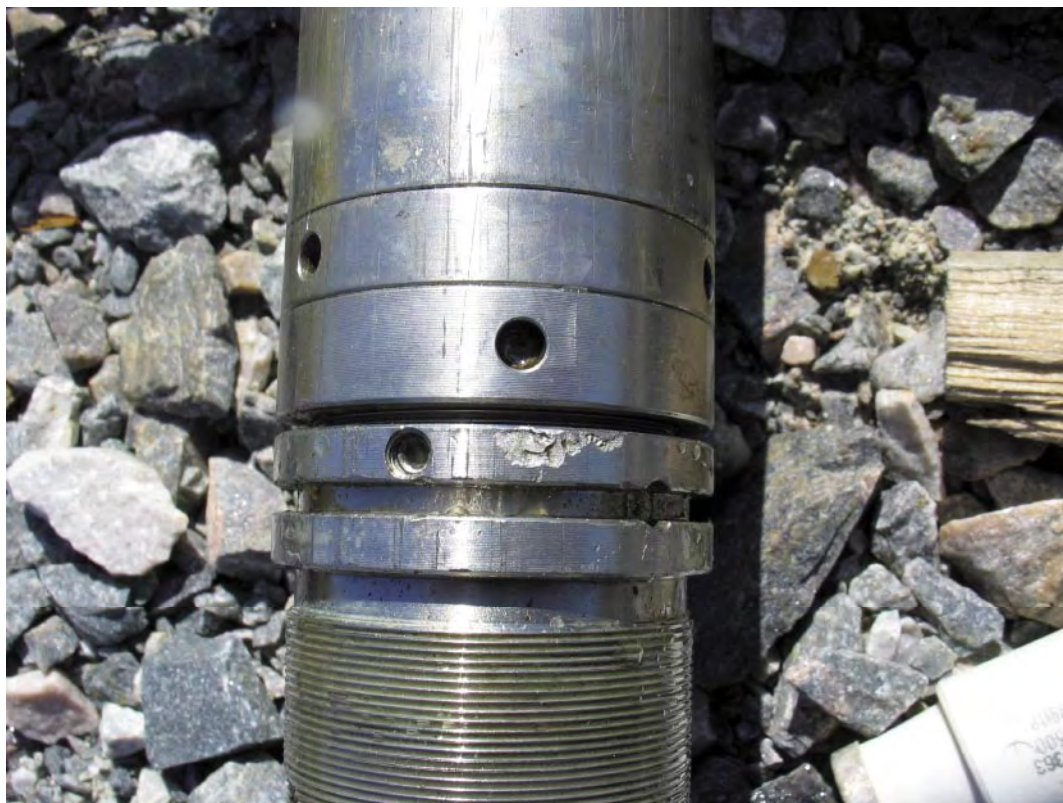
The Figures 2-3 to 2-9 illustrate both pitting and crevice corrosion which was observed on the equipment.

*Figure 2-3. Pitting corrosion on the outside of the chemical analysing equipment.*

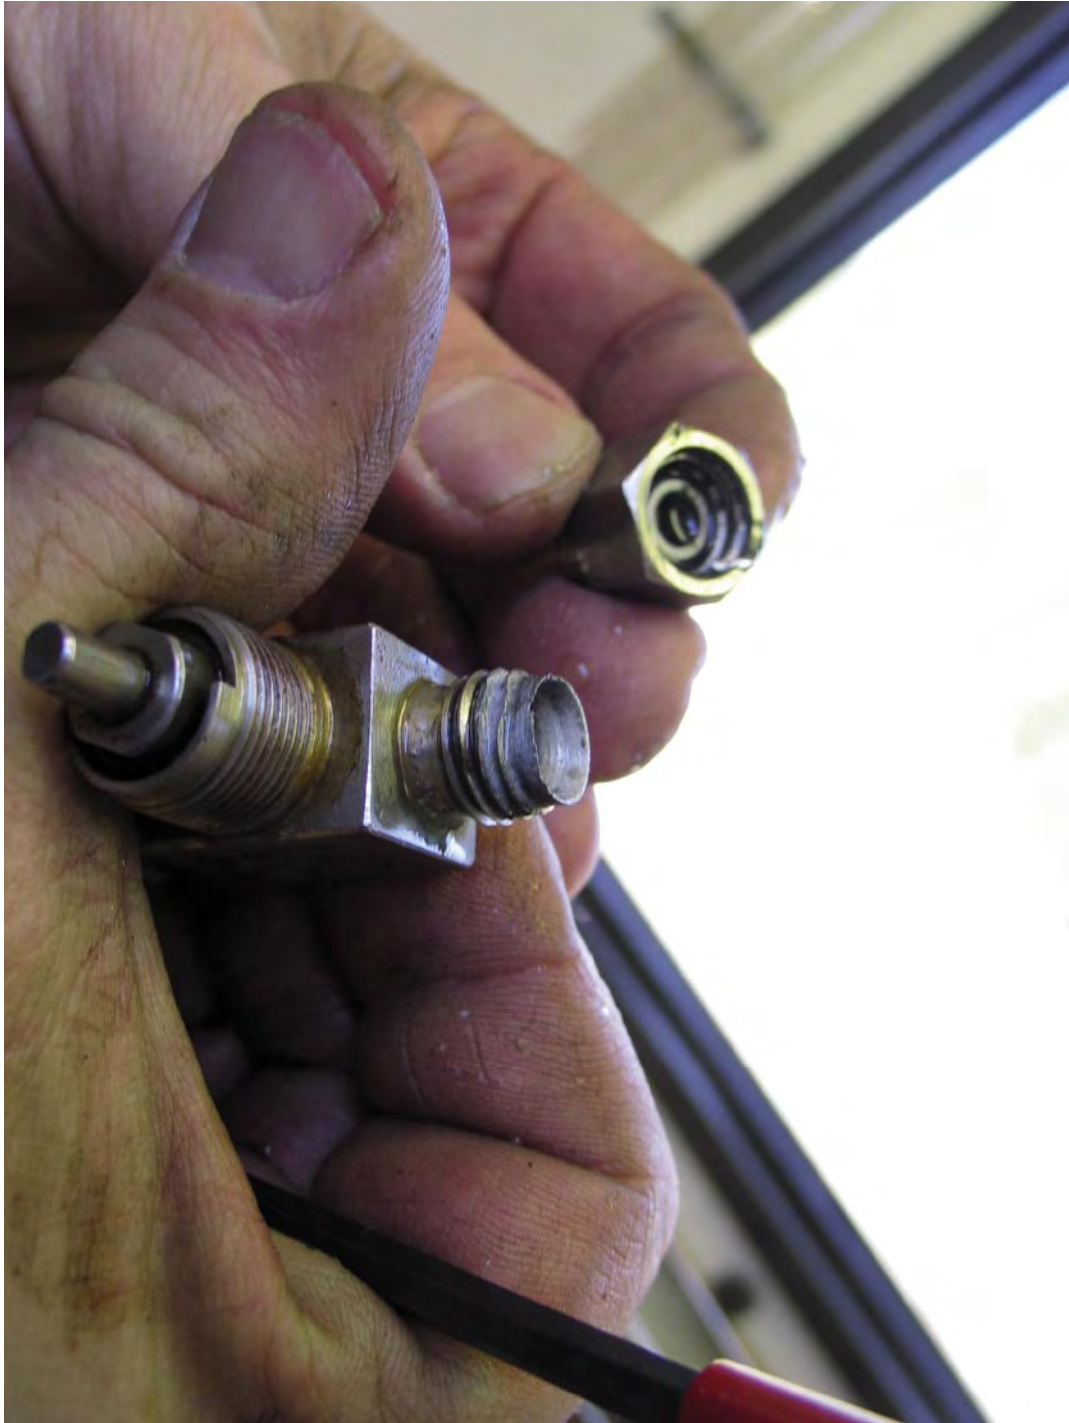
*Figure 2-4. Corroded thread and nut on a valve inside the chemical analysing equipment.*

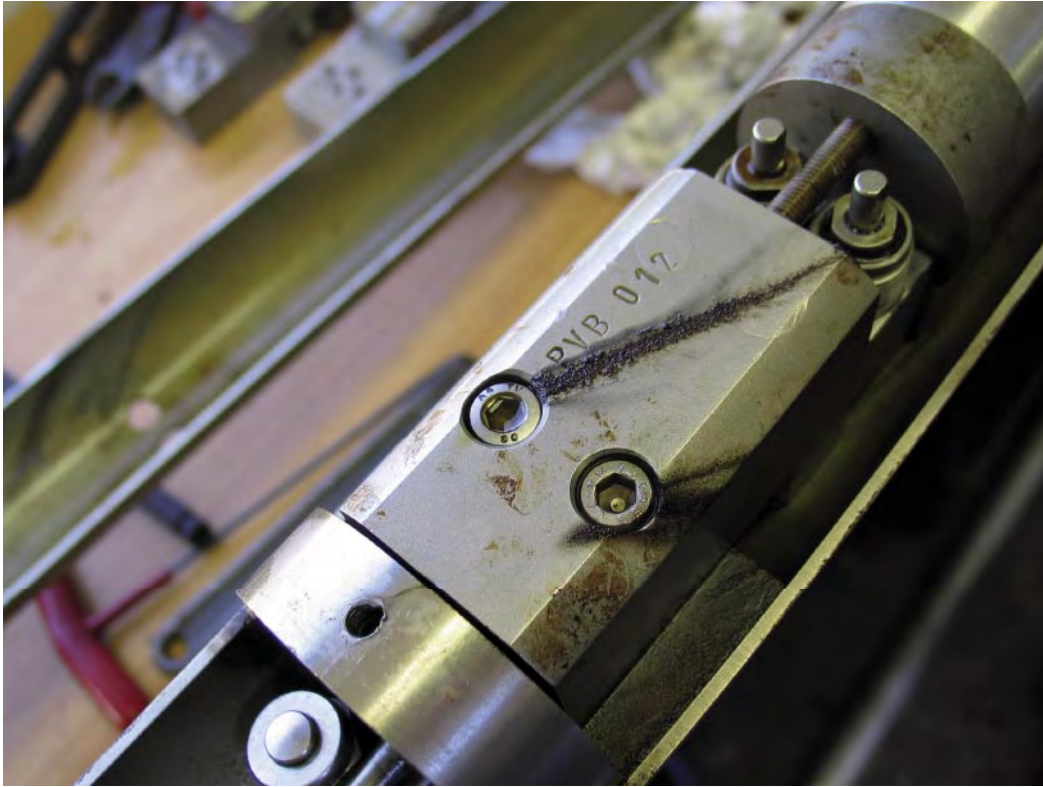
*Figure 2-7. Details with crevice corrosion inside the chemical analysing equipment.*

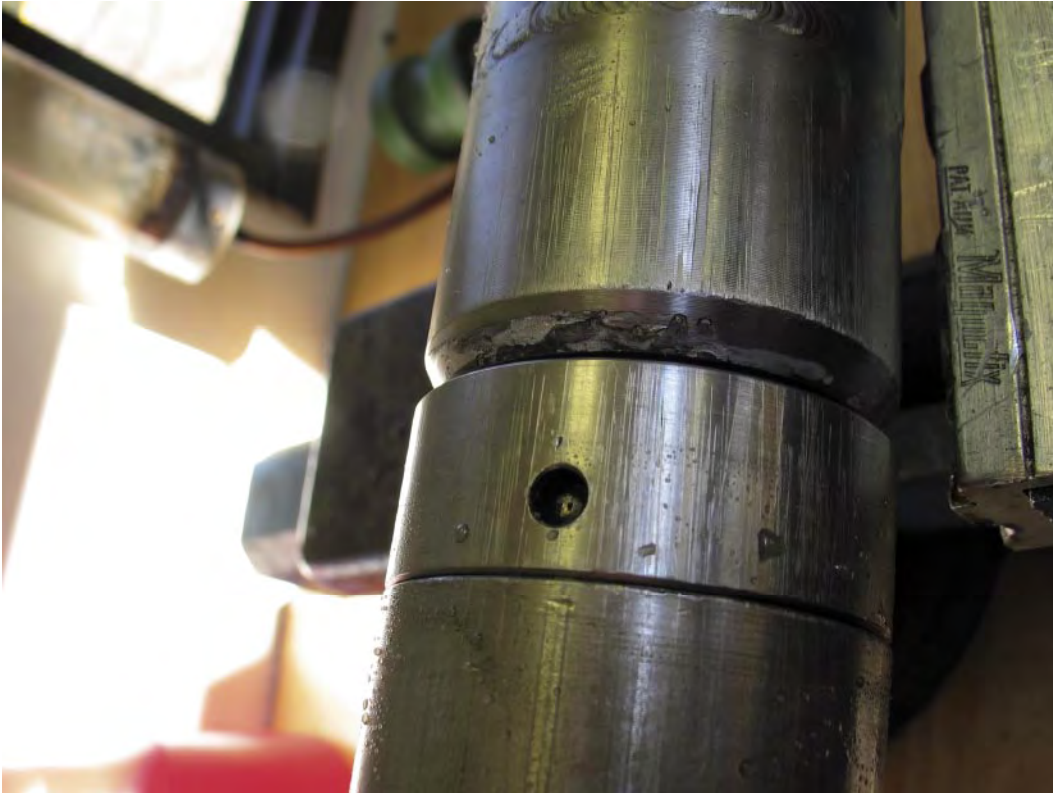
*Figure 2-9. Details with crevice corrosion inside the chemical analysing equipment.*

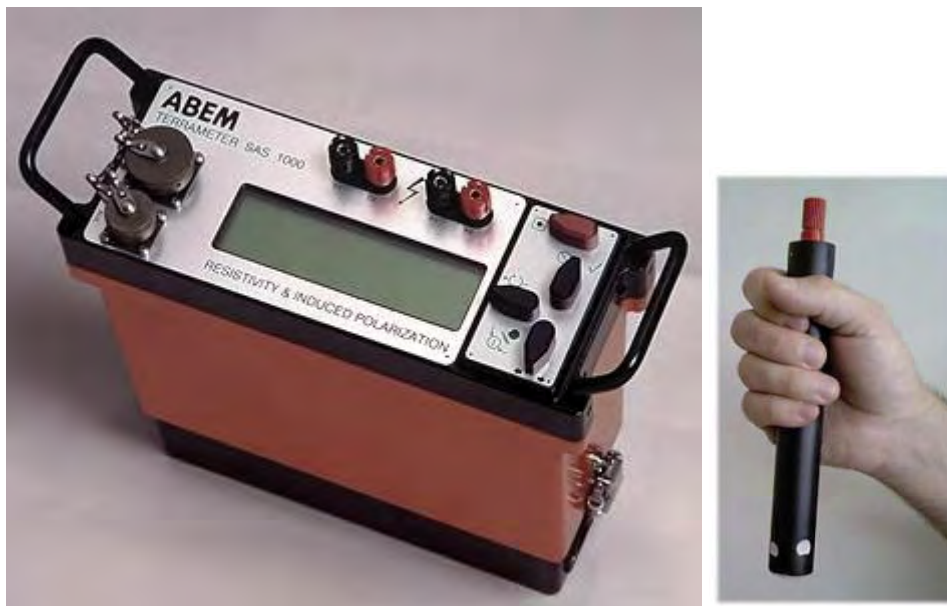
The SAS1000 was also used together with non-polarizable electrodes, manufactured by ABEM. These electrodes consist of a rough tube, containing a matrix of gypsum with lead-chloride, see Figure 3-1.

*Figure 3-1. Picture of the Terrameter SAS1000 and a non-polarizable electrode.*

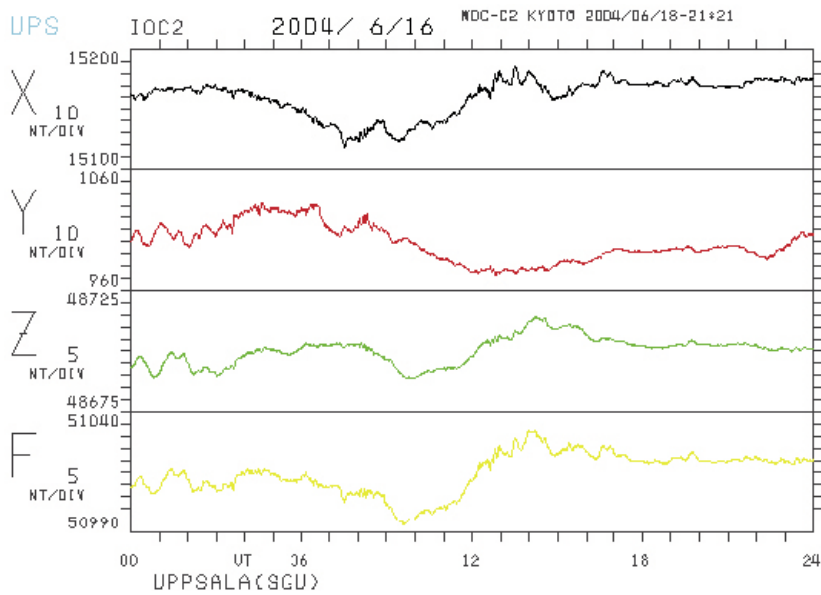
In Figure 5-2 the Earth magnetic field data are presented. As seen, no dramatic changes in the magnetic values are observed within the investigation period, and no correlation between the SP-variations and the magnetic variations are observed.

**Figure 5-2.** Earth magnetic field data from the Uppsala Observatory from 2004-06-16. Between this diagram and the diagrams in Figure 5-1 there is a time shift of 2 hours (12:00 here corresponds to 14:00 in Figure 5-1).

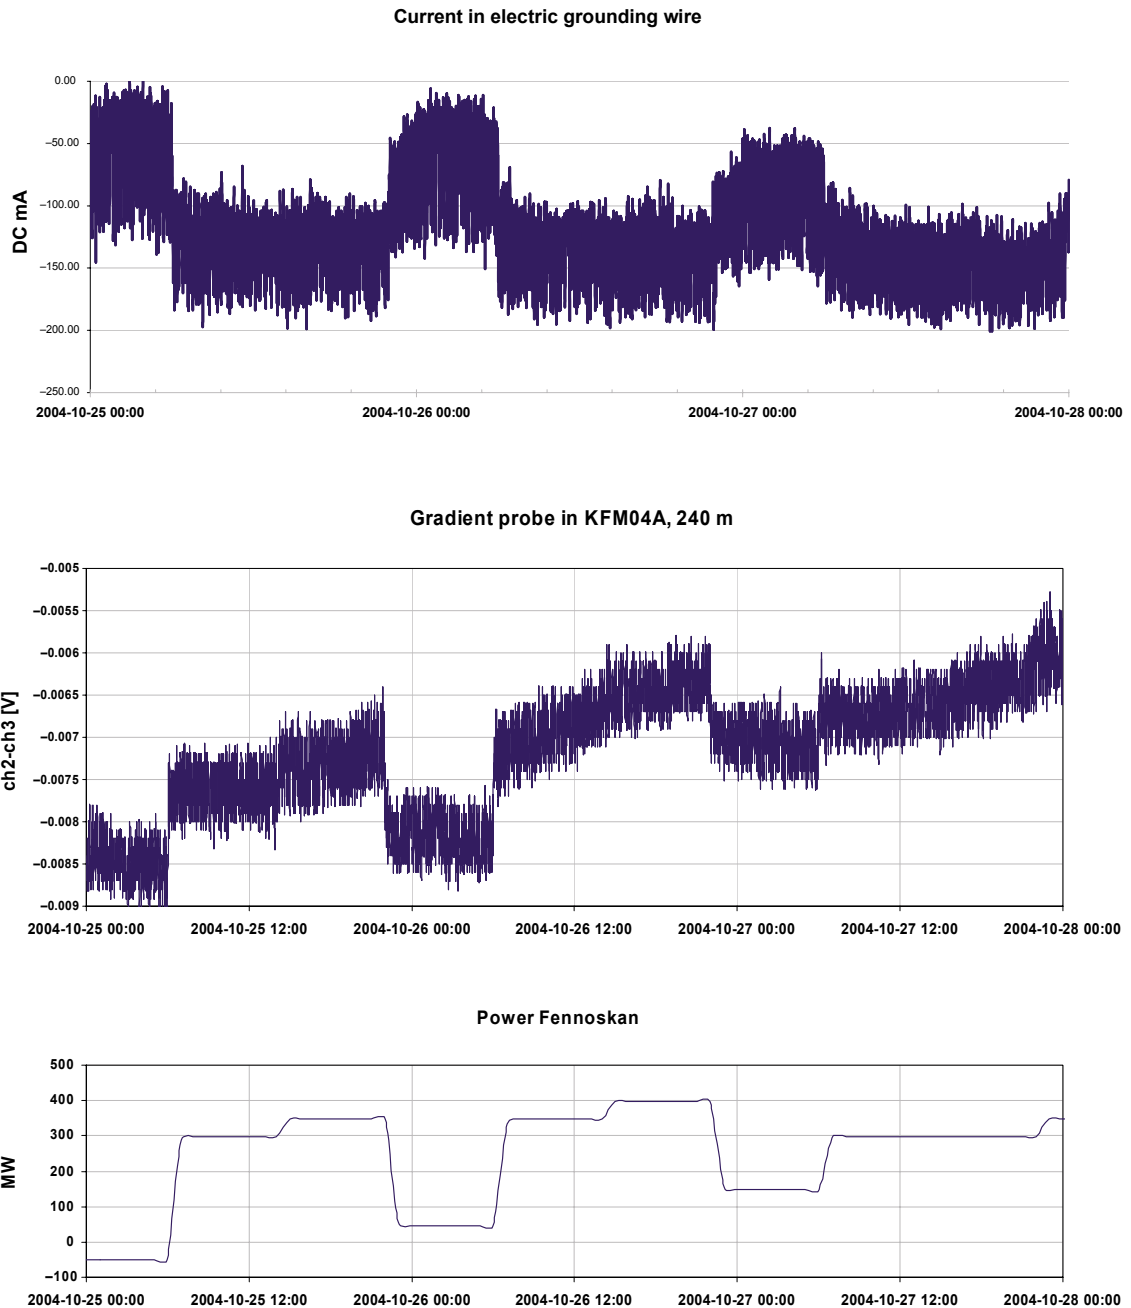
The results from logging the current in the electrical grounding wires are presented in Figure 5-5.

*Figure 5-5. Comparison between current in electrical grounding wire (upper diagram), voltage measured with the gradient probe in KFM04A (middle diagram) and power in the Fennoskan cable (lower diagram) 2004-10-26 to 2004-10-28. A significant correlation is observed.*

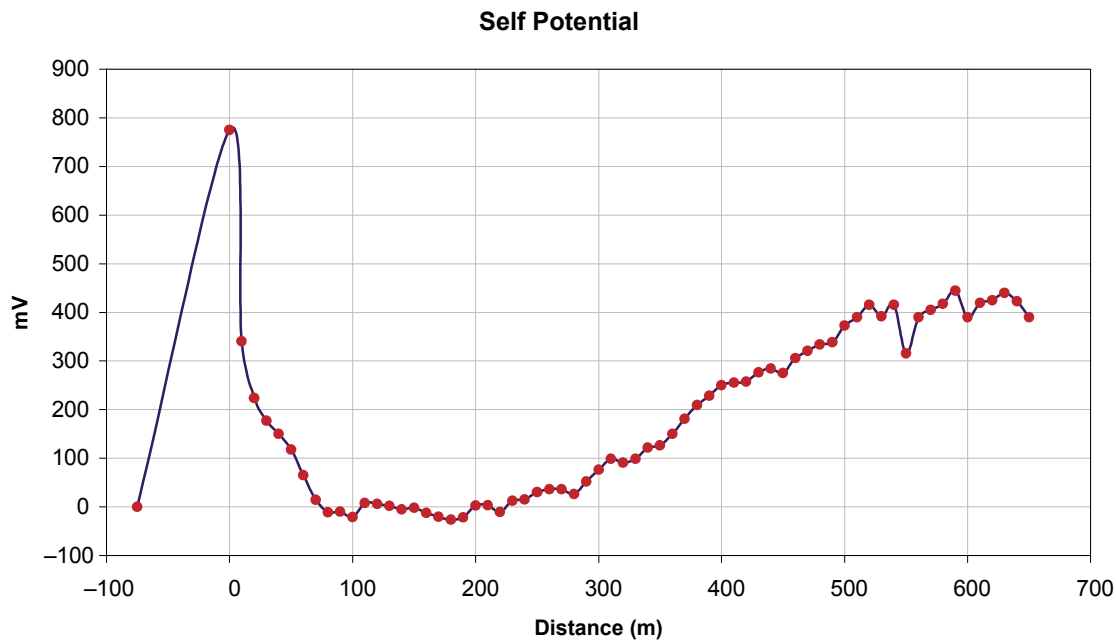
The results from the SP measurements between DS4 and DS1 are illustrated in Figure 5-6 below. For the location of the measured line, see Figure 4-1. The first point in the graph is located approximately 39 m from borehole KFM04A, and the reference electrode is identical with the reference electrode from the logging (Section 5.1).

**Figure 5-6.** The results of the ground SP measurements between DS4 and DS1. Position “0” corresponds to POS 0, position “50 m” with POS 1 etc in the table in Section 4.3. The reference electrode is located at position -75 m.

The distance between the start of the profile and the reference electrode is approximately 75 m. By definition, the SP-reading will come close to zero (0) when approaching the reference electrode. This implies that the high readings in the beginning of the profile in fact are due to an isolated peak. The position of the peak corresponds to DS4.

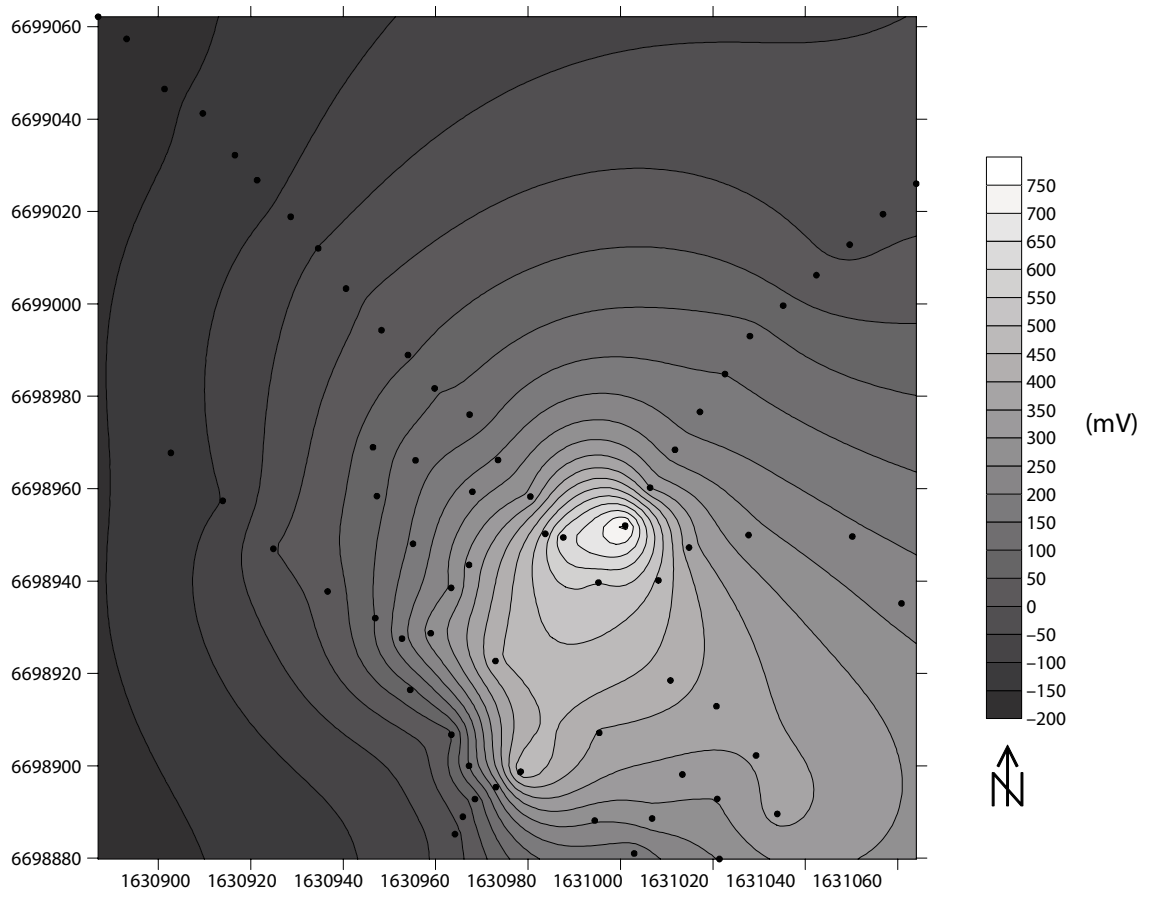
Figure 5-7 clearly demonstrates that the self-potential is highest in the area around the electrical transformer, and decreasing clearly towards northwest. The self-potential is also higher in the area around the road to DS4, which probably to a large extent can be explained by the electric grounding wire installed along this road.

**Figure 5-7.** Surface map of the self-potential in the area around DS 4. Measurements from June and August 2004.

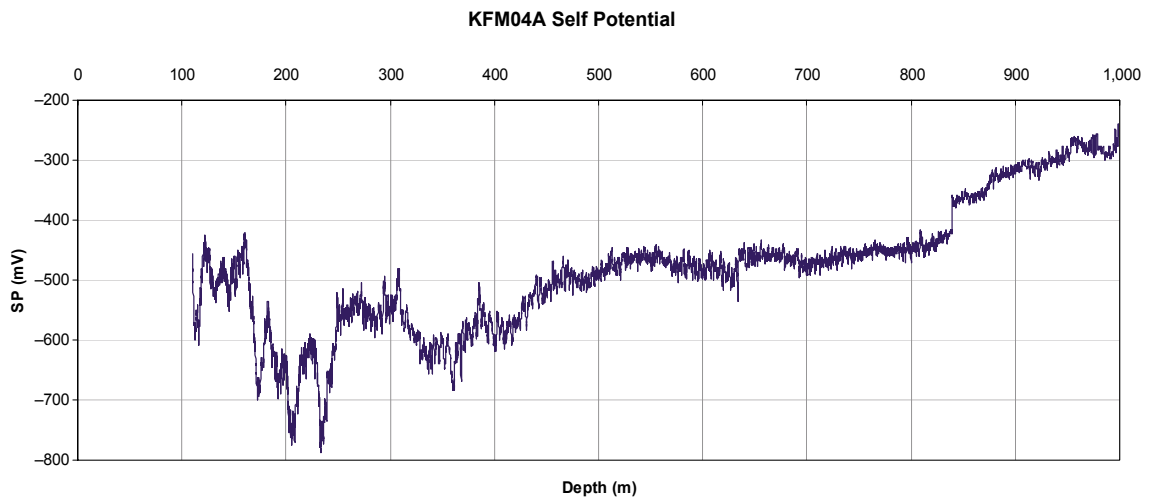
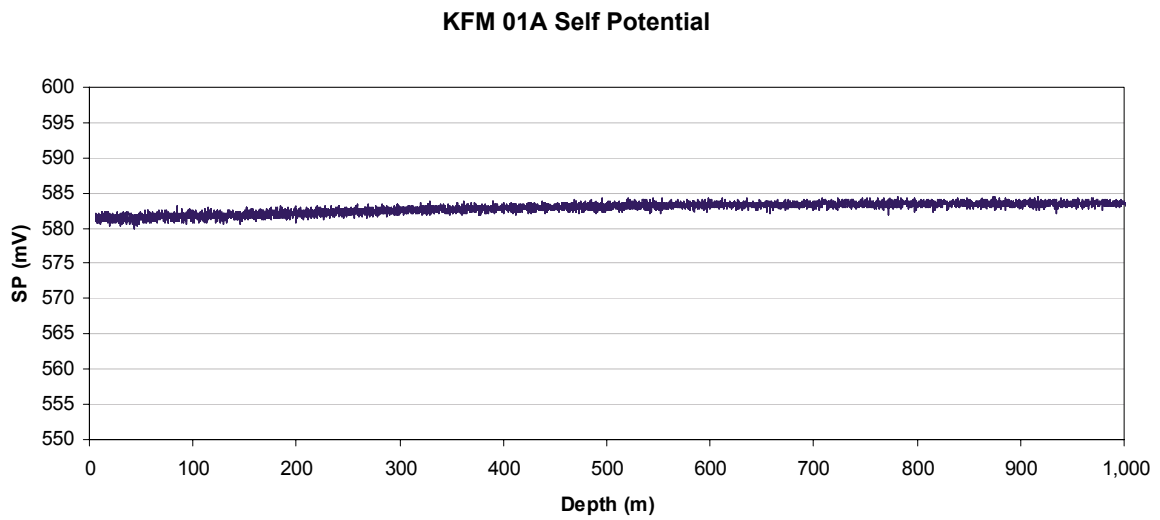
**Figure A-1.** SP-logging in KFM04A (upper diagram) compared with KFM01A (lower diagram). The log shows 100 times larger SP-variations in KFM04A compared with nearby holes (KFM01A and KFM05A). The reference electrodes for these loggings are located on the concrete slab, ca 5 m from the hole.
