Oskarshamn site investigation

Detailed outcrop mapping in trenches

Golder Associates AB

March 2007

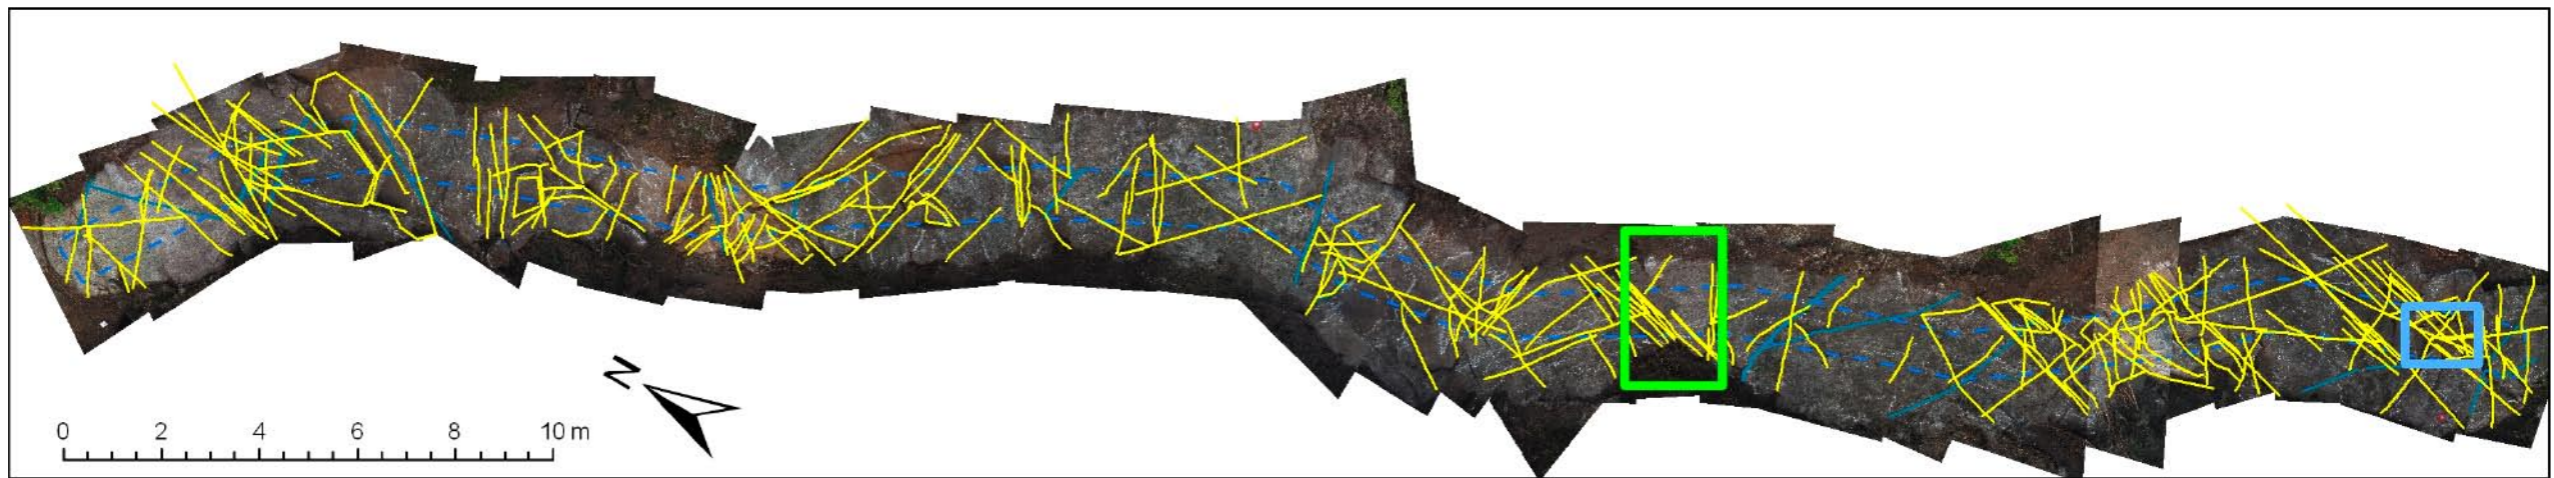
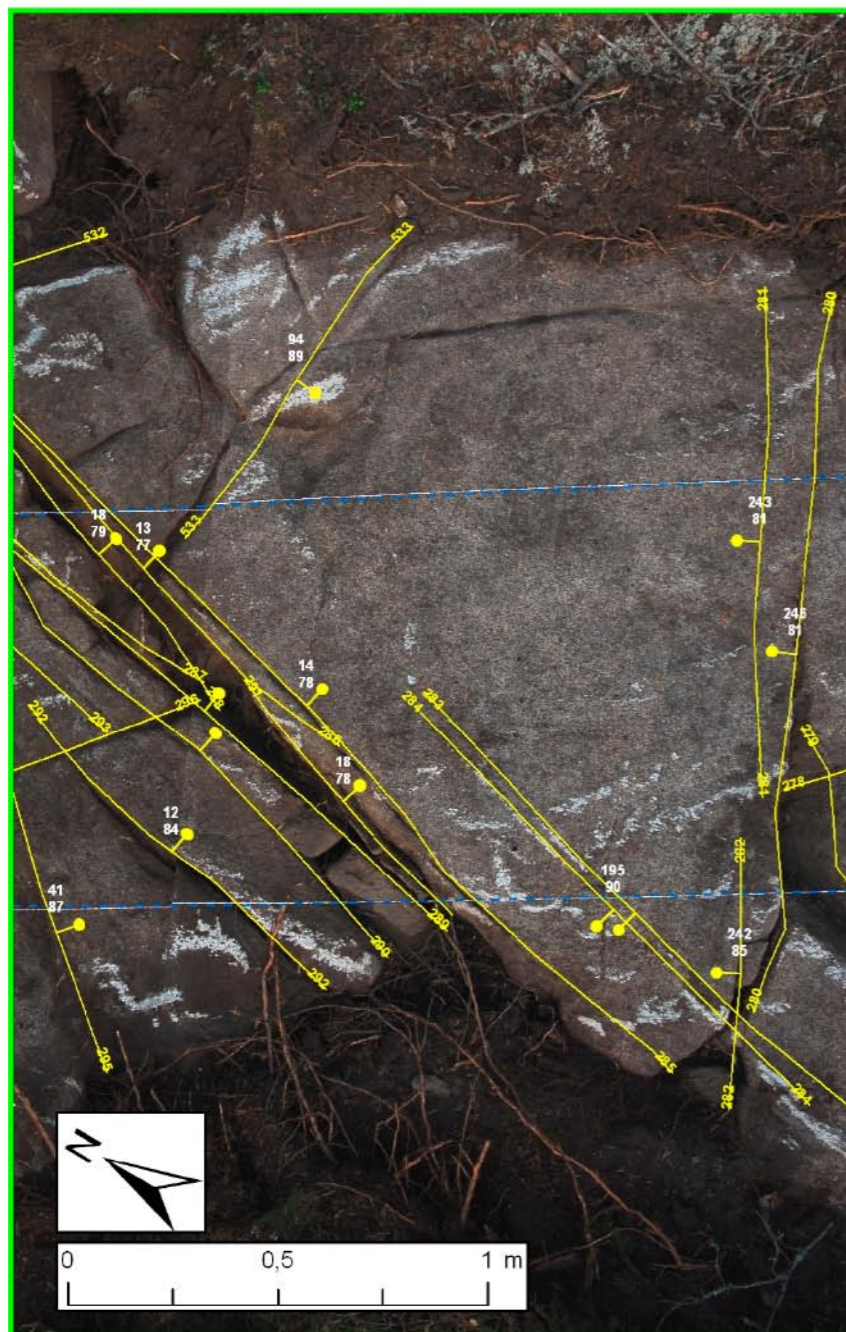
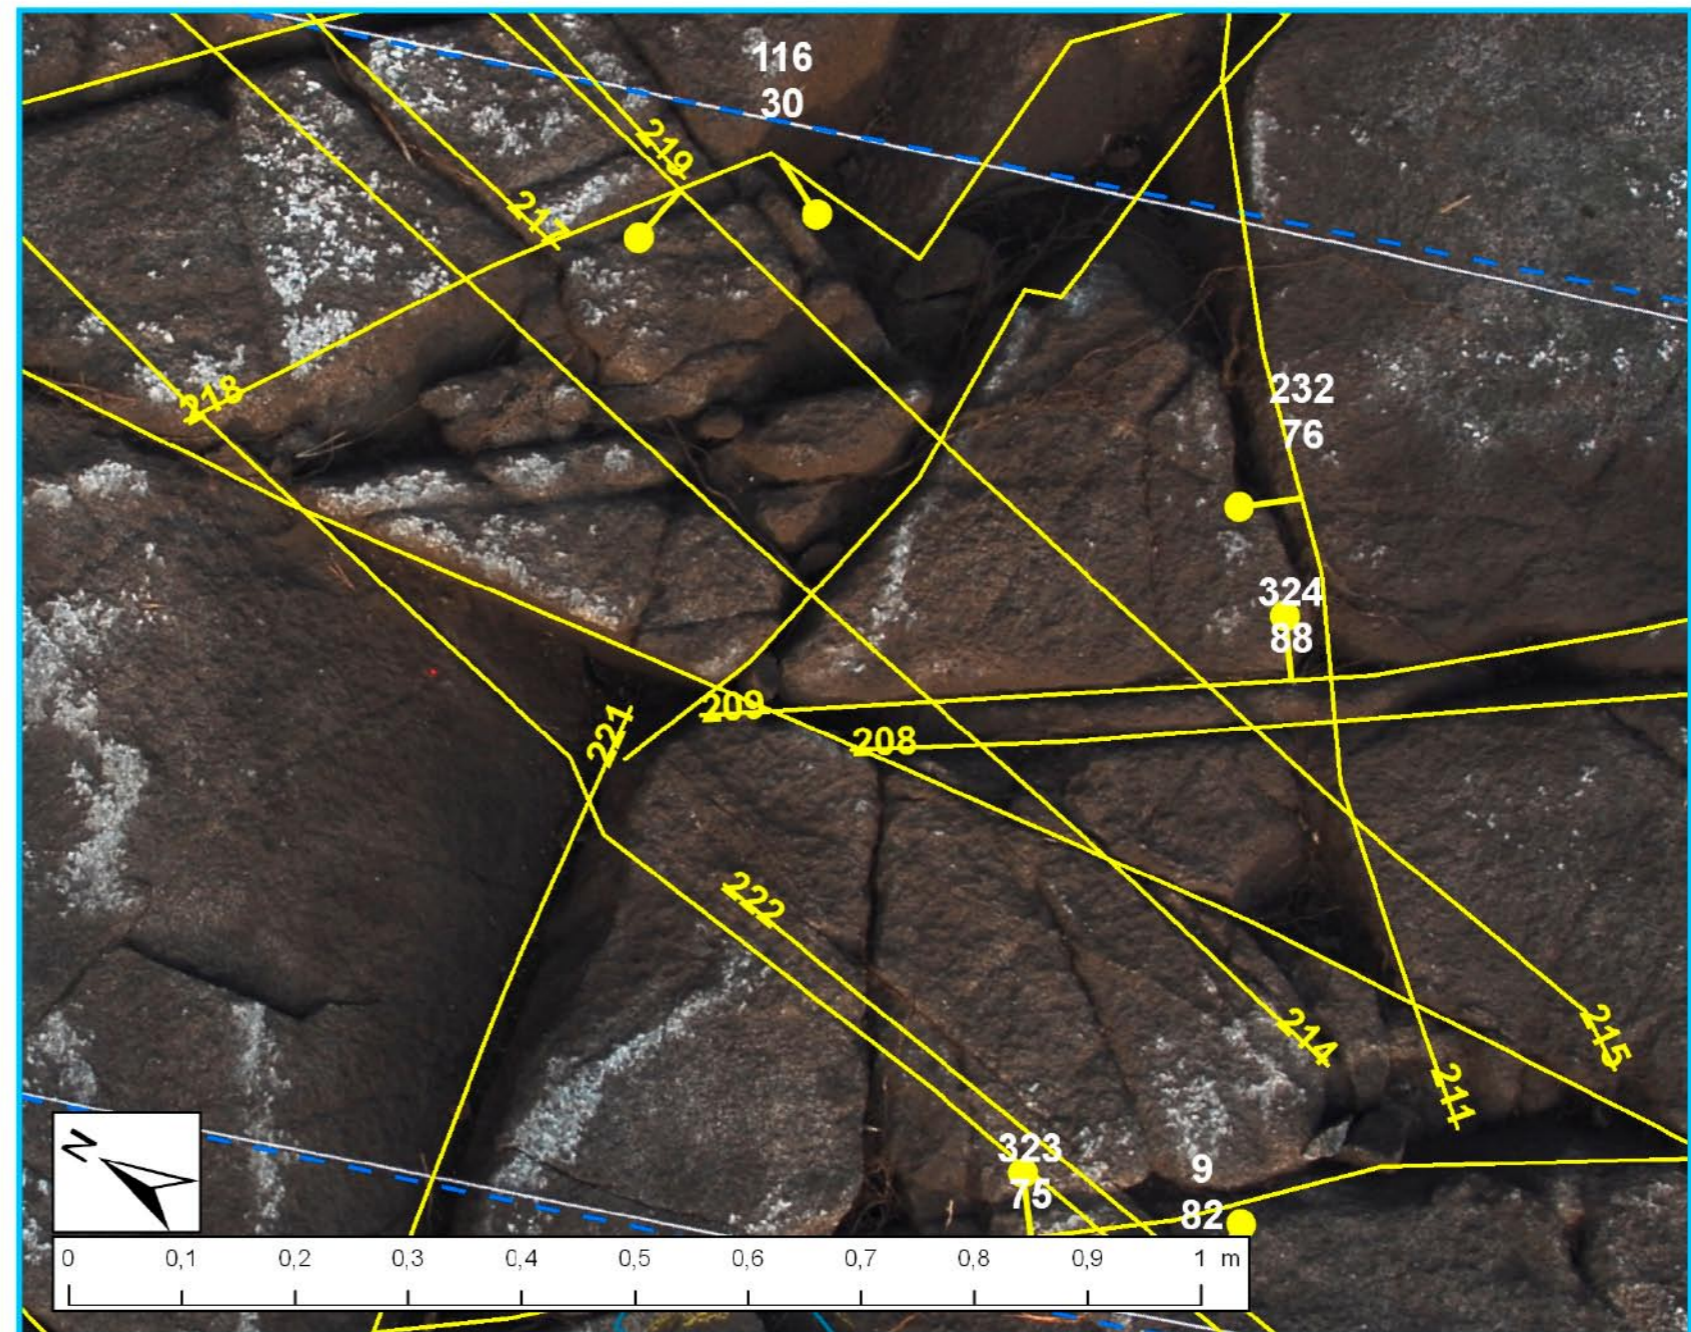
Sample from the detailed photo study. Overview and extracts from trench ASM000122.
