Appendix 7

Backfill in section 2

**PROTOTYPE REPOSITORY IN
OPERATION**

**CANISTER DISPLACEMENT
TRACKING**

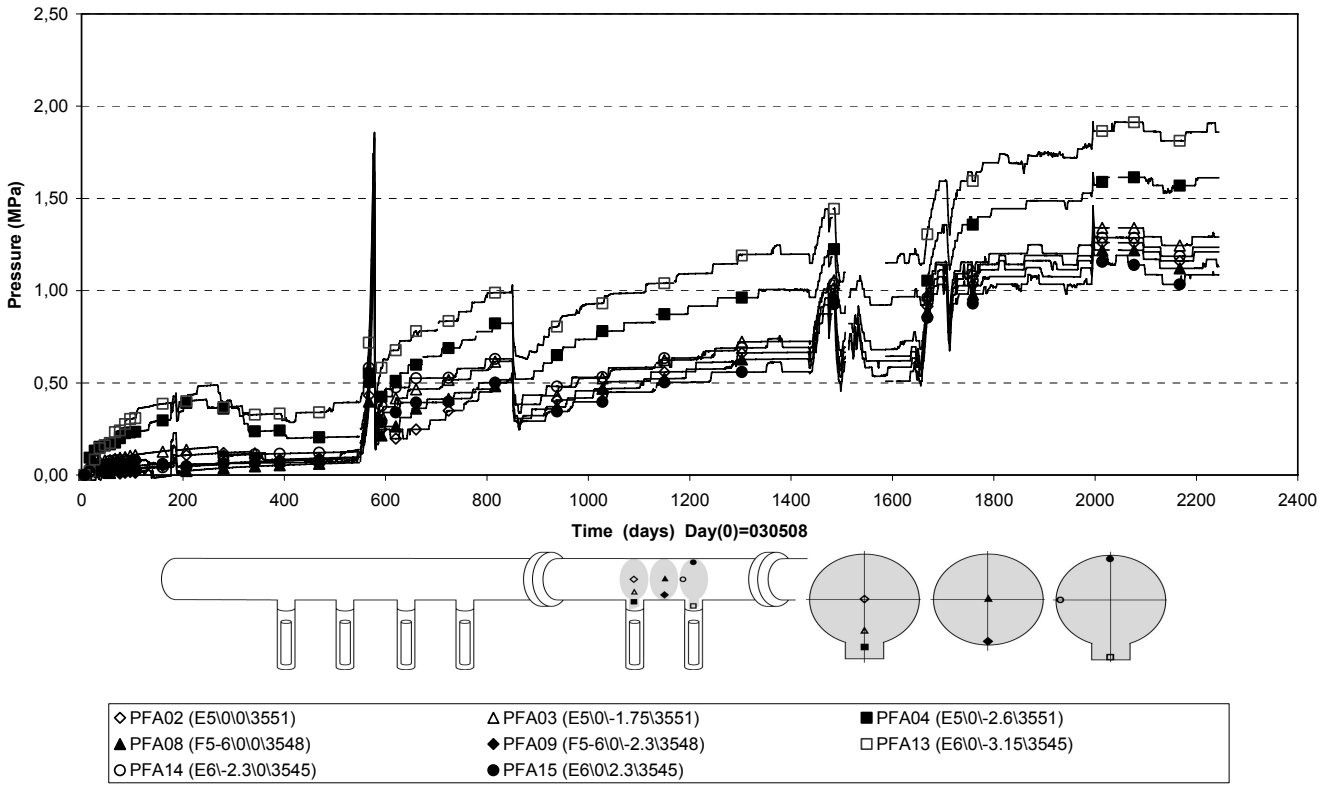
**Total pressure\ Backfill \ Section 2 (030508-090601)
Geokon**

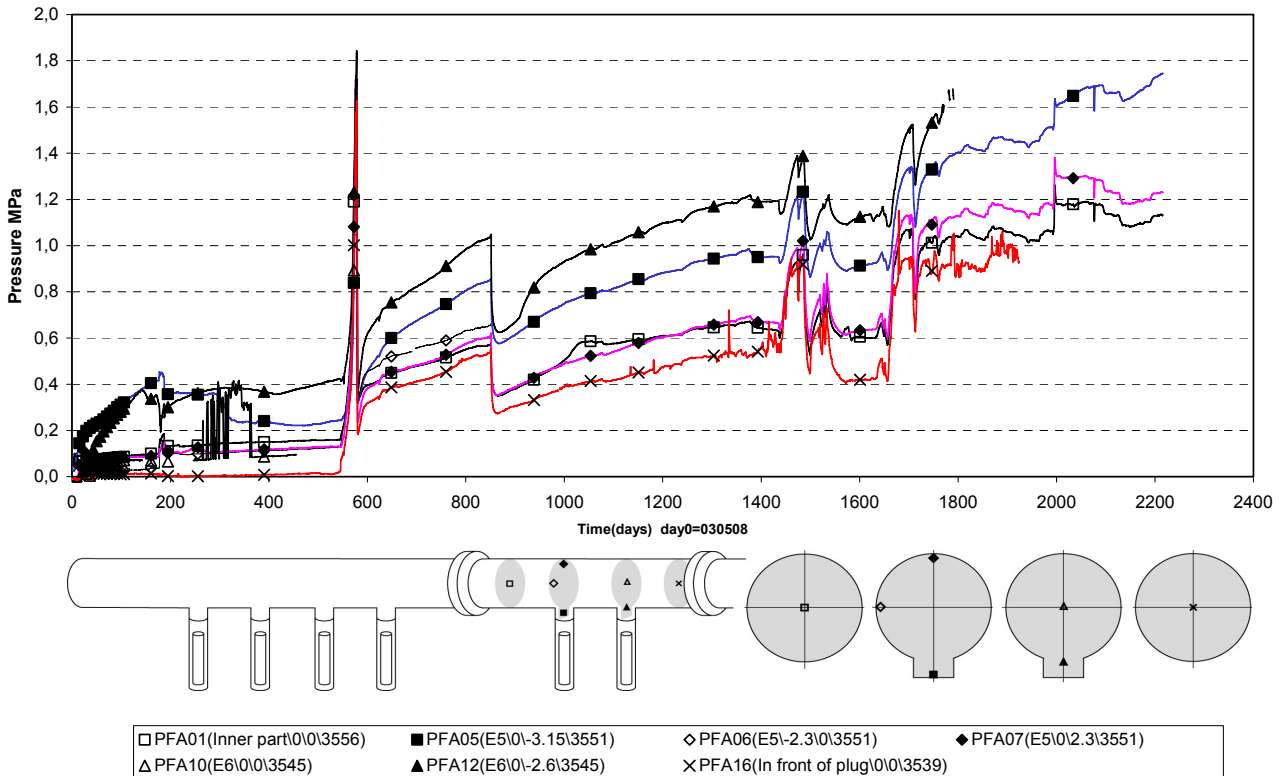
**Prototype\ Backfill \ Section 2 (030508-090601)
Total pressure - Kulite**
