### Counterforce applied to prevent spalling

**Svensk Kärnbränslehantering AB**

This report describes the field experiment performed within the project termed CAPS (Counterforce Applied to Prevent Spalling). The overall aim of the project has been to demonstrate whether a small confining pressure obtained by the application of dry bentonite pellets is sufficient to suppress thermally-induced spalling in KBS-3 deposition holes.

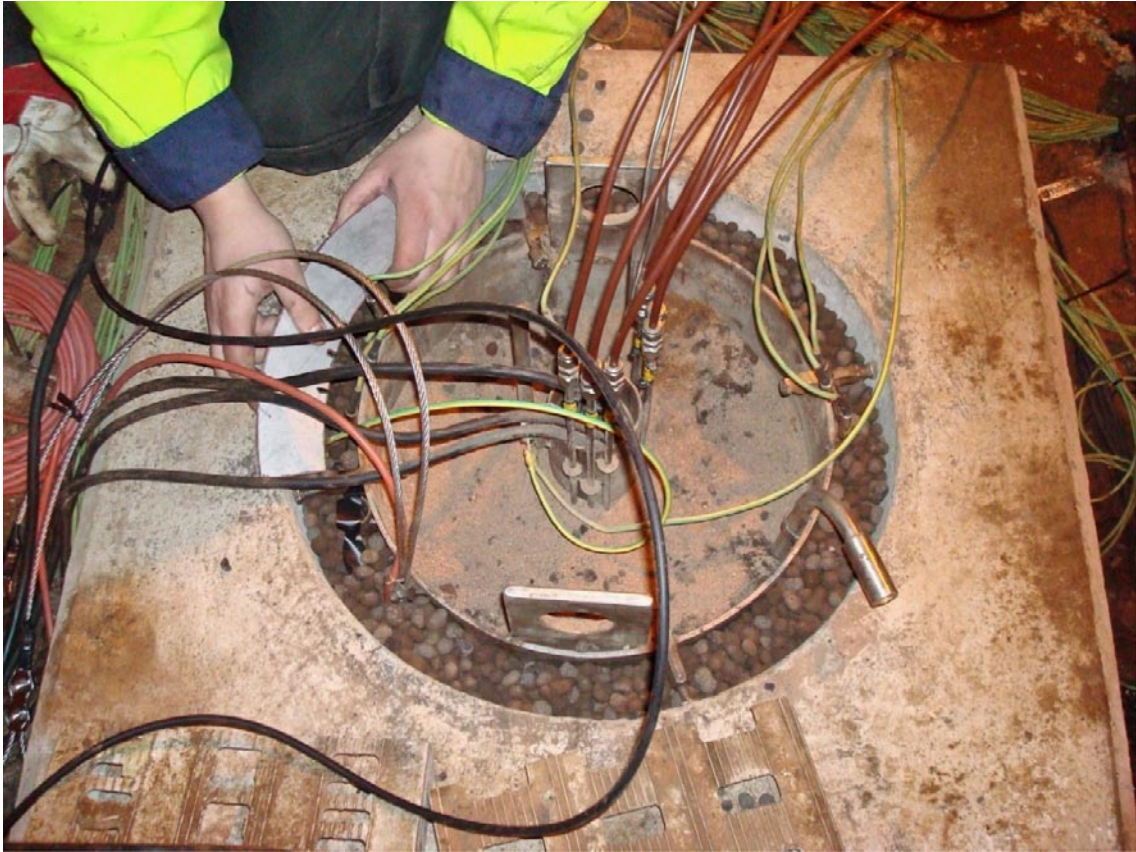
*Figure 3-2. Photograph of the pellet filled slot during preparation of Field Test 4 (Photo R Glamheden).*

A photograph of the pellet filled slot during preparation for Field Test 4 is presented in Figure 3-2. Typical properties of the selected LECA pellet are shown in Table 3-1.

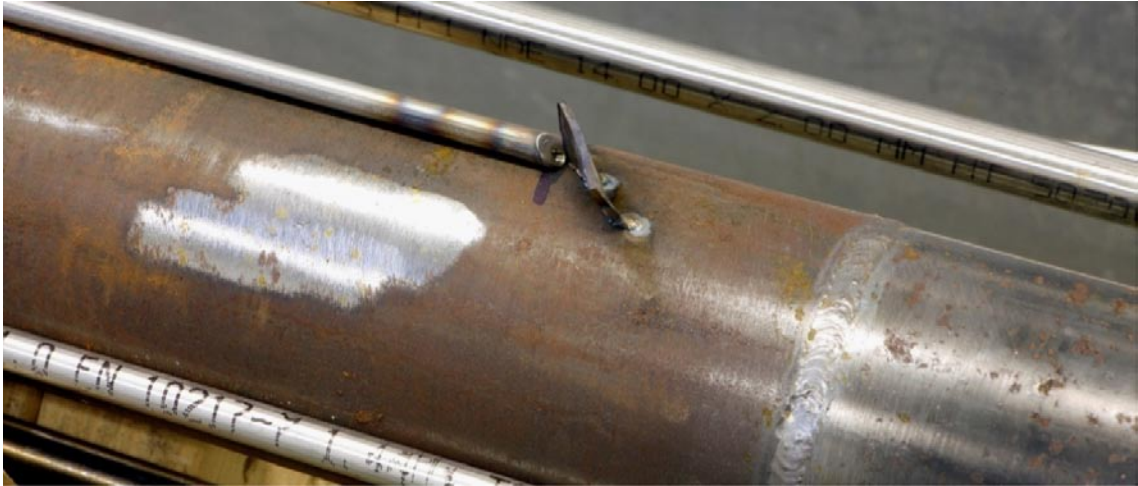
*Figure 3-5. Close-up view of the pipe and the drip plate included in the wetting system used in the second heating test (Photo C-R Lindqvist).*

The second and the fourth heating tests were performed with artificial wetting of the heating holes to preserve the moisture content of the borehole wall. In the second test the wetting was achieved using a system that generated steam in the heating holes. A small flux of water was conducted through six small pipes to drip plates located in pairs on three levels on the heating tube where it vaporized, see Figure 3-5. Drawings of the system are presented in Appendix G.

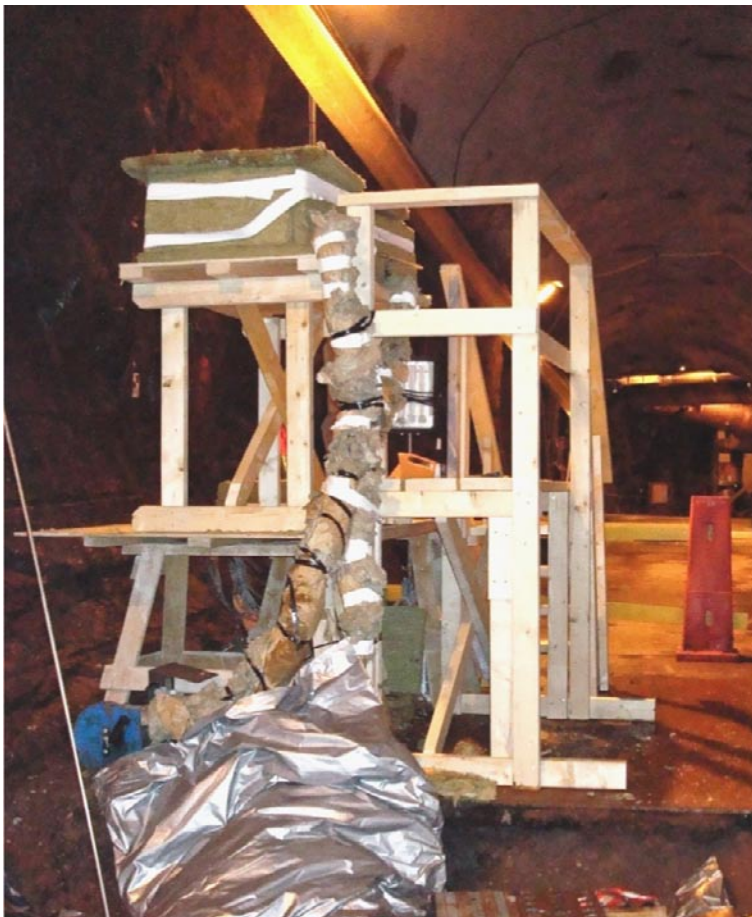
*Figure 3-6. Shows the tank and part of the pipe work of the wetting system installed in the last field test. Both the tank and the pipes were well insulated to minimize heat loss from the system (Photo C-R Lindqvist).*

The instrument holder used in the fourth test was equipped with a wetting system similar to the one used in the second test. However, the system was replaced by another system during the installation and the original one was never used. The system used instead was based on a loop that circulated water in the pellet filled slot and by re-pumping the water from the bottom to an elevated tank shown in Figure 3-6. Both the tank and the pipes were well insulated to minimize the heat loss from the system. The operational experience of the wetting system is discussed in Section 5.1.4.

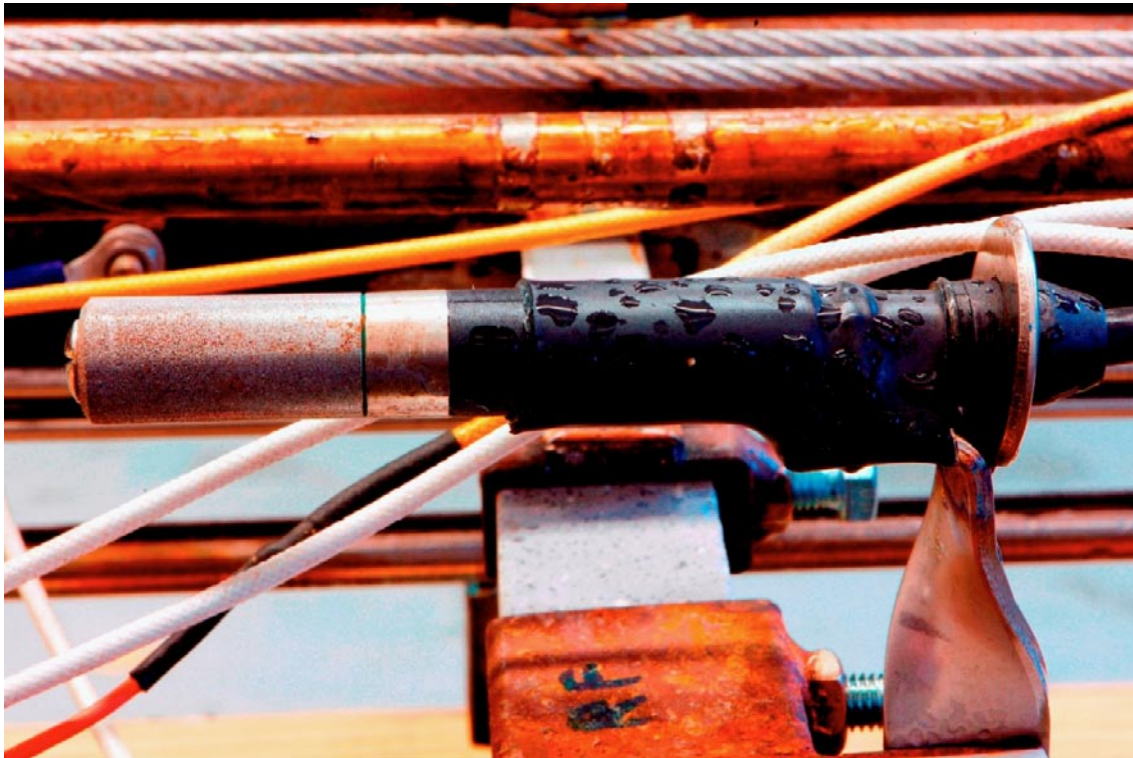
**Figure 3-7.** Close-up view of the type of RH-gauges (Rotronic) used temporarily in the late part of initial field test and for continuous readings in the second field test (Photo C-R Lindqvist).

The RH-gauges used were from three different manufactures, Test 2 – *Rotronics*, Test 3 – *Comet* and Test 4 – *Kimo*. Different types of gauges were utilized since it was difficult to find a gauge that was really suitable for the conditions in the field experiment. A photograph of the gauge used in the late part of the initial field test and in the second field test is shown in Figure 3-7. The technical description of the RH-gauges and the calibration procedure are to be found in Appendix H. The operational experience of the gauges is discussed in Section 5.1.5 and the monitoring results are presented in Section 5.4.

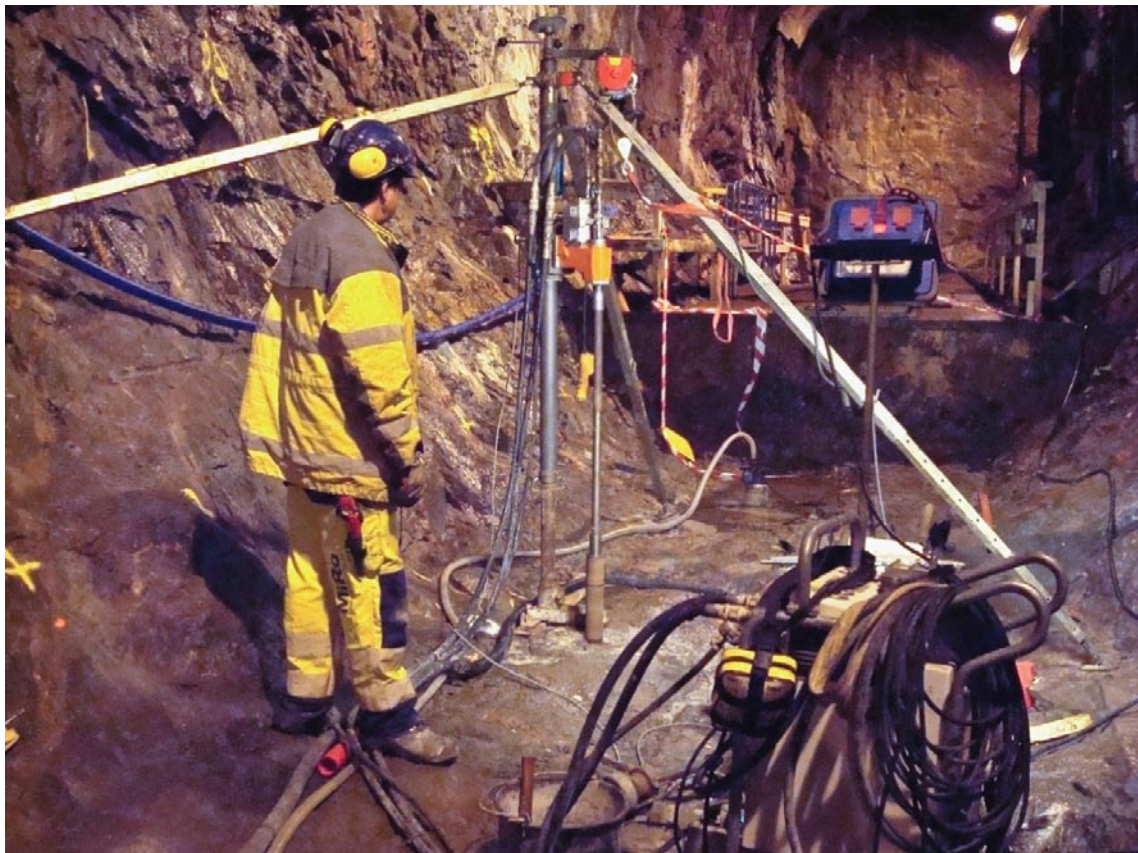
*Figure 4-1. A photograph of the equipment used for the core drilling (Photo R Glamheden).*

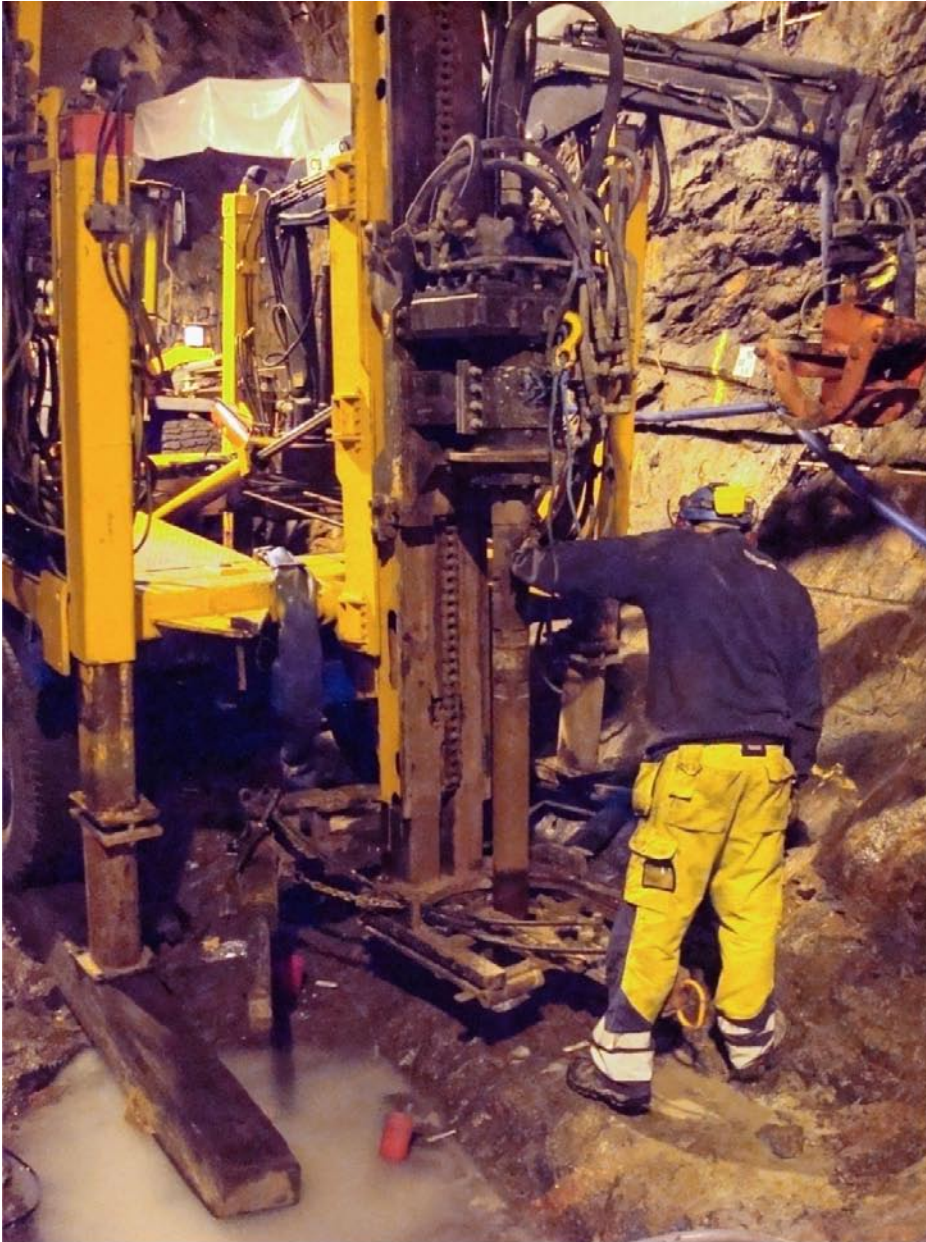
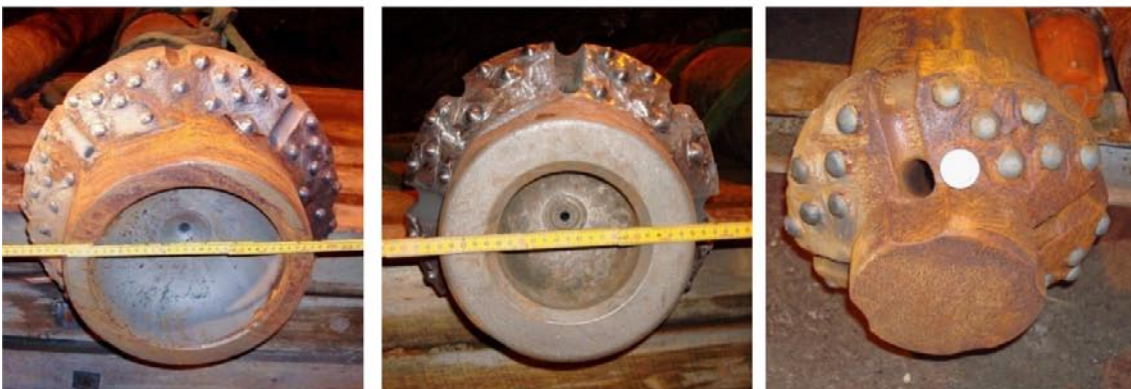
*Figure 4-2. A photograph of the equipment used for reaming the heating holes with close-up views of some of the drill bits that were utilized (Photo R Glamheden).*

The heating holes were reamed up from a core drilled pilot hole of 76 mm to a final dimension by percussion drilling in four steps: 76 – 162 – 242 – 354 – 486 mm. The drilling bits utilized for the reaming were equipped with a guide of about 5–20 cm length to minimize the borehole deviation. The drilling technique used produced a telescopic shape to the bottom of the heating holes over approximately 1 m length. The instrumentation holes were all core drilled with a 56 mm diameter. In Figure 4-1 and Figure 4-2 photographs of the drilling equipment are shown with close-up views of some of the drilling bits utilized for reaming of the heating holes.

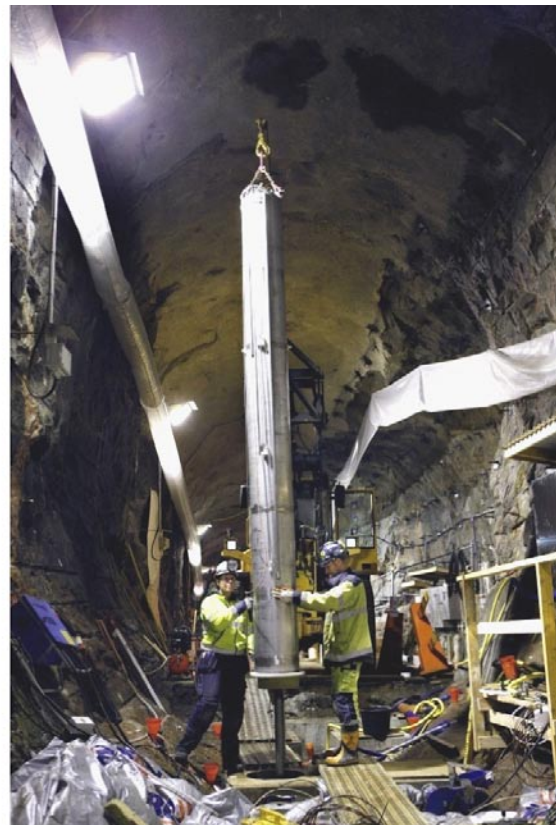
b) Field test 3

*Figure 4-6. The installation of the holder in a) Field Test 1 and b) Field Test 3 (Photo C-R Lindqvist).*

The test equipment and instrumentation used in the heating holes were mounted on the holder described in Section 3.4.1 and installed as one unit by a loading crane. Photographs from the installation of the holder in Tests 1 and 3 are shown in Figure 4-6. Suction pumps were connected to the holder drainage pipe directly after installation of the holder to protect the instruments from inflow of water into the heating holes. A number of drainage pumps were also installed in the tunnel.

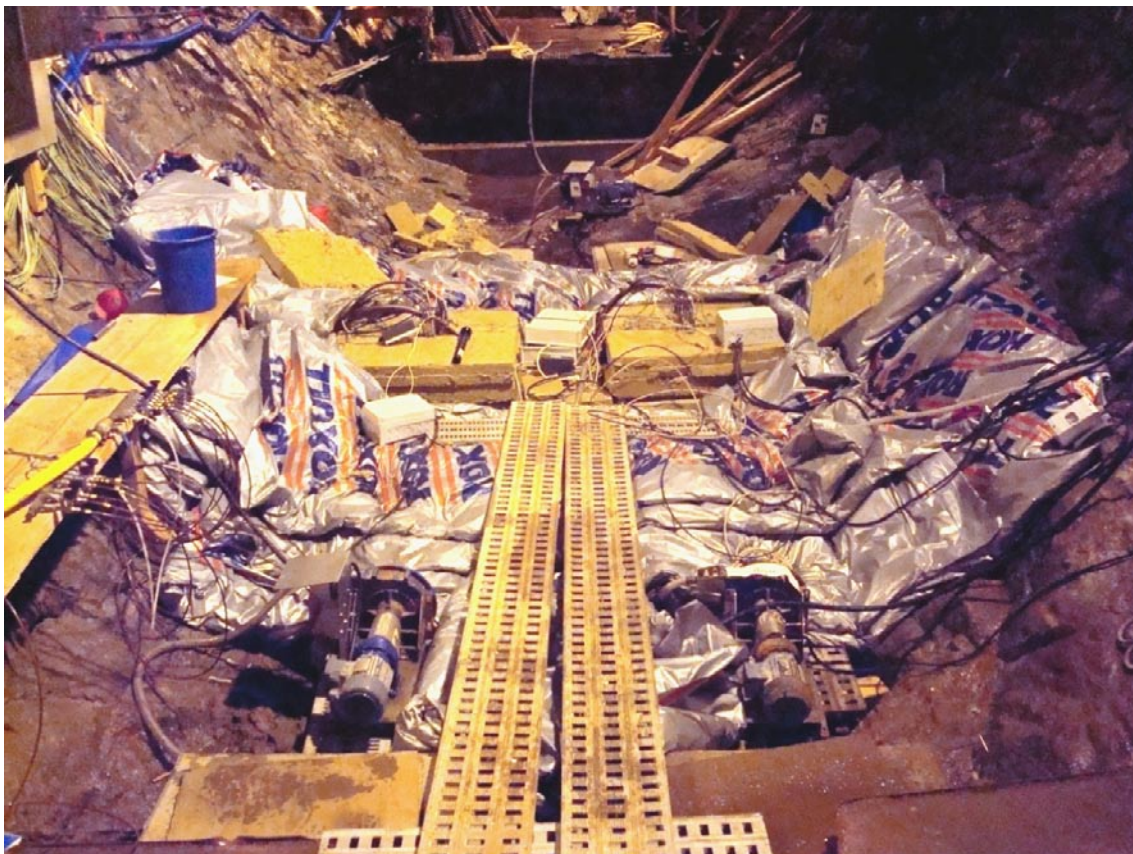
*Figure 4-7. The test site just before starting the second field test (Photo R Glamheden).*

Subsequently the heating holes were closed and covered by insulation. The final step of preparation for the field test, involved the tunnel bottom in the vicinity of the heating holes being covered by blankets of insulation. A photograph of the test site just before starting the second field test is shown in Figure 4-7. Additional photographs from the installation and of the test equipment in place in the various field tests are included in Appendix V.

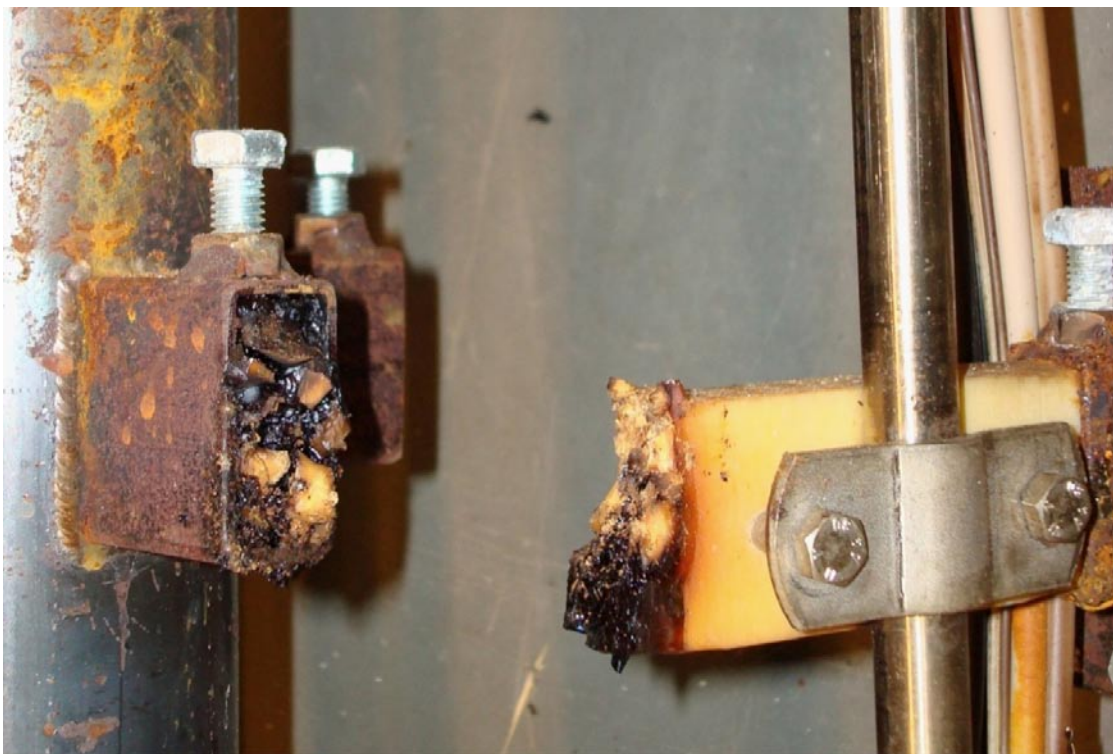
*Figure 5-1. Photograph of one of the spacers used in the first heating test. The spacer of polyurethane became too hot and started to melt (Photo R Glamheden).*

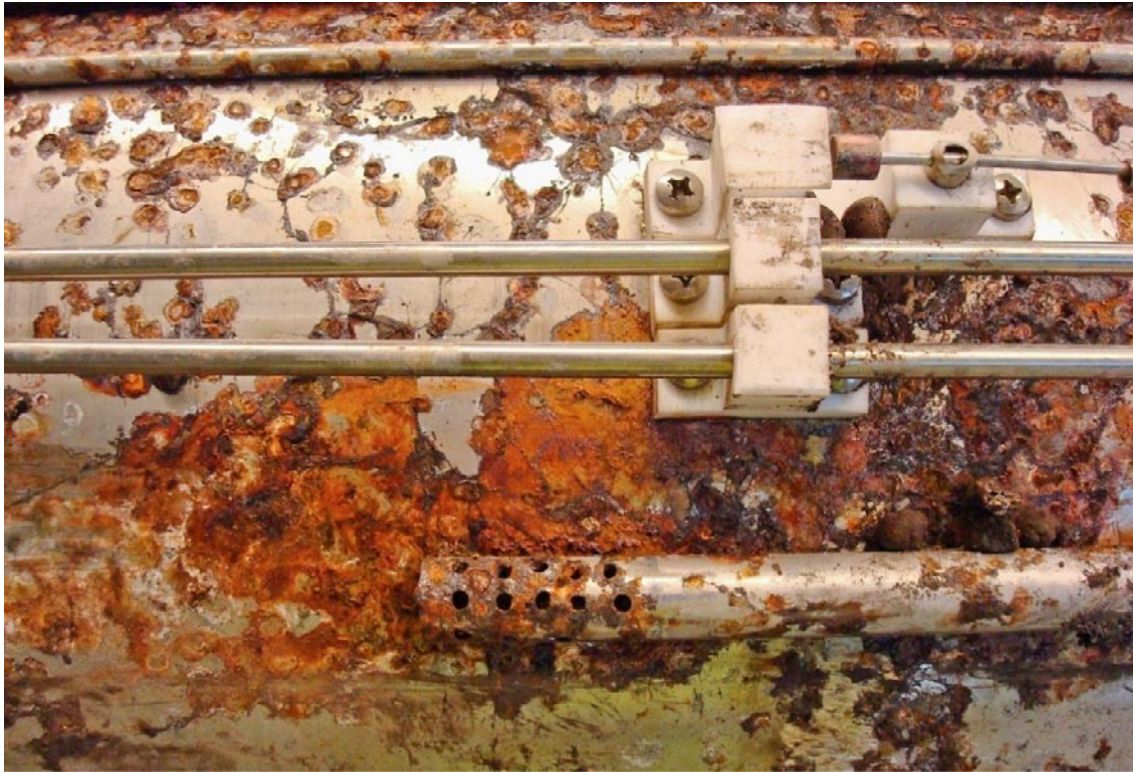
*Figure 5-2. Illustrates the corrosive degradation process the test equipment was exposed to during the heating tests. The photograph shows part of the large tube and the minor tube for the upper RH-gauge from hole KQ0048G04 in Test 3 (Photo R Glamheden).*

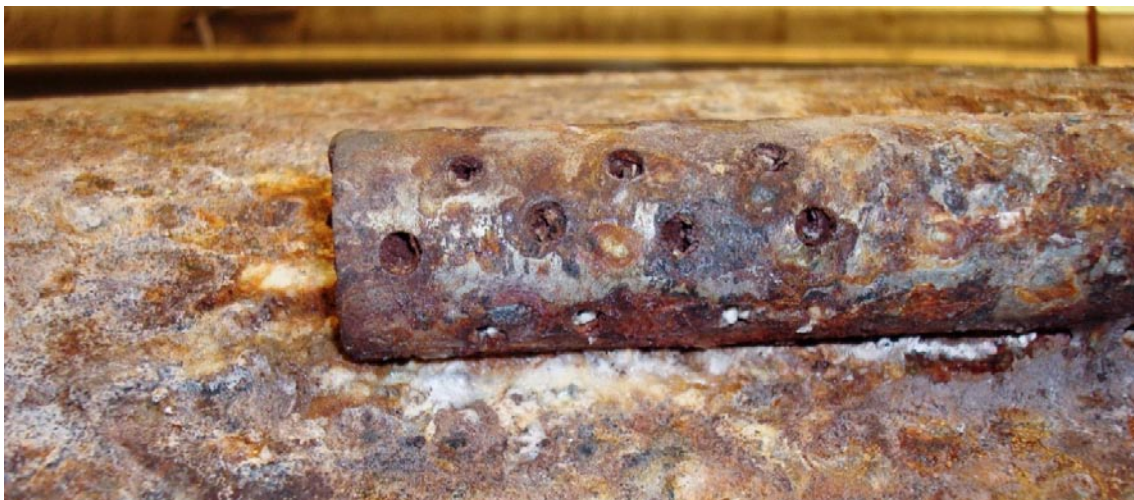
**Figure 5-4.** Photograph of the perforated part of the tube of the lower RH-gauge after removal of the test equipment in Test 3. The perforation was clogged due to substantial corrosion during the test (Photo R Glamheden).

In Tests 3 and 4, where the gauges were installed in tubes located in the pellet filled slot, additional factors that influenced the measurements appeared. The perforated part of the tube of the lower RH-gauge was for example clogged due to substantial corrosion during Test 3, see Figure 5-4. Moreover, in the last heating test it was observed that the RH-tubes caused air circulation in the slot. Air was entering in the shorter tube and vapour went out in the longer tube. The problem was solved by simply sealing the opening of the tubes by tape after the test had been ongoing for some days. The conditions were most likely similar in Test 3 although not observed. Thus, it is likely that the recorded values in Test 3 and during a part of Test 4 have been slightly lower than the true values.

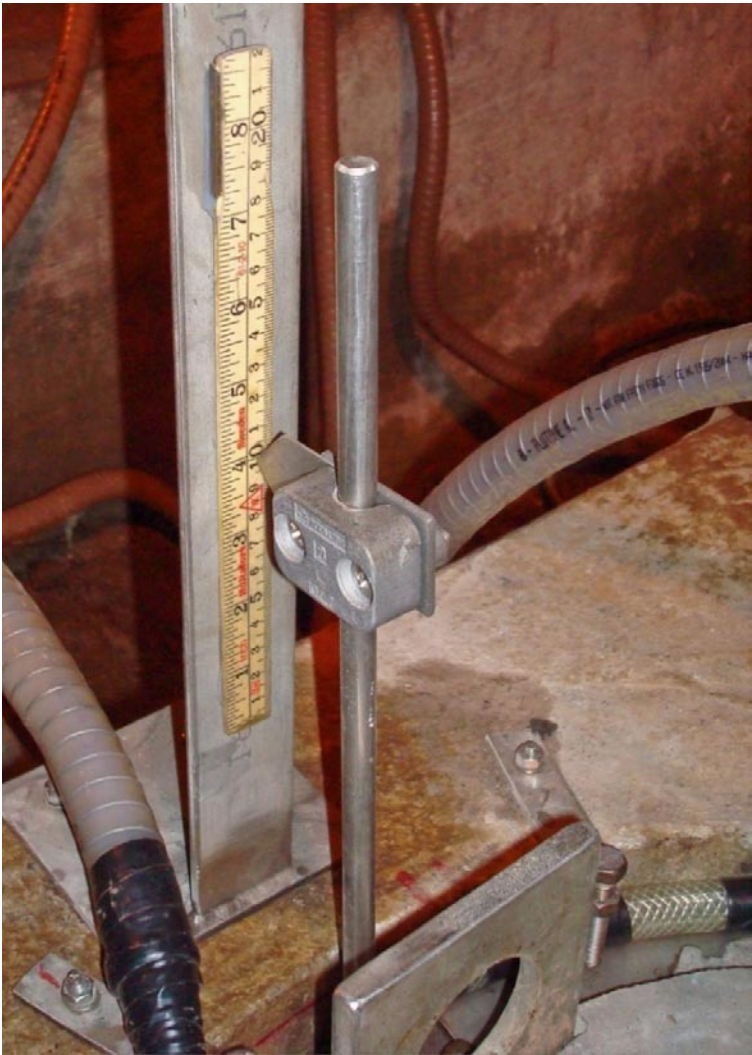
**Figure 5-5.** Photograph of the level gauge installed in the final heating test for checking movements in the pellet filled slot (Photo R Glamheden).

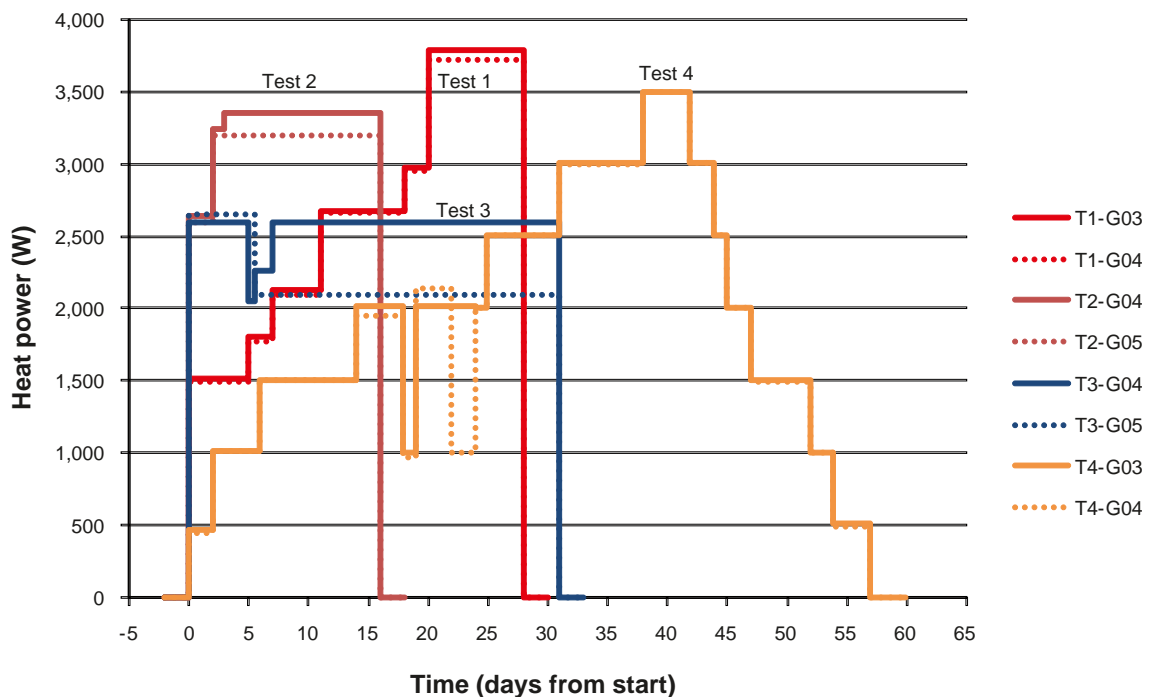
**Figure 5-6.** Applied heating power in each hole during the field tests. Recorded mean values for respective heating step. The borehole label is shortened in the figure. The complete label included “KQ00” and borehole number. The time has been round off to the closest day. Test 1: 080829 11:08–080926 (G03) 18:28, (G04) 20:58; Test 2: 081106 14:51–081122 (G04) 16:19, (G05) 18:09; Test 3: 081128 13:06–091229 (G04) 12:33, (G05) 14:13; Test 4: 090213 10:51–090411 19:31.

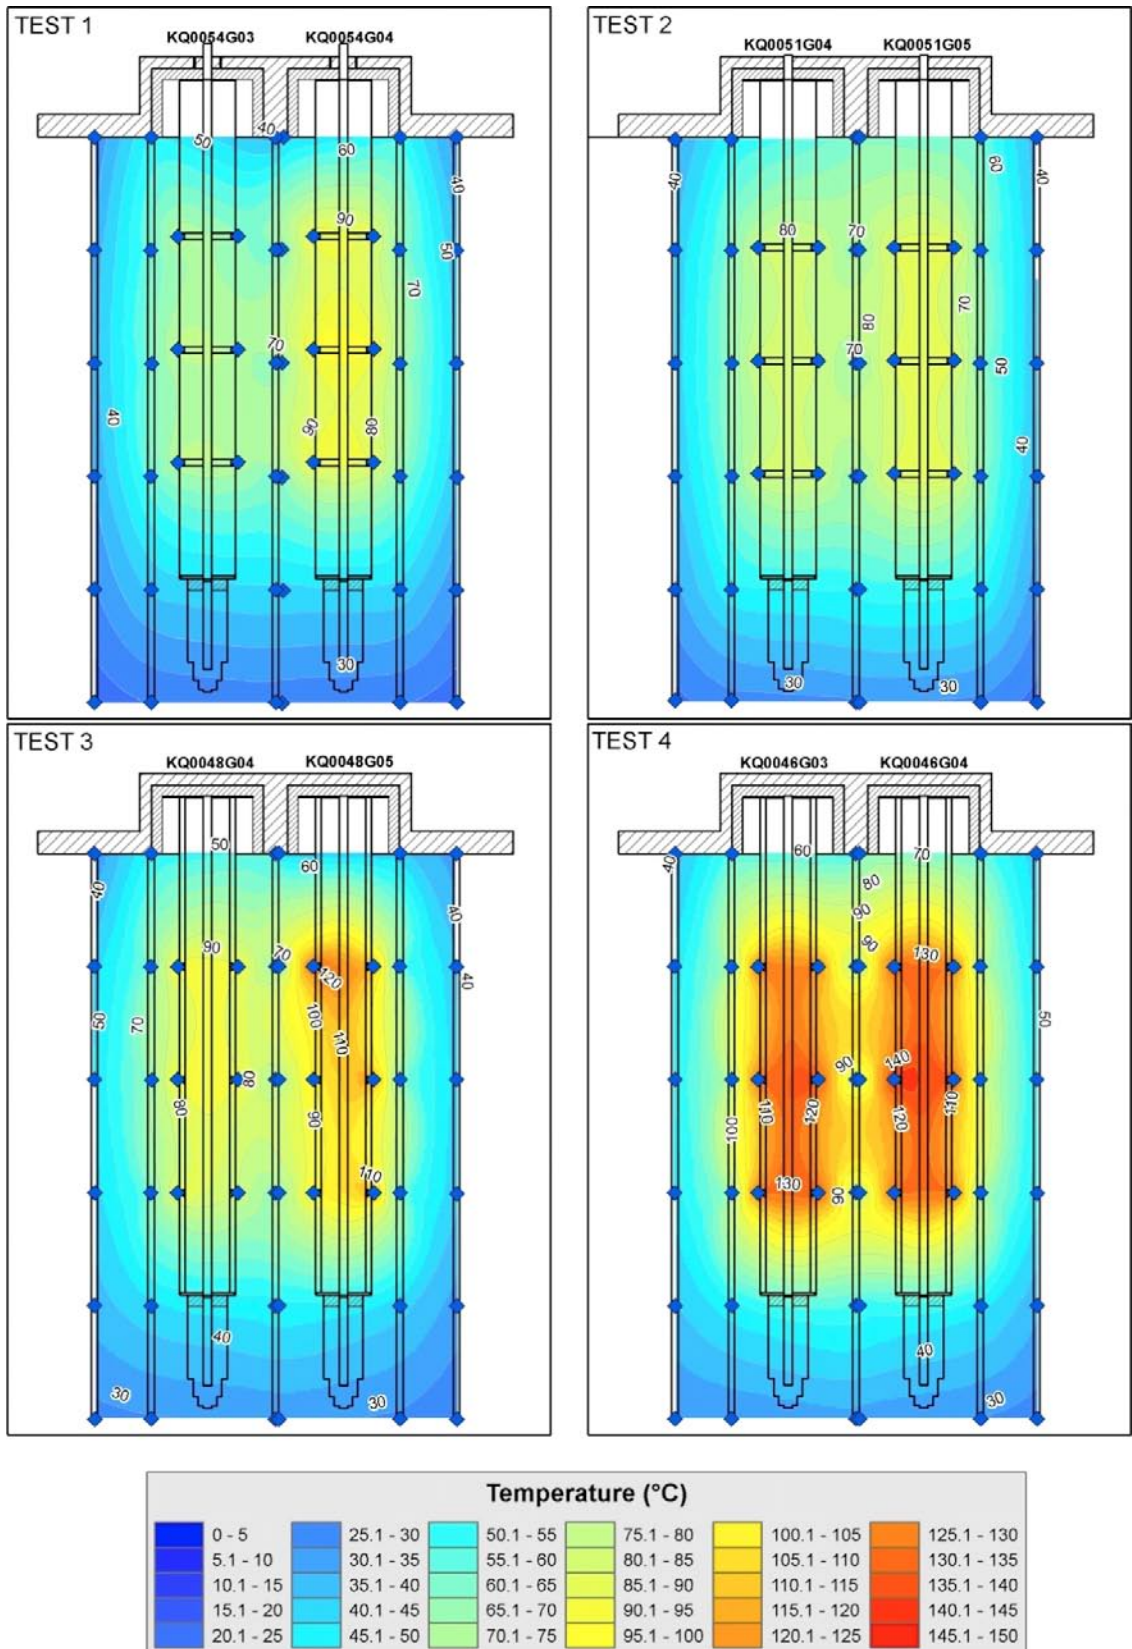
**Figure 5-8.** Recorded temperatures of rock mass in Test 1–4 when the cooling phase was initiated. The squares in blue indicate the position of the temperature gauges that were included in the natural neighbour interpolation of the recorded values.

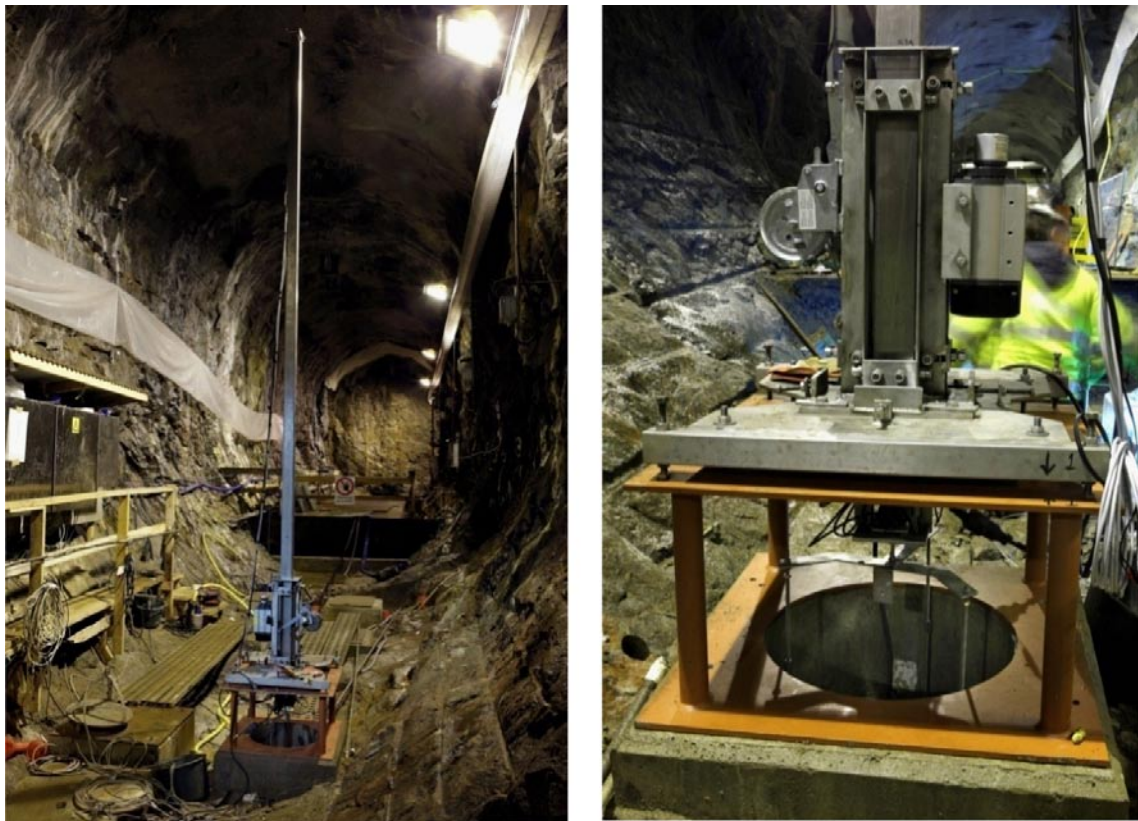
*Figure 7-1. Lifting device for documentation of the spalled notch in the heating holes.*

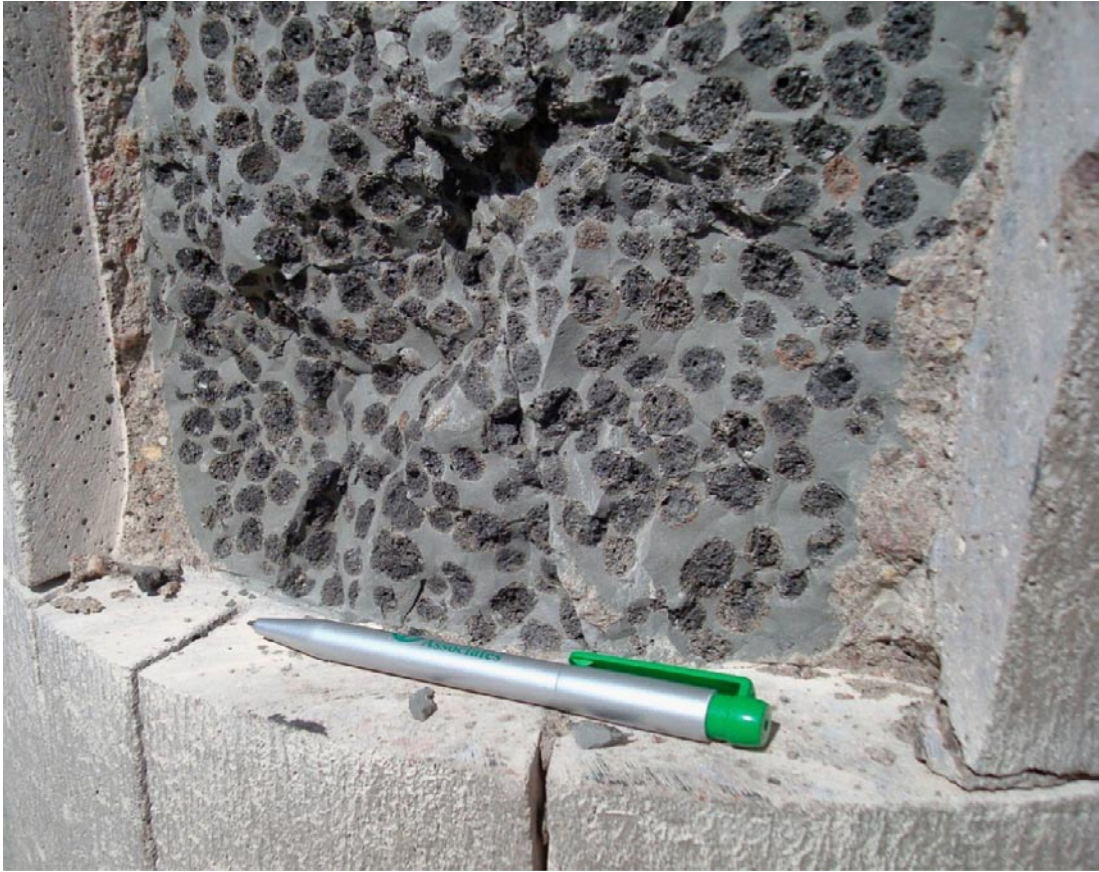
**Figure 7-7.** Photograph from sealing test in 50 mm pellet filled slot. The voids are completely filled and the contact surface is tight (Photo R Glamheden).

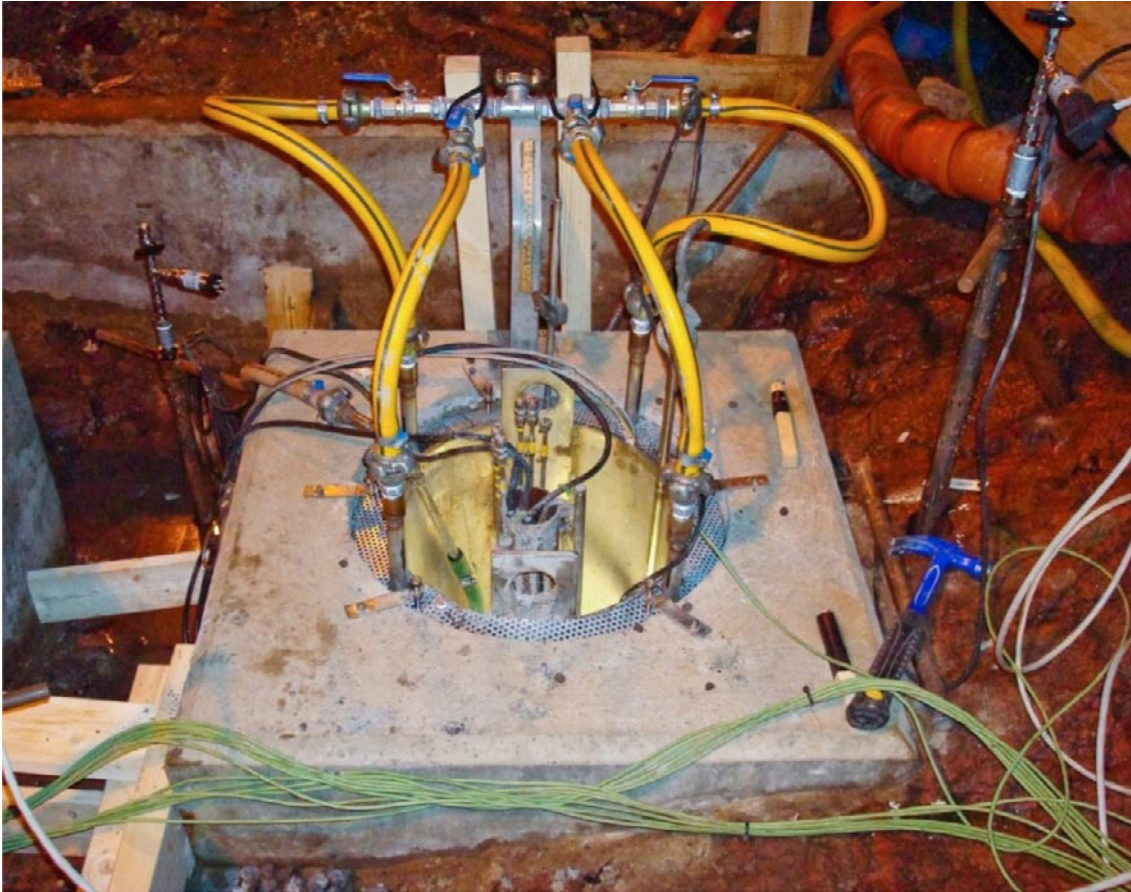
*Figure 7-9. A top view of the pellet filled slot before the start of grouting (Photo R Glamheden).*

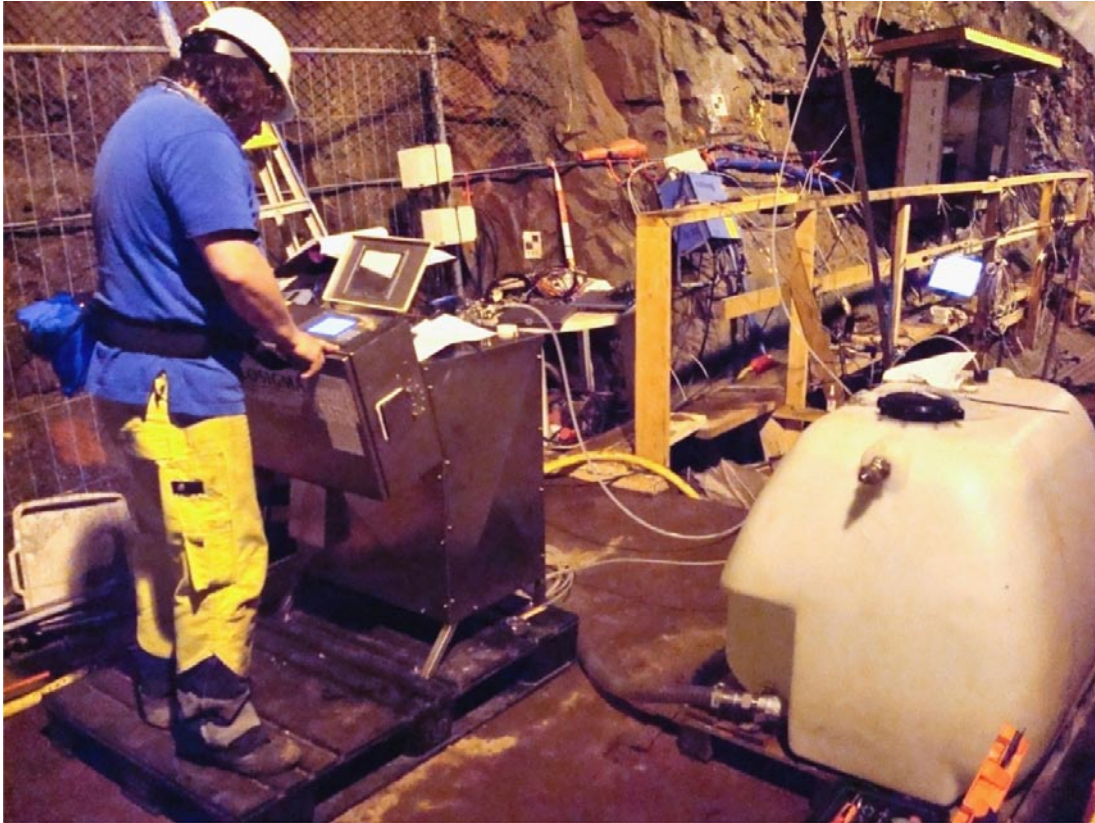
*Figure 7-10. Shows the equipment utilized for the water injection tests (Photo R Glamheden).*

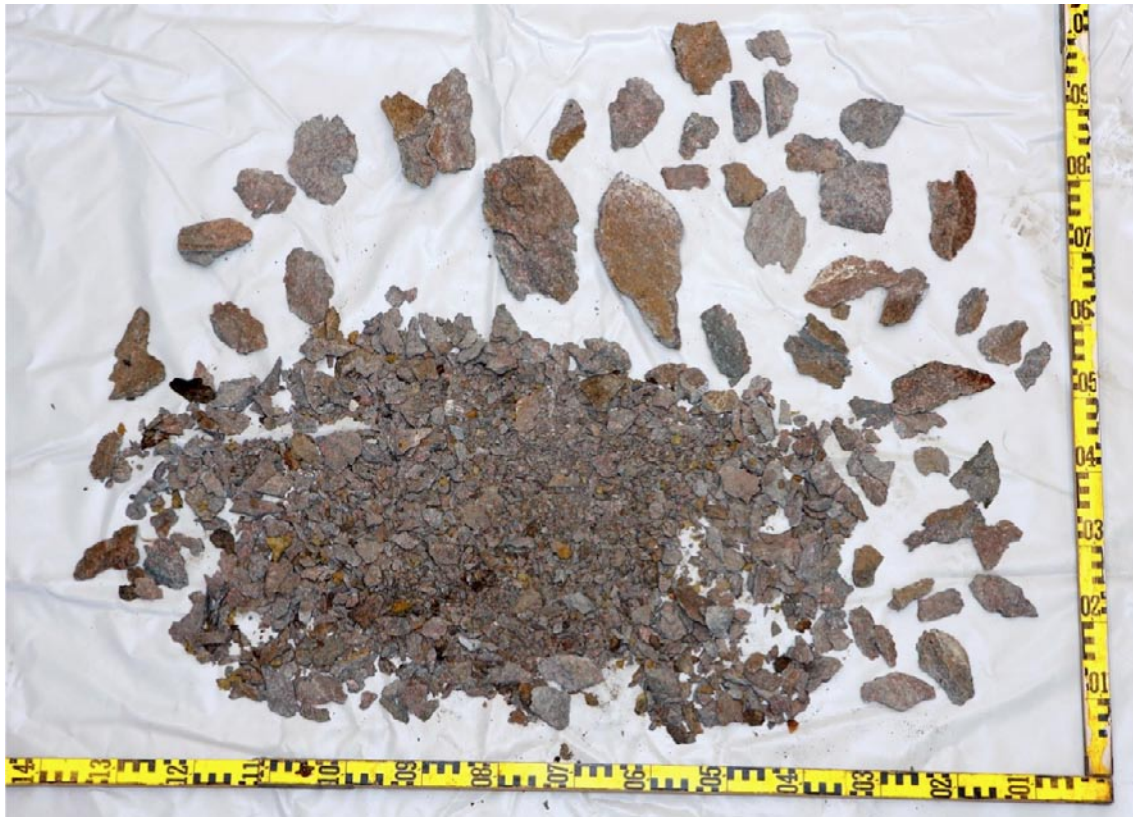
Figure 7-11. Shows the rock fragments collected in KQ0054G03 in Test 1 (Photo C-R Lindqvist).

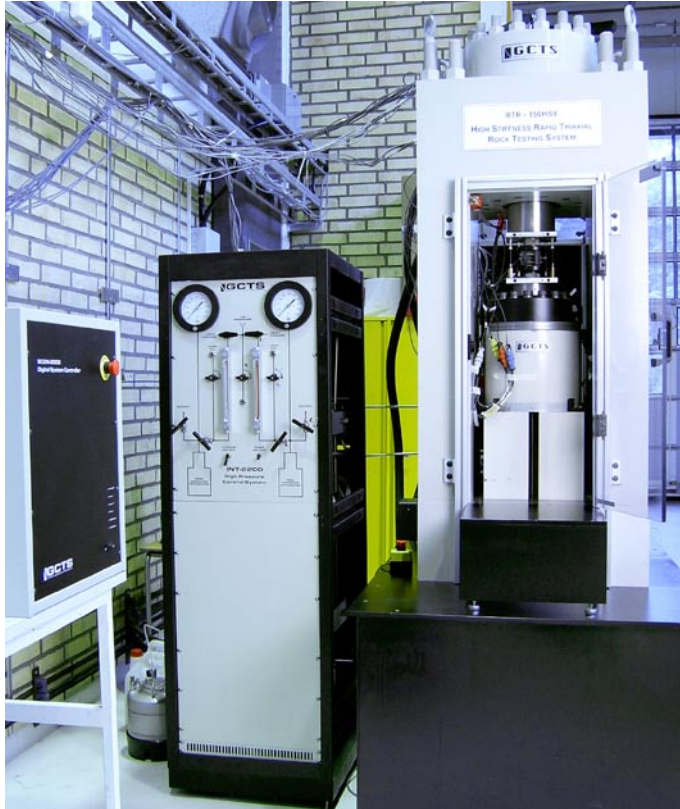
**Figure C-1.** Rock testing system. From left: Digital controller unit, pressure cabinet (used for triaxial tests) and load frame. The PC with the test software (not shown in the picture) is placed on the left hand side of the controller unit.

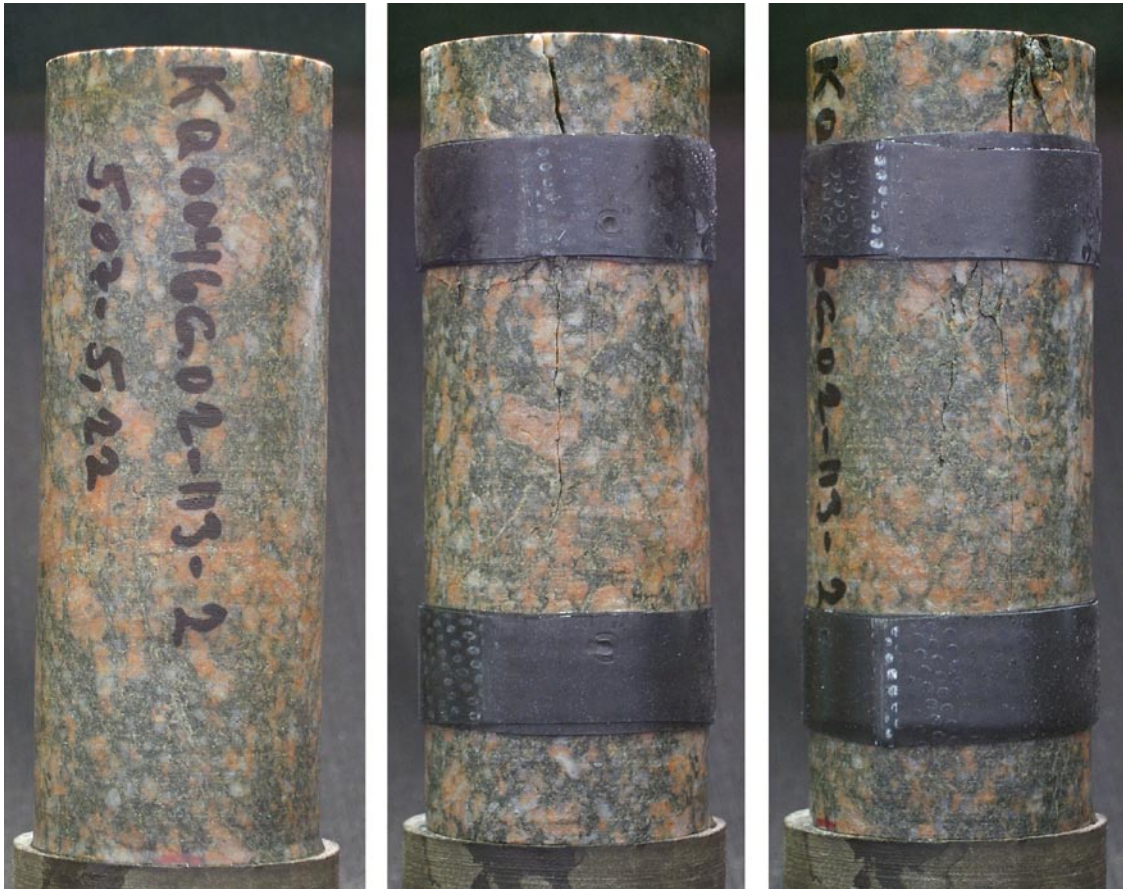
Diameter (mm)	Height (mm)	Density (kg/m <sup>3</sup> )
45.2	123.0	2,740
<b>Comments:</b>	A vertical fracture has developed along the specimen.

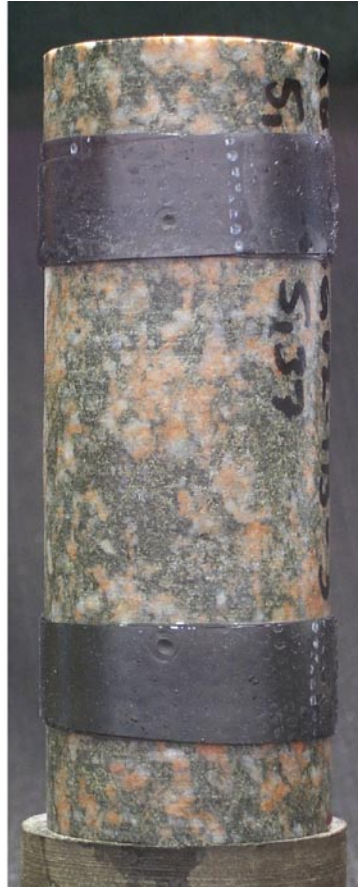
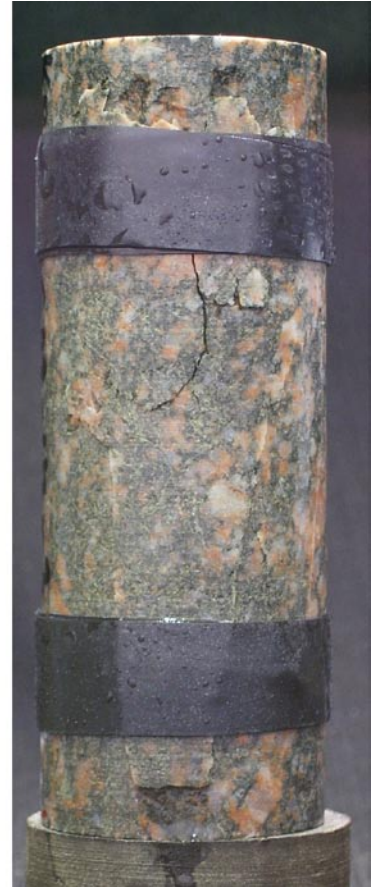
After mechanical test

Diameter (mm)	Height (mm)	Density (kg/m <sup>3</sup> )
45.2	122.0	2,740
<b>Comments:</b>	Deep spalling is observed along one side of the specimen.

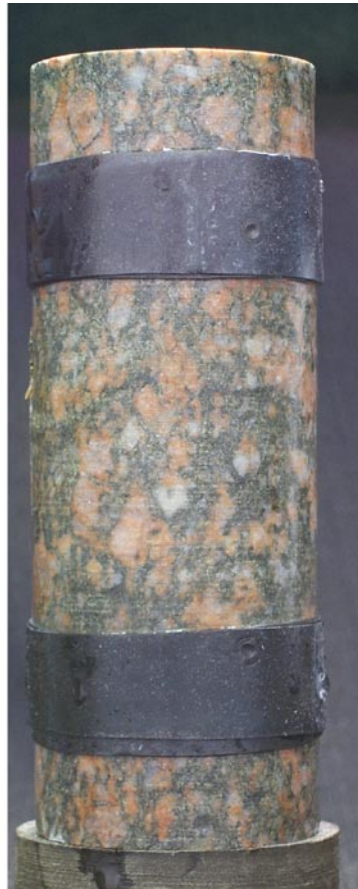
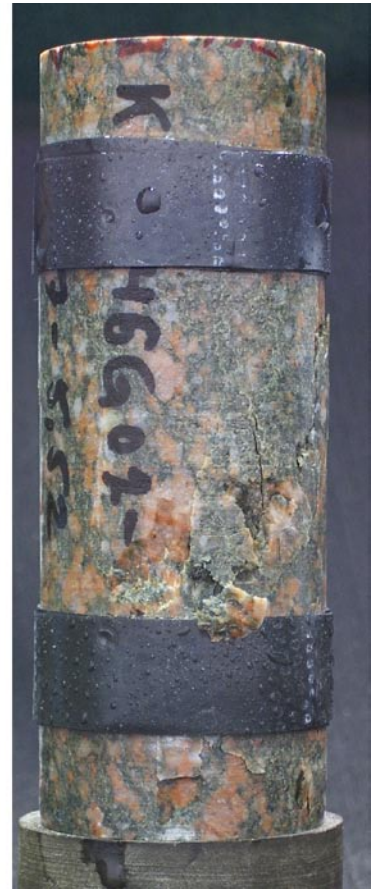
After mechanical test

Diameter (mm)	Height (mm)	Density (kg/m <sup>3</sup> )
45.3	121.5	2,740
Comments:	Spalling is observed along one side of the specimen.
