### Counterforce applied to prevent spalling

**Svensk Kärnbränslehantering AB**

This report describes the field experiment performed within the project termed CAPS (Counterforce Applied to Prevent Spalling). The overall aim of the project has been to demonstrate whether a small confining pressure obtained by the application of dry bentonite pellets is sufficient to suppress thermally-induced spalling in KBS-3 deposition holes.

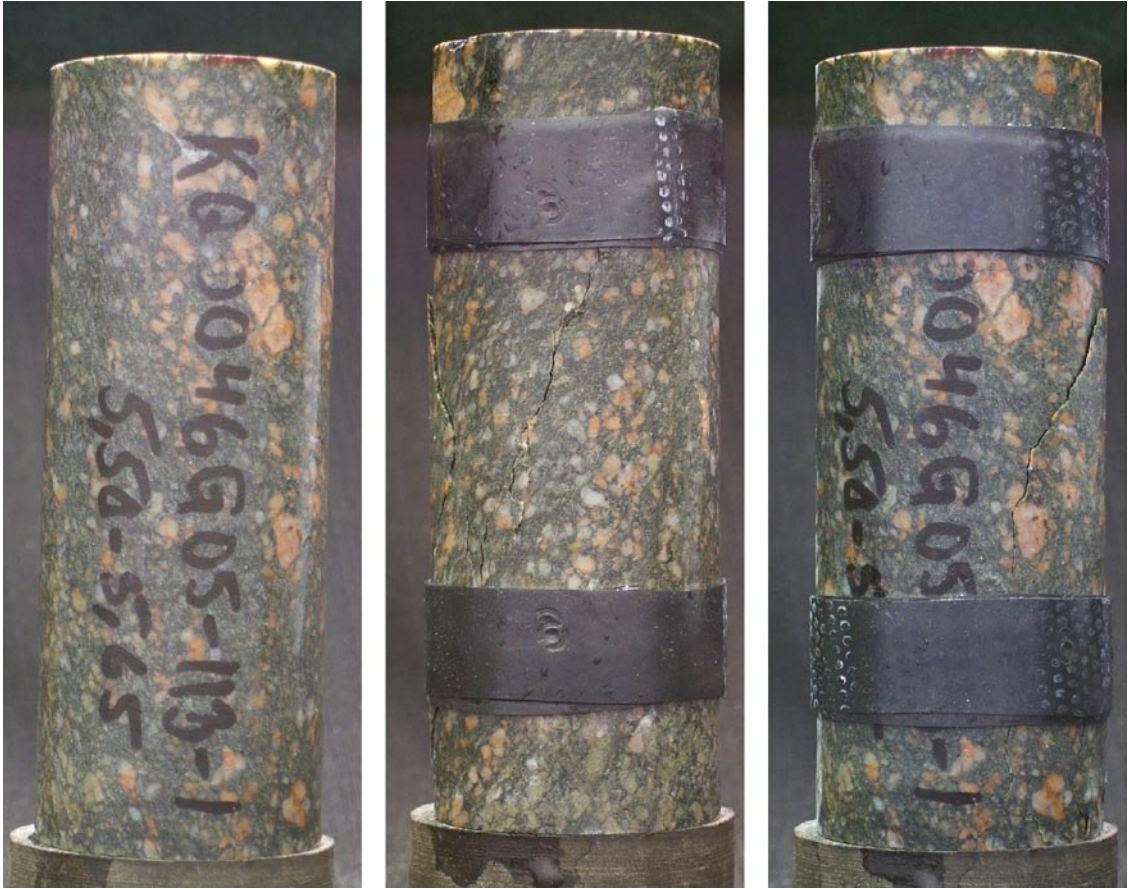
Diameter (mm)	Height (mm)	Density (kg/m <sup>3</sup> )
45.3	121.4	2,780
<b>Comments:</b>	A V-shaped fracture was developed through the specimen.

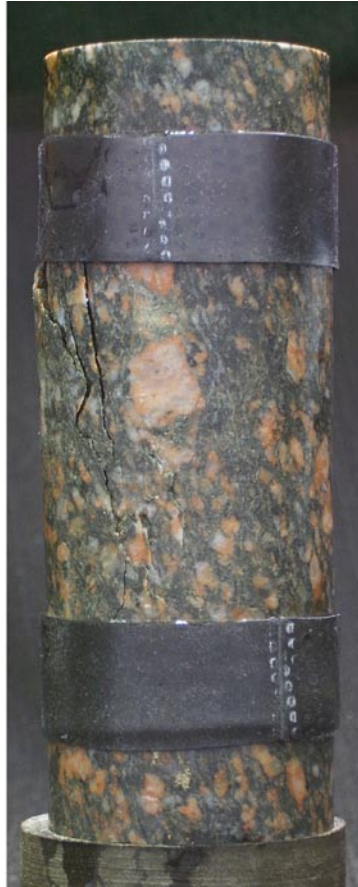
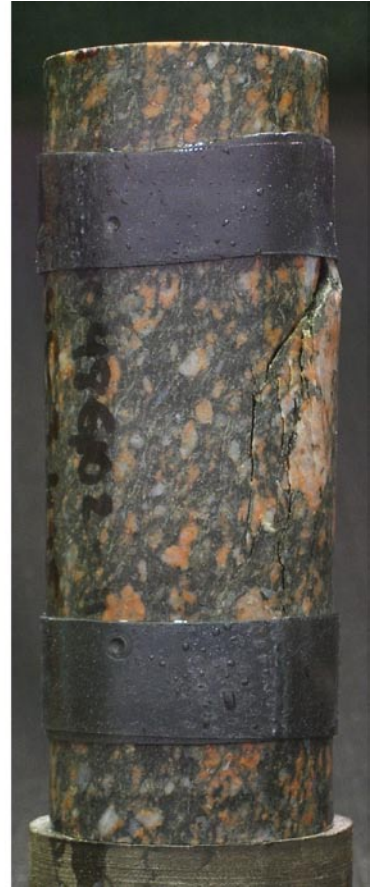
After mechanical test

Diameter (mm)	Height (mm)	Density (kg/m <sup>3</sup> )
45.2	121.6	2,750
<b>Comments:</b>	Spalling is observed along one side of the specimen.

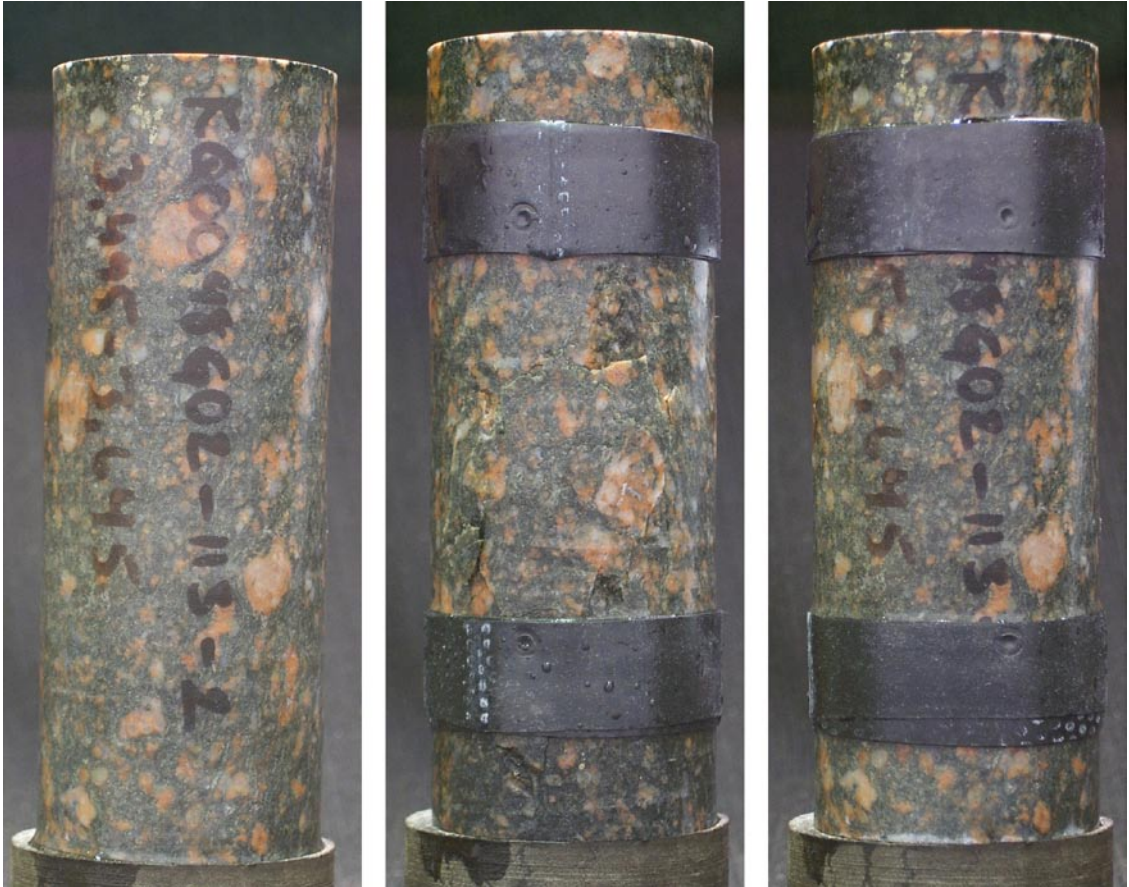
Diameter (mm)	Height (mm)	Density (kg/m <sup>3</sup> )
45.3	122.6	2,740
Comments:	Spalling is observed along one side of the specimen.

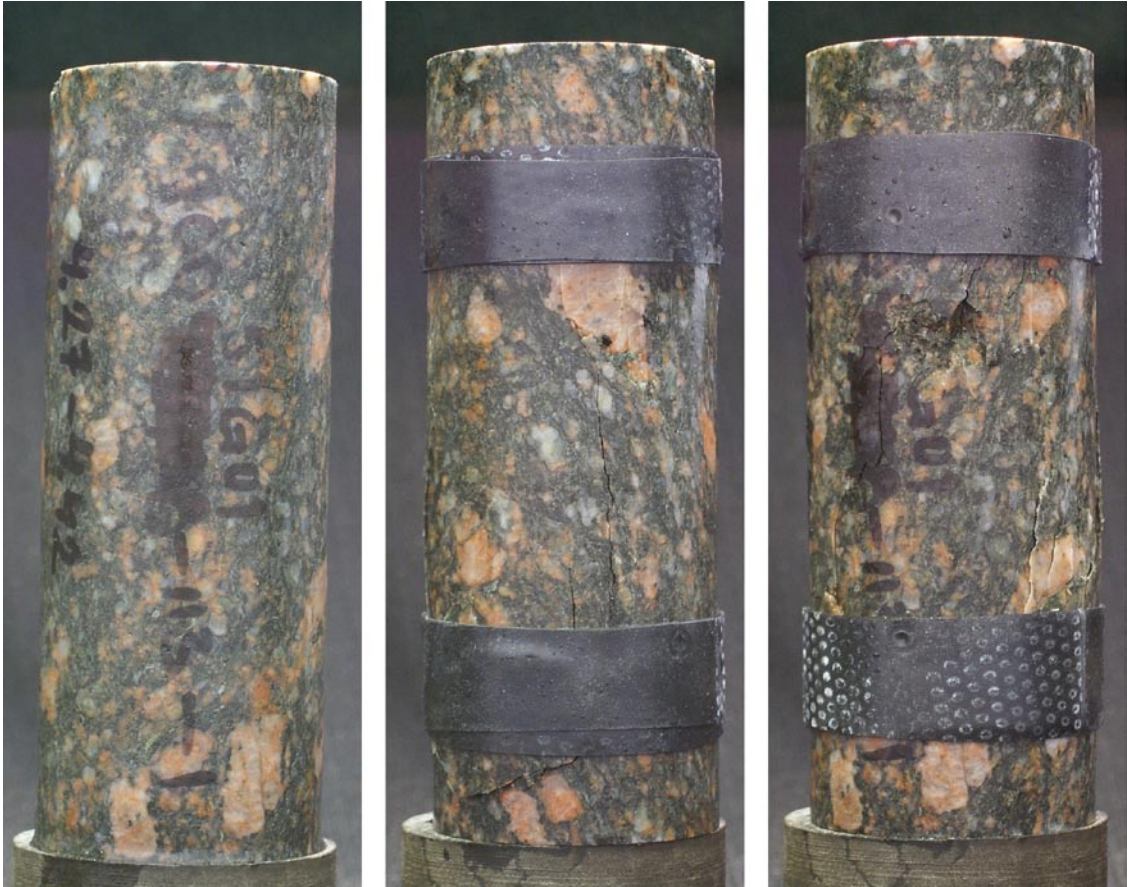
Diameter (mm)	Height (mm)	Density (kg/m <sup>3</sup> )
45.6	121.5	2,750
<b>Comments:</b>	Vertical fractures have been developed along the specimen.

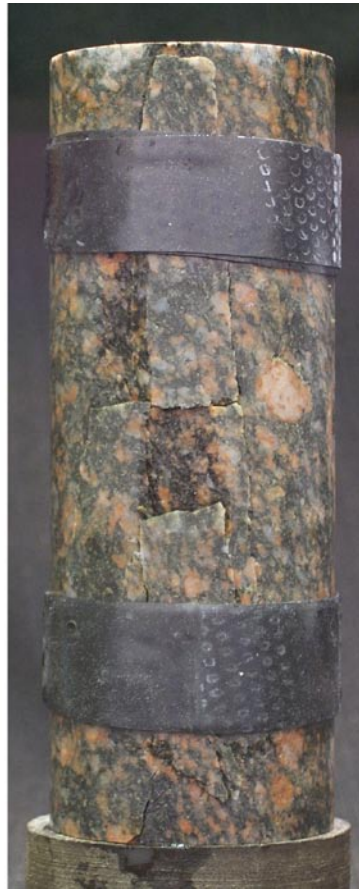
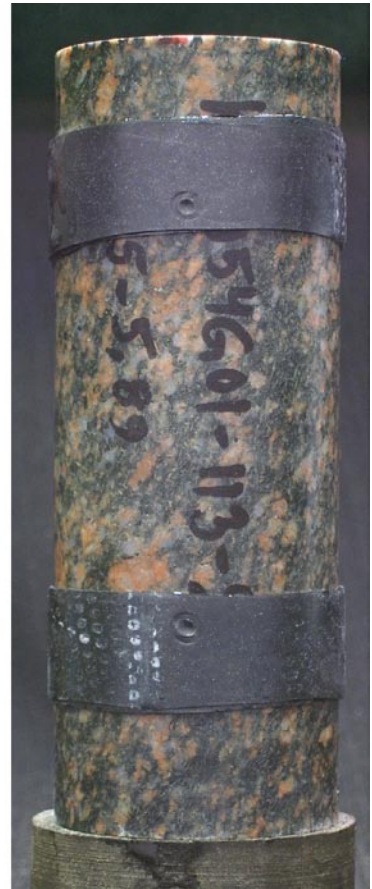
After mechanical test

Diameter (mm)	Height (mm)	Density (kg/m <sup>3</sup> )
45.4	122.0	2,720
<b>Comments:</b>	Spalling is observed along one side of the specimen.

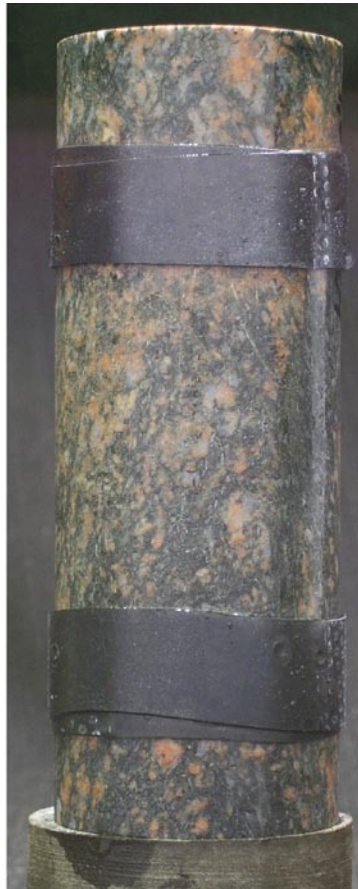
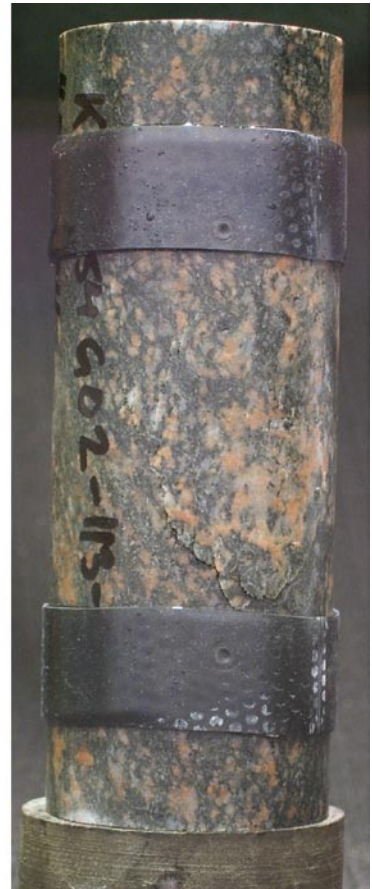
After mechanical test

Diameter (mm)	Height (mm)	Density (kg/m <sup>3</sup> )
45.2	123.0	2,710
Comments:	Spalling is observed along one side of the specimen.

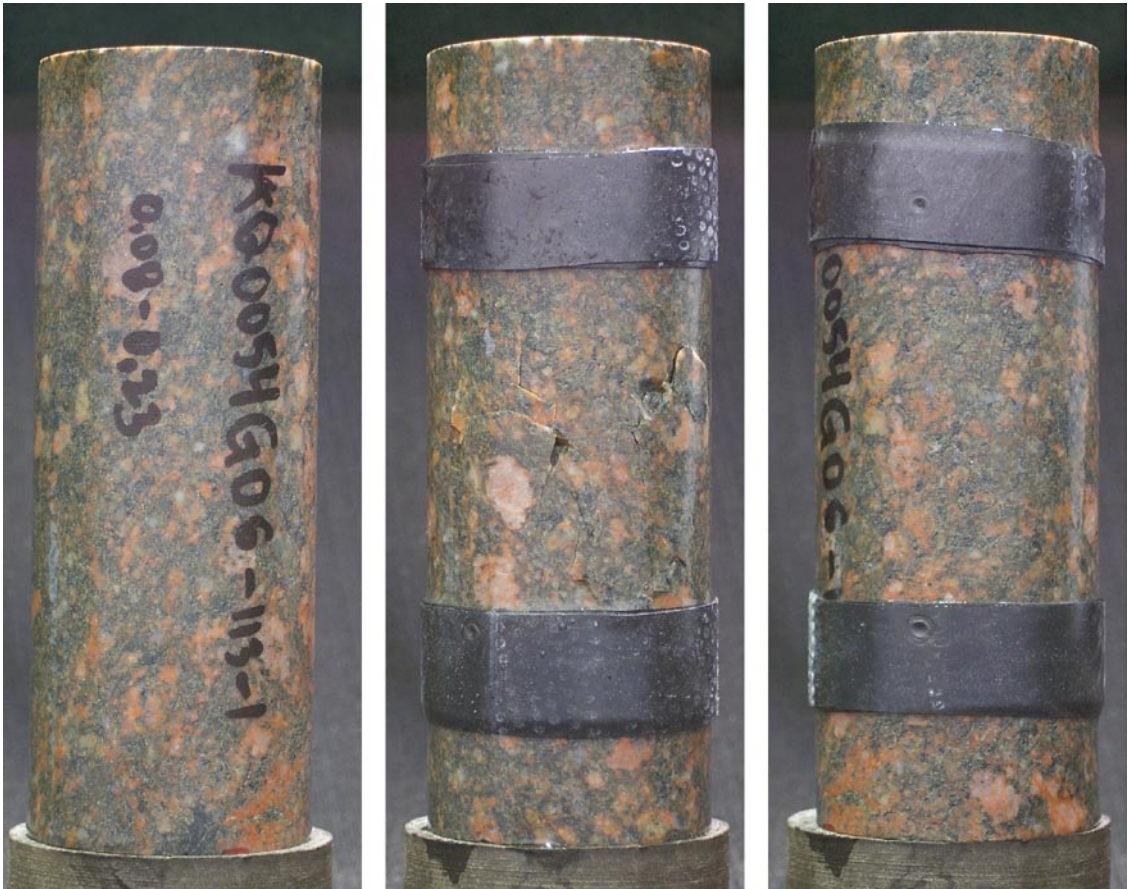
Diameter (mm)	Height (mm)	Density (kg/m <sup>3</sup> )
45.2	122.6	2,750
Comments:	Spalling is observed along one side of the specimen.

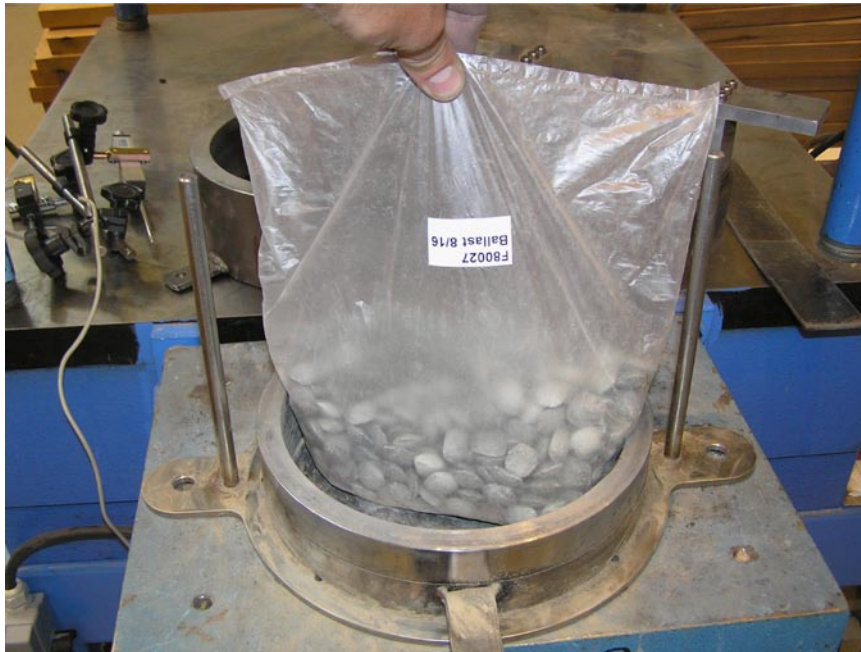
*Figure E-1. Bentonite is poured into the cell. (The label on the plastic bag is not correct.)*

The material kept in a plastic bag was carefully poured into the cell as shown in Figure E-1 in order to obtain a loose packing. A ruler was used to carefully levelling the material and scraping off excess material. Some grains were manually picked and replaced. The cover was placed on the cell and the initial height was measured, see Figure E-2 (bentonite clay). A picture showing the natural gravel placed in the cell is shown in Appendix AE4.

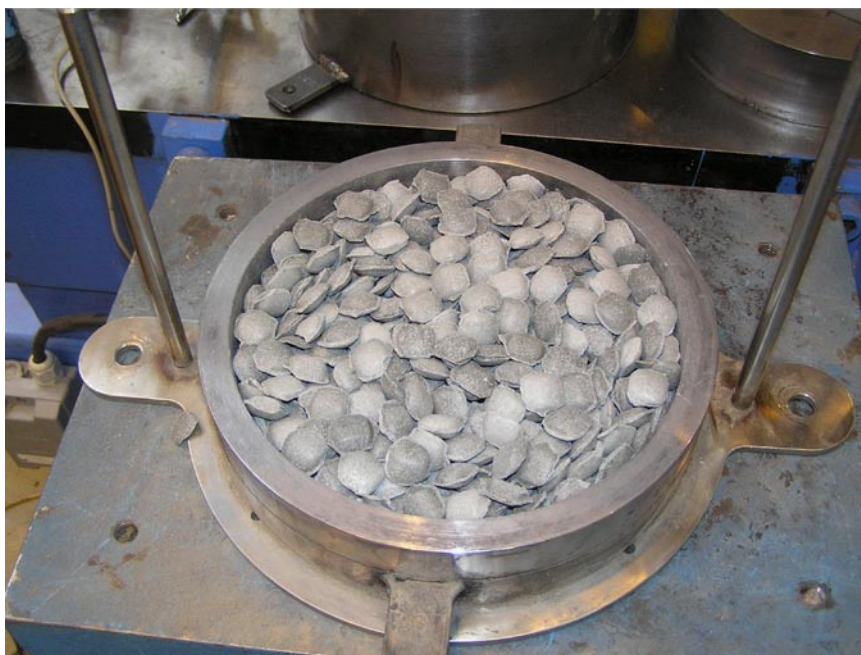
*Figure E-2. The bentonite material placed in cell.*

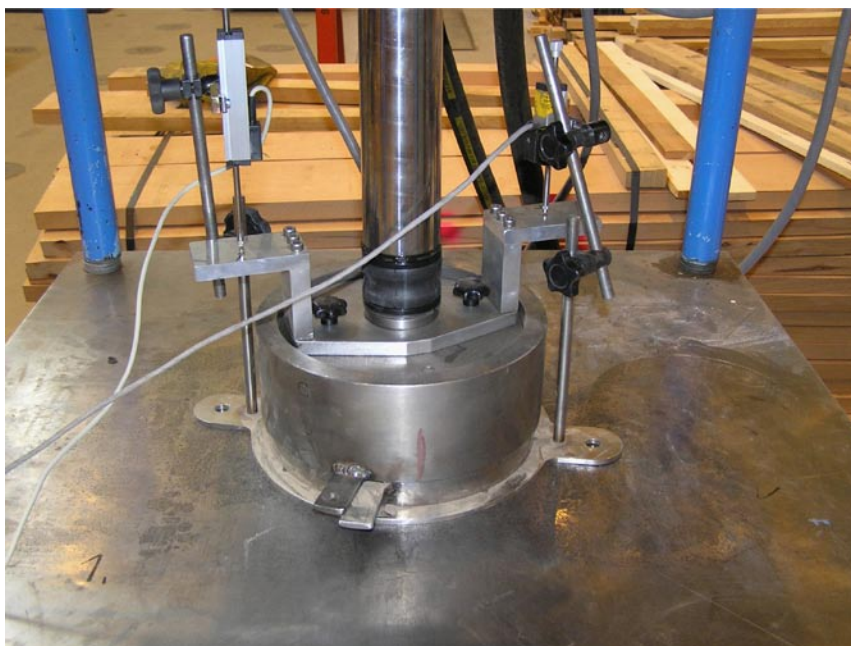
*Figure E-4. The oedometer cell is placed in the load frame. The piston is pressing on the cell cover via a spherical joint. The two linear displacement transducers are installed.*

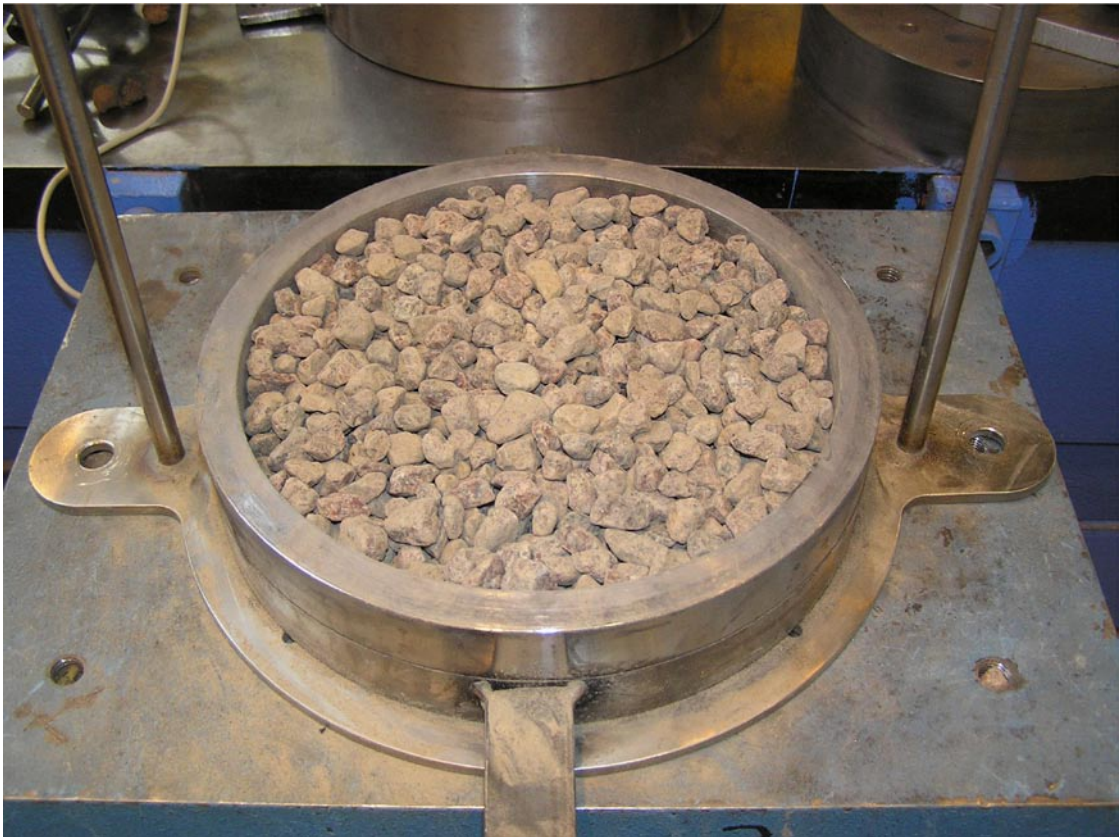
*Figure AE-3. The natural gravel is placed in cell.*

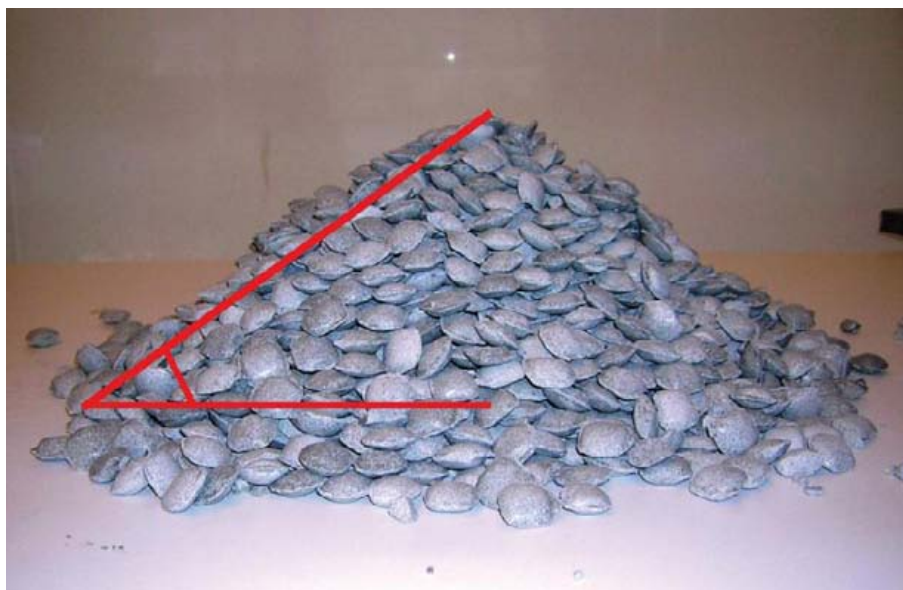
**Figure F-1.** Picture showing a heap of MX-80 pellets. The red angle shows how the angle of friction was determined.

MX-80 pellets: ca 36.3°

Cebogel QSE: ca 37.9°

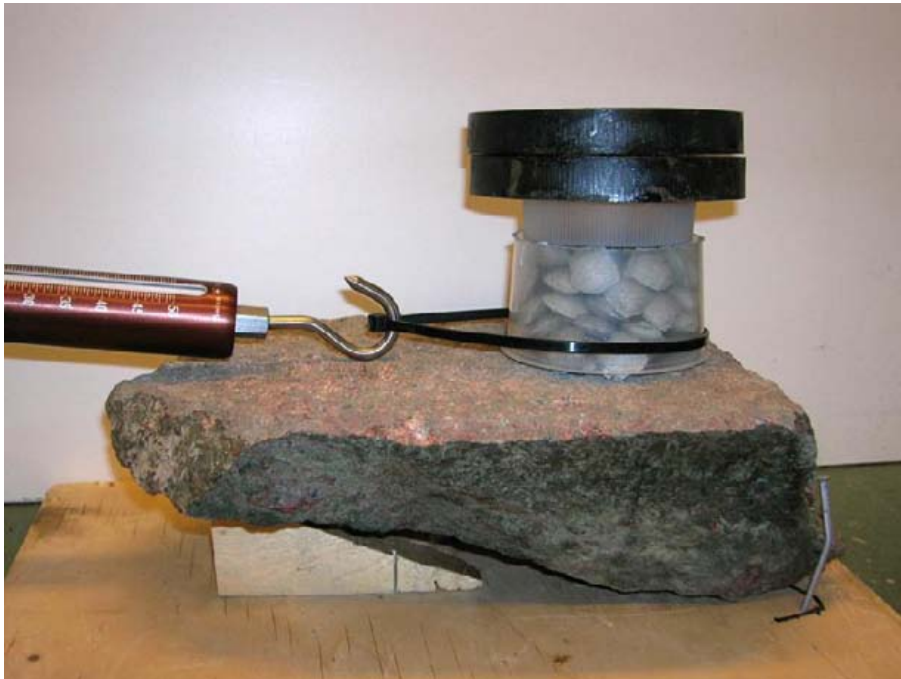
**Figure F-2.** Principle of the measurements. The picture shows a test where the friction between pellets and a TBM drilled rock surface is tested. The cylinder is filled with MX-80 pellets and a normal force of about 20 N is applied on the top.

1. The friction angle between bentonite pellets and a rock surface (TBM-drilled) and between bentonite pellets and compacted bentonite, i.e. the two types of surfaces that can be present in a deposition hole, was determined, see Figure F-3.
2. The friction angle between bentonite pellets and a number of different materials such as plywood, wood particle board, Plexiglas, concrete and LECA (light weight expanded clay aggregate) was then determined in order to find suitable materials for use when building a large scale slot, see Figure F-4 and F-5.

The friction angle was determined as the inclination of the lines (see diagrams in Figure F-3, F-4 and F-5) between the maximum value and the origin of coordinates.

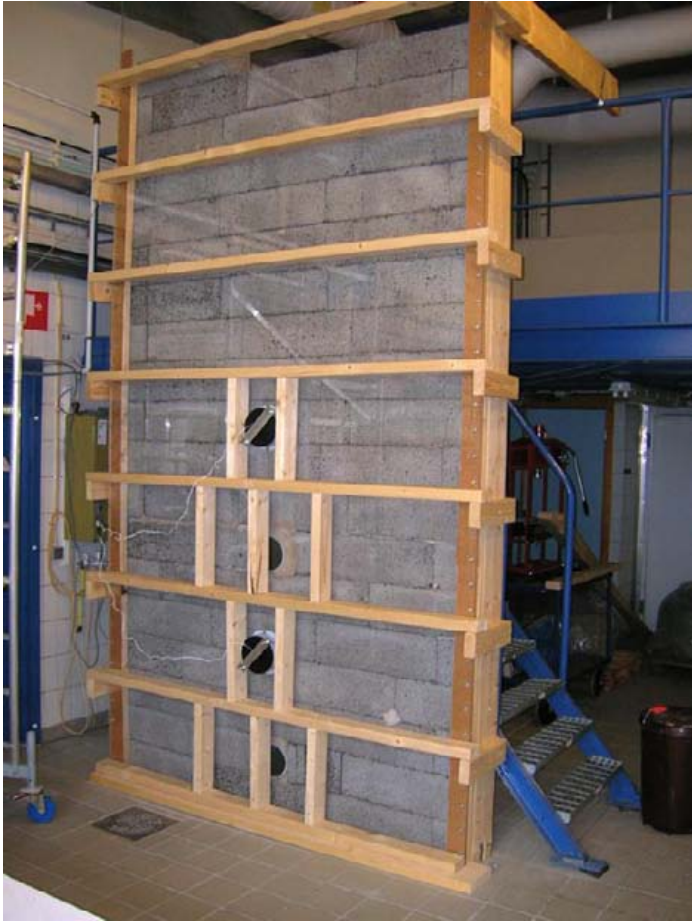
**Figure F-6.** An artificial slot was built in the laboratory (width=2 m and height 3.6 m). The rock wall is simulated with LECA blocks and the bentonite blocks with Plexiglas. The horizontal pressure can be measured at four points, two on the rock wall and two on the bentonite side.

In the first test, pellets were poured into the slot in three steps, up to 1 m, 2 m and 3.6 m above the floor. The results from this test can be seen in Figure F-8. In the diagram, the measured pressure at the different measuring points is plotted versus the pellets height. In the diagram also the theoretical pressure is plotted (see Chapter F4). The achieved pressures are very low in all positions, less than 1 kPa, and the influence of the pellets height seems to be negligible.

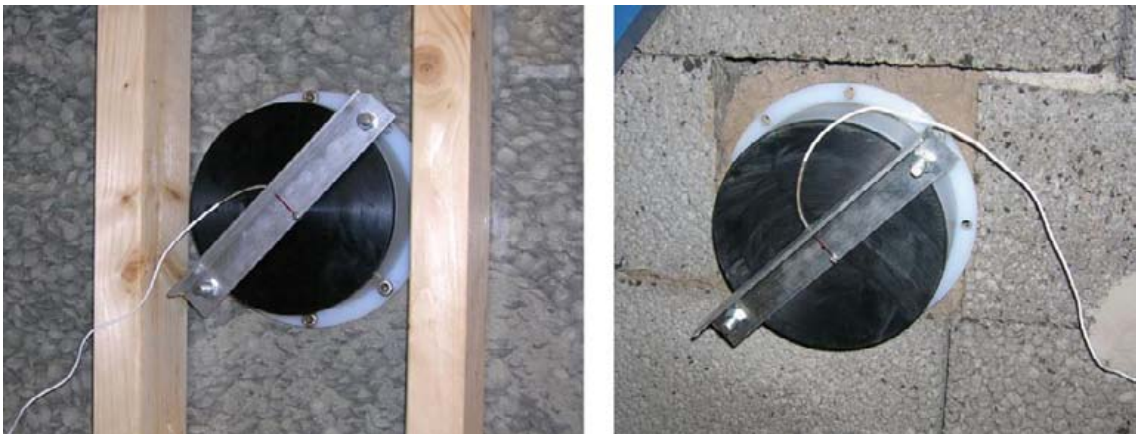
**Figure F-7.** Left: Pressure cell mounted on the “bentonite” side. Right: Pressure cell mounted on the “rock” wall.

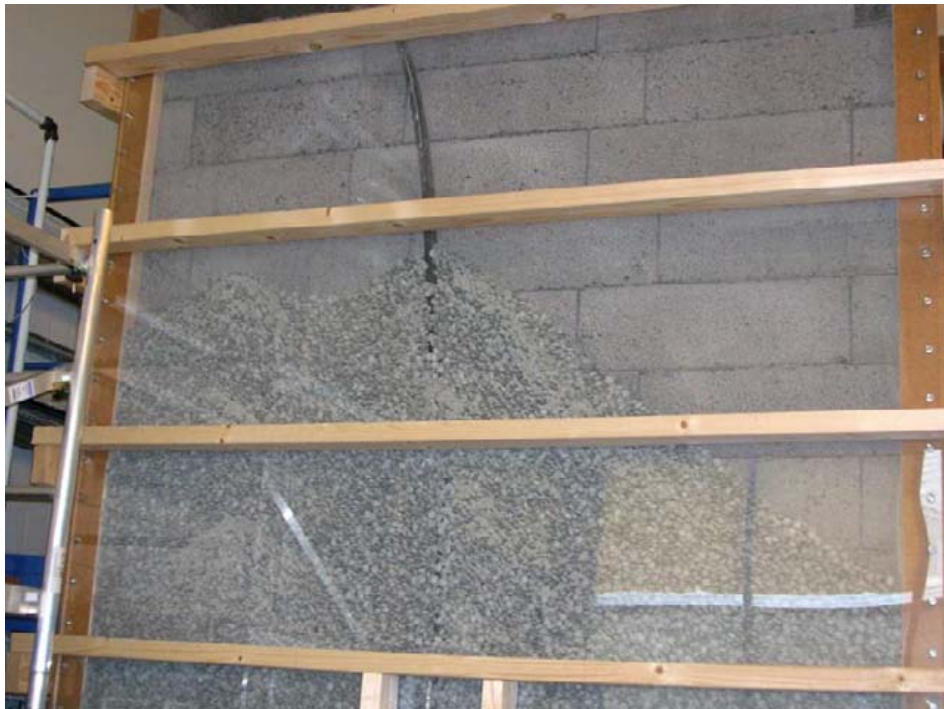
**Figure F-9.** Photo showing the pellets filling and the tube that holds the vibrating staff inside the pellets filling.

Test number two was performed with the same material and in the same filling steps as in test number one, but in addition the filling was vibrated after each step. The vibrating was performed in order to increase the bulk density of the filling. Possibly, this would increase the achieved horizontal pressure. The vibration was made with a concrete vibrator (ANBONI, AX 38). The vibrating staff was placed in the slot before pouring in the pellets and then pulled up in steps, see Figure F-9. During the vibrating, it was observed that the filling was compacted but this seemed to occur rather locally, i.e.

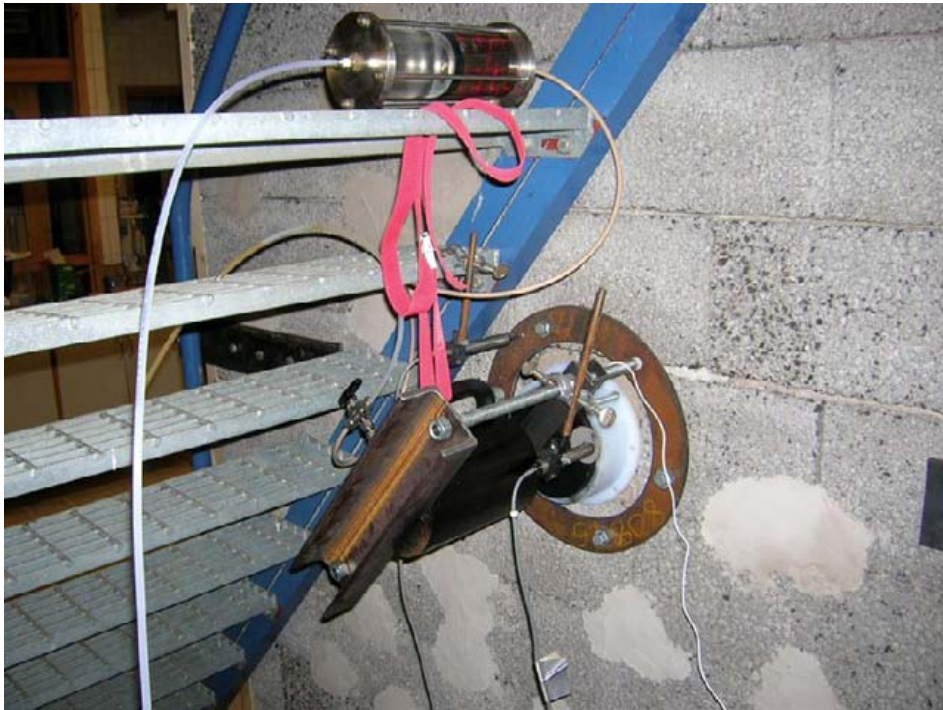
*Figure F-12. One of the pressure cells on the “rock” side was rebuilt and equipped with a hydraulic piston which was controlled by a GDS (microprocessor controlled pump). This made it possible to move the piston with a constant rate forward and measure the displacement and the achieved pressure.*

In addition to the three earlier tests where the horizontal pressure was measured at static conditions, two compression tests, one with each of the materials, (MX-80 pellets and balls of LECA) have been performed. In order to perform these tests, one of the pressure cells on the “rock” side was rebuilt and equipped with a hydraulic piston which made it possible to move the piston forward at a constant rate (6–7 mm/hour), see Figure F-12. During the movement the displacement and the achieved pressure were measured and registered.

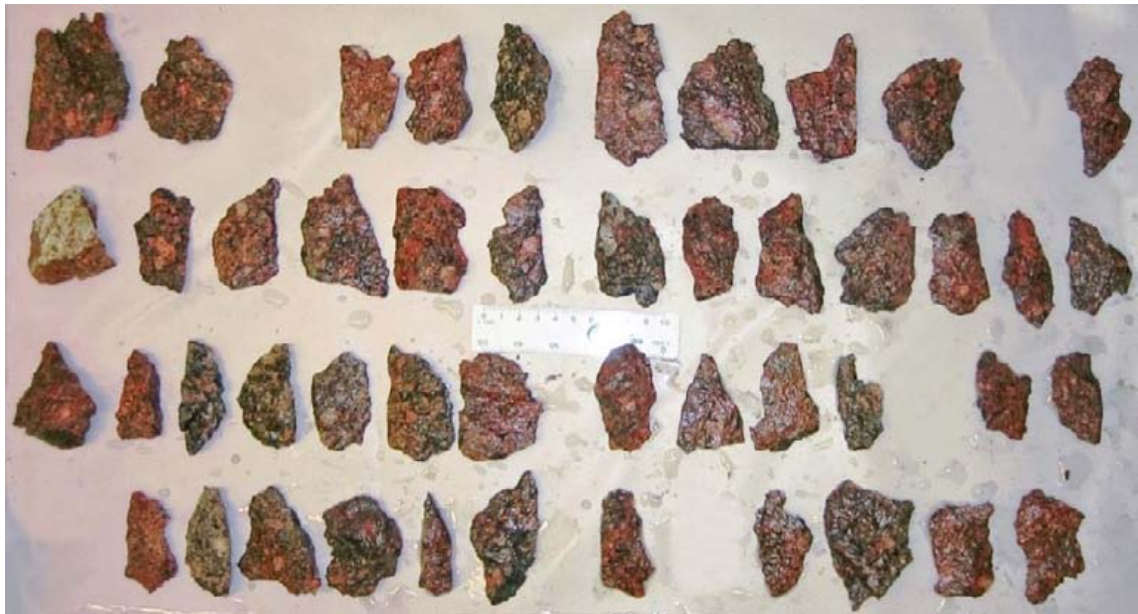
**Figure L-2.** Photograph of fragments no. 38–89 from hole KQ0048G04. The scale bar is 10 cm.

All fragments were documented by photographs. An example of the photographs is shown in Figure L-2. The other photographs are to be found in Appendix AL1 of the memo.

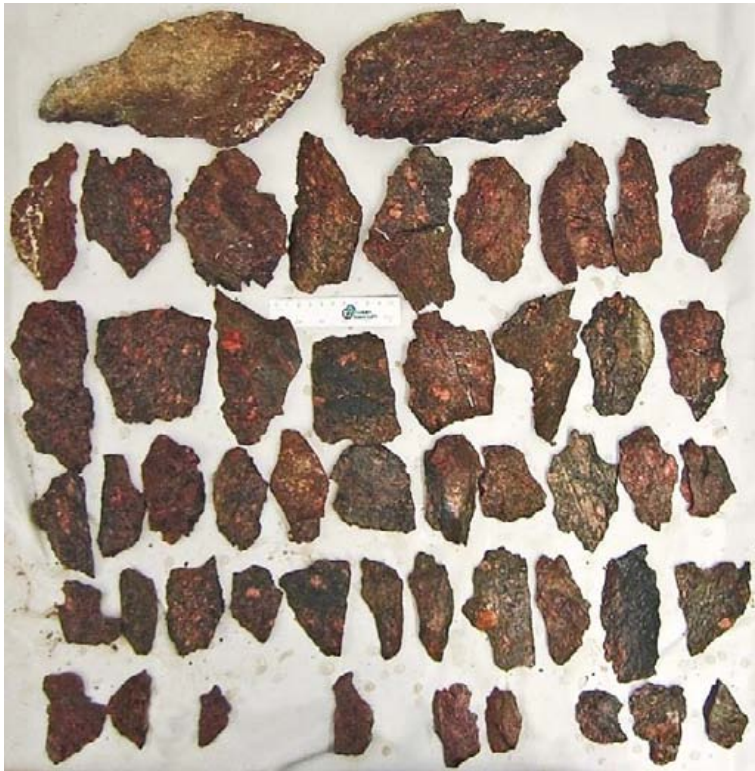
*Figure ALI-1. Investigated fragments in heating hole KQ0054G03 (Test 1), Group 1.*

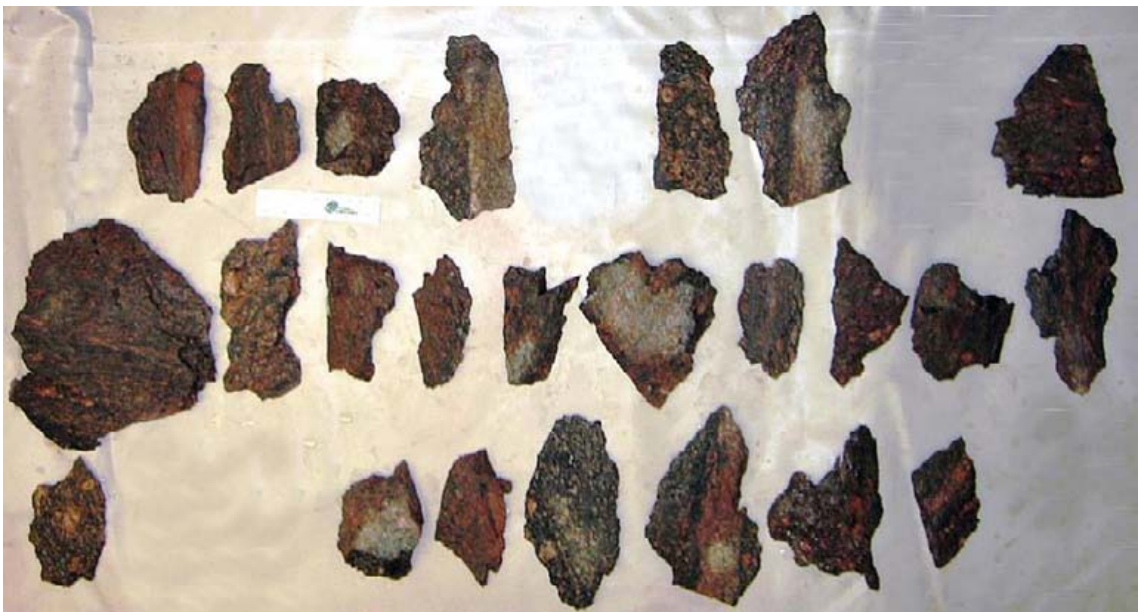
*Figure ALI-4. Investigated fragments in heating hole KQ0051G04 (Test 2), Group 1.*

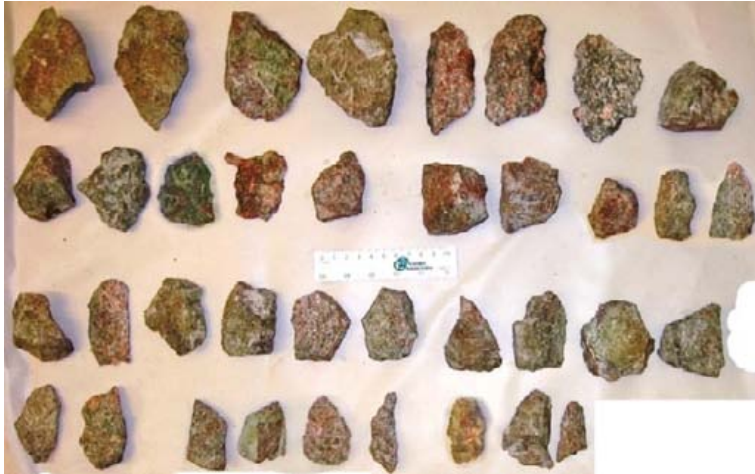
*Figure ALI-9. Investigated fragments in heating hole KQ0048G04 (Test 3), Group 1. Fragments that were brought up with a suction pipe.*

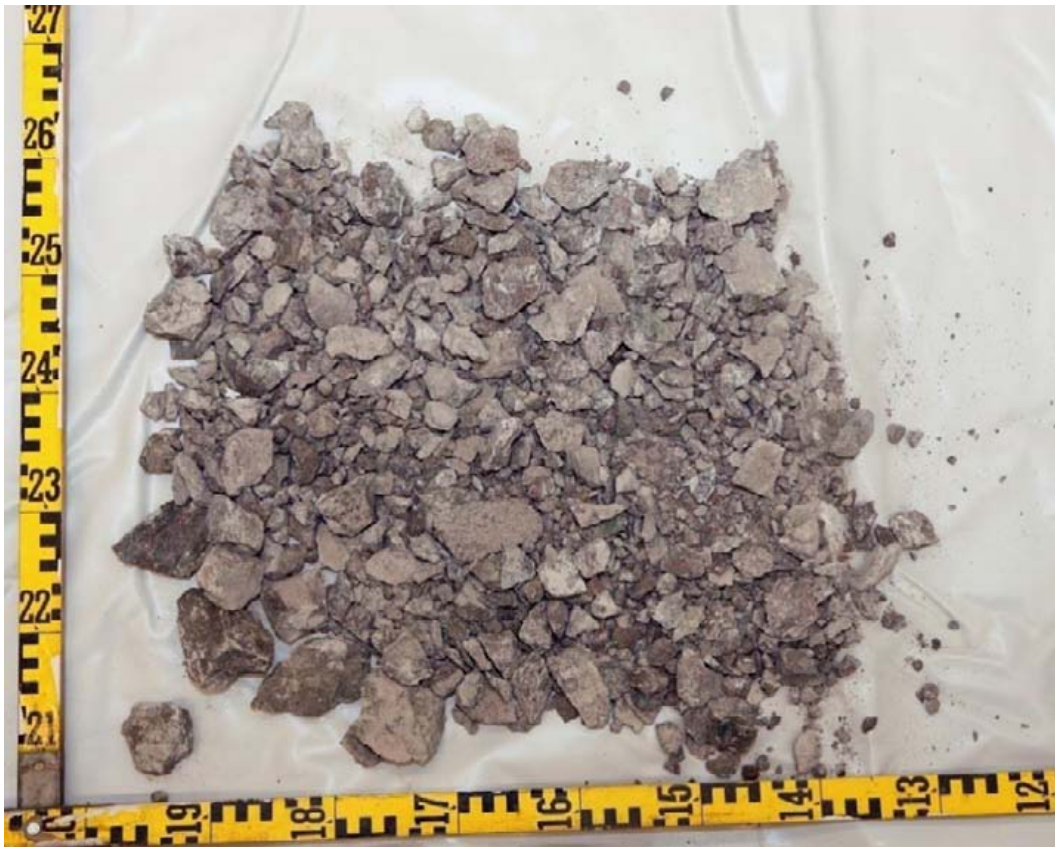
*Figure AL2-6. Collected fragments from the bottom in heating hole KQ0048G04 by the suction pipe (Test 3).*

The rock slabs formed during the spalling process were removed from the heating holes by scaling. Using a scaling rod the borehole wall was cleaned from loose pieces until sound rock was exposed from the top to the bottom of the hole. Most fragments were hoisted up on a wooden plate during the scaling. Fragments that had dropped down to the borehole bottom were removed by a suction tube.

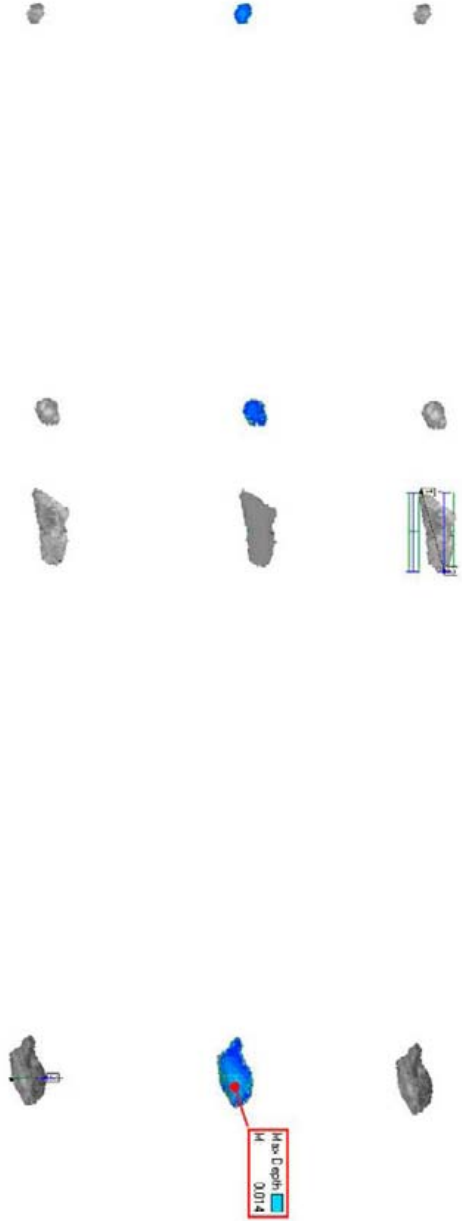
MAX WIDTH: 82MM @ -447.695M  
 MAX DEPTH: 14MM @ -449.071M  
 MAX LENGTH: 187MM

Volume determination for KQ0048G05, sector BC NE-side. Projection from outside.

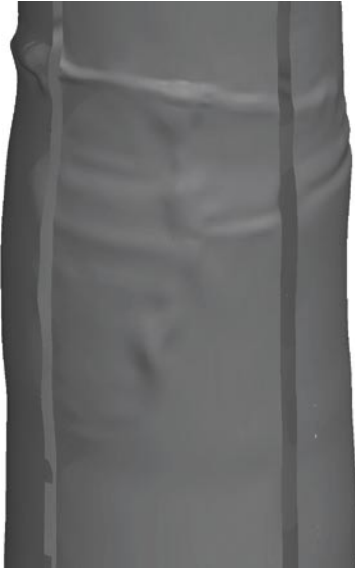
**Figure S-1.** Laser scanned mesh of heating hole KQ0046G04. Spalling can be seen as a vertical trace along the mesh, at a location between ca -446.3 and -446.75 m.

Only restricted spalling has been identified in this borehole. It can be seen both in the mesh from the laser scanning (Figure S-1) and in photographic image (Figure S-2).

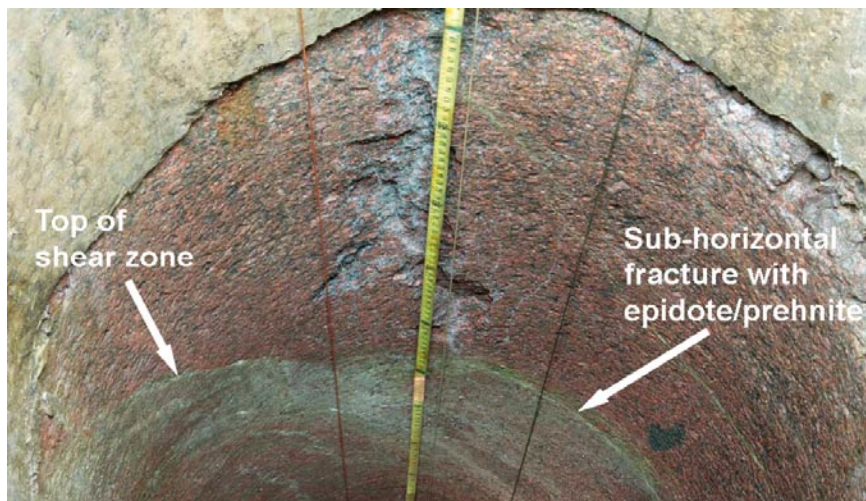
**Figure S-2.** Observed spalling in heating hole KQ0046G04 on the same side as in Figure S-1. The top of the shear zone to the left cuts through the borehole down to the southeast. An epidote/phrenite filled cataclastic structure runs sub horizontally across the borehole. The latter is cut by the shear zone.

The spalling ends just above the cataclastic structure. Below this level spalling is virtually absent. The rock above the shear zone is the normal “Äspö diorite” of the area, which here is very weakly deformed and with a weak alteration. Some sharp edges that bound the spalling, particularly in the top, show that sealed fractures has played some role as a guide. The spalling ends a few cm above a cataclastic structure filled with phrenite and epidote (Figure S-2). In this cataclastically deformed rock and further down, the rock has been much more deformed both by brittle and ductile processes, as evidences by sealed networks, breccias and brittle-ductile shear zones.

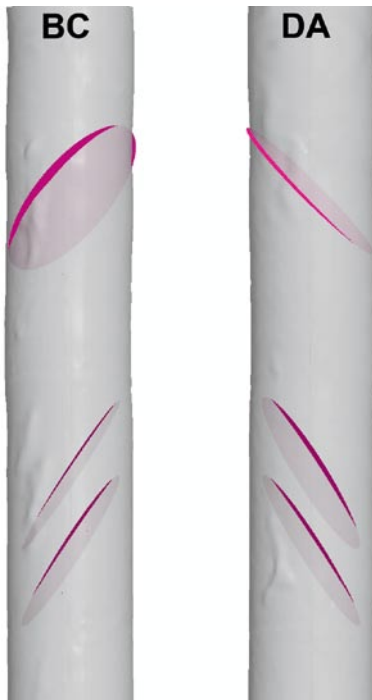
**Figure S-10.** Mesh from the laser scanning in KQ0051G05 showing the spalling and the shear zone in the hole. Discs mark the upper and lower boundary of the zone and the internal foliation. The spalling is not very pronounced in the borehole and is mostly absent within the strongly sheared parts of the shear zone.

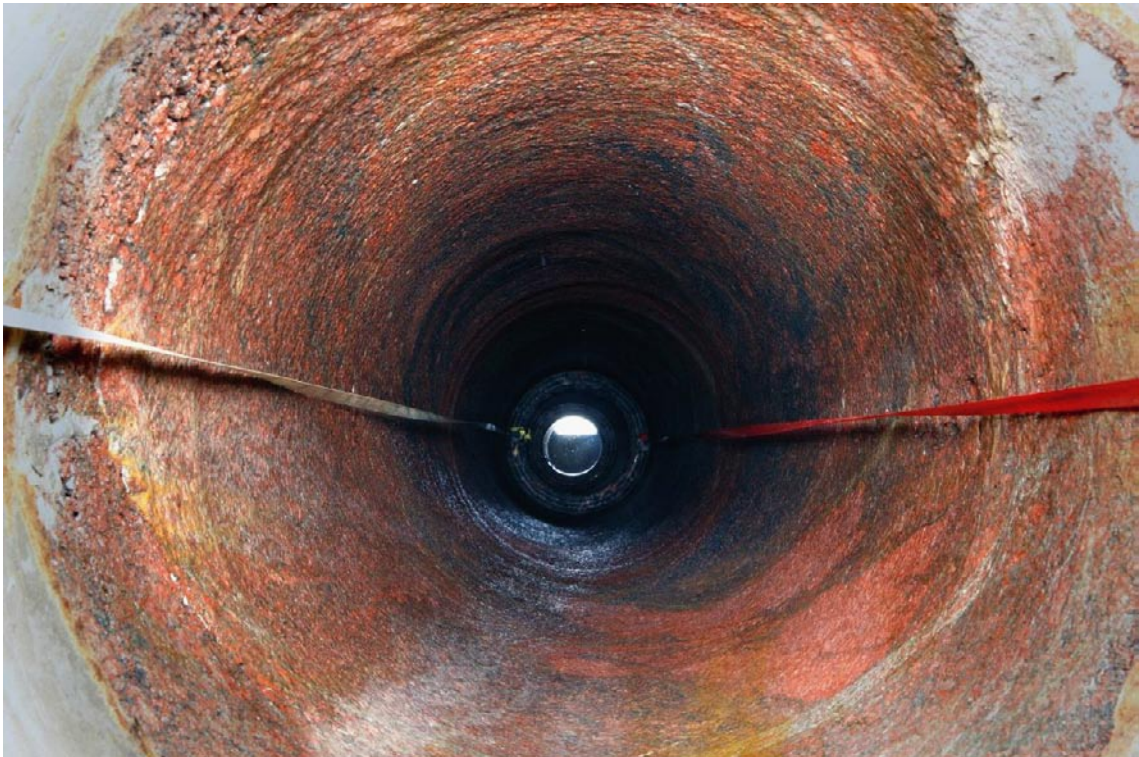
*Figure T-1. Photograph of borehole KQ0054G03 in Field Test 1 before initiating the heating phase.*

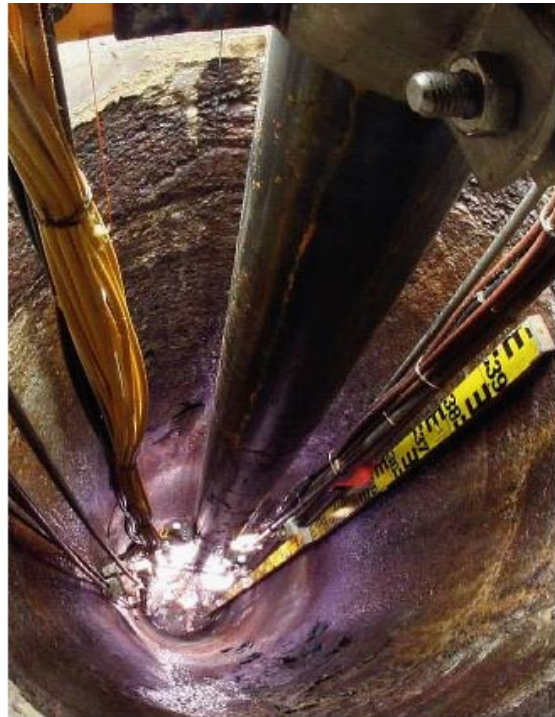
*SW-side*

*Figure T-19. Photographs of the borehole wall in heating hole KQ0054G03 after finished the cooling phase, before scaling of the wall. Field Test 1 was performed without confinement.*

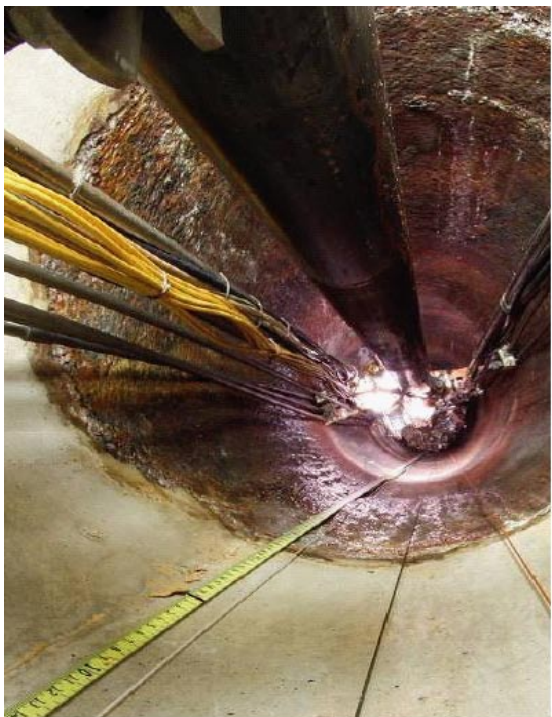
*NE-side*

*Figure T-20. Photographs of the borehole wall in heating hole KQ0054G04 after finished the cooling phase, before scaling of the wall. Field Test 1 was performed without confinement.*

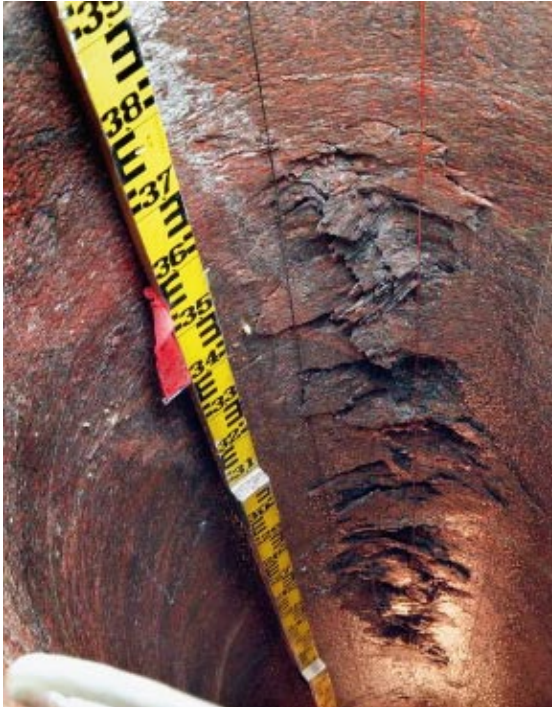
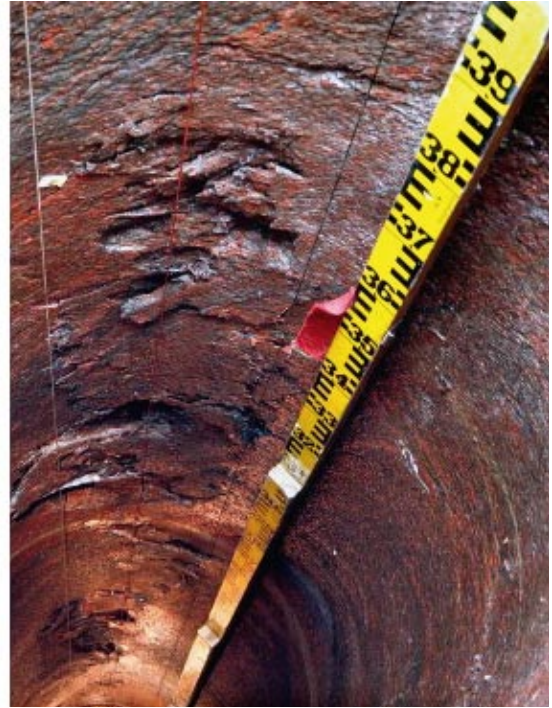
**Figure T-21.** Photographs of the borehole wall in heating hole KQ0051G04 after finished the cooling phase, before scaling of the wall. Field Test 2 was performed without confinement.

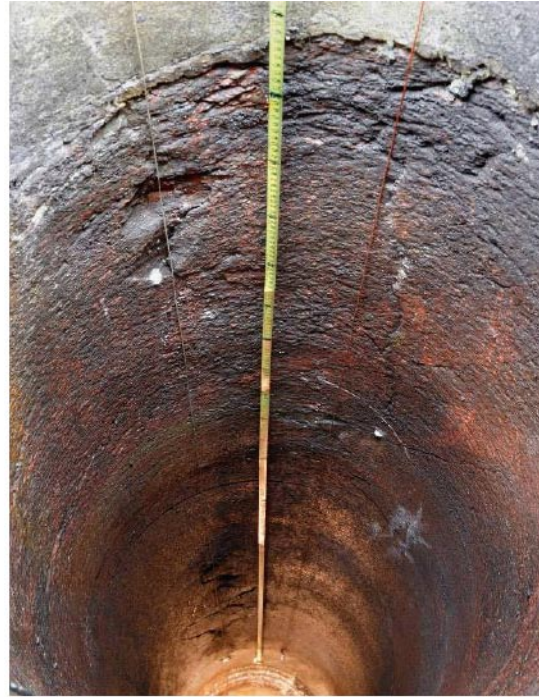
*SW-side*

*Figure T-23. Photographs of the borehole wall in heating hole KQ0048G04 after finished the cooling phase, before scaling of the wall. Field Test 3 was performed with confinement.*

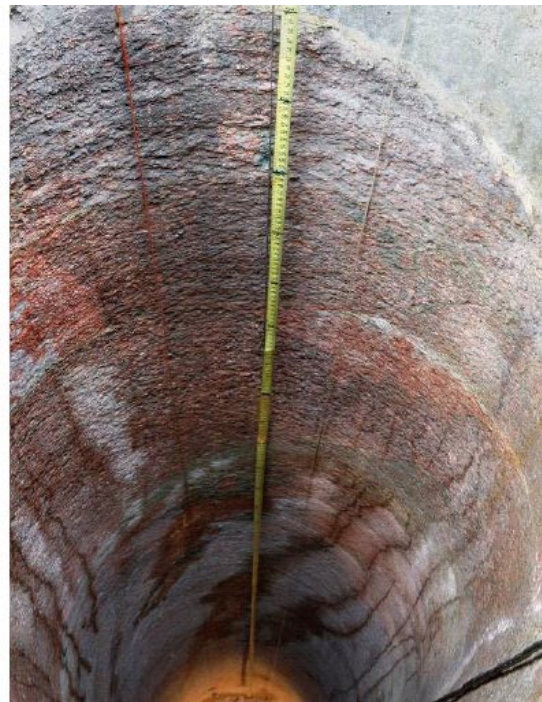
*SW-side*

*Figure T-24. Photographs of the borehole wall in heating hole KQ0048G05 after finished the cooling phase, before scaling of the wall. Field Test 3 was performed with confinement.*
