### Counterforce applied to prevent spalling

**Svensk Kärnbränslehantering AB**

This report describes the field experiment performed within the project termed CAPS (Counterforce Applied to Prevent Spalling). The overall aim of the project has been to demonstrate whether a small confining pressure obtained by the application of dry bentonite pellets is sufficient to suppress thermally-induced spalling in KBS-3 deposition holes.

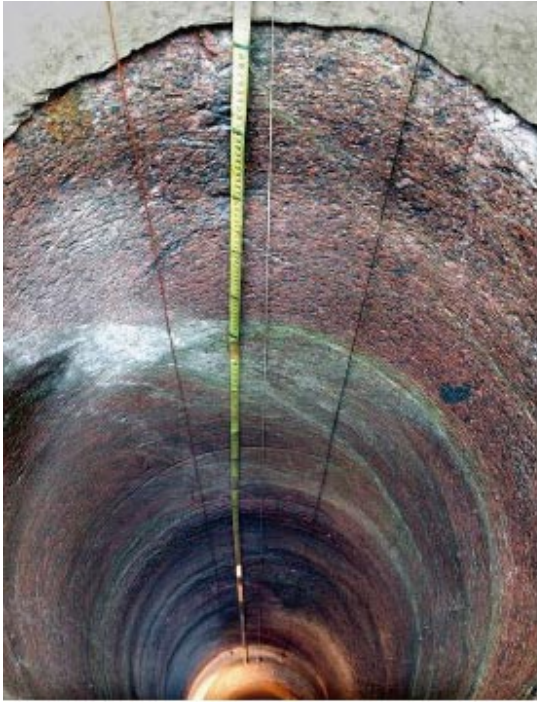
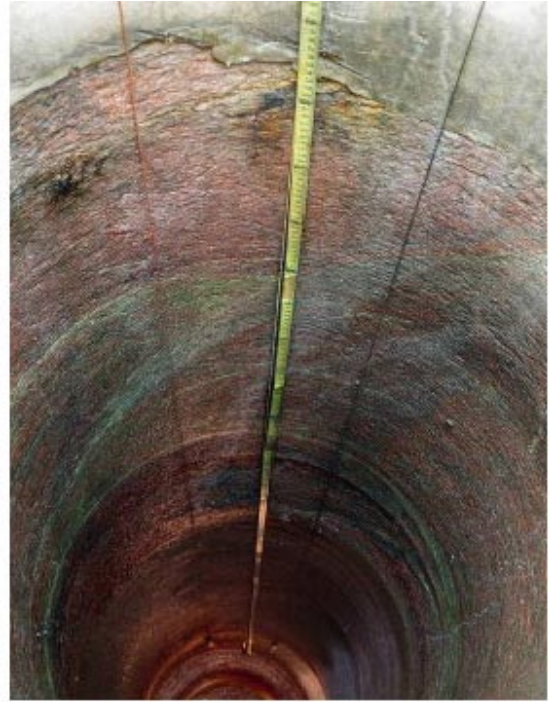
**Figure T-25.** Photographs of the borehole wall in heating hole KQ0046G04 after finished the cooling phase, before scaling of the wall. Field Test 4 was performed with confinement.

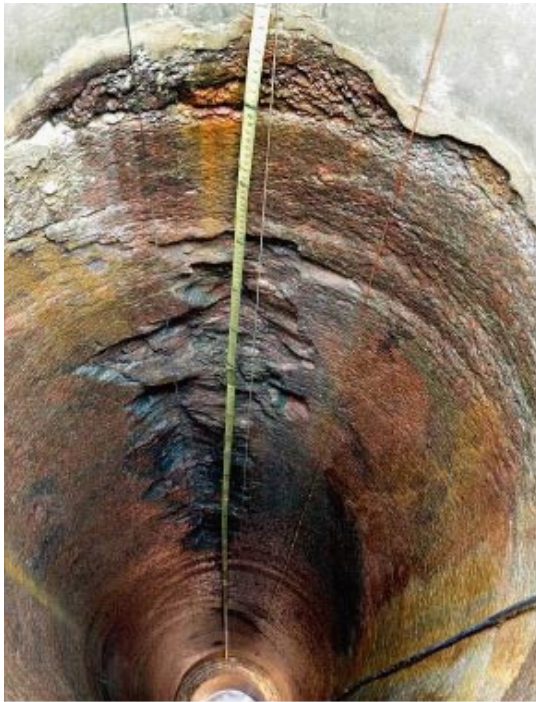
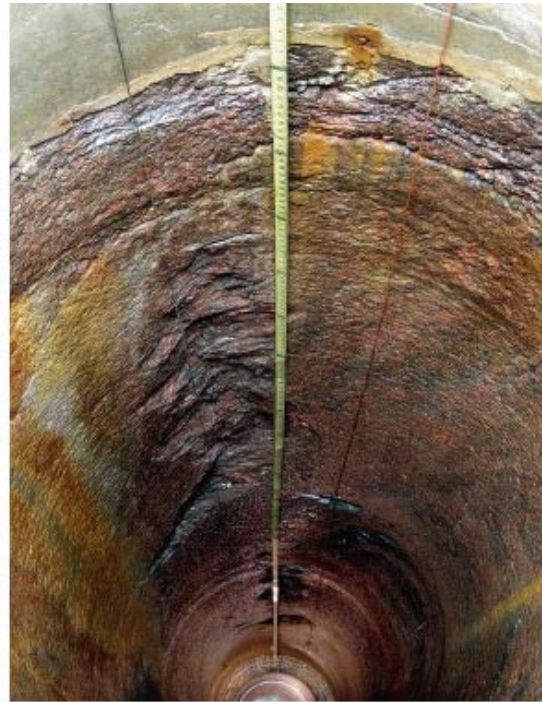
*Figure T-26. Photographs of the borehole wall in heating hole KQ0054G03 after scaling the wall from loose rock fragments. Field Test 1 was performed without confinement.*

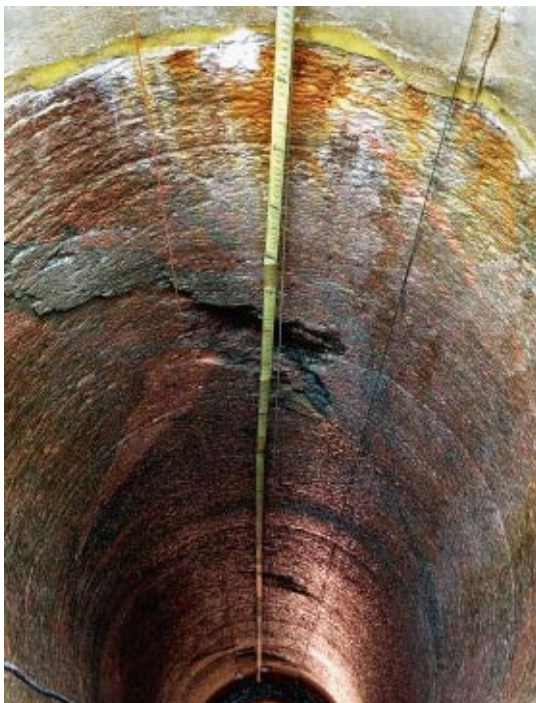
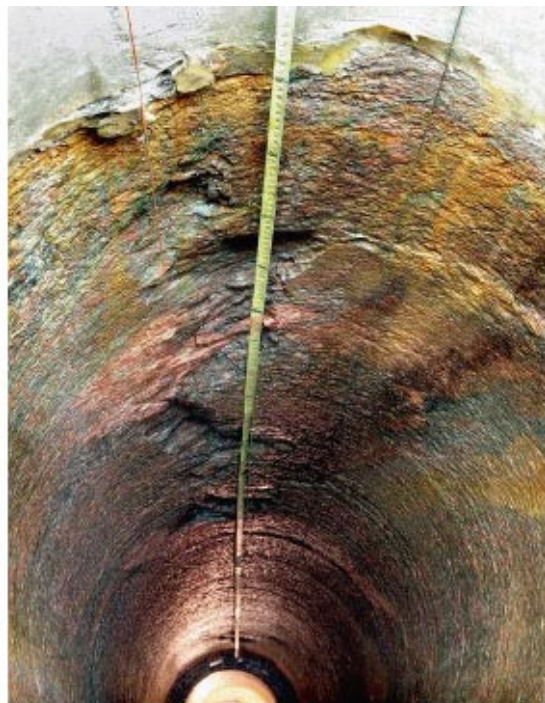
*Figure T-27. Photographs of the borehole wall in heating hole KQ0054G04 after scaling the wall from loose rock fragments. Field Test 1 was performed without confinement.*

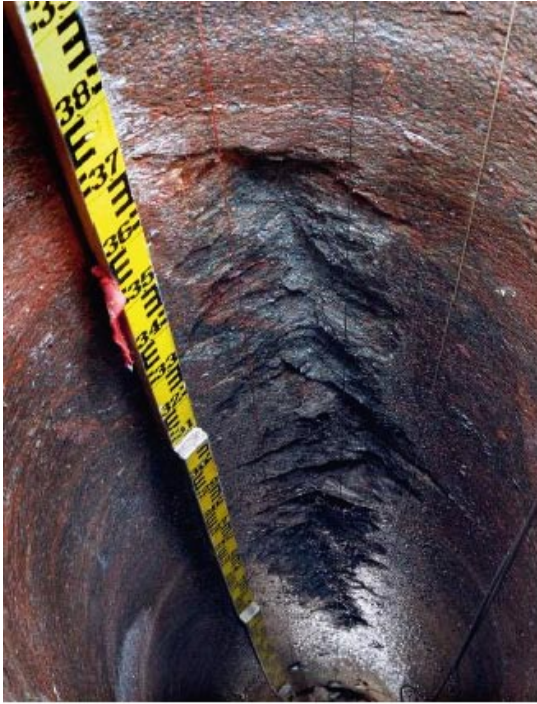
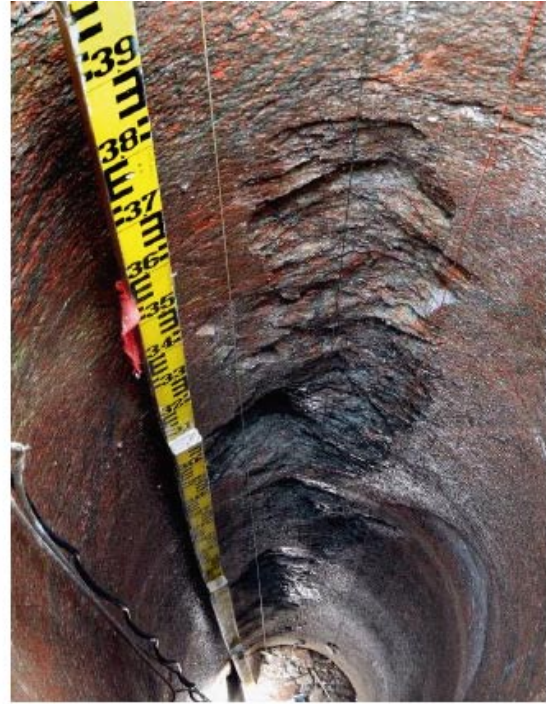
**Figure T-28.** Photographs of the borehole wall in heating hole KQ0051G04 after scaling the wall from loose rock fragments. Field Test 2 was performed without confinement.

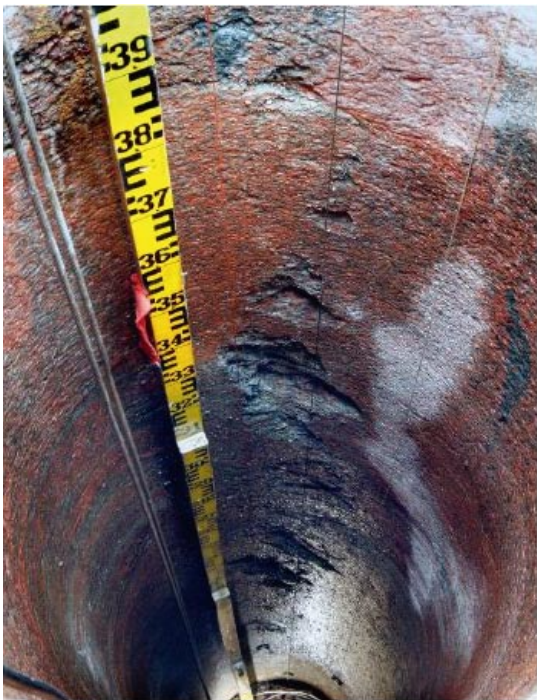
*NE-side*

**Figure T-29.** Photographs of the borehole wall in heating hole KQ0051G05 after scaling the wall from loose rock fragments. Field Test 2 was performed without confinement.

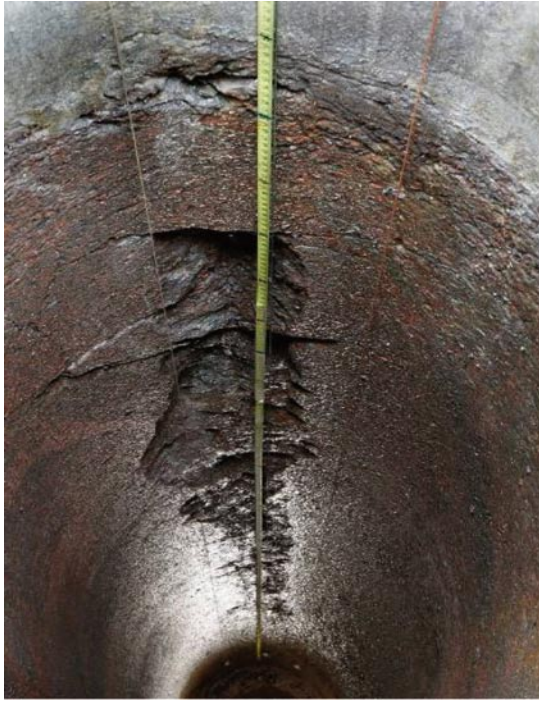
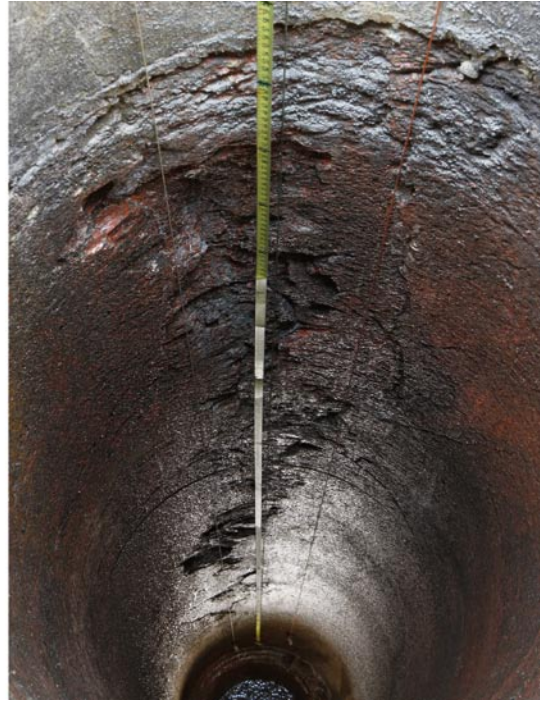
*Figure T-30. Photographs of the borehole wall in heating hole KQ0048G04 after scaling the wall from loose rock fragments. Field Test 3 was performed with confinement.*

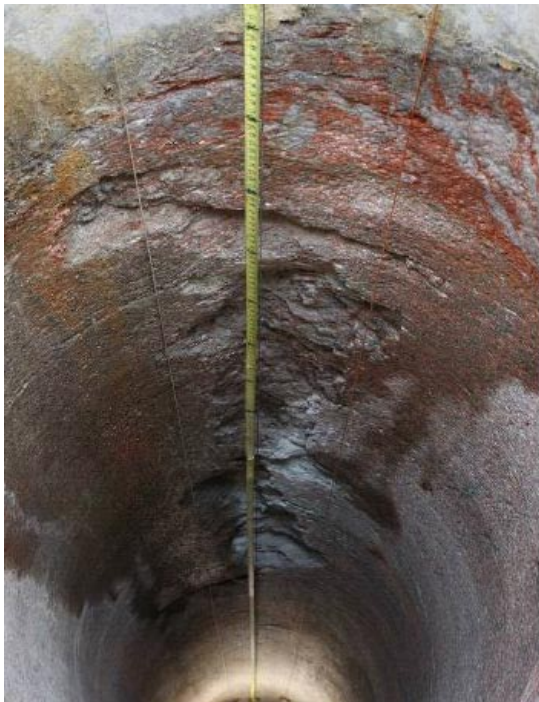
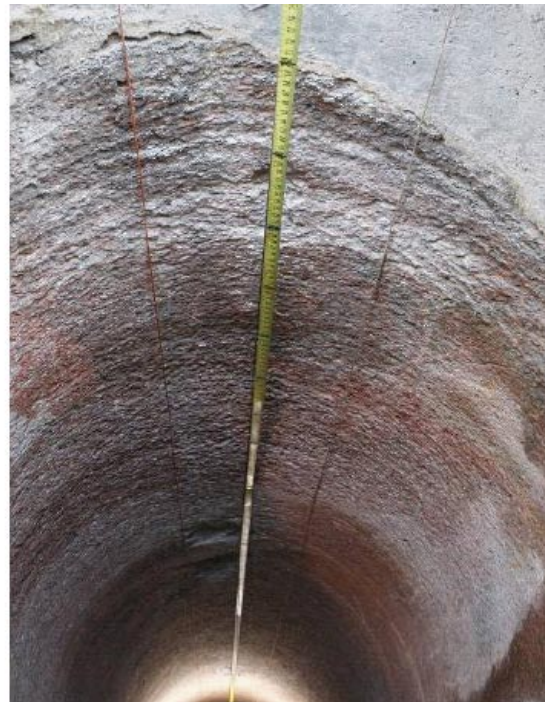
*Figure T-31. Photographs of the borehole wall in heating hole KQ0048G05 after scaling the wall from loose rock fragments. Field Test 3 was performed with confinement.*

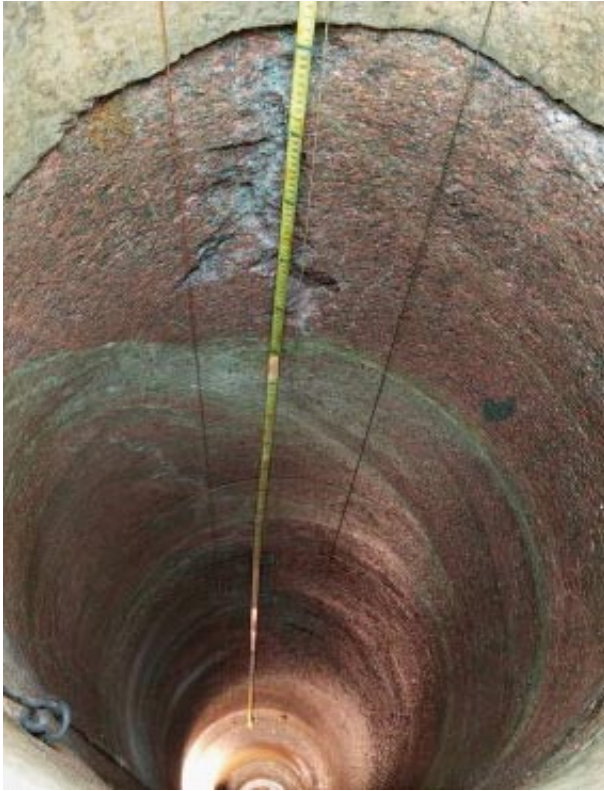
*NE-side*

**Figure T-32.** Photographs of the borehole wall in heating hole KQ0046G04 after scaling the wall from loose rock fragments. Field Test 4 was performed with confinement.

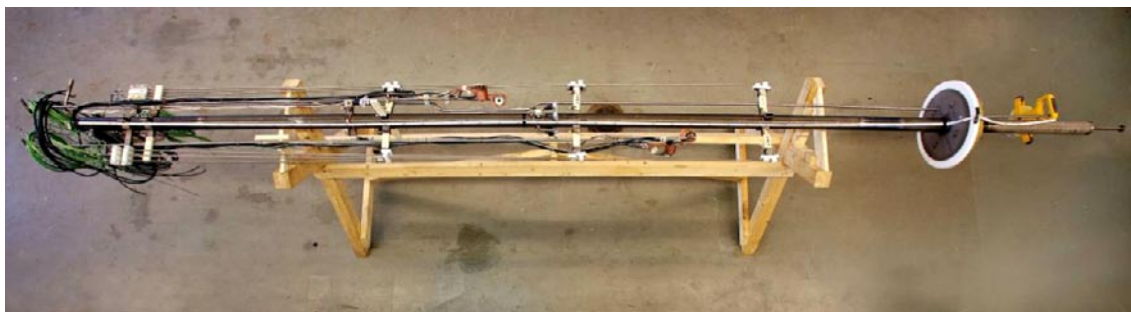
*Figure U-1. Shows the instrument holder installed in Field Test 1.*

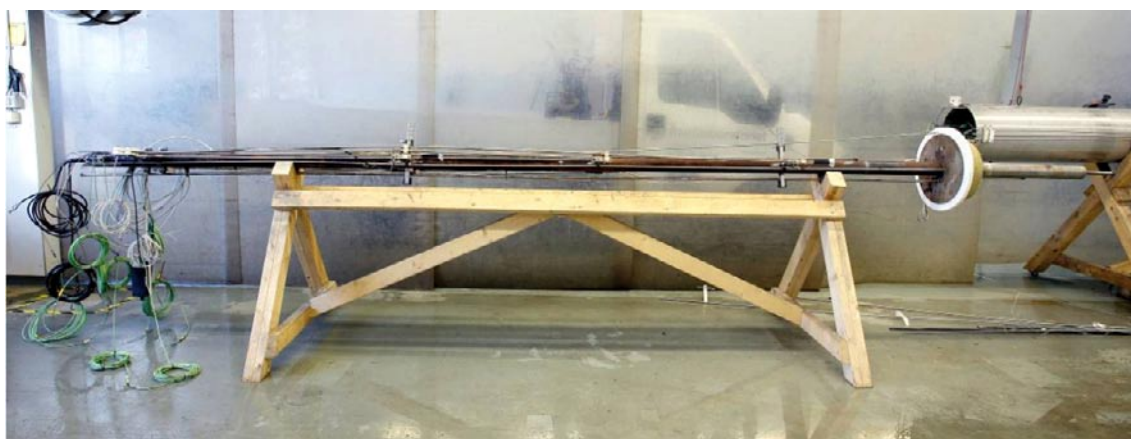
*Figure U-2. Shows the instrument holder installed in Field Test 2.*

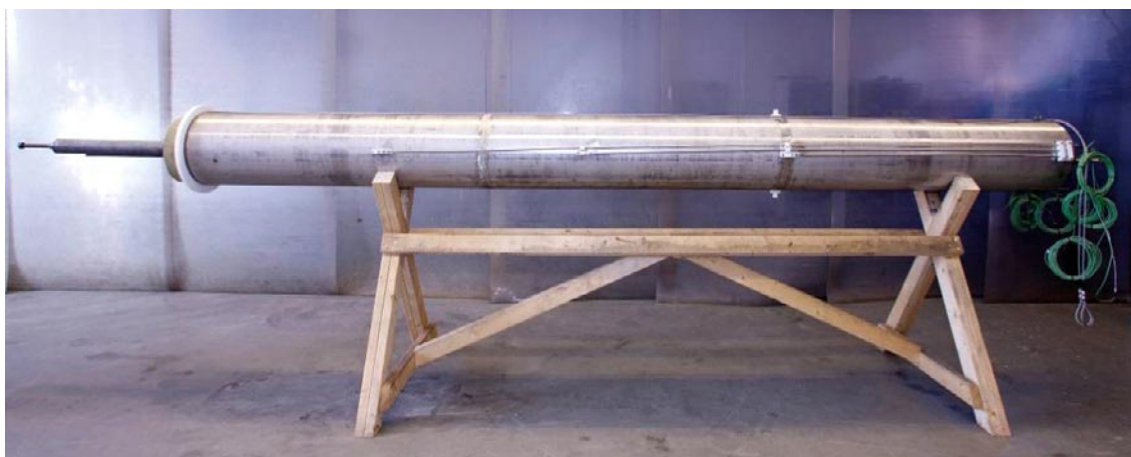
*Figure U-3. Shows the instrument holder installed in Field Test 3.*

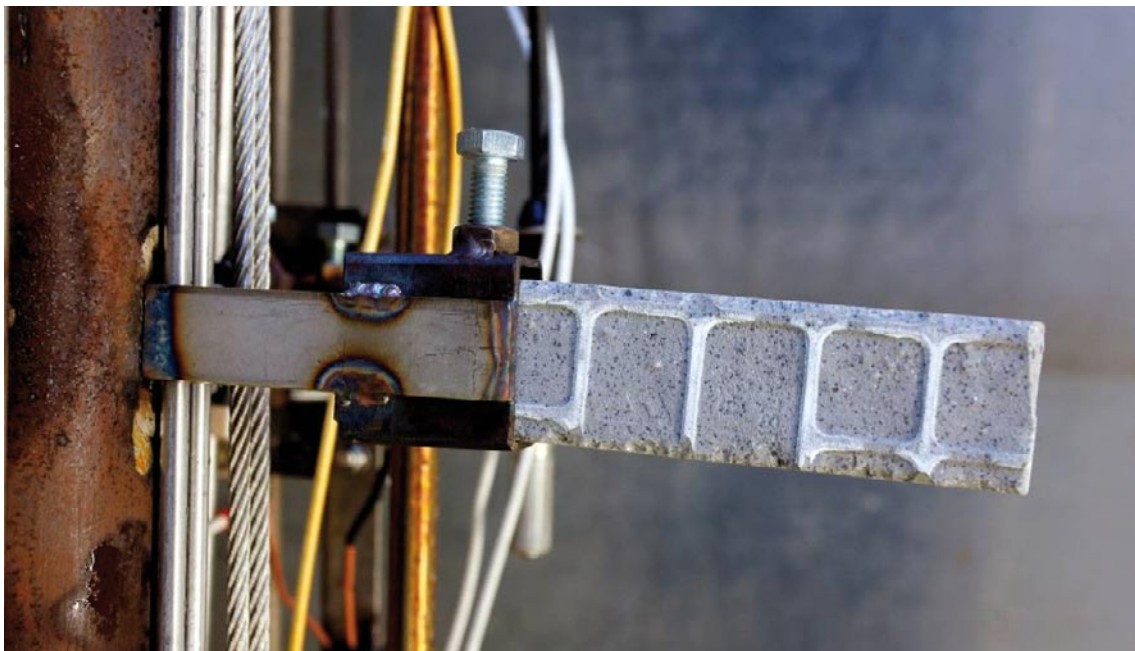
*Figure U-5. Shows a close-up view of the spacers in clinker used in Field Test 2.*

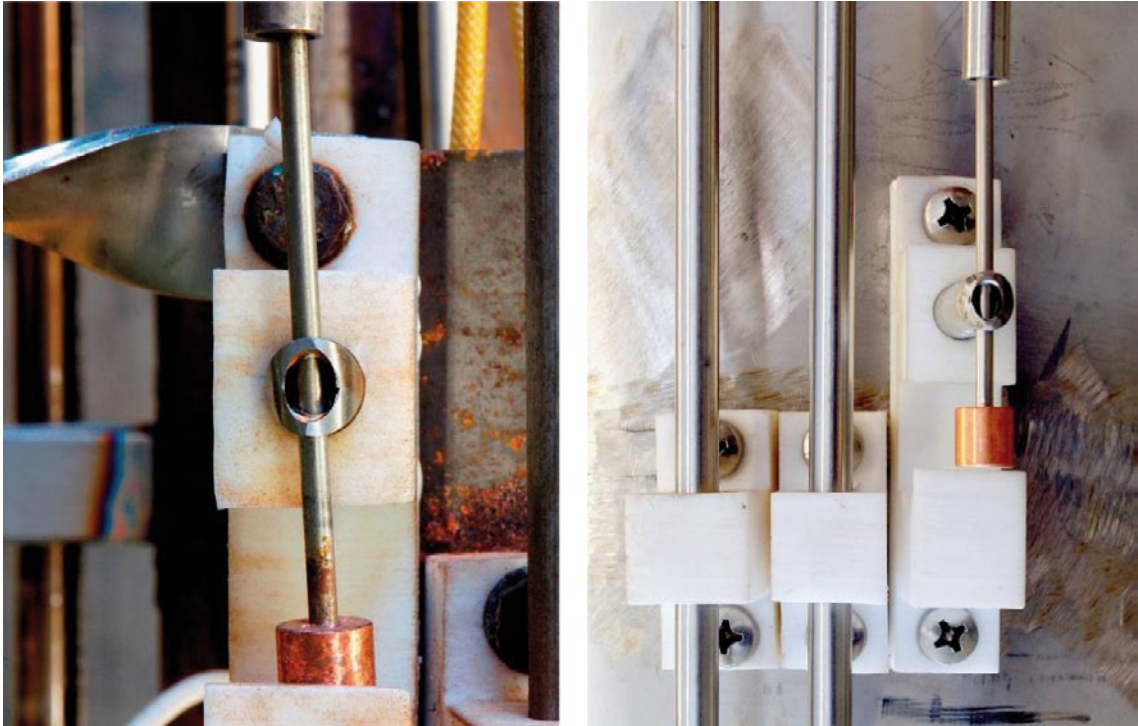
*Figure U-6. Shows a close-up view of the spring loaded mechanism after modification before Field Test 2. The edge of the guide bushing has been chamfered.*

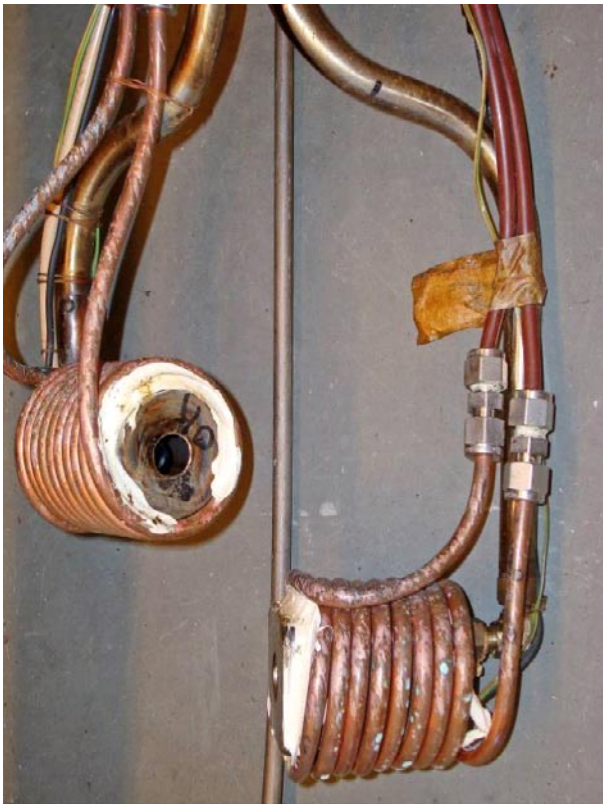
*Figure U-7. Shows the state of the monitoring camera after completion of Field Test 1.*

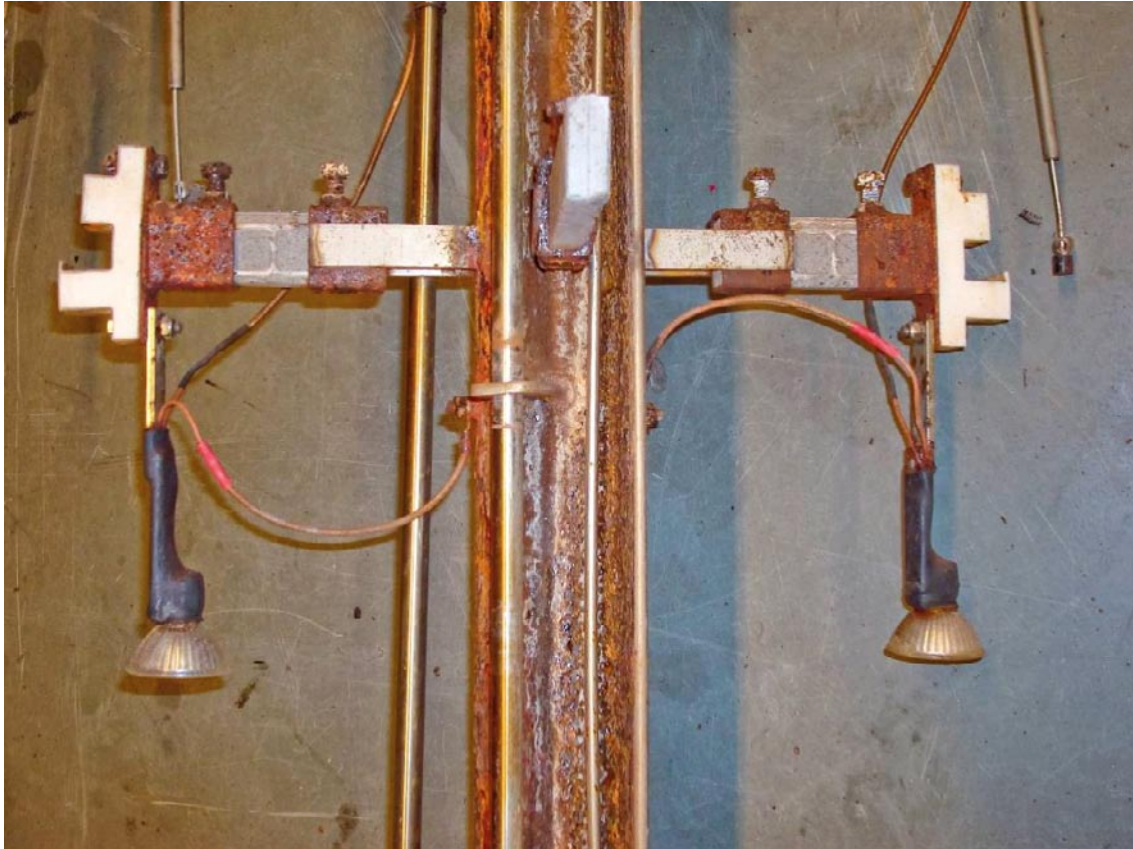
*Figure U-8. Shows the state of the holder after completion of Field Test 2.*

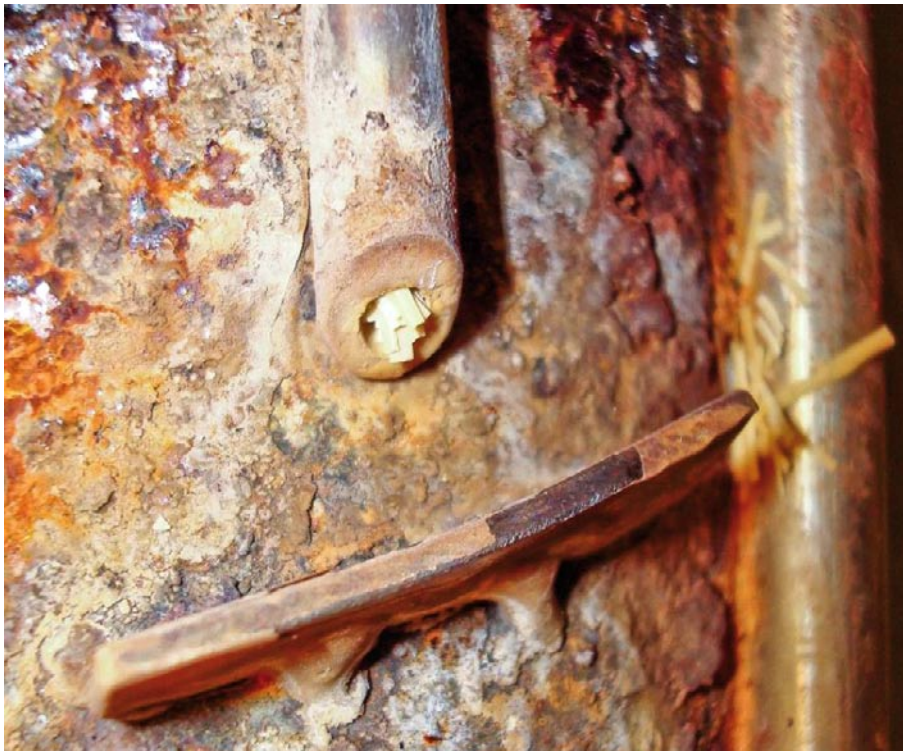
*Figure U-9. Shows a close-up view of one of the drip holes in the wetting system after completion of Field Test 2.*

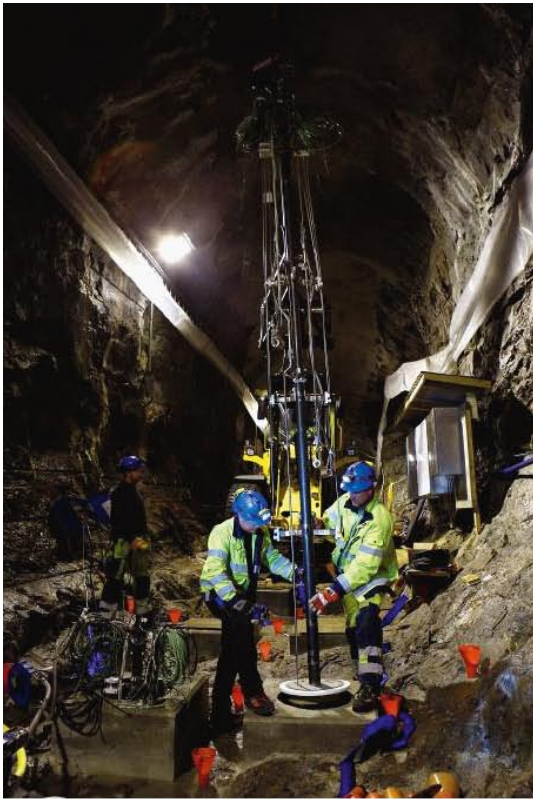
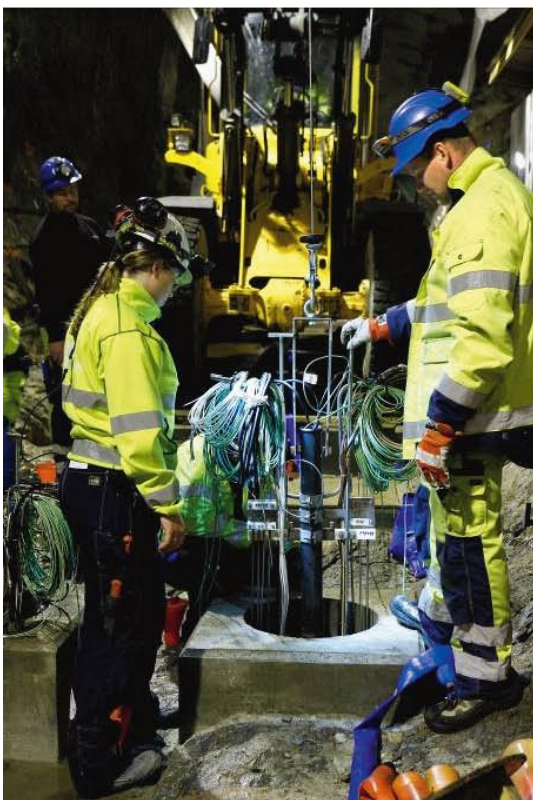
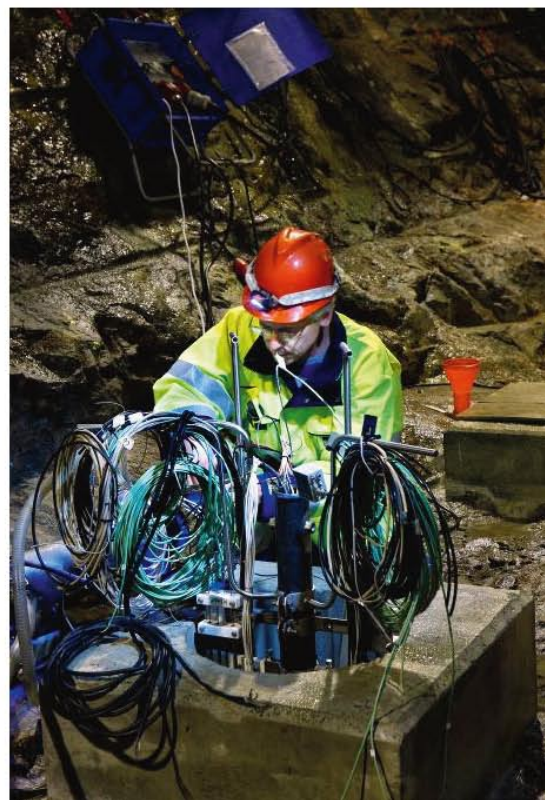
*Figure V-1. Shows a sequence of photographs from the installation of the test equipment in Field Test 1.*

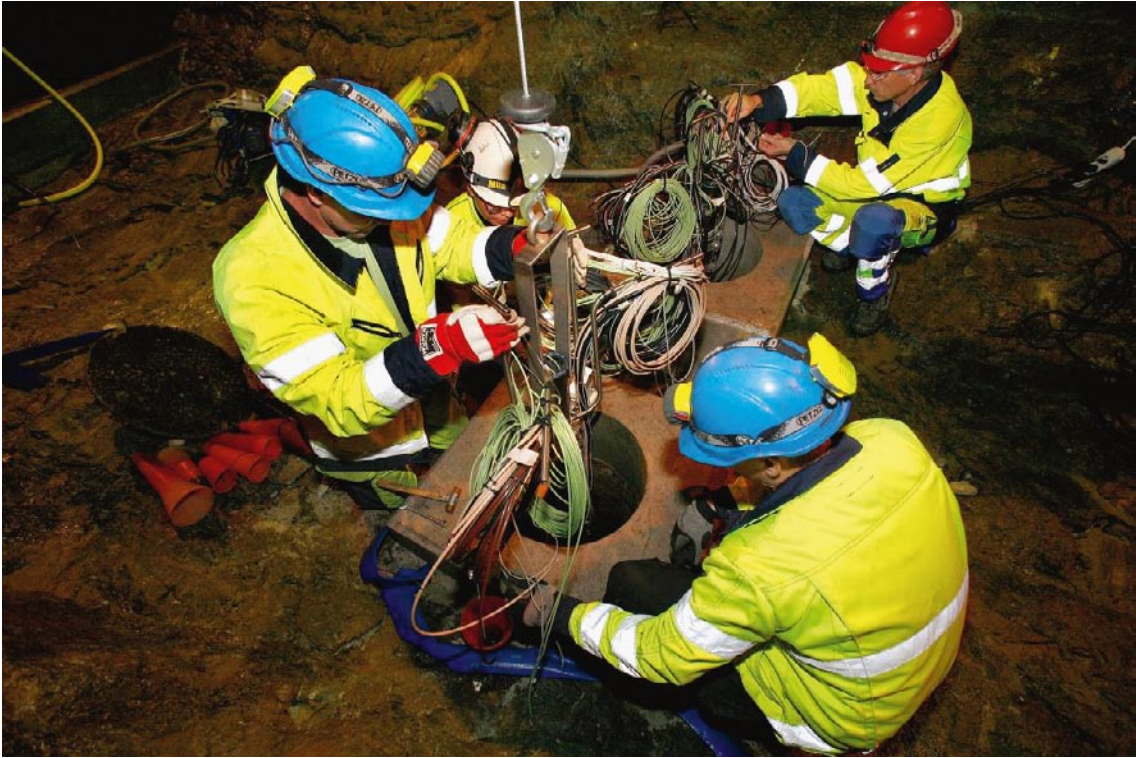
*Figure V-2. Shows the test equipment in place in Field Test 1.*

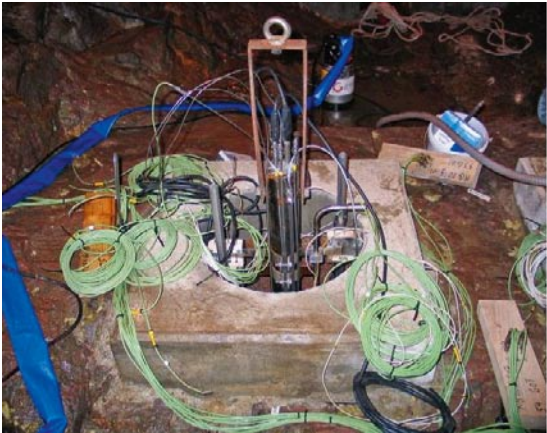
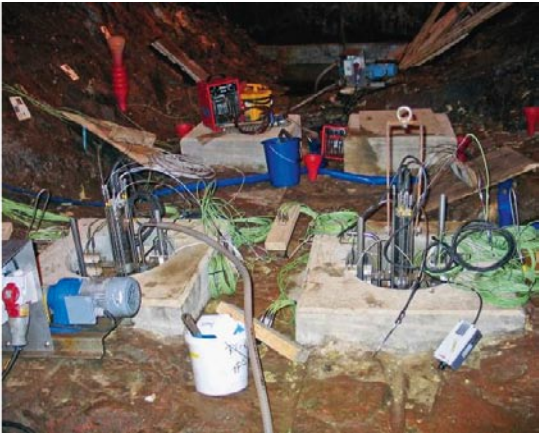
*Figure V-3. Shows the test equipment in place Field Test 2.*

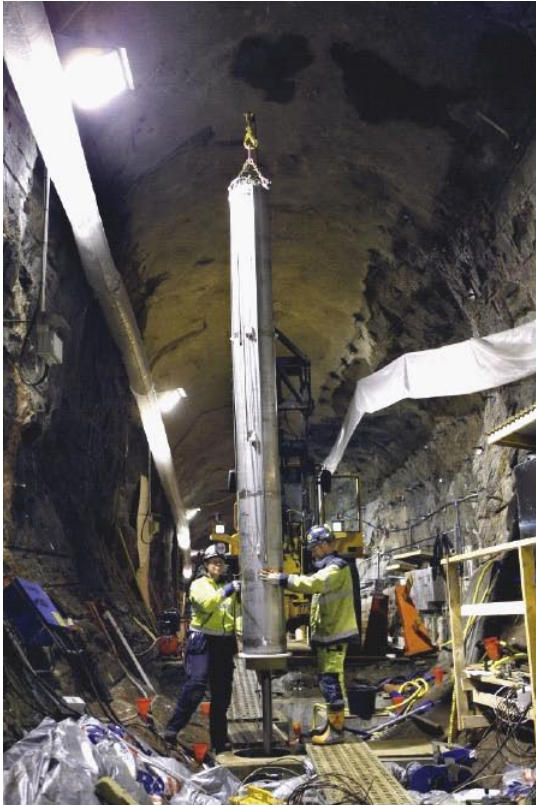
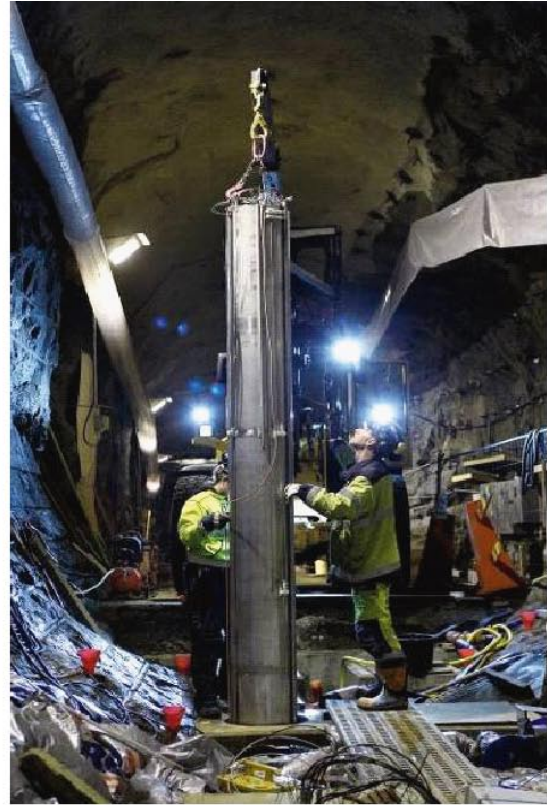
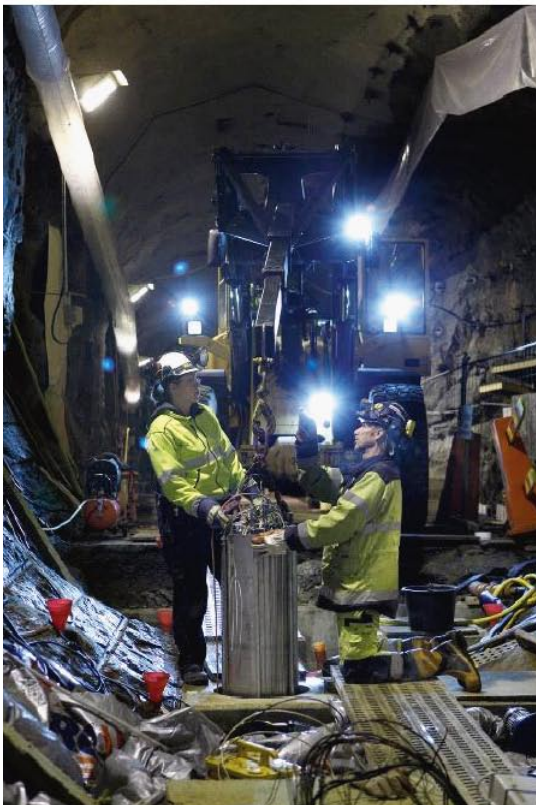
*Figure V-4. Shows a sequence of photographs from the installation of the test equipment in KQ0048G05 in Field Test 3.*

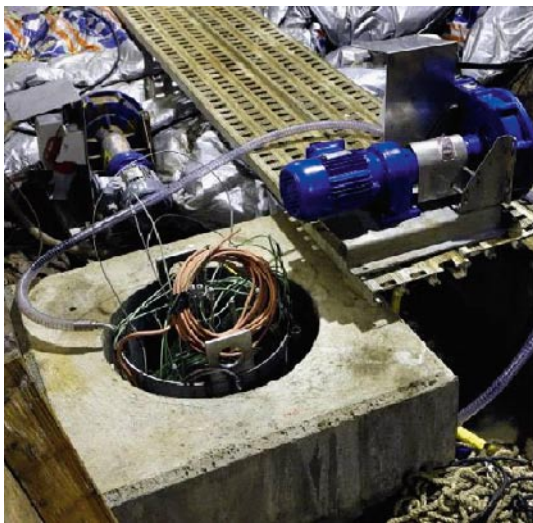
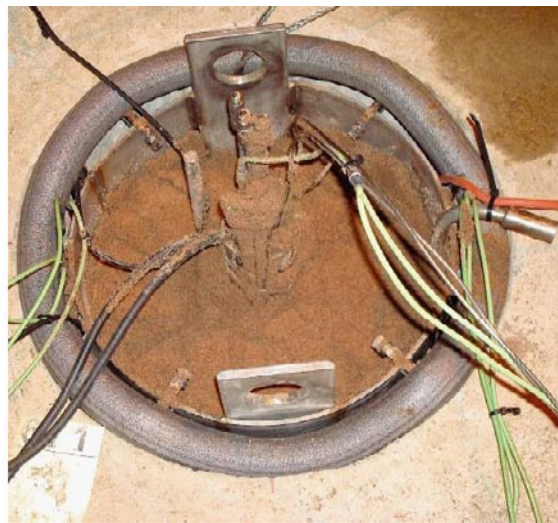
*Figure V-6. Shows the test equipment in place before and after sand filling of the larger tube during preparation for Field Test 3.*

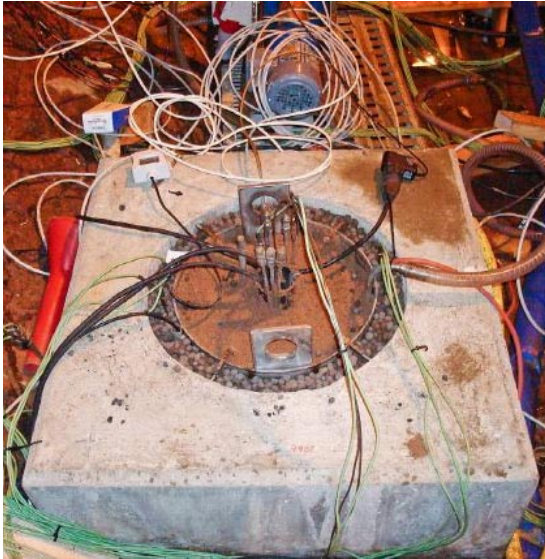
*Figure V-7. Shows the test site just before starting Field Test 3.*

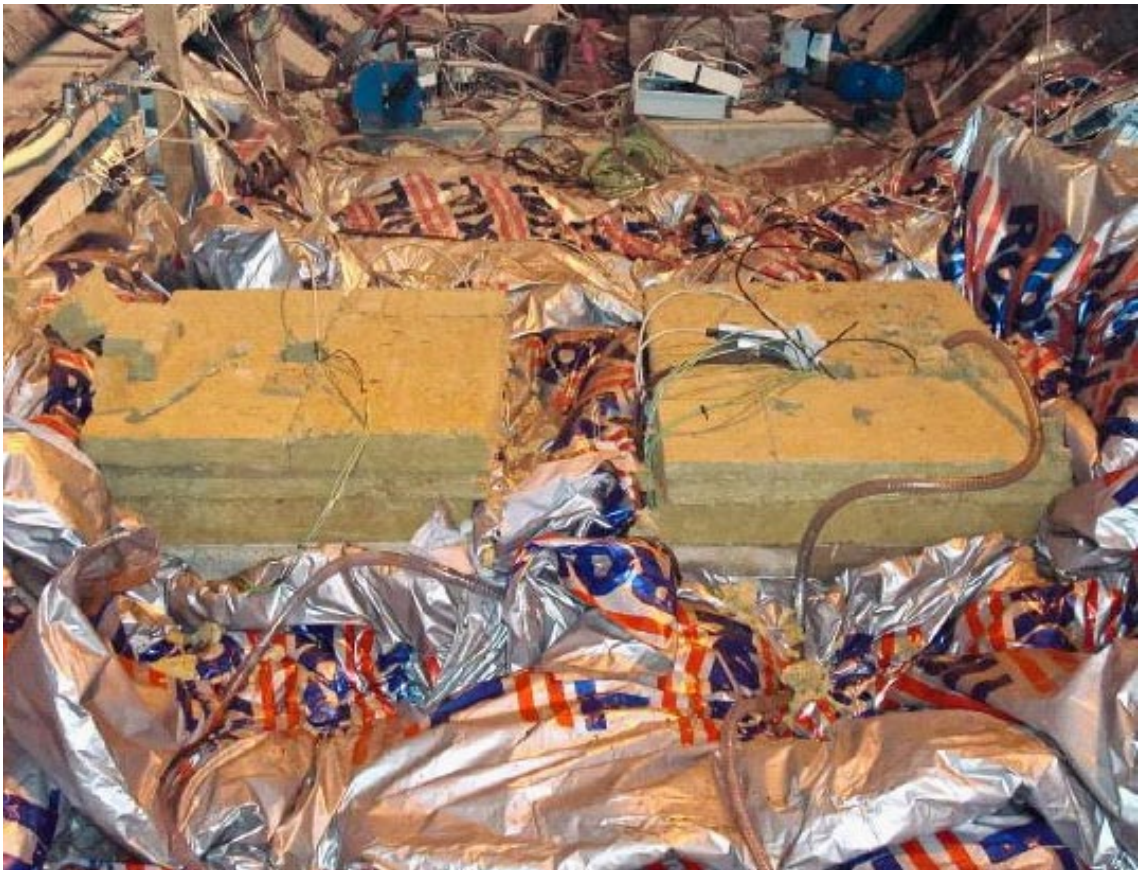
*Figure V-8. Shows the test site during the Field Test 3.*

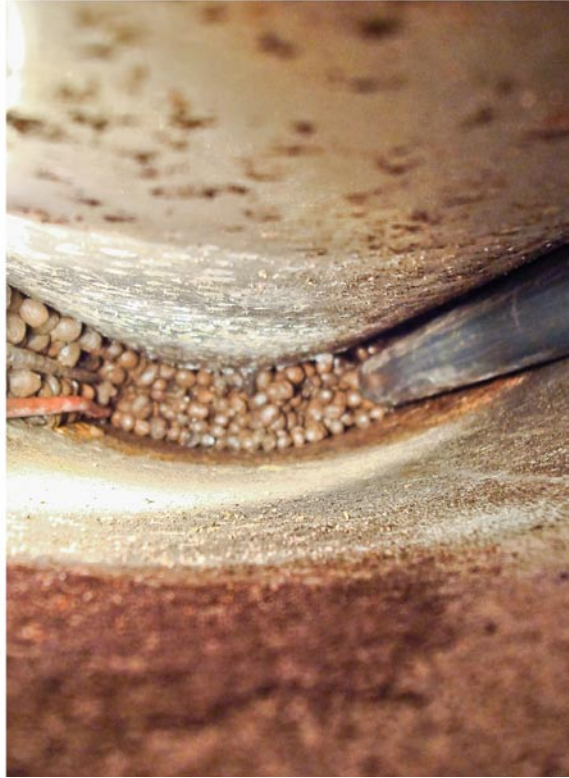
*Figure V-9. Shows the emptying of the pellet filled slot after the completion of Test 3.*

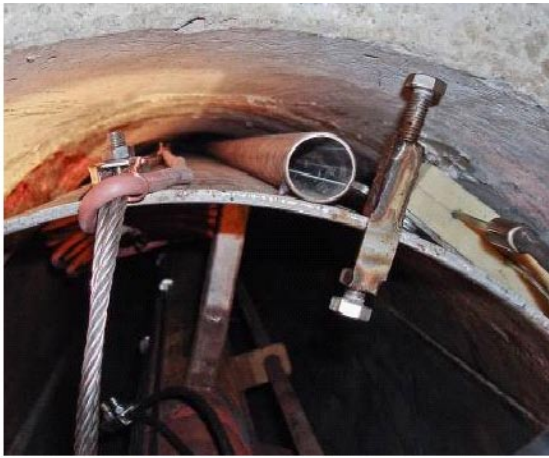
*Figure V-10. Shows the test equipment in place in filed Test 4 with a close-up view of the slot in the position of the RH-tube.*

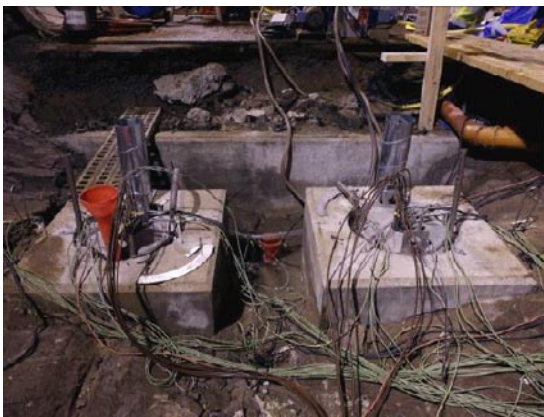
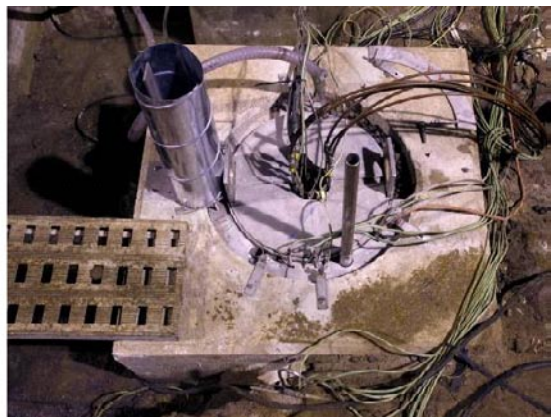
*Figure V-12. Shows the test equipment in place after filling the slot with pellets in the preparation for Field Test 4.*

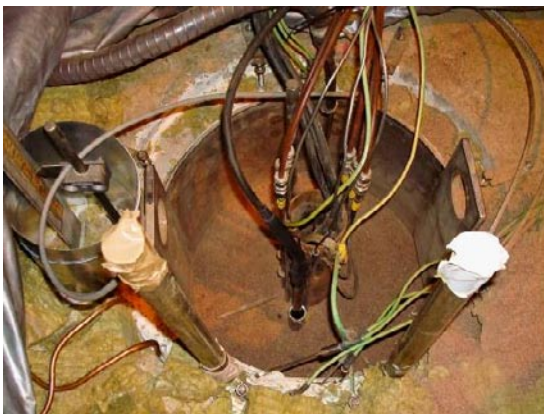
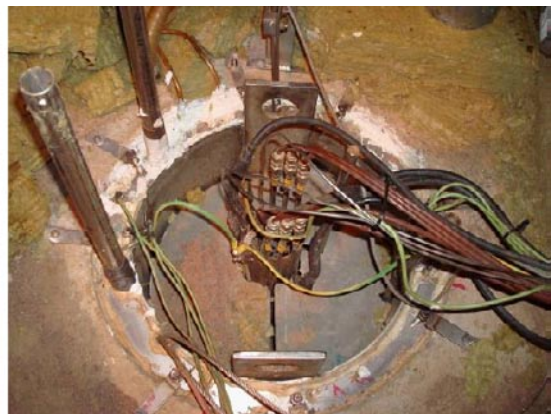
*Figure V-13. Shows KQ0046G04 after replacement of a heater element in Field Test 4.*

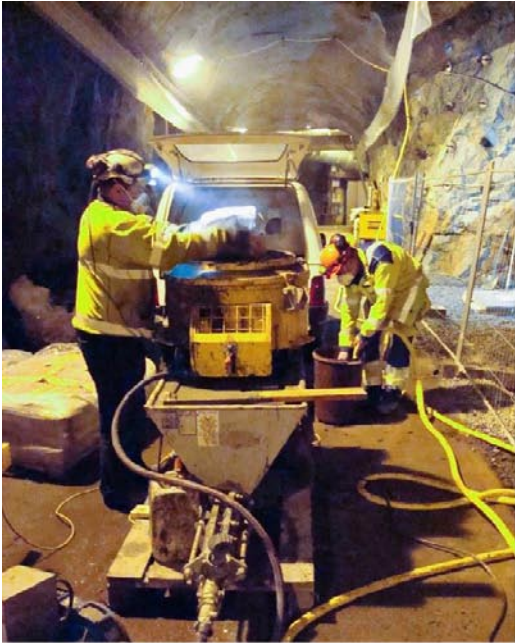
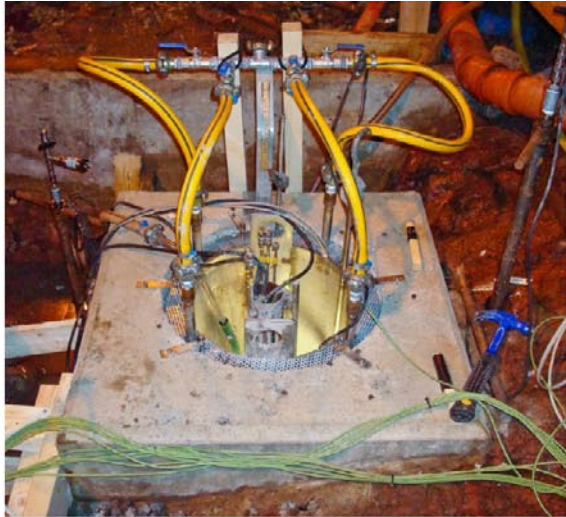
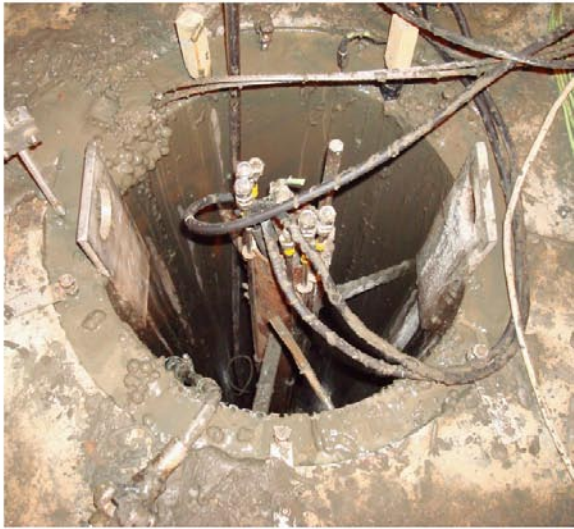
*Figure V-14. Shows the equipment and the pellet filled slot before en after the grouting of the pellet filled slot in KQ0046G03.*

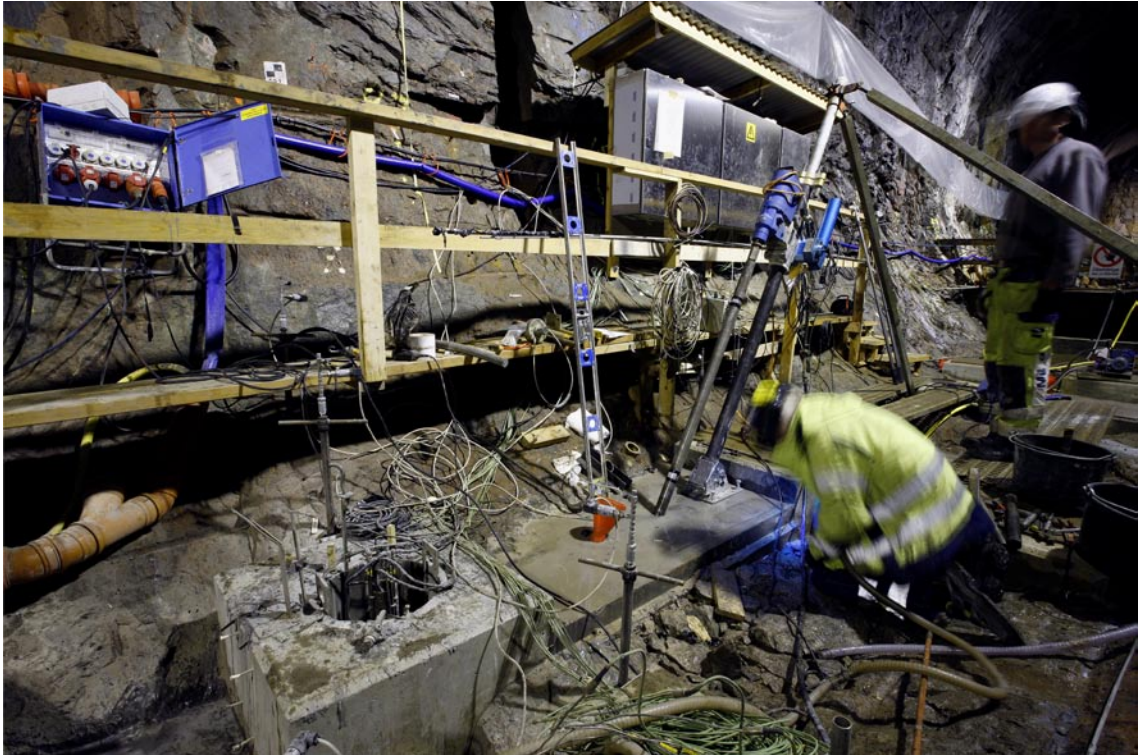
*Figure V-15. Shows the core drilling of the water injection holes used in the post characterization damage zone in KQ0046G03.*

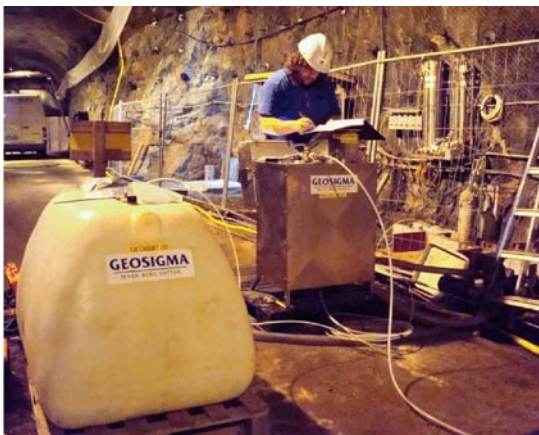
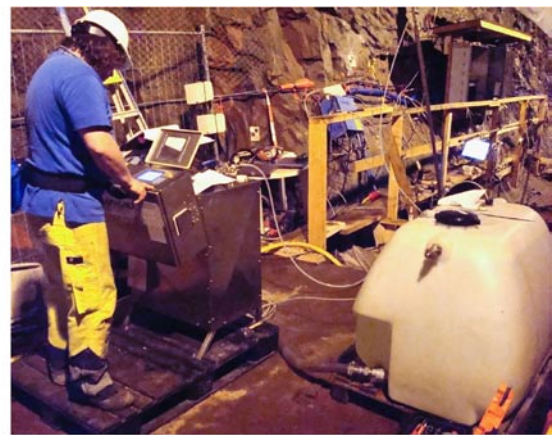
*Figure V-16. Shows the equipment utilized for the water injection tests of the damage zone in KQ0046G03.*

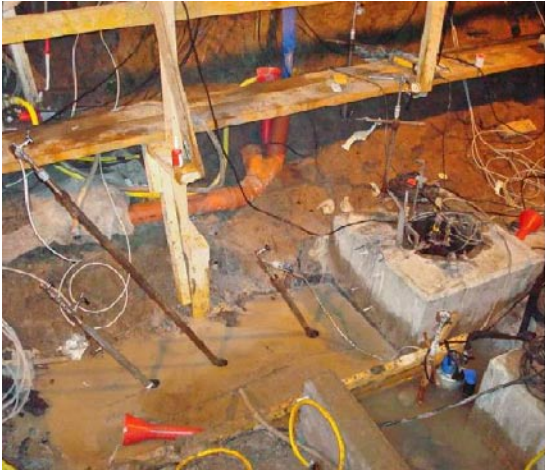
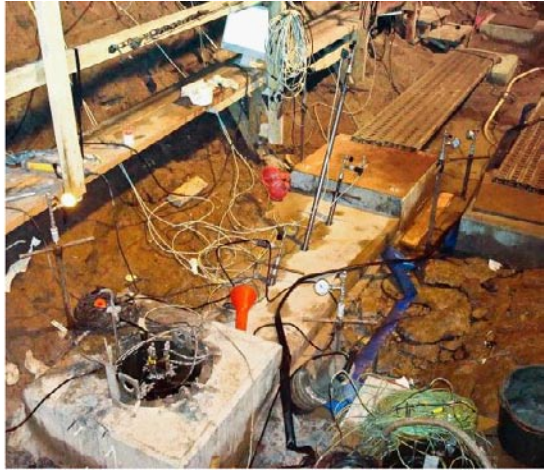
*Figure V-17. Shows the injection holes with installed packers during the hydraulic testing of the damaged zone in KQ0046G03.*
