## **Oskarshamn site investigation**

### **Drill hole: KSH01A**

#### **The normal stress and shear tests on joints**

Panayiotis Chryssanthakis  
Norwegian Geotechnical Institute

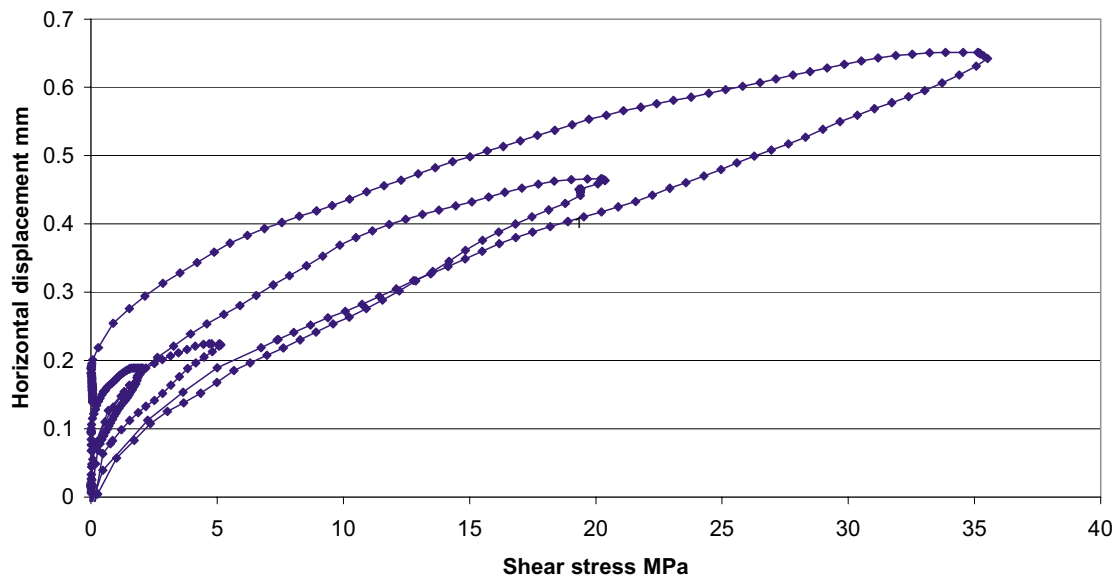
**Figure 4-3.** Horizontal false deformations of the DST apparatus when loading the steel specimen with improved epoxy mix.

Several calibration tests were carried out by the end of February and until the beginning of March 2004. These tests were run in order to be able to correct the test results for false deformations. A steel specimen with the same shape and dimensions as a test specimen with a joint at an angle of about 30 degrees w.r.t the borehole axis (which is approximately the average angle of the tested specimens) was used for calibration purposes (see Figure 4-1). The epoxy mix used to fix the steel specimen to the metal ring was a mixture of dolomite powder and epoxy. The compressive strength of the epoxy mix is according to the manufacturer, 90 MPa. After consulting the manufacturer and in order to be able to increase the strength, more dolomite powder was added to the epoxy mix. However if too much dolomite is added, the epoxy mixture will be too stiff for the casting process to be successful. Different epoxy mixtures were tried. The same loading path as the one followed during the tests on rock was applied to the specimen. The results of the final test on the steel specimen are shown in Figures 4-2 and 4-3 below.

The corrections for false deformations used to calculate vertical and horizontal deformations are based on simplified versions of the observed curves shown in Figures 4-2 and 4-3.

The maximum stresses applied to the specimens during this testing programme resulted in false deformations of the order of 0.11 mm for a normal stress of 20.0 MPa and of about 0.46 mm for a shear stress of 20 MPa. The system was also tried for a normal stress up to 50 MPa, and a shear stress of 35 MPa. The false deformations are taken into account in the formulas used for calculation of horizontal and vertical displacements for the DST tests on the rock specimens.

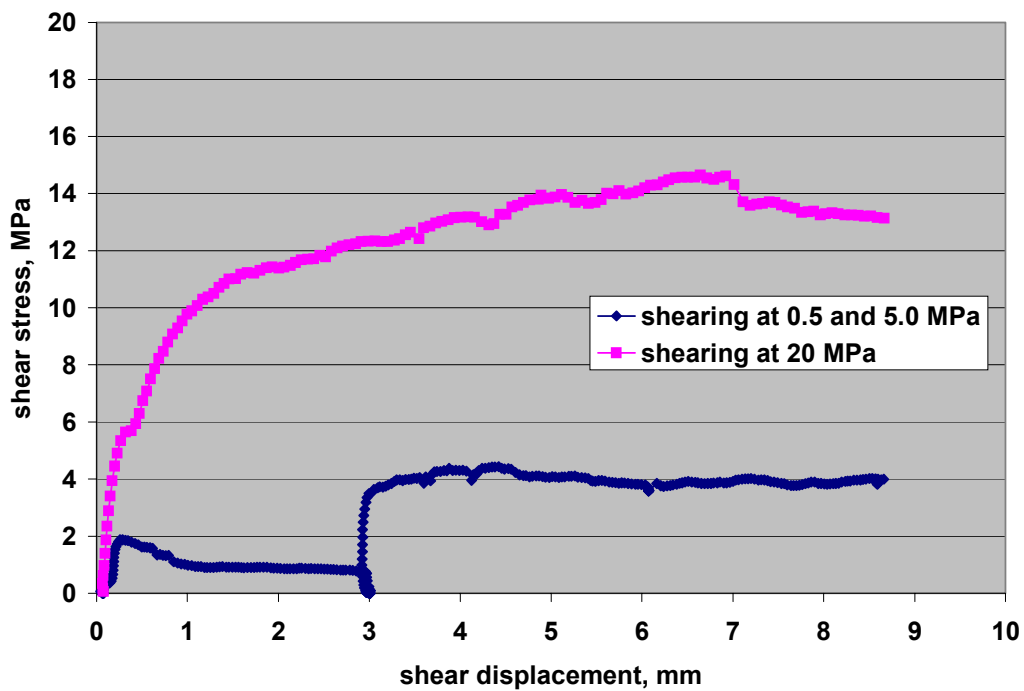
Figure A.2 (bottom): shear stress versus shear displacement for loading cycle B, C, and D

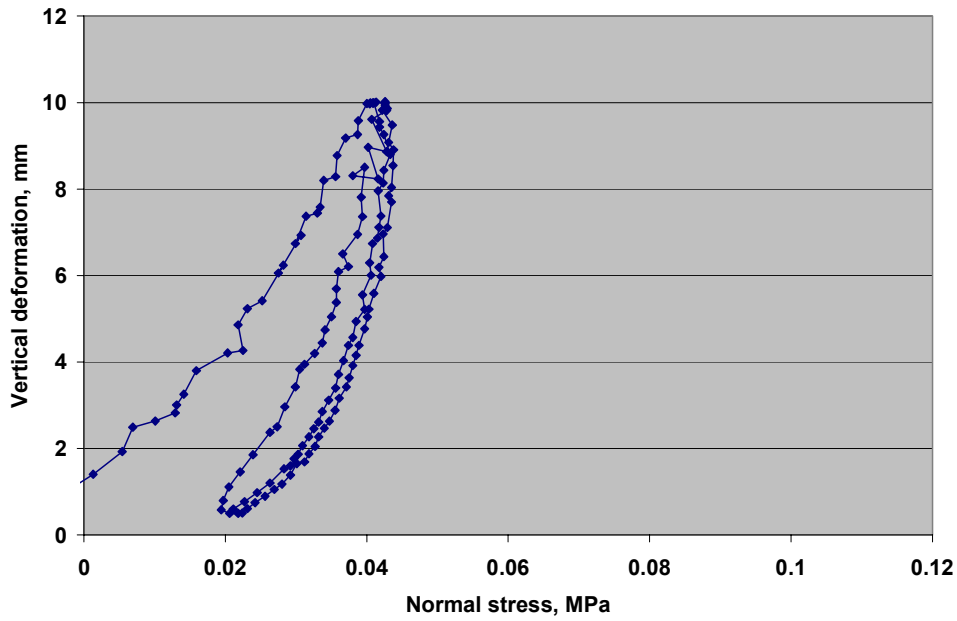
Borehole KSH01A, ID K01-117-15, depth 485.93 m

Figure A.6 (top) vertical stress versus vertical displacement for loading cycle A

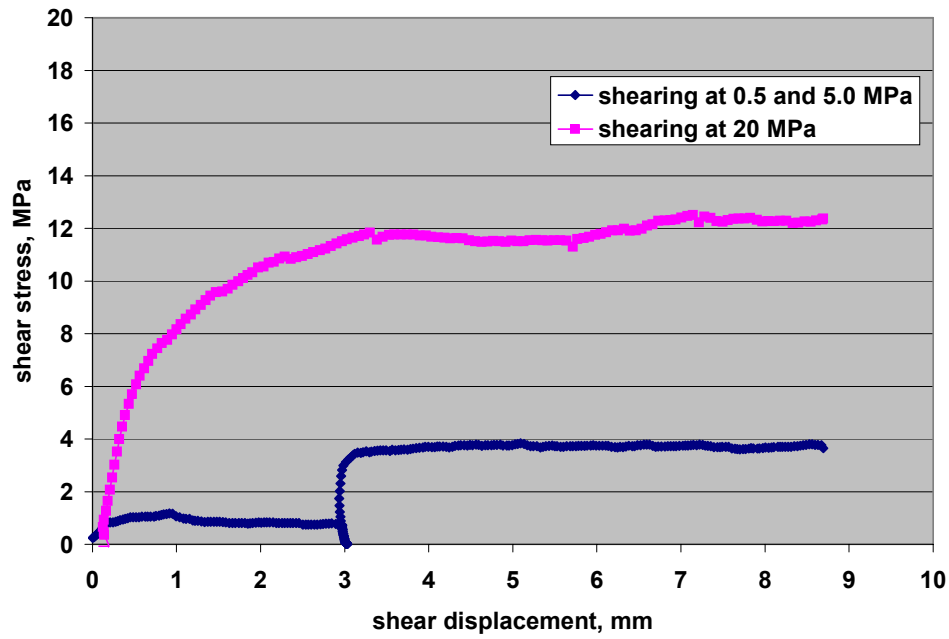
Figure A.7 (bottom): shear stress versus shear displacement for loading cycle B, C, and D

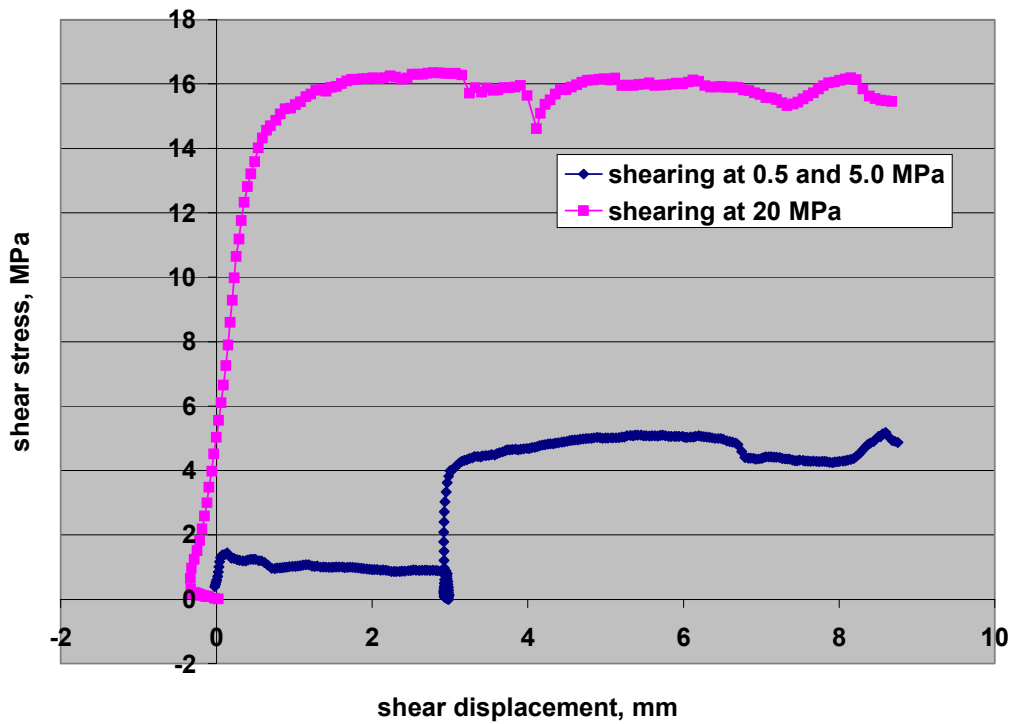
Figure A.12 (bottom): shear stress versus shear displacement for loading cycle B, C, and D

For some of the tests listed in the appendix, for example DST 207, the shear displacement values have a negative sign in the beginning of loading step D. This is because the specimen was not repositioned at exactly zero deformation position. These negative values do not have any effect on the test results.

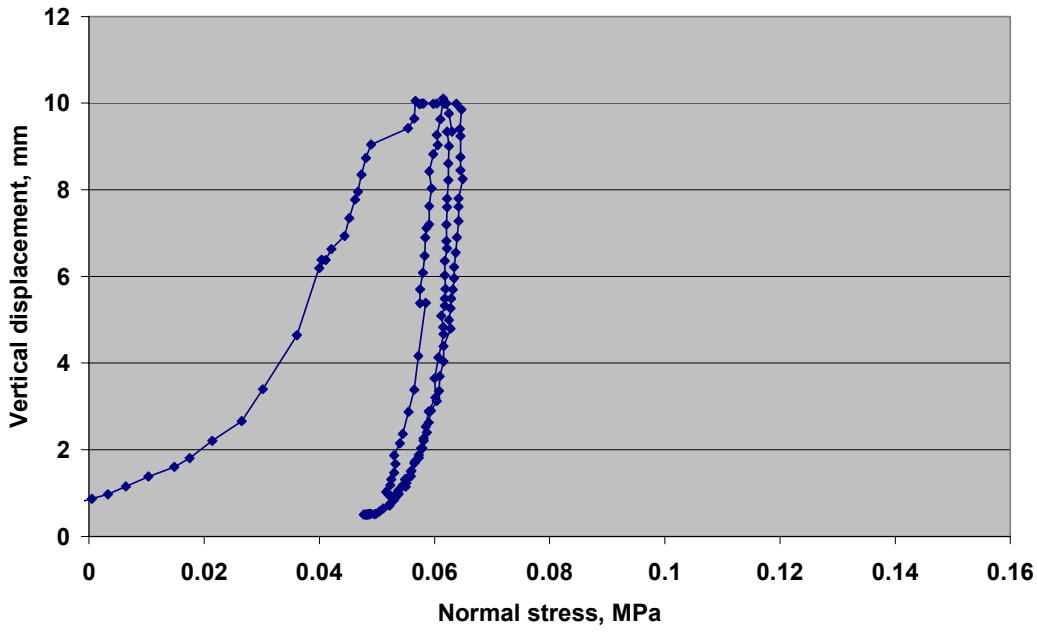
Borehole KSH01A, ID K01-117-19, depth 492.83 m

Figure A.16 (top) vertical stress versus vertical displacement for loading cycle A

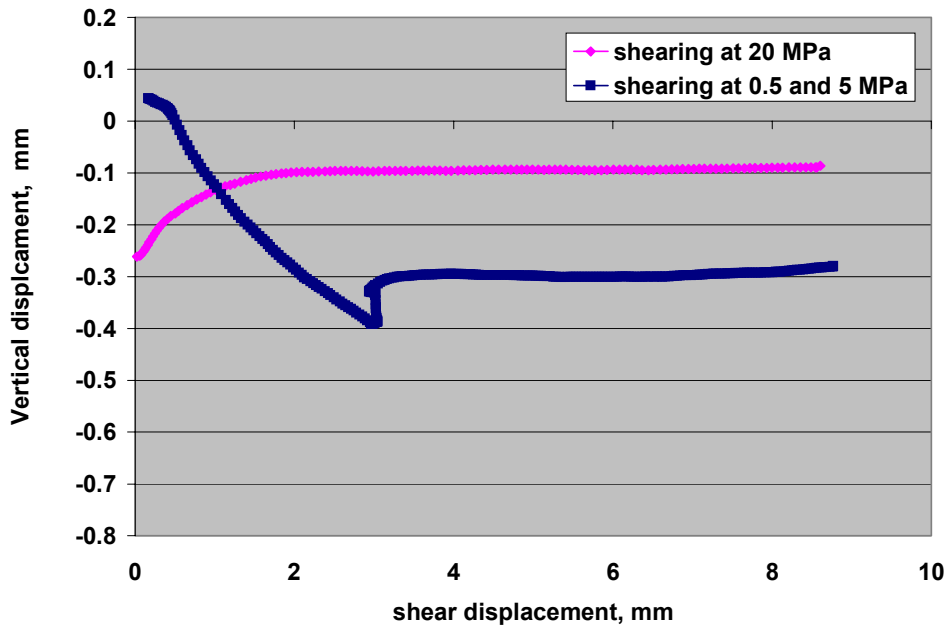
Figure A.18 Normal displacement versus shear displacement loading cycle B, C, and D (dilation)

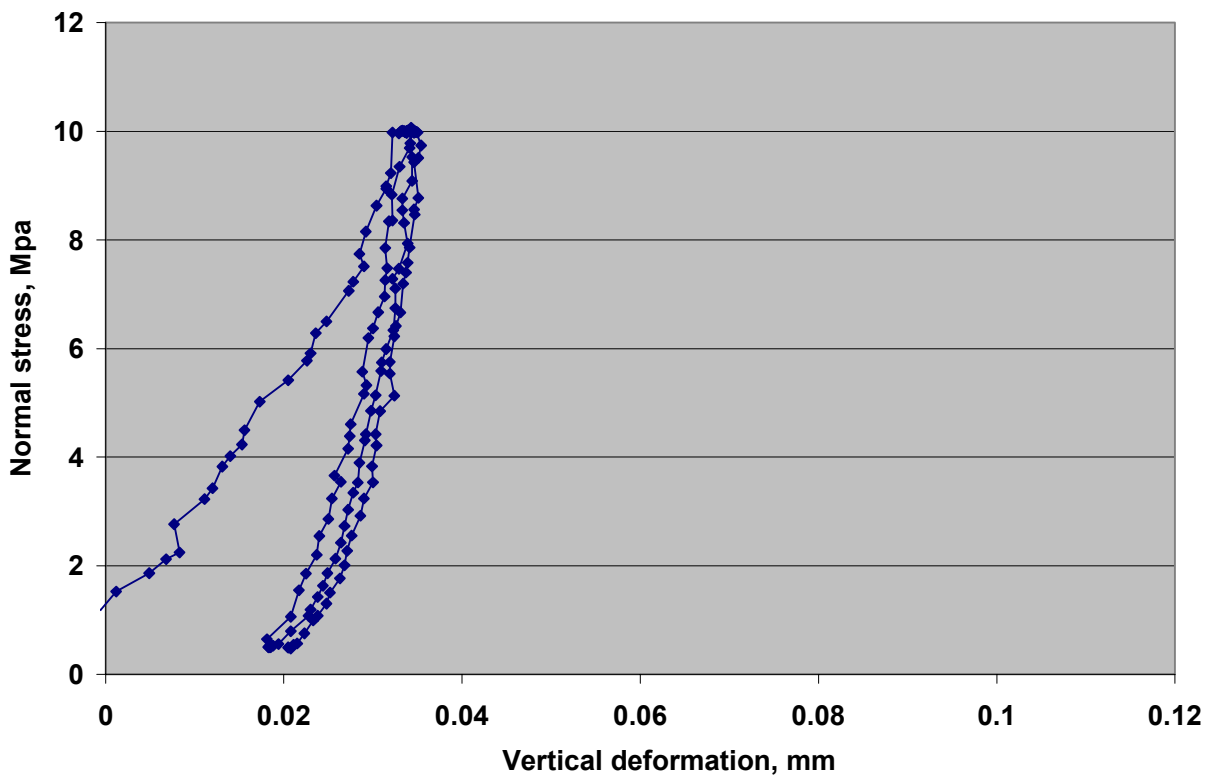
Borehole KSH01A, ID K01-117-23, depth 497.87 m

Figure A.26 (top) vertical stress versus vertical displacement for loading cycle A

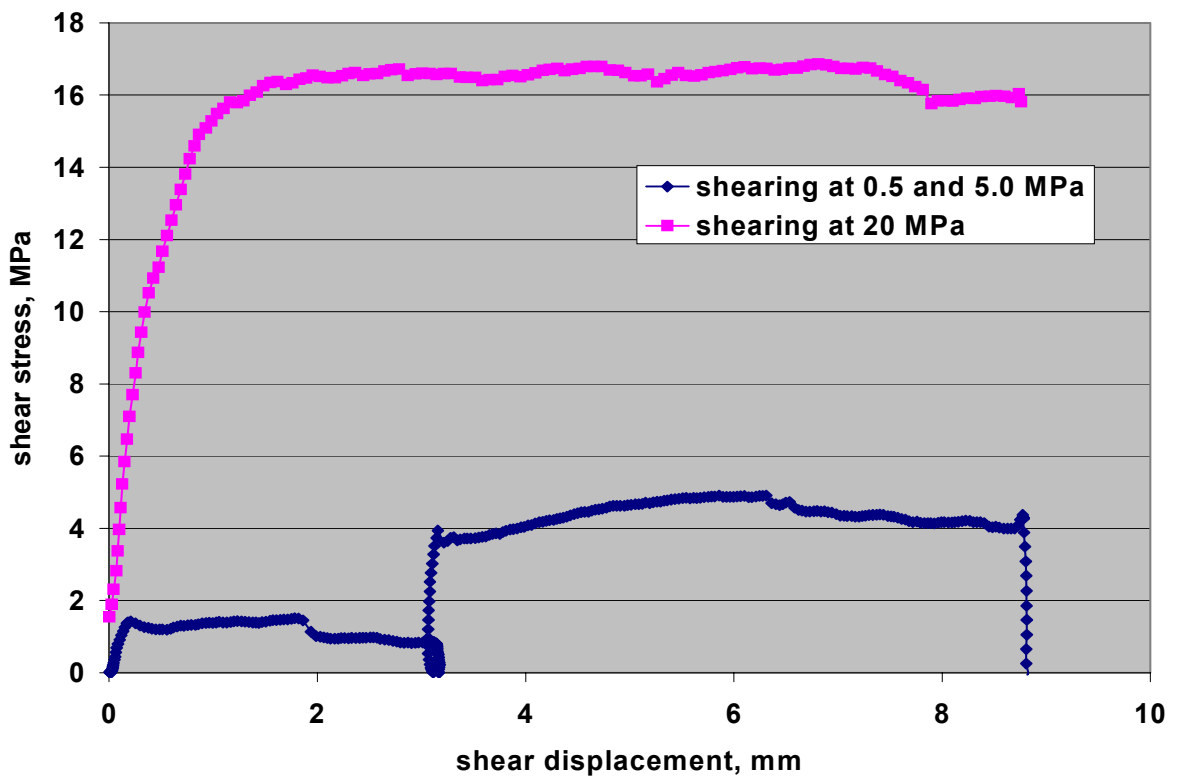
Figure A.32 (bottom): shear stress versus shear displacement for loading cycle B, C, and D

Some minor problems with one of the regulating pumps, for test number DST 209 and DST 217 caused higher normal stress values (1.1 MPa and 0.9 MPa respectively) than specified during a short period of time at loading cycle B. These irregularities are not considered to affect the final residual stress values significantly.
