Temperature buffer test

**Sensors data report
(Period 030326–100301)
Report No: 13**

Reza Goudarzi, Mattias Åkesson, Ulf Nilsson
Clay Technology AB

SKB P-12-03

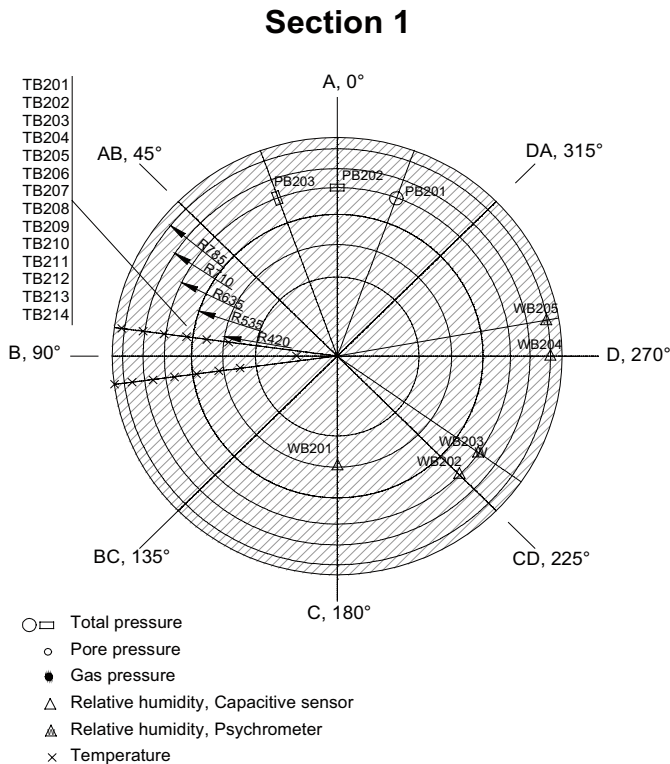
Figure 4-1. Schematic view, showing the main directions of the instrument positioning. The drawing shows the instrumentation in measuring Section 1.

The instruments are located in three main levels in each instrumented block, the surface of the block (only total pressure cells measuring the horizontal pressure) and 50 mm and 250 mm from the upper block surface. The thermocouples and the total pressure cells are placed in the 50 mm level for practical reasons and the other sensors in the 250 mm level.

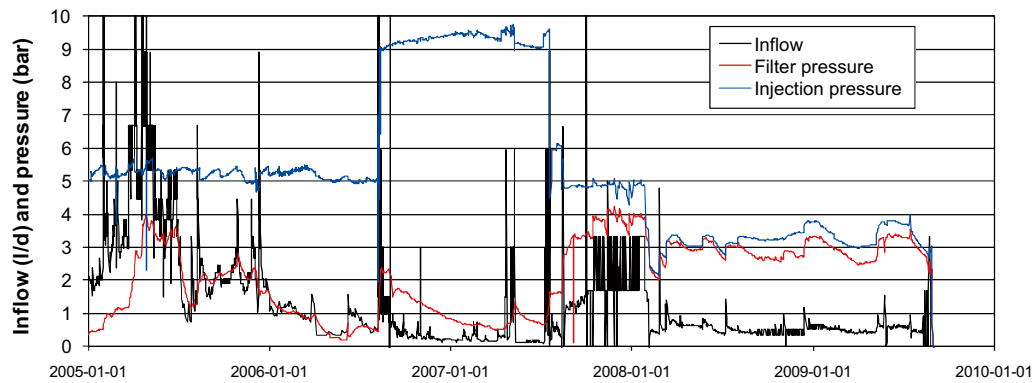
Figure 5-2. Development of relative pressures (injection and in sand filter) and inflow since the second hydraulic test.

The injection pressure was reduced at the end of January 2008 from 5 bar to 3–3.5 bar (see Table 5-2 and Table 5-3). The reason for this was the observed leakage in the middle of January 2008. This leakage was however found to originate from the shield hydration (see below). Due to this event, the pressurization of the filter mat was temporarily turned off (from February 1 to April 1). After this, the injection pressure was kept fairly constant at a level between 3 and 4 bar up till the termination of the water injection.

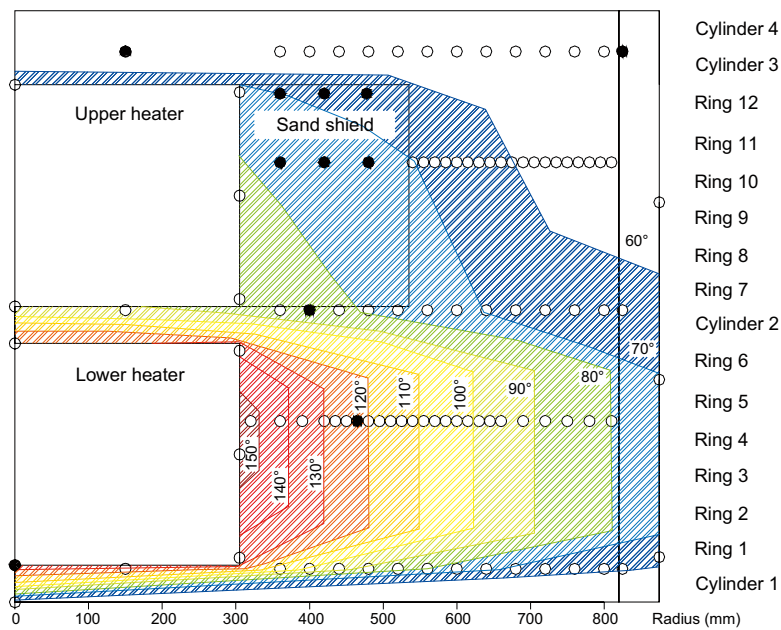
Figure 5-3. Temperature distribution on August 16, 2009. Rings indicate sensor positions. Filled rings indicate sensors out of order.

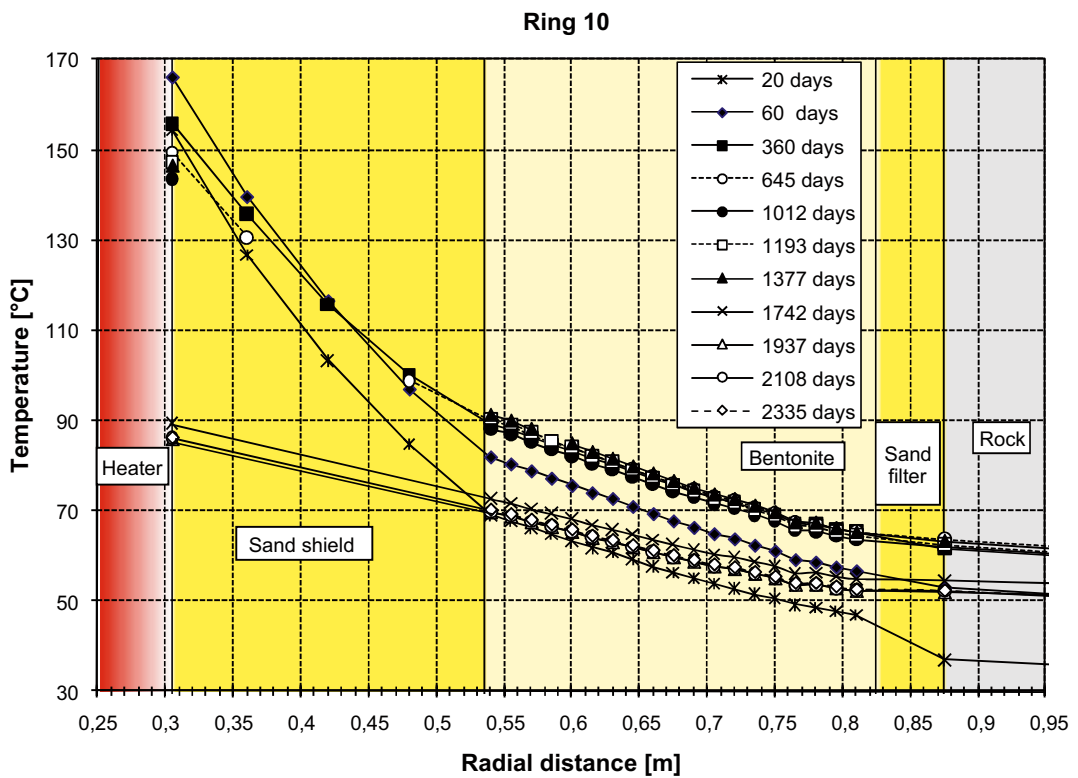
Figure 5-4. Temperatures measured at mid-height of Heater 1 (Ring 4) and Heater 2 (Ring 10).

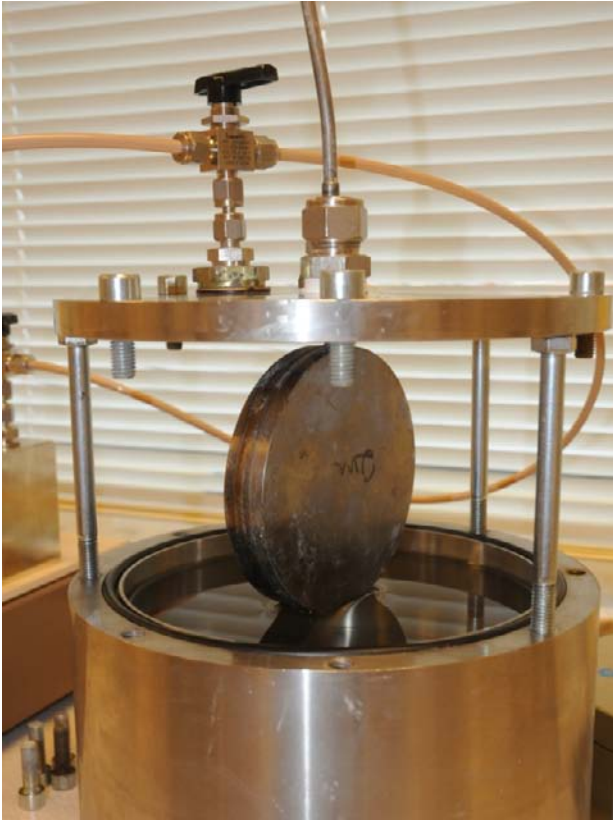
Figure B-1. Test cell with a sensor.

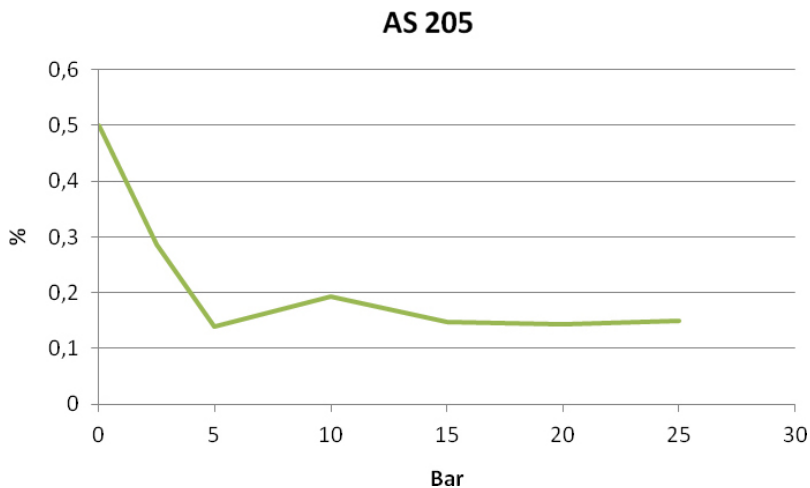
Figure B-4. Error for sensor AS 205 as a function of pressure.

Evaluating these sensors a linear regression curve was made for each. In this way both linear error and offset errors could be seen. Only one of the tested sensors had a linear error less than 5%. The rest of the tested sensors had a linear error of 6 to 10% and an offset error of 0 to -0.64 MPa. This includes the sensors that were damaged by drilling. See also Table B-2. All diagrams are presented in the Section B-6.

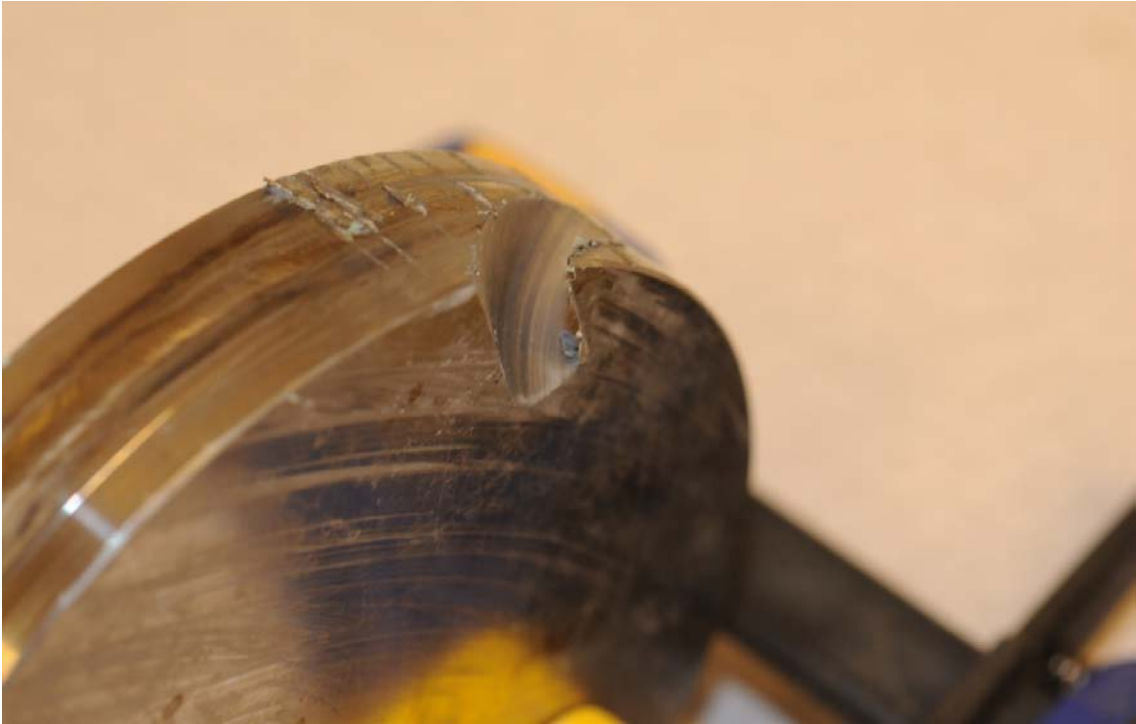
Figure B-7. Sensor Geokon 70042 drill damage.

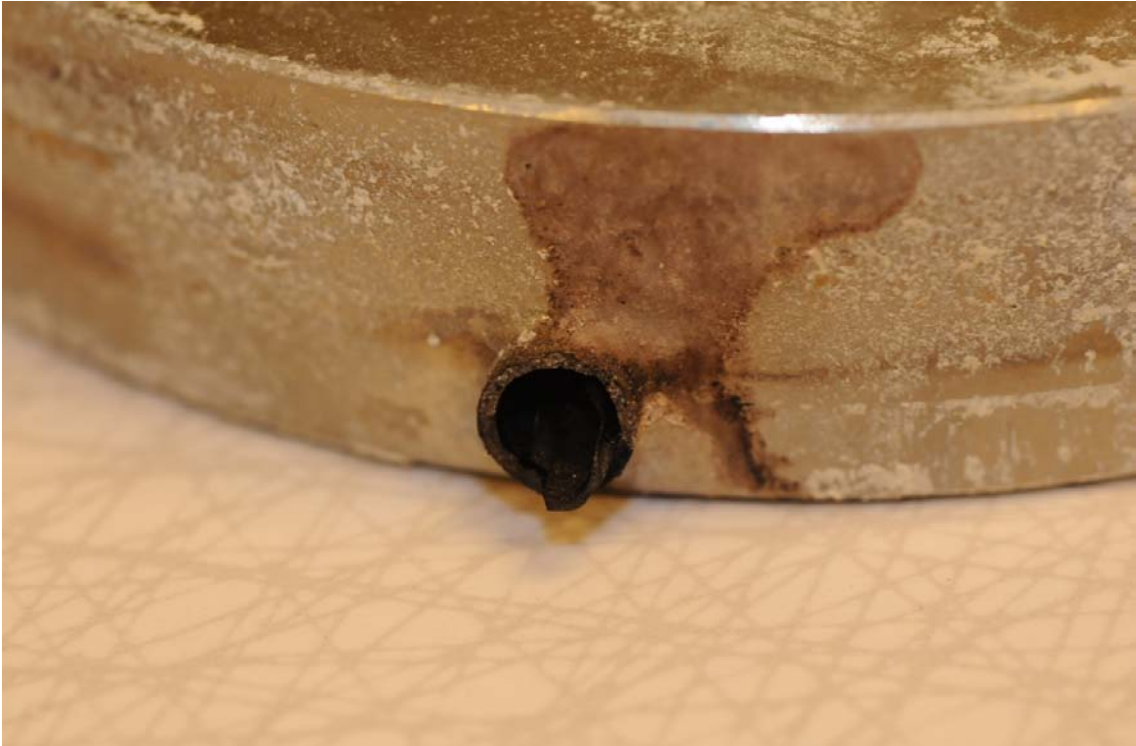
Figure B-8. Sensor 70054, broken in the weld to the housing.

The welds and connections are sensitive to movements. Both the weld between the house and the 8 mm tube, see Figure B-8, and the 6 to 8 mm coupling has broken in several sensors, see Figure B-9, especially the Geokon Total pressure sensors. This damage allows water access into the sensor and there cause corrosion and/or short-circuits. As can be seen in the cable also the shielding can be corroded, see Figure B-10. If the damage occurred during the test, dismantling of the test or in later handling cannot always be clear.

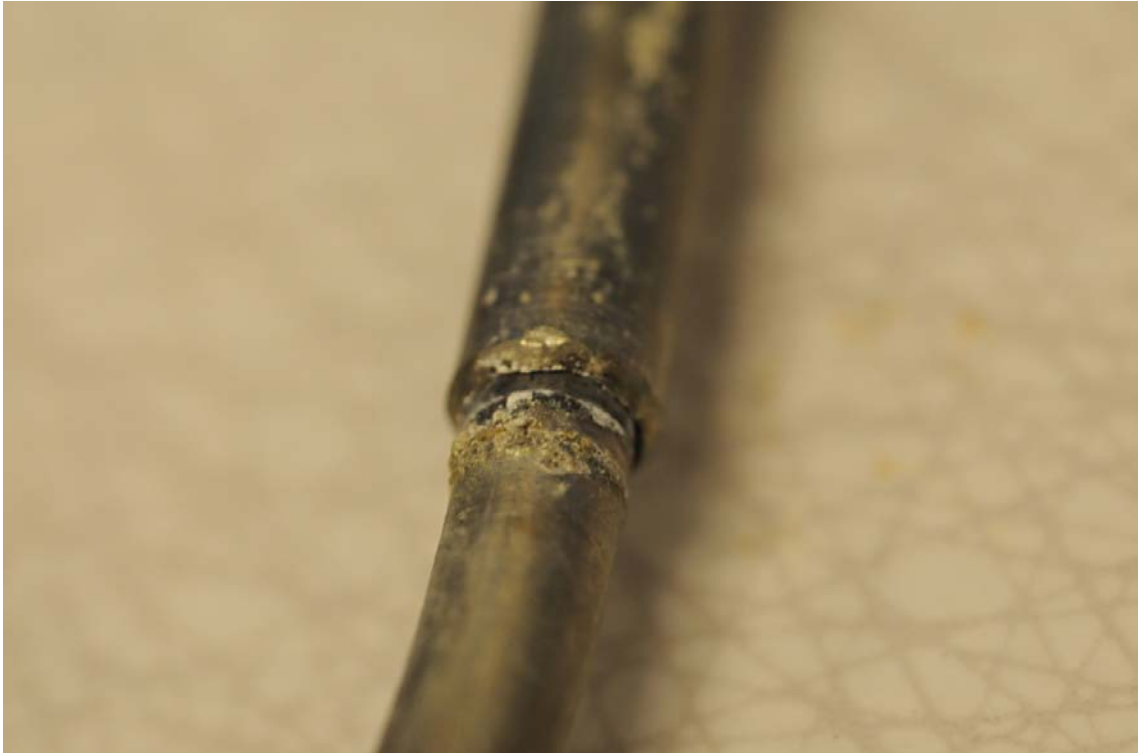
Figure B-9. Sensor Geokon 70064, weld 8 mm to 6 mm tube has broken and water can reach the sensors electronics.

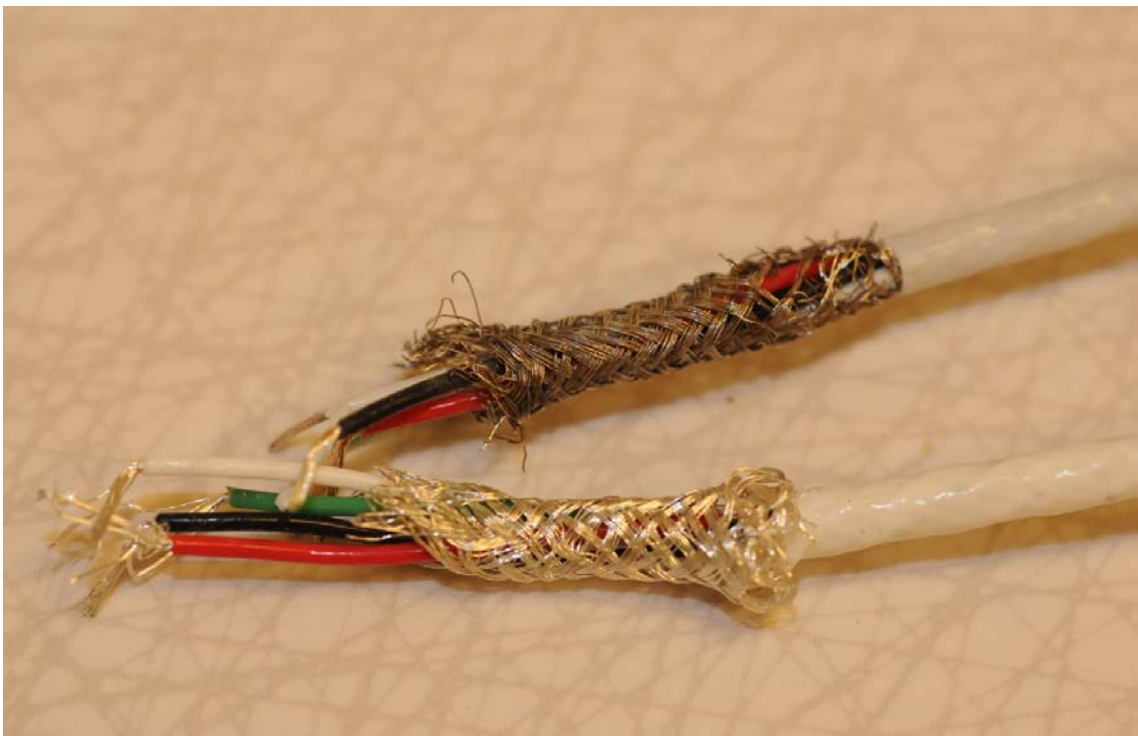
Figure B-10. Sensor cables, the upper showing corrosion in the shield from water. 70039, 70055.

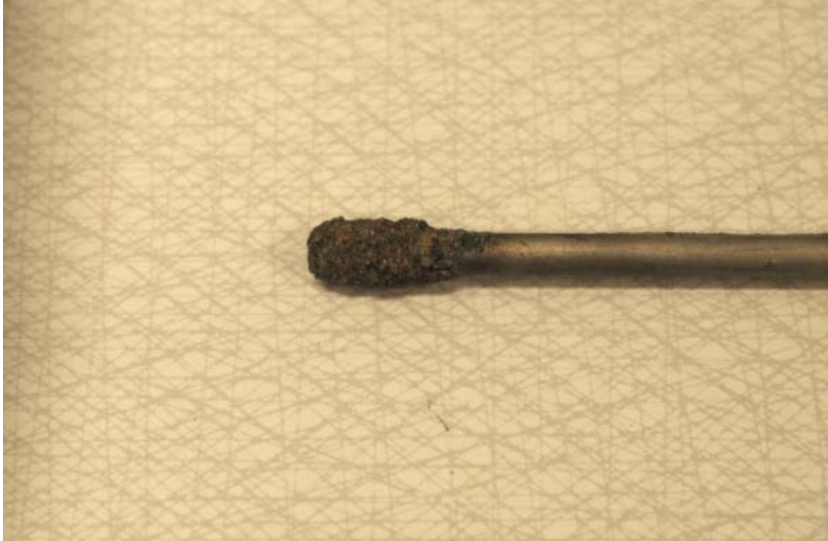
The filter tips in the sand filter have exhibited a high flow resistance, and after the dismantling it was apparent that the filter tips have been covered with some type of precipitate (Figure B-13). This material has been analyzed with X-ray diffraction analysis, and the resulting diffractogram is shown in Figure B-14. The results indicated that the sand particles have been “cemented” together by calcite.

Figure B-13. Filter tip from injection point AS205 with precipitates.
