## KBS-3H

### Upgrading the deposition machine for the Multi Purpose Test

Markku Ojala, Thomas von Numers  
Navitec Systems

SKB P-14-08

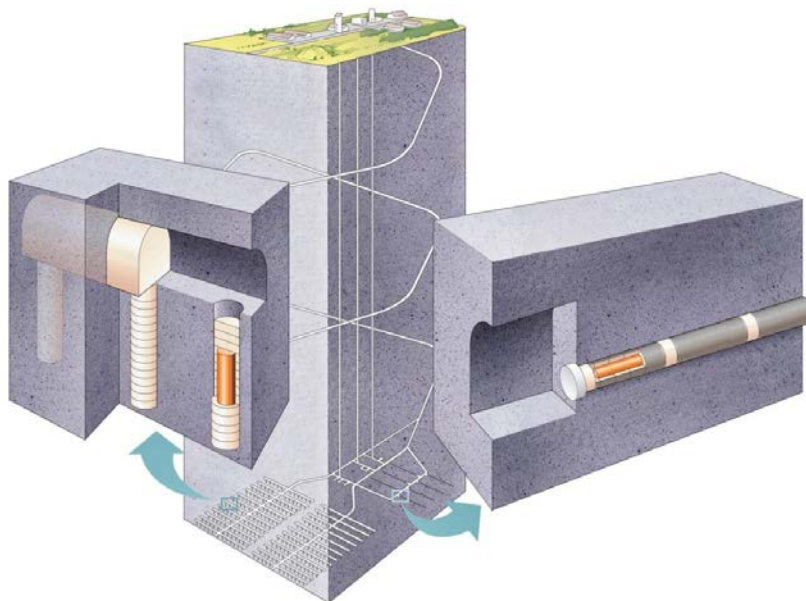
**Figure 1-1.** Schematic illustration of the KBS-3 method with its three barriers: the canister, the buffer and the rock. The vertical reference design is illustrated to the left and the horizontal alternative to the right.

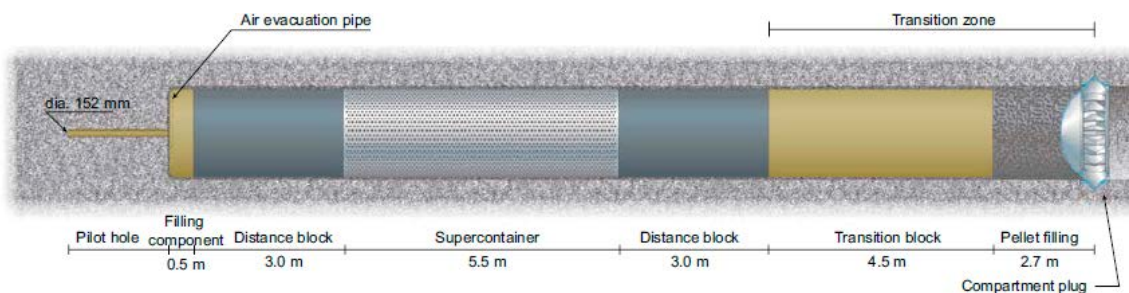
**Figure 1-2.** The main KBS-3H components, a Supercontainer, two distance blocks and a compartment plug with its transition zone.

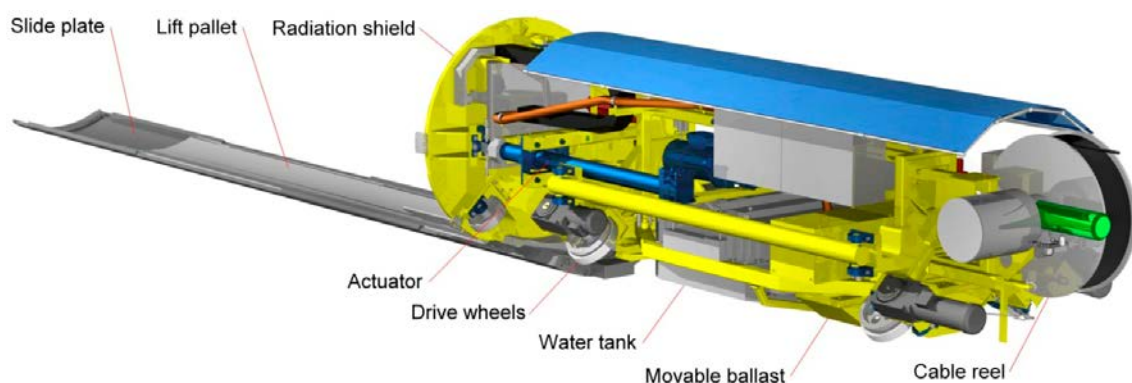
*Figure 2-1. The main functional parts of the horizontal deposition machine.*

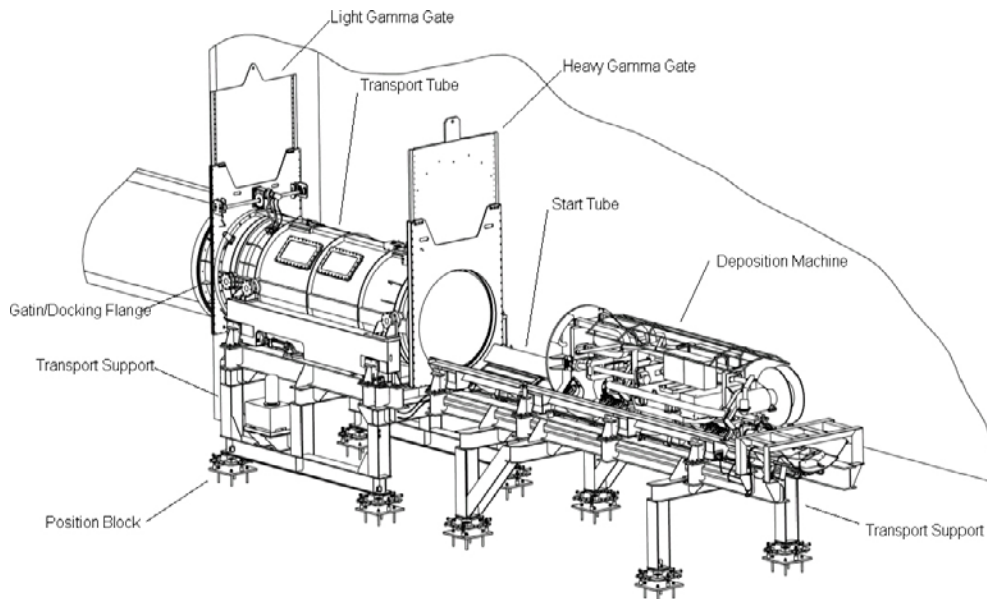
**Figure 2-2.** *Placing of transport tube and start tube outside the drift. The tubes stand on transport supports which are adjusted into correct position and height with the position blocks on the ground.*

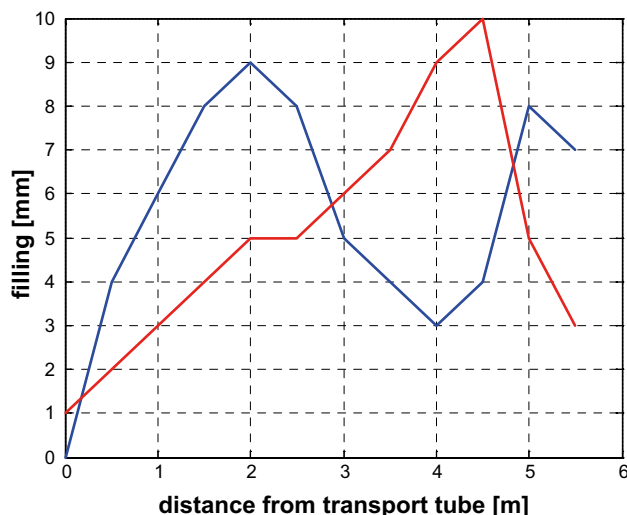
*Figure 3-1. Thickness of steel filling on wheel tracks of start tube, blue – right track, red – left track.*

The work resulted in a reasonably straight start tube and the jamming problems when driving the sliding plate and pallet in under a Supercontainer in the transport tube could be reduced remarkably.

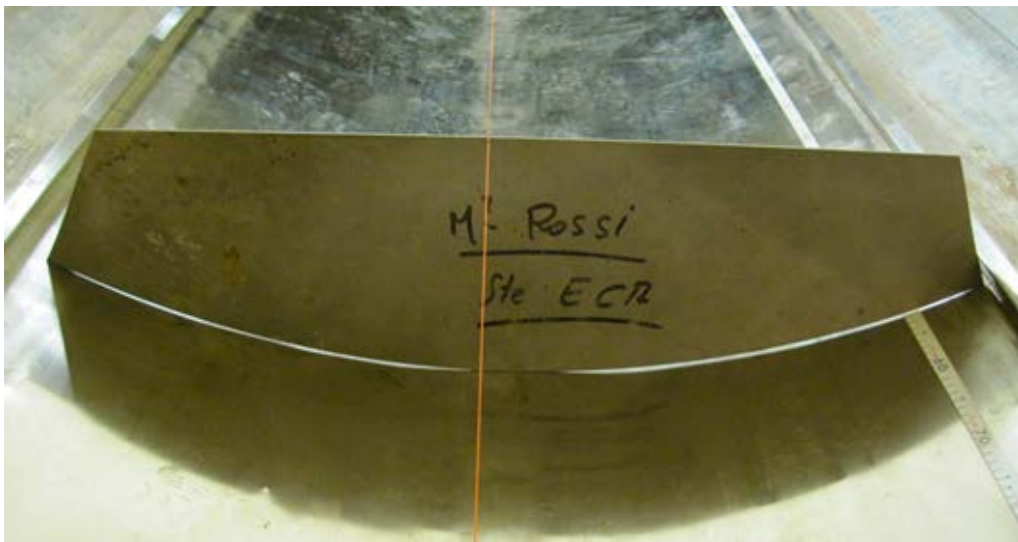
The sliding plate is constantly dragged on the rock surface of the drift and then kind of rolled by the sliding Supercontainer. During every stroke the sliding plate is differently supported by the drift bottom and therefore the rolling forces deform the plate in different ways. Since the lifting cushions slide on the middle part and the sliding plate has stiff box type structures in each end the plate is slowly deformed into a hammock shape. Figure 3-2 shows the two cushion tracks on the plate. Since the front end of the sliding plate is a stiff box-type structure it keeps its' shape. As a result the sliding plate tends to lift its' front end from the drift bottom causing an extra space requirement between the drift bottom and the Supercontainer. Another result is that the front end of the sliding plate is not stably supported over its' whole width by the drift bottom and tends to wiggle somewhat depending on which side the main weight lies on. This is causing some inaccuracy in the angle detection of the front of the sliding plate. It was therefore planned that the sliding plate should be reshaped as part of the machine upgrade. However, the sliding plate is a very large structure and reshaping of the macro deformation could not be done at site. Instead some local deformations caused by stones or local bending caused by the step between the start tube and the transport tube were repaired, Figure 3-3. To avoid excessive wear of the cushions scratches on the upper sliding surface of the plate were removed by polishing.

**Figure 3-2.** The sliding plate is deformed by the pressure from the cushions. The metal sheet is clearly stretched at the two cushion tracks.

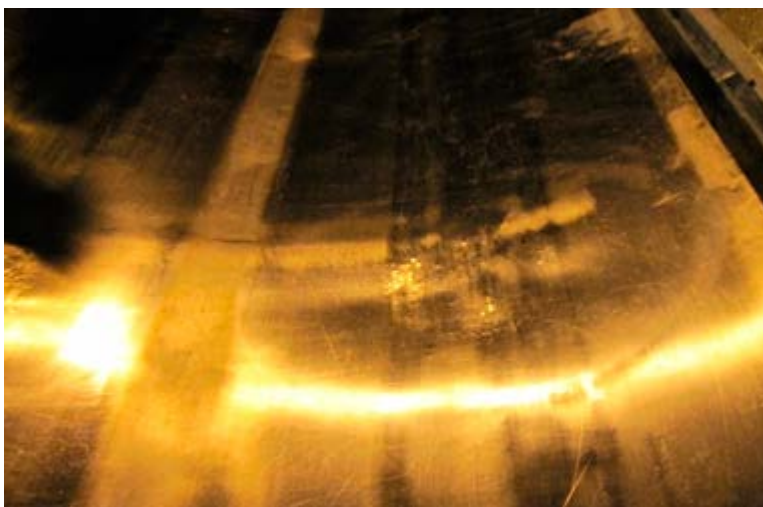
**Figure 3-3.** A heavy load has stamped the shape of the underneath drift surface into the metal sheet.

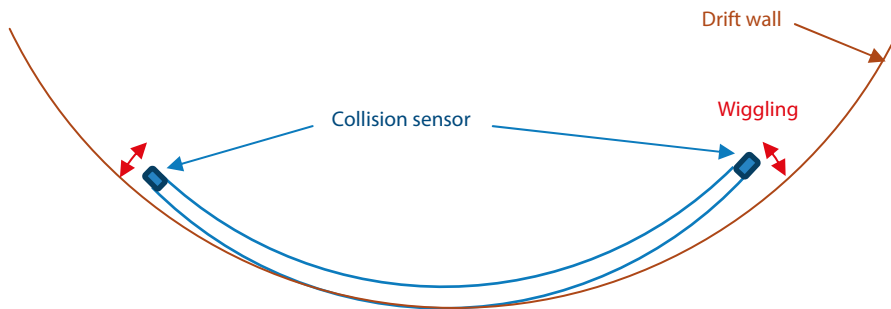
Figure 3-4. The wiggling motion of the front part of the sliding plate caused by a too small radius.

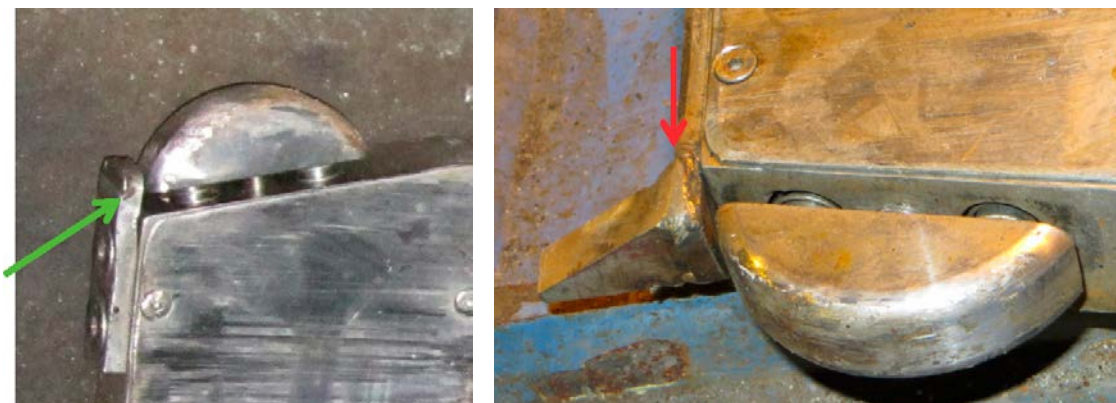
Figure 3-6. To the left the old collision sensor protection consisting of a plate. To the right the new collision sensor protection guiding the sliding plate down.

The design of the sensor was not changed, but the contact body was protected from vertical forces by mounting triangular guides forcing down the sliding plate if in contact with the Supercontainer, Figure 3-6.

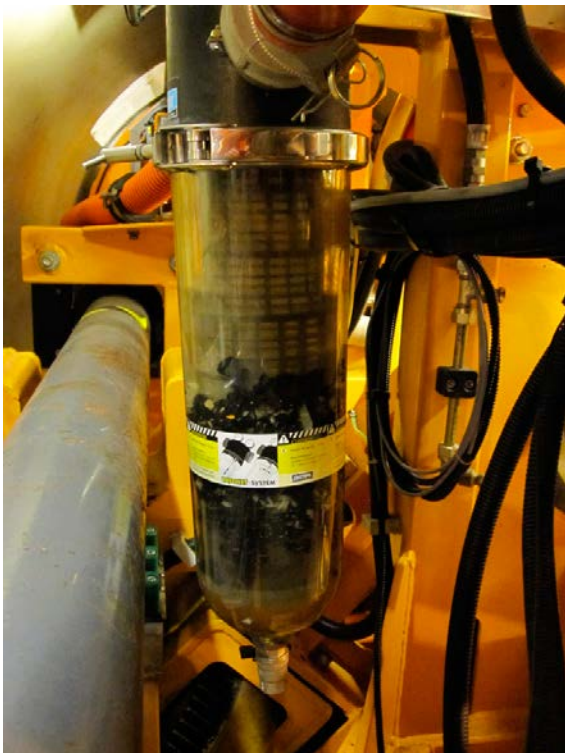
Wear between the guiding edges on the sliding plate and the pallet as well as abrasion of the concrete elements in the Supercontainer dummy have caused contamination of the water returning from the lifting cushions. Since the return water was not filtered, all particles have been able to circulate in the water system. The result has been clogging of lifting cushion valves leading to uneven lifting and sometimes very slow emptying of cushions causing excessive strains on cushions. Since the concrete blocks in the Supercontainer dummy were to be replaced by more brittle bentonite, it was assumed that the amount of particles would increase in real deposition.

***Figure 3-7 . Black chips from the guiding edges of the sliding plate in the water filter.***

Two water filters were therefore mounted in the water return line before the main tank, Figure 3-7. Clogging of valves has not been a problem after this arrangement.

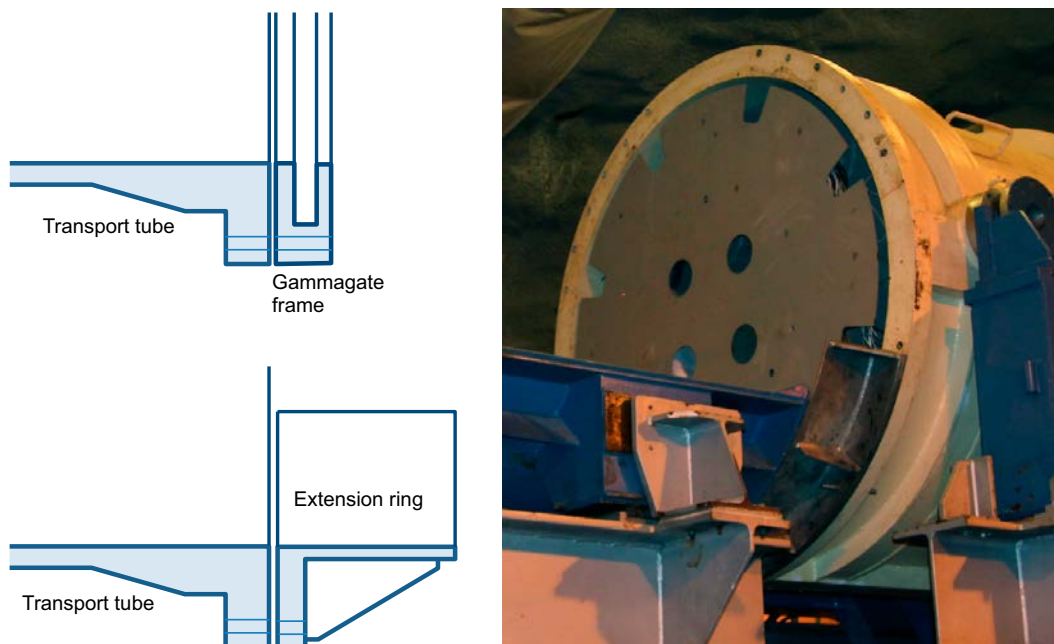
**Figure 3-8.** Left upper drawing shows the end of the transport tube with the frame of the open gammagate. Below the extension ring replacing the two gammagates. To the right a photo with the extension ring mounted to the transport tube and the end of the start tube adjusted towards the ring.

The transport tube cannot be transported in the Äspö ramp tunnel with the gamma gates mounted due to the height limitation. In order to save time in the final MPT experiment, the use of gamma gates at the deposition drift was avoided by designing a replacement ring, Figure 3-8. By mounting this ring in one end of the transport tube the tube is lengthened about as much as the removal of the gammagates shortens it.

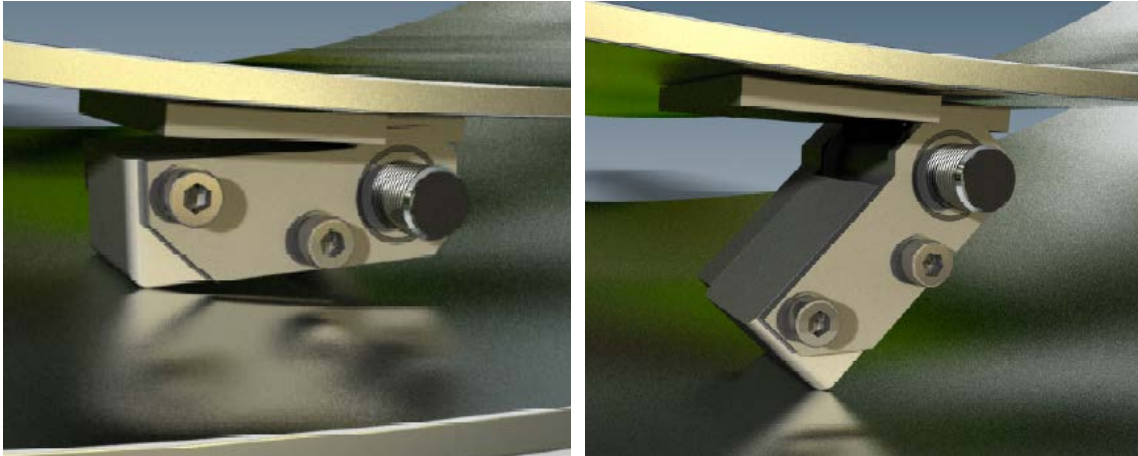
**Figure 3-9.** The design of the new pallet height sensor.

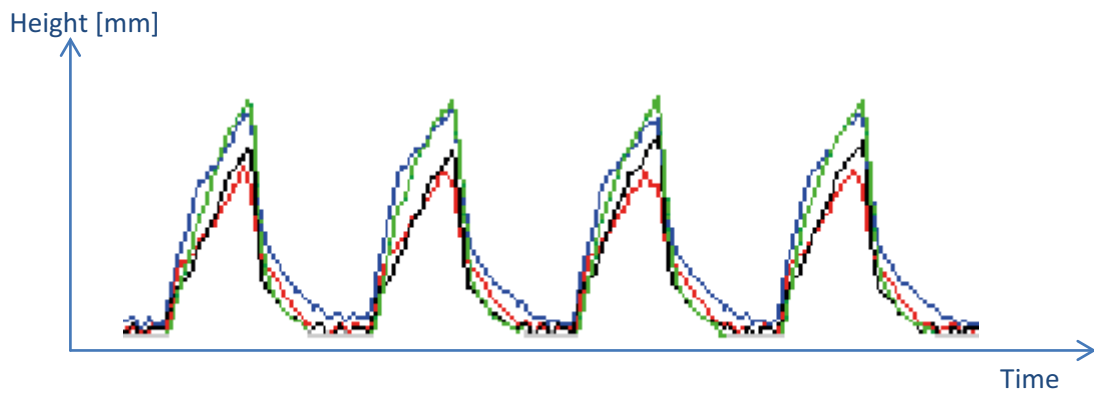
**Figure 3-10.** Typical lifting height logging results. Different corners (blue/green/black/red) have lifted with different speeds and to different heights. The blue graph also showing slow emptying of the cushions.

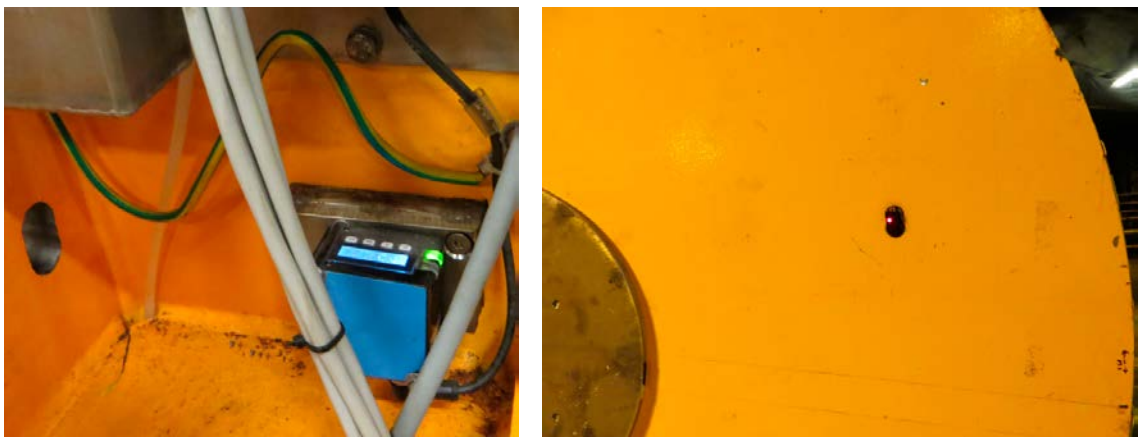
**Figure 3-11.** a) Laser distance sensor mounted behind the main plate of the radiation protection shield and the hole for the beam machined into the shield. b) The laser beam in the hole seen from the lifting pallet side.

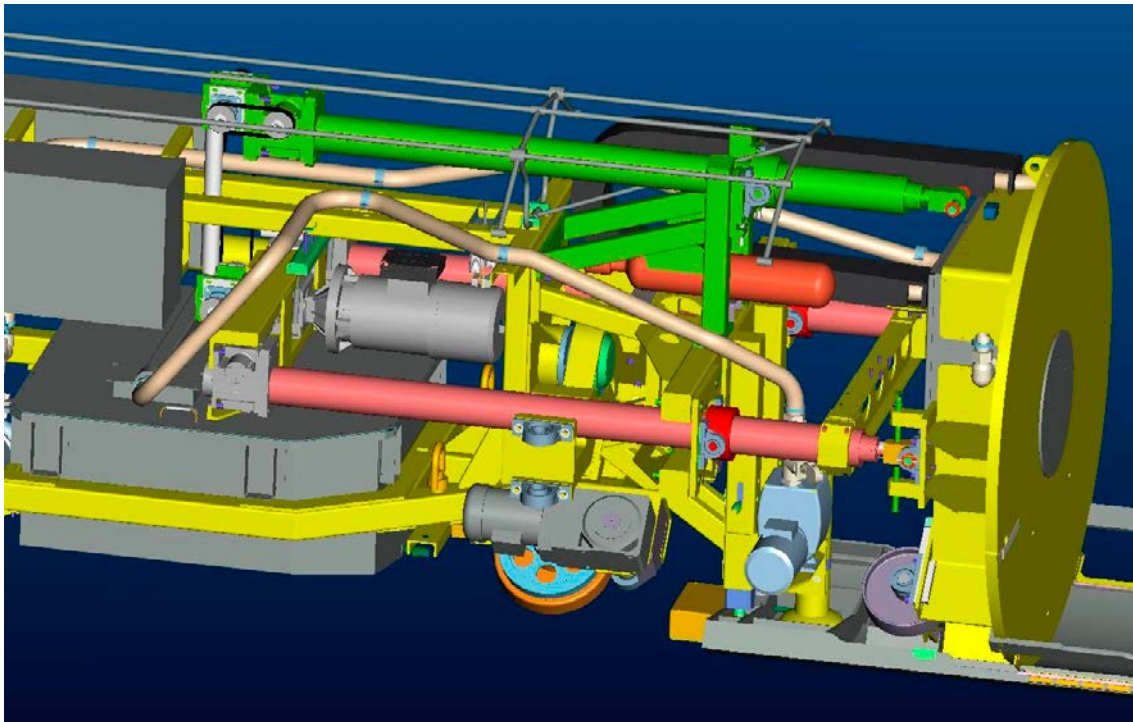
**Figure 3-12.** The two lower actuators (pink) are driven directly by axles between the gearboxes. The third upper actuator (green) is driven by a belt. If the belt jumps the shield turns around the attachment points of the two lower actuators.

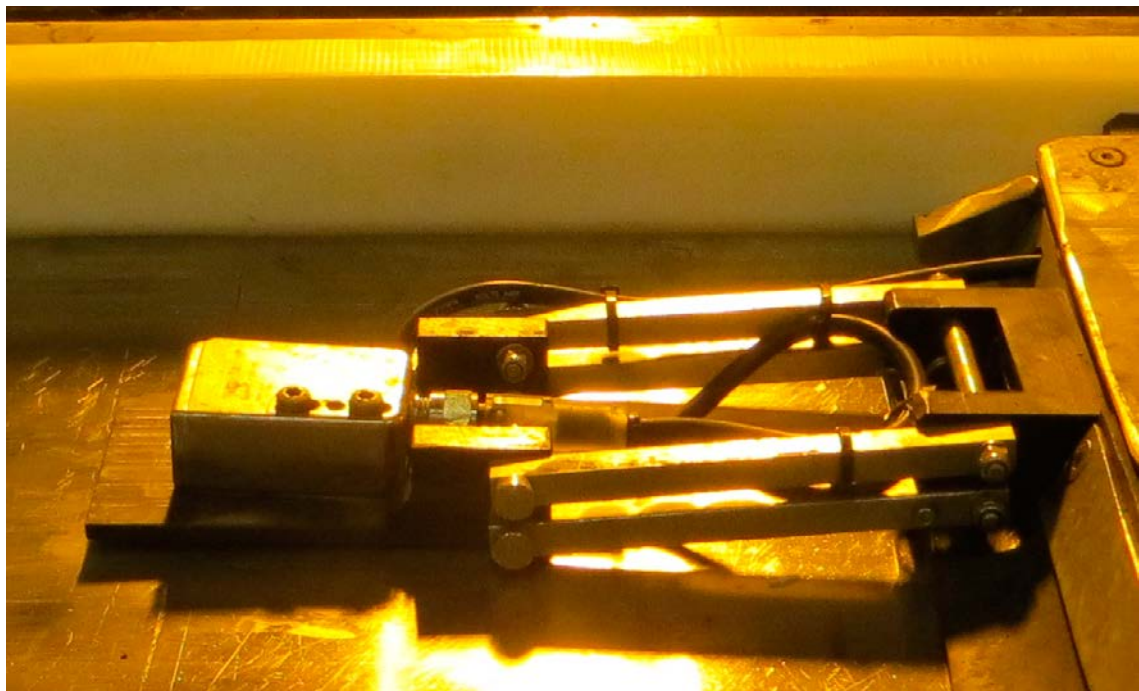
**Figure 3-13.** The design and realisation of the pallet position sensor.

A mounting bracket, Figure 3-13, was designed as a parallelogram with a strong spring pushing the sliding base of the sensor holder towards the sliding plate. The sensor holder worked very well, but despite of that the measurement was unstable. The reason proved to be the poor reflectivity of the laser beam from the black plastic guiding edge. After the black edge was replaced with a white edge, the measurement has worked consistently.

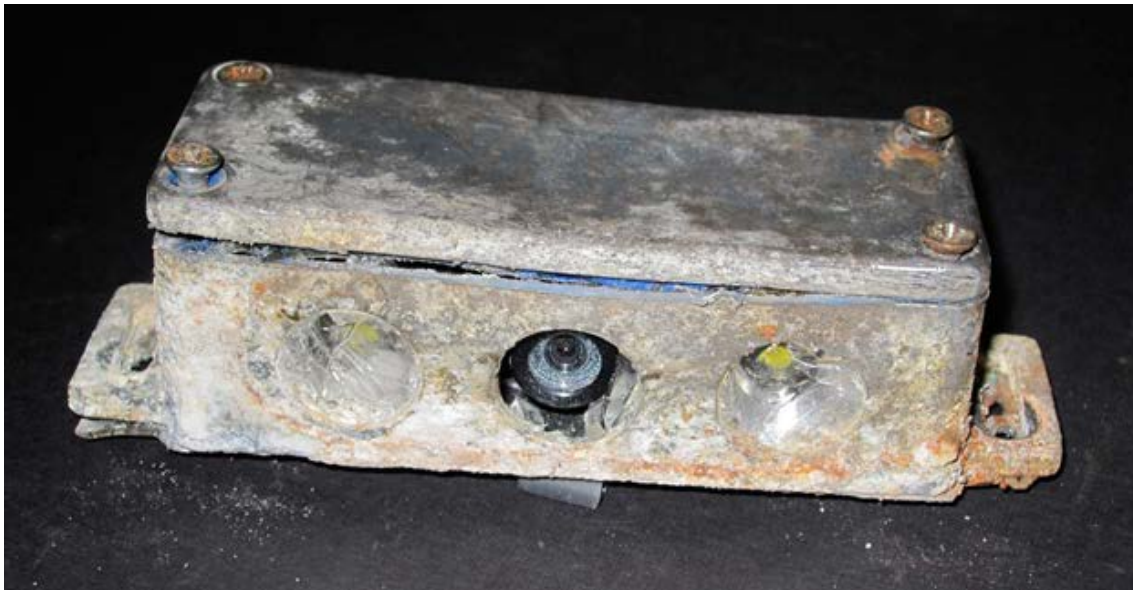
Though the right hand camera was unused it was still powered. As the deterioration of the camera housing reached a critical state, Figure 3-14, it caused a short circuit destroying part of the powering system of the deposition machine. It was discovered that the power lines to the lights and cameras were not fused and therefore a whole multi output transformer unit was destroyed. The camera was removed and in conjunction with renewal of the powering system all sourcing cables were fused.

**Figure 3-14.** The camera unit with two power LED's for lighting and a camera in the middle. Protective glass cracked and fallen apart.

If testing shall continue for a longer time a new camera unit should either be purchased or built. If it is decided to build a new unit some attention must be taken regarding the heat from the lighting. The heat from the power LED's warms up the protecting glass which cracks when water is splashing on it, Figure 3-14. When the glasses fall apart water penetrates into the casing causing oxidation.

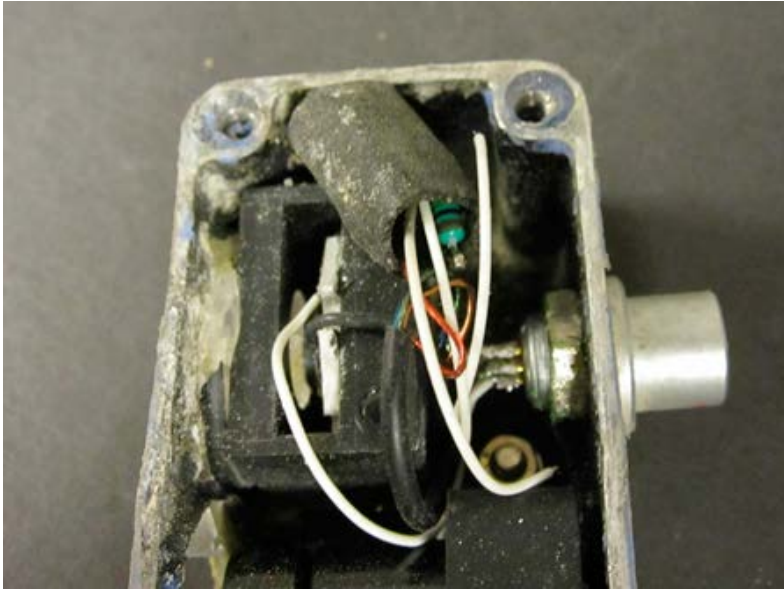
The second camera also stopped working. When opening the camera enclosure it was discovered that some wires between the connector and the electronics were loose due to oxidation and shaking, Figure 3-15. The electronics inside the housing was not documented, and too many wires were loose to try reasoning how they had been connected. Nonetheless, by comparison of the wiring in the two broken cameras the connections could be solved and one functioning camera could be built.

*Figure 3-15. The camera unit internal connections with loose wires, the electronics are inside a piece of crimp tube.*

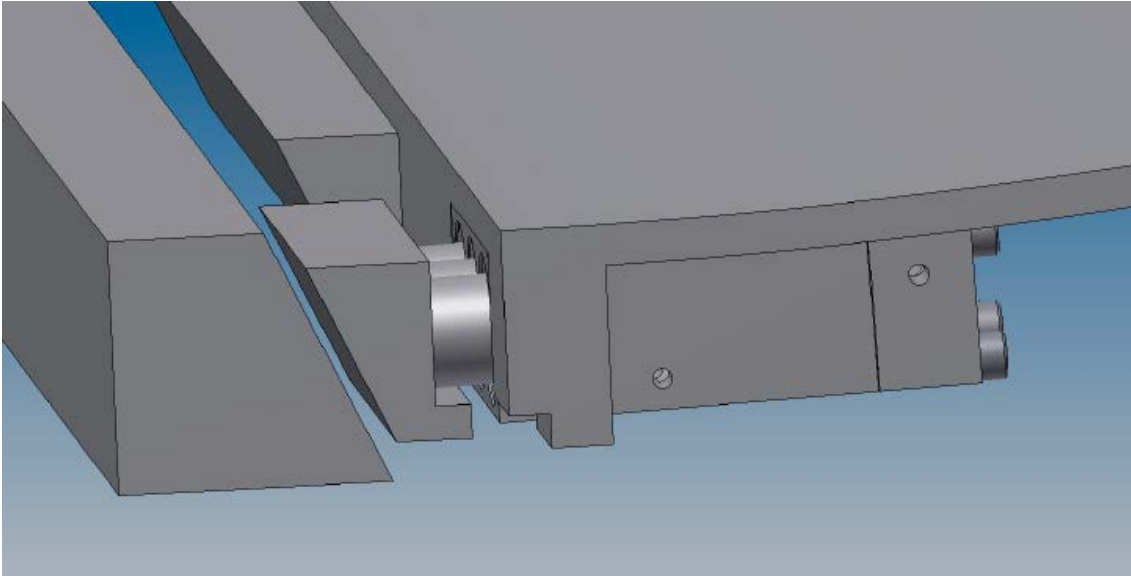
*Figure 3-16. The actuation cylinders of the pallet and sliding plate steering system.*

The best actuation power was achieved by filling the space between the two frontmost cushions in the pallet with water cylinders pushing out the sliding edge of the pallet against the guiding edge of the sliding plate, Figure 3-16. The cylinders are powered by a high pressure water pump using the same water as the main cushion pump. Due to a rather small expansion tank the water pressure fluctuates between 15 and 30 bars, but this pressure has been sufficient. The cylinders are actuated through two on/off valves in the radiation protection shield.

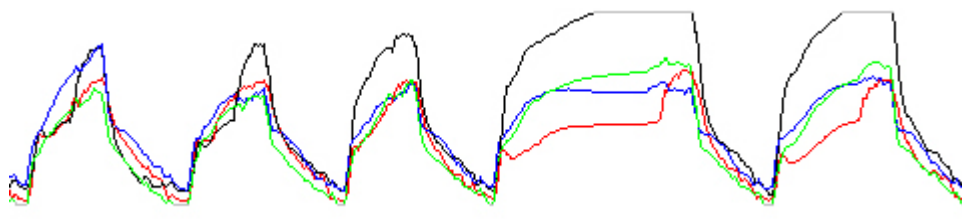
**Figure 3-17.** The first lifting sequence is normal, in the second and third sequences the front left corner (black line) starts lifting higher than the others. In the fourth sequence the imbalance is too big and the front right corner (red) has problems reaching pushing height. The fourth stroke therefore takes twice as long as the normal strokes.

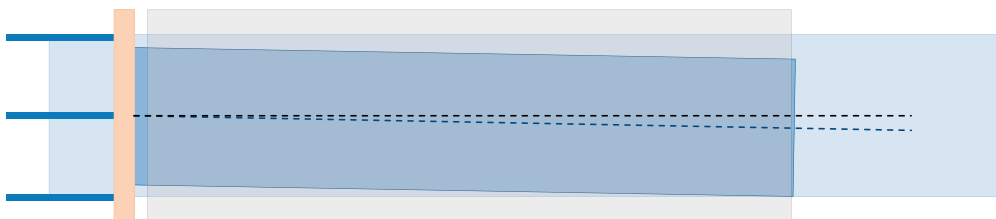
**Figure 3-18.** The lifting pallet (darker blue) is inaccurately attached to the shield causing an angular deviation between the centre axis' of the pallet and the Supercontainer (grey). The load of the Supercontainer on the pallet is imbalanced in the front.

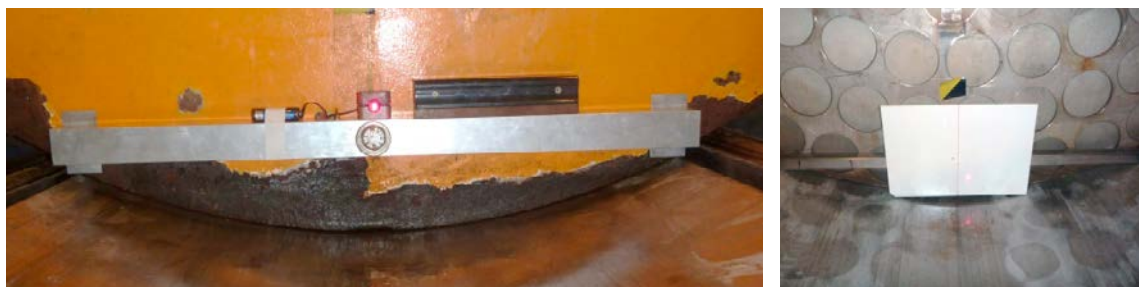
**Figure 3-19.** The calibration tool developed for aligning the lifting pallet with the machine. The ruler against the shield on the left and the target plate in front of the Supercontainer on the right.

The calibration method uses the radiation shield as base for aligning the pallet with the machine. A calibration tool consisting of a ruler with an attached laser transmitter and a target plate was developed, Figure 3-19. The ruler is put against the shield surface and the target plate is centered over the far end of the lifting pallet. The position of the lifting pallet is then shifted until the laser beam hits the middle of the target plate before the lifting pallet is attached to the shield. In this way the lifting pallet is always centered and perpendicular to the shield. The calibration gave good, however not always lasting results, as described in the next chapter.

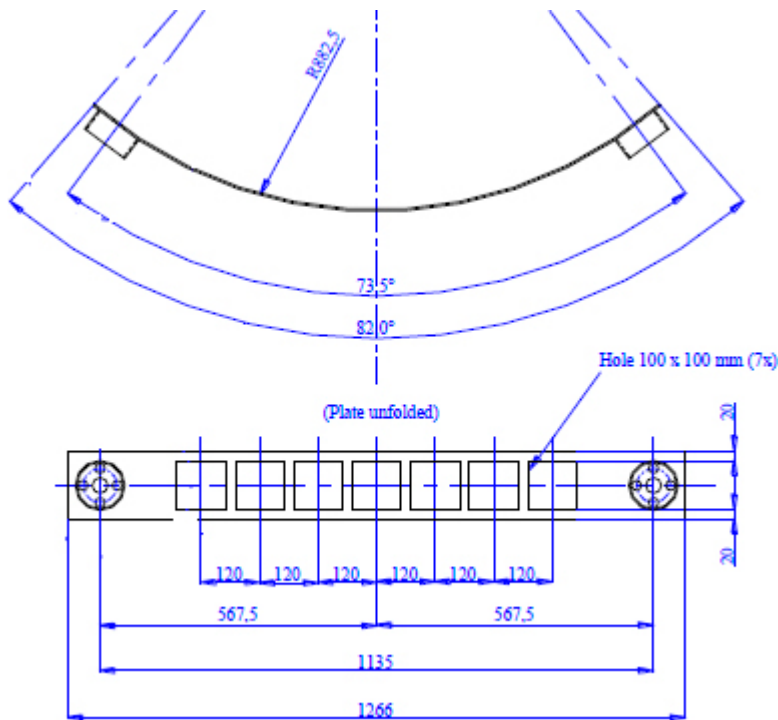
**Figure 4-1.** Foot module design for the distance and transition blocks

A new foot module has been designed for the distance blocks, Figure 4-1. The foot module consists of a perforated metal rim with a circular foot in each end. The foot module is mounted to the distance block with one M30 x 90 mm bolt in the center of each foot. The main concerns were the durability of the feet and their mounting to the blocks. The first tests were actually quite catastrophic, but the remedy was equally simple and effective.

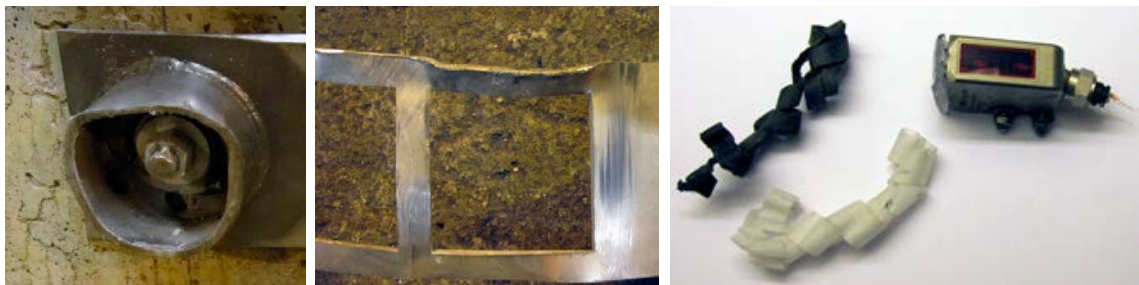
During deposition testing several drives were done, many of them also with the distance block extended out over the end of the lifting pallet. As these were the first tests with a distance block the balancing was not yet fully functional allowing the feet to hit the ground during the stroke. Some feet got remarkable deformation, but stayed fastened to the concrete block. The rims of the foot modules were manufactured by punching from sheet metal forming very sharp edges that scraped off material from the plastic guiding edges on the sliding plate. Had the machine not got a new water filtering system had this test resulted in a major water system clean-up. Nonetheless the test ended very suddenly. One of the foot rims was twisted by the scraping force, Figure 4-2, locking the lifting pallet and the sliding plate under the distance block. The jammed deposition machine had to be rescued from the drift by lifting the distance block with separate watertubes.

**Figure 4-2.** a) Deformed foot due to ground contact during the stroke. b) Bent rim due to scraping against guiding edge. c) Flakes of guiding edge and a sensor torn away by the bent rim (see intact sensor in Figure 3-13).

After redesigning the feet with beveled rim edges the feet worked well without any disturbances. Thus, the foot design was solved.

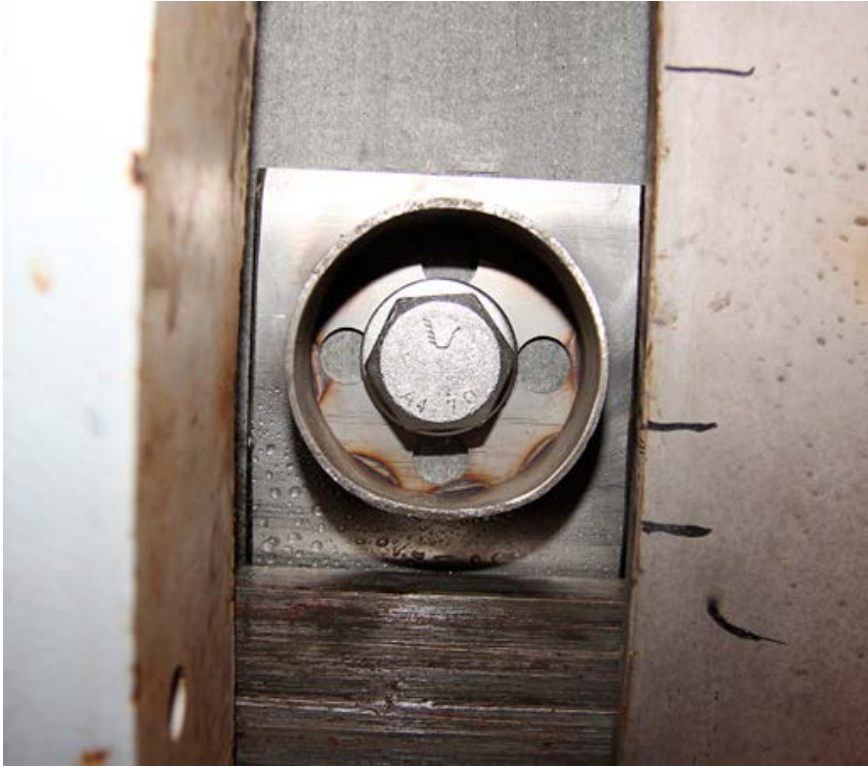
**Figure 4-3.** Slight deformation of the distance block foot after the deposition test. No cracking in the bentonite and firm fastening after the test.

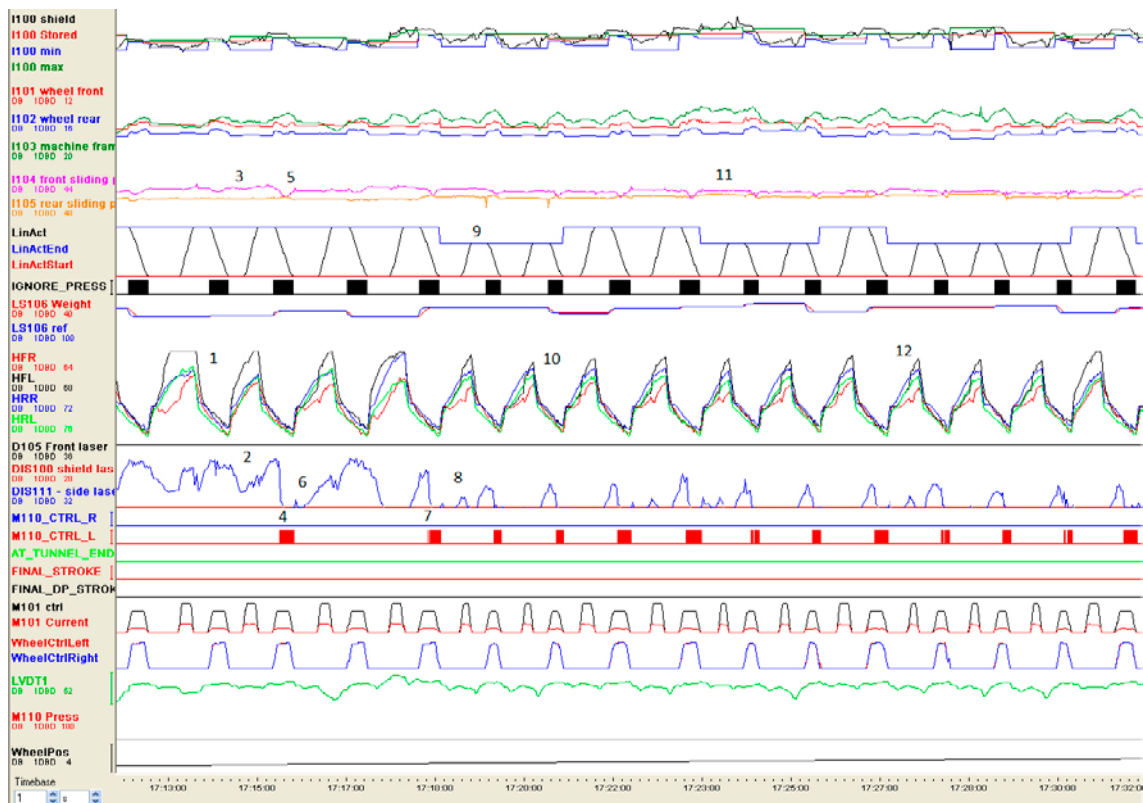
Figure 5-1. Part of the machine log from the transition block deposition.

The log figure is marked with numbers describing phenomena and events of interest.

8. The pushing is stopped when the pushing actuator current (red) raises due to the mechanical contact.
9. During strokes c,d,e the machine has not moved (no red, blue wheel control).

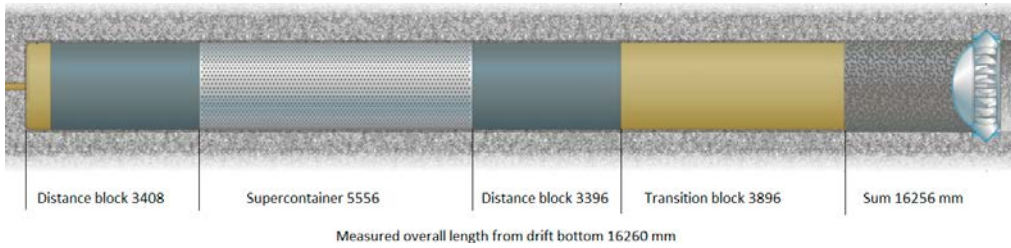
*Figure 5-2. The component lengths measured during final assembly and the overall length of the deposited components measured as the distance of the outer surface of the last component from the drift end.*

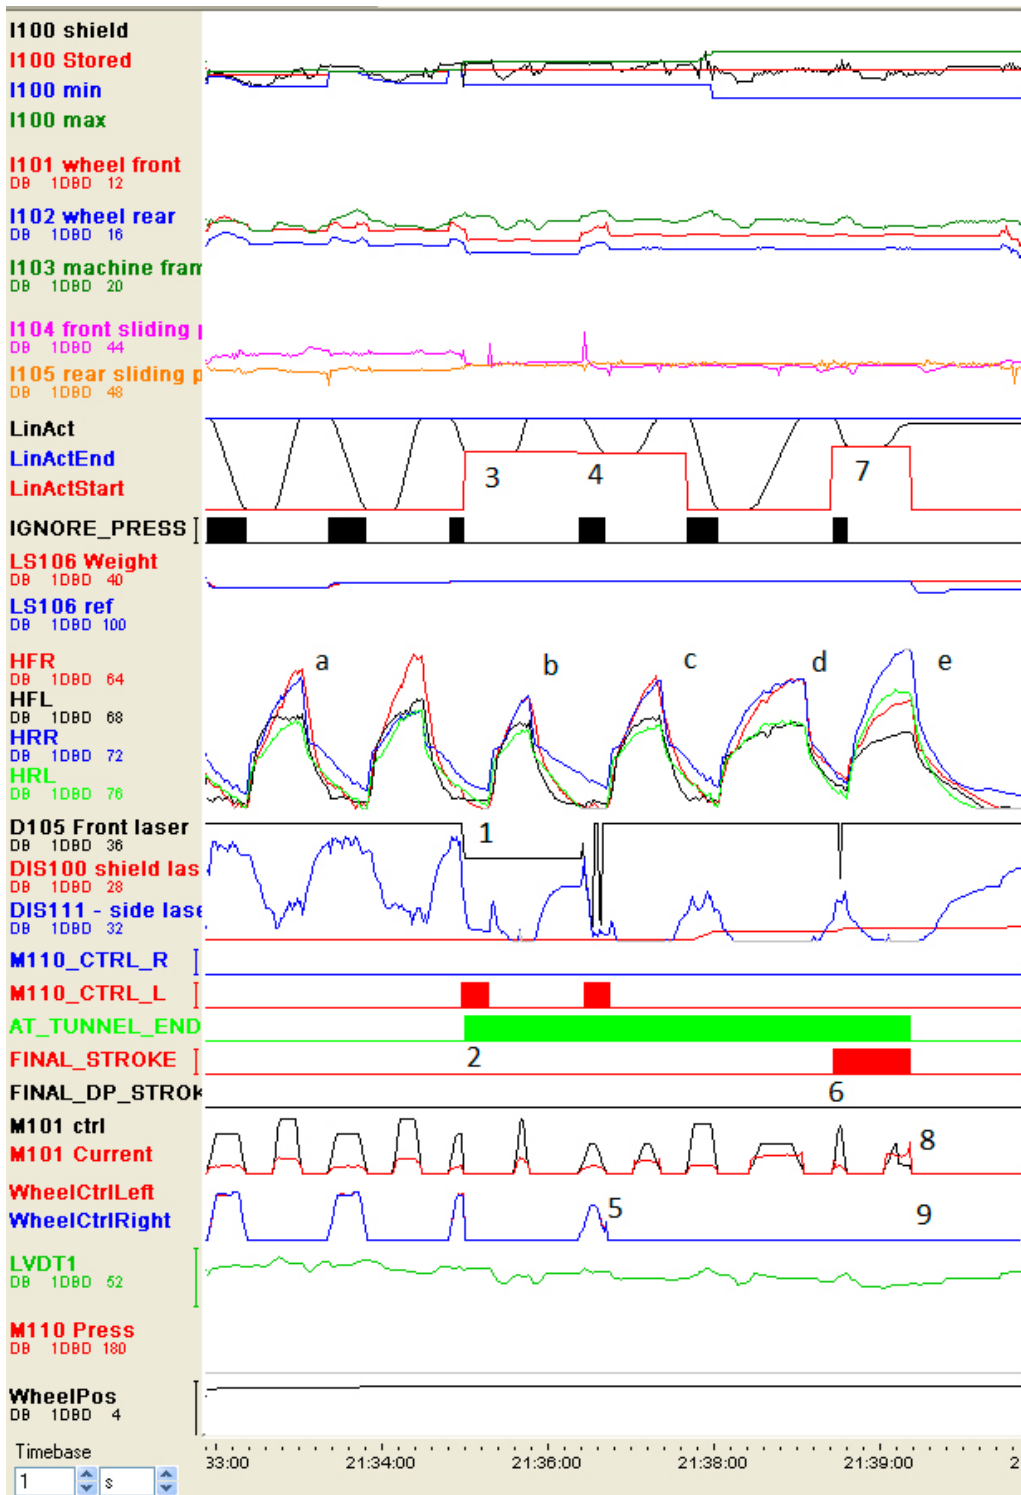
*Figure 5-3. Last part of the machine log from the second distance block deposition.*

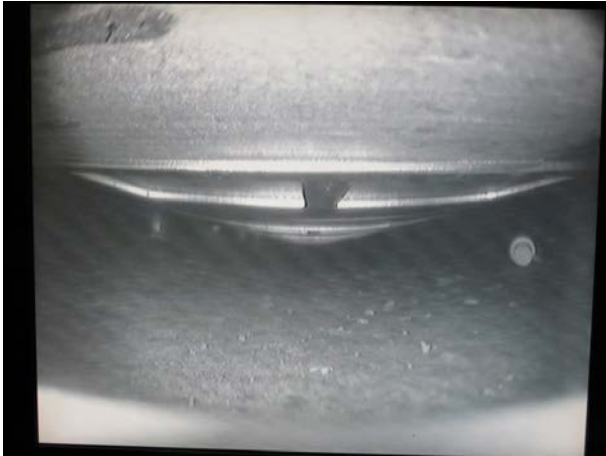
Splashing was not a problem with any of the distance or transition blocks, Figure 5-4, even when the load was a bit unbalanced longitudinally. However, the big unbalanced load of the Supercontainer with the cable block caused rather severe splashing problems, Figure 5-5 and Figure 5-6. It is difficult to assess how big the influence of the greater load was compared to the imbalance, but splashing was remarkable especially in the rear of the lifting pallet where the cushions reached their maximum lifting height during the long lifting times.

**Figure 5-4.** The bottom of a distance block seen with the camera in the front of the sliding plate after deposition. A small dark spot in the upper left corner probably comes from splashing.

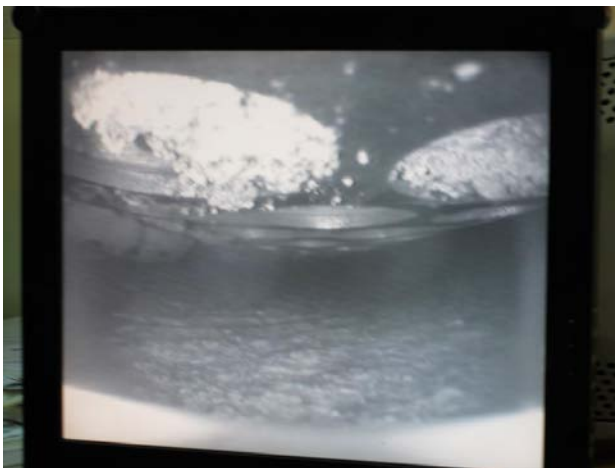
**Figure 5-5.** The bottom of the Supercontainer after deposition. Splashing has wetted the bentonite so much that it is pouring out of the holes in the steel shell.

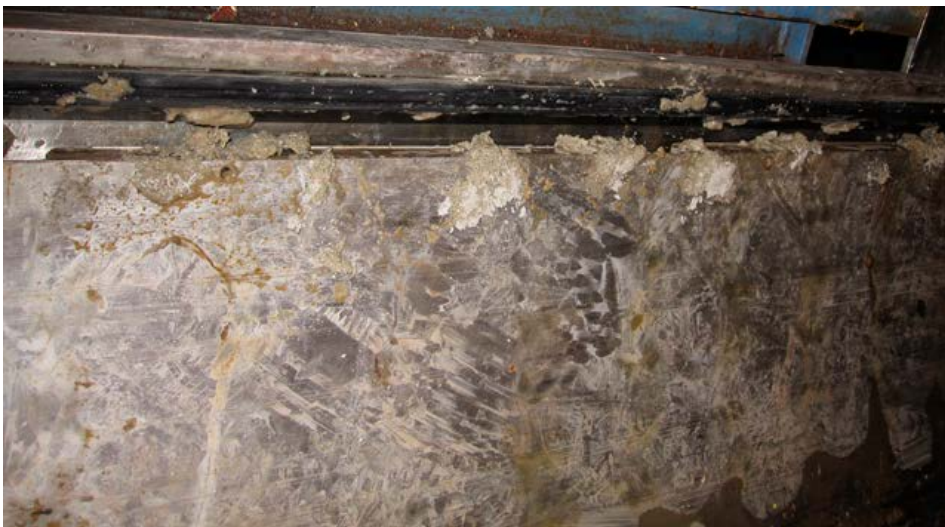
**Figure 5-6.** The lifting pallet after deposition of the Supercontainer. Wetted bentonite was left on the pallet.

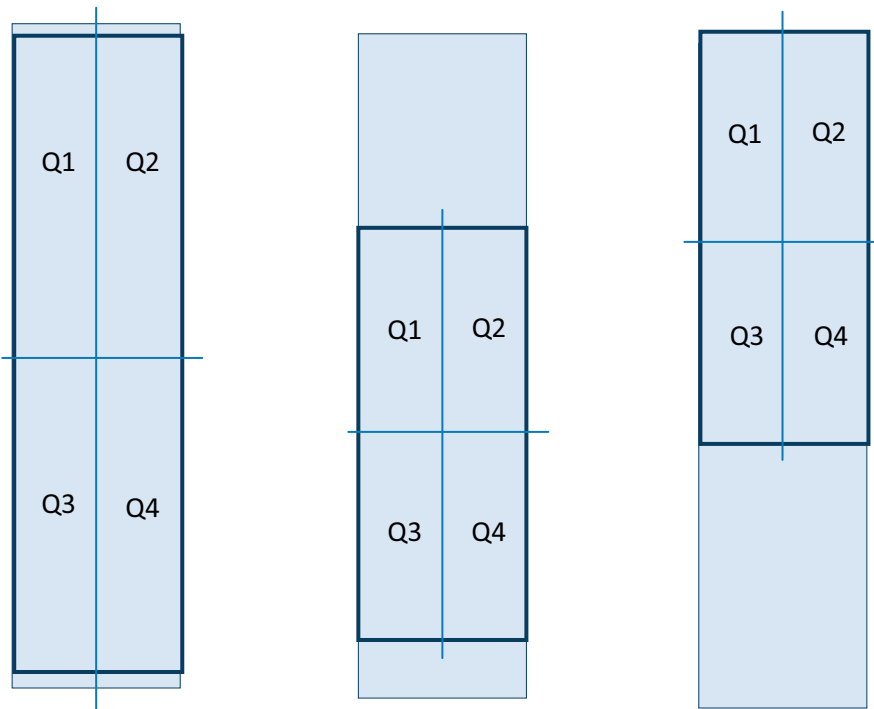
**Figure 7-1.** *Balanced lifting requires cushion deactivation outside the load and use of different pressures in different quarters of the load.*

Many times the imbalance of the load starts by poor lifting in either front corner. During forward pushing the load then tilts towards the lower corner increasing the imbalance. Since the height sensors in each corner of the pallet give an accurate detection of the situation the imbalance could be avoided with better individual pressure control of the lifting cushions. Quite simply, lifting of the pallet would be controllable if any quarter of the pallet could be lifted with increased or decreased pressure, Figure 7-1. However, since distance blocks cover only part of the pallet, lifting should be controllable with individual pressure regulating valves on all cushions. Then the quarterly balancing could be implemented for any size of distance block in any position on the pallet. The piping in the pallet would remain the same, but the valves would have to be replaced and the piping in the valve cabinet would have to be rebuilt.

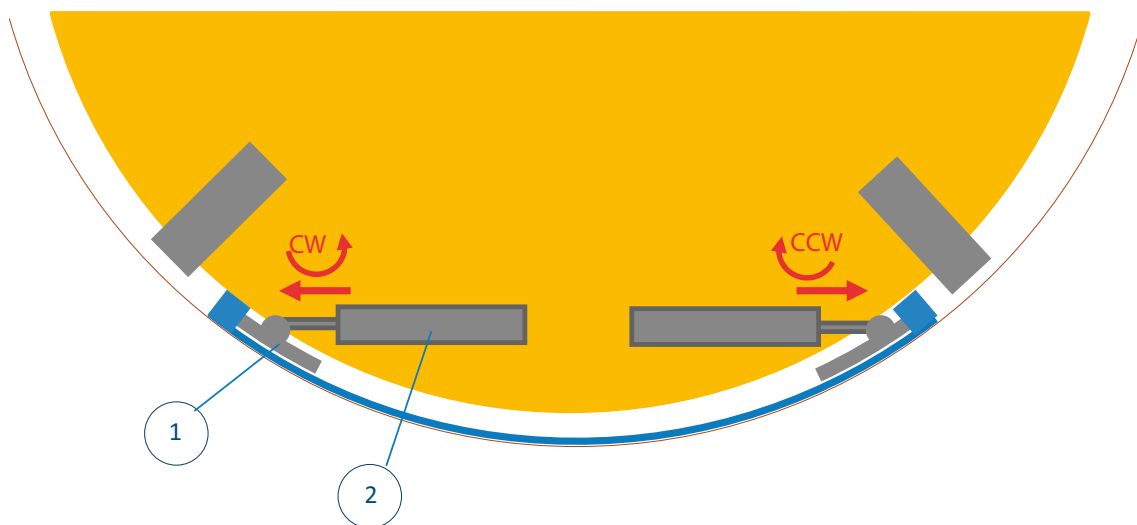
**Figure 7-2.** Schematic illustration of turning plates 1) lying on the sliding plate under the shield pushed by linear actuators 2) mounted on the shield towards the guiding edges of the sliding plate.

Though the splashing did not harm the bentonite distance block remarkably a splashing prevention has been prepared by providing guiding edges over the whole length of the sliding plate. The edges are intended as counter surface for a splashing cover on the sides of the lifting pallet. A cover has never been designed though, due to other more prioritized work. A design is schematically presented in the Figure 7-3. The splashing cover material should be flexible but still have an internal tension pushing the outer edge against the guiding edge of the sliding plate despite the elevation of the lifting pallet.

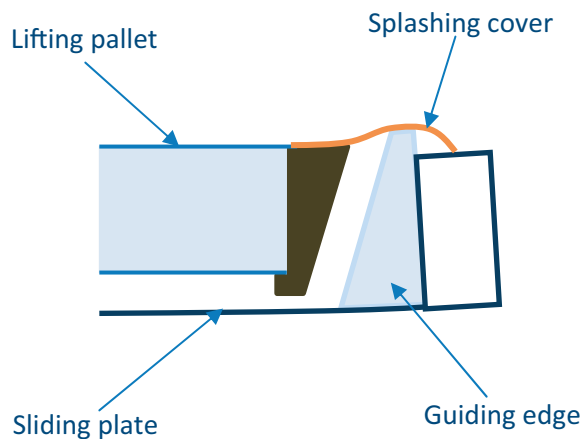
*Figure 7-3. Schematic splashing cover design.*
