**Overcoring of resin-impregnated
boreholes KXTT3 and KXTT4 at
the TRUE-1 site**

TRUE-1 Completion

Oskar Sigurdsson, H Ask Geokonsult AB

December 2014

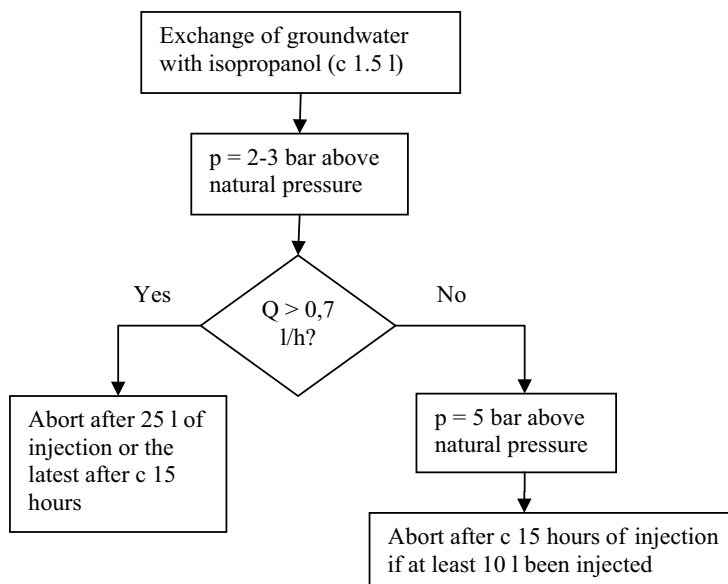
Figure 3-2. Strategy for injection of isopropanol.

The injections of isopropanol and epoxy were carried out according to a pre-defined made strategy. The strategy included establishment of appropriate flow rates and pressures required in order to inject the desired amount of isopropanol and epoxy within a reasonable time. The injection strategies of isopropanol and epoxy are shown in Figure 3-2 and Figure 3-3. Based on prior injections of water in KXTT4:T3 during a SWIW-test (Nordqvist et al. 2014), it was foreseen that an injection pressure of 2 to 3 bars above the natural pressure would be sufficient, despite the slightly higher viscosity of the epoxy. Feature A has a higher hydraulic transmissivity in KXTT3 than in KXTT4 (Winberg et al. 2000), implying that 2–3 bars also would be sufficient in the case of KXTT3:S3. The reason for not using a higher injection pressure than necessary is the increased risk for displacement of fracture material in the fracture.

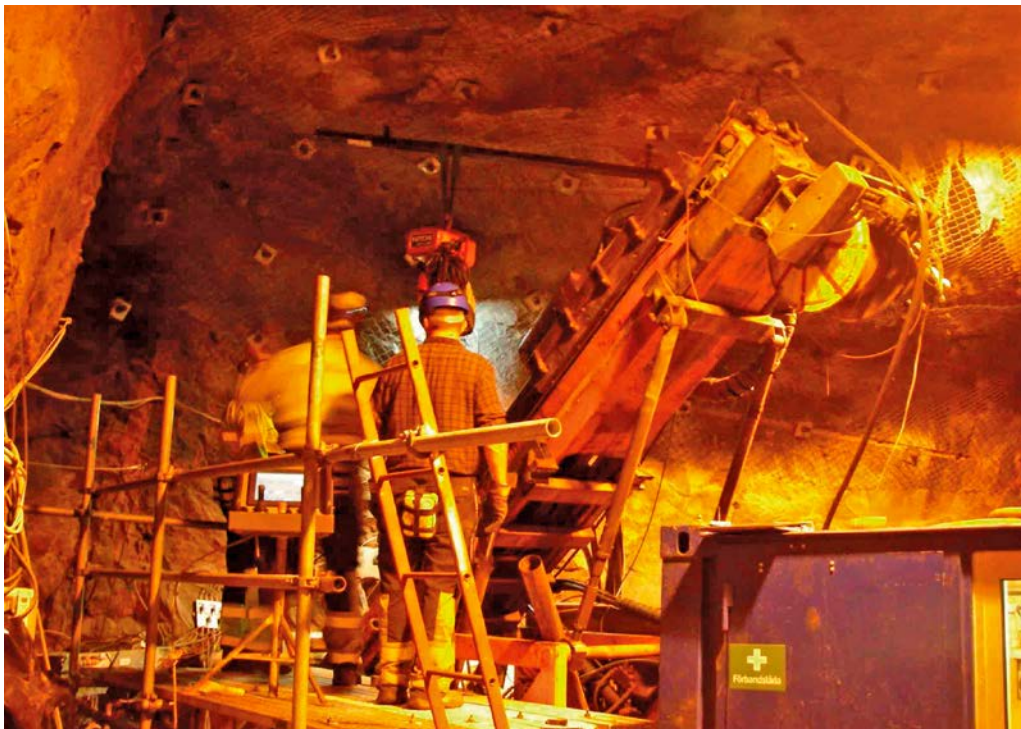
Figure 3-5. The Onram 2000 CCD computer controlled drill rig used for the overcore drilling of KXTT3 and KXTT4. The screen of the computer-aided control unit can be seen centre-left, behind the drillers.

The overcoring of the boreholes KXTT3 and KXTT4 was made with an Onram 2000 CCD (Computer Controlled Drilling) drilling rig operated by the contractor Drillcon AB, see Figure 3-5 and 3-7 (a–d).

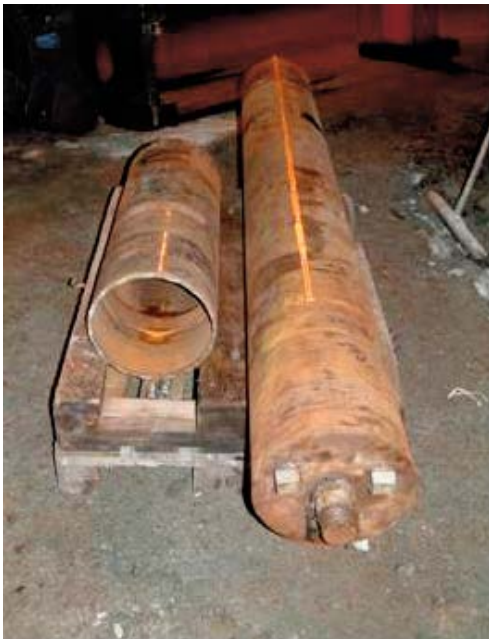
Figure 3-8. 300 mm Core barrels of 76 cm and 225 cm core length, respectively (from Mærsk Hansen and Staub 2004).

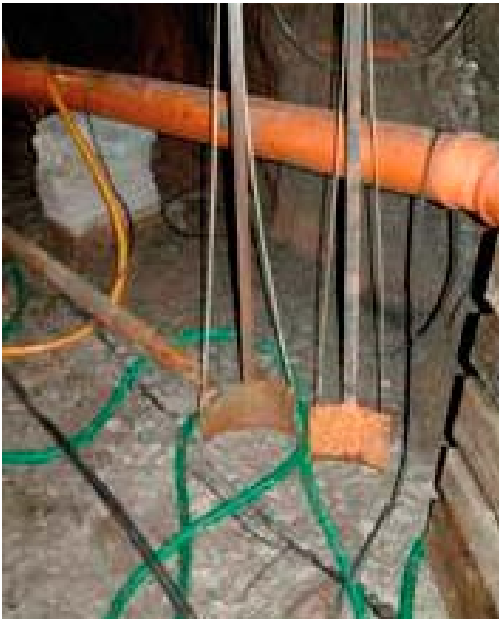
Figure 3-9. Tools for inducing core breakage, double steel plates (before being expanded using hydraulics), (from Mærsk Hansen and Staub 2004).

Another important component of the methodology was the breaking of the core, which also caused considerable problems. In the end the drillers had both a tool which broke the core from below as well as a specially constructed sledge that held a core breaking tool which could then be slid in above the core for breaking it. The rule was to try and break the core first from below and if that did not succeed, sometimes because the core breaking tool could not be slid in under the core, the sledge was lowered to try and break the core from above.

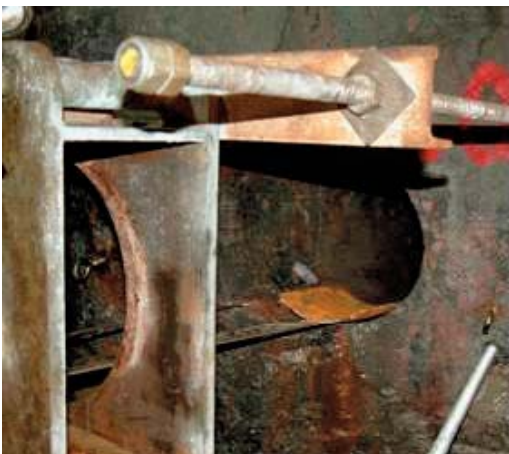
Figure 3-10. Insertion of tool for core breakage, sliding below core (from Mærsk Hansen and Staub 2004).

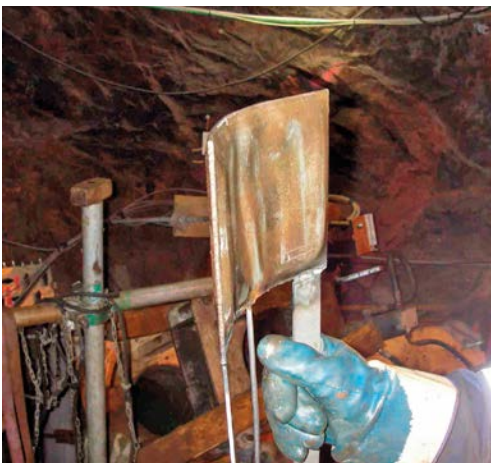
Figure 3-11. Tool for inducing core breakage, double steel plates (after being expanded using hydraulics, up to 80 bars).

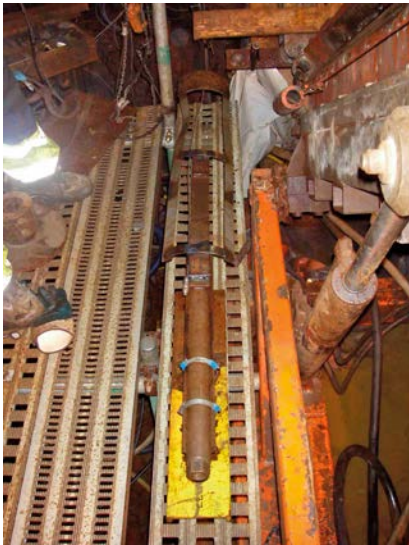
Figure 3-12. A sledge constructed on site for core breakage, sliding the tool for core breakage into the borehole above the core.

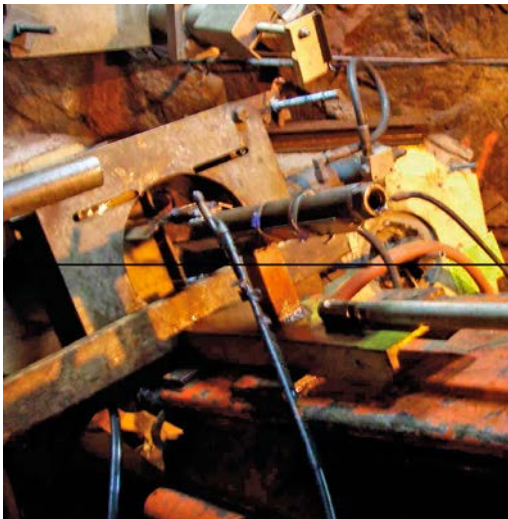
Figure 3-13. The sledge holding the tool for breaking, lined up to be connected to the drill stem for lowering into the hole.

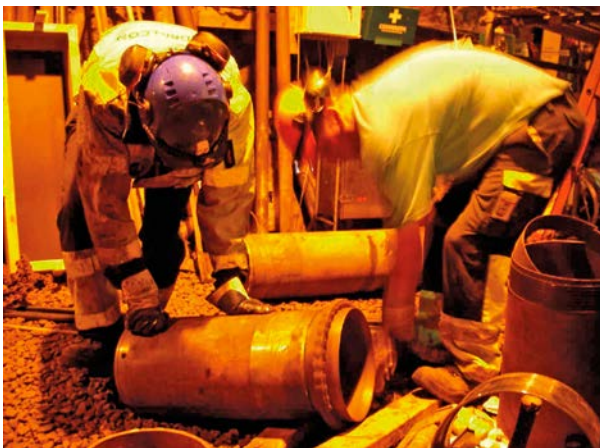
Figure 3-14. Drillers tightening the leading edge attached to the end of the capturing ring on the end of the core recovery barrel at ground level at the TRUE-1 drill site.

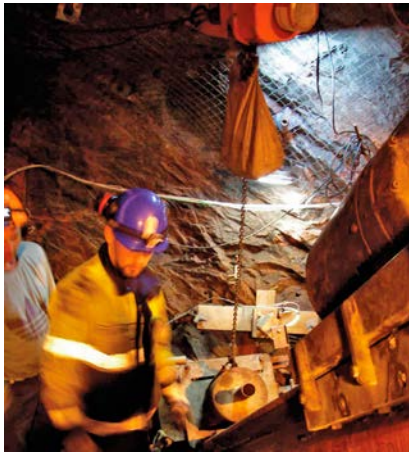
Figure 3-15. Core recovery barrel fastened to lifting device above drill rig for hoisting from the borehole to the drill rig platform.

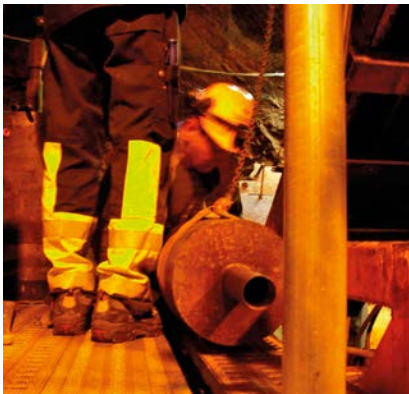
Figure 3-16. Core recovery tool on drill rig platform, drillers preparing for lowering the core recovery barrel with core down to ground level beside drill rig.

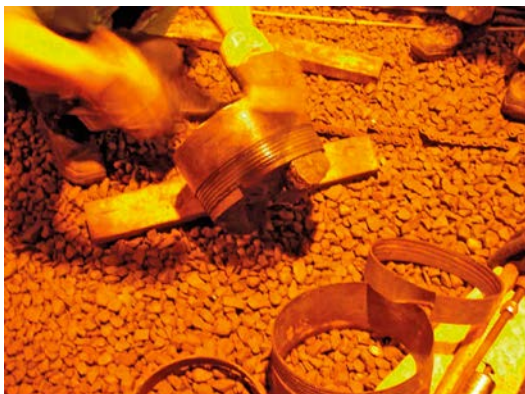
Figure 3-17. Drillers extracting core piece from the capturing ring at the end of the core recovery barrel.

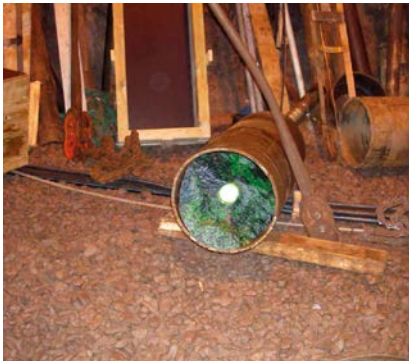
Figure 3-18. Core recovery barrel on ground level beside drill rig with core capturing ring still attached to the barrel, containing a core piece from KXTT3, showing the fracture at 13.9 m (looking up hole), with chlorite (black) and some epoxy (green) filling.

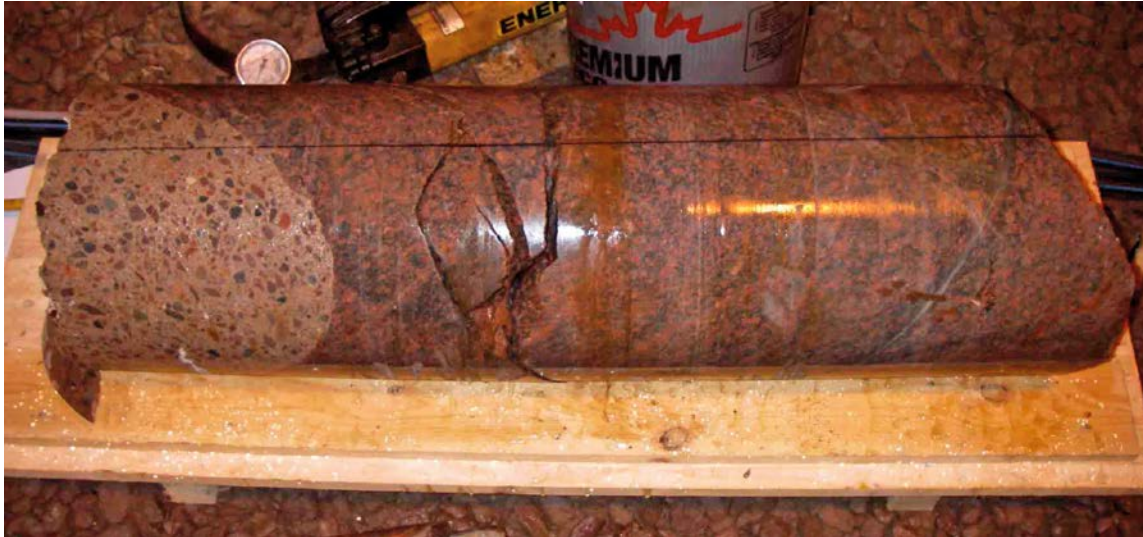
Figure 3-20. The first core pieces from borehole KXTT3 in core box at drill site, where preliminary core logging, orientation and photographing was performed. Top of core to the left, concrete slab visible, black line marks vertical down of core. Length of core is approximately 0.0–0.74 m.

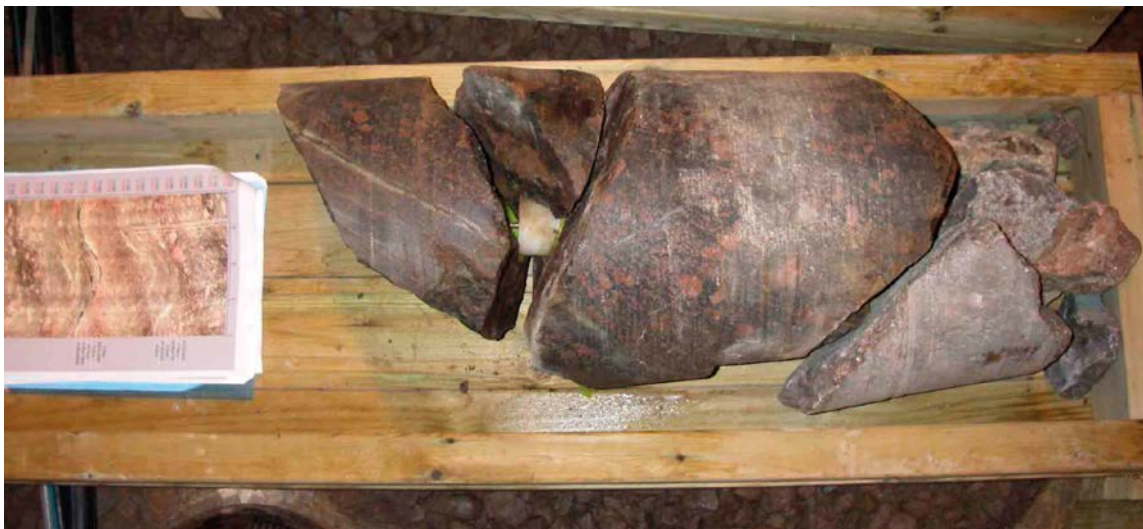
Figure 3-21. Core pieces from target section of KXTT3 in core box at drill site, paper print of BIPS image left of core in core box. Subsequent logging in the core shed at Äspö HRL revealed that the right side of the core is facing the camera, down hole to the left, with the fracture at 13.9 m furthest to the left. Core length is approximately 13.3–13.9 m.

Specific instructions for drilling lengths specified for safe extraction of target sections from both boreholes, see Appendix 6, were revised because of problems that arose during drilling. When drilling across open fractures the rock often broke into wedge-formed pieces which then became loose and started to rotate within the core barrel, causing grinding of the core pieces. These loose core pieces could also be instrumental in further fracturing of the core, so early uptakes of core were often needed, see Figure 3-21 and Appendix 6.

It became readily apparent shortly after the drilling commenced that the core pieces did not always come out of the borehole intact, see Figure 3-21. This made the orientation of the core by fitting the pieces together very difficult and sometimes impossible due to many small core pieces in some sections. Instead, BIPS images previously made in the 56 mm holes were used as a reference for deciding the orientation and location (depth) of those core pieces that had recognisable features by which to orient the core from (e.g. fractures, rock veins etc.), see Figure 3-21. Data on strike and dip from the BIPS logging of the various mapped structures was obtained from Bossart et al. (2001, Appendix 1.1). The data in Bossart et al. (2001) is in agreement with BIPS images in the Sicada archive for the target sections. The BIPS images from the target sections in the 56 mm holes are shown in Appendices 3 and 4. All core pieces in the target sections that could be re-fitted together were given a number for easier identification, see Figure 3-23. Four orientation lines were drawn along the core in four colours with length markings every 10 cm.

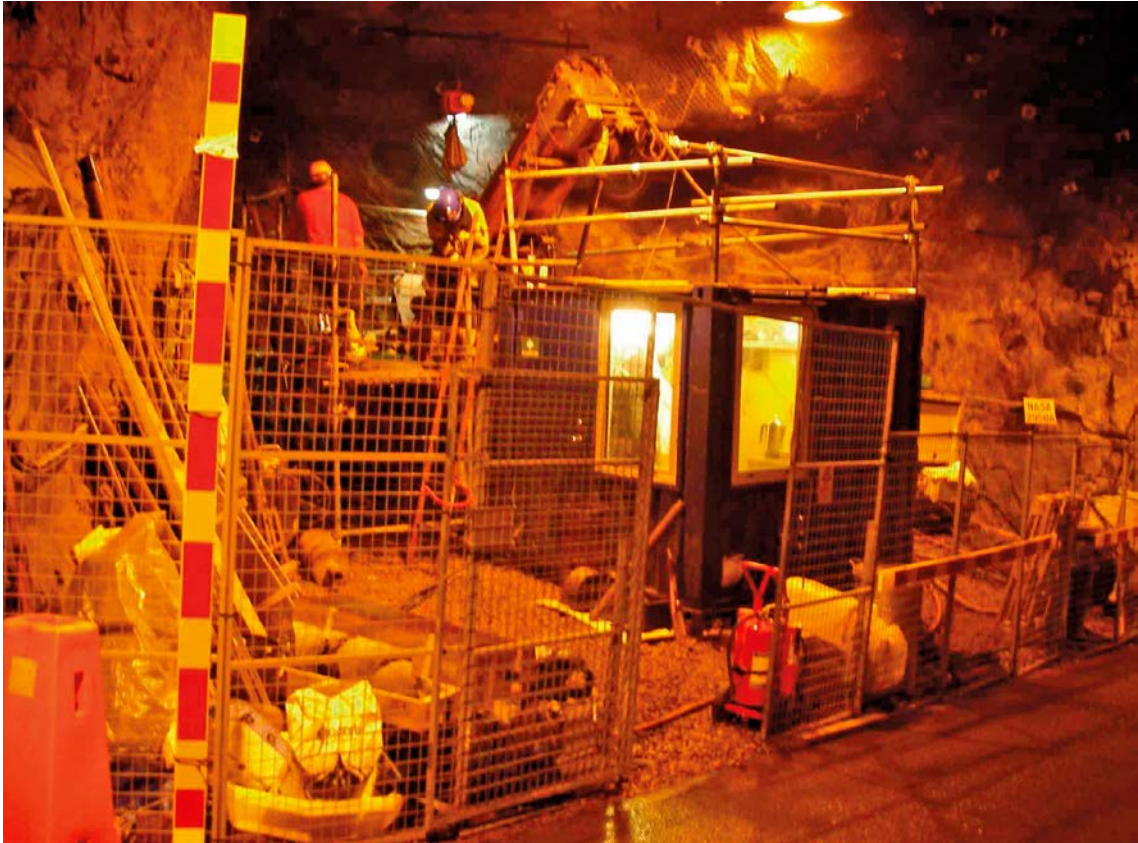
Figure 3-22. The fenced-in drill site for the TRUE-1 overcoring activity, drill rig in position for overcoring of KXTT3.

Overview logging and photography was done at the drilling site, but because of lack of space in the tunnel niche, see Figure 3-22, the core down to the target sections of each borehole were only tentatively checked and registered, except for the first part of KXTT3. Instead, the cores were packed into boxes which were clearly marked in sequential order and transported off the site. The core from KXTT3 was transported to the Äspö HRL core shed. The same also applied to the material from KXTT4, with the exception of material from the target section in KXTT4, which was transported to Clab, because of radiation protection measures and regulations. The main logging and photography sessions of the target sections were carried out in their respective location at Äspö HRL and Clab.

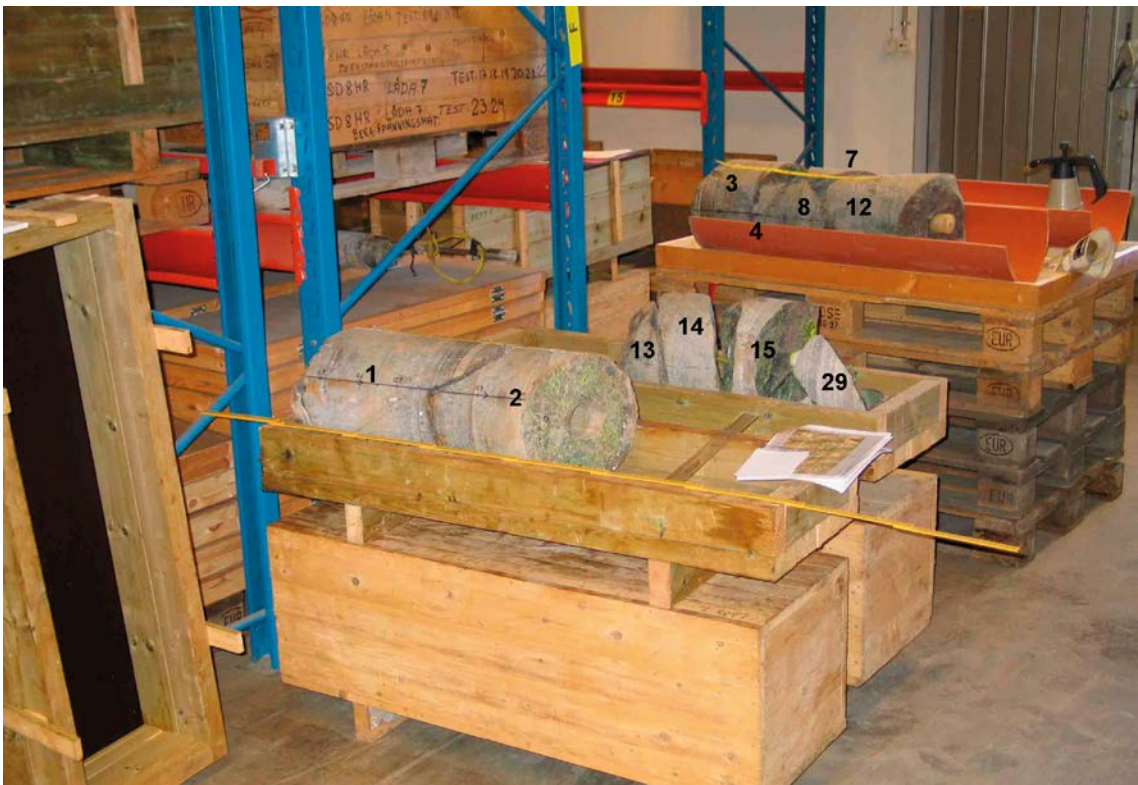
Figure 3-23. Mapping of core pieces from target area of KXTT3 in progress in core boxes in the core shed at the Äspö HRL. Numbers of identified core pieces can be seen and black orientation line on core pieces #1 and #2 which indicates vertical down of core.

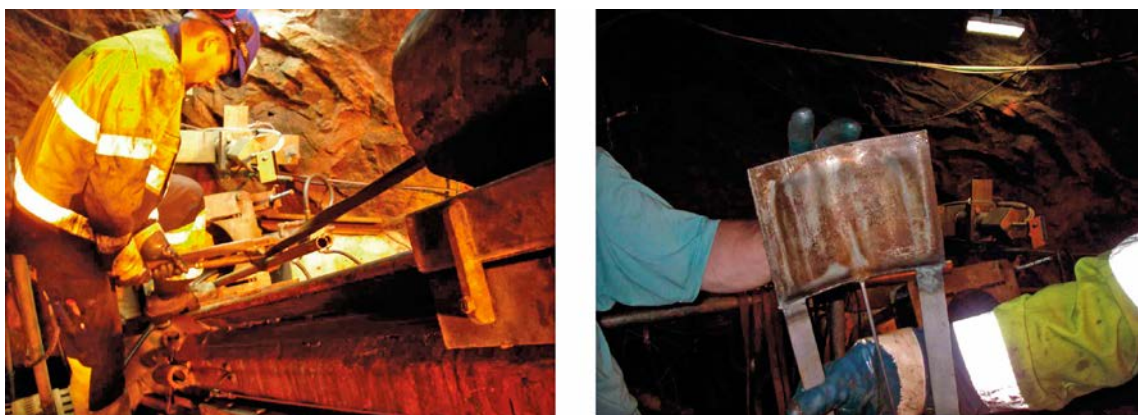
Figure A6-4. Drill site of TRUE-1, core breaking in KXTT3. (a) Disconnecting core breaking sledge (for breaking core from below) from drill string. (b) Core breaking device after being inflated to 80 bars.

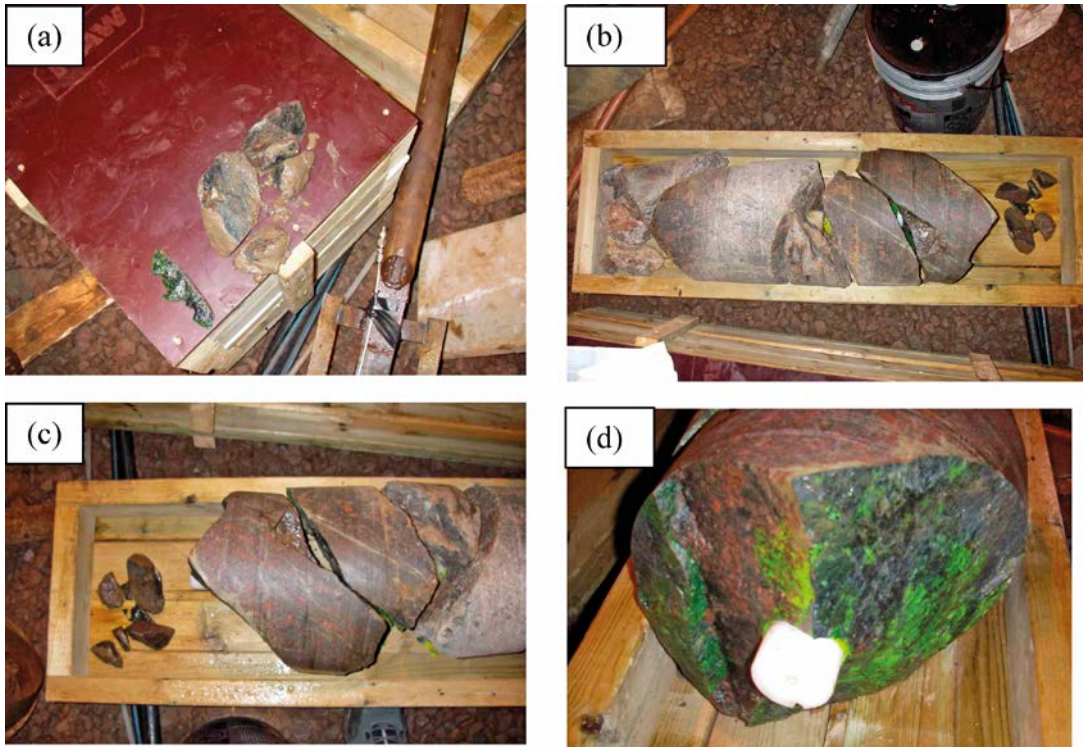
Figure A6-8. Core pieces #8, #12–#15 and #16–#20 from the target section of KXTT3. (a) Core pieces #16–#20 fresh from the core capturing barrel on top of a core box. (b) Core pieces #8, #12–#15 and #16–#20 from target section of KXTT3 in core box, down hole to the right. (c) Core pieces #12–#15 and #16–#20 from target section of KXTT3 in core box, down hole to the left. (d) Core piece #15, showing two natural fractures at approximately 14.1 m length, looking up hole. Fracture filling epoxy (yellow-green) and chlorite (black).

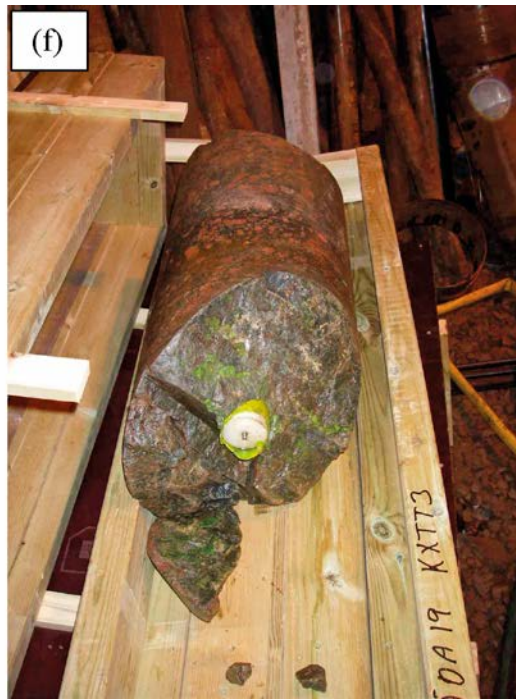
Figure A6-10. The taking down of core retrieving barrel containing the last core pieces from the KXTT3 overdrilling from core platform down to ground level beside the drilling machine at the TRUE-1 drill site. Core pieces #29–#33 from target section of KXTT3 at the drill site. (a) Unhitching the core retrieving barrel from the lifting device. (b) Detaching the last bit of drill string from the core retrieving barrel. (c) Preparing to lift down the core retrieving barrel from the drilling platform down to ground level. (d) Lowering the core retrieving barrel down from the drilling platform to ground level. (e) Preparing to disassemble the core retrieving barrel and take out the core. (f) The large core piece #34 with the smaller core piece #35 as support. The fracture surface at approximately 14.1 m length is facing the camera, which is looking down hole. Smaller amounts of epoxy (yellow-green) occur as fracture filling as well as some chlorite (black).

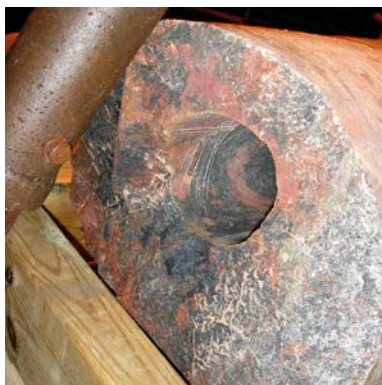
Figure A6-11. *The overcoring of borehole KXTT4 at the TRUE-1 site. The deviation at approximately 10.2 m drilling length is approximately 44 mm of to the side.*

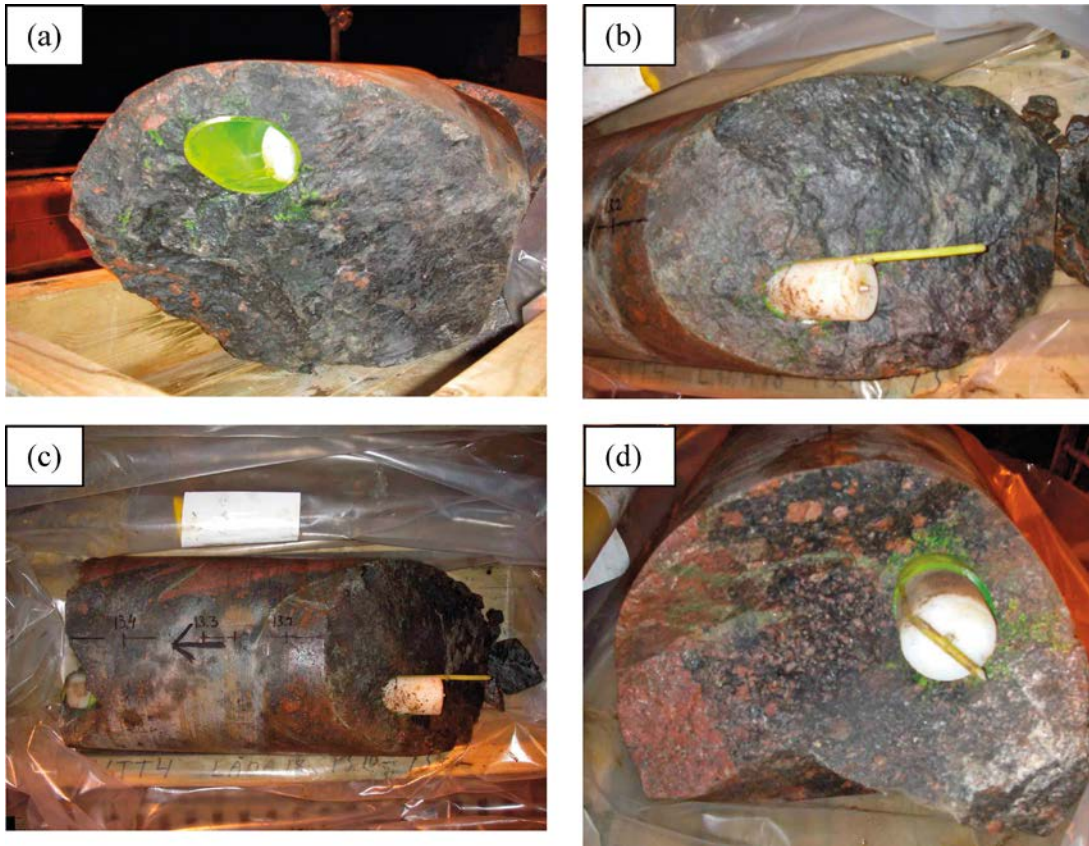
Figure A6-14. Core pieces #8 and #11 from target section of KXTT4 at the drill site. (a) Core piece #8 in the core box. The fracture facing the camera, looking up hole, is at approximately 13.0 m borehole length, fracture filling chlorite (black) and some epoxy (yellow-green). (b) Core piece #11 in the core box. The fracture facing the camera, looking down hole, is at approximately 13.0 m borehole length, fracture filling chlorite (black) and minor epoxy (yellow-green). (c) Core piece #11 in the core box, down hole to the left. (d) Core piece #11 in the core box. The drill induced fracture facing the camera, looking up hole, is at approximately 13.5 m borehole length, minor epoxy (yellow-green) occurs close to pilot hole.
