**TR-16-01**

# Copper in ultrapure water

## **Copper in ultrapure water**

Uppsala University, Department of Chemistry  
– Ångström Laboratory

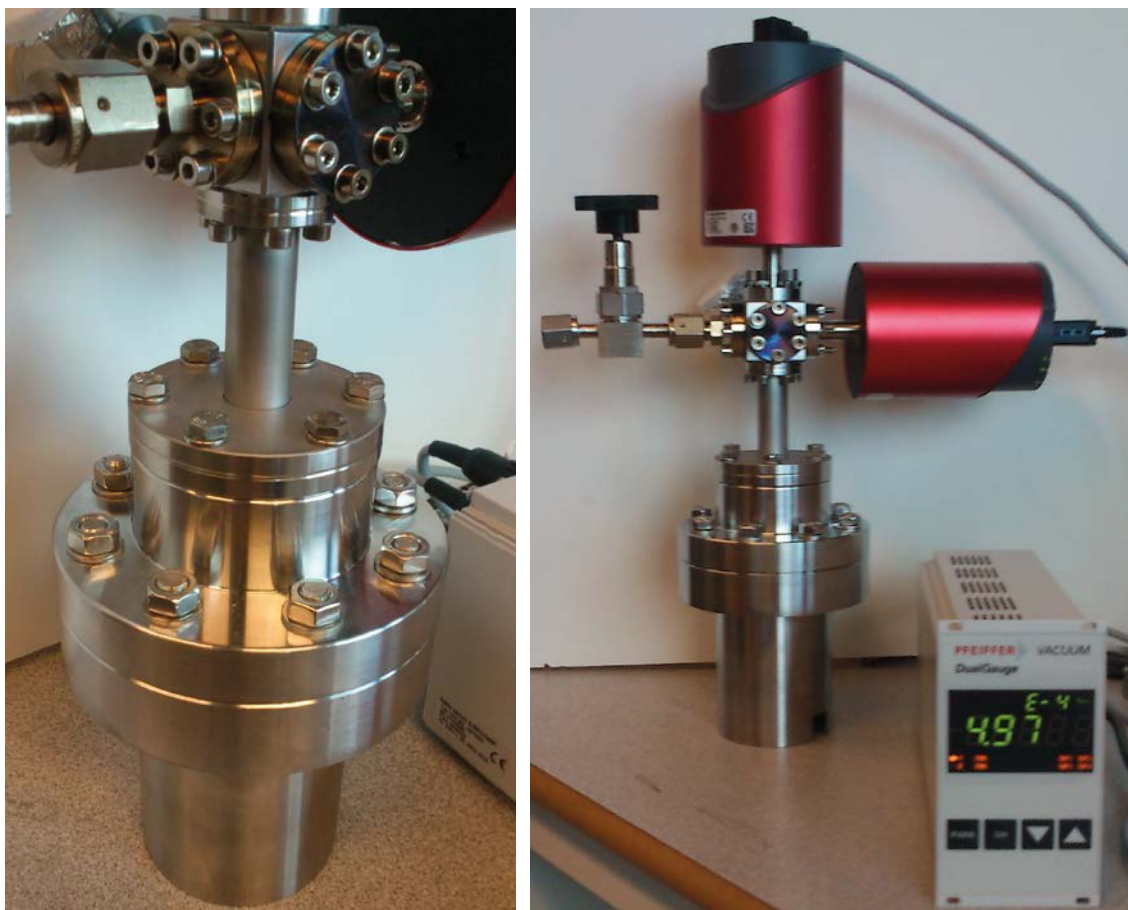
**Figure 2-1.** A new setup for pressure measurements (Main 3) equipped with a new lid including the Pd membrane (cf. Figure 2-3). The outer diameter of the lower chamber has been reduced.

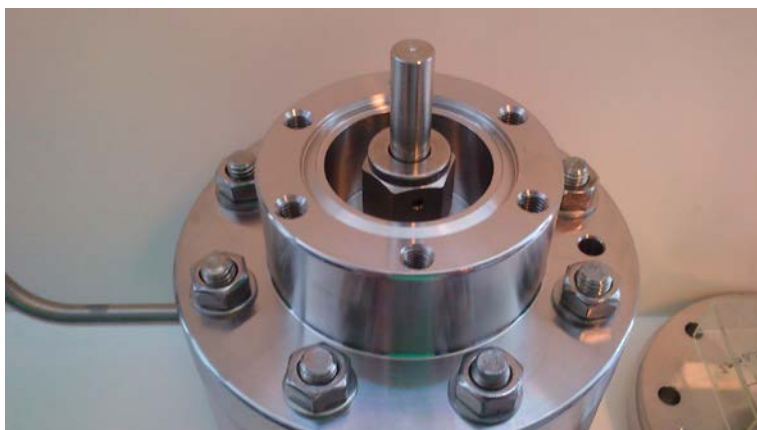
**Figure 2-3.** The new lid, here with blind VCR 1/4" connection together with the outer CF-38 seal.

In the new design of the connection between the measuring and reaction chambers (*i.e.* the lid with its Pd membrane; see Figure 2-3 and details in Appendix A), no hydrogen at all can leave the system. In comparison with the former design (in Main 1 and reference setups), the diameter of the membrane is now reduced with a factor of 2. Therefore, the increase rates of the pressure curves cannot be directly compared with those of Main 1. The new design was fitted onto the vessels of Main 2 and Main 3. Testing of outgassing was made *without* Pd foil after another baking out at 150°C for 5 days (“postbakeout”). This was followed by a blank test *with* Pd foil and loaded reaction chamber but without copper.

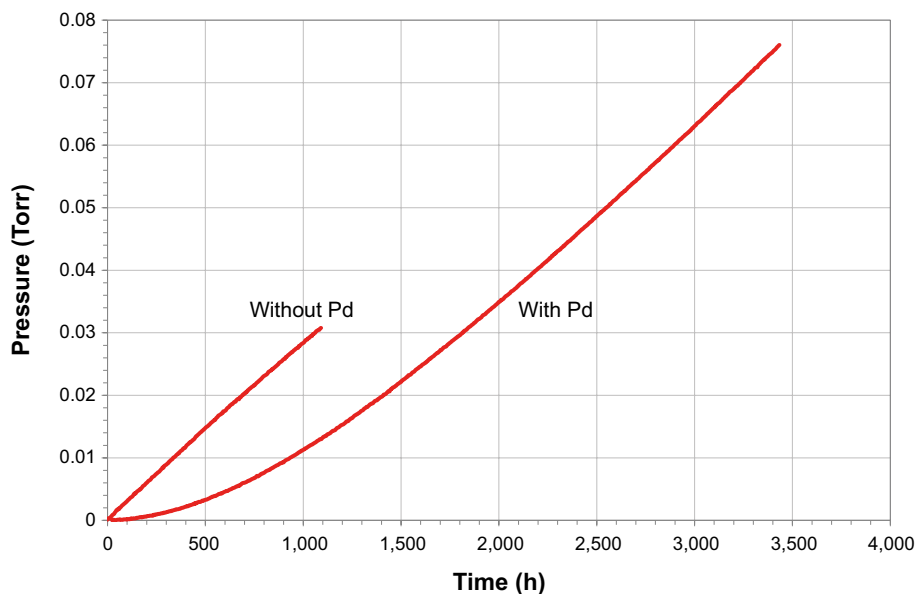
Figure 3-1. Pressure rise in a system with or without the Pd membrane between the two compartments.

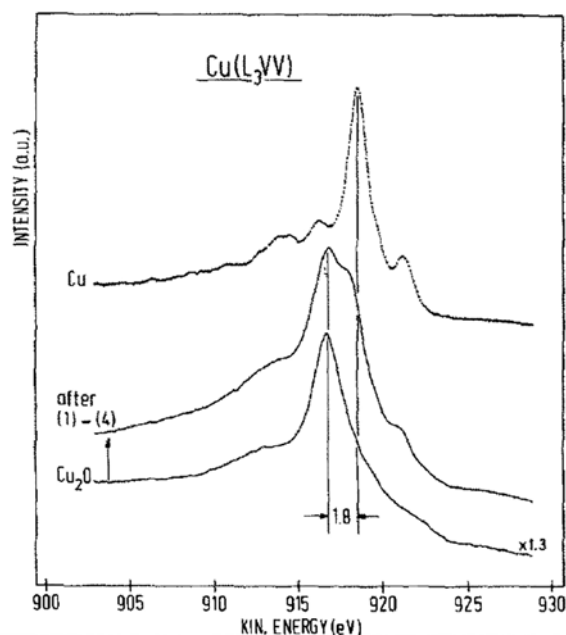
**Figure 3-9.** Comparative Auger spectra of  $\text{Cu}_2\text{O}$  and Cu, the latter obtained after sputtering a copper surface covered by the oxide and eventually exposing copper (Panzner et al. 1985).

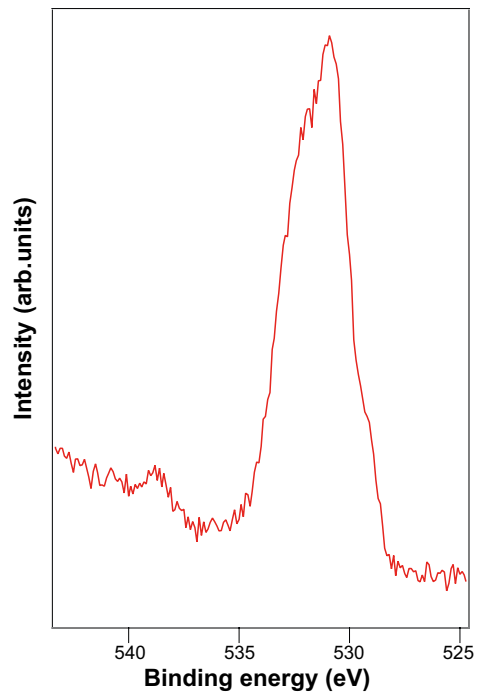
*Figure 3-17. XPS contributions from oxygen and antimony from sample M3-diam.*

From Figure 3-17 compared with Figure 3-12 it is obvious that the overlap between O *1s* and Sb  $3d_{5/2}$  is different. In that respect, it seems that M3-diam is more similar to the long-term samples of Figure 3-10a. More than one O *1s* peak contribute, and the deconvolution of the total is difficult without a thorough knowledge of the constraints. Still, there is no obvious oxide contribution from Cu<sub>2</sub>O (or CuO) as Figure 3-18 demonstrates, and the Cu *2p* spectrum (not displayed) shows the very same features of a clean copper surface as those of Figure 3-8a.

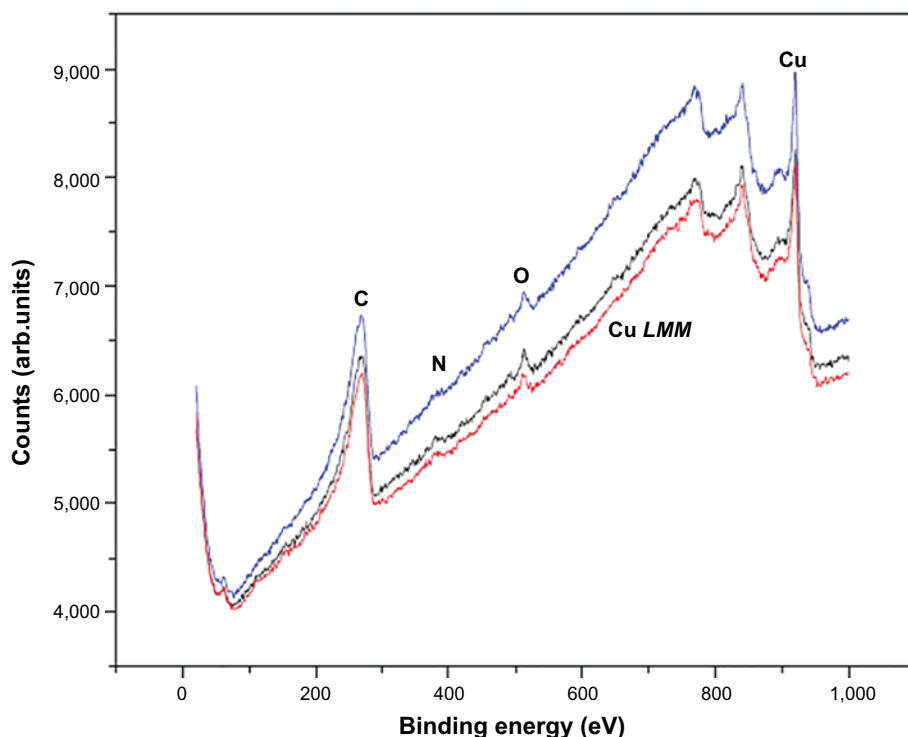
**Figure 3-24.** Corresponding AES data from the spots 3-1-2 chosen in Figure 3-19 (number 3-blue, 1-black, 2-red). The middle curve (1-black) comes from the point at the grain boundary. The energy is here given as binding energy for an easier comparison with values from XPS spectra (see Figure 3-11 for proper denotations).

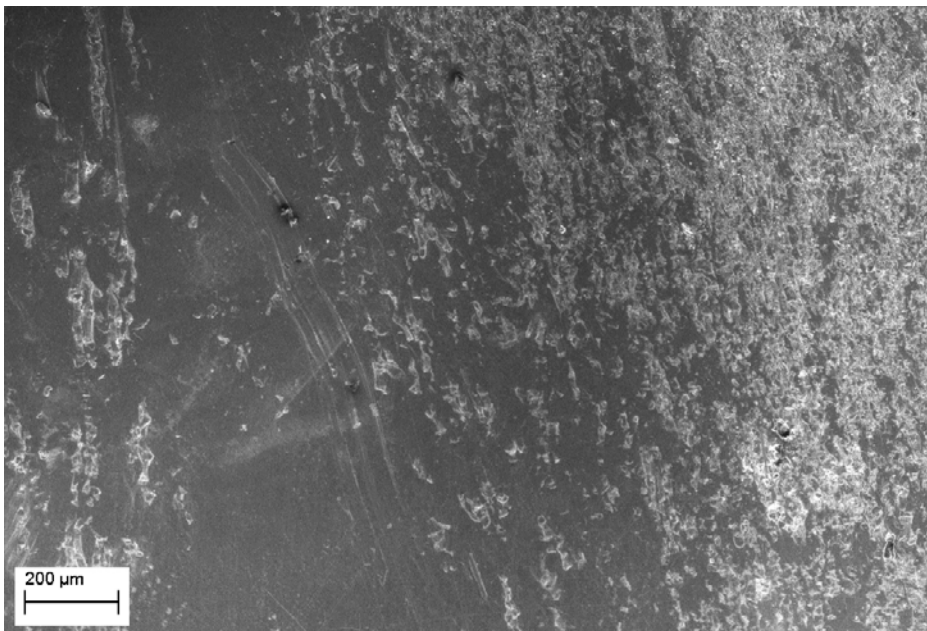
**Figure 3-29.** Copper surface after scratching with diamond (as in sample M2-diam). The right side with a heavily disturbed surface might show the effect of impressions by diamond particles, not detectable themselves in SEM.

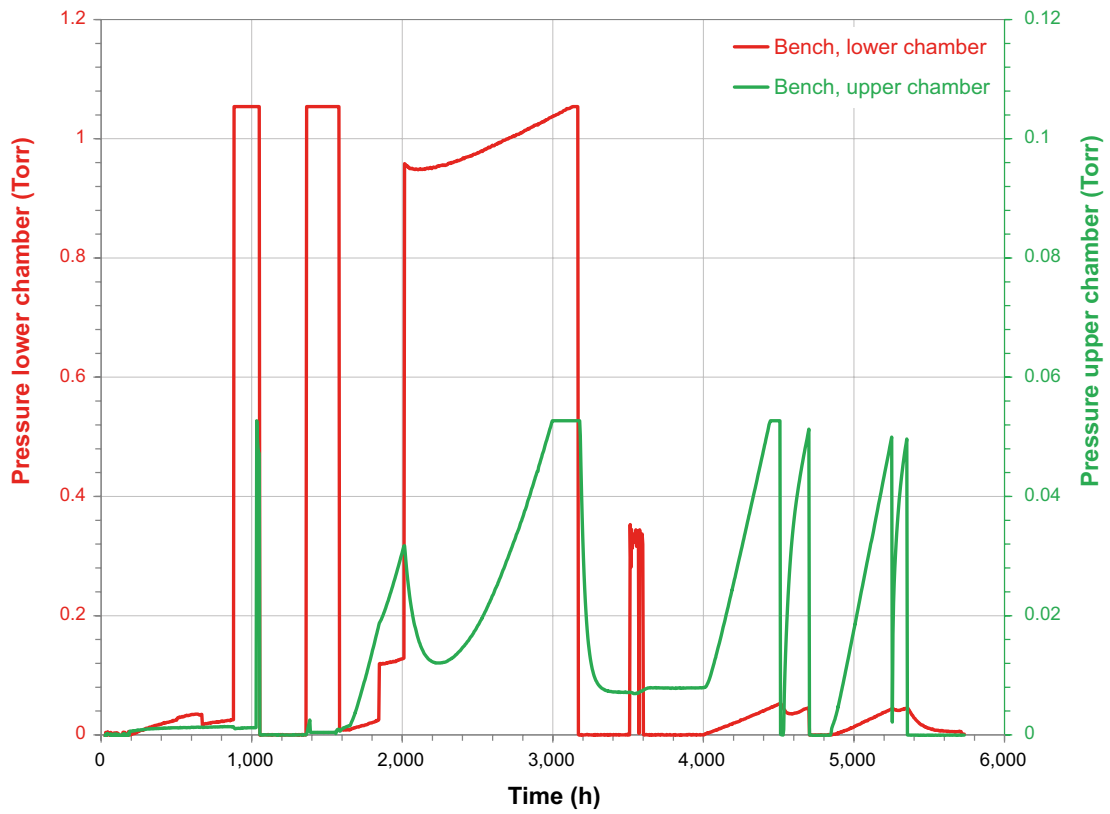
**Figure C-2.** Supplemented data of Figure C-1. The background measured after 4,000 hrs are only due to the outgassing from the stainless steel.

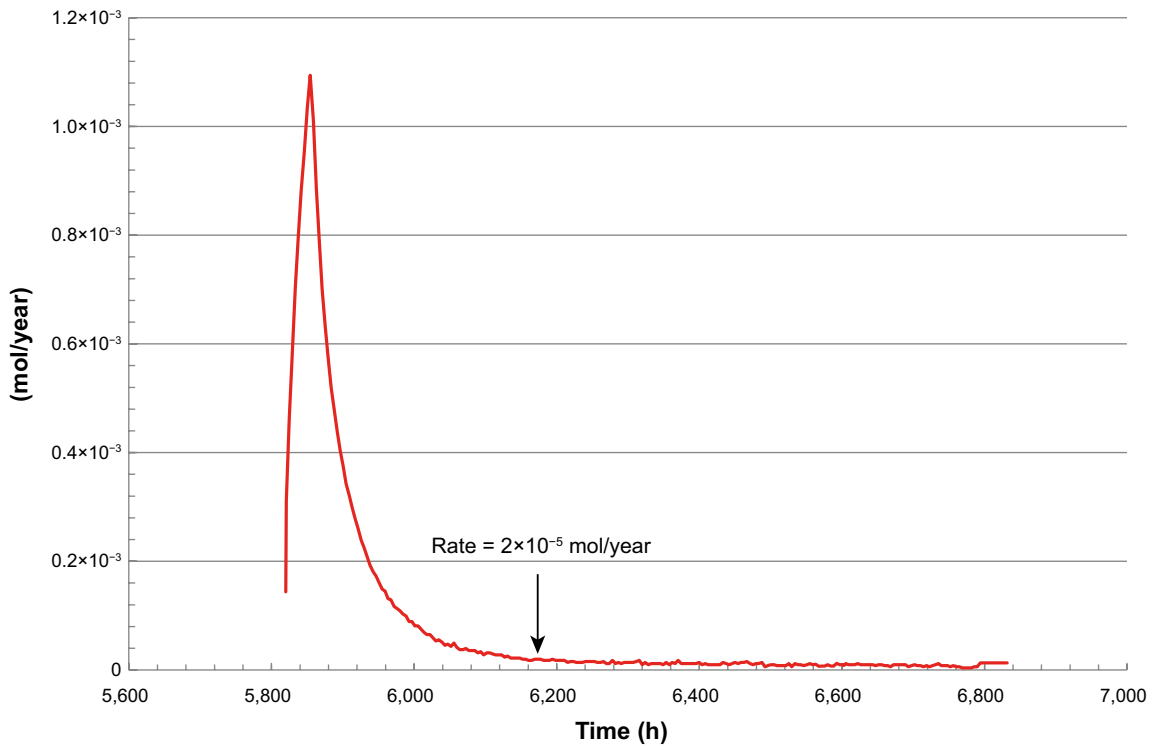
*Figure C-6. Rate evolution from Figure C-5.*
