**TR-15-09**

# Vapor transport and sealing capacity of buffer slots ("sauna" effects)

SVENSK KÄRNBRÄNSLEHANTERING AB

Clay Technology AB

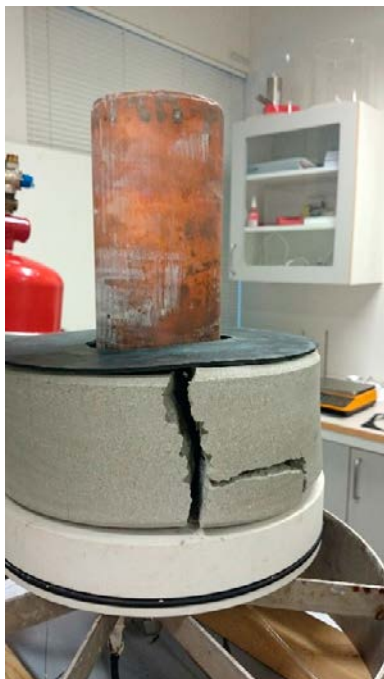
*Figure 2-4. Test 2 at termination.*

Figure 2-3 displays the water consumed during test 2. During ca 2.8 days, approximately 0.4 kg of water was fed to the system. Despite this consumption, the amount of water in the bentonite actually decreased during the test (with ca 0.1 kg), i.e. the bentonite dried. The total loss rate was thus approximately 0.19 kg/day. Although the bentonite lost water as a whole, it was also evident that water was taken up from the vapor flowing in the inner slot. This uptake manifested itself in swelling which caused the block to crack, as shown in Figure 2-4 (picture taken at termination).

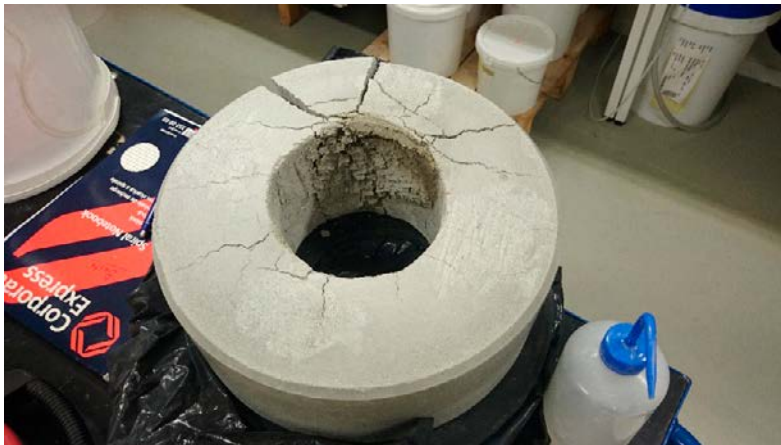
**Figure 2-5.** Bottom side of the bentonite ring in test 2 after termination. Vapor has been taken up unevenly, by local condensing.

Further inspection of the block (Figure 2-5) revealed that the water uptake had occurred locally in a condensation spot rather than uniformly (as suggested by the radial symmetry). This type of water uptake via a condensation “nucleus” was also observed in the previous study on vapor transport in pellets (Birgersson and Goudarzi 2013).

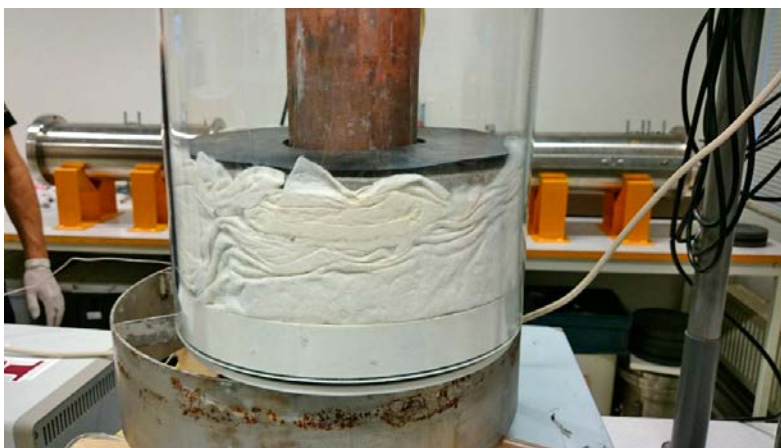
**Figure 2-6.** Test 3 at the start of the test.

In an attempt to reduce drying of the block, test 3 was performed with a convection inhibitor in form of a cloth sandwiched between the outer surface of the bentonite block and the confining plexiglass, as shown in Figure 2-6. Initially, this test was run for 4 days without water access. The conditions were otherwise the same as for test 2: a single bentonite ring was used covered with a plastic mat, and after the initial 4 days, the system was given full access to water. Figure 2-7 show the full water consumption and uptake history during the course of test 3. The bentonite is seen to lose approximately 0.15 kg water during the phase without water access. This loss is comparable to that measured in test 2, and consequently indicates that the convection inhibitor did not have a significant influence on drying of the block. Moreover, after connecting the external water reservoir (day 4), the water consumption is seen to be similar to that in test 2 (ca 0.15 kg/day).

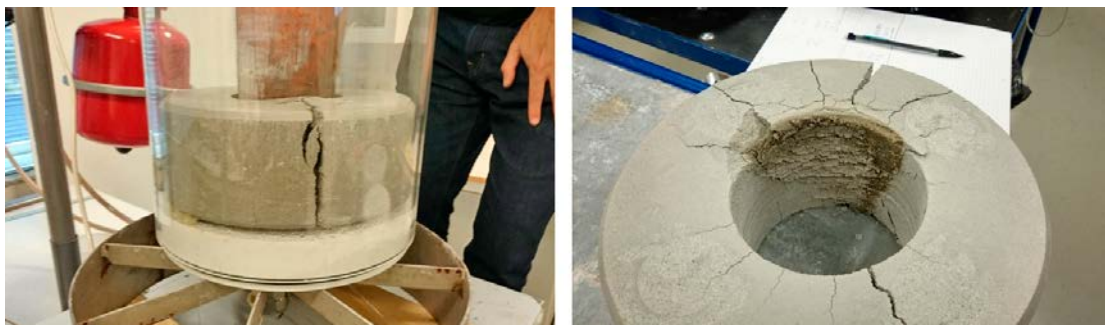
Figure 2-8. Left: Test 3 at termination. Right: Bottom side of the bentonite ring showing a condensation “nucleus”.

During the stage with water access, the bentonite mass stayed more or less constant. This behavior could indicate that the available water vapor simply were transported through the inner slot without interacting with the bentonite. As in the case of test 2, however, such an interpretation is not correct, as illustrated by the massive local swelling occurring at this stage; the bentonite ring quickly cracked when water was applied, and the inspection of the block after test termination clearly showed local water condensation (Figure 2-8).

It must thus be concluded that water was simultaneously taken up locally in a “condensation nucleus”, while the block simultaneously lost water by drying, at basically the same rate.

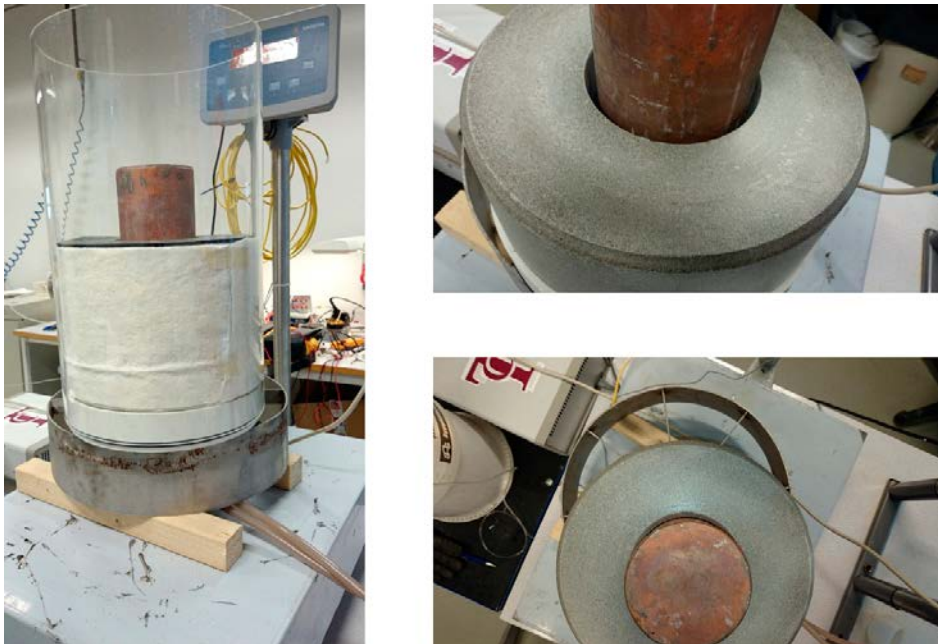
**Figure 2-9.** Test 4 at the start of the test. The top ring had an inner radius small enough as to basically seal off the inner slot (bottom right).

Test 4 was performed with two bentonite rings, the top one having a radius small enough as to basically seal off the inner slot (see Figure 2-9). The test had full access to water during the whole test period, and a convection inhibitor in the form of a cloth was used, as well as a plastic mat on top of the top block.

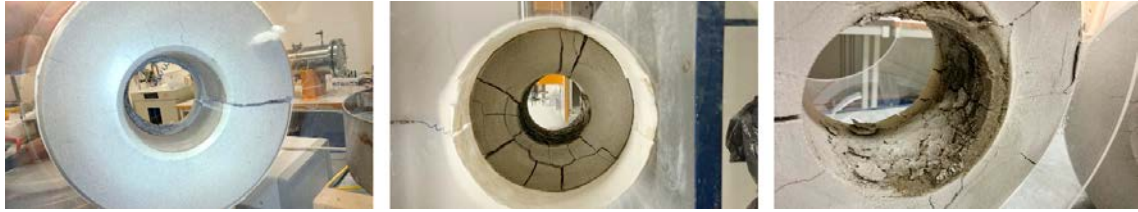
**Figure 2-11.** Test 4 at termination. Left: the top side of the top ring. Middle: Top side of bottom ring. Right: Bottom side of bottom ring.

As shown in Figure 2-11, inspection of the bentonite at test termination showed localized water uptake – of the same type as also documented in tests 2 and 3. This inspection also showed massive cracking of the lower block while the top block had a single crack (Figure 2-11). Combining these observations with the observed water uptake, it seems reasonable to conclude that the bottom bentonite ring took up water during the first two days of the test, since the top ring basically functioned as a seal in this set-up. As a consequence of the water uptake, the bottom ring swelled and developed massive cracks, through which vapor escaped during the final part of the test (days 2–10).

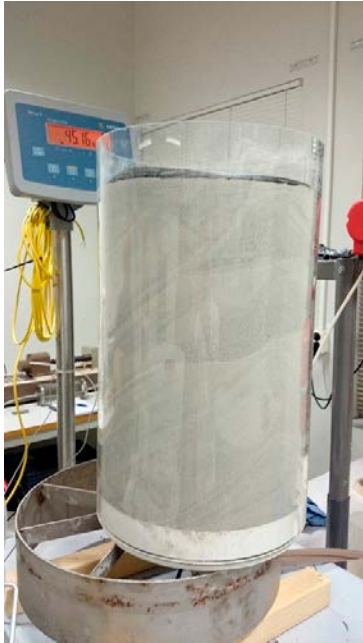
*Figure 2-13. Test 5 at the start of the test.*

Test 5 consisted of three bentonite rings stacked on top of each other (all having a radius giving a copper tube/bentonite slot of approximately 5–10 mm) as well as a massive block on top. The set-up was thus identical with that shown schematically in Figure 2-1. The spacing between the outer side of the blocks and the plexiglass tube was in this test filled with bentonite powder (MX-80, water-to-solid mass ratio 16 %), as shown in Figure 2-13. On top of the top block was placed a plastic mat. In order to adjust the height of the stacked rings, a piece of plastic mat was also placed in between the mid ring and the top ring. The system had full water access during the whole course of the test. The water consumption and uptake is plotted in Figure 2-14.

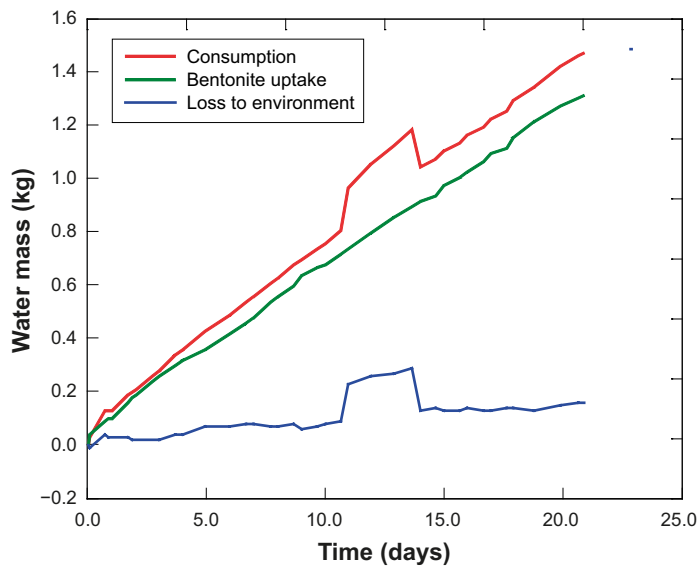
*Figure 2-14. Water consumption and uptake in test 5. The “hunch” in the consumption curve is an artefact due to incorrect measuring during this time interval.*

In contrast to the water consumption in the earlier tests, test 5 is shown to have very little loss to the environment (Figure 2-14), less than 0.01 kg/day. It is thus evident that the layout of this test – with a massive block functioning as a lid over the copper tube/bentonite slot, and with bentonite powder functioning as a seal on the outside – basically made it isolated from the environment.

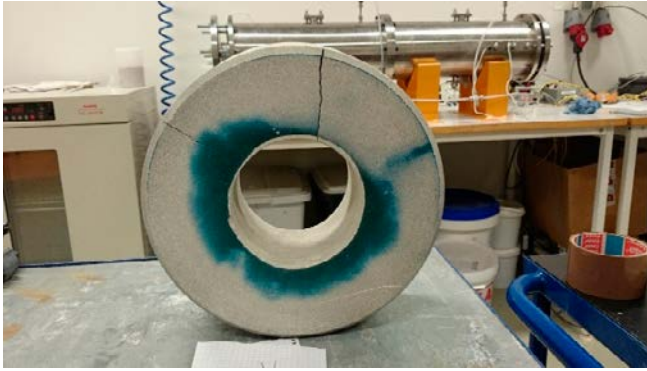
**Figure 2-16.** The mid ring seen from the top side. The blue coloring is due to a plastic mat which was placed in between this and the top ring in order for the blocks to line up with the copper tube.

The mid ring was much less affected by water uptake, although still showing a few cracks (Figure 2-16). No water condensation was observed in this block.

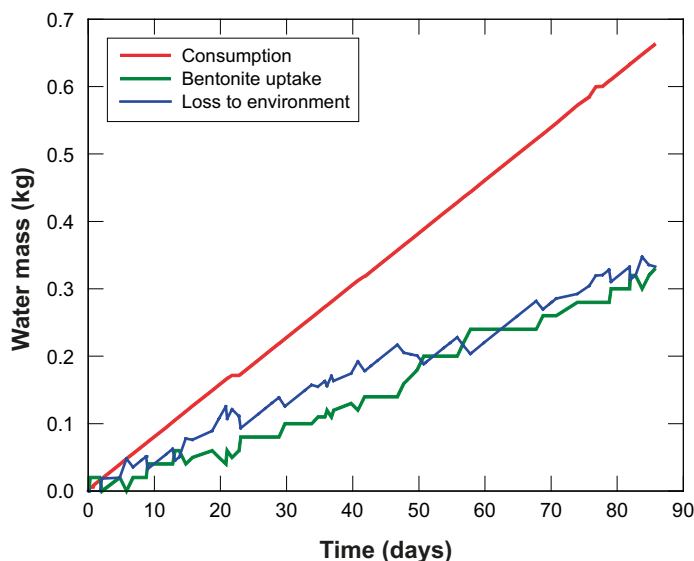
**Figure 2-20.** Water consumption and uptake in test 6.

Figure 2-20 shows water consumption and uptake during the whole course of test 6; as the consumption (now controlled) was much lower than in previous tests, the testing time was considerably longer – almost 90 days – in order to consume a comparable amount of water.

Figure 2-20 reveals that the bentonite took up water also with restricted water access in this type of slot geometry. The constant rate of the water uptake indicates that the capacity of transporting water away from possible condensation points in this system (to the environment) is considerably slower than the rate at which water was fed, i.e. much lower than 8 ml/day. The observed loss to the environment should consequently be attributed to drying of outer parts of the bentonite, independent of whether the system had access to water or not.

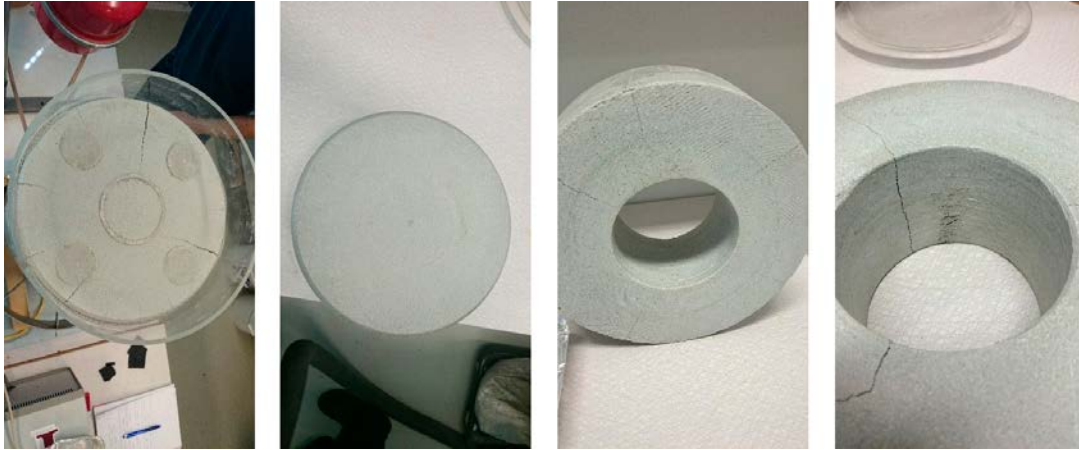
**Figure 2-21.** Excavation of test 6. Left: The top of the massive top block. Second to left: bottom side of the top block. Second to right: bottom side of the top ring. Right: top side of the bottom ring.

The blocks showed significantly less damage at excavation as compare to test 5 (Figure 2-21). Although they showed some cracks, all blocks still held together. Note that a comparable total amount of water was added to this system as compared to previous tests. Thus, the rate at which water is being fed to the system strongly influence the damage that is done to the blocks.

No visible sign of water condensation was found on the top block or the top ring. However, the bottom ring showed the flaky pattern, significant for water condensation (right picture in Figure 2-21). Thus, condensation of vapor did occur also with restricted water supply.

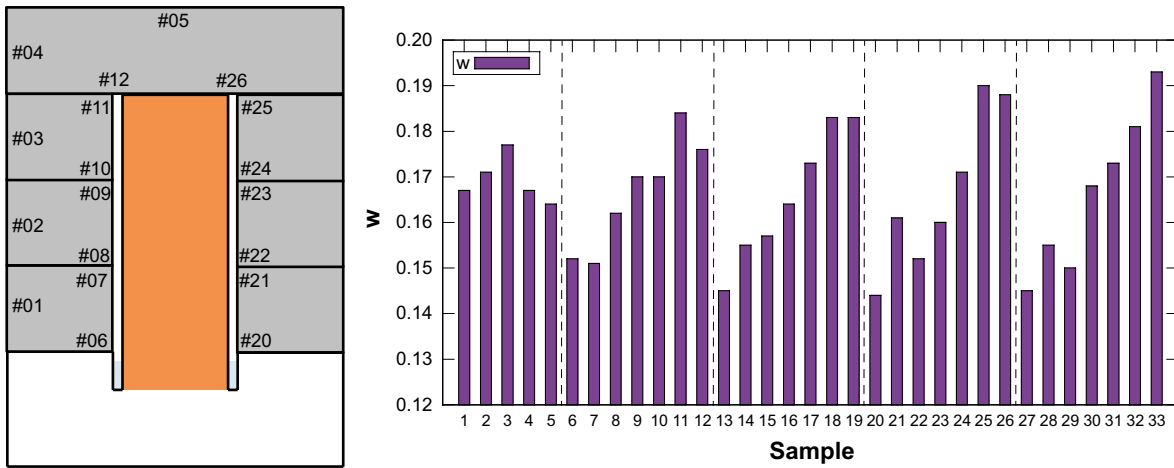
**Figure 2-22.** Water-to-solid ratio ( $w$ ) in samples taken during the excavation of test 6. The left figure shows the approximate positions of the samples. The samples not indicated in the left figure (Sample 13–19 and 27–33) represent the same type of vertical series as samples 06–12 and samples 20–26, but oriented perpendicular to the plane of the picture.

The measured water-to-solid ratios, however, show no indication of water accumulation in the lower ring (Figure 2-22). The water was much more evenly and symmetrically distributed in this test as compared to test 5, but with a clear trend of increasing water-to-solid ratio with height (Figure 2-23). Also, in the lower parts, at trend of increasing water content with radius is distinguishable.

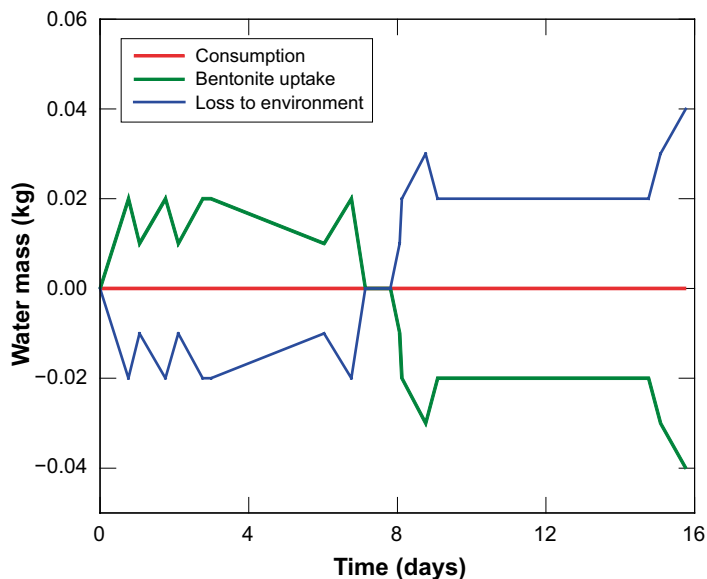
**Figure 2-24.** Water consumption and uptake during the first phase of test 7. In this phase, no water was supplied to the system. The top was covered with a rubber mat at this stage.

The water loss during the first sequence is plotted in Figure 2-24. During 16 days the system lost approximately 60 g of water to the environment. The loss rate is thus approximately 0.004 kg/day, similar to what was measured in tests 5 and 6. This observation confirms the conclusion that the loss of water is due to drying of the outer parts of the bentonite in this set-up, independent of the moisture distribution in the inner slot.

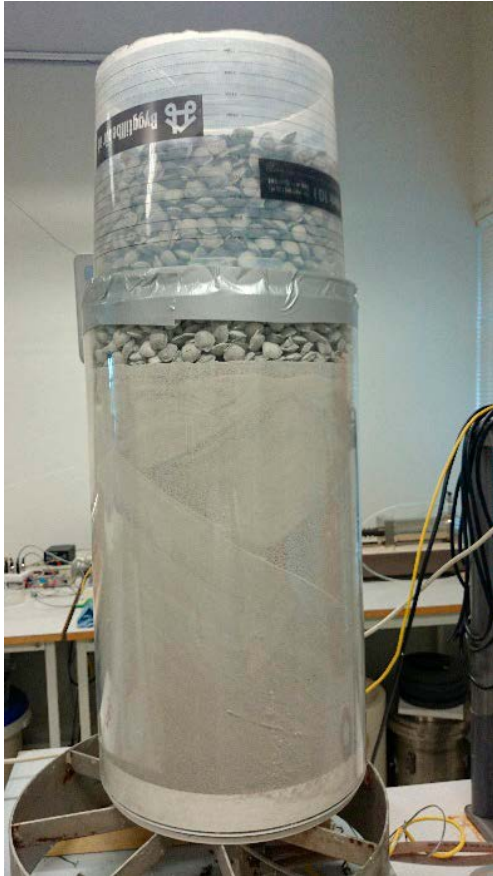
Figure 2-25. Test 7 with a 20 cm thick pellets filling replacing the rubber mat as top seal.

In the second phase of test 7 the plastic mat on the top of the set-up was removed and replaced by a 20 cm thick layer of bentonite pellets (MX-80), as pictured in Figure 2-25. The set-up was then continued to be run without water supply for 14 days. The loss of water during this period corresponded roughly to 0.01 kg/day (Figure 2-26). Hence, replacing the plastic mat with pellets gave an increase of the drying rate of a factor of ca 2.5.

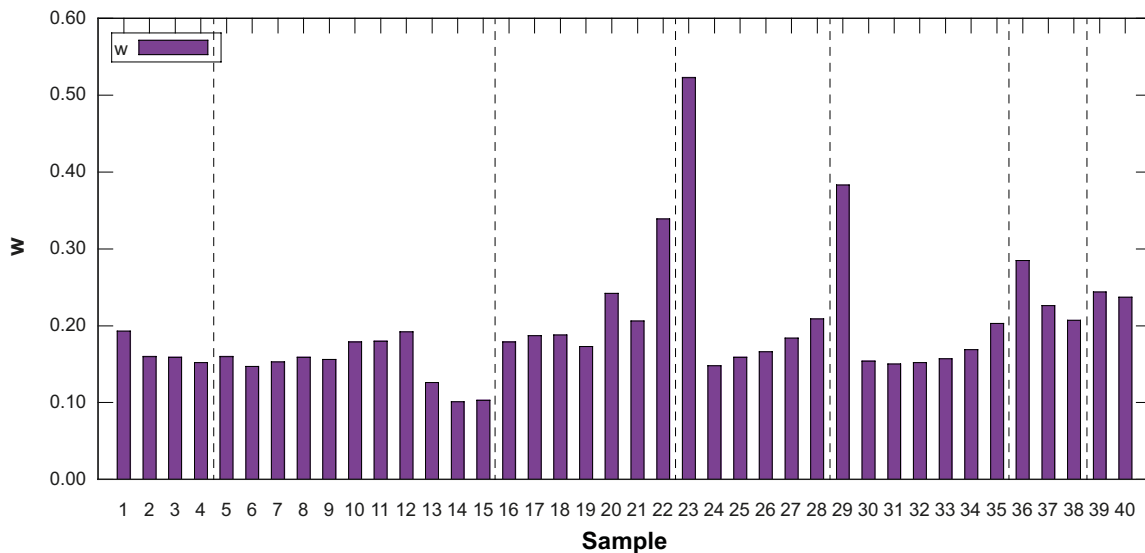
Figure 2-28. Water-to-solid ratio ( $w$ ) in samples taken during the excavation of test 7. The lower figure shows the approximate positions of the samples.

The water distribution measured at termination is shown in Figure 2-28. In the pellets filling in the top was observed pellets of distinctly different color (Figure 2-27). These were seemingly distributed randomly throughout the filling. The average water content of two samples was 0.127 for the darker pellets and 0.106 for the lighter ones.
