**TR-16-07**

# Full scale Buffer Swelling Test at dry backfill conditions in Äspö HRL

## In situ test and related laboratory tests

SVENSK KÄRNBRÄNSLEHANTERING AB

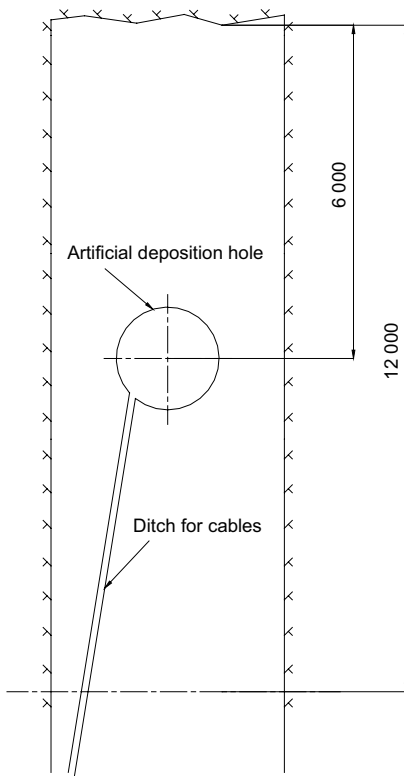
**Figure 2-4.** Drawing showing the deposition hole position in the TASS tunnel.

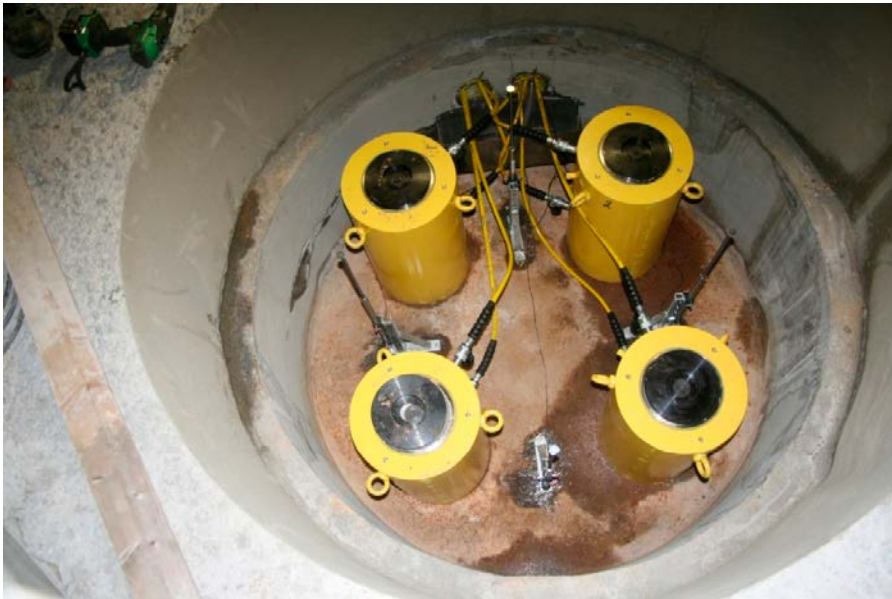
*Figure 3-1. The four hydraulic jacks and the four displacement sensors installed in the artificial deposition hole*

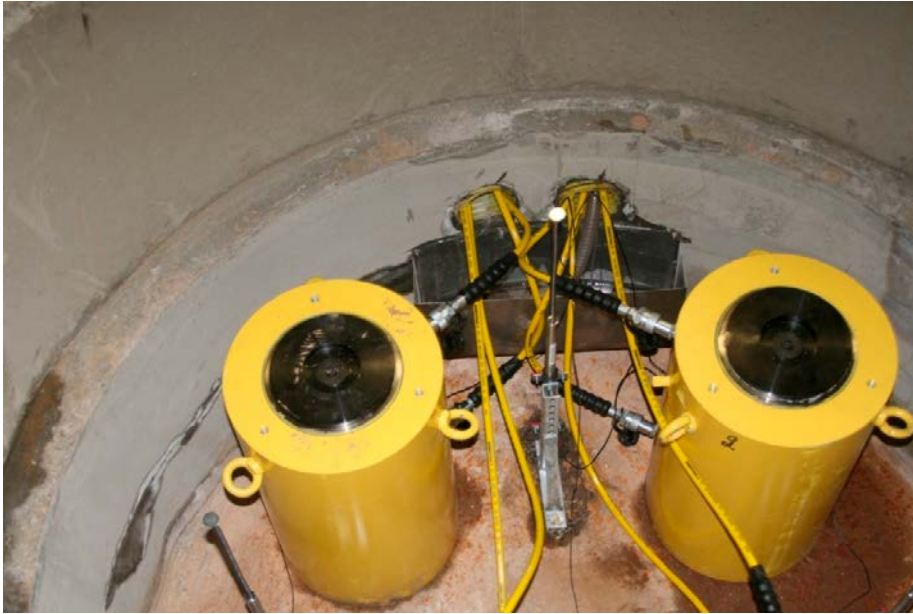
**Figure 3-2.** Close-up showing the entrance leading out cables from the deposition hole. Note the vessel that collects water leaking in from the cable ditch. A tube, connected to a pump, was continuously leading out water from the vessel.

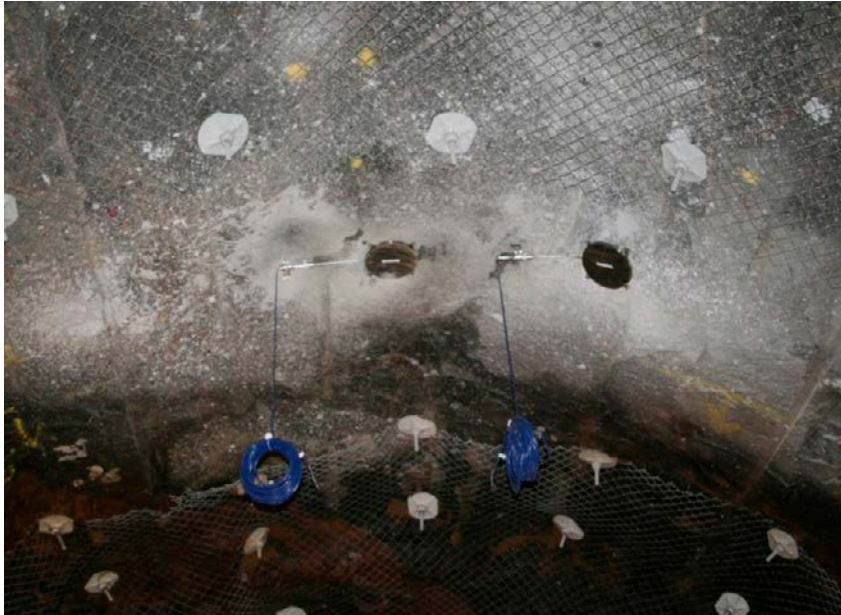
*Figure 3-5. Five pressure sensors were installed in the ceiling above the deposition hole.*

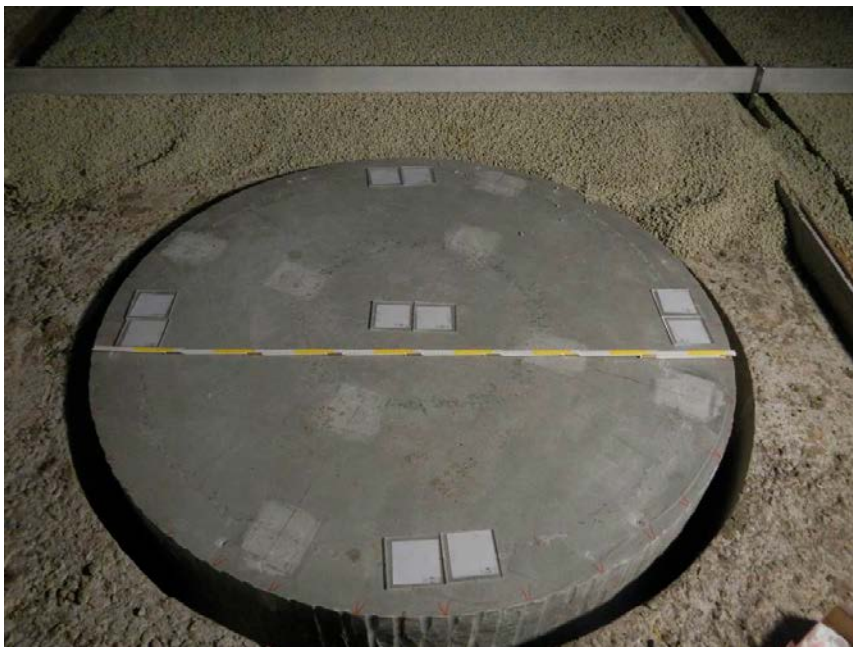
*Figure 3-6. Pressure indicators placed on the buffer block.*

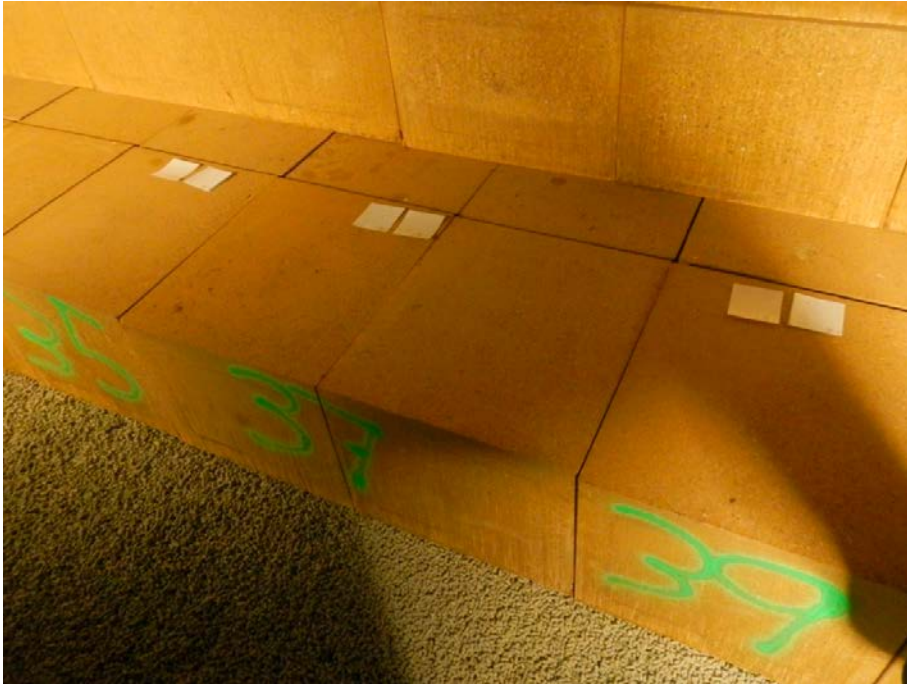
**Figure 3-7.** The pressure indicators were placed between the backfill blocks at selected positions. Two sensors with different measuring range were placed on each block.

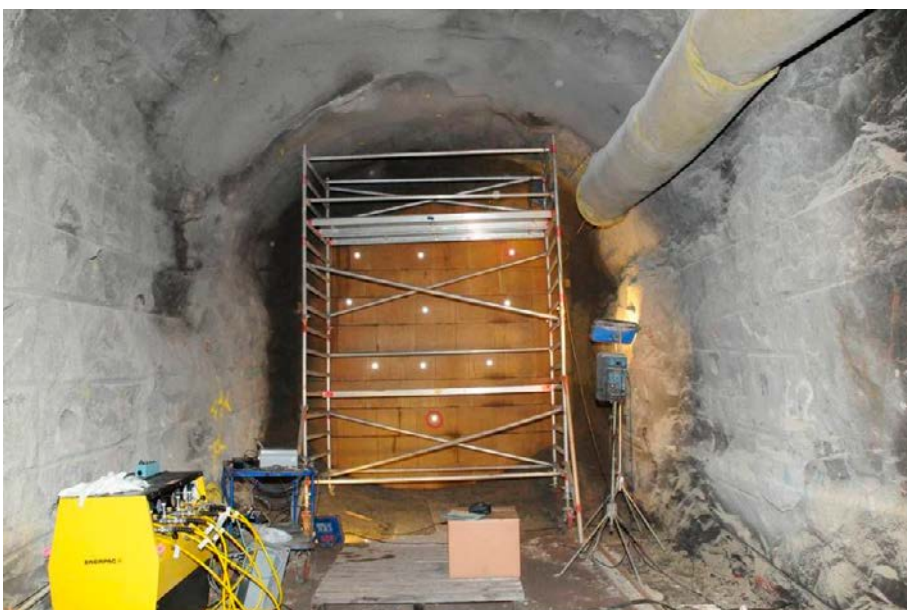
**Figure 3-8.** The block positions were determined with reflectors at ten points at the end of the block stack.

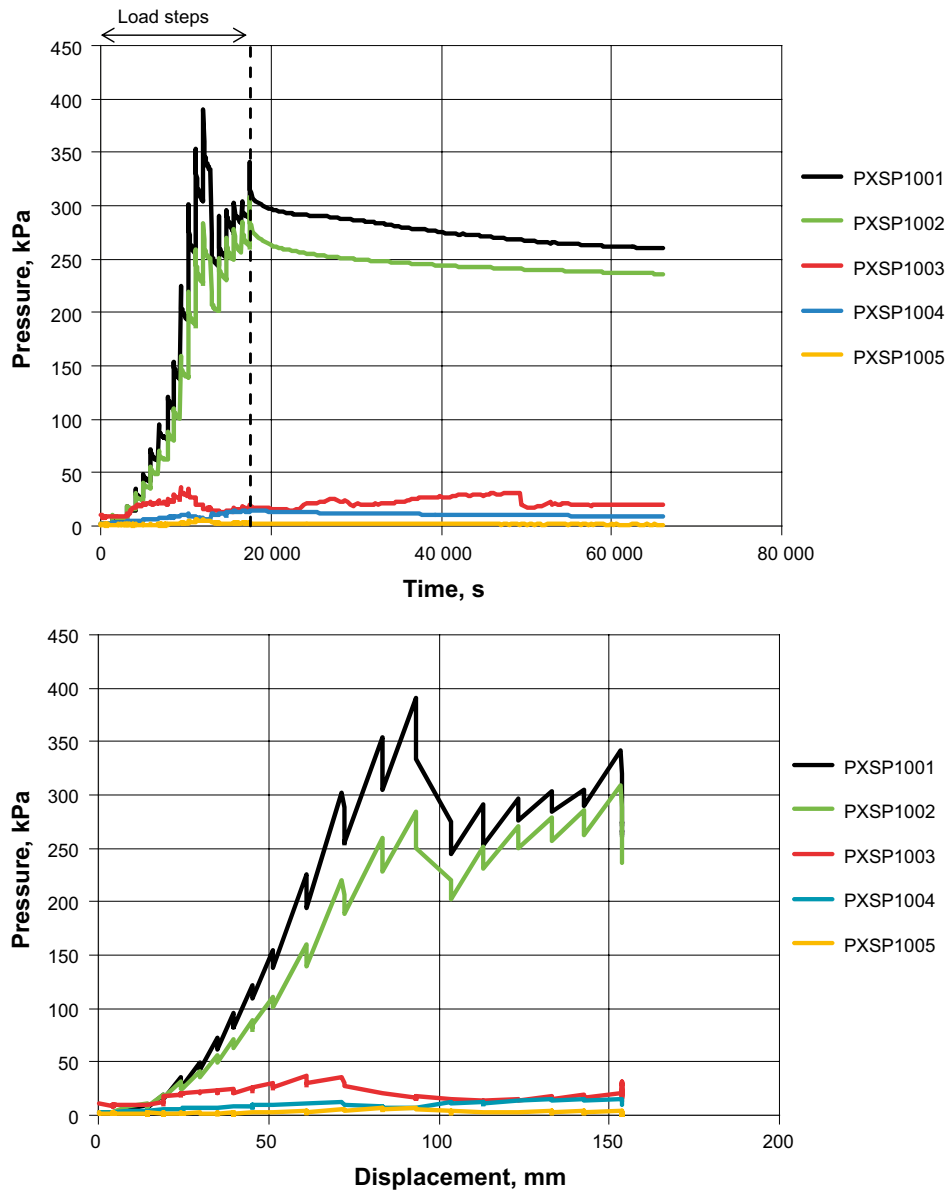
Figure 4-5. Upper: Pressure registered at the sensors placed on the rock ceiling and walls plotted versus time. Lower: Pressure registered at the sensors placed on the rock ceiling and walls plotted versus displacement.

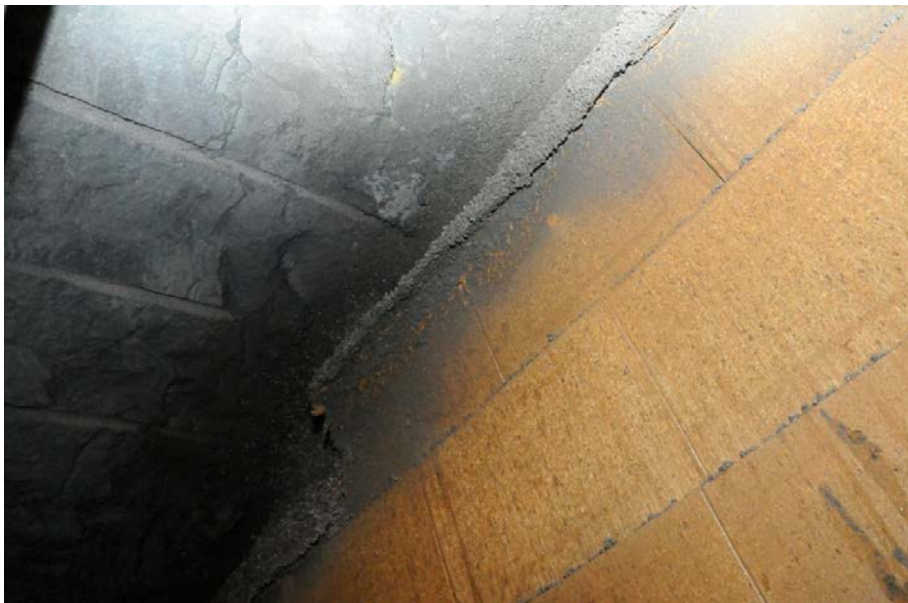
*Figure 4-6. The pellet filling on top of the block stack had been pushed out about 40 to 50 mm. The outermost part of the pellet filling was pre-wetted, during the BST construction in order to keep loose dry pellet materials from falling out of the downstream face. The result of this is that the pellets stick to the ceiling and when extruded by internal deformation, do so as a plastic mass.*

In the final part of the test, it was observed that the pellet filling at the ceiling had moved forward about 40 to 50 mm, Figure 4-6. During the last load step the location of the outer edge of this material was observed very carefully but it was not possible to detect any movement during this time.

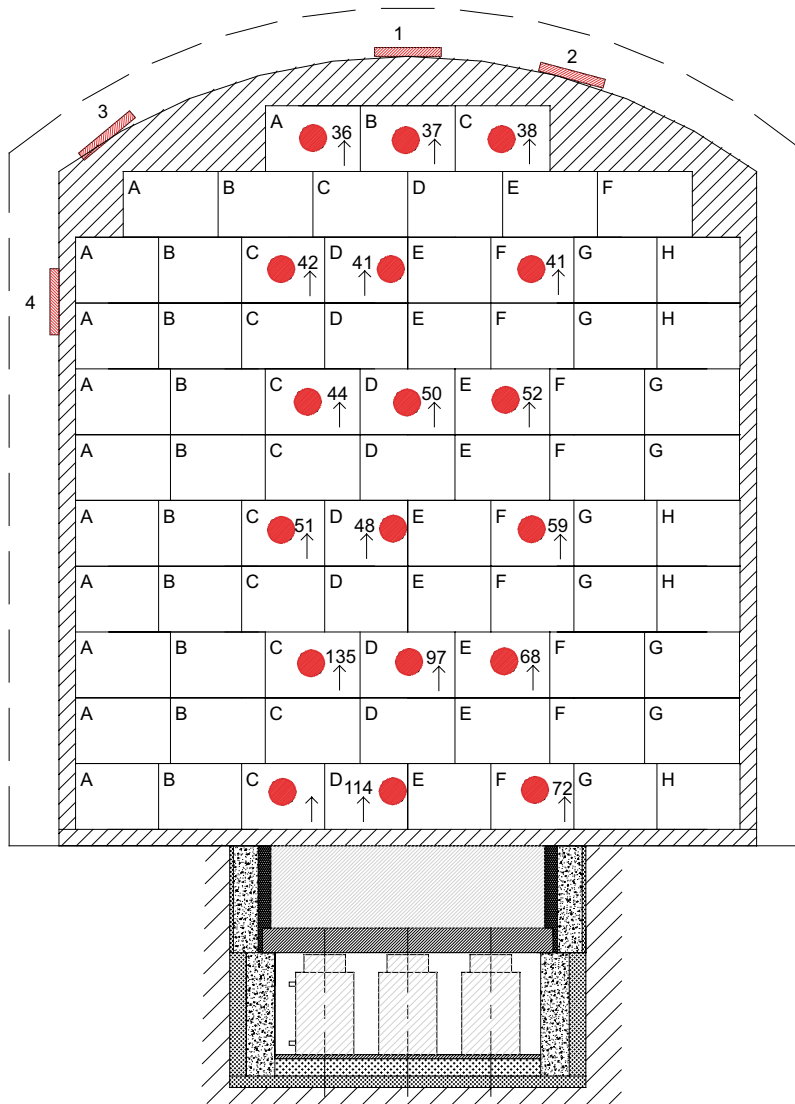
**Figure 4-7.** Vertical layer 4 immediately above the deposition hole showing block locations measured with a total station before and after installation. The numbers beside each red point indicate the vertical movement of each block.

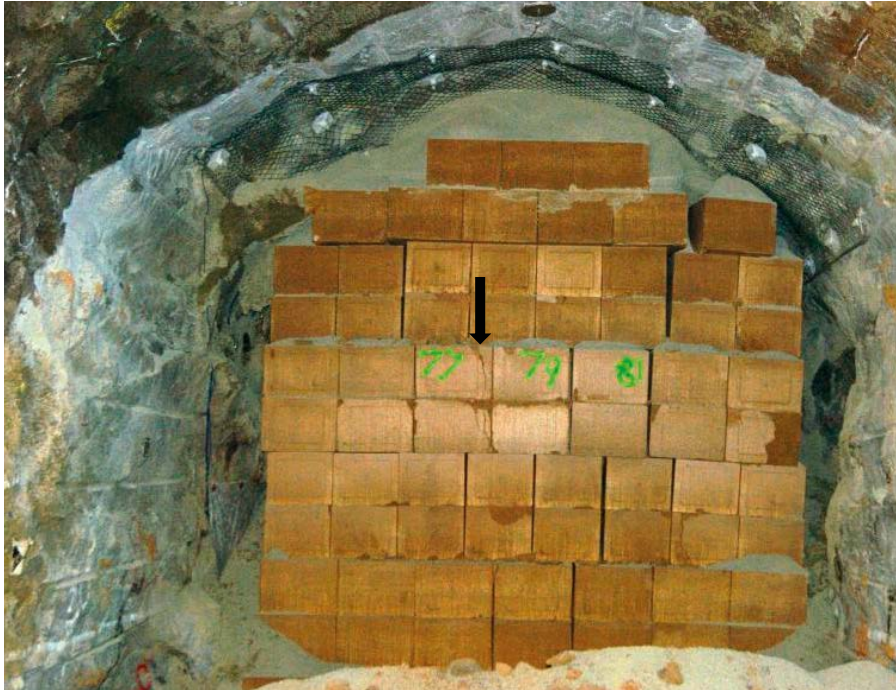
**Figure 4-8.** The block stack at the vertical section 6 (see Figure 3-10) just before reaching the deposition hole (at the lower part) and close to the midpoint over the deposition hole at the top of the block stack.

The photo provided as Figure 4-8, shows the block stack at vertical section 6 (see Figure 3-10), which goes over the deposition hole at the top. Cracks can be seen in some of the blocks (e.g. block marked 77 and the one immediately below, see black arrow in photo) but many of the blocks in the stack have displaced laterally towards the right rock wall.

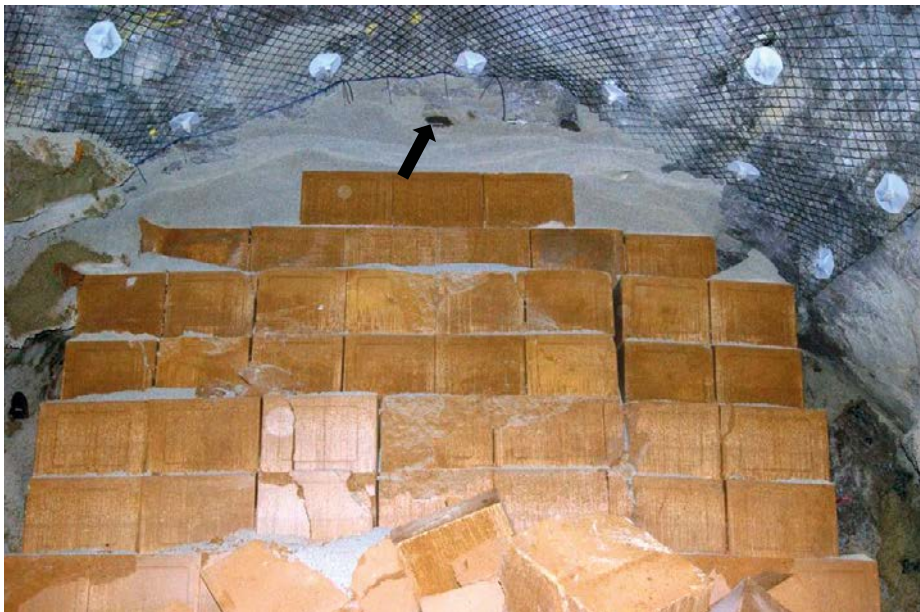
**Figure 4-9.** Photo showing the block stack top and the pressure sensor on the rock ceiling just above the deposition hole (black arrow).

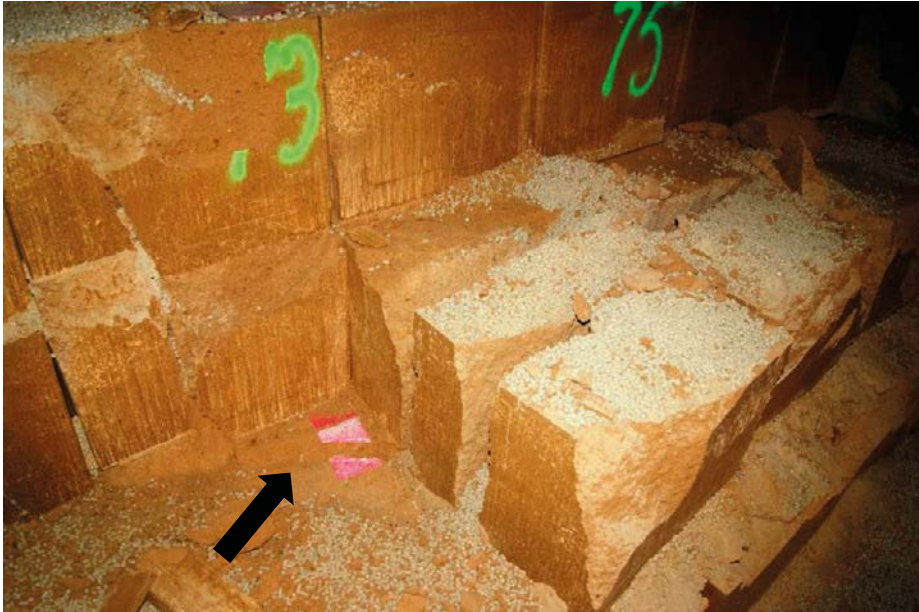
**Figure 4-10.** The pressure indicator on the photo was positioned on top of layer 3. The block below has been sheared and the shear surface can be seen very evidently (black arrow). Parts of the block have been vertically sheared approx. 50–60 mm relative the rest of the block.

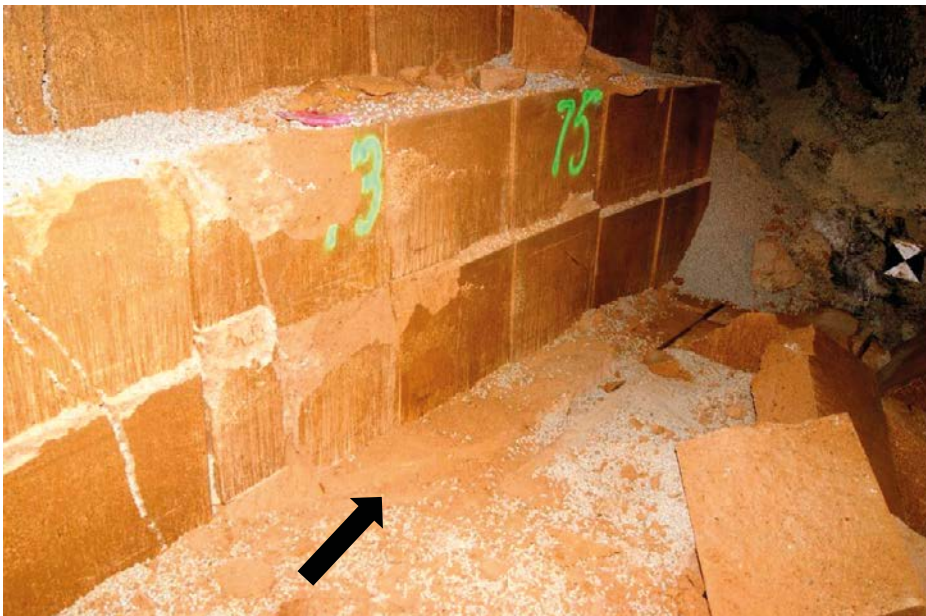
**Figure 4-11.** Some additional blocks of the ones shown in Figure 4-10 have been removed and the shear surfaces can be seen clearly (black arrow at the top on block layer 3).

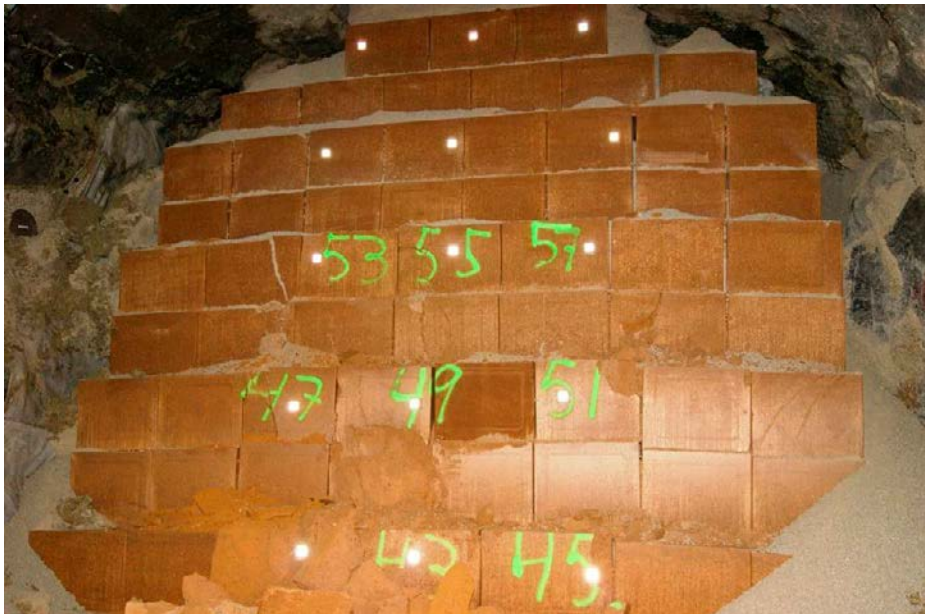
**Figure 4-13.** The vertical layer 4 (see Figure 3-10) above the deposition hole, where blocks were equipped with reflectors and their position determined with a total station before and after test.

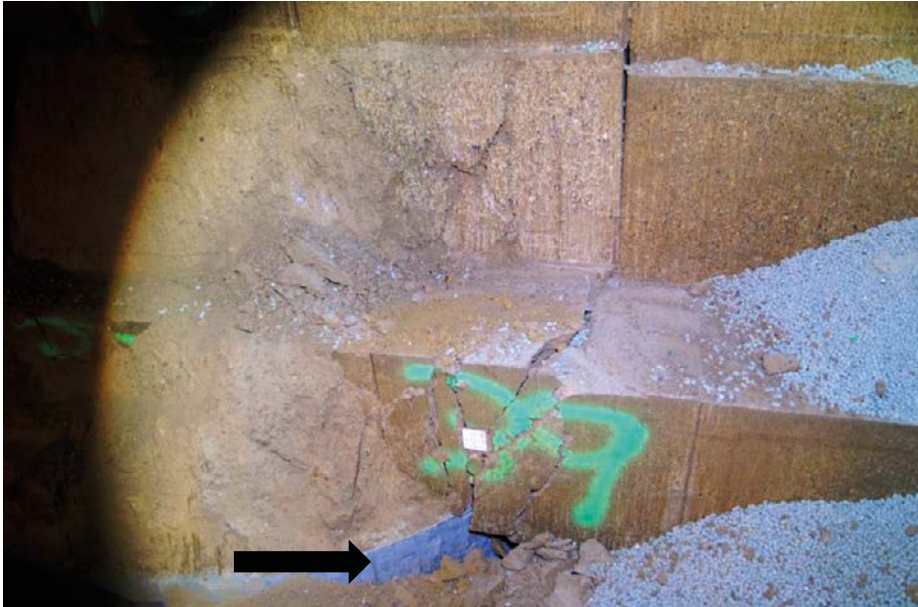
*Figure 4-14. The edge of the buffer block (black arrow) and the sheared block above.*

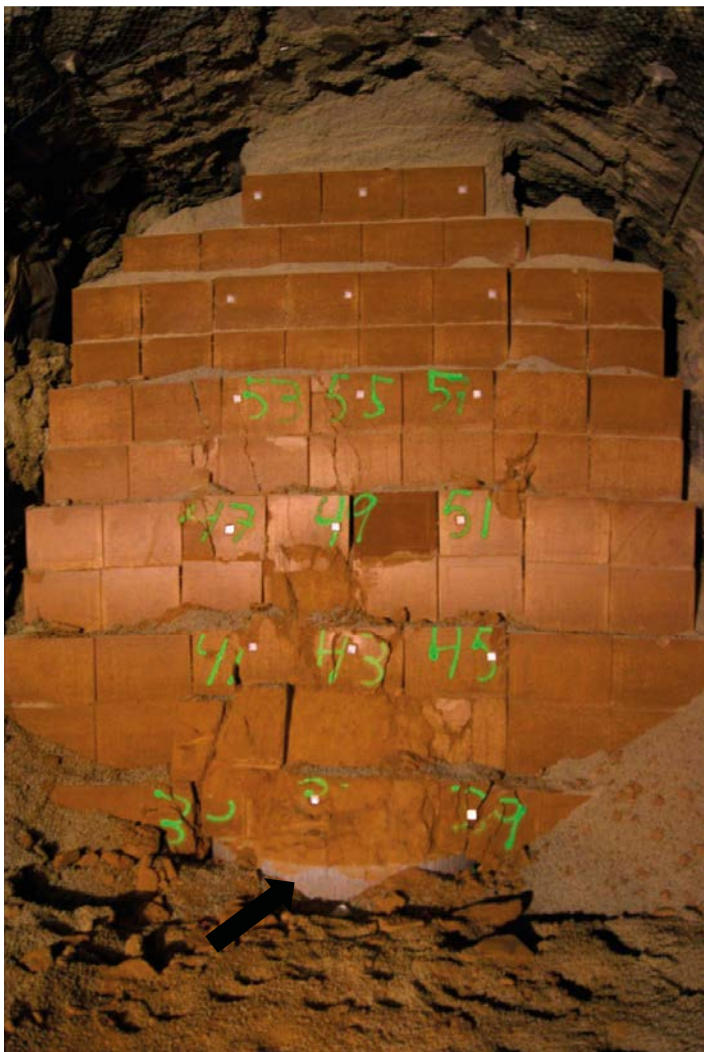
**Figure 4-17.** Overview of the block stack above the deposition hole with buffer showing at the base (black arrow). The shearing of backfill blocks is mostly to the left of center, while blocks on the right side seem to have moved out into the pellet slot rather than failing.

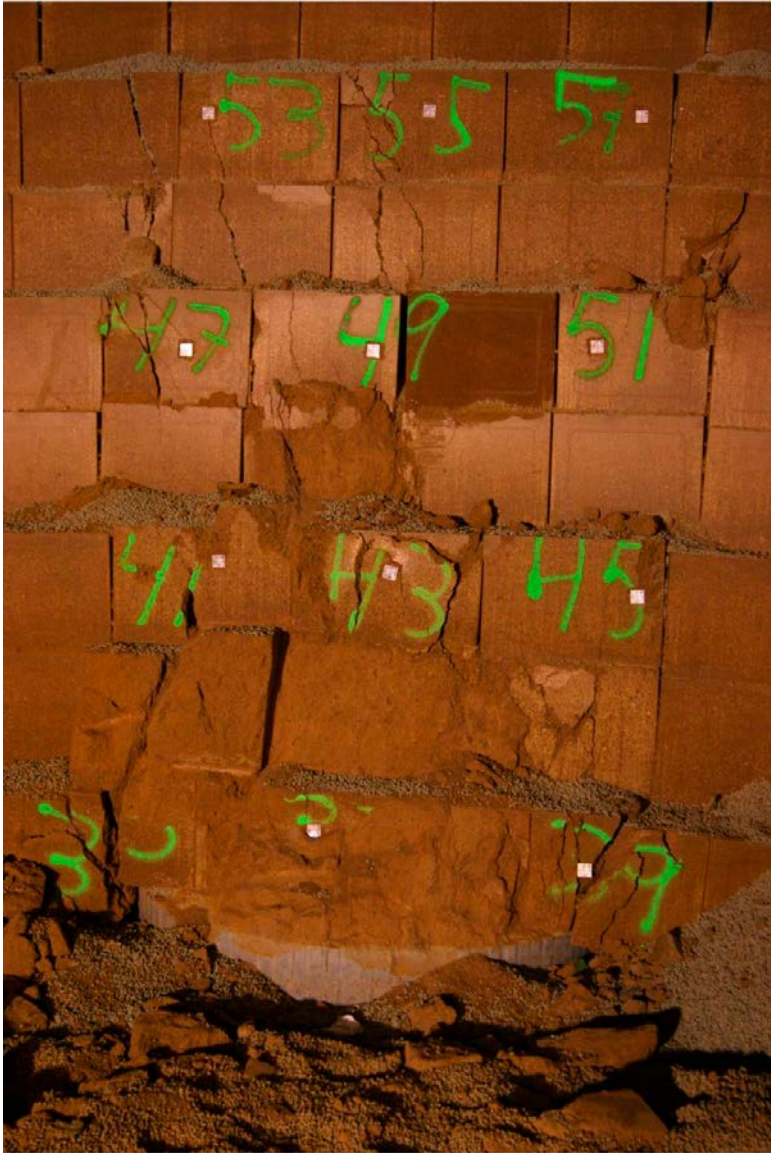
*Figure 4-18. Extensive shear surfaces and fractures in the blocks immediately above the deposition hole.*

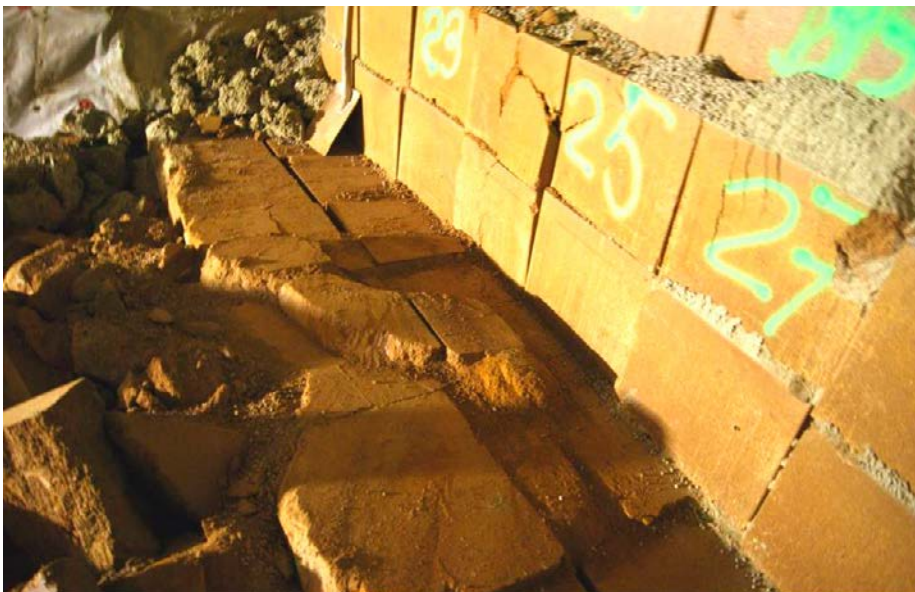
*Figure 4-19. Shear surfaces on vertical block layer 3. See also Figure 4-11.*

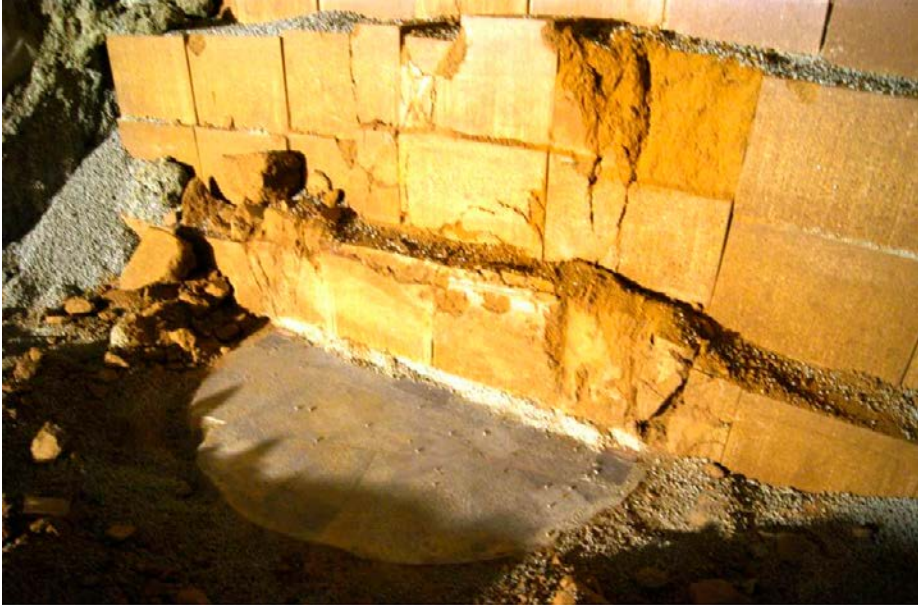
**Figure 4-20.** Photo showing the buffer block surface, the pellet layer and the backfill blocks at the midpoint of the deposition hole.

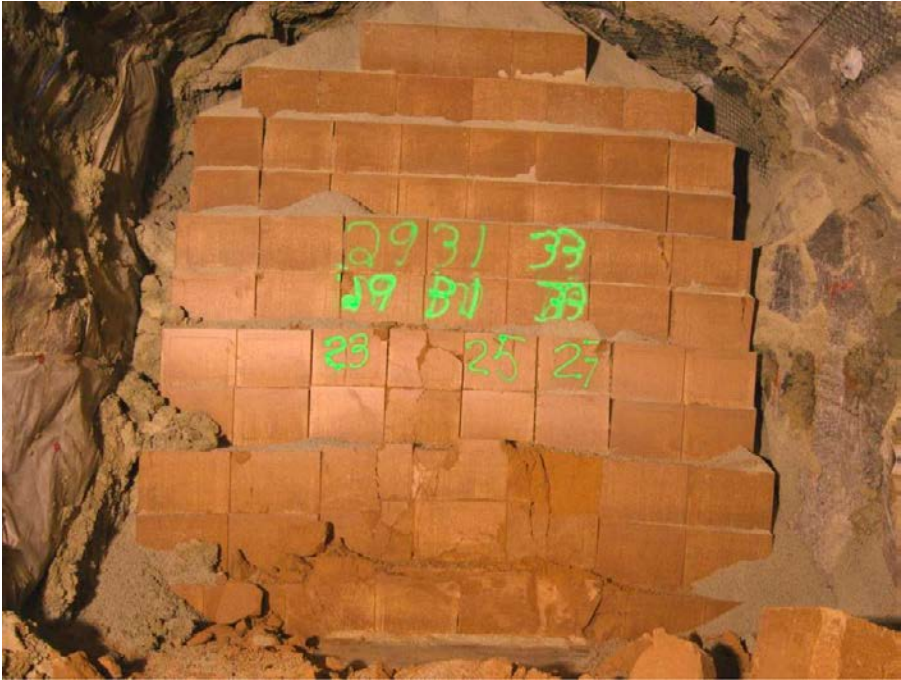
**Figure 4-21.** The backfill at the innermost part of the deposition hole in vertical layer 2 (see Figure 3-10). The shear and fracture surfaces can be seen very clearly.

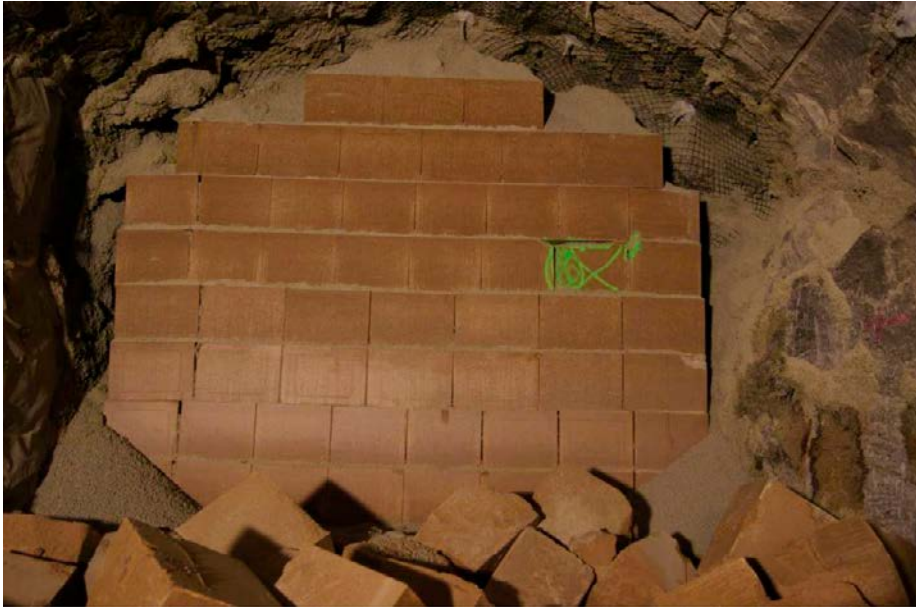
*Figure 4-22. The block stacks inside the deposition hole beyond vertical section 1 are almost unaffected by the buffer heaving.*

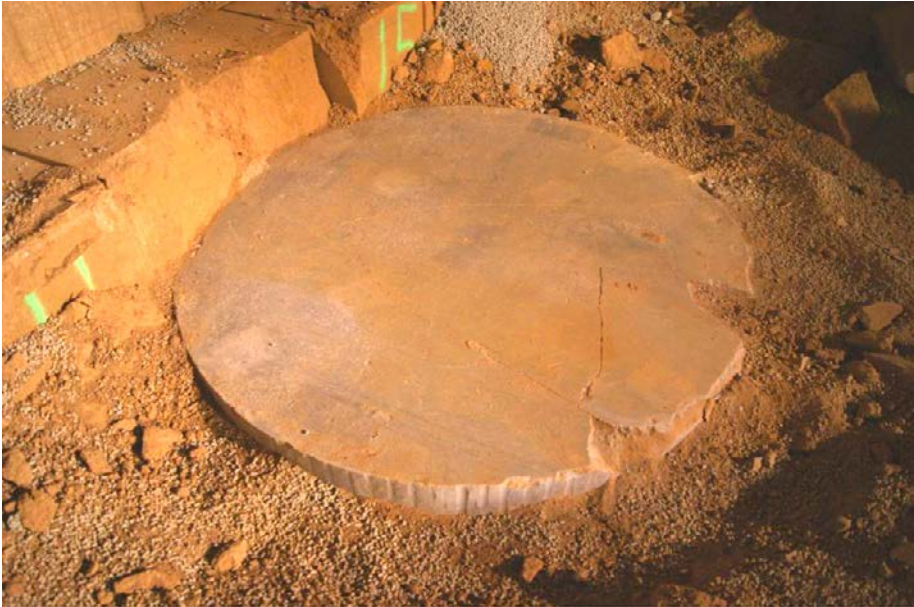
**Figure 4-24.** *The buffer block is rather unaffected by compressive interaction with backfill blocks, only a few fractures can be seen.*

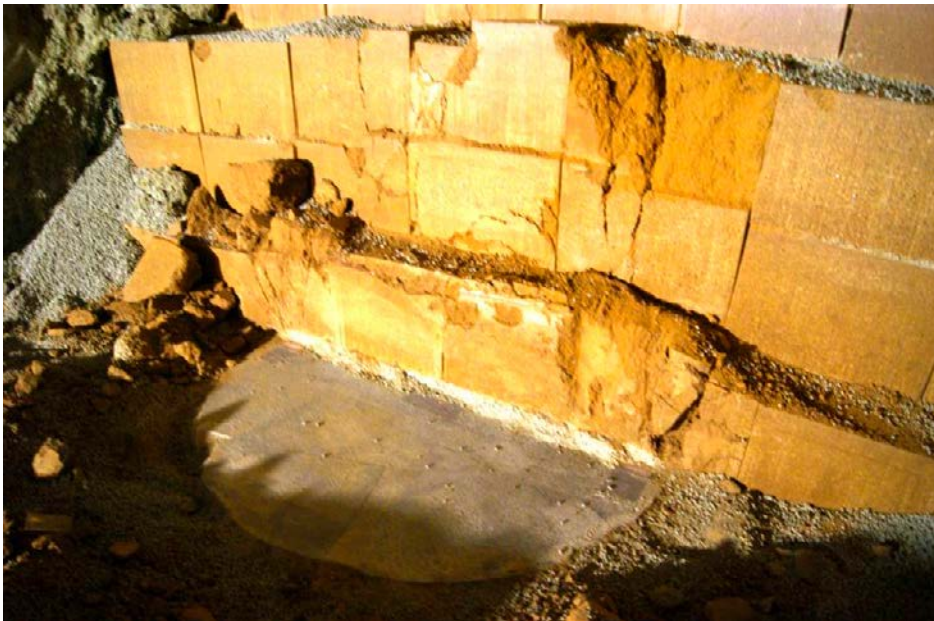
**Figure 4-26.** Photo showing the middle part of the buffer block together with the compressed pellet and backfill blocks (same as Figure 4-20).

The thickness of the pellet layer was measured during the excavation. It was found that the thickness at the end of the test was about 25 mm at the front and approx. 45–50 mm at the midpoint of the buffer block Figure 4-25 and Figure 4-26.

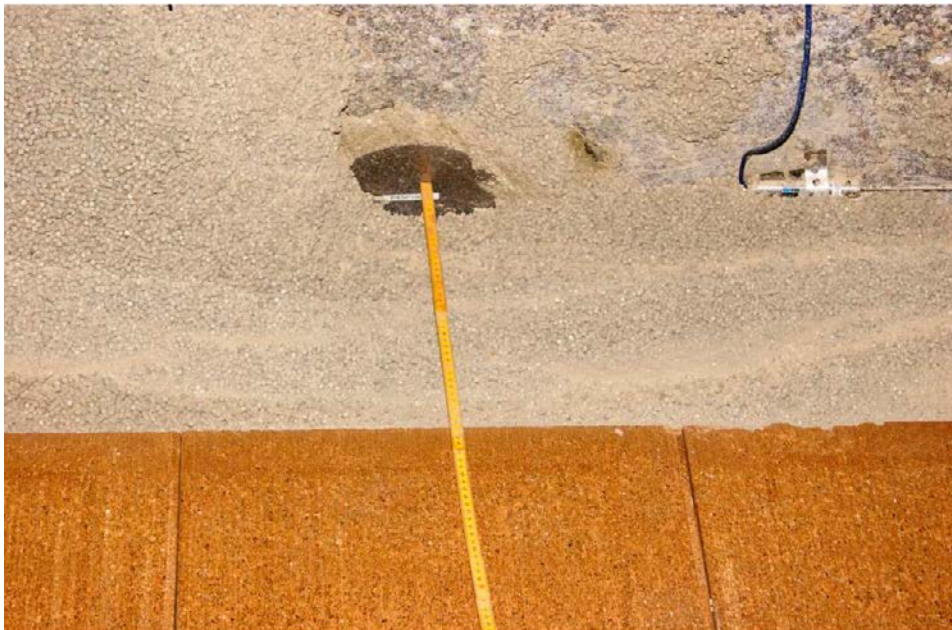
**Figure 4-28.** The distance between block stack and the pressure sensor (1) was determined to be 383 mm after test. .

The distance between backfill block stack and pressure sensor on the rock surface right above the deposition hole, was during installation measured to be 427 mm. Corresponding measurement was made during the excavation and the distance after the test was found to be 383 mm, Figure 4-11. This means that the block stack had moved approx. 440 mm upwards. The measurement of the block positions made by total station and reflectors, see section 4.3.2, indicated that the uppermost blocks had moved between 36 to 38 mm upwards.

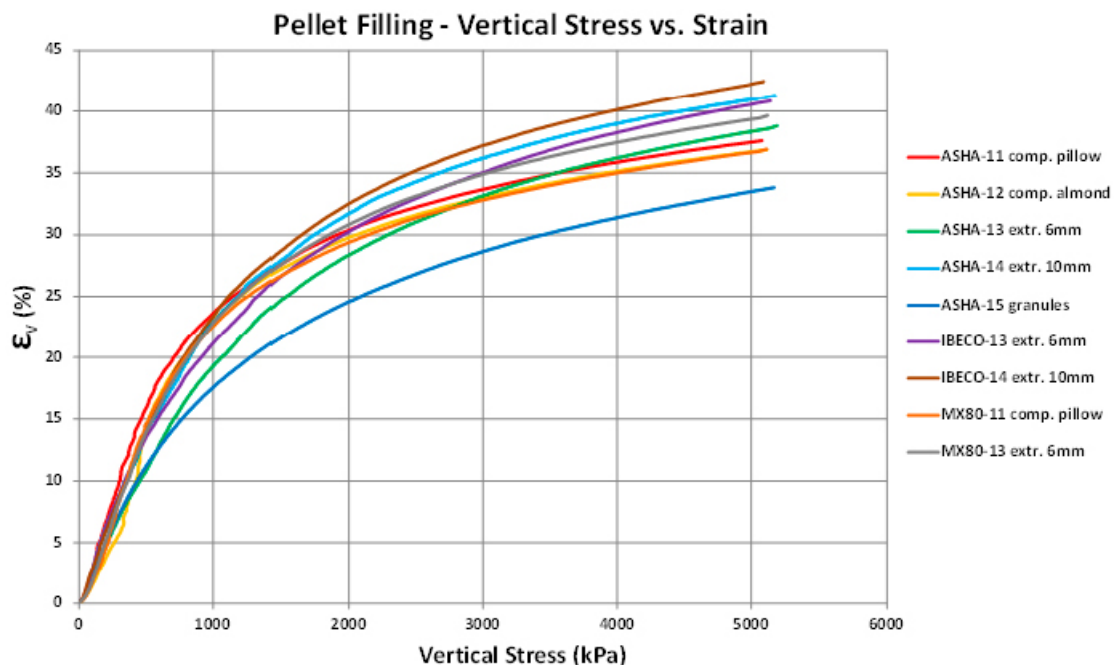
Figure 4-29. The strain of different pellet fillings plotted versus stress (Andersson and Sandén 2012).

Figure 4-29 shows results of a number of compression tests made in a large oedometer (Andersson and Sandén 2012). The strain of several different pellet fill options are plotted versus applied stress. In the Buffer Swelling Test, the maximum applied pressure from the buffer block was approx. 1.8 MPa. Figure 4-29 shows that this pressure corresponds to a strain of approx. 27–30 %. The measured compression of the layer above the buffer block was approx. 30 to 37 %, which is a little higher than observed in the laboratory. The comparison of lab and field data should also recognize that the buffer block was pushed an additional 80 mm upwards after reaching the maximum vertical stress. This reflects pellets (and backfill blocks) that were no longer consolidating but crushing. The BST arrangement also allowed for internal (and external) movements and volume strains as well as lateral displacement to occur, whereas the laboratory pellet tests did not allow for such mechanisms, hence larger strains could be reasonably expected to be observed in the field test.

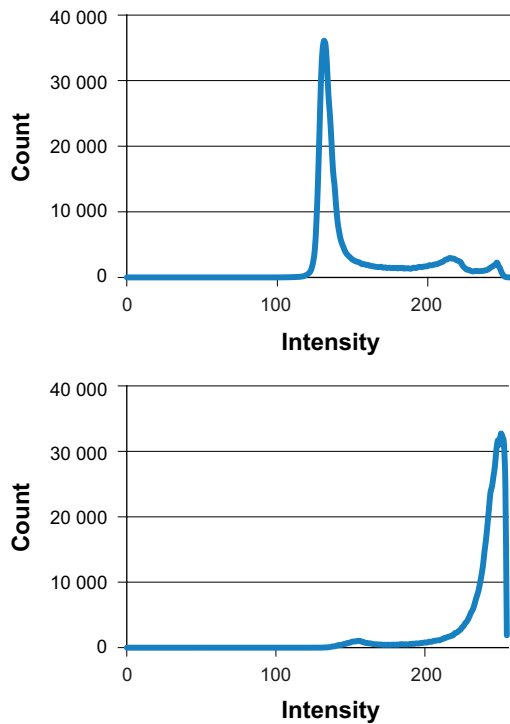
**Figure 5-3.** Histogram of scan shown in Figure 5-2. The number of pixels are on the Y axis and the intensity is on the X-axis with 0 = black and 256 = white. 0 corresponds to max pressure 2.5 MPa or 10 MPa depending on which film was used.

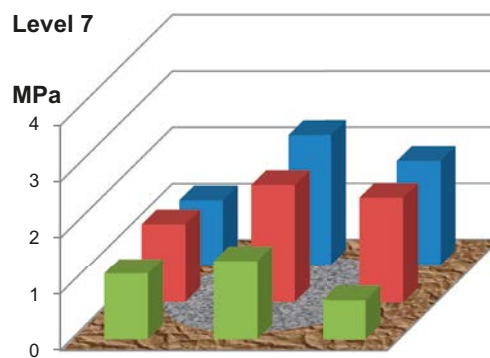
**Figure 5-6.** Evaluated pressure on the different instrumented horizontal levels seen from the tunnel entrance. Level 1 is located on the first backfill block layer etc. (see Figure 3-10).

Figure 5-5 to 5-7 show the evaluated stress from all pressure films.

The results provided by the pressure films are very scattered, varying from less than 0.5 MPa up to more than 3.0 MPa. There is no obvious trend, i.e. no decrease with distance from the floor or distance from the center line. This is probably a sign of that the results are not very reliable. However, it could also be caused by the failure of many blocks above the simulated deposition hole, since such a failure would reduce the lateral spreading of the pressure and tend to keep the pressure rather constant inside the cracked blocks. However, this trend is contradicted by the fact that the measured pressure in the ceiling was much lower.

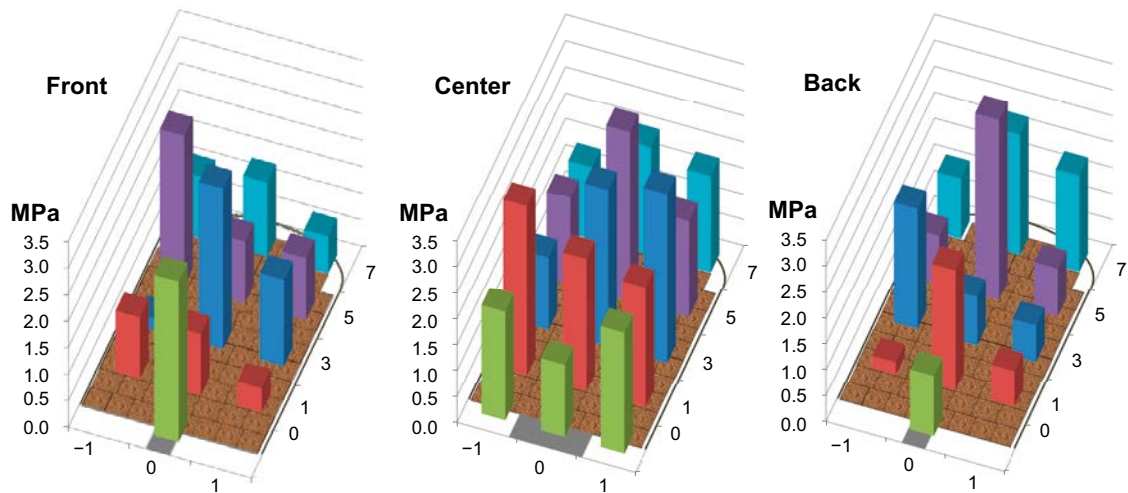
**Figure 5-7.** Evaluated pressure on the different instrumented vertical levels seen from the tunnel entrance (see Figure 3-10).

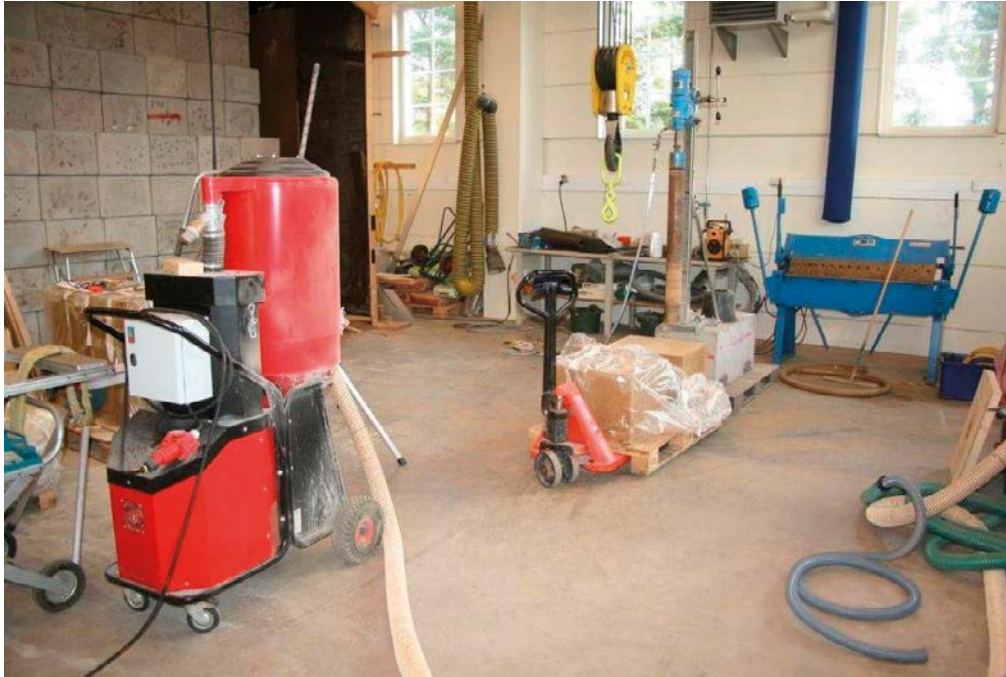
*Figure 6-1. Arrangement for the block sampling. The core drill is seen in the back of the picture and the vacuum cleaner, used for removing dust, in the front.*

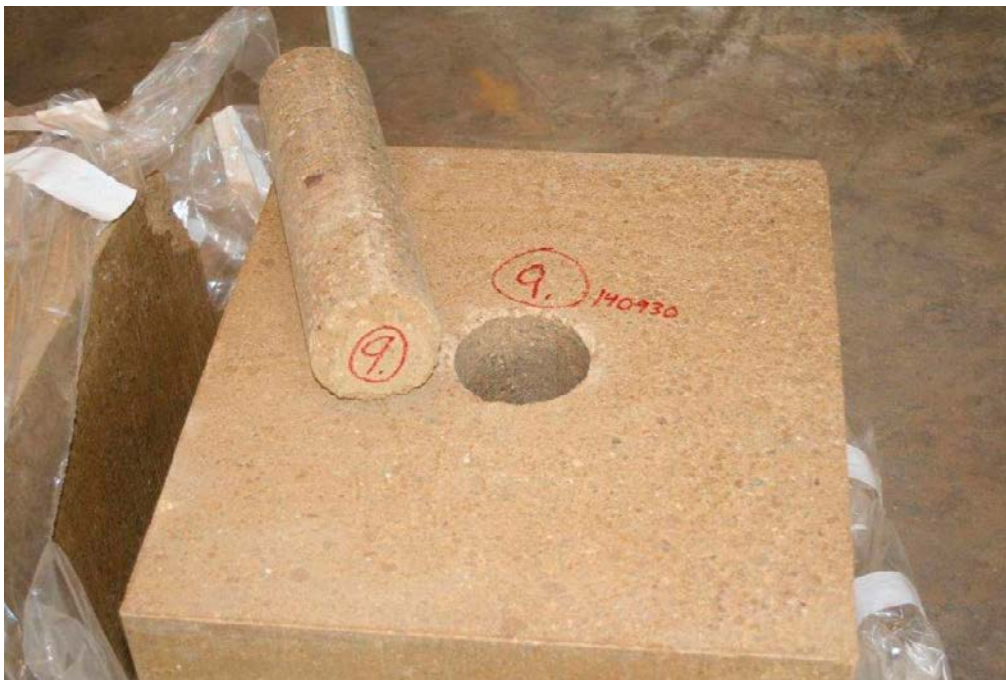
*Figure 6-2. A core with diameter 100 mm has been drilled out from the block centre.*

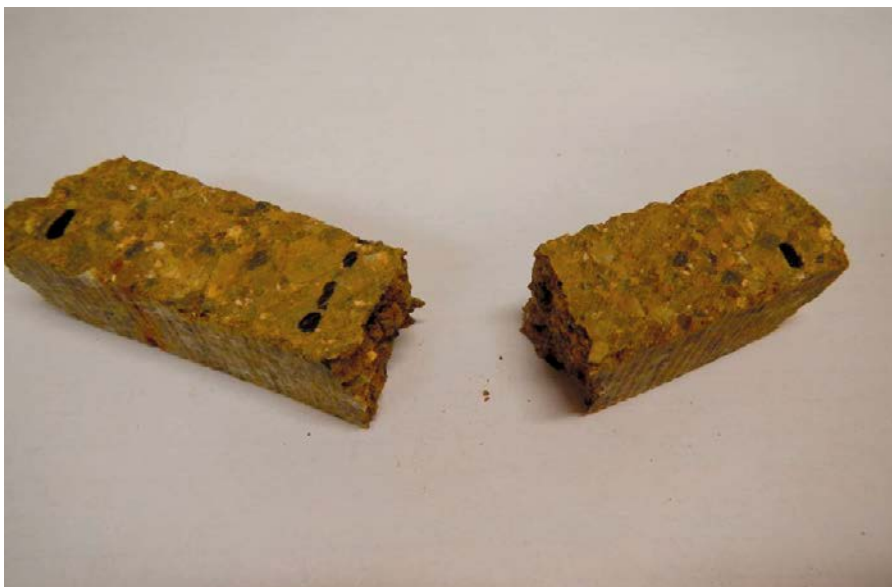
*Figure 6-5. Photo showing a beam after the test.*

Figure 6-4 shows a typical behaviour of the beams tested. A small fracture develops close to the midpoint and finally the beam is divided in two pieces, Figure 6-5. After the tests the pieces of beam were used to determine the density and water content. Figure 6-4 and Figure 6-5 also show how the original granularity of the crushed raw bentonite used in manufacturing the backfill blocks remain visible (individual granules still visible in the beam) and that the fracture is developed between the granules.

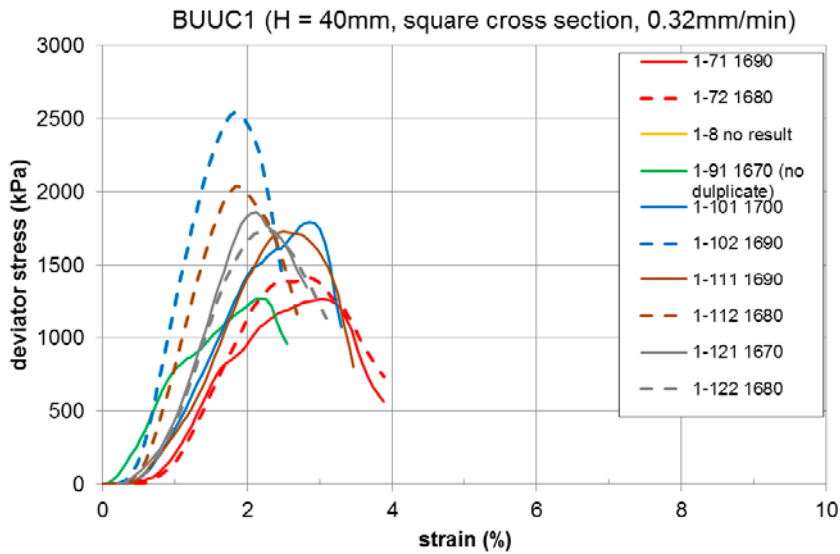
**Figure A3-1.** Deviator stress as a function of strain resulting from test series 1 (BUUC1). A total of 9 samples from blocks 7–12, not from block 8, were tested. The deformation rate was 0.32 mm/min and the specimens had square cross section with a side of 20 mm and a height of 40 mm.

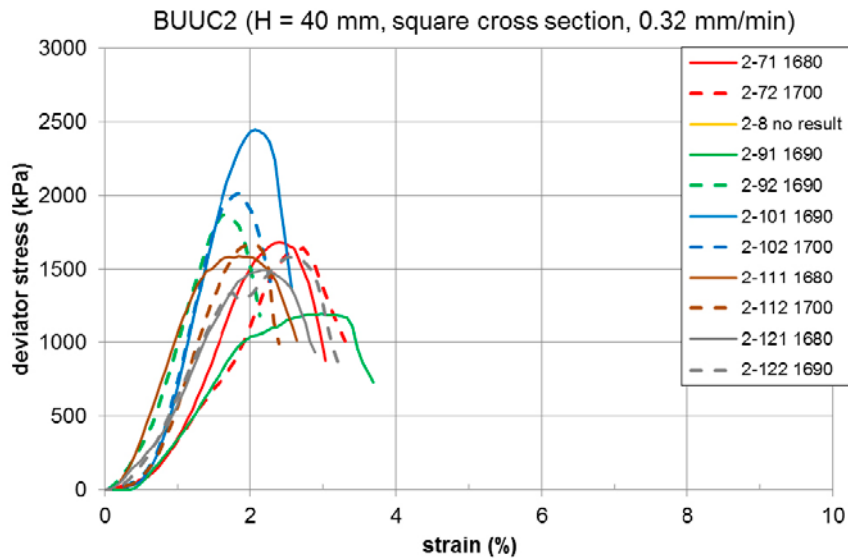
**Figure A3-2.** Deviator stress as a function of strain resulting from test series 2 (BUUC2). A total of 10 samples from blocks 7–12, not from block 8, were tested. The deformation rate used was 0.32 mm/min and the specimens had square cross section with a side of 20 mm and a height of 40 mm.
