**TR-16-07**

# Full scale Buffer Swelling Test at dry backfill conditions in Äspö HRL

## In situ test and related laboratory tests

SVENSK KÄRNBRÄNSLEHANTERING AB

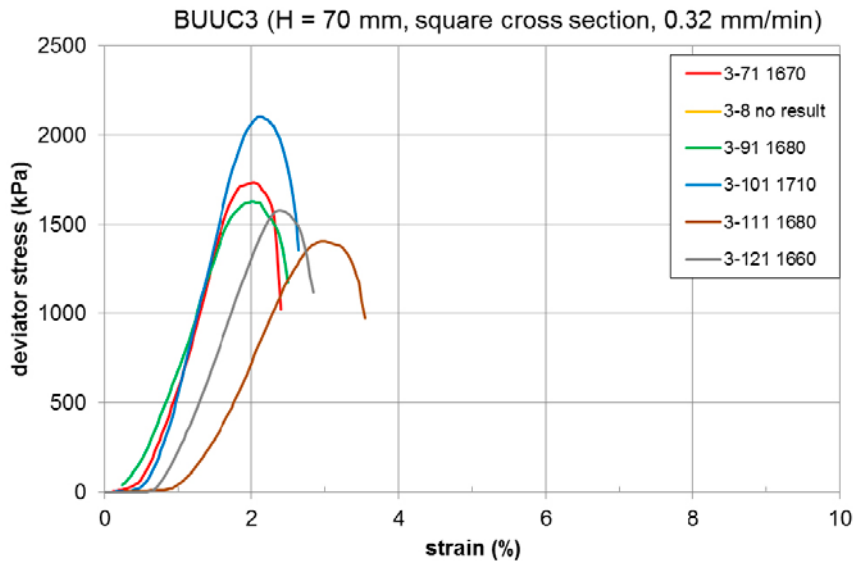
**Figure A3-3.** Deviator stress as a function of strain resulting from test series 3 (BUUC3). A total of 5 samples from blocks 7–12, not from block 8, were tested. The deformation rate of the tests was 0.32 mm/min and the specimens had square cross section with a side of 35 mm and a height of 70 mm.

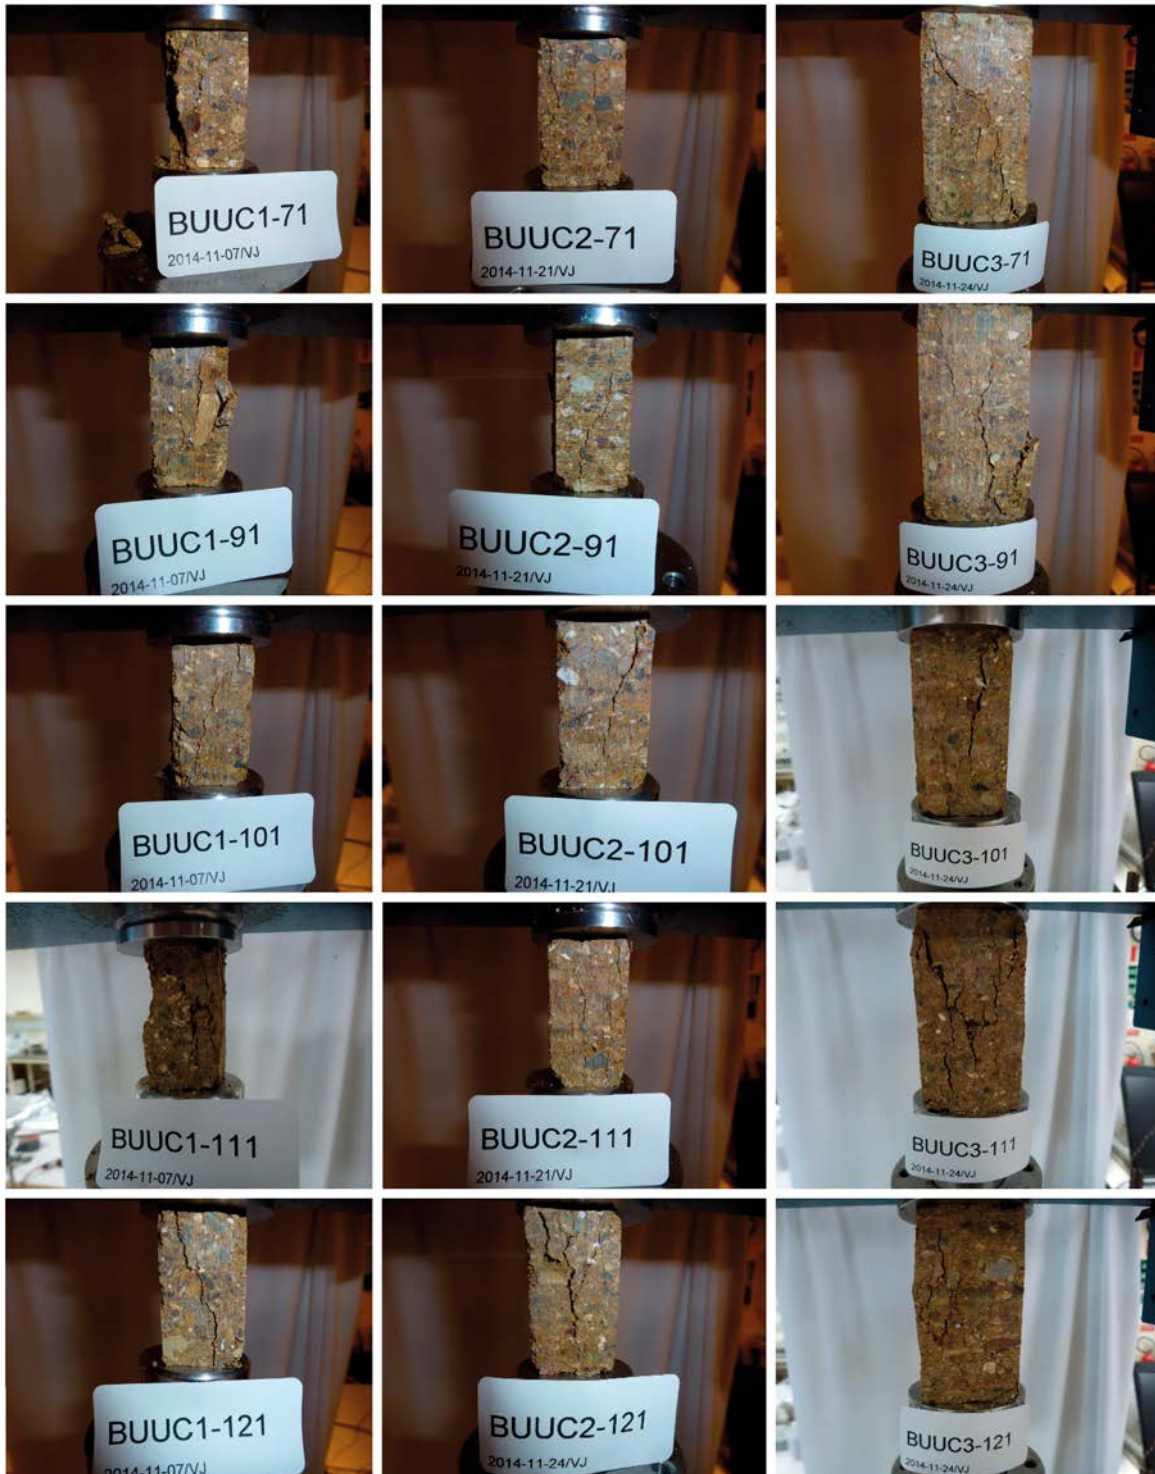
*Figure A4-1. Post-failure photos from series 1 (BUUC1 – column to the left), series 2 (BUUC2 – the middle column) and series 3 (BUUC3 – column to the right). Each row show photos of samples from the same block, i.e. 7–12, except 8.*

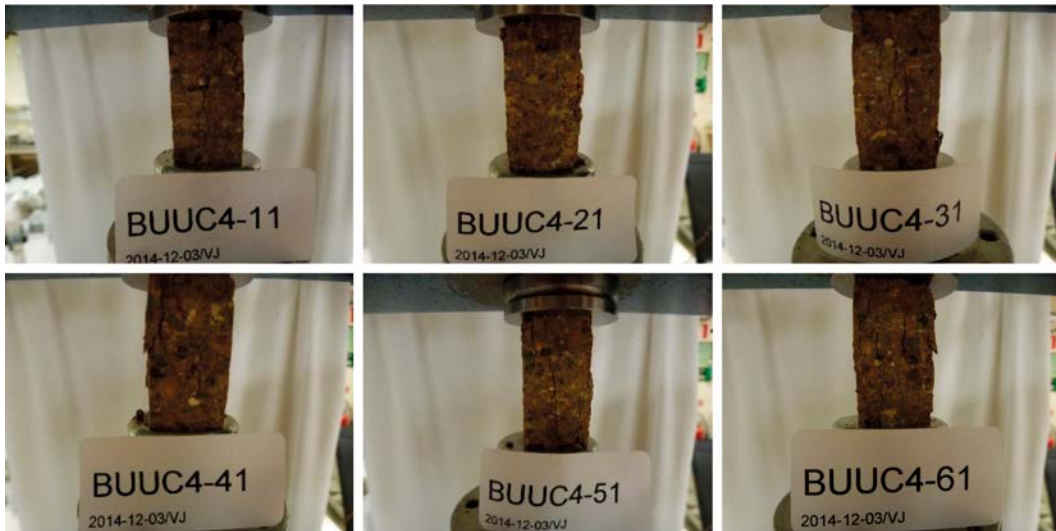
*Figure A4-2. Photos of specimens from blocks 1–6 tested in series 4 (BUUC4).*
