**TR-18-12**

January 2019

# Concrete caissons for 2BMA

## Large scale test of design and material

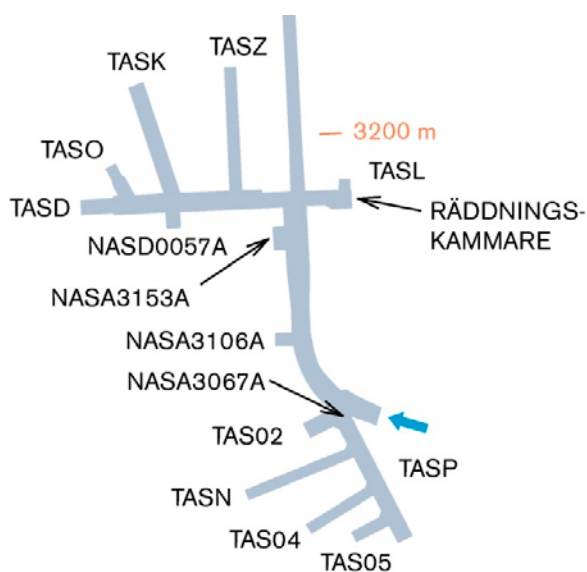
Figure 2-1. The location of TAS05.

TAS05 is situated in the TASP section of the tunnels at Äspö HRL, approximately 3 100 m from the entrance at a depth of about 420 m. The dimensions of TAS05 are approximately 16 m in length, 6 m in height and 4.5 m in width. When the work was initiated, TAS05 had been cleaned from all rock debris from the excavation work and solid rock was exposed on all sides. An overview of the area around TAS05 is shown in Figure 2-1.

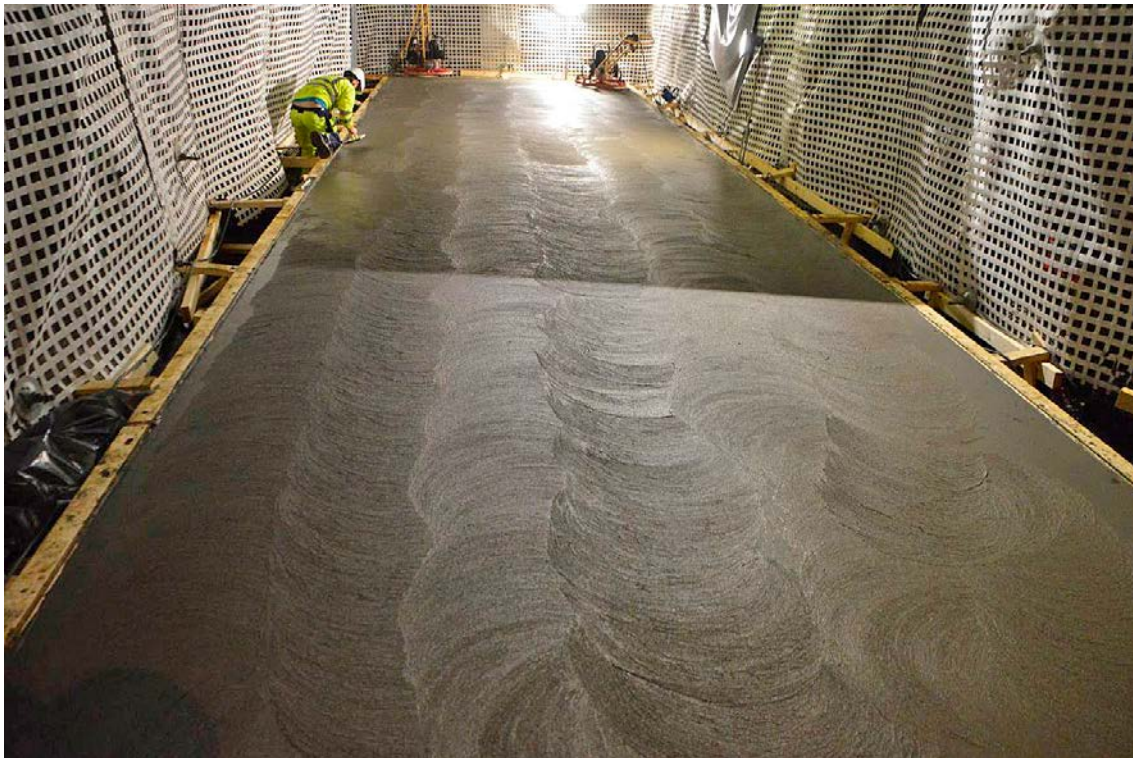
*Figure 2-2. Levelling of TAS05 with a reinforced slab on the crushed rock.*

The reinforced concrete slab which is part of the foundation has the dimensions 15 x 4.05 x 0.5 m. The total height of the foundation was approximately 0.8 m. Therefore, the available height in TAS05 was about 5.2 m.

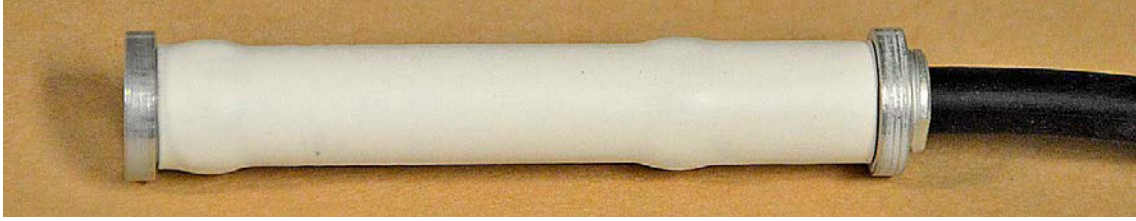
The basic setup of the transducer is simple. A strain gauge is attached to a metal bar with end caps. The metal bar is placed inside a tube (metal or plastic) for sealing off the strain gauge from the surrounding concrete and thus achieving a free strain length between the end caps. Manufactured strain transducers with a length of 2 m have been successfully used in projects with field measurements (Vogt et al. 2010). Figure 3-4 shows a manufactured strain transducer.

Figure 3-3. Strain gauge transducer.

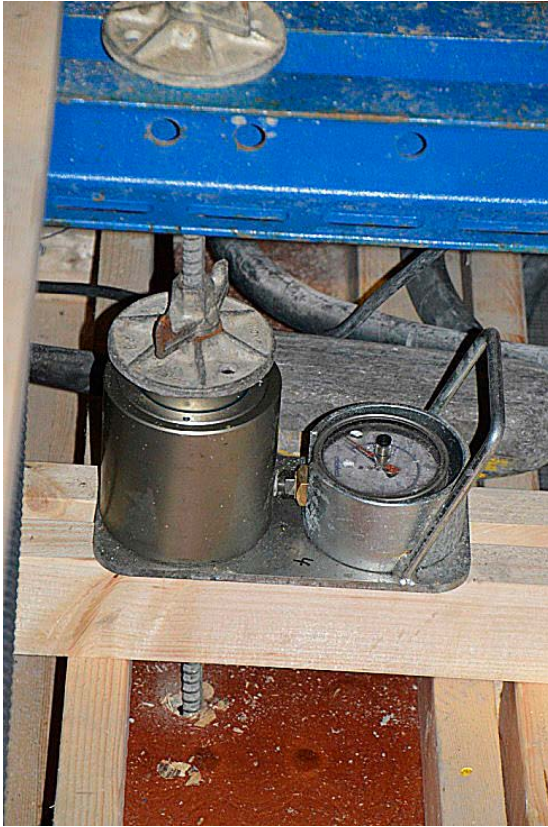
Formwork pressure was monitored using mechanical analogue load cells mounted on the tie rods of the form work, Figure 3-9. This was used only to follow the form work pressure during casting to ensure that form work pressure did not exceed the dimensioning loads.

*Figure 3-9. Load cell for control of formwork pressure during casting.*

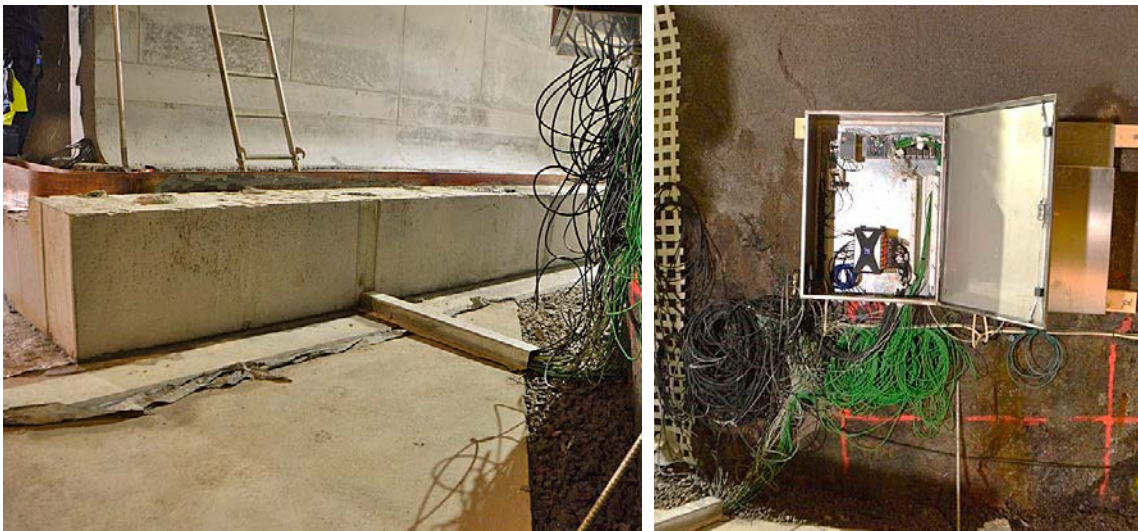
*Figure 3-10. All cables from the different sensors were collected into one bundle (left image) and signals were collected in the control cabinet (right image).*

A system for data acquisition and storage was installed, Figure 3-10. The installation was constructed to withstand the high humidity in the tunnel. Data could be remotely downloaded.

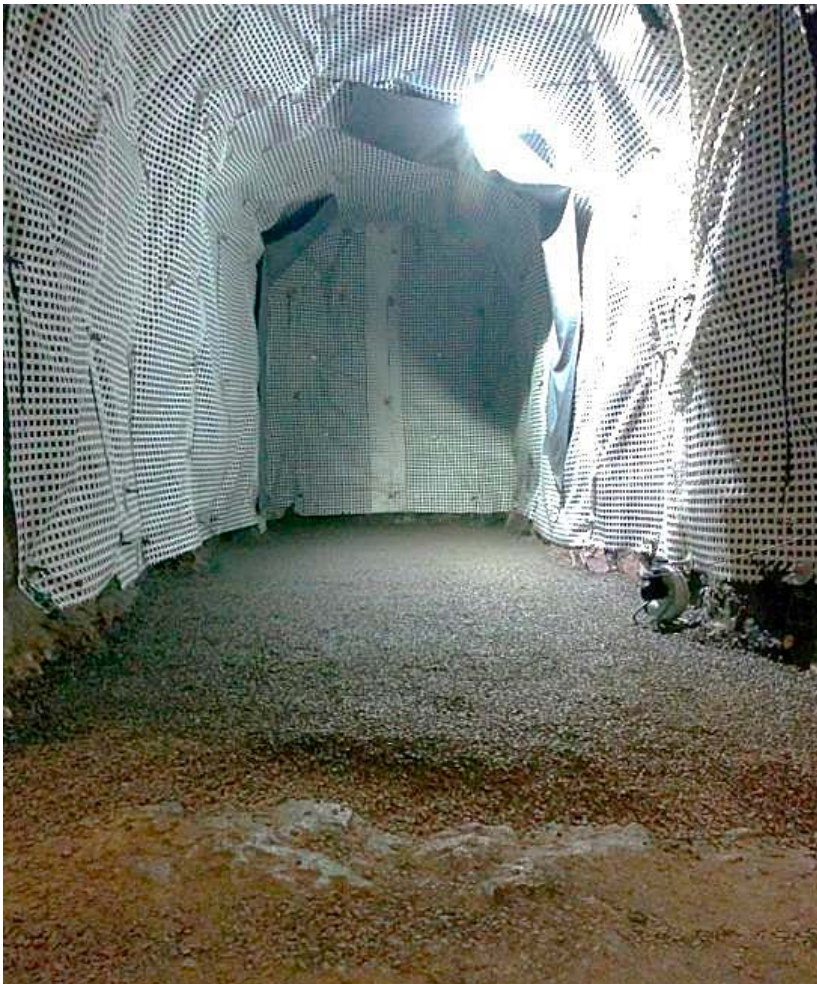
*Figure 4-1. TAS05 after rock reinforcement and levelling of the tunnel floor.*

After excavation, TAS05 was cleaned from the debris caused by blasting leaving a bare but rather uneven rock floor. After the largest level differences in the tunnel floor were remedied, the floor was covered with a draining bed of macadam with a minimum thickness of about 100 mm. The bed was levelled and packed according to industry standard, Figure 4-1.

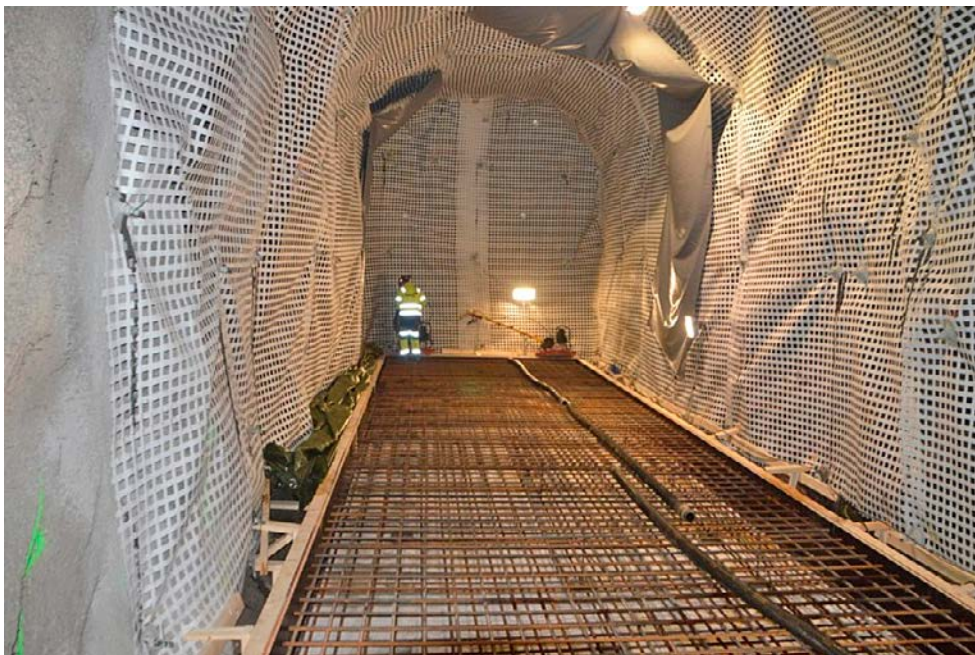
The formwork was made from simple wooden board kept in place by wooden studs fixed to the rock wall. A geo textile was placed on the drainage layer on which then the reinforcement was mounted. In Figure 4-2 all preparations for casting of the concrete slab have been made and the concrete hose laid out on the reinforcement bars.

*Figure 4-2. All preparations have been made for casting of the concrete slab.*

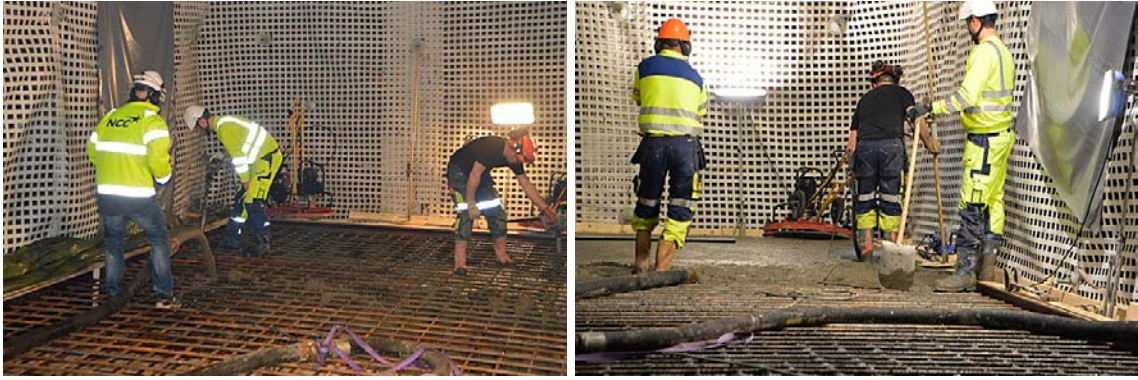
*Figure 4-3. Casting of the concrete slab has started (left image) and casting and trowelling of the topmost layer (right image).*

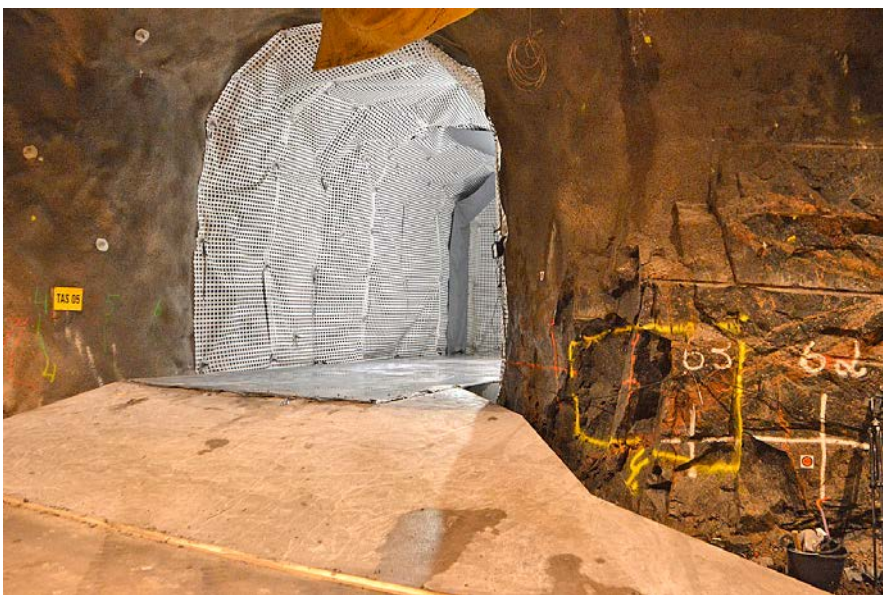
Finally, in order to facilitate easy access to the concrete slab during the following work, a ramp was constructed, Figure 4-5.

*Figure 4-5. All is ready for erecting the formwork for section 1.*

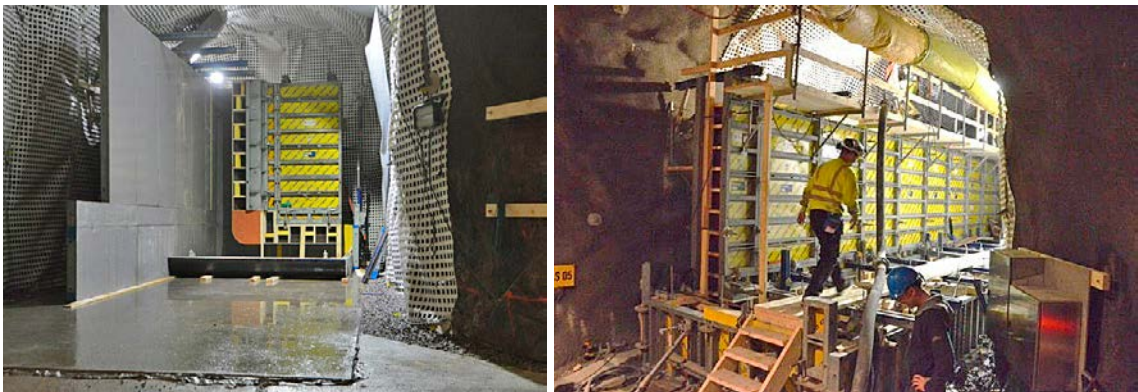
*Figure 5-1. The formwork under construction (left image) and ready just prior to casting (right image).*

The formwork (Doka system formwork) was erected on top of the foundation and fixed against the adjacent rock walls, Figure 5-1. In Figure 5-2 an example of the wooden structure made to shape the fillets is shown.

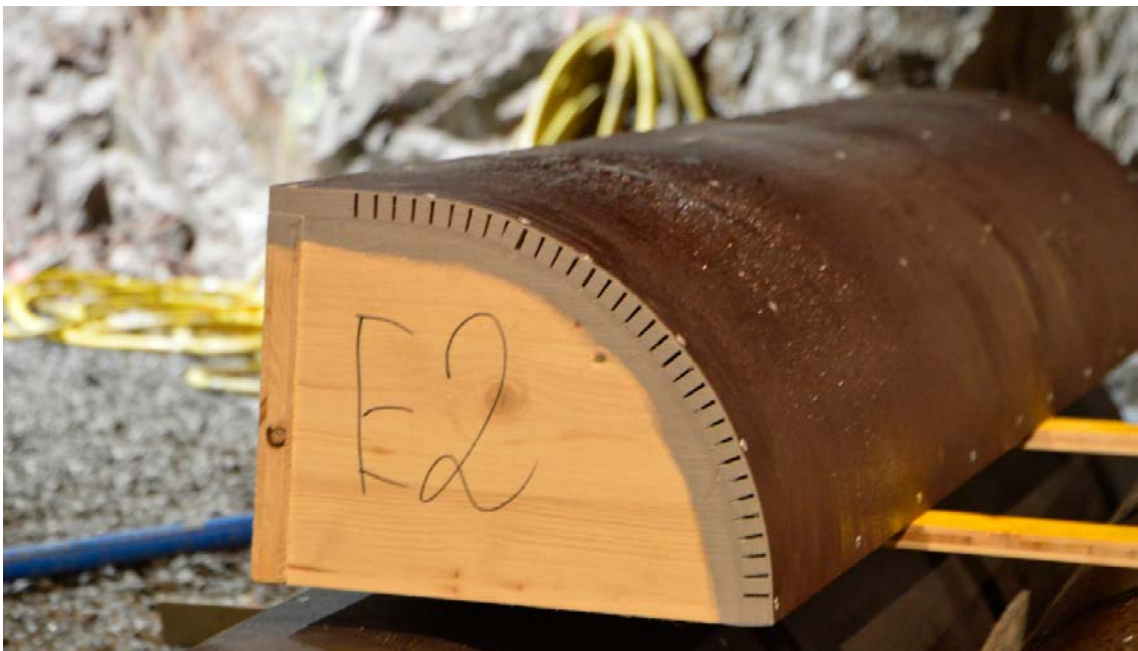
*Figure 5-2. The part of the formwork used to shape the radius between the base slab and the wall of section 1.*

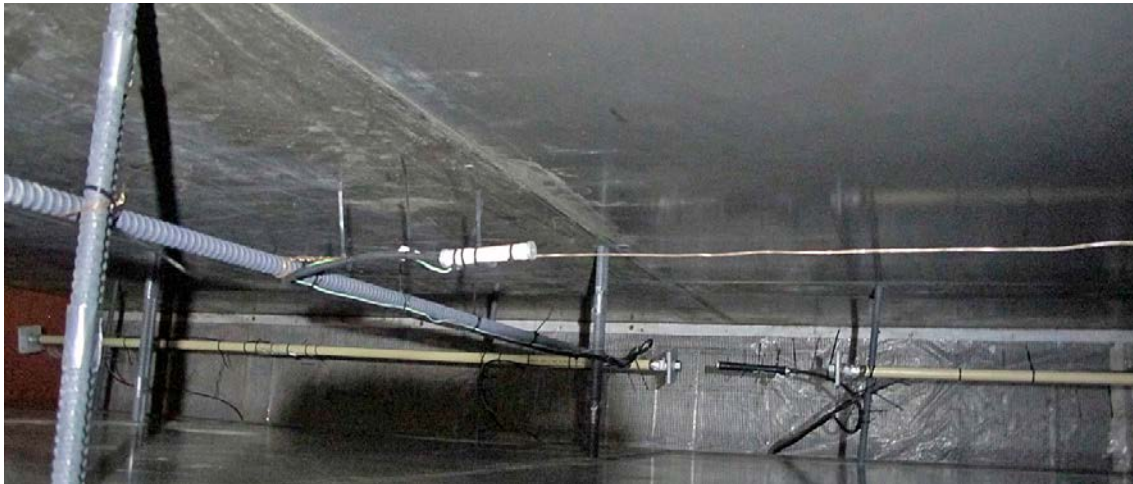
*Figure 5-3. Sensors suspended on the system of rods inside the form work of the wall of section 1.*

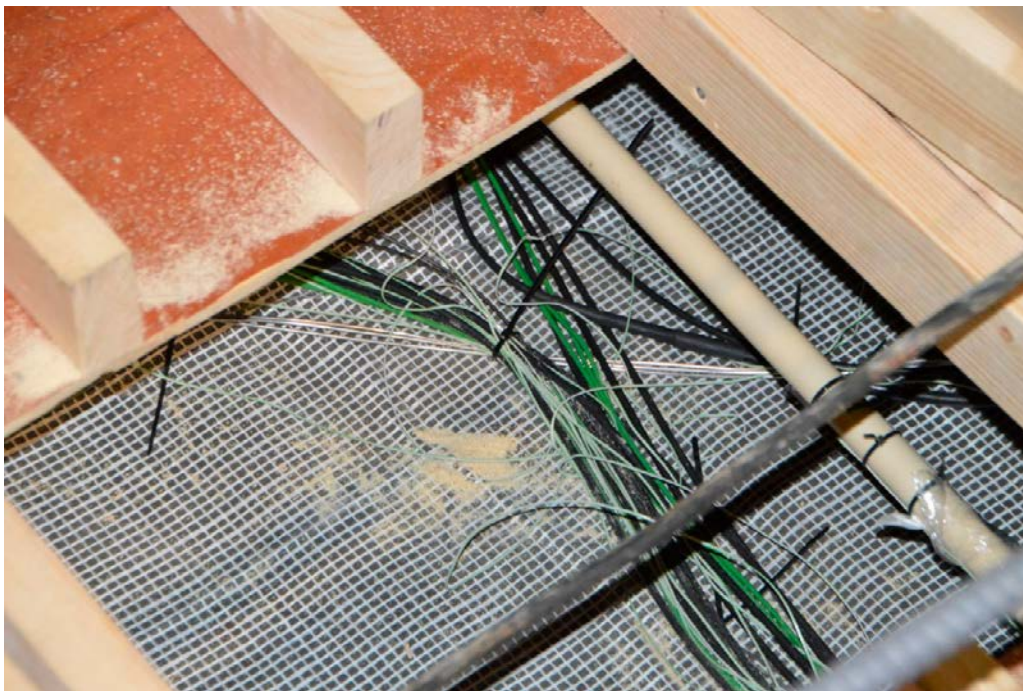
*Figure 5-4. Cables from the sensors placed on the plastic foil on top of the concrete slab. Note that the cables are loose and unprotected.*

In order to reduce the adhesion between the base slab of section 1 and the foundation, the concrete slab was covered with a reinforced plastic foil, Figure 5-4. This foil was put in place when the base slab was covered so that it would not be damaged during formwork construction.

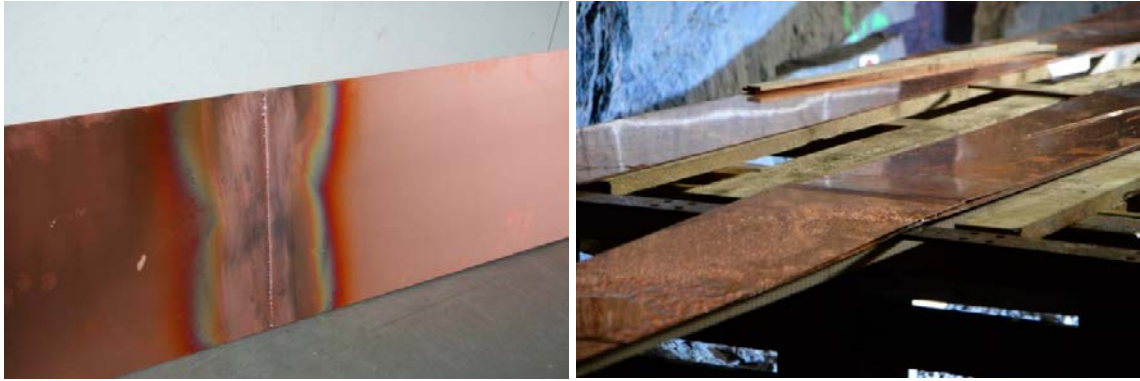
The joint seals were manufactured from 1.5 mm thick and 300 mm wide copper sheets on site. The copper sheets were then welded together to the required length, Figure 5-5, and mounted in the formwork of section 1, Figure 5-6, according to the outline in Section 2.5.2.

*Figure 5-5. Welded copper sheets.*

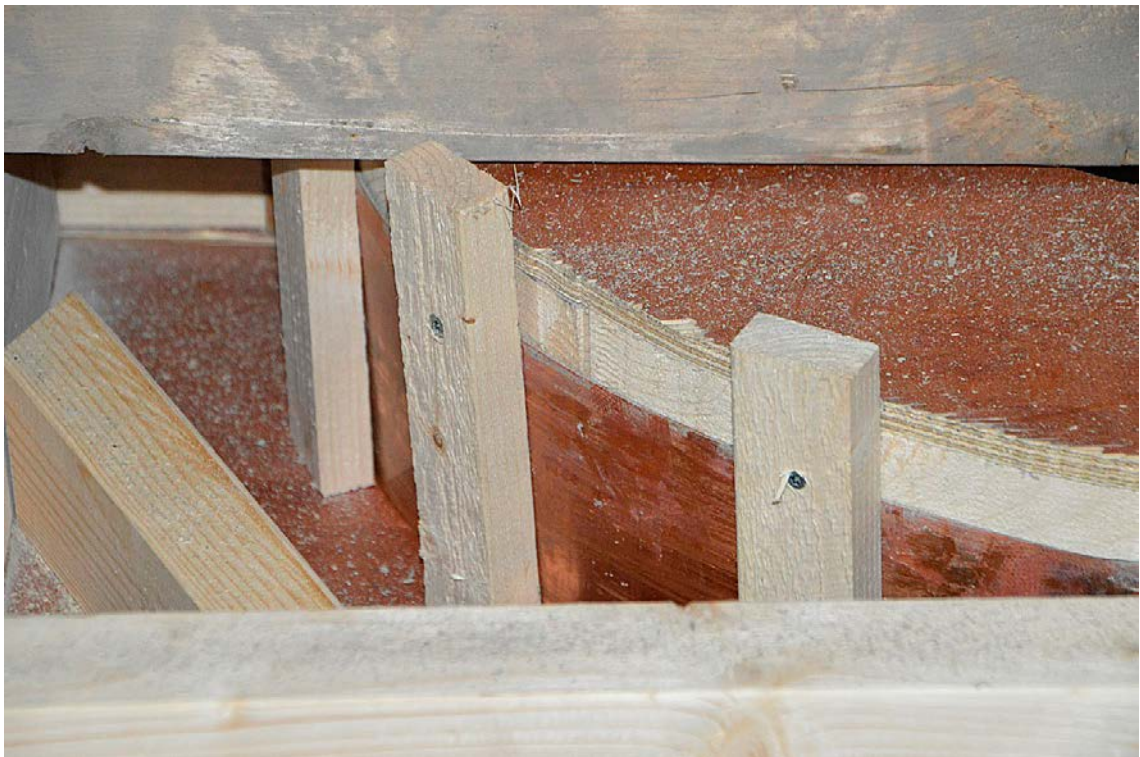
*Figure 5-6. A copper joint seal is mounted in the radius between the two walls of section 1.*

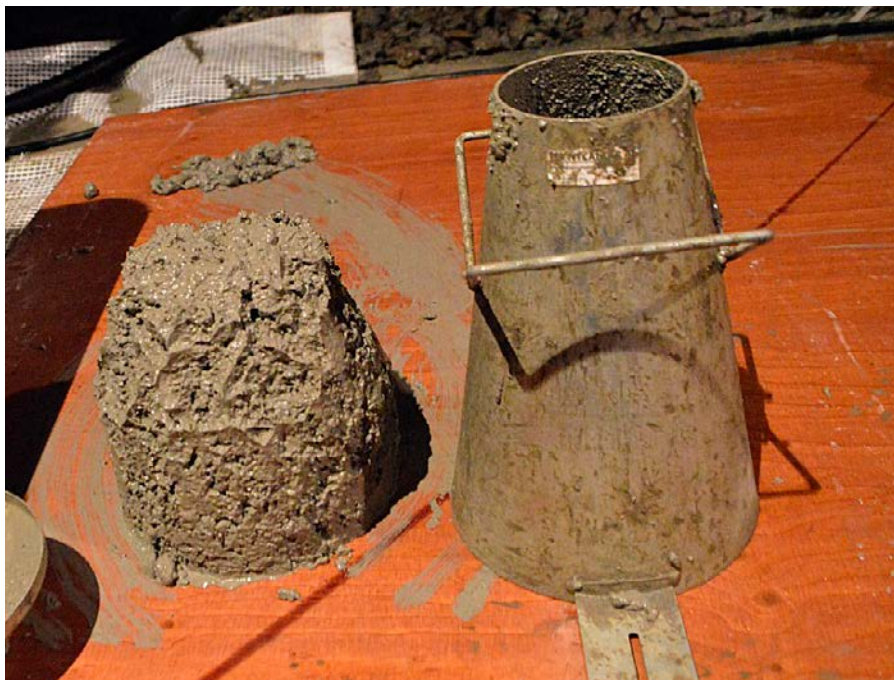
**Figure 5-8.** A typical example of a stiff concrete from one of the concrete trucks prior to adjustments.

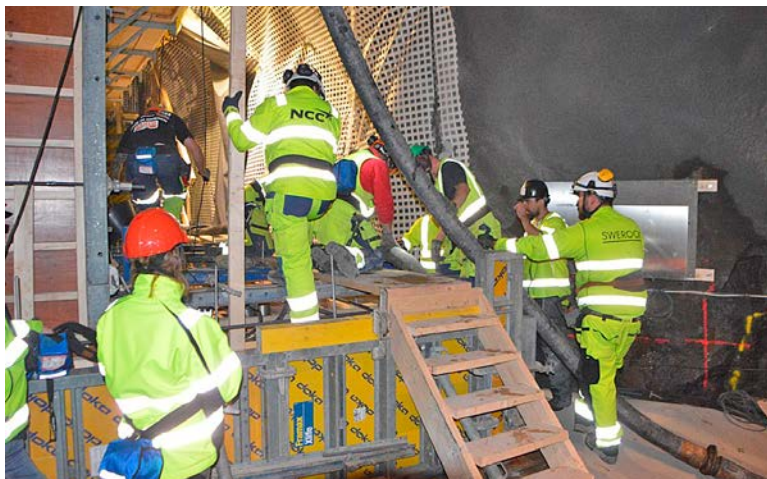
*Figure 5-9. Casting of the base slab.*

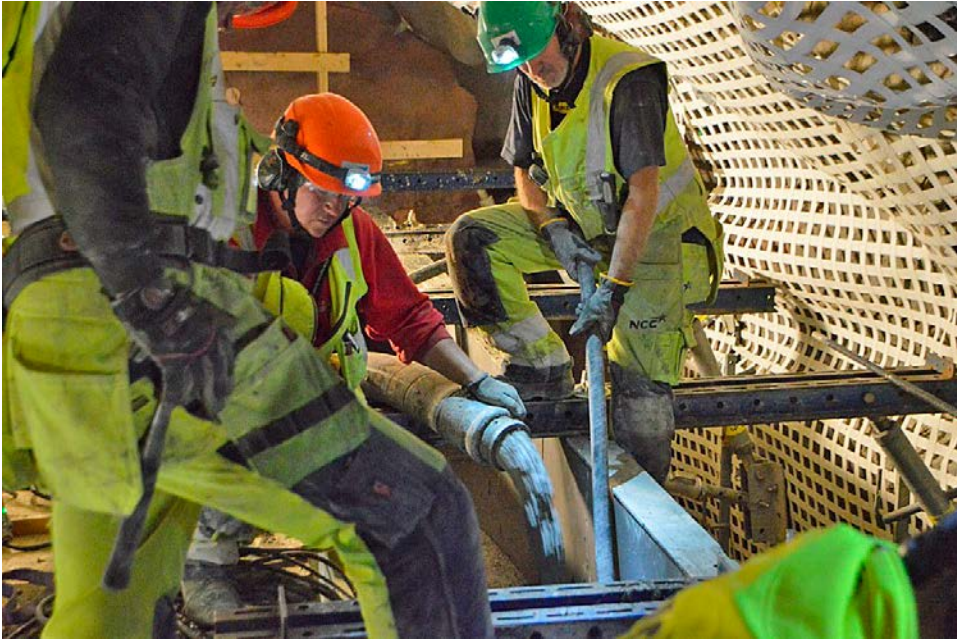
*Figure 5-10. Casting of the walls of section 1 and vibrating the concrete.*

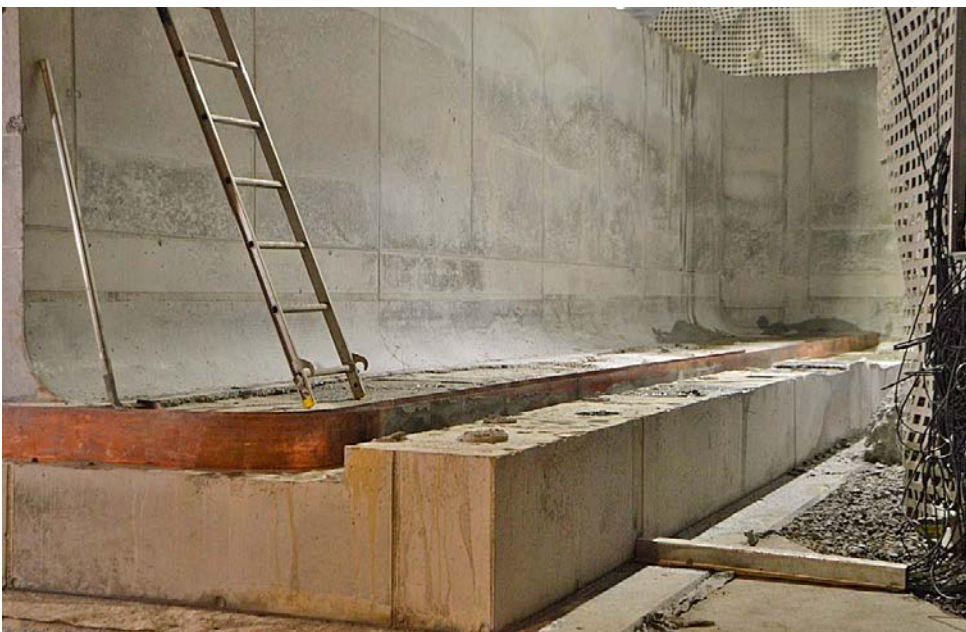
Immediately after demoulding, an inspection was carried out where the result of the casting was investigated. The focus was on surface smoothness, occurrence of air blisters or other surface imperfections, adhesion to joint seals and finally mould filling where the main focus was on mould filling in the base slab. An overview image is shown in Figure 5-11.

As shown in Figure 5-11, section 1 has the expected shape with joint seals at the location where the wall to section 2 is to be erected. At first glance the wall looks fine while the base slab is rough and very uneven.

*Figure 5-11. Section 1 just after disassembling of the formwork.*

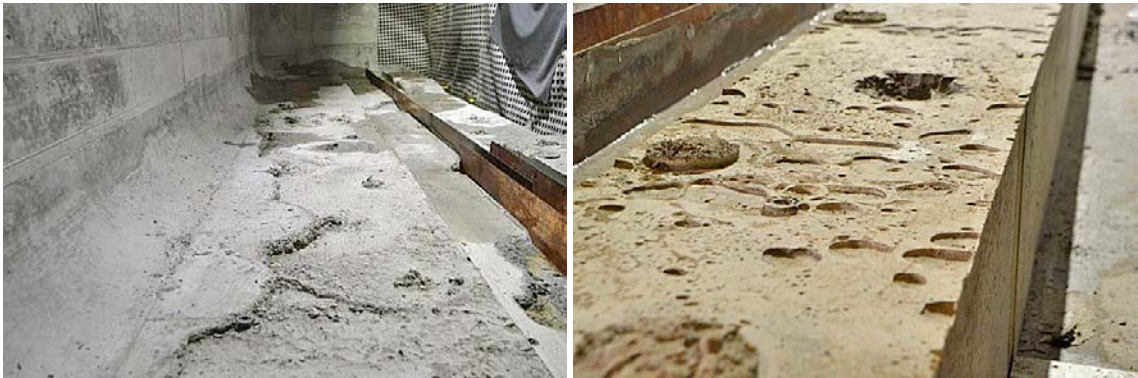
As shown in Figure 5-12, full form filling of the base slab has not been obtained. This is explained by the fast stiffening of the concrete during casting of the base slab. For a more detailed discussion of the problems encountered during this work, please refer to Section 5.7.1.

*Figure 5-12. Images showing details of different types of imperfections in the base slab.*

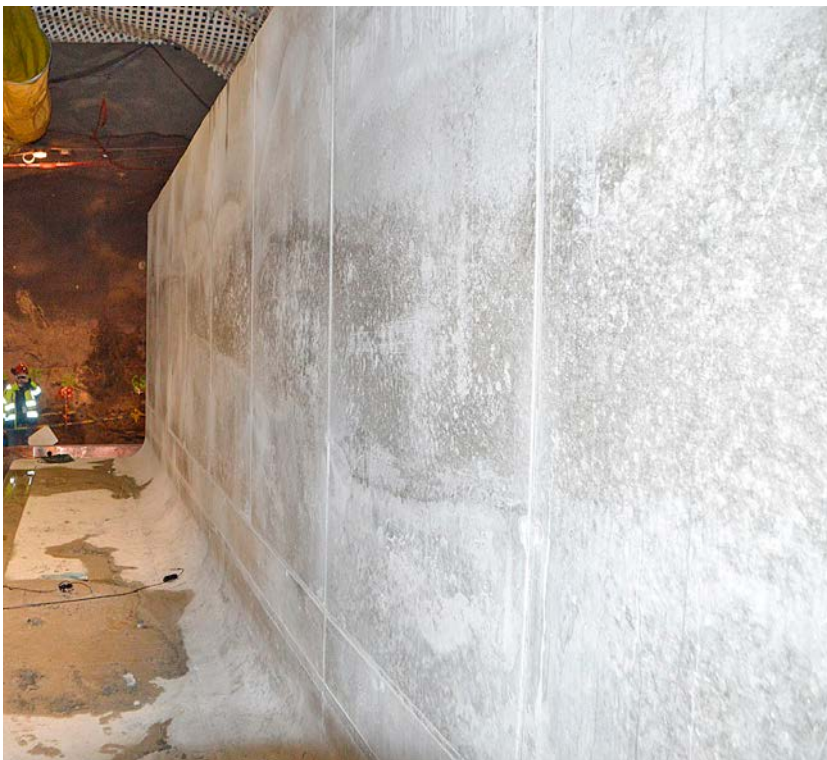
The mould filling in the walls and fillets was considerably better than the base slab and the surfaces were smooth with only a few very small imperfections, Figure 5-13.

*Figure 5-13. The surface of the walls were smooth and only a very few imperfections were detected. Also, the concrete was dense and homogeneous in spite of the encountered problems.*

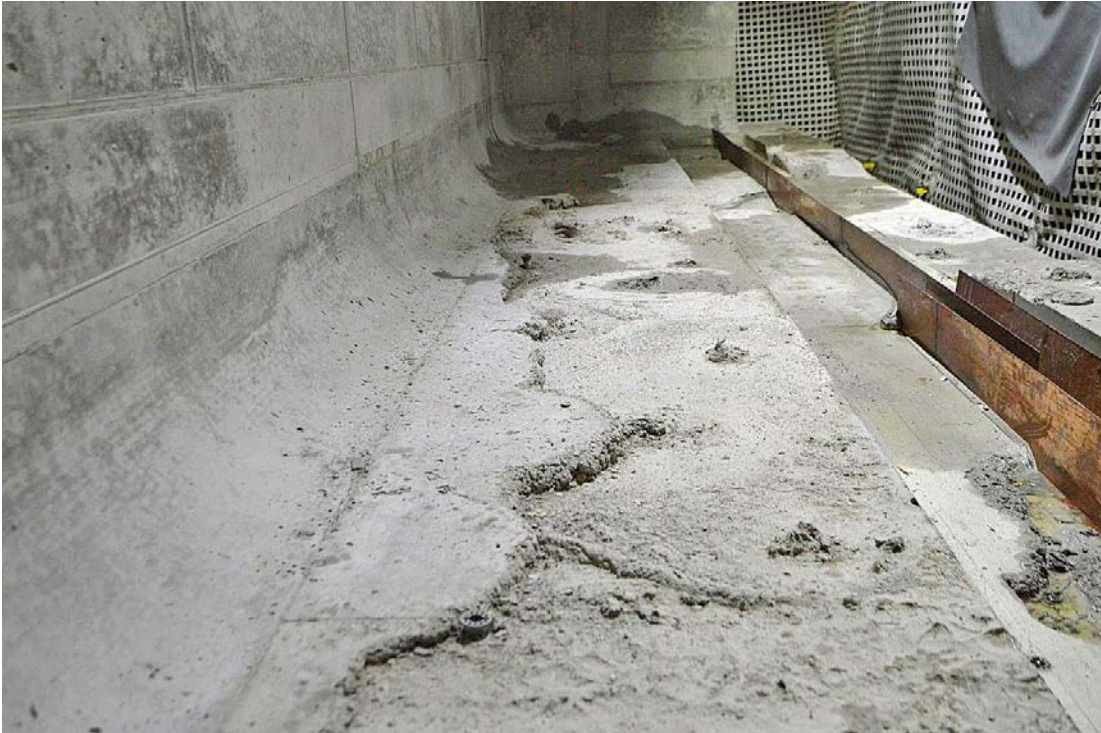
*Figure 5-14. Image showing the complete filling of the fillet between the wall and the base slab of section 1. However, in this image it is also shown that the concrete has not entirely covered the surface of the base slab due to low mobility.*

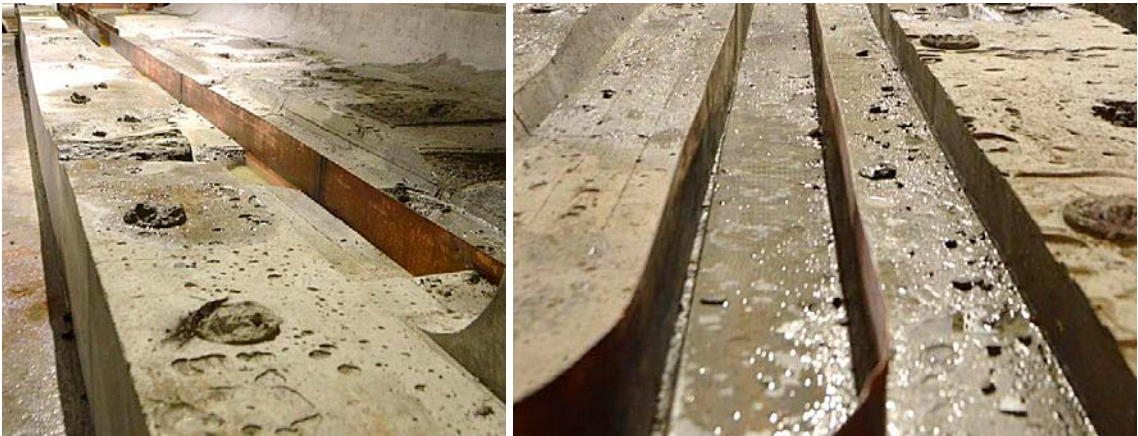
*Figure 5-15. The joint seal mounted in the base slab at the position of the future section 2 of the concrete structure.*

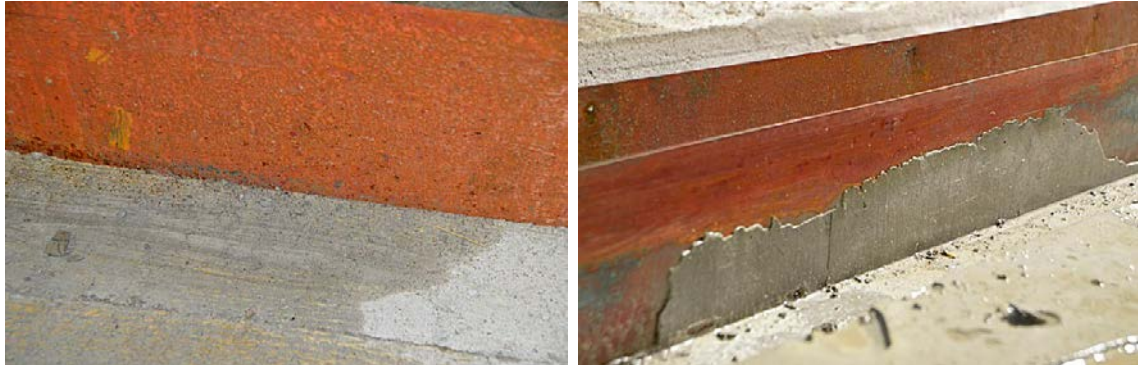
As shown in the left image in Figure 5-16 the connection between joint seal and concrete was good and no gaps were noted. In addition, the right picture in Figure 5-16 shows that the adhesion was strong enough to withstand the forces occurring during demoulding.

Figure 5-16. Images showing the adhesion between the concrete and the joint seal.

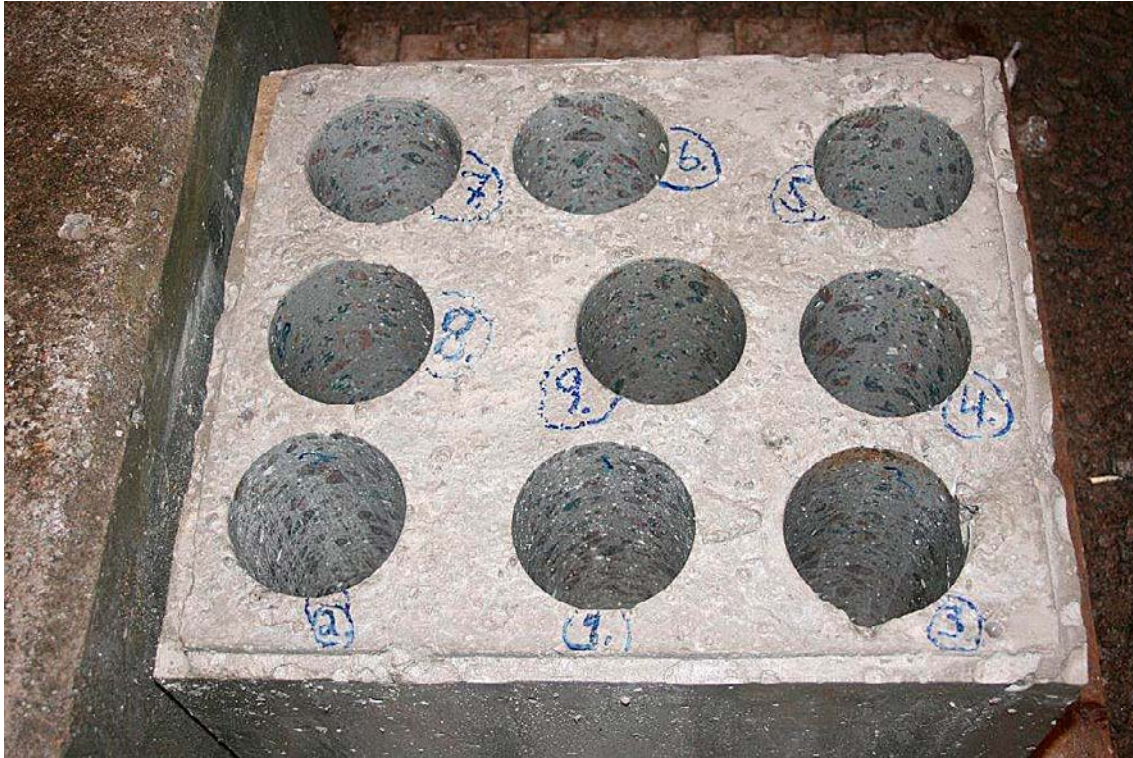
**Figure 5-17.** The small cube cast from concrete from truck #7 after drilling of cores for testing of compressive and tensile strength. Numbers refer to specimens numbers in Table 5-6 and 5-7.

Core	Weight (g)	Density (kg/m <sup>3</sup> )	Force (kN)	Compressive strength (Mpa)
1	1833	2360	527.2	67.0
2	1852	2360	527.6	67.2
5	1821	2360	539	68.4
8	1822	2340	529.9	67.3
9	1820	2360	540.6	68.6

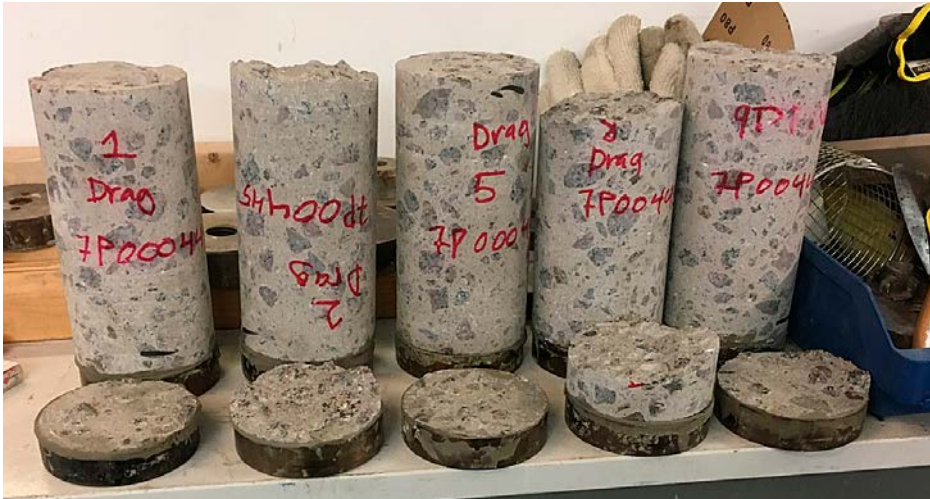
Figure 5-18. Cores used for measurements of tensile strength after testing.

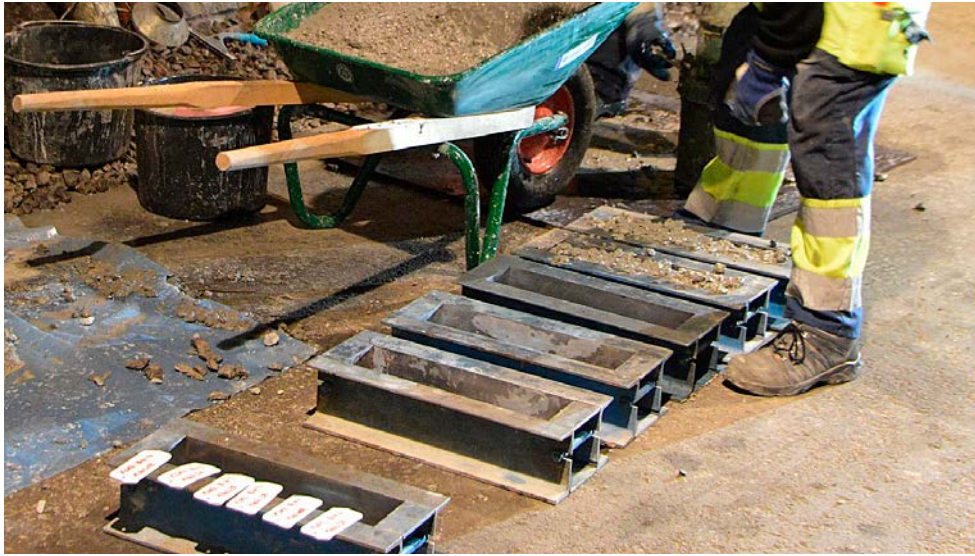
Figure 5-20. Casting of specimens for shrinkage measurements.

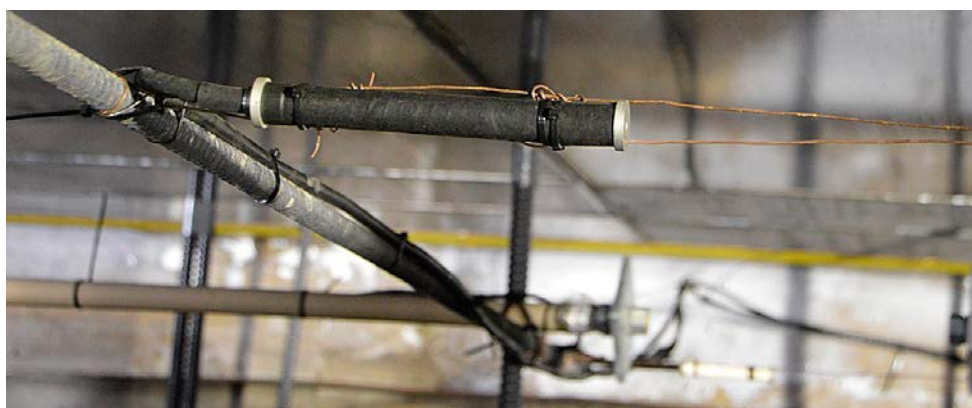
The sensors were mounted in the formwork according to principles used for section 1, Figure 6-2. See Chapter 3 for details on the sensors used and their respective positions.

*Figure 6-2. Sensor suspended on the system of rods inside the formwork of the wall of section 2.*

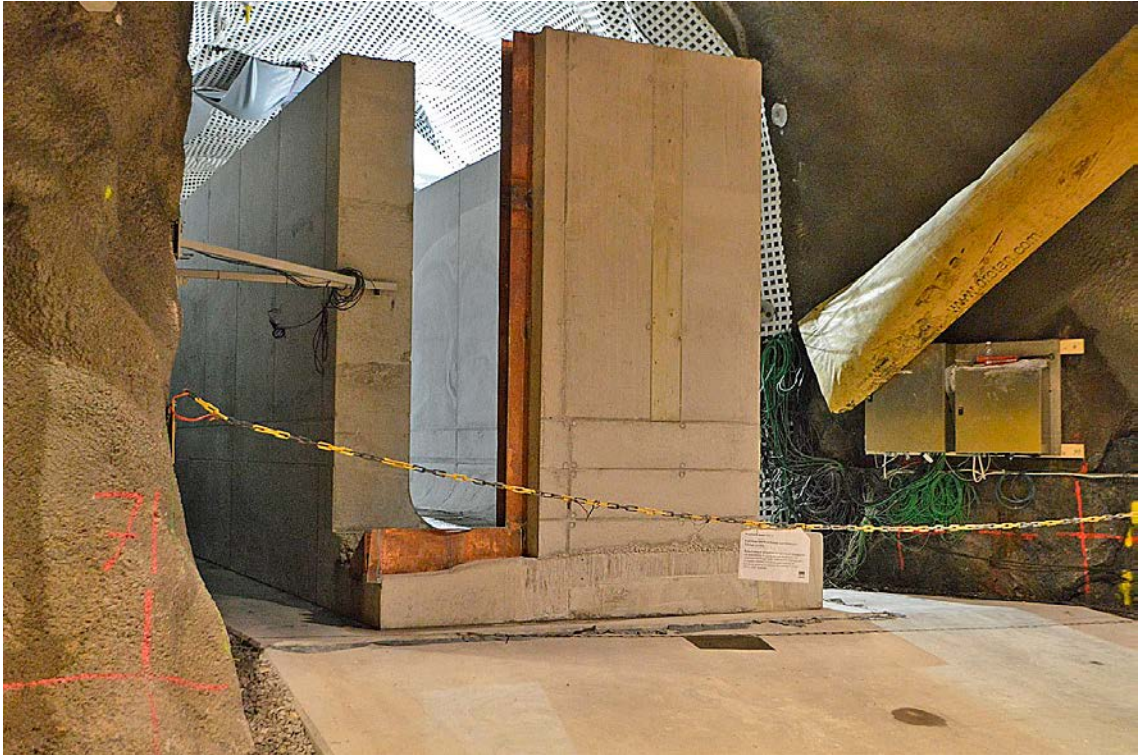
**Figure 6-5.** An overview image of section 1 (left part) and section 2 (right part). The horizontal joint seal in the base slab and the vertical joint seal in the wall of section 2 are clearly visible.

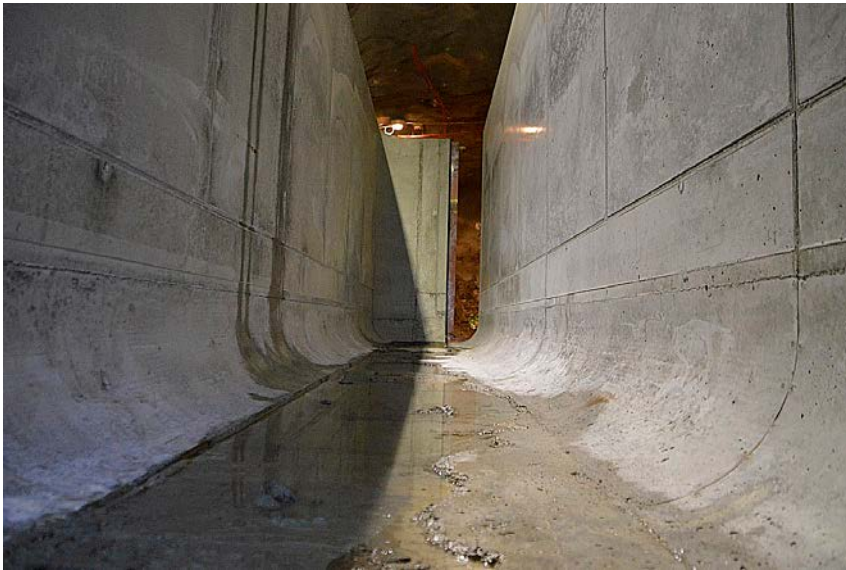
**Figure 6-6.** The interior of the concrete structure with section 2 to the left and section 1 to the right. Note the rather large amount of water on the base slab caused by ground water dripping from tunnel roof.

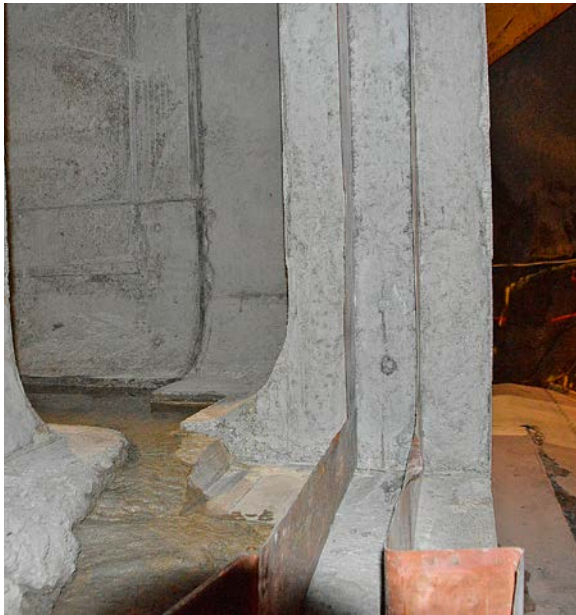
As shown in Figure 6-7, filling between the double joint seals is complete. This was expected thanks to the excellent properties of the fresh concrete. An image of the interface between the joint seal and the concrete is shown in Figure 6-8. Here it is shown that the connection between the joint seal and the concrete is also of high quality and no gao has been formed. Attempts to measure the tensile strength of the bond between the concrete and the copper sheet were, however, not successful due to debonding during specimen preparation.

*Figure 6-7. Form filling in the fillet between section 2 and the base slab of section 1. This image also shows that the filling between the vertical joint seals in section 2 is complete.*

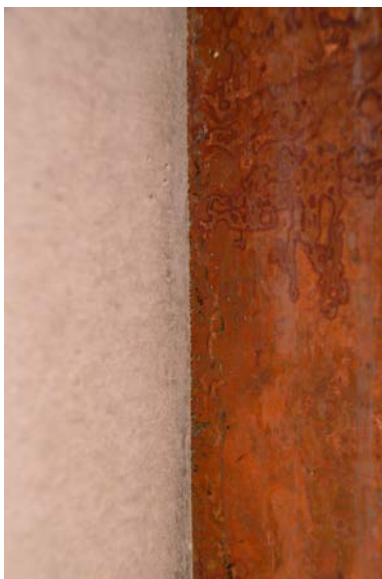
*Figure 6-8. Image showing the interface between the concrete and the joint seal.*

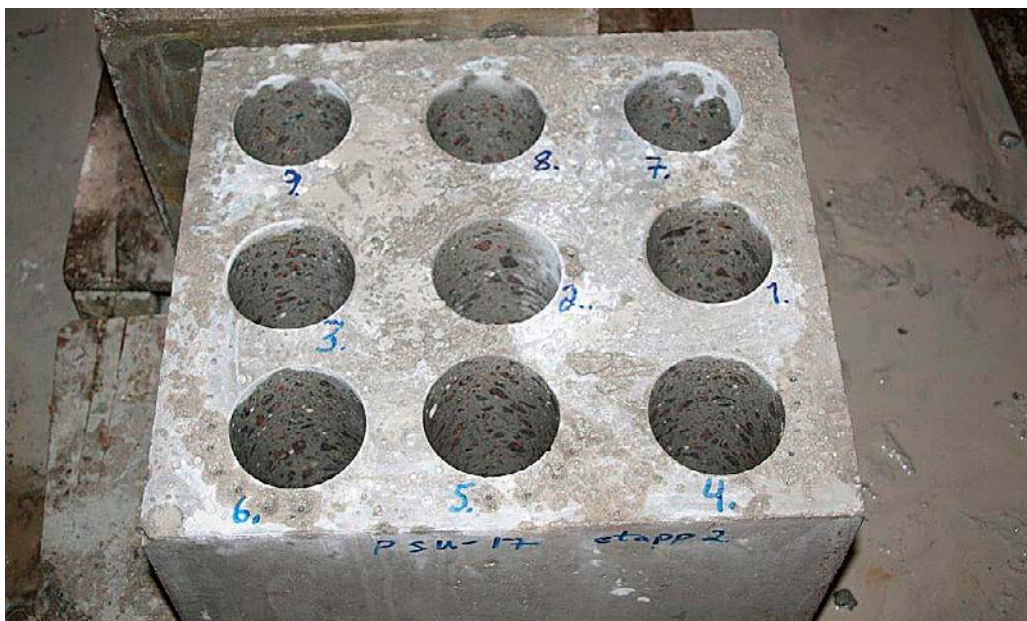
6 months compressive strength of the concrete was measured on  $\varnothing$  100 mm cores drilled from the small cube made from concrete from truck #4, Figure 6-9. The results are shown in Table 6-5.

**Figure 6-9.** The small cube cast from concrete from truck #4 after drilling of cores for testing compressive and tensile strength. Numbers refer to specimens numbers in Table 6-5 and 6-6.

On arrival at the main tunnel, TASP, the concrete slump, temperature and air content were measured, Table 6-3. Also, small cubes were cast for later testing of compressive strength as well as a larger cube from which cores for later studies of 6 month tensile and compressive strength were drilled, Figure 6-9. This cube had the approximate dimensions 500   500   300 mm (l   w   h).

6 months tensile strength of the concrete was measured using Ø 100 mm cores extracted from the small cube made from concrete from truck #4, Figure 6-9. The results are shown in Table 6-6.

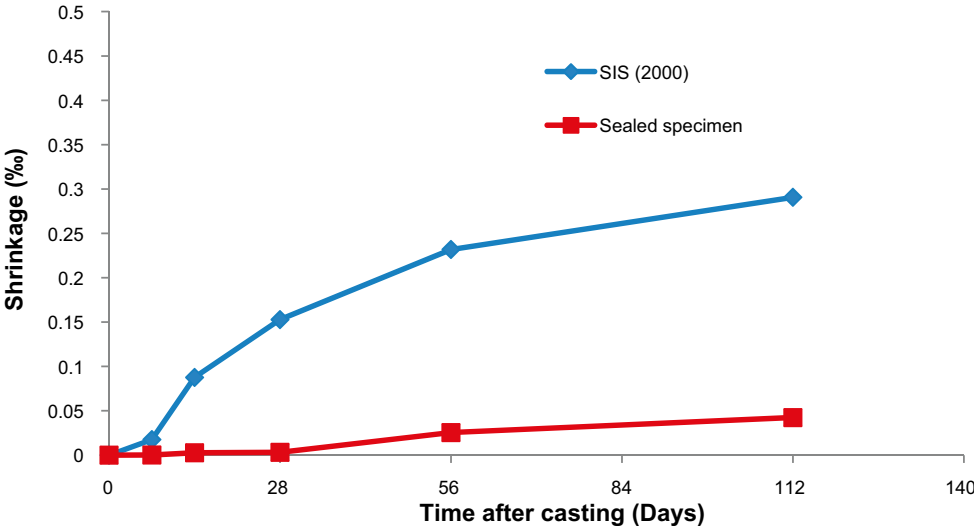
**Figure 6-10. Results from shrinkage measurements using two methods: SIS (2000) and sealed specimens.**

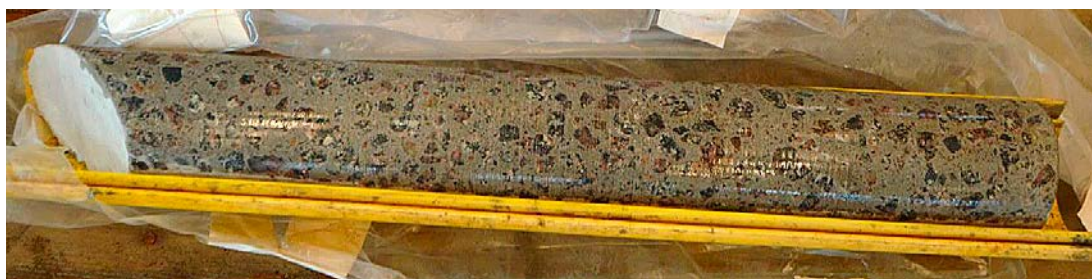
A visual inspection of the cores showed that the concrete was homogeneous and only minor variations in the distribution of paste and aggregates were observed. An image of core TAS05\_10 as a typical example is shown in Figure 7-2 and a close-up showing the distribution of smaller and larger particles is shown in Figure 7-3.

*Figure 7-2. An overview image showing the core TAS05\_10 as an example of a typical core.*

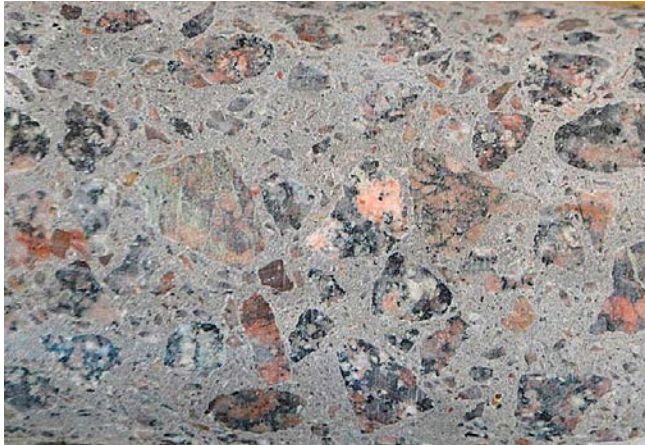
**Figure 7-3.** Particle distribution in the concrete from core TAS05\_08. This image is from the inner part of the core, approximately 500 mm from the surface of the concrete structure.

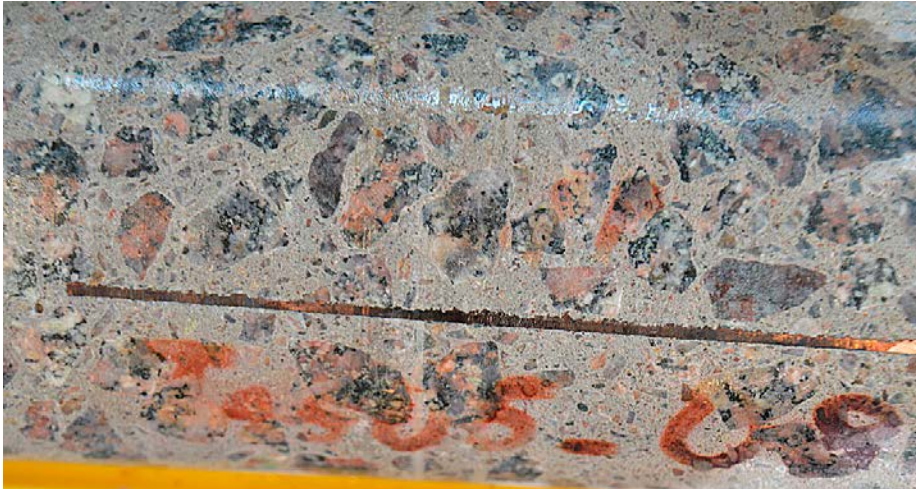
Figure 7-5 shows that the interface between the concrete and the copper sheet is free from pores and larger voids and that the concrete has a similar aggregate distribution close to the copper sheet and further away. The rough surface on the upper side of the copper sheet was most likely caused during drilling.

*Figure 7-5. Image showing the contact zone between concrete and joint seal from core TAS05\_08.*
