**TR-18-12**

January 2019

# Concrete caissons for 2BMA

## Large scale test of design and material

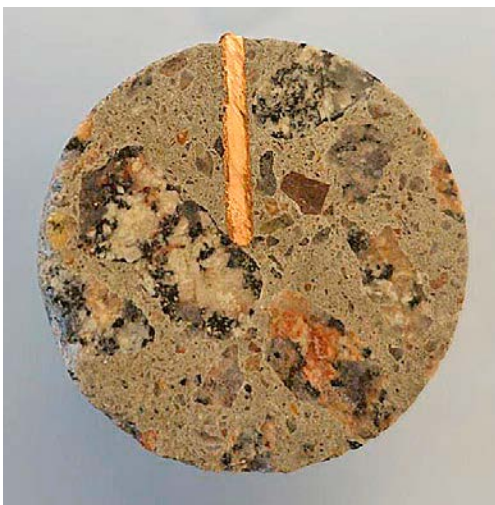
*Figure 7-6. Core containing a joint seal. Note that it was not possible to prepare specimens where the 2 halves of the specimen were completely separated by the joint seal as this caused the specimen to split.*

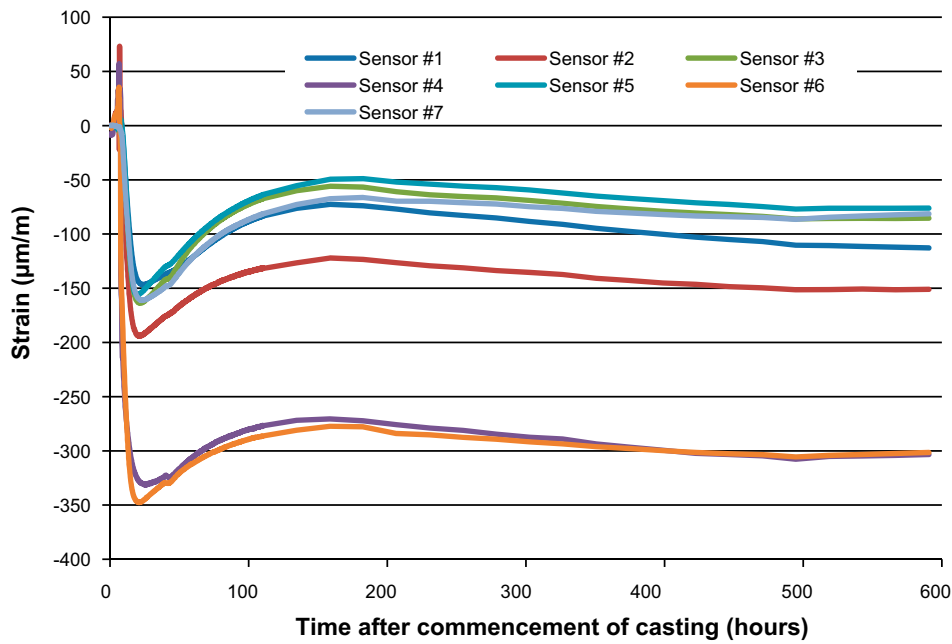
**Figure 8-4.** Internal strain in the wall after casting of section 1. Please refer to Figure 3-5 and 3-6 for details on position of the different sensors.

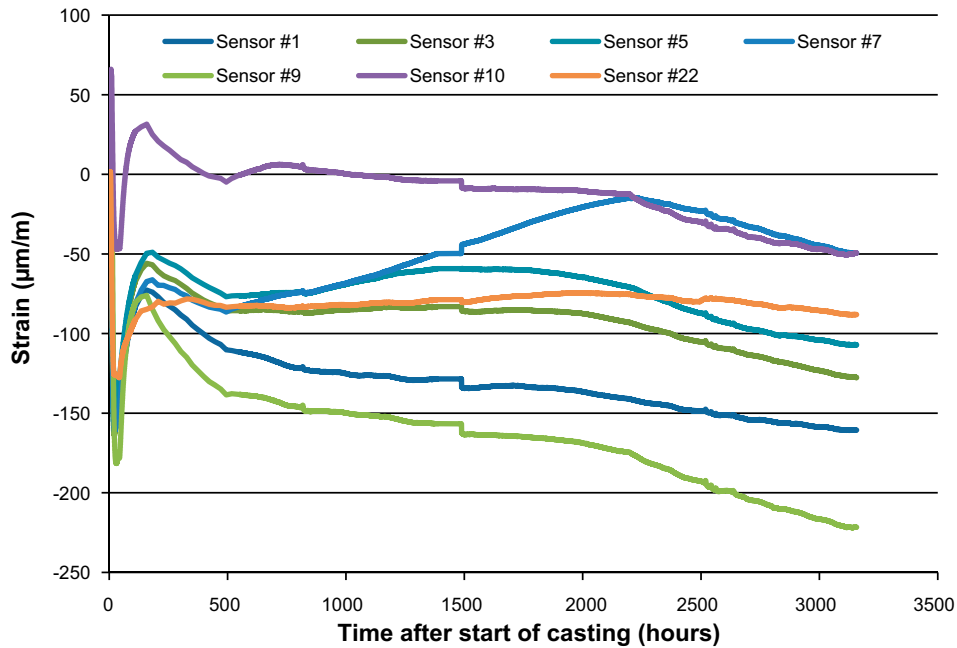
**Figure 8-7.** Internal strain in section 1. The diagram covers the period from November 16 2016 to March 28 2017.

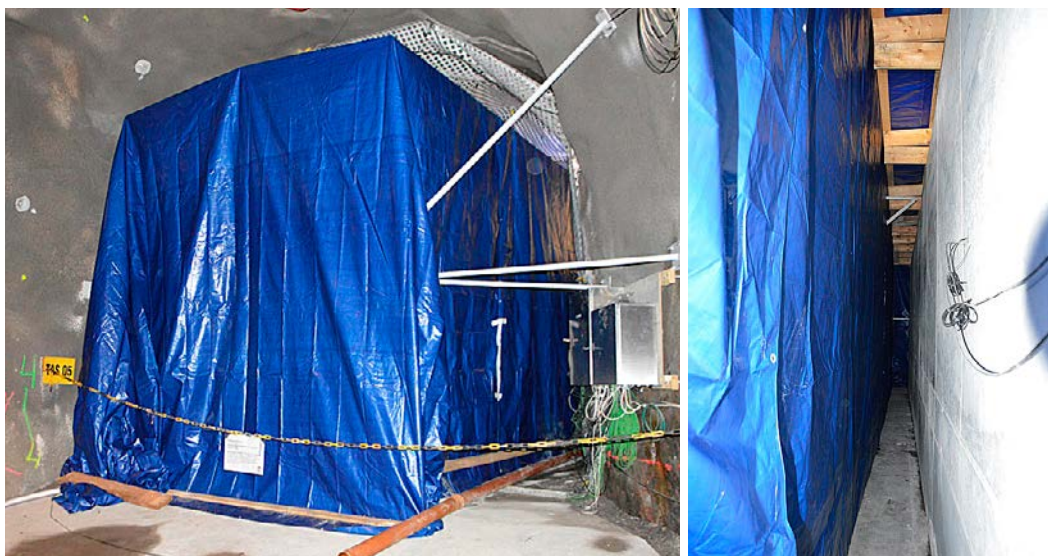
*Figure 10-1. The tent covering the concrete structure during the stress test.*

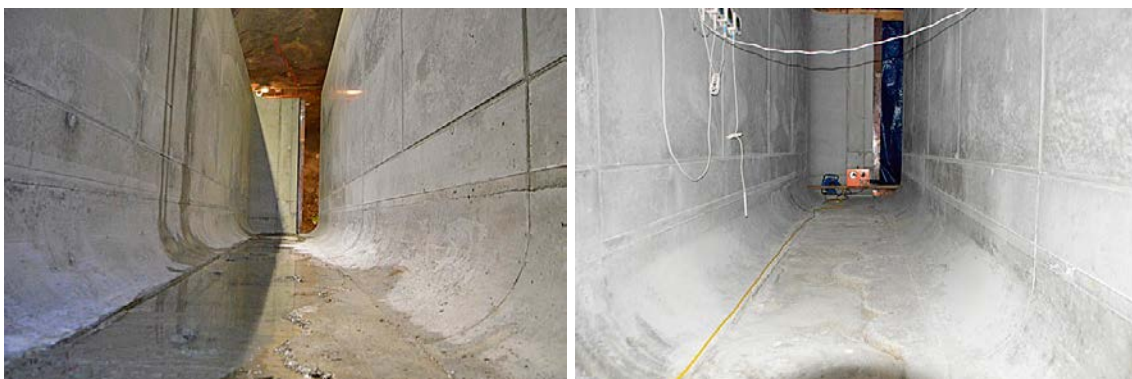
**Figure 10-2.** The space between section 1 and section 2 prior to start of stress test (Left image) and about 1 month after the start of the stress test (Right image).

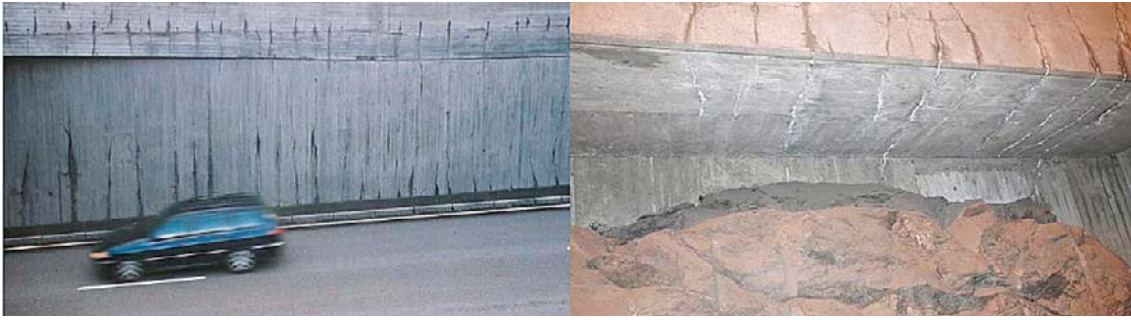
**Figure A-1.** Early age cracks in retaining walls, left picture: Anders Hösthagen, BOSTEK, right picture: Jonatan Paulsson-Tralla, BOSTEK.

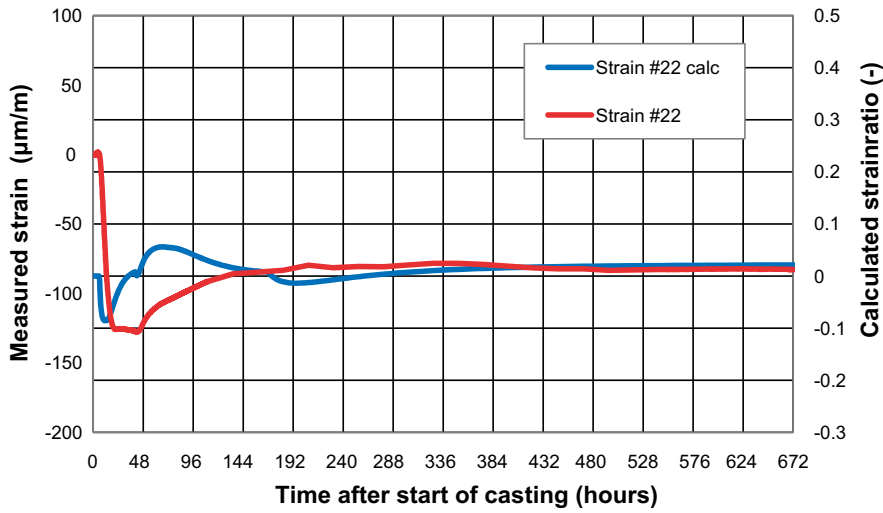
Figure A-28. Comparison between measured and calculated strain for the slab, section 1.

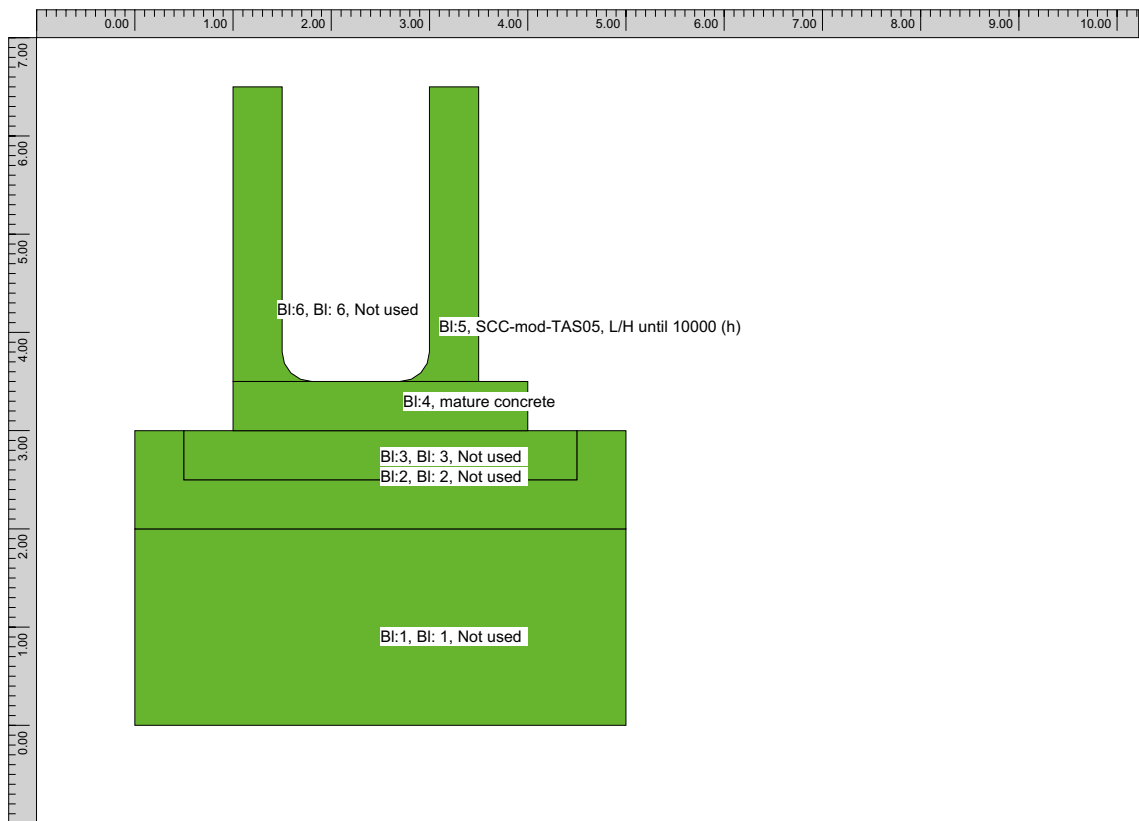
*Figure C-5. Blocks used in stress calculation, section 2.*
