December 2024

Corrosion of copper in unsaturated bentonite clay as a function of oxygen consumption

SKB R-24-06

Amentum Clean Energy Limited

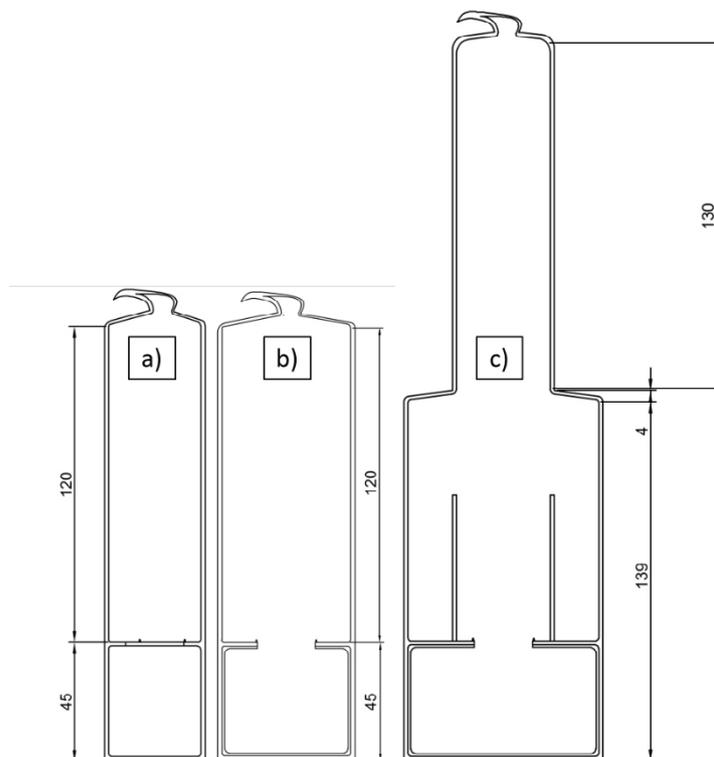
Figure 2-1. Diagram of the empty glass cells a) small (0.20 L), b) medium (0.40 L), c) large (0.75 L). Note the difference in scale between the large glass cell, and the small and medium glass cells.

The cell design consists of a stainless steel sample holder and filter containing copper coupons embedded within bentonite sealed within a glass cell (Figure 2-1). Stainless steel was chosen for the sample holder and filter to prevent the movement of bentonite out of the experiment. The stainless steel would also resist the swelling pressure produced by the bentonite, but this is not expected to occur as the bentonite was equilibrated with a 75 % RH environment for 47 days prior to the experiment (Section 2.2.1). Under the experimental conditions (50 °C, 75 % RH) stainless steel is expected to be corrosion resistant (Figure 2-4 in King et al. (2016)). The stainless steel holder has holes on the sides and the top to allow the transport of oxygen and water vapour into the cell. Between the holes and the bentonite are two fluid permeable stainless steel filters, a circular filter on the top of the bentonite and a cylindrical filter surrounding the bentonite. Beneath the bentonite is the solid stainless steel base of the sample holder. The base of the glass cells contains a reservoir that was filled with a saturated sodium chloride salt solution to give a RH of ~75 % (Greenspan 1977). A silicone rubber lining was applied to the walls of the reservoir prior to adding the saturated salt solution to prevent salt from creeping up the walls of the reservoir. Figure 2-2 shows the configuration of a fully assembled glass cell containing a sample holder.

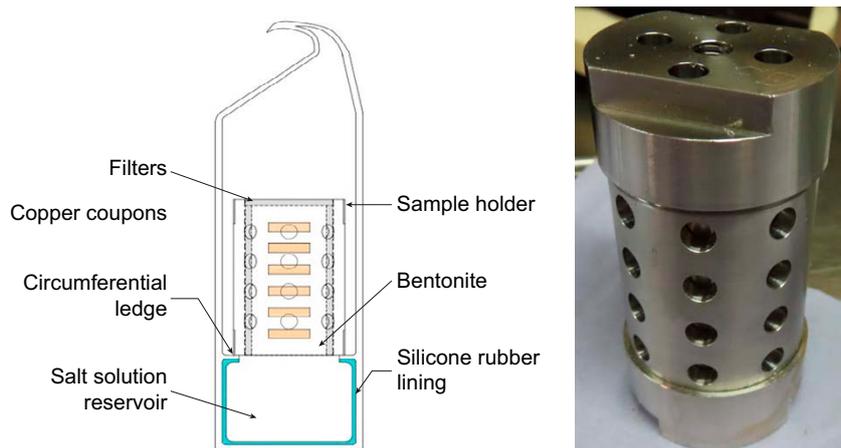
Figure 2.2. Diagram of a fully assembled small glass cell (left). The stainless steel sample holder is outlined. Inside the sample holder is a stainless steel filter highlighted in grey, the bentonite, and copper coupons (orange). The sample holder sits on a circumferential ledge that allows water vapour to disperse throughout the whole cell. A saturated salt solution sitting in the blue outlined reservoir humidifies the glass cell. A silicone rubber lining prevents salt creep from occurring. An image of the sample holder is shown on the right.

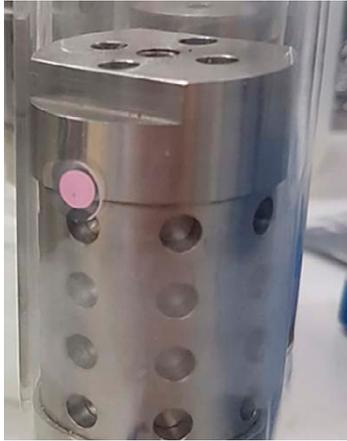
Figure 2-3. Close up image of one of the glass cells showing the location of an oxygen sensing spot (pink). The spot is attached to the inside of the glass using silicone rubber.

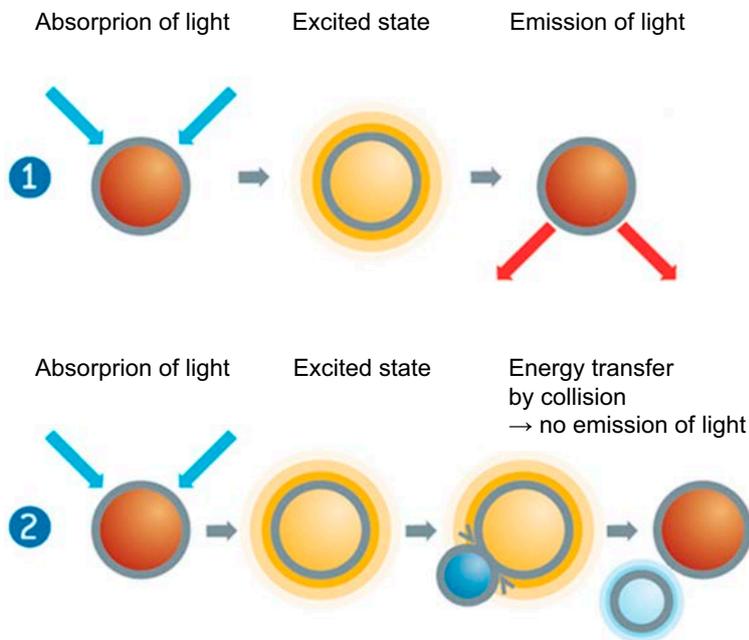
Figure 2-4. Diagram explaining how the Presens (Regensburg, Germany) oxygen sensors work adapted from PreSens (2024). 1. Luminescence process in the absence of oxygen leading to the emission of light. 2. Deactivation of the luminescent indicator molecule by molecular oxygen.

Measurement of the gas phase oxygen concentration was achieved using remote sensing spots. Oxygen concentration refers to the concentration of oxygen in the gas phase throughout the report and is proportional to the partial pressure. The sensor spots allow for the determination of the oxygen concentration through transparent materials i.e., glass (Figure 2-3). This enables measurement of the oxygen concentration in glass vessels without opening them. The sensors manufactured by Presens (Regensburg, Germany) react with oxygen and, in doing so, limit the fluorescence lifetime of an excited dye molecule (Liesch et al. 2000). The greater the oxygen concentration, the shorter the lifetime of the excited molecule (Figure 2-4). The dye molecule is initially excited by light produced by a fibre optic cable connected to the measurement device (Presens, Fibox 3 LCD trace). Collisions between the dye molecules (luminophores) and the quencher (in this case oxygen) cause radiationless deactivation known as dynamic quenching. Following collision the dye molecules do not emit luminescence and the measurable luminescence signal from the sensor spots decreases.

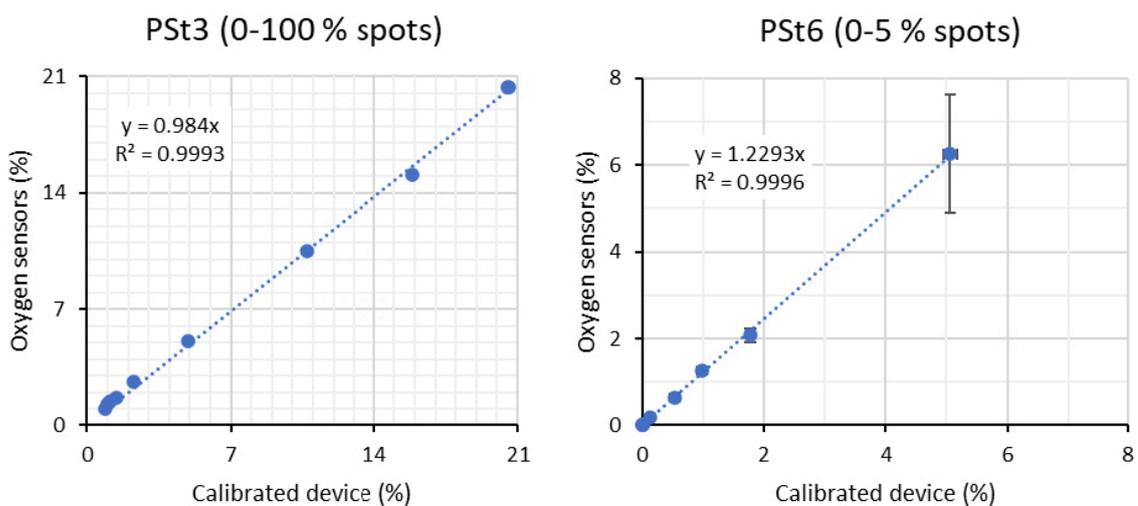
Figure 2-5. Comparison of the oxygen reading from the Presens oxygen sensor spots, compared to a calibrated Systech oxygen meter. PSt3 and PSt6 are the product names provided by the manufacturer.

Pre-determined calibration constants for the individual oxygen sensor spot batch were provided by the manufacturer. These constants were programmed into the measurement device before each set of measurements. Verification of the sensor spots was completed during the initial tests and the results are shown in Figure 2-5. The readings produced by the oxygen sensor spots were compared to a Systech oxygen meter in a closed system. The results from both the PSt6 (0 to 5 %) and the PSt3 (0 to 100 %) spots show that the readings can be fitted linearly with R^2 values of 0.9996, and 0.9993 respectively. Despite the high precision of the two techniques, as judged by the size of the error bars, the two techniques were not in complete agreement. In the case of the PSt6 (0 to 5 %) oxygen sensor spots the sensor spots had a value 19.7 % higher than the measured percentage on the Systech oxygen meter, excluding the result outside of the 5 % measurement range. The PSt3 (0 to 100 %) oxygen sensor spot oxygen saturation readings were 1.6 % lower than the measured percentage on the Systech oxygen meter. Several differences exist between the two sampling techniques that may explain the discrepancy observed between the measurements. For example, the oxygen sensor spots measure the concentration of oxygen in contact with the sensor spot, which is a small volume of the test vessel, while the Systech oxygen meter pumps the oxygen through an electrochemical cell which is a more representative sample of the whole system. The sampling times of the two techniques are also different with the oxygen sensor spots having a sampling time of less than 6 seconds, while the sampling time of the Systech oxygen meter is 30 seconds.

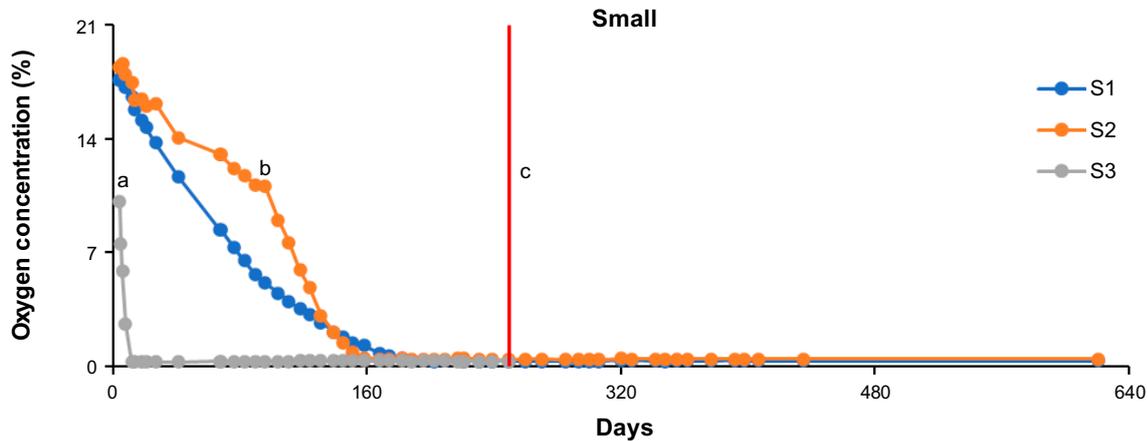
Figure 3-1. Oxygen concentration in the small cells (S#) over the initial 621 days of the experiment. ^aCell S3 was tipped at the start of the experiment. ^bCell S2 was tipped after 96 days. ^cCell S3 was dismantled after 251 days. Glass cells were operated at 50 °C.

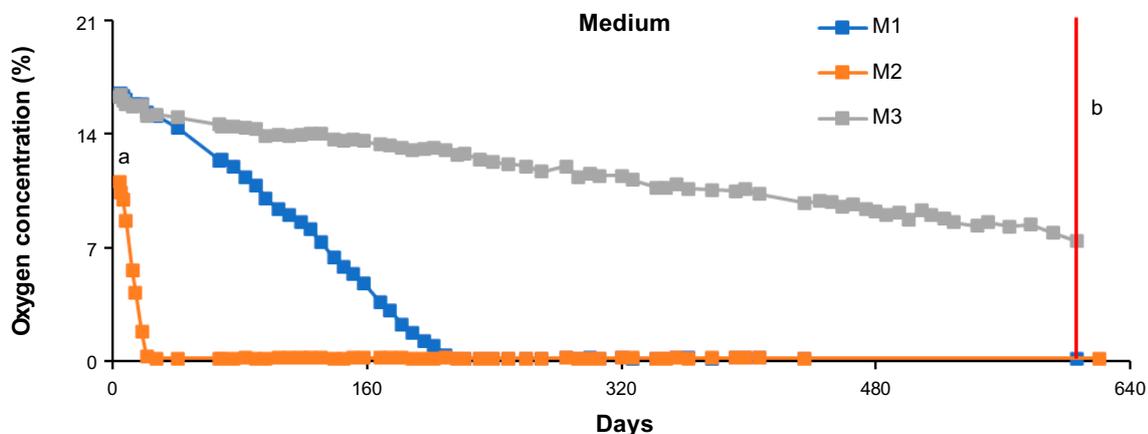
Figure 3-2. Oxygen concentration in the medium cells (M#) over the initial 621 days of the experiment. ^aCell M2 was tipped at the start of the experiment. ^bCells M1 and M3 were dismantled after 614 days. Glass cells were operated at 50 °C.

The oxygen concentration of the medium cells over 621 days is shown in Figure 3-2. Cell M2 was tipped at the start of the experiment and became anoxic by day 21 and remained depleted until day 621. The consumption of oxygen in Cell M1 was fairly linear with an oxygen concentration of 16.5 % on day 4 and reaching depletion by day 209. Cell M3 remained oxidic over the reported period with the oxygen concentration decreasing from 16.3 % on day 4 to 7.4 % on day 607. Cells M1 and M3 were dismantled on day 614.

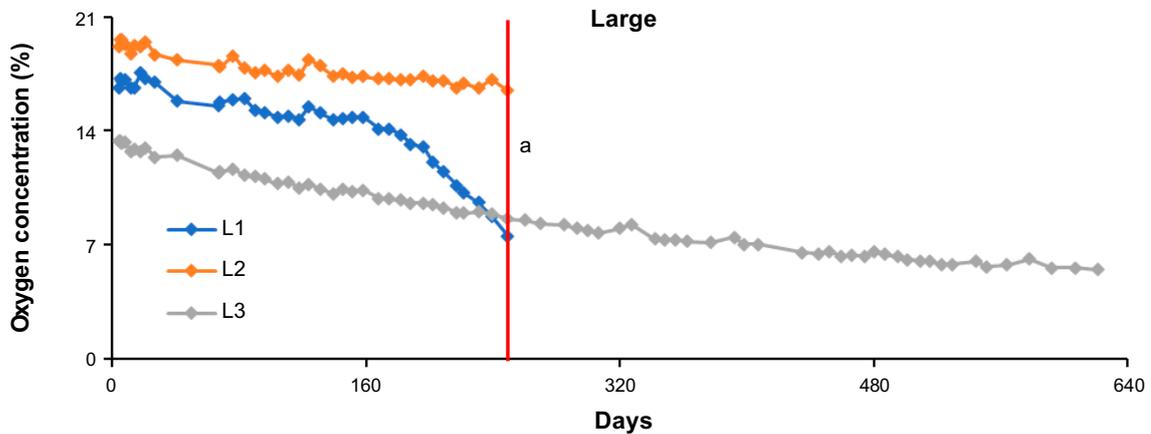
Figure 3-3. Oxygen concentration in the large cells (L#) over the initial 621 days of the experiment. ^aCells L1 and L2 were dismantled after 251 days. Glass cells were operated at 50 °C.

The starting oxygen concentration in individual glass cells exhibited a modest variability, probably because of a small amount of oxygen being consumed in the glass blowing process used to seal the glass cells. Additionally, there was a significant difference in the rate of oxygen consumption in glass cells that were nominally identical. In some circumstances the rate of oxygen consumption seemed to change within specific cells but not others. This observation was particularly apparent in glass cell L1, in which the oxygen consumption rate accelerated after 174 days (Figure 3-3), this was not observed in other cells.

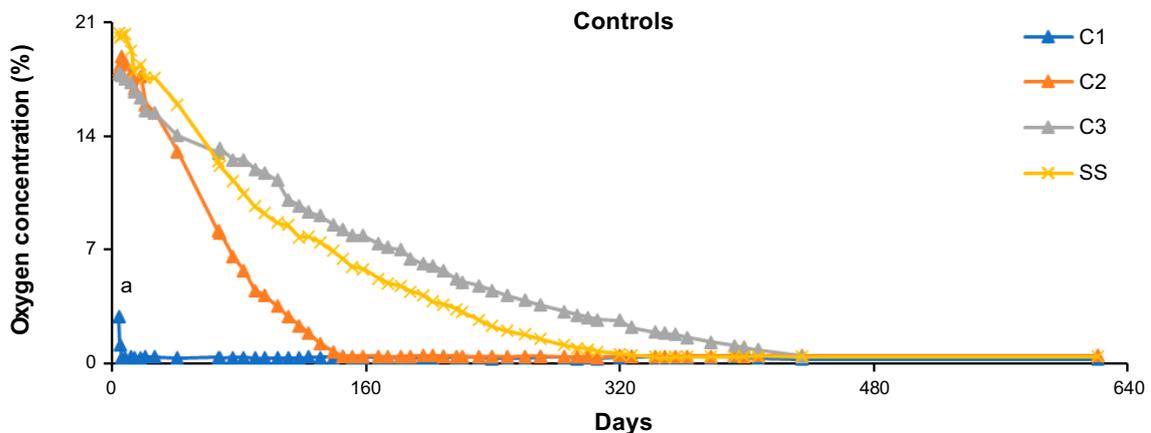
Figure 3-4. Oxygen concentration in the bentonite + sample holder control cells (C#) and the sample holder only control cell (SS) over the initial 621 days of the experiment. ^aCell C1 was tipped at the start of the experiment. Glass cells were operated at 50 °C.

The oxygen concentrations of the control cells over 621 days are shown in Figure 3-4. Cell C1 was tipped at the beginning of the experiment, and its oxygen concentration was depleted by day 6. The oxygen concentration in Cells C2 and SS decreased in a smooth continuous trend, with Cell C2 decreasing from 18.1 % on day 4 to depletion by day 145, and Cell SS decreased from 20.4 % on day 4 to depletion on day 342. The oxygen concentration in Cell C3 decreased at the slowest rate from 17.9 % on day 4 to depletion on day 435. After oxygen depletion all the control cells remained anoxic until day 621.

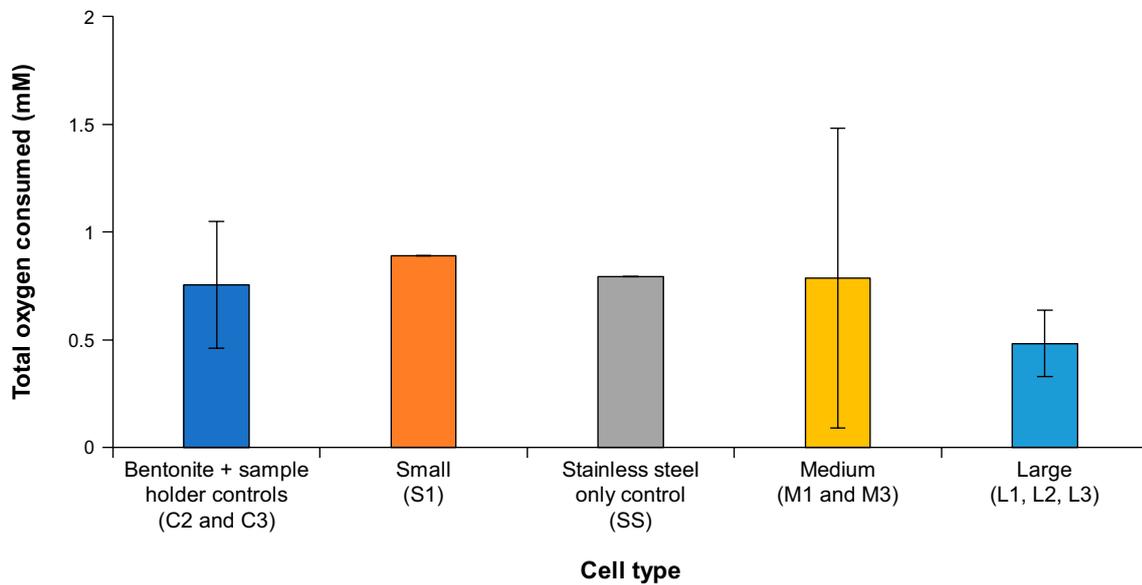
Figure 3-5. Comparison of the total amount of oxygen consumed in the glass cells between day 4 and day 158. Small, medium and large cells contained 22.3 g of bentonite. Bentonite and sample holder control cells contained 26.6 g of bentonite (note that control cells have the same volume as the small cells). Tipped cells were excluded from the comparison.

The amount of oxygen consumed in each set of glass cells was compared to determine if there was a difference between different cell volumes and the controls (Figure 3-5). Note that the control cells had the same size as small cells, thus comparisons between those cells are more appropriate than comparisons between control cells and medium or large cells.

The amount of oxygen consumed was compared between day 4 and day 158, as this period provided the most datapoints where the oxygen consumption was steady. Tipped cells were excluded from the interpretation due to the measurements being influenced by the saturated sodium chloride solution. The amount of oxygen consumed over the 154 day period in each glass cell was approximately 0.69 mM. The greatest standard deviation in the oxygen consumption rates was observed in the medium cells (± 0.70 mM), and bentonite and sample holder controls (± 0.29 mM), which comprised two functioning tests (i.e., those that had not been tipped over). The large cells exhibited the lowest standard deviation (± 0.15 mM) from measurements taken from three functional tests. Standard deviations of the small cells and stainless steel only control test were not reported as only one functional cell was available from each.

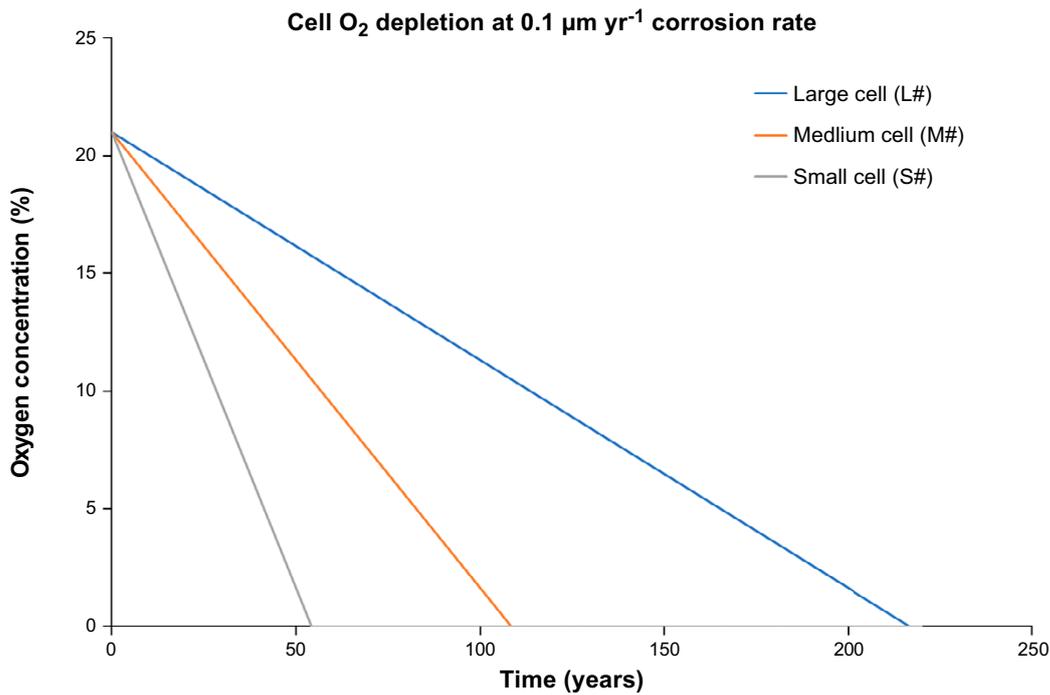
Figure 3-6. Estimated rate of depletion of different sized cells based on an assumed copper corrosion rate of $0.1 \mu\text{m yr}^{-1}$.

The estimated rate of depletion and time to depletion of oxygen in each of the three cell volumes (small, medium and large) based on the assumed corrosion rate of $0.1 \mu\text{m yr}^{-1}$ is shown in Figure 3-6. The estimated time to depletion of the small, medium and large cells based on the assumed corrosion rate is 54 years (19810 days), 108 years (39610 days) and 217 years (79210 days), respectively. These durations correspond to depletion rates of 0.4 \% yr^{-1} , 0.2 \% yr^{-1} and 0.01 \% yr^{-1} for different types of cells respectively. Hence, based on the durations of exposure reported in Section 3.1 (249 days), at a corrosion rate of $0.1 \mu\text{m yr}^{-1}$ the amount of oxygen consumed by copper corrosion would be of the order of 0.07 to 0.27 % depending on the cell volume. The amount of oxygen consumption in the glass cells far exceeded that expected by copper corrosion alone. Therefore, under the prevailing assumptions (specifically the corrosion rate measured for copper), it can be inferred that most of the oxygen depletion that was observed in all cells, both those that tipped and those that remained upright, was attributable to processes other than copper corrosion e.g., stainless steel corrosion and possibly also reactions with bentonite.

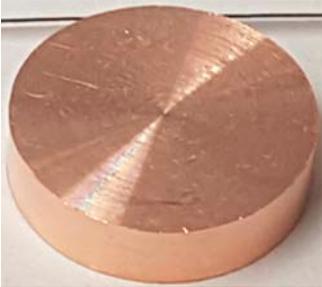
L1-4

Photographs of the corrosion coupons were taken before sample holder preparation, and after exposure and removal from the glass cell. Table 3-3 provides representative images of the pristine and ‘as removed’ coupons (i.e., no treatment of the coupons before the photographs were taken). Key observations with respect to the bentonite and corrosion coupons are reported below,

- All the coupons removed had bentonite adhered to their surface. The coupons from Cell S3 had a purple sheen to them, but the original copper colour was still visible in some areas. Coupons from the two large cells exposed for 249 days (L1 and L2) exhibited shiny patches of orange/red and separate regions of dull brown colour. The colouration of the coupons from the medium cells after exposure for 614 days (M1 and M3) was similar to the coupons from the large cells, but more tarnishing, as well as the presence of purple areas, was observed. Individual coupons from the same large and medium cells exhibited a variation in the extent of discolouration, with some appearing more corroded than others.

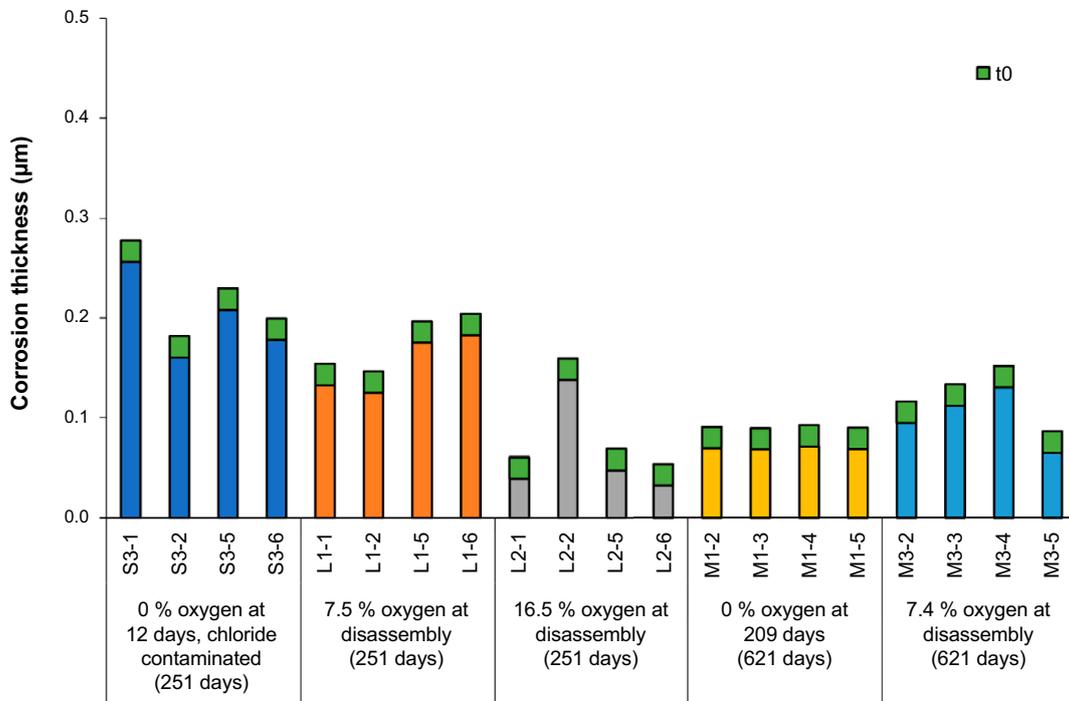
Figure 3-7. Total corrosion thicknesses for the copper coupons removed from the small cell (S3) and the large cells (L1 and L2) after 251 days, as well as the medium cells (M1 and M3) after 621 days. The amount of corrosion that is anticipated to have occurred prior to sealing the vessels (based on the t_0 coupons) is highlighted in green, with the remainder being the test corrosion thickness. Glass cells were operated at 50 °C. Moisture contents at disassembly: S3, 27.7 %; L1, 12.0 %; L2, 12.8 %; M1, 13.5 %; M3, 8.2 %.

The corrosion losses over the total exposure period were determined from the mass loss of four coupons taken from each of the disassembled cells according to the procedure described in Section 2.4.4. These measurements reflect the average corrosion thickness loss from the point when the coupons were in contact with the bentonite (including the brief period prior to the cells being sealed), until the experiments were dismantled. The extent of corrosion was also determined for the t_0 coupons, which reflects the extent of corrosion that took place from the initial exposure to the bentonite, up to the point at which the cells were sealed. The mean loss of material that occurred on the t_0 specimens was subtracted from that measured on each of the tested coupons to allow determination of the extent of corrosion that took place once the cells were sealed (i.e., the test period) as shown in Figure 3-7. As corrosion was expected to halt on the development of anoxia in the glass cells, an oxidic corrosion rate could have been determined considering the duration of exposure from assembly until all the oxygen was consumed (as indicated by the oxygen spots). However, this approach was disregarded as oxygen might have been present in the bentonite after depletion of the head space. The presence of a copper and iron sulphide corrosion product in Cell S3 (Figure 3-12) also suggests that anoxic corrosion had occurred in the tipped cell.

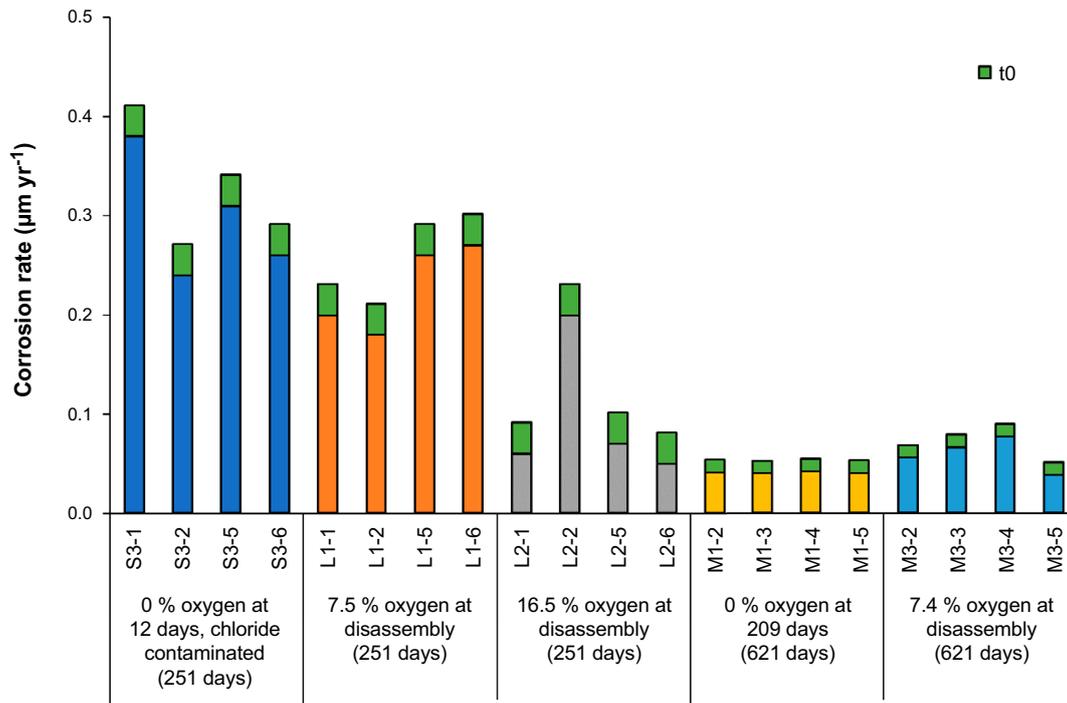
Figure 3-8. Average corrosion rates for the copper coupons removed from the small cell (S3, which was tipped over) and the large cells (L1 and L2) after 251 days, as well as the medium cells (M1 and M3) after 621 days. The amount of corrosion that is anticipated to have occurred prior to sealing the vessels (based on the t_0 coupons) is highlighted in green, with the remainder being the test corrosion rate. Note, that conversion of the t_0 mass loss is dependent on the duration of exposure, which was different for the large and medium cells. Glass cells were operated at 50 °C. Moisture contents at disassembly: S3, 27.7 %; L1, 12.0 %; L2, 12.8 %; M1, 13.5 %; M3, 8.2 %.

Unsurprisingly, the highest corrosion rates were observed in Cell S3 ($0.30 \mu\text{m yr}^{-1}$), which tipped over, exposing the coupons to saturated salt water. Comparing cells L1 and L2 shows that the coupons in Cell L1 exhibited a higher CR_{test} on average ($0.23 \mu\text{m yr}^{-1}$) when compared to Cell L2 ($0.10 \mu\text{m yr}^{-1}$), despite exhibiting a lower oxygen concentration throughout the test⁹. It should also be noted that the variation in corrosion rates observed between coupons in the same cell was rather high, as indicated by the standard deviations reported in Table 3-6 and the individual results shown in Figure 3-8. This can be accounted for by the uncertainty of the measurements which had a maximum of $\pm 0.123 \mu\text{m yr}^{-1}$ with a confidence of 95 %. This indicates that the difference in mass loss between individual coupons in the large cells, and between the cells themselves is not statistically significant.

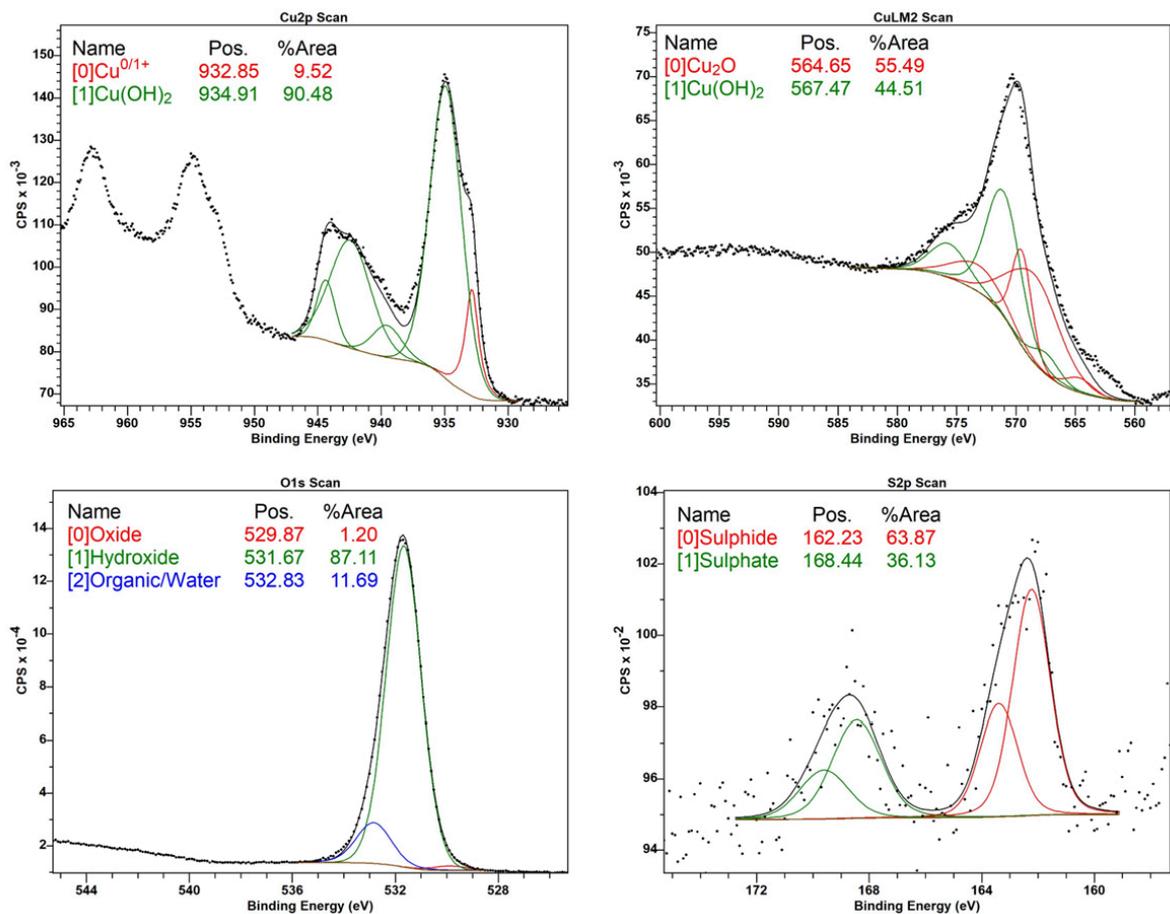
Figure 3-9. Representative XPS spectra of L1-4 (0.75 L, 7.5 % O₂, 249 days) surface profile.

A large amount of adventitious carbon was present on the as-examined coupon (44.2 at. %), along with oxygen (41.1 at. %) and copper (11.1 at. %). Following depth profiling the carbon concentration decreased to 9.6 at. %, and a larger proportion of oxygen (48.2 at. %) and copper (39.2 at. %) was observed. Small amounts of sulphur (1.3 at. %), and silicon (1.7 at. %) were also present post-depth profiling. High resolution spectra in Figure 3-9 show that, prior to depth profiling, the Cu2p and Cu L₃M_{4,5}M_{4,5} spectra were consistent with the presence of spertiniite (Cu(OH)₂) and a small amount of cuprite (Cu₂O). The proportion of cuprite compared to spertiniite increased after depth profiling. The S2p spectrum presented with two distinct peaks, one characteristic of sulphide and the other sulphate. Due to the trace concentration of sulphur on the surface one cannot reliably determine the exact binding energy of the components past them being characteristic of a sulphide and sulphate. The C1s spectra showed a peak characteristic of carbonate at 289.7 eV (spectra not included in below figure) and this peak remained post-depth profile, indicating it is present throughout the depth of profiled material.

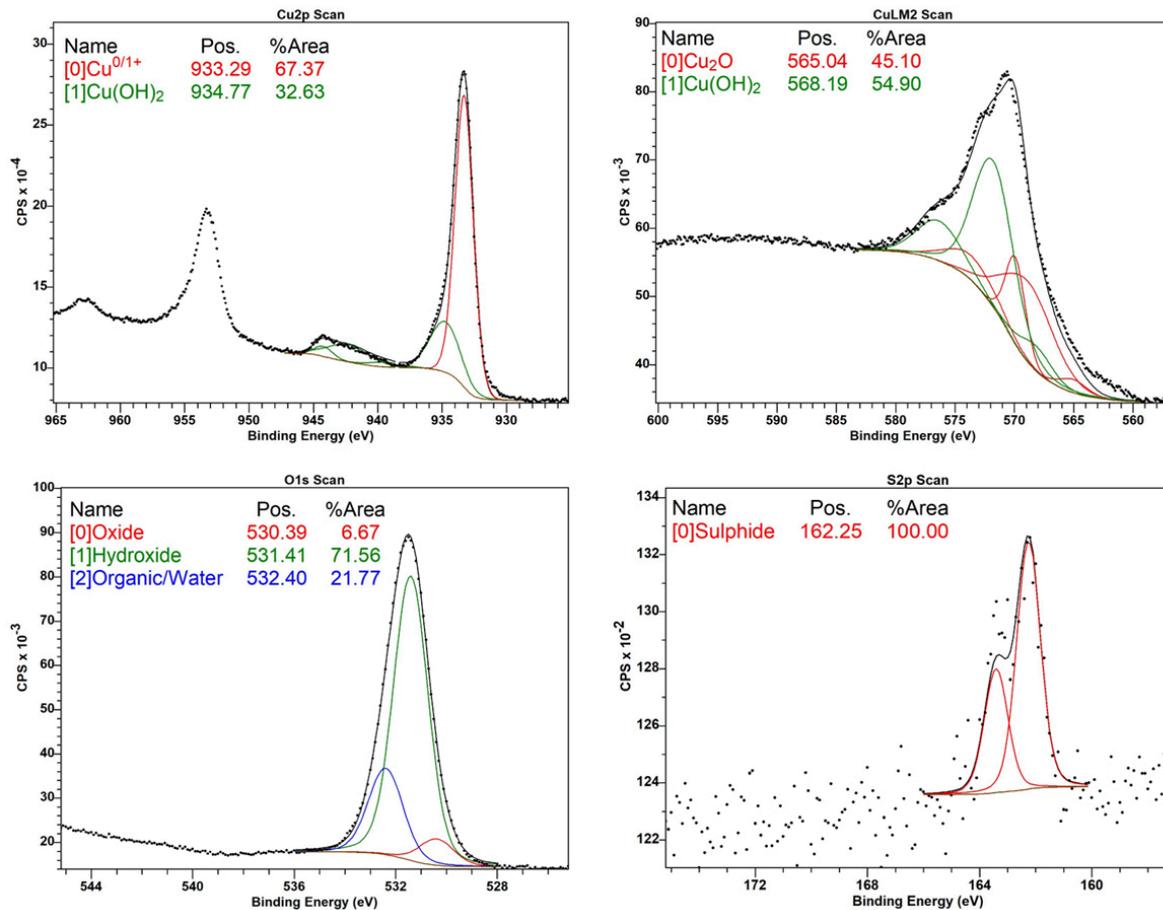
Figure 3-10. Representative XPS spectra of L2-4 (0.75 L, 16.5 % O₂, 249 days) surface profile.

As with copper coupon L1-4 previously discussed, L2-4 had a large amount of adventitious carbon on its surface (46.7 %). Oxygen (29.1 %) and copper (12.1 %) were also present surface profiling, along with smaller amounts of silicon (4.1 %), chlorine (1.3 %), and sodium (0.9 %). It is possible that these trace elements are associated with residual adherent bentonite on the specimen surface. High resolution Cu2p and Cu L₃M_{4,5}M_{4,5} spectra were largely consistent with the presence of spertiniite and cuprite (see Figure 3-10). The Cu2p spectrum showed that cuprite was the main copper species on the surface of L2-4, contrasting to L1-4 where spertiniite was the dominant species in the Cu2p spectrum surface profile. Minimal carbonate was observed on L2-4, unlike L1-4 where a clear component was identified in the C1s spectrum. Following depth profiling a small amount of carbon was present (3.9 %), with the rest of the area comprising oxygen (9.8 %) and copper (86.3 %). Cuprite was shown to increase in relation to spertiniite post-depth profile, as seen on L1-4.

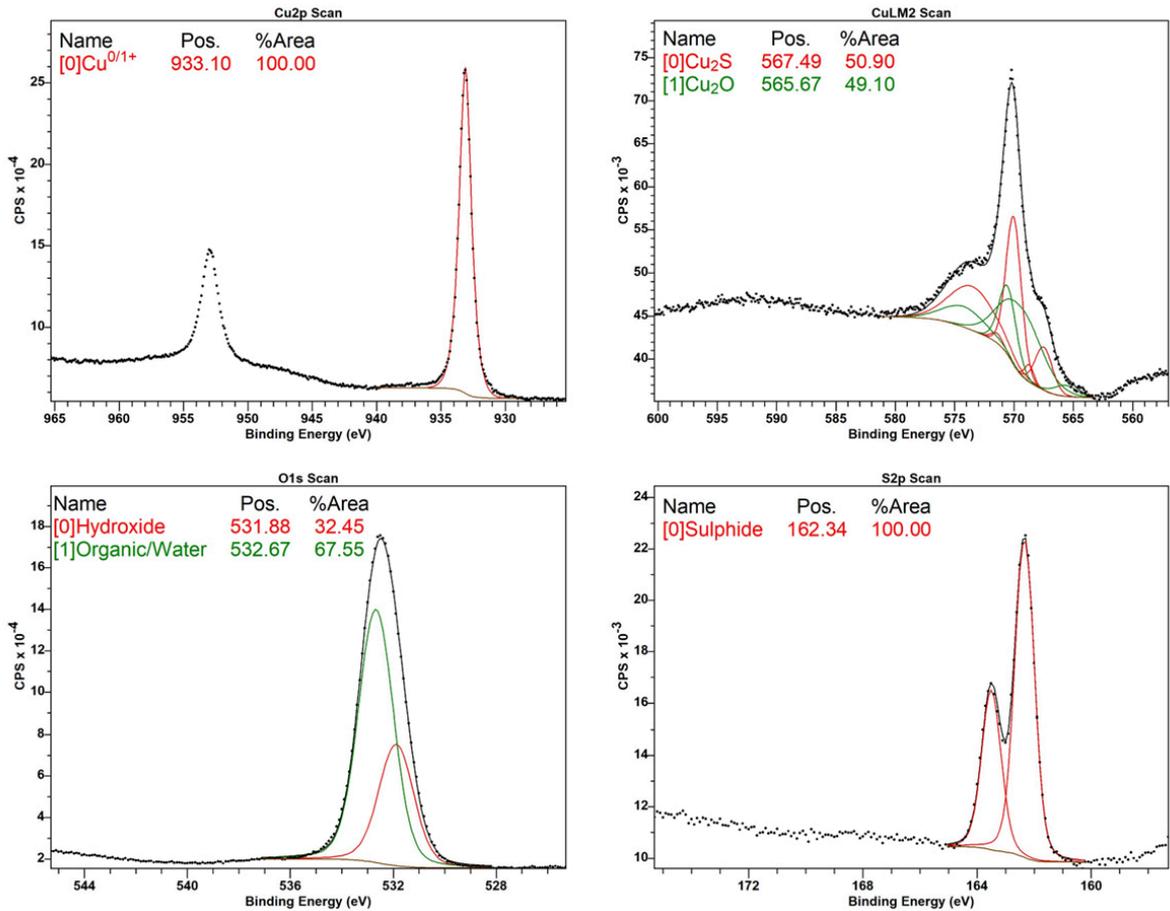
S3-4 (0.20 L, 0 % O₂, 249 days, chloride contaminated)

Figure 3-11. Representative XPS spectra of S3-4 (0.75 L, 0 %) surface profile.

Pre depth-profile, the elemental composition consisted of carbon (20.6 %), oxygen (47.9 %), and silicon (14.8 %), with a smaller proportion of copper (6.6 %). The Cu2p and Cu L₃M_{4,5}M_{4,5} spectra shown in Figure 3-11 were consistent with a mixture of chalcocite (Cu₂S) and cuprite. The S2p spectrum was also characteristic of a sulphide, which is in agreement with the assignment of chalcocite in the copper spectra. After depth profiling the silicon content was largely the same (14.7 %), with greater contributions from oxygen (40.4 %) and copper (32.1 %) following the removal of adventitious carbon. The presence of a high proportion of silicon is indicative of the presence of adherent bentonite.

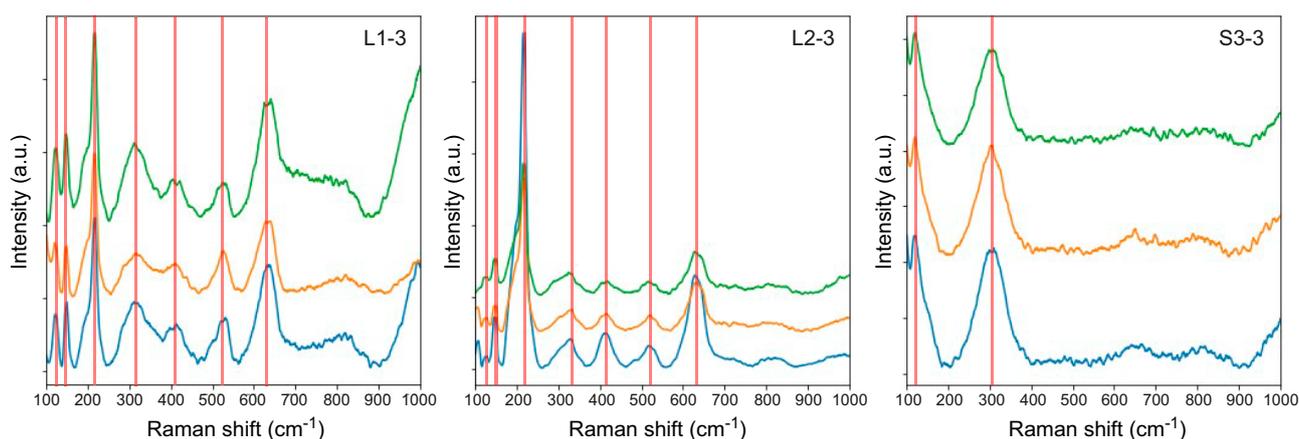
Figure 3-12. Representative Raman spectra obtained from copper coupons L1-3 (0.75 L, 7.5 % O₂, 249 days), L2-3 (0.75 L, 16.5 % O₂, 249 days), and S3-3 (0.20 L, 0 % O₂, 249 days, NaCl contaminated). Broad fluorescence associated with montmorillonite has been subtracted from the spectra.

The Raman spectra for coupons L1-3 and L2-3 showed similar spectra to each other, consistent with the presence of cuprite (Cu₂O). An additional peak at 520 cm⁻¹ tentatively indicated the presence of spertiniite (CuOH₂) on both coupons as well. The peaks on L2-3 were stronger and the broad fluorescence associated with montmorillonite (associated with the bentonite) was also weaker when compared to L1-3. The spectra for S3-3 showed a broad peak at 310 cm⁻¹, which is consistent with the spectra of bornite (Cu₅FeS₄). Tenorite (CuO) also shows a peak at 310 cm⁻¹, but the peak is typically sharp compared to the broader peak associated with bornite. Broad fluorescence associated with montmorillonite (associated with the bentonite) was also observed on the spectra of S3-3. Note that the broad fluorescence from the montmorillonite has been subtracted from the spectra.

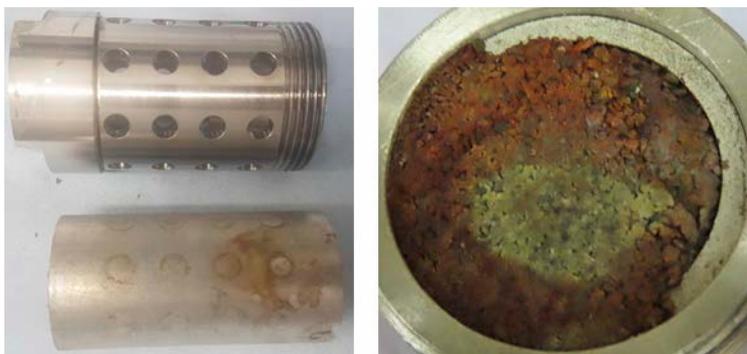
Figure 4-1. Images of the stainless steel sample holder (upper left) and steel filter (lower left) and the bentonite (right) from tipped glass cell S3 (0.20 L, 0 % O_2 , 249 days, NaCl contaminated).

During the test programme, several issues were identified that placed limitations on the usability of the results. Mitigations for these issues are discussed in Section 4.4. The geometry of the small and medium glass cells made them prone to tipping. A few of the glass cells tipped upon initial placement in the 50 °C oven, along with an additional glass cell being tipped because of human error. Disturbance of the glass cells in the oven was mitigated using a walled tray, but the removal of human error could not be achieved as oxygen measurements required physical manipulation of the cells. None of the large cells were tipped during the experiment due to their wider base. Once tipped, the stainless steel sample holders containing the bentonite were contaminated with the saturated sodium chloride solution originally contained in the glass cell reservoirs (Figure 2-2). The oxygen in the tipped cells was consumed in days, decreasing the amount of repeat tests available for analysis (Figure 3-1, Figure 3-2 and Figure 3-4). Dismantling of a tipped cell (S3) revealed significant corrosion of the stainless steel sintered filter (Figure 4-1), partial saturation of the contained bentonite (Table 3-5), deposition of red corrosion products (presumably iron oxides) in the bentonite (Figure 4-1), and potentially the formation of bornite (Cu_5FeS_4) (Table 3-9). The above observations indicate that the stainless steel was probably responsible for the oxygen consumption rather than the copper coupons in the tipped cells. While the stainless steel might not be expected to corrode in conditions of limited corrosivity, the saturated chloride solution provided a harsh environment, and the porosity (33 to 38 %) of the stainless steel filter provided a large surface area for corrosion to take place. As a result of the tipping event and the contact with salt water, the bentonite moisture content of cell S3 was 27.7 wt. %.

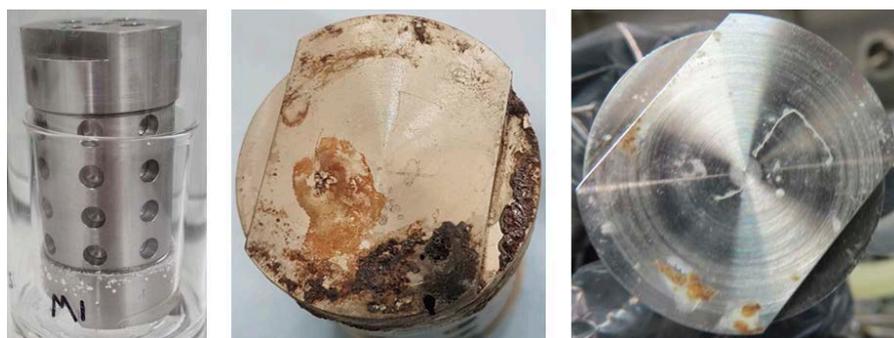
Figure 4-2. Images of the white crystals formed on M1 (left), and of the corrosion of the stainless steel sample holder bases of L1 (middle) and L2 (right).

Perhaps more importantly, white crystals were observed on most of the stainless steel sample holders, and the base of the sample holders showed visible signs of localised corrosion (Figure 4-2). The white crystals might have been sodium chloride; however, the deposition also occurred in glass cells that had not been tipped suggesting that unexpected chemical processes might have been occurring in the cells. Beyond the localised corrosion of the base of the sample holders, no further visible corrosion of the stainless steel including the filters was observed in the non-tipped cells. Follow up analysis revealed that the pH of the reservoir water in glass cell L1 was approximately 2.8 (Table 3-4), and IC analysis (not shown) of the water revealed the presence of an organic acid (probably acetic acid). Inspection of the technical specification of the silicone rubber compound (RS Components Ltd 2023) used to line the reservoirs (to prevent salt creep) revealed it contained methyltriacetoxysilane, which liberates acetic acid on contact with moisture (<https://pubchem.ncbi.nlm.nih.gov/compound/77929#section=Names-and-Identifiers>). Acetic acid is highly volatile and probably caused corrosion of the stainless steel which in turn consumed the oxygen in the headspace. This hypothesis was further backed up by the high rate of oxygen consumption which was far greater than what could be achieved from the corrosion of the copper coupons alone (Section 3.2) and by the fact that the rate of oxygen consumption in the cell containing stainless steel alone was similar to that of experimental cells.

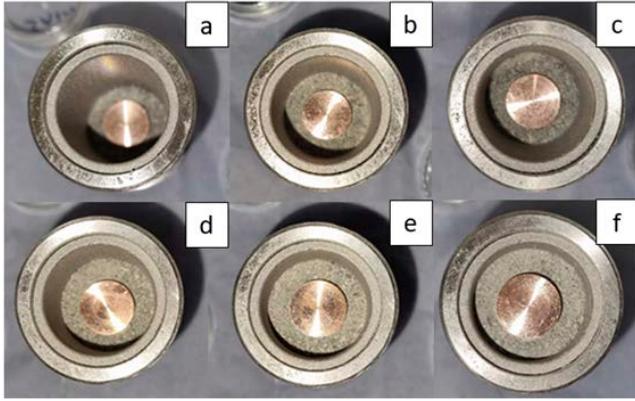
Figure A-1. Image of each coupon during the assembly of the S1 sample holder: a, layer 6; b, layer 5; c, layer 4; d, layer 3; e, layer 2; f, layer 1.
