TR-24-06

Evaluation of microstructural defects in wedge-open loaded stress corrosion cracking specimens from the MiniCan field test

James Hesketh, Amentum Clean Energy Limited

Johannes Johansson, Svensk Kärnbränslehantering AB

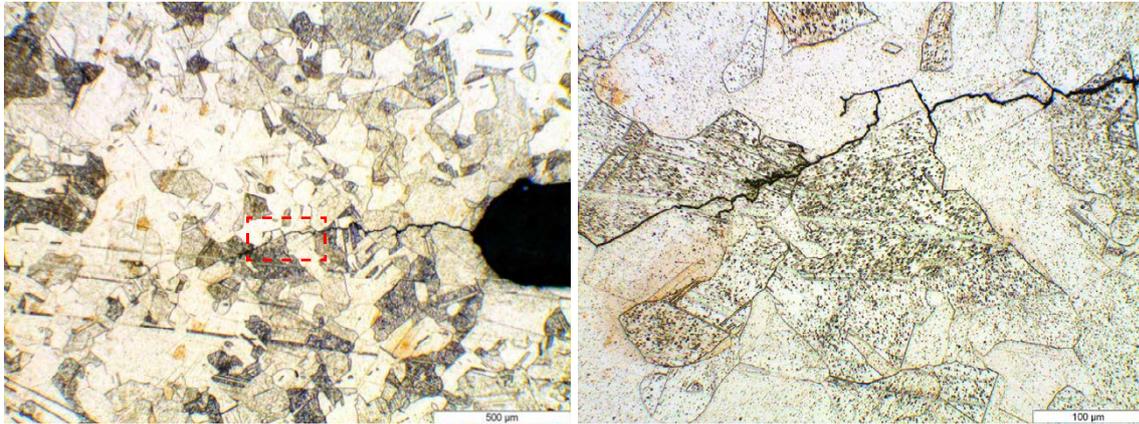
Figure 1-1. Optical micrograph of cross-section through WOL specimen 1 (near borehole flange – shown in Appendix A) from MiniCan 3 (Figure 3-16 in Smart et al. (2013)) showing entire crack length (left) and zoomed section (right). The specimen was etched in NH_4OH (S.G. 88) + H_2O + H_2O_2 (equal volumes) for 20 seconds to show grain boundaries.

The specimens installed in MiniCan 3 were examined visually after the retrieval in 2011 (Smart et al. 2012) and were later examined further by metallographic methods (Smart et al. 2013), (Aggarwal et al. 2015). Metallographic examination using Scanning Electron Microscopy (SEM) of the WOL specimens from MiniCan 3 showed branching from the pre-crack, with cracks of the order of 10 to 100 μm in size emanating from the pre-crack, see e.g. Figure 1-1 and Figure 1-2 reproduced from (Smart et al. 2013).

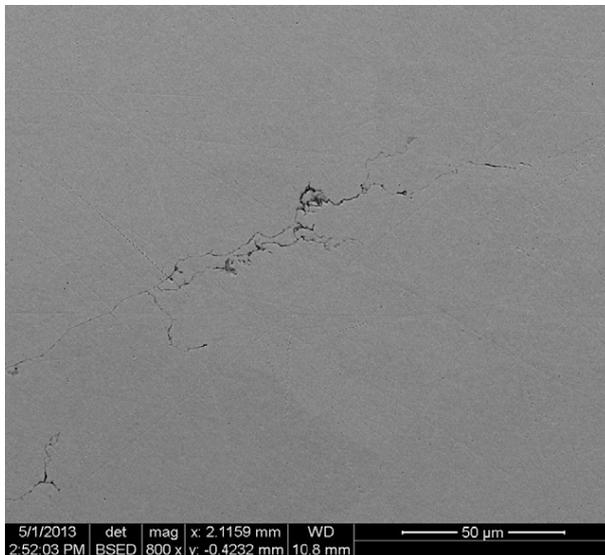
Figure 1-2. SEM micrograph of cross-section through WOL specimen 1 (near borehole flange – shown in Appendix A) from MiniCan 3 (from Figure 3-20 in Smart et al. (2013)) showing crack branching.

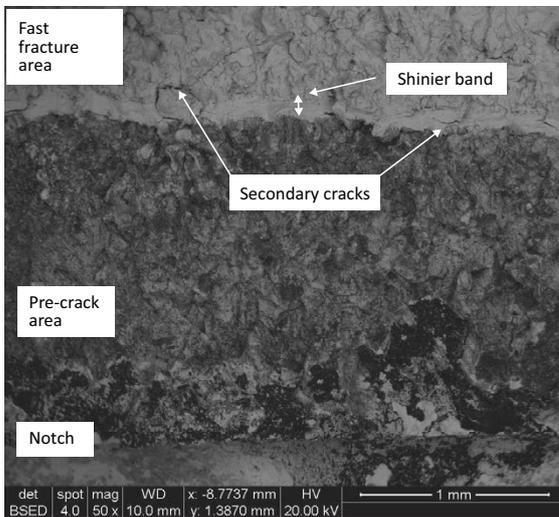
Figure 1-3. SEM image of WOL specimen B1 (near to borehole flange – shown in Appendix A) from MiniCan 3, end of pre-crack, $\times 50$ magnification (from Figure 3-10 in Aggarwal et al. (2015)).

During further metallographic examination, the two WOL specimens from MiniCan 3 were broken apart by fatigue crack opening (fast fracture) to expose the fracture surfaces for analysis. The original pre-cracked surface was easily distinguished from the new fractured area (created post-test) since the latter exhibited a shiny metallic face, while the original pre-cracked surface was covered by a dark deposit (e.g. Figure 1-3 taken from (Aggarwal et al. (2015))). Energy Dispersive X-ray Spectroscopy (EDS) of the dark deposit was consistent with it being a copper oxide. Although the nominal target length of the pre-crack was 1.5 mm, the lengths of the pre-crack measured after opening the specimens varied within 935–1258 μm and 1631–1961 μm for the two WOL specimens, respectively. Accounting for the uncertainty in the crack length associated with the pre-cracking procedure, which was several hundred microns, there were no obvious signs of growth of the pre-crack in these specimens during exposure (Aggarwal et al. 2015). Examination of the fracture surfaces by SEM using secondary electron imaging showed smaller secondary fractures of the order of ca 100 μm , which appeared to emanate from the shiny fast fracture surface and extend inwards (i.e. perpendicular to the main fracture surface). The location of these fractures implies that they were formed during fatigue fracturing that was performed to open the specimen for examination after exposure in the borehole, see e.g. fast fracture area in Figure 1-3 and Figure 1-4, reproduced from (Aggarwal et al. 2015).

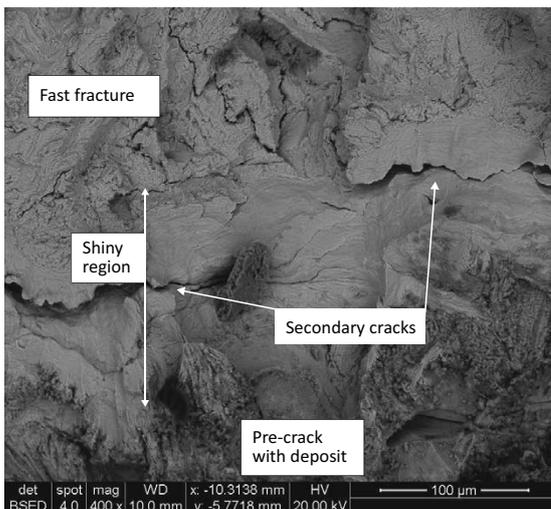
Figure 1-4. SEM image of WOL specimen B2 (near to borehole flange – shown in Appendix A) from MiniCan 3, end of pre-crack, $\times 400$ magnification (from Figure 3-12 in Aggarwal et al. (2015)). Note the ca 100 μm fractures in the fast fracture surface.

The fatigue hypothesis is further supported by the observation of fractures of similar size (ca 100 μm) in the fast fracture surface of WOL specimens from MiniCan 3 (Figures 1-3 and 1-4), after further fatigue cracking was used to open up the specimens for SEM-EDS analysis of the fracture surface, as reported in Aggarwal et al. (2015).

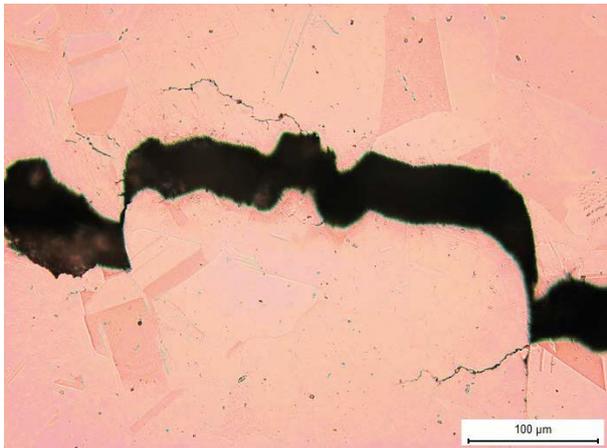
Figure 1-5. Optical image of the middle part of the pre-crack of WOL sample M4 4:1 from MiniCan 4, showing smaller fractures emanating from the pre-crack (Figure 4-7 in Gordon et al. (2017)).

MiniCan 4 was retrieved in 2015 (Gordon et al. 2017). The surfaces perpendicular to the crack generated through fatigue loading (pre-cracked specimens) were polished and examined with Light Optical Microscopy (LOM), while SEM was used to determine the crack length. One of the specimens was opened to expose the fracture surfaces by fast fracture, as described previously. SEM-EDS analysis of the WOL samples detected the presence of small amounts of sulfur at the crack tip in the surface oxide. As with the MiniCan 3 specimens, secondary fractures (up to ca 100 μm) were noted seemingly emanating from the main pre-crack into the cold deformation area of the parent material on either side of it, see e.g., Figure 1-5. Some of the secondary fractures that branched from the main pre-crack were orientated perpendicular to the direction of the pre-crack, i.e. parallel to the direction of the applied load during fatigue pre-cracking and exhibited subsequent branching. Furthermore, a secondary crack ca 100 μm in length was observed emanating from the notch ca 150 μm from the opening of the main pre-crack, see Figure 1-6.

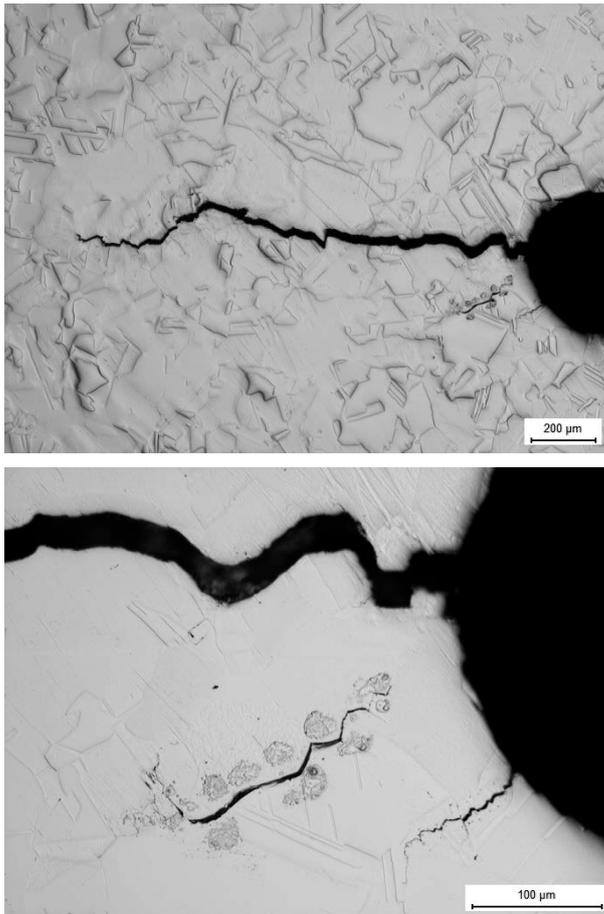
Figure 1-6. Optical micrographs of the same region of WOL specimen at a coarser (top) and finer (bottom) scale showing small secondary fractures close to and emanating from the notch of WOL specimen (M4 3:1) from MiniCan 4, the cracks are below the main fatigue pre-crack (Figure A3-35 in Gordon et al. (2017)).

- In both the new specimens and the MiniCan specimens there are secondary fractures extending around one or several crystal grains, which then appear to be “detached” when viewed in cross-section (two dimensional). These seem to occur in the cold deformed zone near the surface. Examples can be seen e.g. in Figure 3-2 close to the opening of the pre-crack at the notch, near the corresponding position in Figure 4-4, and in close-up in Figure 4-5.
- In both the new specimens and in the MiniCan specimen there are fractures of up to ca 100 μm length, extending from the notch near the opening of the pre-crack. This can be seen for both the new specimens in Figure 3-1 and Figure 3-2, as well as for the MiniCan specimens in Figure 1-6 and Figure 4-6.

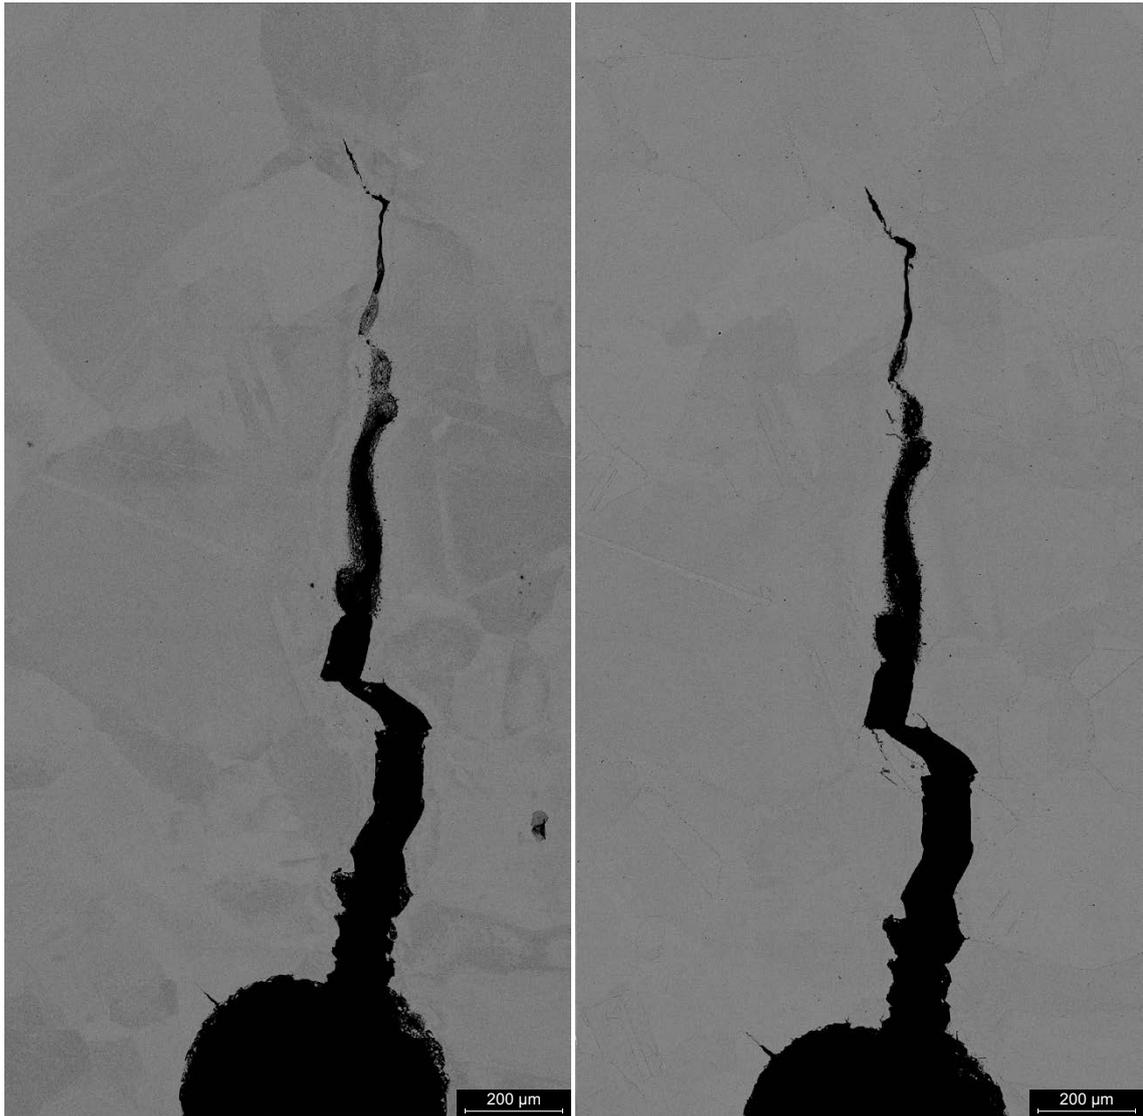
Figure 3-1. SEM micrographs of the WOL specimen BBG01 pre-etch (left) and post-etch (right) that was pre-cracked by fatigue but was not exposed to a corrosive environment prior to metallographic analysis. Some features appear more clearly after etching the specimen surface.

Figure 3-1 and Figure 3-2 show pre- and post-etching SEM images of the newly manufactured WOL specimens BBG01 and BBG02, respectively. In both instances, the team who produced the cracks inspected them and deemed them to be typical of those produced during pre-cracking. Some features appeared more clearly after etching, but etching did not seem to cause any other changes in the morphology of the pre-crack. Both specimens exhibited clear evidence of secondary branching cracks, emanating from the main pre-crack as well as from the notch.

- The pre-cracks in the new WOL specimens are nominally of the same length (1.5 ± 0.3 mm) as the pre-cracks of the MiniCan specimens and the fracture morphology appeared similar. Comparing Figure 3-1 and Figure 3-2 with Figure 4-1 and Figure 4-2 show that in both cases the cracks are mainly transgranular. However, Gordon et al. (2017) reported the pre-crack to be mostly intergranular, and Figure 1-1 appears to show the pre-crack as both transgranular and intergranular.
- For both the new specimens and the MiniCan specimens there are small secondary fractures emanating from the main pre-crack.
- For both the new specimens and the MiniCan specimens, the number and length of the secondary fractures are similar. Comparing Figure 3-1 and Figure 3-2 with Figure 4-1 to Figure 4-4 there are 3 to 7 secondary fractures per ca 1.5 mm (primary) pre-crack, and the secondary fractures vary

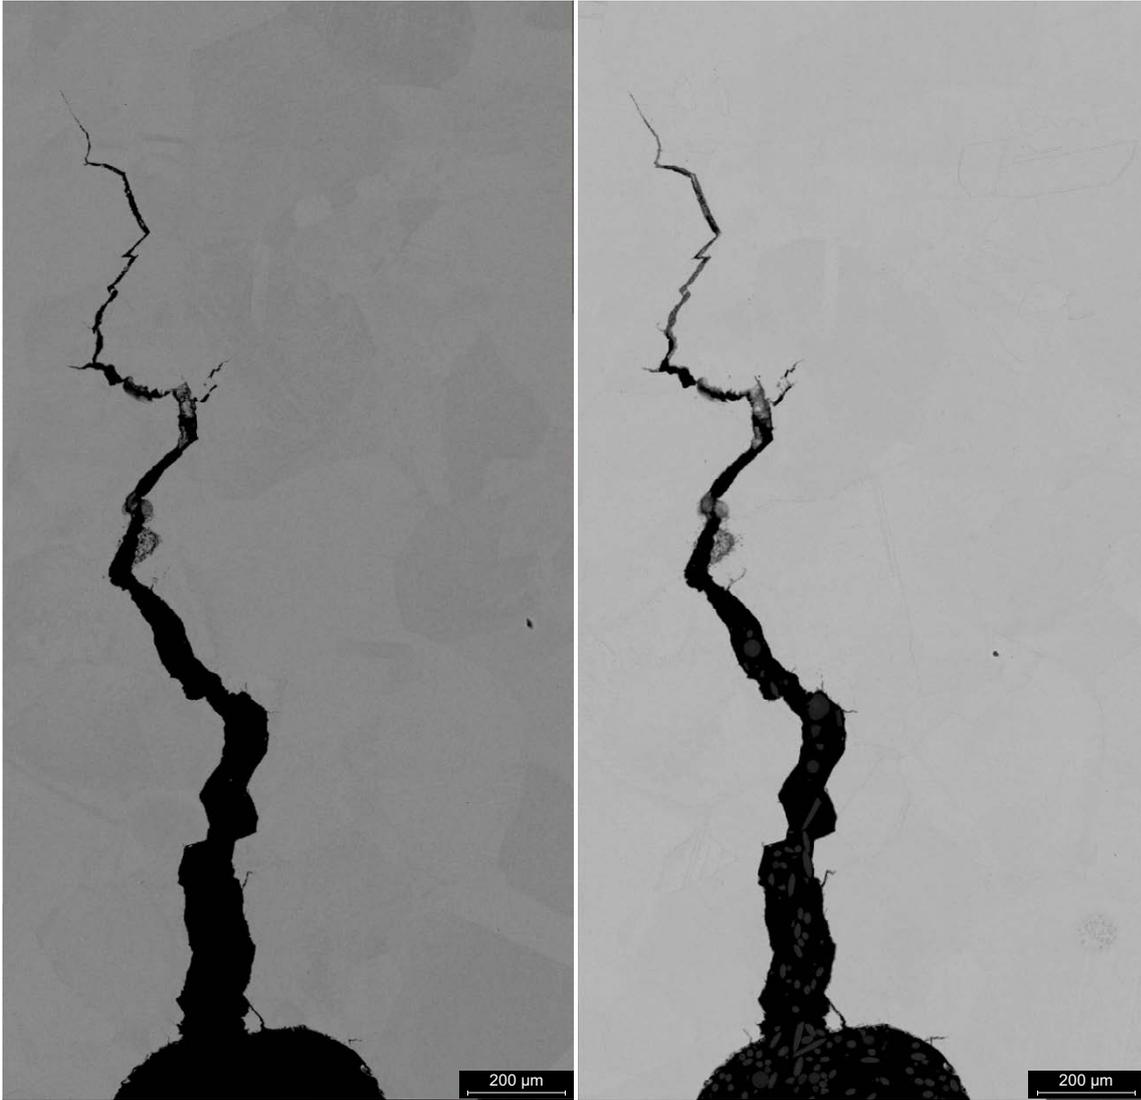
Figure 3-2. SEM micrographs of WOL specimen of BGG02 pre-etch (left) and post-etch (right) that was pre-cracked by fatigue but was not exposed to a corrosive environment prior to metallographic analysis.

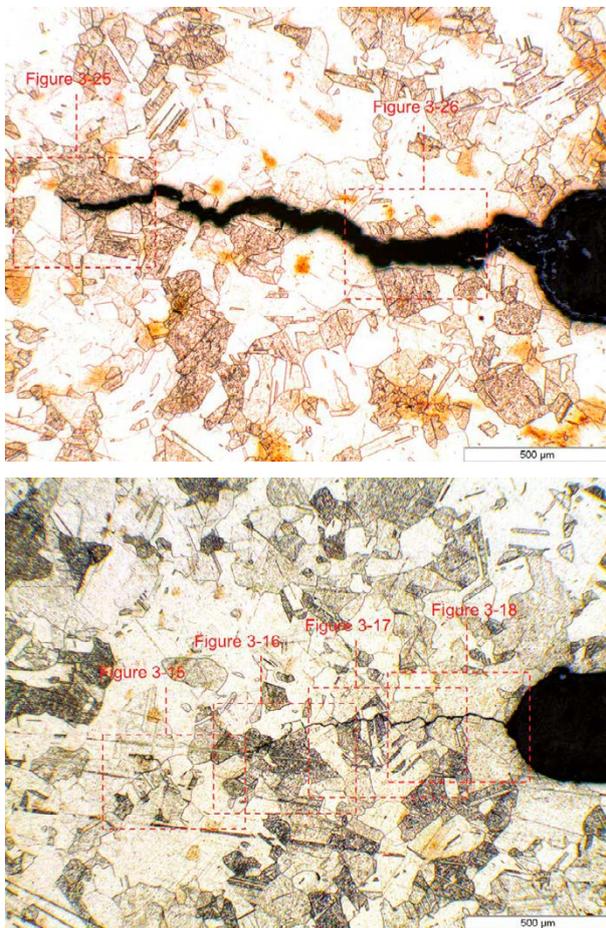
Figure 4-1. Optical micrographs of the pre-cracks in WOL specimen 2 (top) and WOL specimen 1 (bottom) from MiniCan 3 (Figures 3-14 and 3-24 in (Smart et al. 2013)). Figure numbers in the images refer to figures in the report (Smart et al. 2013).

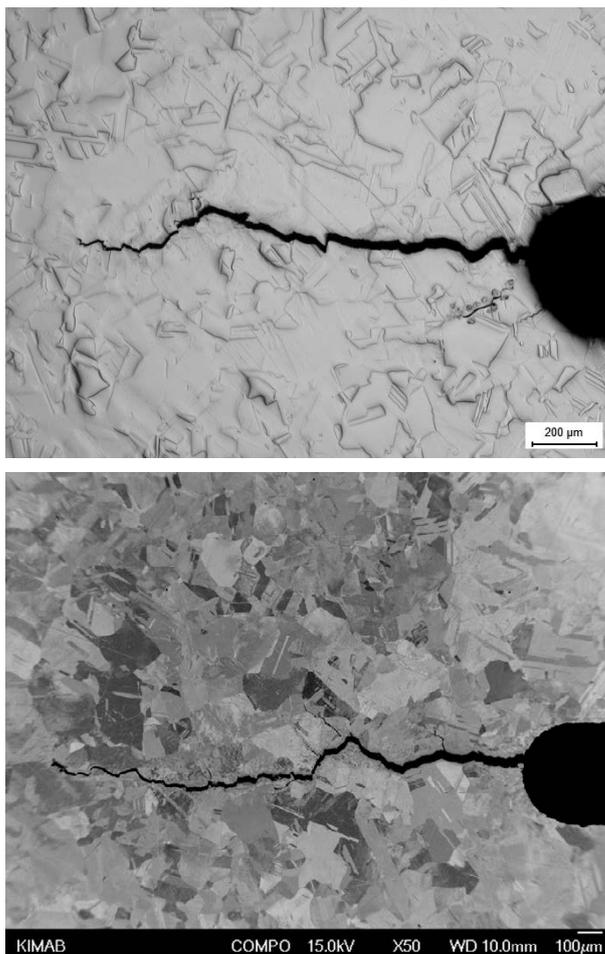
Figure 4-2. Optical (top) and SEM (bottom) micrographs of pre-cracks in WOL specimen M4 3:1, from MiniCan 4 (Figures A3-34 and A3-40 in Gordon et al. (2017).

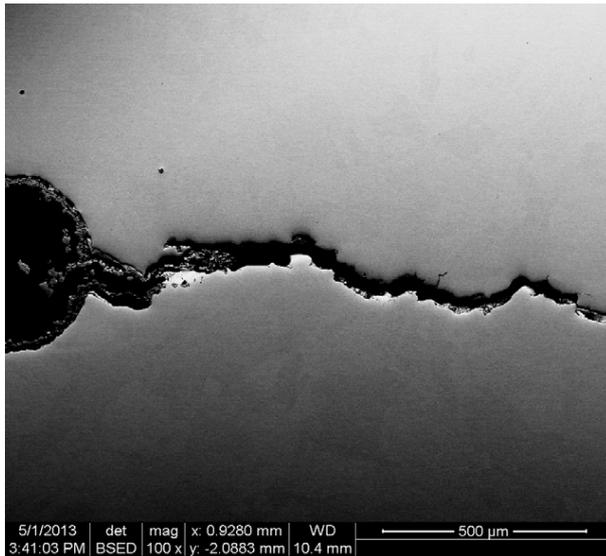
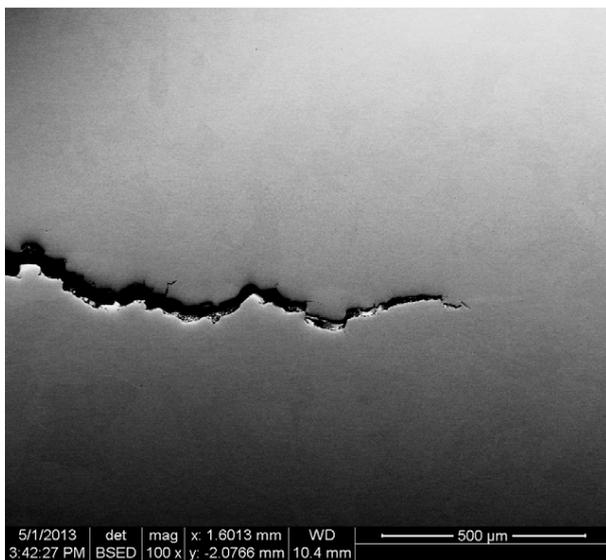
Figure 4-3. SEM micrographs of the pre-crack in WOL specimen 2 from MiniCan 3 (located near to support cage) at the notch (top) and the crack tip (bottom) (Figure 3-27 in Smart et al. (2013)).

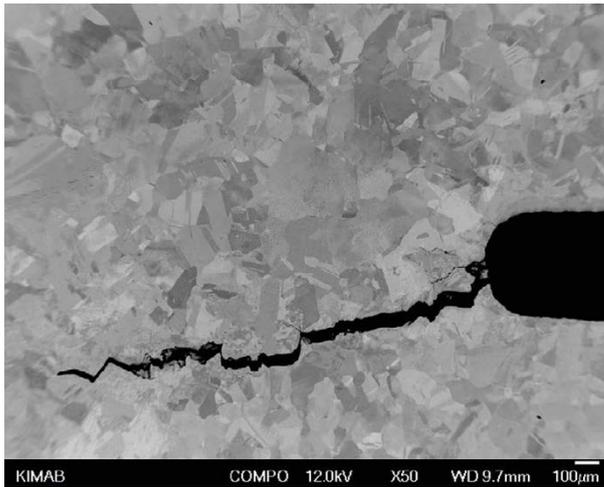
Figure 4-4. SEM backscattered electron micrograph of the pre-crack in WOL specimen M4 4:1 from MiniCan 4 showing the pre-crack emanating from the notch (Figure A3-60 in Gordon et al. (2017)).

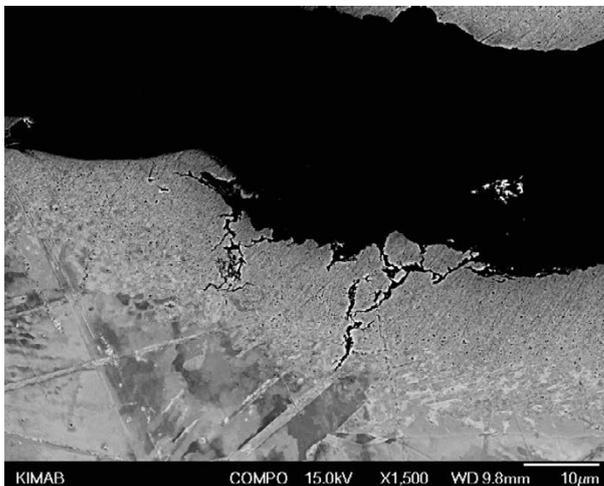
Figure 4-5. SEM image showing detail of the pre-crack of WOL specimen M4 3:1, from MiniCan 4, showing smaller secondary cracks in the cold deformed area of the material (Figure A3-44 in Gordon et al. (2017)).

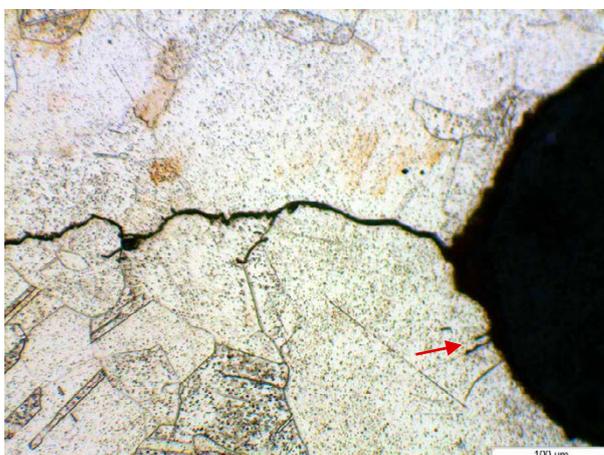
Figure 4-6. Optical image of the pre-crack in WOL specimen 1 from MiniCan 3. Note the ca 40 µm fracture emanating from the notch (red arrow) near the opening of the pre-crack. (Figure 3-18 in Smart et al. (2013)).

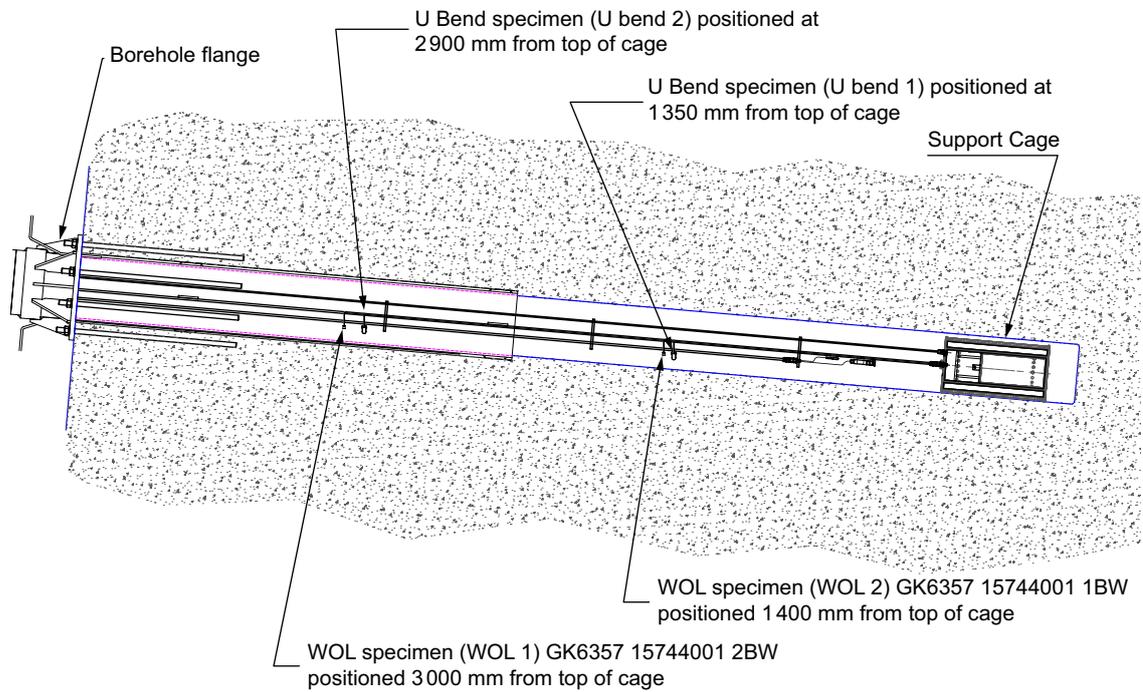
Figure A-1. Location of U-bend and WOL specimens in MiniCan borehole relative to the position of the support cage containing the MiniCan experiment and the borehole flange.

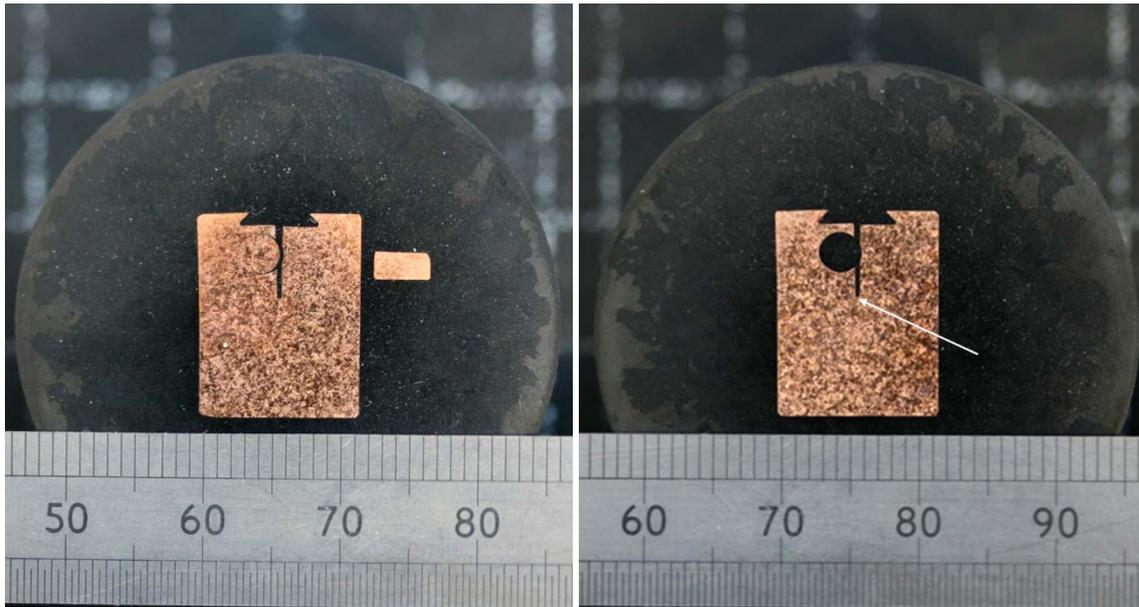
Figure B-2. Sectioning of WOL specimens from the MiniCan experiment. The arrow in the right photograph indicates the location of the notch from which the pre-crack initiates. The direction of the pre-crack is a continuation of the notch.

The original fatigue pre-cracking procedure of WOL specimens consisted of the formation of a crack nominally 1.5 mm in length, leading to a crack length-to-width ratio of $a/W \approx 0.4$. The stress intensity factor used was $K_{max} = 8.5 \text{ MPa}\sqrt{\text{m}}$ throughout, with an R-ratio of 0.1. Typically, 550 000 cycles were required to generate the fatigue crack, at a frequency of around 100 Hz. Details of the procedure are shown in Figure B-1. After exposure in the borehole, specimens were sectioned for analysis as shown in Figure B-2.

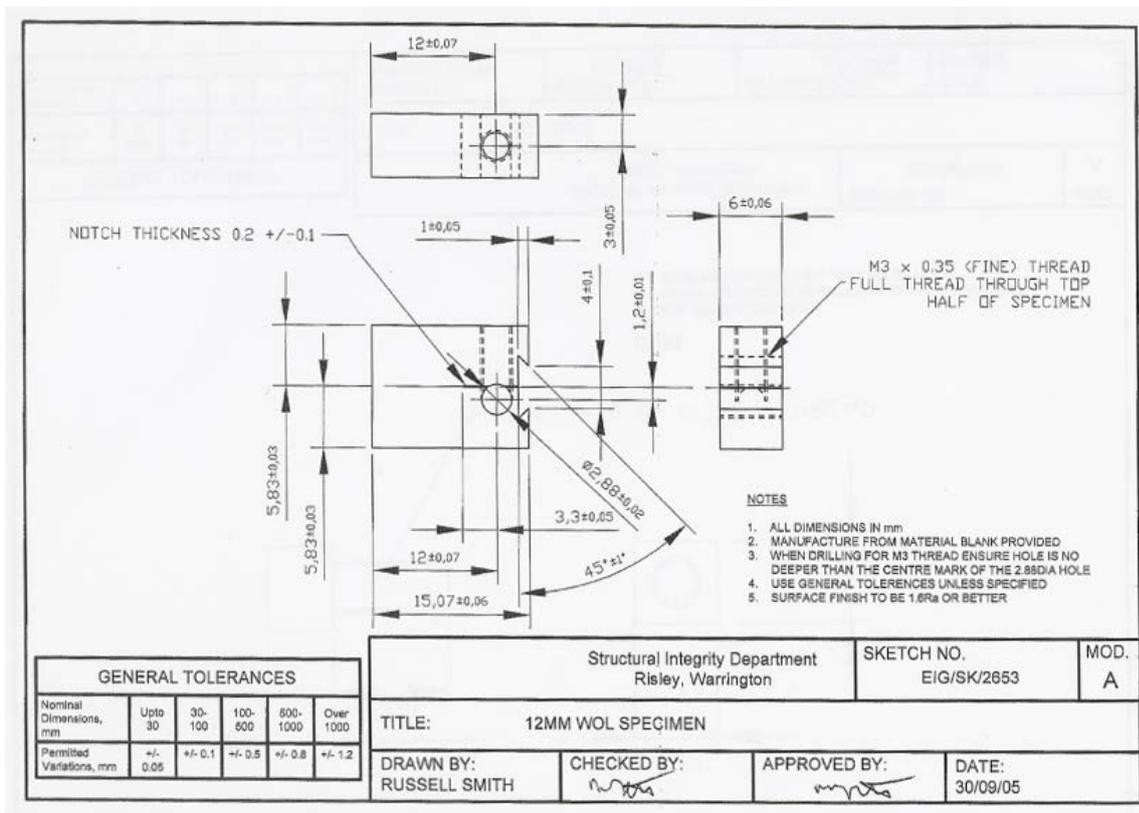
Figure B-3. Original drawing of WOL specimens from the MiniCan experiment.

A diagram of the WOL specimen design that was used in the MiniCan experiment and subsequently for the new WOL specimens is shown in Figure B-3.

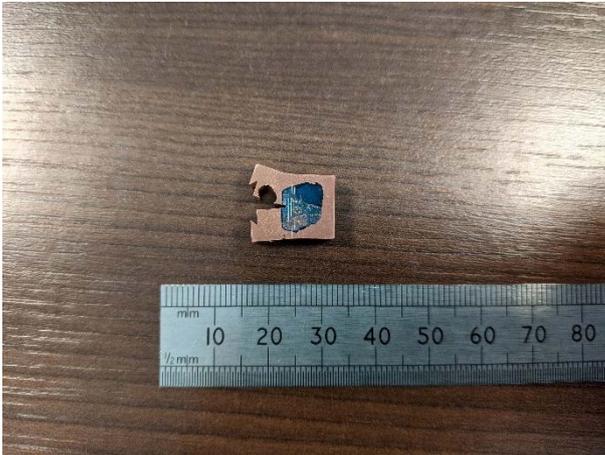
Figure C-1. Side view of overloaded WOL specimen.

During initial attempts to perform fatigue pre-cracking of the specimens the specimens were overloaded, leading to plastic deformation prior to the formation of a crack. Images of an overloaded WOL specimens are shown in Figure C-1 to C-2.

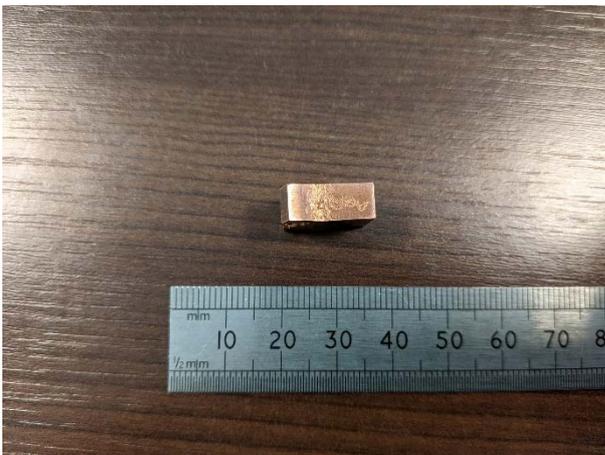
Figure C-2. Top view of overloaded WOL specimen.
