SKB R-25-08

Evaluation and analysis of Cu samples exposed at elevated temperature to various bentonites

RISE Research Institutes of Sweden AB

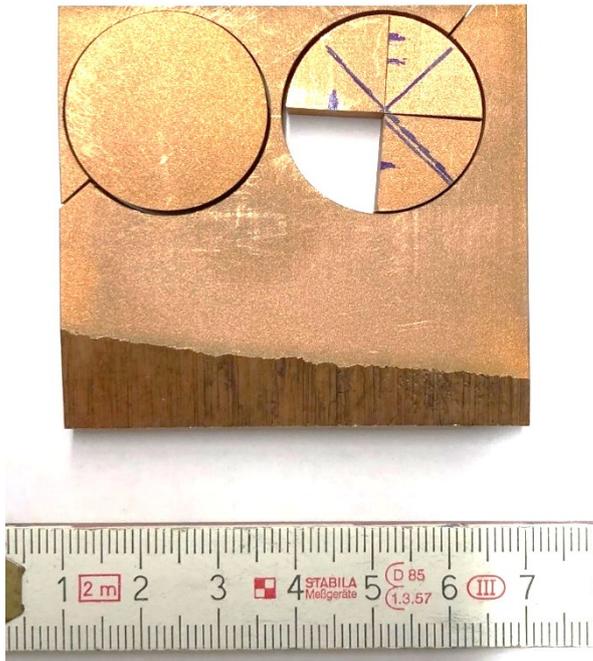
Figure 1-1. Electrical discharge machined cylinders from the material supplied by SKB.

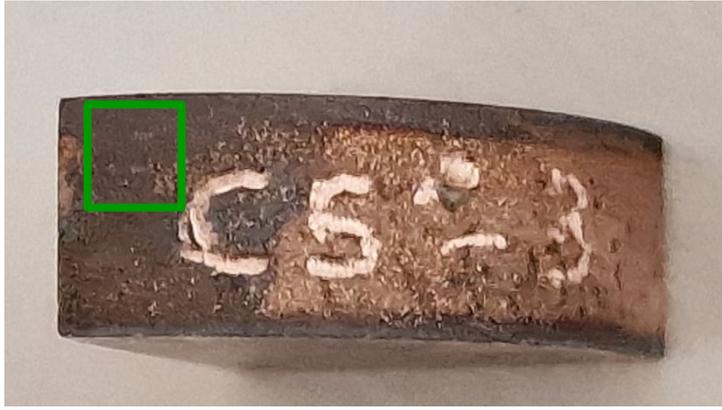
Specimens in contact with MX-80 bentonite exhibited in some areas increased amounts of sulphur. The sulphur signals were found in coexistence with Cu, which might indicate the presence of copper sulphides, for example spectrum 2 in sample C1-3, Area 1, see Figure 7-91 and Table 7-1. Thicker deposit was found in some areas following the outer border of the specimens (grey-hue deposit), with the presence of iron, aluminium and silicon. Large areas in EDS maps show mostly copper and sulphur in coexistence (see Figure 7-90). The rim of the specimen exposed for 12 months (C5, see Figure 3-1) exhibited a dark colour which was not visible in other samples, including the ones exposed to the same type of bentonite for 6 months (C1). This rim was examined by SEM/EDS and XRD, showing mainly signals from Cu, O, Si, Ca, S and Al (see Figure 3-2).

Figure 3-1. Blackened edge observed on sample C5-3.

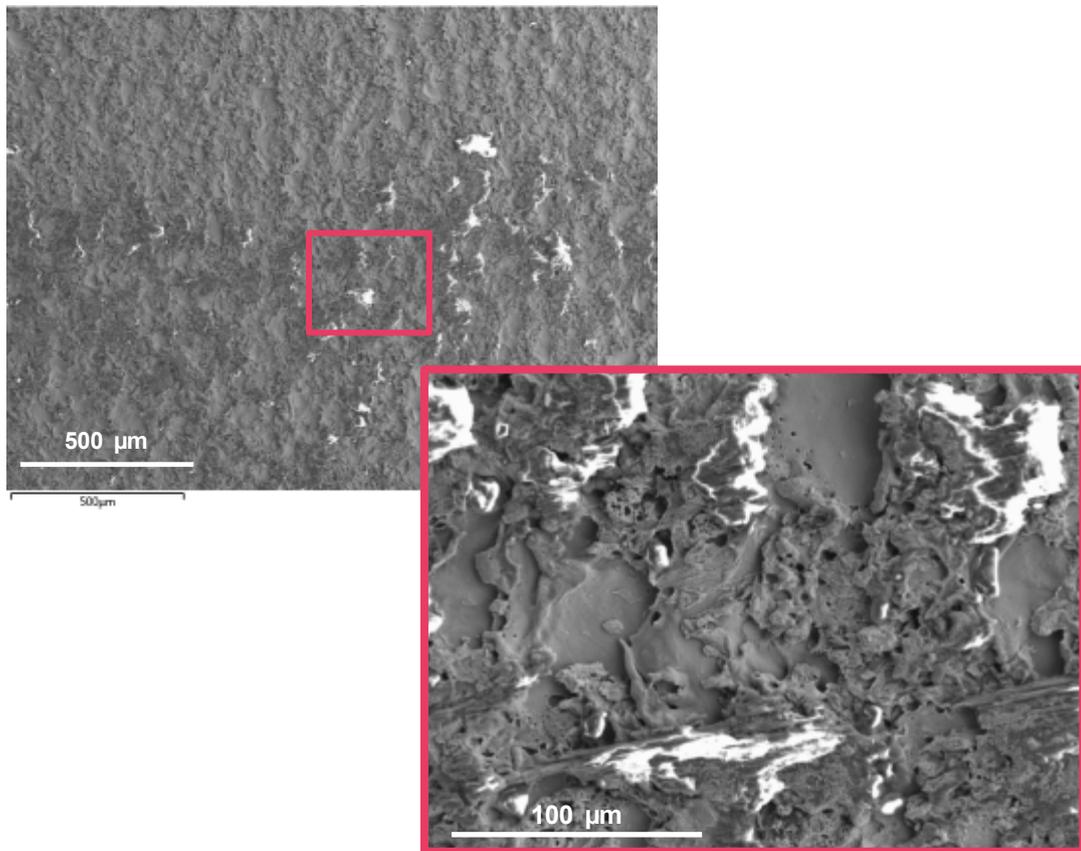
Figure 3-2. SEM image of specimen C5-3 (blackened edge shown in Figure 3-1, approximately inside the green square). The image to the right corresponds to a magnification (1000x) of the red square area.

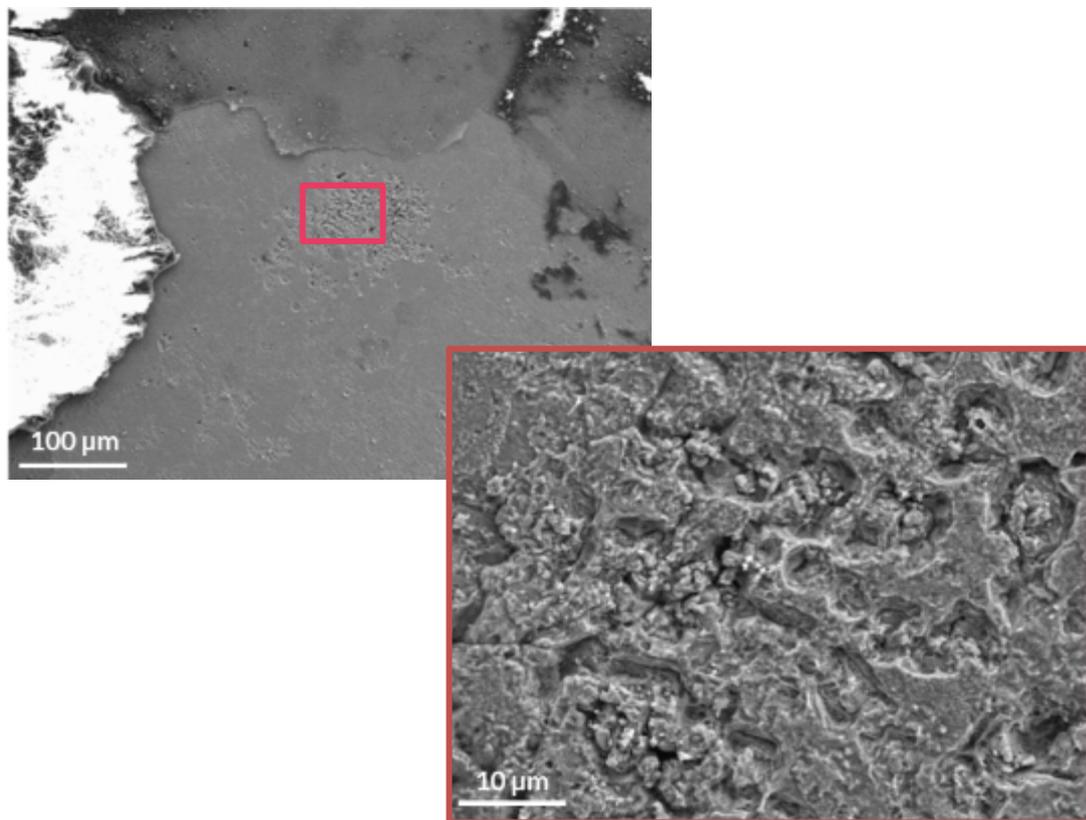
Specimens in contact with Asha bentonite (C4 and C8) exhibited large areas of their surfaces covered with deposit. These deposits contained mostly O, Na, Mg, Al, Si, Ca and Cu. Areas without deposit were observed as well. It was observed in the specimen exposed for 12 months (C8-3) a structure resembling pits (see Figure 3-3), without visible corrosion products. Spots with higher amounts of iron were also observed in all examined areas, in connection with silicon.

Figure 3-3. Examined surface of specimen C8-3 (Area 1). The image to the right corresponds to a higher magnification of the squared area (1000x). A structure resembling pits is observed in areas not covered by bentonite or deposits. The pits were analyzed using EDS and no visible corrosion products were identified.

A structure resembling pitting corrosion was observed in specimen C8-3. The appearance of the pitting resembles the so-called “ant-nest” corrosion, which affects copper and its alloys in different industrial applications. It is however mostly associated with the presence of formic acid (Corbett and Elliott 2000). The observed pits could have been formed entirely during the exposure or possibly constitute slightly corroded cavities from pre-exposure defects in the material. However, existence of pre-exposure defects would not by itself explain the difference in observed pits, depth and frequency, between the various bentonite qualities. The EDS analysis of that area showed little to negligible amounts of corrosion products. The area was not covered in bentonite either, which suggests that a dissolution mechanism might have taken place. If bentonite was present at the pitted area, copper could conceivably have migrated into the bentonite by some kind of ion exchange. The corroded copper could be transported out of the cavity as dissolved ions or complexes. Copper in dissolved form from corrosion usually requires oxidizing conditions. Oxidizing conditions generates Cu(I) in the forms: Cu^+ , $\text{CuOH}(\text{aq})$, $\text{Cu}(\text{OH})^{-2}$, but mostly as chloride complexes. While Cu(II) in the forms: Cu^{2+} and in hydroxide, carbonate and sulphate complexes. Dissolved oxygen is usually the oxidant for these corrosion products. However, pit-like features can also form during reducing conditions when sulphide is present at a concentration in the order of 1mM, as HS^- (Taxén et al. 2023). In this case, the oxidant could be water. The oxidant can also be copper (e.g. solid copper oxide). Simultaneous presence of dissolved oxygen and dissolved sulphide does not seem likely. It is recommended to perform cross sections of the affected areas to study the phenomena further, whether the pits have penetrated into the bulk and if there are corrosion products present there. It is recommended as well to perform a compositional analysis on the Asha bentonite used for this exposure, to determine if there was any noticeable increase in Cu content. Laser Ablation Inductively Coupled Plasma Mass Spectrometry (LA-ICP-MS) or possibly GDOES on the bentonite surface could give a copper profile, perpendicular to the metal surface.

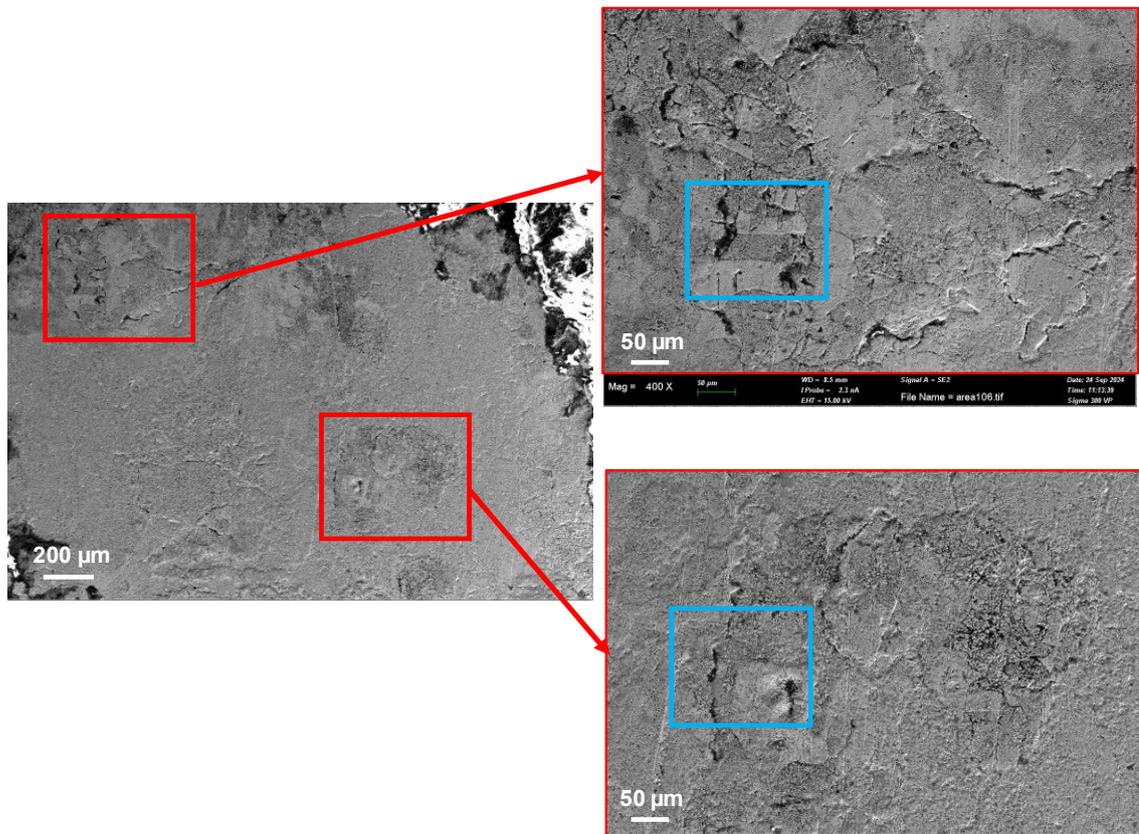
The specimen C4-2 was examined once more after observing the pit-like damage in C8-3 (Figure 3-4 and Figure 3-5). Different types of damage were identified at the surface, including preferential grain dissolution, grain boundary attack, and formation of deep pit-like features.

Figure 3-4. Examined surface of specimen C4-2. The image to the right corresponds to a higher magnification of the squared areas in red. The blue squares are shown magnified in Figure 3-5.

Specimen C4-2 (non-pickled) was examined a second time using SEM, with special attention to the surface underneath bentonite deposits. Pit-like features and possibly preferential dissolution of certain grains were observed, as well as intergranular attack. The cross section of C4-2 revealed heavier pitting-like features on the side with more bentonite deposits, suggesting a link between the type of bentonite and the observed degradation.

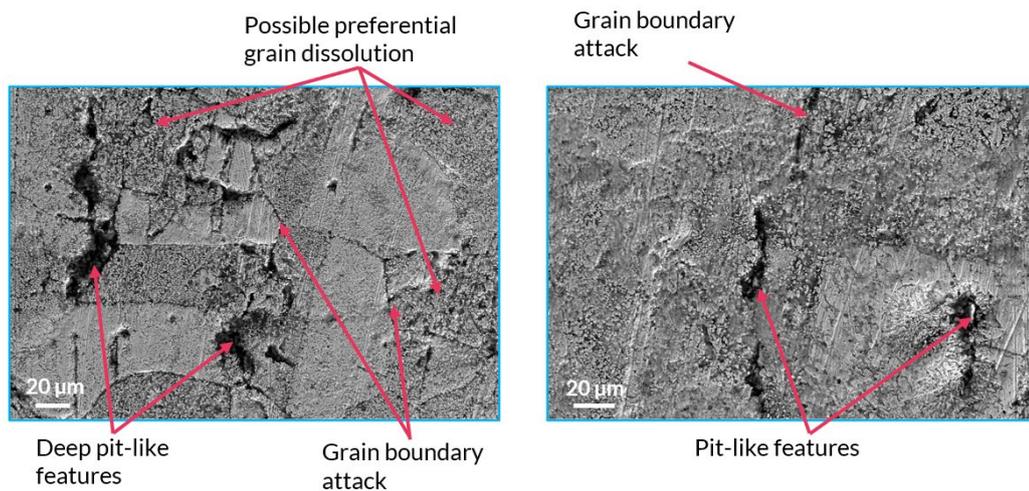
Figure 3-5. Magnified areas from Figure 3-4. Examples of preferential grain dissolution, grain boundary attack, and pit-like features are indicated. Note that not all affected areas have been marked.

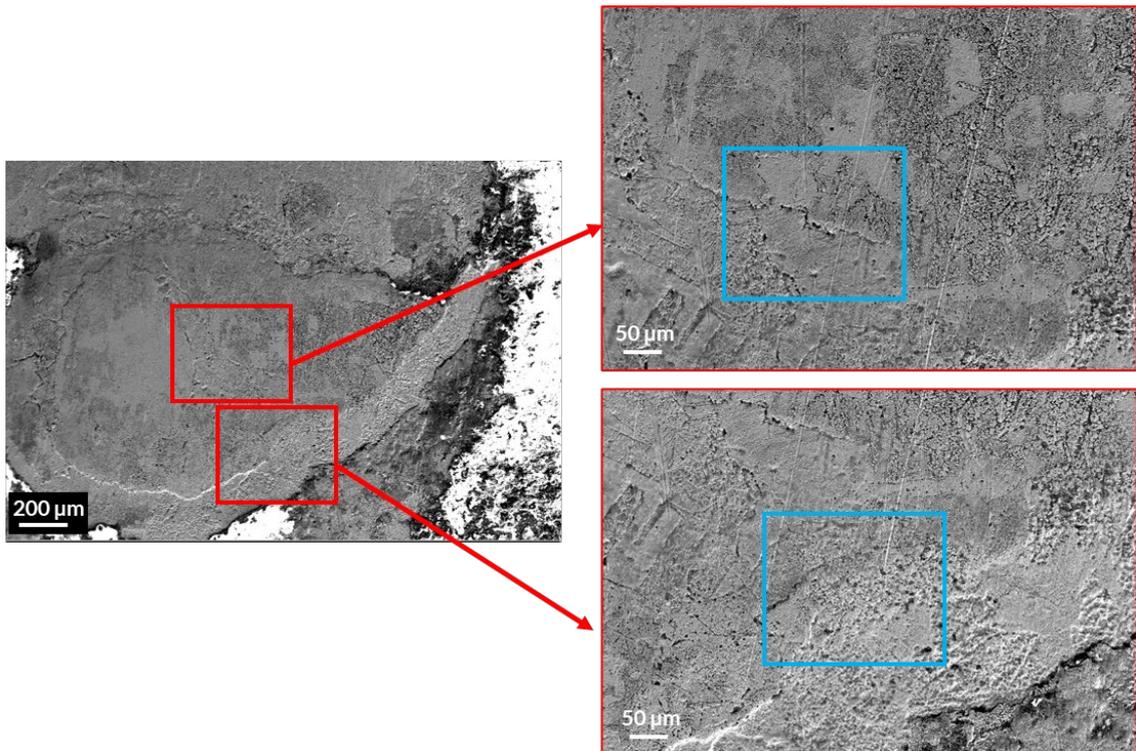
The bentonite deposits were carefully removed from C4-2 with a soft plastic brush and the specimen was once more examined using SEM. Similar degradation patterns were observed underneath the bentonite deposit (see Figure 3-6 and Figure 3-7).

Figure 3-6. Examined surface of specimen C4-2, underneath bentonite deposit (mechanically removed). The image to the right corresponds to a higher magnification of the squared areas in red. The blue squares are shown magnified in Figure 3-7.

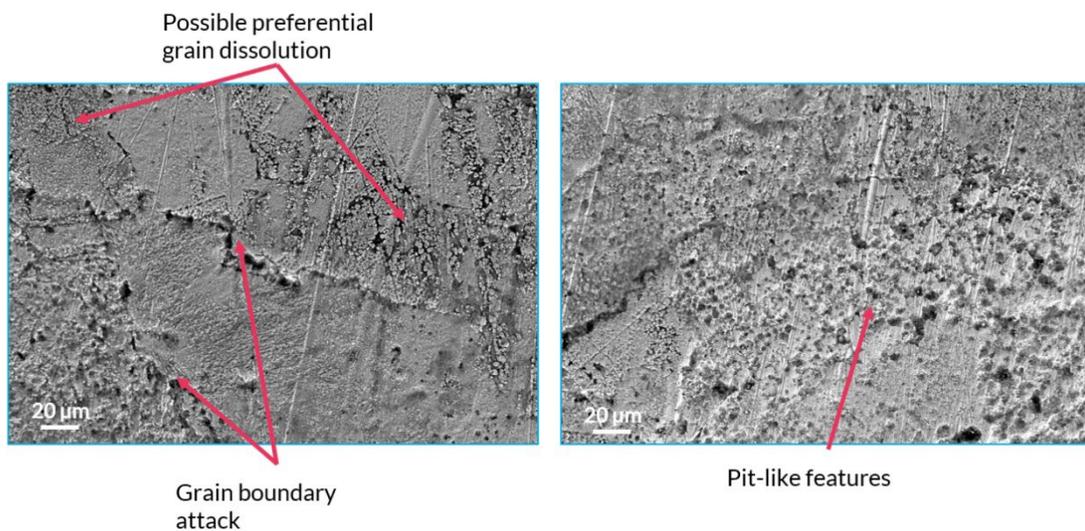
Figure 3-7. Magnified areas from Figure 3-6. Examples of preferential grain dissolution and pit-like features are indicated. Note that not all affected areas have been marked.

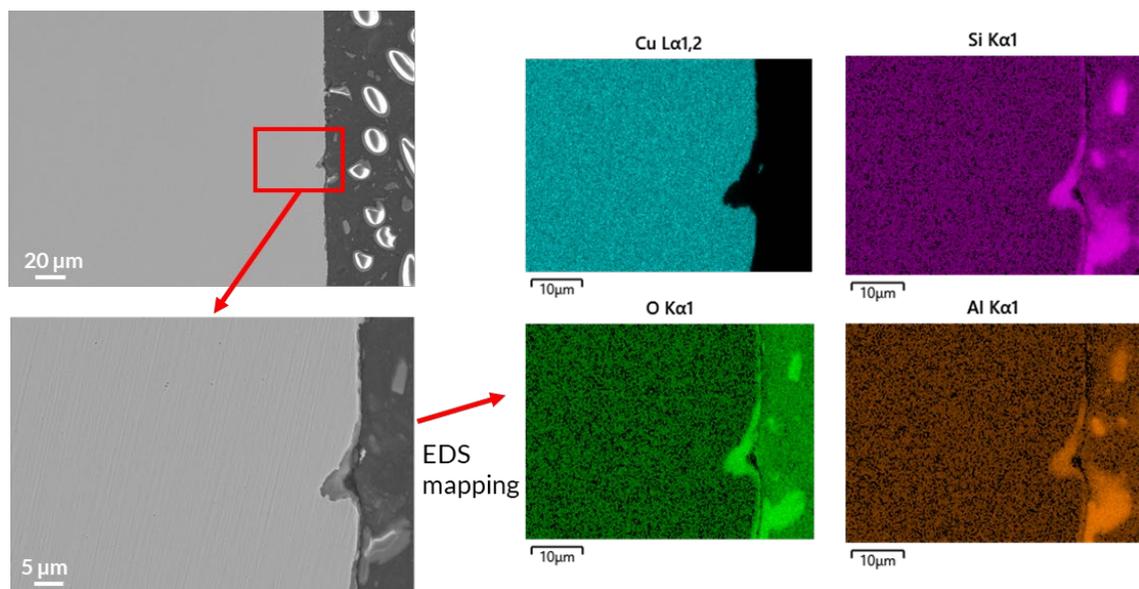
Figure 3-9. SEM/EDS analysis of cross section of specimen C4-2. Side corresponding to the bottom of the left image in Figure 3-8.

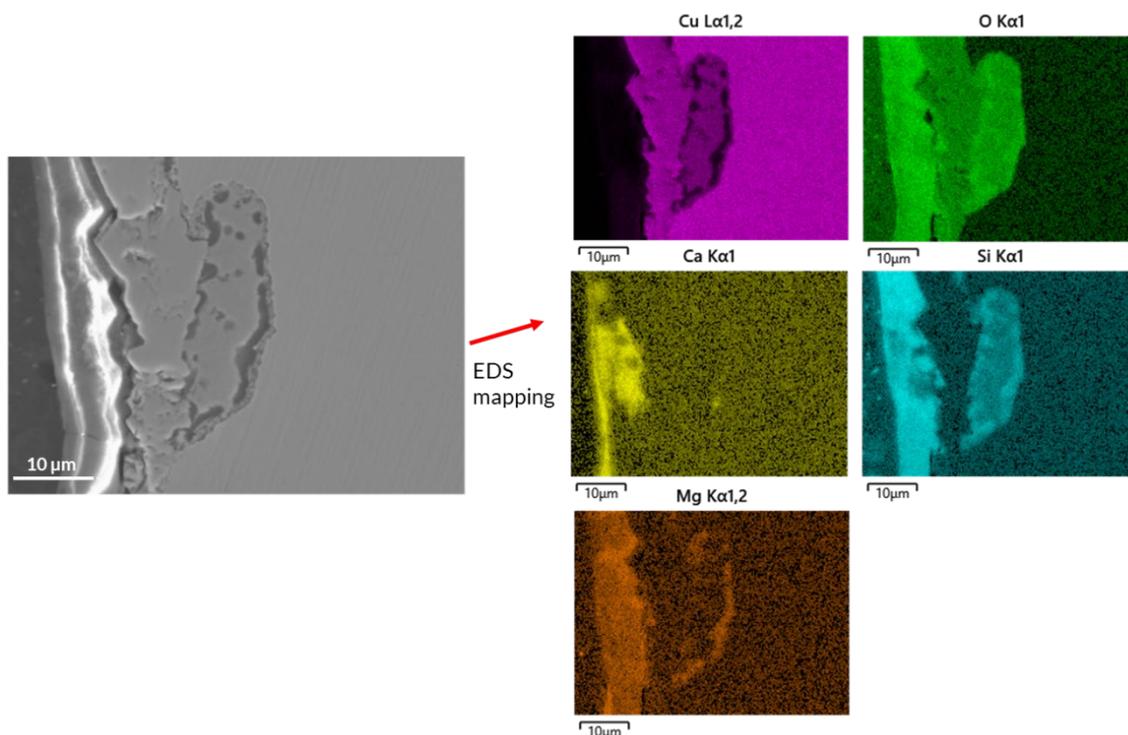
Figure 3-10. SEM/EDS analysis of cross section of specimen C4-2. Side corresponding to the top of the left image in Figure 3-8.

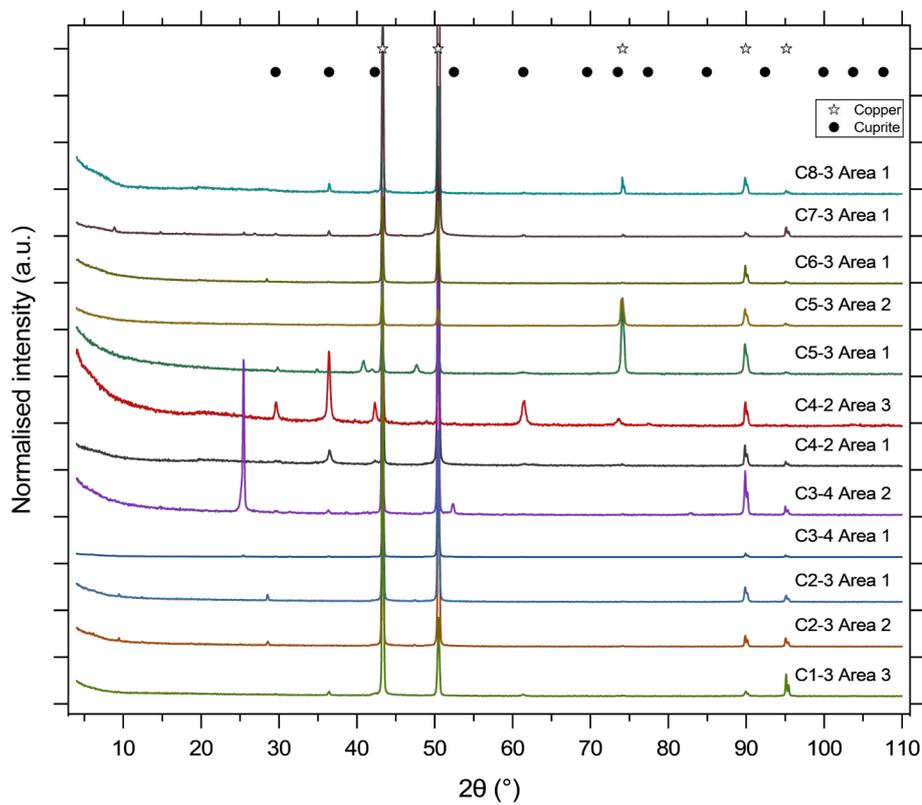
The specimen C3-4 Area 2 had one peak at approximately $2\theta = 25.4^\circ$ that matches with the double peak with highest intensity of the anhydrous form of gypsum. Minor peaks between $0-20^\circ$ were not indexed. Other phases specifically atacamite, paratacamite, or malachite were not identified in any sample. No copper sulphides were identified in any sample.

Figure 3-11. Normalised intensity of XRD patterns for the investigated specimens. One or two areas of each specimen were analysed and reported in the stacked plot. The designated "Areas" correspond to the images shown in the Appendix.

Generally it was found that the samples had not corroded during the exposure, as was observed by the appearance of the exposed samples (see Table 3-1) as well as the mass loss analyses (see Table 3-5). The chemical analyses indicated the presence of sulphur in C1 and C5 samples, although mostly in connection with calcium, however no indication of gypsum was identified in the XRD analysis of these samples. Raman spectroscopy of C5-3 specimen gave no indication of copper sulphides, however some bands from the spectra obtained by FTIR could be contributions from copper sulphides. It is recommended to perform complementary Raman and IR analysis on reference samples of Cu_2S and different types of bentonite. Specimens C2 and C6 exhibited high amounts of chlorine in the EDS analysis, with some areas showing signs of the formation of copper chlorides. C3 and C7 specimens contained sulphur in connection with calcium. The XRD analysis of these samples shows an indication of the anhydrous form of gypsum (see Figure 3-11).

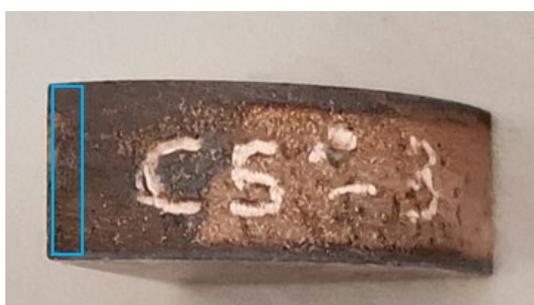
Infrared spectroscopy measurements were performed within the marked area on the black top on sample C5-3, see Figure 3-14. The spectra obtained by ATR-measurements are shown in Figure 3-15. At higher wavenumbers, IR-bands due to stretching vibrations from hydroxyl groups for bentonite are seen at 3621 cm^{-1} and water at 3388 cm^{-1} . C-H vibrations from organic contamination are seen clearly. A OH-bending band for water is present at 1633 cm^{-1} . Bands due to carbonate and Si-O vibrations due to bentonite are seen in the region from $1500\text{--}500\text{ cm}^{-1}$, see Table 3-7 for band assignments. Metal-S vibrations in sulphides are often seen in the far-IR region $500\text{ to }100\text{ cm}^{-1}$ (Brusentsova et al. 2012). It could be possible that the band 438 and 208 cm^{-1} have contributions from Cu-S vibrations due to copper-sulphide compounds, although the assignment to sulphide is quite uncertain. It has been reported that the transmission IR-spectra for CuS and Cu_2S are largely featureless (Brusentsova et al. 2012, Kendix 2009). Here, we can see strong relatively distinct and broad bands in the far-IR region. It is also possible that bentonite have bands in the far-IR region, including lattice vibrations as seen in various silicates (Farmer 1974). Measurements of bentonite references should be performed as well as for copper sulphides.

Figure 3-14. Side of specimen C5-3. The blue rectangle indicates the area where infrared spectroscopy measurements were performed.

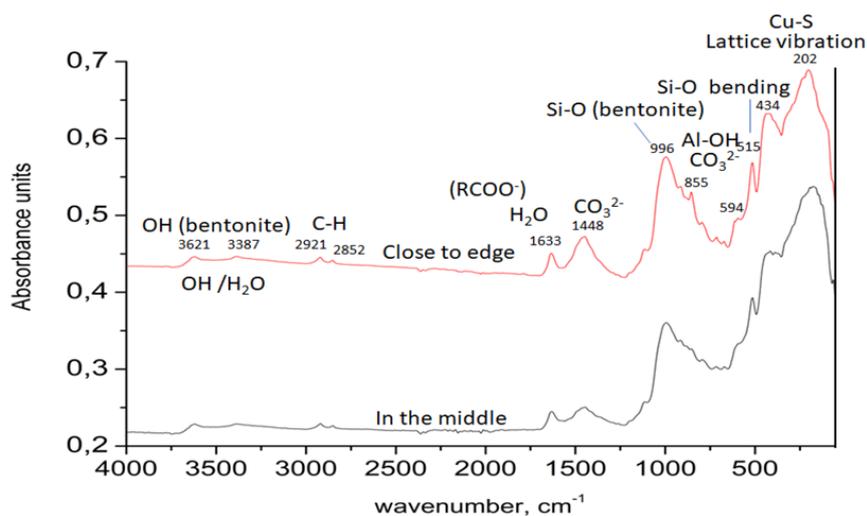
Figure 3-15. FTIR-ATR spectra of sample in the region $50\text{--}4000\text{ cm}^{-1}$. Red spectrum was measured close to samples edge and black spectrum on the middle of the studied area.

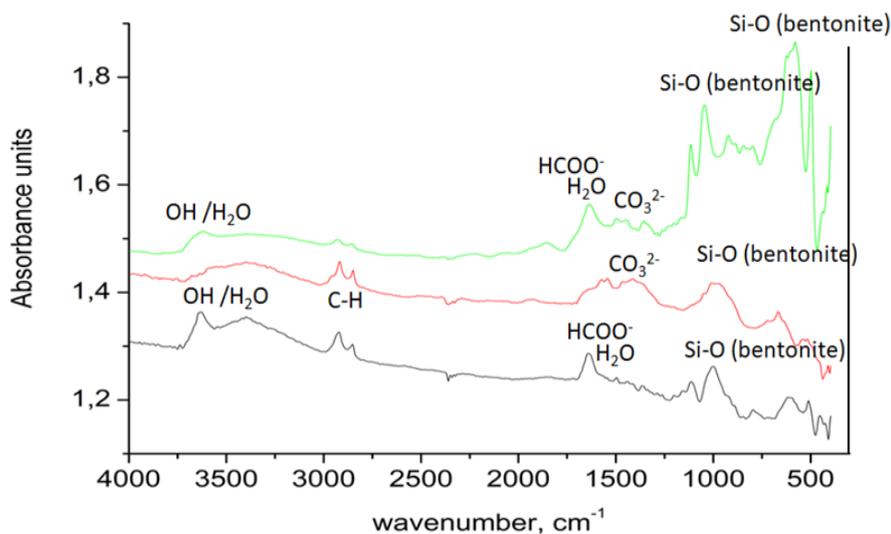
The reflection spectra obtained with the multireflection accessory have large problems with baseline bending and inverted bands at low wavenumbers which makes the interpretation and correction of data (such as baseline correction) difficult (see Figure 3-16). The spectra obtained with specular reflection measurements with the microscope do not cover wavenumbers below 400 cm^{-1} where vibrational bands due to sulphides can be found (see Figure 3-17).

Figure 3-17. FTIR specular reflection spectra obtained in the region $400\text{--}4000\text{ cm}^{-1}$ measured with microscope. The green, red and black spectra correspond to three different areas measured within the marked area.

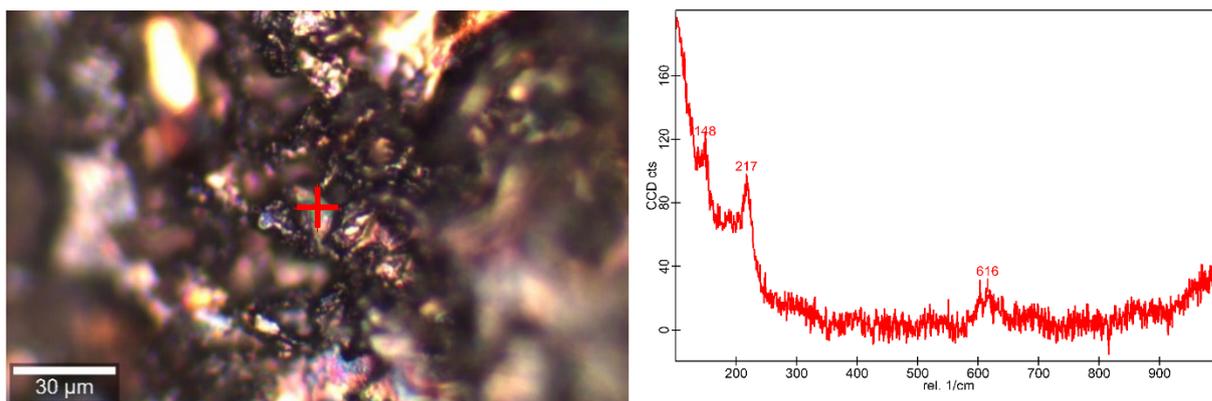
The conducted Raman measurements indicate that most of the studied areas have characteristic Raman features for copper oxides Cu₂O (often, 8 out of 9 studied areas) and CuO (seldom, 1 out of 9 studied areas). There is also a possibility that hydrated copper chloride (CuCl₂·2H₂O) is formed on the surface, since some characteristic bands can overlap with the Cu₂O.

Figure 3-18. Area 9. Left: The studied area where the spectrum was measured is marked with a red cross (optical image). Right: Measured Raman spectrum.

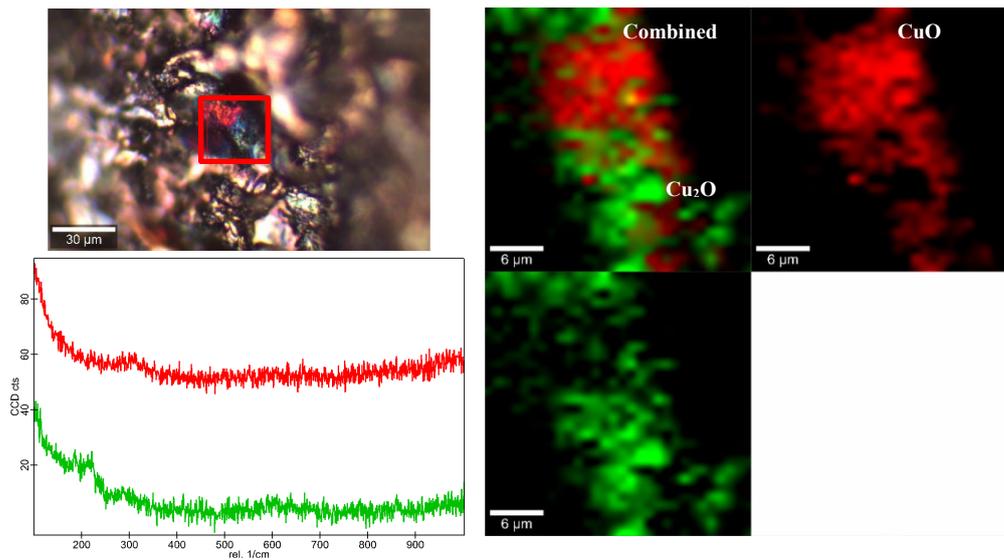
Figure 3-19. Top left: Optical image showing the studied area for the mapping (red square). The reconstructed Raman maps for combined and individual signal map (CuO shown in red and Cu₂O shown in green) are shown to the right. The measured typical spectra used to reconstruct the maps are also shown (CuO shown in red, Cu₂O shown in green).

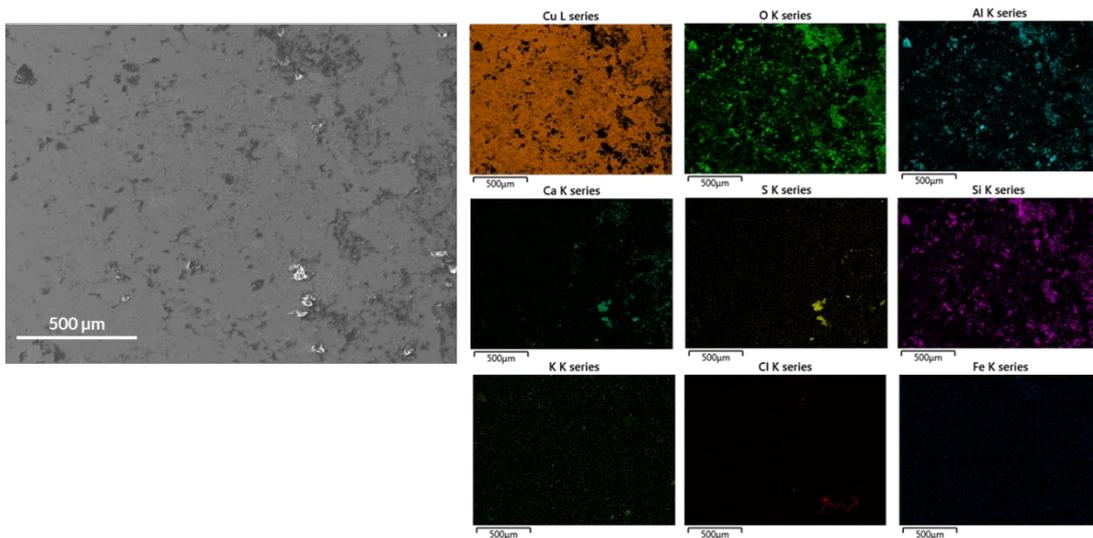
Specimens in contact with Calcigel bentonite (C3 and C7) exhibited increased amounts of sulphur in some areas. However, these deposits do not seem to have interacted with the underlying copper substrate, which is indicated by the EDS maps showing distinctly separate areas containing either copper or sulphur. Thick deposits are observed on the surface of this specimen, with visible white deposits (see images in Table 3-1) containing mostly O-Ca-S (see EDS maps in Figure 7-110 and Figure 7-159), possibly calcium sulphate (gypsum).

Figure 7-159. SEM and corresponding EDS maps of sample C7-3 (Area 3 from Figure 7-151).

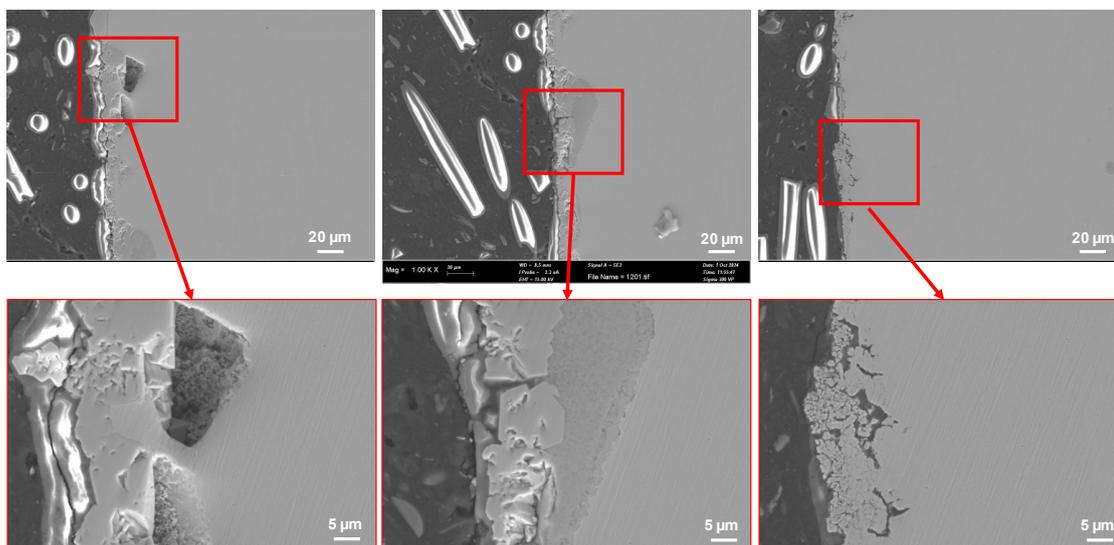
Figure 7-170. SEM images (Secondary Electrons) of cross section of specimen C4-2, corresponding to the top side in Figure 3-8. Generally, more pit-like features were observed on the cross section of the top side of specimen C4-2, which was heavily covered in bentonite deposits.

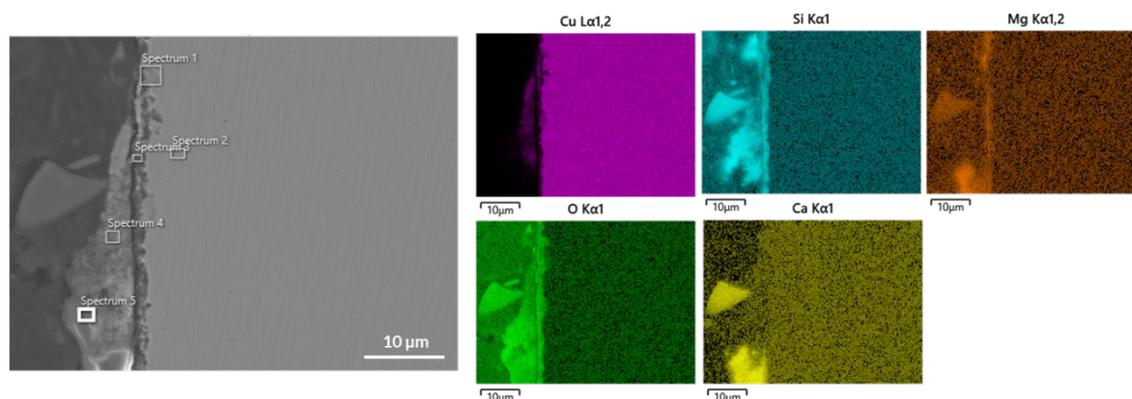
Figure 7-171. SEM image (Secondary Electrons) of cross section of specimen C4-2 (top side in Figure 3-8) and corresponding EDS maps. EDS spectra shown in Table 7-41.

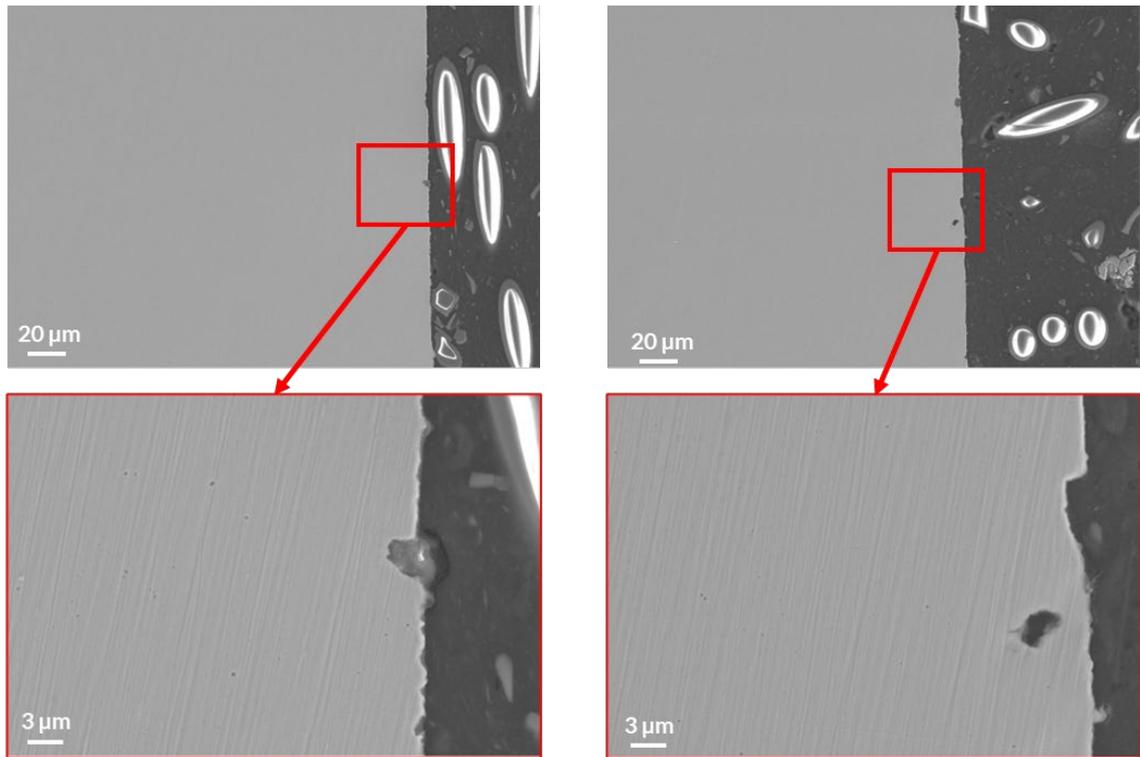
Figure 7-172. SEM images (Secondary Electrons) of cross section of specimen. C4-2, corresponding to the bottom side in Figure 3-8. Generally, fewer pit-like features (which can be even attributed to sample preparation or defects prior to the exposure) were observed in comparison to the “top” side of C4-2.

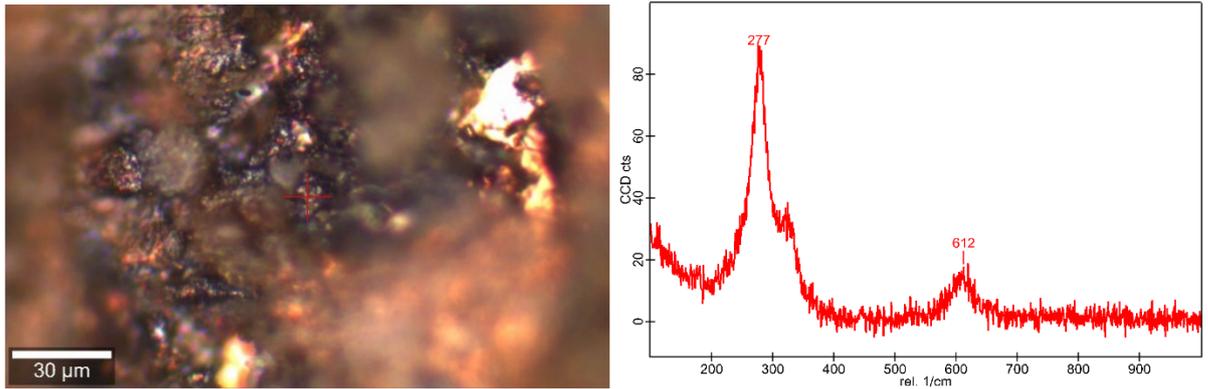
The studied area 1 is shown in Figure 7-173. Both observed peaks at 277 rel.cm with a shoulder peak at around 350 rel.cm and 610 rel.cm can be attributed to CuO. As can be seen from literature these bands are characteristic for CuO and may have shifts depending on the structure (Sriyutha Murthy et al. 2011, Deng et al. 2016).

Figure 7-173. Area 1. Left: Optical image showing the area were the Raman spectrum was measured (red cross). Right: Measured Raman spectrum.

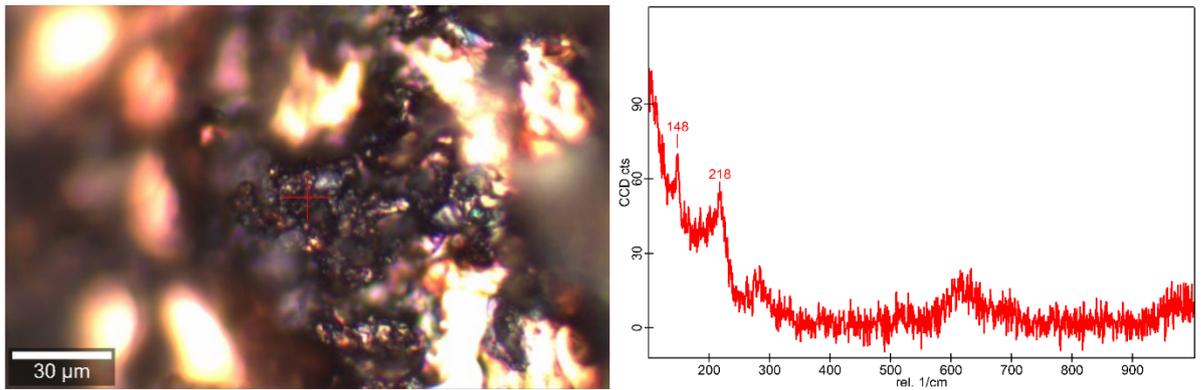
The studied area 5 is shown in Figure 7-177. The observed peaks at 148 rel.cm (weak), 218 rel.cm and 619 rel.cm can be attributed to Cu₂O. As can be seen from literature these bands are characteristic for Cu₂O and may have shifts depending on the structure (Deng et al. 2016, Ravichandiran et al. 2019). However, both peaks at around 215 rel.cm and 110–120 rel.cm can be also characteristic for CuCl₂·2H₂O (Medeiros et al. 2018).

Figure 7-177. Area 5. Left: Optical image showing the area were the Raman spectrum was measured (red cross). Right: Measured Raman spectrum.

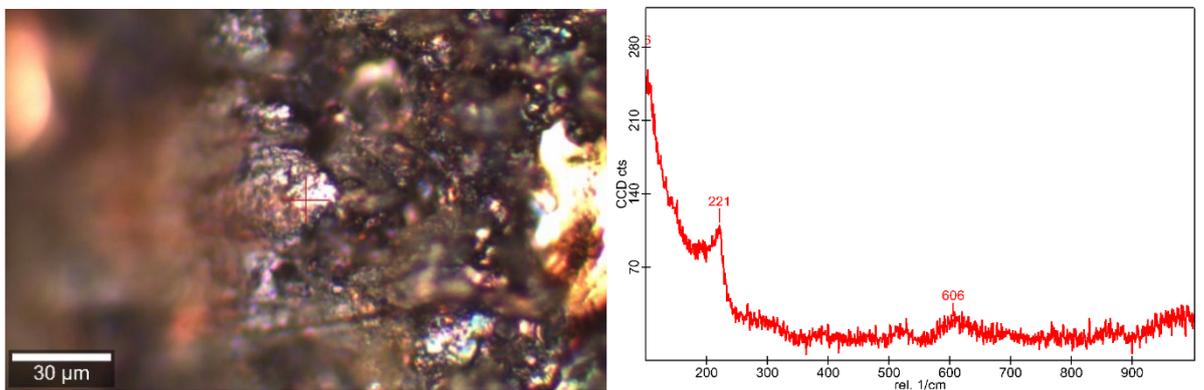
The studied area 6 is shown in Figure 7-178. The observed peaks at 221 rel.cm and 606 rel.cm can be attributed to Cu₂O or most likely CuCl₂·2H₂O since there is no peak at around 150 rel.cm.

Figure 7-178. Area 6. Left: Optical image showing the area were the Raman spectrum was measured (red cross). Right: Measured Raman spectrum.
