SKB TR-26-06

Äspö Hard Rock Laboratory

Concrete and Clay

Long-term corrosion studies

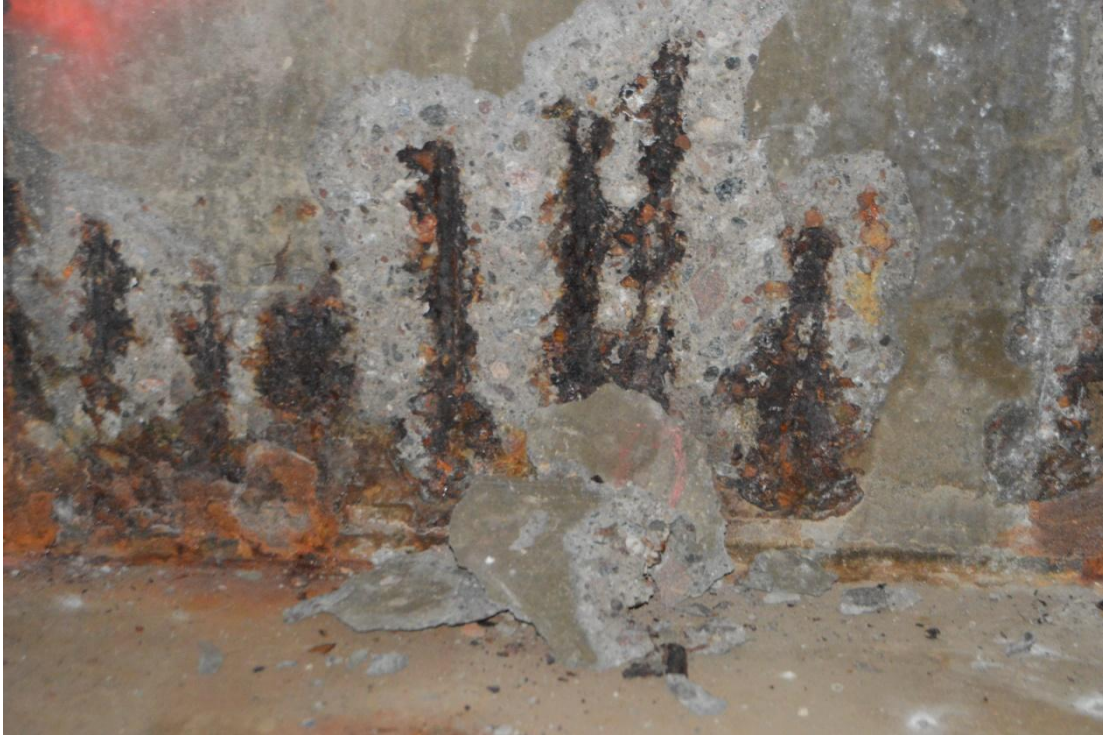
Figure 1-1. Concrete spalling due to corrosion of reinforcement bars.

The often most visible effects of metal corrosion are discoloration of the concrete surface and concrete spalling caused by the formation of voluminous corrosion products on the metal objects embedded in the concrete structure, as shown in Figure 1-1. For corrosion of the reinforcement bars within a concrete structure, this leads to a loss of function of the reinforcement bars and a reduced load-bearing capacity of the concrete structure. See (Höglund 2014 and SKB 2023c) for more details.

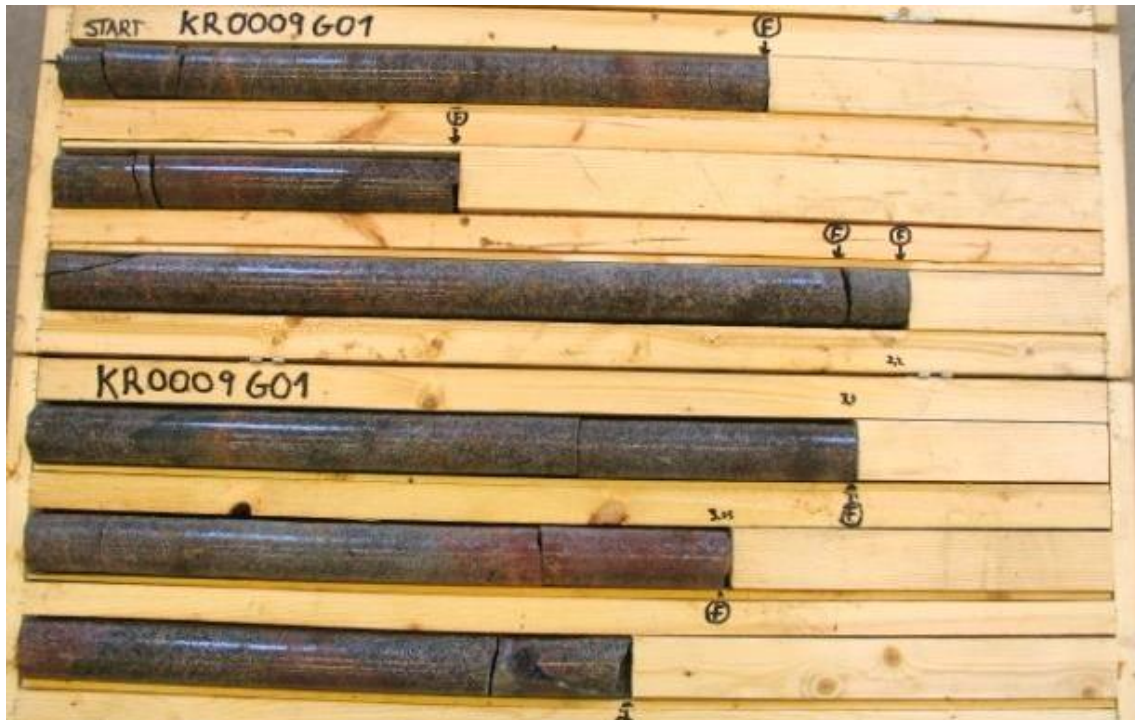
Figure 2-3. A photograph of the cores from KR0009G01.

The cores were photographed both dry and wet and a core mapping protocol was prepared. A photograph of the wet cores from KR0009G01 also representative for KR0014G01 is shown in Figure 2-3.

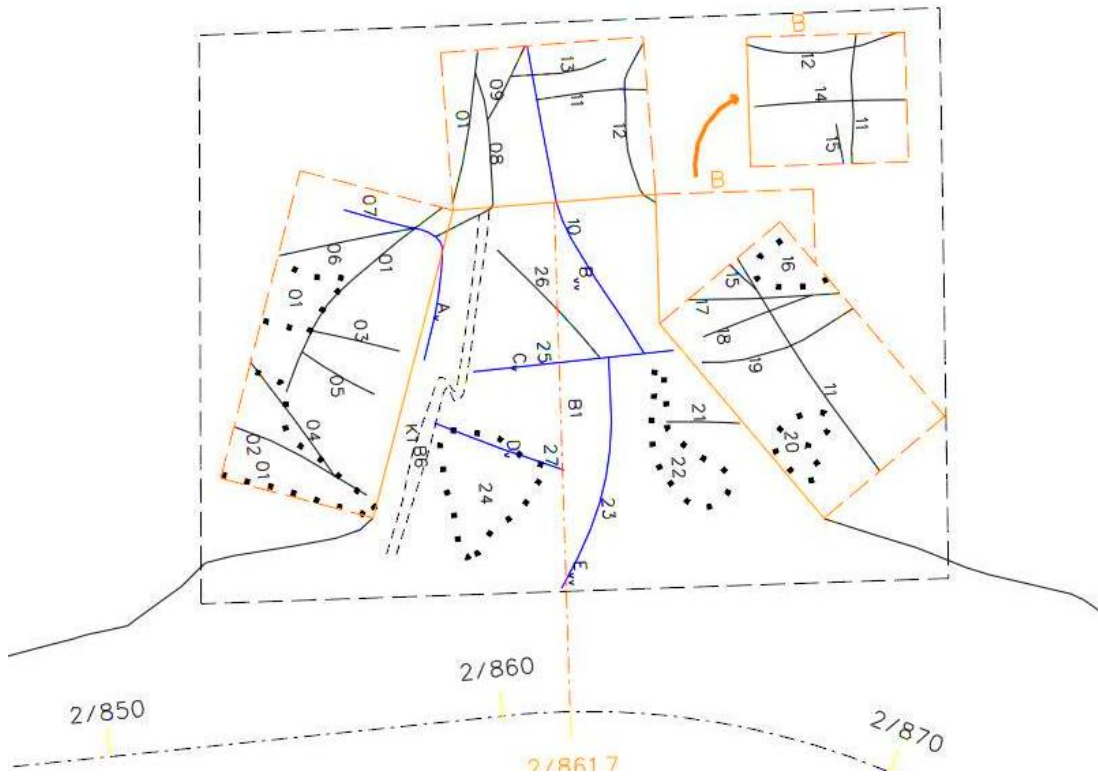
Figure 2-5. A schematic illustration of NASA2861A showing both the tunnel floor and walls. Blue lines illustrate water-bearing fractures whereas black lines illustrate dry fractures.

NASA2861A is located 2861 meters down in the main tunnel at a depth of -383 meters, Figure 2-4. An illustration of the niche is shown in Figure 2-5.

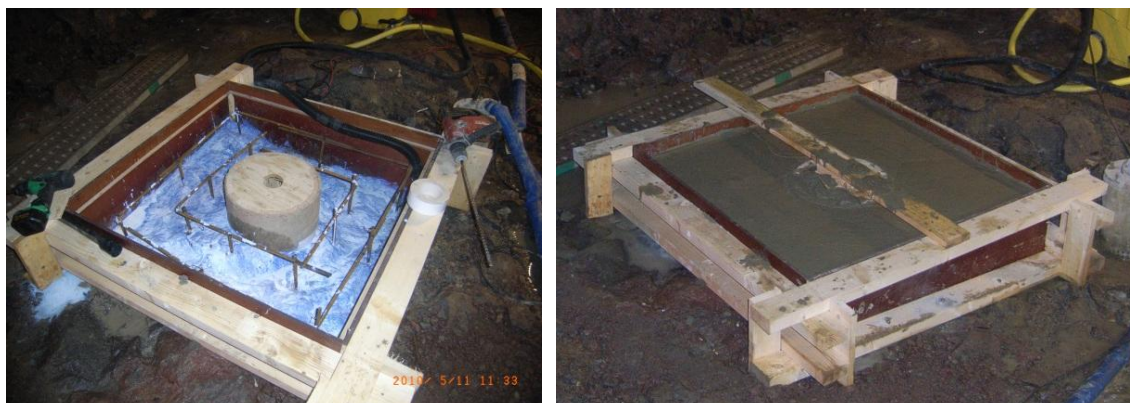
Figure 2-7. Casting of a concrete base.

Site preparation comprised removing loose rock debris from the tunnel floor in the area around the installation hole and casting of the concrete base to which the lid should be secured after installation of the concrete cylinders, Figure 2-7.

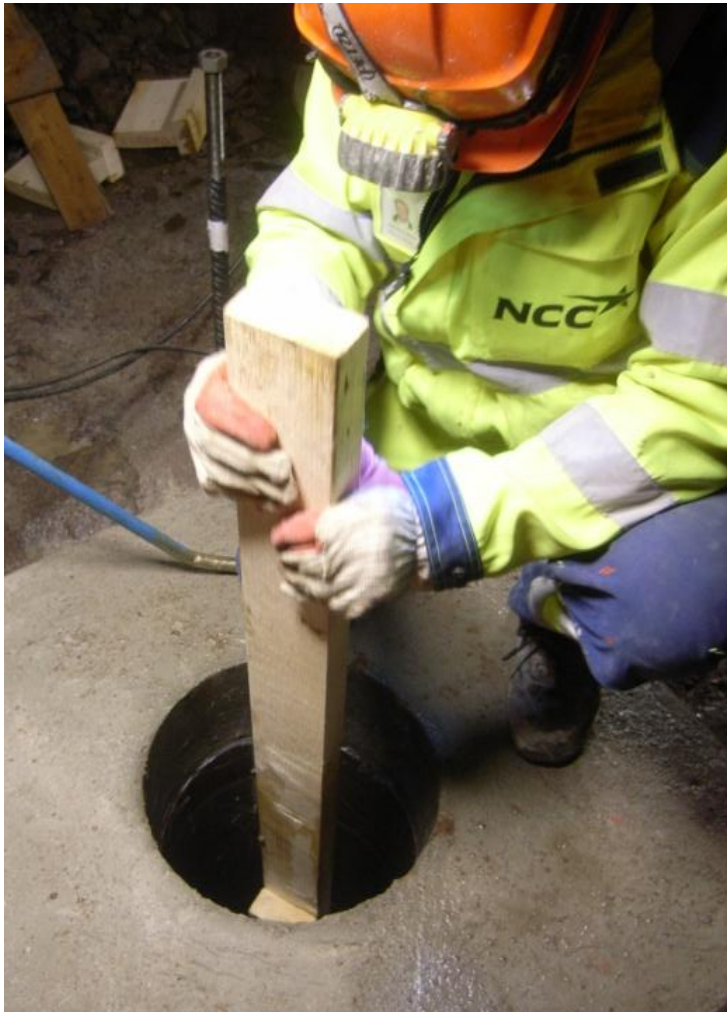
Figure 2-8. Levelling the bottom and measuring the depth of the installation hole.

Just prior to installation of the concrete cylinders, sand was poured into the installation hole to adjust its depth but also to level its bottom, Figure 2-8.

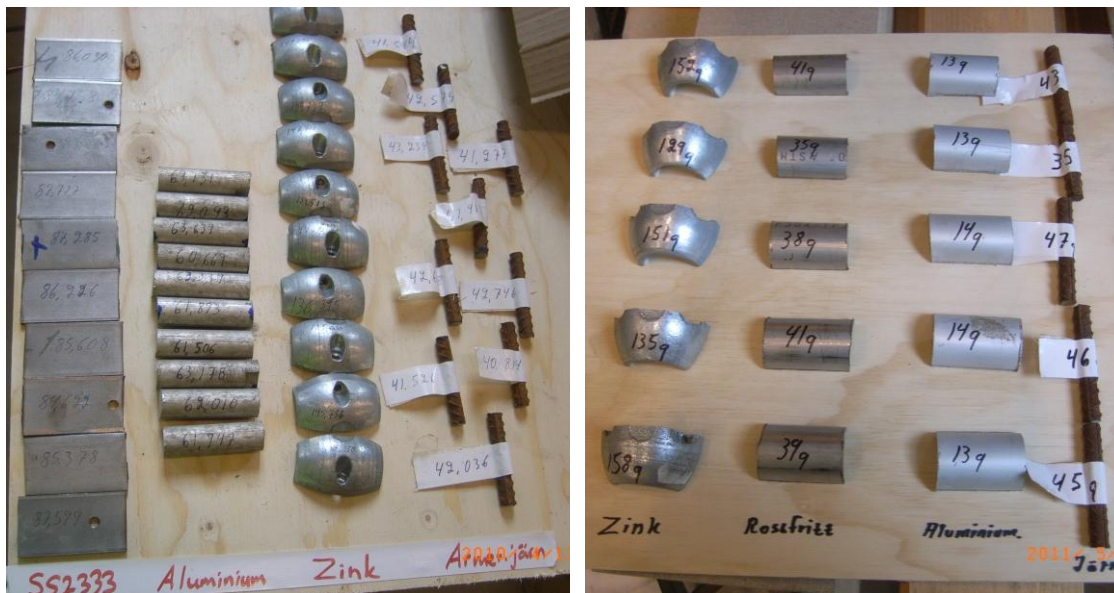
Figure 3-2. Metal objects used in the long-term corrosion studies. Metal objects for concrete cylinders installed in TASR and NASA2821A to the left and right respectively.

Each metal object was cut into a suitable size if required and weighed prior to casting of the concrete cylinders, Figure 3-2. Further information is given in Mårtensson (2015, Appendix B and C).

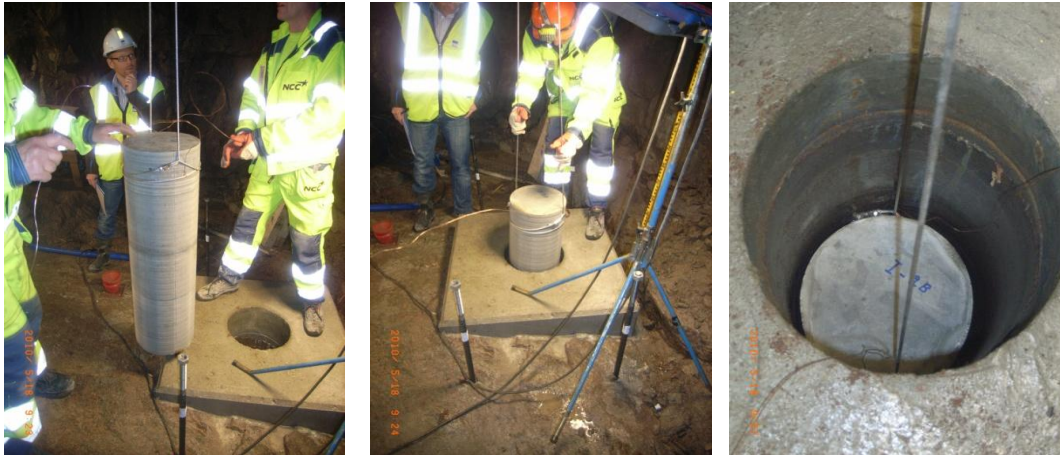
Figure 3-4. Installation of a concrete cylinder.

After installation, the slit between the concrete cylinders and the bedrock in the wet holes was filled with sand. In the dry hole, the slit was instead filled with the same type of grout as was used for casting of the concrete cylinders, i.e. 50 VF. The purpose of this was mainly to centre the concrete cylinders in the installation hole but the sand also filled the purpose of distributing any water from the bedrock evenly within the installation hole.

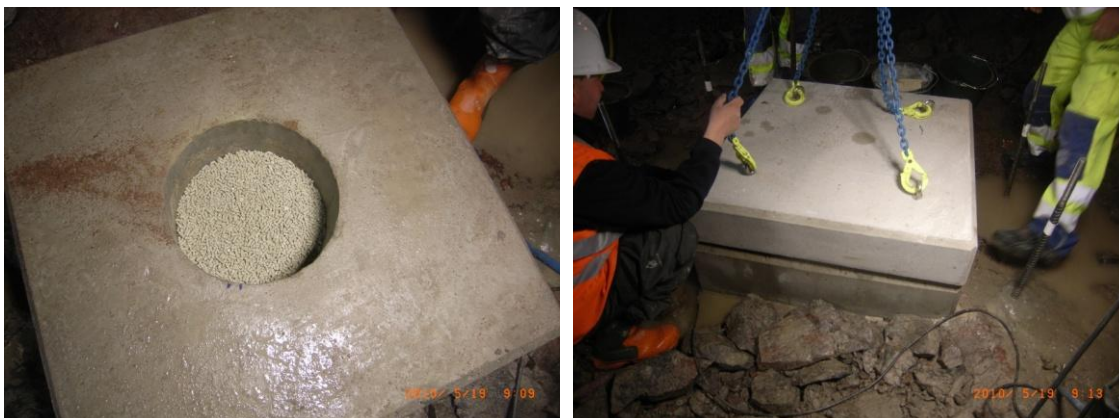
Figure 3-5. Sealing and closure of a long-term corrosion experiment.

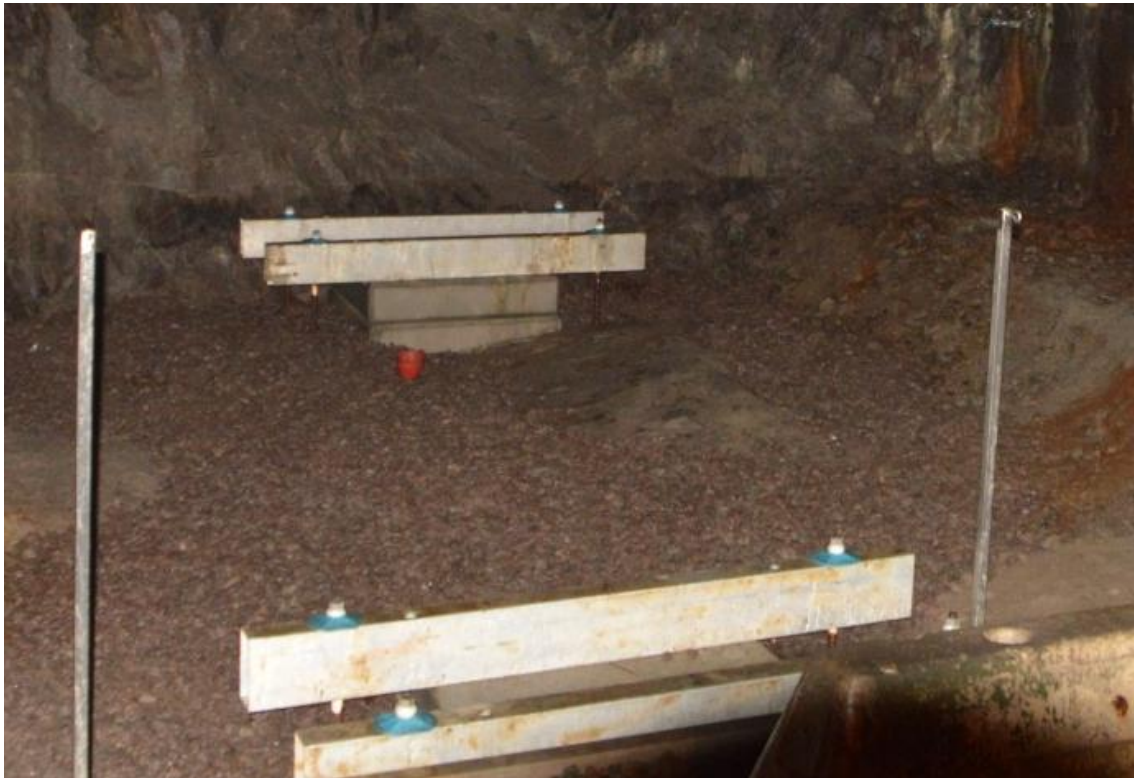
Figure 3-6. Installation of the long-term corrosion experiments in TASR completed

Finally, the hole was filled with sand up to its rim after which the lid was placed on top of the concrete base (Figure 3-5, right). The lid was then secured by means of two steel beams placed horizontally on top of the lid. The steel beams were finally secured in the bedrock by means of large bolts, Figure 3-6.

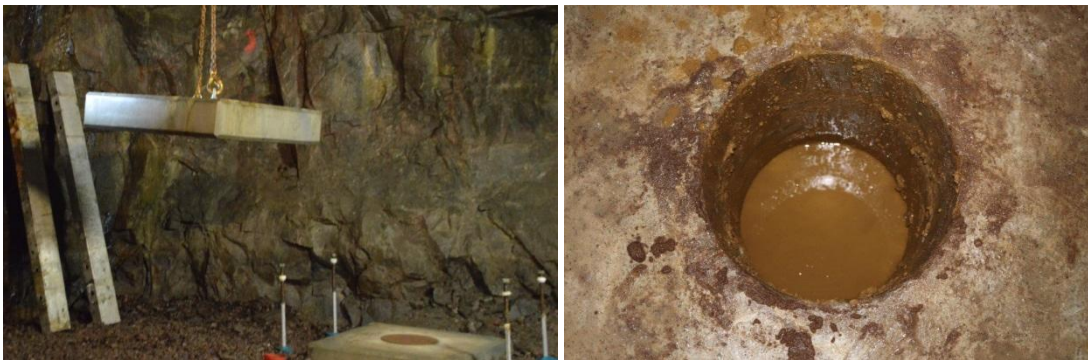
Figure 4-1. The concrete lid is removed (left image). After removing the top seal, water was observed in the installation hole.

As a first step, the bolts holding the beams securing the lid were unscrewed and the concrete lid removed, Figure 4-1, left image. After that, the top sand was removed by means of a powerful vacuum cleaner. This was followed by removal of the concrete slab which separates sand and bentonite and finally, the bentonite was dug out. At this point, water was observed in the installation holes, Figure 4-1, right image, indicating that sufficient amounts of groundwater had been available to ensure water saturation of the concrete cylinders.

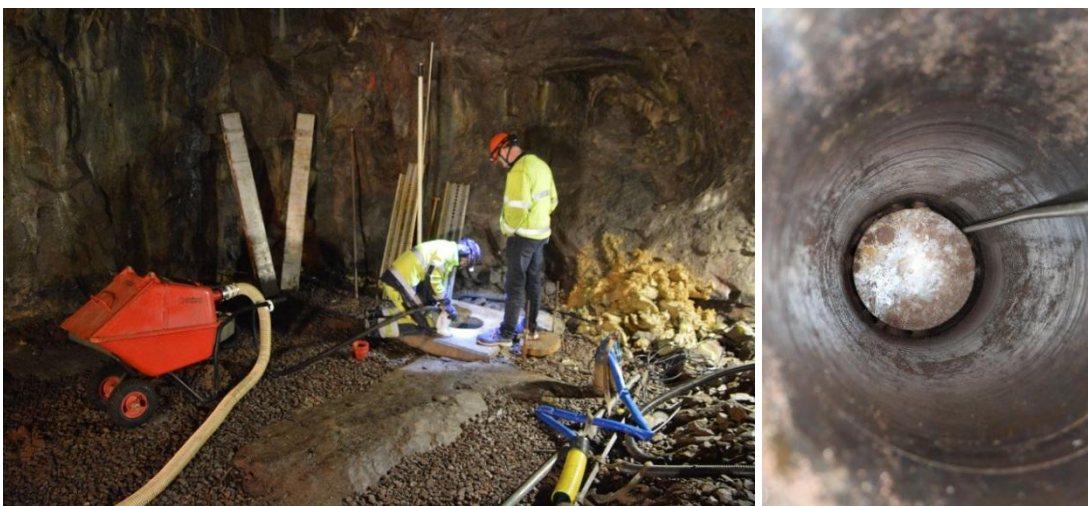
Figure 4-2. Cleansing of the sand-filled slit between the concrete cylinders and the wall of the installation hole.

The most laborious part of the retrieval turned out to be cleansing of the sand-filled slit. Attempts to lift the concrete cylinders without removing the sand were unsuccessful. Different methods were attempted to loosen up the sand and the work was both physically exhausting and rather time-consuming. However, eventually enough sand had been removed for the concrete cylinders to be hoisted up from the installation hole with the assistance of a front loader truck, Figures 4-2 to 4-4.

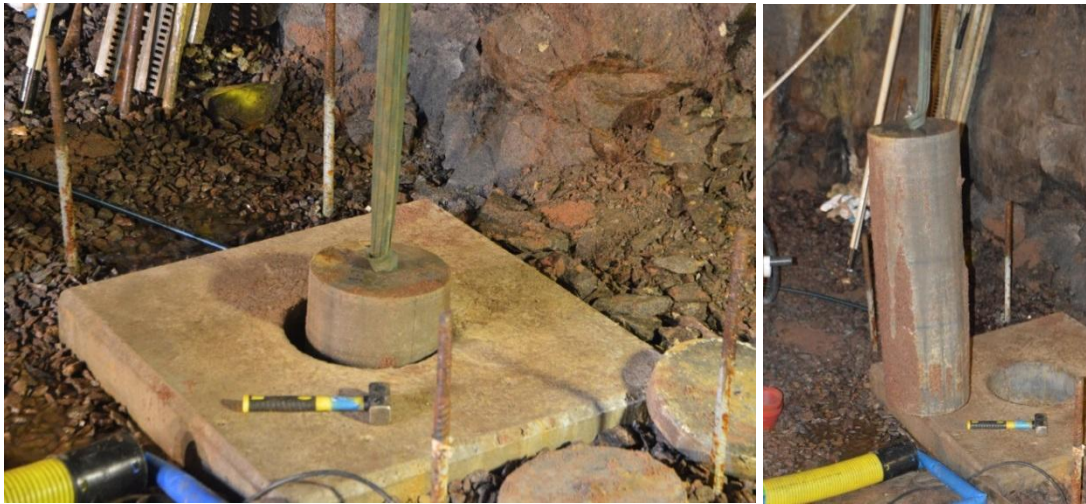
Figure 4-3. The concrete cylinder is being hoisted up from the installation hole.

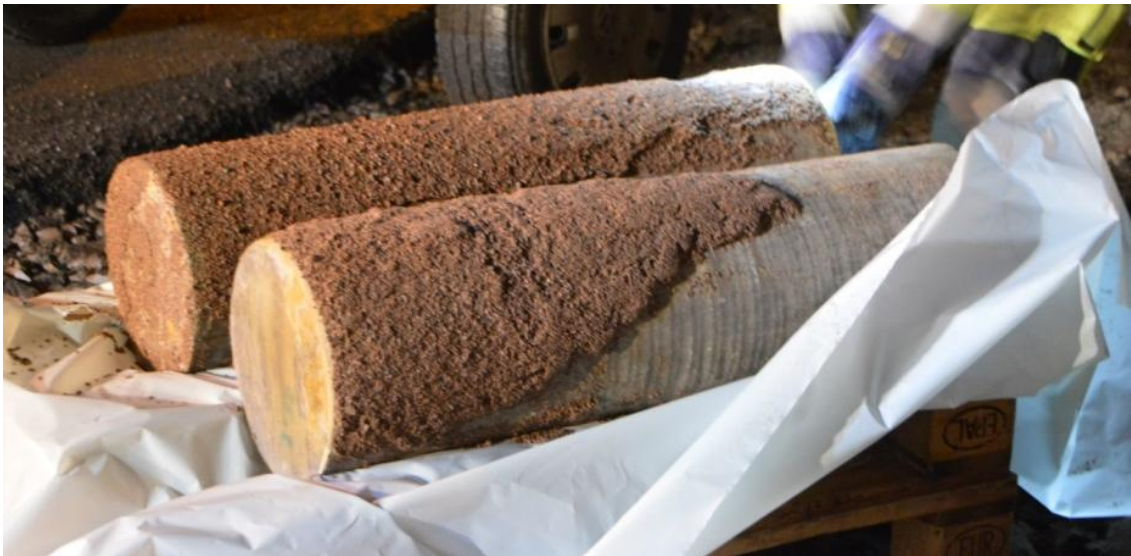
Figure 4-4. The concrete cylinders have been placed on a pallet for transport.

After the lift, the concrete cylinders were wrapped in plastic, placed on a pallet and transported up to the laboratory for sectioning, packaging and labelling, Figure 4-4.

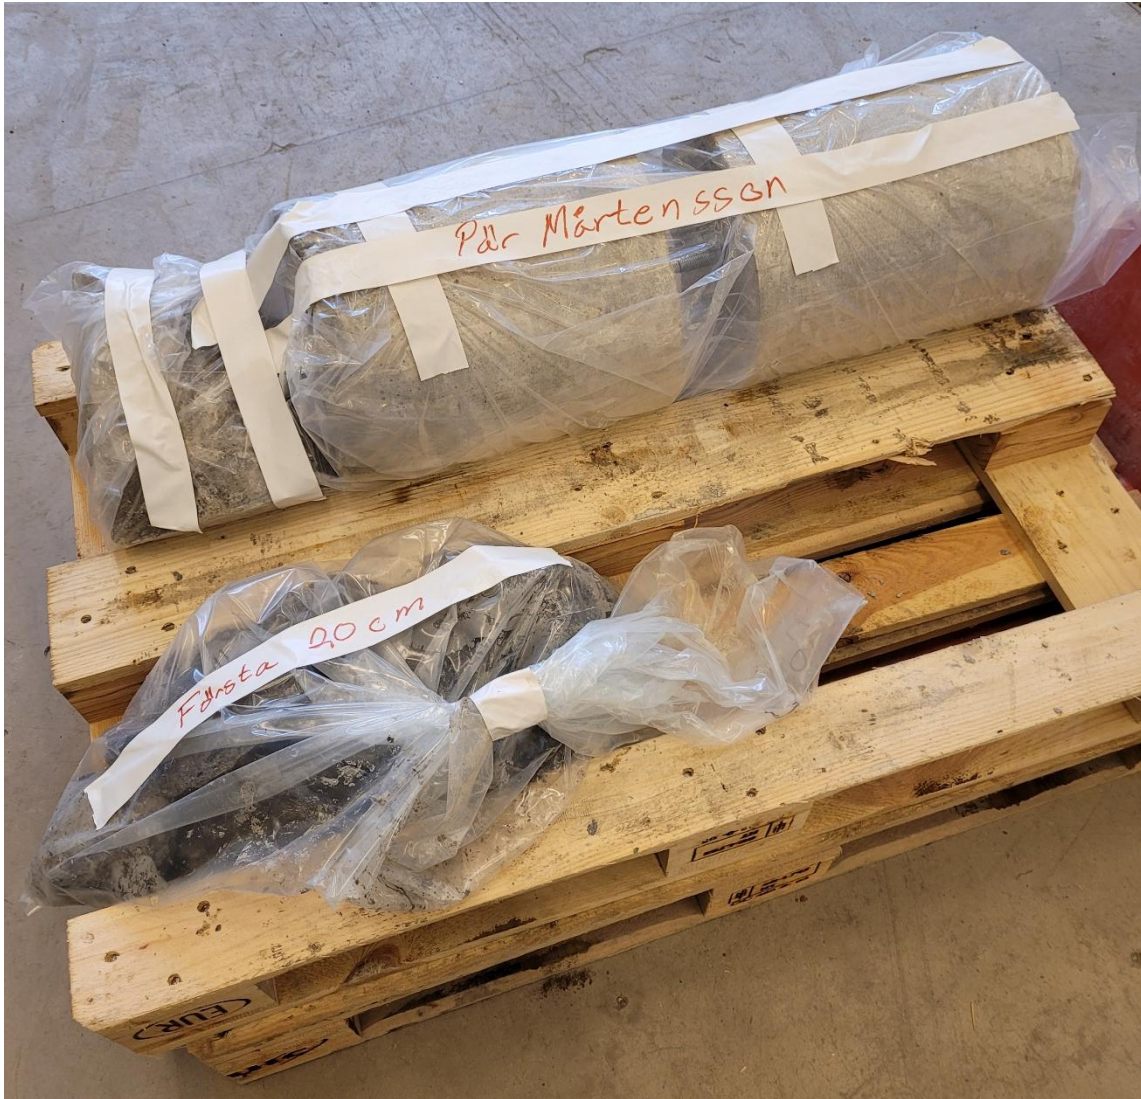
Figure 4-5. Concrete cylinder from the nominally dry hole in NASA2861A.

Eventually, the concrete cylinder could be hoisted up of the hole but as shown in Figure 4-5 it was severely cracked.

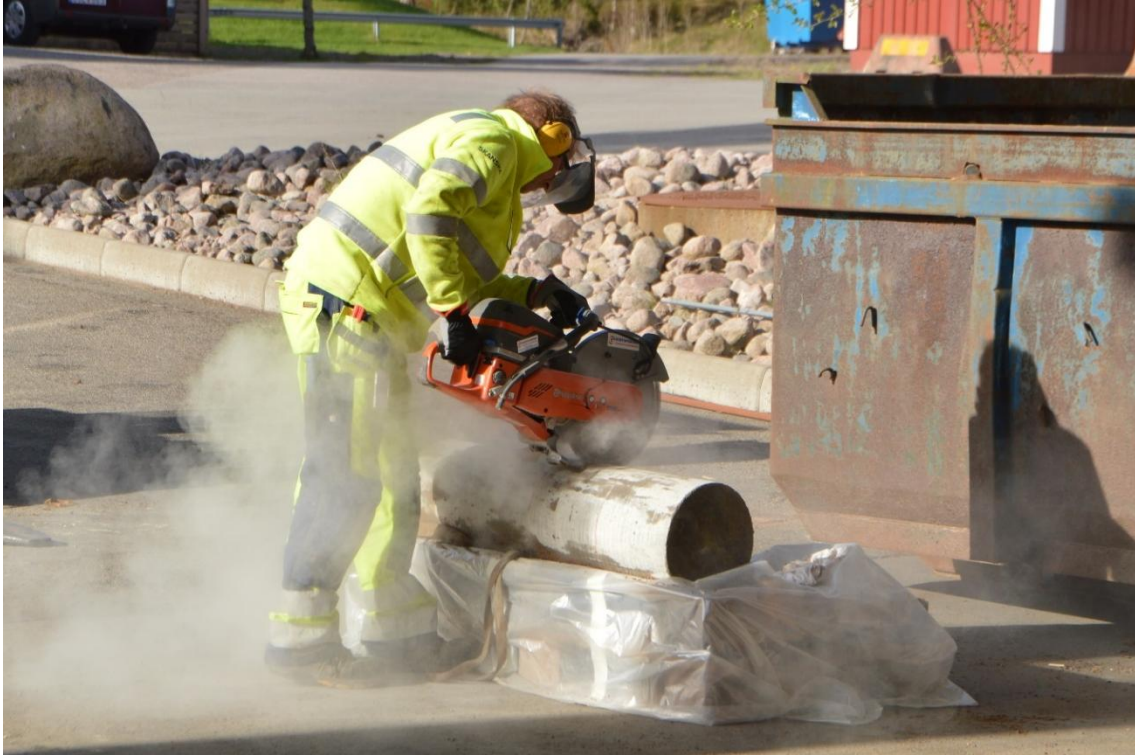
Figure 4-6. Sectioning of a concrete cylinder

The concrete cylinders were each sectioned into four parts, Figure 4-6, each part containing objects of one type of metal and then wrapped in plastic prior to shipment, Figure 4-7. The different parts were numbered from 1 (top) to 4 (bottom).

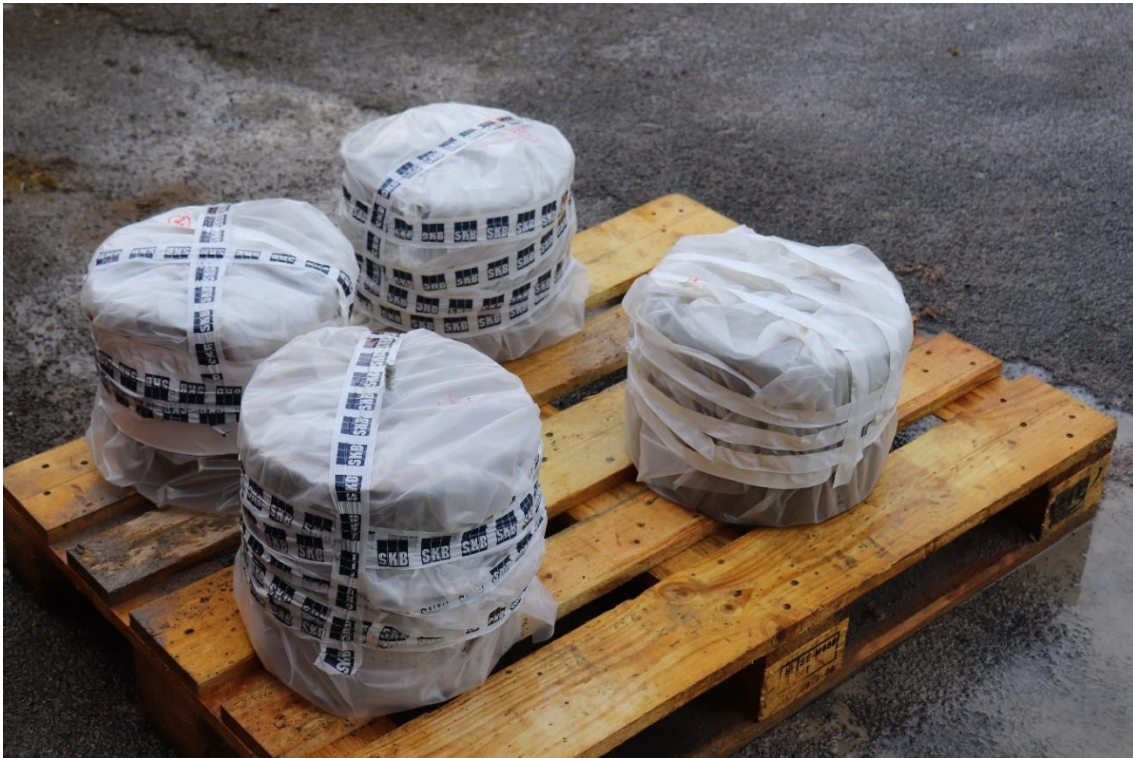
Figure 4-7. The four parts of a concrete cylinder after sectioning and packaging.

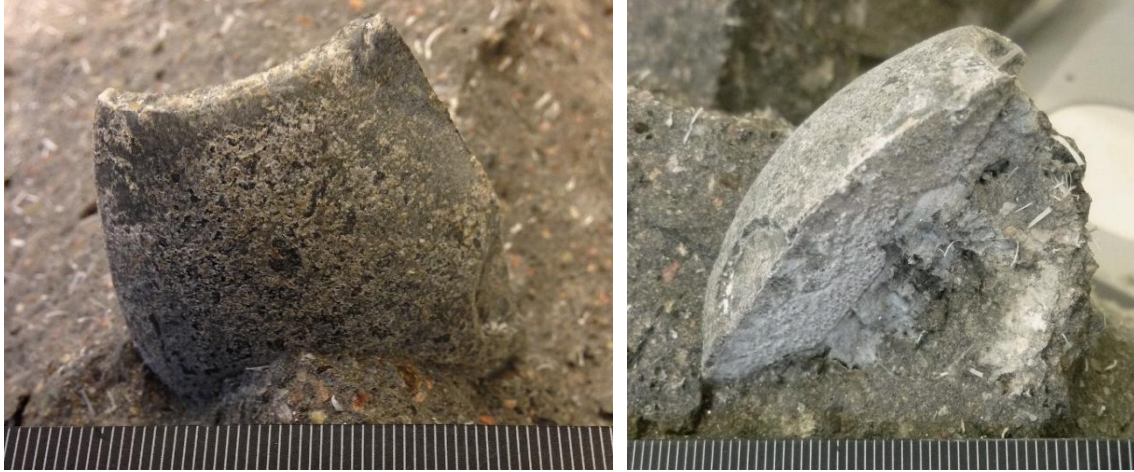
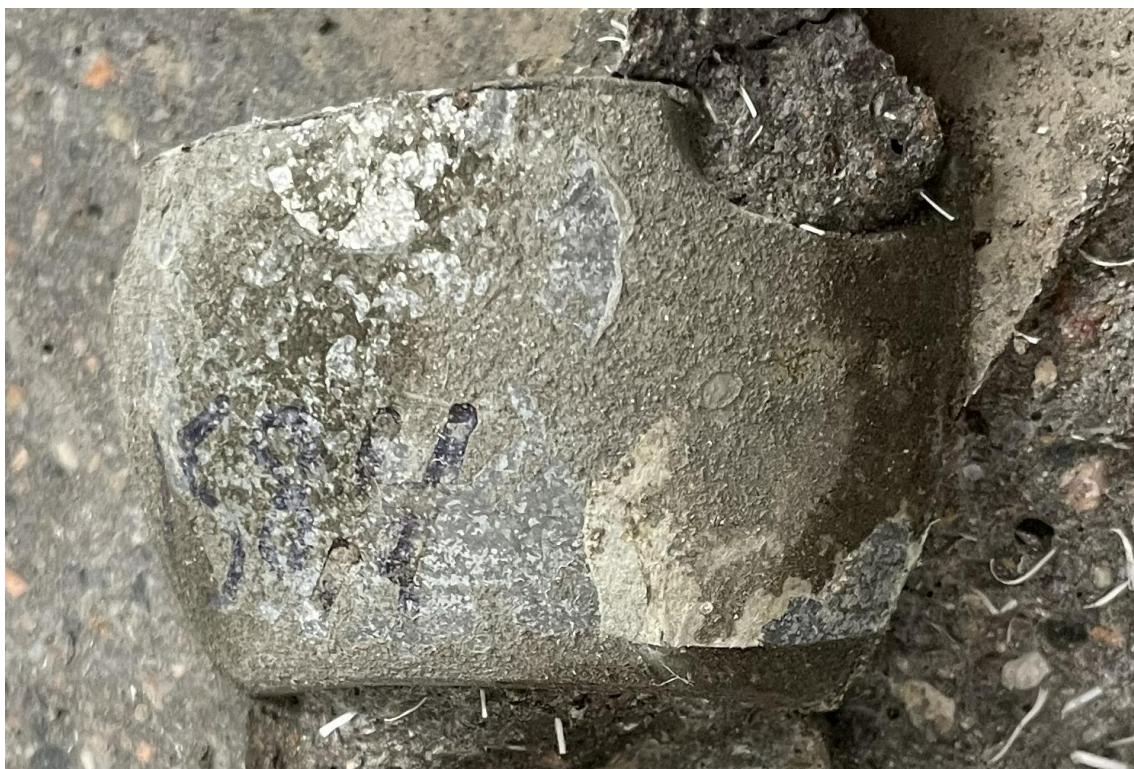
Figure 6-1. Surface of the zinc object from samples 5YW-Zn (Top left image), 10YW-Zn (Top right image) and 15YD-Zn (lower image).

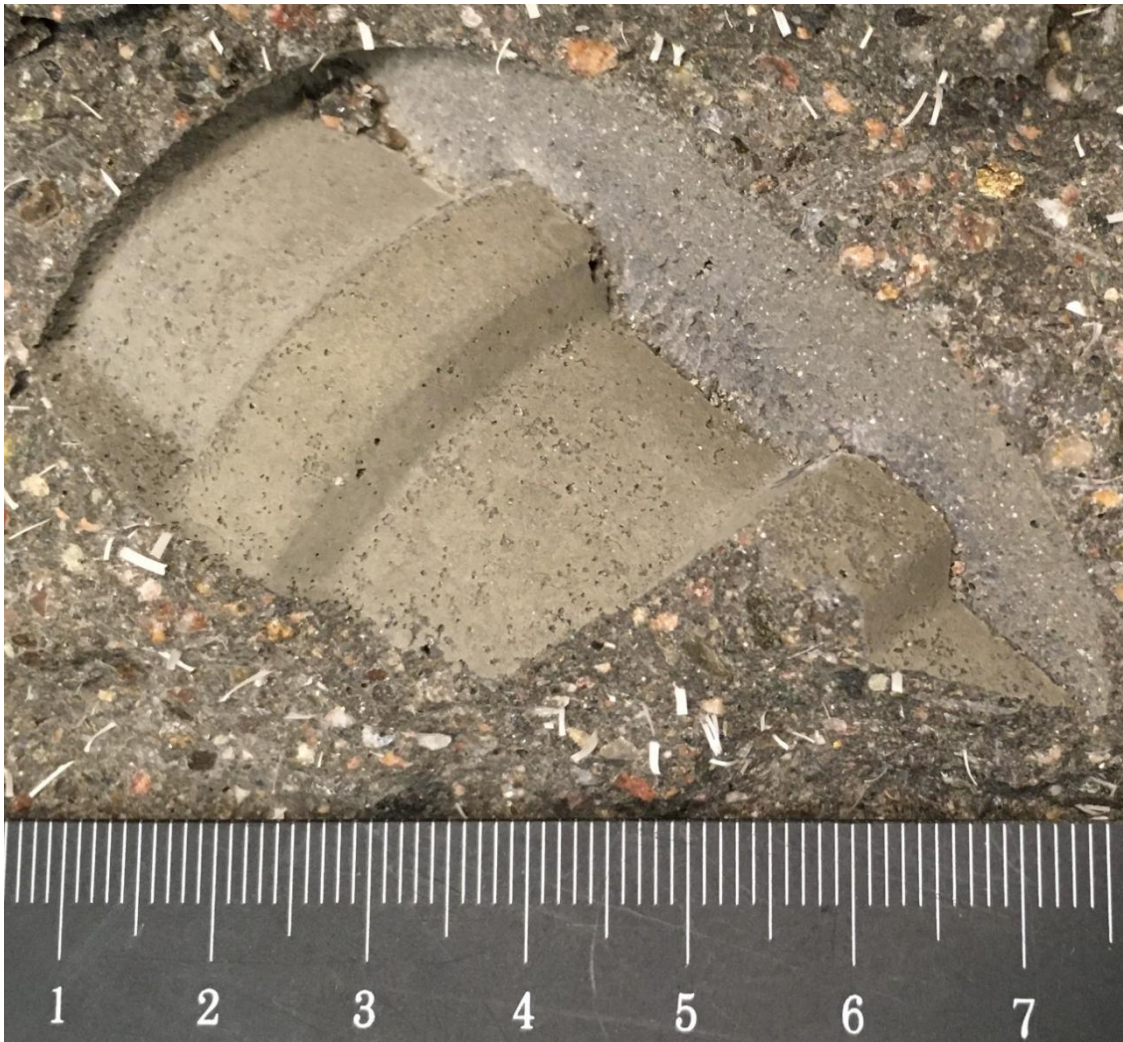
Figure 6-2. A concrete imprint of a zinc object from sample 10YW-Zn.

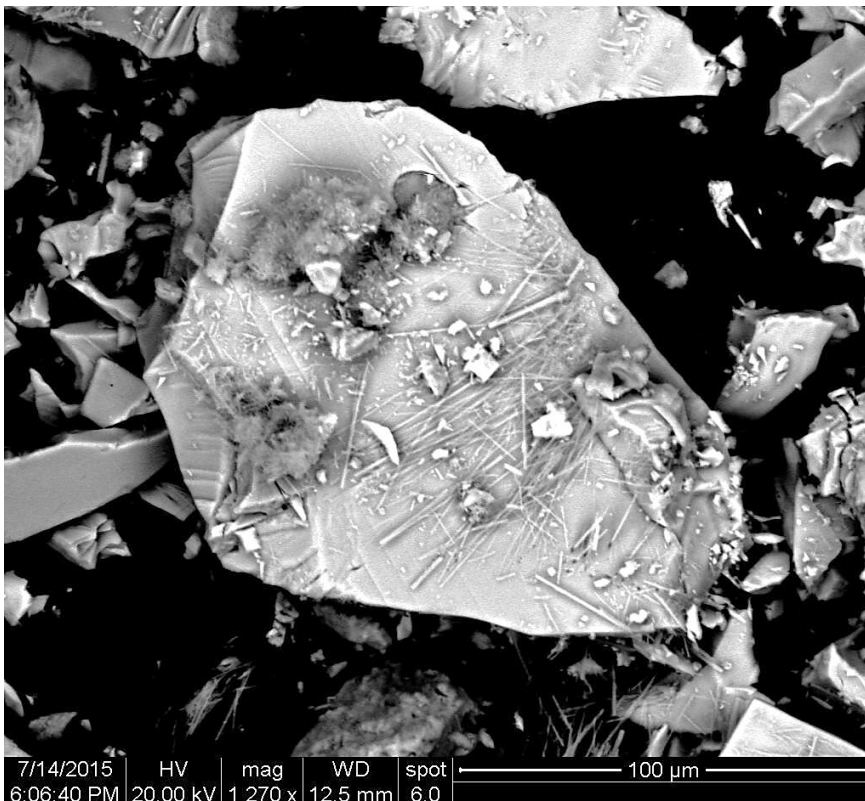
Figure 6-5. A single grain used to analyse the chemical composition of the grains identified on the surface of the zinc object, SEM/BSE detector. (Kalinowski 2015)

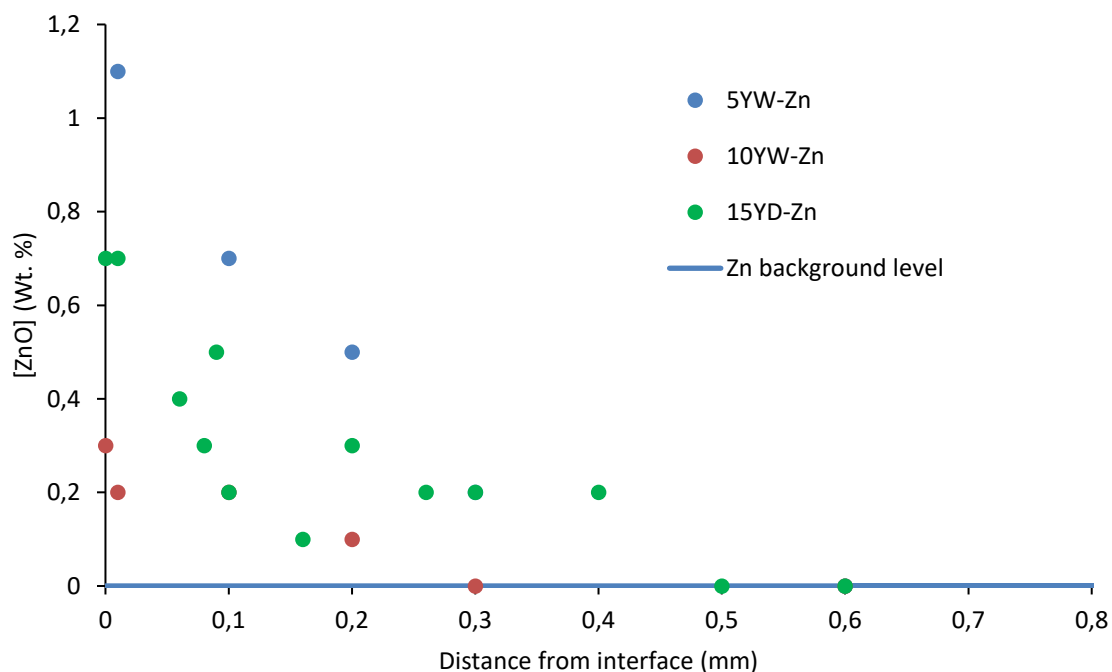
Figure 6-8. Zinc (as ZnO) concentration profiles in the concrete adjacent to the zinc objects for samples 5YW-Zn, 10YW-Zn and 15YD-Zn. Average data from the EDS-analyses also including additional elements are presented in Appendix 1.

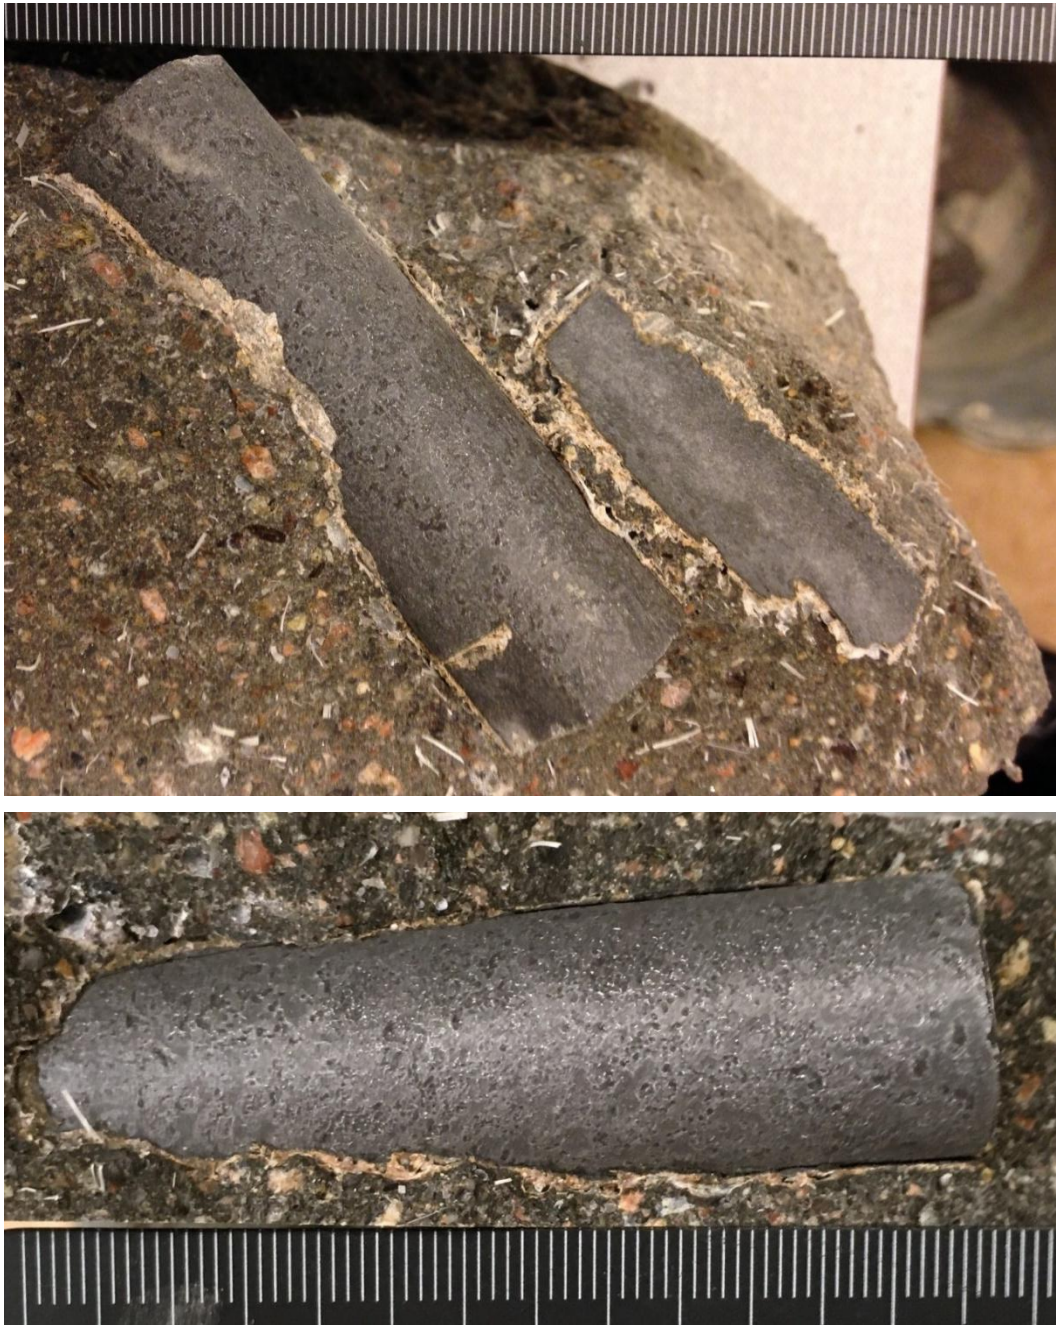
Figure 7-1. Surface of the aluminium object 5YW-Al (top) and 10YW-Al (bottom).

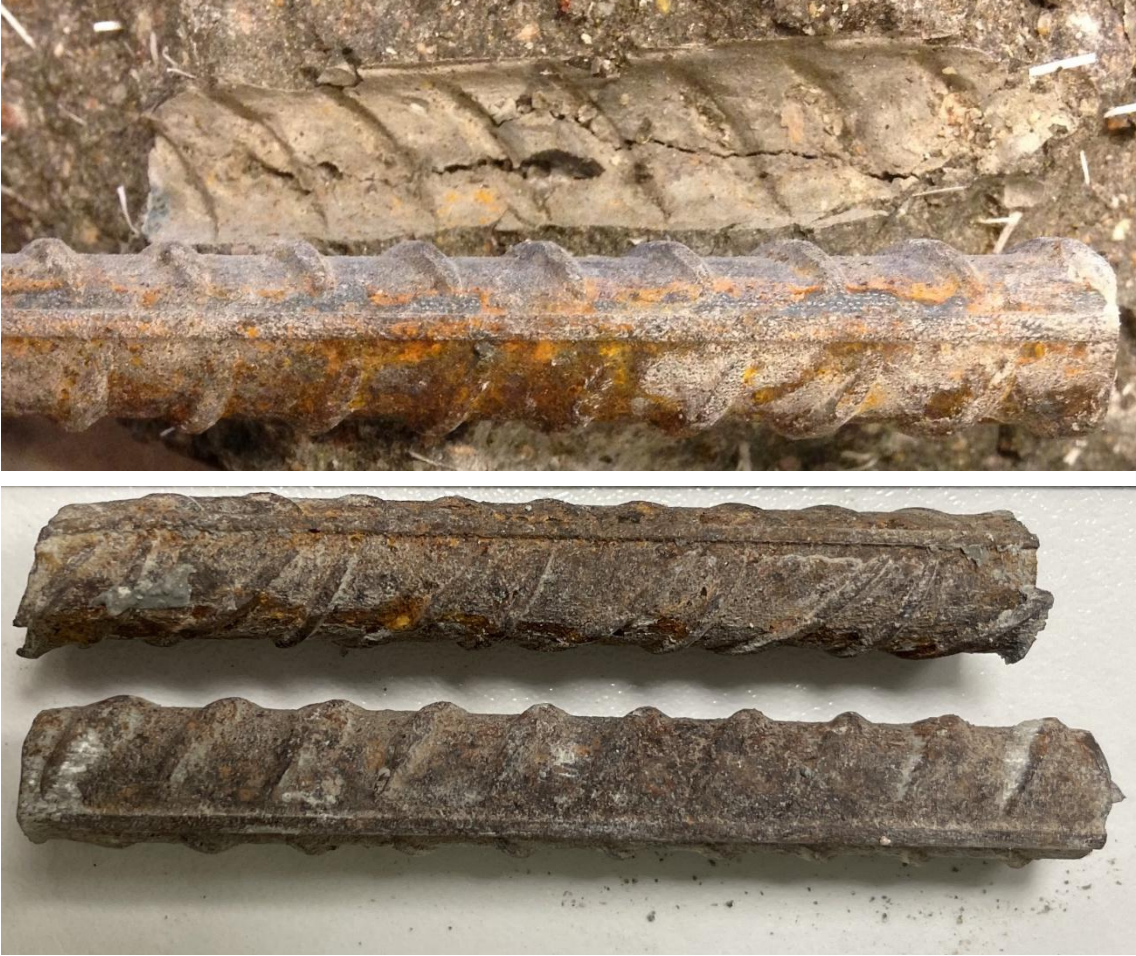
Figure 8-1. Photograph of carbon-steel objects 5YW-CS (with concrete imprint) (top) and 15YD-CS (bottom).

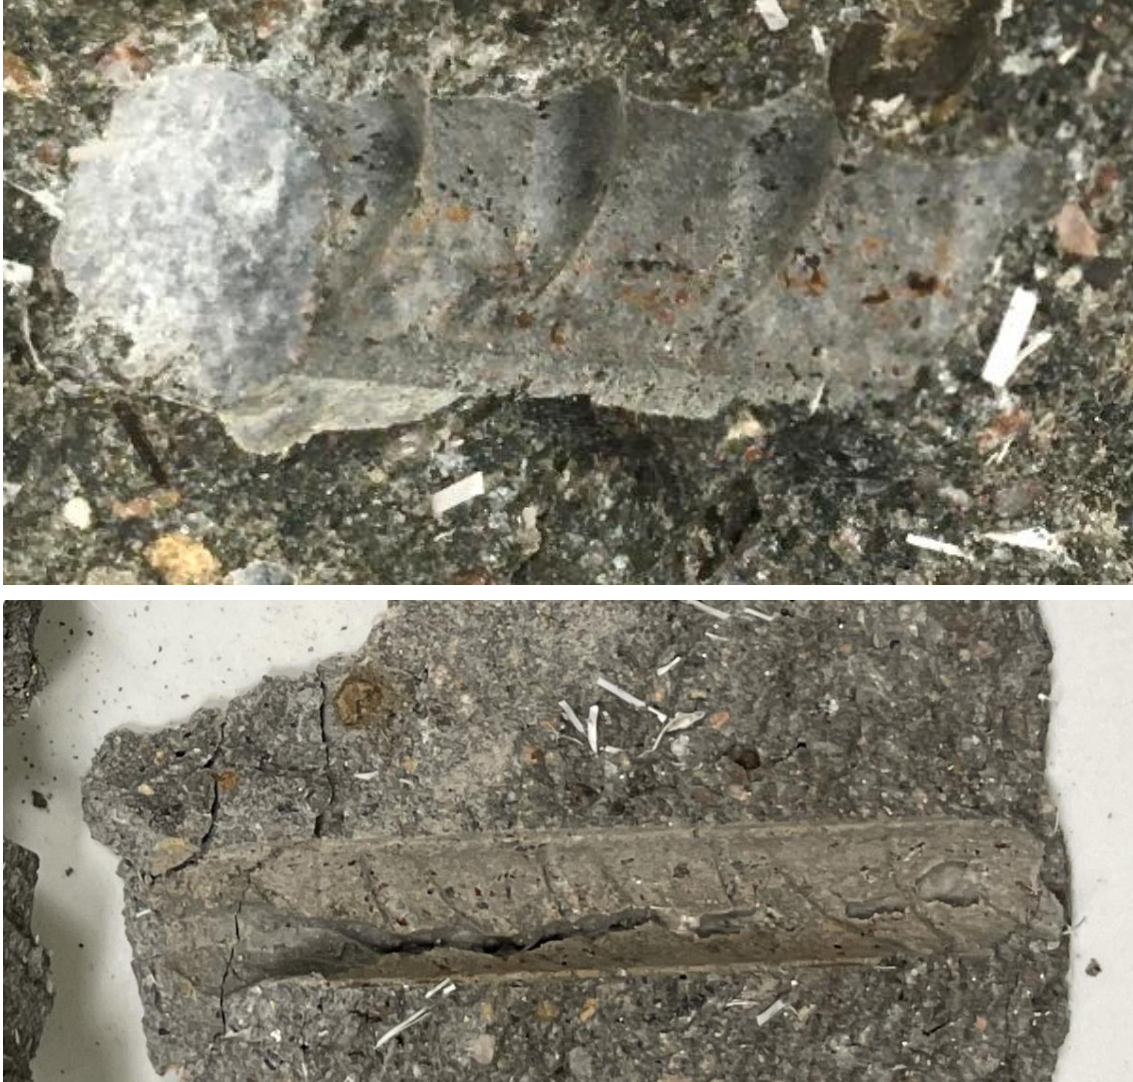
Figure 8-2. Concrete imprints of carbon-steel objects for samples 10YW-CS (top) and 15YD-CS (bottom).

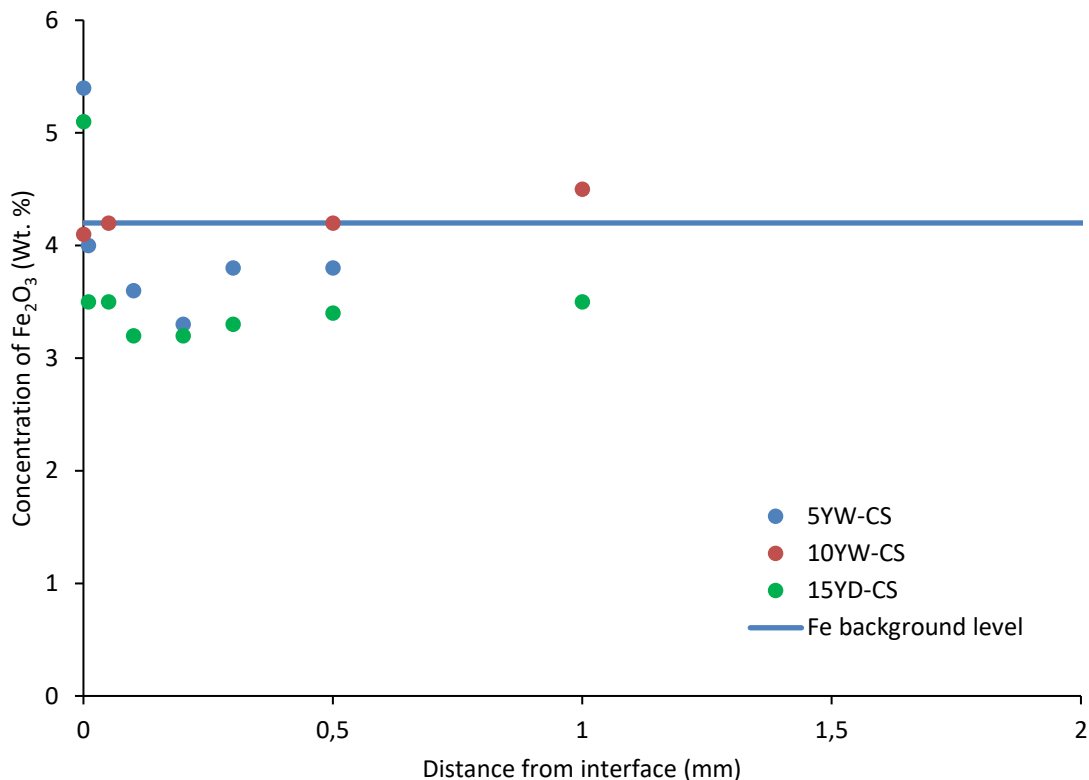
Figure 8-7. Iron (as Fe_2O_3) concentration profiles in the concrete adjacent to the carbon-steel objects in samples 5YW-CS, 10YW-CS and 15YD-CS. Average data from the EDS-analyses also including additional elements are presented in Appendix 1.

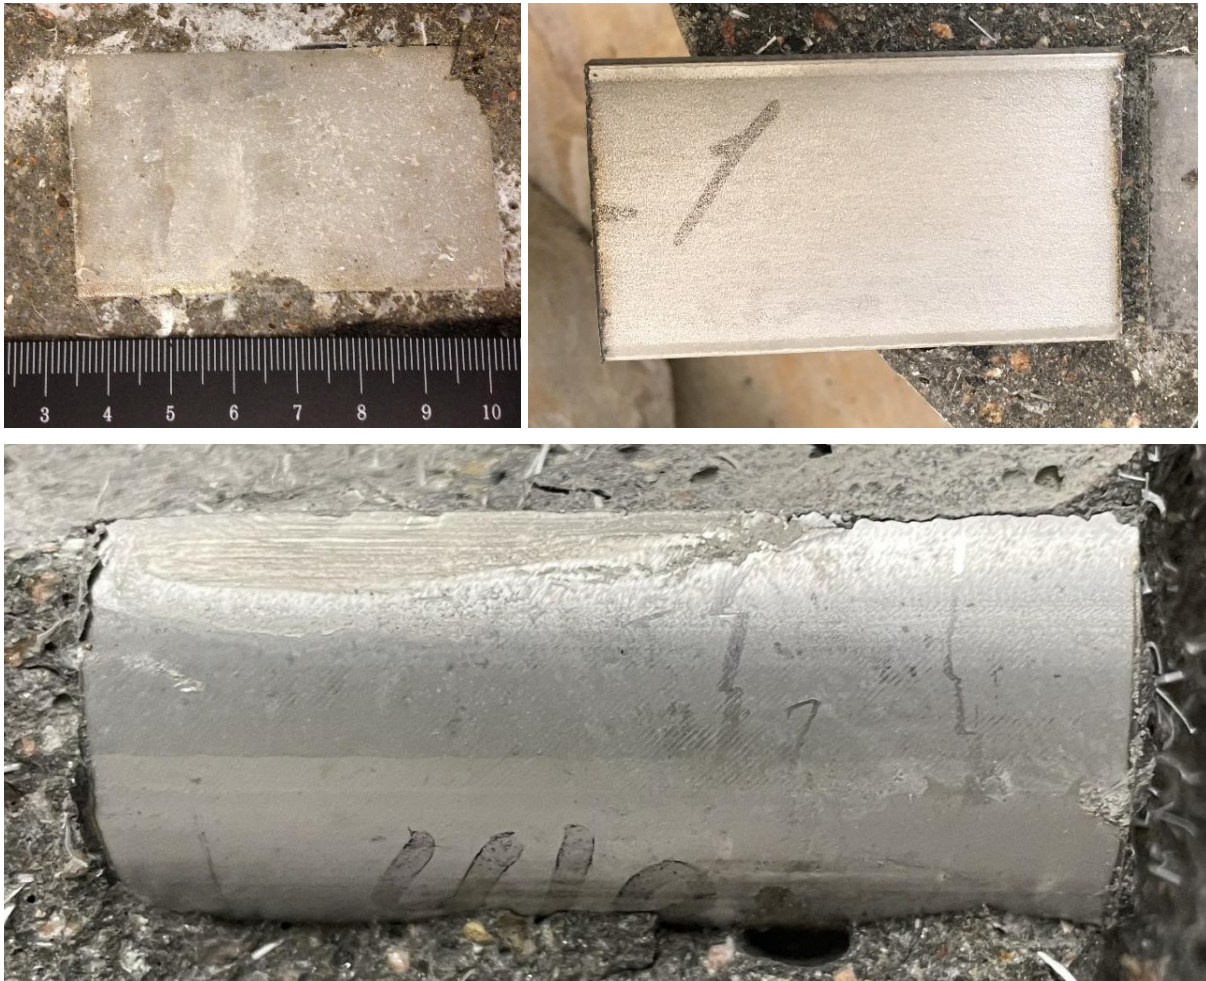
Figure 9-1. Surface of the stainless-steel objects from samples 5YW-SS (top left), 10YW-SS (top right) and 15YD-SS (lower).
