P-05-153

Forsmark site investigation

Manual discharge measurements in brooks, April 2002–April 2005

Per-Olof Johansson, Artesia Grundvattenkonsult AB

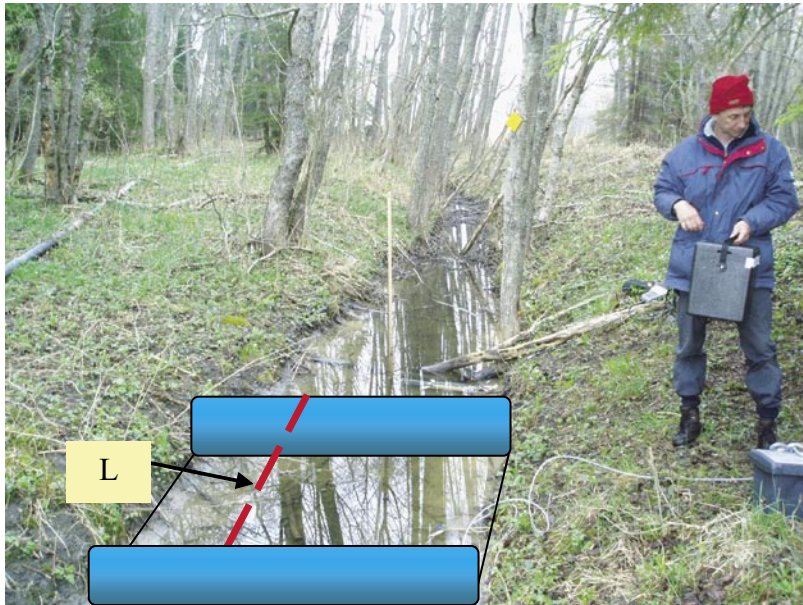
Figure 3-1. Schematic illustration of the float method used for the manual discharge measurements (PFM000073 South of Bredviken) /From Nilsson et al. 2003/.

The discharge measurements were performed by the float method. The equipment used was a float, a stop watch and a measuring tape. A 150 mL plastic bottle, filled to 2/3 by water, was used as a float. The time (T) required for the bottle to float a known distance (L) between two points in the water course was measured, see Figure 3-1. This procedure was repeated 5 times, and the average value of T was calculated. Based on the average width (W) and depth (D) of the brook over the measured distance, the discharge Q was estimated as

$$Q = \frac{L \times W \times D}{T}$$

where all parameters except L are average values.
