P-05-199

Forsmark site investigation

Investigations of superficial fracturing and block displacements at drill site 5

Bengt Leijon (ed)
Svensk Kärnbränslehantering AB

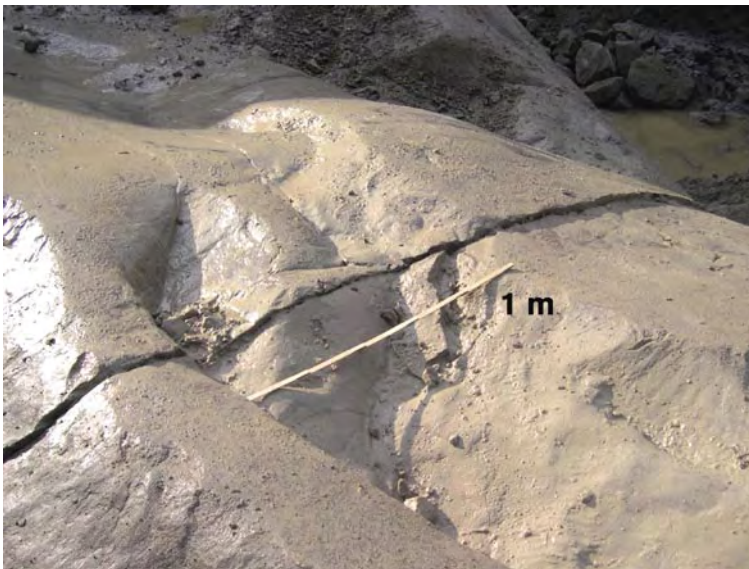
Figure 1-3. Example of a fracture cutting almost vertically through a large surface block. The originally polished surface is displaced and the resulting block edges do not show any signs of glacial abrasion.

Frequent examples of fracture displacements leaving apparently fresh block edges with little or no signs of glacial abrasion were readily seen at the site. Examples can be seen in Figures 1-3, 2-2 and 2-3. Many of the displaced fractures were clearly older features that had been reactivated but fractures cutting through virtually intact rock were also to be seen. Examples were also observed where reactivation of older fractures seemed to have generated secondary fracturing of intact rock. The overall effect of the fracturing and block dislocations was a general expansion and partial disintegration of the rock overlying the major, sediment-filled fractures described.

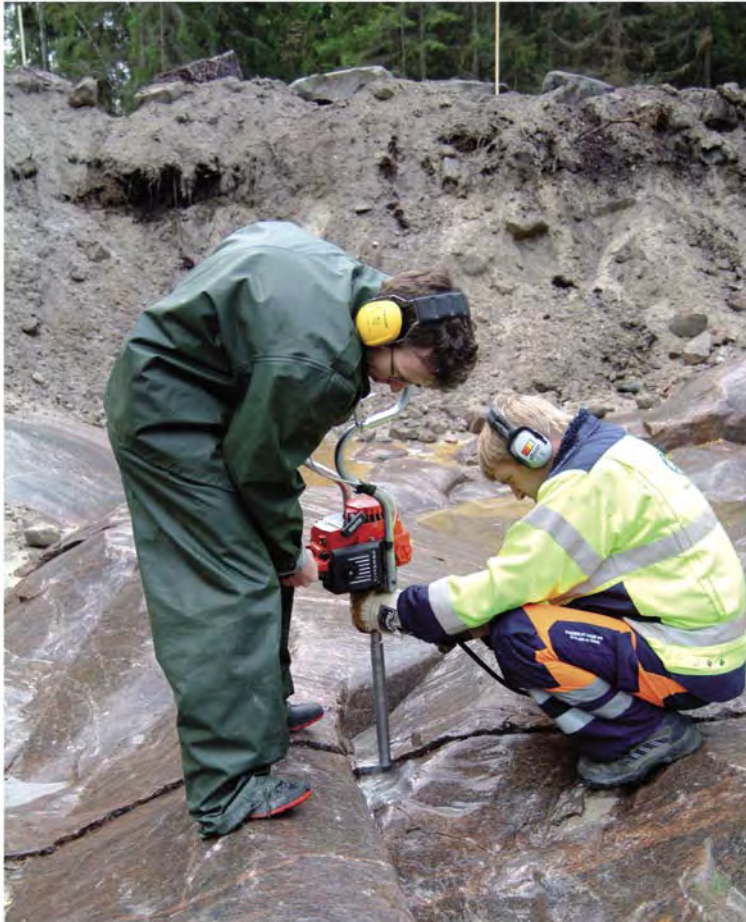
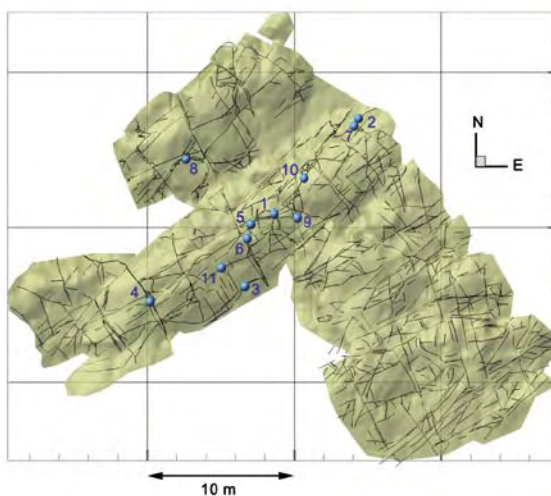
Figure 2-2. Sampling of fracture surfaces for electron microscopy. Upper: Hand-held drilling to retrieve a small core sample across a fracture. Lower: Sampling points.

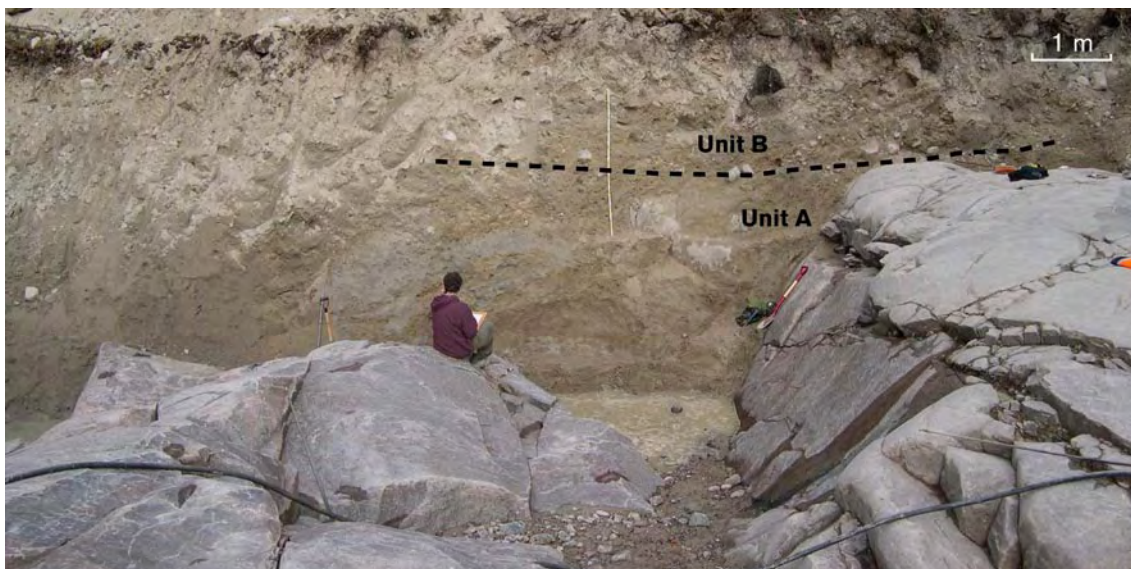
Overburden thickness at drill site 5 varies from almost zero to c 5 m. In contrast to the rugged surface morphology of the underlying rock, the overburden surface was rather flat and almost horizontal. Investigations of the northeastern wall cut revealed an overburden comprising two major lithological units of till (Figure 4-1). The lower is described as a deformation till, formed by sedimentation of debris flow as well as sorted material and subsequently deformed by moving ice. The upper unit is interpreted as a basal till, likely deposited by an ice movement direction from north. It is likely that both units were deposited during the same glaciation. Pollen analyses of samples from the sediments suggest an original pollen deposition under interglacial conditions, but do also indicate that the microfossils are not in situ. Neither the composition and structure of the sediments, nor the contained pollen flora show any notable differences from what may be described as typical conditions in the Forsmark area.

Figure 4-1. Drill site 5, with the overburden as seen in the northeastern wall of the excavation in the background. Unit A denotes the lower deformation till and Unit B the upper basal till.

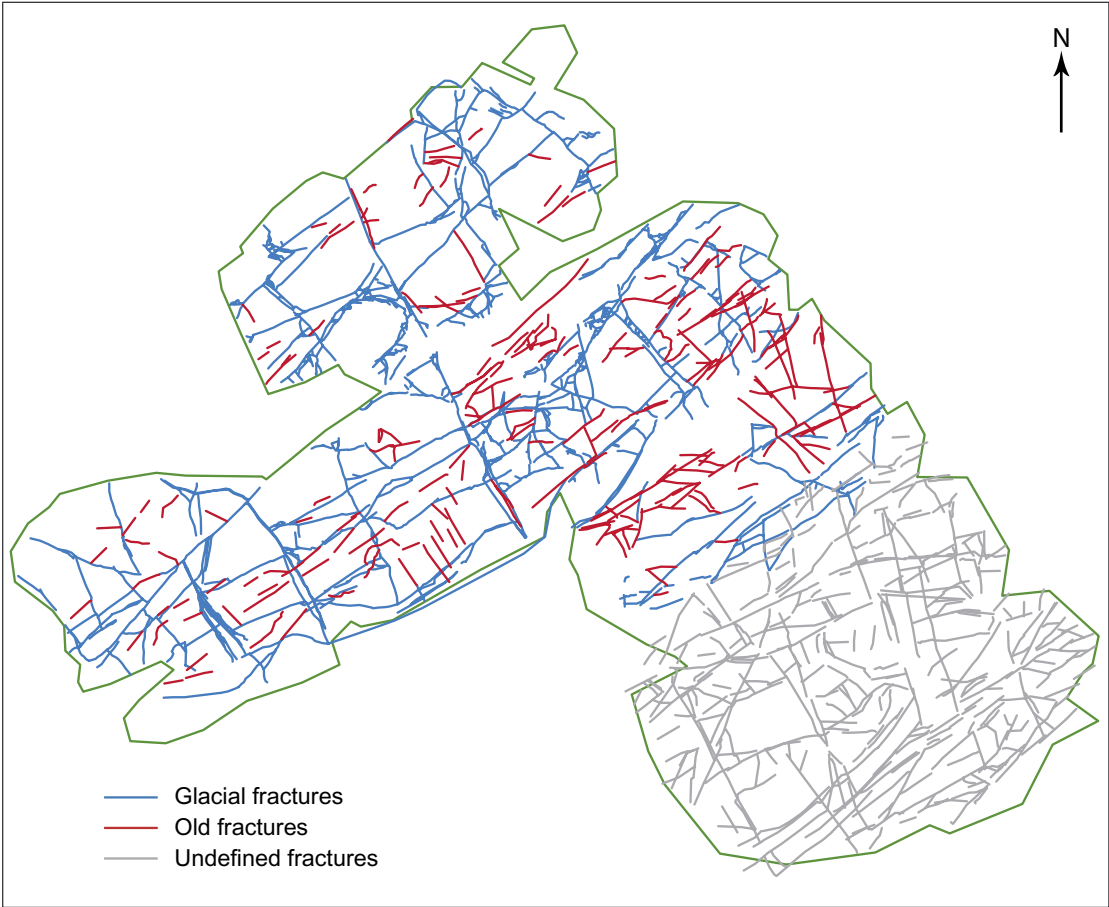
Open fractures	Closed fractures	All fractures
“Glacial” fractures	707	0	707
“Old” fractures	17	222	239
Unspecified fractures	203	131	334
Total	927	353	1280

Figure 4-3. Fracture data from Table 4-3 displayed on a map of the exposed rock surface at drill site 5.

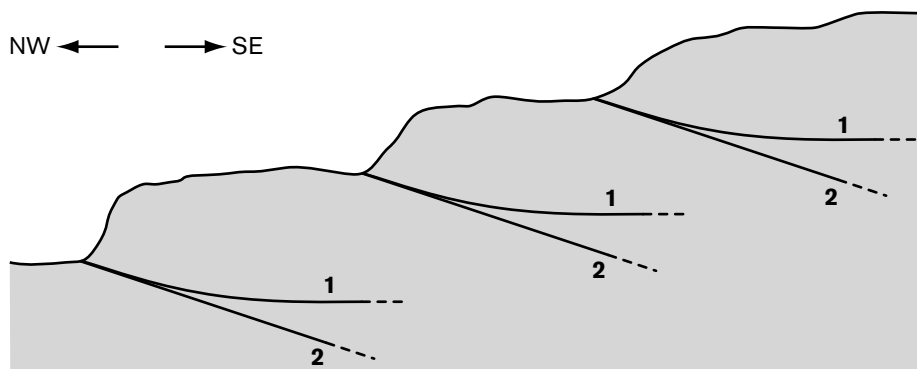
Figure 5-2 illustrates two alternative conceptual explanations for the major, gently dipping fractures. The most likely alternative is that they are sheet structures. /Carlsson 1979/ proved this to be the case for the in all respects similar fractures he investigated some 2 km northwest of drill site 5. Another factor supporting this interpretation is the tendency of the fracture planes to curve towards surface. GPR- and borehole data indicate that orientations change as the fractures approach surface, from almost horizontal to a dip of about 25° at the surface intersections. The extensional fracturing mechanism causing sheet structures offers mechanical explanations for this geometry to develop, when initially horizontal fractures are extended and eventually “find their way” to the surface. The sloping bedrock surface would facilitate such a process. The fact that anomalous fracture apertures and sediment fillings are found only in the uppermost few metres also support the concept of sheet structures.

The other possibility is that the fractures are local manifestations of the major, gently dipping fracture zone termed “A2” that has been identified during the site investigation work. According to current site models, the centre of this zone intersects ground surface some 250 m northwest of drill site 5. Its orientation agrees closely with the orientation of the major fractures at drill site 5 at their surface intersections. A number of smaller “sister zones”, have been identified further to the southeast. As mentioned, material interpreted to be sediment infillings have been found in fractures within such zones, to depths of c 50 m.

Figure 5-2. Alternative, conceptual explanations for the major fractures at drill site 5: 1) Sheet fractures, curving up towards their surface intersections. 2) Gently dipping fractures, attributable to the nearby, similarly oriented fracture zone A2.

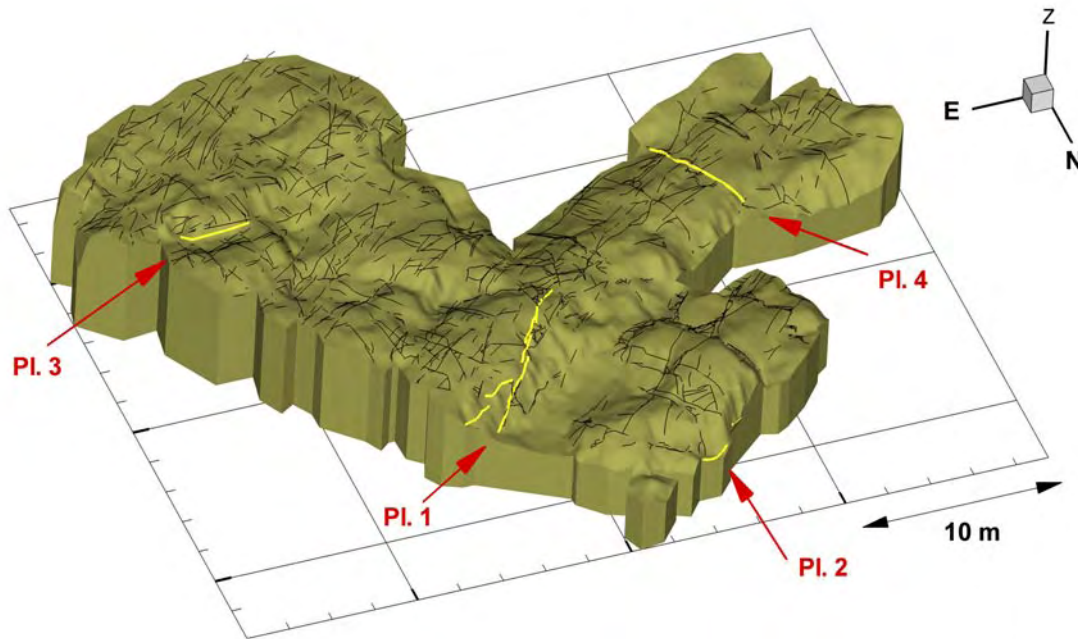
Upon exposure of the rock surface at drill site 5, it soon became obvious that the fracture pattern displayed evidences of post- or late glacial activity (hereinafter referred to as “glacial fractures”). This included anomalous fracture apertures, uplift of surface blocks by up to 20 cm and infillings of sediments in some fractures. Figure A-2 shows the excavated rock surface viewed from the southwest. A graphic of the excavated rock surface with documented fracture pattern and locations of four more spectacular fracture concentrations, labeled Pl 1, Pl 2, Pl 3 and Pl 4 is shown in Figure A-3. Subhorizontal glacial fractures have been mapped beneath the large blocks in the far left of Figure A-2, and other glacial fractures are present in the far middle (cf Pl 2 and Pl 1 respectively, in Figure A-3).

Figure A-3. Block diagram of drill site 5 at Forsmark, with surveyed fracture pattern and dominating glacial fractures highlighted.

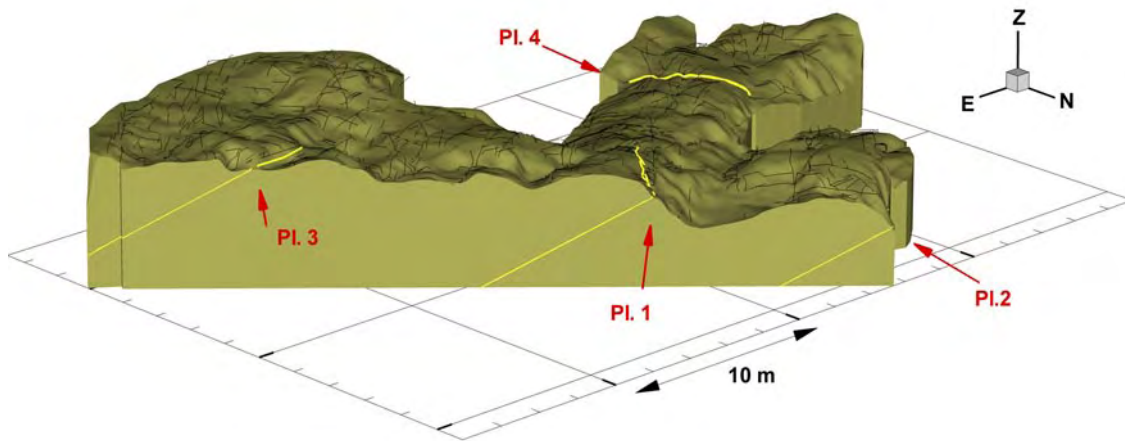
The gently dipping fractures are filled with glacial sediments of various grain size compositions. At Pl 1 the total observed fracture length is more than 10 m, and the subhorizontal fracture seems to be continuous. It is believed to be a reactivation of an older fracture. Several rotational subvertical displacements can be observed, as shown in Figure A-5 to Figure A-8. The surrounding rock is also rich in fractures with trace lengths of 50 cm or less.

The subhorizontal fractures at Pl 2 occur together with vertical fractures, striking NE and NW, thus dividing the rock mass into loose box-shaped boulders as shown in Figure A-9. The fracture at Pl 3 has a trace length of ca 3 m and varies in width from 10 cm in the middle to a few mm towards the ends (Figure A-10). The fill material is silt and sand showing a laminated structure (Figure A-11). Finally, at Pl 4 a relative vertical displacement of 2–3 cm can be observed (Figure A-12) in a NW striking subvertical fracture with 1–2 mm thick coating of crystalline calcite.

Figure A-4. Block diagram of drill site 5 at Forsmark, showing the gentle dip of the fractures at locations Pl 1, Pl 2 and Pl 3.

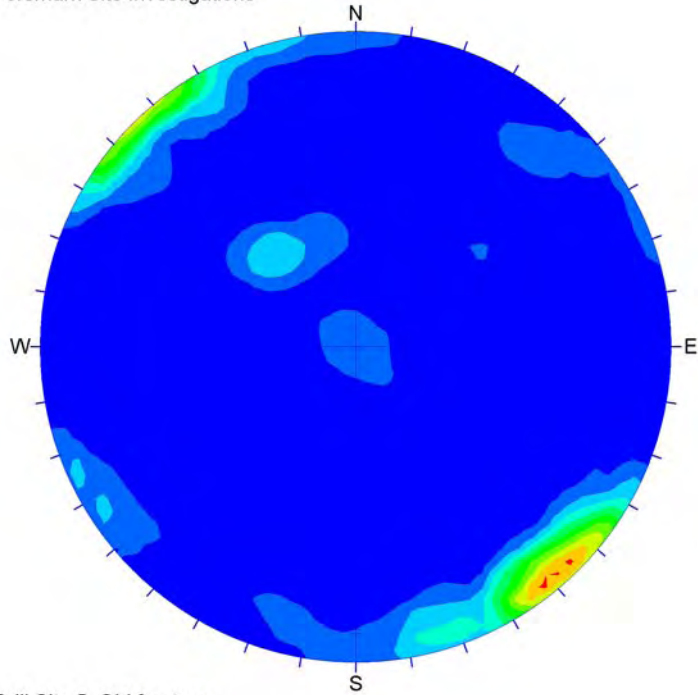
Figure A-15 shows a stereographic contour diagram for fractures classified as older (cf Section A3). The concentration to the three sets is much more distinct for this category than for the total population. Figure A-16 shows a stereographic contour diagram for fractures classified as glacial. The distribution is similar to that of all fractures (cf Figure A-13), but also featuring several pole concentration centres in addition to the general spread. The conclusion is that most of the randomly striking fractures are glacial.

Figure A-15. Stereographic pole plot contour diagram of older fractures at drill site 5.

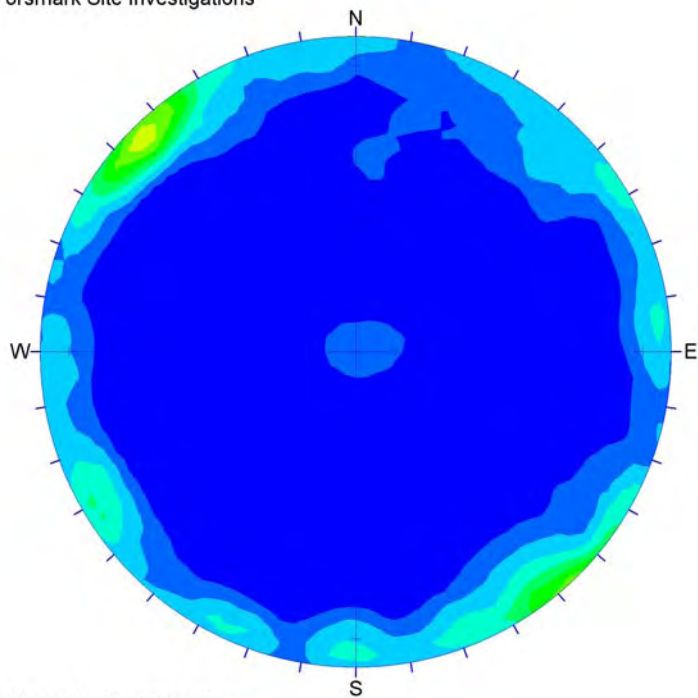
Figure A-16. Stereographic pole plot contour diagram of glacial fractures at drill site 5.

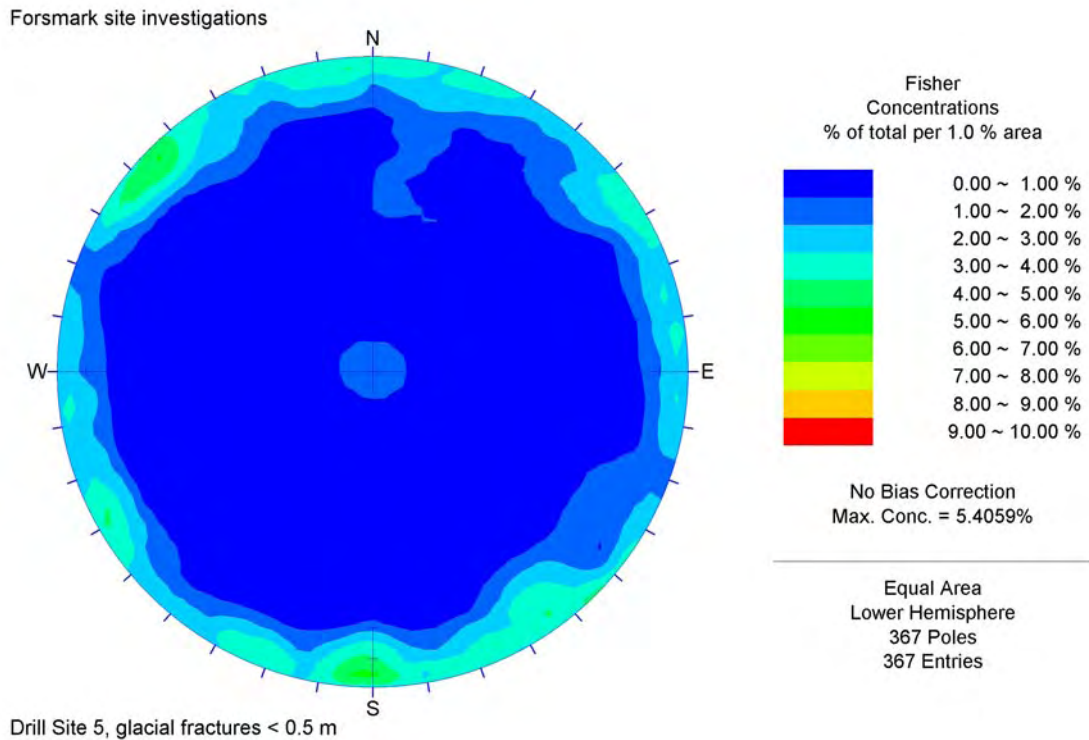
Glacial fractures have been categorized with respect to trace length. Those with trace lengths less than 50 cm (Figure A-17) feature much wider spreading than does the total population of glacial fractures and the entire fracture population (Figure A-13). These short fractures can be regarded to constitute almost the entire random fracture group. Glacial fractures with a trace length of 50 cm or more (Figure A-18) show a similar pattern as the entire fracture population at the site. Fractures classified as reopened (Figure A-19) do not differ from glacial fractures in general (cf Figure A-16).

Figure A-17. Stereographic pole plot contour diagram of glacial fractures with a trace length of less than 50 cm at drill site 5.

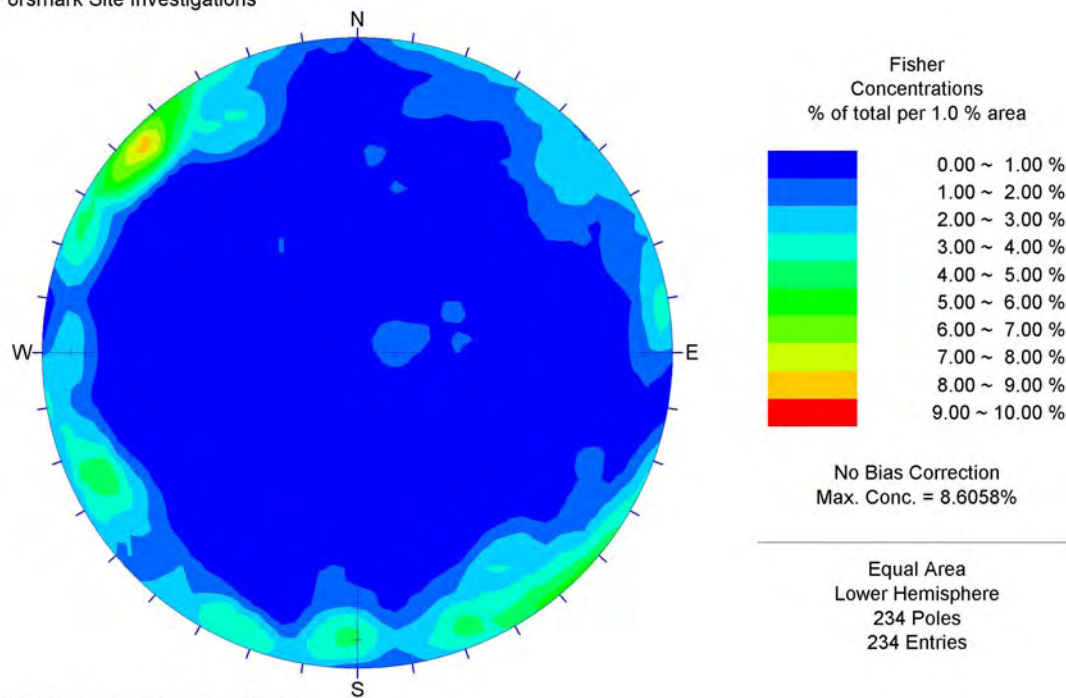
Figure A-19. Stereographic pole plot contour diagram of glacial fractures which are deemed to be reopened older fractures at drill site 5.

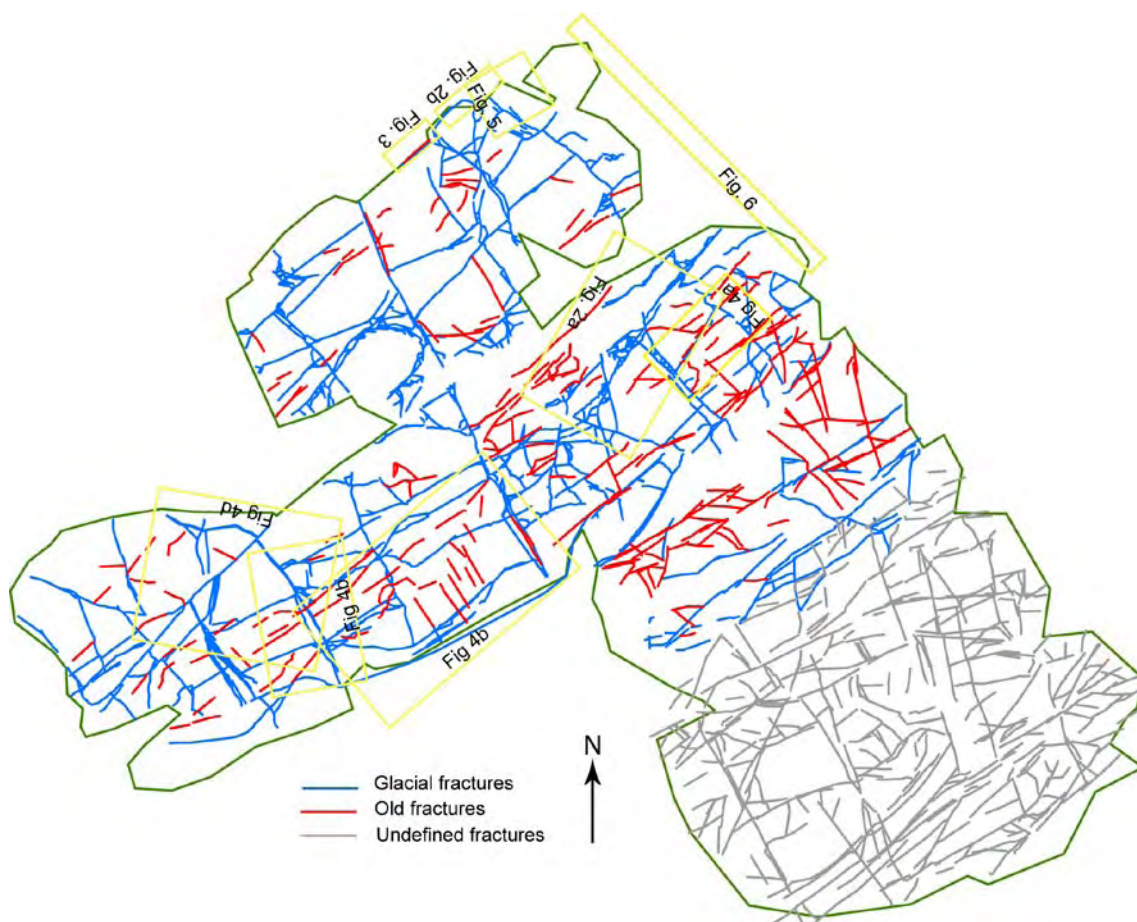
Figure B-1. Fracture data as reported in Appendix A displayed on a map of the exposed rock surface at drill site 5. Yellow symbols indicate locations of objects shown in figures with numbers as indicated.

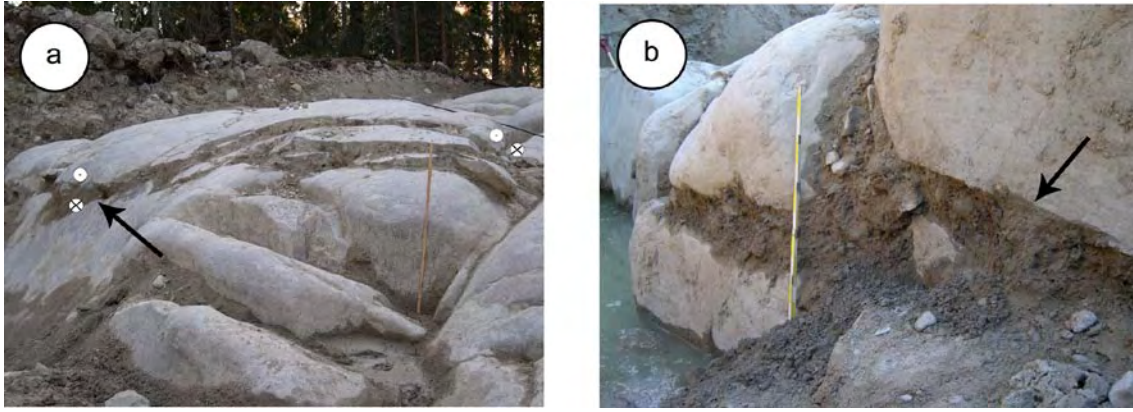
Figure B-3. Horizontal to gently dipping sediment filled fractures with till in the outer parts. a) fracture in the NW part of the SE outcrop. The vertical displacement is approximately 10 cm and the relative movement is indicated by upwards (point) and inward (cross) going arrows. b) fracture in the NW part of the outcrop.

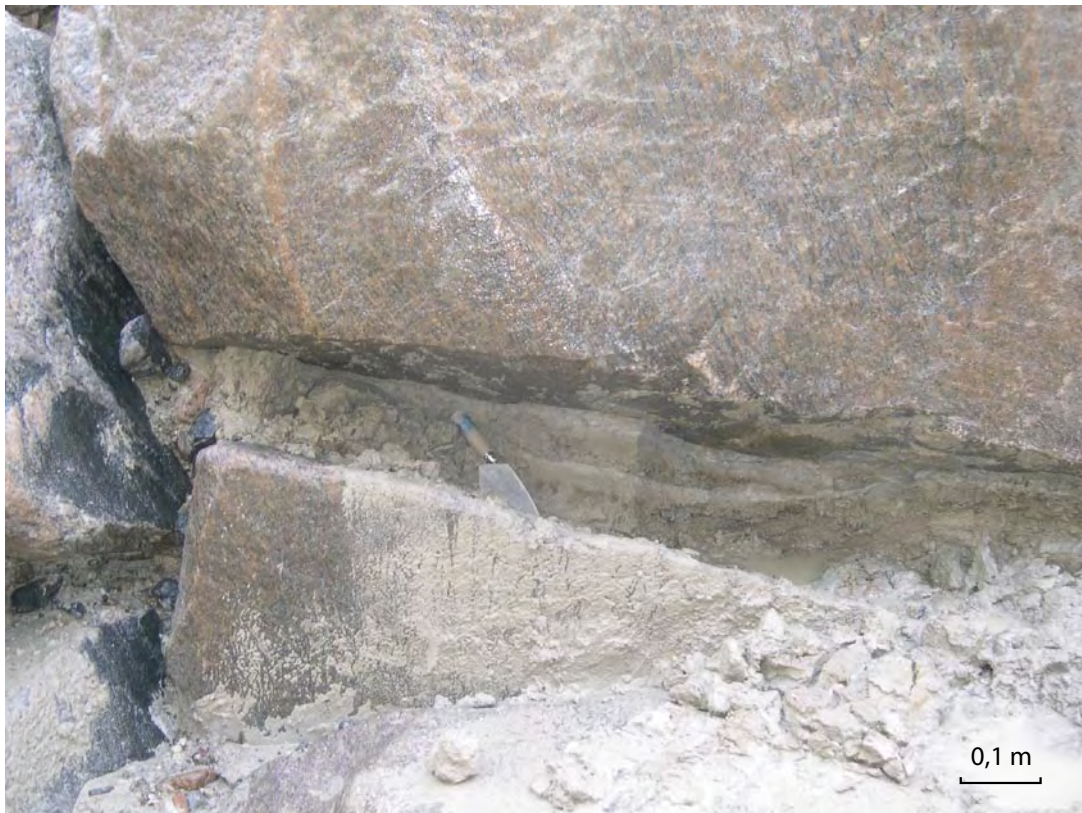
Figure C-1. Sediment in bedrock fractures, as well as the till, was sampled at drill site 5.

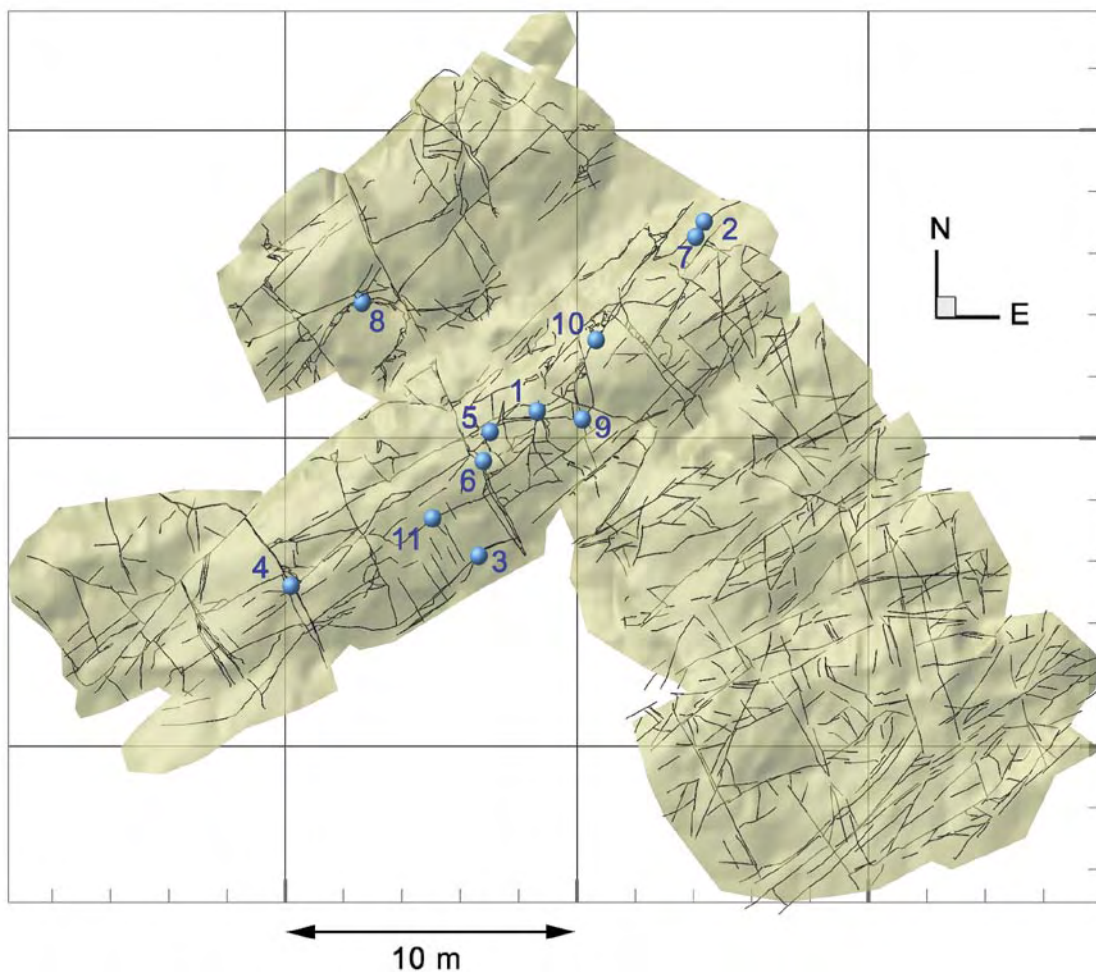
Figure D-1. Map showing the outcrop exposed after excavation with the mapped fractures and the ten short drill holes marked with blue points. Drillcores 1 and 10 from subhorizontal fractures and 3, 4, and 6 from steeply dipping fractures have been sampled for this study.

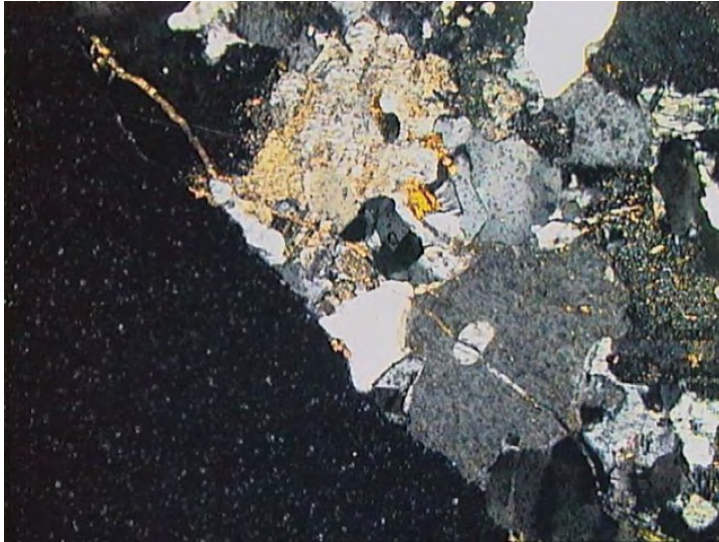
Figure D-3. Micro-fracture parallel to the main fracture, filled with calcite. (Photomicrograph with crossed polars, width of photo c 10 mm).

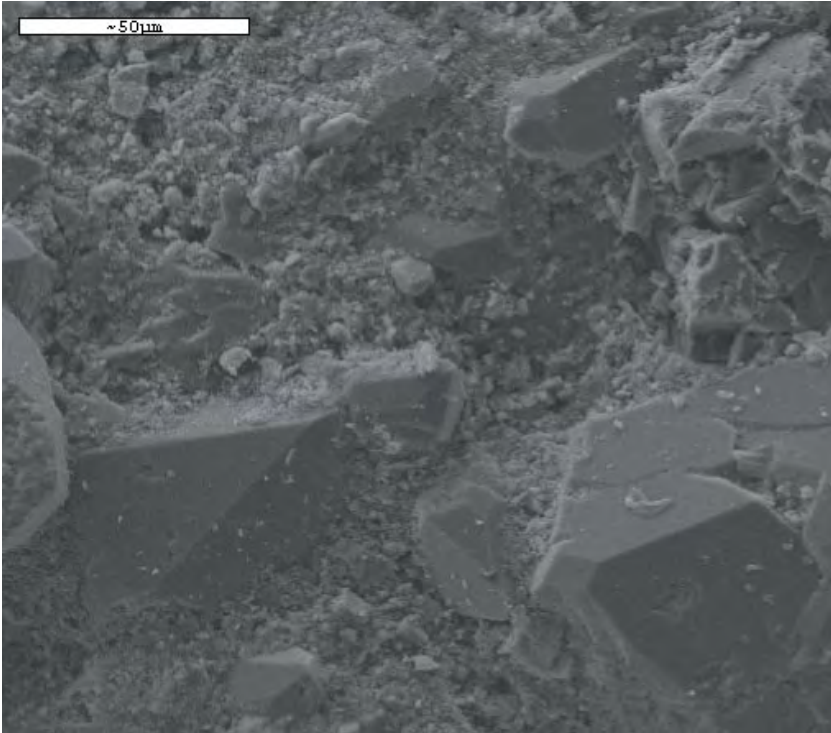
The fracture surface contains small crystals of quartz. When viewed in the scanning electron microscope, the quartz crystals show euhedral crystals indicating that they have grown in an open fracture. No pronounced traces of weathering can be seen on the surface. The small irregular grains are not attached to the surface (Figure D-5).

Figure D-5. Electron image of quartz crystals on fracture surface from drill core 1.

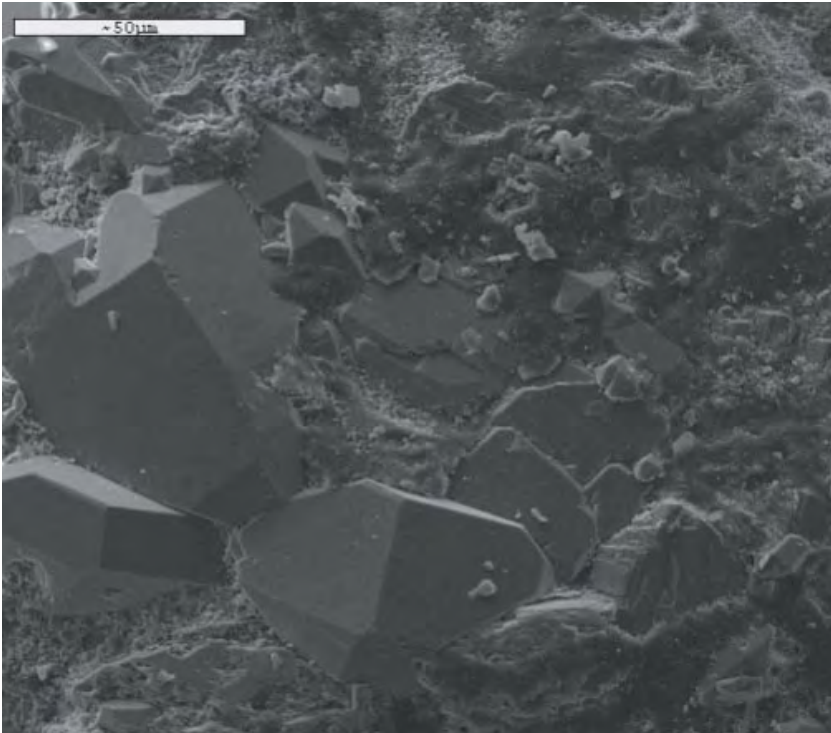
Figure D-6. Electron image of euhedral quartz crystals on fracture surface from drill core 10.

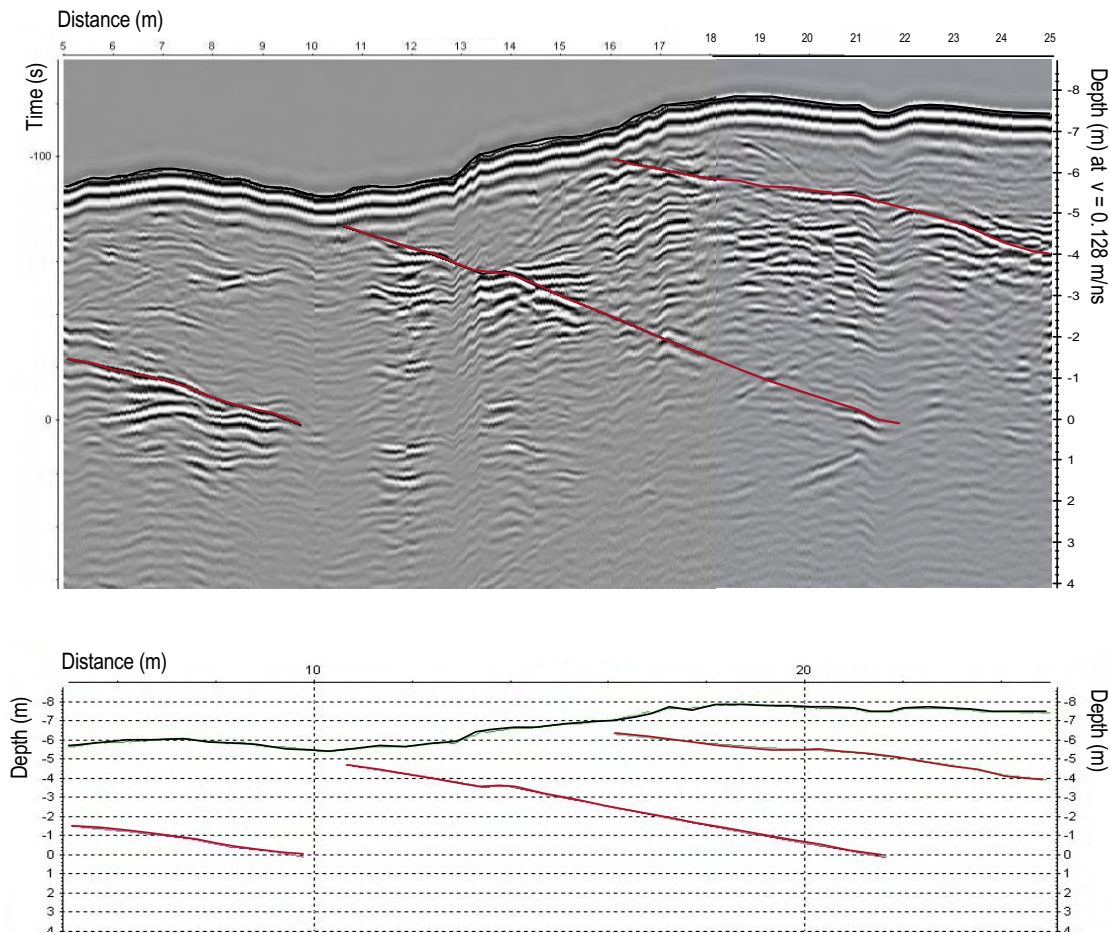
Figure E-5 shows one of the profiles (Profile 8) processed in REFLEX. The interpreted fracture zones are displayed in the radargram as well as in a separate plot. All profiles measured with the 250 MHz antenna show the same general behaviour, and are of equal quality. The processed data and interpretation are delivered to SKB.

Figure E-5. Processing result and interpretation of GPR Profile 8.

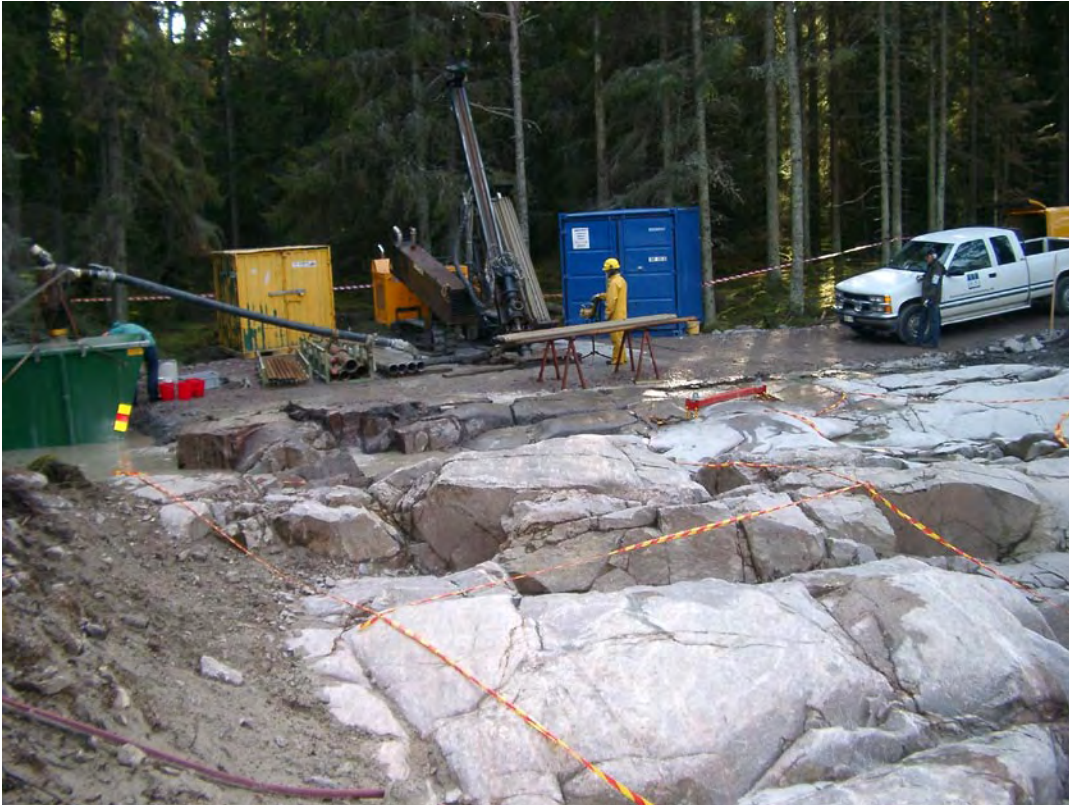
Figure F-3. The Nemek 407 percussion drilling machine in operation at drill site 5. Water and drilling debris is discharged to the container to the left. The fractured bedrock is seen in the foreground.

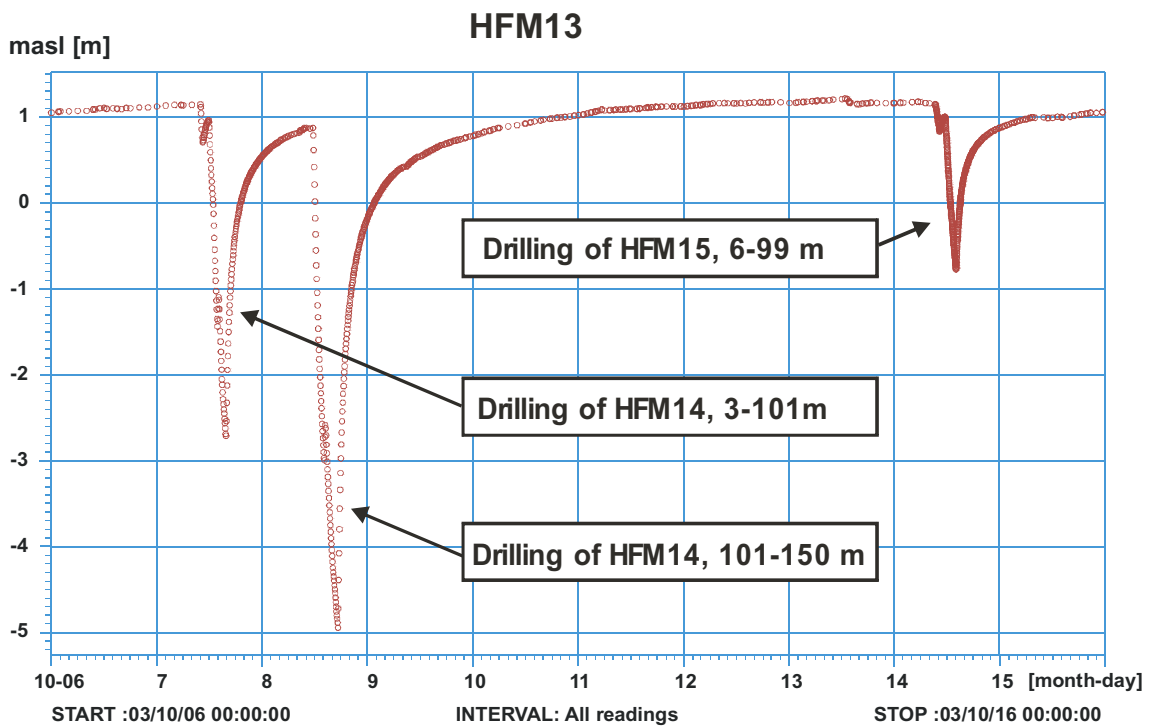
Figure F-7. Hydraulic responses in HFM13 when drilling HFM14 and HFM15.

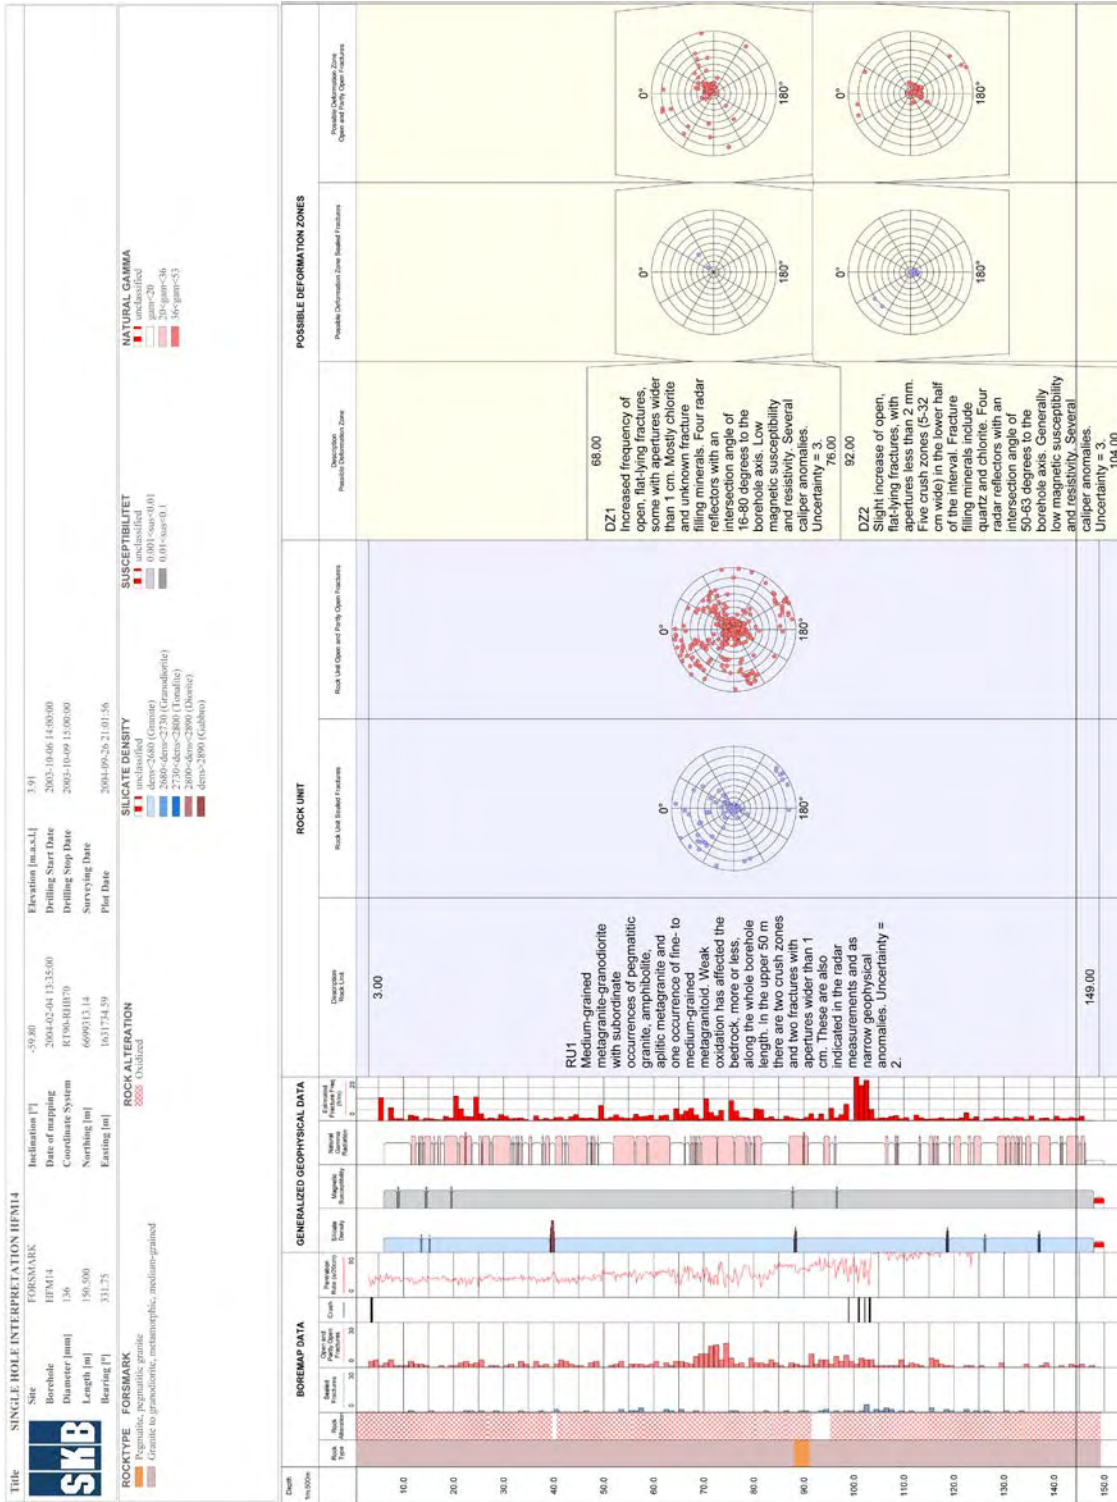
3–149 m *RUI: Medium-grained metagranite-granodiorite with subordinate occurrences of pegmatitic granite, amphibolite, aplitic metagranite and one occurrence of fine- to medium-grained metagranitoid. Weak oxidation has affected the bedrock, more or less along the whole borehole length. In the upper 50 m, there are two crush zones and two fractures with apertures wider than 1 cm. These are also indicated in the radar measurements and as narrow geophysical anomalies. Uncertainty = 2.*

68–76 m *DZ1: Increased frequency of open, flat-lying fractures, some with apertures wider than 1 cm. Mostly chlorite and unknown fracture filling minerals. Four radar reflectors with an intersection angle of 16–80° to the borehole axis. Low magnetic susceptibility and resistivity. Several caliper anomalies. Uncertainty = 3.*

92–104 m *DZ2: Slight increase of open, flat-lying fractures, with apertures less than 2 mm. Five crush zones (5–32 cm wide) in the lower half of the interval. Fracture filling minerals include quartz and chlorite. Four radar reflectors with an intersection angle of 50–63° to the borehole axis. Generally low magnetic susceptibility and resistivity. Several caliper anomalies. Uncertainty = 3.*

Figure F-8. Geological single-hole interpretation for borehole HF14 (from Carlsten et al. 2004).

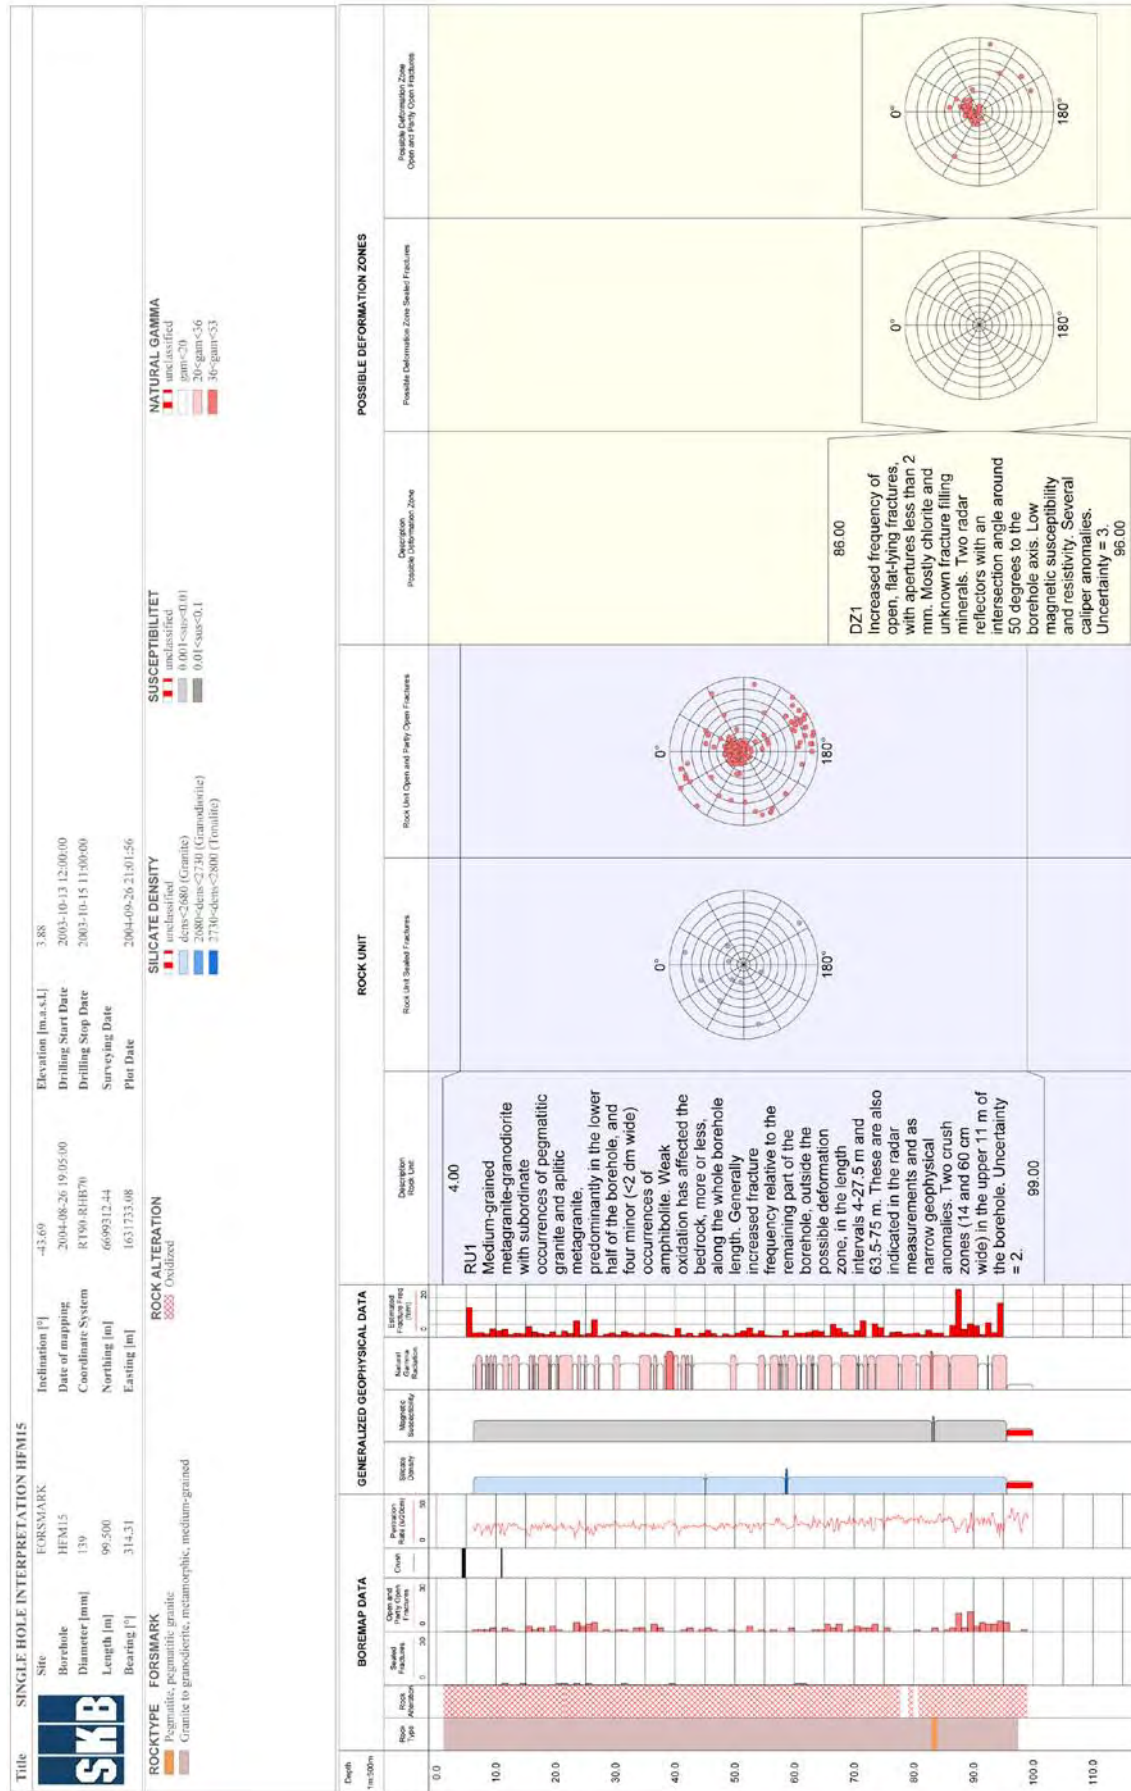
4–99 m *RUI: Medium-grained metagranite-granodiorite with subordinate occurrences of pegmatitic granite and aplitic metagranite, predominantly in the lower half of the borehole, and four minor (< 2 dm wide) occurrences of amphibolite. Weak oxidation has affected the bedrock, more or less along the whole borehole length. Generally increased fracture frequency relative to the remaining part of the borehole, outside the possible deformation zone, in the length intervals 4–27.5 m and 63.5–75 m. These are also indicated in the radar measurements and as narrow geophysical anomalies. Two crush zones (14 and 60 cm wide) in the upper 11 m of the borehole. Uncertainty = 2.*

86–96 m *DZ1: Increased frequency of open, flat-lying fractures, with apertures less than 2 mm. Mostly chlorite and unknown fracture filling minerals. Two radar reflectors with an intersection angle around 50° to the borehole axis. Low magnetic susceptibility and resistivity. Several caliper anomalies. Uncertainty = 3.*

Figure F-9. Geological single-hole interpretation for borehole HFMI5 (from Carlsten et al. 2004).

It may be added that observations during drilling clearly indicated a crushed section at 4.3–4.9 m. Since the uppermost 6 m of the hole were cased while drilling, this section was not logged. Another, c 15 cm wide crushed zone was found at about 10.9 m.
