P-05-199

Forsmark site investigation

Investigations of superficial fracturing and block displacements at drill site 5

Bengt Leijon (ed)
Svensk Kärnbränslehantering AB

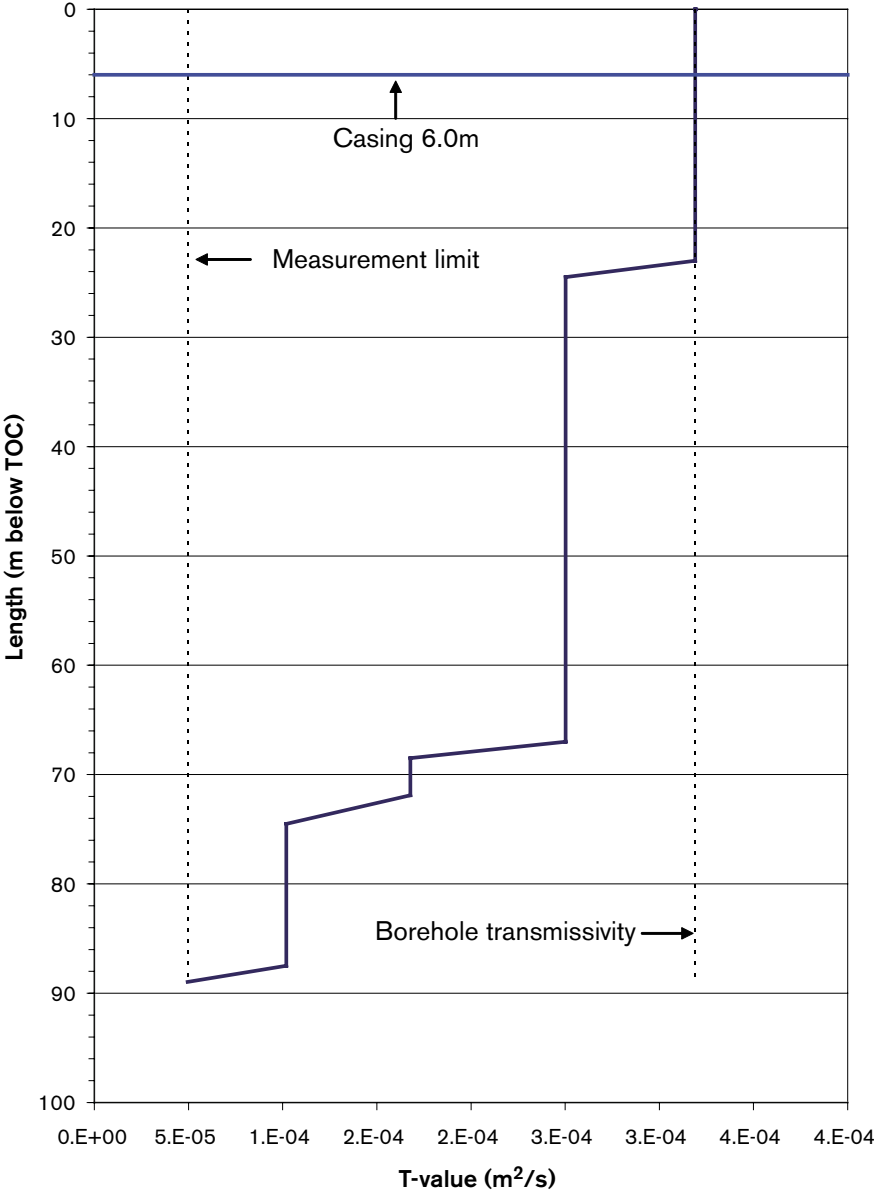
HFM15 was also subject to hydraulic testing. Figure F-10 shows a result from this work. The diagram illustrates calculated, cumulative transmissivity along the hole. Below c 89 m, the borehole transmissivity falls below the measurement limit. As can be seen, transmissivity changes are found in four sections indicating one or more conductive structures within each section.

Figure F-10. Calculated, cumulative transmissivity along the flow-logged part of borehole HFM15 /from Ludvigson et al. 2004/.

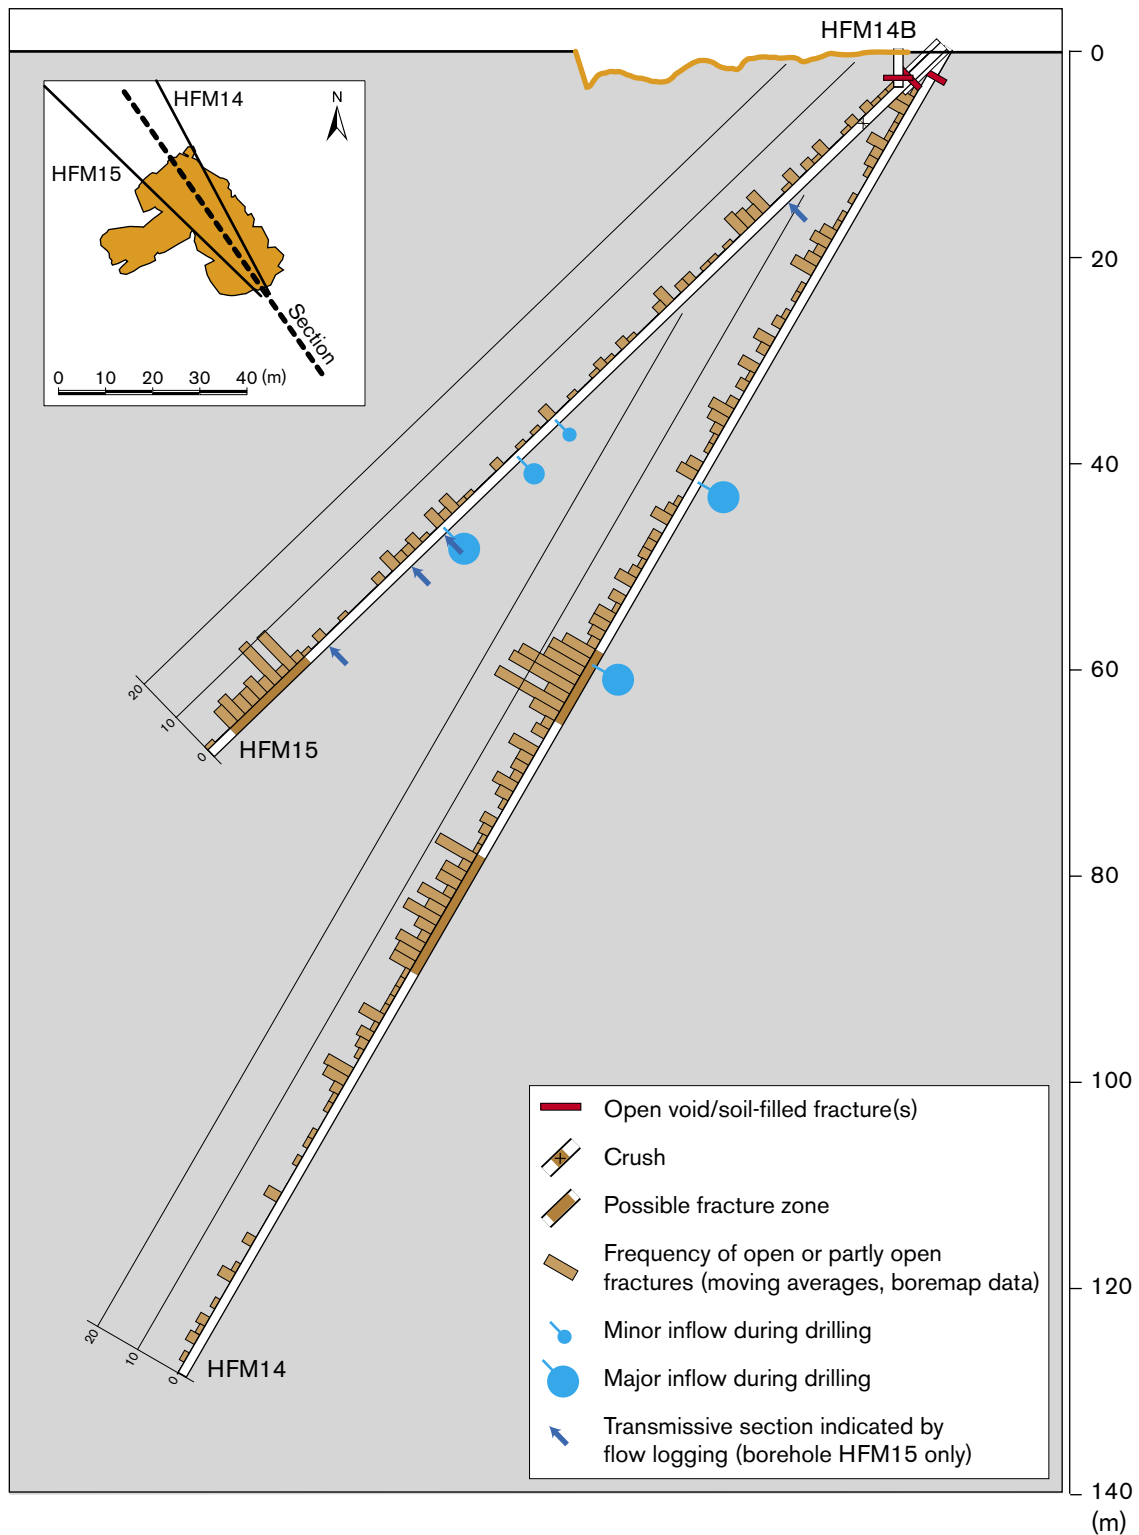
Figure F-12 shows the same section as Figure F-11, but in a scale such that HFM 14 and HFM15 are displayed to their full lengths (neglecting borehole deviations). As far as fracturing is concerned, borehole data towards depth offer few surprises. Overall fracture frequencies are low. In both HFM14 and HFM15, increased fracturing indicates a possible fracture zone within the approximate depth interval 60–67 m. In HFM14, another similar zone is indicated at 79–90 m. The fractures constituting the inferred zones are largely subhorizontal.

Figure F-12 also indicates hydraulic conditions observed in the boreholes. It is seen that:

- Excluding the open, superficial fractures resulting in surface discharge of drilling water (cf Figure F-6), the first indication of a conductive structure (from flow logging, cf Figure F-10) is observed at about 16.5 m depth in HFM15.
- A number of water bearing structures are found within the approximate interval 40–60 m.

Some of the water bearing structures are highly conductive. Inflows tended to occur distinctly and could in many cases be correlated with individual fractures.

Figure F-12. NW-SE section of the uppermost 140 m at drill site 5, showing main results from the borehole investigations.
