IPR-03-28

TBM assembly hall

Geological mapping of the assembly
hall and deposition hole

SwedPower AB

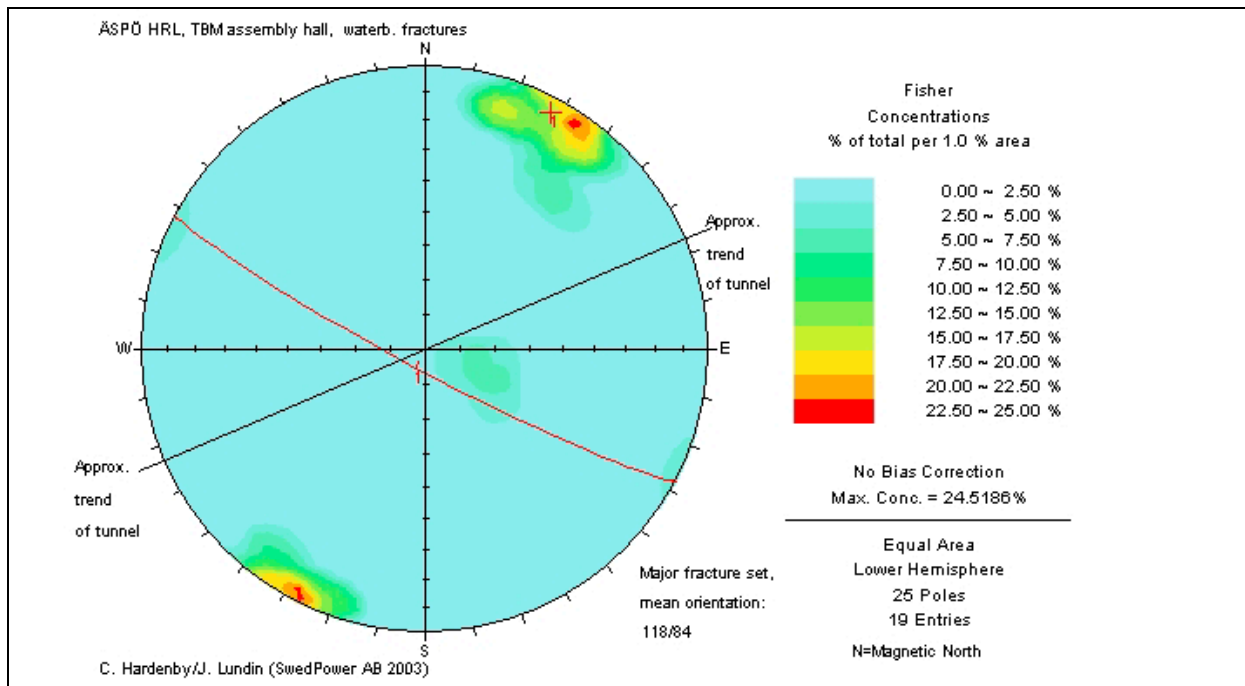
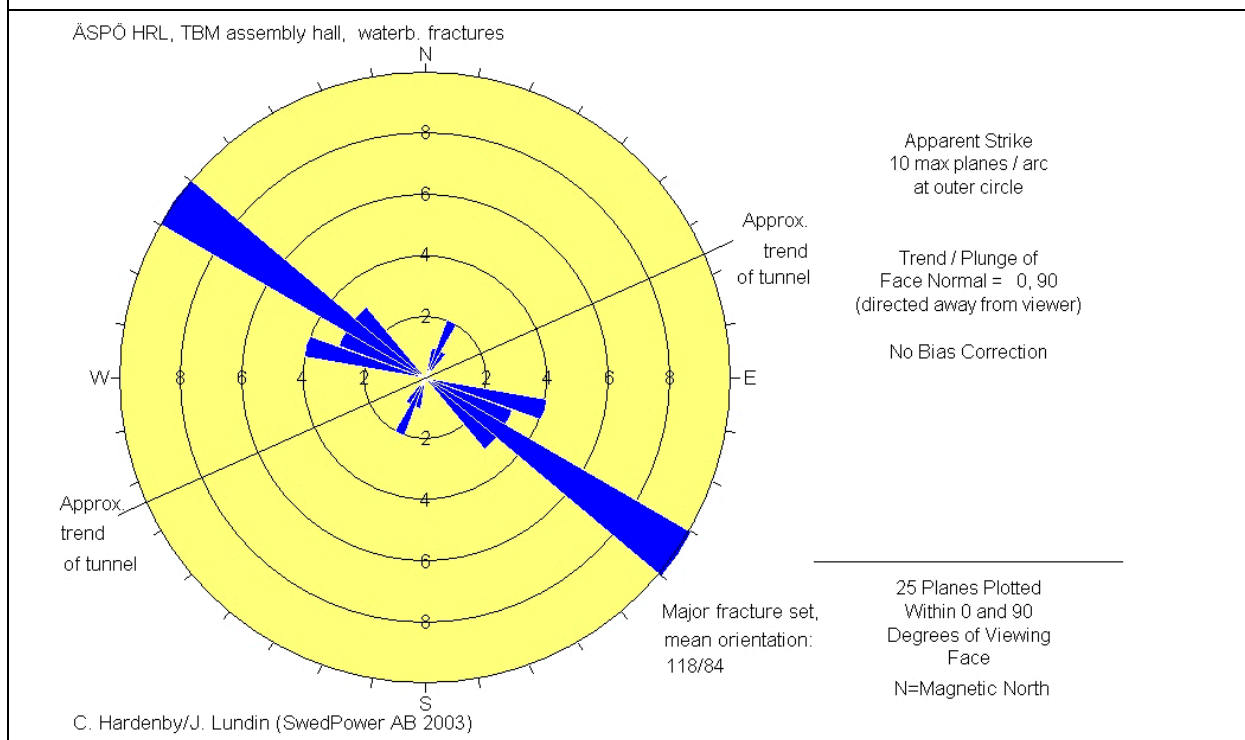
Water was found at a number of locations of which some were patches on the rock surface and some were fractures. Where water was observed it appeared commonly in only minor amounts (<0.5 litres/minute). Three fractures in the walls and roof have, however, been reported to each carry 2-4 litres of water /minute. The water-bearing fractures mostly dip steeply towards the NE or SW. In the deposition hole a few sub-horizontal (10-20°NNW dipping) are found as well. In the Äspö tunnel system as a whole the water-bearing fractures commonly are steeply dipping, striking NW or SE (cf. appendix 7).

The strikes of the majority of water bearing fractures and those containing grout coincide more or less with the maximum horizontal stresses in the rock mass (Rhén et al.1977).

Appendix 7. Fracture orientations of water-bearing fractures presented in Schmidt net and joint rosette diagrams. The TBM assembly hall, collective diagrams – roof, walls and deposition hole

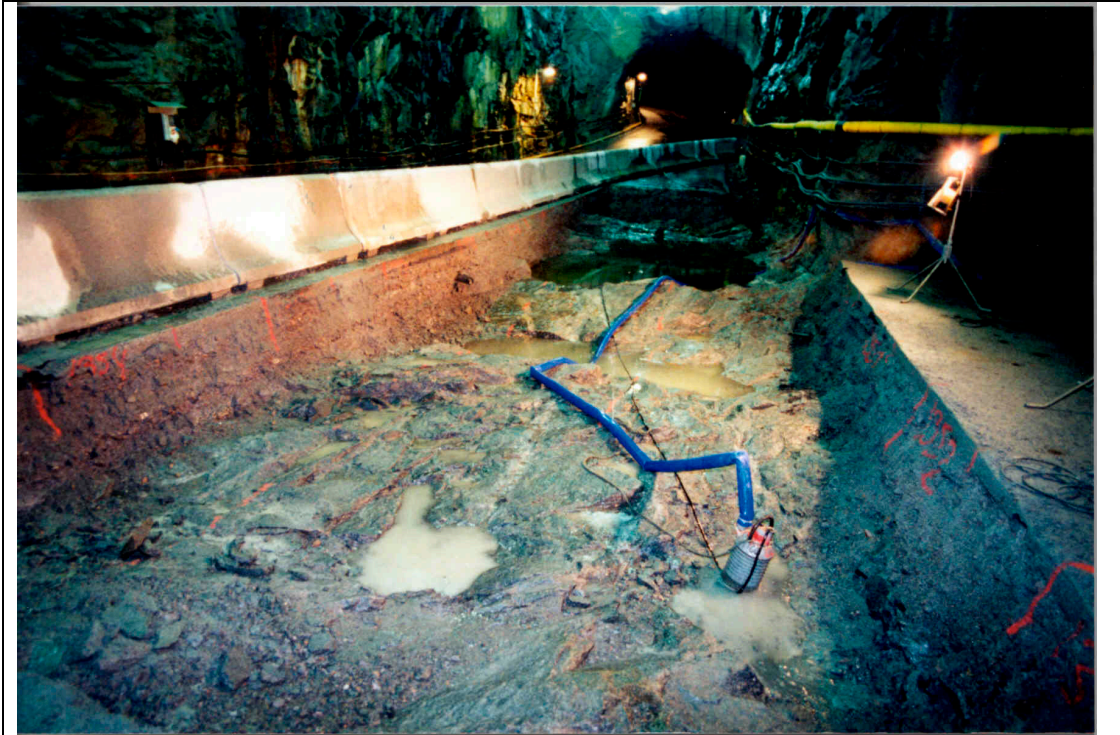
Appendix 8A. Photos showing the pit-floor in the TBM assembly hall (photos: Lars Andersson, SKB). Overview of the pit looking up the ramp

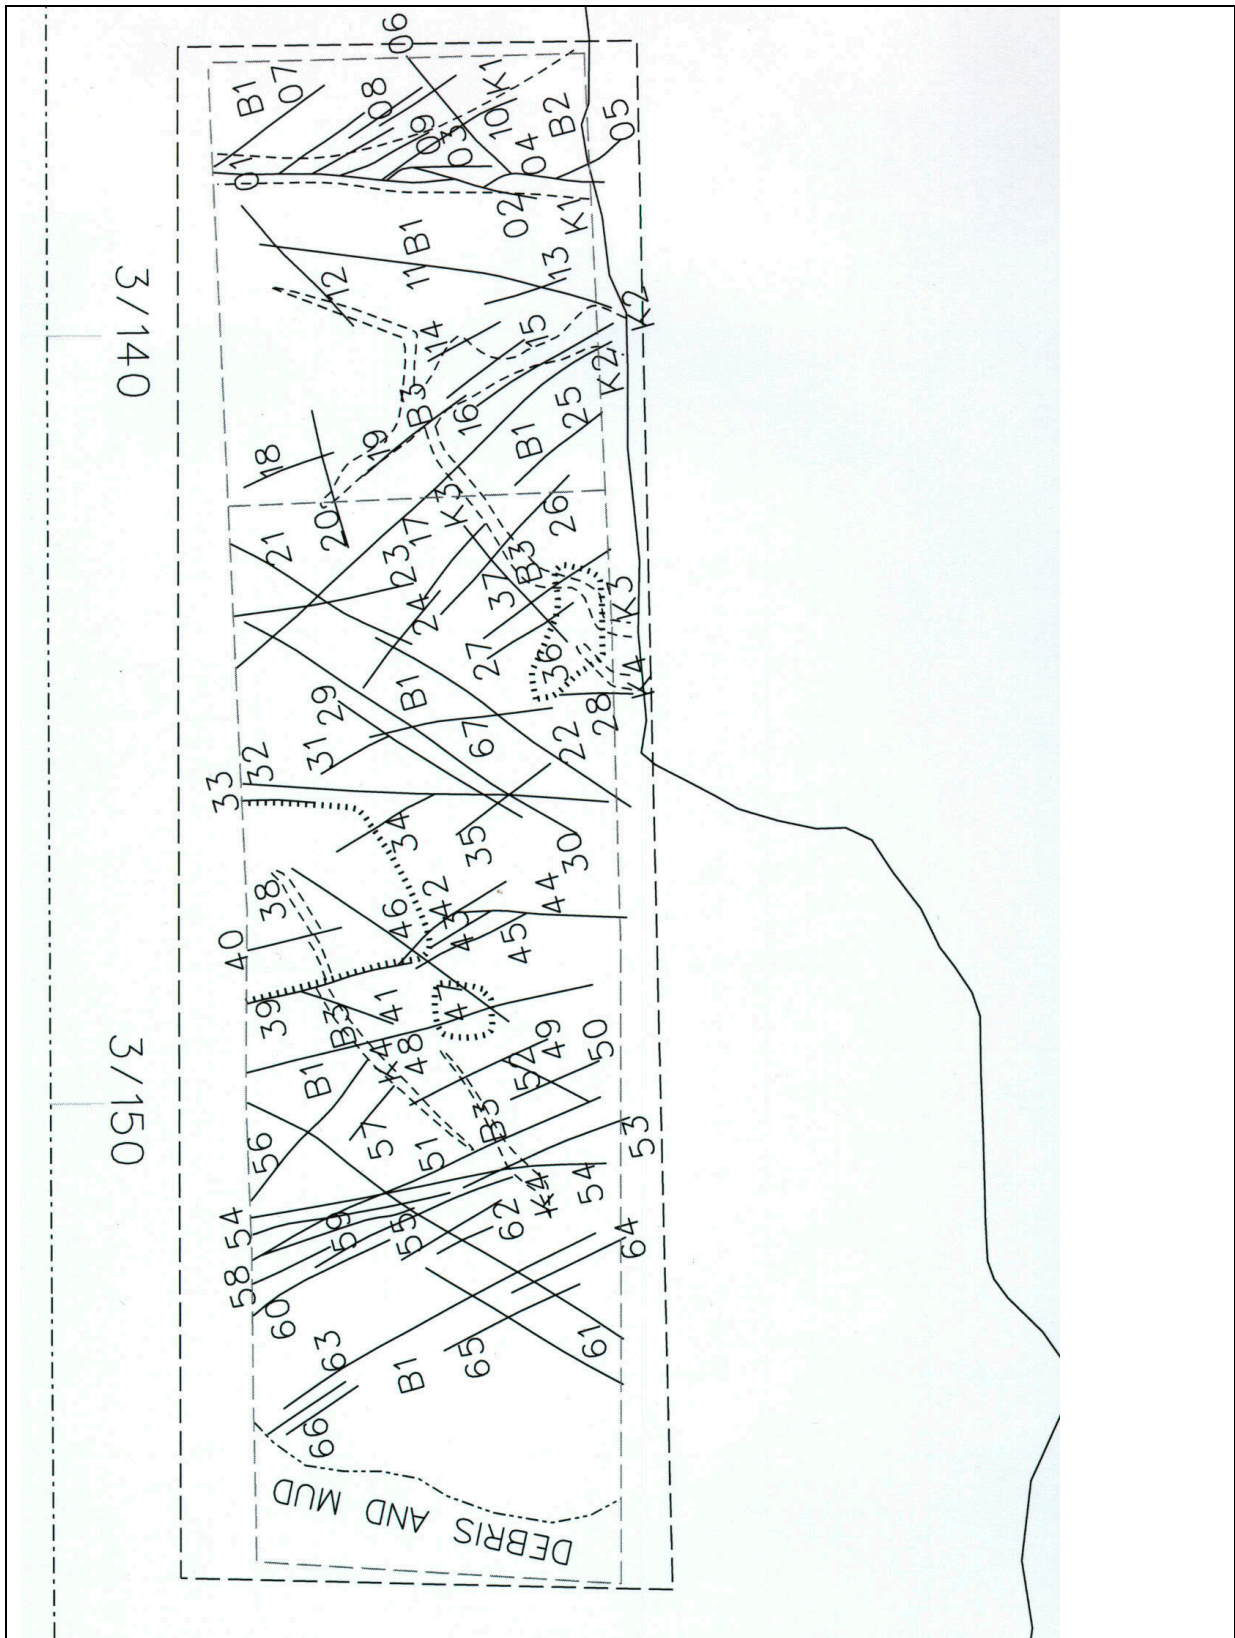
Appendix 9: Geological mapping of the pit floor in the TBM assembly hall

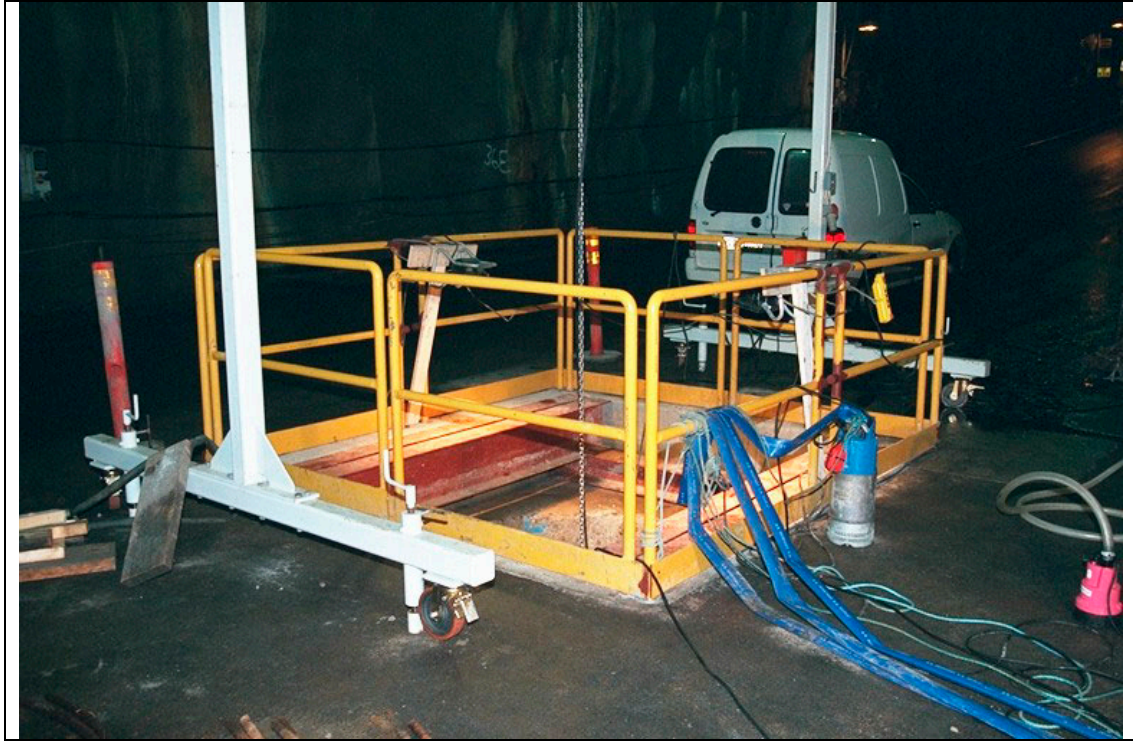
Appendix 11A. Photos from deposition hole DA3147G01 (photos: Lars Andersson, SKB). Top of the hole with safety fence and part of the lift.

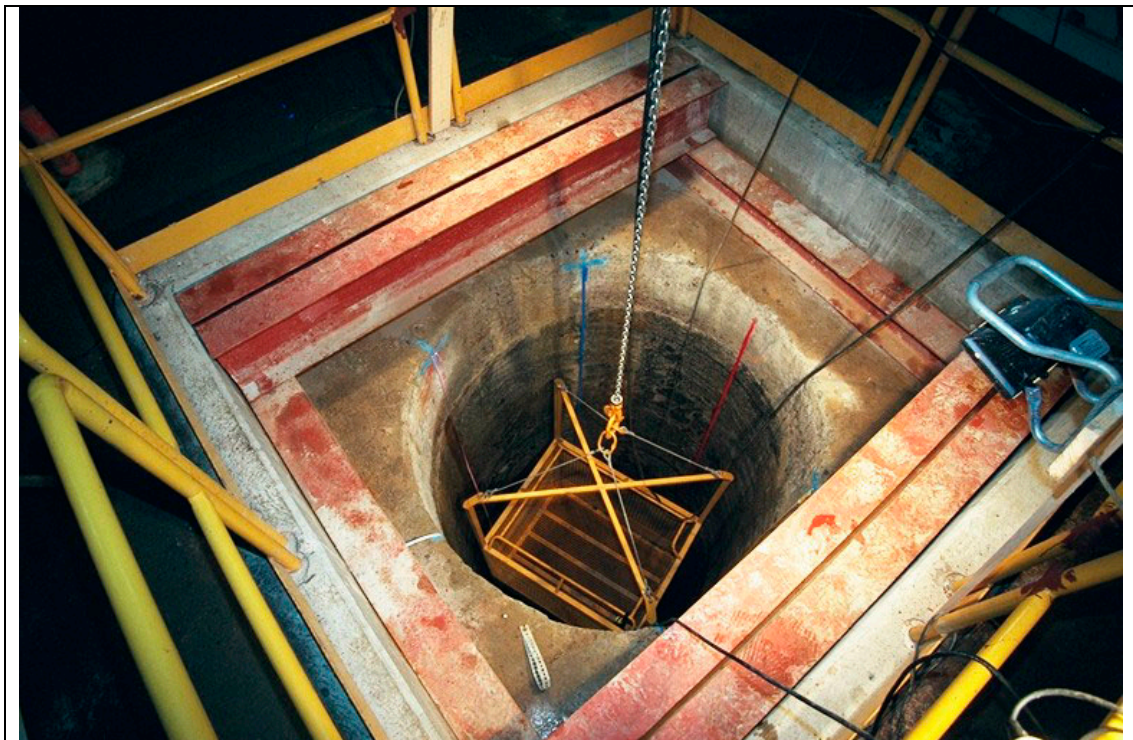
Appendix 11B. Photos from deposition hole DA3147G01 (photos: Lars Andersson, SKB). Top of the hole with safety fence and lift cage. The blue and red ribbons were used during the mapping procedure not only for orientation but were also a part of a grid system

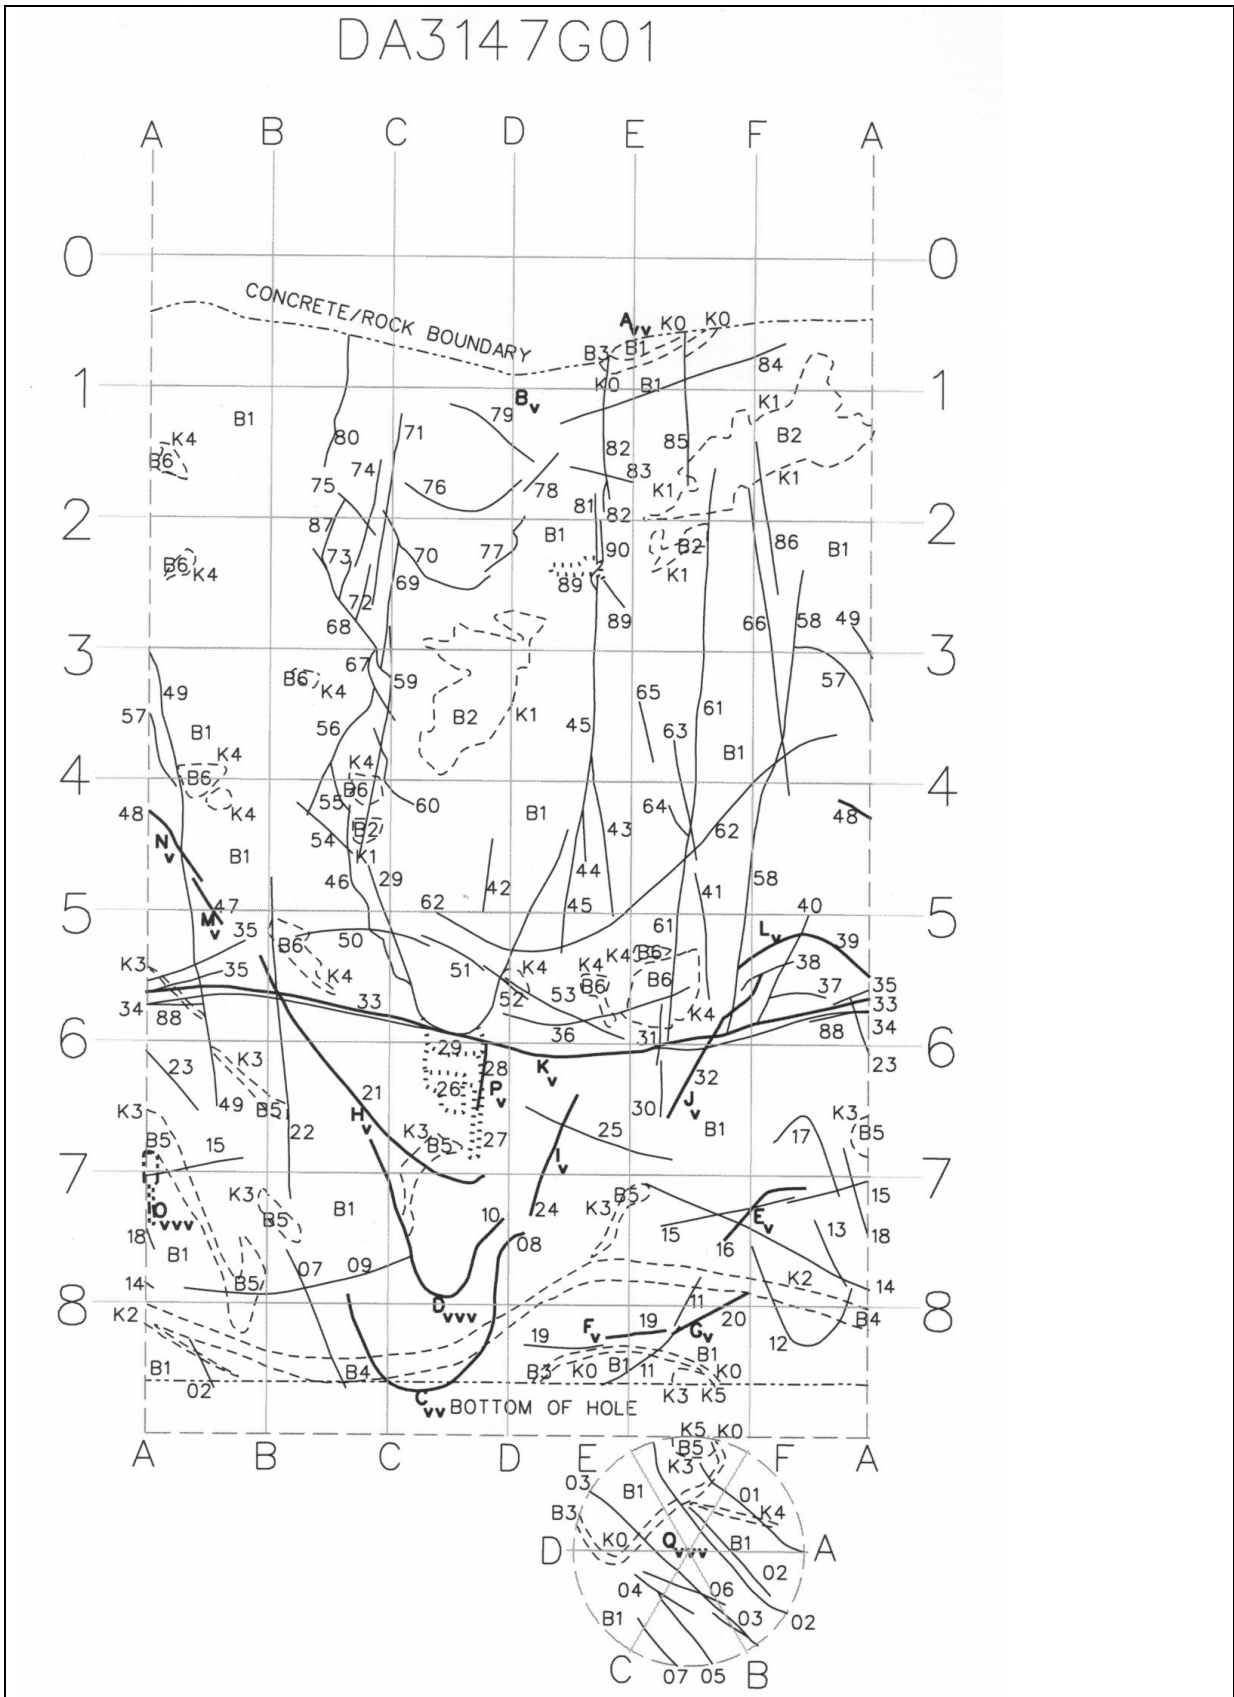
Appendix 12: Geological mapping of the deposition hole DA3147G01

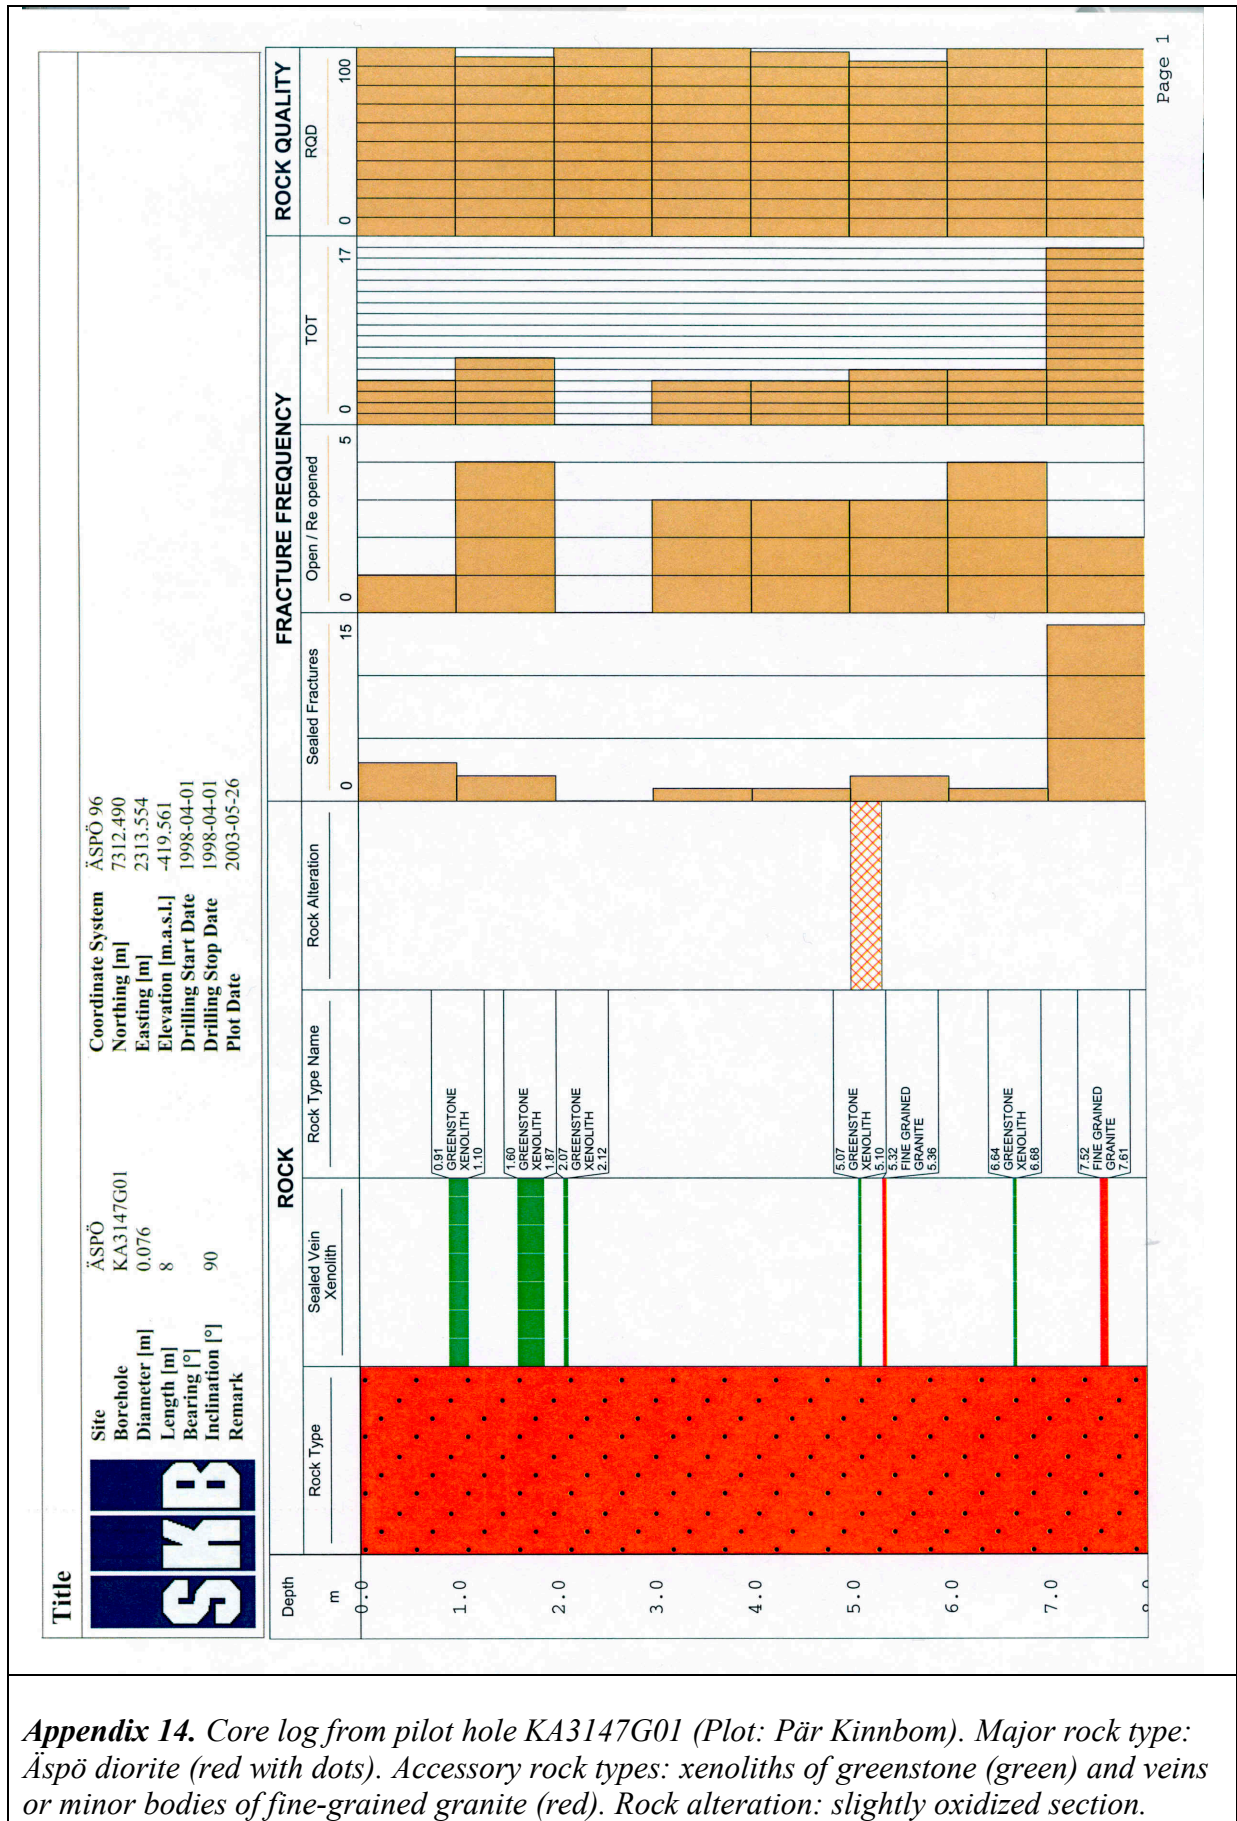
The rather high fracture frequencies occurring in the last metre of the cores of both the pilot holes have no correspondence in the deposition hole. This indicates that these fractures have very little persistence.

Appendix 14. Core log from pilot hole KA3147G01 (Plot: Pär Kinnbom). Major rock type: Äspö diorite (red with dots). Accessory rock types: xenoliths of greenstone (green) and veins or minor bodies of fine-grained granite (red). Rock alteration: slightly oxidized section.

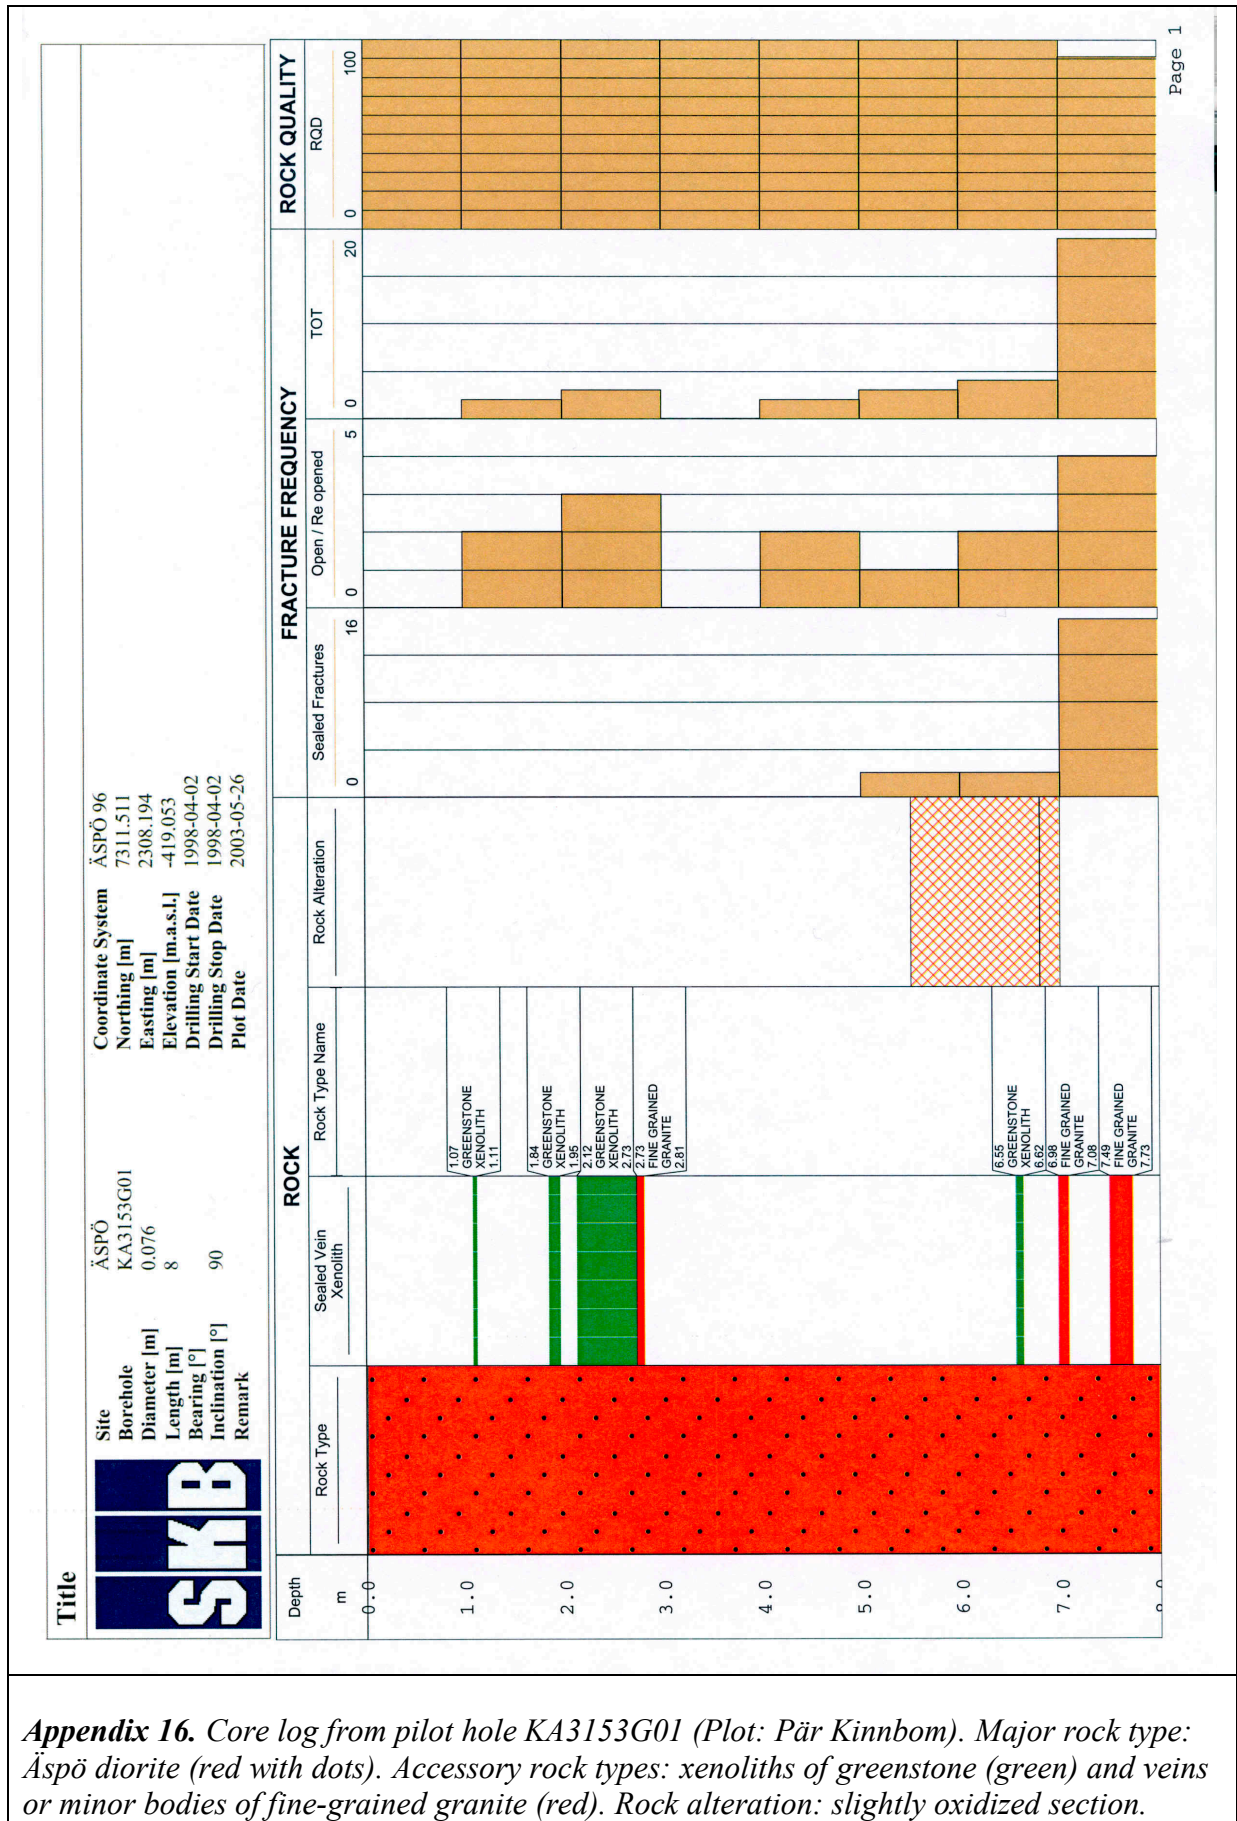
Appendix 16. Core log from pilot hole KA3153G01 (Plot: Pär Kinnbom). Major rock type: Äspö diorite (red with dots). Accessory rock types: xenoliths of greenstone (green) and veins or minor bodies of fine-grained granite (red). Rock alteration: slightly oxidized section.
