SKB TR-25-06

August 2025

Analysis of copper samples from the canister in deposition hole 4 in the Prototype repository

Abdelkader Meroufel, Xuying Wang, Dan Persson, Alice Moya Nunez,
Kristina Lindgren, David Malmström, Rikard Norling
RISE AB

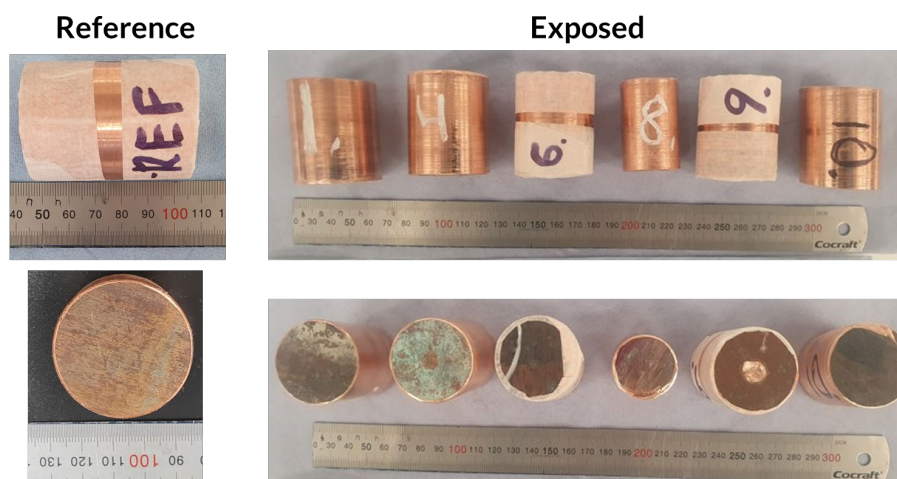
Figure 3. Overview pictures (from side and top view) of six exposed samples (to bentonite) and one non-exposed reference sample.

The surface displayed considerable variation, largely consisting of a combination of dark black, white, green and red surfaces. In some regions, metallic shiny surface with typical copper colour was observed. Surface machining striations were observed and are expected to be related to the canister manufacturing stage

Evidence of mechanical damage was observed for certain samples (either in the core or the edge) which can be due to sampling and/or handling procedures as for samples #4, #6, #8, #9 and #10.

Solid corrosion products and probably bentonite residues are visible with variable appearance on the surface, compared with the reference sample. Samples #1 and #4 surfaces distinguish from the others by their colour, texture and flaking which may indicate thicker surface layer. Unexpected surface redness was detected on samples #1 and #8. The presence of white line on sample #6 is caused by marking during sampling as confirmed by SKB engineer. In general, all surfaces exhibited a non-uniform appearance when it comes to surface products coverage. Also, it is not obvious to correlate the visual appearance to the sample's locations in the absence of surrounding environment information.

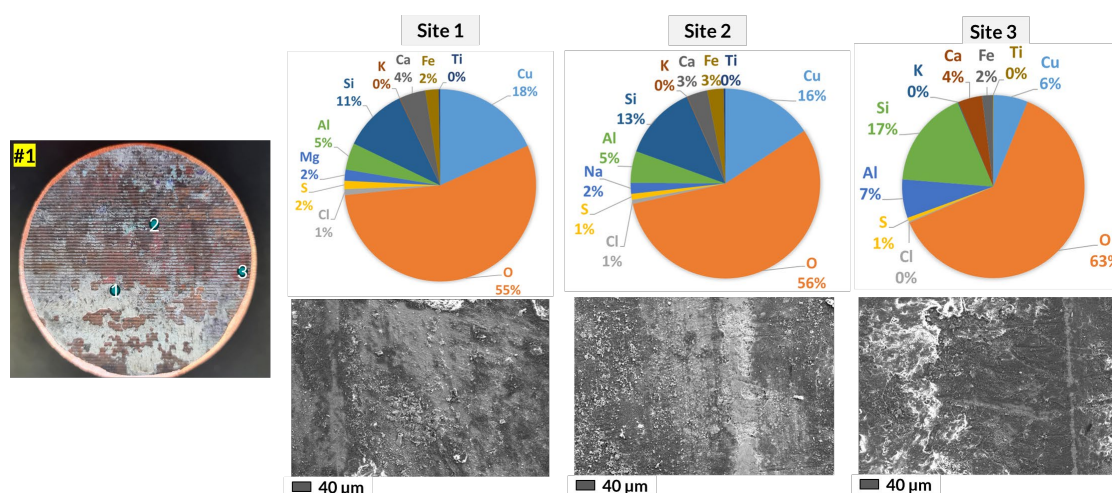
SEM images revealed microscopic details of the machining striations observed visually (section 3.1) and the patchy character of surface products. The images depicted light grey areas, which appear to be bare copper surfaces with a thin oxide layer, while darker areas with bright white are attributed to corrosion products and some surface deposits (probably bentonite). The white regions could result from the charging effect of the non-conductive bentonite which is more significant for thicker locations.

Figure 9. SEM images of analyzed area and corresponding average elemental composition (at. %) by EDS mapping of sample #1 for three different sites.

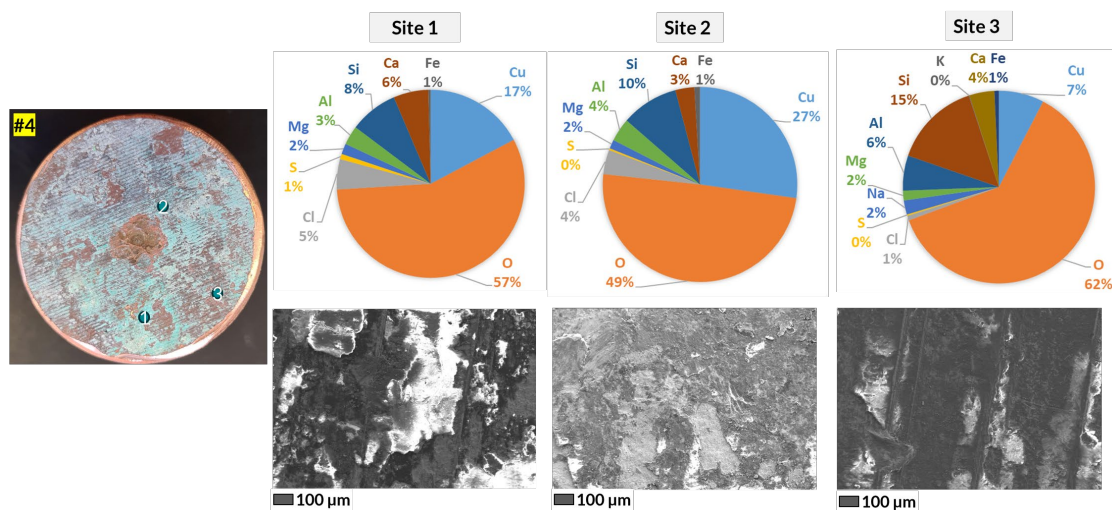
Figure 10. SEM images of analyzed area and corresponding average elemental composition (at. %) by EDS mapping of sample #4 for three different sites.

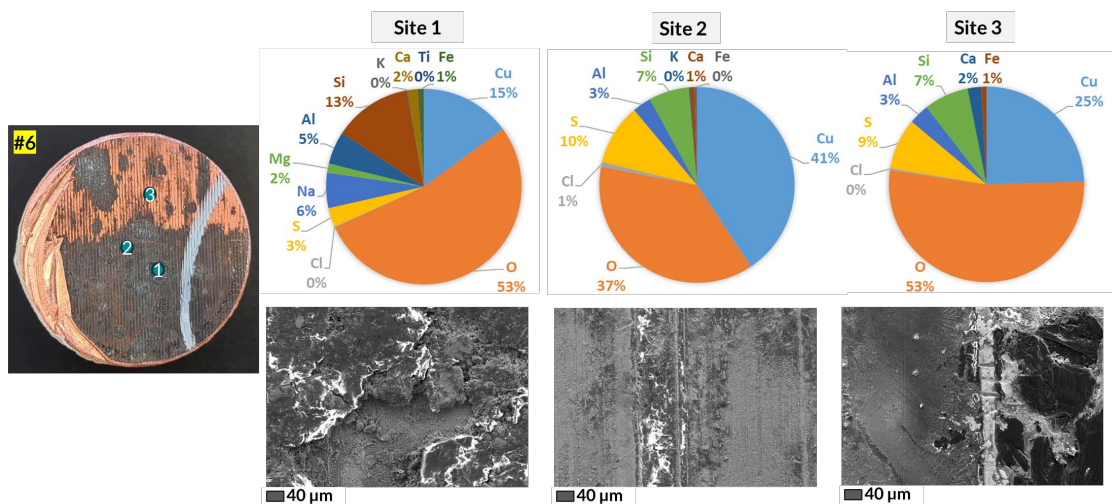
Figure 11. SEM images of analyzed area and corresponding average elemental composition (at. %) by EDS mapping of sample #6 for three different sites.

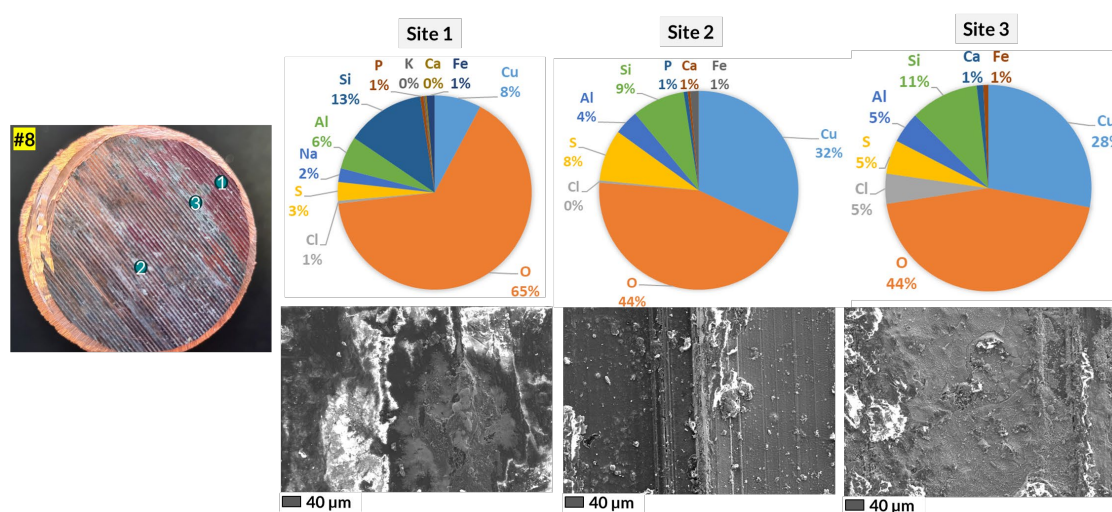
Figure 12. SEM images of analyzed area and corresponding average elemental composition (at. %) by EDS mapping of sample #8 for three different sites.

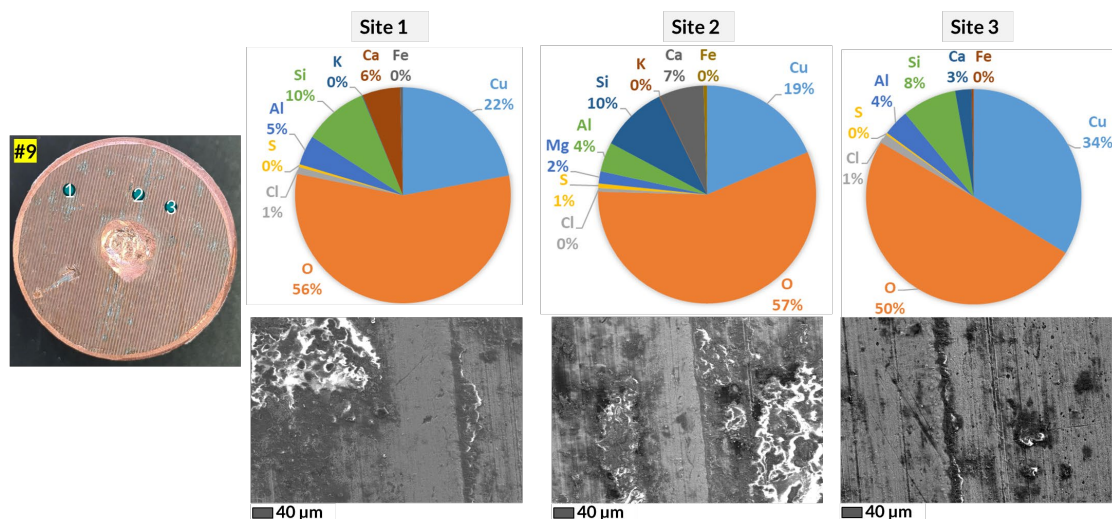
Figure 13. SEM images of analyzed area and corresponding average elemental composition (at. %) by EDS mapping of sample #9 for three different sites.

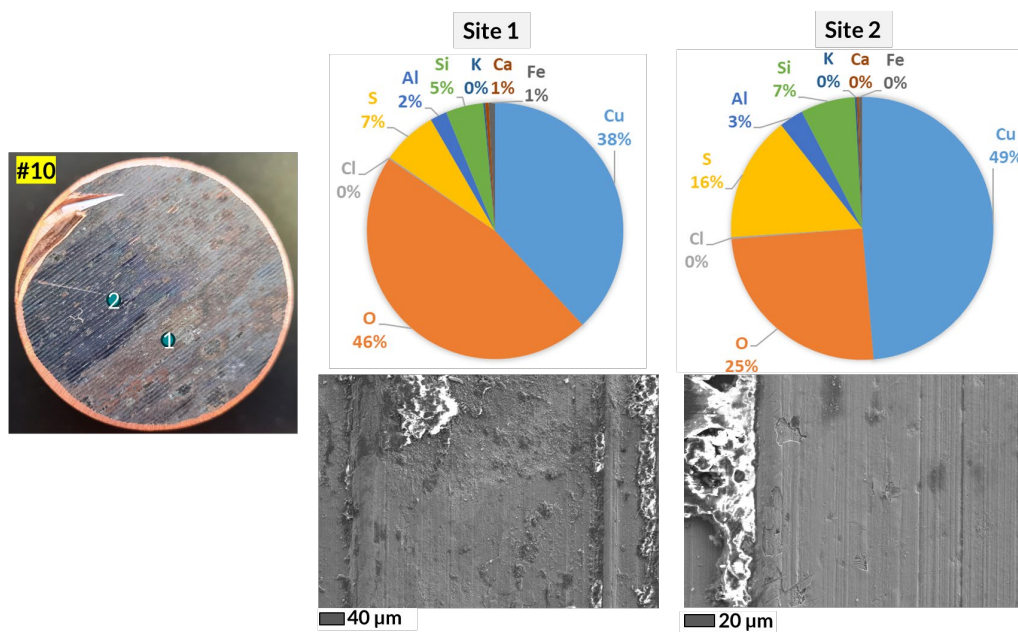
Figure 14. SEM images of analyzed area and corresponding average elemental composition (at. %) by EDS mapping of sample #10 for two different sites.

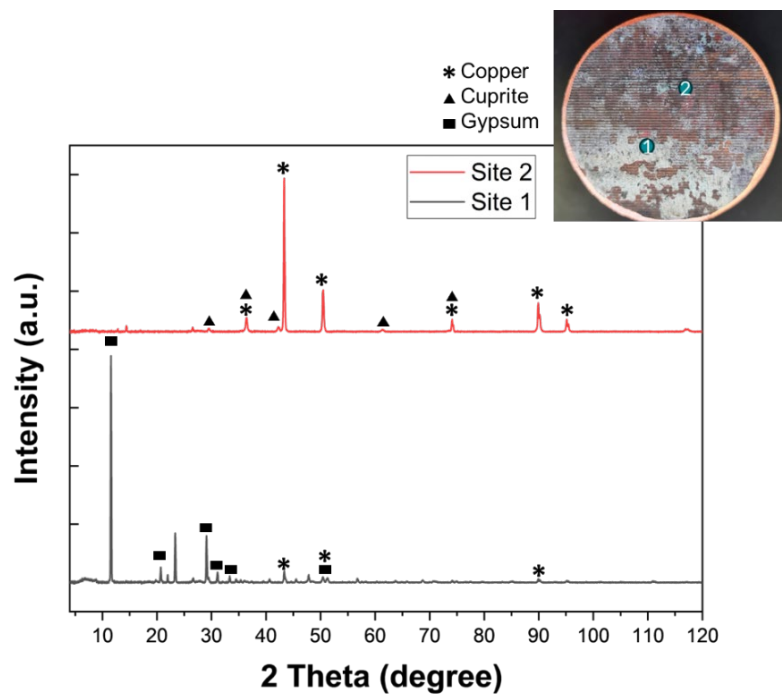
Figure 16. XRD diffractograms obtained from the surface of sample #1. Inserted image shows the measurement locations.

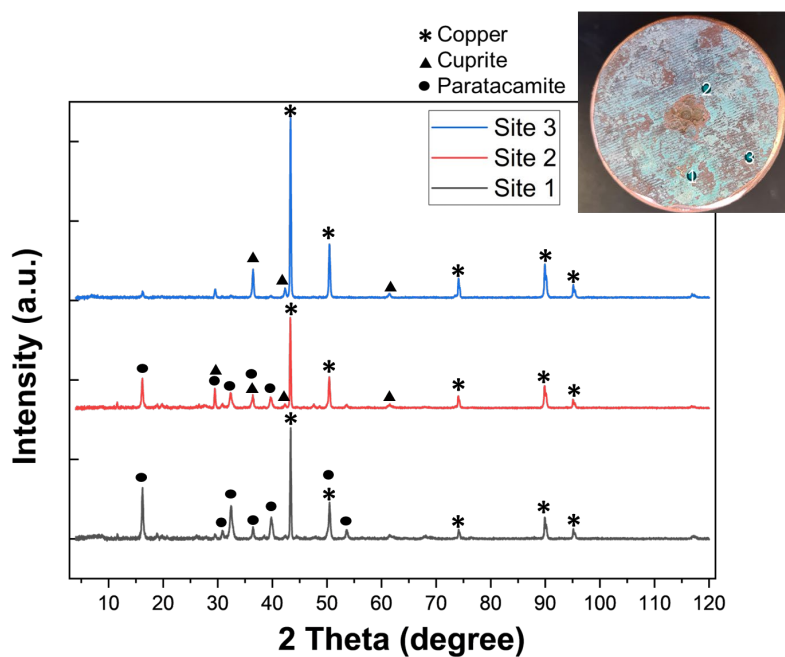
XRD analysis was performed on six exposed sample surfaces in their as-received state to identify corrosion products, as shown in Figures 16 to 21. In addition to metallic Cu, characteristic peaks of cuprite (Cu_2O) were observed on most detected samples. This is consistent with previous findings from field test (Wendel et al. 2022). Moreover, besides Cu and Cu_2O , gypsum ($\text{Ca}(\text{SO}_4) \cdot 2\text{H}_2\text{O}$) was identified on the white area of sample #1 (Krejsová 2024), and paratacamite ($\text{Cu}_2(\text{OH})_3\text{Cl}$) on the green area of sample #4. Gypsum was mentioned to be one of the bentonite accessory minerals (Johanson et al. 2020).

Figure 17. XRD diffractograms obtained from the surface of sample #4. Inserted image shows the measurement locations.

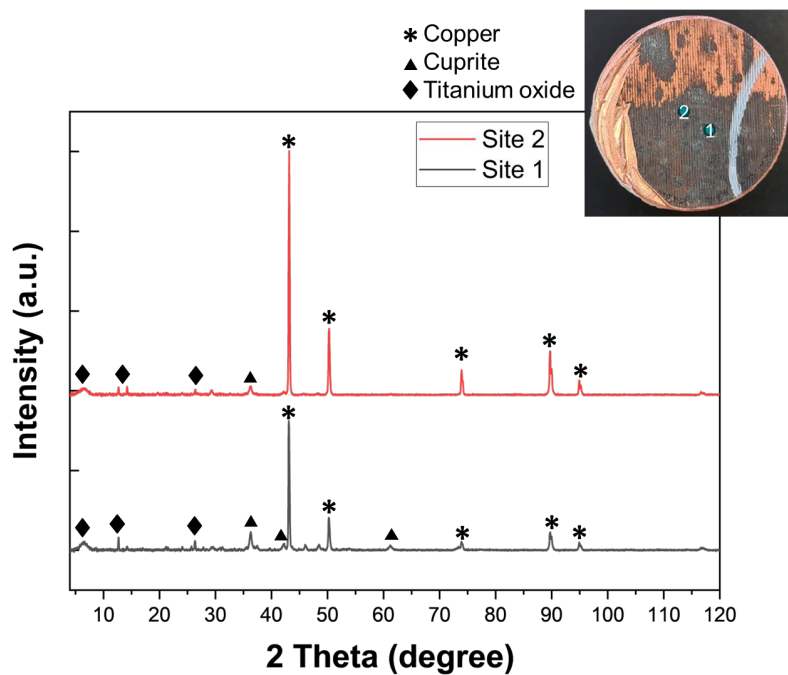
There is also an indication of TiO_2 on sample #6 which was attributed to the white marker as confirmed by an SKB engineer. However, there was no substances other than Cu found by XRD from the surface of sample #8.

Figure 18. XRD diffractograms obtained from the surface of sample #6. Inserted image shows the measurement locations.

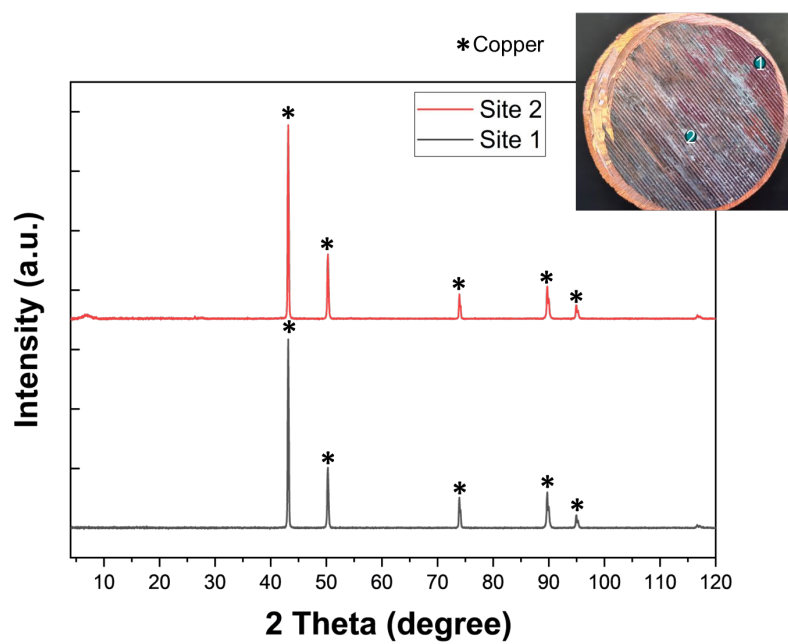
Figure 19. XRD diffractograms obtained from the surface of sample #8. Inserted image shows the measurement locations.

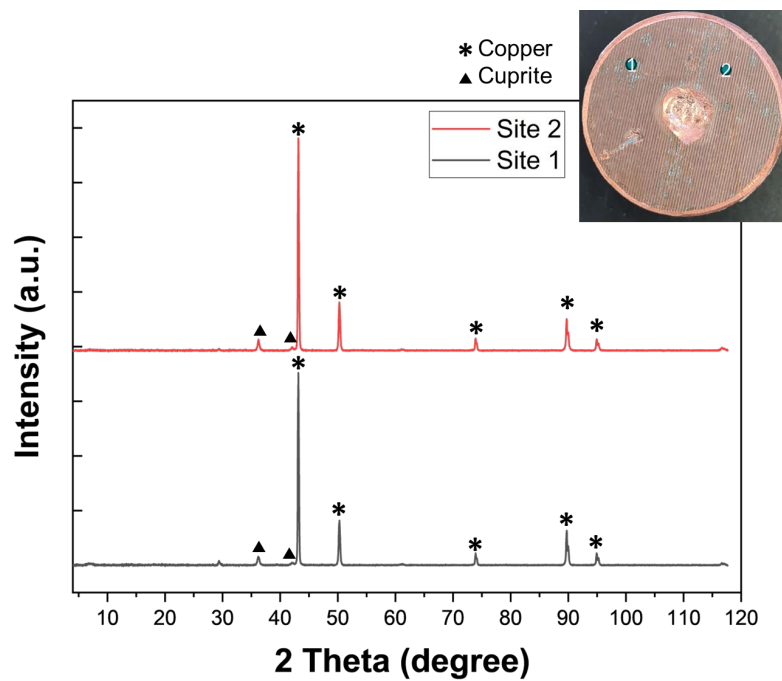
Figure 20. XRD diffractograms obtained from the surface of sample #9. Inserted image shows the measurement locations.

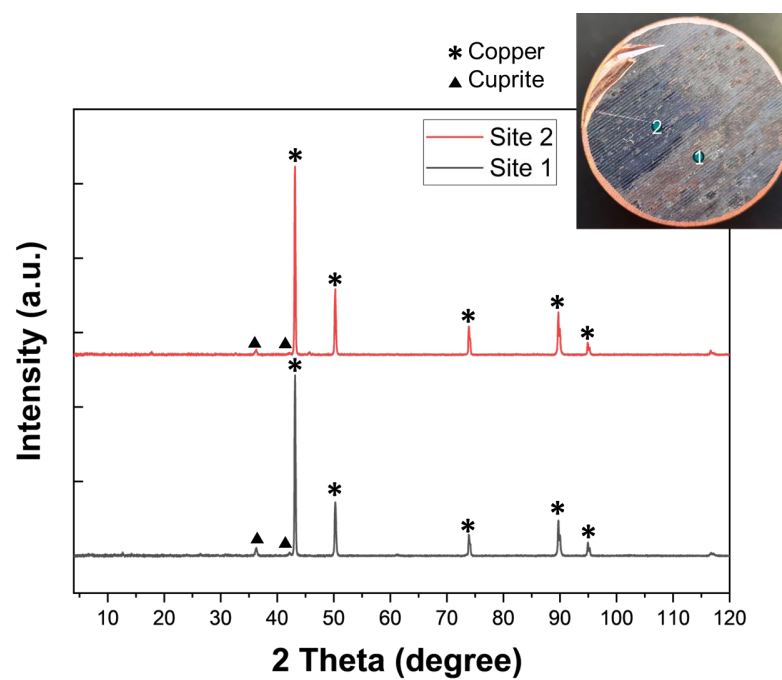
Figure 21. XRD diffractograms obtained from the surface of sample #10. Inserted image shows the measurement locations.

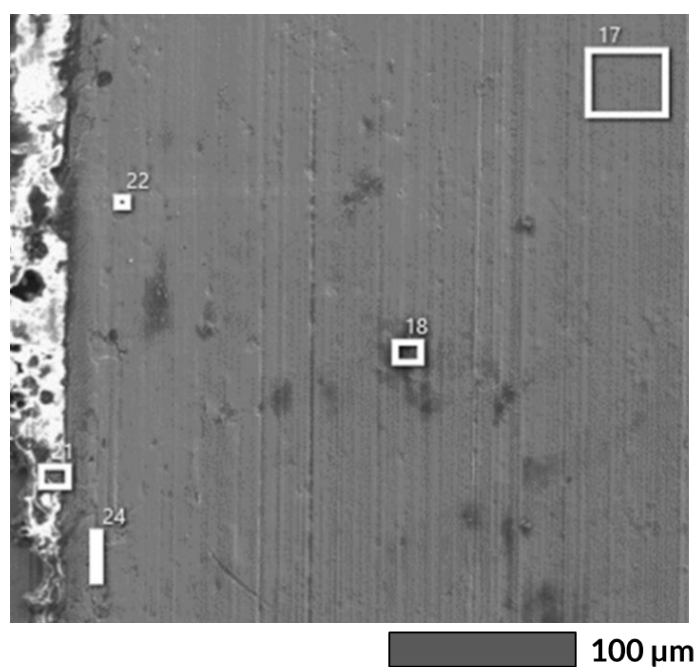
Figure A-1. SEM image (up) and associated EDS analysis results (down) from sample #10 at site 2.

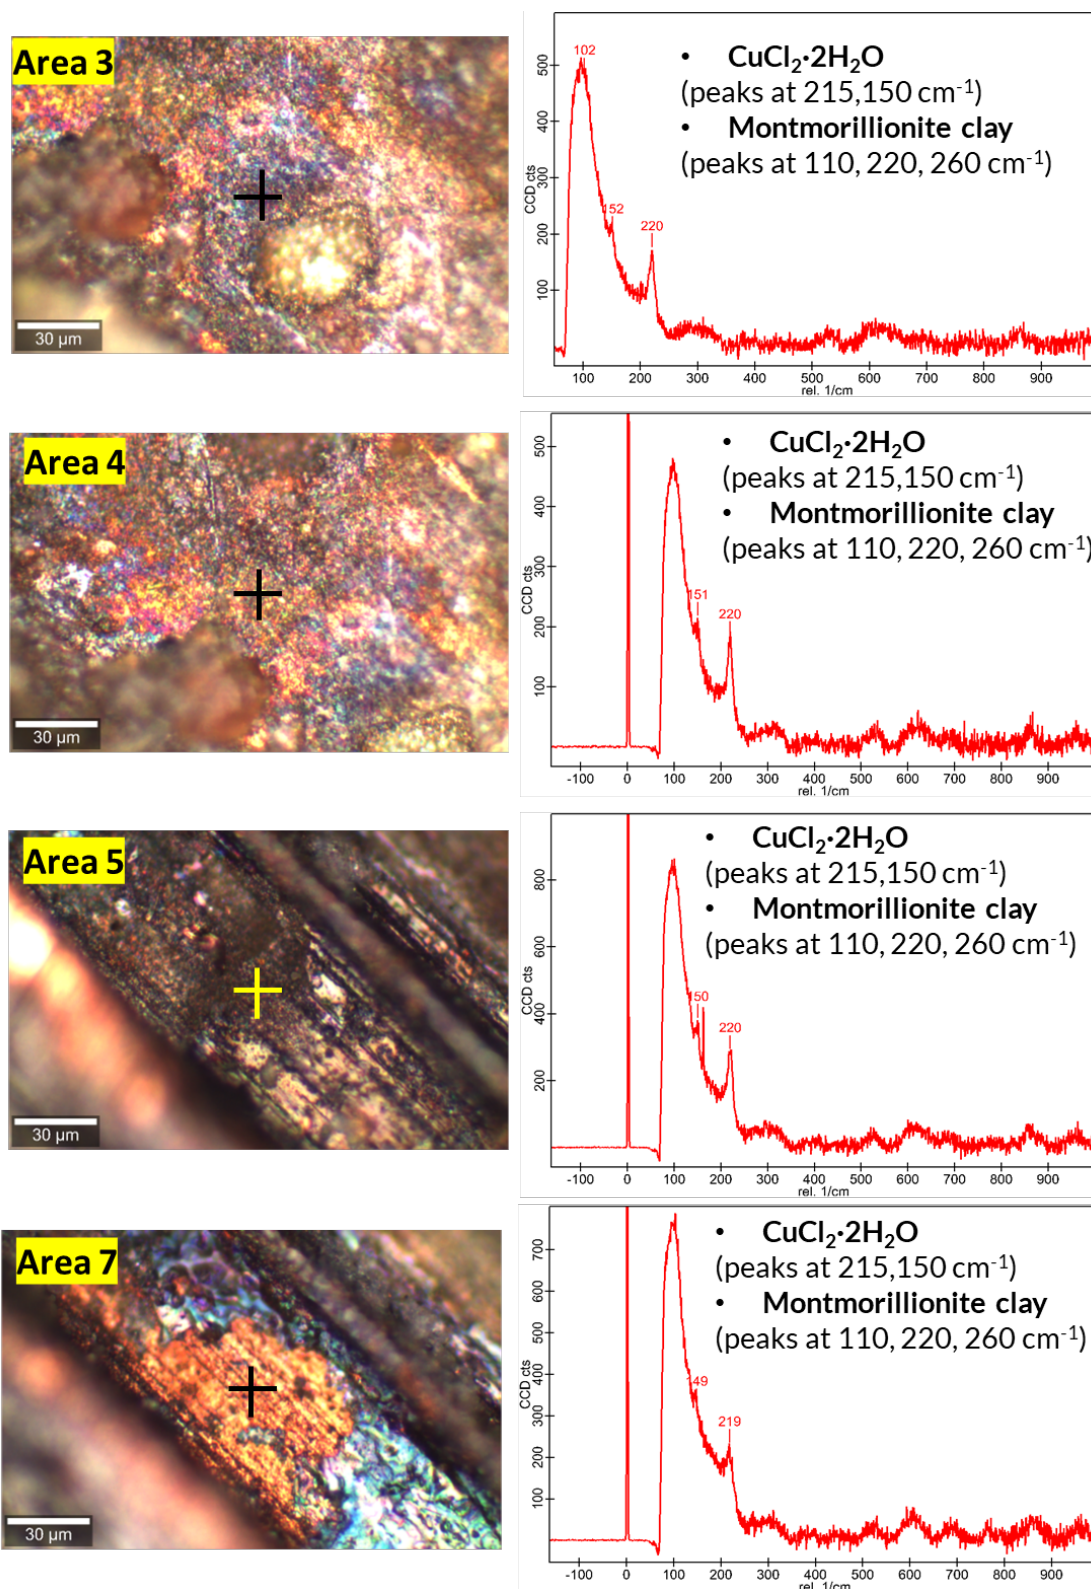
Eight different sites from the surface of sample #10 were analysed. Raman spectra of four representative different areas, along with the identified compounds are shown in Figure 29. The remaining area results can be found in Appendix B (Figure B-1). Most areas showed the presence of dehydrated copper chloride ($\text{CuCl}_2 \cdot 2\text{H}_2\text{O}$) (Medeiros et al. 2018) and montmorillonite clay (one of the bentonite constituents) characteristic Raman bands. The spectrum range beyond 1000 cm^{-1} (where further Raman bands of $\text{CuCl}_2 \cdot 2\text{H}_2\text{O}$ exist) was not explored due to the purpose of this characterization (detection of sulfur-based corrosion products). In two other areas (6 and 8), with greenish appearance, the surfaces were detected with copper oxides (CuO , Cu_2O) and with dehydrated copper compound (Guha 1991, Debbichi 2012). Thus, Raman results confirmed previous XRD and FTIR findings.

Figure B-1. μ -Raman spectra on four different areas of the sample #10, and corresponding spectra and identified compounds (analysis location indicated by cross mark).

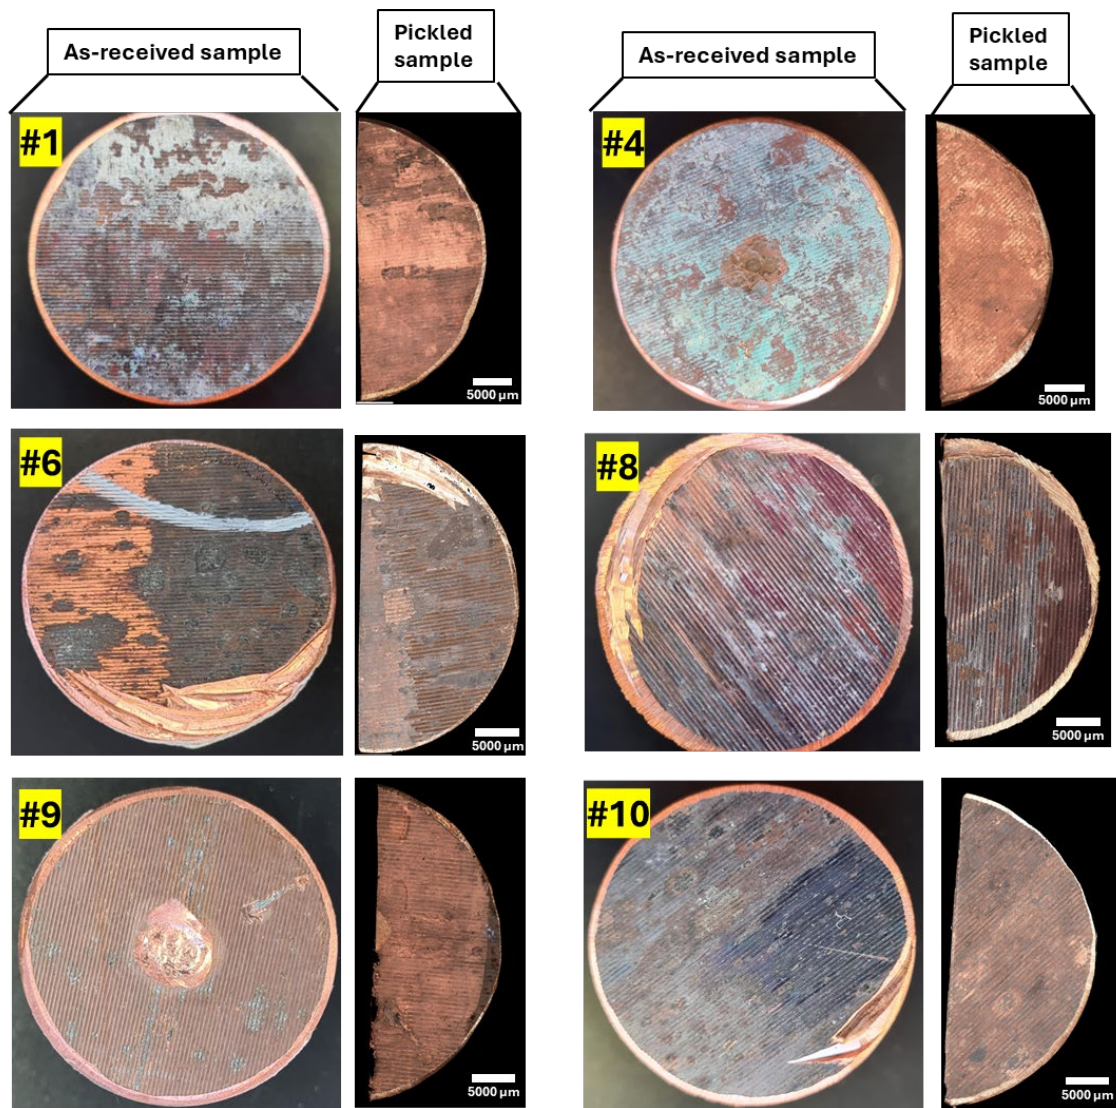
The surface topography before and after chemical pickling is shown in Figure F-1 (Appendix F). The surface topography of the samples was examined using optical profilometer both before and after the removal of corrosion products by pickling, as shown in Figures 34. Mechanically damaged zones are excluded when applicable. Surface profile measurements showed clearly that the surface striations are attributed to the machining of the canister. Their measured height is equal to 10 μm and is relatively sharp, see the line profiles of each sample in the Appendix F, Figure F-2. The height of striations determined by the optical profilometer on non-pickled samples was found between 12 and 17 μm in previous characterization (Taxén et al. 2012). Through these line profiles, corresponding to the topographic analysis before pickling, it can be found that the maximum surface product height reaches 50 μm . This height includes the contribution of existing surface products such as bentonite, gypsum, and corrosion oxide products.

Figure F-1. Images of exposed samples before (left) and after (right) removal of corrosion products.
