## TR-12-09

### Analysis of SKB MiniCan Experiment 3

Nick Smart, Andy Rance, Bharti Reddy, Paul Fennell, AMEC

November 2012

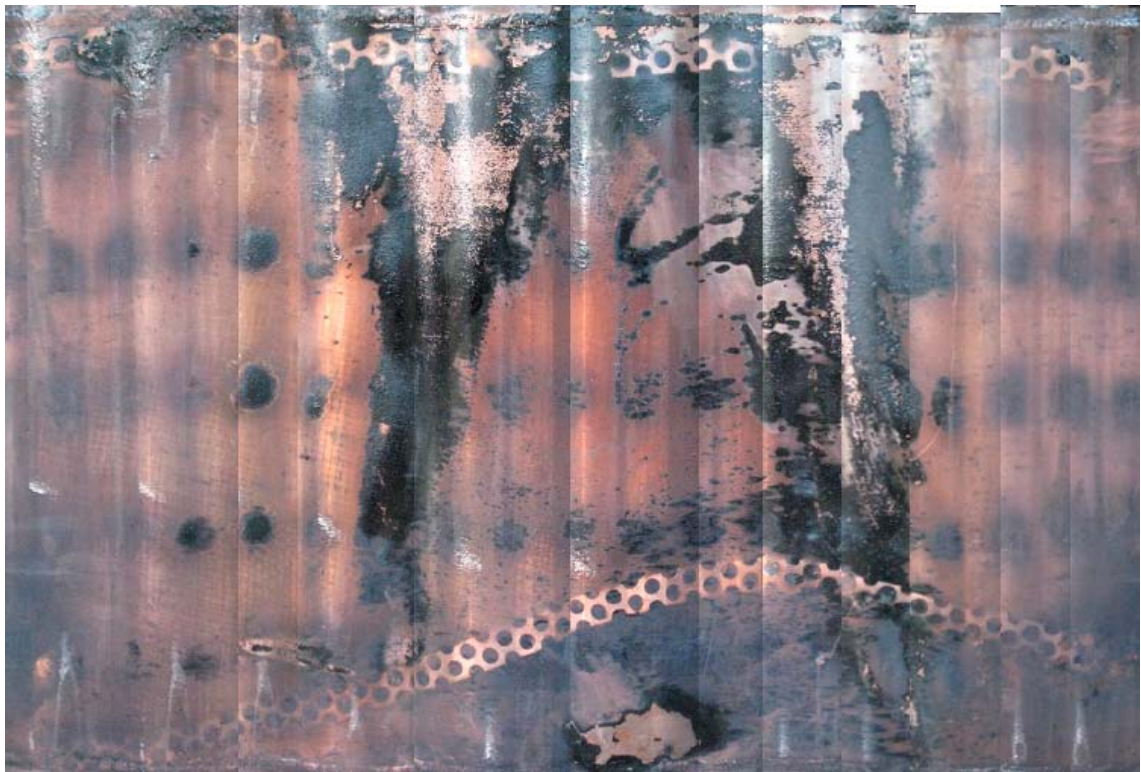
The copper MiniCan was then removed from the support cage using the overhead crane, as shown in Figure 6-10 and close up photographs of the surface of the copper canister at various locations are shown in Figure 6-11 to 6-14. It can be seen that there was significant, non-uniform blackening of the surface of the canister and that the blackening was concentrated on areas facing the holes in the inner cylinder of the support cage (see Figure 6-4). Other notable features of the appearance of the canister were as follows:

- The top 1 mm defect which was located near to the top weld appeared to have a black volcano-shaped extruberance emerging from it. The thickest layer of black deposit on the canister surface was around the hole, suggesting that it was due to material that had extruded out of the defect.

- There were areas with a green tinge around the black areas on the surface of the copper canister.
- There was a clear 'chain-like' pattern on the surface, which corresponded with the plastic insulator that was placed around the copper canister to prevent electrical contact between the copper canister and the support cage. This would suggest that the insulator material had screened the surface for material deposited from the groundwater, or that it had prevented access of the substances that caused development of the black layer.

*Figure 6-14. Panoramic photo-montage of surface of copper canister on removal from support cage.*

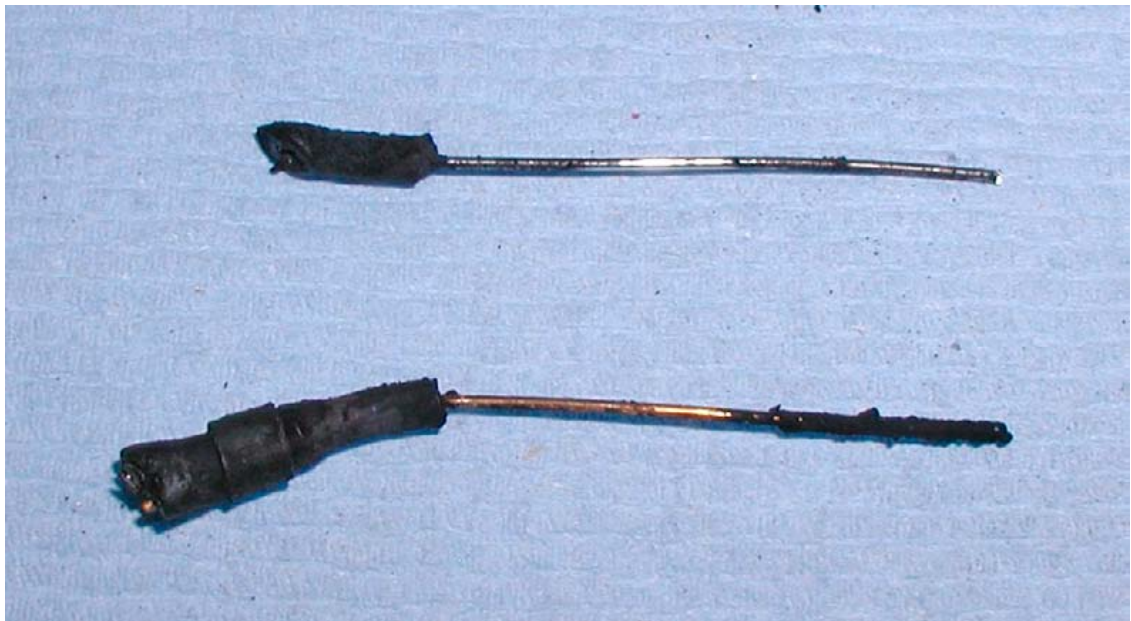
The appearance of the platinum and gold wires following removal from Experiment 3 is shown in Figure 7-18. A mass of black deposit had formed at the tip of the electrodes. The deposit on the gold wire was analysed by Raman spectroscopy (Figure 7-19) and the dark areas were found to contain a sulphide species, with indications of graphitic carbon on the clean areas.

*Figure 7-18. Platinum (top) and gold (bottom) electrodes removed from MiniCan Experiment 3. The insulating sheathing is still present at the left hand end of the wires.*

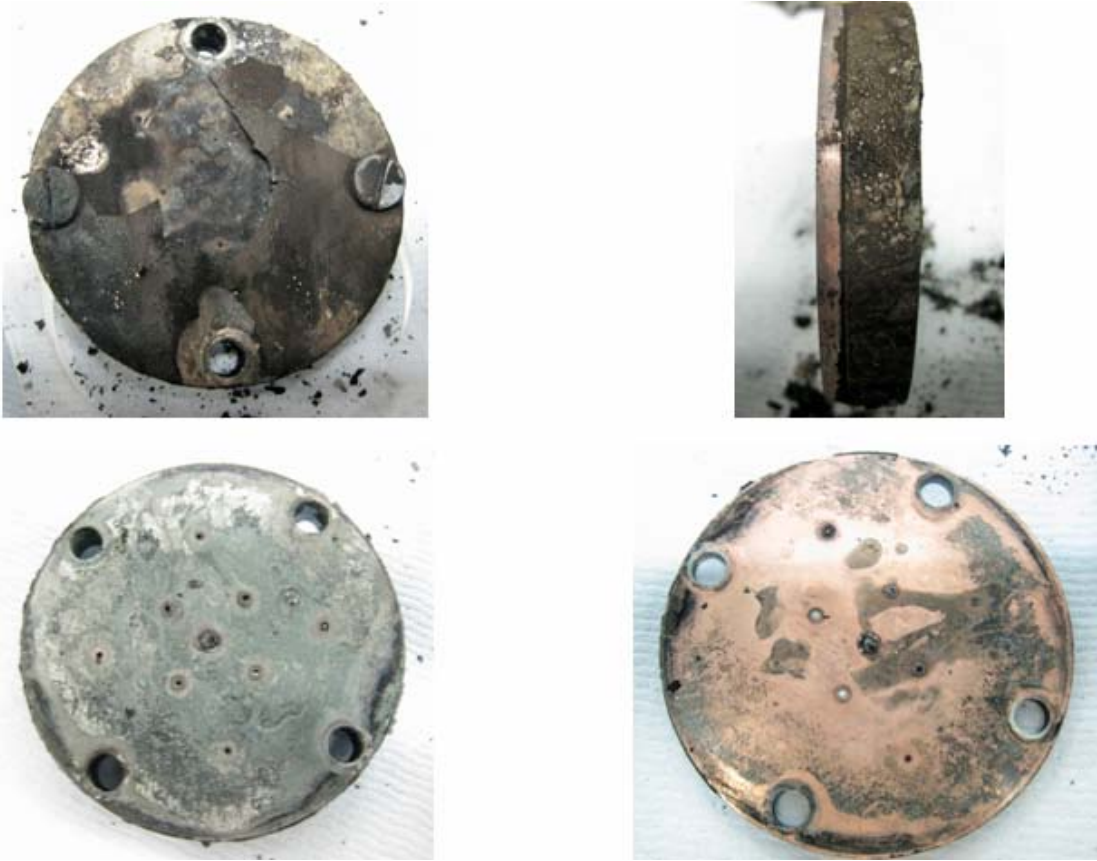
The condition of the sandwich specimen can be seen in Figure 6-9, 7-20 and 7-21. No expansion of the sandwich specimen was observed, as shown by Figure 7-22. The inner surfaces were relatively clean and uncorroded, whereas the outer cast iron surface had a thick black flaky layer of material. The dimensional measurements indicate that the layer was approximately 1 mm thick. Raman analysis was performed by encasing the samples in custom-built Perspex specimen holders fitted with optical glass windows (see Appendix 1 for details) and the results of the Raman analysis are shown in Figure 7-23 and 7-24, for the iron surfaces (outer and inner surfaces respectively), and Figure 7-25 and 7-26, for the copper surfaces (outer and inner surfaces respectively). The main features of the analysis of the sandwich specimen are as follows:

**Figure 7-21.** Appearance of sandwich specimen when removed from MiniCan Experiment 3. The lower two photographs show the interior surfaces of the specimen.

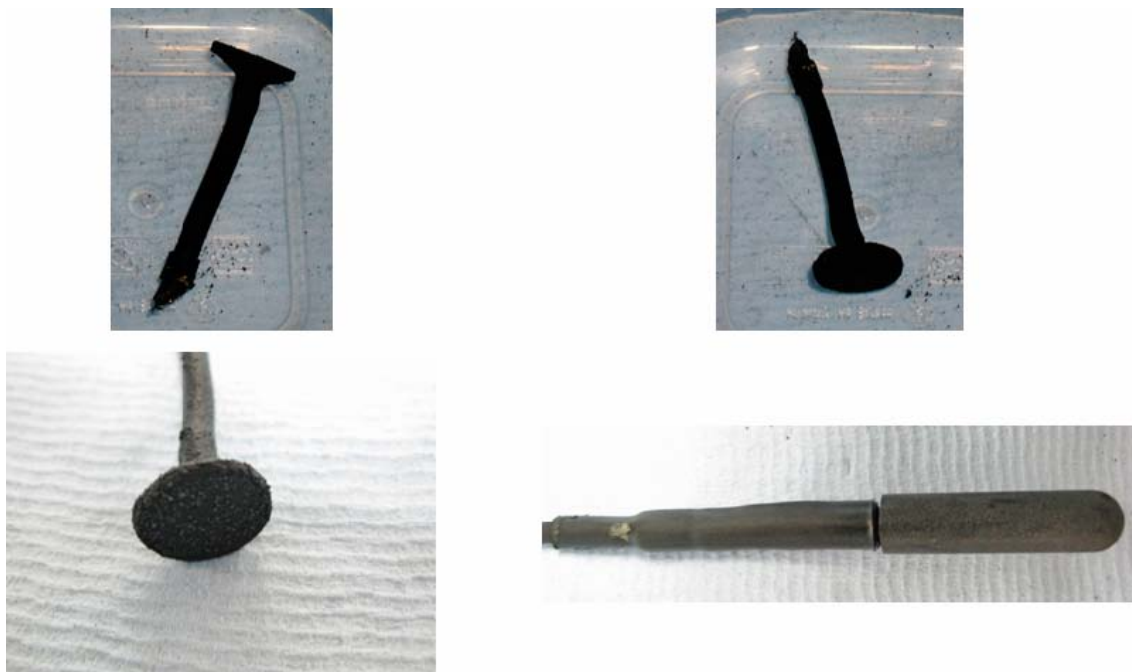
The silver-silver chloride disc electrodes had become covered in a layer of black deposit as shown in Figure 7-27. SEM/EDX analysis of the material on the reference electrodes (Appendix 2) showed the black material on the surface was predominantly composed of iron, sulphur, carbon and oxygen with small amounts of calcium, silicon, magnesium, sodium and aluminium. It is noteworthy that no silver was detected, indicating that the whole surface had become sealed with a layer of deposit. This explains why the electrodes no longer functioned as reference electrodes (Smart et al. 2012). It is also possible that some of the deposit is of organic origin (e.g. microbial material).

**Figure 7-27.** Appearance of silver-silver chloride electrodes and metal oxide  $E_h$  probe (bottom right hand corner) after removal from MiniCan Experiment 3. The top two photographs show the disc electrodes submerged in groundwater.

The Silvion reference electrode (not shown), which was mounted in the borehole outside the support cage, was not covered with black deposit and the sintered disc at the tip of the electrode remained relatively clean, apart from a few black spots. The  $E_h$  probe, which was also mounted outside the support cage, showed no signs of degradation (Figure 7-27). Both electrodes functioned satisfactorily during the test period.

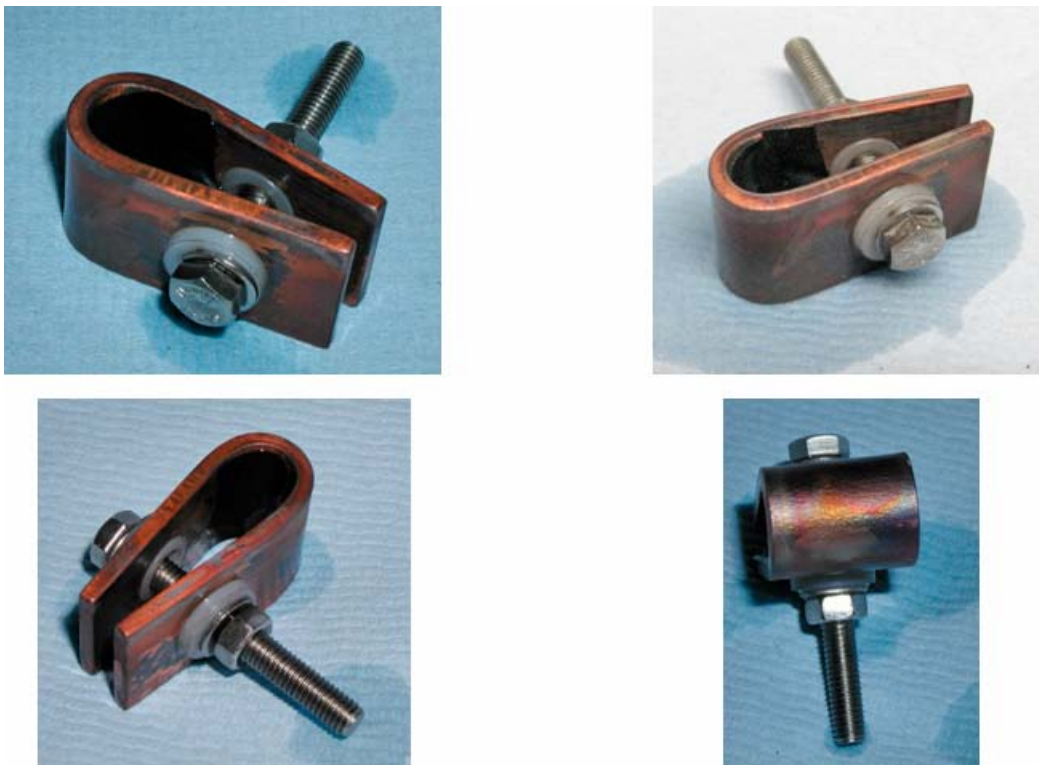
*Figure 7-34. Photographs of U-bend SCC specimens from near the support cage removed from borehole Experiment 3.*

Two copper U-bend specimens were removed from Experiment 3; one was suspended on the pull rod attached to the support cage near the support cage and the other was suspended on the pull rod near the flange on the borehole. Photographs of both specimens are shown in Figure 7-34 and 7-35. Both specimens had a dark appearance due to the formation of a surface film. The black tape on the specimens was present when they were inserted into the borehole; the tape was placed on the surface when the specimens were manufactured and it was mistakenly left in place. The surface film was analysed using X-ray Photoelectron Spectroscopy (XPS) and FTIR and the results of this examination are shown in Figure 7-36 and 7-37. The analysed sample was cut from the unstressed section of the specimen (i.e. a flat section). The XPS analysis shows that the main components of the top layer of the film (a few nm or atomic layers sampling depth) were copper, carbon and oxygen, with a trace of sulphur. The composition from the XPS analysis was (at%) C 41.8; O 39.7; Cu 14.6; S 3.9. The FTIR analysis (Figure 7-37) showed peaks that can be attributed to hydrocarbons C-H bonds, aromatic C-H bonds, metal-oxygen bonds, water and OH groups. Note that this sample was only exposed to groundwater, rather than water conditioned by bentonite, since it was mounted in the borehole water rather than inside the support cage. No indications of stress corrosion cracking were observed in the U-bend specimens using optical microscopy, although further metallurgical analysis is planned to confirm this.

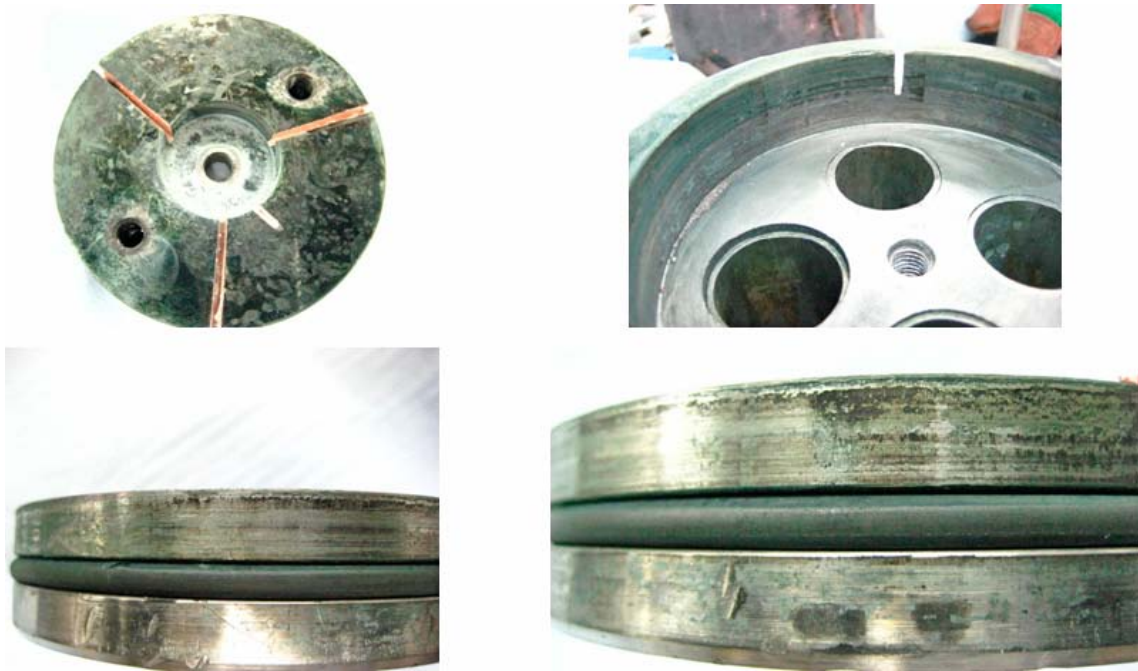
*Figure 7-43. Lid of cast iron insert removed from Experiment 3 in an anoxic glovebox.*

The lid region of the cast iron insert was carefully dismantled and examined for any signs of crevice corrosion around the gasket material. The appearance of these components is shown in Figure 7-43. No corrosion was observed below the level of the O-ring seal, whereas tarnishing of the iron surface was visible above the level of the O-ring and on the top surface of the lid. The simulated fuel channels inside the cast iron insert were dry and uncorroded (Figure 7-43).
