P-08-21

Oskarshamn site investigation

Core drilling of short borehole KLX14A

Henrik Ask, H Ask Geokonsult AB

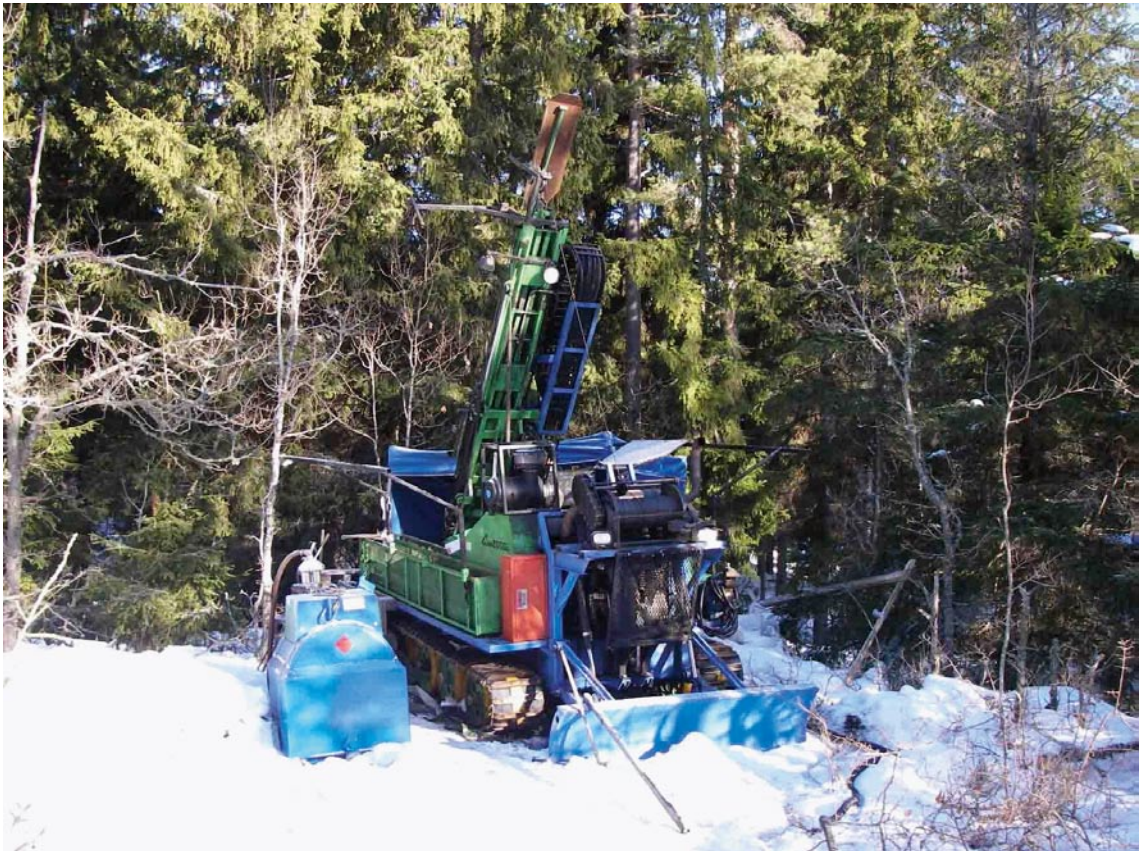
Figure 3-1. The Geomachines GM200 drill rig.

Drilling of borehole KLX14A was made with a trackmounted, self-propelled Geomachines GM200 drilling machine supplied with accessories.

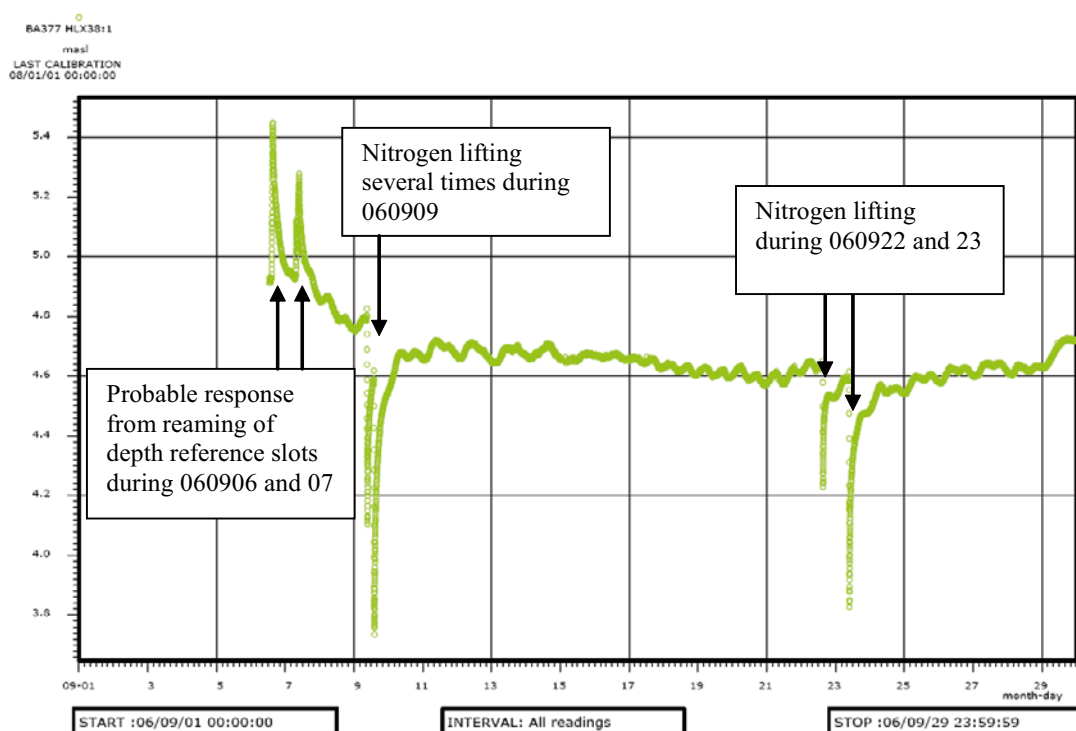
Figure 5-2. Groundwater level in borehole HLX38 during nitrogen gas lifting in borehole KLX14A, 2006-09-01 to 2006-09-29. Clear hydraulic responses from nitrogen gas lifting in KLX14A can be seen as drawdowns in HLX38 on September 9, 22 and 23. The temporary increase in water level on September 6 and 7 are here interpreted as hydraulic responses from reaming of reference slots in KLX14A. The times are given in Swedish Normal Time GMT+1.

A distinct response from nitrogen lifting and probably also from reaming of reference slots in KLX14A could be seen in HLX38, see Figure 5-2. The groundwater level in borehole HLX38 is affected by nitrogen gas lifting in borehole KLX14A. Clear hydraulic responses from the nitrogen gas lifting in KLX14A can be seen as drawdowns in HLX38 on September 9, 22 and 23. It should be noted that there is also a hydraulic response in HLX38 on the afternoon of September 9, 2006. There is no note of nitrogen lifting or any other activity in KLX14A at this time that would give a drawdown in HLX38. It is nevertheless likely that the drawdown on the afternoon of September 9 is caused by nitrogen lifting in KLX14A.
