IPR-01-41

Äspö Hard Rock Laboratory

TRUE Block Scale project

October 1997 Structural model;
Update using characterisation data
from KA2511A and KI0025F

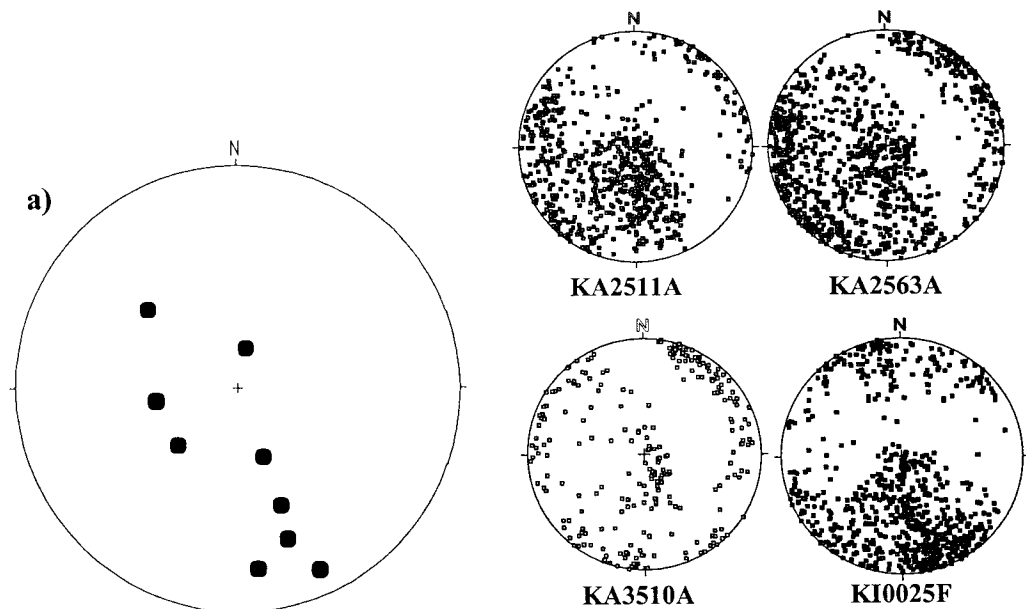
Figure 2-1 a) Fine-grained granite contacts in KA2563A. b) All mapped fractures in boreholes KA2563A, KA3510A, KA2511A and KI0025F. Poles of fracture planes projected on the lower hemisphere.

The lithology of the studied block consists of Äspö Diorite intersected by a number of fine-grained granites and a few greenstone bodies. The abundance of fine-grained granite in relation to the host rock (diorite) is 12% and greenstone 1% which is similar to the general picture in the HRL. As seen in Figure 2-1, the lithological contacts of the fine-grained granites and greenstones are generally gently dipping implying that there is a general sub-horizontal lithology in the central area of the studied block. This pattern is also seen in boreholes KA2598A (north-western HRL) and in KA2162A (central HRL) and indicates that the lateral extent of gently dipping structures may extend beyond the limits of the block scale volume. However, from experience, the Äspö type of fine-grained granite is variable in width and is unlikely to extend as one single body at a 100 m scale. Rather, it is suggested that several bodies may occur roughly in the same plane but with limited individual extent ($\approx 5\text{-}50\text{ m}$?).

Studying the general fracturing of KA3510A, KA2563A, KA2511A one finds that there exists a pronounced sub-horizontal fracture set as well as two steep NW and NNE trending sets. The sub-horizontal fracturing is most pronounced in KA2511A, whereas few sub-horizontal fractures are intersected in KI0025F. The latter influenced by the sub-horizontal inclination of KI0025F. This is a pattern that is well known from

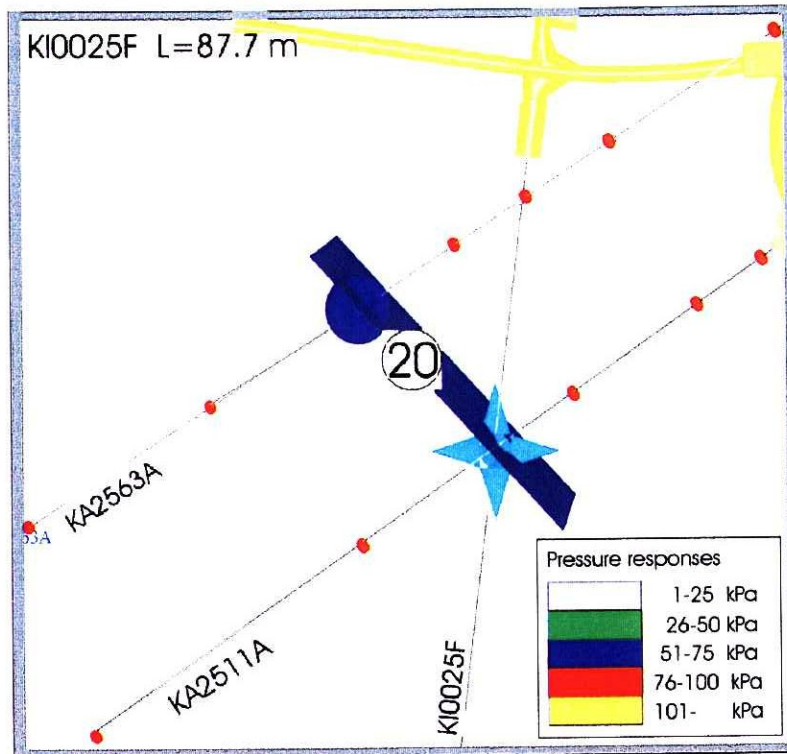
Figure 4-4 Graphical presentation of the deterministic structures likely to be associated to the pressure responses when drilling into $L = 87.7$ m in KI0025F. The response is distinct and singular, (110 kPa) in a 9 m section in KA2563A, implying a single structure only.

l/min for this section and if it is the only conductive structure in the section, its interpreted transmissivity is around $6 \times 10^{-7} \text{ m}^2/\text{s}$. Up till this point this intercept has not been attributed to any known structure. The geological imprint is not considered to be similar for the three intercepts, L=87.5 in KI0025F, L=188.7 in KA2563A and L = 122 m in KA2511A although the intercept in the latter borehole is suggested to be non-conductive. Connectivity exist and may be attributed to either an indirect connectivity through Structure #9 or Structure #6, or direct through Structure 20. Figure 4-4 shows the interpreted orientation of Structure 20, and how it intersects in KA2563A, section P3.

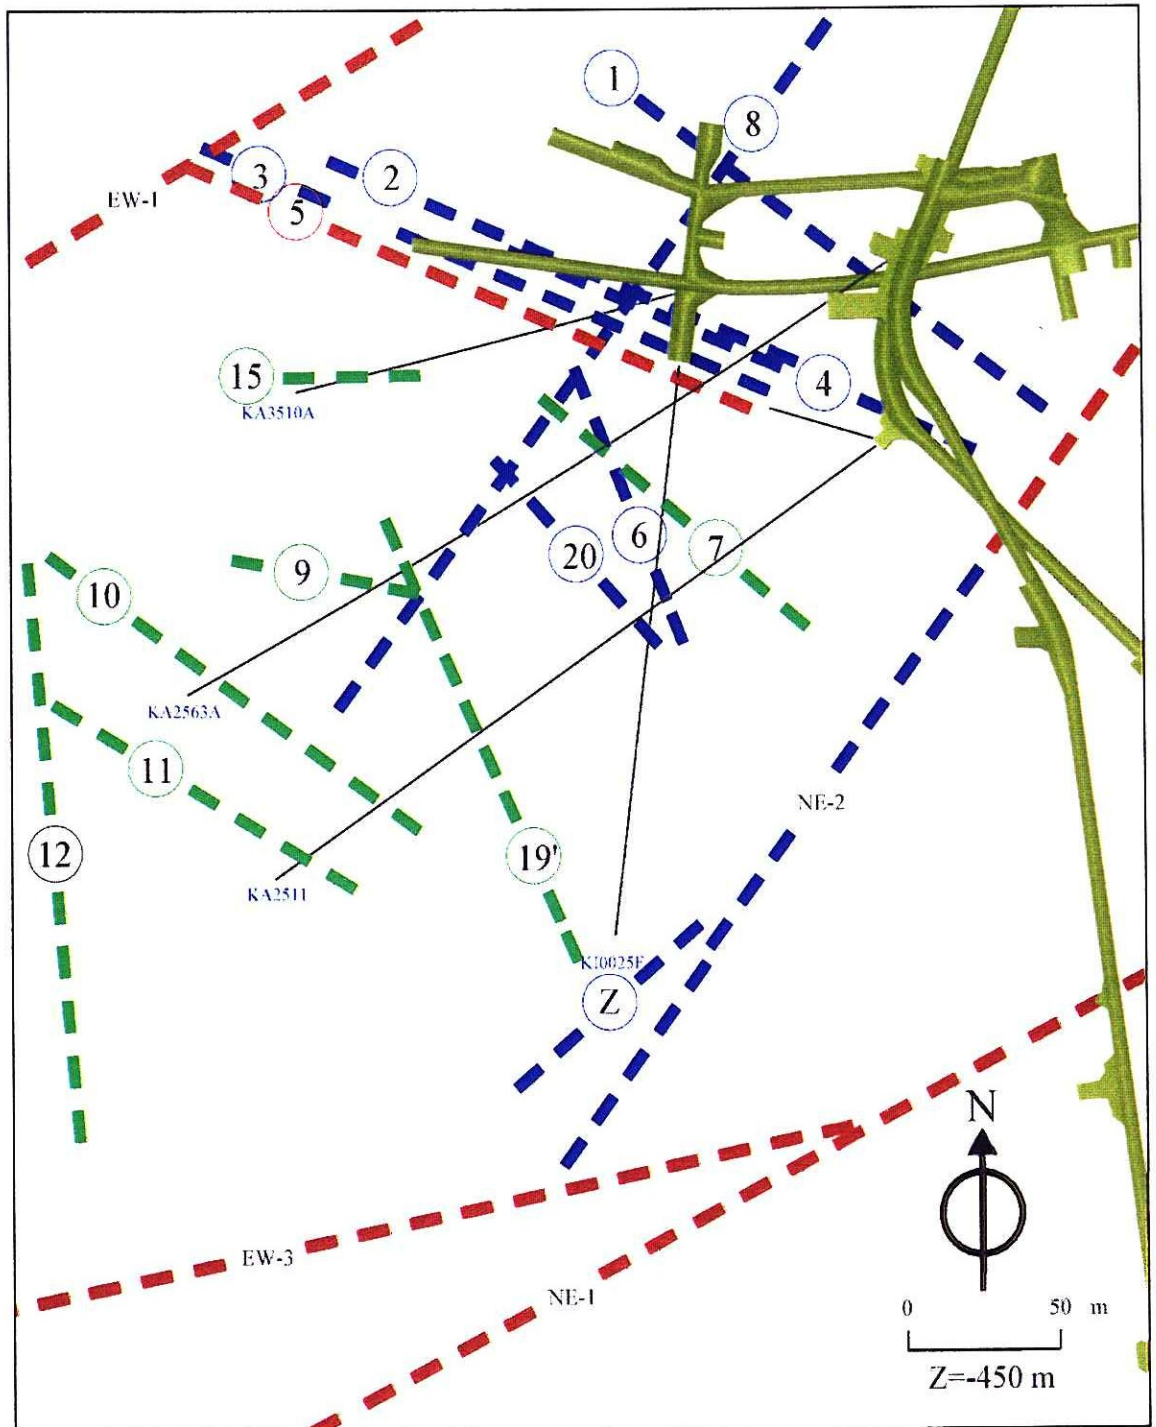
Figure 4-7 Structural model of the TRUE block scale volume. Planar section at Z=-450 m. Different colours represent different degrees of reliability. Red = certain, blue = probable green = possible structures.

The presented geological indications and hydraulic responses for the TRUE Block Scale volume are summarised in Figure 4-7 presented as a planar view with predicted zones and observed structures in tunnel sections and in the drillcores in and around the target volume. Colouring of the structures represent the degree of reliability as presented in Hermanson & Follin (1997).
