**International
Progress Report**

IPR-02-67

Äspö Hard Rock Laboratory

**Geological study on block scale
water-conducting structures
representative in the tunnel**

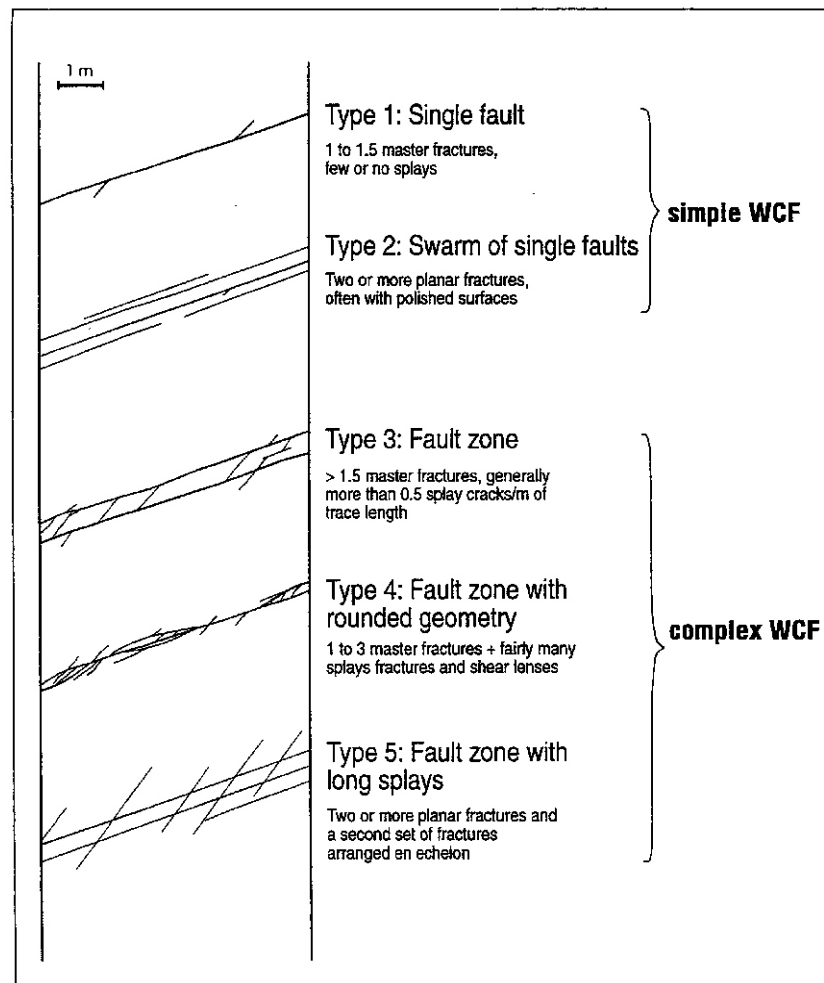
Figure 1-4: Classification of water-conducting features in the FCC-project (after Mazurek, et al., 1996).

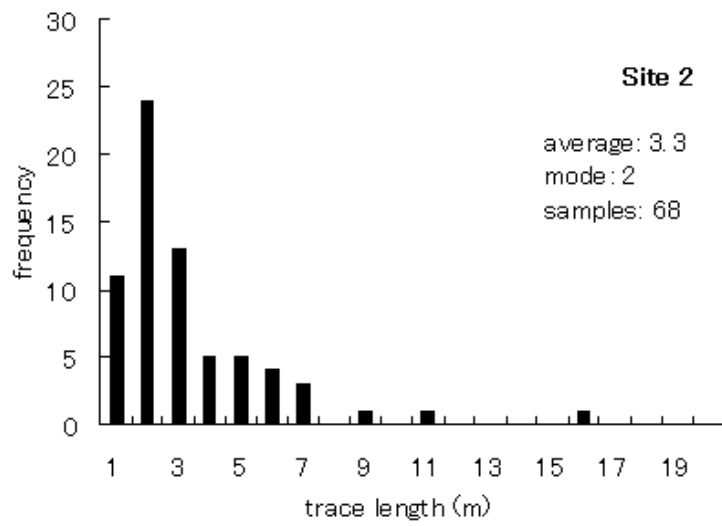
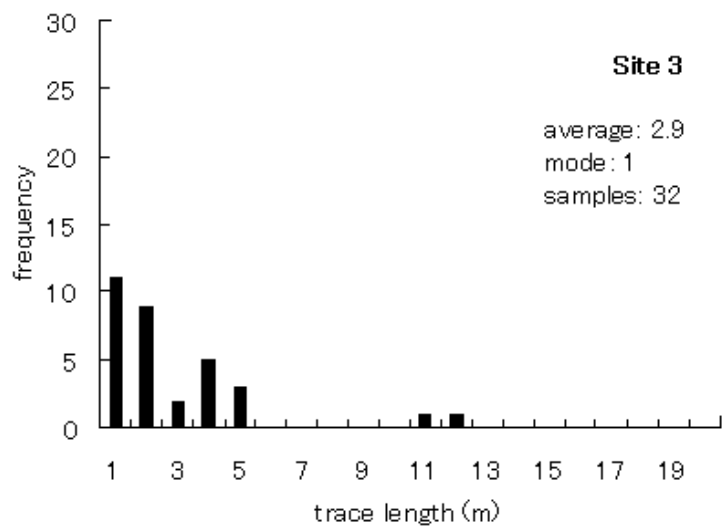
Figure 3-2. Histogram of trace length of structures on the ceiling

Average and mode trace length of all structures on the ceiling are 3.7 m and 2 m respectively (Figure 3-2).

Average and mode trace length of all structures on the ceiling are 2.9 m and 1 m respectively (Figure 3-2). It is noted that shape of histogram is different from those of the other sites.

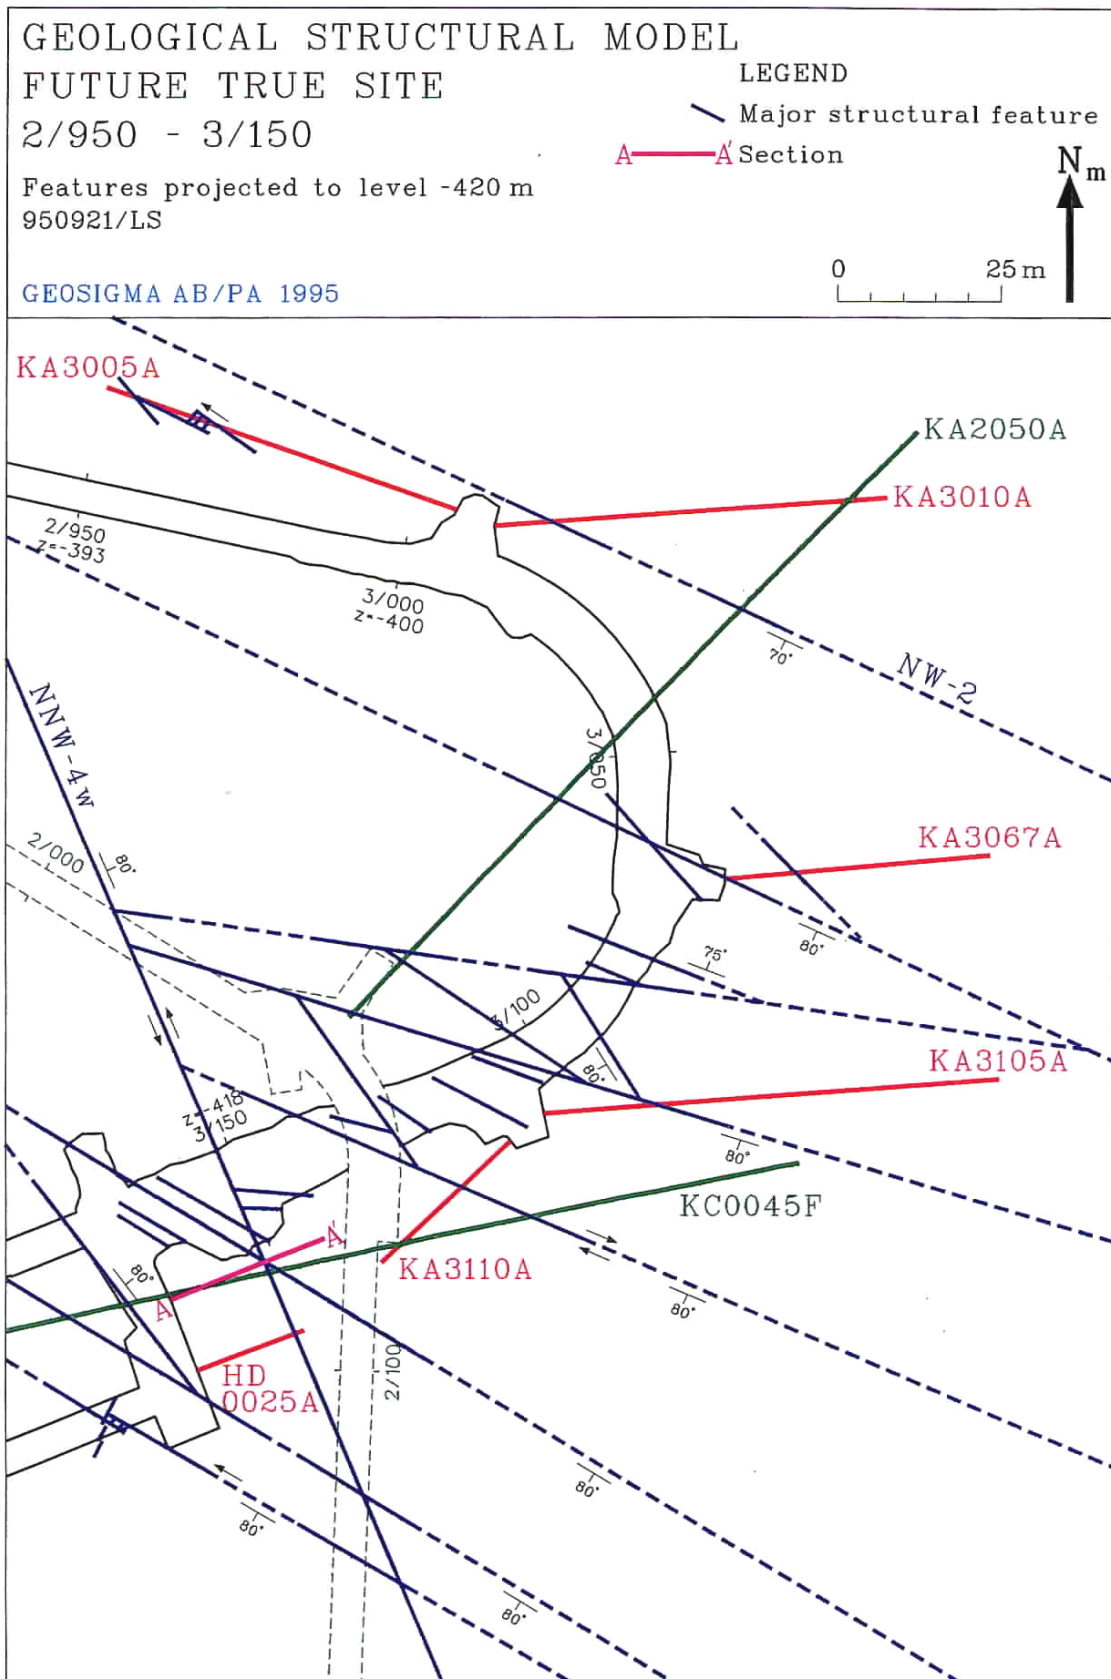
Figure 3-6. Structural setting at one of the site in the SELECT project
 (Winberg, et.al., 1996)

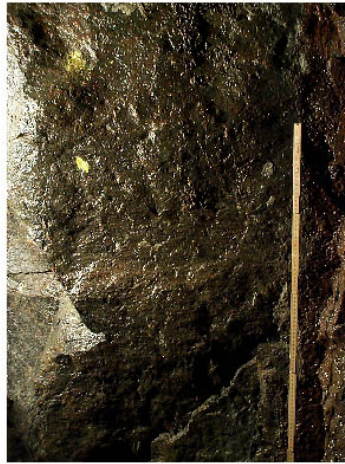
Photo 4: Structure1558m at 1566A (Site 1)
 Looking normal to the same fault plane. Steps and subhorizontal striations indicating dextral strike-slip. Width of photo ca.90cm.

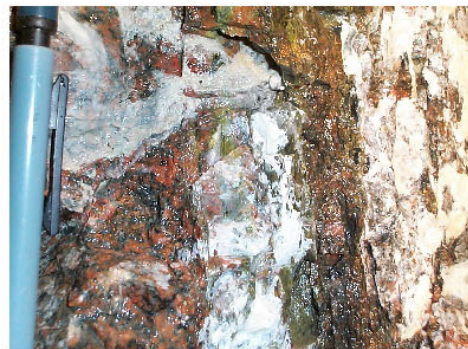
Photo 7: Structure2198m at 2198B (Site 3)
 The structure comprises of several fault planes lying in a thin zone of moderate mylonite (centre) between weak mylonite (right) and undeformed diorite (left). White material is re-precipitated grout. Width of photo ca.15cm.

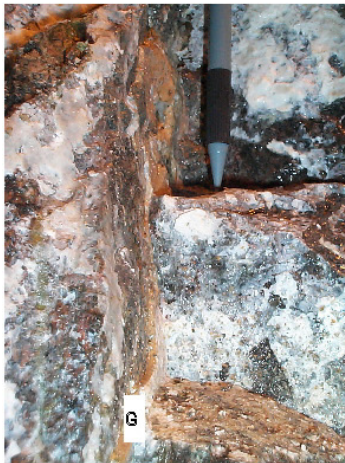
Photo 8: Structure 2198m at Niche 2198A (Site 3)
Grout (G; light orange colour) injected into the master fault No. 1 with maximum thickness of 8mm. White material is re-precipitated grout. Width of photo ca. 15 cm.

It was impossible to make detailed observation of the flow path indicated by the grout at sidewall 2198B because the leached and re-precipitated grout covers the surface of structure (Photo 8 and 9).

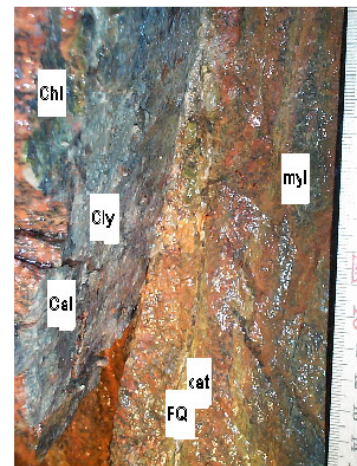
Photo 10: Close-up of fault No. 27 (Site 3)
Fault plane (left) coated by chlorite (Chl), calcite (Cal) clay/gouge (Cly). Mylonite (myl), cataclasite (cat) and fluorite-quartz vein (FQ) on the wall (right). Width of photo ca. 10 cm.

Filling/coating minerals differ within the master faults on the sidewall and niche wall. Epidote, chlorite, calcite, clay (gouge) and grout are common filling minerals/material outside to inside in this order (Photo 10). Epidote is sometimes missing or postdates chlorite. Two thin veins along the fault No. 27, a vein of fluorite with local quartz and a

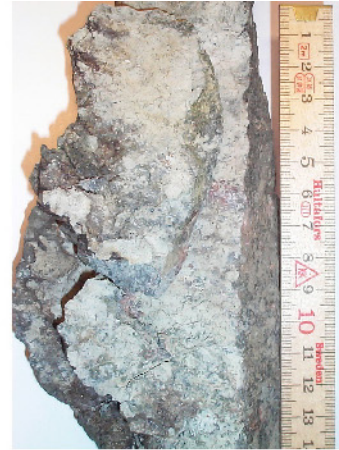
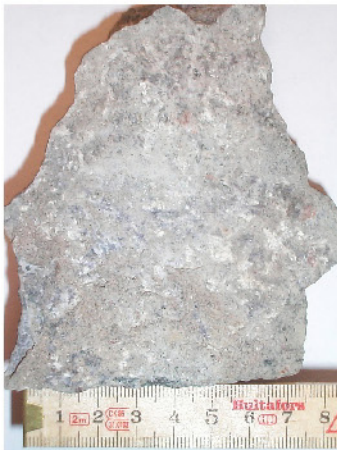
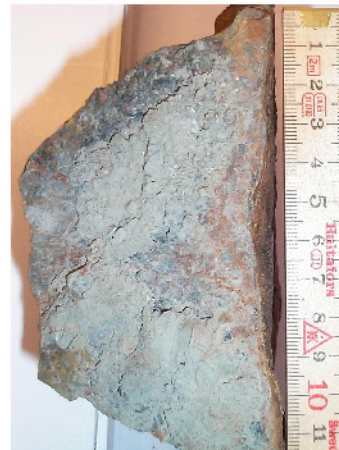
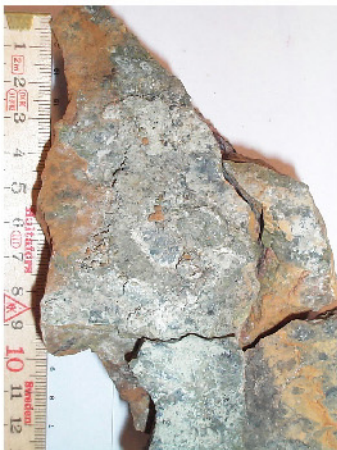
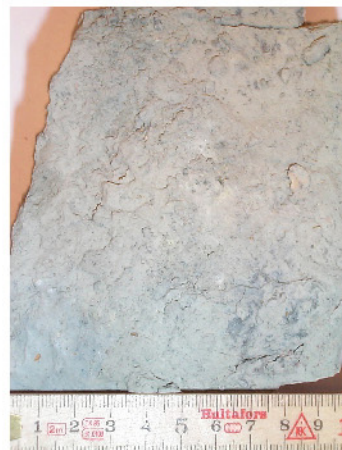
Photo 13: Oriented samples of fault plane for microscopy and XRD
 See Figure 4-1 for explanation of orientation.

Oriented rock samples were collected from sidewalls and niche wall of the six mapped structures (Figure 4-1, Photo 13). The samples contain half side of the structure, i.e. wall rock and fault plane with fault gouge and filling/coating materials. The samples are collected carefully with the least use of hammer to minimize damage. Orientations of the ceiling and north were marked on the samples. The sampling points are indicated on the sidewall/niche maps (Maps 2, 4 and 6 in Appendix 2).

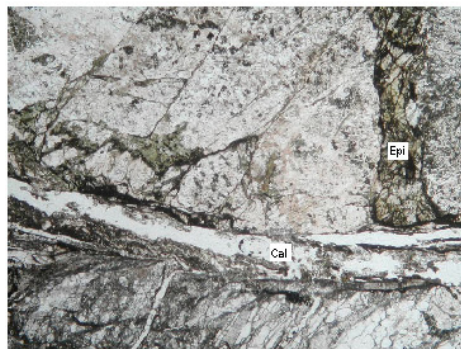
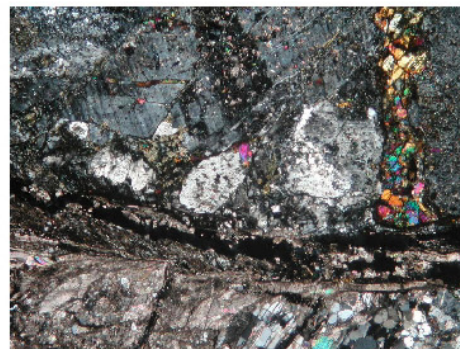
Photo 16: 1561B (width of photo ca. 5mm)
The older calcite-filled parallel micro fractures (Cal-1) in the epidote-cataclasite matrix are cut by the younger calcite-filled veins (Cal-2). These are then cut by the fault gouge (g).

This thin section is divided into two domains. The half consists of cataclasite facing the main fault plane, and another half, bounded by a smaller fault, comprise fractured and altered wall rock. No significant ductile texture is observed. Five brittle deformation events are presumed (Photo 16). 1) The first is formation of cataclasite or fault gouge, details of which is not obvious due to the subsequent epidote alteration. 2) In this epidote cataclasite, parallel micro fractures filled with calcite is observed that imply a sinistral displacement relative to the fault planes. 3) The set is cut by a calcite filled fracture that implies the opposite sense. 4) The above fractures are cut by the main and smaller fault. The fault planes are coated with drusy calcite (Photo 17), locally fluorite and probably thin chlorite. 5) Fault gouges are formed along the main and smaller fault planes. It contains fragments of sub-angular calcite, and minor K feldspar and quartz grains within the matrix of very fine clay minerals. An open fracture that is locally filled with the gouge implies the sinistral strike-slip displacement of the faults. Drusy calcite grows on the open fractures within and parallel to the fault gouges. In addition to the chloritisation and saussuritisation, red stains of very fine hematite spread in the feldspar grains and grain boundaries within the wall rock.

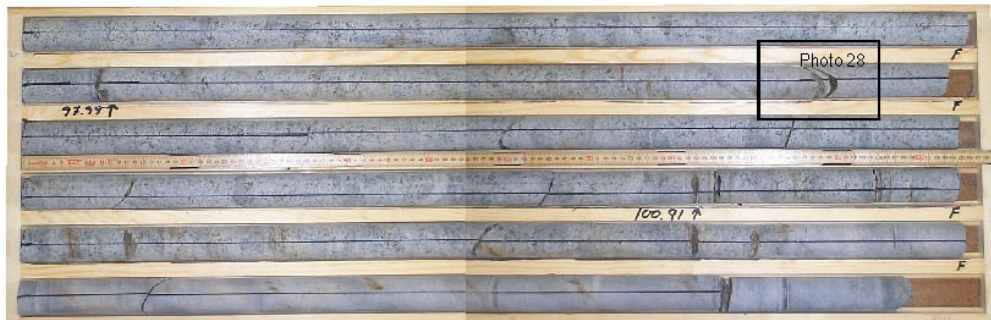
Photo 24: Section 1 whole view
Length of box = 120cm.

Section 1 (Photo 24)

There is a zone of higher fracture density between 85.2 and 86.1m where the intersection of the structure 2154 m is estimated nearby. There are 14 fractures in this zone and many of which have similar orientations (Photos 25). 5 fractures are open where fracture planes do not fit or partly fit, and may cause the inflow (Photos 26). No ductile deformation or fault rock but a 40 cm of red alteration with epidotic network veins exists. It is impossible to determine that this zone is the extension of structure 2154 m because characteristics of fractures in this zone are not identical with the structure. It is noted that the lithology is dominantly Småland granite that has more tendency to exhibit parallel fractures than Äspö diorite.

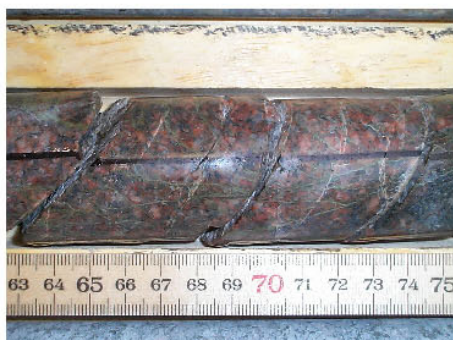
Photo 25: Section 1 No.9, No.10 and No.11
Parallel open fractures and random network veins of epidote.

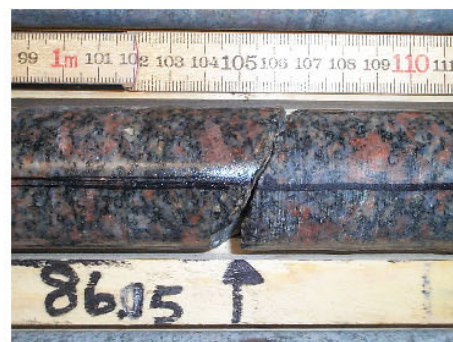
Photo 26: Section 1 No. 16
An open fracture with clay coating, no visible alteration and ductile deformation.

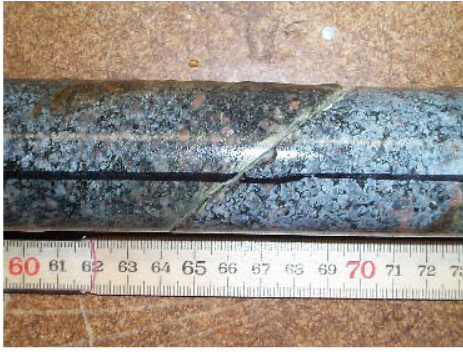
Photo 27: Section 1 No.32
A slightly open fracture along epidote vein with calcite coating.

There is a tight or slightly open fracture, No. 32, with epidote vein and thin calcite coating at 95.6 m where inflow was reported at 95 m (Photo 27). This fracture is estimated to strike NE given the orientation of No. 34 and 35 are identical with the structure 2163 m. Also there is no water-conducting structure between 2154 m and 2163 m in the tunnel.

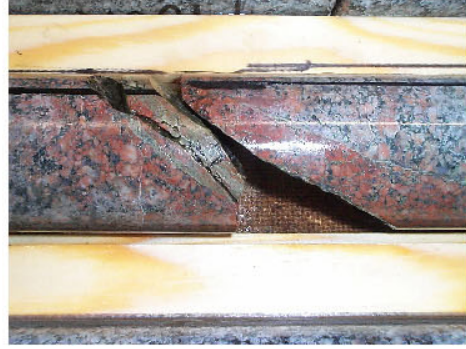
Photo 28: Section 1 No.34 and No.35
Open fractures along epidote-cataclasite with red alteration halo.

An identical structure with 2163 m was observed at 98.9 m, where open fractures No. 34 and 35 in re-activated cataclasite with similar red alteration halo and fracture mineralogy (Photo 28). However, no inflow was reported during drilling.

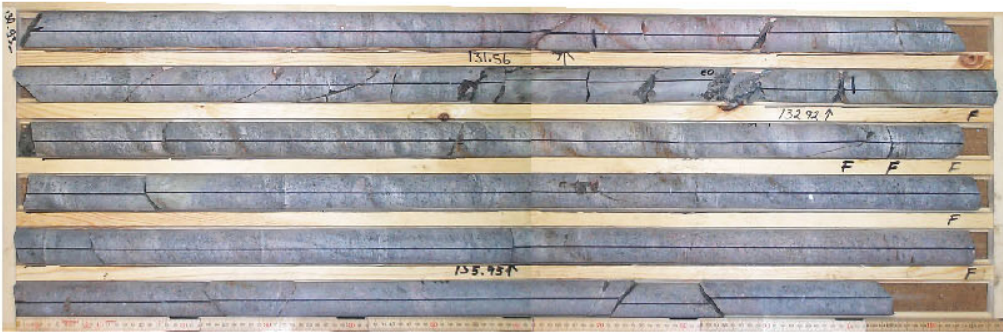
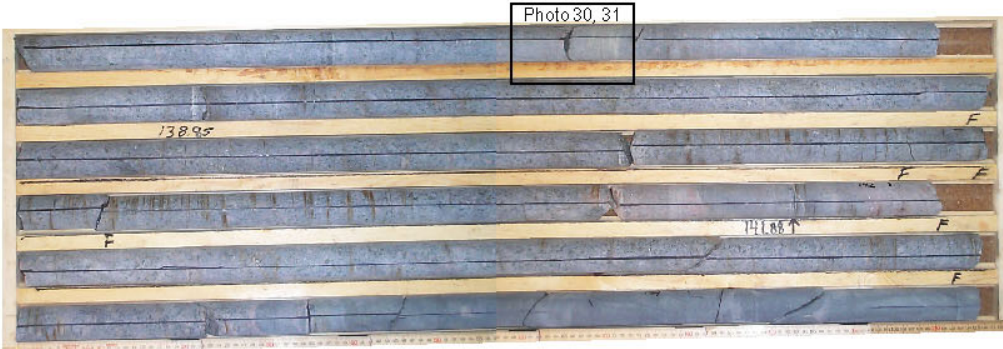
Photo 29: Section 2 whole view
Length of box = 120cm.

Section 2 (Photo 29)

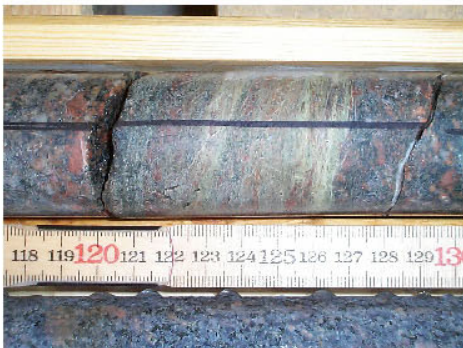
Photo 30: Section 2 No.7(left) and No.8 (right)
Fractures at the rim of mylonite.

An identical structure with 2198 m was observed at 138.2 m, where an open fracture No. 7 occurs at the rim of distinct mylonite with similar alteration halo and fracture mineralogy (Photos 30 and 31). Occurrence of the fracture at the rim of the mylonite is consistent with the observations in the tunnel mapping and microscopy, and implies its preferred location where a contrast in physical property occurs. An extreme inflow of 150 l/min at 138 m is also consistent with the existence of this structure.

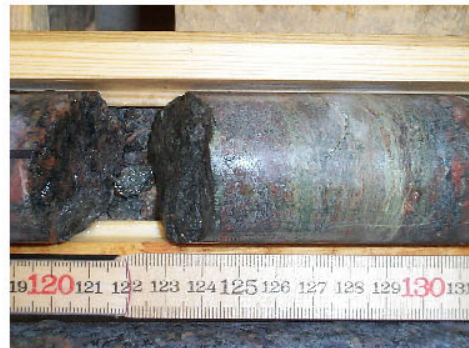
Photo 31: Section 2 No.7
Fracture surfaces and fragments.

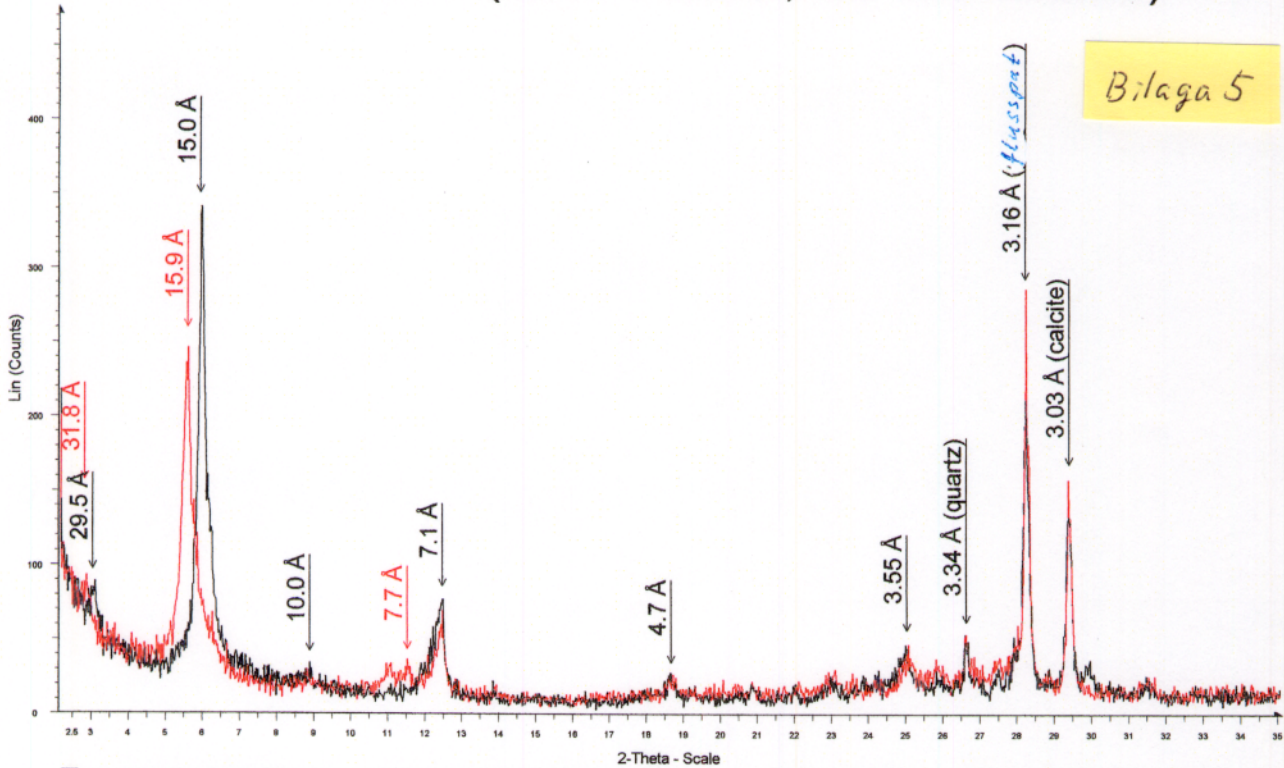
Bilaga 5

1575A <2 micron (black=natural, red=EG saturated)

A: C:\Sven\Uppdrag\Terralogica\1575A-2mc.RAW - File: 1575A-2mc.RAW - Type: 2Th/Th locked - Start: 2.119 ° - End: 35.114 ° - Step: 0.020 ° - Step time: 1.0 s - Temp.: 27.0 °C - Time Starter
 Operations: Y Scale 0.750 | Displacement -0.417 | Import
 A: C:\Sven\Uppdrag\Terralogica\1575A-2mc+EG.RAW - File: 1575A-2mc+EG.RAW - Type: 2Th/Th locked - Start: 2.119 ° - End: 35.114 ° - Step: 0.020 ° - Step time: 1.0 s - Temp.: 27.0 °C - Tin
 Operations: Y Scale 0.750 | Displacement -0.417 | Import

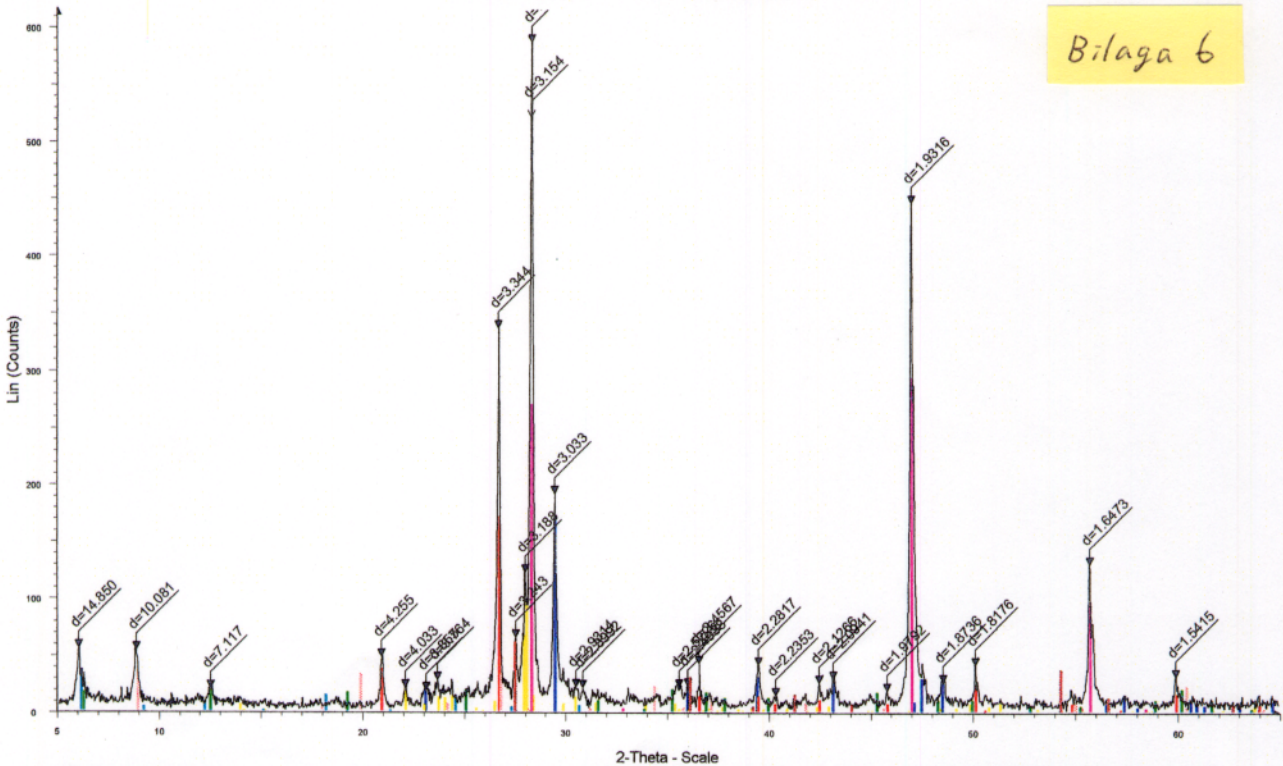
Bilaga 6

1575A >2 micron

A: C:\Sven\Uppdrag\Terralogica\1575A+2mc.RAW - File: 1575A+2mc.RAW - Type: 2Th/Th locked - Start: 2.119 ° - End: 35.114 ° - Step: 0.020 ° - Step time: 1.0 s - Temp.: 27.0 °C - Time Starter
 Operations: Displacement 0.083 | Displacement 0.167 | Import
 05-0586 (*) - Calcite, syn - CaCO₃ - Y: 29.17 % - d x by: 1.000 - WL: 1.54056
 33-1161 (*) - Quartz, syn - SiO₂ - Y: 29.17 % - d x by: 1.000 - WL: 1.54056
 41-1480 (l) - Albite, calcian, ordered - (Na,Ca)Al(Si,Al)₃O₈ - Y: 16.67 % - d x by: 1.000 - WL:
 35-0816 (*) - Fluorite, syn - CaF₂ - Y: 50.00 % - d x by: 1.000 - WL: 1.54056
 13-0190 (D) - Corrensite - Mg₈Al₃(Si₆O₂₀(OH)10.4H₂O - Y: 6.25 % - d x by: 1.000 - WL: 1.5
 19-0749 (D) - Clinocllore-2Mlib - Mg₅Al(Si₃Al)O₁₀(OH)₈ - Y: 4.17 % - d x by: 1.000 - WL: 1
 09-0343 (D) - Illite, trioctahedral - K_{0.5}(Al,Fe,Mg)₃(Si,Al)₄O₁₀(OH)₂ - Y: 6.25 % - d x by: 1.0
 21-1276 (*) - Rutile, syn - TiO₂ - Y: 10.42 % - d x by: 1.000 - WL: 1.54056
