TR-09-03

**Mineralogical investigations of the
interaction between iron corrosion
products and bentonite from the
NF-PRO Experiments (Phase 2)**

A E Milodowski, M R Cave, S J Kemp, H Taylor,
K Green, C L Williams, R A Shaw, C J B Gowing,
N D Eatherington
British Geological Survey

January 2009

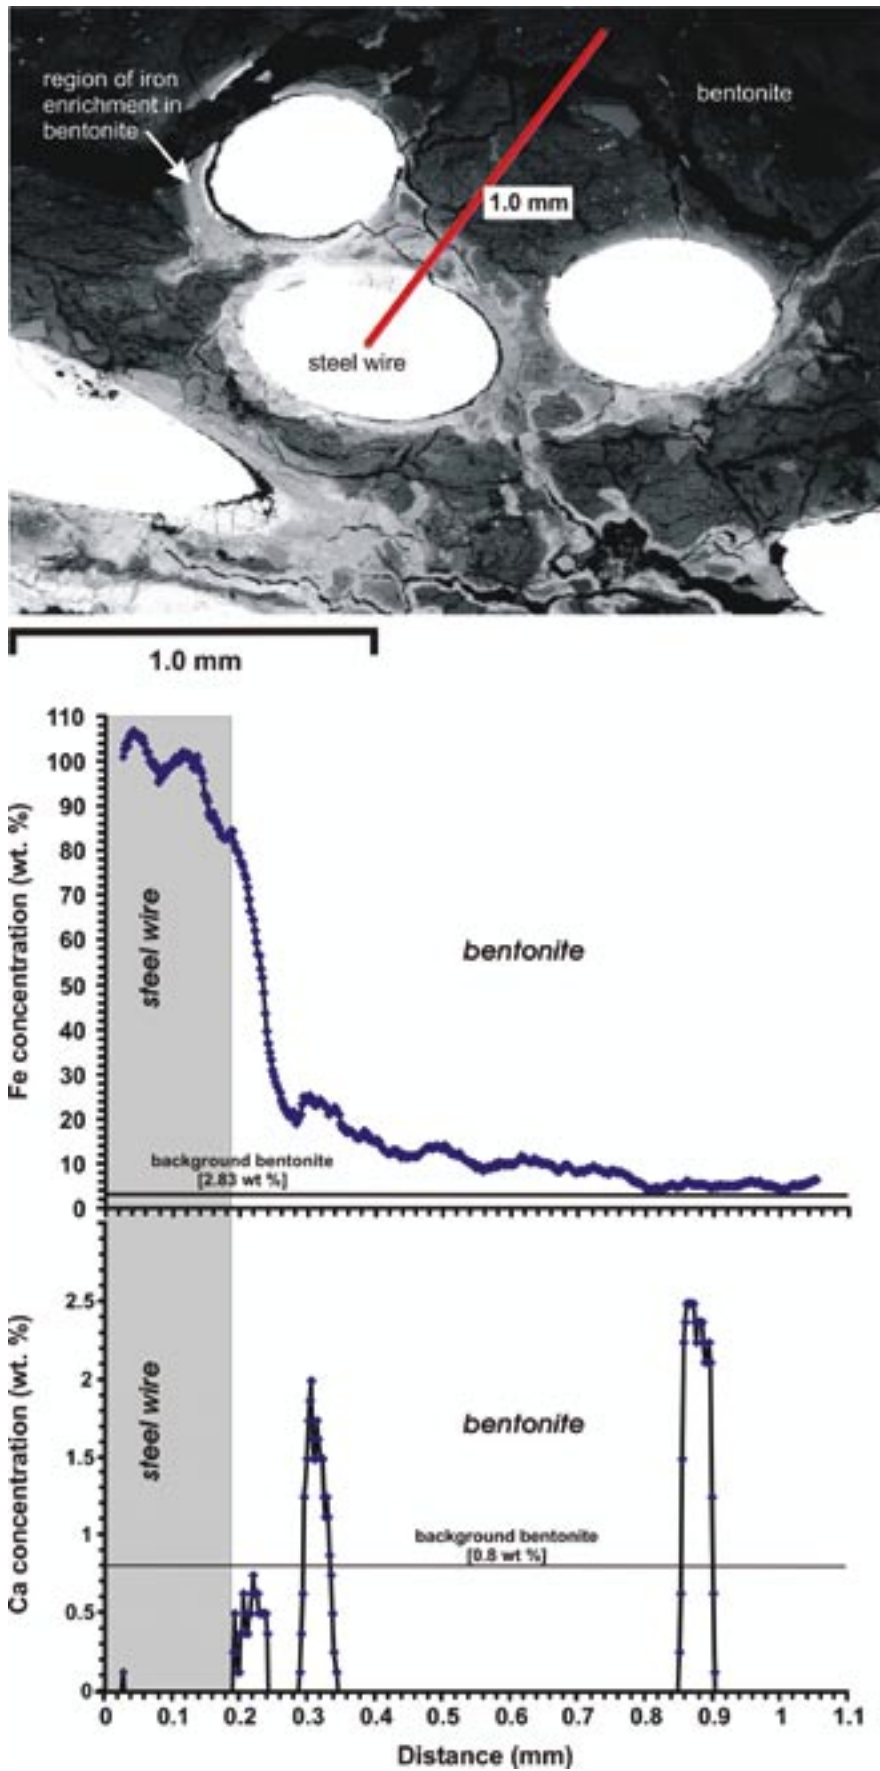
Figure 4-6. EDXA concentration profiles for Fe and Ca in bentonite with distance from corroding steel wire. Line of profile shown in BSEM photomicrograph (top). NF-PRO-Experiment NFC1 (Serco Assurance Sample 1, Cell 1 – BGS sample MPLM767).

Figure 4-6 shows a typical Fe concentration profile in the bentonite around a corroding wire. Immediately adjacent to the corroded metal surface Fe concentrations were observed to be up to 80 wt %, decreasing to about 70 wt % at about 40 μm from the steel. Within this narrow region the alteration halo must therefore consist mainly of iron oxides (cf. wustite (FeO) contains 77.7 wt % Fe) magnetite (Fe_3O_4) contains 72.4 wt % Fe and hematite (Fe_2O_3) contains 69.9 wt % Fe). Petrographical analysis confirms that abundant discrete iron oxide has formed immediately against the steel within this interval, displacing the bentonite and penetrating the adjacent bentonite along grain boundaries and microfractures (Figure 4-7). Between 40 and 100 μm distance, the Fe concentration decreases rapidly to about 25 wt % Fe, thereafter decreasing less rapidly to a concentration close to that expected for background unaltered bentonite (average 2.83 wt % Fe from data in Appendix 1) at a distance of between 600–1,000 μm from the metal. The amount of Fe present within this altered zone is much greater than can be accounted for by Fe in exchangeable cation sites. BSEM-EDXA reveals that some Fe is present as discrete very fine Fe oxide (Figure 4-7). However, the very fine smectitic matrix also appears to be significantly enriched in Fe (it has a much higher backscattered electron coefficient) than unaltered silicate matrix), with no discrete iron oxides resolvable by BSEM-EDXA. In this case, it would appear that at least part of the Fe has been incorporated within the silicate clay mineral, at least at the scale of resolution of these petrographical observations.

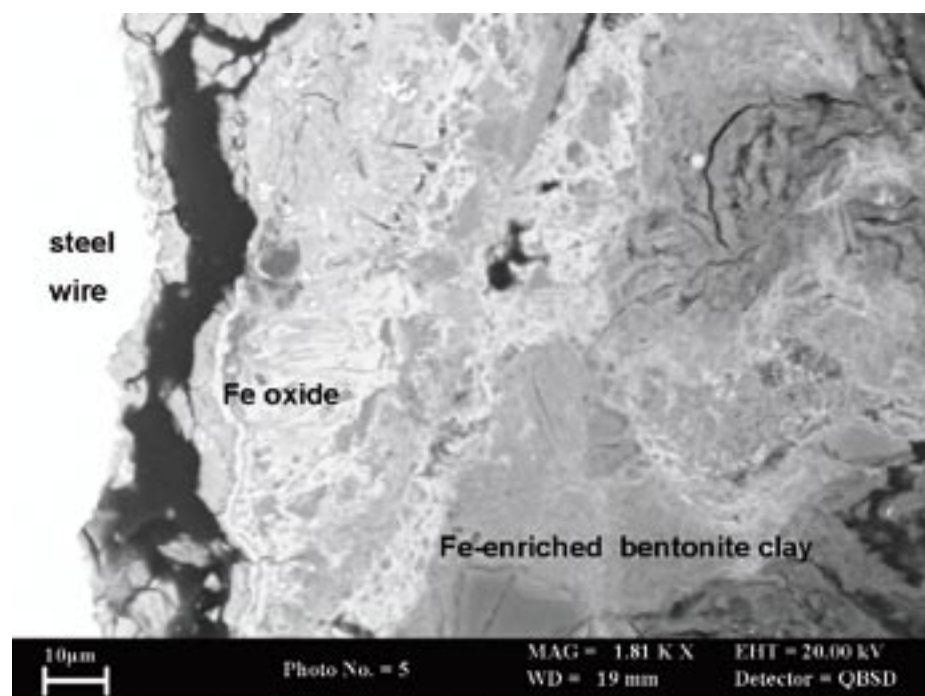
Figure 4-7. BSEM photomicrograph showing colloform and gel-like dense iron oxide alteration products (bright) formed immediately adjacent to the corroding steel wire, and penetrating into the smectitic clay matrix along grain boundaries (grey). NF-PRO-Experiment NFC1 (Serco Assurance Sample 1, Cell 1 – BGS sample MPLM767).

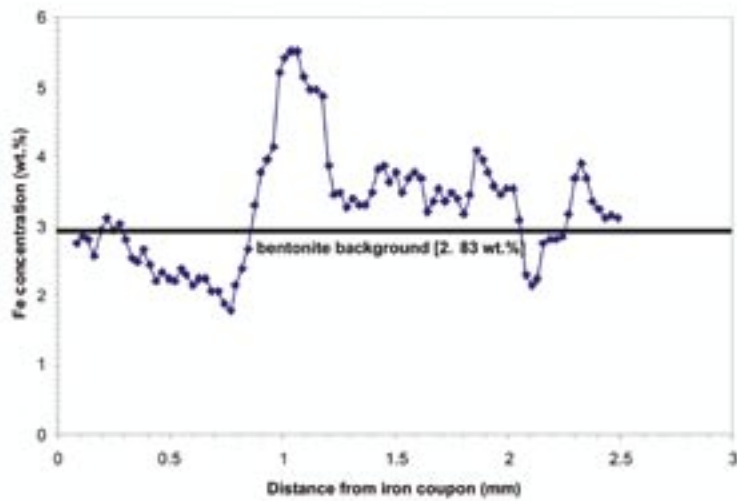
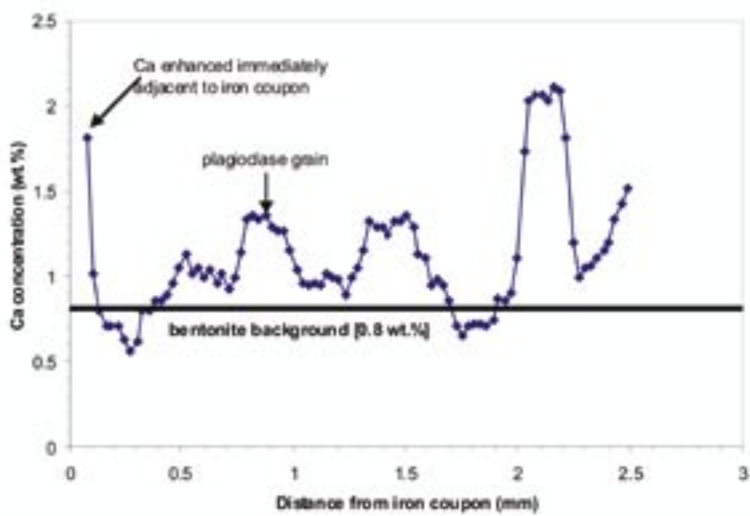
Figure 4-13. EDXA concentration profiles for Fe and Ca in bentonite with distance from corroded iron coupon. Line of profile shown in BSEI photomicrograph (top). NF-PRO-Experiment NFC4 (Serco Assurance Section 1, Cell 4 “steel side/bentonite” – BGS sample MPLM768).

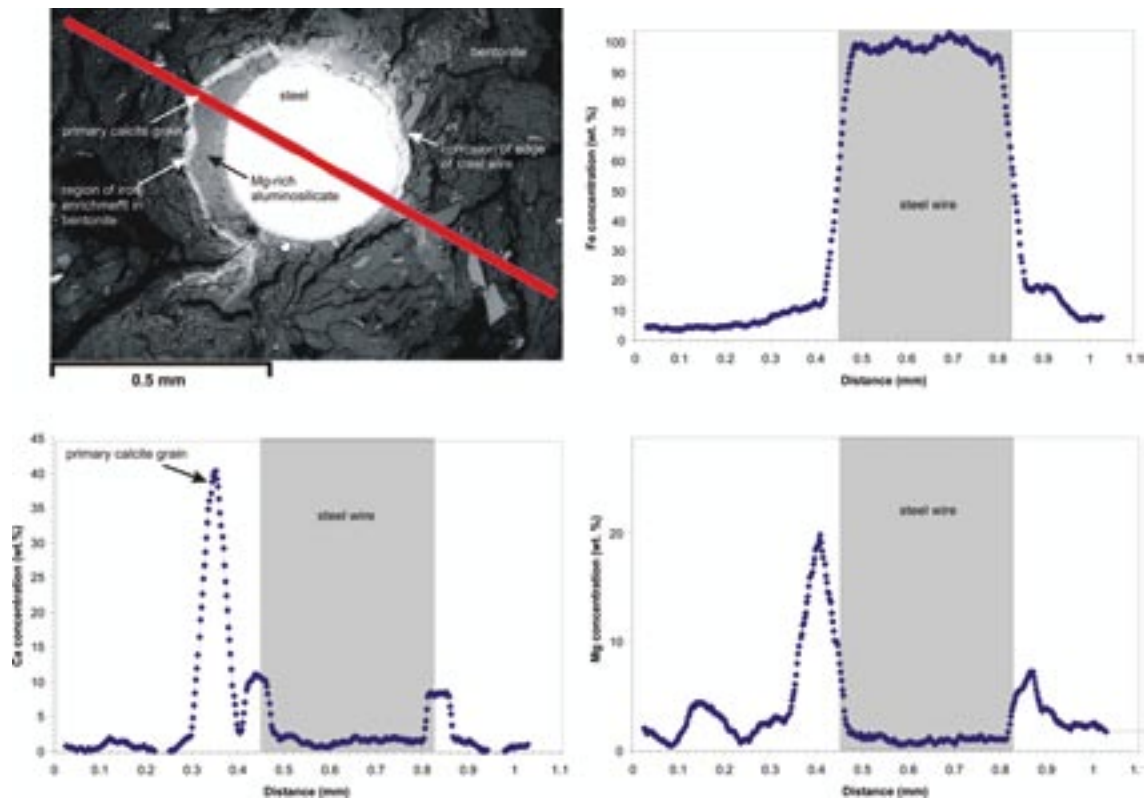
Figure 4-18. EDXA concentration profiles for Fe, Ca and Mg in bentonite with distance from corroding steel wire. Line of profile shown in BSEM photomicrograph (top). NF-PRO-Experiment NFC1 (Serco Assurance Section 1, Cell 4 “wire/bentonite” – BGS sample MPLM771).

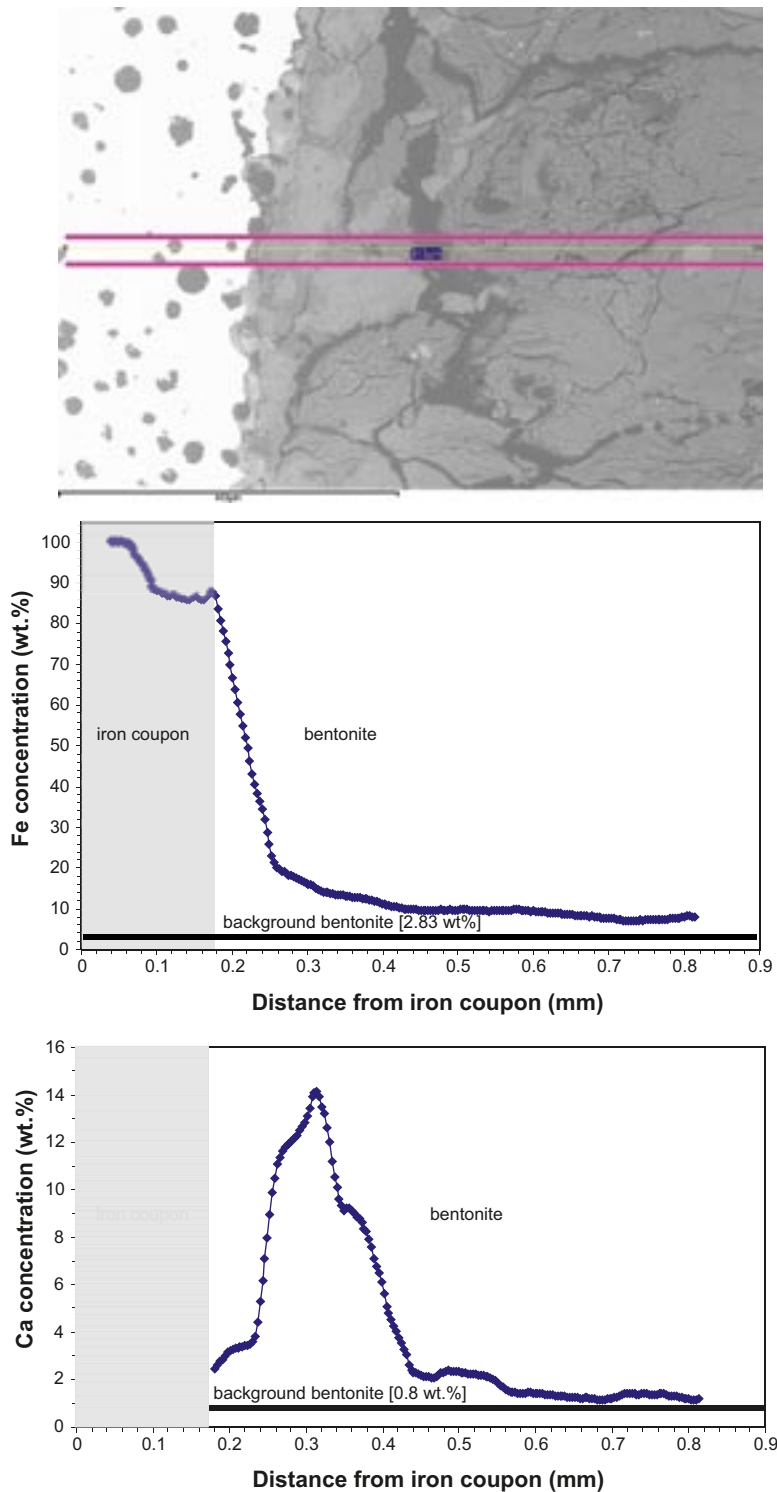
Figure 4-21. BSEM photomicrograph (top) with distribution profiles for Fe (middle) and Ca (bottom) in the bentonite alteration zone around corroded iron coupon. [Note: dark specs in the bright iron coupon are grains of embedded polishing paste] NF-PRO-Experiment NFC7 (Serco Assurance Section 1, Cell 7 “carbon steel surface/bentonite” – BGS sample MPLM769).

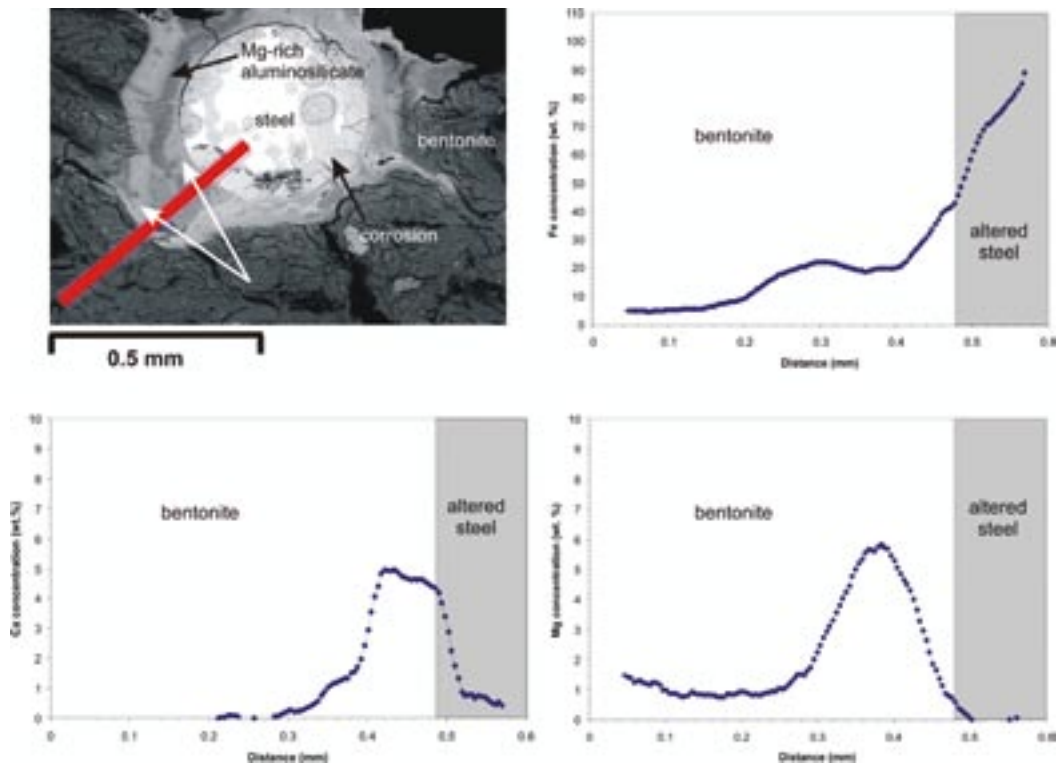
Figure 4-26. EDXA concentration profiles for Fe, Ca and Mg in bentonite with distance from corroding steel wire. Line of profile shown in BSEM photomicrograph (top). NF-PRO-Experiment NFC7 (Serco Assurance Section 2, Cell 7 “wire/bentonite” – BGS sample MPLM772).

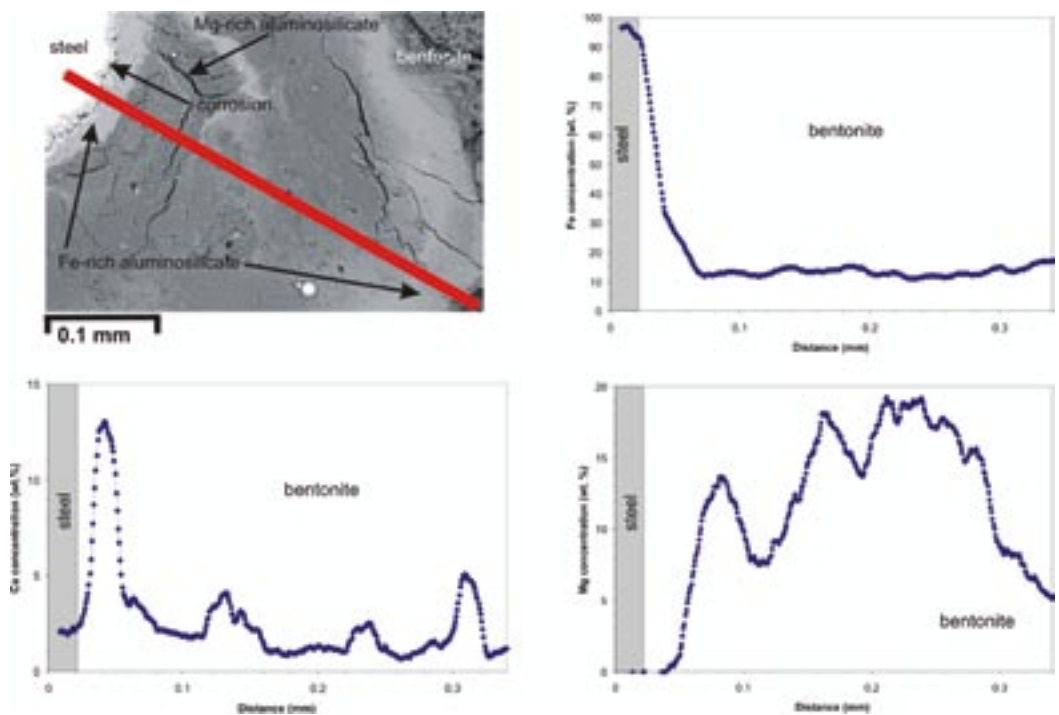
Figure 4-27. EDXA concentration profiles for Fe, Ca and Mg in bentonite with distance from corroding steel wire.. showing detail of Ca and Mg concentrations along a series of antithetic “fronts” within with Fe-enriched altered bentonite halo. Line of profile shown in BSEM photomicrograph (top). NF-PRO-Experiment NFC7 (Serco Assurance Section 2, Cell 7 “wire/bentonite” – BGS sample MPLM772).

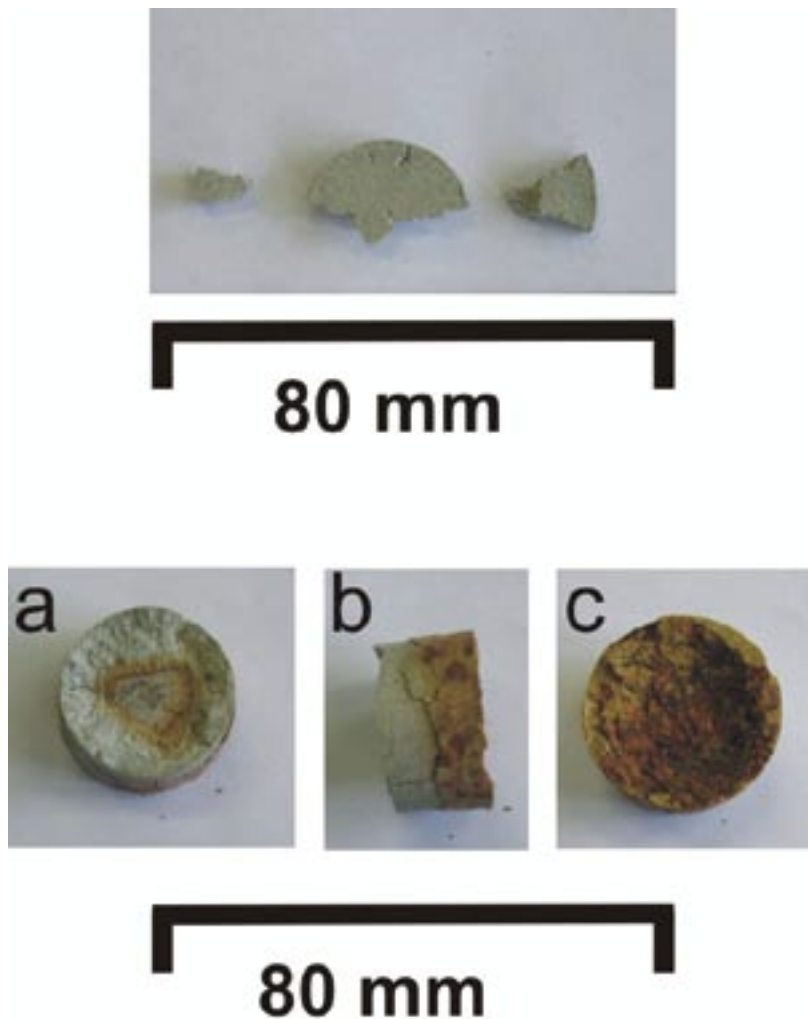
Figure 4-28. Photograph of bentonite samples from NF-PRO-Experiment NFC13. Top: Serco Assurance Section 1, Cell 13, “cell end section” (BGS sample MPLM770) showing unaltered grey-green background bentonite. Bottom: Serco Assurance Section 2, Cell 13 “wire/bentonite”, (BGS sample MPLM773): (a) end-face containing ferruginous staining and impression from corroded iron coupon (coupon removed); (b) interface between heavily iron-stained zone around corroded steel wires and unaltered bentonite; (c) end-face exposing corroded steel wires surrounded by halos of red-brown iron oxide and iron oxide-stained bentonite.
