IPR-10-05

Äspö Hard Rock Laboratory

Prototype Repository

**Sensors data report
(Period 010917-091201)
Report No: 22**

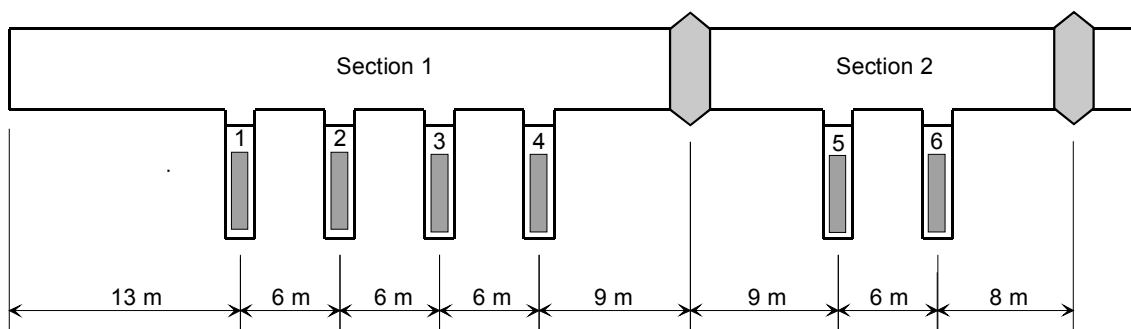
Figure 1-1. Schematic view of the Prototype Repository.

Section 1 consists of four full-scale deposition holes, copper canisters equipped with electrical heaters, bentonite blocks and a deposition tunnel backfilled with a mixture of bentonite and crushed rock and ends with a concrete plug as shown in Figure 1-1. Section 2 consists of two full-scale deposition holes with a backfilled tunnel section and ends also with a concrete plug.

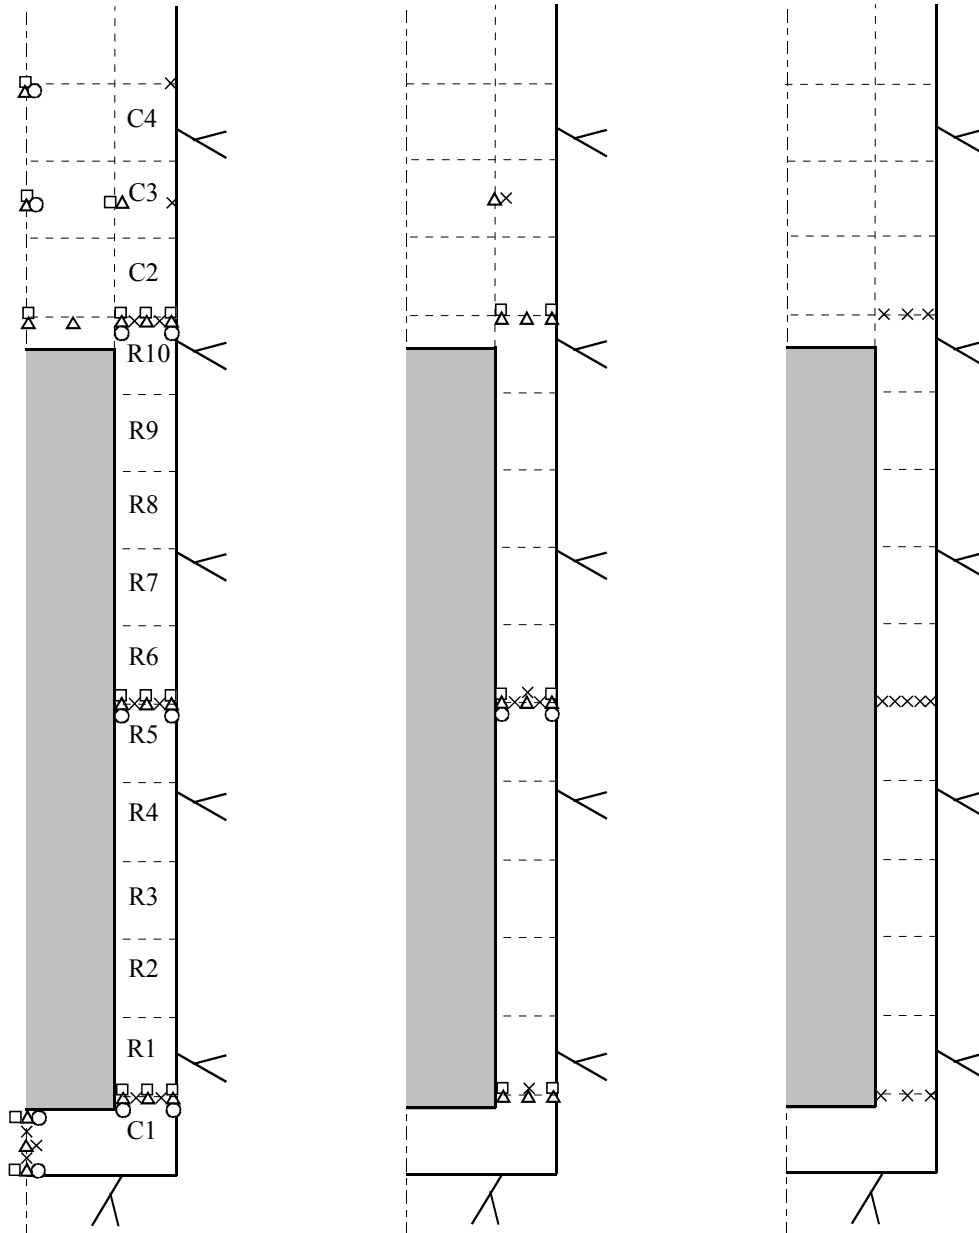
Figure 4-1. Schematic view over the instruments in four vertical sections and the block designation.

The instruments are located in three main levels in the blocks, 50 mm, 160 mm and 250 mm, from the upper surface. The thermocouples are mostly placed in the 50 mm level and the other gauges in the 160 mm level except for the Geokon type 1 pressure sensors and the Rotronic humidity sensors, which are placed in the 250 mm level depending on the size of the sensor house.

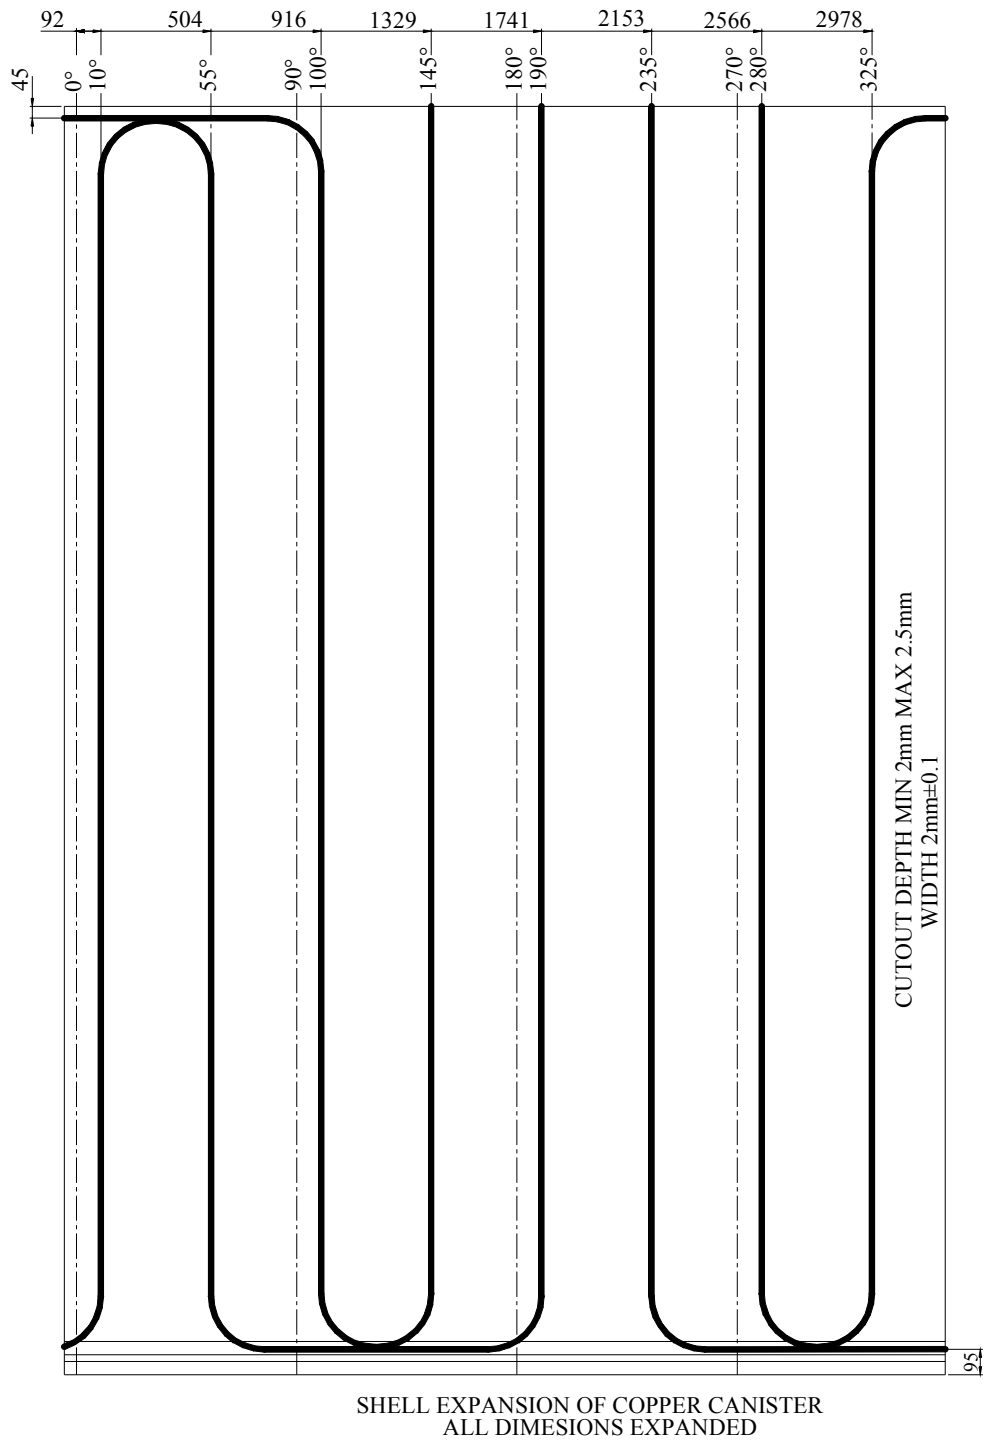
Figure 4-2. Laying of the optical fiber cables with protection tube of Inconel 625 (outer diameter 2 mm) for measurement of the canister surface temperature (surface unfolded).

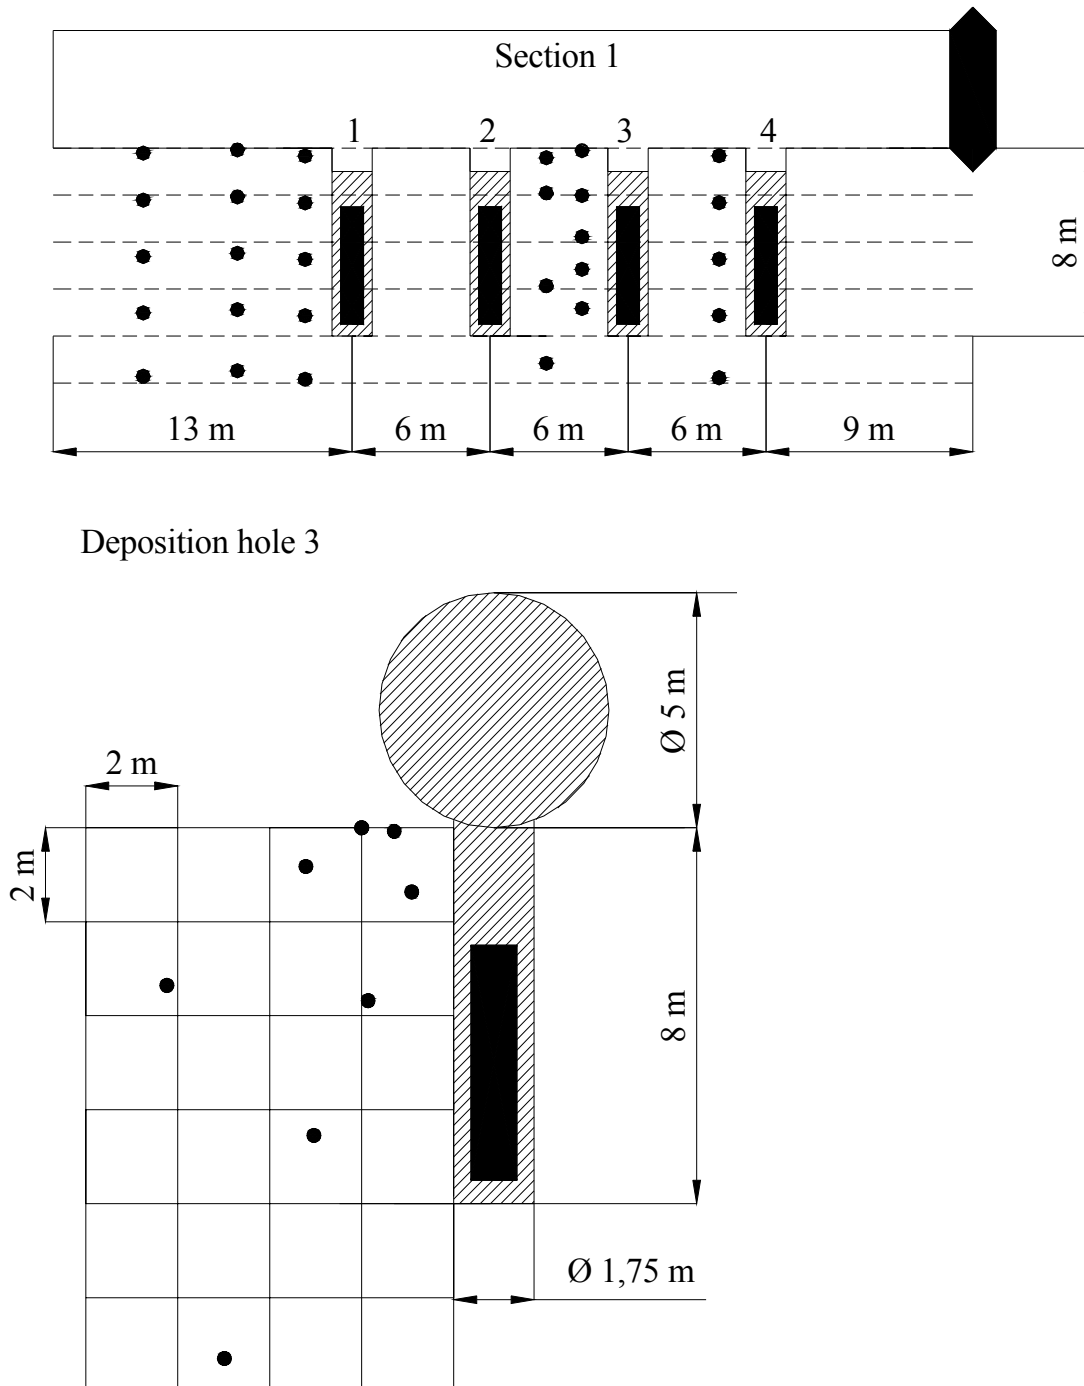
Figure 4-3. Overview of the temperature sensors in the rock. Length section (upper) and cross section (towards the end of the tunnel).

The positions of the temperature sensors in the rock are termed in the same way as the sensors in the buffer in the deposition holes. Figure 4-3 shows an overview of the temperature sensors placed in the rock. The sensors are assigned to the closest deposition hole. The positions are described in Table 4-10.

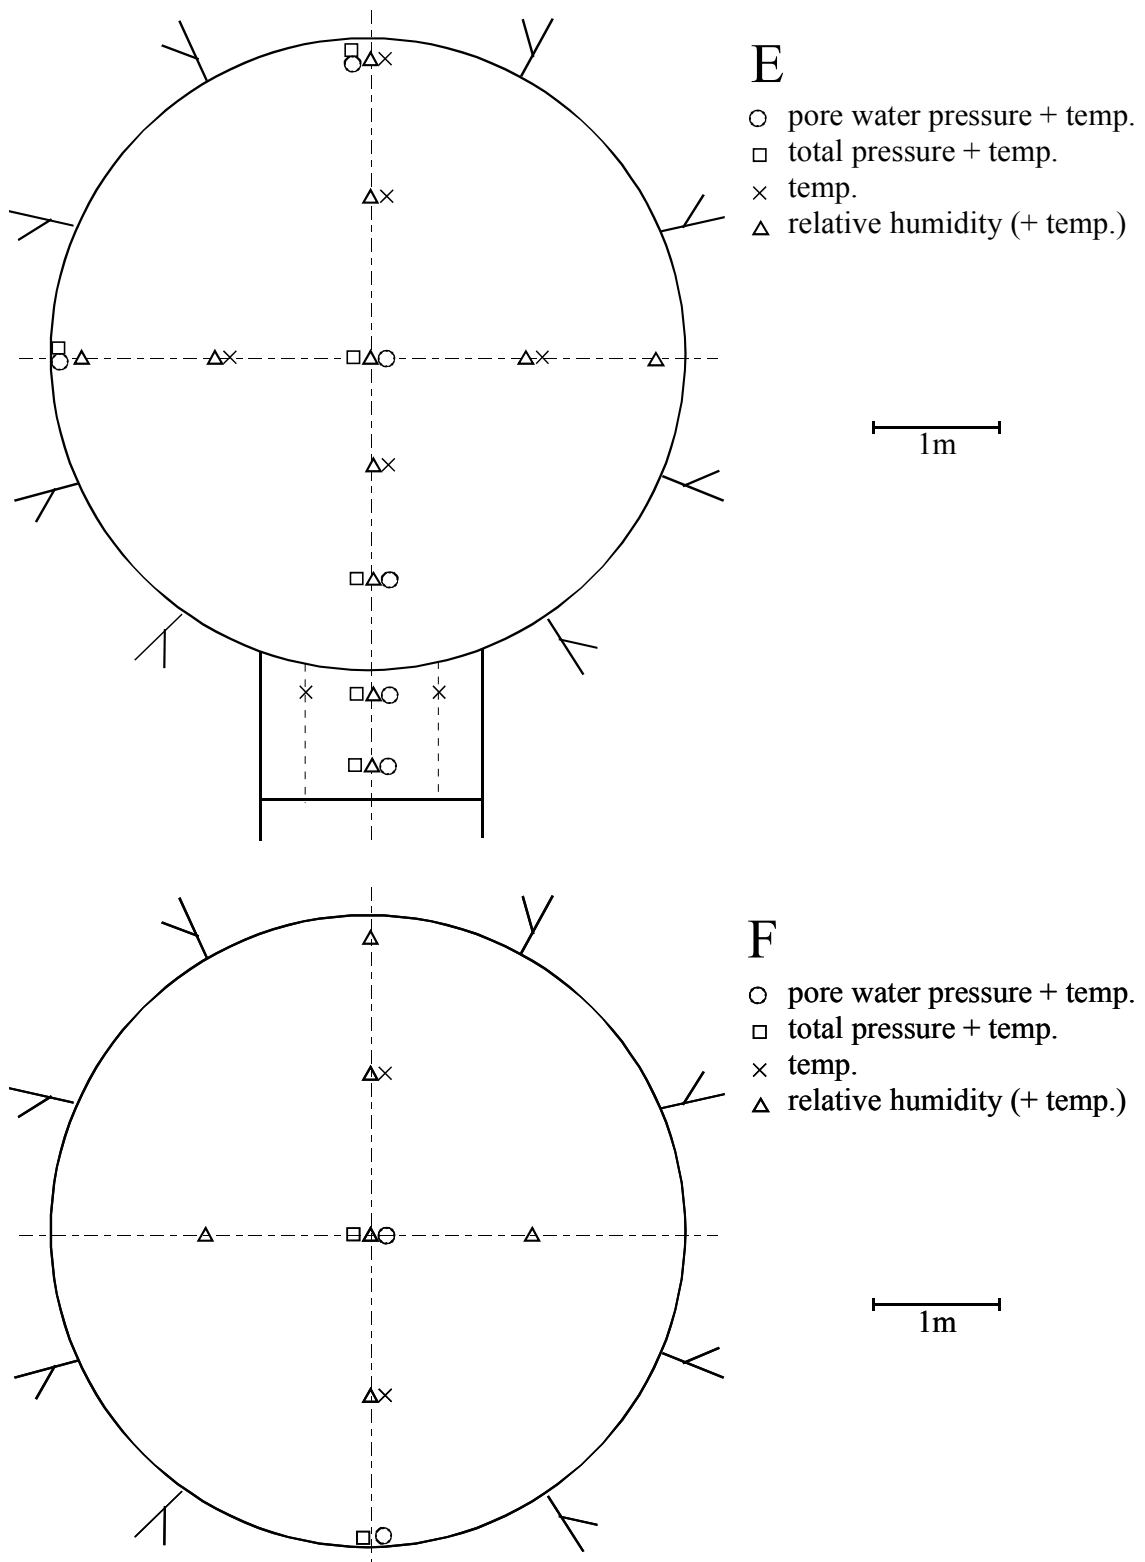
Figure 4-5. Schematic view over the sensors positions in the different sections.

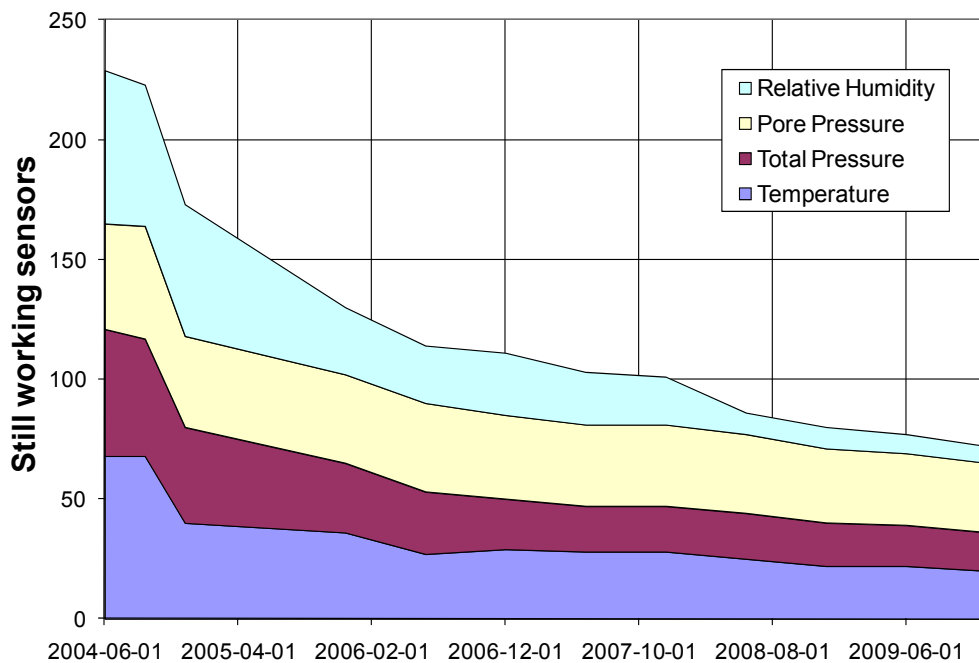
Figure 5-1. The number of still working sensors placed in the buffer and backfill in Section 1 as function of time. The coloured fields are representing the four types of installed sensors.

At present about 254 (excluding water pressure sensors in the rock and the displacement sensors for the canister) out of totally 363 installed sensors are out of order. In Figure 5-1 the numbers of still working sensors in the buffer and the backfill of Section 1 are plotted as function of time from June 2004. The figure shows that the majority of the broken sensors are RH-sensors and thermocouples (in deposition hole 3). The figure also shows that the numbers of broken sensors increased after the closing of the drainage of the tunnel.

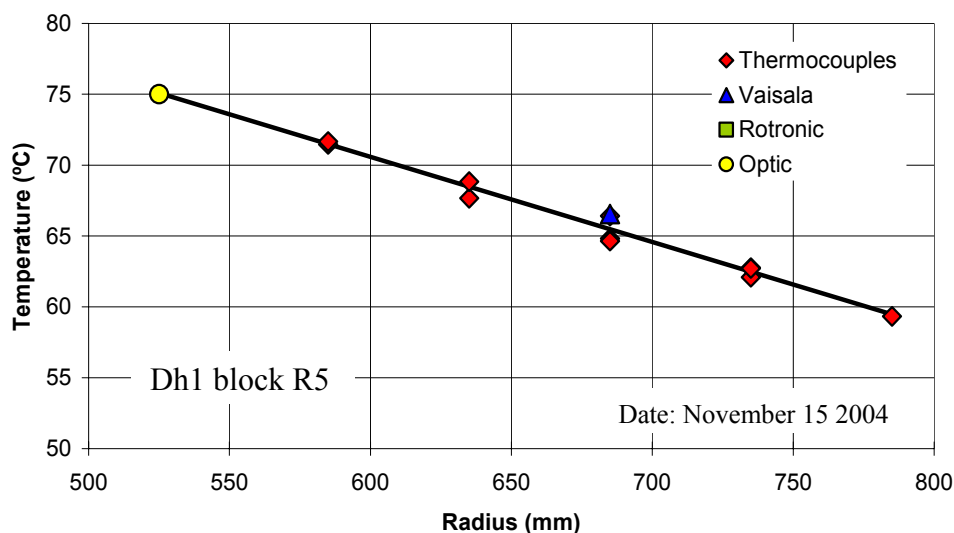
Figure 5-2. The temperature in block R5 in Dh 1 as function of radius from the centre of the deposition hole on November 15, 2004.

In Figure 5-2 the temperature in the buffer is plotted as function of the radius from the centre of the deposition hole. The measurements are made with different type of sensors in block R5 (at mid height of the canister). A straight line is fitted to the measured values. The temperature gradient is determined from the fitted line in the figure. This gradient together with the temperature on the canister surface and the temperature in the buffer close to the outer radius of the ring shaped block ($r = 785$ mm) are plotted as function of time in Figure 5-4. The shaded part of the plot represents the time when the power to the canister was switched off at the beginning of December 2004. The plot shows that the temperature after this is somewhat lower than before, probably due to the fact that no power is applied to canister 2 after December 2 2004. However the temperature gradient over the buffer is similar before and after the switch on/off the power of the canisters. The determination of the gradient was made up to the beginning of December 2005. After that the number of still working sensors are too few, to be able to determine the temperature gradient.

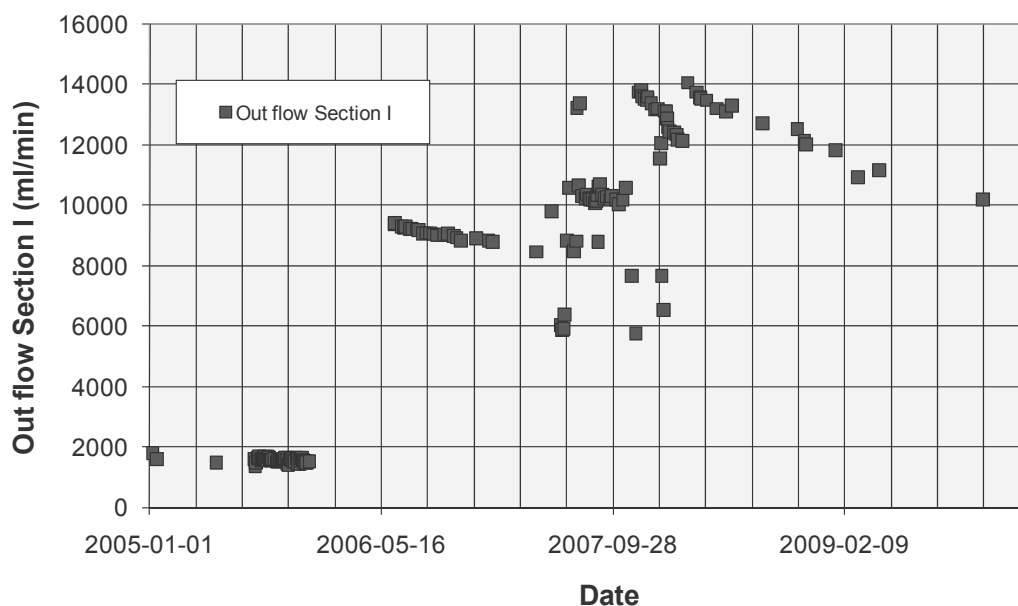
Figure 5-9. The measured outflow from the inner section of the Prototype tunnel.

The outflow from the inner section of the Prototype tunnel as function of time is shown in Figure 5-9. The figure is showing that the outflow from Section I increased from about 1.8 l/min to about 9 l/min when the installed packer was broken. The large scatter and the increase in the outflow starting at the beginning of summer 2007 are probably caused by the work with the new tunnel placed close to the Prototype tunnel.

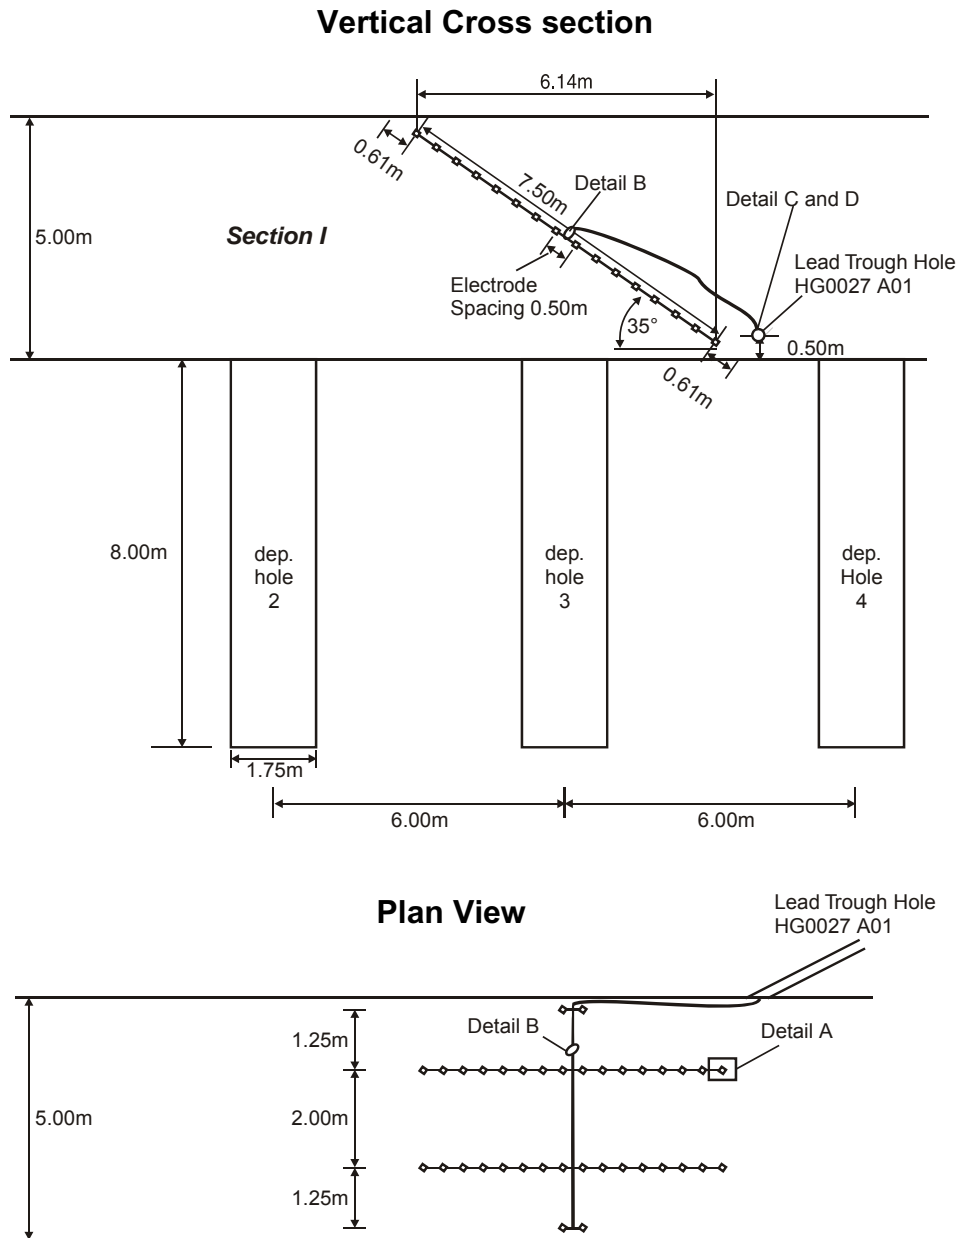
Figure 2-1. Electrode array in the backfill in section 1.

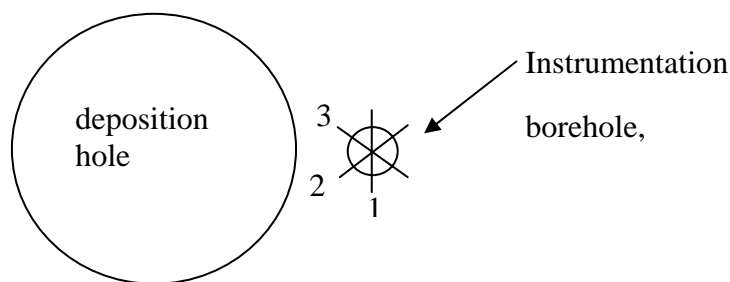
The Geokon model 4350 vibrating wire biaxial stressmeter was installed for monitoring stress changes. This instrument was designed to measure compressive stress changes in rock, salt, concrete or ice. The instrument consists of a stiff high-strength steel cylinder, which is grouted into a BX (60 mm) size borehole. Stress changes in the host material cause the cylinder to deform, and the deformations in the plane perpendicular to the borehole are measured by means of two sets of three vibrating wire sensors spaced at 60° intervals (measurements are made at two levels within the cylinder). The gauges also include two longitudinal strain sensors and temperature sensors. The deformation of the steel cylinder, and resulting changes in resonate frequency of the vibrating wires, are used to determine both the magnitude and orientation of the change in stress in the host material.

Installation of the stressmeter gage is accomplished by inserting the gage into a grout-filled borehole using a setting tool and self-aligning setting rod. The stress cell is orientated so that the first vibrating wire is orientated tangentially to the canister hole. The second wire is orientated 60° from tangential direction and the third wire is orientated 120° from tangential direction.

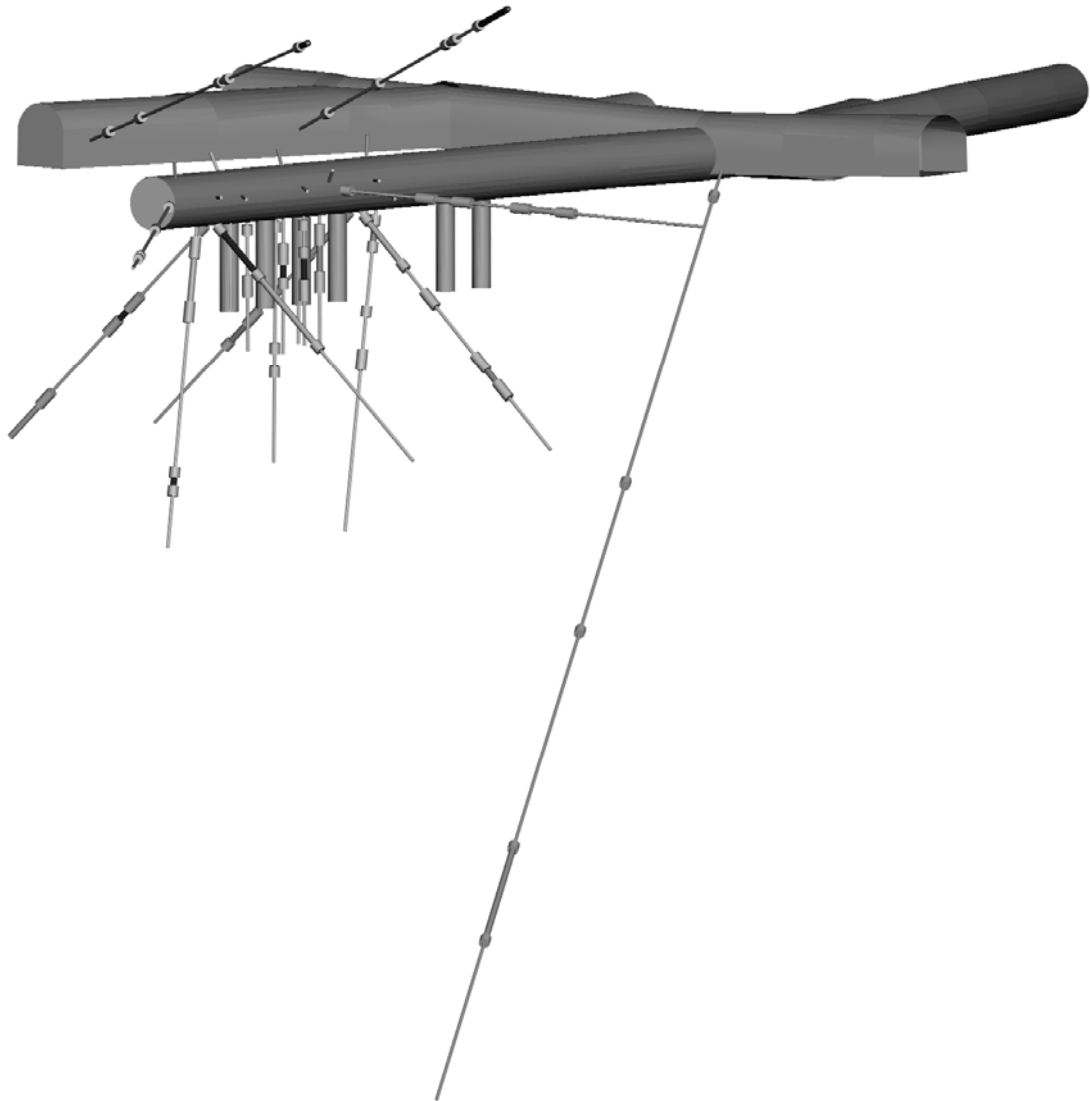
Figure 1. View of the drilled core holes in the Prototype Repository Section I. The length from the I-tunnel to the end of the TBM-tunnel is 90 m. The diameter of the TBM tunnel is 5m and the diameter of the deposition holes is 1.75 m. The depth of the deposition holes is 8.37 m in the centre and 8.15 m along the deposition hole wall. The diameter of the core holes is 76 mm except for the short core holes in the roof of the TBM tunnel that have a diameter of 56 mm. The monitoring boreholes used in the presentation in this report are located in the inner part of the tunnel surrounding the area with the four innermost canister holes. Also included are two holes drilled from the G-tunnel and the long hole KA3510A drilled from the main tunnel.

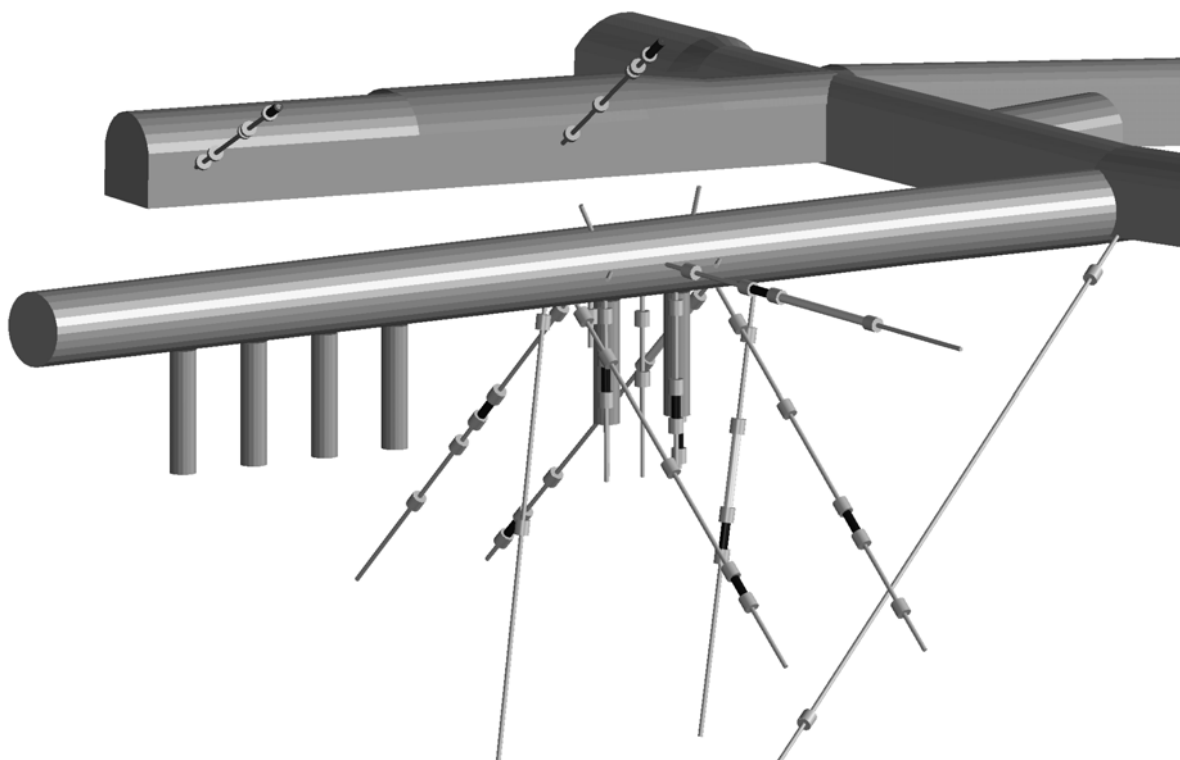
Figure 3. View of the drilled core holes in the Prototype Repository Section II. The length from the I-tunnel to the end of the TBM-tunnel is 90 m. The diameter of the TBM tunnel is 5m and the diameter of the deposition holes is 1.75 m. The depth of the deposition holes is 8.37 m in the centre and 8.15 m along the deposition hole wall. The diameter of the core holes is 76 mm except for the short core holes in the roof of the TBM tunnel that have a diameter of 56 mm. The monitoring boreholes used in the presentation in this report are located in the inner part of the tunnel surrounding the area with the four innermost canister holes. Also included are two holes drilled from the G-tunnel and the long hole KA3510A drilled from the main tunnel.
