SKB P-23-12

Prototype Repository – Sensor data report

Period 2001-09-17 to 2023-01-01

Report No 34

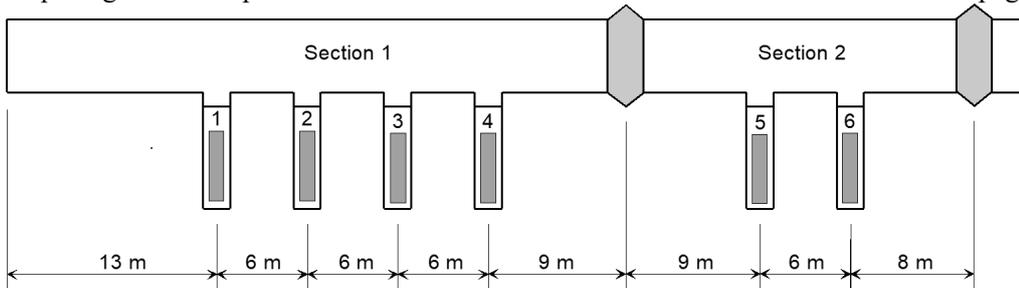
Figure 1-1 Schematic view of the Prototype Repository

The Prototype Repository consist of, after the dismantling of the outer section, one tunnel section (Section 1) and four deposition holes, see Figure 1-1. The installation of the first Section of Prototype Repository was made during summer and autumn 2001 and Section 2 was installed in spring and summer 2003.

Section 1 consists of four full-scale deposition holes, copper canisters equipped with electrical heaters, bentonite blocks and a deposition tunnel backfilled with a mixture of bentonite and crushed rock and ends with a concrete plug as shown in Figure 1-1. Section 2 consists of two full-scale deposition holes with a backfilled tunnel section and ends also with a concrete plug. Section 2 was excavated during 2010.

The Prototype Repository consists of two sections as shown in Figure 1-1. The geometry and the coordinate system for the sensors are different for the deposition holes and the tunnel. The temperature sensors in the rock are defined with the same coordinate system as the deposition holes.

In Section 1 the deposition holes are termed 1-4 according to Figure 1-1. The coordinate system for these holes is shown in Figure 2-1. With the z -axis starting from the cement casting and the angle α counted anti-clockwise from direction A. Measurements are mainly made in four vertical sections A, B, C and D according to Figure 2-1. Direction A and C are placed in the tunnels axial direction with A headed against the end of the tunnel i.e., almost towards West.

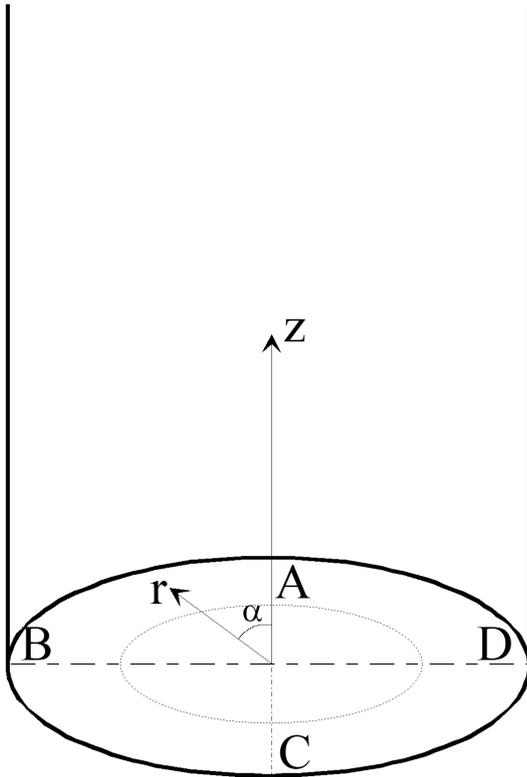
Figure 2-1 Figure describing the instrument planes (A-D) and the coordinate system used when describing the instrument positions (A headed against the end of the tunnel).

The type of instruments and their locations are described in detail in Börgesson and Sandén (2001). Every instrument is named with a unique name consisting of 1 letter describing the type of measurement, 2 letters describing where the measurement takes place (buffer, backfill, rock or canister), 1 digit denoting the deposition hole (1-4) and 4 specifying the instrument according to a separate list (see Table 4-1 to 4-9). Every instrument position is then described with three coordinates according to Figure 2-1.

The r -coordinate is the horizontal distance from the centre of the hole and the z -coordinate is the height from the surface of the bottom casting of the hole (the block height is set to 500mm). The α -coordinate is the angle from the vertical direction A (almost West).

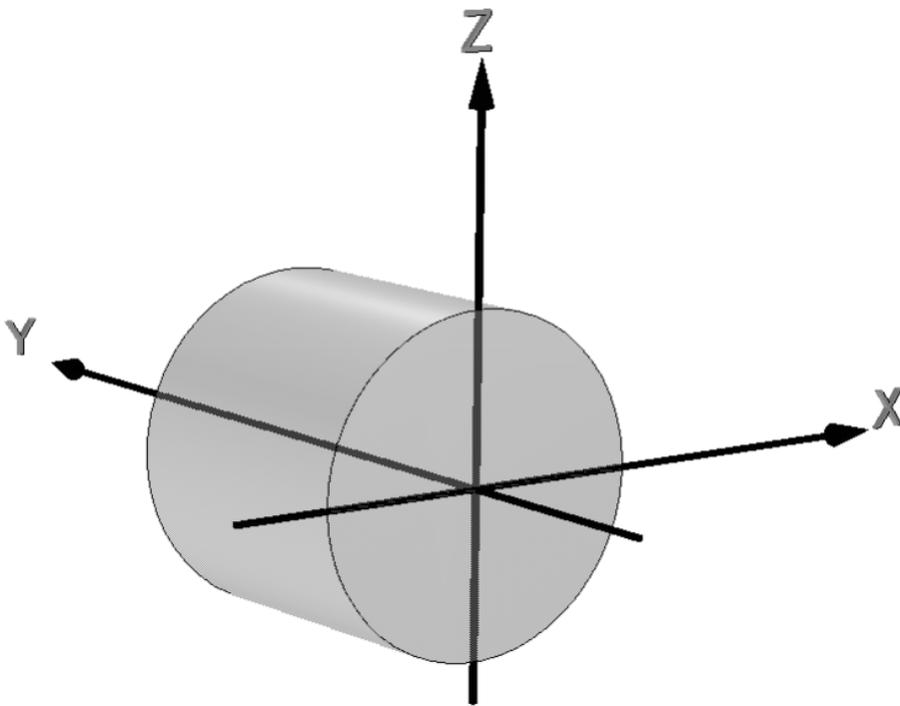
The coordinate system of the backfill in the tunnel is shown in Figure 2-2. The coordinate y starts at the entrance on ground, which means that the tunnel ends at $y = 3599,8$. The y -axis runs in the centre of the tunnel, which means that the tunnel walls intersect the z and x -axes at ± 2.5 m. The z -coordinate is determined positive upwards, and the x -coordinate is determined positive to the right when facing the end of the tunnel.

Figure 2-2 Coordinate system of the tunnel

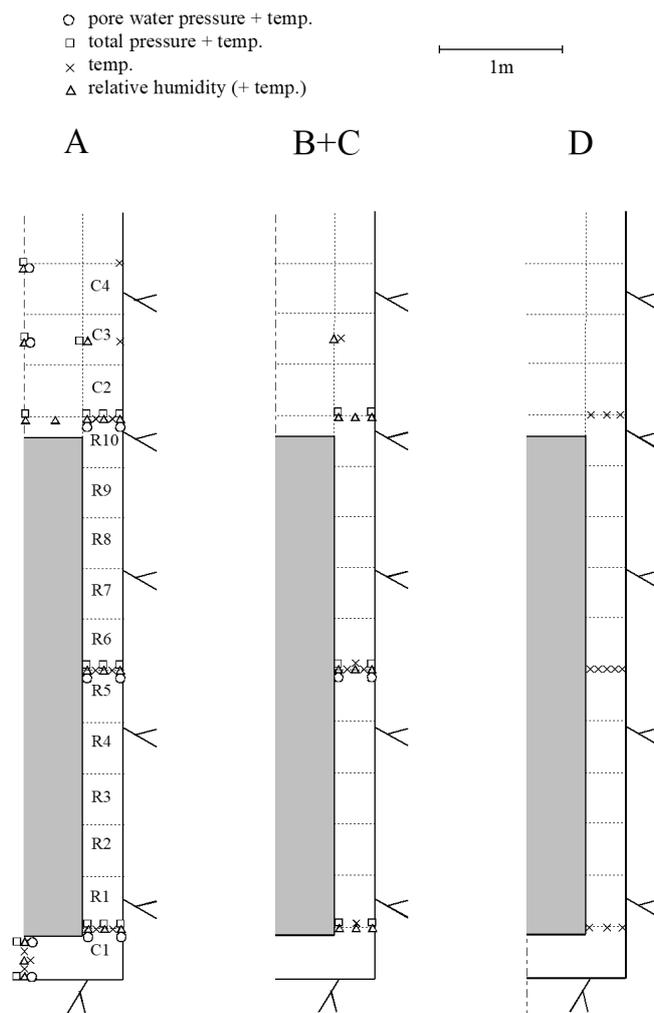
Figure 4-1 shows an overview of the instruments in the buffer. The bentonite blocks are called cylinders and rings. The cylinders are numbered C1-C4 and the rings R1-R10 respectively.

Figure 4-1 Schematic view over the instruments in four vertical sections and the block designation.

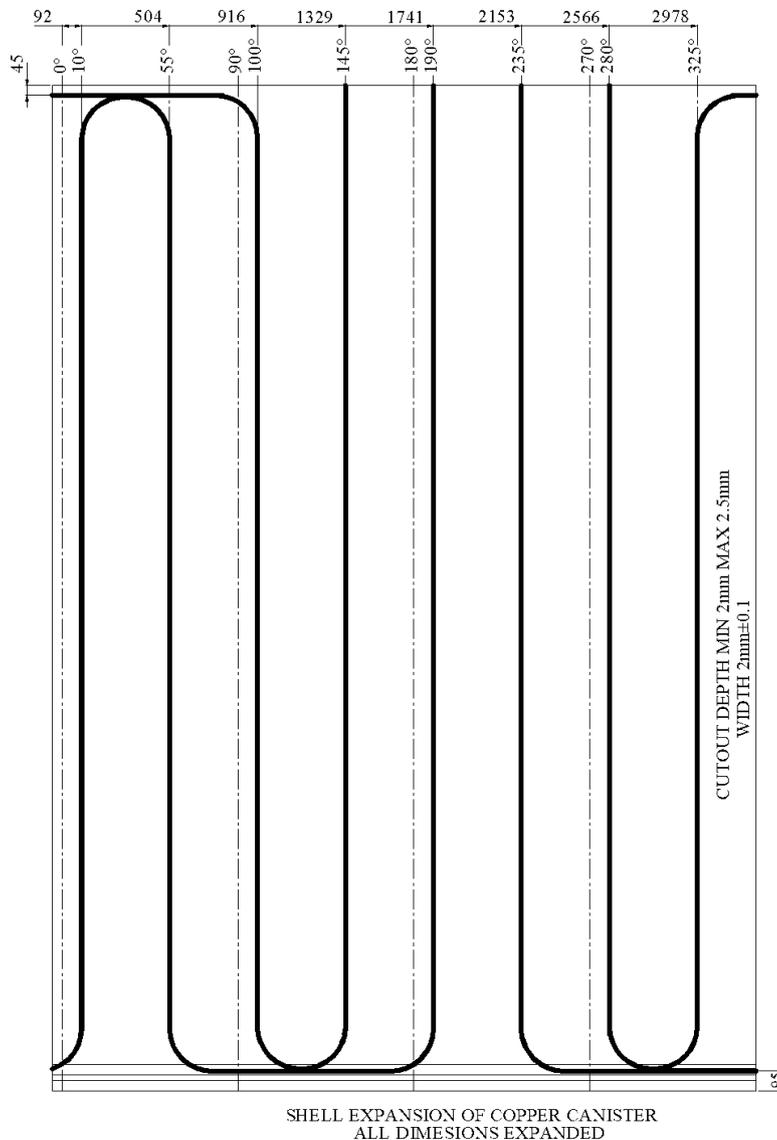
Figure 4-2 shows how two optical fibre cables are placed on the canister surface. Both ends of a cable are used for measurements. This means that the two cables are used for four measurements.

With this laying the cables will enter and exit the surface at almost the same position. Curvatures are shaped as a quarter circle with a radius of 20 cm. The cables are placed in a milled out channels on the surface. The channels have a width and a depth of just above 2 mm.

Figure 4-2 Laying of the optical fibre cables with protection tube of Inconel 625 (outer diameter 2 mm) for measurement of the canister surface temperature (surface unfolded).

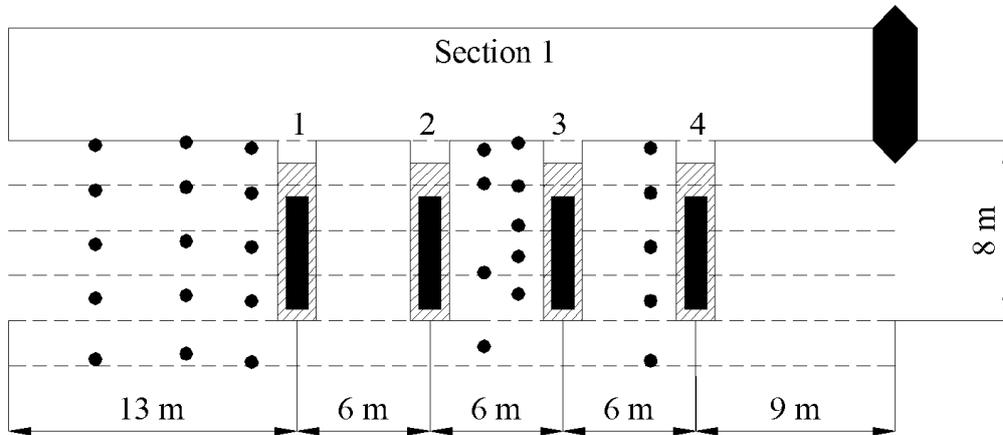
The positions of the temperature sensors in the rock are termed in the same way as the sensors in the buffer in the deposition holes. Figure 4-3-1 and figure 4-3-2 shows an overview of the temperature sensors placed in the rock. The sensors are assigned to the closest deposition hole.

Figure 4-3 Overview of the temperature sensors in the rock. Length section.

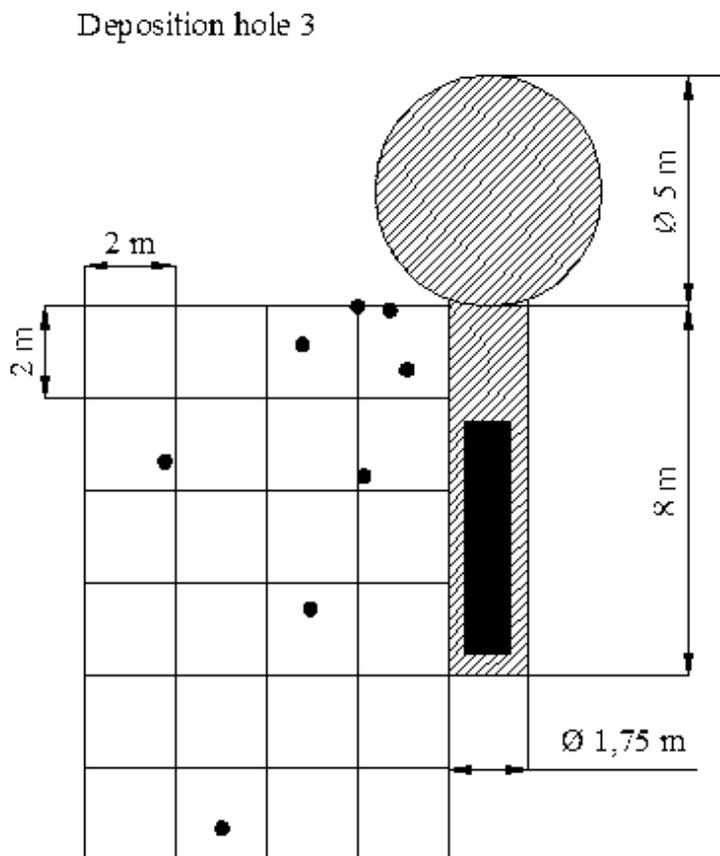
Figure 4-4 Overview of the temperature sensors in the rock. Cross section around hole 3 (towards the end of the tunnel).

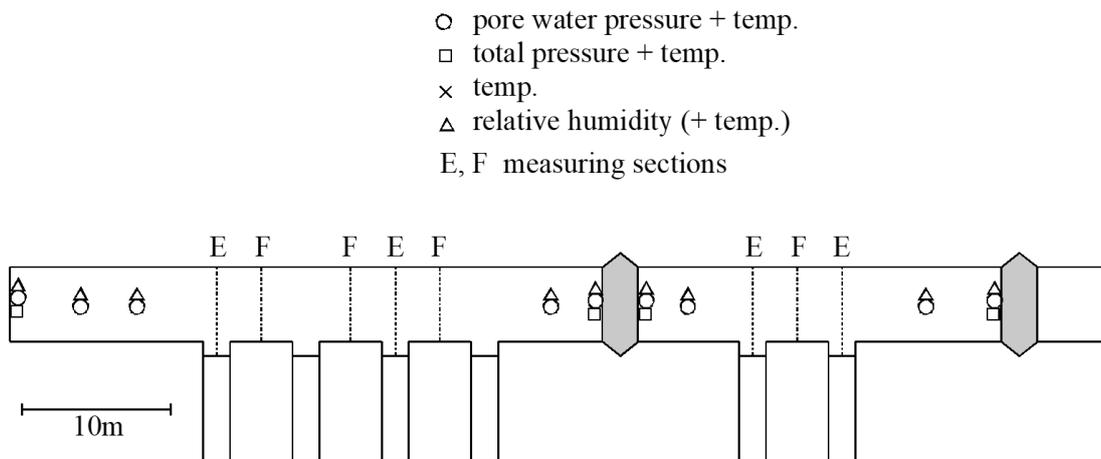
The backfill is mainly instrumented in vertical sections straight above and between the deposition holes (Figures 4-4 and 4-5).

Figure 4-5 Schematic view over the instrumentation of the backfill.

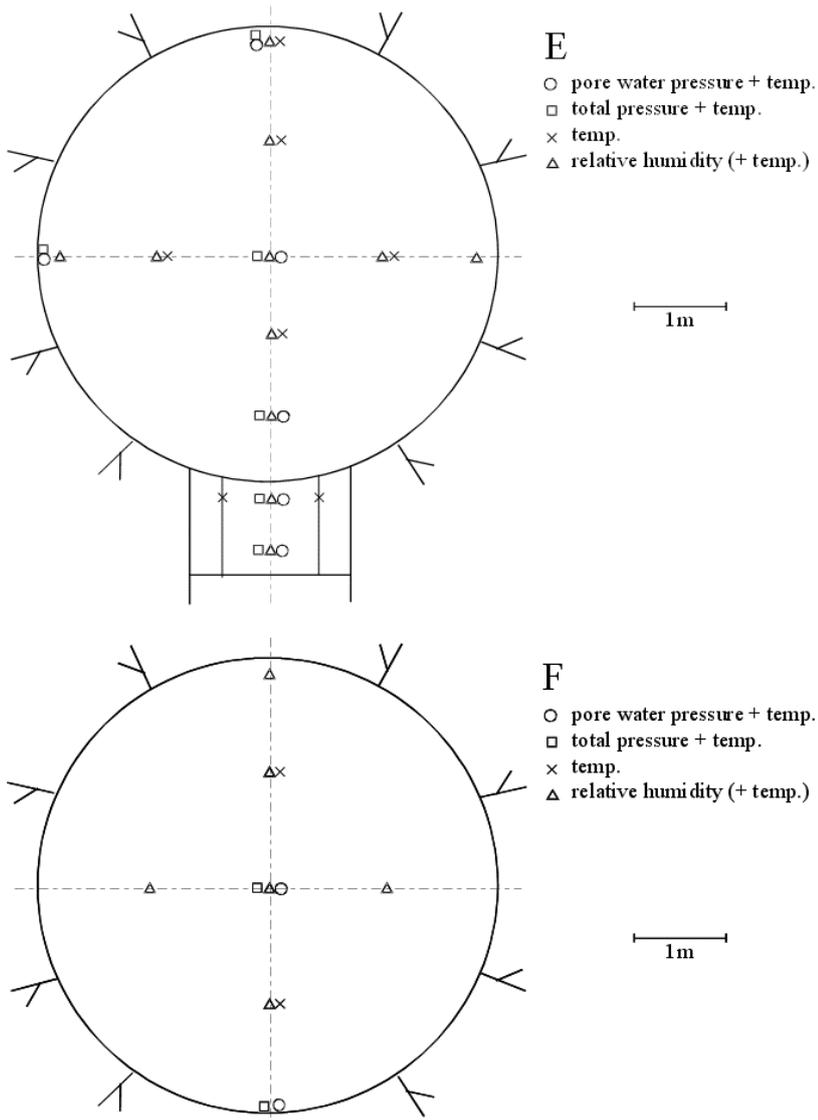
Figure 4-6 Schematic view over the sensors positions in the different sections. (Towards the end of the tunnel).

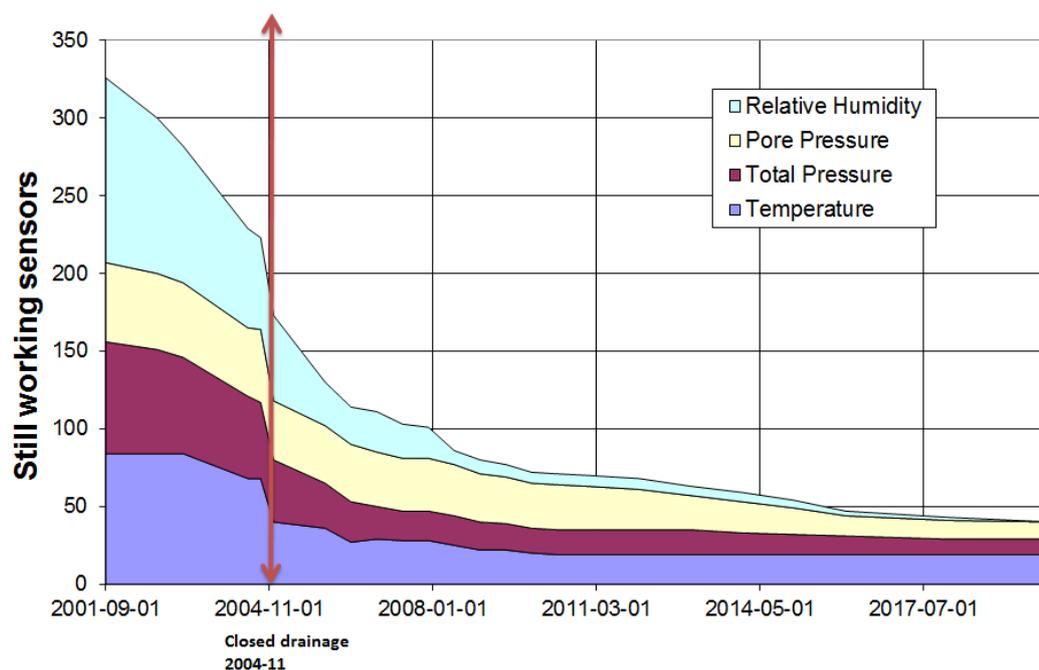
Figure 5-1 The number of still working sensors placed in the buffer and backfill in Section 1 as function of date. The coloured fields are representing the four types of installed sensors.

In Figure 5-1 the numbers of still working sensors in the buffer and the backfill of Section 1 are plotted as function of time from September 2001. The figure shows that many of the broken sensors are RH-sensors and thermocouples (in deposition hole). The figure also shows that the numbers of broken sensors increased after the closing of the drainage of the tunnel.

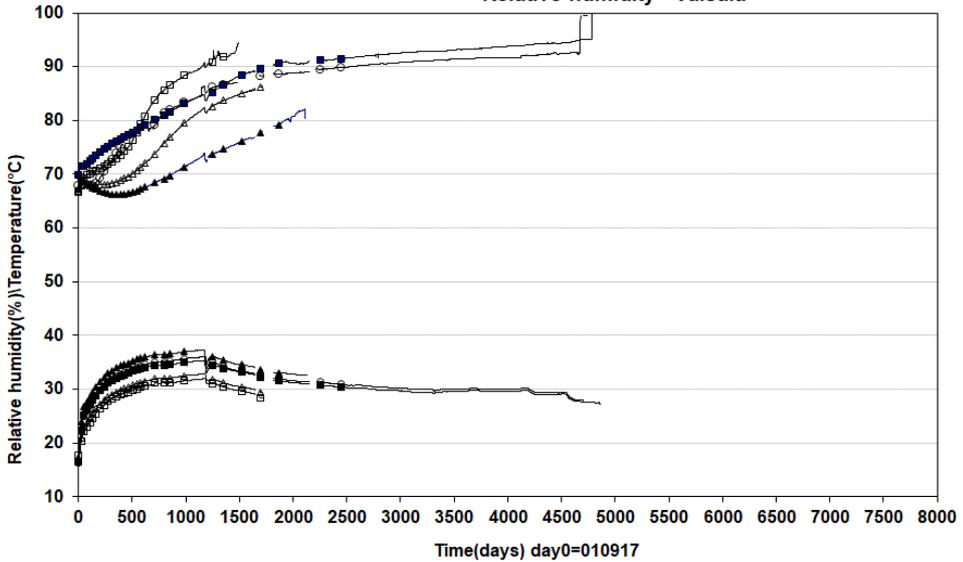
Prototype\Hole 1\Cyl.3 and Cyl.4 (20010917-20230101)
Relative humidity - Vaisala

| ▲ WBU10032(6.317\270°\0.050) | ■ WBU10033(6.317\350°\0.585) | ○ WBU10034(6.317\90°\0.585) |
| □ WBU10036(6.916\180°\0.050) | △ WBU10037(6.756\270°\0.050) | |

The sensors placed above the canister (in Cylinder 3 and 4) are indicating that these sensors have reached 100 relative humidity at day 4740. Sixteen sensors are out of order, most of them due to high water saturation of the buffer.

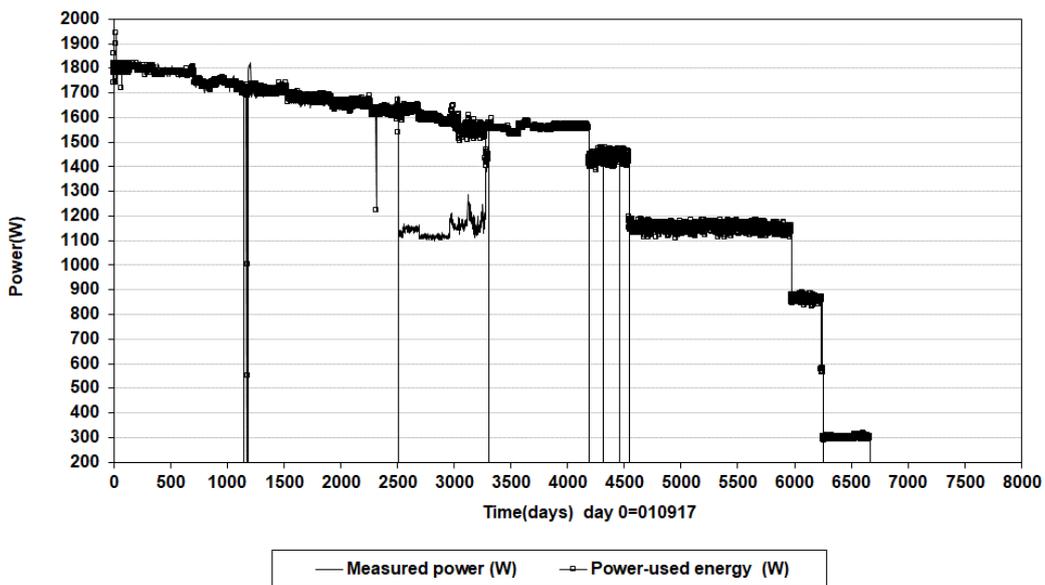
PrototypeHole 1 (20010917-20230101)
Canister power

The power has switched off at 2019-12-17(day 6665) due to all electrical heater failures.

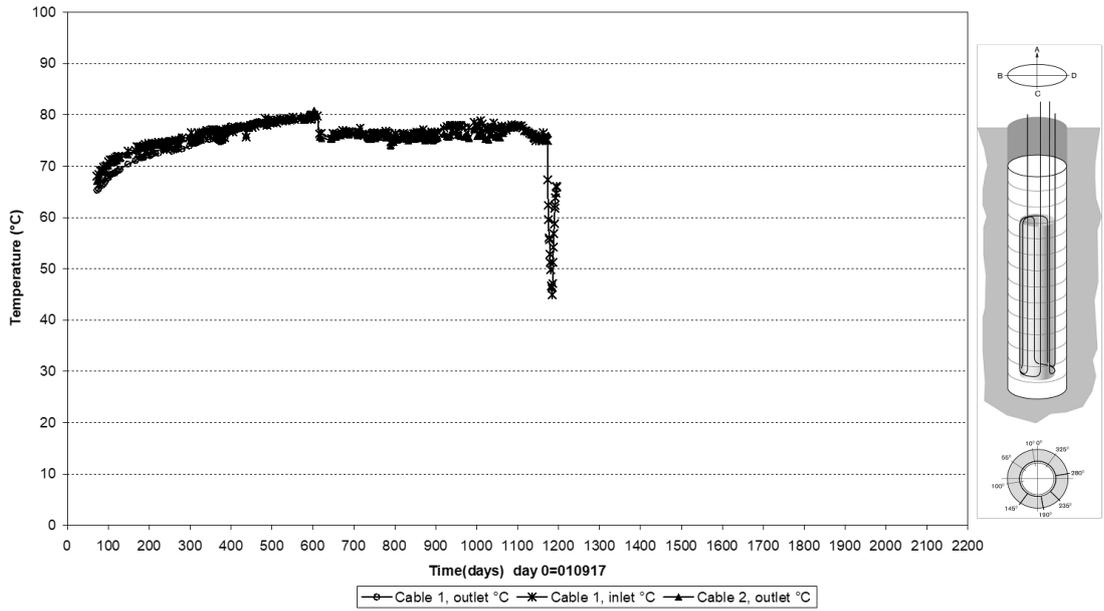
Prototype\ Hole 1 \Canister (010917-070601)
 Max. temperature on the canister surface - Optical fiber cables

The first diagram shows the maximum temperature, measured with the optical cables placed on the surface of the canister, plotted as function of time. The maximum measured temperature on the canister surface is about 75 °C. With no damages on the optical cables this plot should have four curves. Only one curve with relevant values is plotted up to December 24 which indicates that the optical cables are damaged. The second diagram shows the distribution of the temperature along the optical cables on December 1, 2004. The length of the cables on the canister surface is about 20 m. The variation of a few degrees is caused by the difference in temperature in the centre and ends of the canister. On 2004-12-15, the optical system for measuring the temperature on this canister stopped functioning.

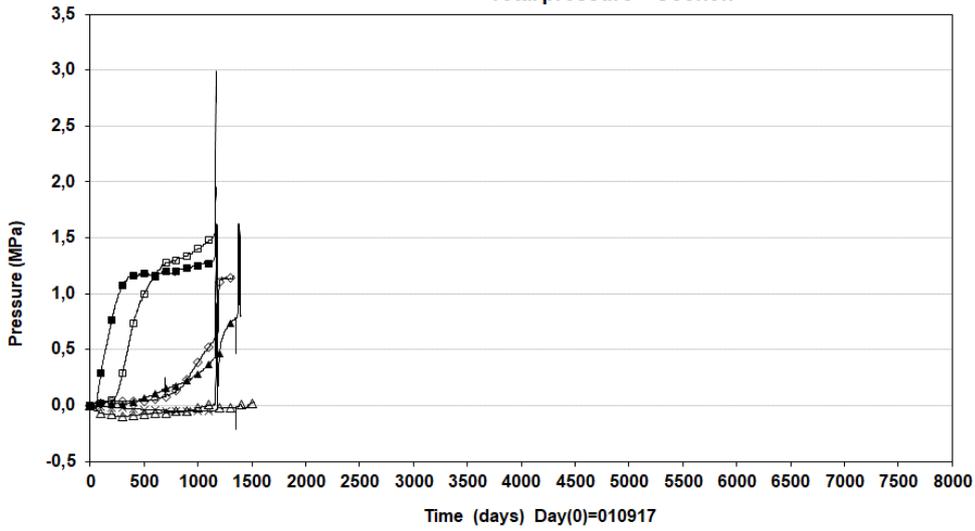
PrototypeHole 3\Ring10 and Cyl.3 (20010917-20230101)
Total pressure - Geokon

| ×PBU30017(5.556\0°\0.050) | ▲PBU30021(5.556\90°\0.635) | ◇PBU30022(5.556\100°\0.735) |
| △PBU30026(6.654\5°\0.585) | □PBU30023(5.556\190°\0.735) | ■PBU30024(5.556\190°\0.635) |

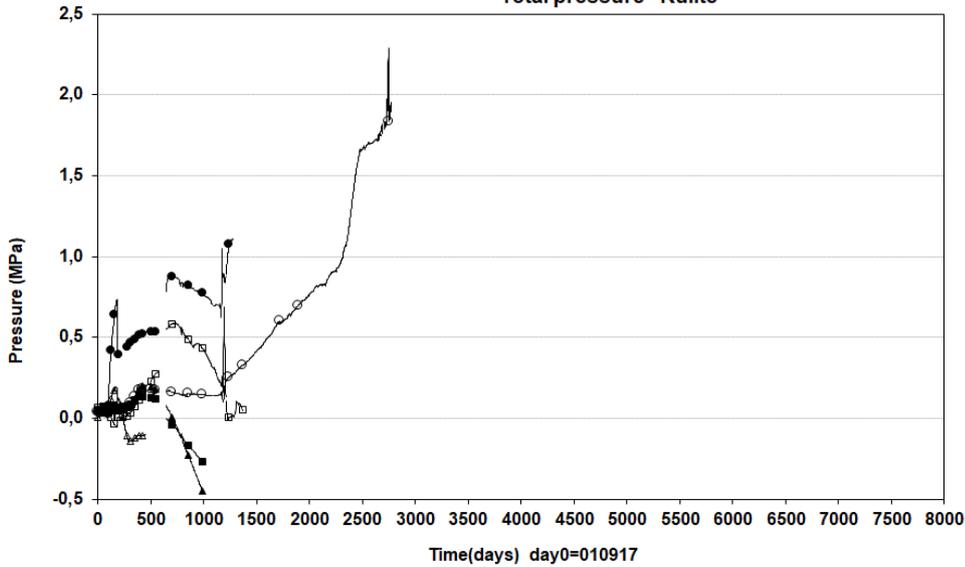
PrototypeHole 3\Cyl.1 and Ring5 (20010917-20230101)
Total pressure - Kulite

| □PBU30003(Cyl.115°\0.585) | ▲PBU30004(Cyl.115°\0.685) | ○PBU30005(Cyl.115°\0.785) |
| △PBU30010(Ring5\5°\0.585) | ●PBU30012(Ring5\5°\0.825) | ■PBU30016(Ring5\185°\0.825) |

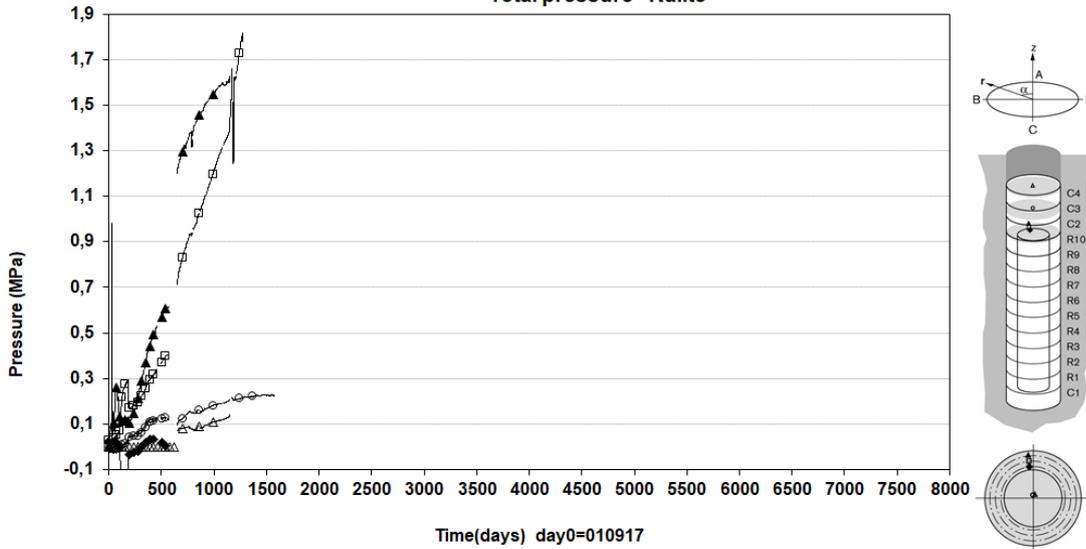
Prototype\Hole 3\Ring10 and Cyl.3-4 (010917-20230101)
Total pressure - Kulite

- ◆ PBU30018(Ring10 15° 0.585)
- PBU30019(Ring10 15° 0.685)
- ▲ PBU30020(Ring10 15° 0.785)
- PBU30025(Cyl.3 10° 0.050)
- △ PBU30027(Cyl.4 10° 0.050)

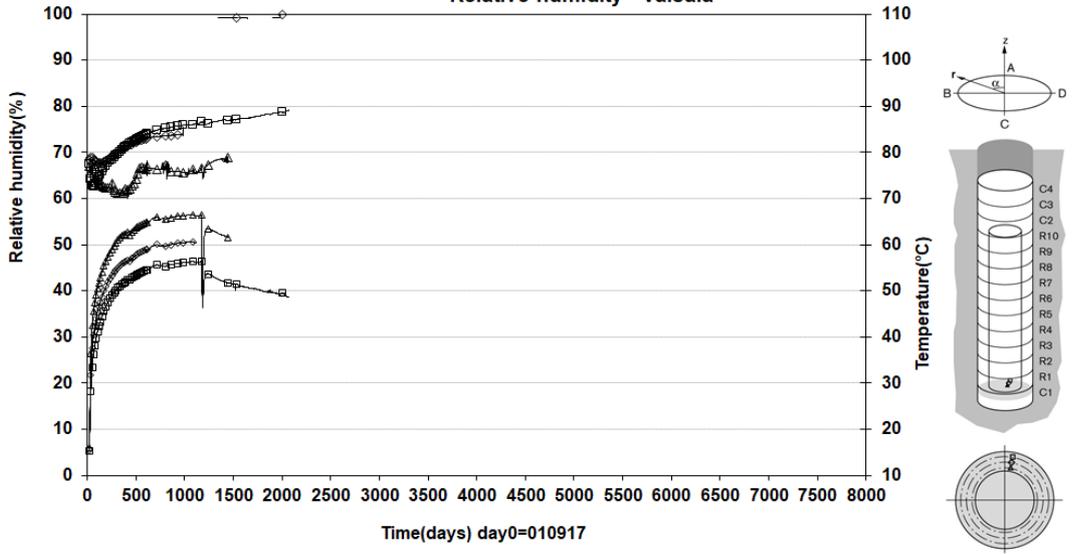
Prototype\Hole 3\Cyl.1 (20010917-20230101)
Relative humidity - Vaisala

- WBU30004(0.335\350 $^{\circ}$ 0.785)
- ◇ WBU30005(0.335\350 $^{\circ}$ 0.685)
- △ WBU30006(0.335\350 $^{\circ}$ 0.585)

All Rotronic sensors in hole 3 have failed or increased the measured RH to 100%. The reason for this is unclear. Since there are no other signs of strong wetting, malfunction is more probable than strong wetting. One sensor (WBU30016) placed close to the canister in block R5 was indicating a drying of the bentonite until it failed.

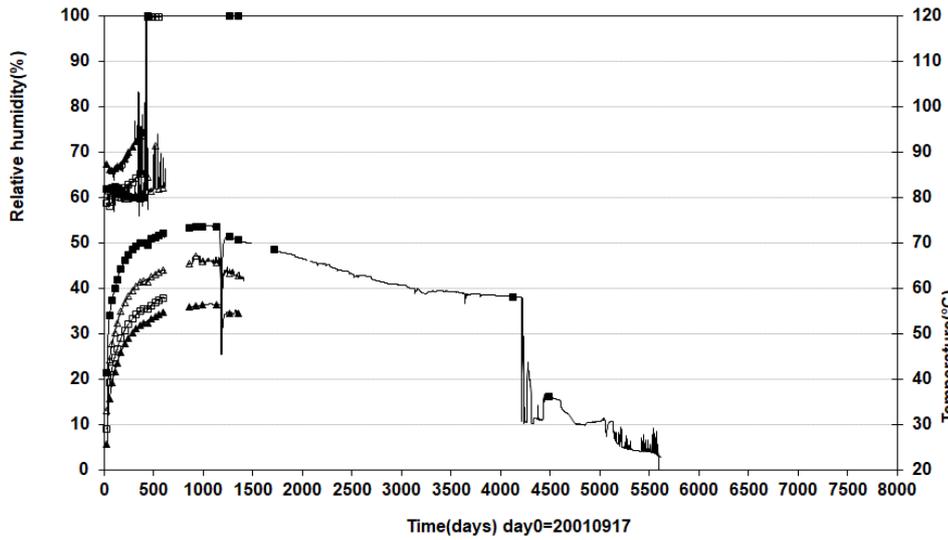
Prototype\Hole 3\Cyl.1 (20010917-20230101)
Relative humidity - Rotronic

| □ WBU30001(0.045\180°\0.050) | △ WBU30002(0.215\0°\0.400) |
| ■ WBU30003(0.245\180°\0.100) | ▲ WBU30008(0.245\80°\0.685) |

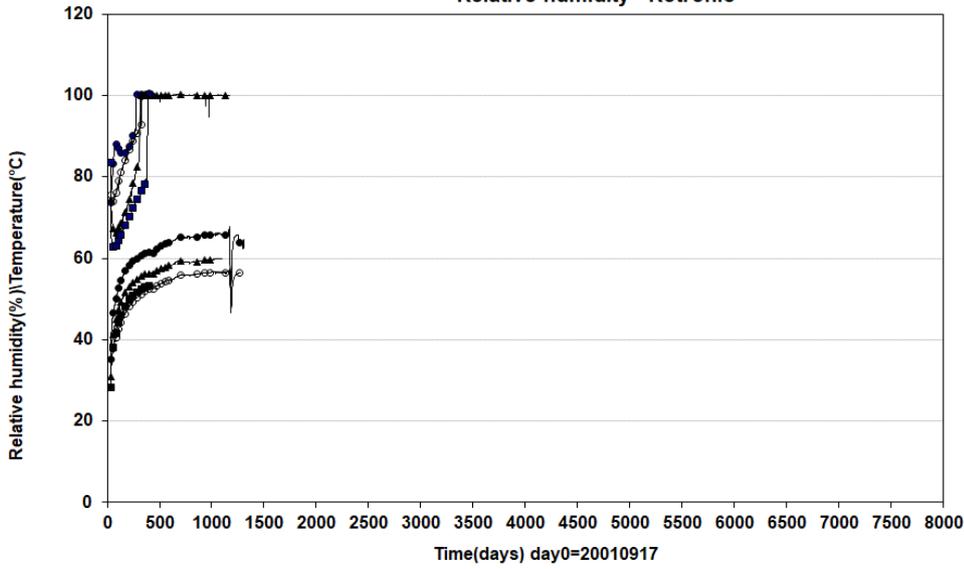
Prototype\Hole 3\Ring 10 (20010917-20230101)
Relative humidity - Rotronic

- WBU30027(5.306180°\0.585)
- ▲ WBU30028(5.306180°\0.685)
- WBU30029(5.306180°\0.785)
- WBU30031(5.306170°\0.785)

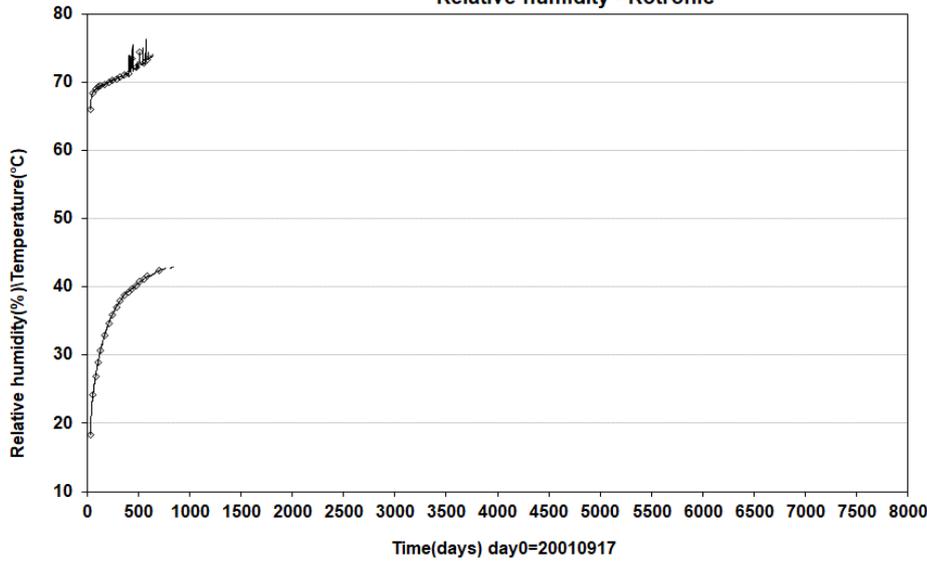
Prototype\Hole 3\Cyl.3 (20010917-20230101)
Relative humidity - Rotronic

- ◇ WBU30035(6.314180°\0.585)

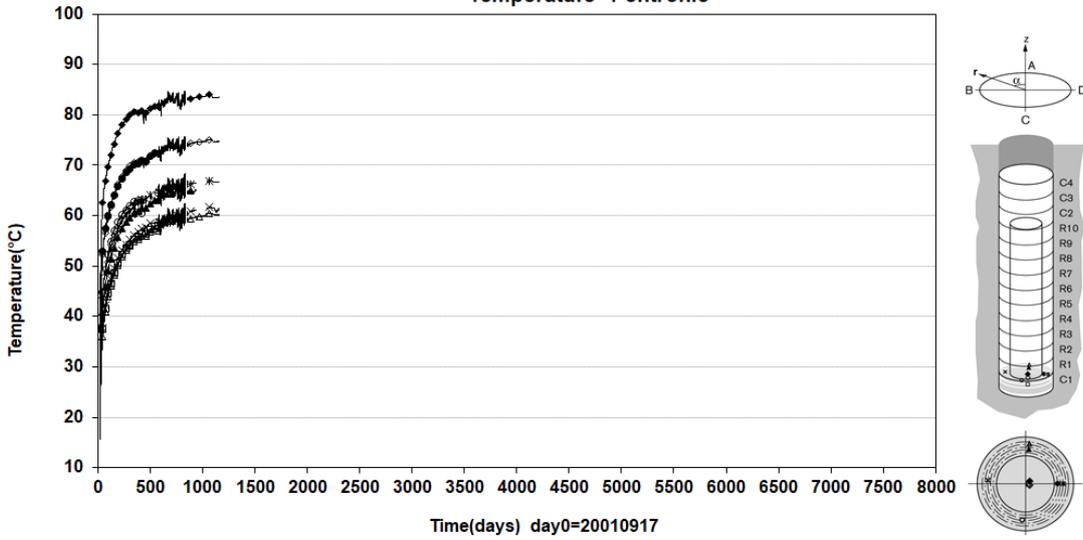
Prototype\Hole 3\Cyl.1 (20010917-20230101)
Temperature - Pentronic

| □ TBU30001(0.095 270° 0.050) | ◇ TBU30002(0.295 270° 0.050) | ◆ TBU30003(0.445 270° 0.050) |
| ▲ TBU30004(Cyl.1 355° 0.635) | △ TBU30005(Cyl.1 355° 0.735) | × TBU30006(Cyl.1 85° 0.685) |
| ○ TBU30007(Cyl.1 175° 0.685) | ● TBU30008(Cyl.1 270° 0.585) | ✕ TBU30009(Cyl.1 270° 0.685) |

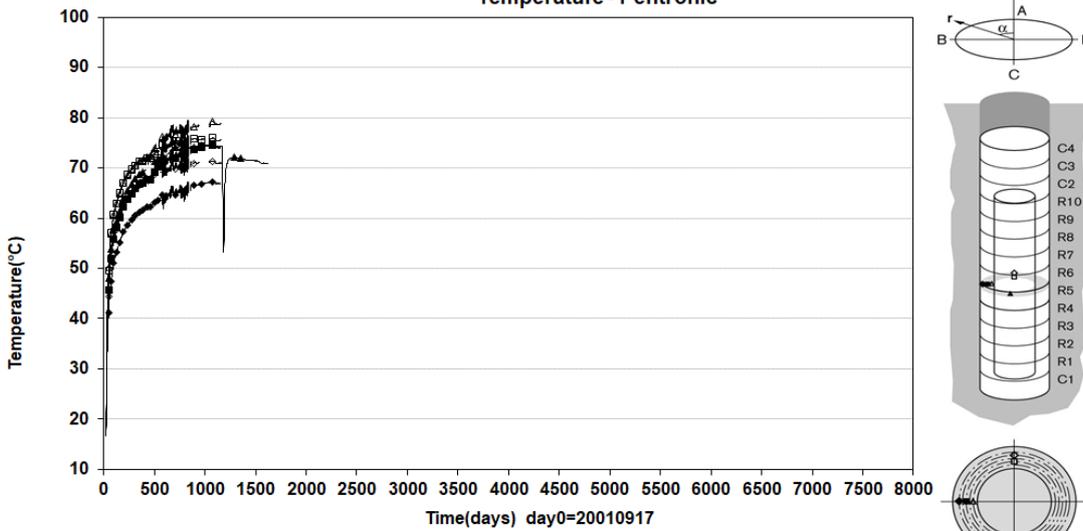
Prototype\Hole 3\Ring5 (20010917-20230101)
Temperature - Pentronic

| □ TBU30011(2.971 0° 0.635) | ◇ TBU30012(2.971 0° 0.735) | △ TBU30013(2.971 90° 0.585) |
| ■ TBU30014(2.971 90° 0.685) | ◆ TBU30015(2.971 90° 0.785) | ▲ TBU30017(2.971 175° 0.685) |

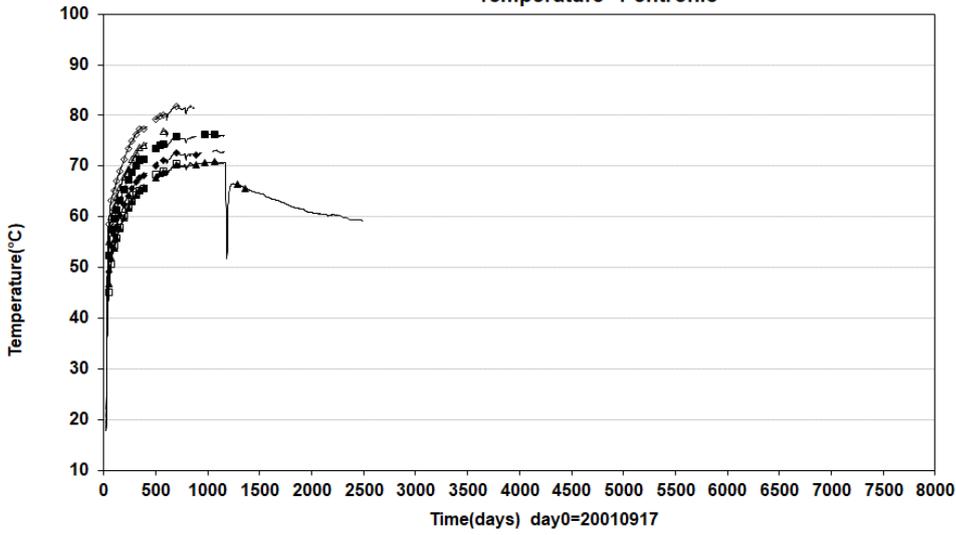
Prototype\Hole 3\Ring5 (20010917-20230101)
Temperature - Pentronic

| □ TBU30018(2.9711175°\0.735) | ◇ TBU30019(2.9711270°\0.585) | △ TBU30020(2.9711270°\0.635) |

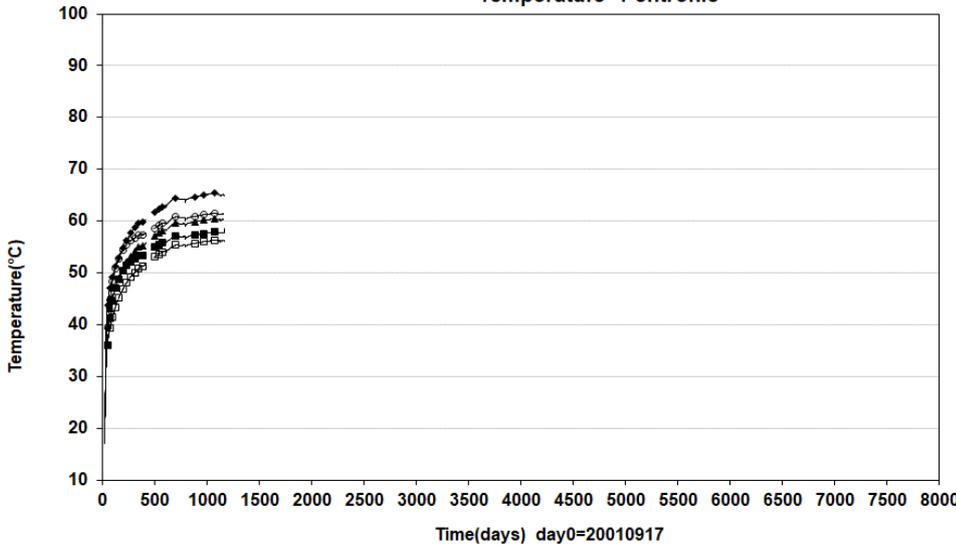
Prototype\Hole 3\Ring10 (20010917-20230101)
Temperature - Pentronic

| ○ TBU30024(5.50410°\0.635) | ■ TBU30025(5.50410°\0.735) | ◆ TBU30026(5.5041270°\0.585) |

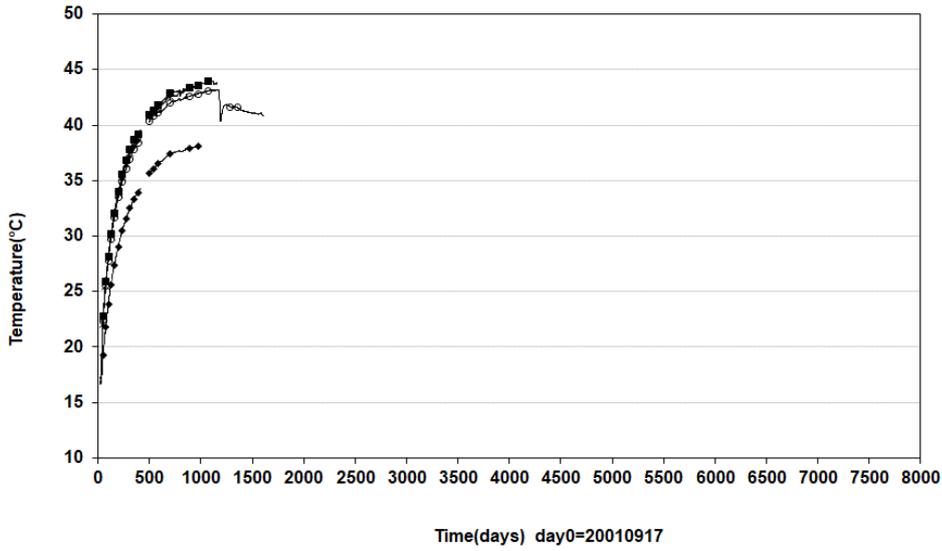
Prototype\Hole 3\Cyl.3 and Cyl.4 (20010917-20230101)
Temperature - Pentronic

| x TBU30029(6.314 0° 0.785) | o TBU30030(6.314 95° 0.585) |
| ■ TBU30031(6.314 185° 0.585) | ◆ TBU30032(7.015 0° 0.785) |

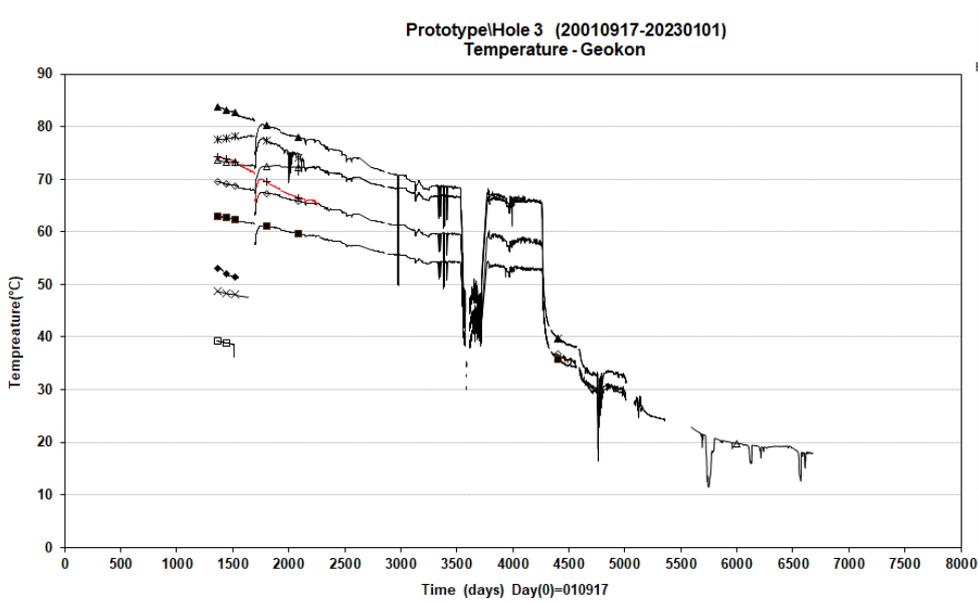
Prototype\Hole 3 (20010917-20230101)
Temperature - Geokon

| x PBU30001(0 0° 0) | ▲ PBU30002(0.495 0° 0.100) | ◊ PBU30008(0.495 185° 0.635) | ■ PBU30009(0.495 195° 0.735) | x PBU30013(2.771 95° 0.585) |
| △ PBU30015(3.021 185° 0.535) | + PBU30017(5.556 0° 0.050) | ◆ PBU30022(5.556 100° 0.735) | □ PBU30026(6.654 5° 0.585) | |

The temperature in the buffer is also measured with the Geocon sensors (from day 1350). The temperature drops in the buffer measured by the Gecon sensors is caused by the reduction in the applied power on the canister (day 4599). (App. 2\page 76).

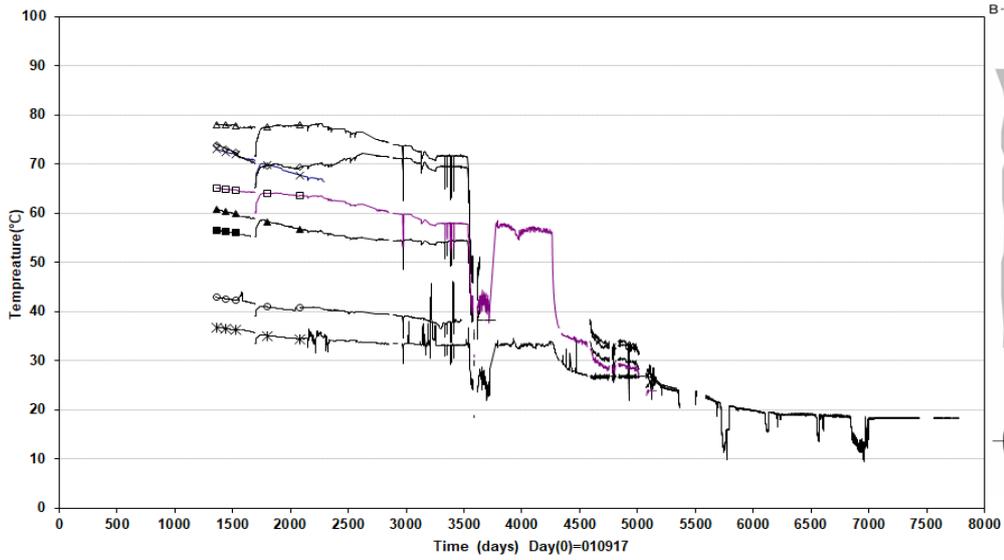
PrototypeHole 3 (20010917-20230101)
Tempreture - Geokon

| × UBU30002(0.245\90°\0.100) | ▲ UBU30003(0.335\355°\0.585) | ◇ UBU30005(2.771\355°\0.585) |
| △ UBU30009(2.771\175°\0.535(in the slot)) | □ UBU30010(2.771\175°\0.825(in the slot)) | ■ UBU30012(5.306\355°\0.785) |
| ○ UBU30013(6.314\90°\0.050) | × UBU30014(6.910\90°\0.050) | |

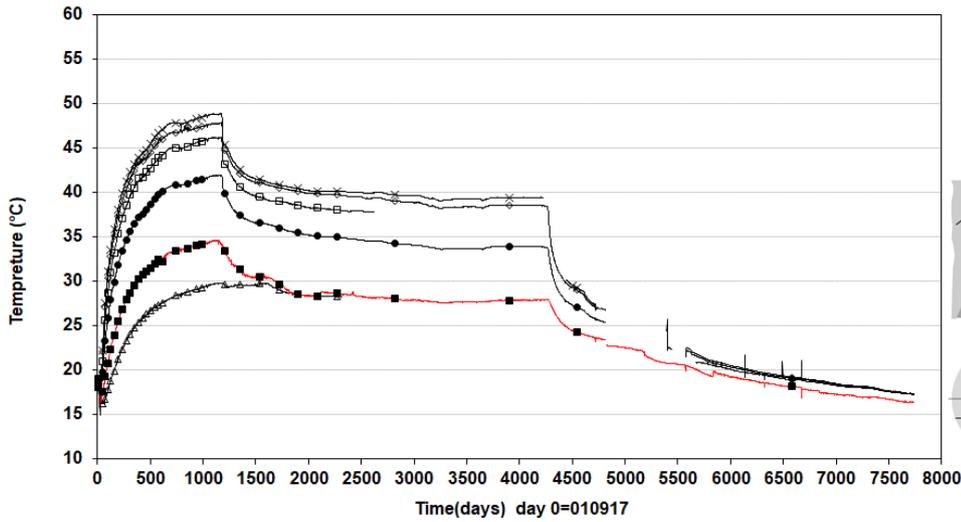
PrototypeRock\Hole 3 (20010917-20230101)
Temperature - Pentronic

| △ TROA2150(7.958\134°\3.284) | ● TROA2140 (5.979\1°\1.999) | ◇ TROA2130(4.230\2°\1.981) |
| × TROA2120(2.840\2°\1.967) | □ TROA2110(1.170\3°\1.950) | ■ TROA1850 (7.889\0°\2.019) |

The maximum temperature in the rock (48.8 °C) was measured by TROA2120 located 1.967 m from the centre of the canister in deposition hole 3 just before the power to the canisters was switched off. Although the power was switched on again the temperature around the deposition hole is continuing to drop. This is most obvious for the sensors installed in the direction towards deposition hole 2. The maximum temperature measured temperature at the end of this measuring period is about 18 °C. The temperature decreasing in the rock caused by problem with applied power in the canister.

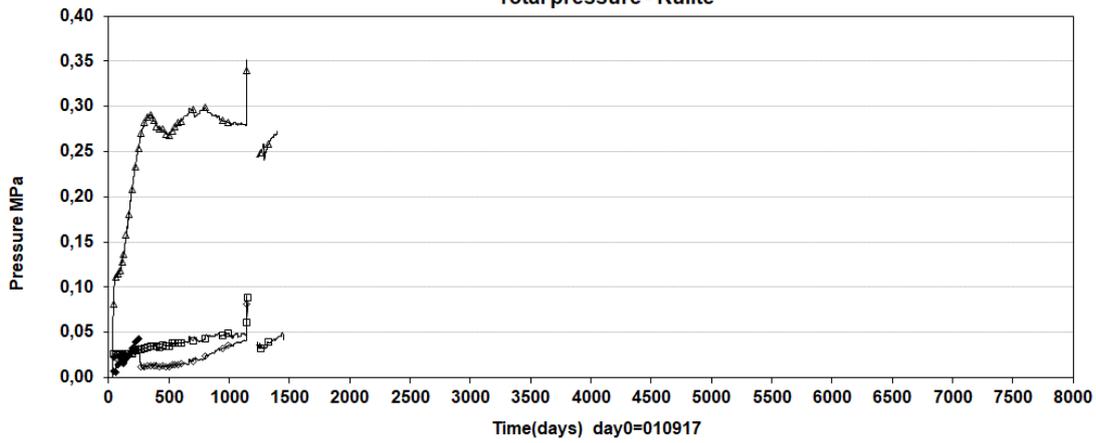
Prototype\BackfillSection 1 (20010917-20230101)
Total pressure - Kulite

□ PBA10010(F1-2\0-0.2\3578) ◇ PBA10011(F1-2\0-2.3\3578) △ PBA10013(E3\0-1.82\3575) ◆ PBA10020(In front of plug\0\3561)

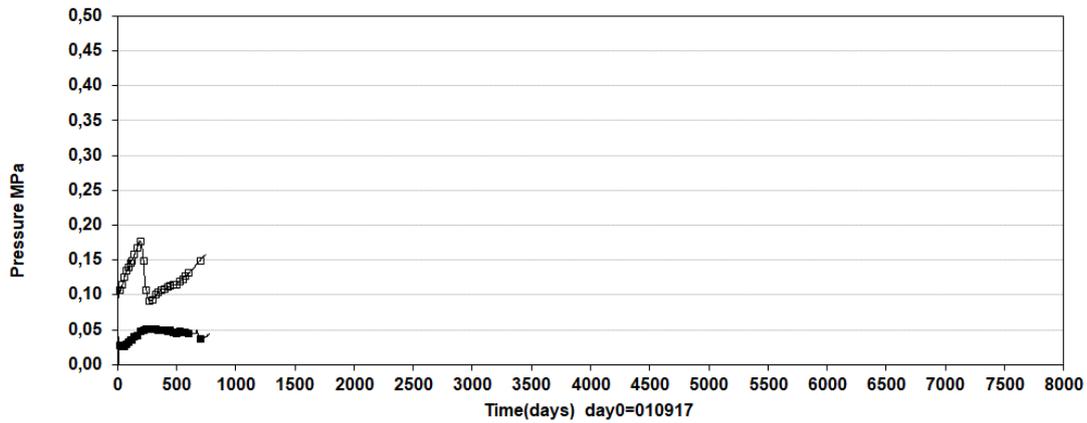
Prototype\BackfillSection 1 (20010917-20230101)
Total pressure - Kulite

□ PBA10005(E1\0-3.1\3587) ■ PBA10006(E1-2.3\0.1\3587)

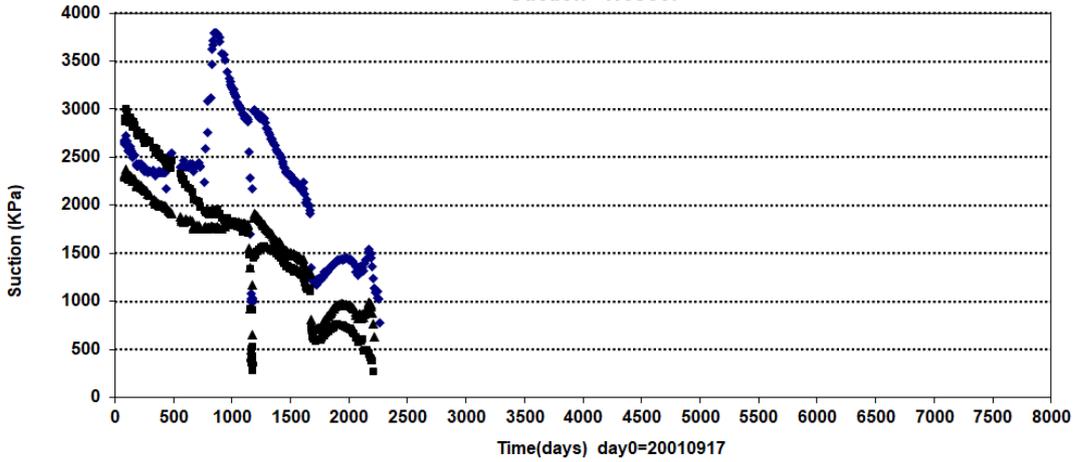
Prototype\Backfill\ Inner part (20010917-20230101)
Suction - Wescor

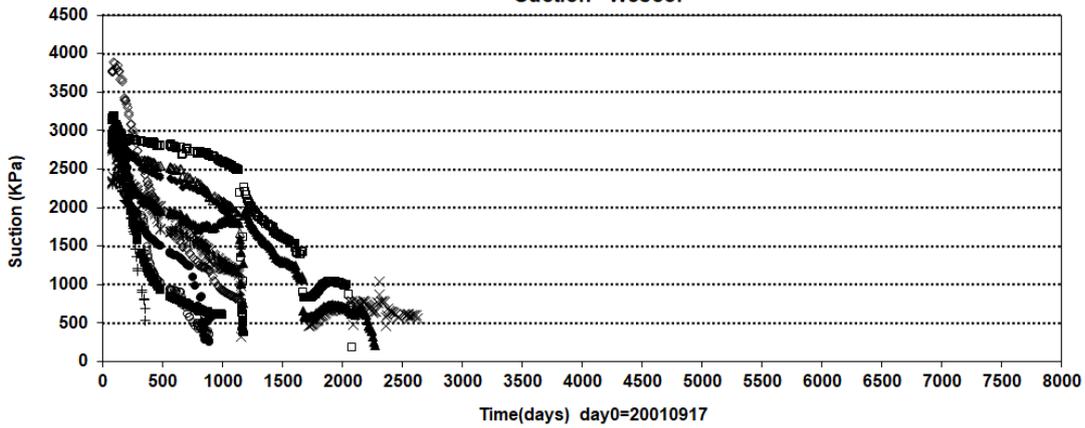
Prototype\Backfill\ Above dep.hole 1 (20010917-20230101)
Suction - Wescor

- ◇ WBA10004(E1\0.25\2.3\3587)
- WBA10005(E1\0\1.25\3587)
- ▲ WBA10006(E1\0\0.1\3587)
- × WBA10007(E1\0.1\0.8\3587)
- ✕ WBA10008(E1\0\1.7\3587)
- WBA10009(E1\0.1\2.6\3587)
- + WBA10010(E1\0.5\3.13\3587)
- WBA10011(E1\2.3\0.1\3587)
- △ WBA10012(E1\1.3\0\3587)
- ◆ WBA10013(E1\1.3\0\3587)
- WBA10014(E1\2.3\0\3587)

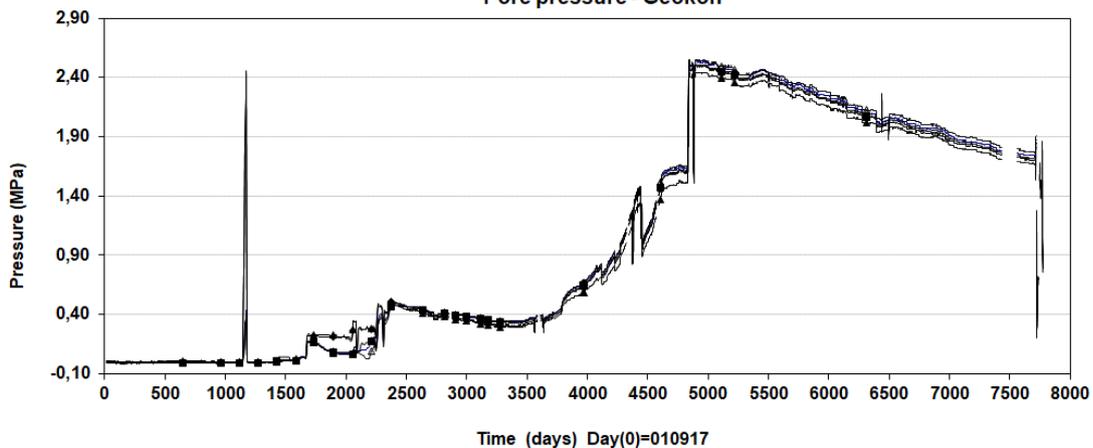
Prototype\Backfill\Section 1 (20010917-20230101)
Pore pressure - Geokon

- ◇ UBA 10002 (Inner part\0\0\3592)
- △ UBA 10003 (Inner part\1-0.2\1-0.1\3590)
- UBA 10004 (E\1\0\1\3587)
- ▲ UBA 10008 (E\1-2.3\0\3587)
- ◆ UBA 10009 (E\1\0\2.3\3587)

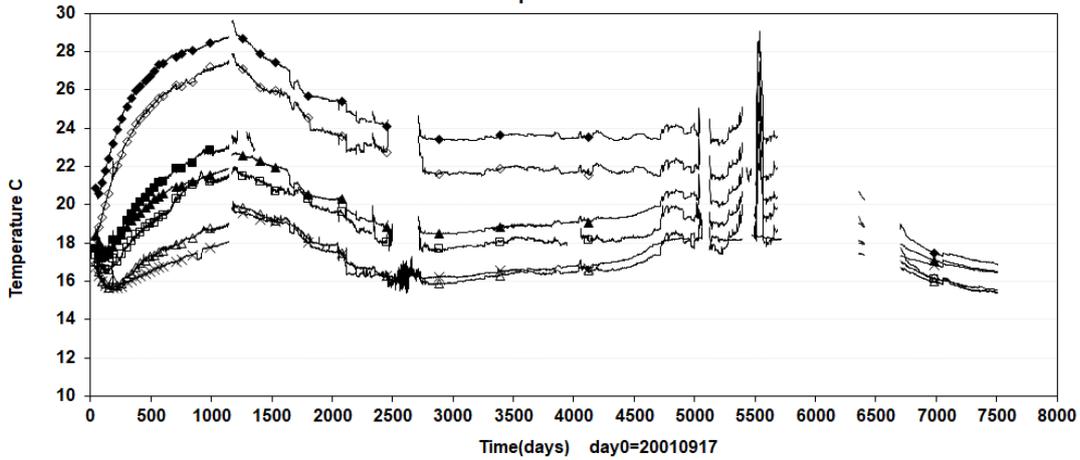
Prototype\ Backfill \ Above dep.hole1 (20010917-20230101)
Temperature - Pentronic

| □ TBA10001(E1\1-1.25\0-0.1\3587) | △ TBA10002(E1\0.1\1.3\3587) | ■ TBA10003(E1\0\0-0.8\3587) |
