SKB P-23-12

Prototype Repository – Sensor data report

Period 2001-09-17 to 2023-01-01

Report No 34

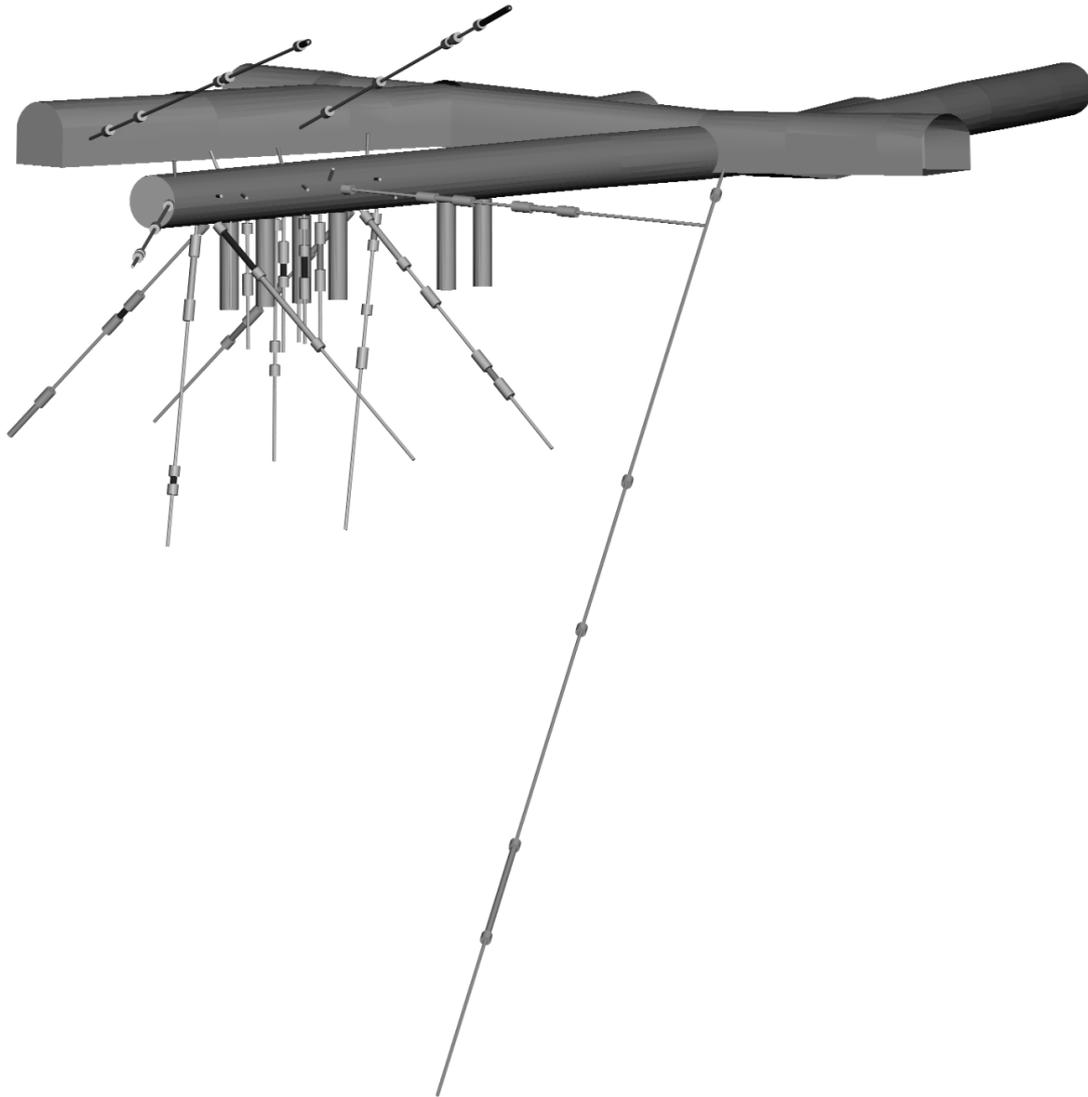
Figure A5-10-1. View of the drilled core holes in the Prototype Repository Section I. The length from the I-tunnel to the end of the TBM-tunnel is 90 m. The diameter of the TBM tunnel is 5m and the diameter of the deposition holes is 1.75 m. The depth of the deposition holes is holes is 8.37 m in the centre and 8.15 m along the deposition hole wall. The diameter of the core holes is 76 mm except for the short core holes in the roof of the TBM tunnel that have a diameter of 56 mm. The monitoring boreholes used in the presentation in this report are located in the inner part of the tunnel surrounding the area with the four innermost canister holes. Also included are two holes drilled from the G-tunnel and the long hole KA3510A drilled from the main tunnel.

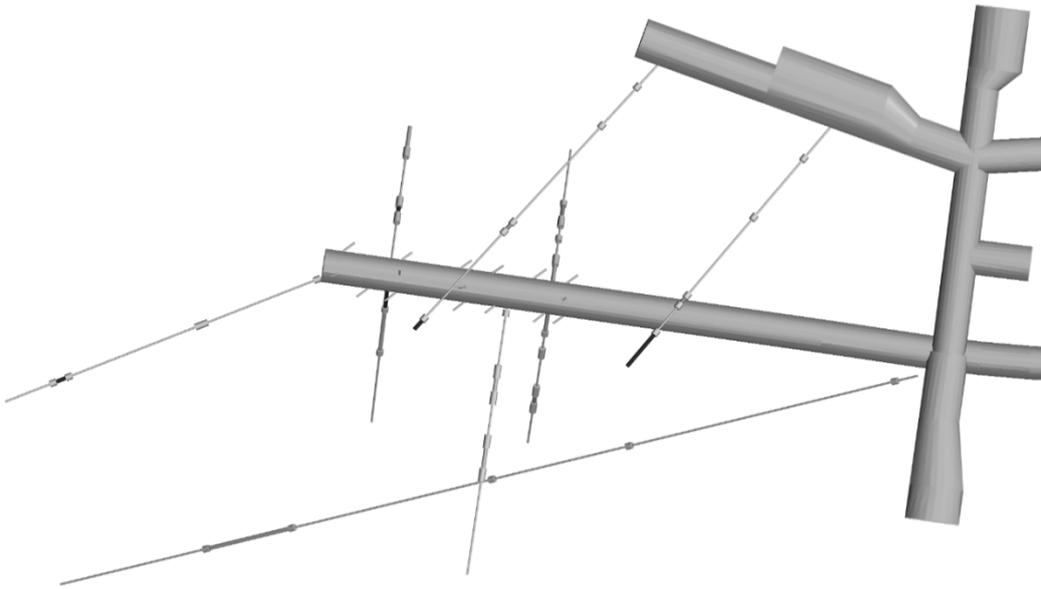
Figure A5-10-2. Overview of Section I in Prototype Repository.

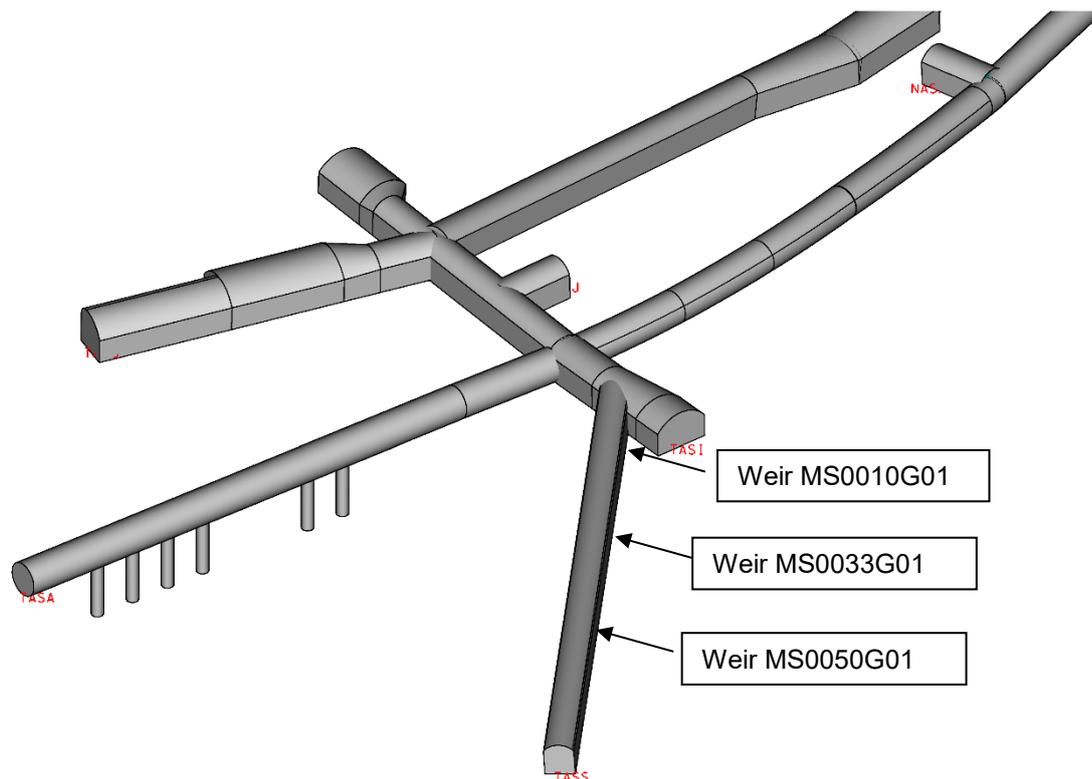
Figure A5-10-3 The tunnel-system including the TASS-tunnel with indication of the weir locations in TASS.

Three weirs are located within the TASS-tunnel and their locations are shown in Figure A5-3 below, measuring the flow into sections 10–33 m, 33–50 m and 50–80.7 m respectively.

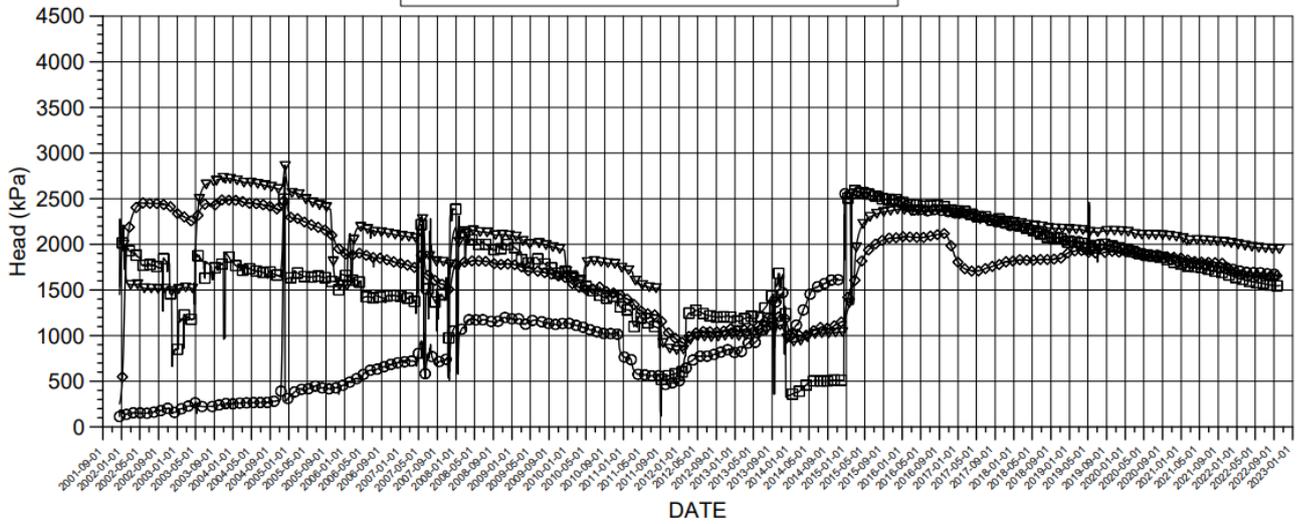
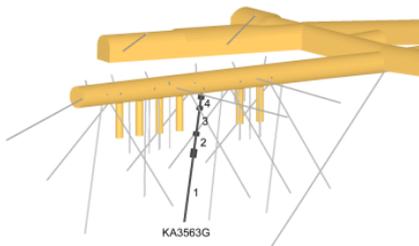
KA3563G PRESSURE HEAD

- Events**
- Start backfilling of section I 2001-09-03
 - Stop backfilling of section I 2001-11-20
 - Casting of inner plug finalized 2001-12-19
 - Start backfilling of section II 2003-04-29
 - Stop backfilling of section II 2003-06-27
 - Casting of outer plug finalized 2003-09-11
 - Packer failure of KA3573A:3 2006-04-18
 - Start drilling of Fine Sealing Project 2007-03-12
 - Start grouting of Fine Sealing Project 2007-11-19
 - Excavation start of TASS tunnel 2007-12-11
 - Excavation stop of TASS tunnel 2008-12-18
 - Demolition work start Section II December 2010
 - Demolition work Section II finalized 2011-12-15
 - Replacement of packers Section II December 2014

- Borehole sections**
- ▽—▽ G:1 15 m - 30 m
 - ◇—◇ G:2 10 m - 13 m
 - G:3 4 m - 8 m
 - G:4 1.5 m - 3 m

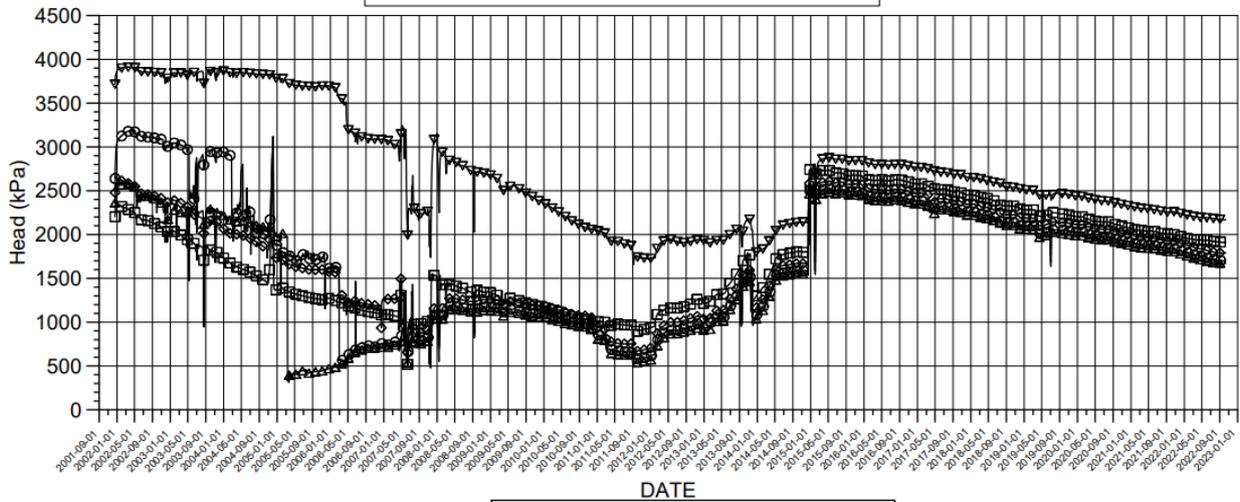
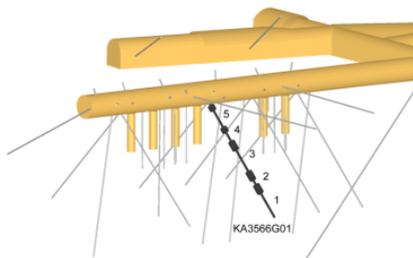
KA3566G01 PRESSURE HEAD

- Borehole sections**
- ▽ G01:1 23.5 m - 30 m
 - ◇ G01:2 20 m - 21.5 m
 - G01:3 12 m - 18 m
 - G01:4 7.3 m - 10 m
 - △ G01:5 1.5 m - 6.3 m

A pressure drop of around 700 kPa in KA3566G01:4 is observed 2004-02-25. It remained so for some weeks before recovering but dropped again in May and remains that way at the end of the month. This pattern was also observed in this section during the spring 2003. The following investigation showed a faulty data-scan coupling (corrosion) which was replaced 2004-08-10.

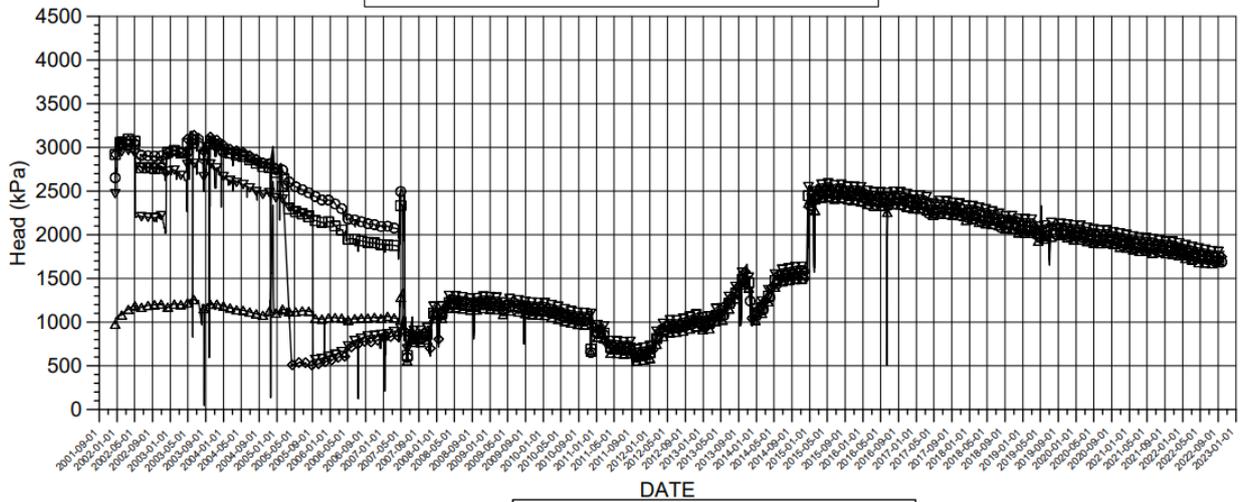
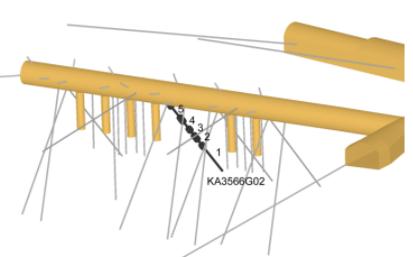
KA3566G02 PRESSURE HEAD

- Borehole sections**
- ▽ G02:1 19 m - 30 m
 - ◇ G02:2 16 m - 18 m
 - G02:3 12 m - 14 m
 - G02:4 8 m - 11 m
 - △ G02:5 1.5 m - 6 m

A pressure-drop 2002-05-07 for most of the observation sections are shown in the plots. The most major pressure change happens in the lowest section of KA3566G02 (approx. 70 m) but are also clearly visible for section 2-4 of the same borehole. The pressure recovered during the evening of 2002-12-02. The cause for the pressure change is unknown.

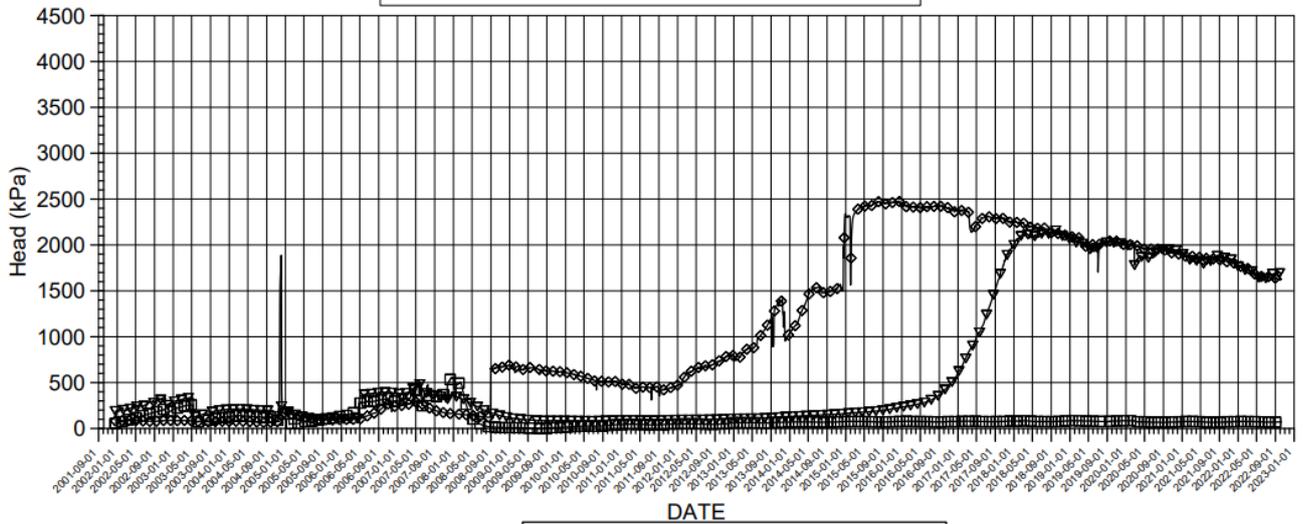
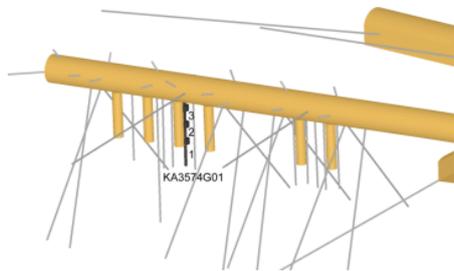
KA3574G01 PRESSURE HEAD

- Borehole sections**
- ▽ G01:1 8 m - 12 m
 - ◇ G01:2 5.1 m - 7 m
 - G01:3 1.8 m - 4.1 m

- KA3574G01:1. Oriented vertically compared with tunnel A. The section shows a sudden drop in pressure 2020-06-25. The pressure decreases ~210 kPa throughout two days. The recovery takes until September the same year. The reason is not to be found in the activity logs or quality comments.

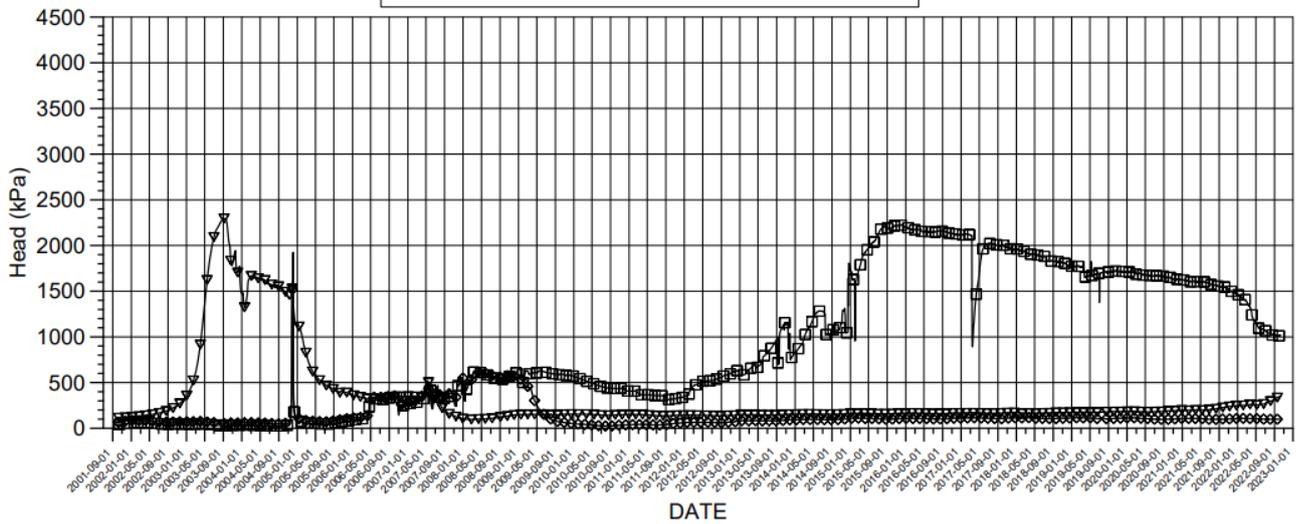
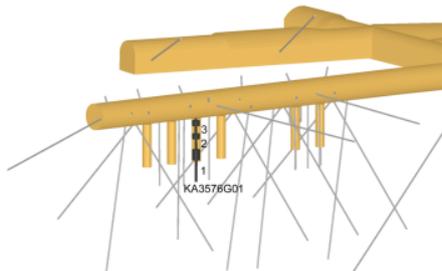
KA3576G01 PRESSURE HEAD

- Borehole sections**
- ▽ G01:1 7.9 m - 12 m
 - ◇ G01:2 3.9 m - 5.9 m
 - G01:3 1.4 m - 2.9 m

The 14th of March 2017 a sudden decrease in pressure is observed in KA3572G01:1, KA3576G01:3 and KA3578G01:2. The magnitude of the disturbance is ~250 kPa in KA3572G01:1 and KA3576G01:3 while in KA3578G01:2 it is ~1000 kPa. What caused the decline is yet not known.

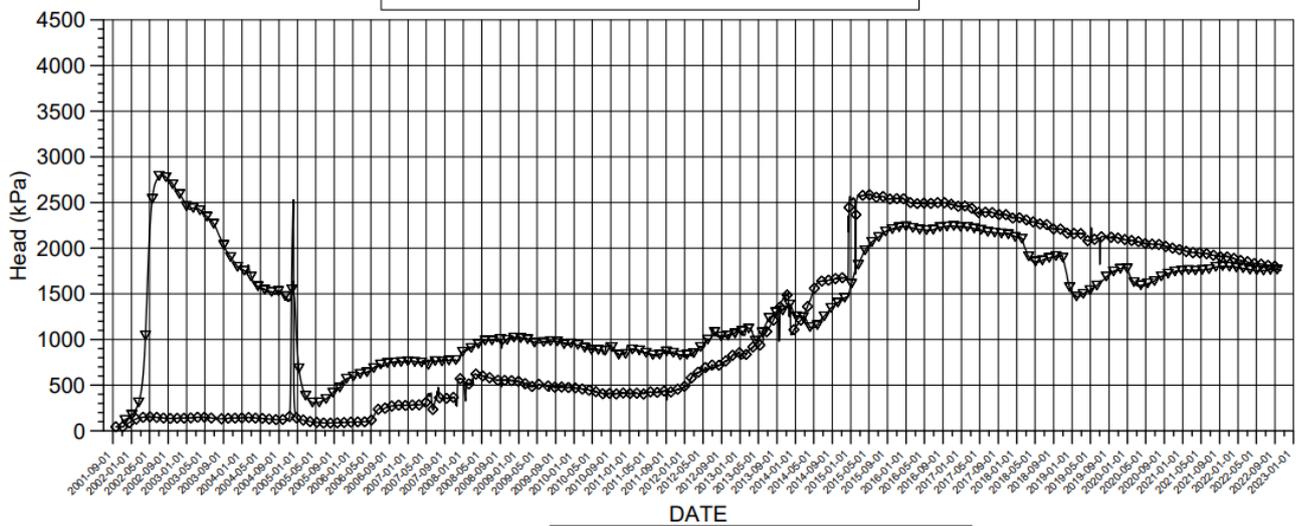
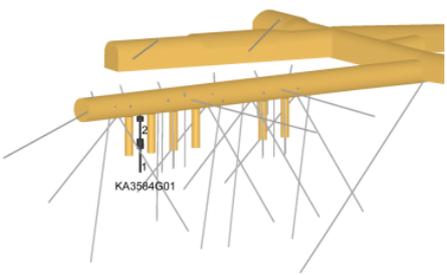
KA3584G01 PRESSURE HEAD

- Borehole sections**
- ▽ G01:1 7 m - 12 m
 - ◇ G01:2 1.4 m - 5 m

- KA3584G01:1. Shows two stepwise decreases in pressure during 2018. The first one includes a drop of approximately 260 kPa and it occurs between 2018-01-31 and 2018-04-24. This coincide with the time period when rock reinforcement was conducted in the G-tunnel (including drilling of approximately 2,5 m long holes). However, no certain conclusions have been able to make if this could be the cause of the pressure drop. The second decline in pressure included a total loss of 400 kPa and it occurred between 2018-10-26 and 2018-12-31. The weir was damaged by a falling boulder the 22nd of October which caused the pressure to drop. The weir was restored again the 6th of December 2018.

- KA3584G01:1. Oriented vertically compared with tunnel A. The section showed two stepwise decreases 2018 and was increasing again 2019. However, the section had a falling pressure head during the last days of 2019 until March 2020 (2019-12-28 until approximately 2020-04-03). The decrease continued for approximately three months and was of a magnitude of ~190 kPa. The reason is not to be found in the activity logs or quality comments.

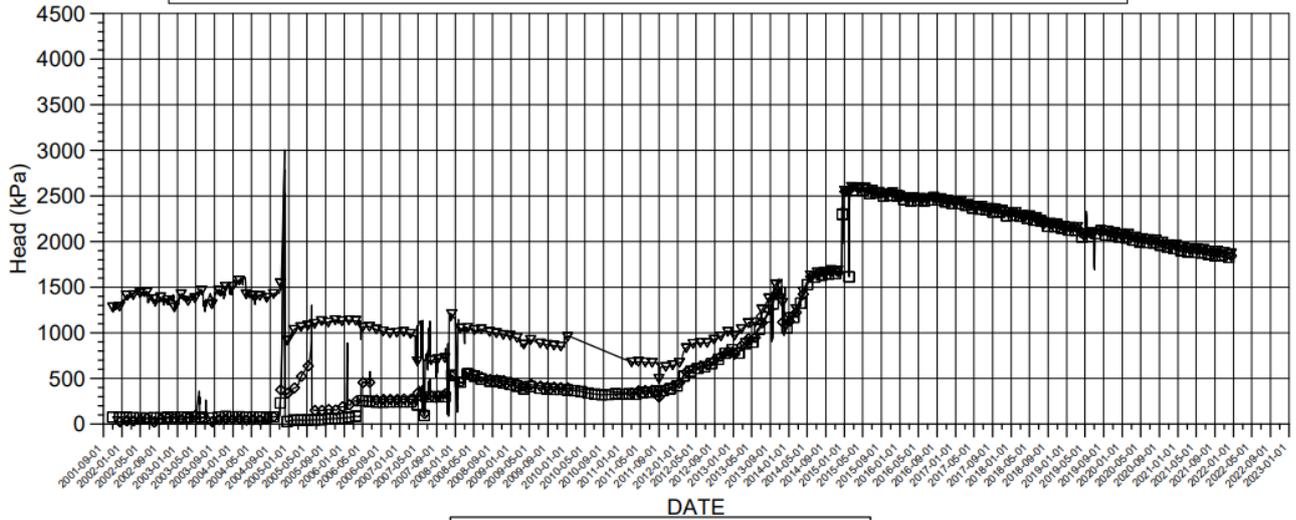
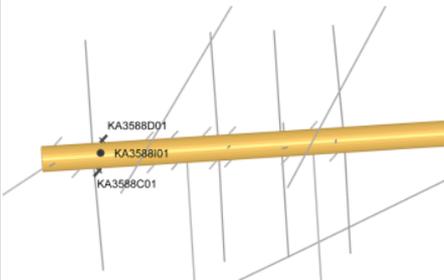
KA3588C01, KA3588D01, KA3588I01 PRESSURE HEAD

- Borehole sections**
- ▼ KA3588C01:1 0.65 m - 2 m
 - ◆ KA3588D01:1 0.65 m - 2 m
 - KA3588I01:1 0.65 m - 2 m

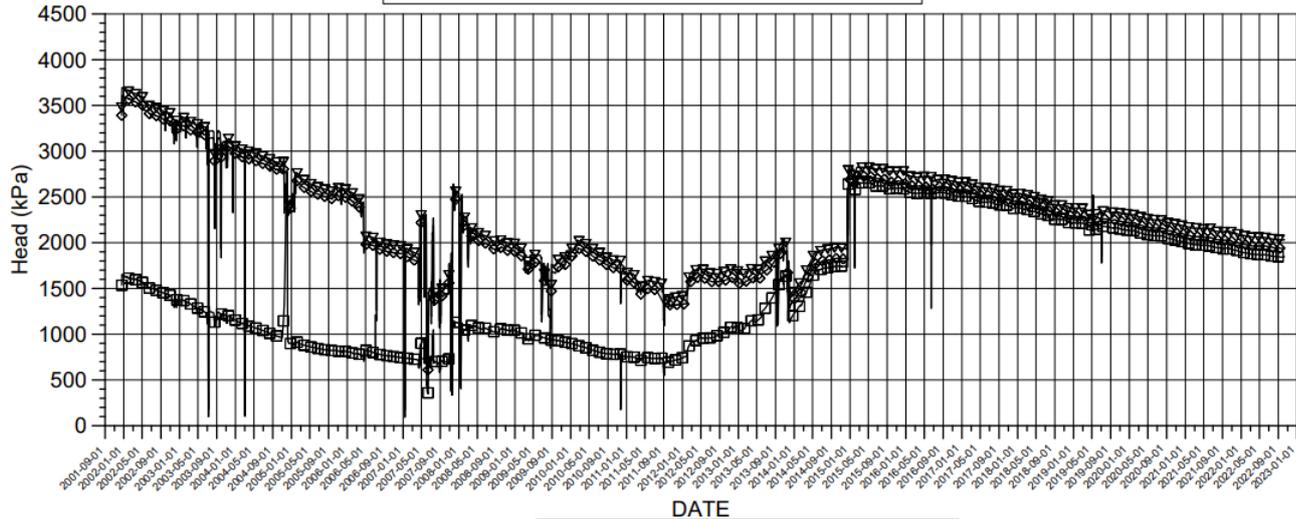
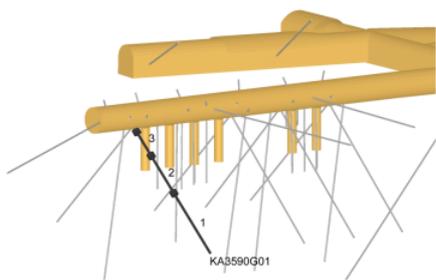
KA3590G01 PRESSURE HEAD

- Borehole sections**
- ▼ G01:1 16 m - 30 m
 - ◆ G01:2 7 m - 15 m
 - G01:3 1.5 m - 6 m

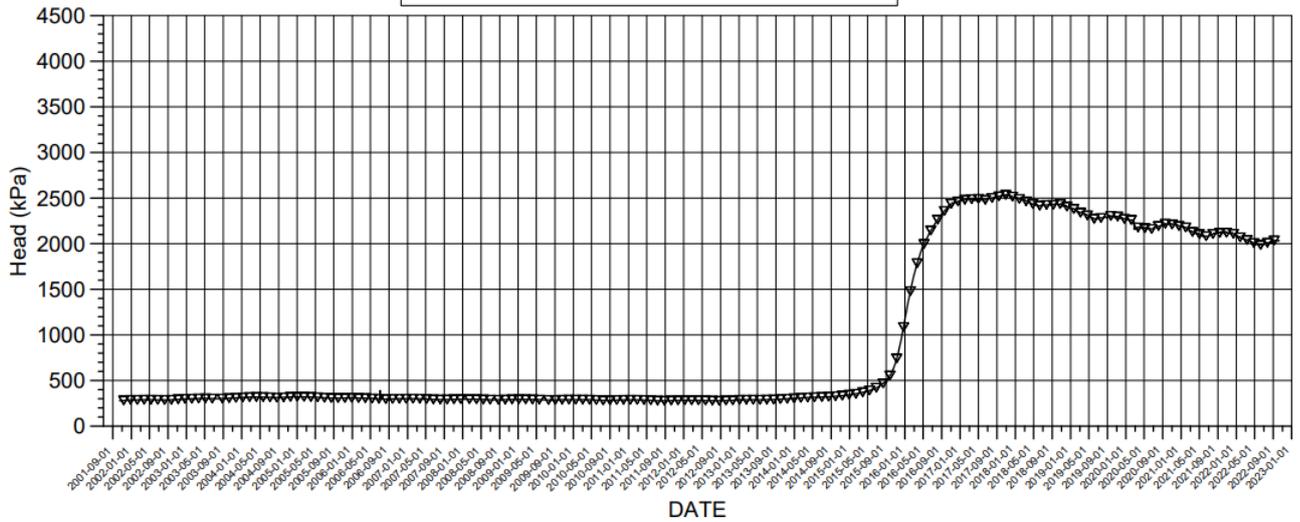
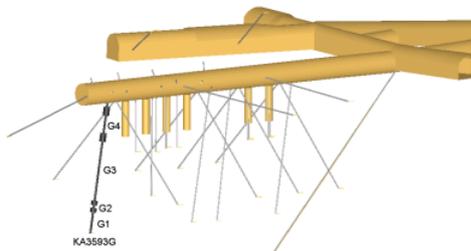
KA3593G PRESSURE HEAD

- Borehole sections**
- ▽ G:1 25.2 m - 30 m
 - ◇ G:2 23.5 m - 24.2 m
 - G:3 9 m - 22.5 m
 - G:4 3 m - 7 m

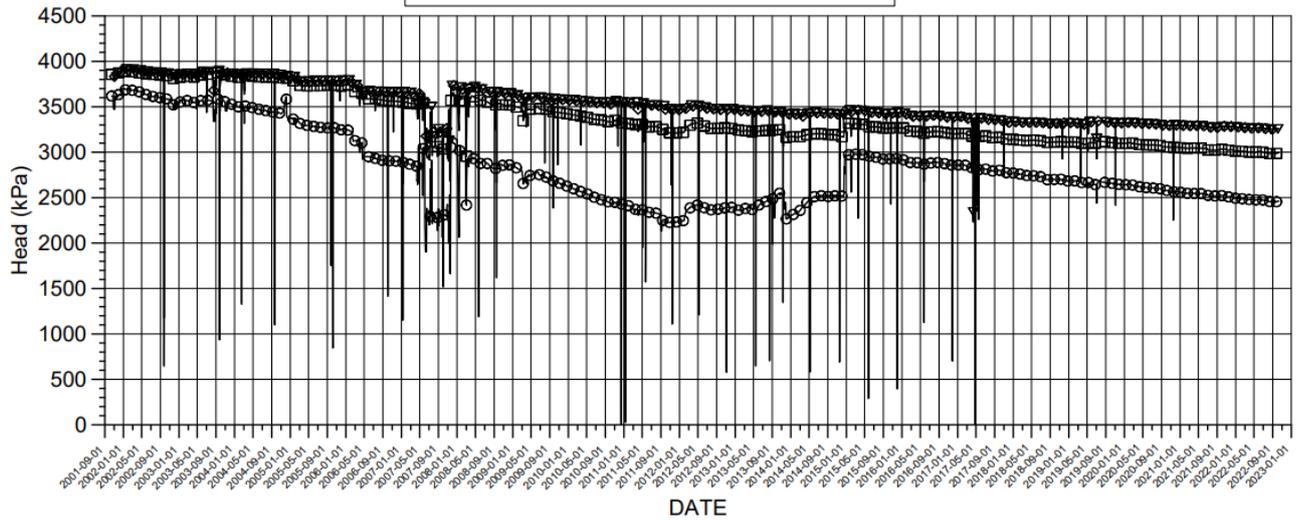
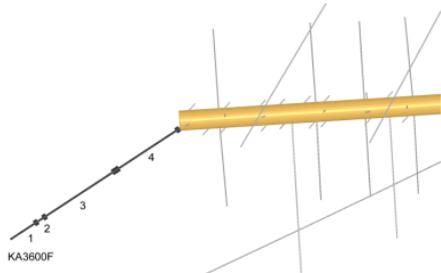
KA3600F PRESSURE HEAD

- Borehole sections**
- ▽ F:1 43 m - 50.1 m
 - ◇ F:2 40.5 m - 42 m
 - F:3 20 m - 39.5 m
 - F:4 3.4 m - 18 m

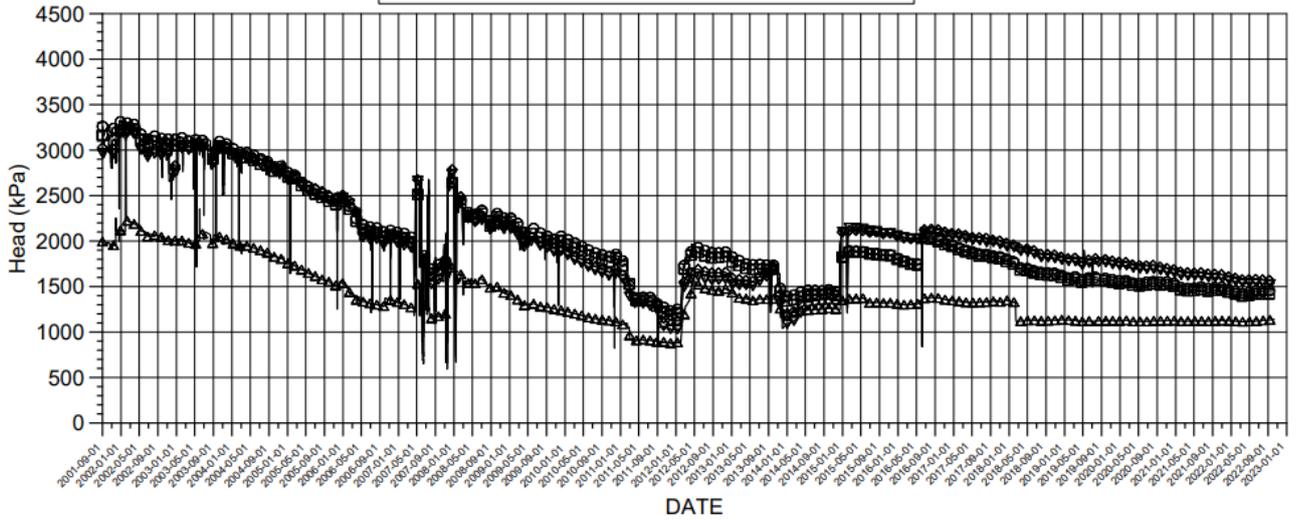
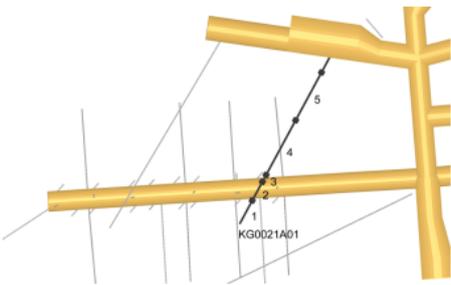
KG0021A01 PRESSURE HEAD

- Borehole sections**
- ▽ A01:1 42.5 m - 48.82 m
 - ◇ A01:2 37 m - 41.5 m
 - A01:3 35 m - 36 m
 - A01:4 19 m - 34 m
 - △ A01:5 5 m - 18 m

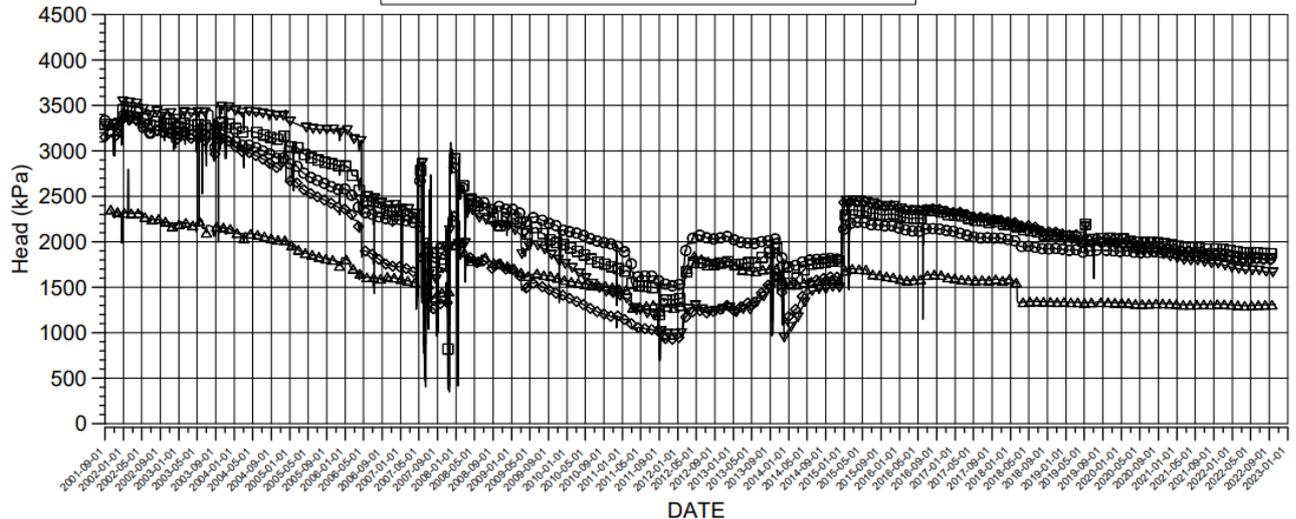
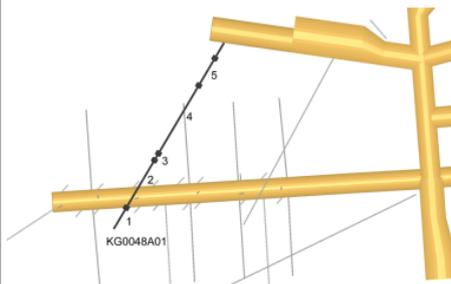
KG0048A01 PRESSURE HEAD

- Borehole sections**
- ▽ A01:1 49 m - 54.69 m
 - ◇ A01:2 34.8 m - 48 m
 - A01:3 32.8 m - 33.8 m
 - A01:4 13 m - 31.8 m
 - △ A01:5 5 m - 12 m

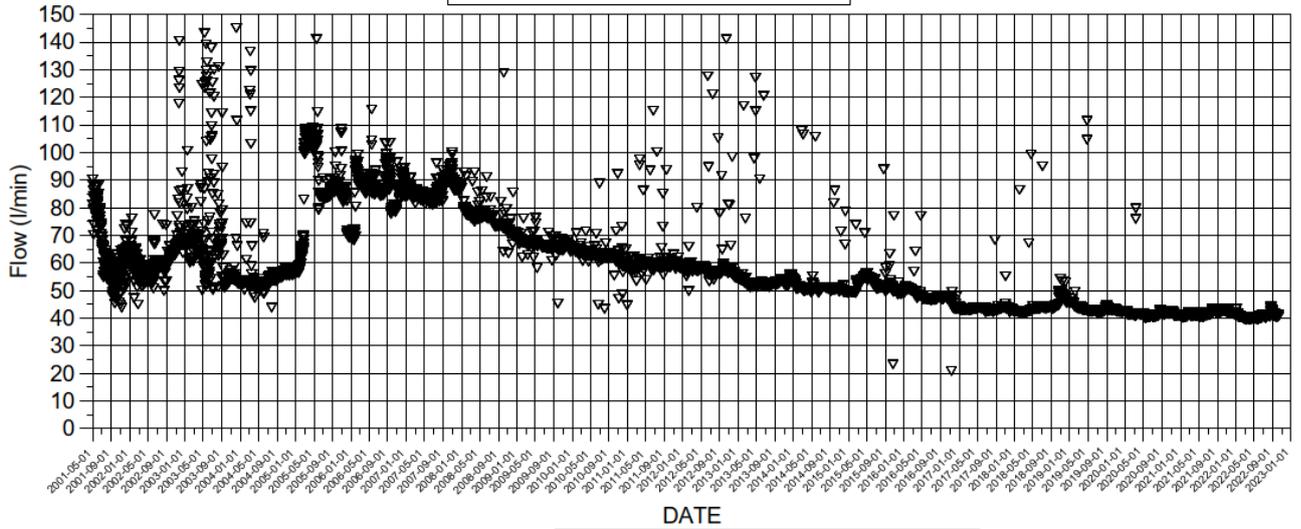
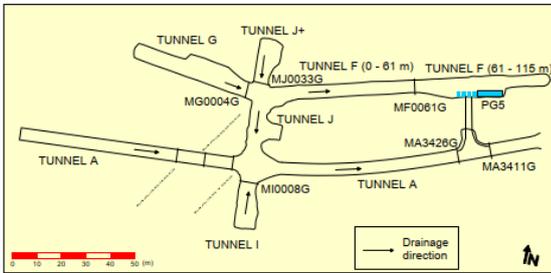
MA3411G WEIR FLOW

- Events**
- Start backfilling of section I 2001-09-03
 - Stop backfilling of section I 2001-11-20
 - Casting of inner plug finalized 2001-12-19
 - Start backfilling of section II 2003-04-29
 - Stop backfilling of section II 2003-06-27
 - Casting of outer plug finalized 2003-09-11
 - Packer failure of KA3573A:3 2006-04-18
 - Start drilling of Fine Sealing Project 2007-03-12
 - Start grouting of Fine Sealing Project 2007-11-19
 - Excavation start of TASS tunnel 2007-12-11
 - Excavation stop of TASS tunnel 2008-12-18
 - Demolition work start Section II December 2010
 - Demolition work Section II finalized 2011-12-15
 - Replacement of packers Section II December 2014

▽ WEIR MA3411G

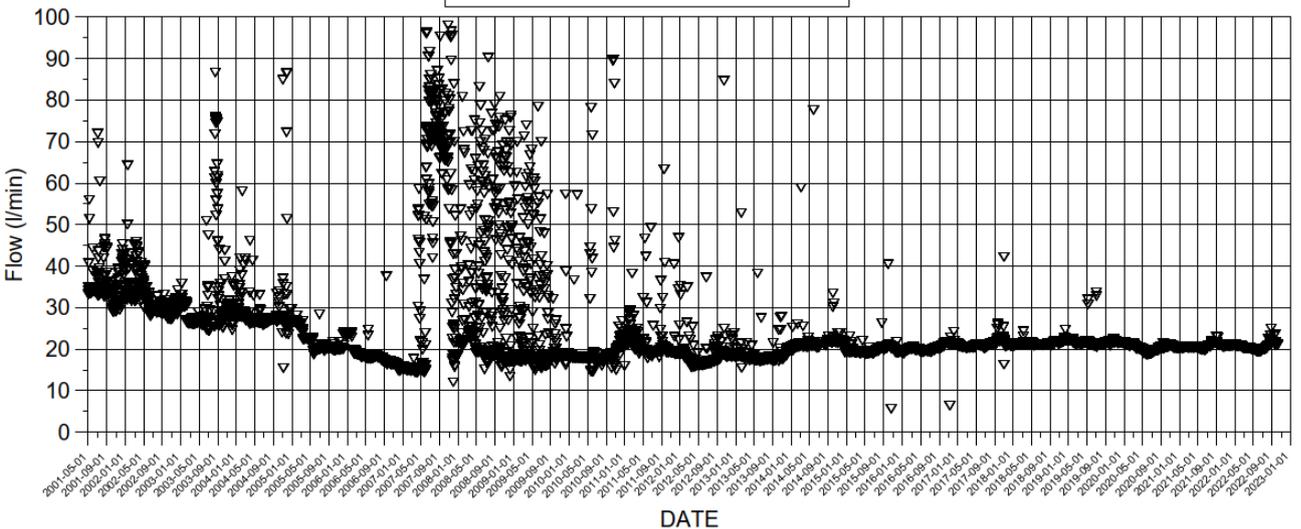
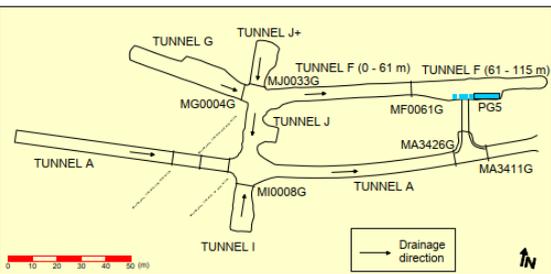
MA3426G WEIR FLOW

▽ WEIR MA3426G

The weir MA3426G measures the flow rates from the south part of tunnel J and tunnel at chainage 3426 – 3514 m. Until December 2003 the in-leaking amounts from tunnel section 3515 – 3600 was included in the presented flow rate. The in-leaking water in tunnel I is included in this weir's flow rate.

The flow rate in MA3426G has been extremely high during the period June until November 2007. This is due to that in-leaking water from the new boreholes KI0010B01 and KI0016B01 together with the water previously measured in MI0008G is led to MA3426G. A single rate measurement 2007-10-18 gives a flow rate from KI0010B01 of 44 L/min and from KI0016B01 of 7 L/min.

The pre-investigations for TASS resulted in major in-leaking amounts through the three long core holes drilled in the planned direction of TASS. During this period the in-leaking accumulated initial flow rates from the three boreholes was approximately 230 L/min, but the overall flow rate during the period until they were grouted was approximately 65 L/min which is the increase of flow in weir MA3426G where the water was directed.

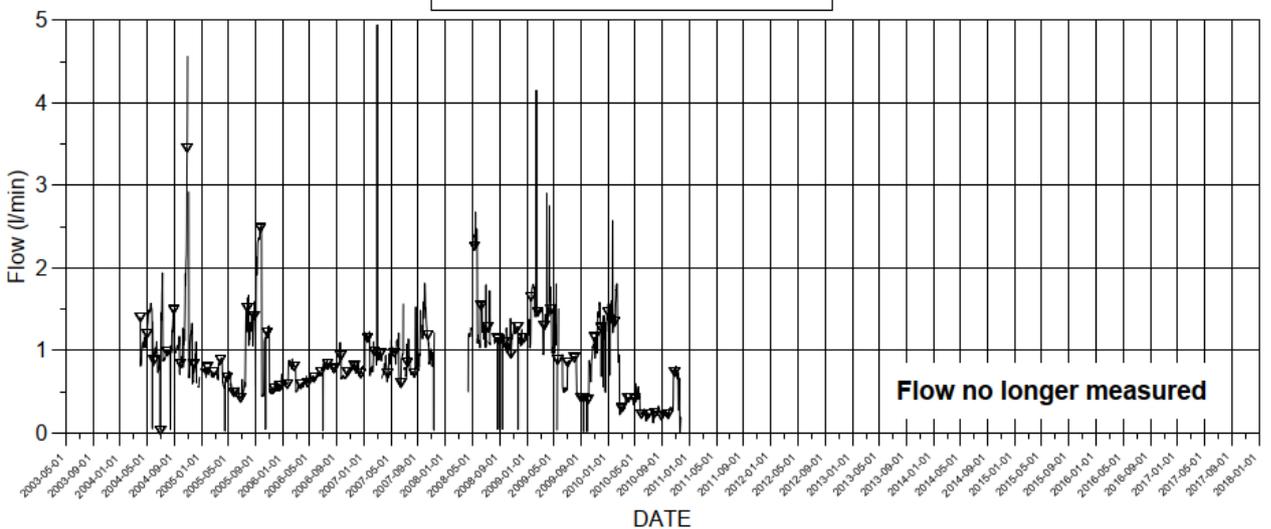
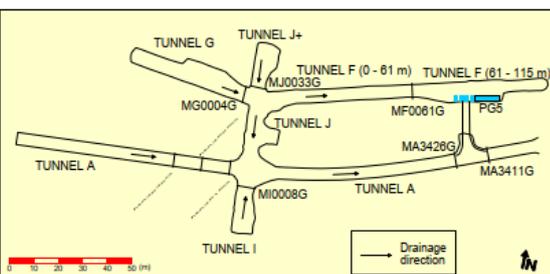
MA3525G WEIR FLOW

▼ WEIR MA3525G

In December 2003 three new flow measurement weirs were constructed in the A-tunnel outside Section II plug. They are called MA3515G, MA3525G and MA3535G (in operation 2003-12-10). The water from these three weirs is led to MA3426G. Continuous measurement is done since the spring of 2004. Manual measurements done in December 2003 show a flow rate for MA3515G of 0.175 – 0.19 L/min, for MA3525G of 1.15 – 1.25 L/min and for MA3535G of 0.38 – 0.45 L/min. The increase of flow during October 2004 was caused by yet unknown causes, but it is believed that the final grouting that was done around Plug 2 October 8, 2004 is the cause to it. The flow rates have since then decreased again.
