## TR-12-09

### Analysis of SKB MiniCan Experiment 3

Nick Smart, Andy Rance, Bharti Reddy, Paul Fennell, AMEC

November 2012

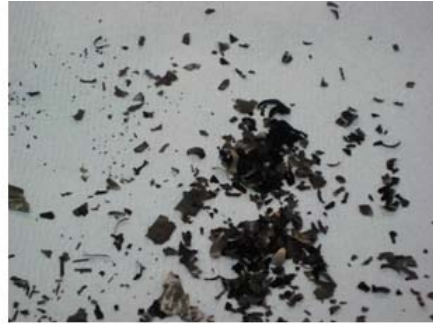
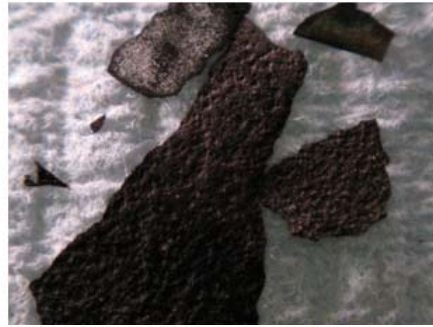
Figure 7-28. Black flakes from support table.

As the support table dried out, the black coating material started to flake off. Examples of the appearance of this material are shown in Figure 7-28 and 7-29. In close up it can be seen that the surface had dried to leave some white fluffy material on the surface. Raman analysis of flakes from the table (Figure 7-30 and 7-31) gave indications of  $\text{Fe}_2\text{O}_3$ , carbonate, graphitic carbon and iron sulphide, and generally the material was amorphous.

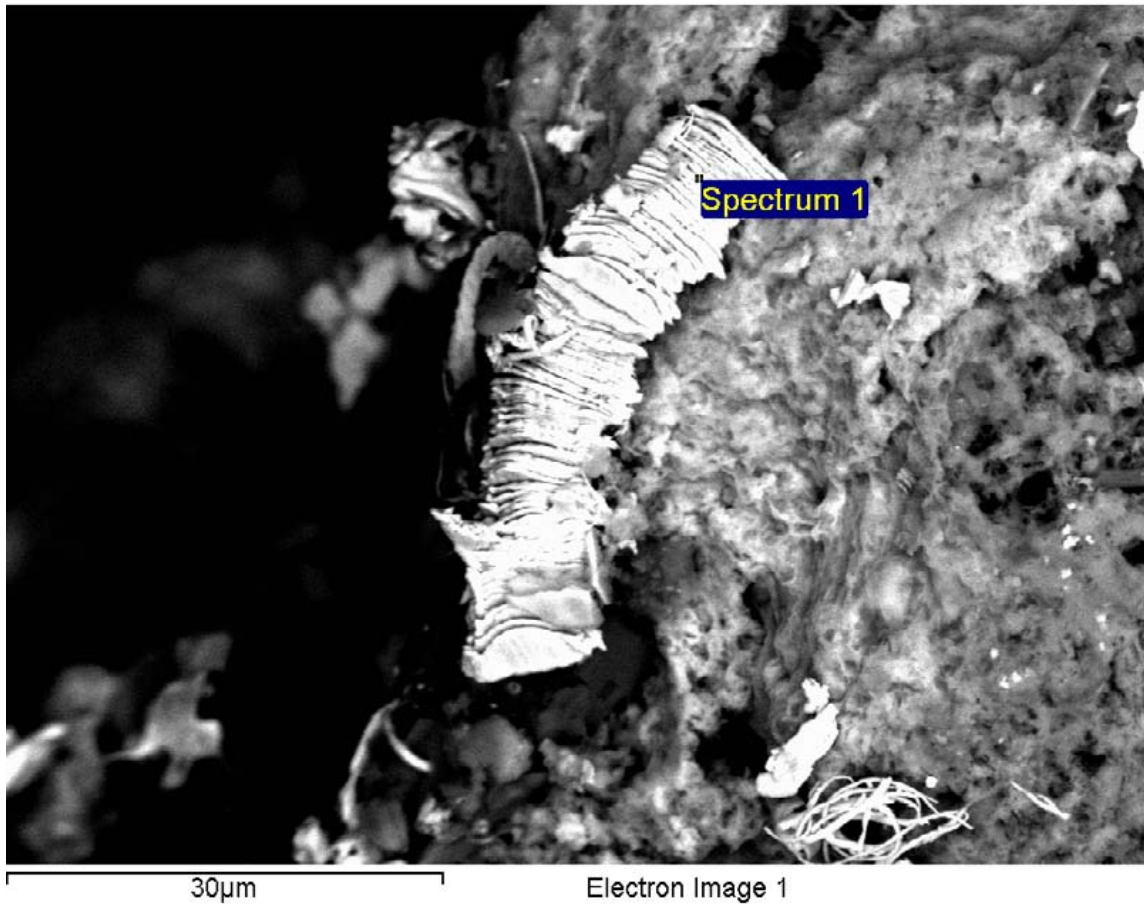
Figure A-178. Inner surface of copper canister around the top hole and EDX analysis at position of Spectrum 1

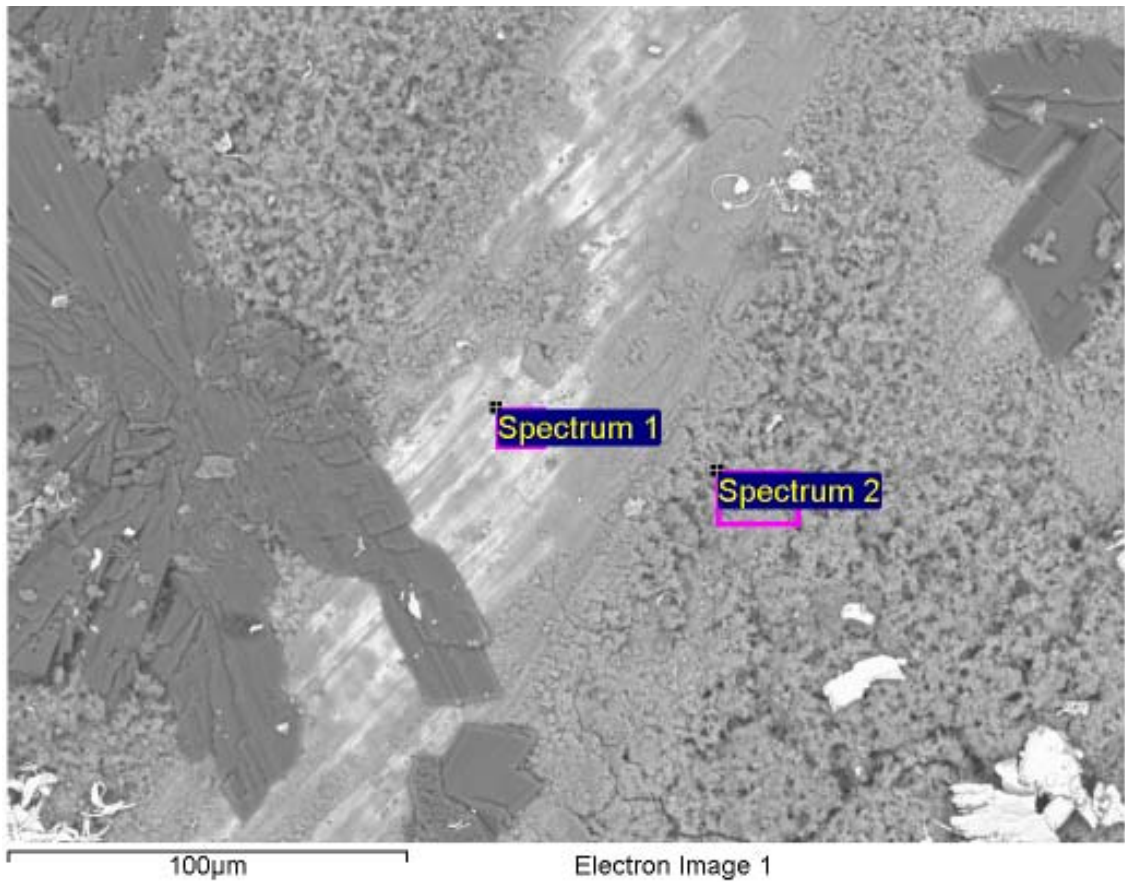
**Figure A-195. Inner surface of copper canister around the top hole and EDX analysis at position of Spectrum 1**

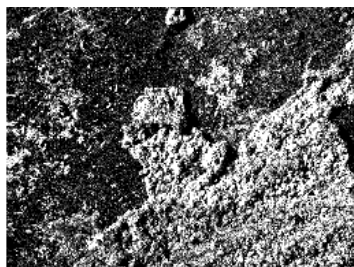
Figure A-215. Elemental maps for outer surface of copper canister around the top hole

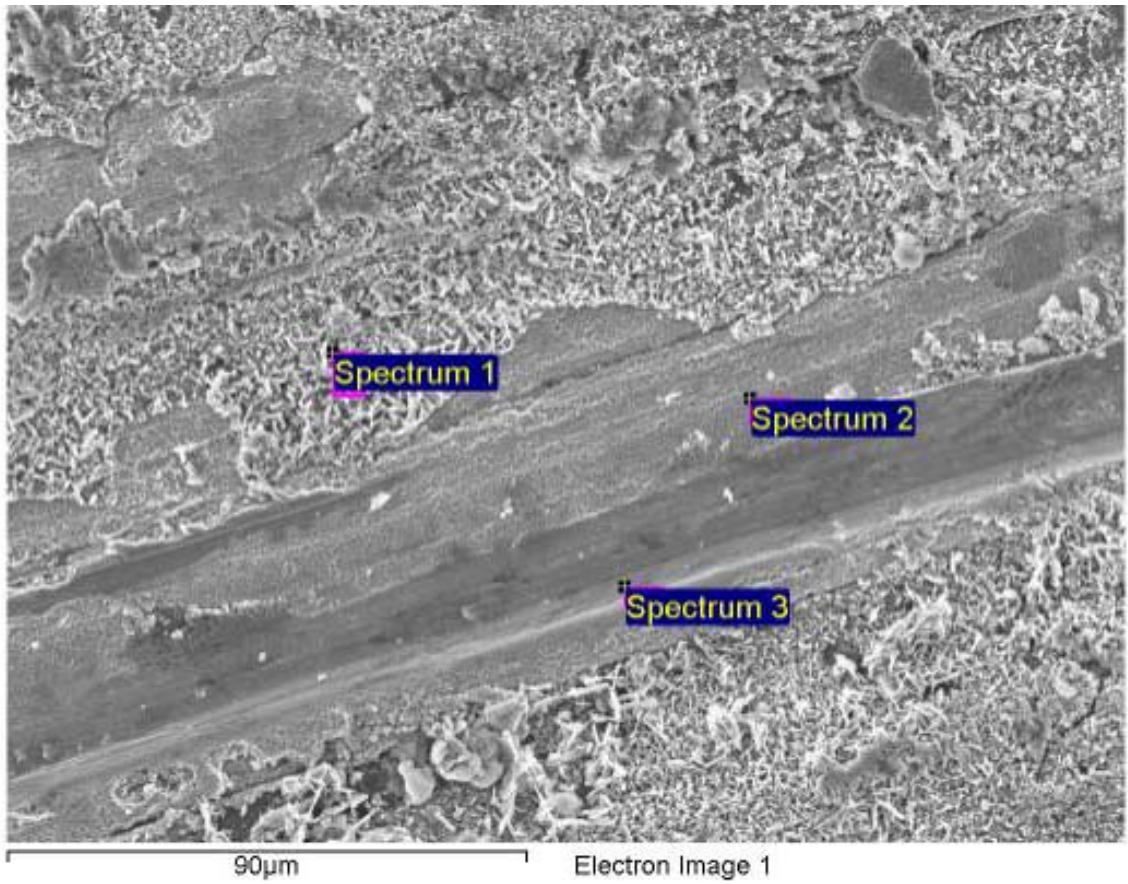
Figure A-318. Outer surface of copper canister and EDX analysis at position of Spectrum 1
